**ANNE ARUNDEL COUNTY
ILLICIT DISCHARGE DETECTION
AND ELIMINATION
2015 ANNUAL REPORT**

PERMIT NUMBER MD0068306

January 12, 2016

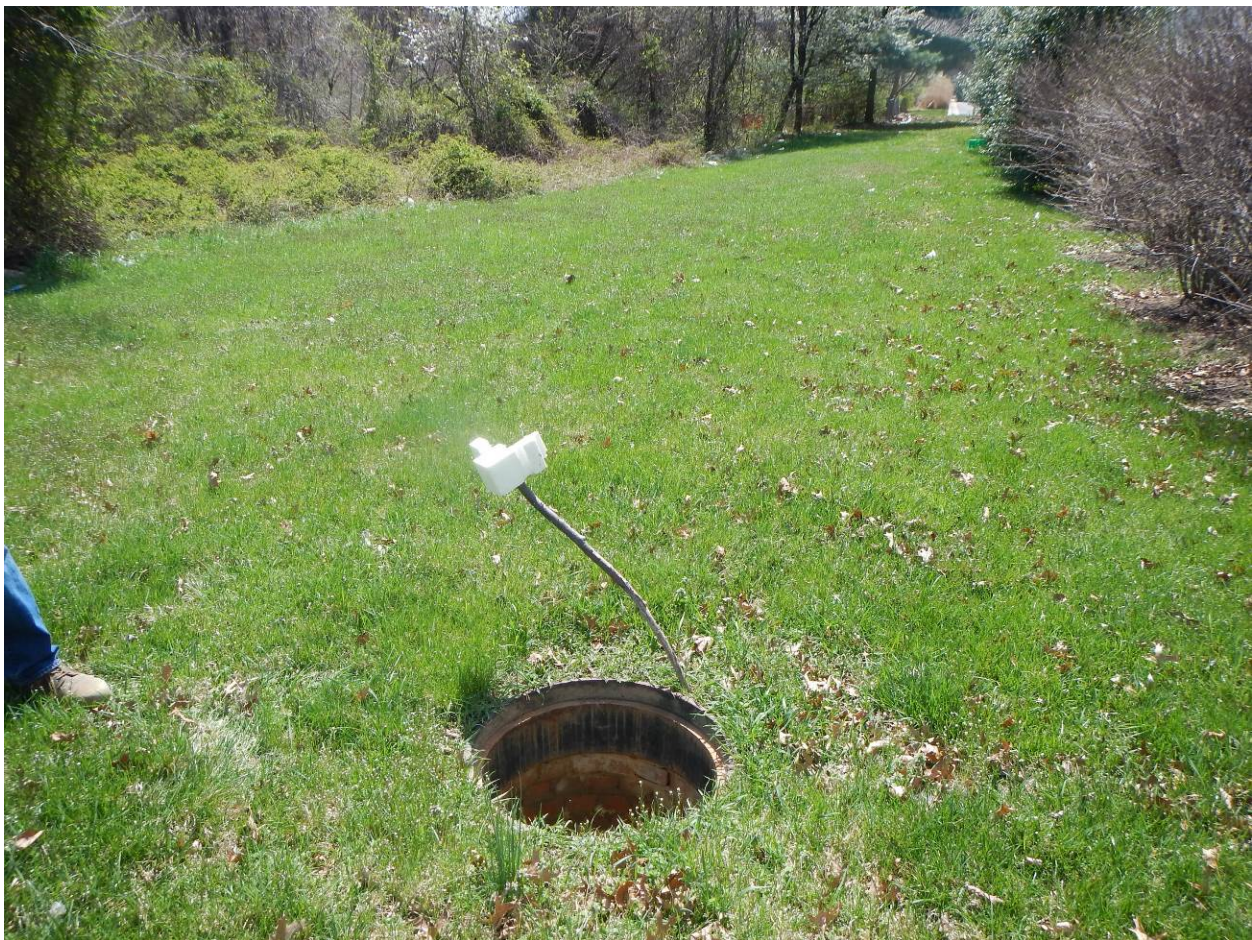
A LimnoTech field team discovered an open stormwater manhole behind the building (unoccupied) at the above address (Figure 1). An open hole in the ground presents a significant safety hazard for the public, although someone has attempted to create a make-shift marker to alert people of the opening. An area map, indicating the location of the missing manhole cover, is provided in Figure 2.

Figure 1. Stormwater system manhole found open

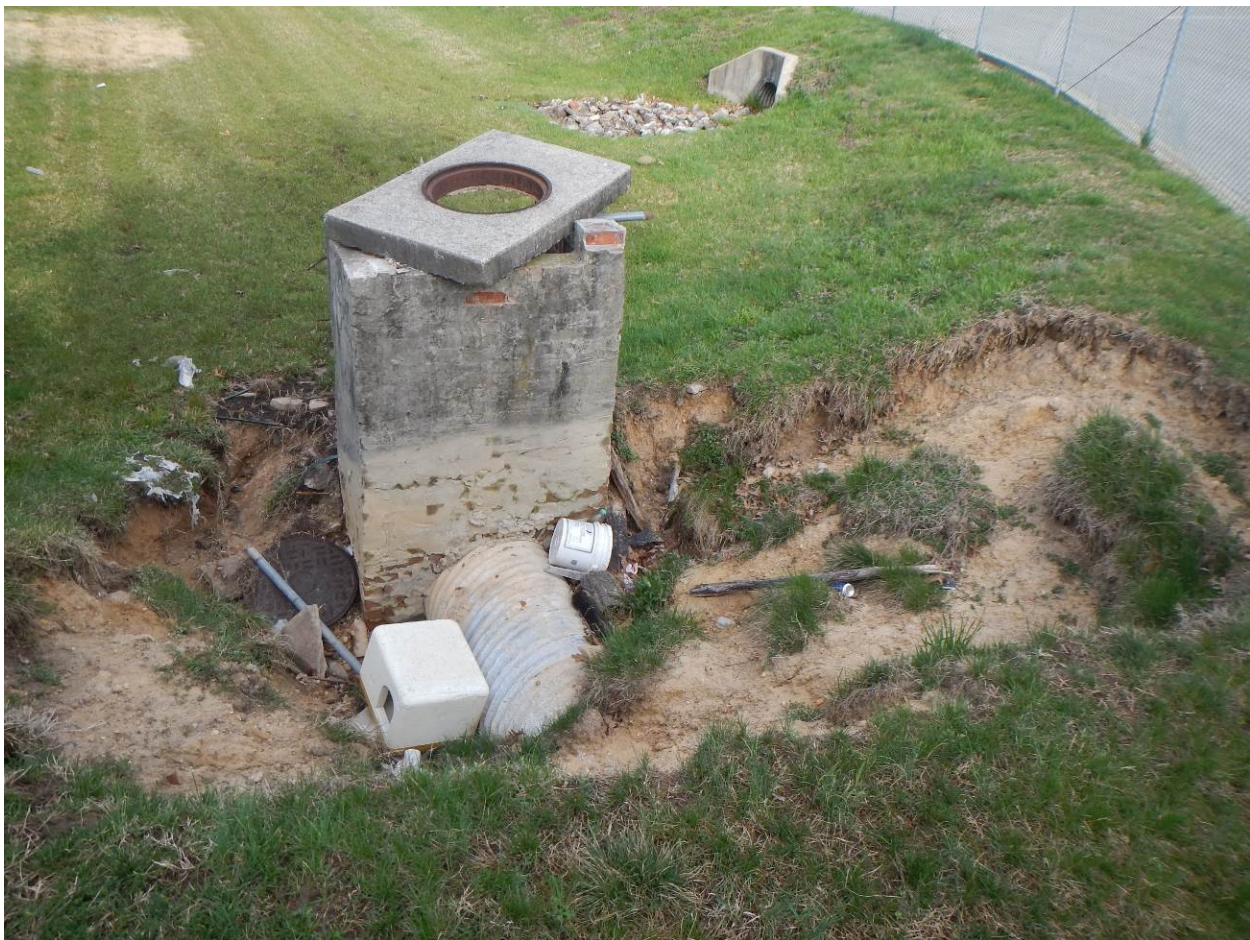
A LimnoTech field team discovered unsafe conditions with a stormwater detention basin riser structure behind the Best Buy store at the above address. The field crew inspected the device and photo-documented the extent of the destruction of the facility. The top of the riser was dislocated and the manhole cover was lying on the ground at the base (Figure 1). The embankment behind the riser shows signs of extensive erosion (Figure 2), which suggests that the facility may no longer be properly functioning. The eroded area has been accumulating debris, also. The device in this condition presents a significant safety hazard for the public, although the fence may deter many trespassers. An area map, indicating the location of the damaged riser, is provided in Figure 3.

Figure 1. Stormwater riser structure condition showing dismantled top

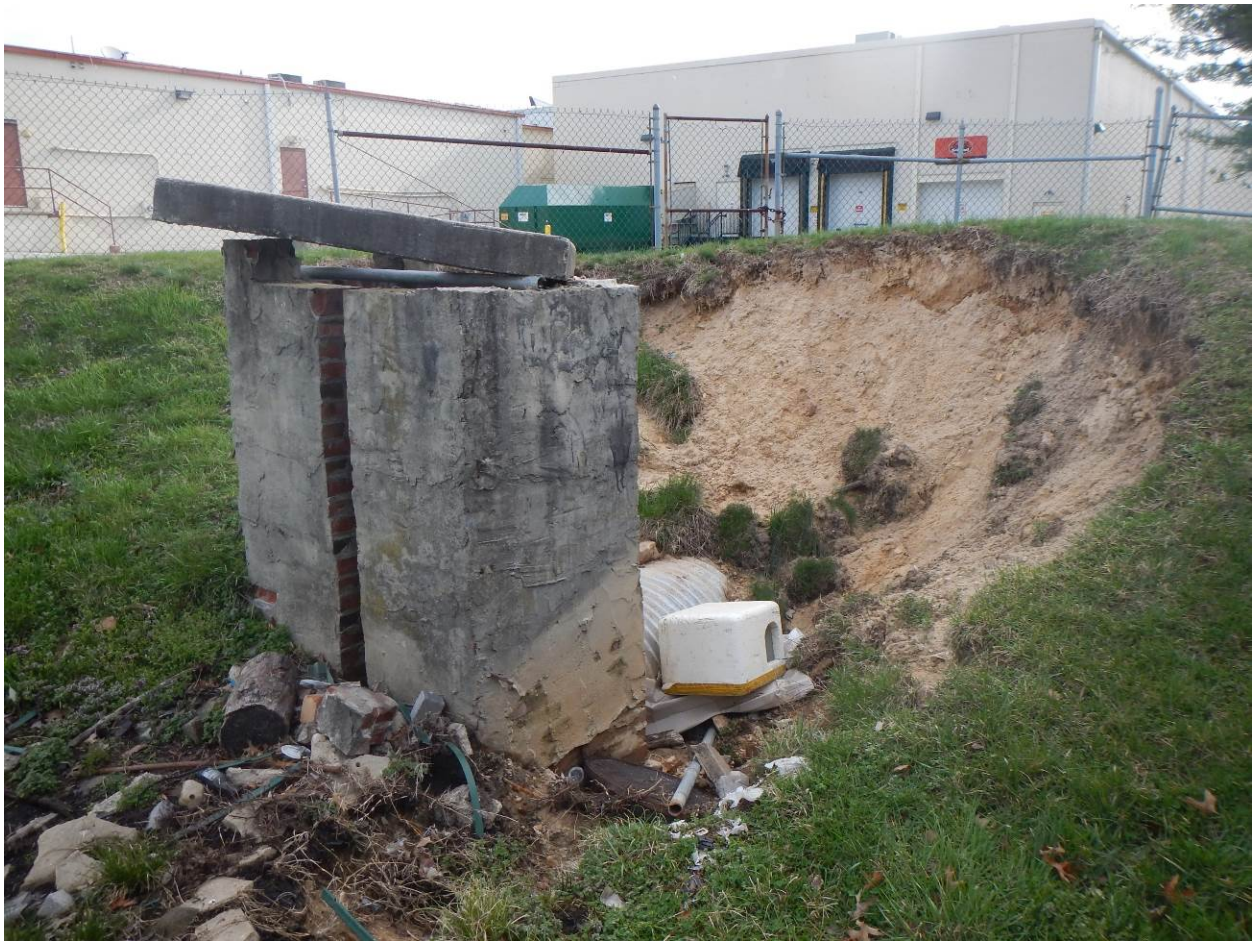
Figure 2. View from the detention basin showing the extent of erosion on the rear bank

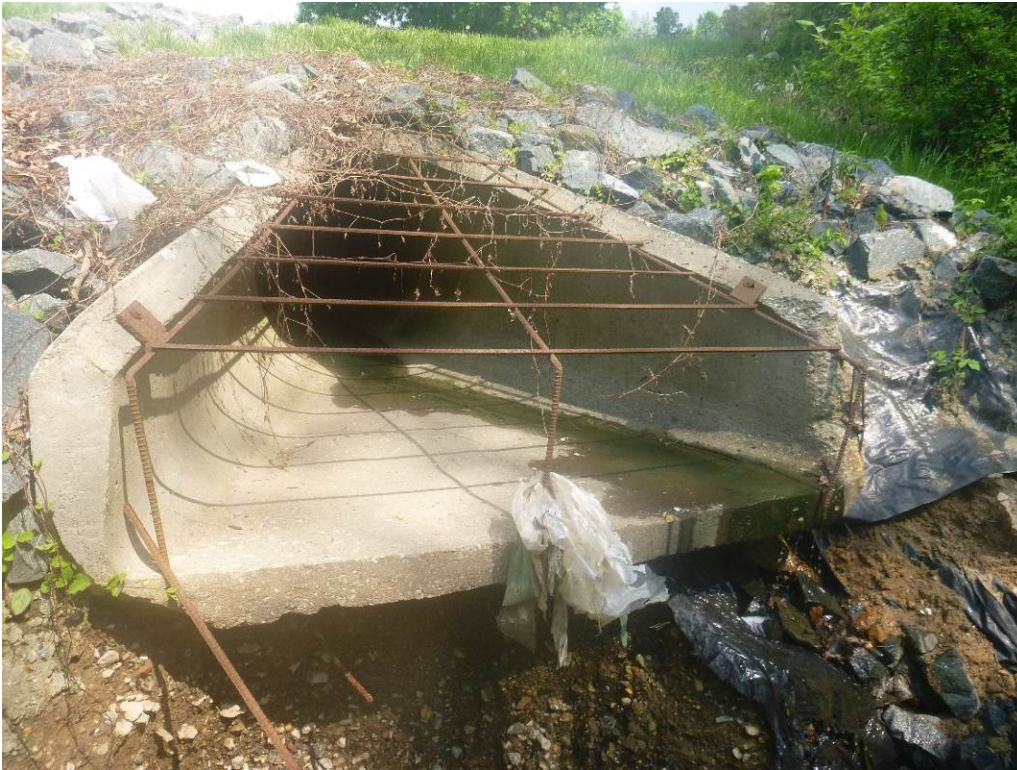
Figure 1. Outfall F09F5O001

Table 1. Chemical test results (red values indicate above action level concentration) for outfall F09F5O001.			
	Action Level	Test 1 Result	Test 2 Result
pH	≤ 6.5 or ≥ 8.5	7.35	N.T.
Temperature (°F)		N.T.	N.T.
Ammonia (mg/l)	≥ 1	0.0	N.T.
Total Chlorine (mg/l)	≥ 0.4	0.0	N.T.
Detergents (mg/l)	≥ 0.5	0.9	3
Fluoride (mg/l)	≥ 0.75	0.6	N.T.
Phenols (mg/l)	≥ 0.17	0.0	N.T.
Copper (mg/l)	≥ 0.21	0.0	N.T.
N.T. = not tested

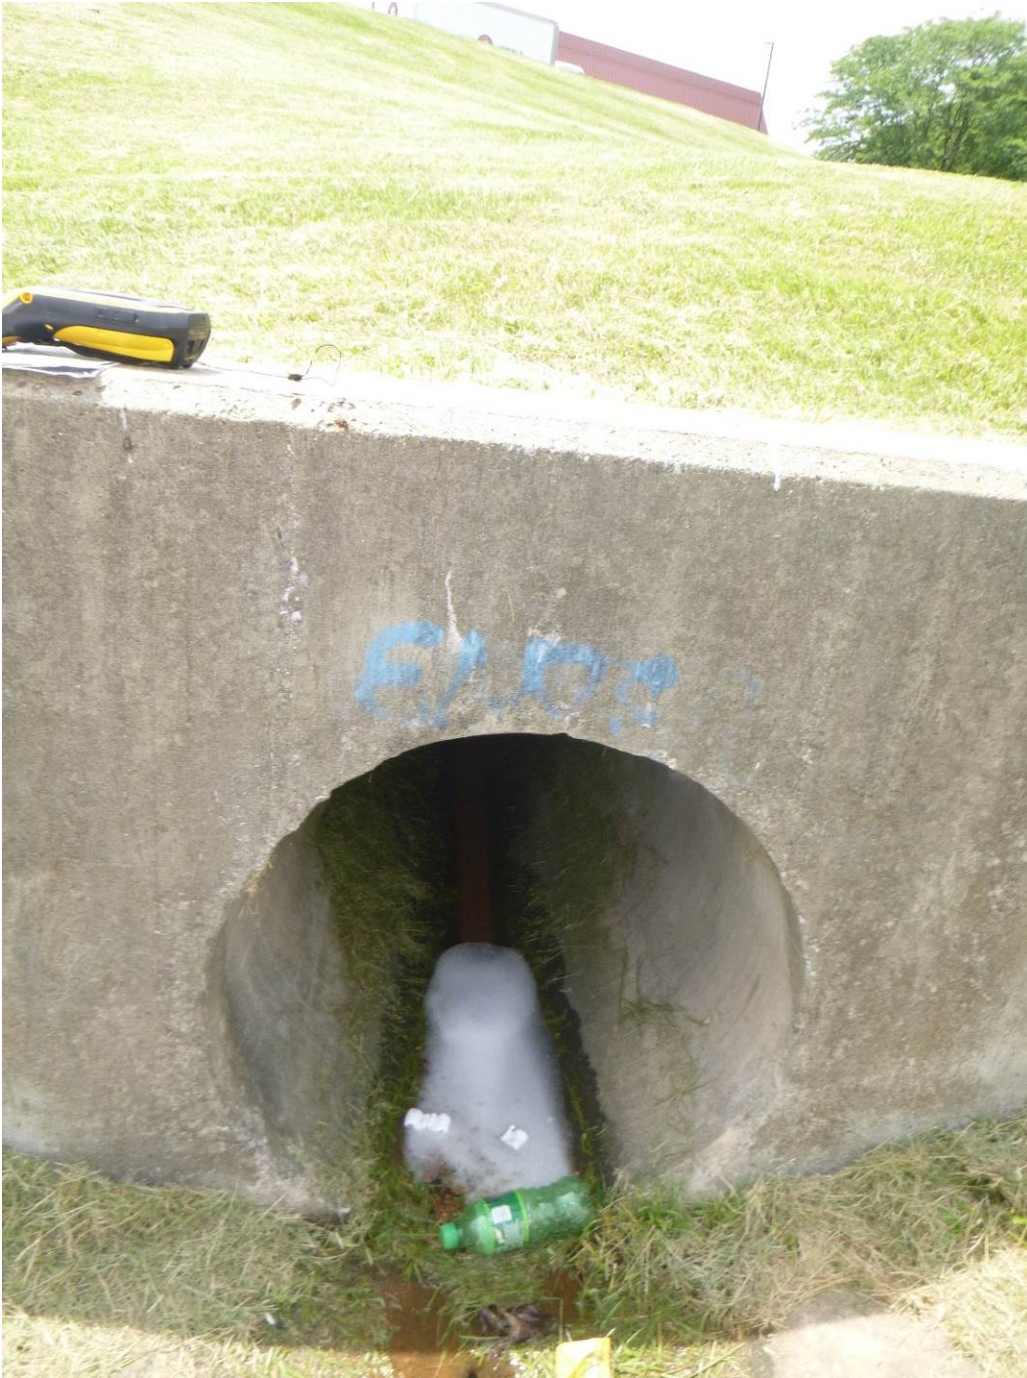
Table 1. Chemical test results (red values indicate above action level concentration) of outfall K02B8O002.			
	Action Level	Test 1 Result	Test 2 Result
pH	≤ 6.5 or ≥ 8.5	7.06	7.43
Temperature (°F)		70.7	71.8
Ammonia (mg/l)	≥ 1	0.0	0.0
Total Chlorine (mg/l)	≥ 0.4	0.0	0.0
Detergents (mg/l)	≥ 0.5	0.75	2.00
Fluoride (mg/l)	≥ 0.75	0.0	0.0
Phenols (mg/l)	≥ 0.17	0.0	0.0
Copper (mg/l)	≥ 0.21	0.0	0.0

Figure 1. Outfall K02B8O002 with suds, May 28, 2015

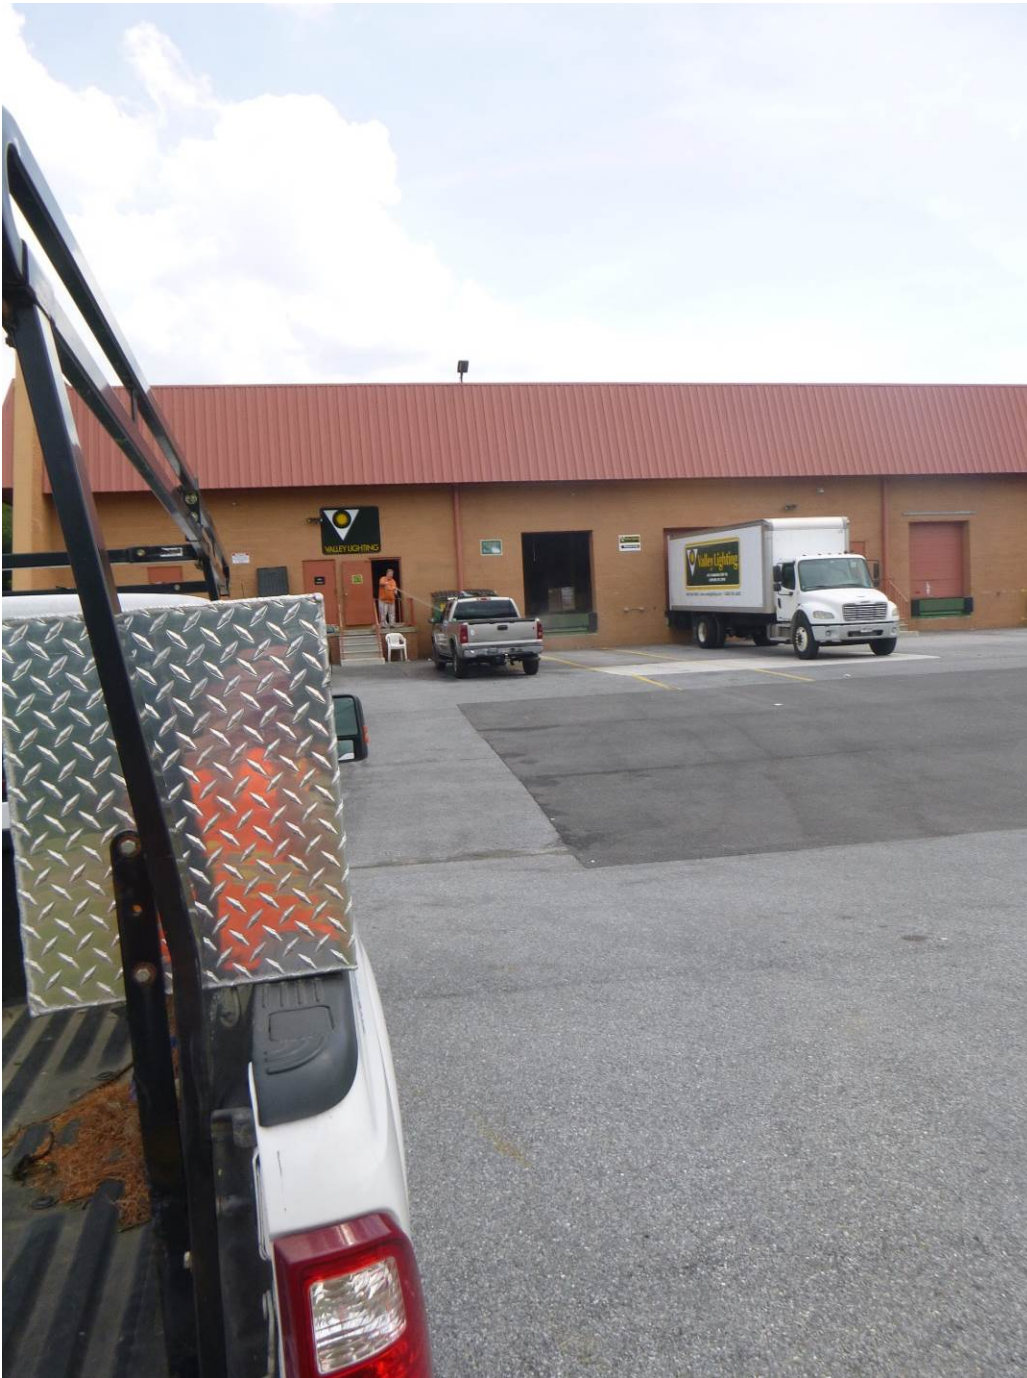
Figure 2. Washdown activity observed at 601-611 Hammonds Ferry Rd. on May 28, 2015

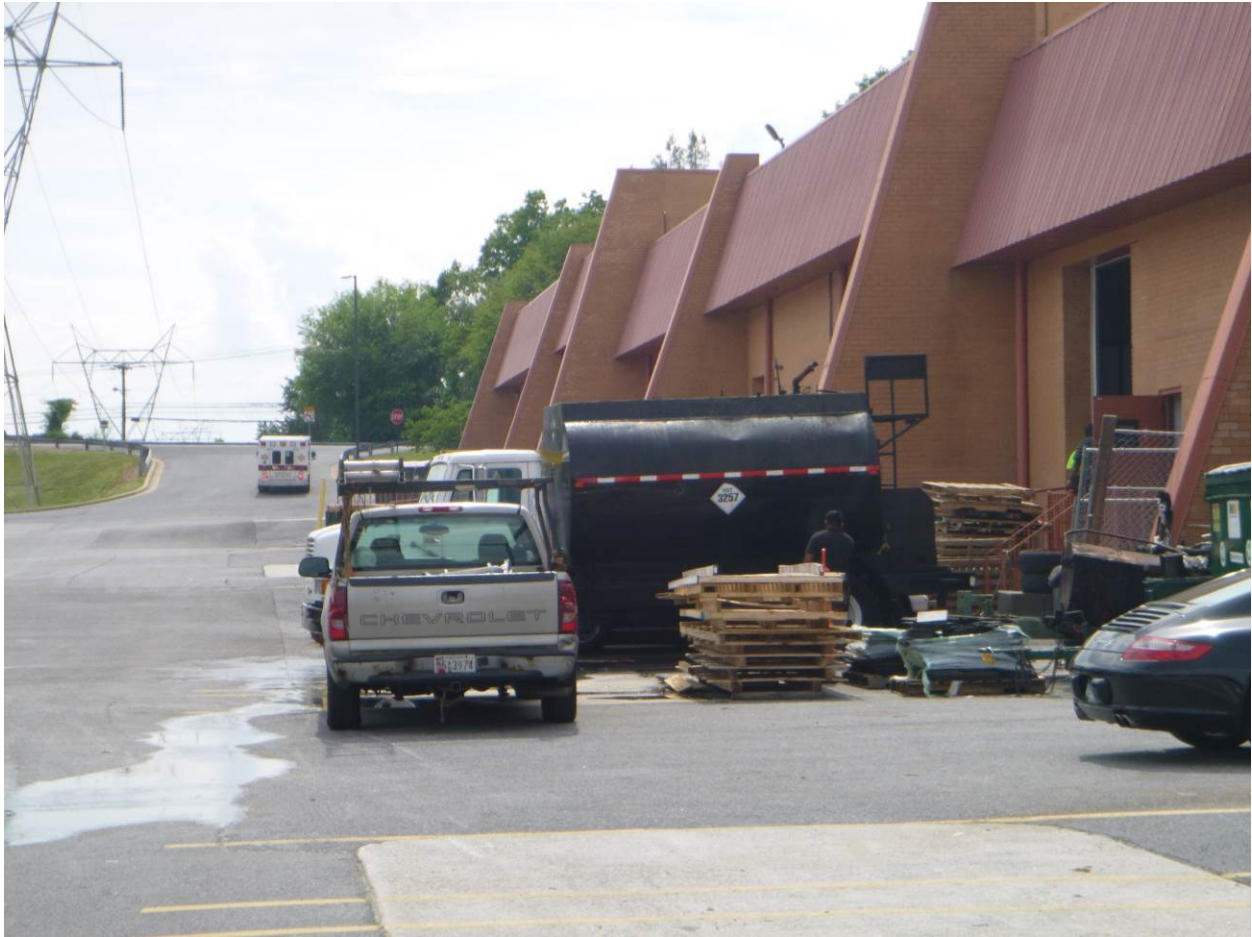
Figure 3. Washdown activity observed at 601-611 Hammonds Ferry Rd. on May 28, 2015

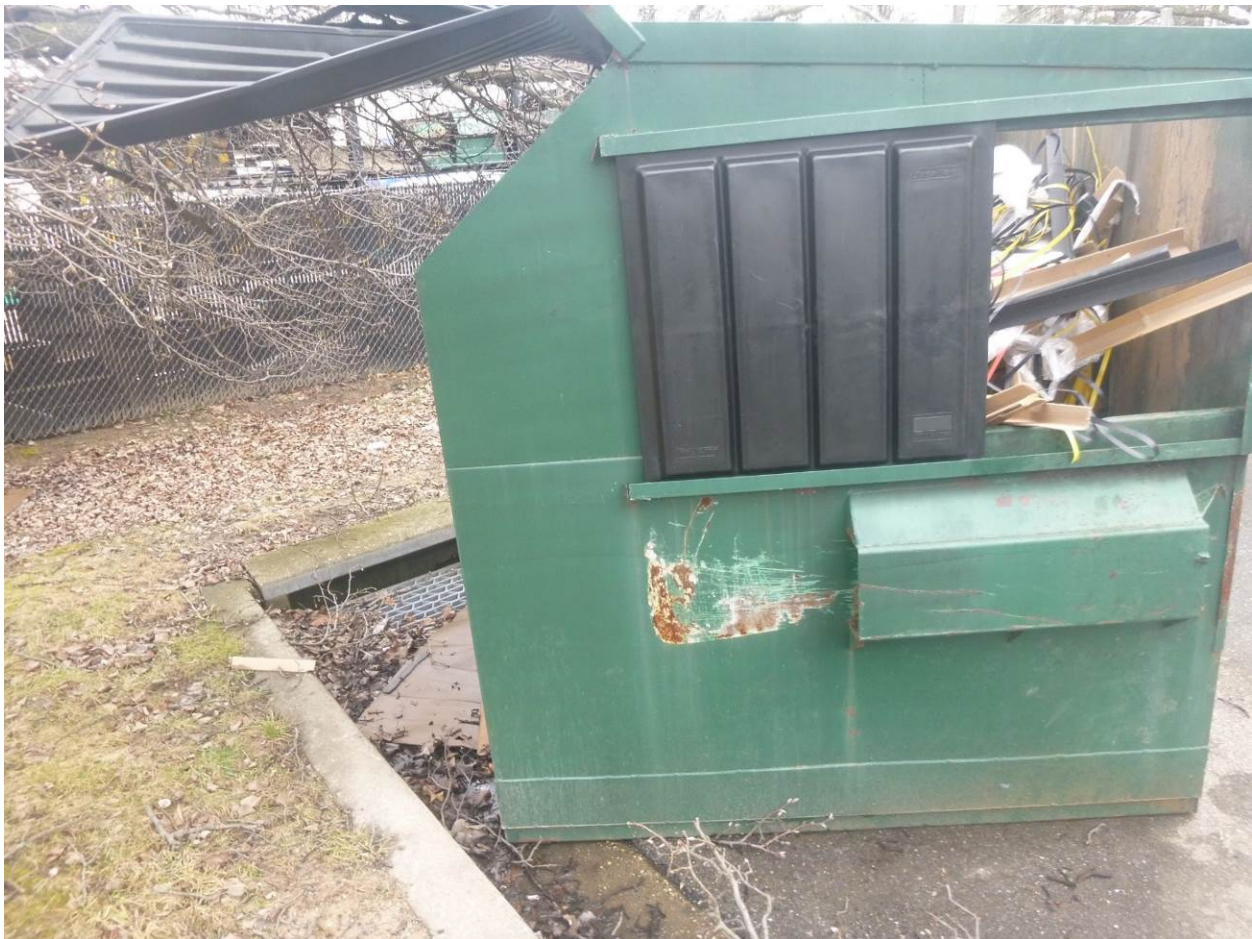
A Versar field team discovered an open dumpster behind the Royal Plus building at the above address (Figure 1). The field crew was unable to determine whether the dumpster was being shared by several businesses. The dumpster had been placed in a corner of the parking lot immediately adjacent to a storm drain inlet. The photographs taken on the day of the visit reveal some debris in the area surrounding the dumpster, which could also enter the storm drain system. An area map, indicating the location of the dumpster, is provided in Figure 2.

Figure 1. Open dumpster placed by a storm drain inlet found behind the Royal Plus building

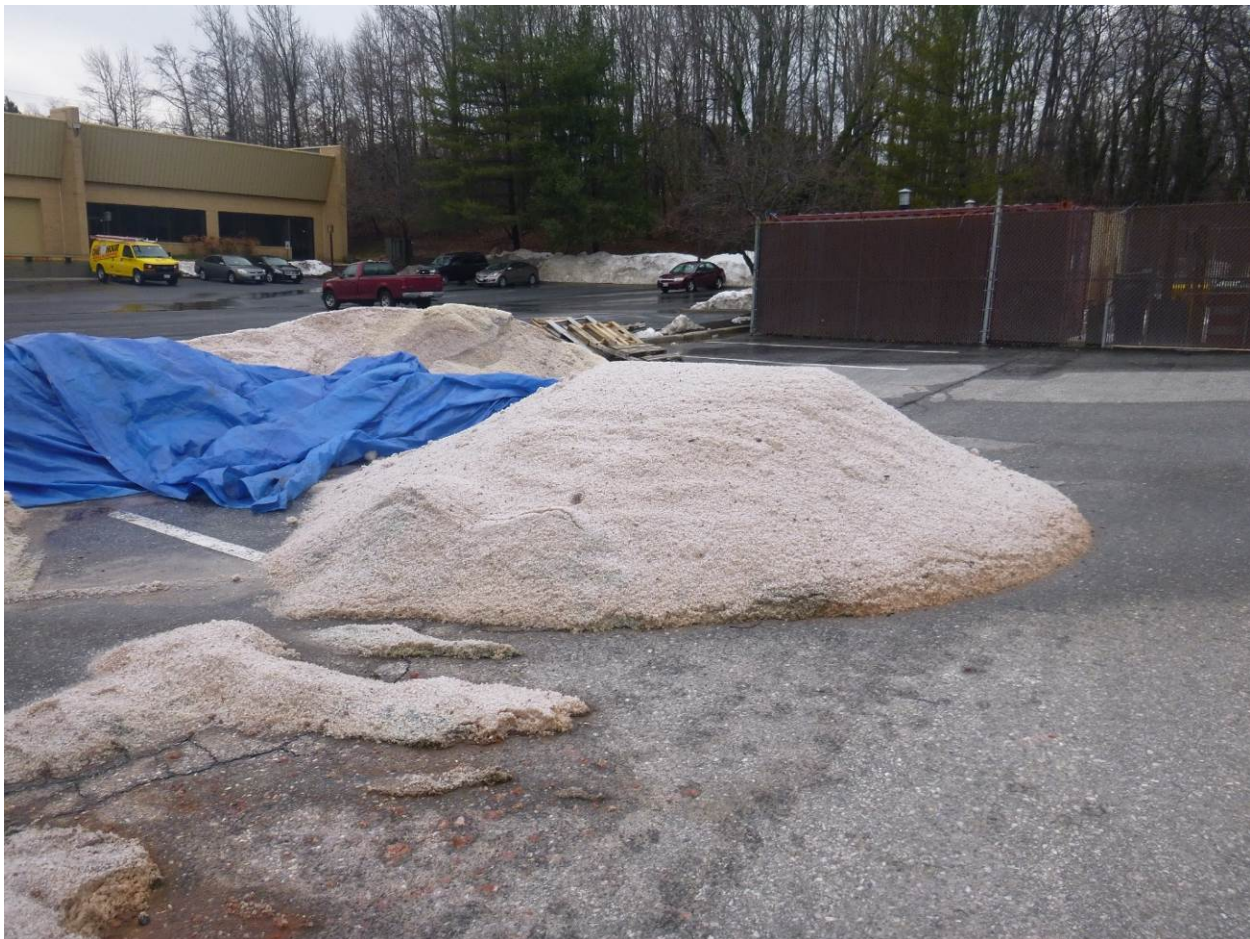
A Versar field team discovered very large, uncovered piles of road salt in the parking lot associated with Stevens Auto Transport (Figure 1). Near the salt piles, the field crew photo-documented a company truck with a snow plow installed on the front (Figure 2). The salt may have been intended, then, for surface treatment as part of snow removal services. The placement of salt on an impervious surface introduces the risk of distribution, by wind or rain, of salt particles and associated nutrients which could wash into adjacent storm drain inlets or open water. An area map, indicating the location of the salt piles, is provided in Figure 3.

Figure 1. Exposed piles of salt found in a parking area associated with Stevens Auto Transport

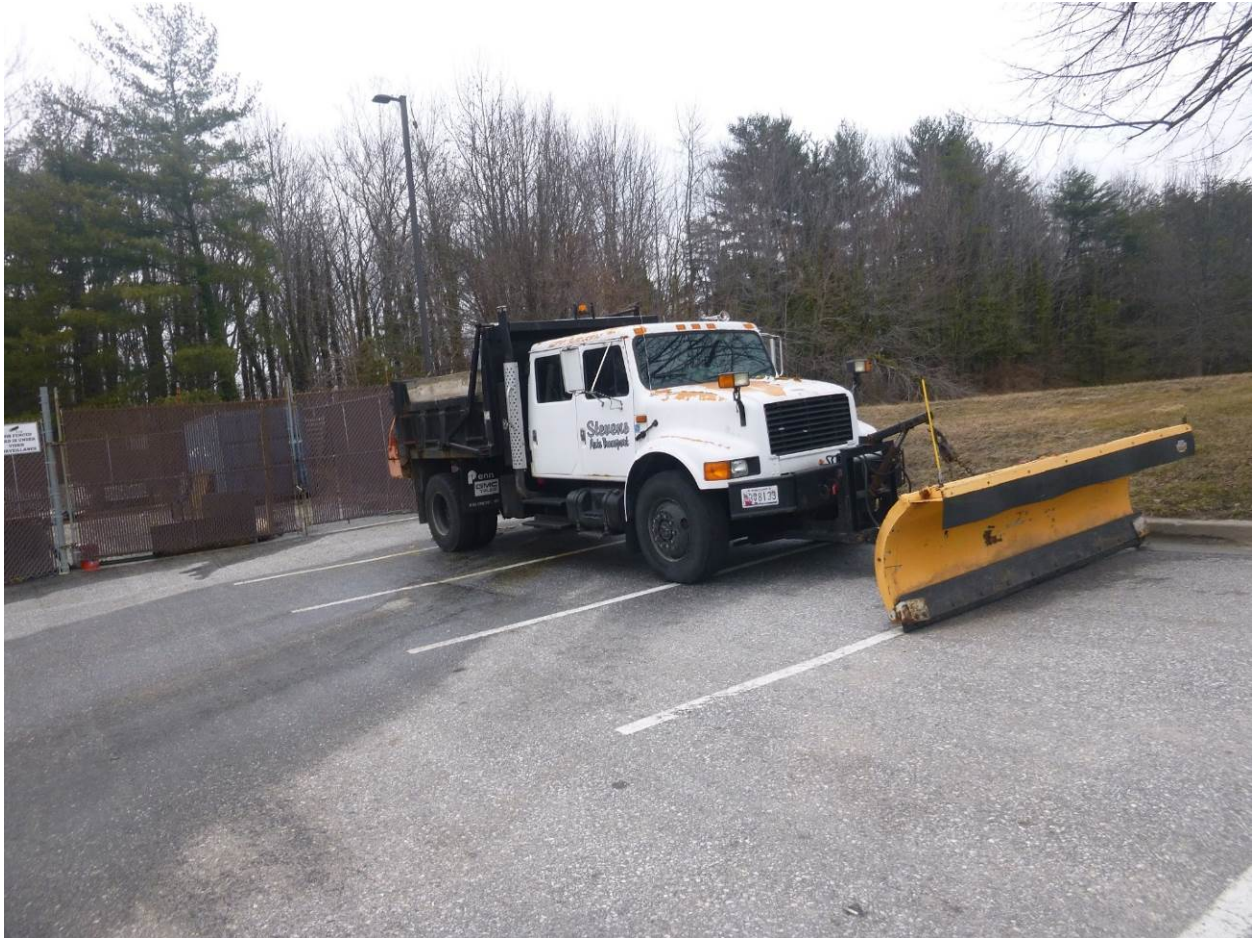
Figure 2. Truck with mounted snow plow, belonging to Stevens Auto Transport, found near the salt piles

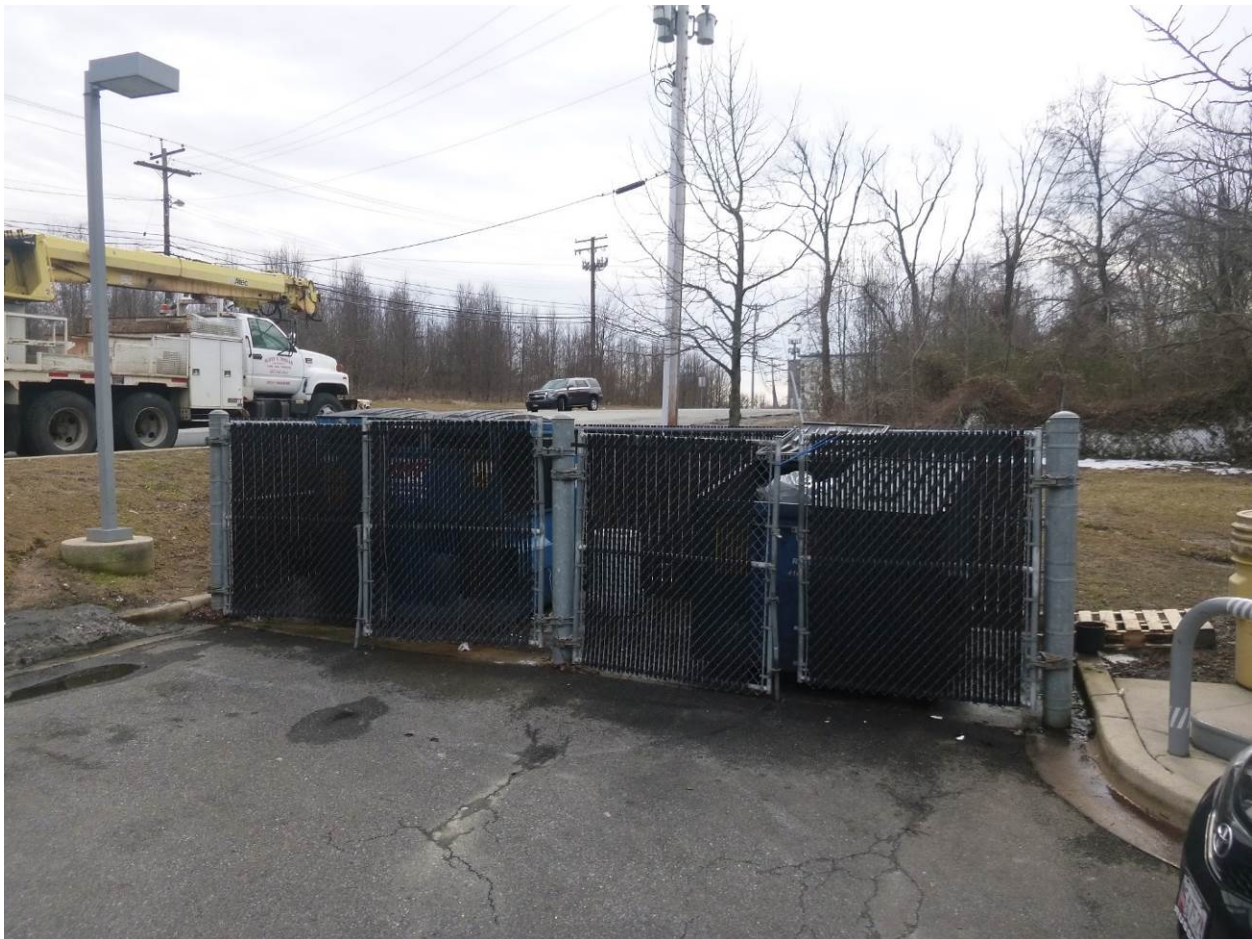
A Versar field team discovered an open dumpster and scattered debris associated with a 7-11 store at the above address. The field crew found one of the dumpsters open and filled with trash (Figure 1). Behind the store, the field crew found a large amount of debris (filled bags, cardboard, and food containers) among the bushes (Figure 2). Debris deposited on the ground may allow trash to blow off-site or leak potentially contaminating contents onto surfaces that could lead to adjacent storm drain inlets or open water. An area map, indicating the location of the open dumpster, is provided in Figure 3.

Figure 1. Open dumpster (right) found in the parking area of the 7-11 store

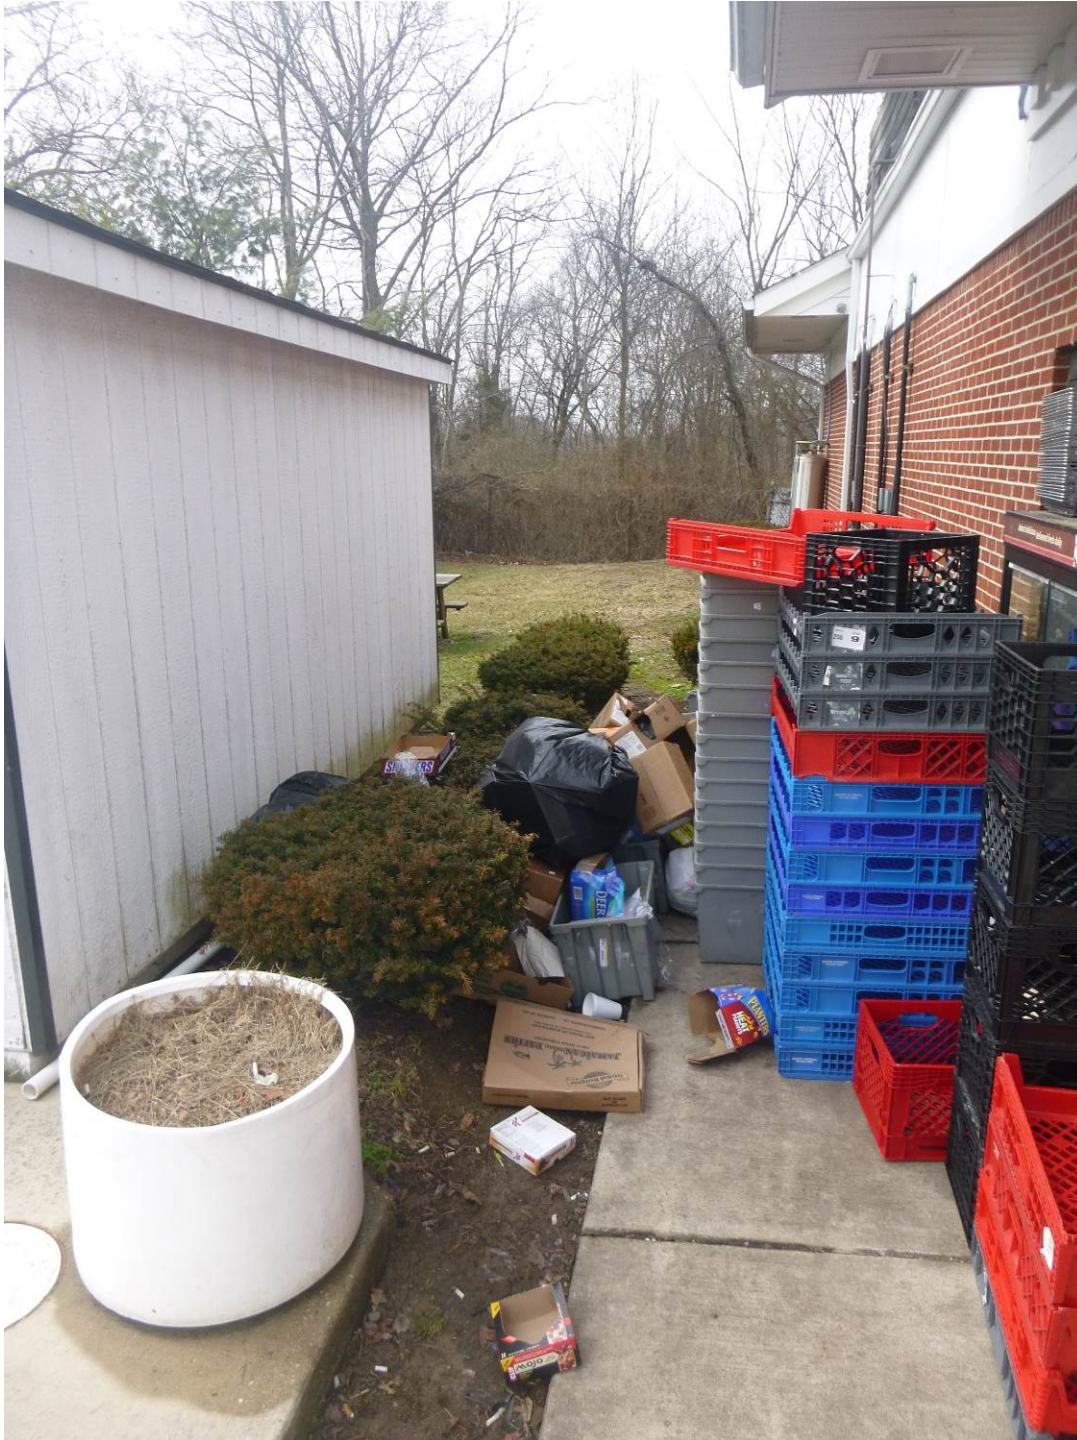
Figure 2. Debris found strewn behind the 7-11 store

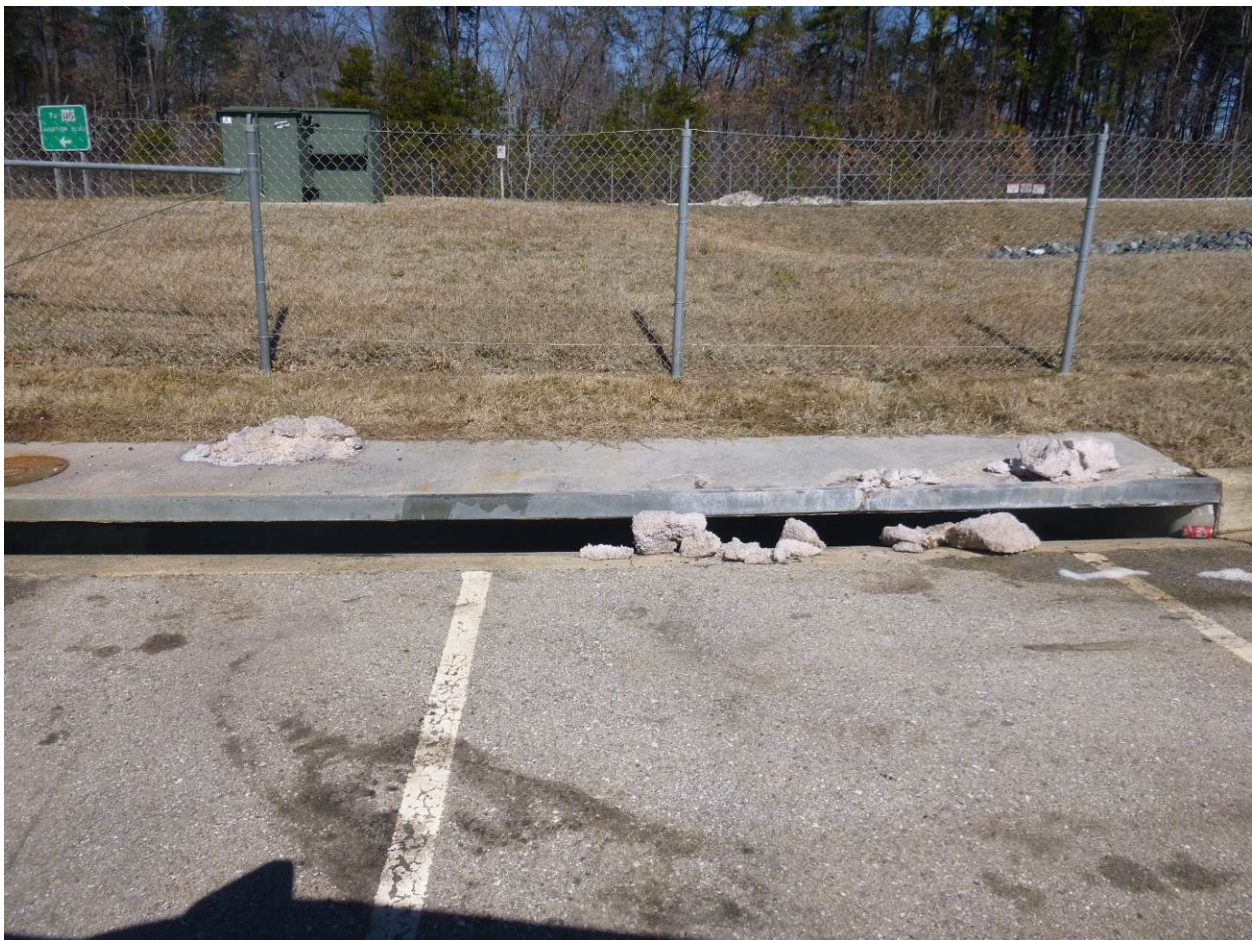
A Versar field team discovered large chunks of road salt at a curb inlet in the parking lot associated with BWI Freight (Figure 1). The placement of salt on an impervious surface introduces the risk of distribution, by wind or rain, of salt particles and associated nutrients which could easily enter the adjacent storm drain inlet. An area map, indicating the location of the salt chunks, is provided in Figure 2.

Figure 1. Road salt found at a curb inlet in a parking area associated with BWI Freight

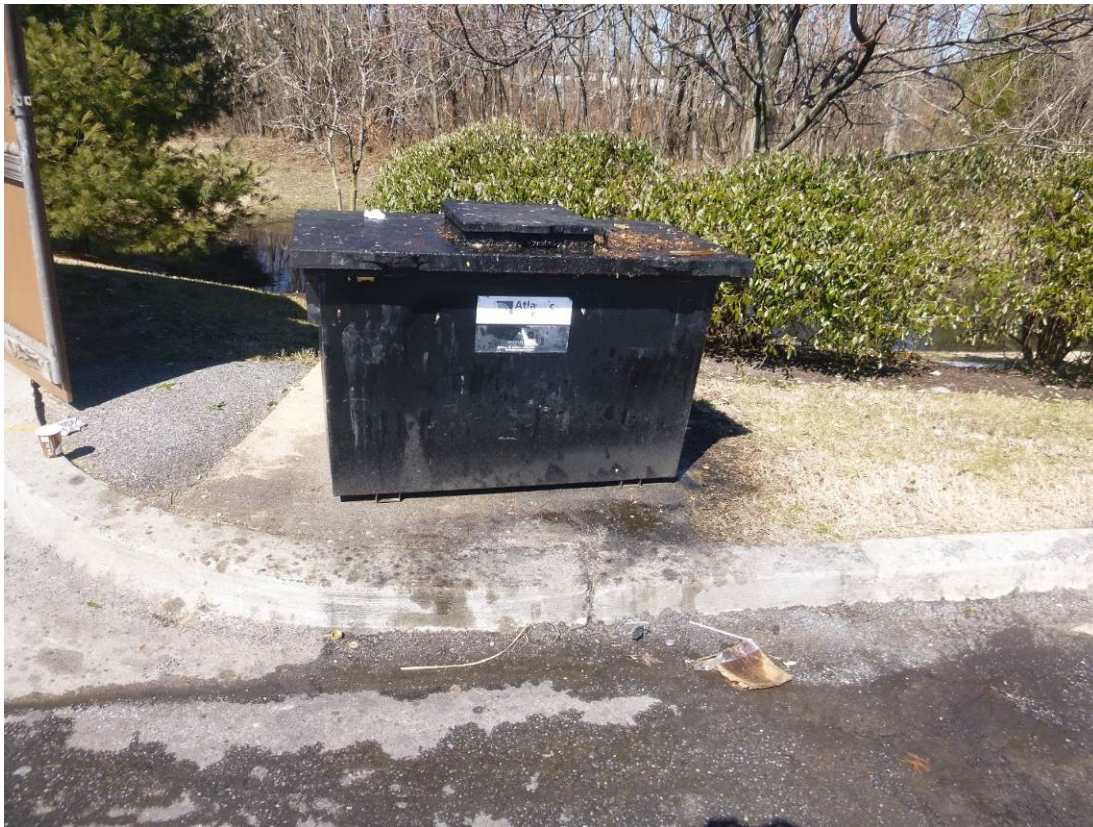
The field team discovered a soiled biofuels collection container, intended for the disposal of waste kitchen oil, alongside the parking lot at Cromwell Center. The field crew photo-documented fresh oil on and around the container, and extensive stains on the pavement (Figure 1); this suggests that oil may be coming from a leak in the container and spills during attempts to empty materials into the container. Cooking oil on an impervious surface poses a hazard to pedestrians; in a rain event, the oil may also distribute contaminants to adjacent impervious surfaces and eventually to storm drain inlets or open water. There is also a concern for attracting pests to the site.

Figure 1. Oil collection container with fresh residue on top of the container and surrounding it; older stains are also present

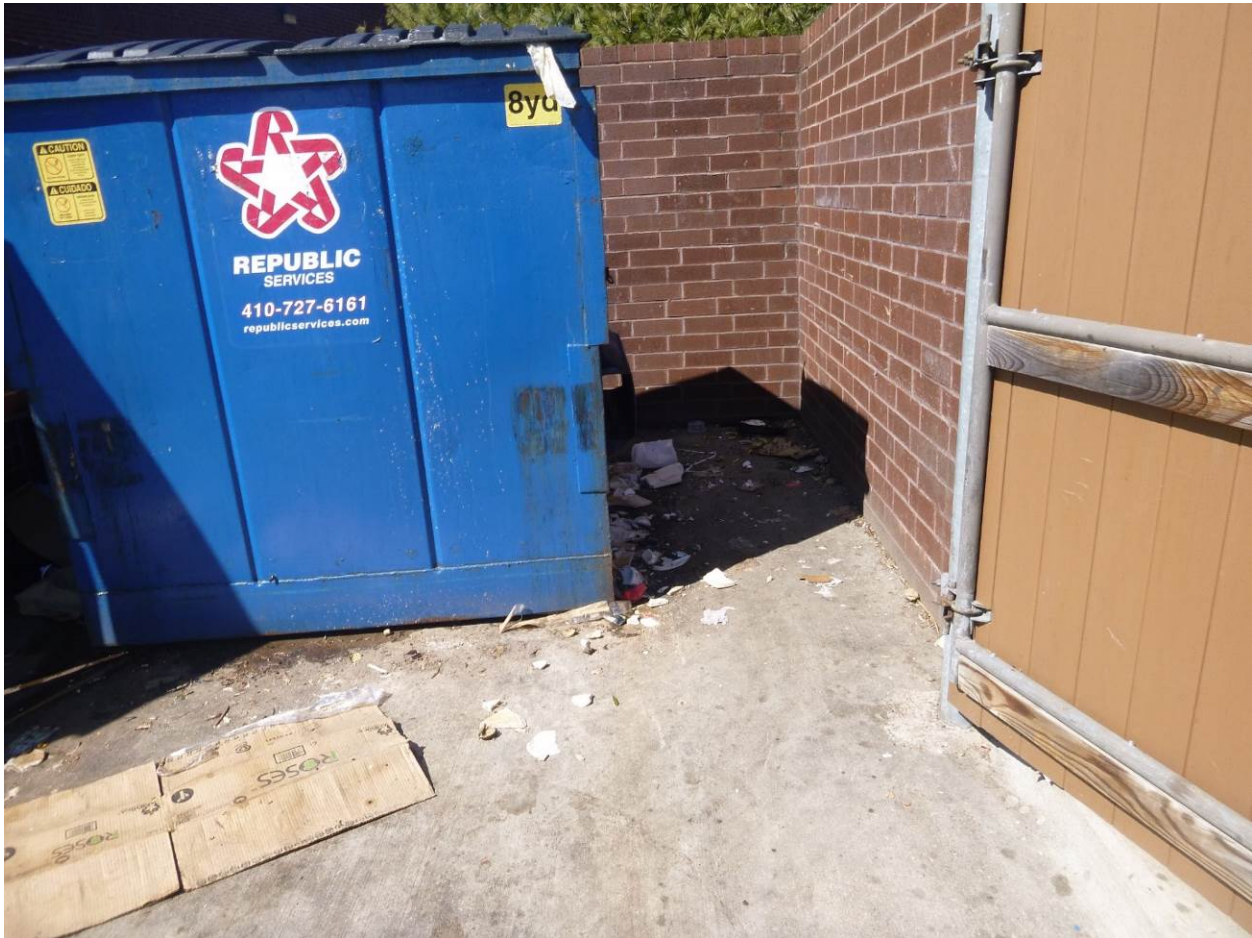
The Versar field team also found a dumpster surrounded by scattered debris in the same area alongside the parking lot (Figure 2). Debris deposited on the ground may allow trash to blow off-site or leak potentially contaminating contents onto surfaces that could lead to adjacent storm drain inlets or open water. An area map, indicating the locations of the oil collection container and the dumpster, is provided in Figure 3.

Figure 2. Dumpster found with debris scattered around it

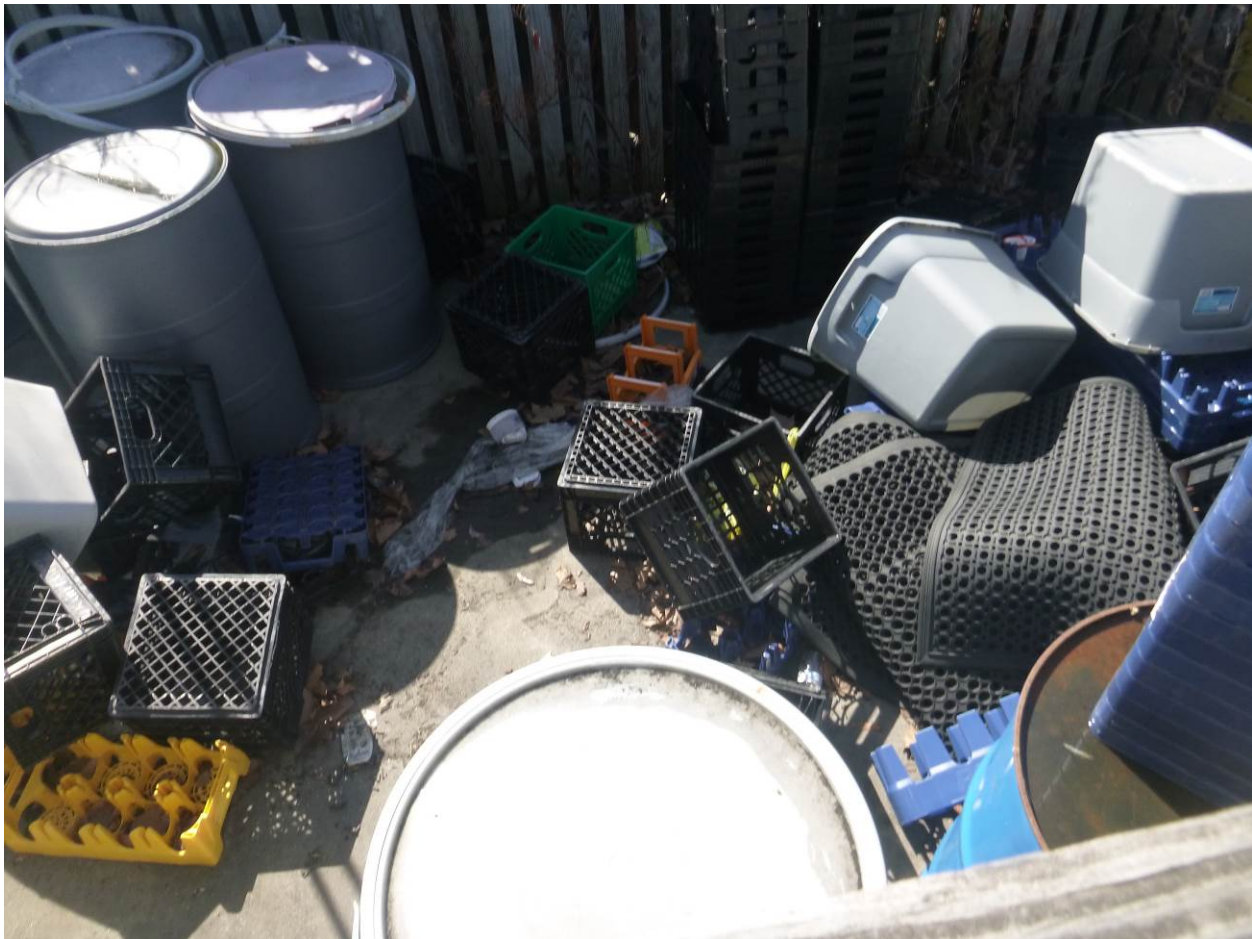
In an enclosure on the edge of the parking lot, the field team observed unmarked storage drums among other stored items (Figure 1). The field crew counted six 55-gallon drums in this storage area. Liquid materials in barrels should have secondary containment if placed on an impervious surface. Drums for liquids should also be labeled appropriately with content descriptions and hazard notices. As the contents of these containers were not specified, it is possible that the storage arrangements need to be modified to accommodate these guidelines.

Figure 1. Unmarked drums found in an enclosure associated with the Shell fuel station

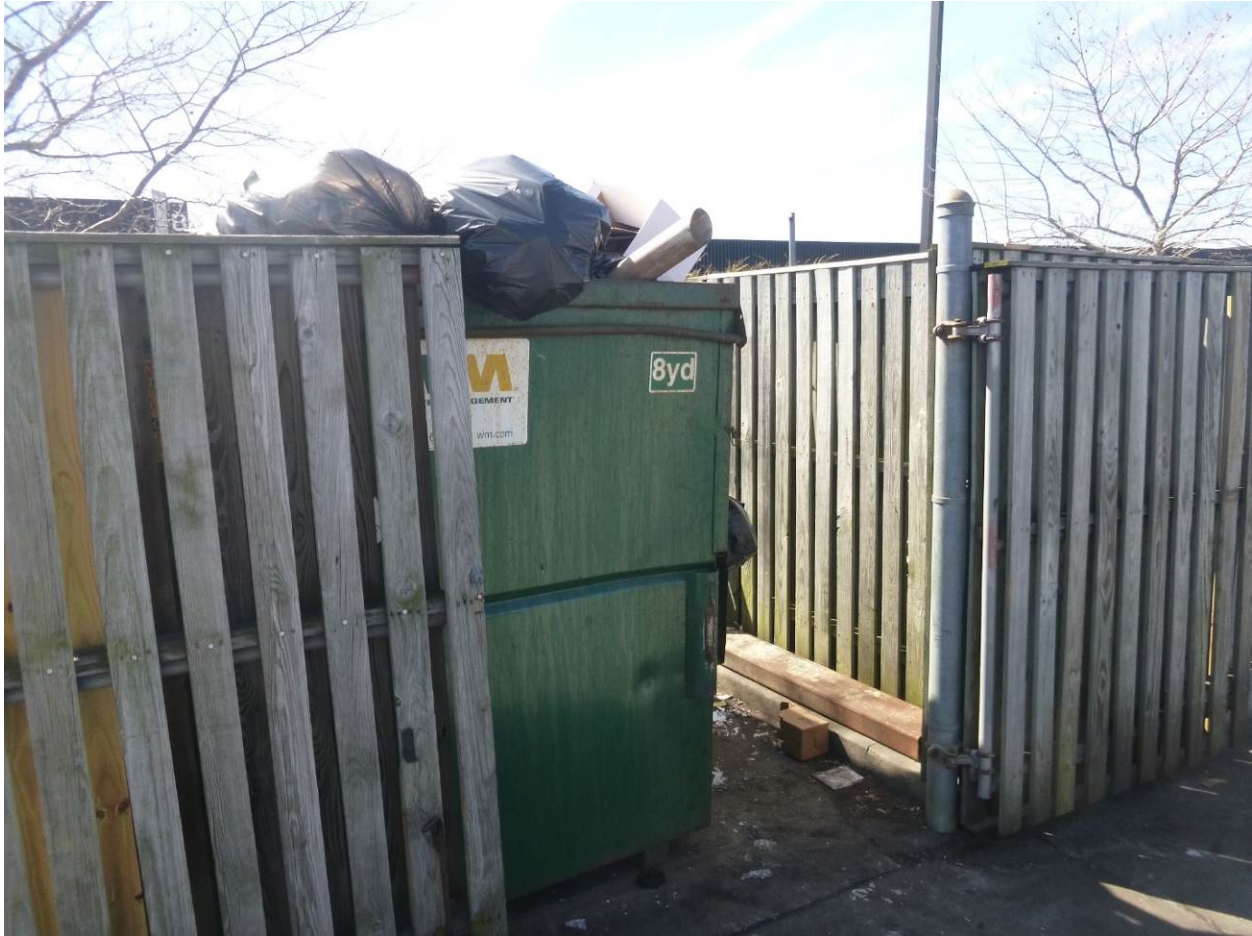
The Versar field team also documented an overflowing dumpster on the property at the same Shell fuel station (Figure 2). On closer inspection, the field team noted debris scattered on the pavement around the dumpster (Figure 3). The lack of proper storage (preferably in closed containers under shelter) may allow trash to blow off-site and into the storm drain system. Debris deposited on the ground may leak potentially contaminating contents onto surfaces that could also lead to adjacent storm drain inlets or open water. Some debris may also attract pests to the site. An area map, indicating the location of the enclosures that house the drums and the nearby dumpster, is provided in Figure 4.

Figure 2. Open dumpster found overfilled with trash on March 12
