**ANNE ARUNDEL COUNTY
ILLICIT DISCHARGE DETECTION
AND ELIMINATION
2015 ANNUAL REPORT**

PERMIT NUMBER MD0068306

January 12, 2016

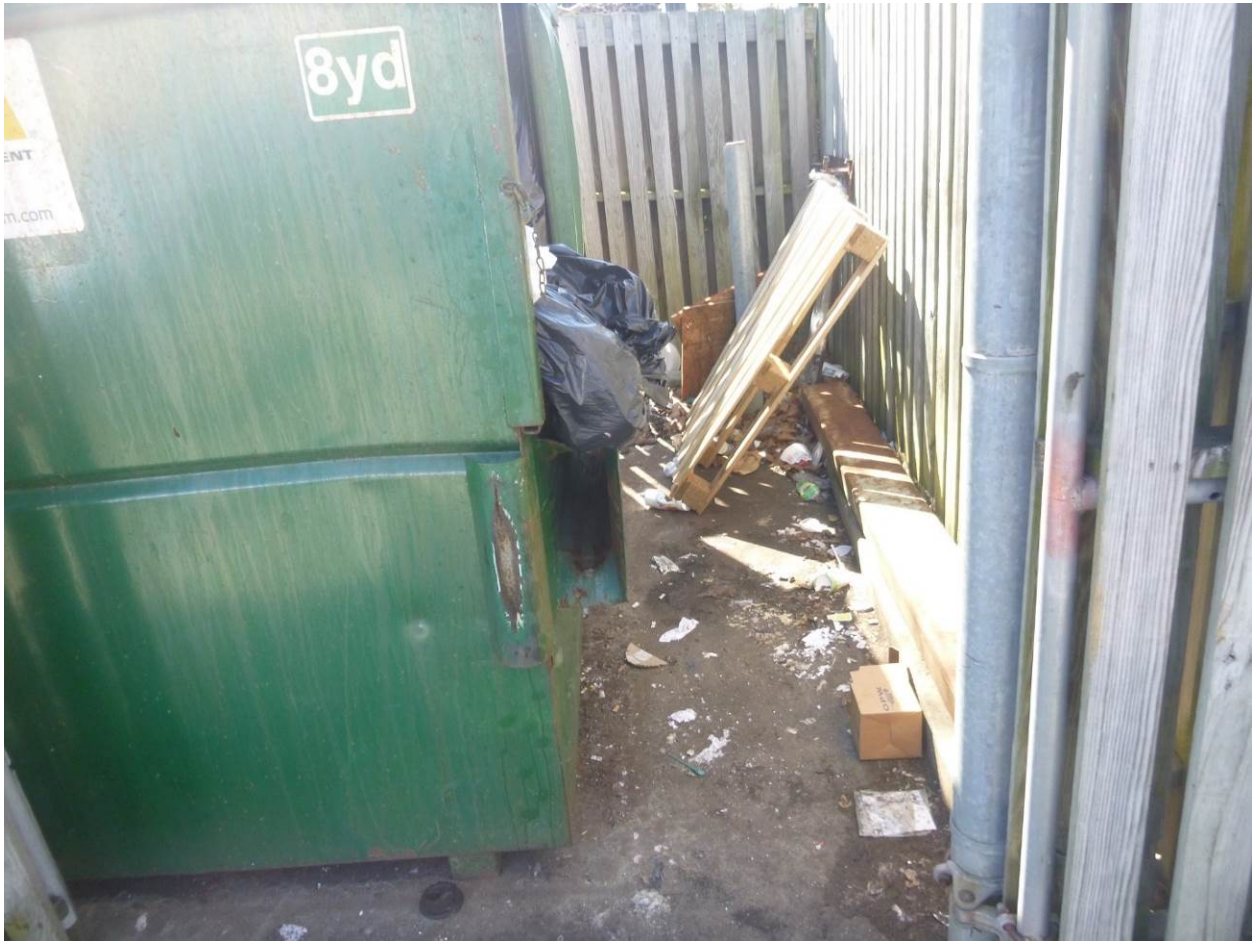
Figure 3. Dumpster found with debris scattered around it on March 12

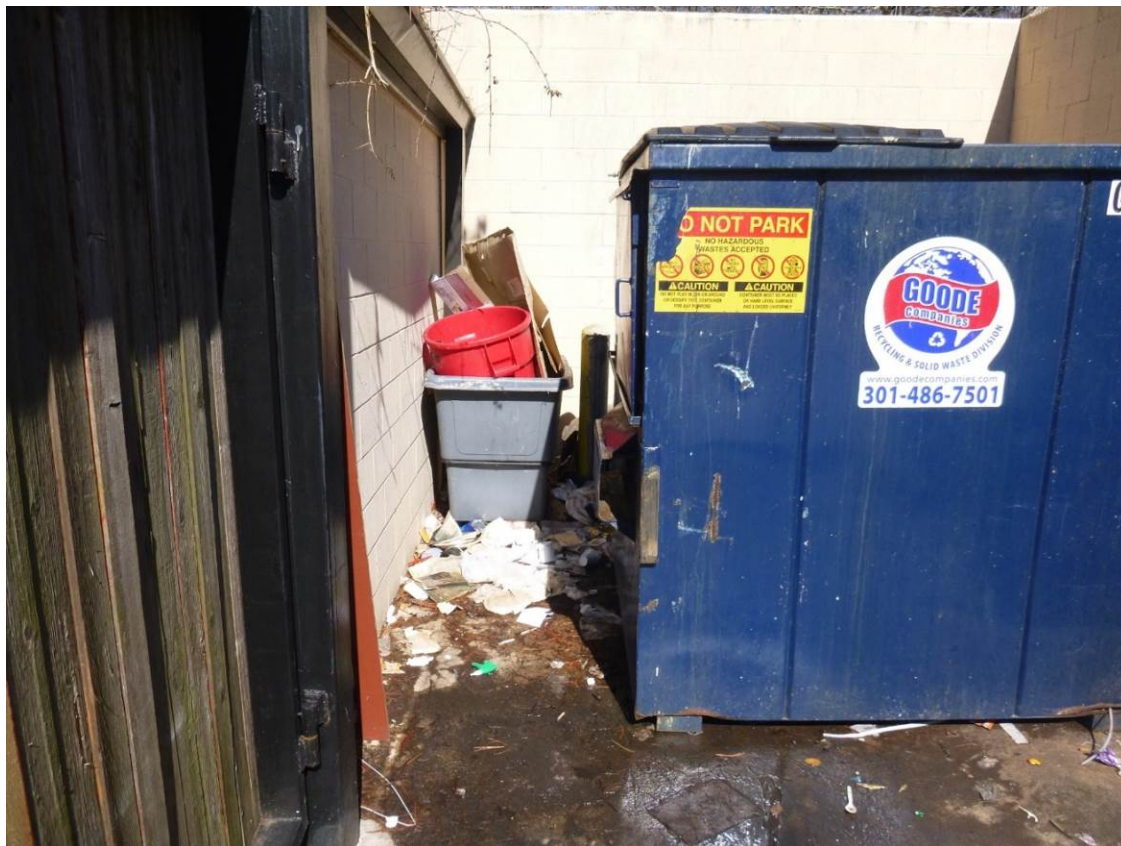
A Versar field team discovered a large amount of debris surrounding an open dumpster associated with the Hampton Inn hotel at the above address (Figure 1). The open dumpster was not full (Figure 2); this suggests that the debris may have been deposited on the ground at an earlier time, perhaps when the unit was full, or that the dumpster is not being used routinely for trash disposal. The field team documented debris on all sides of the unit, including a mattress (Figure 3) and bagged and loose trash, including food containers (Figure 4). Alongside the dumpster enclosure, the field crew observed several discarded ventilation units (Figure 5). The lack of proper storage (preferably in closed containers under shelter) may allow trash to blow off-site and into the storm drain system. Debris deposited on the ground may leak potentially contaminating contents onto surfaces that could also lead to adjacent storm drain inlets or open water. Some debris may also attract pests to the site. An area map, indicating the location of the dumpster, is provided in Figure 6.

Figure 1. An open dumpster with debris and loose bins deposited around it

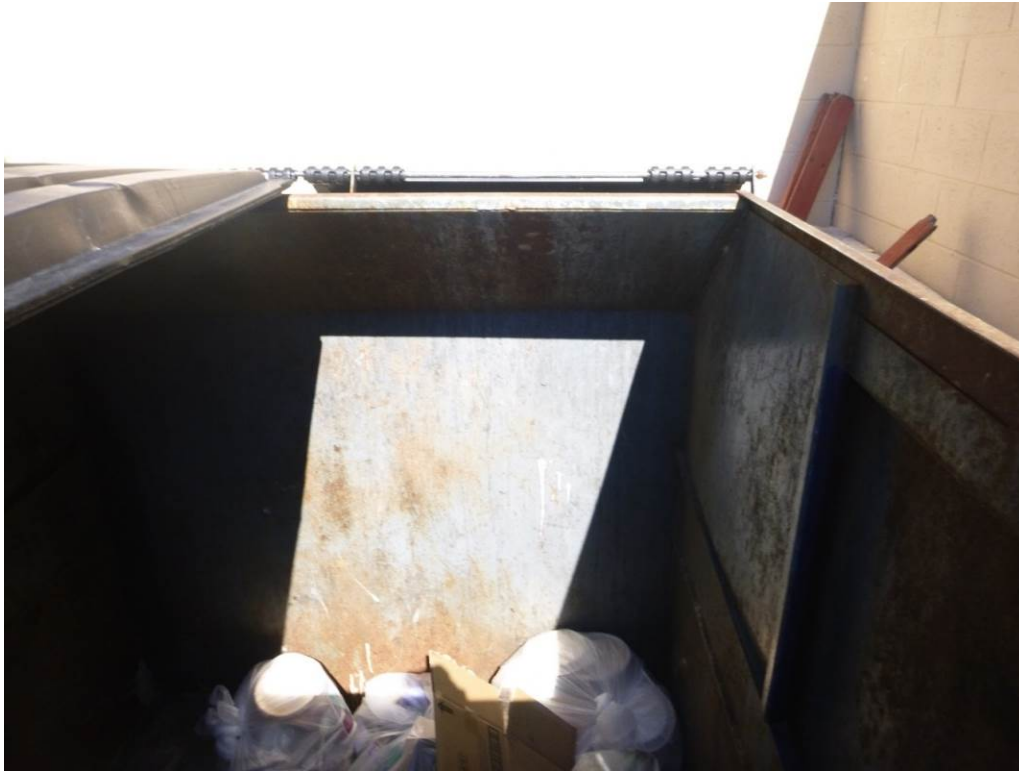
Figure 2. A view inside the open side of the dumpster showing that the unit is not full

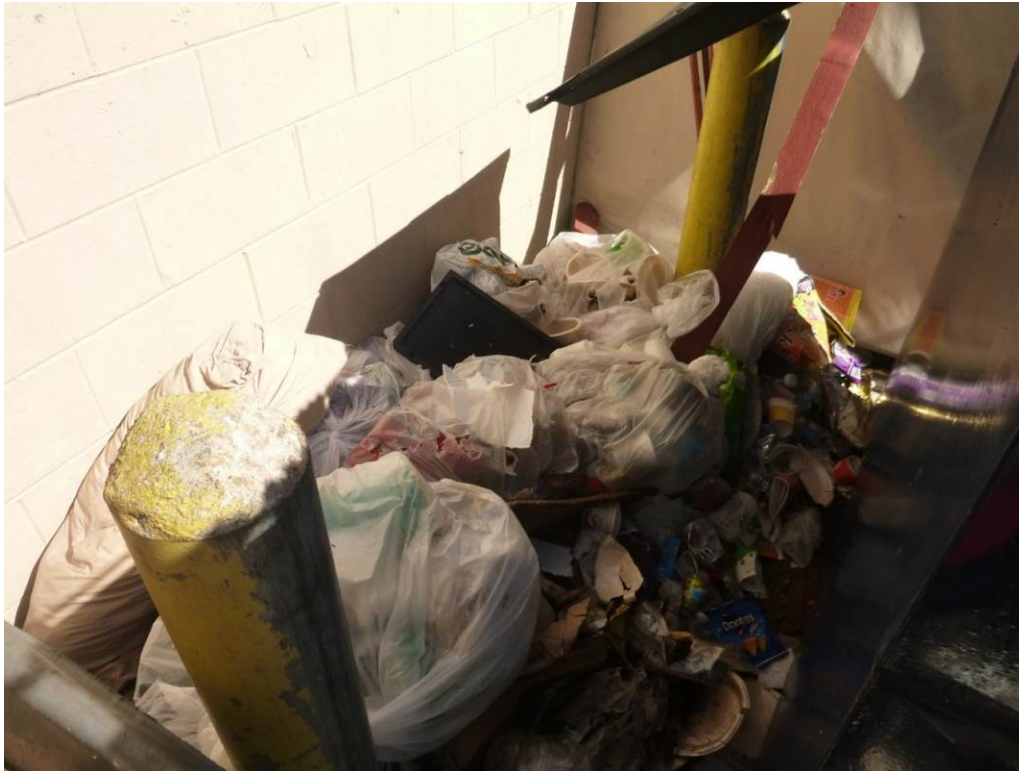
Figure 4. Bagged and loose trash, including food containers, found behind the dumpster

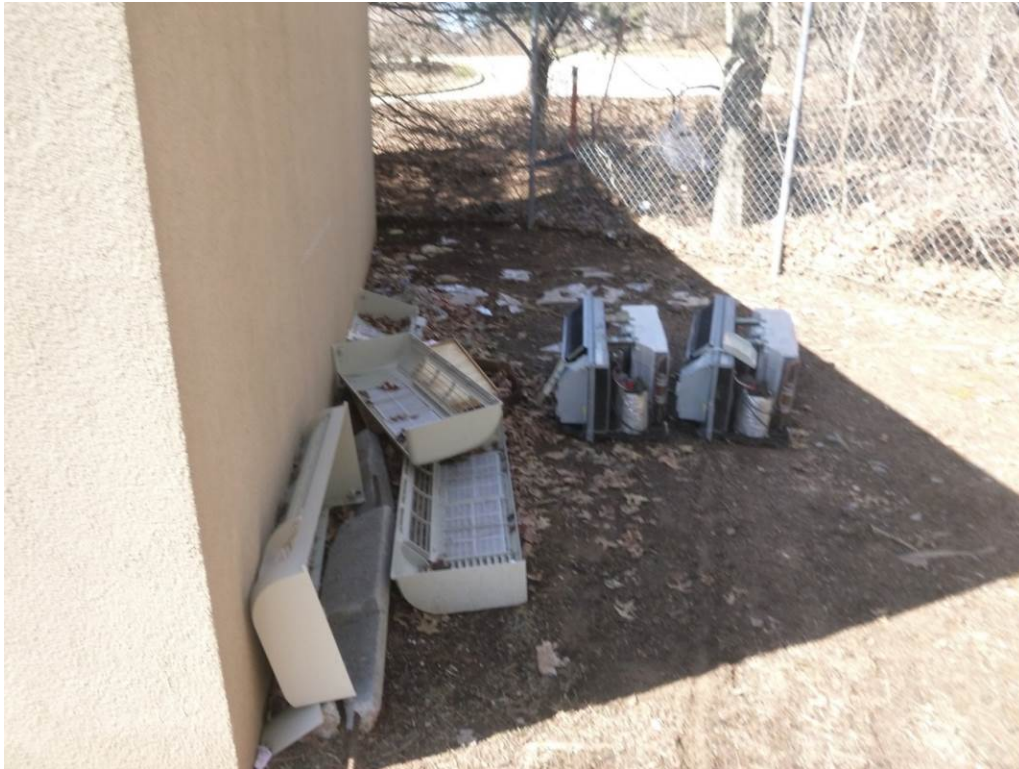
Figure 5. Several ventilation units and associated parts found on the ground near the dumpster

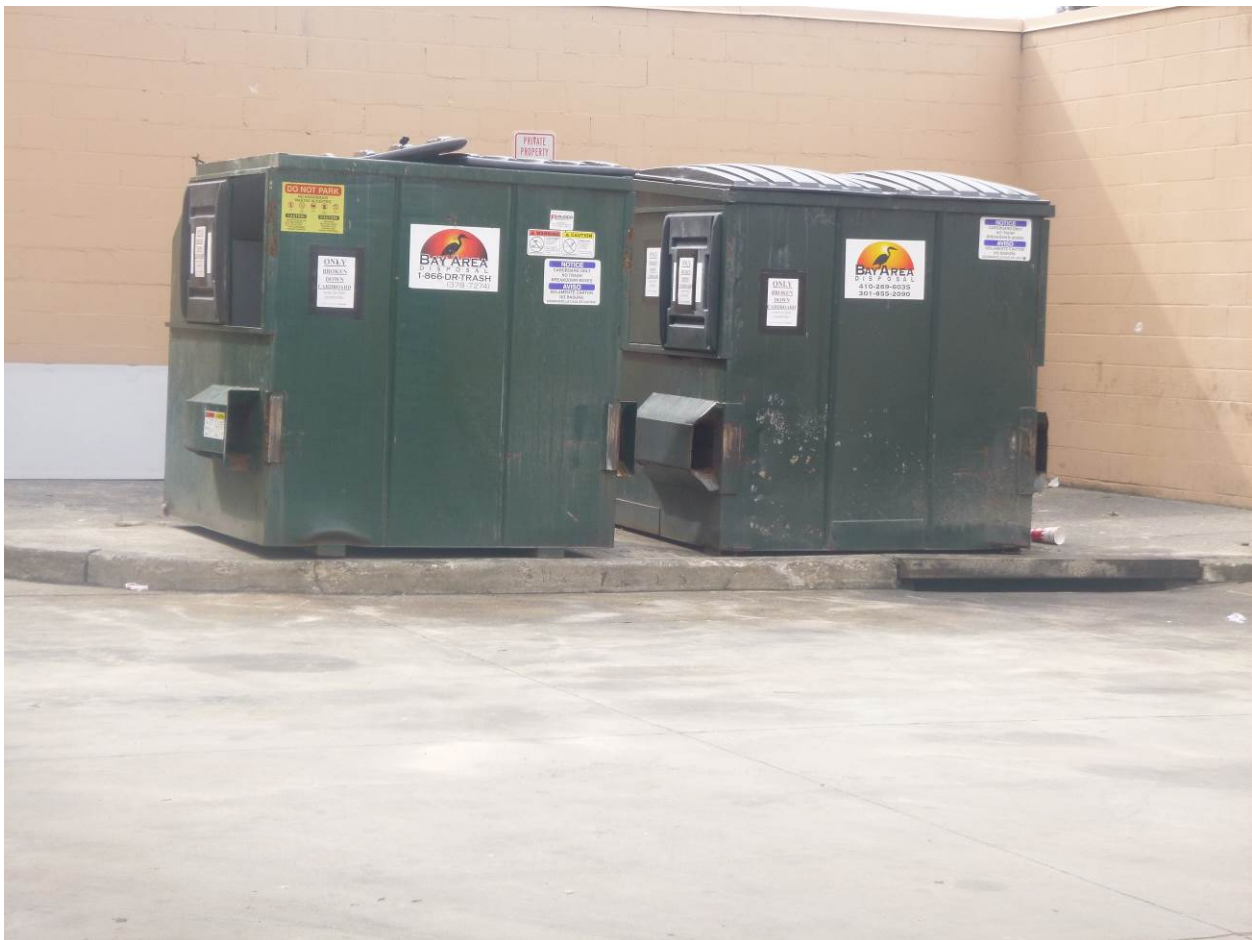
A Versar field team found two dumpsters that had been placed over a storm drain curb inlet alongside the Cinemark Egyptian 24 and XD (movie theater) at the above address (Figure 1). The field team noted that there were stains leading to the curb inlet, suggesting that materials other than water have been entering the storm system at this location (Figure 2). Although the field crew found the dumpsters appropriately closed, any trash alongside the containers, or exposed when the lids are open may blow off-site or into the adjacent opening to the storm drain system. Any debris deposited on the ground may also leak potentially contaminating contents onto surfaces that could enter the storm drain inlet easily. An area map, indicating the location of the dumpsters, is provided in Figure 3.

Figure 1. Dumpsters found immediately adjacent to a curb inlet to the storm system

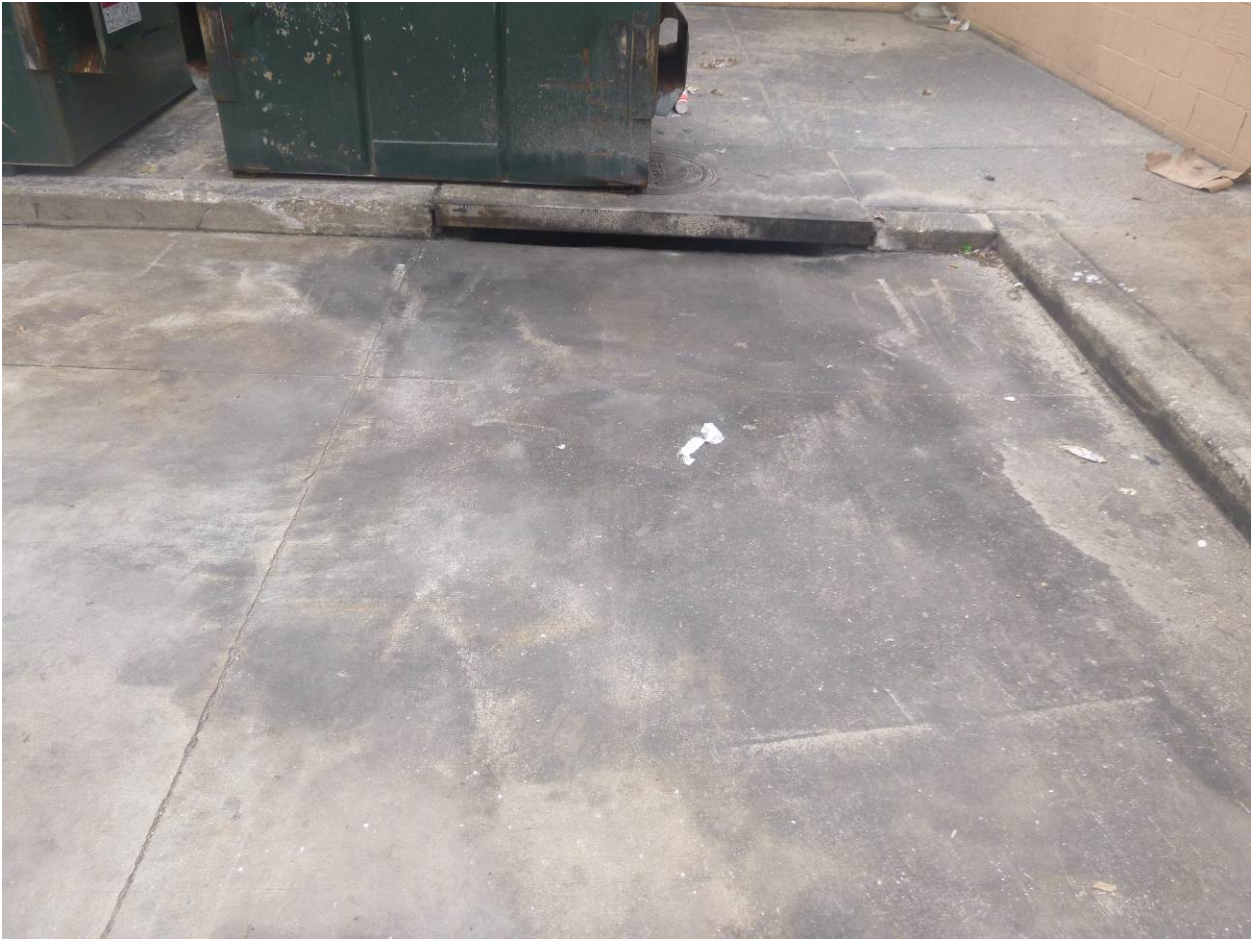
Figure 2. Stains found leading to the curb inlet

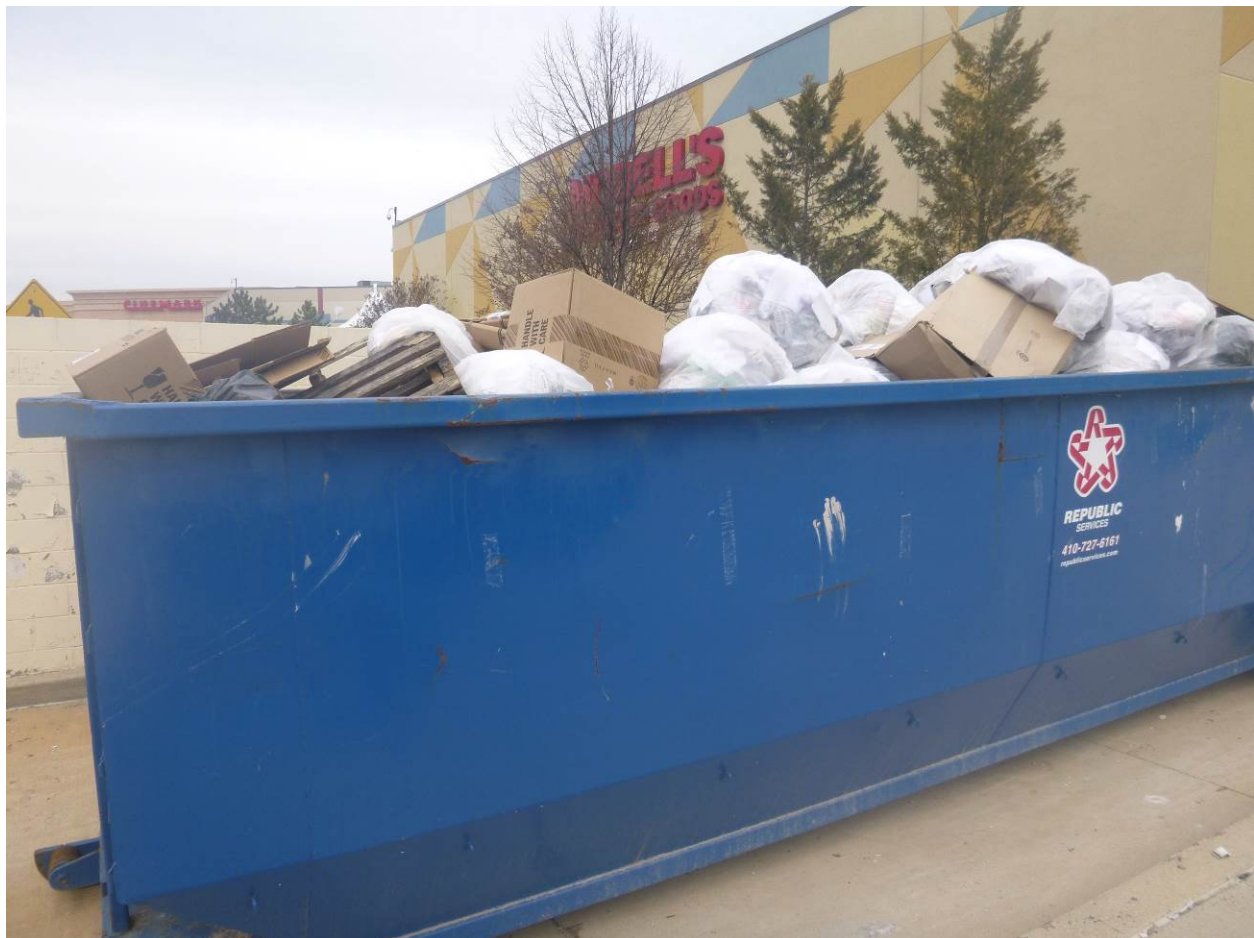
A Versar field team found an overfilled roll-off dumpster in the parking lot near the Modell's Sporting Goods store at the above address (Figure 1). The lack of proper storage (preferably in closed containers under shelter) may allow trash to blow off-site and into the storm drain system. Debris that falls to the ground may leak potentially contaminating contents onto surfaces that could also lead to adjacent storm drain inlets or open water. Some debris may also attract pests to the site. An area map, indicating the location of the dumpster, is provided in Figure 2.

Figure 1. Overfilled roll-off dumpster found near Modell's Sporting Goods store on March 13

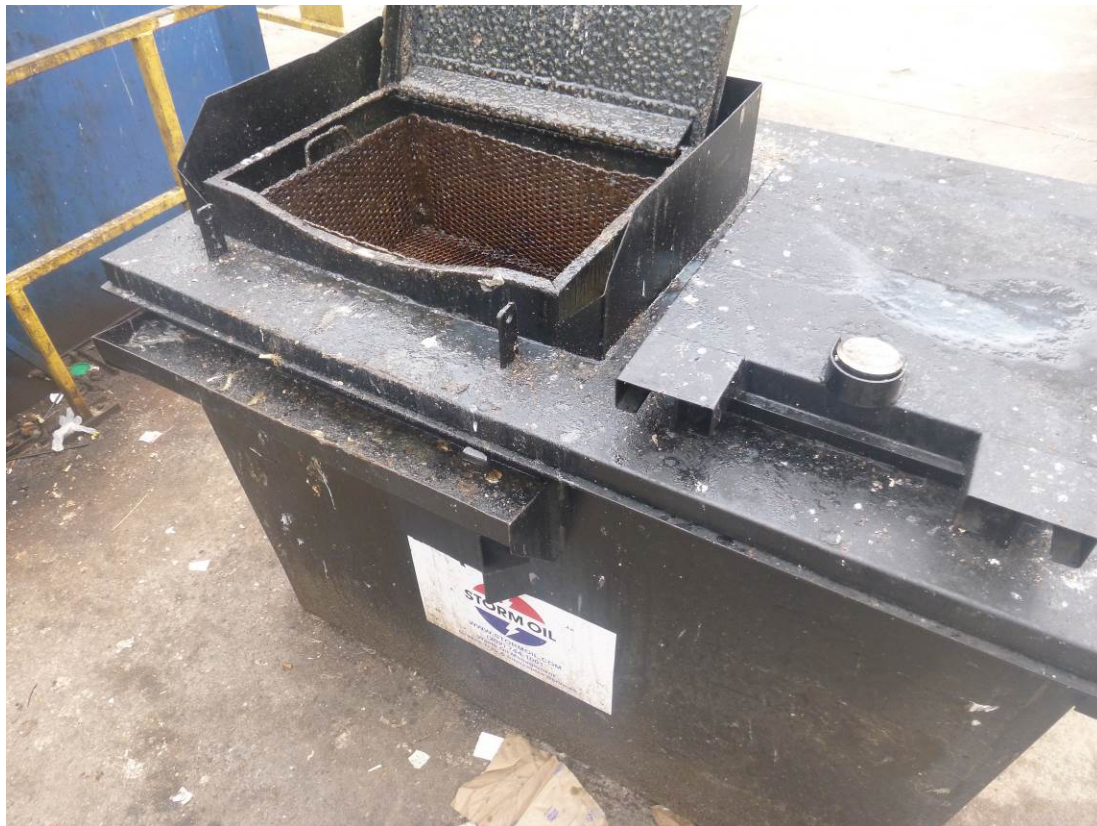
The field team found a kitchen oil collection container with an open lid in the parking lot associated with the restaurant when they visited the site at 2:45 p.m. (Figure 1). The team noted that the open container was located uphill of a curb inlet for the parking area (Figure 2). Cooking oil on an impervious surface poses a hazard to pedestrians; in a rain event, the oil may also distribute contaminants to adjacent impervious surfaces and eventually to storm drain inlets or open water. There is also a concern for attracting pests to the site.

Figure 1. Cooking oil collection container found with an open lid; the container was located uphill of a curb inlet in the same parking lot

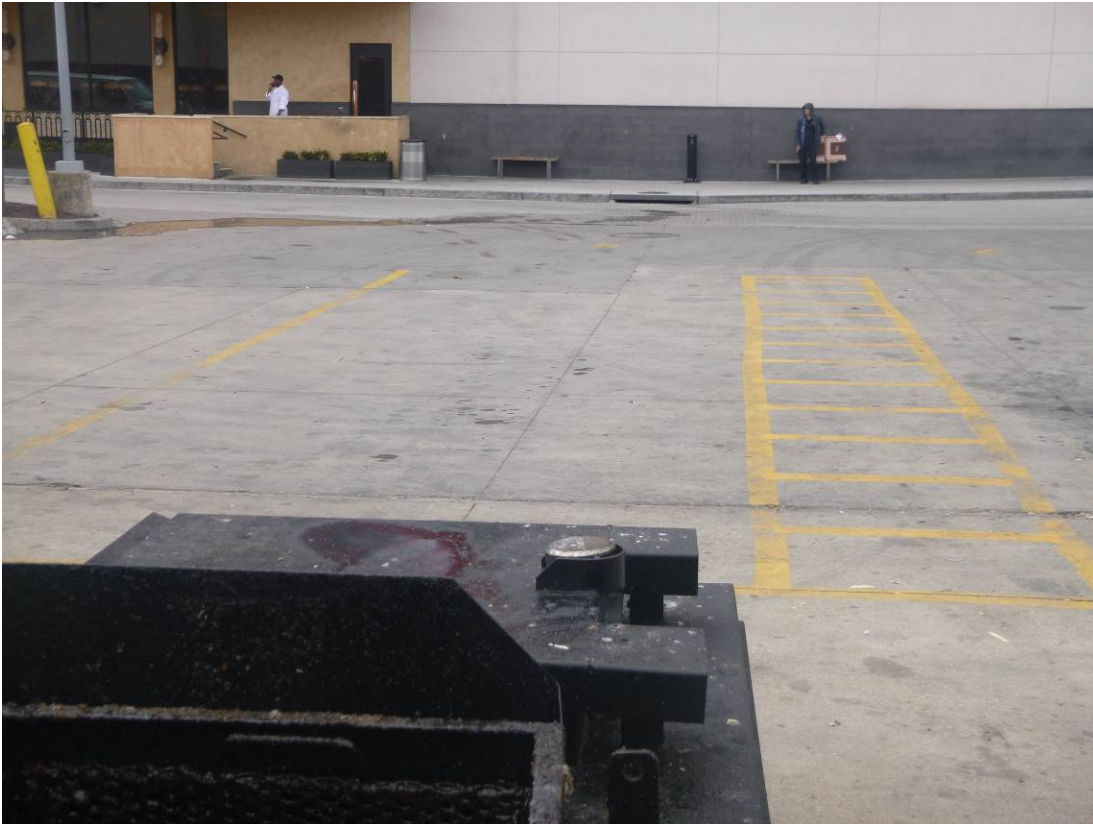
Figure 2. Photograph showing the relative location of the cooking oil storage bin to the nearby curb inlet

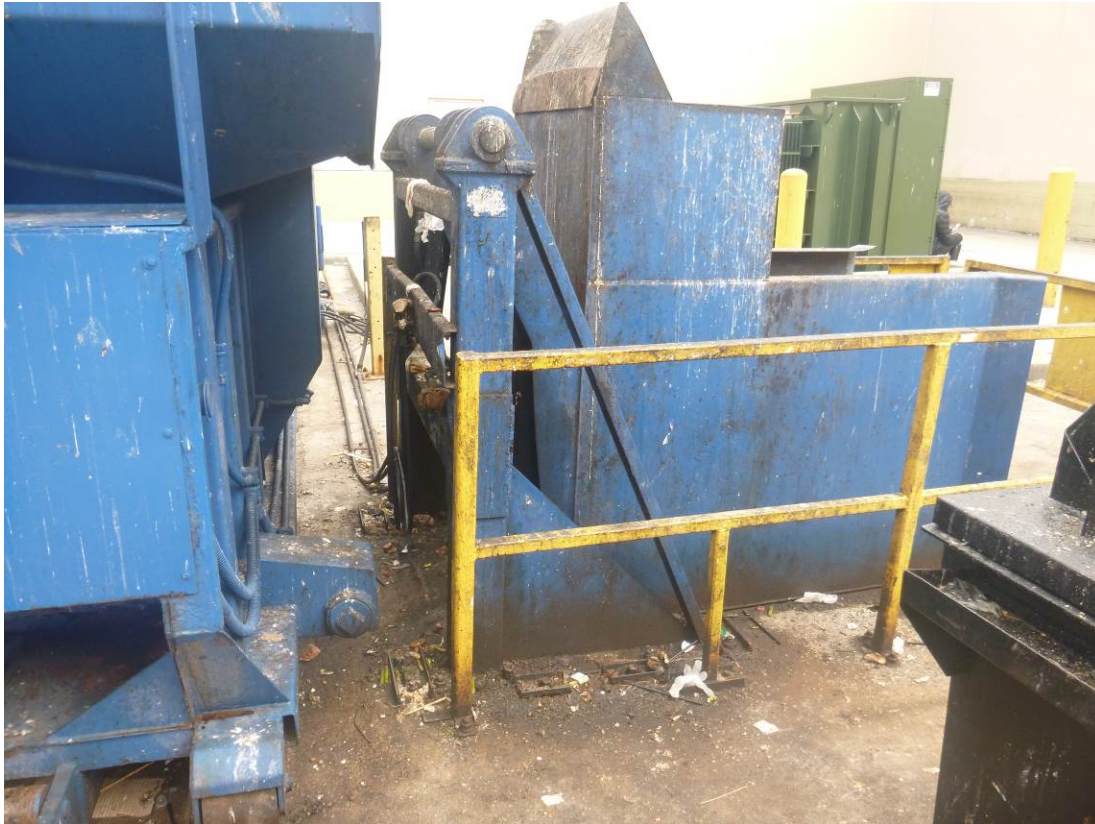
The Versar field team found some trash - including food - littering the area around a dumpster adjacent to the cooking oil bin in the same parking lot (Figure 3). Debris on the ground may be carried by wind or water to nearby storm drain inlets; it may also leak potentially contaminating contents onto surfaces that could also lead to adjacent storm drain inlets or open water. Food debris may also attract pests to the site. An area map, indicating the locations of the cooking oil bin and the dumpster, is provided in Figure 4.

Figure 3. Debris, including food, found scattered around a dumpster near the Cheesecake Factory restaurant on March 13

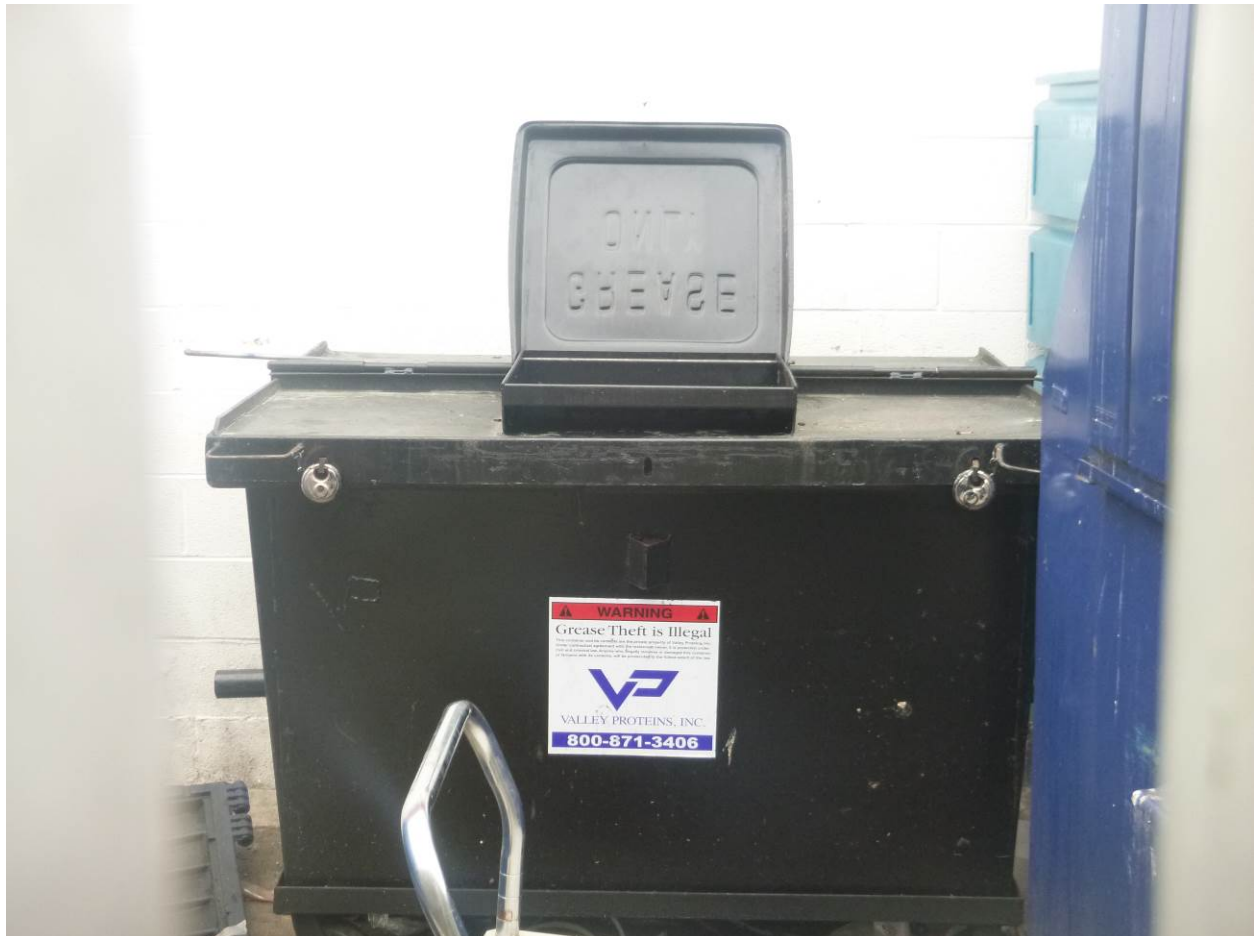
A Versar field team discovered a grease collection container, intended for the disposal of waste kitchen grease, in the parking lot associated with the Red Lobster restaurant at the above address. The field crew members found the container lid open when they visited the site at 2:55 p.m. (Figure 1). Cooking oil on an impervious surface poses a hazard to pedestrians; in a rain event, the oil may also distribute contaminants to adjacent impervious surfaces and eventually to storm drain inlets or open water. There is also a concern for attracting pests to the site. An area map is provided as Figure 2.

Figure 1. Kitchen grease collection container found with an open lid

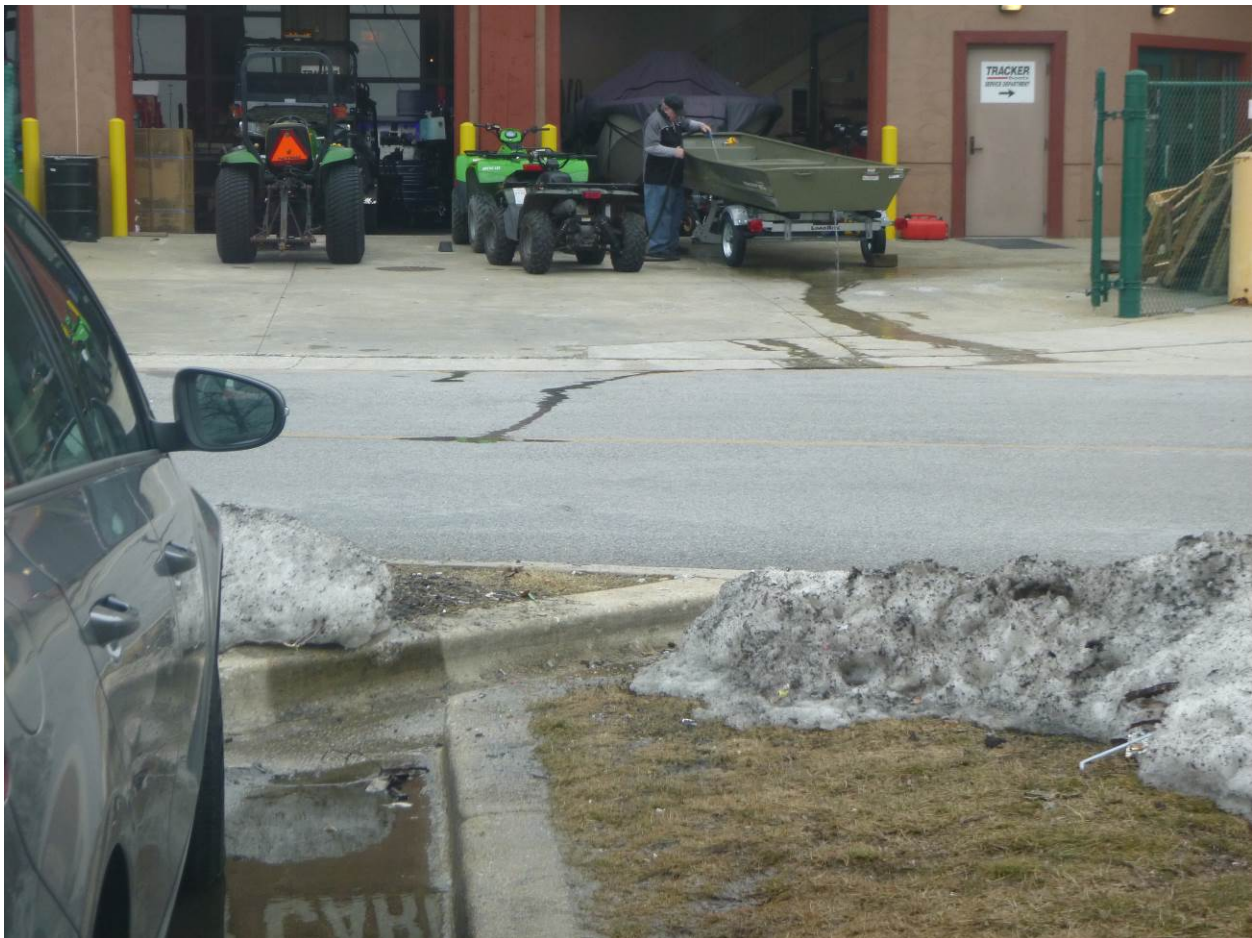
A Versar field team discovered a man washing a boat with water from a hose at the service entrance of Bass Pro Shops at the above address (Figure 1). This activity, conducted on impervious surface, may allow tap water to enter the storm drain system; the activity would constitute an illicit discharge. The field crew photo-documented the wastewater entering the roadway via paved surfaces. The current storm drain network is not available in digital format for this location to assess the relative location of the wastewater to an inlet. An area map, indicating the location of the washdown activity, is provided in Figure 2.

Figure 1. Boat washdown observed at the service entrance to Bass Pro Shops

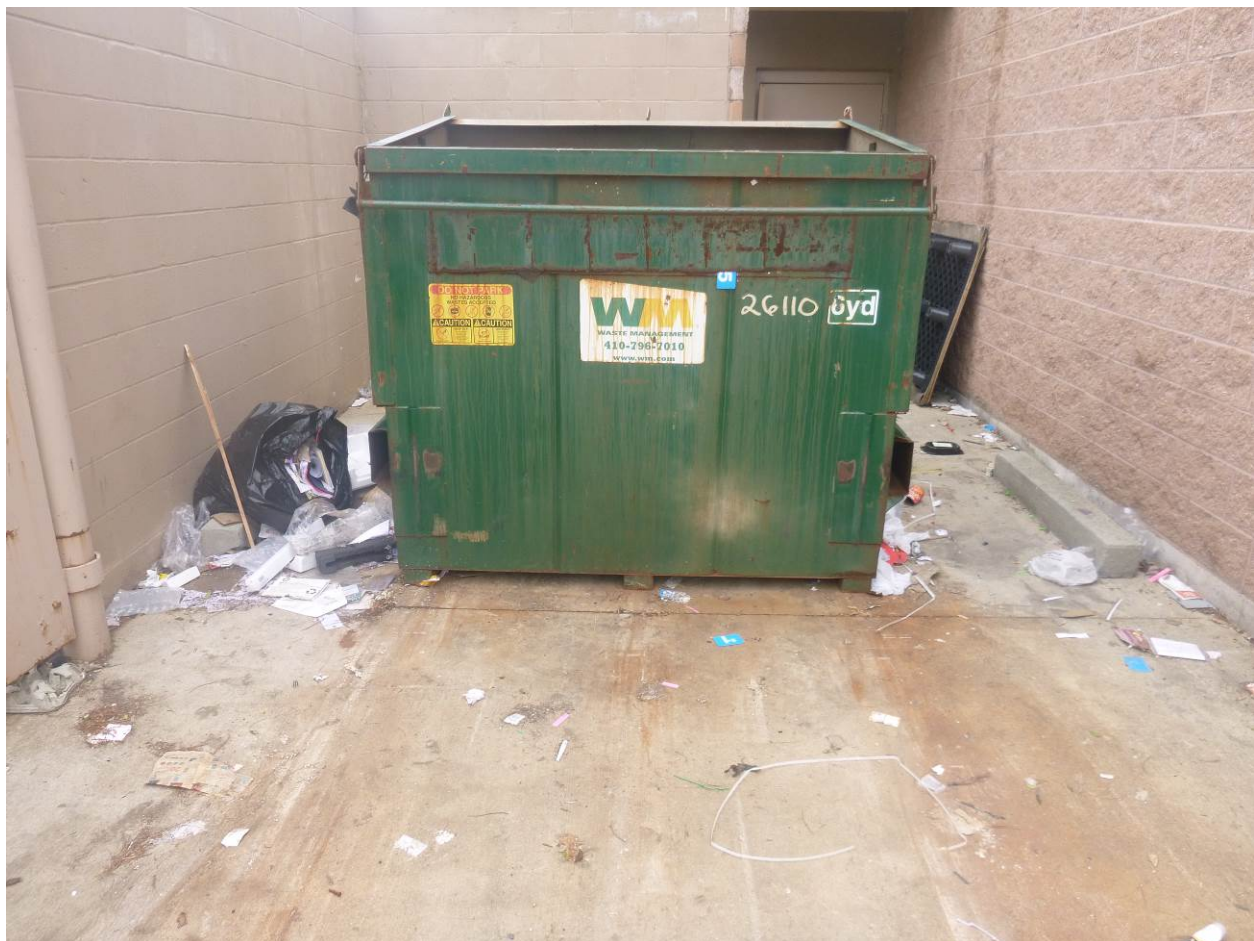
A Versar field team found an open dumpster with debris scattered around it behind the Staples store at the above address (Figure 1). The lack of proper storage (preferably in closed containers under shelter) may allow trash to blow off-site and into the storm drain system. Debris on the ground may be carried by wind or water to nearby storm drain inlets; it may also leak potentially contaminating contents onto surfaces that could also lead to nearby storm drain inlets or open water. Some debris may also attract pests to the site. An area map, indicating the location of the dumpster, is provided in Figure 2.

Figure 1. An open dumpster with debris scattered around in found near the Staples store on March 13

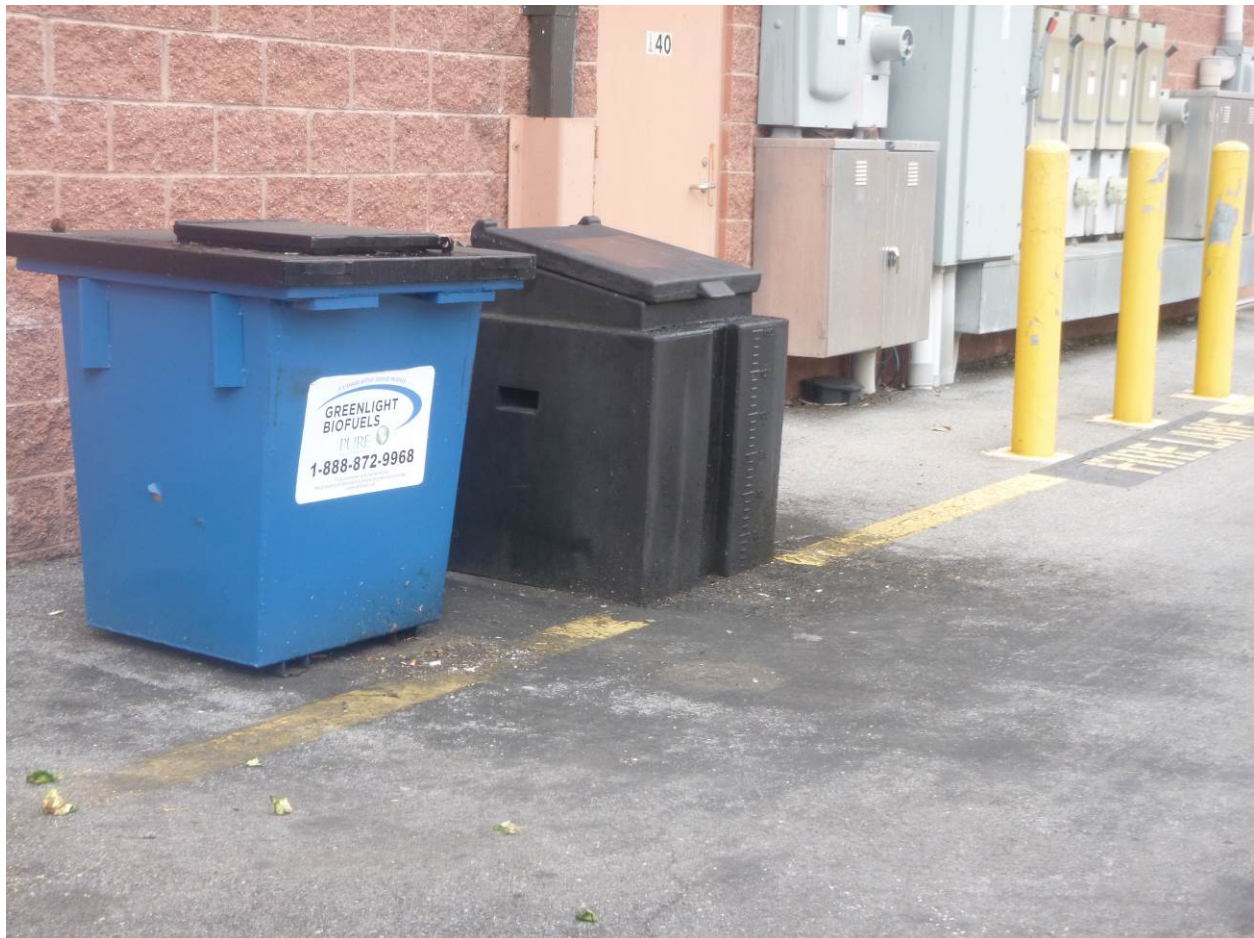
A Versar field team discovered two cooking oil collection containers, intended for the disposal of waste kitchen oil, in the parking lot associated with the Baja Fresh restaurant at the above address. The field crew documented significant oil stains around the containers; the oil may be coming from leaks in the containers and spills during attempts to empty materials into the containers. Cooking oil on an impervious surface poses a hazard to pedestrians; in a rain event, the oil may also distribute contaminants to adjacent impervious surfaces and eventually to storm drain inlets or open water. There is also a concern for attracting pests to the site. An area map is provided as Figure 2.

Figure 1. Cooking oil collection bins with oil stains surrounding both of the containers

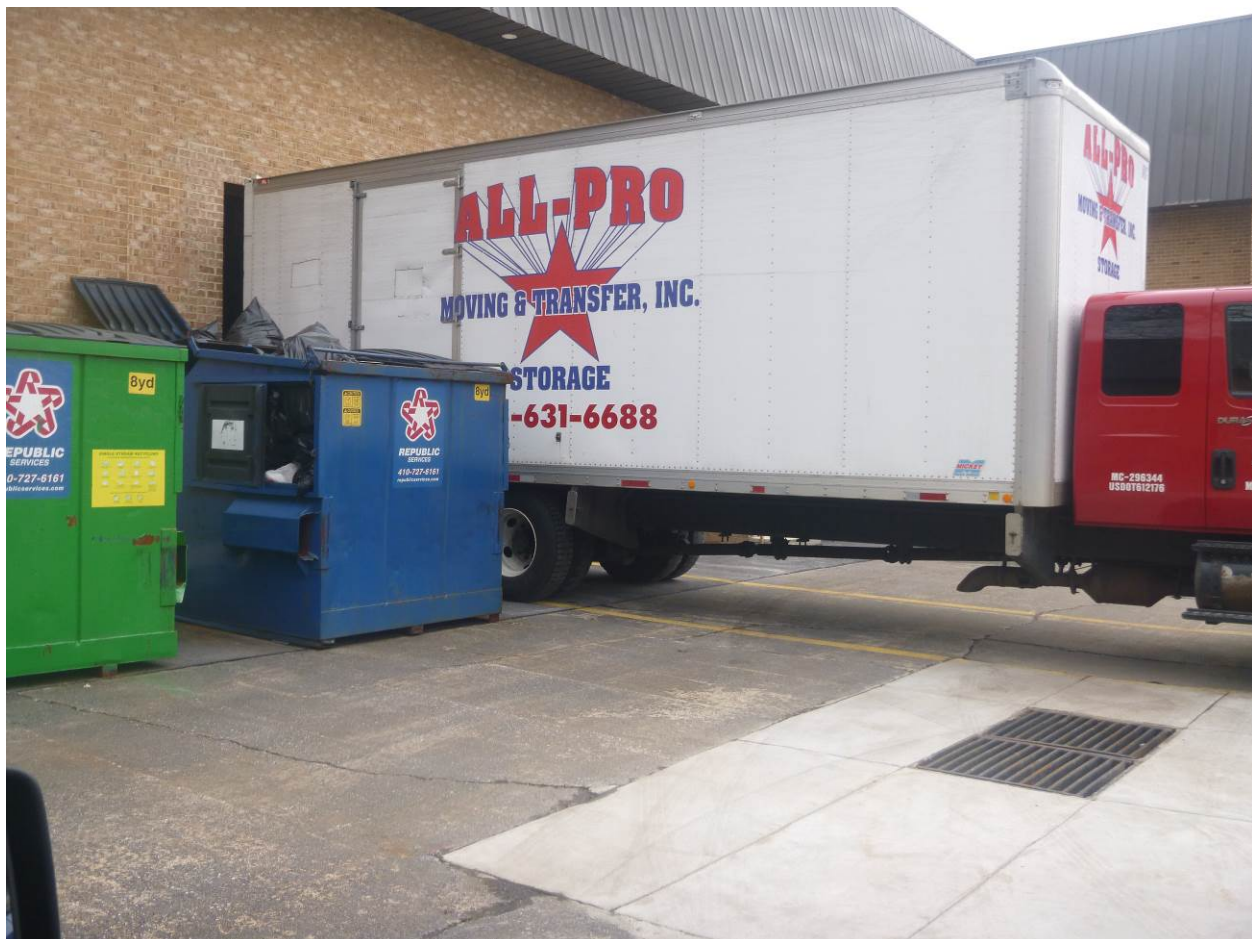
A Versar field team found an open, overfilled dumpster near a yard grate in the parking lot associated with the Computer Sciences Corporation at the above address (Figure 1). The lack of proper storage (preferably in closed containers under shelter) may allow trash to blow off-site or into the nearby storm drain system. Debris that falls on the ground may also leak potentially contaminating contents onto surfaces that could lead to nearby storm drain inlets or open water. Some debris may also attract pests to the site. An area map, indicating the location of the dumpster, is provided in Figure 2.

Figure 1. An open, overfilled dumpster located near a yard grate that was found on March 13

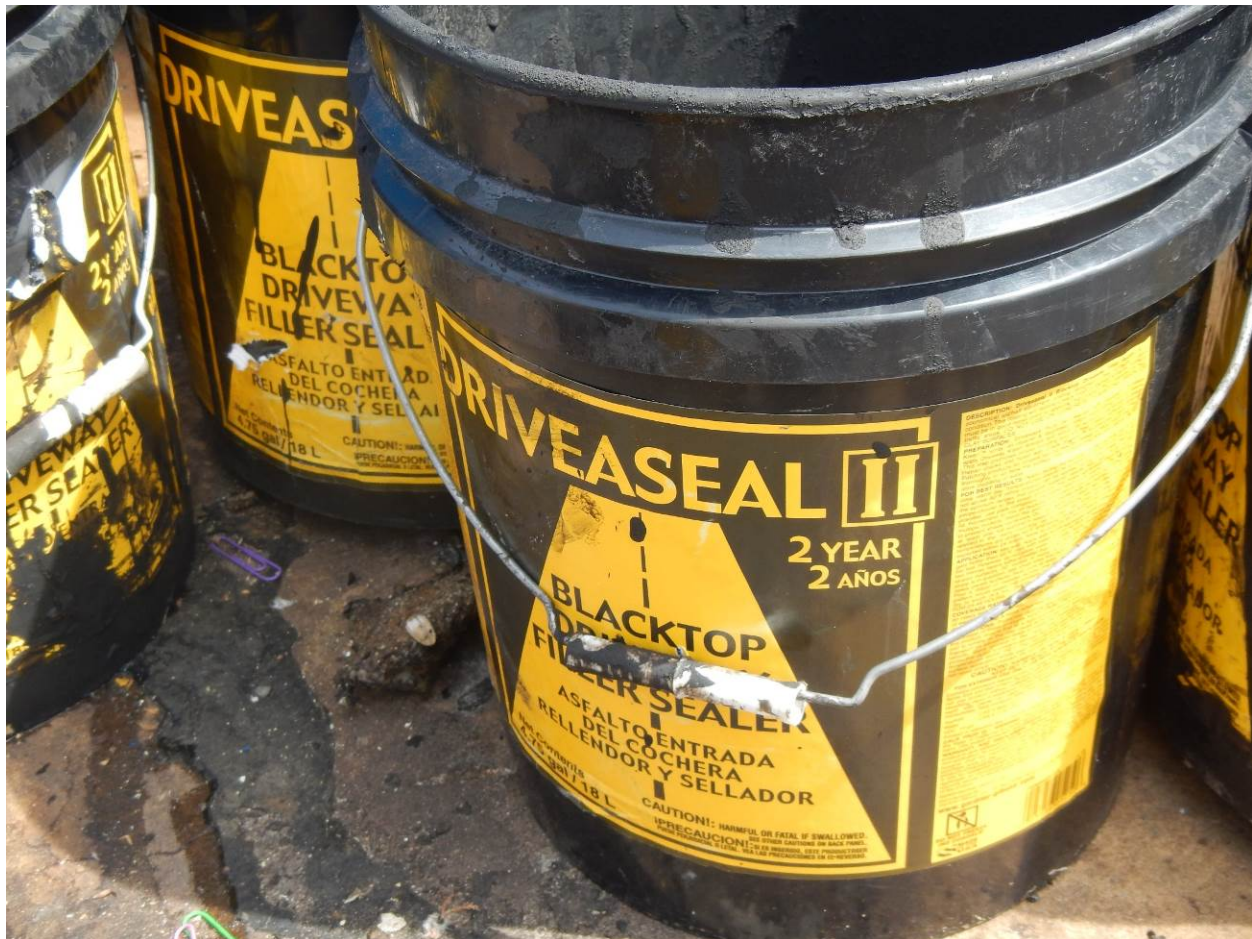
A LimnoTech field team discovered several open buckets of blacktop sealer on a sidewalk behind the D J Liquidators store (approximately) at the above address (Figure 1). The field crew noted that there was extensive staining on the sidewalk (Figure 2) suggesting that sealer has been transferred or spilled in this location in other recent incidents. Residue washed from the buckets or the sidewalk could easily enter the nearby curb inlet and introduce petroleum-based contaminants to the storm sewer system and receiving waters. An area map, indicating the location of the open buckets of sealer, is provided in Figure 3.

Figure 1. Open containers of blacktop sealer found on the sidewalk

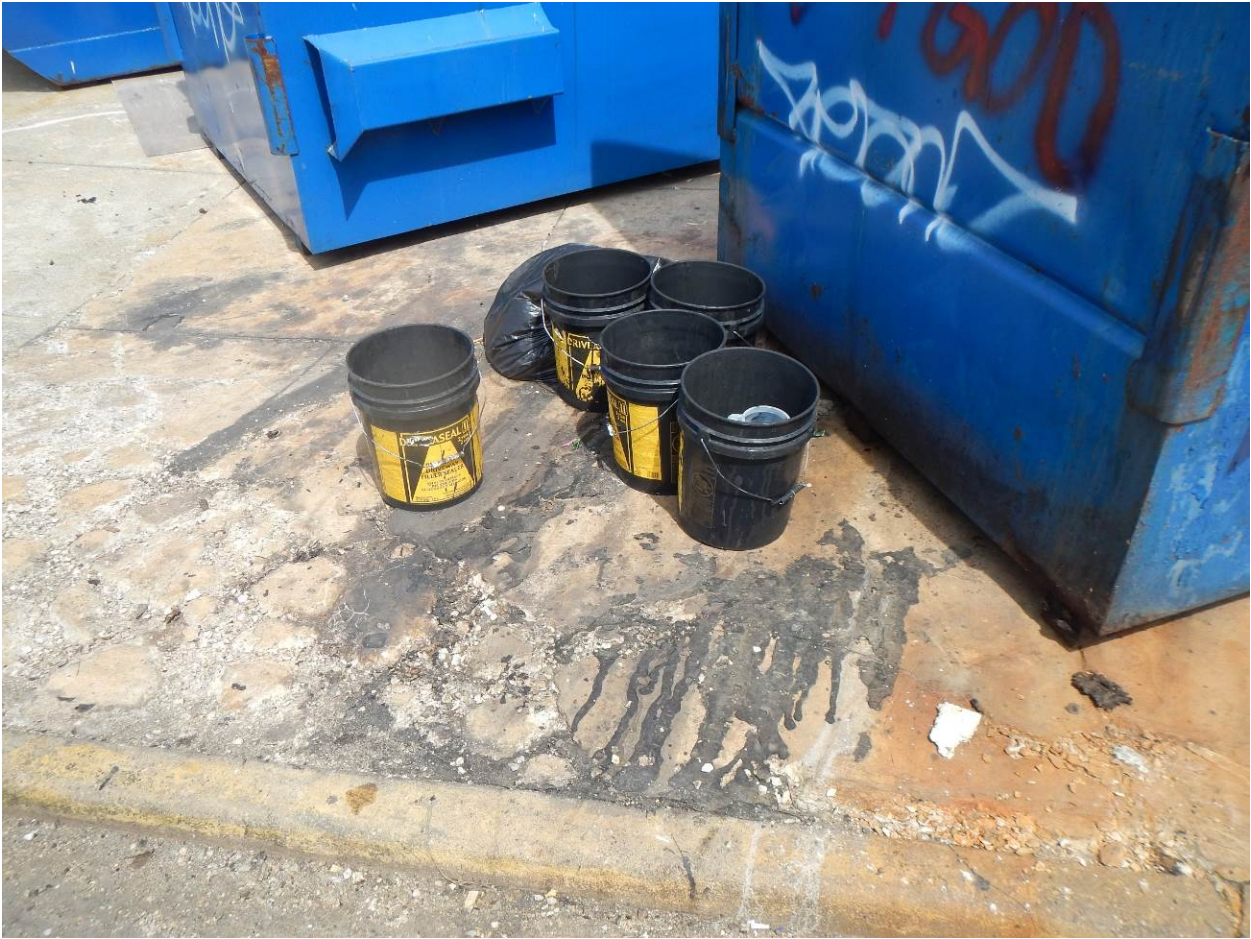
Figure 2. Extensive staining on the sidewalk near the open buckets of sealer

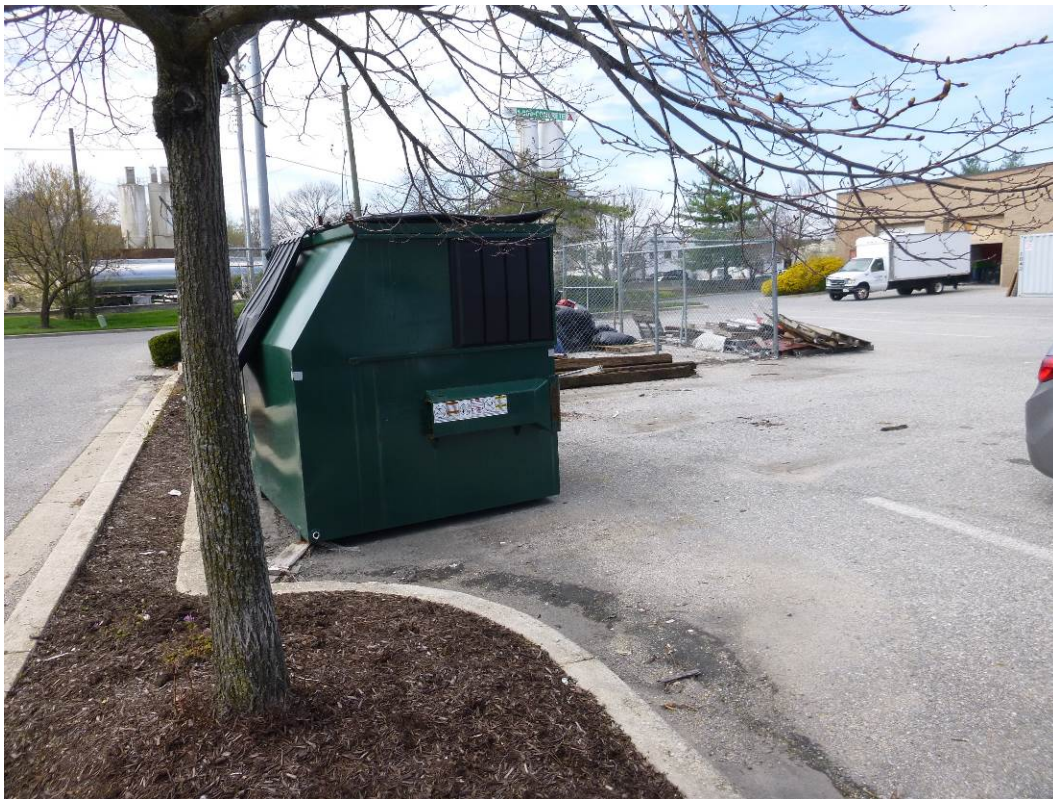
A Versar field team identified several issues of concern related to waste management in an area of the parking lot associated with 2421 Crofton Lane (multiple businesses). The field team discovered an open dumpster (Figure 1). The dumpsters were located next to an enclosed outdoor storage area. The field crew documented that some large pieces of debris have been placed both inside and outside of this enclosure (Figure 2). In a nearby corner of the parking lot, the field crew found more debris blocking a corner drain opening for the lot (Figure 3). The nearest stormwater system inlet is some distance away from the dumpsters and debris; the field team photo-documented its position relative to the storage area (Figure 4). The lack of proper storage (preferably in closed containers under shelter) may allow trash to blow off-site or into the nearby storm drain system. Debris that falls on the ground may also leak potentially contaminating contents onto surfaces that could lead to nearby storm drain inlets or open water. Large debris may pose a hazard to drivers in the parking lot, or block efficient drainage of rainwater across the impervious surface to the stormwater inlets. An area map, indicating the location of the dumpster and the debris, is provided in Figure 5.

Figure 1. An open dumpster found on April 16
