**ANNE ARUNDEL COUNTY
ILLICIT DISCHARGE DETECTION
AND ELIMINATION
2015 ANNUAL REPORT**

PERMIT NUMBER MD0068306

January 12, 2016

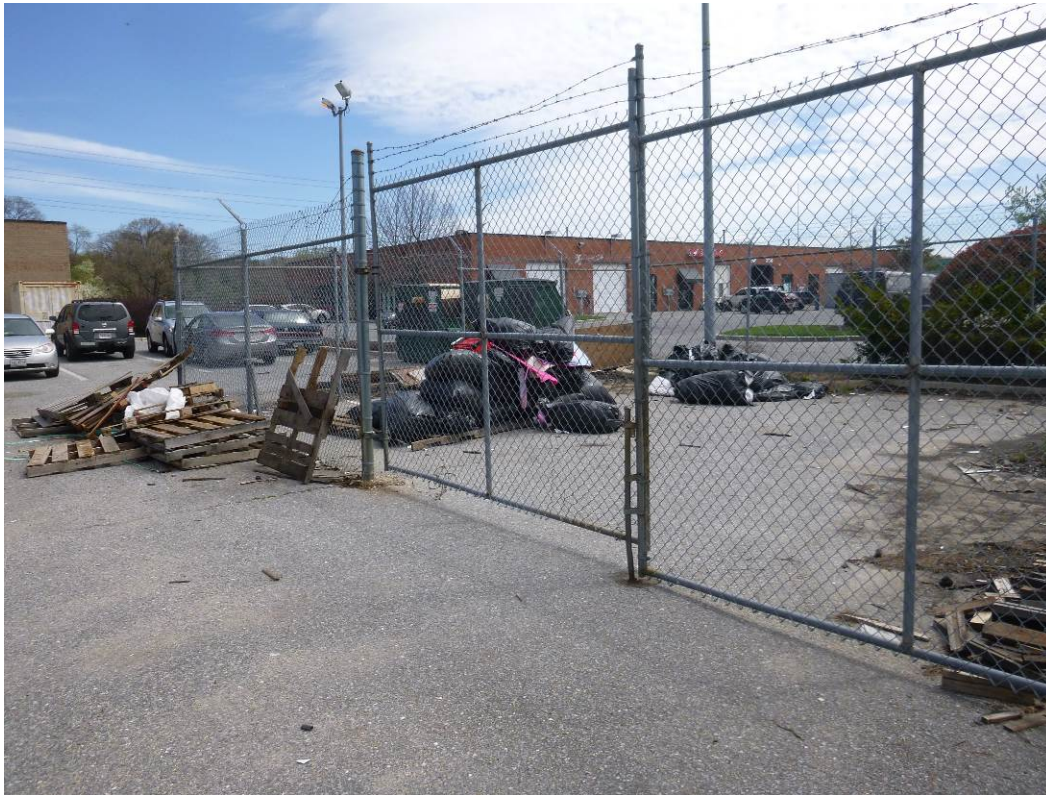
Figure 2. Large pieces of debris placed outside of the storage enclosure

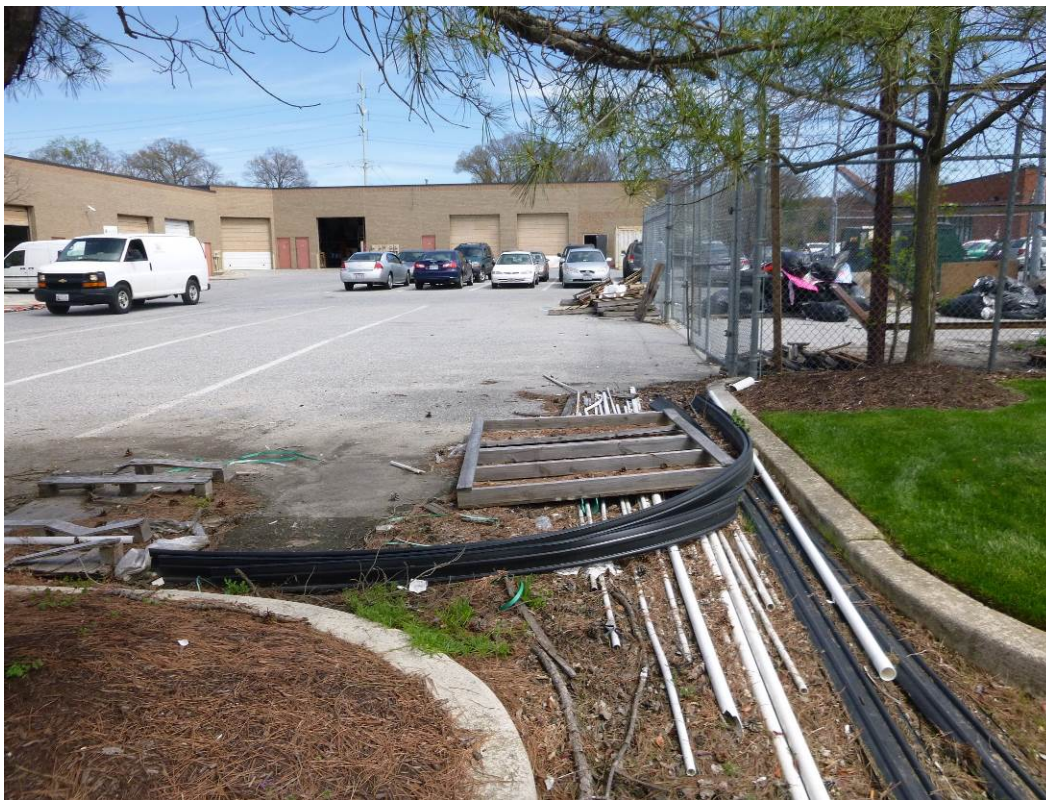
Figure 3. Pipes and other debris found in a parking lot corner drain area

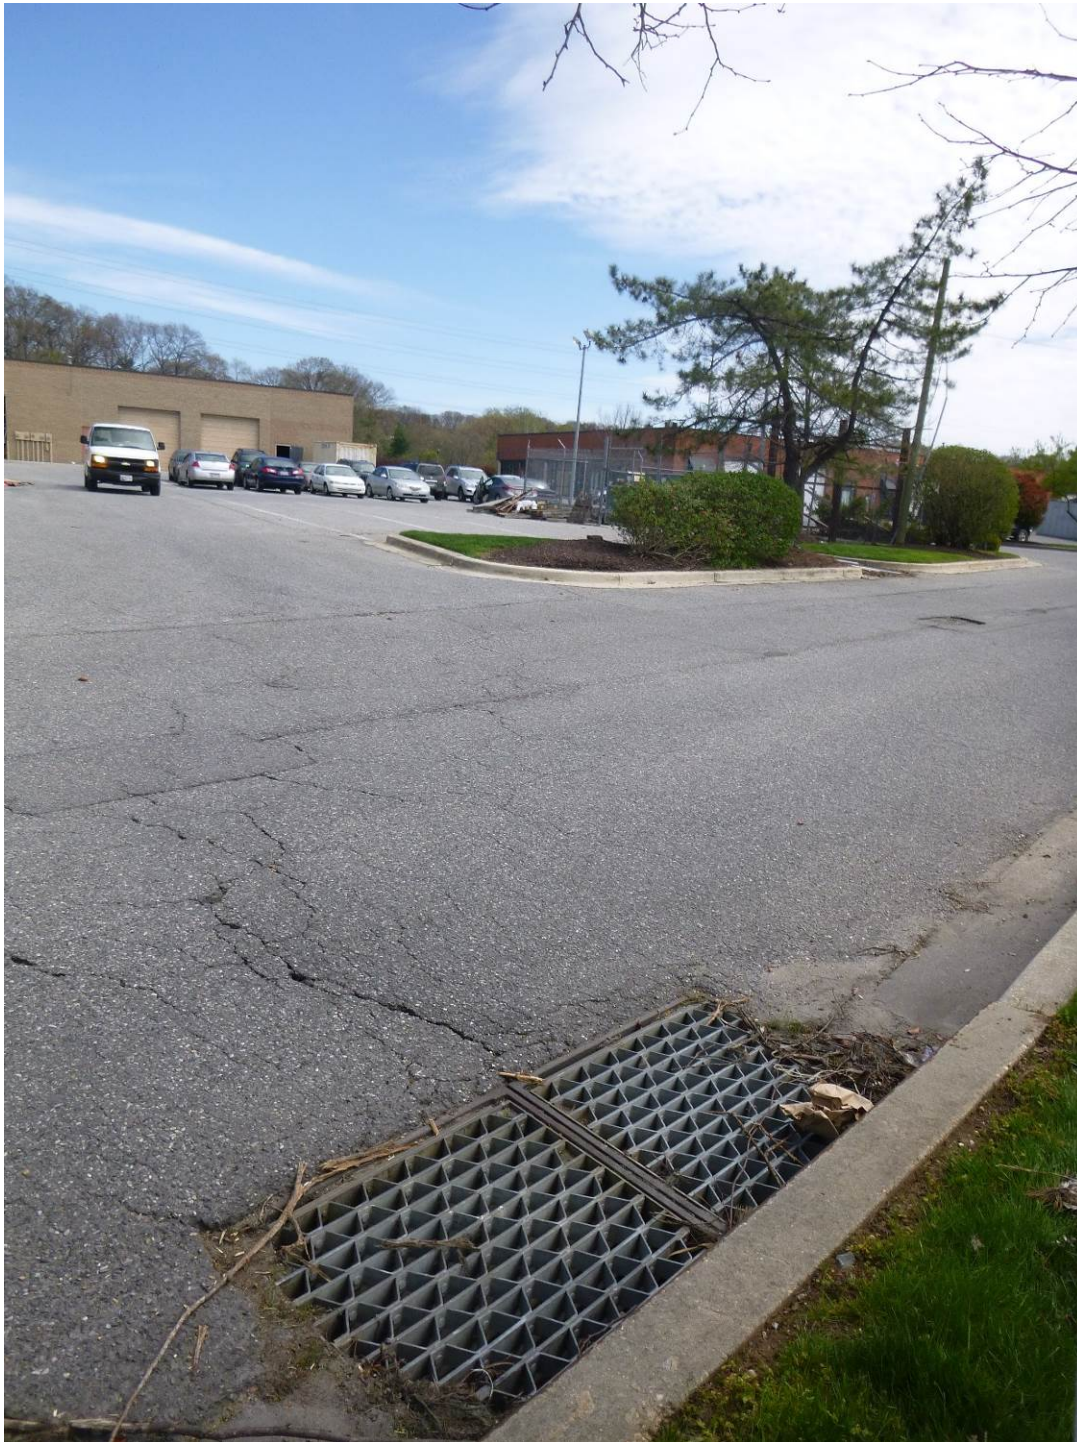
Figure 4. Relative location of the inlet that would receive drainage from the dumpsters and storage areas

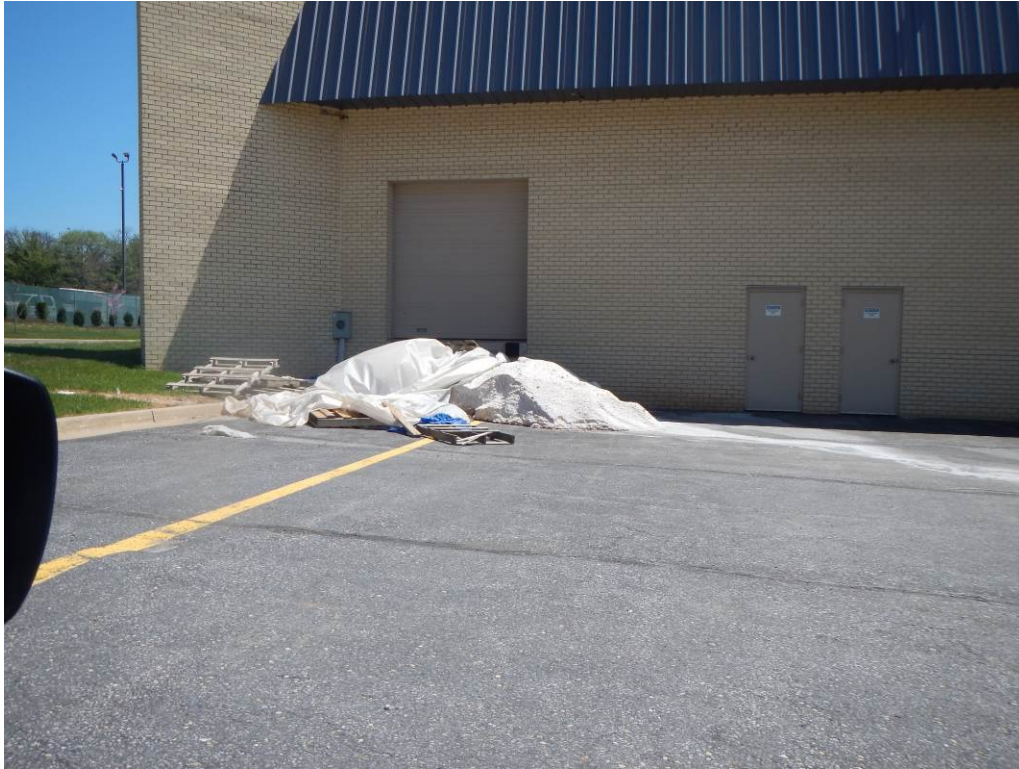
Figure 1. A large, partially uncovered pile of road de-icing salt found on April 24

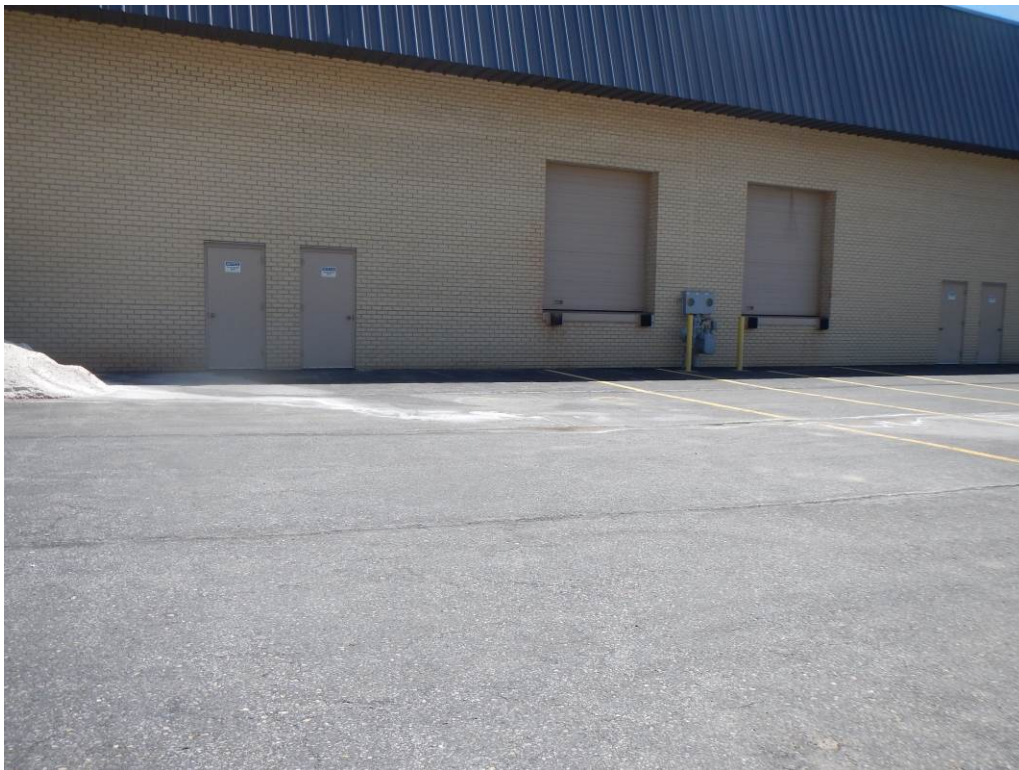
Figure 2 Evidence of the distribution of salt residue along the parking lot surface from the exposed pile of road salt

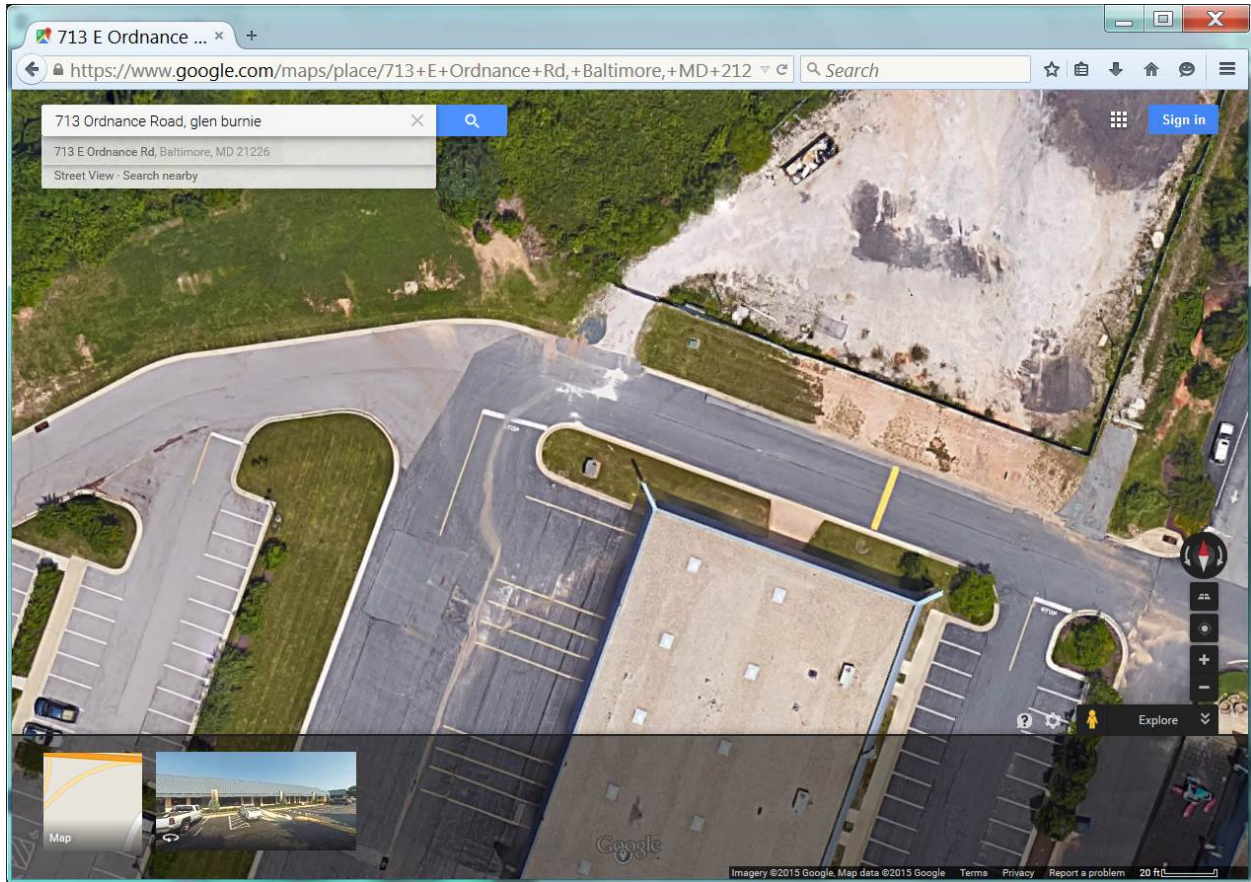
Figure 3. Similar evidence of a trail of residue from the corner of the parking lot where the exposed road salt was found apparent in an image available on the Internet from Google Maps (source: <https://www.google.com/maps/place/713+E+Ordnance+Rd,+Baltimore,+MD+21226/@39.2047719,-76.5954318,92m/data=!3m1!1e3!4m2!3m1!1s0x89b7fd7ffce1ba43:0x26055e1250fd82d!6m1!1e1?hl=en>, obtained May 11, 2015)

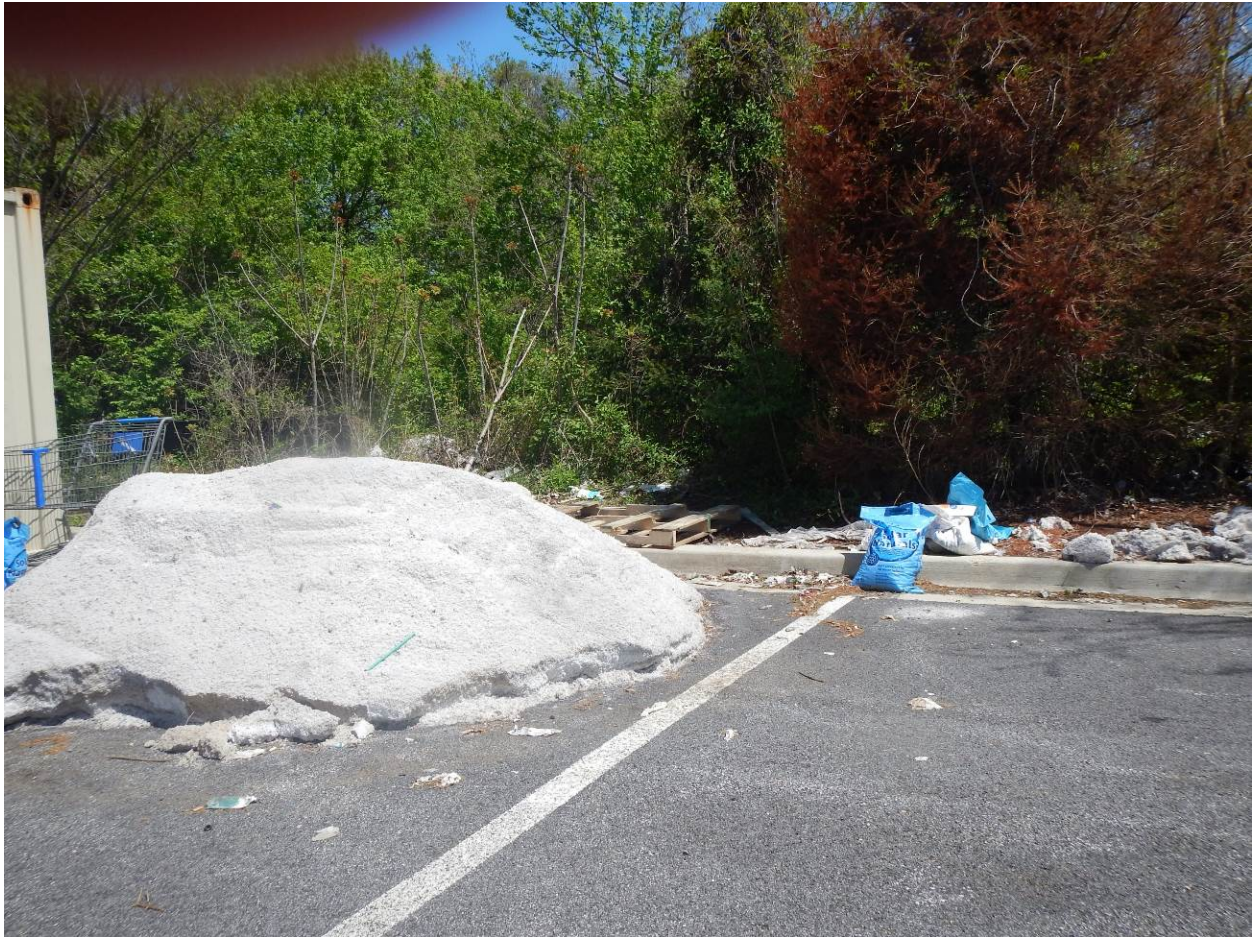
Figure 1. A large, uncovered pile of road de-icing salt in the parking lot, small piles of road salt on the ground, and several bags of water softener salt crystals found on the day of the site visit

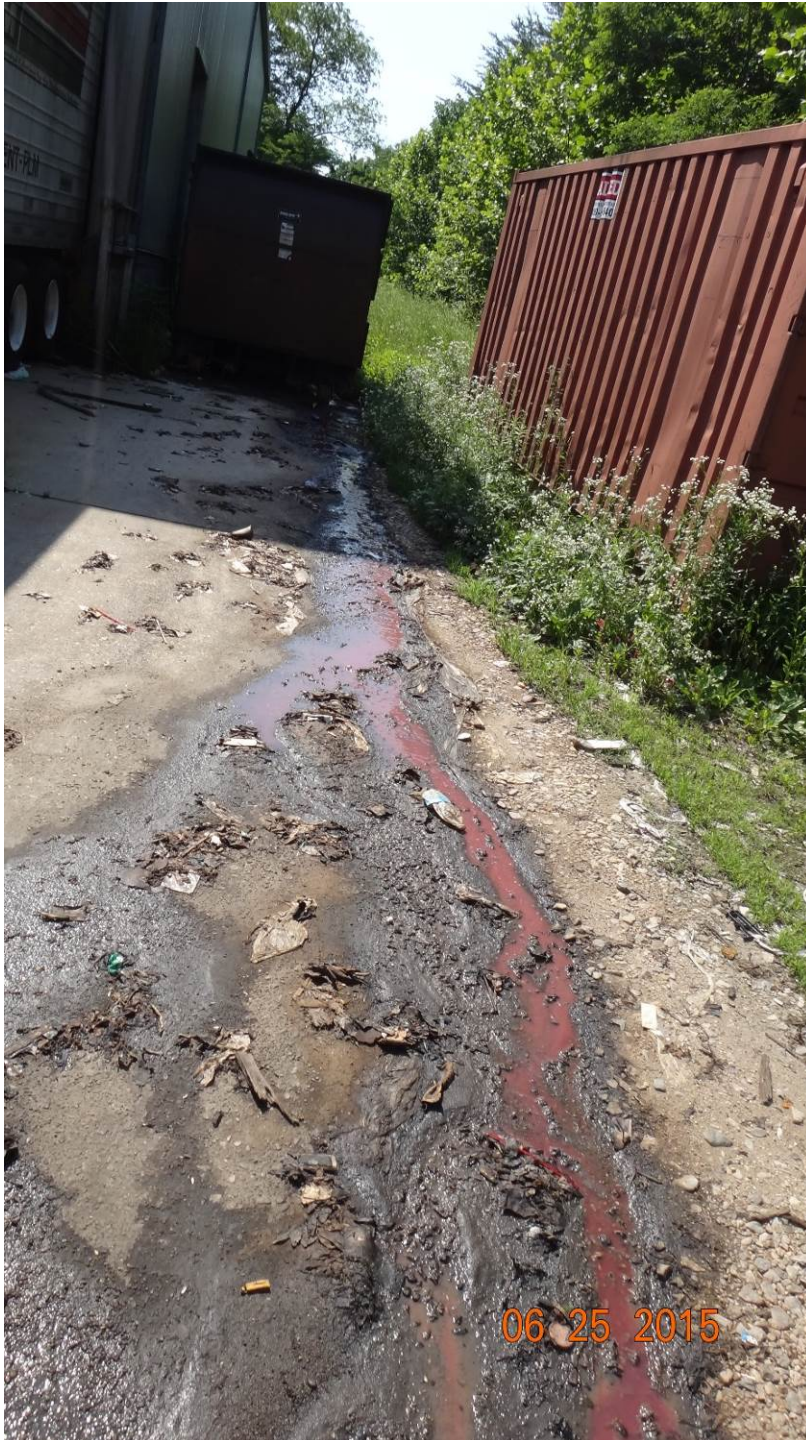
Figure 1. Red liquid observed leaking from a roll-away dumpster found behind the Belair Produce building on June 25, 2015

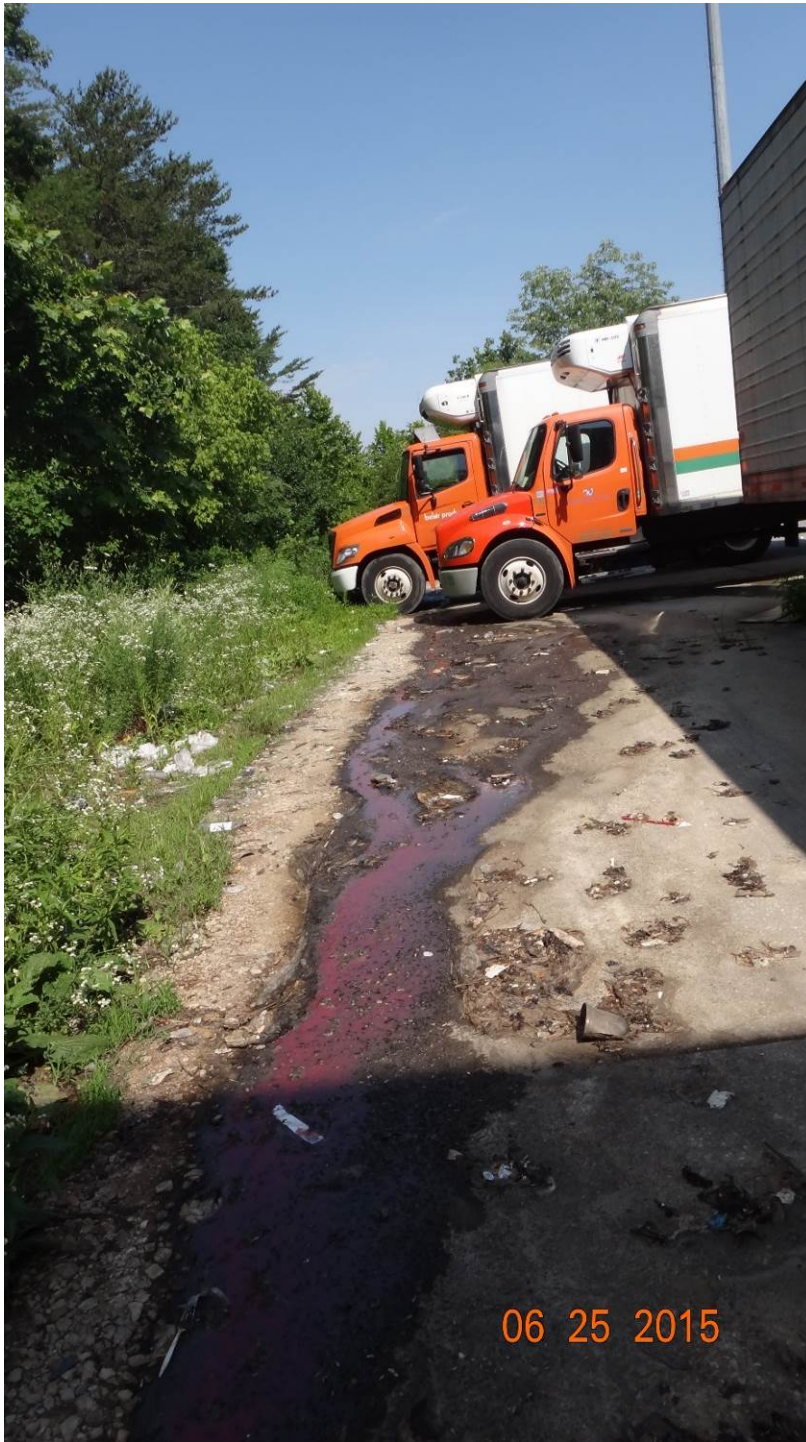
Figure 2. Fluid observed leaking from the dumpster on June 25, 2014 in amounts sufficient to run a course along the edge of the parking lot

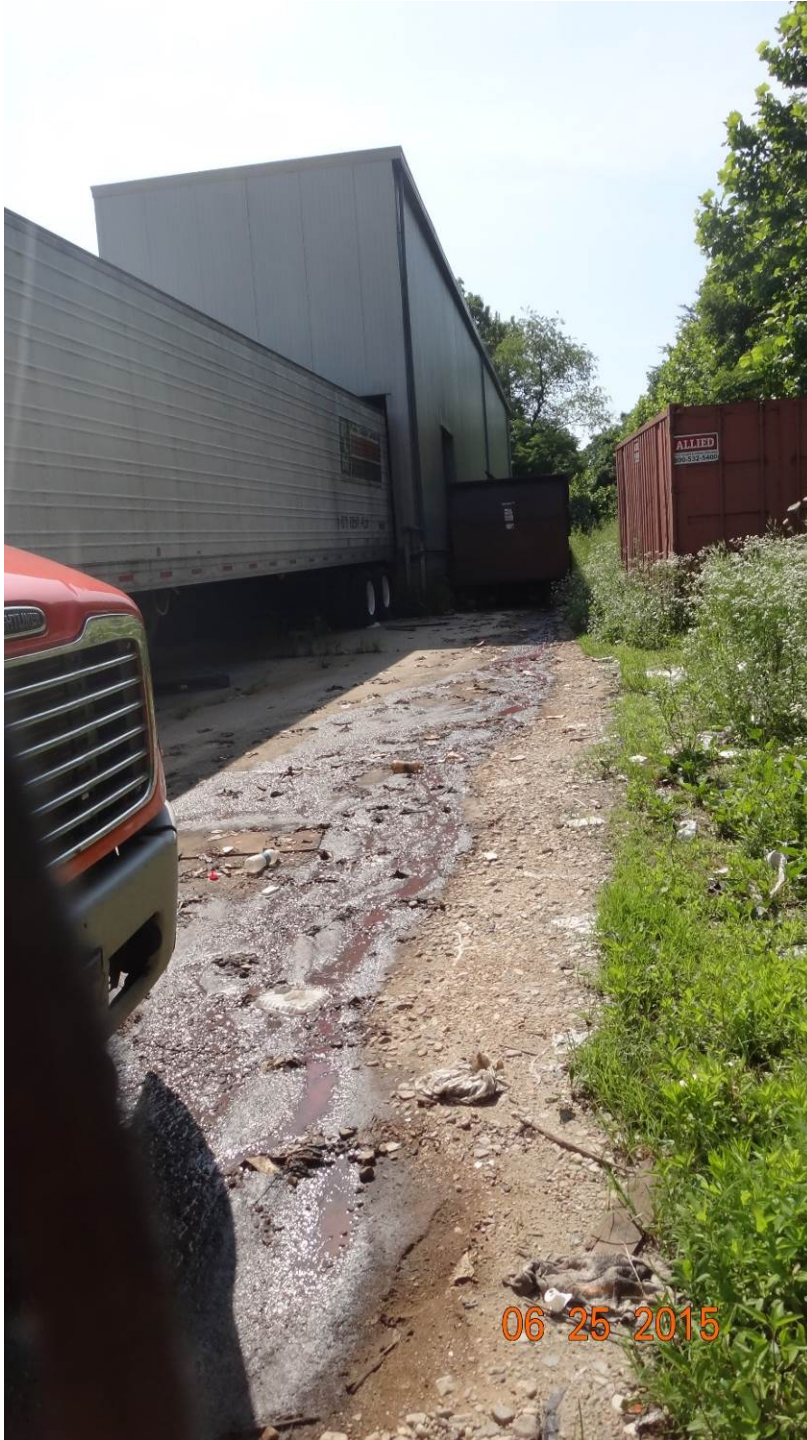
Figure 3. Fresh leachate trail as observed facing the dumpster on June 25, 2015

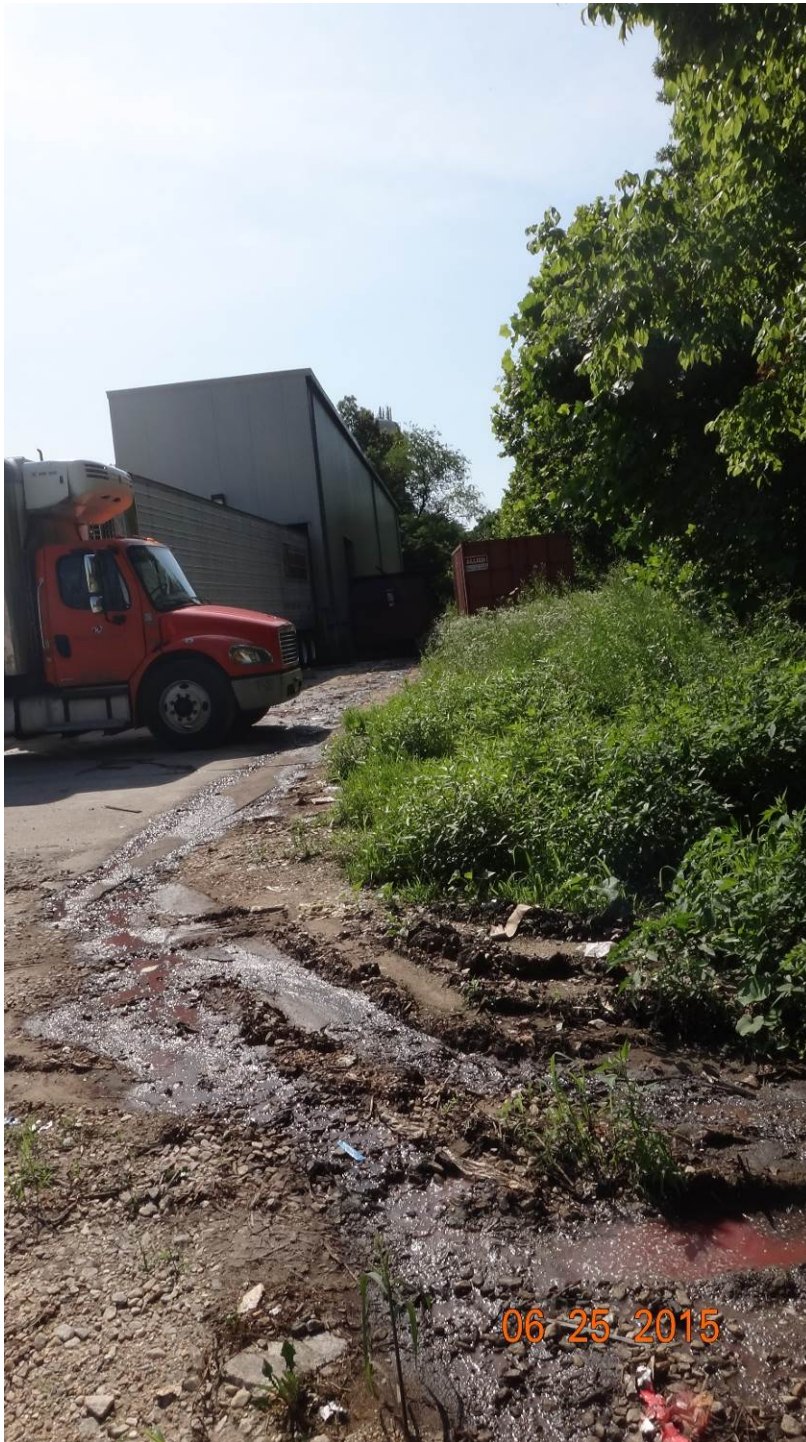
Figure 4. Red liquid leachate leading into the woods from the parking lot, as observed on June 25, 2015
