**BIOLOGICAL AND
GEOMORPHOLOGICAL CONDITION
IN THE PICTURE SPRING BRANCH
SUBWATERSHED, SEVERN RIVER
WATERSHED, ANNE ARUNDEL COUNTY,
MARYLAND: 2015 - 2016**

FINAL REPORT

Versar, Inc.
9200 Rumsey Road
Columbia, MD 21045

February 1, 2017

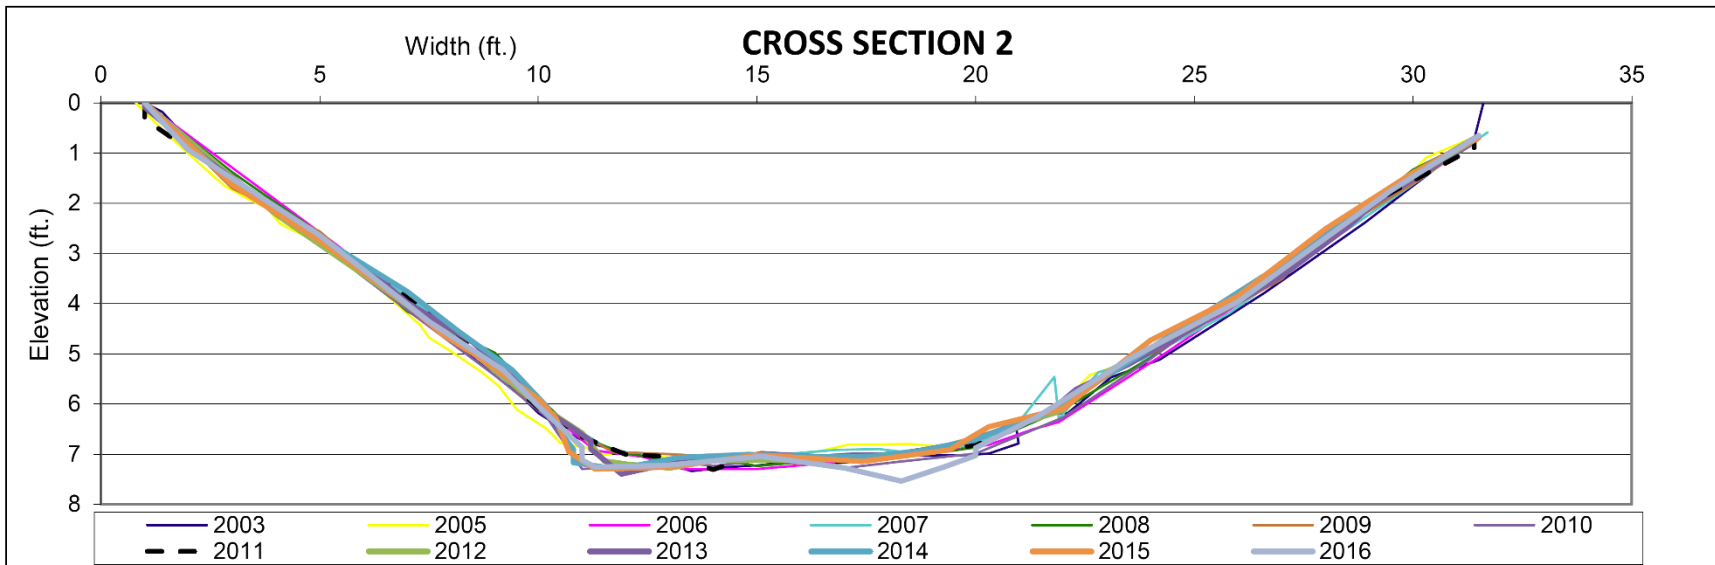
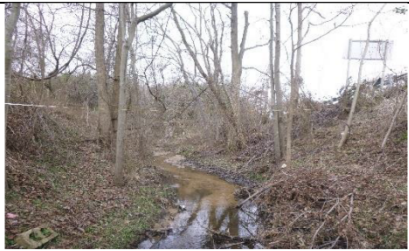
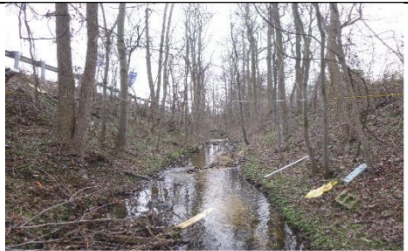
2016 Geomorphic Assessment Results	
Upstream View		Downstream View		Bankfull Width (W_{bkt}) (feet)	11.8
				Mean Depth (d_{bkt}) (feet)	1.0
Left Bank View		Right Bank View		Bankfull Cross-sectional Area (A_{bkt}) (feet ²)	11.9
				Width/Depth Ratio (W_{bkt}/d_{bkt})	11.7
Left Bank View		Right Bank View		Width of Flood-prone Area (W_{fpa}) (feet)	16.9
				Entrenchment Ratio (ER) = W_{fpa}/W_{bkt}	1.4
Left Bank View		Right Bank View		Channel Materials D_{50} (millimeters)	0.20
				Water Surface Slope (S)	0.0018
Left Bank View		Right Bank View		Sinuosity (K) = stream length/valley length	<1.2
				Adjustments?	Sin ↑, WD ↑
Left Bank View		Right Bank View		STREAM TYPE	F5

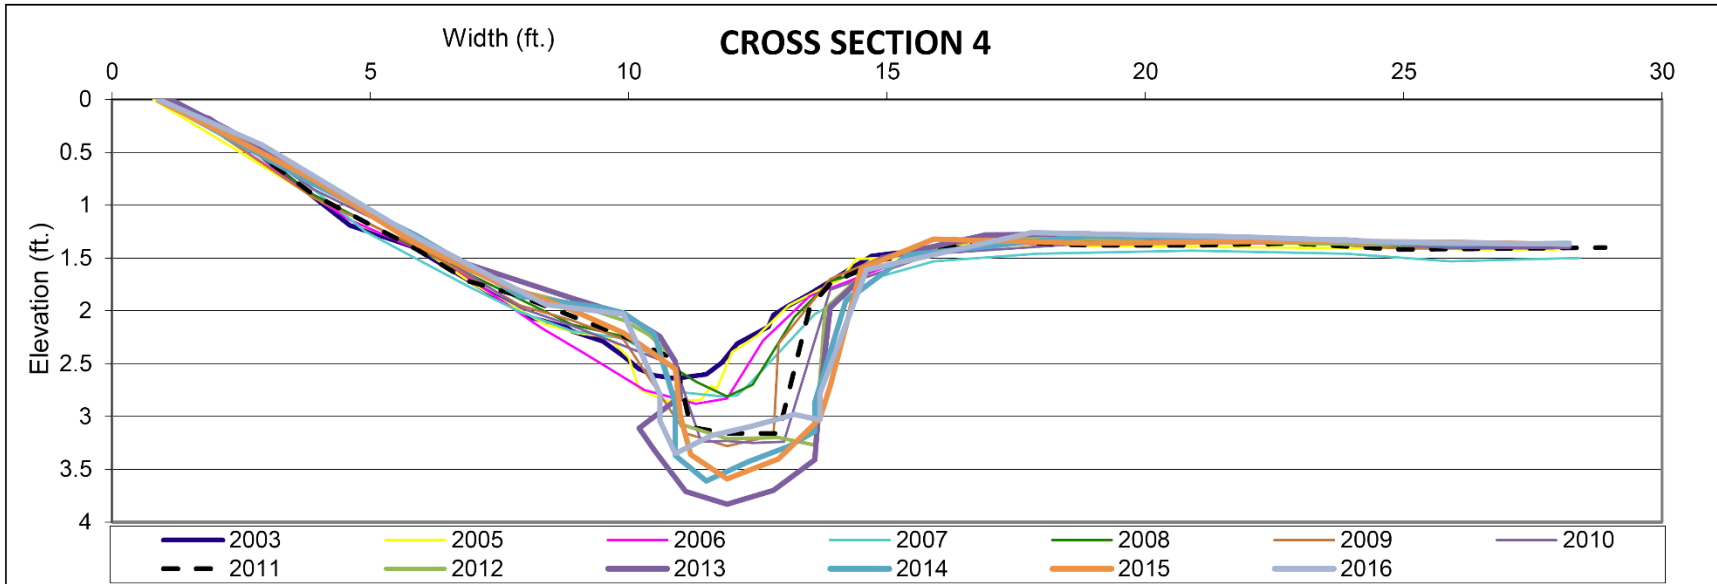
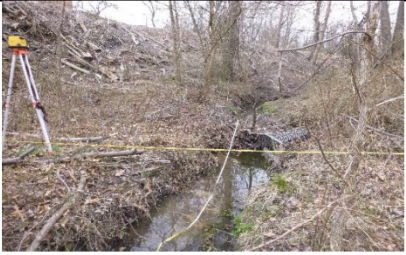
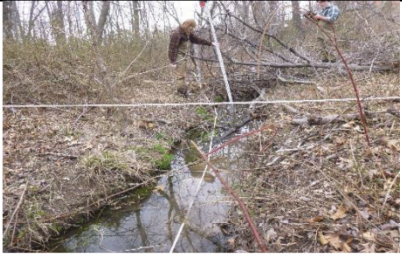
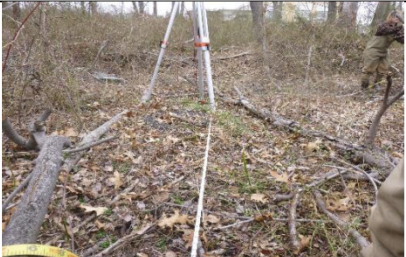
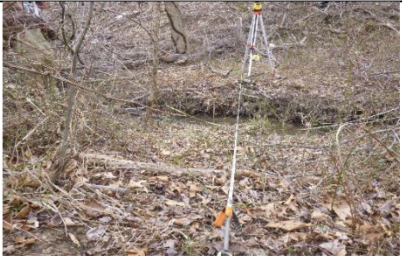
An E channel was identified at cross section 4 on the South Tributary, which appeared to have been channelized in the past and is piped underground for a significant distance upstream, further modifying its hydrology. However, the South Tributary is not overwidened and is significantly steeper than the North Tributary. Indicators were observed that show some limited floodplain connectivity along the upstream portion of the tributary where the cross section is located. However, just downstream of the cross section location, the channel became noticeably entrenched and showed signs of active downcutting. While it is possible that this reach may exhibit both B and E characteristics along different portions of the reach, it was assigned an E5 classification primarily based on the entrenchment and width/depth ratios measured at the cross section location. Evidence of recent downcutting (e.g., nick points) suggests that the reach is unstable and is likely shifting from an E channel to a B channel. Significant changes in the shape of this cross section were observed during the 2013 survey, as the channel had noticeably deepened and widened since the 2012 survey (Appendix B). Over the next year, as seen in the 2014 survey, aggradation occurred affecting the bed level by raising it approximately 0.5 feet. From 2014 to 2015, the channel has shifted slightly, but has remained stable in terms of aggradation or deepening. Noticeable aggradation once again occurred in 2016 by an approximate 0.5-foot rise in bed elevation. Analysis of the longitudinal profile overlay from 2007 through 2016 shows considerable downcutting between stations 1+00 and 2+20 (Appendix B). However, during 2014 the pool near station 2+00 has mostly filled in. This trend has continued in 2015, with the pool working its way up the reach to station 1+80. In 2016, the pool has remained at station 1+80 but has deepened by almost a foot. The headcut and large scour pool between stations 2+68 and 2+90 just downstream from this eroded section have not worsened. However, in 2016 this scour pool has shifted downstream by a few feet. It is recommended that this area continue to be monitored, since further erosion could eventually lead to undermining of the concrete-lined channel just downstream.

Mean Depth (d_{bkt}) (feet)	0.9
				Bankfull Cross-sectional Area (A_{bkt}) (feet ²)	3.9
<p style="text-align: center;">Upstream View</p>		<p style="text-align: center;">Downstream View</p>		Width/Depth Ratio (W_{bkt}/d_{bkt})	4.9
				Width of Flood-prone Area (W_{fpa}) (feet)	24.3
<p style="text-align: center;">Left Bank View</p>		<p style="text-align: center;">Right Bank View</p>		Entrenchment Ratio (ER) = W_{fpa}/W_{bkt}	5.6
				Channel Materials D_{50} (millimeters)	0.28
<p style="text-align: center;">Left Bank View</p>		<p style="text-align: center;">Right Bank View</p>		Water Surface Slope (S)	0.015
				Sinuosity (K) = stream length/valley length	<1.2
<p style="text-align: center;">Left Bank View</p>		<p style="text-align: center;">Right Bank View</p>		Adjustments?	Sin ↑
				STREAM TYPE	E5

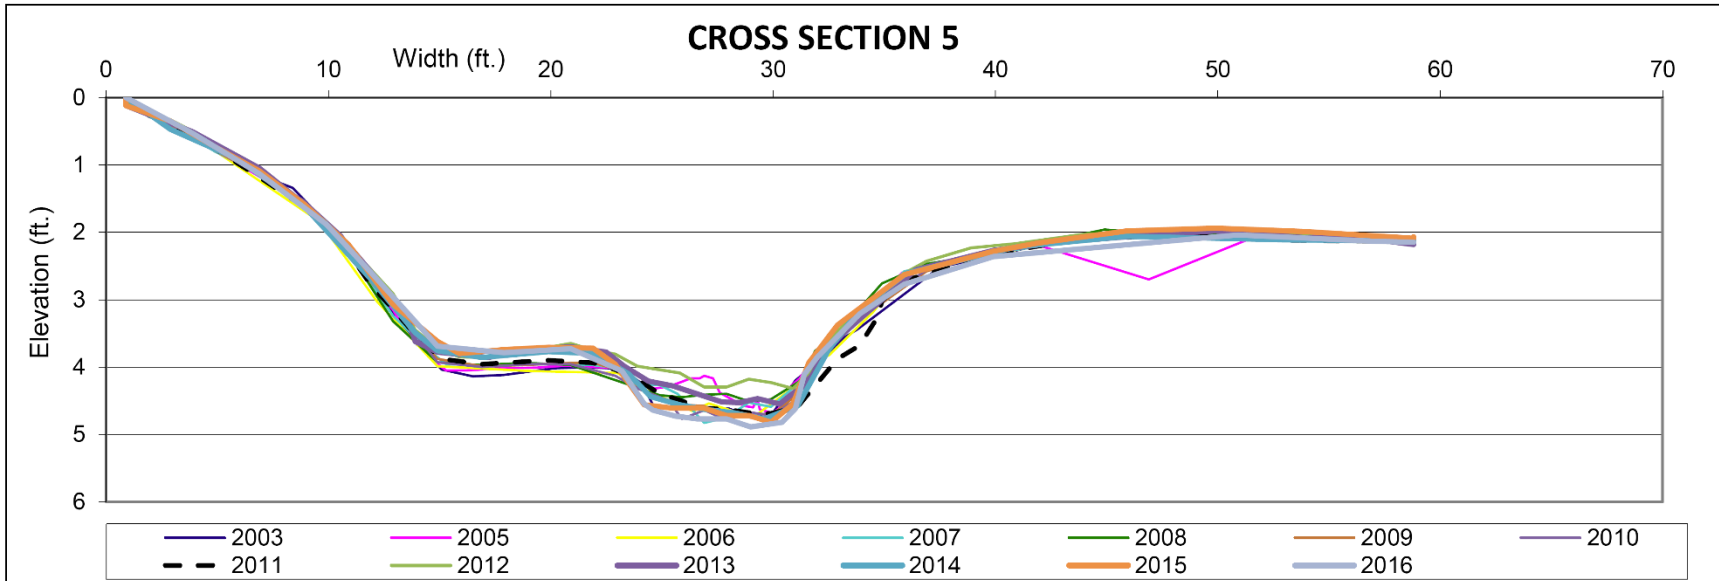
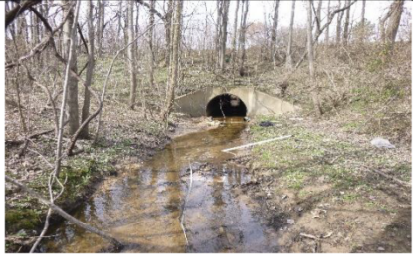
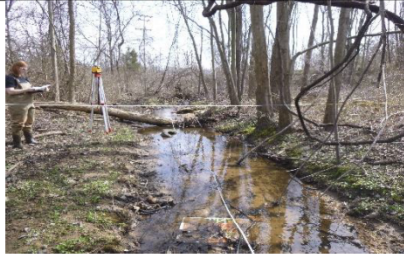
2016 Geomorphic Assessment Results	
Upstream View		Downstream View		Bankfull Width (W_{bkt}) (feet)	8.3
				Mean Depth (d_{bkt}) (feet)	0.6
Left Bank View		Right Bank View		Bankfull Cross-sectional Area (A_{bkt}) (feet ²)	5.2
				Width/Depth Ratio (W_{bkt}/d_{bkt})	13.4
Left Bank View		Right Bank View		Width of Flood-prone Area (W_{fpa}) (feet)	20.2
				Entrenchment Ratio (ER) = W_{fpa}/W_{bkt}	2.4
Left Bank View		Right Bank View		Channel Materials D_{50} (millimeters)	0.40
				Water Surface Slope (S)	0.003
Left Bank View		Right Bank View		Sinuosity (K) = stream length/valley length	<1.2
				Adjustments?	Sin ↑
STREAM TYPE		C5
