**CHEMICAL, BIOLOGICAL, AND PHYSICAL
CHARACTERIZATION
OF THE CHURCH CREEK AND
PAROLE PLAZA NPDES MONITORING
STATIONS: 2015 - 2016**

FINAL REPORT

Anne Arundel County
Department of Public Works
Watershed Protection and Restoration Program
2662 Riva Road
Annapolis, MD 21401

February 1, 2017

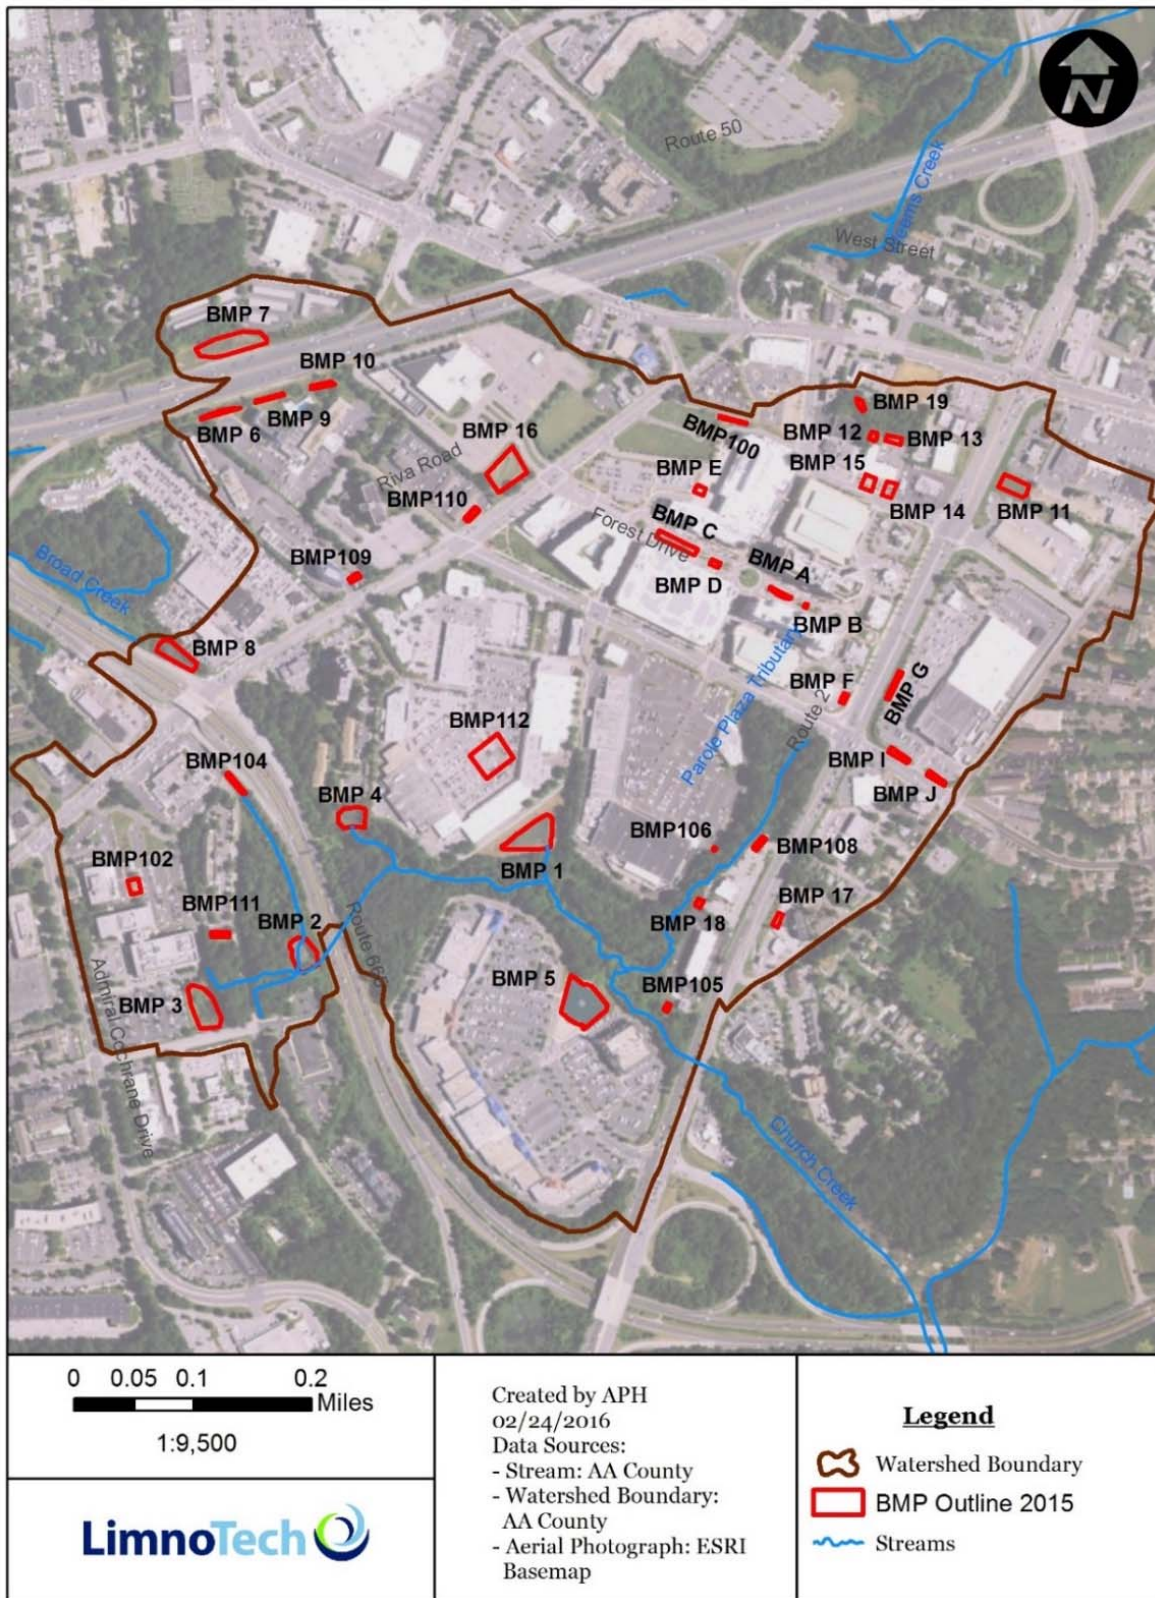
Figure 2-2. Church Creek BMPs

- BMP 19, located at 2200 Somerville Road, should be considered non-functional and failing. The inspection revealed standing water, significant amounts of trash, heavy vegetative debris, and a clogged orifice. Immediate action is recommended to restore this BMP to its original condition.

- BMP 4 had an eroding hole in the southern embankment as well as ponding, suggesting it is either failing or has been misclassified. This BMP should be evaluated for either maintenance or to correct the information in the database

- BMPs 2 and 8 have standing water even though the BMPs are classified as a Dry Pond and an Infiltration Basin, respectively. These BMPs are either failing or are Extended Detention Structures, Wet (PWED that have been characterized incorrectly. These BMPs should be evaluated for either maintenance or to correct the information in the database.

- BMP 102 has standing water, debris buildup, and missing curb cuts for two flow-in points to the BMP. Removal of leaf debris and installation of curb cuts in east parking lot are recommended.

- BMPs 2, 6, 8, 9, 10, 18, 19, G, I, J, 101, 103, and 105 are not currently included in the Urban BMP database. LimnoTech recommends adding these BMPs to the database.
- The location of BMP 7 data point in the Database appears incorrect. It is currently situated on a building to the northeast of the actual pond.

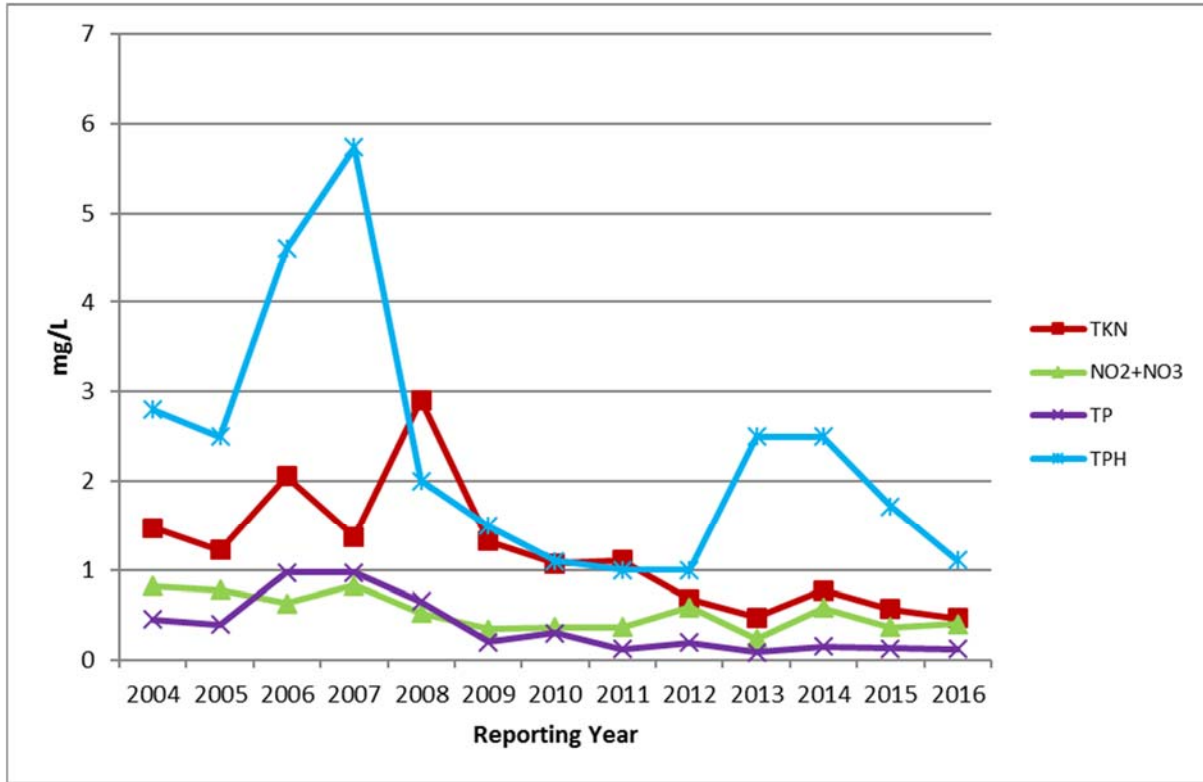
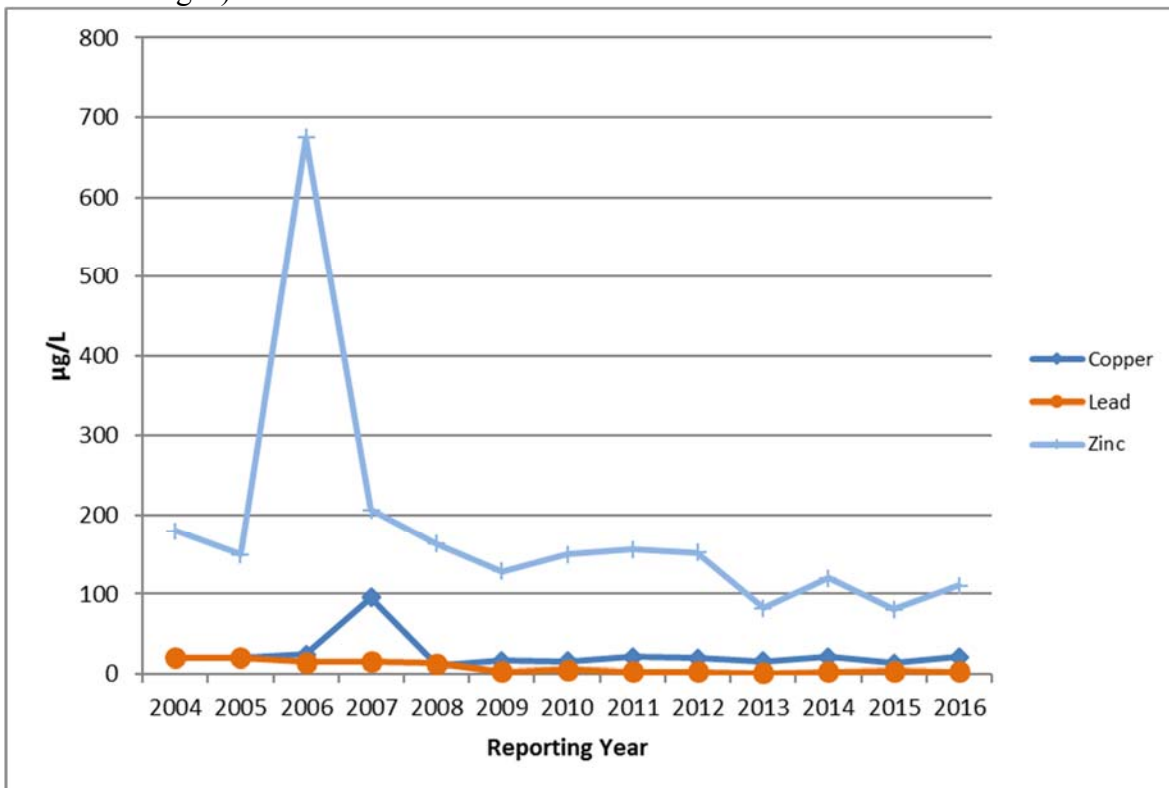
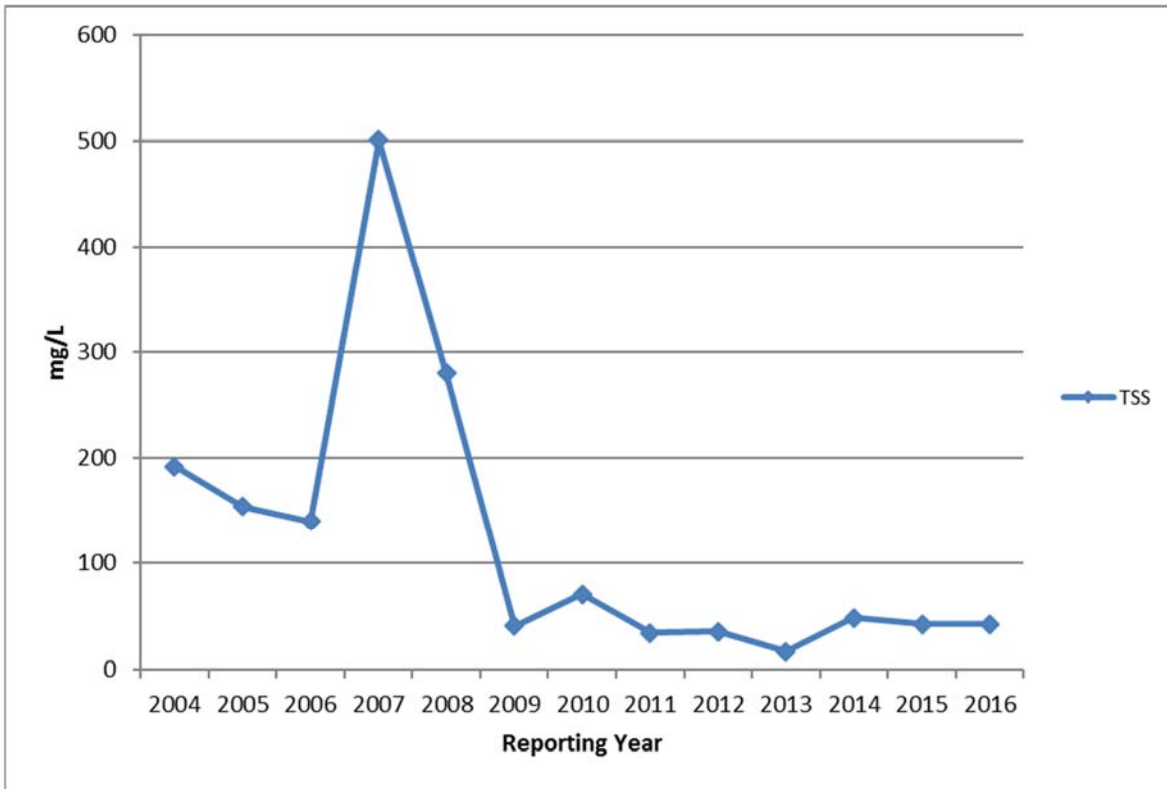
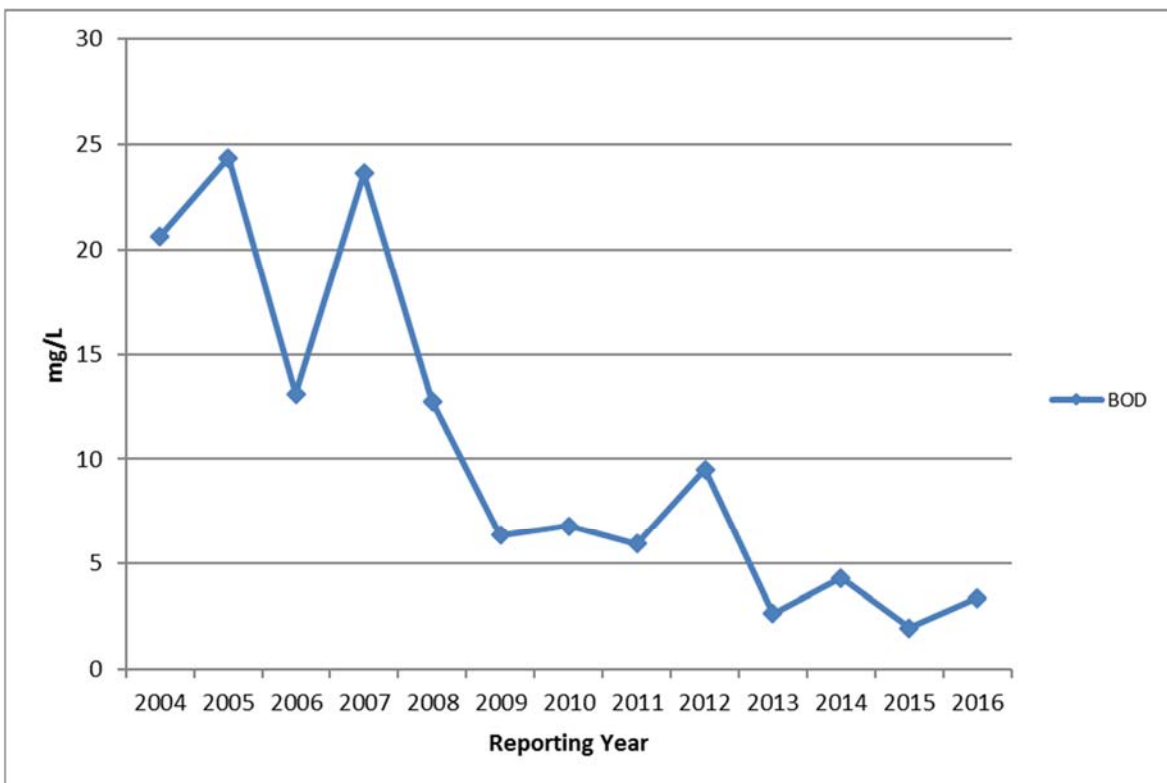
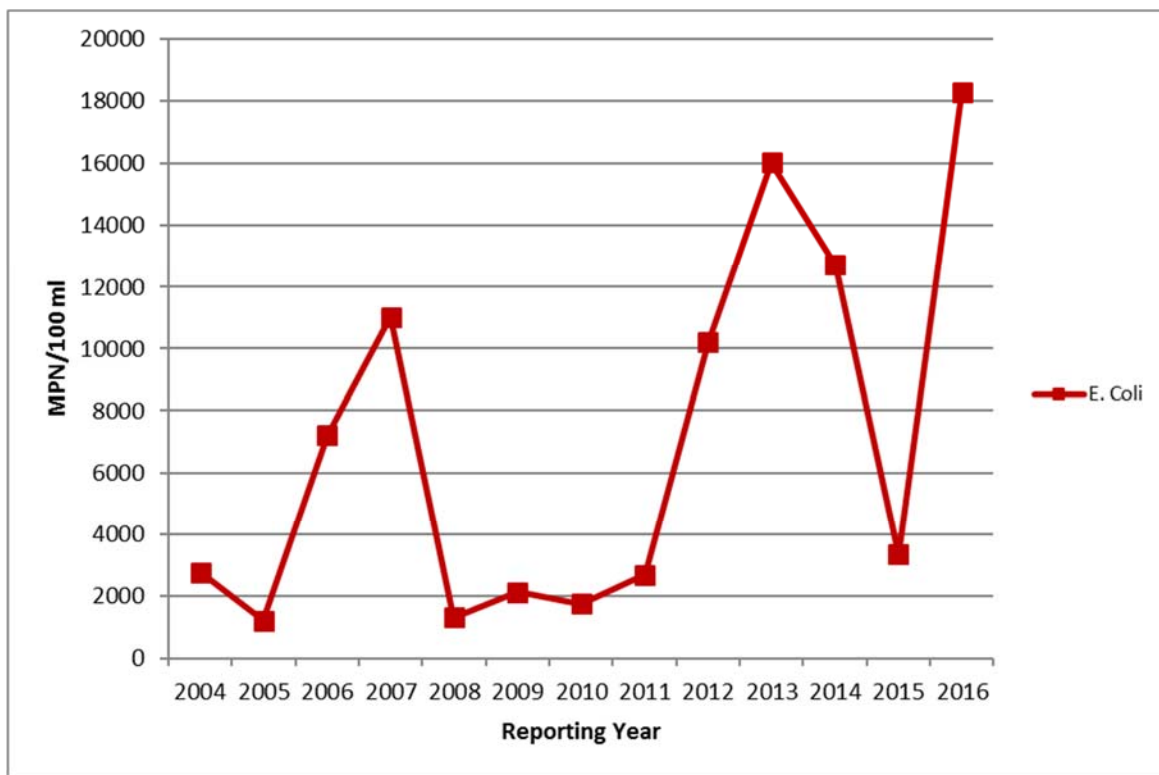
Annual average EMCs were plotted for each monitoring year. Plots were constructed to illustrate the impact that construction activity and redevelopment of the Annapolis Towne Centre site has had on water quality within the study reach. Figures 4-1 through 4-5 show how EMCs have changed from 2004 to 2016 at the Parole Monitoring Station. Nearly every concentration rose

substantially between 2006 and 2007 when the majority of the site work was being conducted at the Towne Centre. These concentrations notably fell in 2008, as the site stabilized. This downward trend continued in 2009. The reduction in pollutant concentrations stabilized in 2010 and 2011 possibly indicating that the stream has reached a post-construction baseline. Pollutant concentrations in 2016 have slightly increased for most parameters when compared to those from 2015, with the exception of a slight decrease in TPH. The 2013 rise in TPH was due to an increase in the detection limit, and may not be associated with an actual increase in concentration, as greater than 95% of TPH concentrations fell below the detection limit. It is important to note that the 2013 data included in these plots do not include summer season data, which is often the season that produces the highest EMCs for many of the parameters, although this was not the case in 2016 except for *E.coli*.

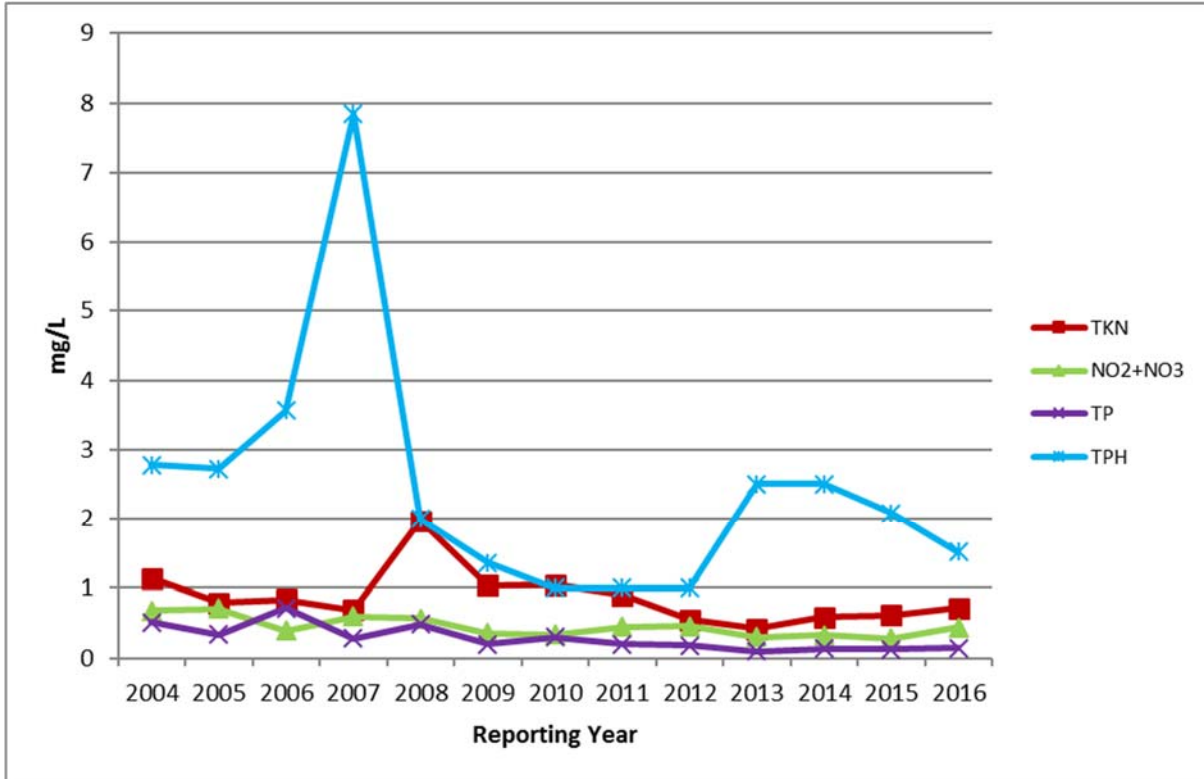
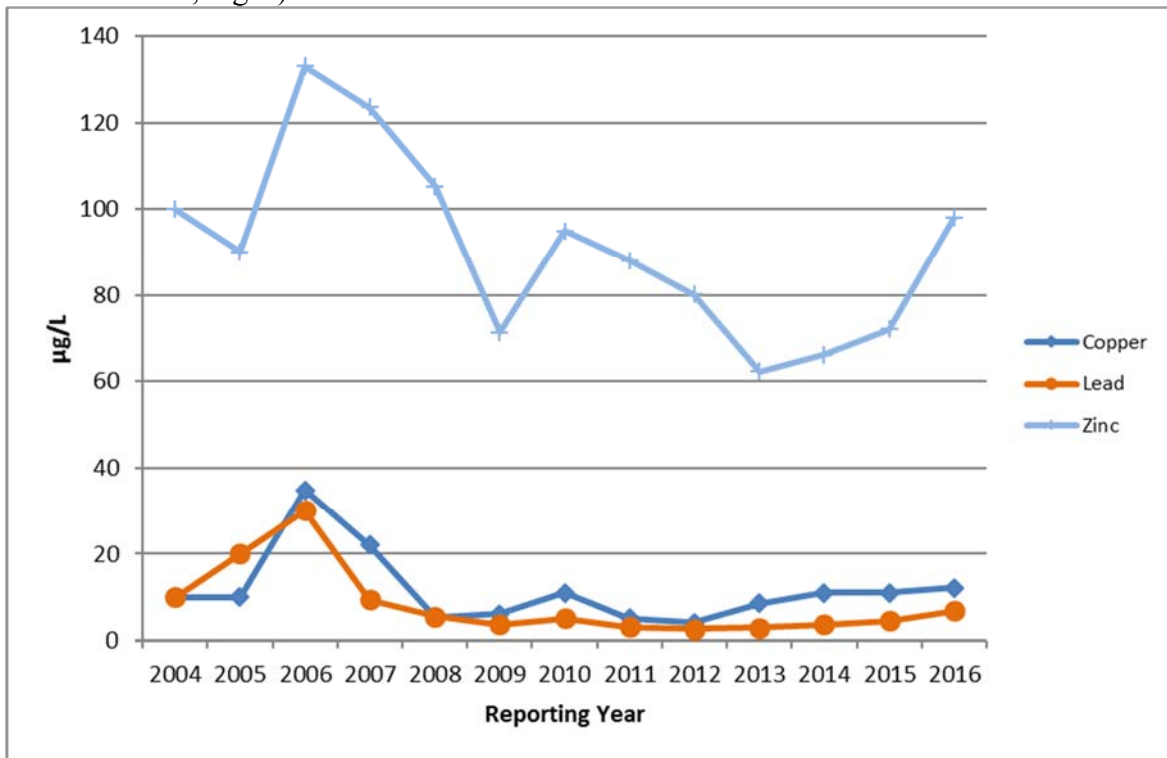
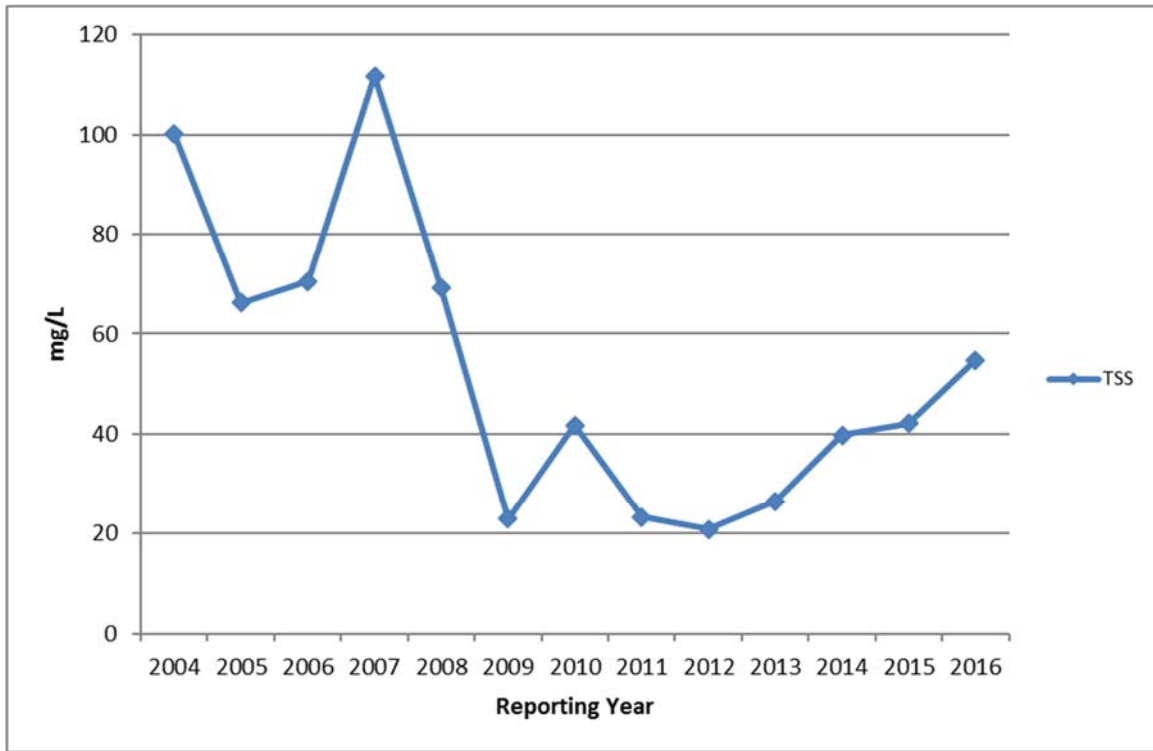
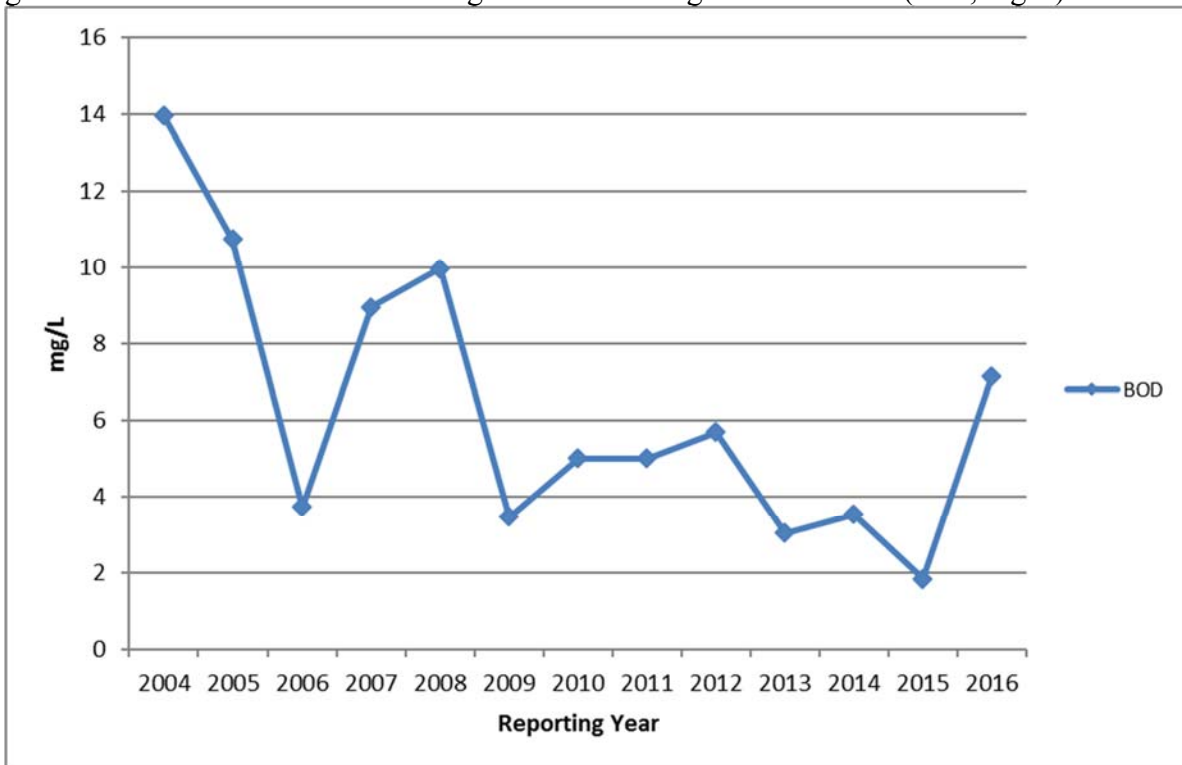
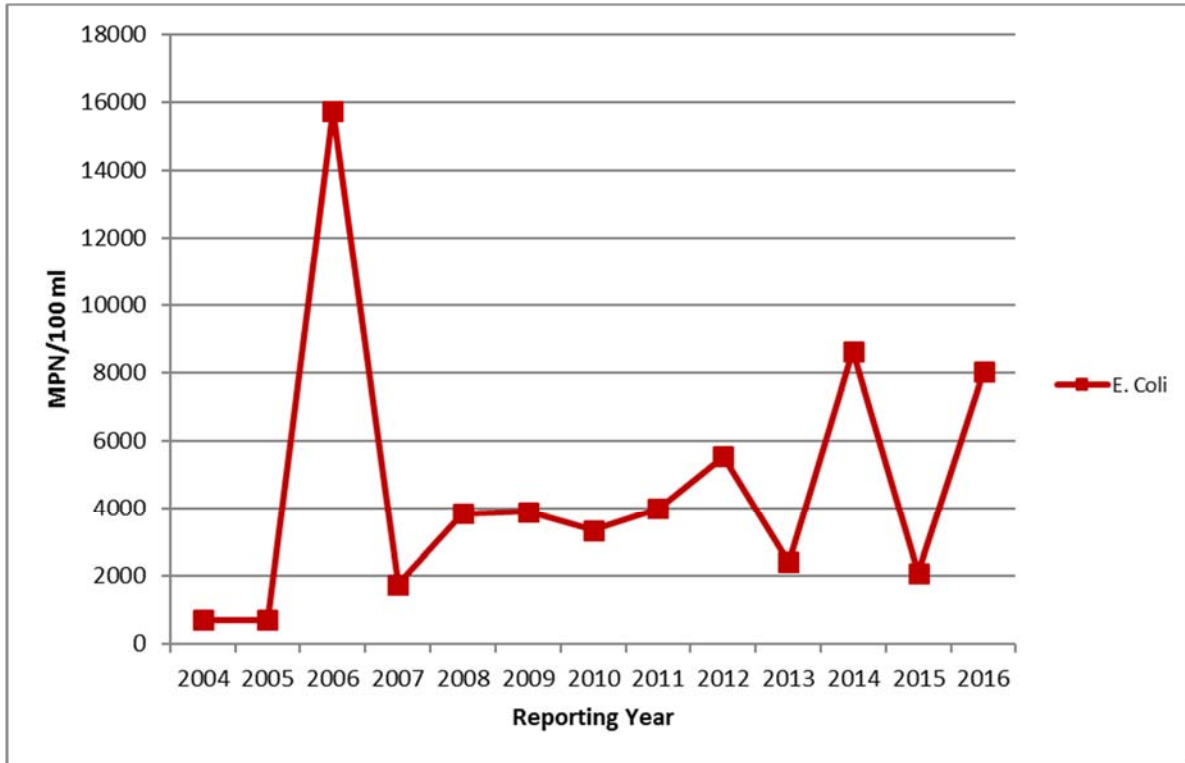
Figures 4-6 through 4-10 show almost the same trend in EMCs for the Church Creek Monitoring Station. A slight rise in pollutant concentrations at Church Creek was observed in 2016 for TKN, nitrate-nitrite, lead, and copper when compared to 2015 EMCs. However, TSS, zinc, BOD, and *E.coli* have increased substantially when compared to the last three years. Note that the apparent rise in TPH at Church Creek in 2013, like Parole Plaza, was due to an increase in the detection limit. Also like Parole Plaza, summer season concentrations were not included with the 2013 EMC data.

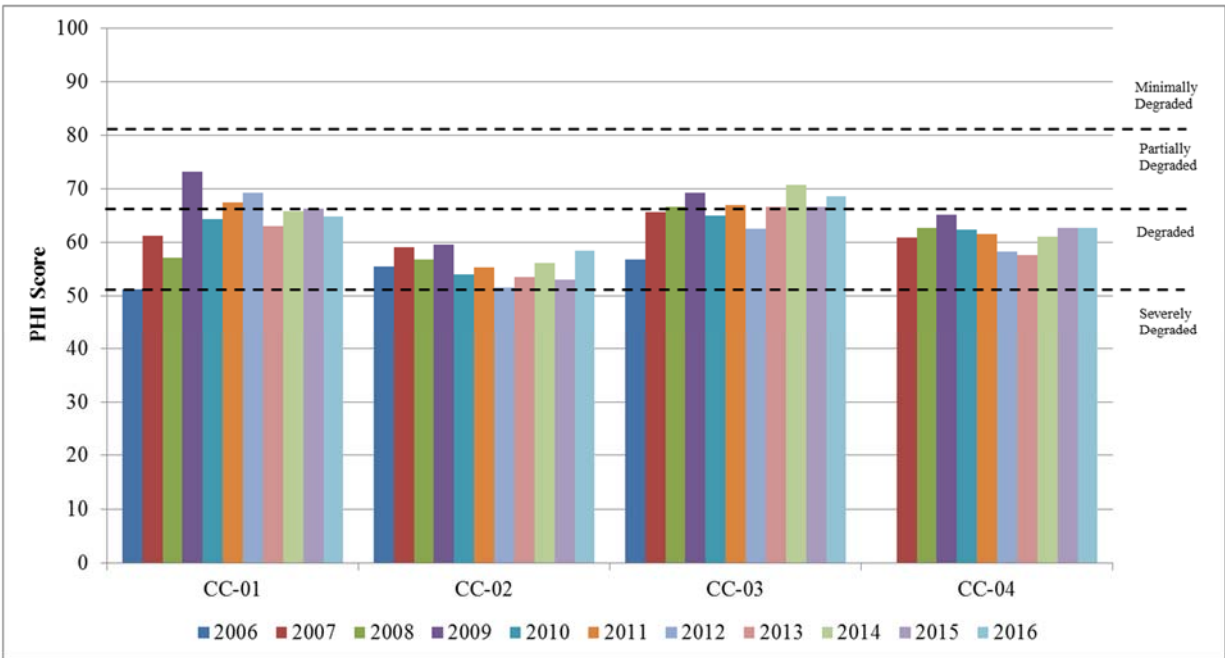
Figure 4-11. Comparison of PHI scores from 2006 to 2016

2016	PHI Score	64.80	58.47	68.64	62.70
	Rating	Degraded	Degraded	Partially Degraded	Degraded

In 2013 and 2014, the updated MBSS PHI methods (Paul et al. 2003) were used to calculate PHI instead of the original MBSS methods (Hall et al. 2002) which had been used in the Church Creek watershed reports from prior years. Scores for 2006-2012 shown in Table 4-9 and Figure 4-11 were calculated using the original method, while scores for 2013-2016 were calculated using the updated method.

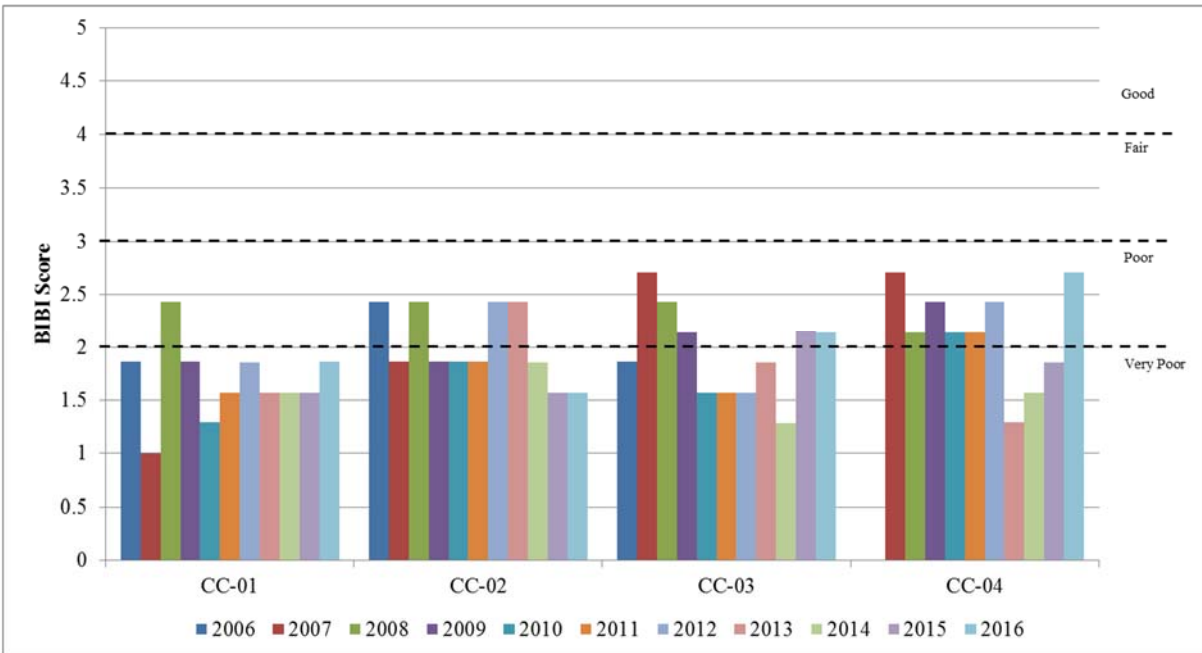
Figure 4-12. Comparison of BIBI scores from 2006 to 2016

Biological impairment is evident within this watershed as reflected by the macroinvertebrate communities found throughout the study reach. A comparison of BIBI scores from 2006 through 2016 (Table 4-10) shows no substantial change in biological conditions throughout the study reach. While BIBI scores tend to fluctuate from year to year, overall classifications have changed very little with sites consistently rating either “Poor” or “Very Poor,” no clear trends have been established (Figure 4-12). It appears that the biological community continues to be limited by the presence of urban stressors and degraded physical condition of the stream, and annual shifts in BIBI scores are likely related to random and systematic variability inherent in the assessment process.

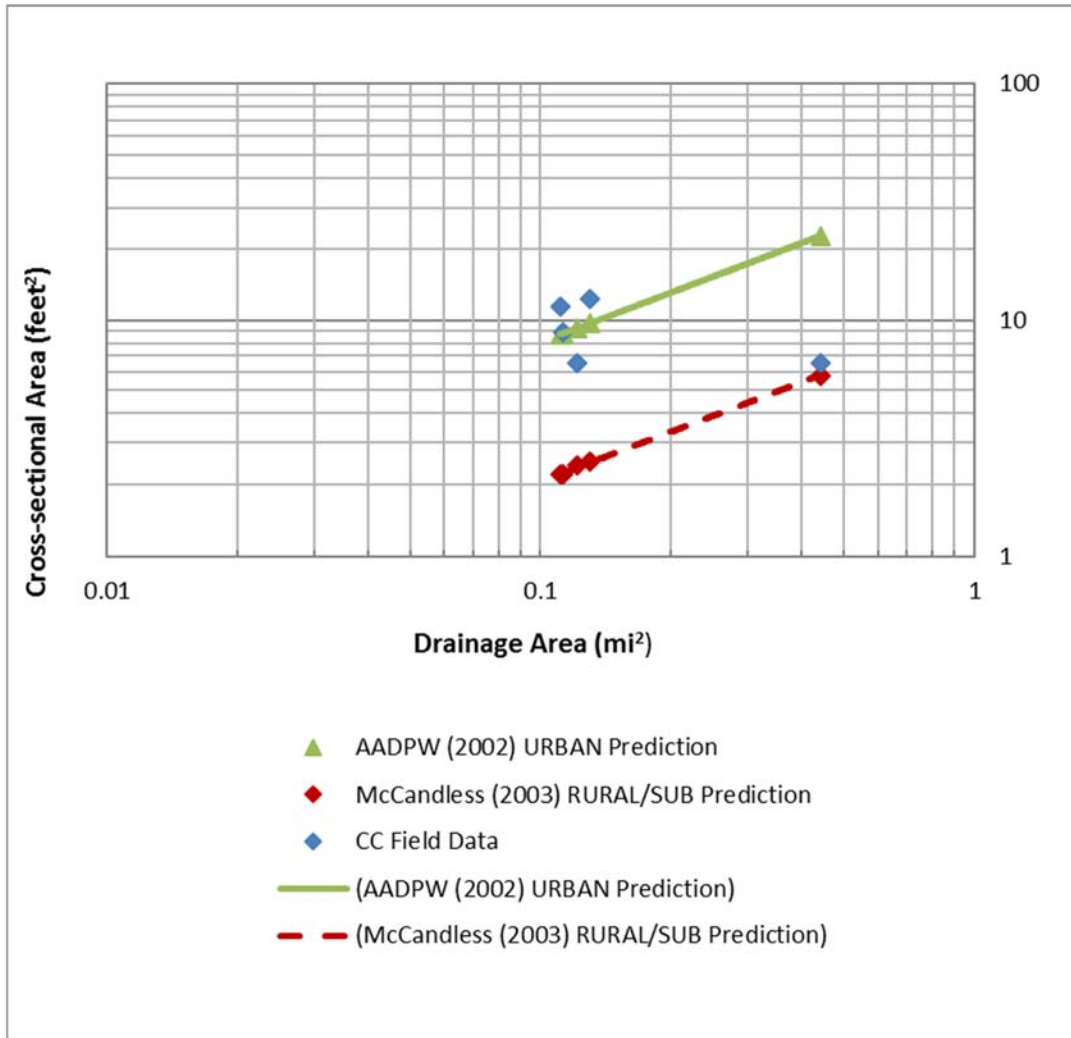
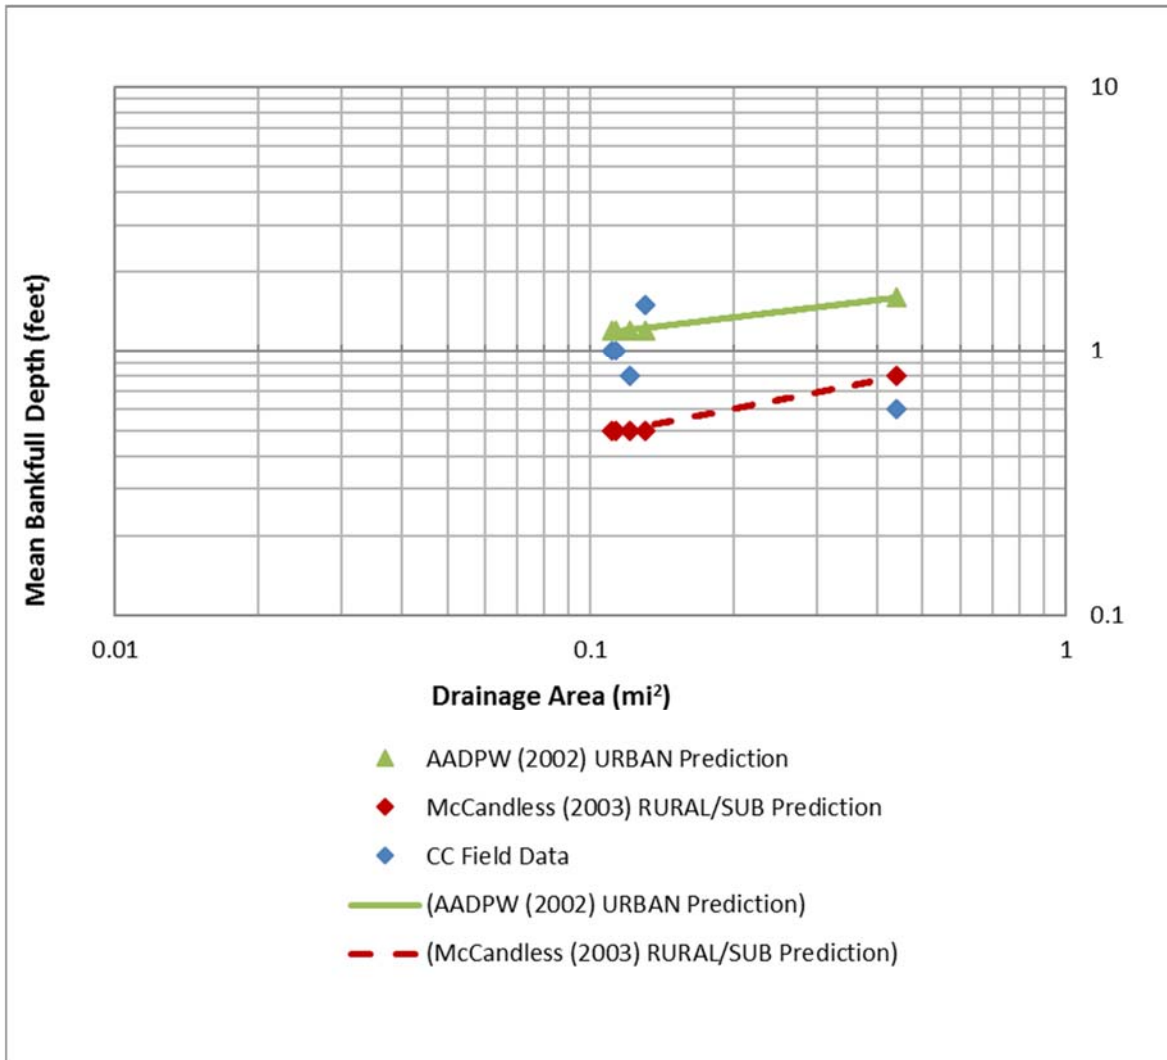
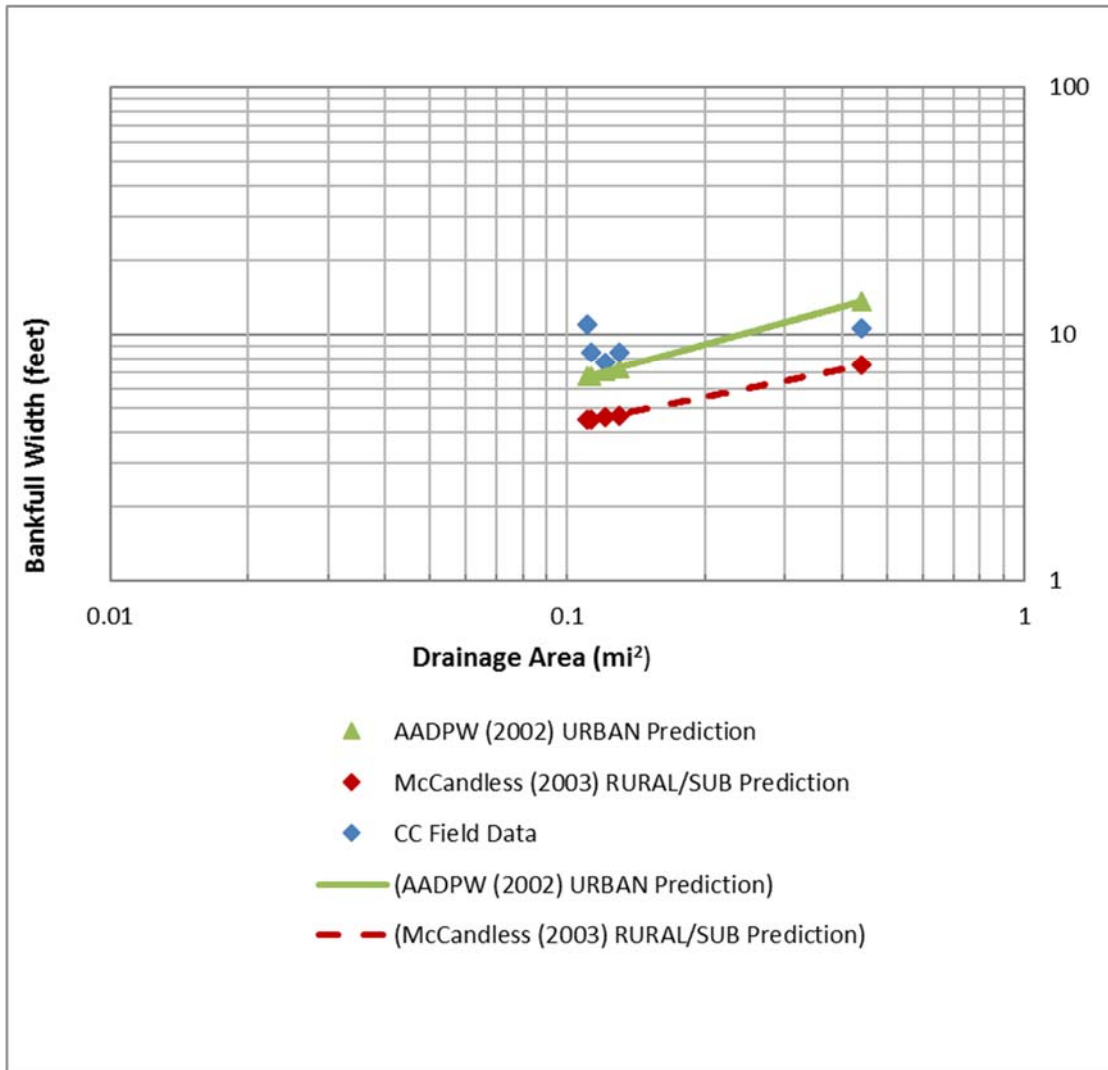
Bankfull channel dimensions (cross sectional area, width, depth) in the Church Creek study area showed significant departure from expected values, as derived from Maryland Coastal Plain regional relationships of bankfull channel geometry (McCandless, 2003). Almost all dimensions were generally larger in the Church Creek study area (see Figures 4-13, 4-14, and 4-15), and were often more similar to relationships of bankfull channel geometry derived from gaged urban watersheds located in the Coastal Plain. These relationships were developed for an urban stream restoration project in Anne Arundel County (AADPW 2002). Values measured in 2016 were roughly consistent with prior assessment results. This reflects the higher level of imperviousness in the study area, as compared to the lower impervious levels in the drainage areas used to develop the regional relationship data. The results suggest that this stream has become enlarged as a result of the high imperviousness, and is both wider and deeper than stable C and E type channels located in rural/suburban watersheds of the coastal plain. It should be noted, however, that locating bankfull elevations in the field on actively eroding, previously stabilized, or incising channels is difficult and not recommended due to unreliable and/or misleading indicators, and instead bankfull elevations should be estimated using the aforementioned regional curves (Rosgen, personal communication, May 2011). Where bankfull indicators were suspect or questionable, the indicator approximating the rural/ suburban regional curve for bankfull area was used to estimate bankfull

elevations. Additionally, the Rosgen method is best used on streams that are free to adjust their lateral boundaries under the current discharge regime experienced by the system (Rosgen 1996). Given the high levels of rip rap and/or concrete rubble armoring found in the reaches containing cross sections 2, 3 and 5, the accurate determination of the bankfull indicators in the field at these locations is problematic.
