**ANNE ARUNDEL COUNTY
ILLICIT DISCHARGE DETECTION
AND ELIMINATION
2016 ANNUAL REPORT**

PERMIT NUMBER MD0068306

FINAL: January 2017

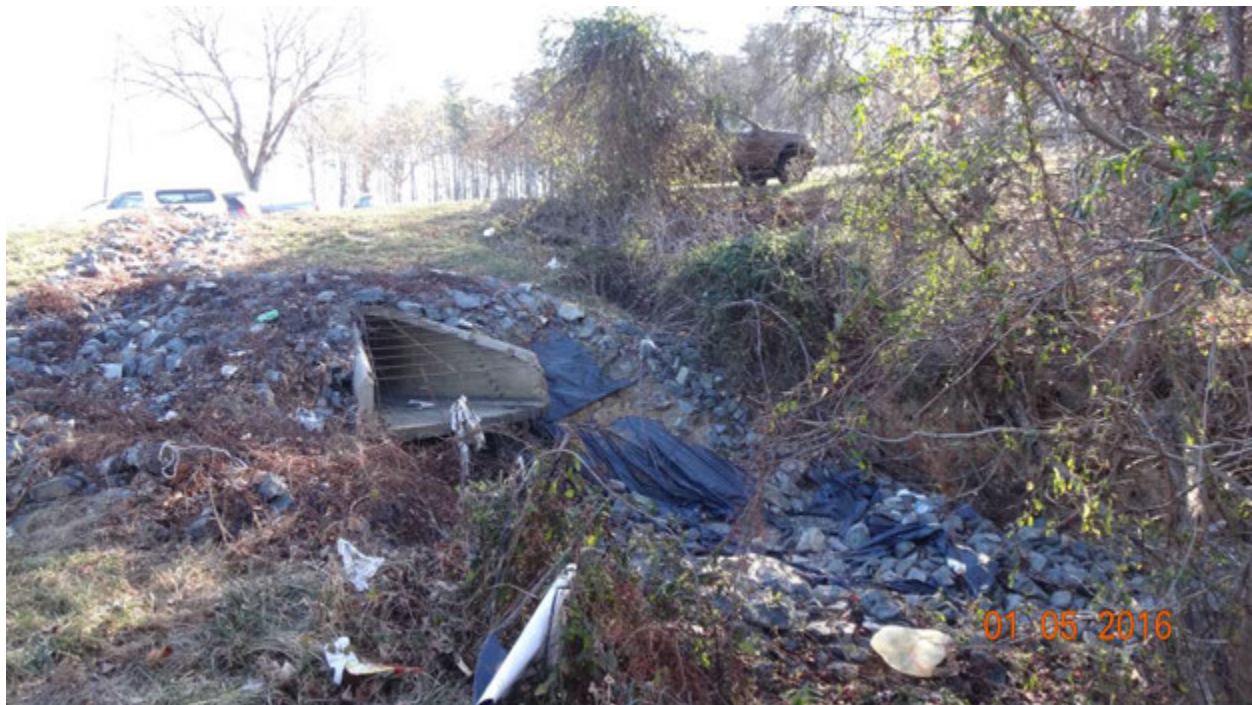
While investigating outfall F09F5O001, on the east side of the Ridgeview Plaza Shopping Center, a Versar field team observed signs of destructive runoff forces at the outfall. On the southeast side of the outfall, the rocks and plastic of the rip rap, intended to stabilize the bank, had been dislodged and pushed downstream (Figure 1). The flared end section of the outfall on the same side showed signs of crumbling during the field visit (Figure 1). Also, the erosion had started to undercut the outfall, so that the opening was found to be no longer fully supported underneath (Figure 1). The force of the runoff coming out of the pipe had eroded the opposite bank, exposing tree roots (Figure 2). The hydrology of the outfall's flow may have been altered over time, in part by the collected rocks in the plunge pool, so that it now follows a path toward the trees on the left before returning to the intended alignment (Figure 2). An area map, indicating the location of the erosion at the outfall, is provided in Figure 3.

Figure 1. Photograph of outfall F09F5O001 showing the erosion and disturbed rip rap assembly on the southeast (right) side of the structure and the beginnings of undercutting erosion below the opening; note, also, the crumbling flared end on the right side of the outfall opening

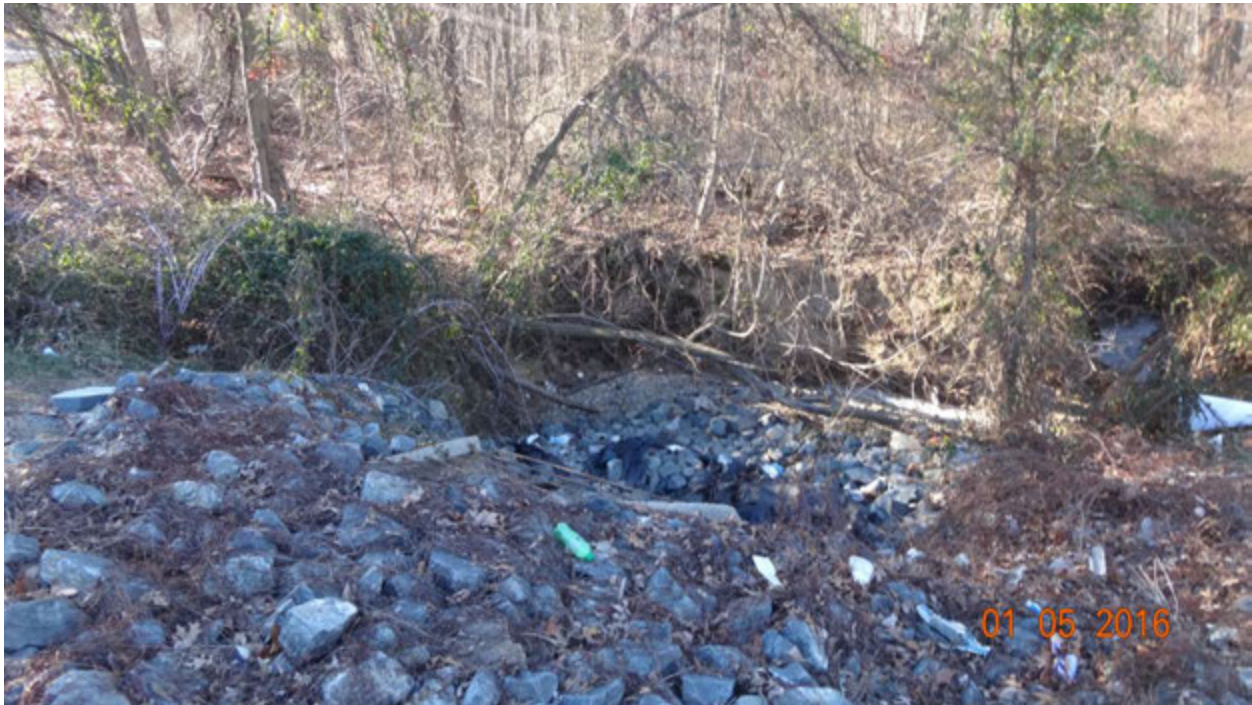
Figure 2. View looking over the top of the outfall showing the extent of erosion on the opposite bank caused by excessive, uncontrolled flows; note the collection of rip rap rocks in the plunge pool which may be acting as a partial blockade for the water, forcing the flows to veer left after exiting the pipe

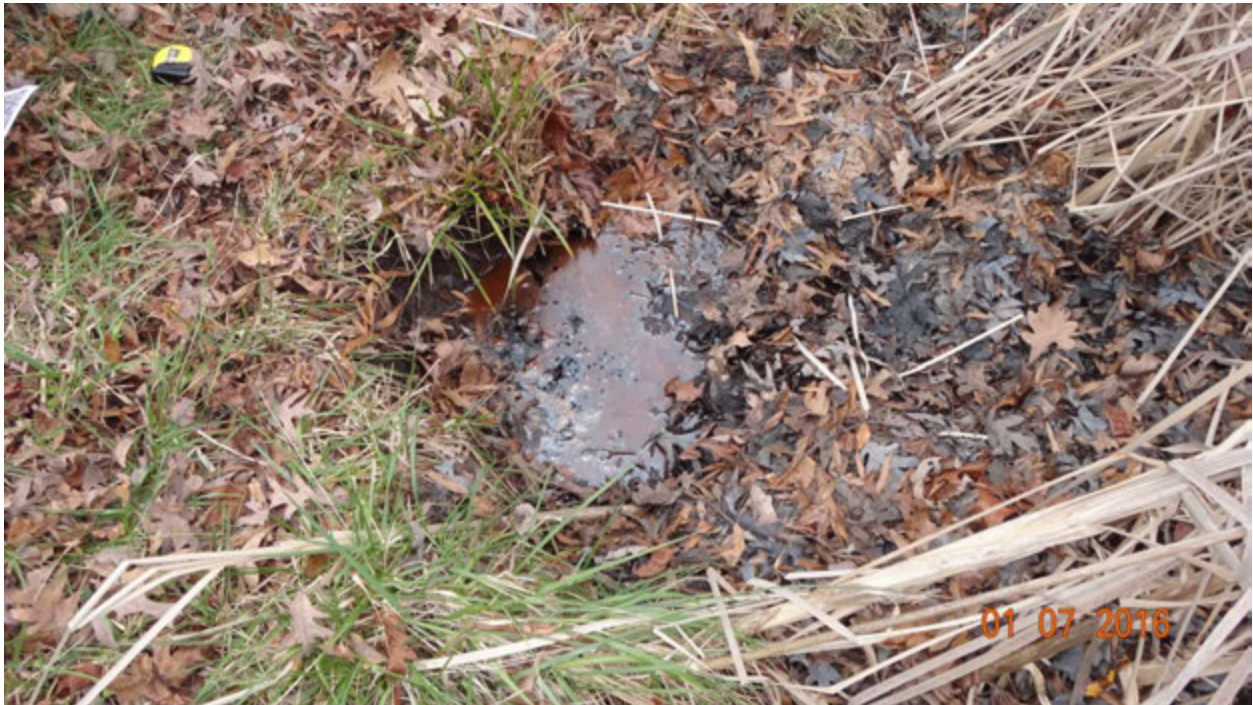
Figure 4. Detail of effluent from outfall I13B1O009 (presumed) showing oily sheen

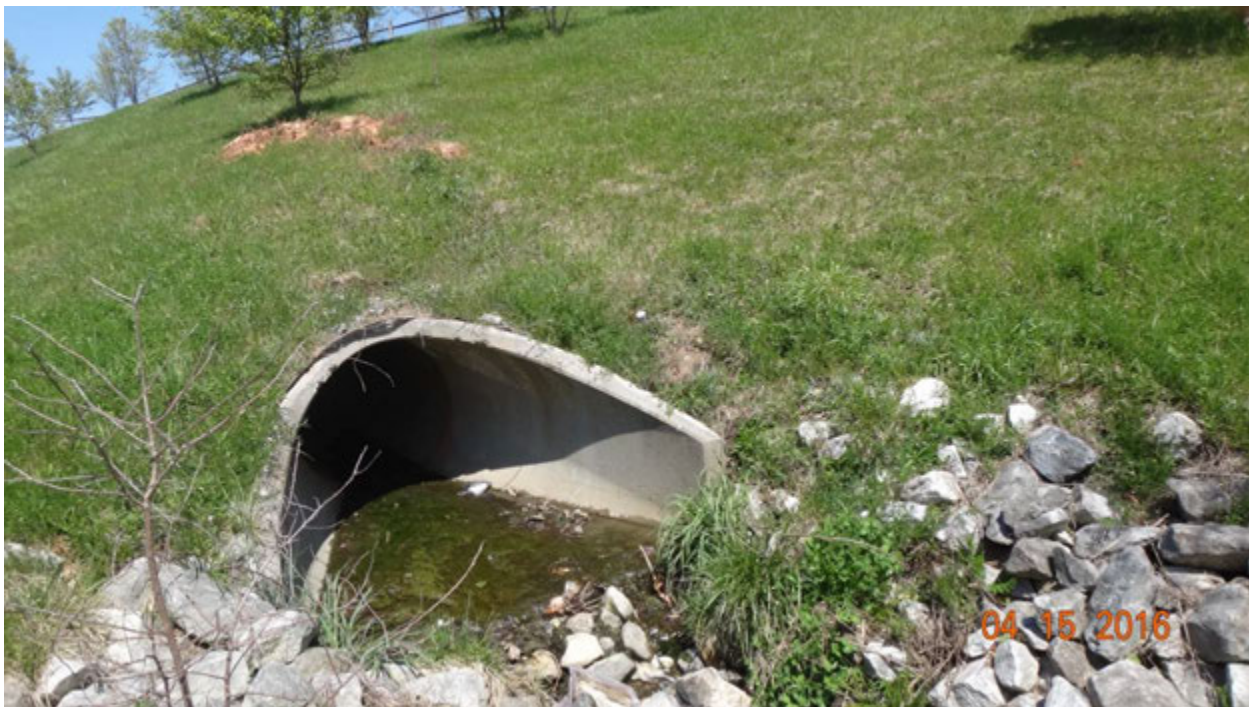
Figure 1. Outfall K10D8O004 as observed on April 15

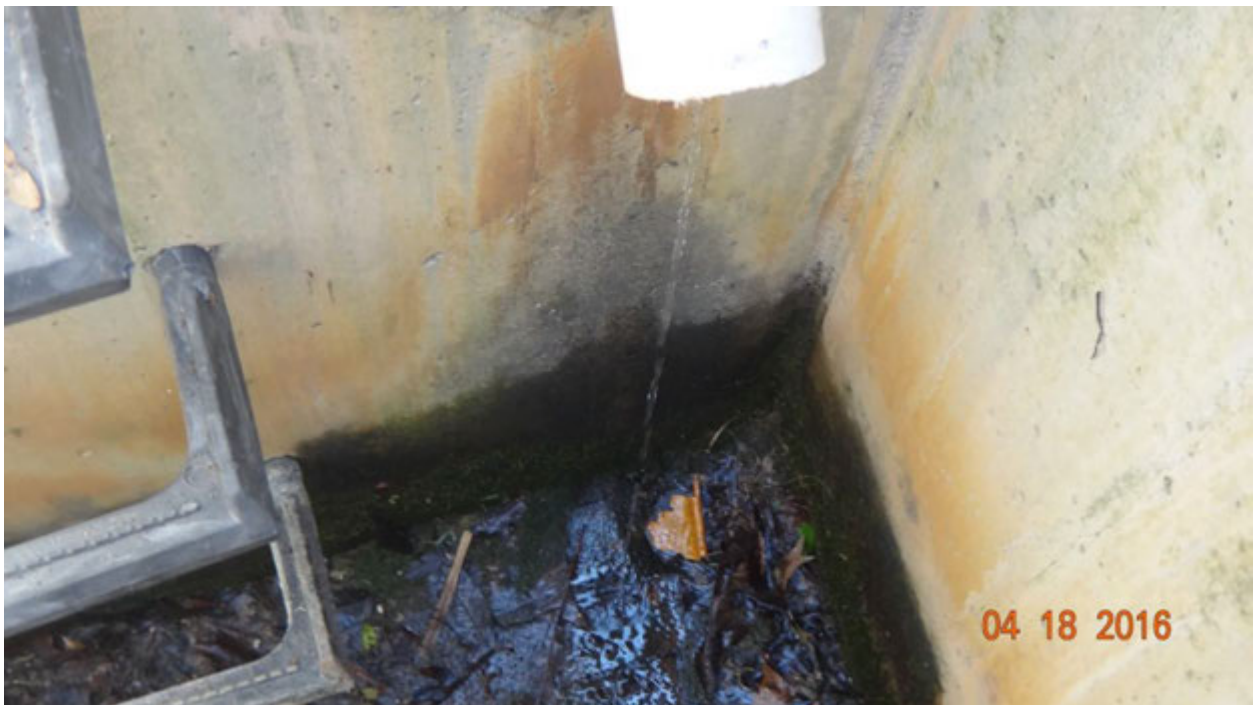
Figure 3. Trickleing effluent from the PVC pipe observed on April 18

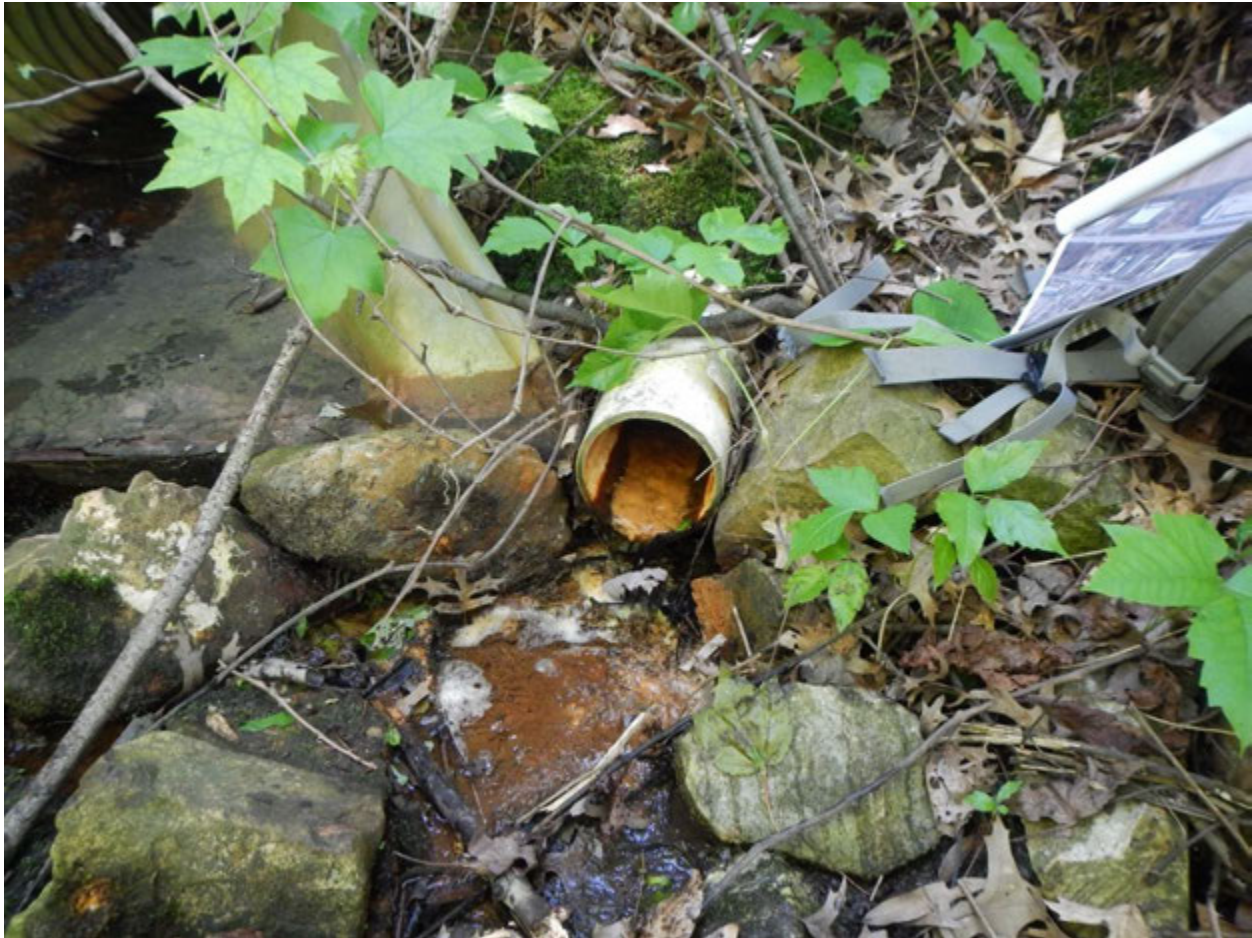
Figure 1. The conditions of Outfall J15H5Onew1 as observed on May 20; note the orange material evident in the pipe and the orange staining on the rocks near the opening. The discharge's blue oil sheen can be seen in the lower center of the photograph. Part of the adjacent 18-inch corrugated metal pipe is shown on the left side of the photograph.

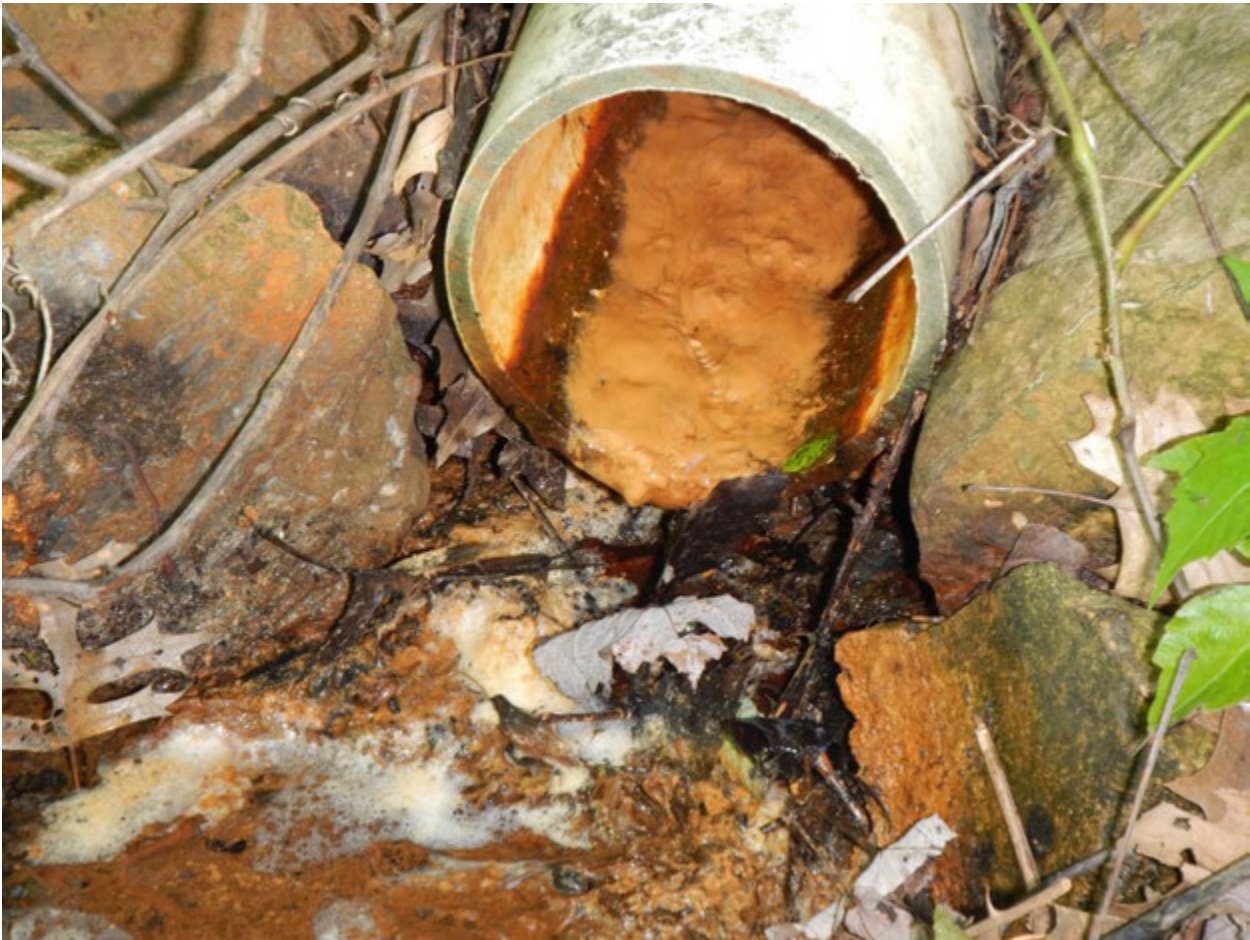
Figure 2. A close view of the opening for Outfall J15H5Onew1; note the thick orange material on the floor of the pipe and the staining on the walls of the pipe (this may be evidence of iron-oxidizing bacteria)

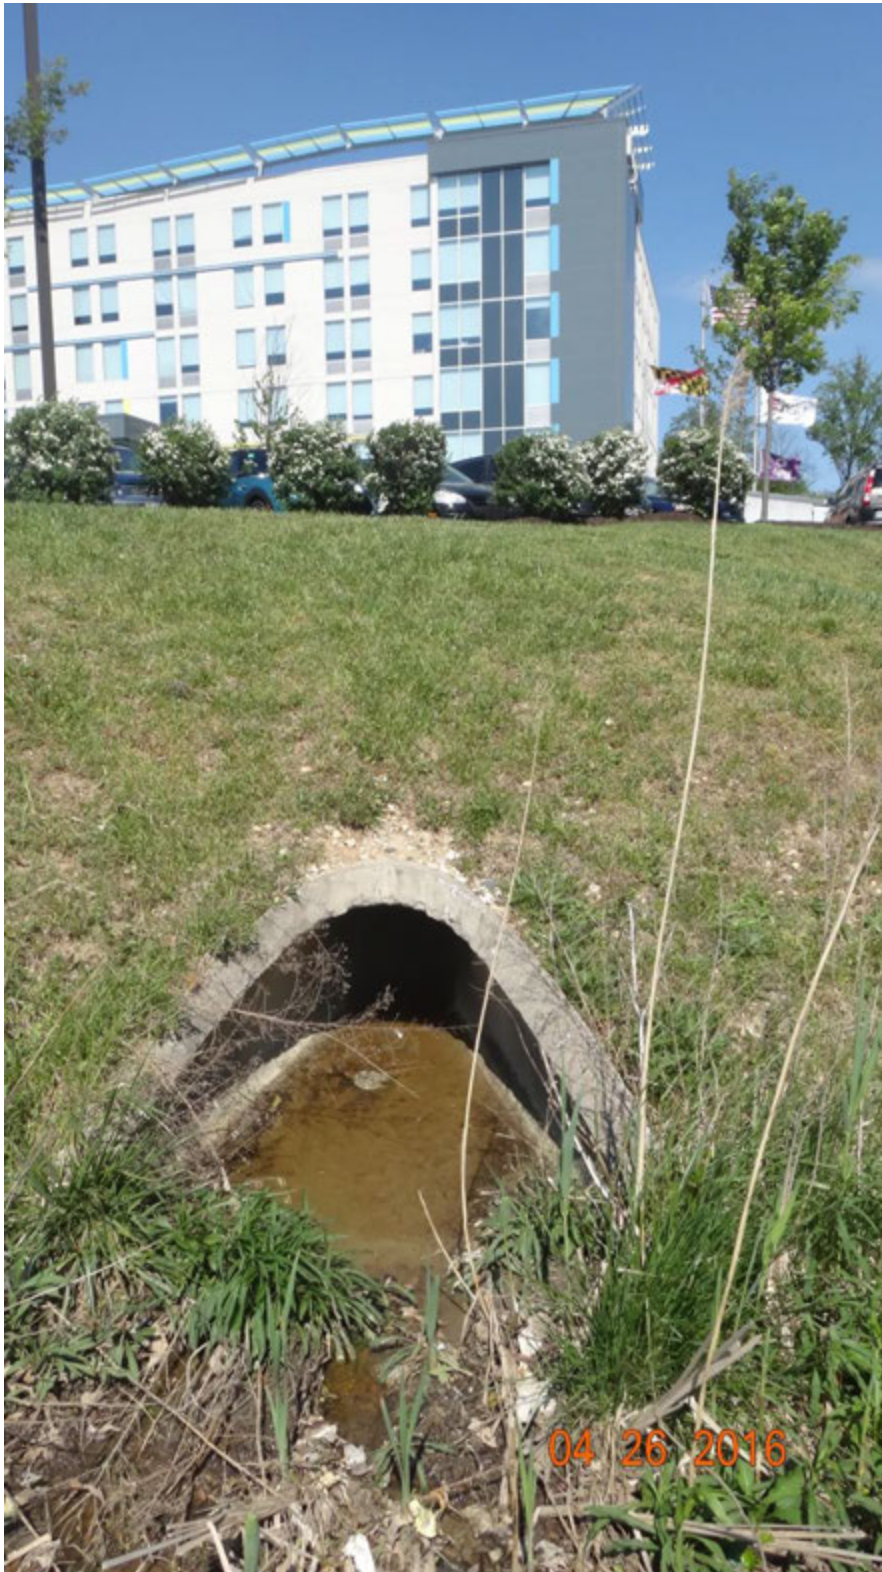
Figure 1. Outfall J04A7O026new2 as observed on April 26, 2016

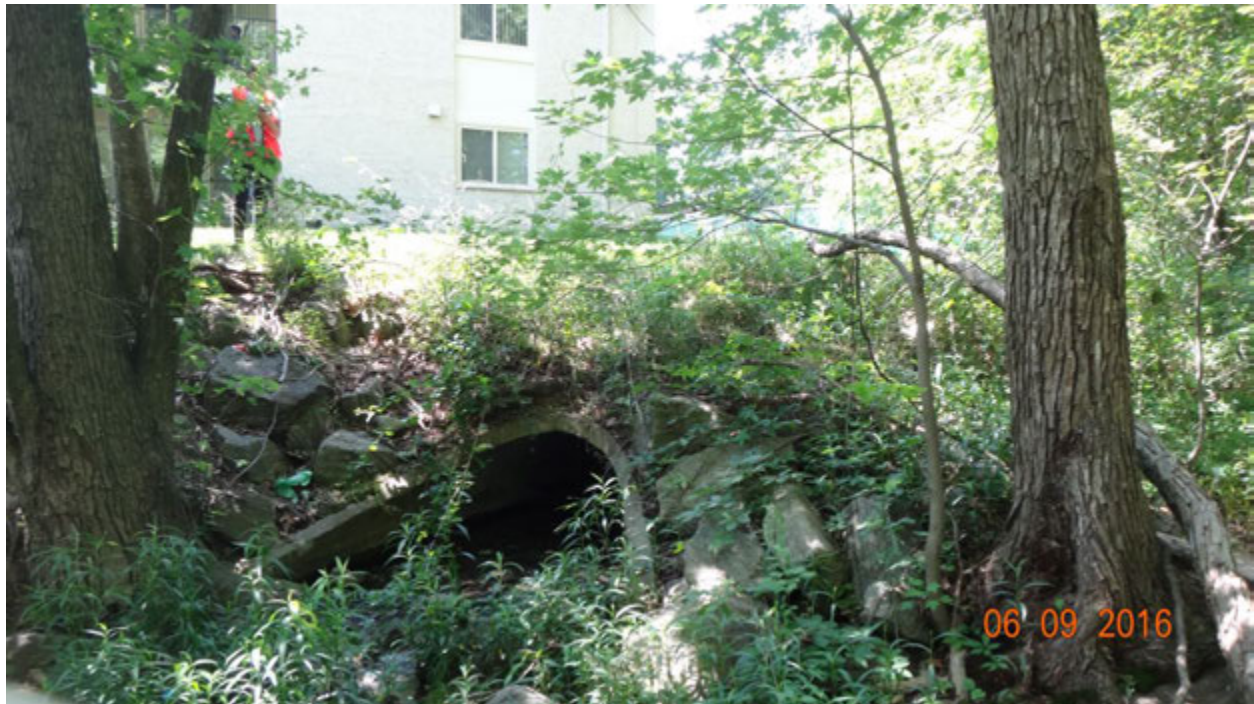
Figure 1. Outfall B12G2O001 as observed on June 9, 2016

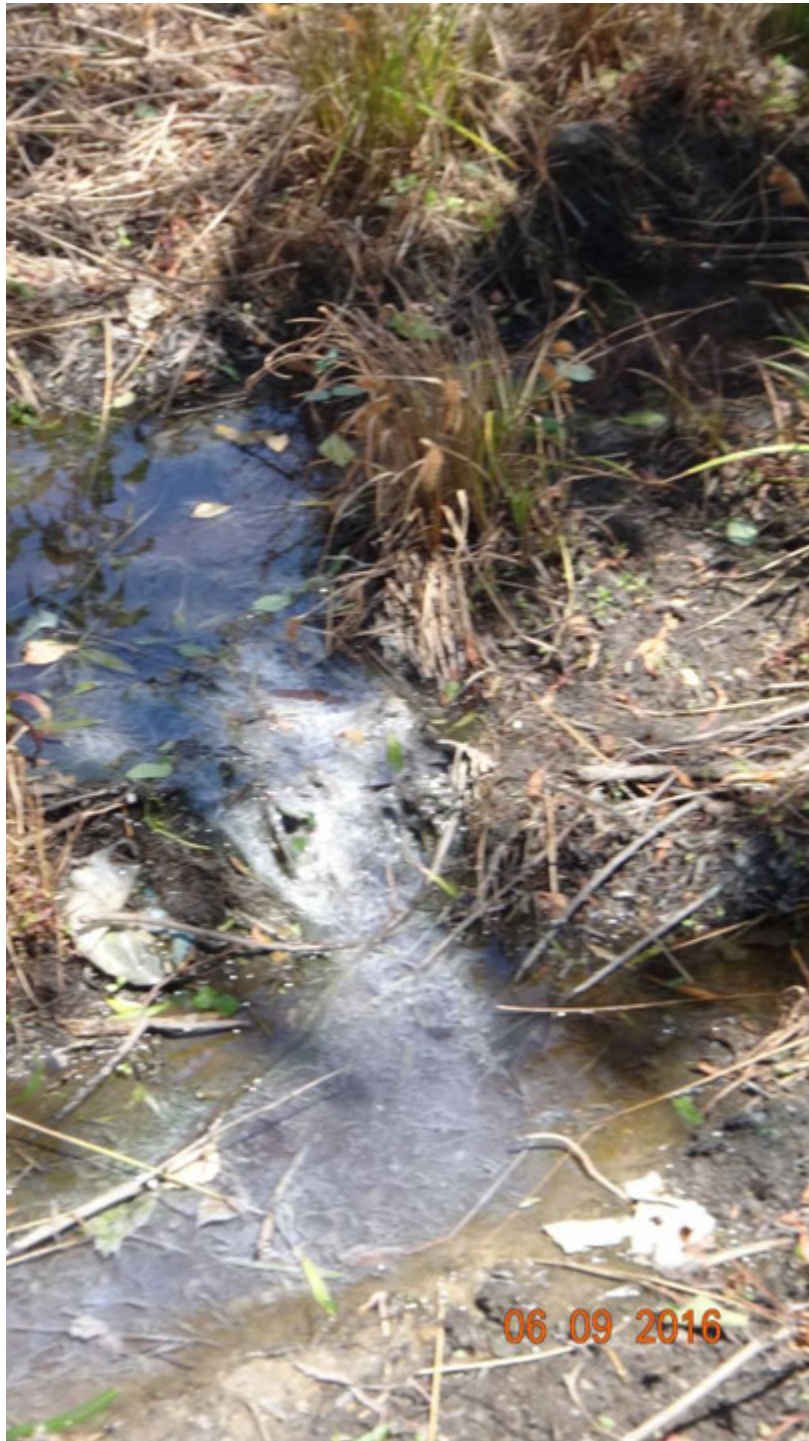
Figure 4. Effluent from outfall F09G5O001 (top left), observed on June 9, 2016, showing greyish-white residue as it entered the receiving stream

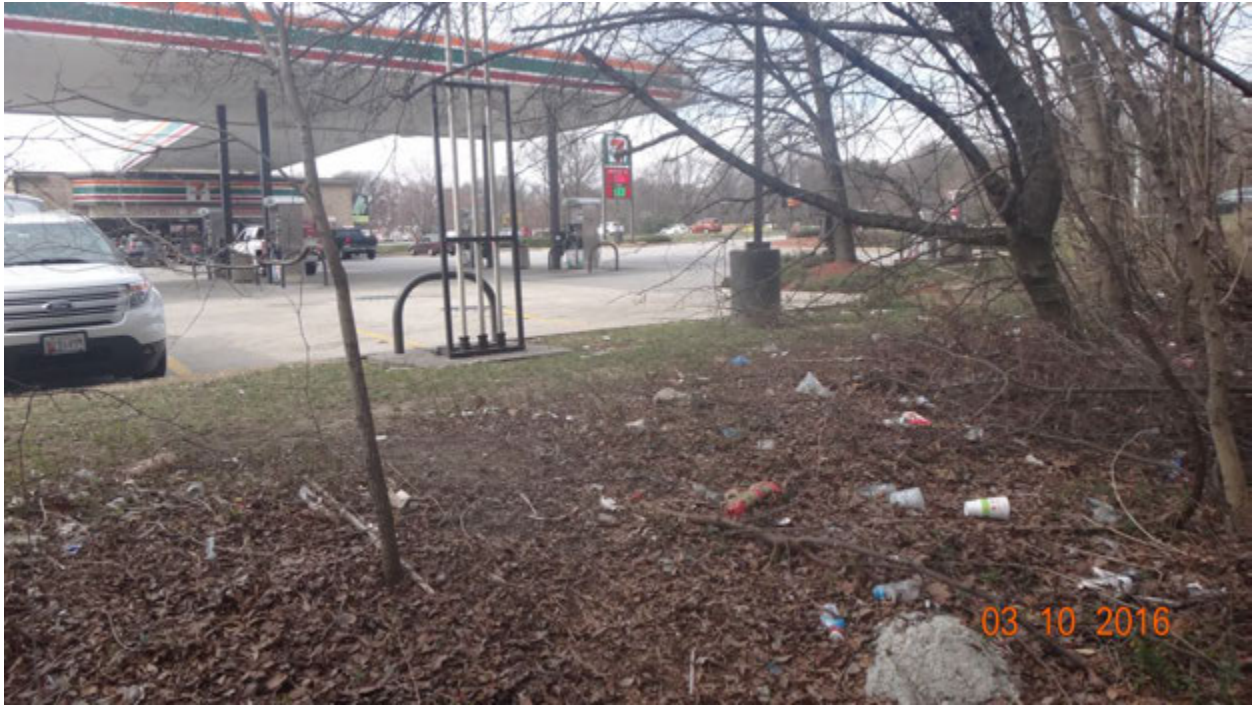
On a day when a Versar field team was screening outfalls in the area, the team discovered a waste management issue associated with the 7-11 business at the above address. The business activities included a convenience store and a fueling station; a station for vacuuming vehicles may have been installed at one corner in the past. The team noted that on-site waste disposal and storage at the business seemed to be managed generally well; the lot was generally clean, and the dumpster was in good condition. The team documented a litter problem on the northeast side of the parking lot, along an adjacent wooded area; this region had accumulated an excessive amount of debris. The team surmised, from the types of trash found (food containers and wrappers) that the sources may have included people who were clearing their cars while preparing to use an on-site vacuum system, or patrons who disposed of containers and wrappers associated with consumables purchased at the store. The team investigated the extent of the trash distribution and found that debris was also scattered along the curbs, within the grass strip between the fuel island and the woods (Figure 1), and well into the woods (Figures 2 and 3). The team inferred from the characteristics of the debris that since customers may have been largely responsible for the inappropriate disposal over time, the business' waste management protocol should include debris removal efforts for the full lot as well as strategic placement of trash receptacles. The debris field is adjacent to a drainage ditch that may serve as a conduit for transport of trash to surface waters downstream. An area map, indicating the location of the debris, is provided in Figure 4.

Figure 1. Debris found along the northeast side of the parking lot, near the fueling stations

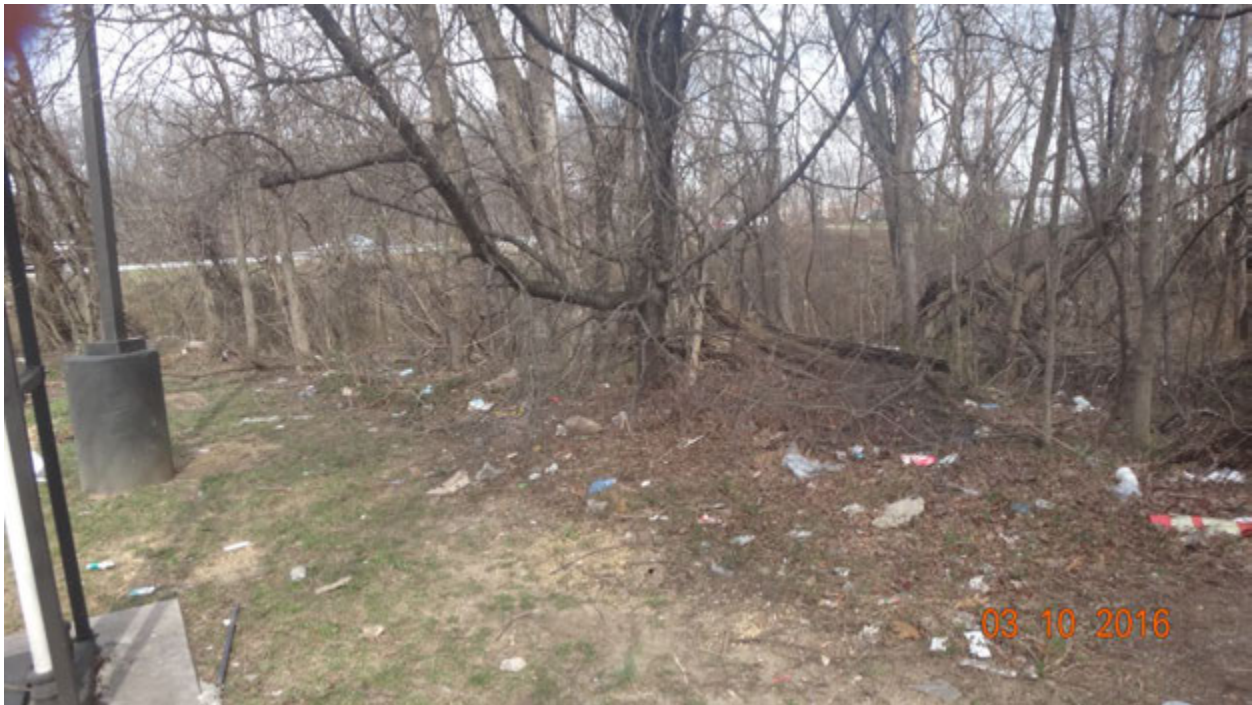
Figure 2. Accumulated debris found on the grass and in the woods along the northeast edge of the parking lot, as seen looking northwest

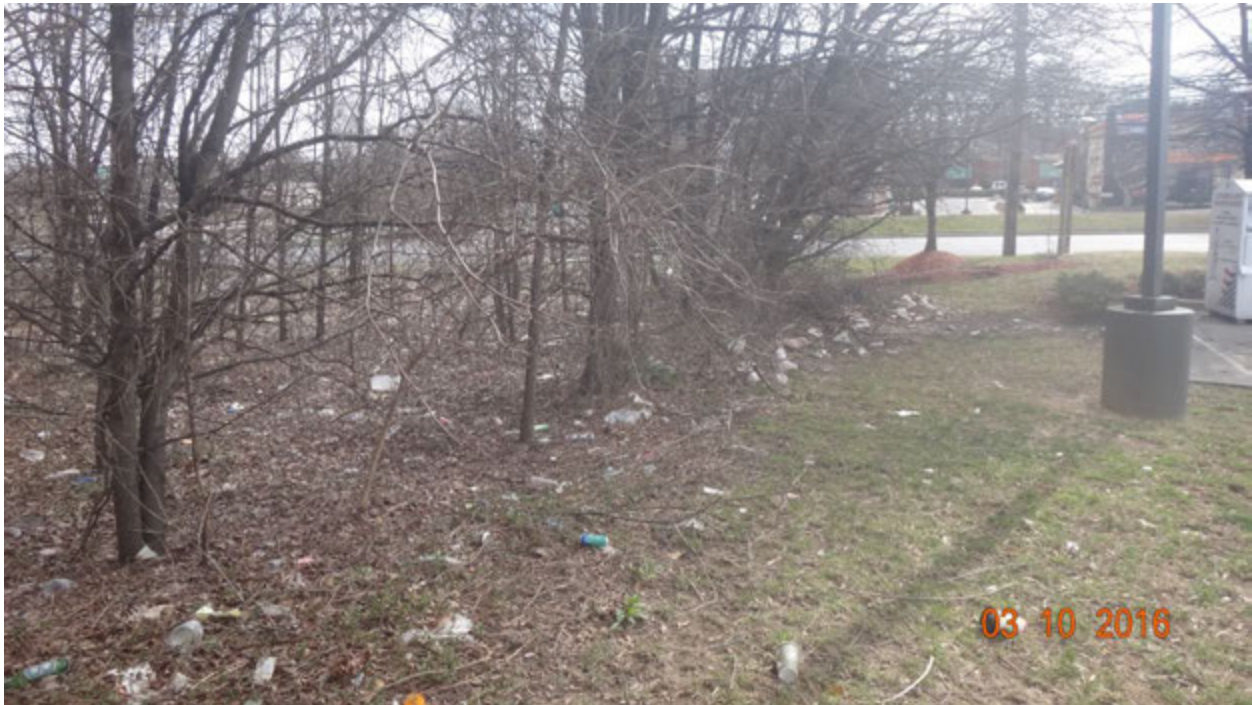
Figure 3. Accumulated debris found on the grass and in the woods along the northeast edge of the parking lot, as seen looking southeast

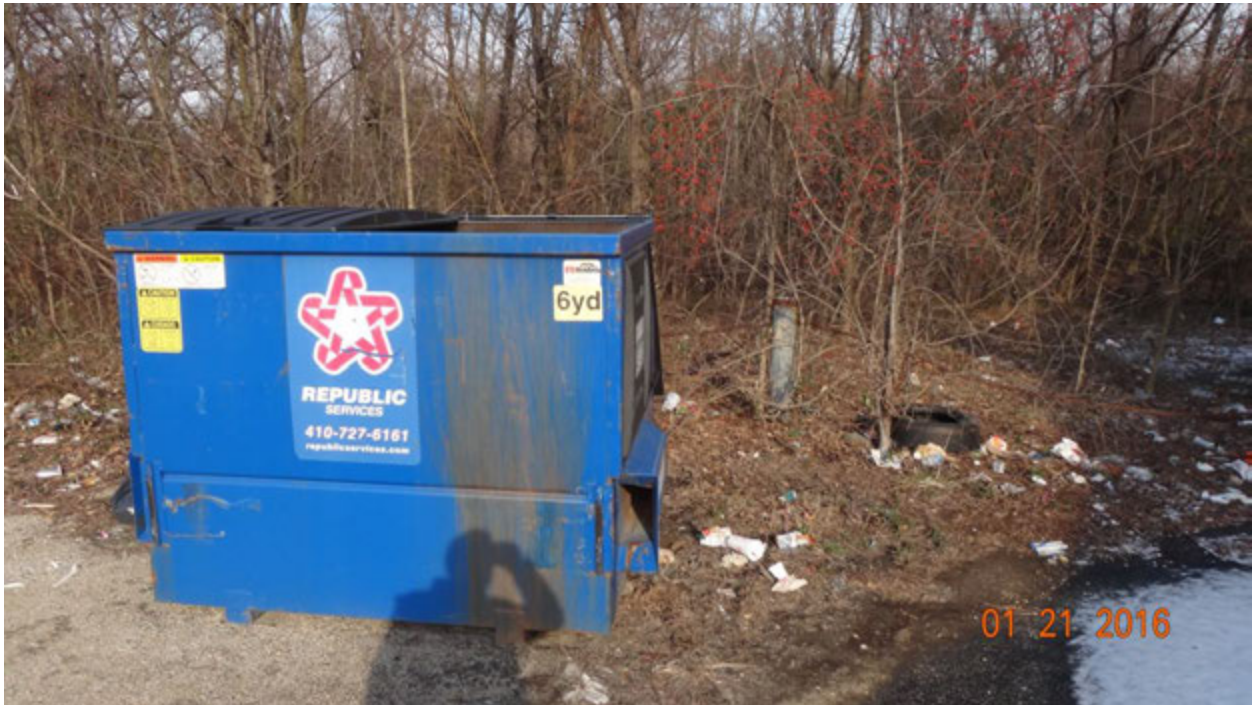
Figure 2. Excess debris, including a tire, found scattered at the edge of the woods behind the vacant lot

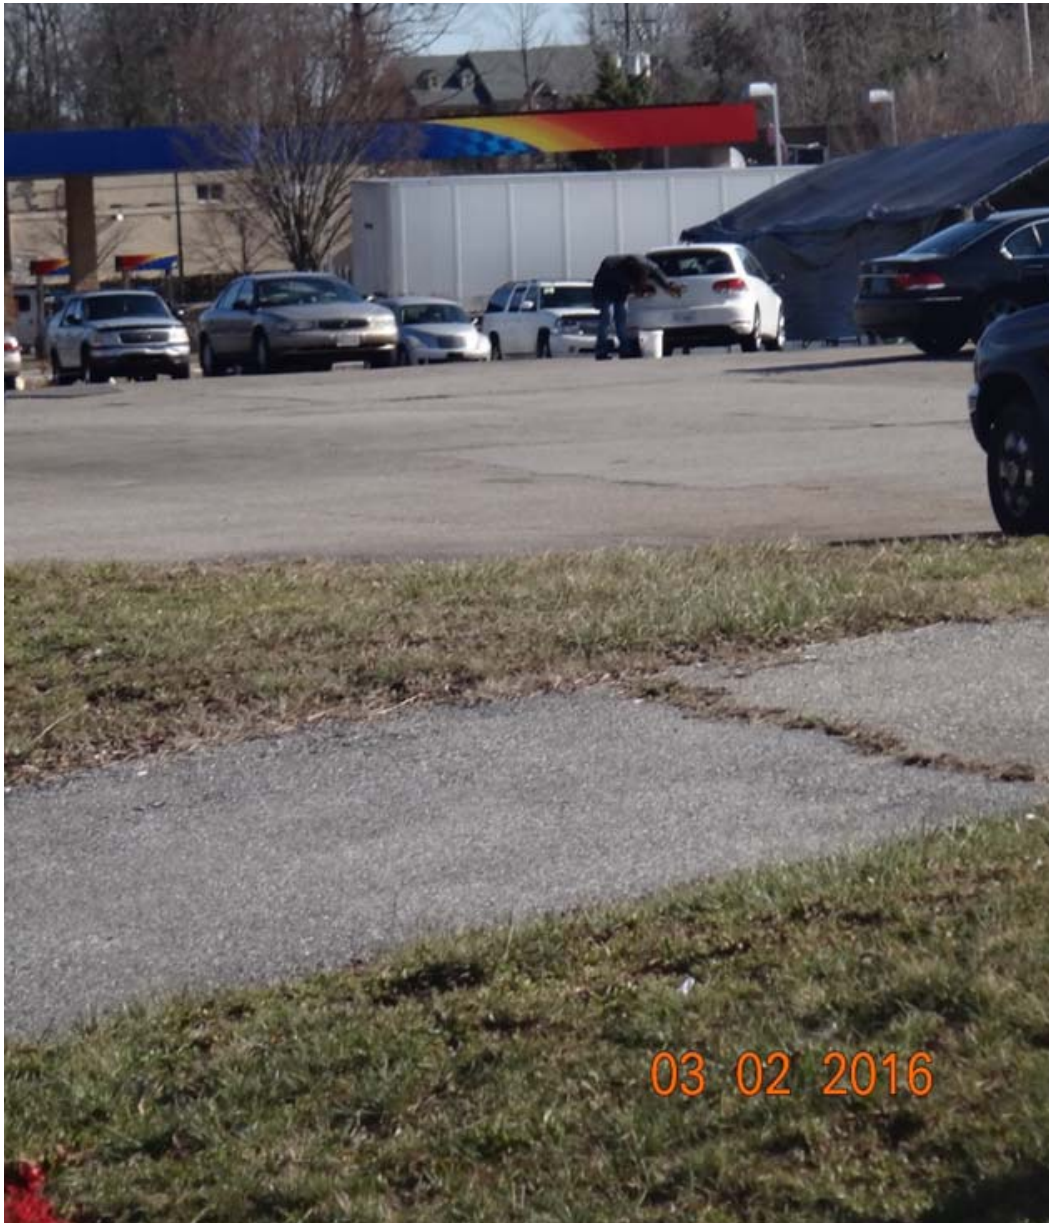
Figure 2. Photograph of a business employee scrubbing a vehicle with liquid from a bucket in the parking lot; note the downward slope of the parking lot in the background

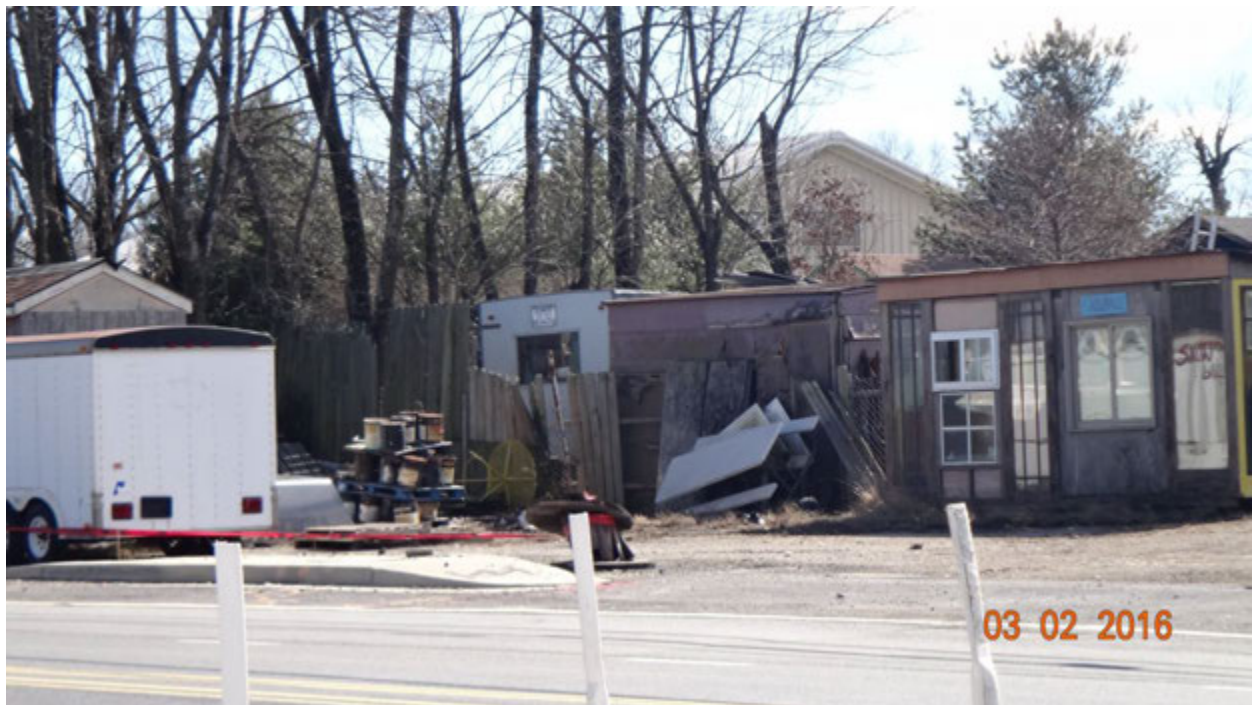
A Versar field team investigated one or more parcels, located at 2827 and 2829 Jessup Road, at the corner with Sellner Road, for a possible issue with waste management. The two lots appeared to function, together, as storage lots for miscellaneous construction debris and discarded furniture. A sign on one building indicated that it may have functioned as a snowball stand at one time (Figure 1). A sign on one of the lots advertised building materials for sale (Figure 2). The team also found a collection of buckets stored outdoors that the team surmised contained roofing or asphalt sealing tar (Figure 3). Only one of the labels is barely legible in the photograph; the others appear to be weather-worn beyond identification. The team did not investigate the buckets to determine if any of them still contained roofing materials that could present a pollution hazard if leaked to the environment. An area map, indicating the location of the buckets, is provided in Figure 4.

Figure 1. Photograph of some of the conditions in the lots at 2829 and 2827 Jessup Road; note the dilapidated "snowball" building and the discarded furniture

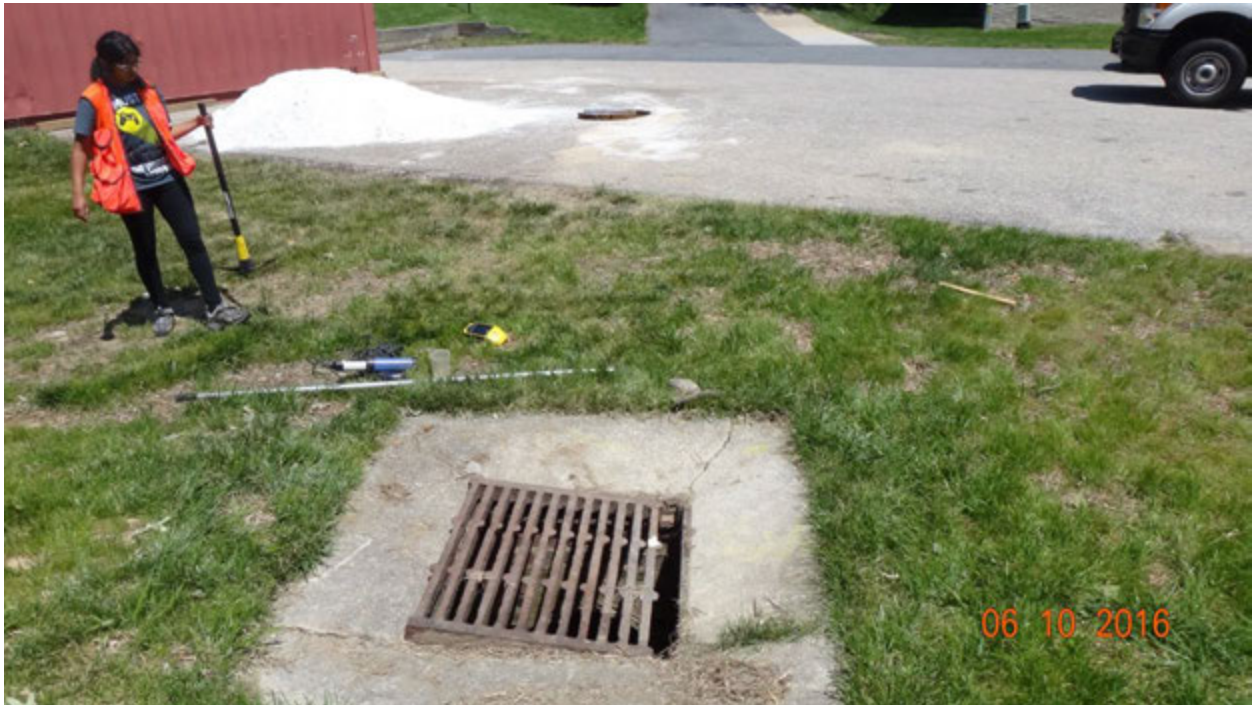
Figure 2. A view of the relative locations of the pile of salt and the yard drain which may be receiving salt residue under certain conditions

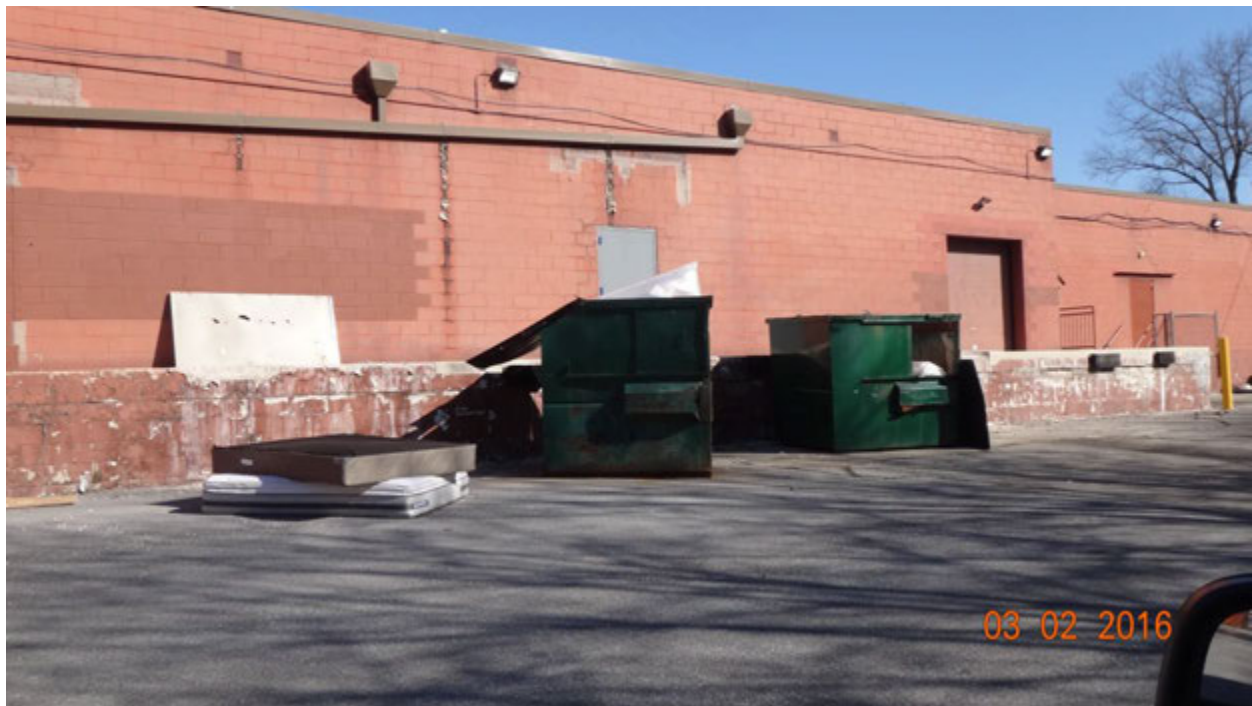
Figure 1. Two open dumpsters with large pieces of debris near them found behind the Aaron's Rentals store

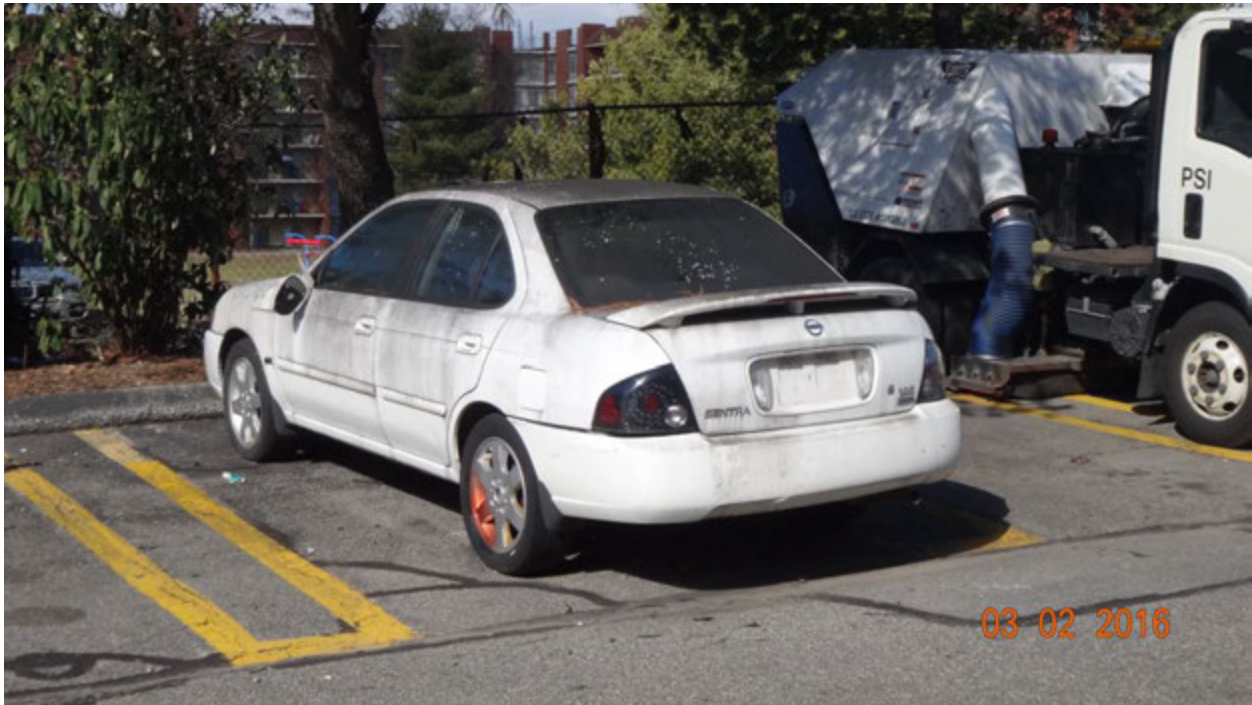
Figure 4. Photograph of neglected and possibly abandoned car found in the parking lot

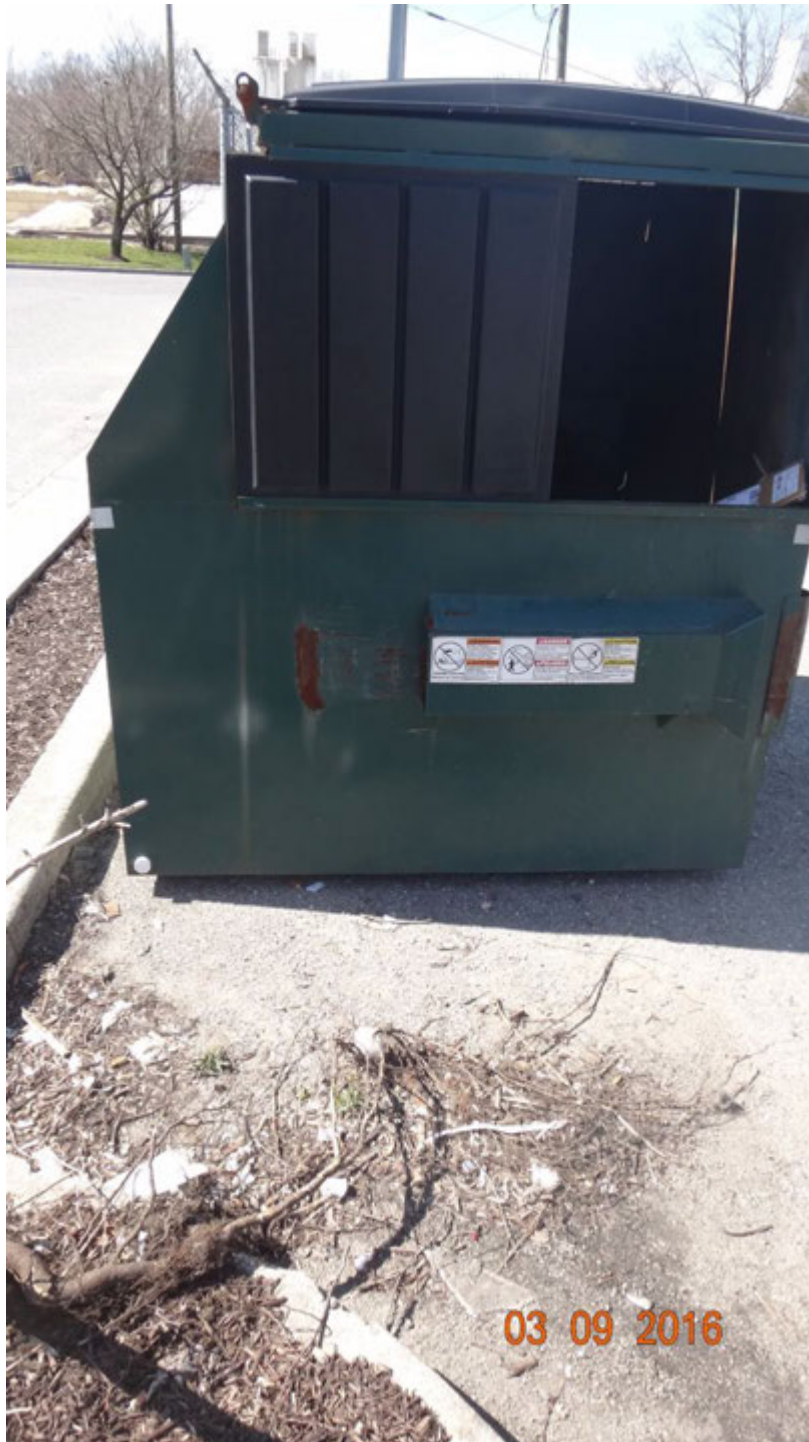
Figure 1. Photograph showing partially open dumpster found on March 9, 2016

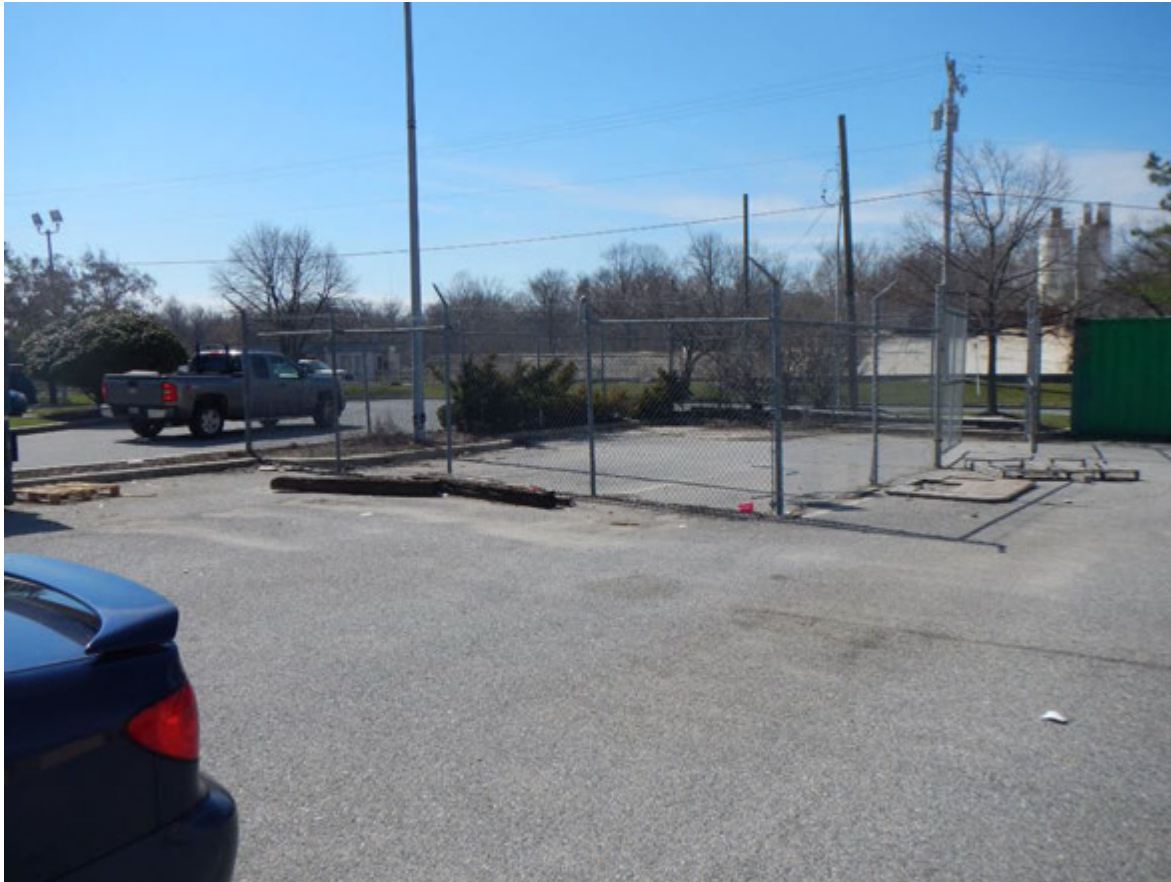
Figure 2. Bulk debris deposited in the parking lot
