**ANNE ARUNDEL COUNTY
ILLICIT DISCHARGE DETECTION
AND ELIMINATION
2016 ANNUAL REPORT**

PERMIT NUMBER MD0068306

FINAL: January 2017

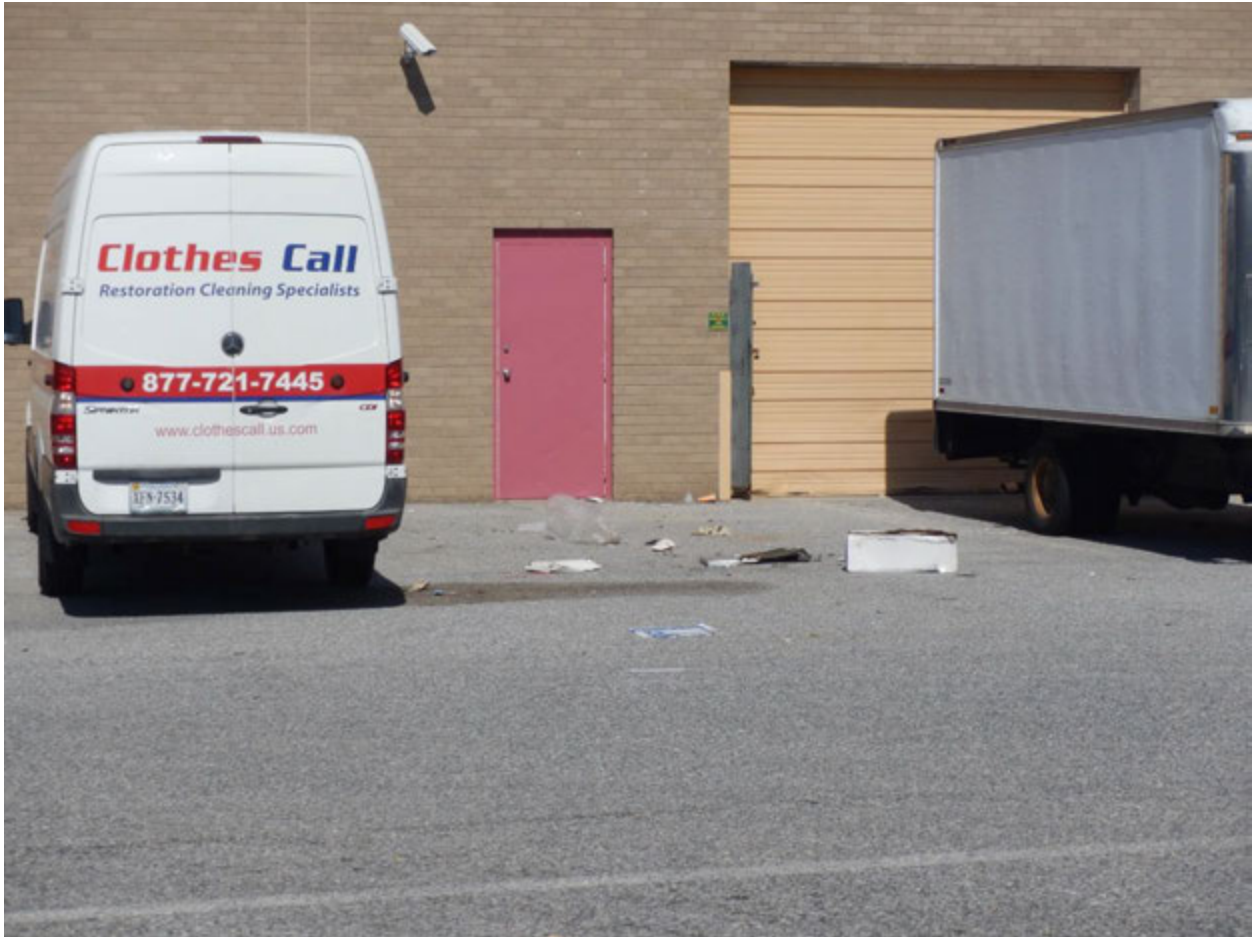
Figure 4. Loose debris found among vehicles in the parking lot in March 9, including food containers, plastic, and cardboard

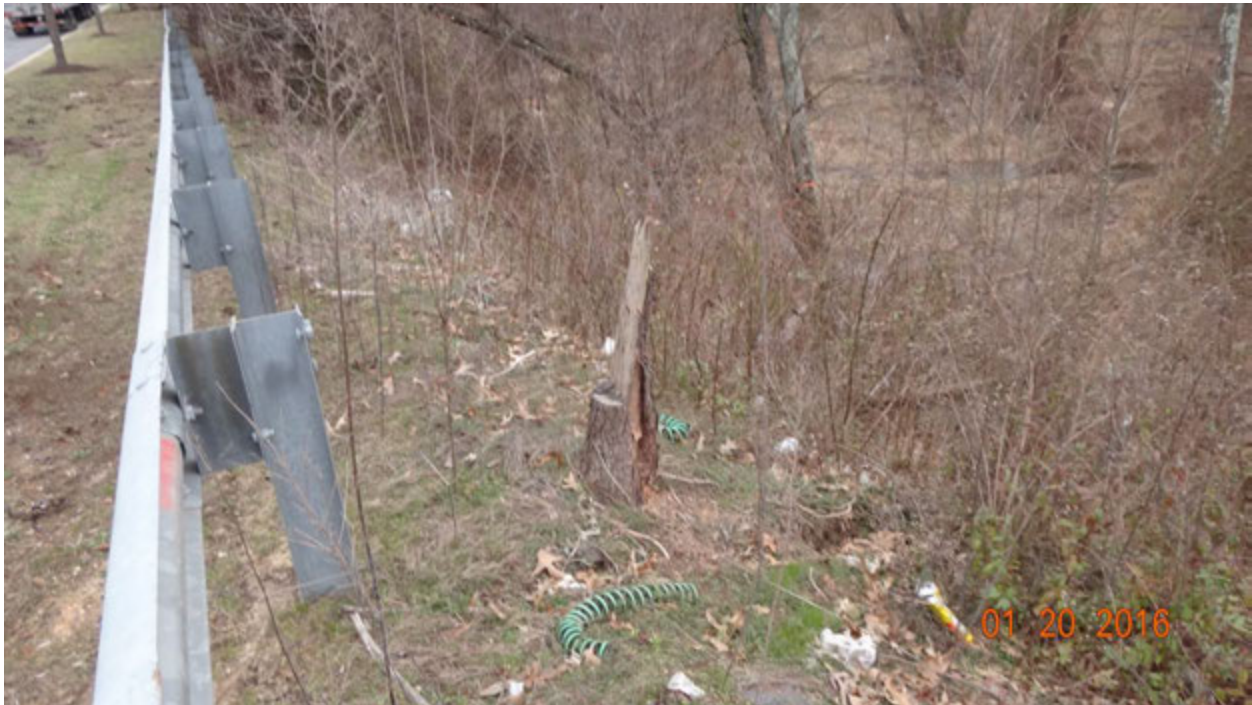
Figure 2. Photograph of discarded green tractor-trailer brake hoses and loose debris found along the south side of Crossroads Drive during the site visit

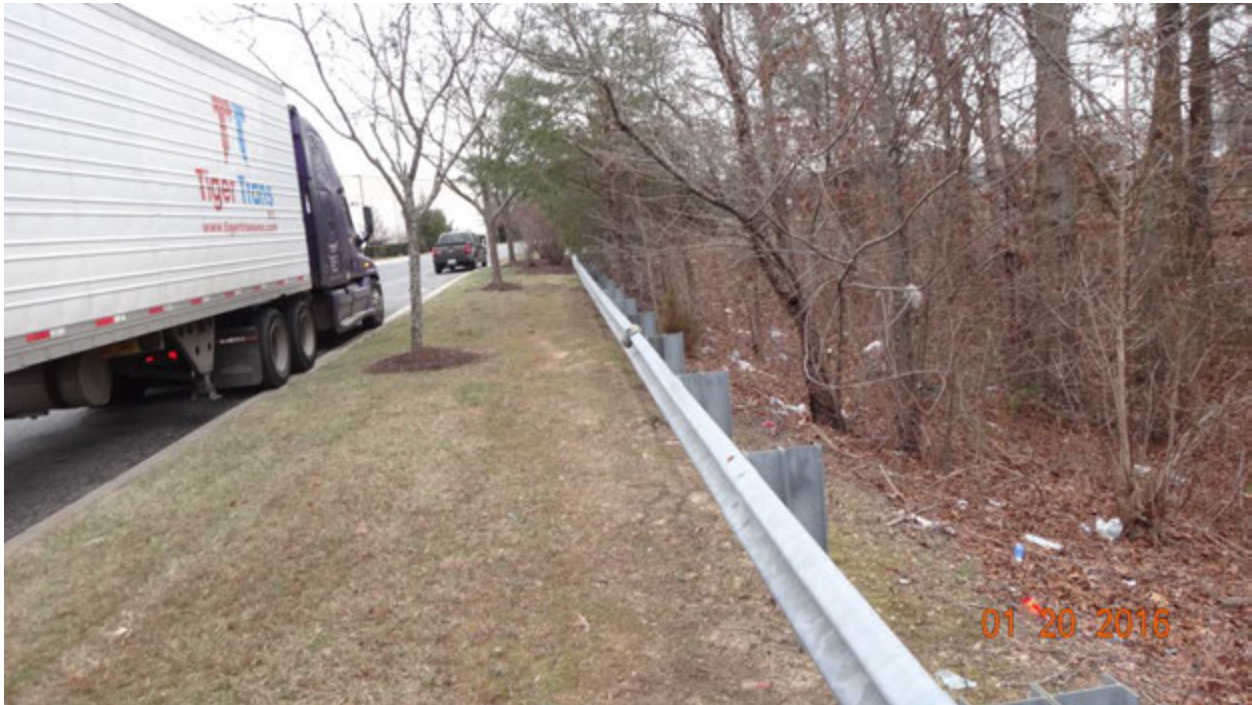
Figure 4. Photograph of a section of the Crossroads Drive (south side) where trucks are commonly parked and discarded debris accumulates on the roadside (seen to the right of the guardrail)

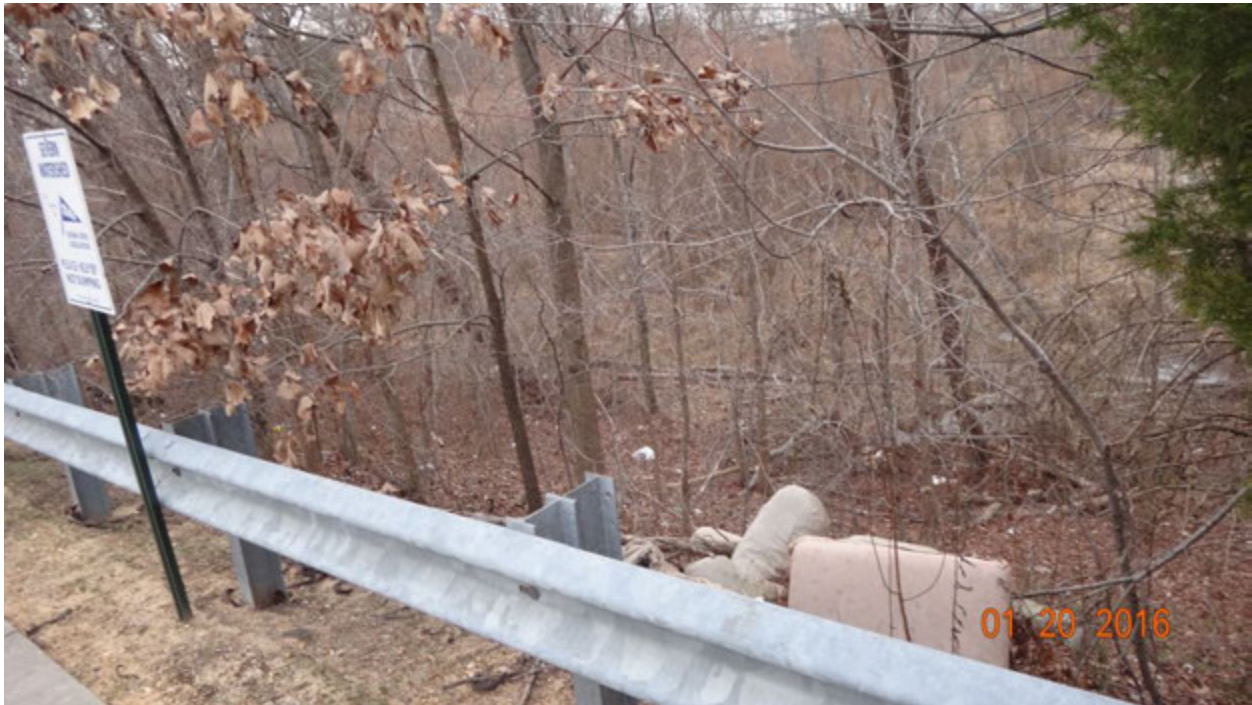
Figure 8. Discarded furniture found along the north side of Crossroads Drive; the sign on the left claims that this area is cleaned by the Severn River Association

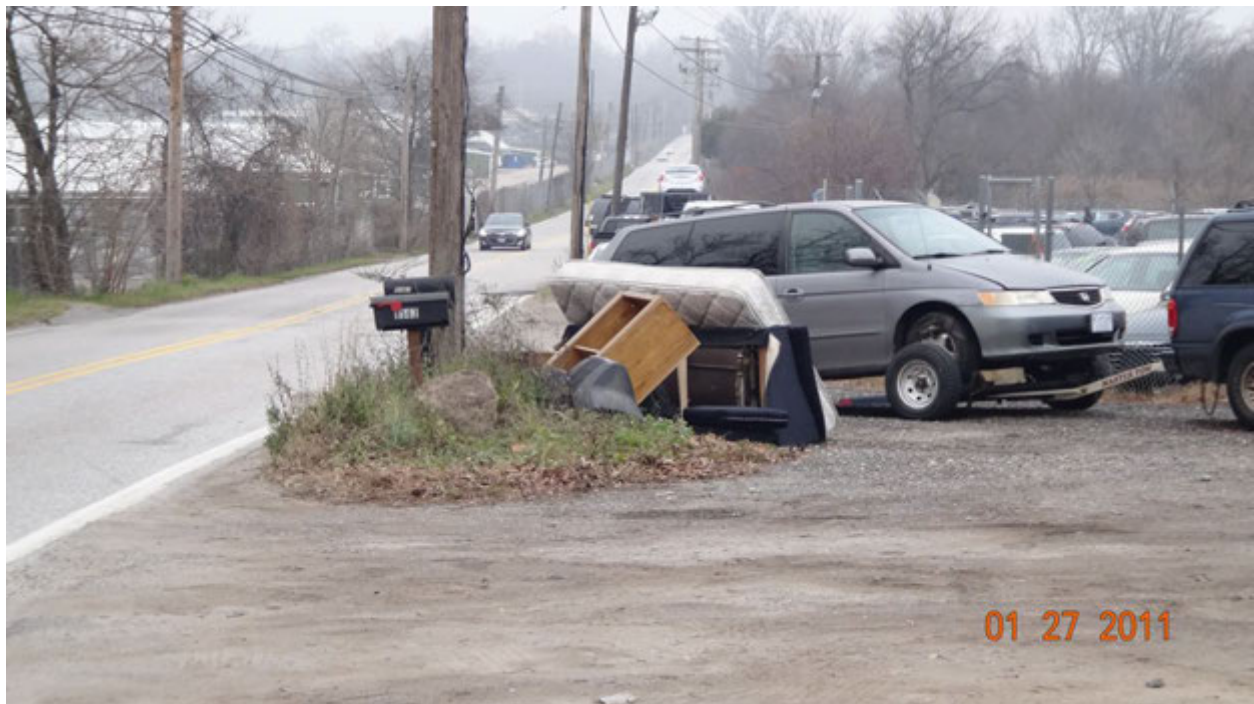
Figure 1. A collection of large pieces of furniture deposited near the roadway, facing north on Brock Bridge Road (photography date: December 9, 2015)

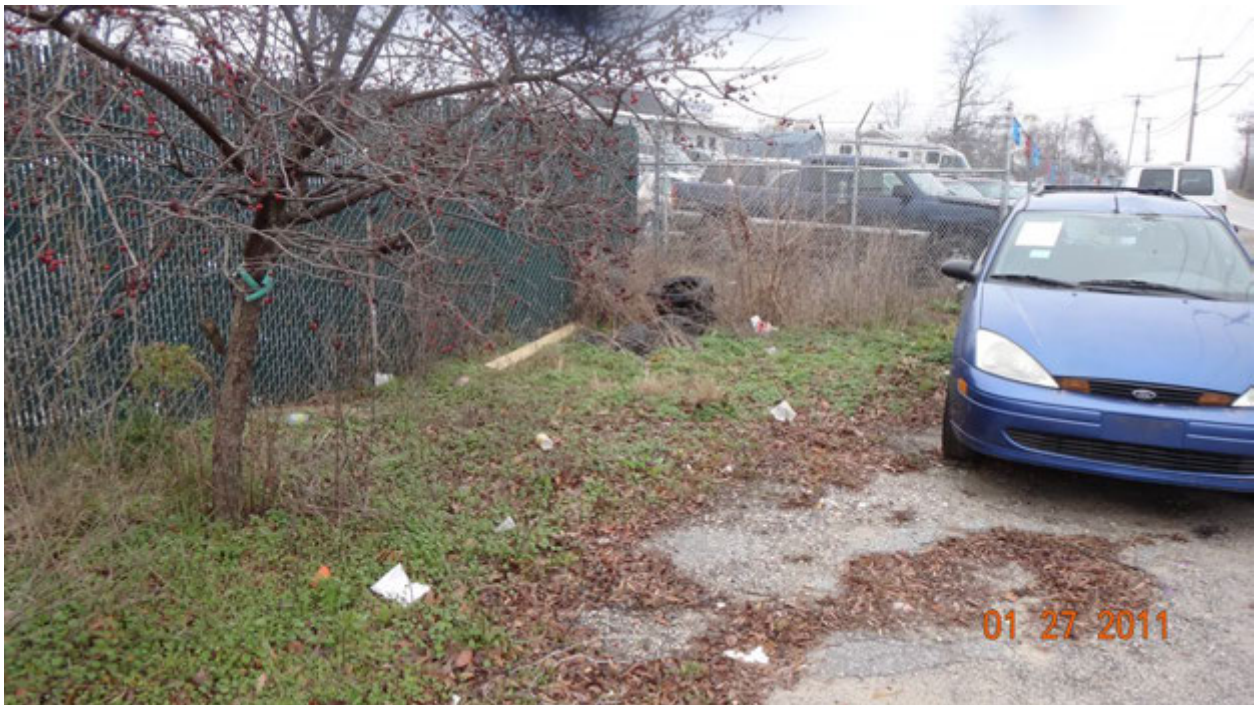
Figure 3. Several tires and loose debris observed along a fence line (photography date: December 9, 2015)

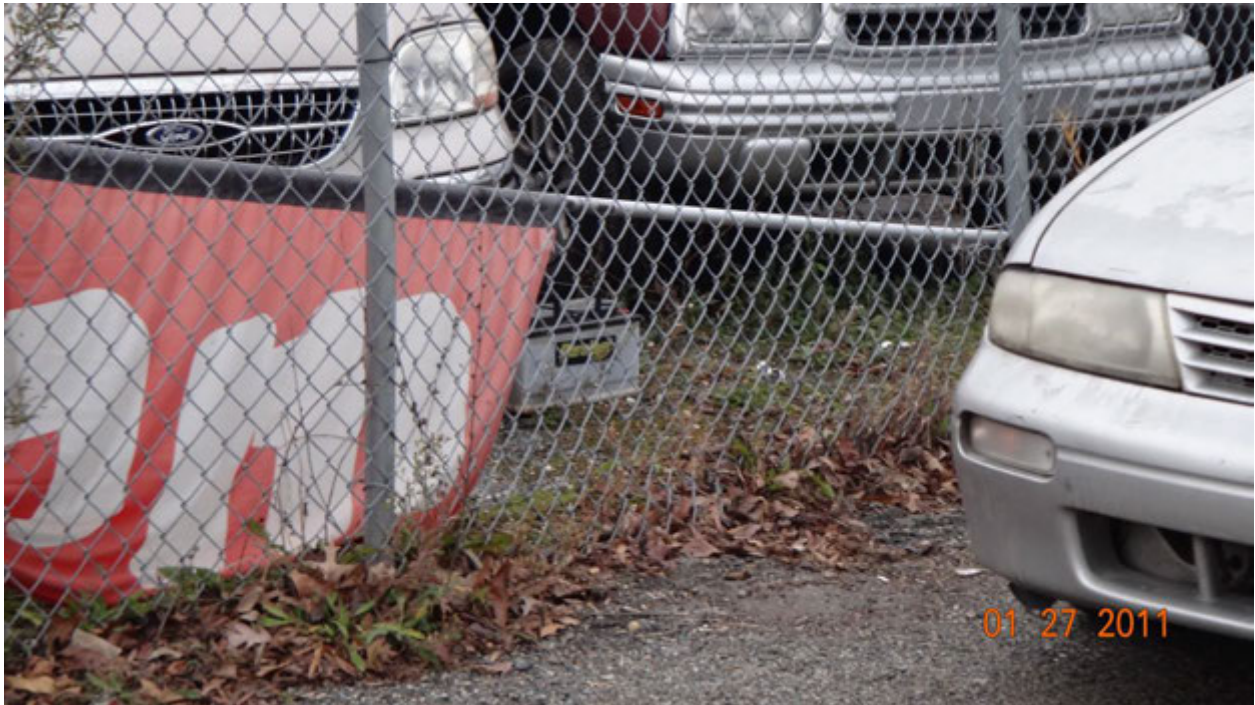
Figure 4. A car battery observed on the ground (photography date: December 9, 2015)

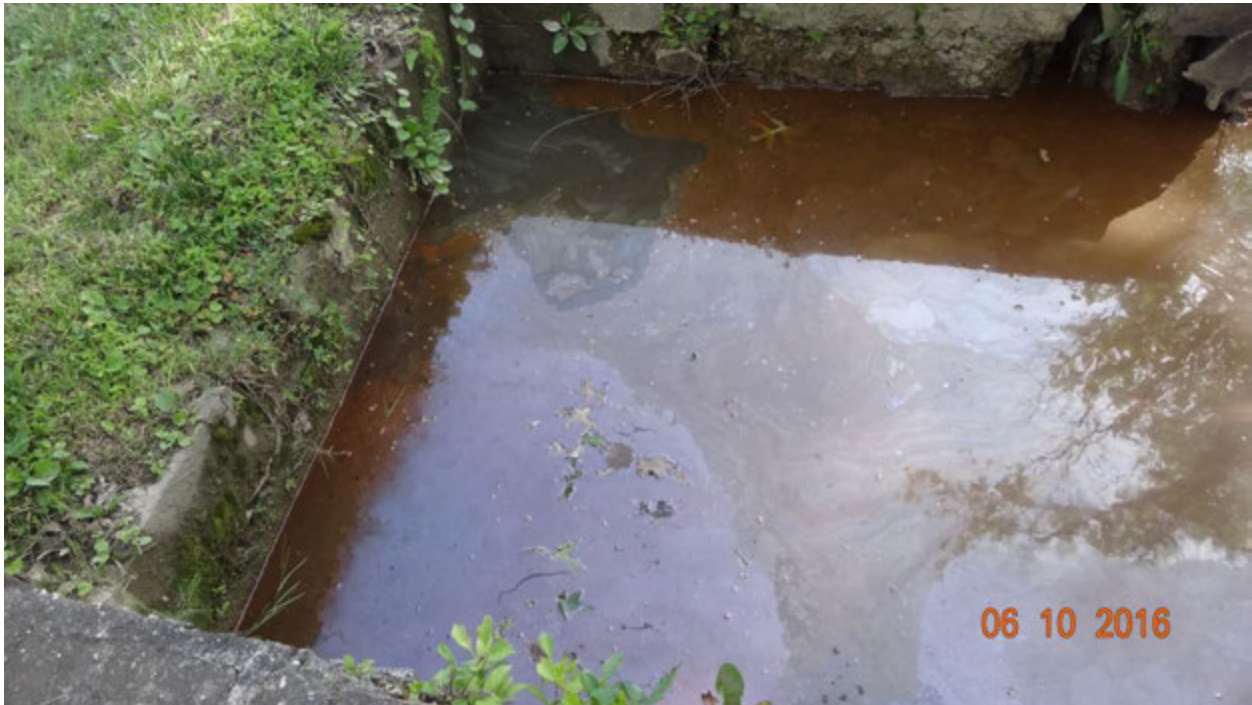
Figure 2. Observed conditions in the pooled water at outfall A11C7O001; note the orange color and the oil sheen

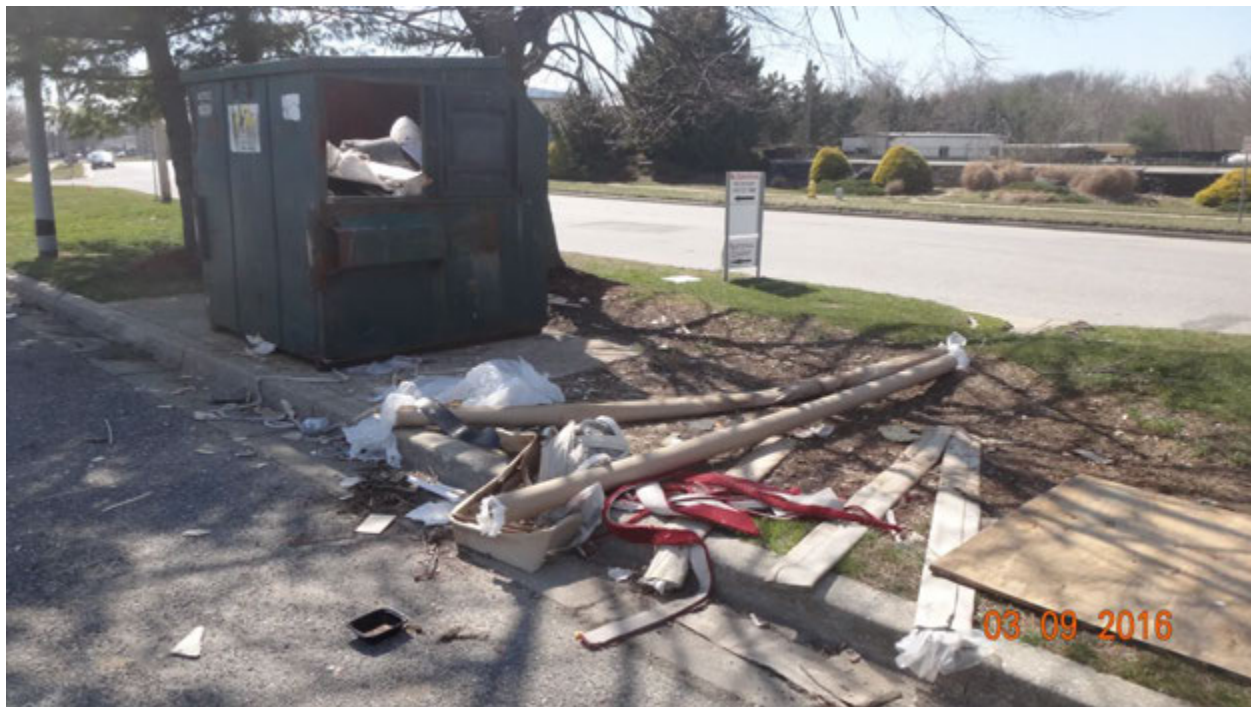
Figure 1. Photograph showing partially open dumpster and loose debris related to the carpeting business scattered around it on March 9

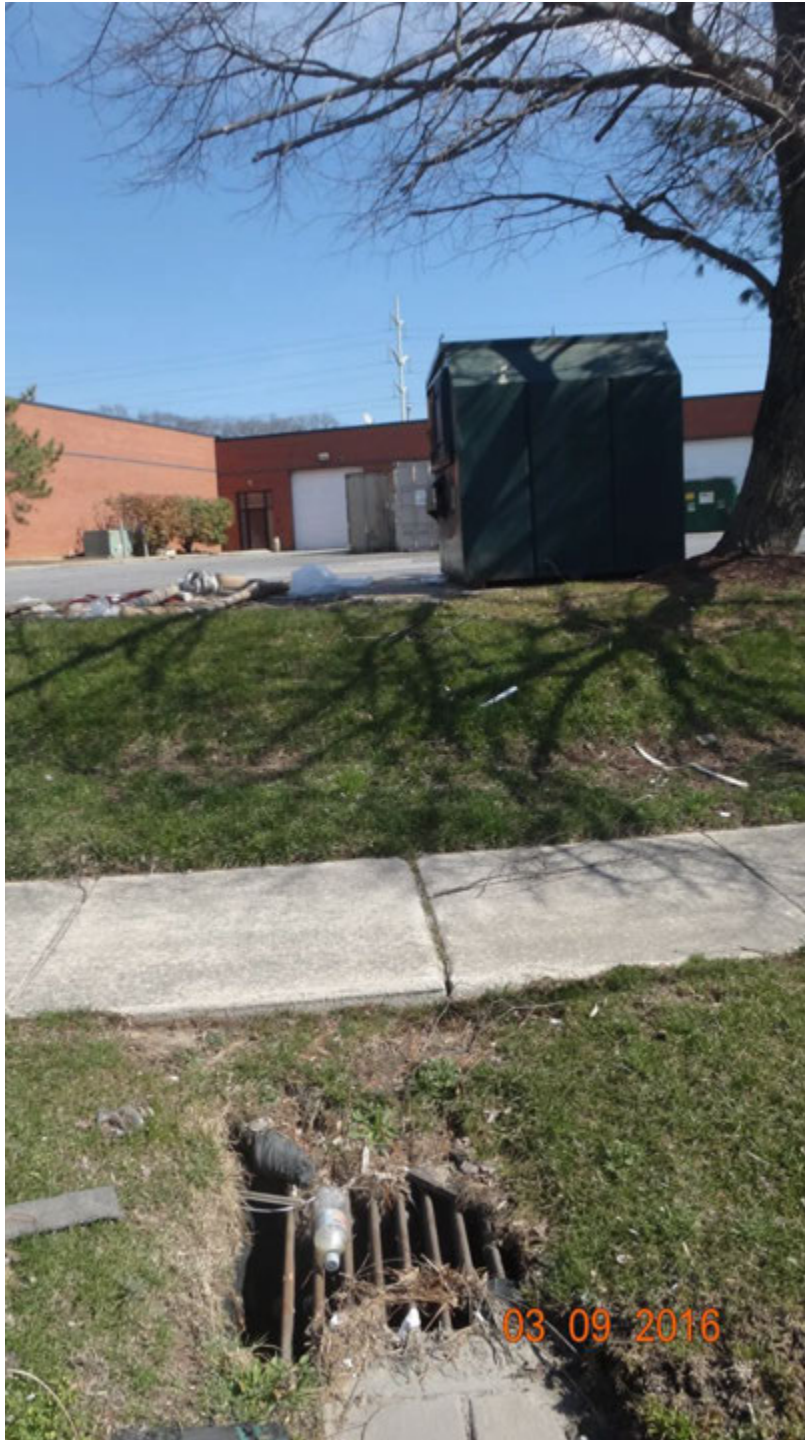
Figure 2. Photograph showing the relative location of the dumpster seen in Figure 1 to the nearby storm drain

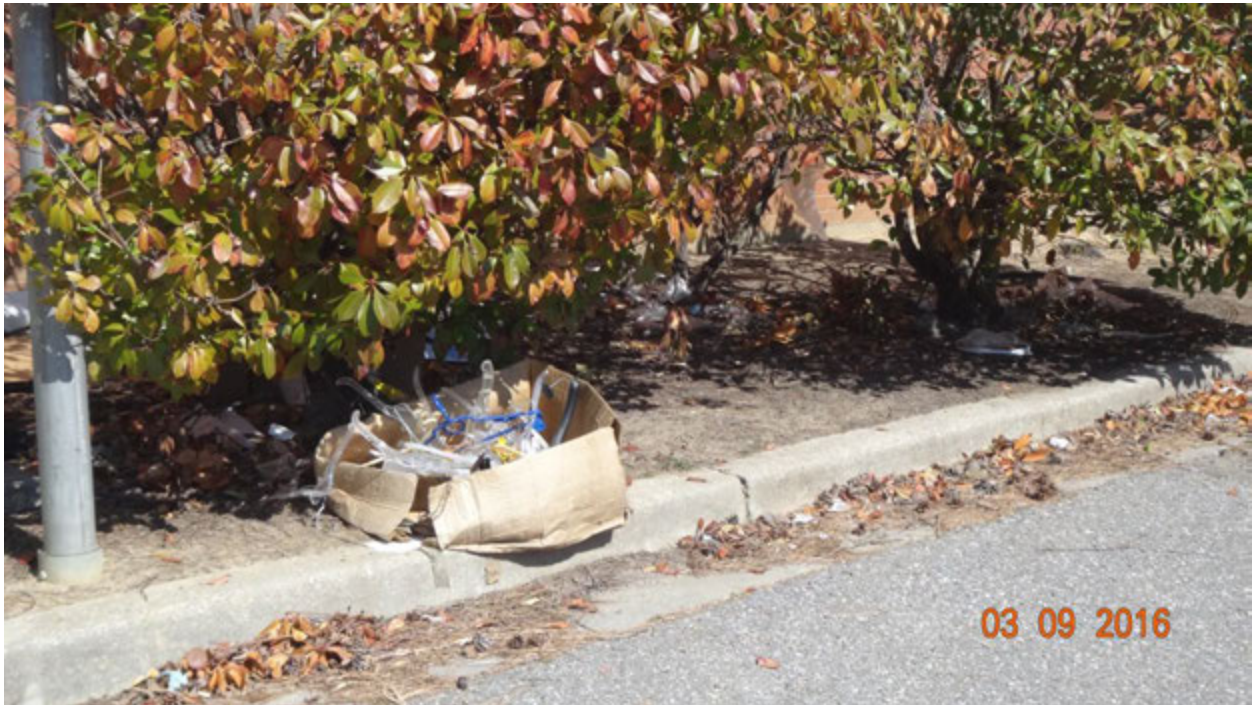
Figure 3. A box of plastic clothes hangers and loose plastic sheeting trapped in the bushes found by the field crew on March 9

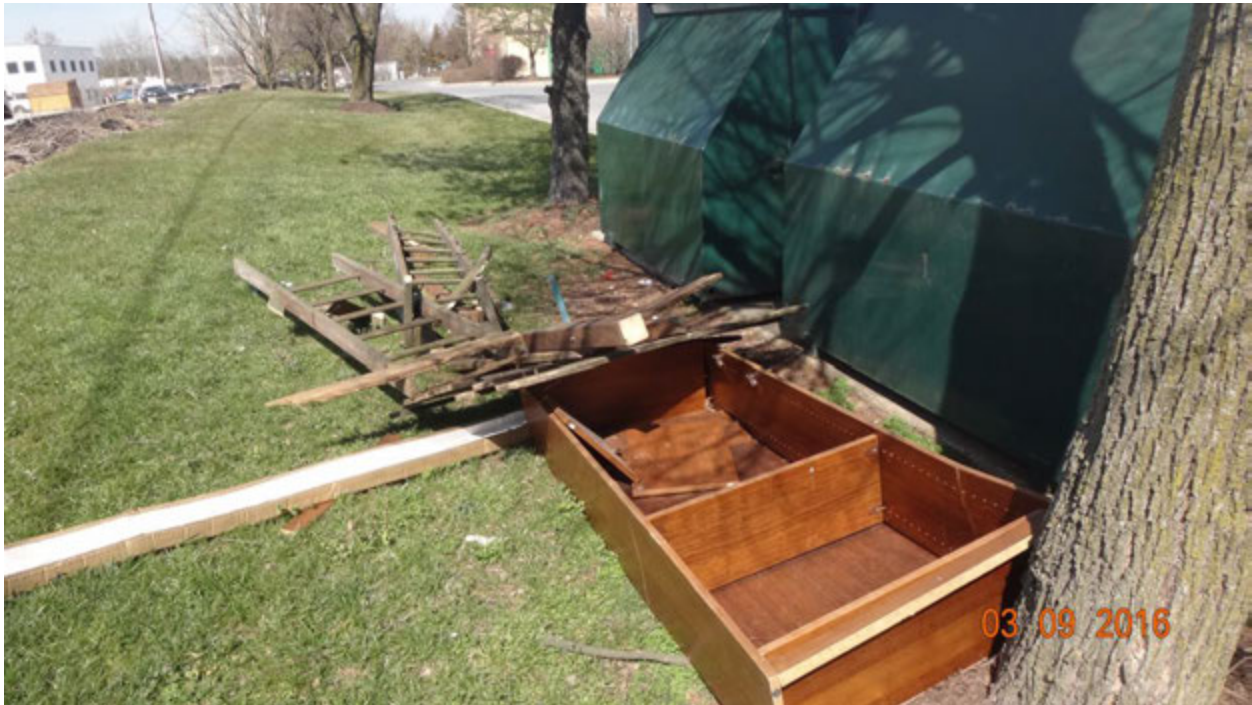
Figure 5. Loose debris found surrounding the dumpster to the north

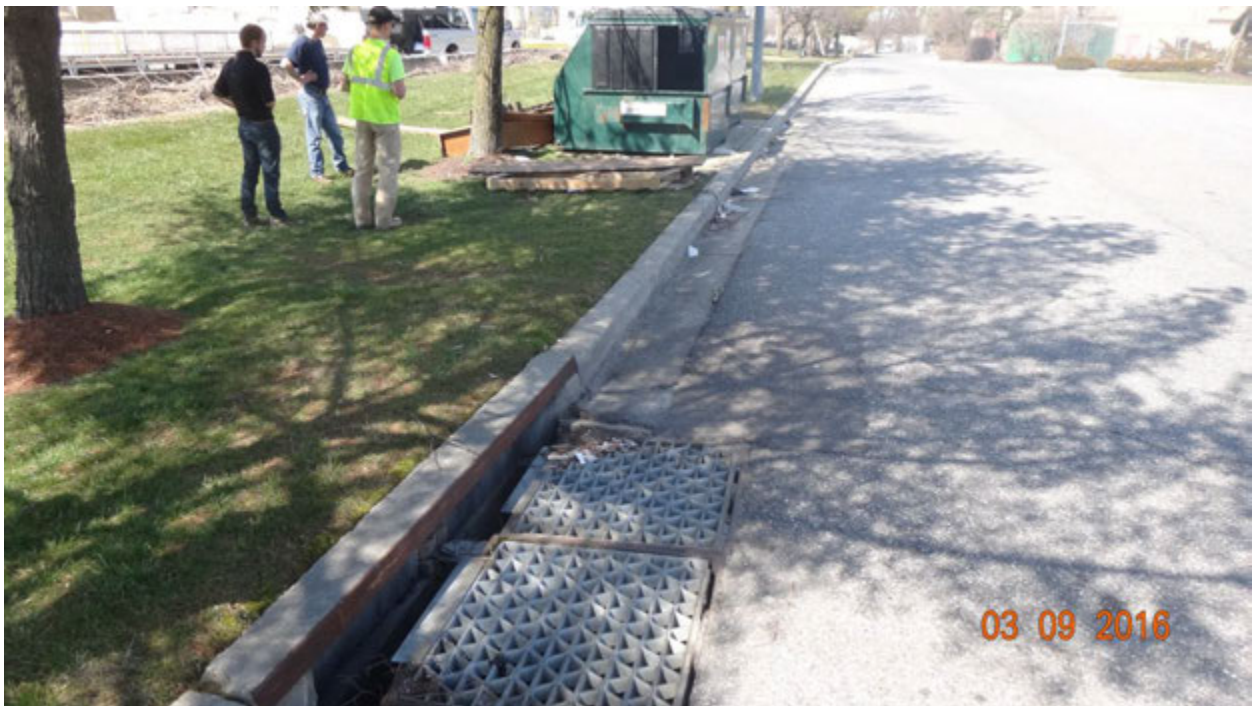
Figure 6. Relative location of the nearby storm drain inlet to the loose debris seen in Figure 5

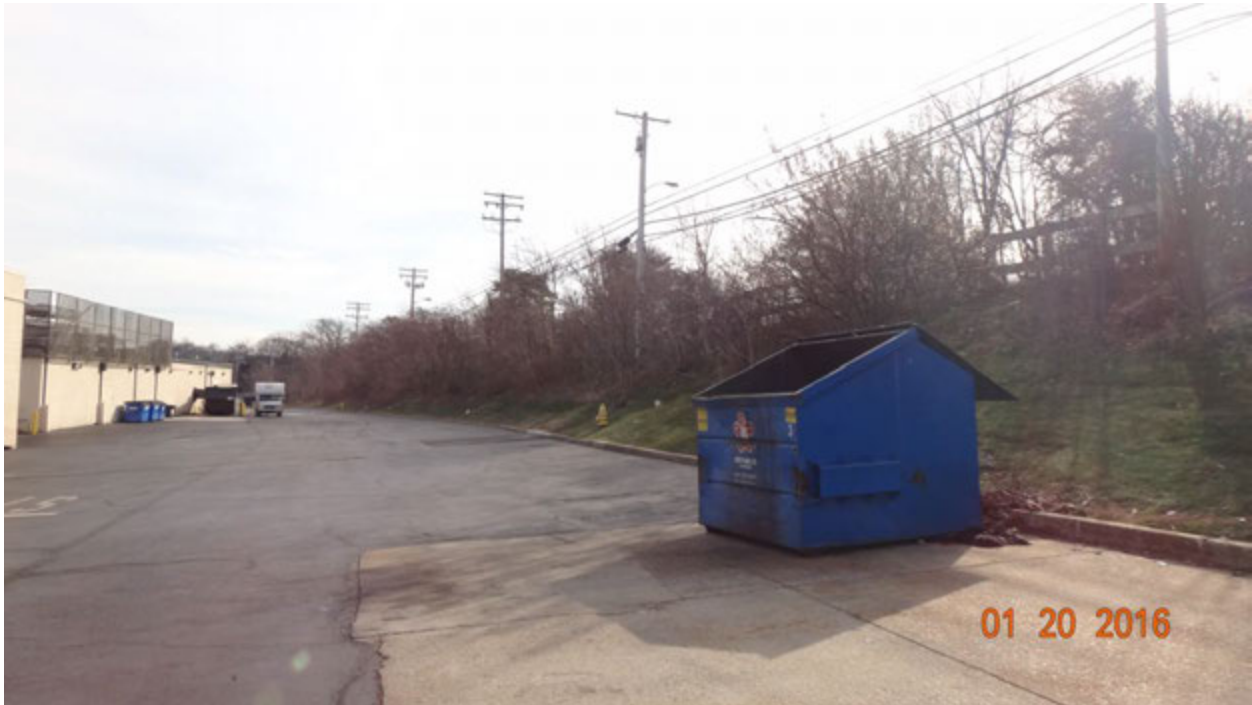
Figure 1. Photograph of one open dumpster found near the west corner of the parking lot, generally behind the Five Guys Burgers and Fries restaurant

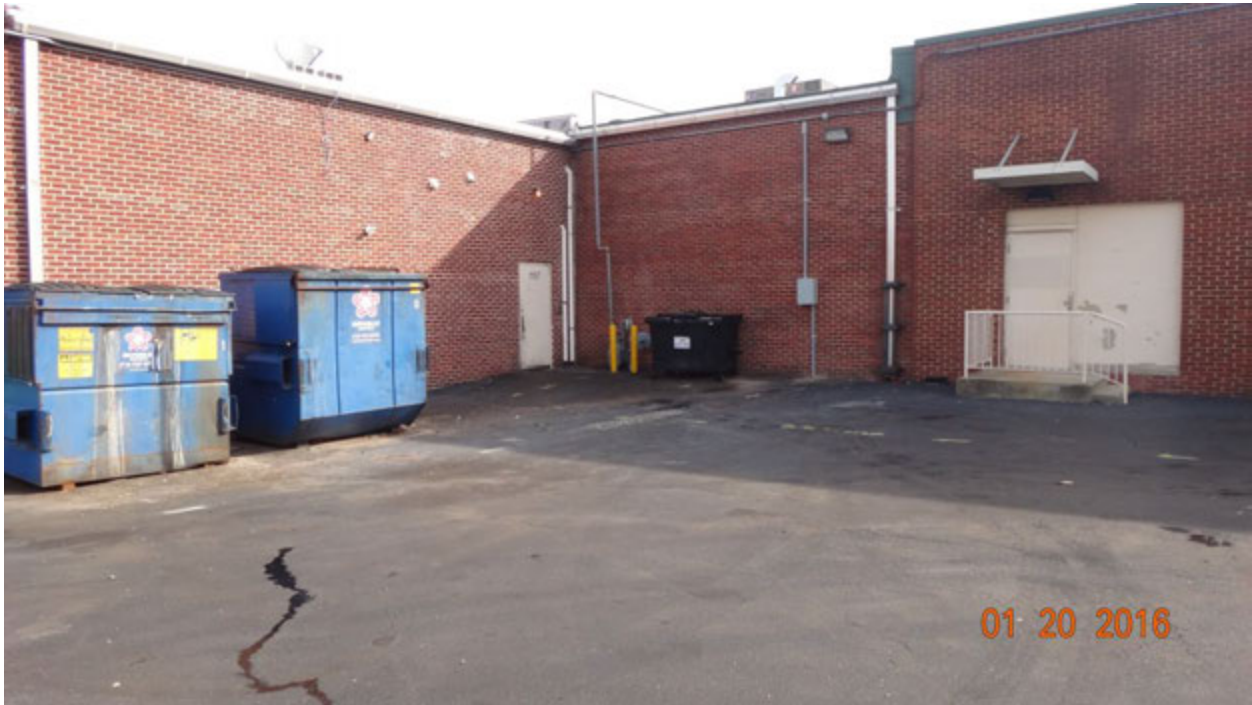
Figure 3. Photograph of the second open dumpster (the rightmost dumpster) and a kitchen grease waste receptacle (rear center) by a side door of the Five Guys Burgers and Fries restaurant; note the dark stains on the pavement around the side door and the grease container

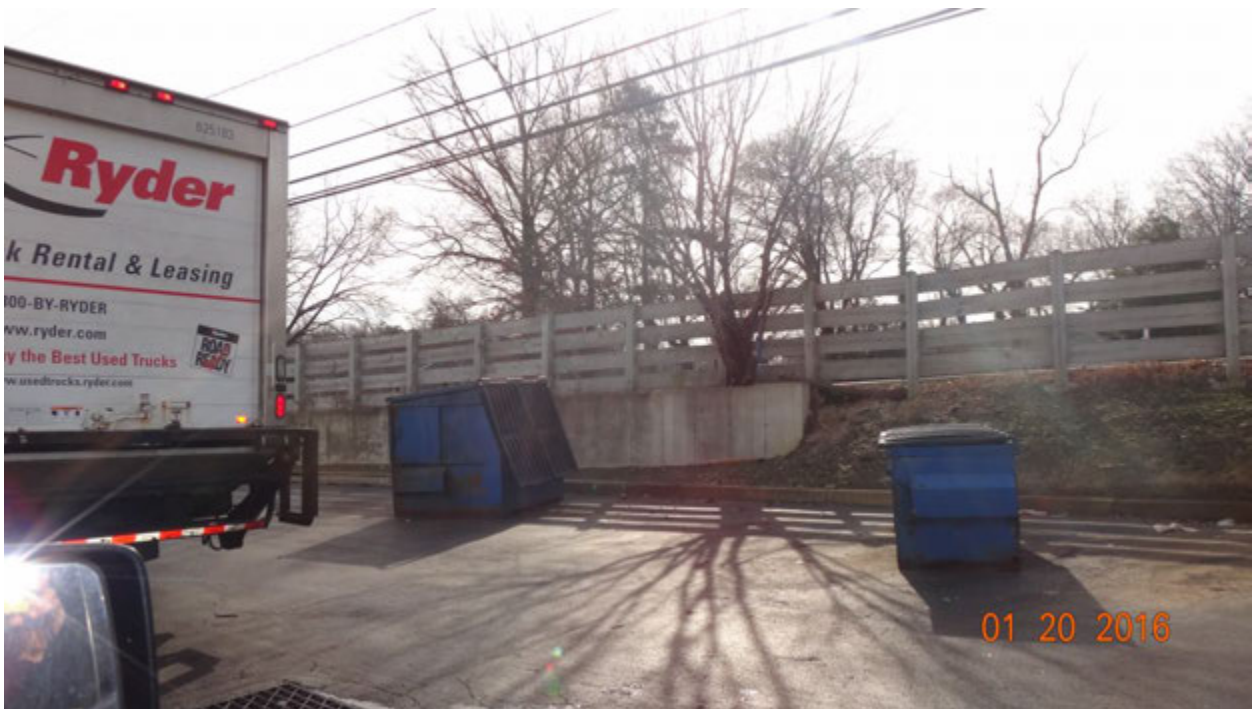
Figure 4. Photograph of a third open dumpster (on the left) found generally behind the Three Brothers Pizza restaurant

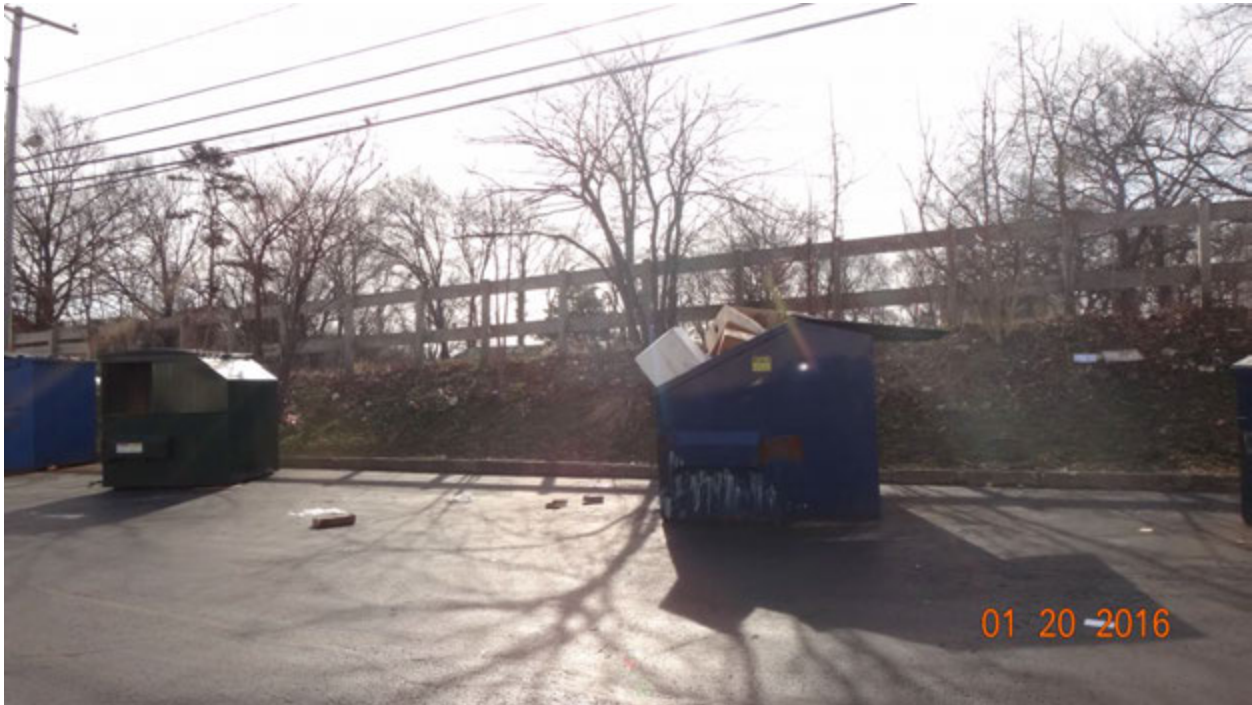
Figure 5. Photograph of a fourth open, and overfilled, dumpster found generally behind the Advance Auto Parts store; note the debris scattered on the pavement near the dumpster and debris on the hill behind the parking lot

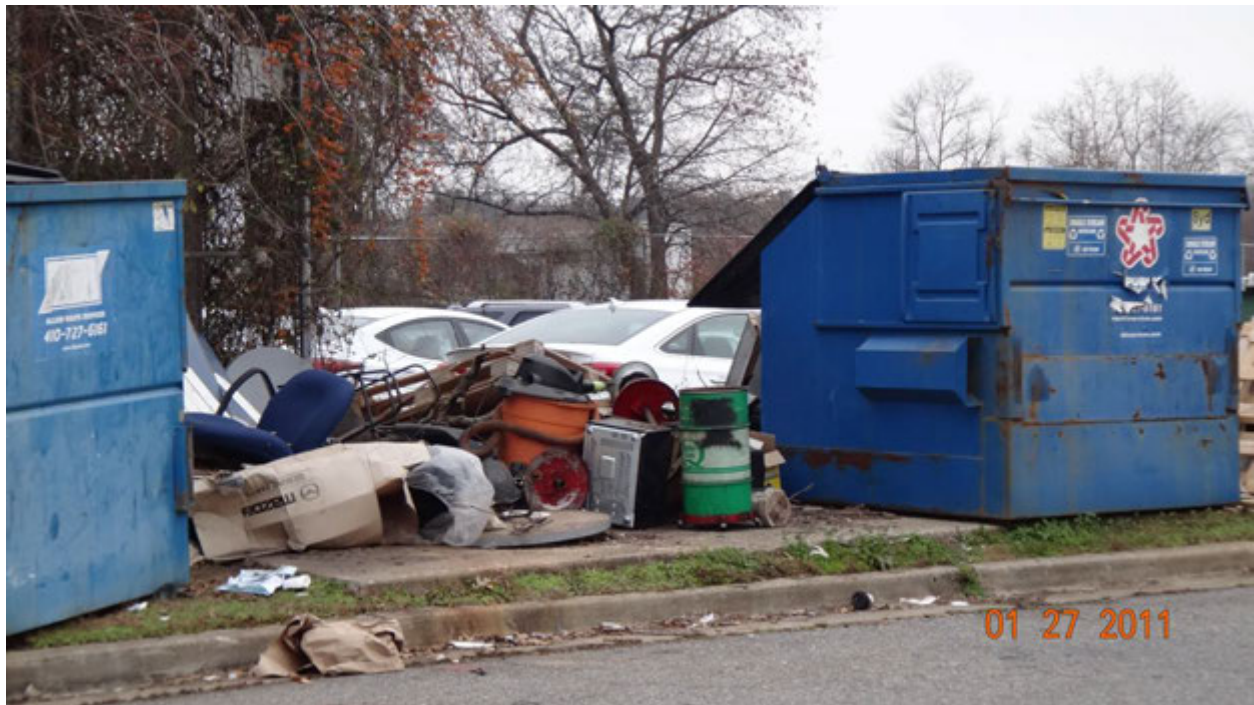
Figure 1. A collection of large pieces of debris deposited alongside two open dumpsters (photography date: December 9, 2015)

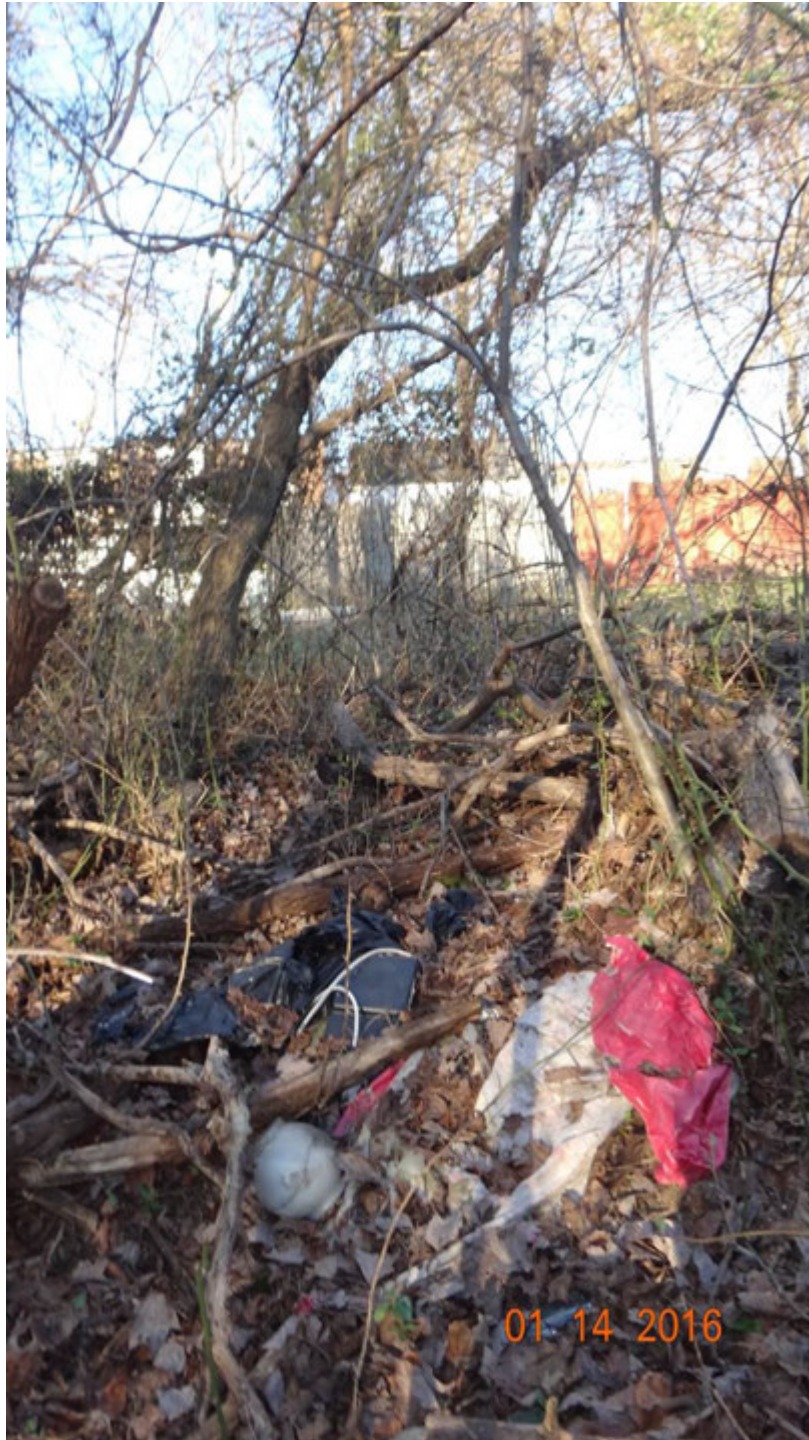
Figure 1. Photograph of general types of household items found deposited as trash in the wooded area behind the townhouse lots along Pioneer Drive

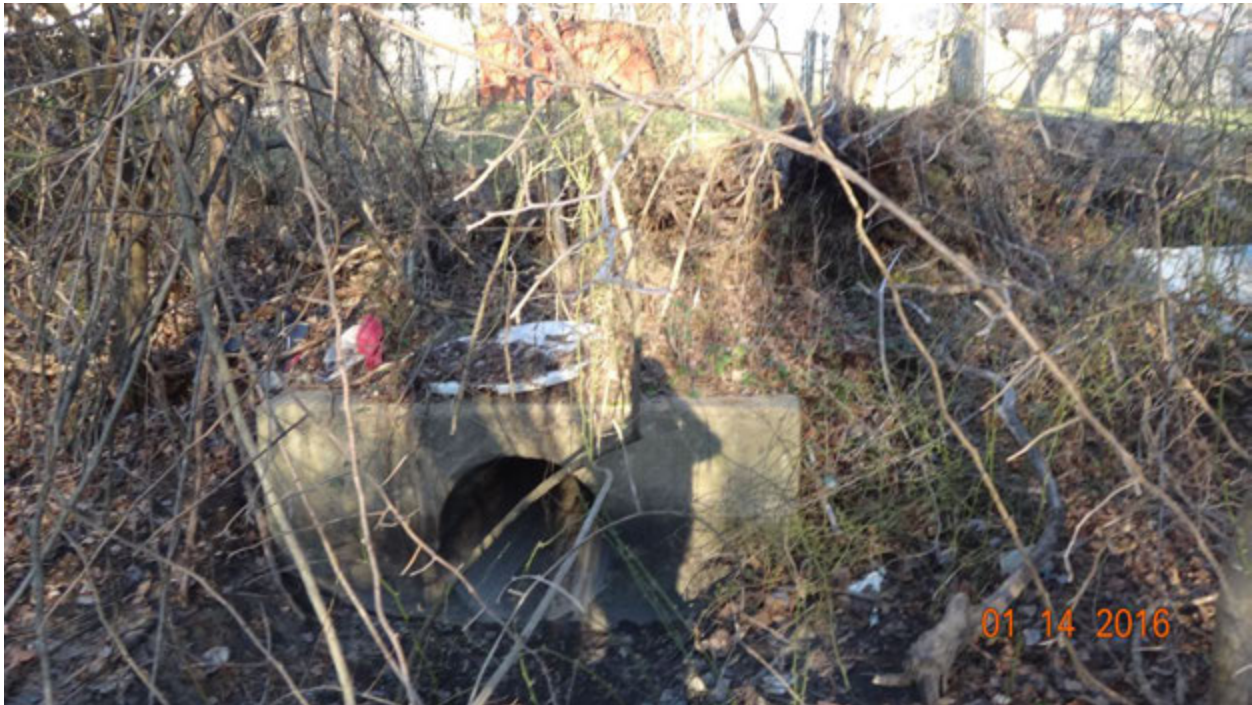
Figure 2. Photograph of outfall H10E5O001 with debris scattered around it; note the mattress on the right side of the photograph

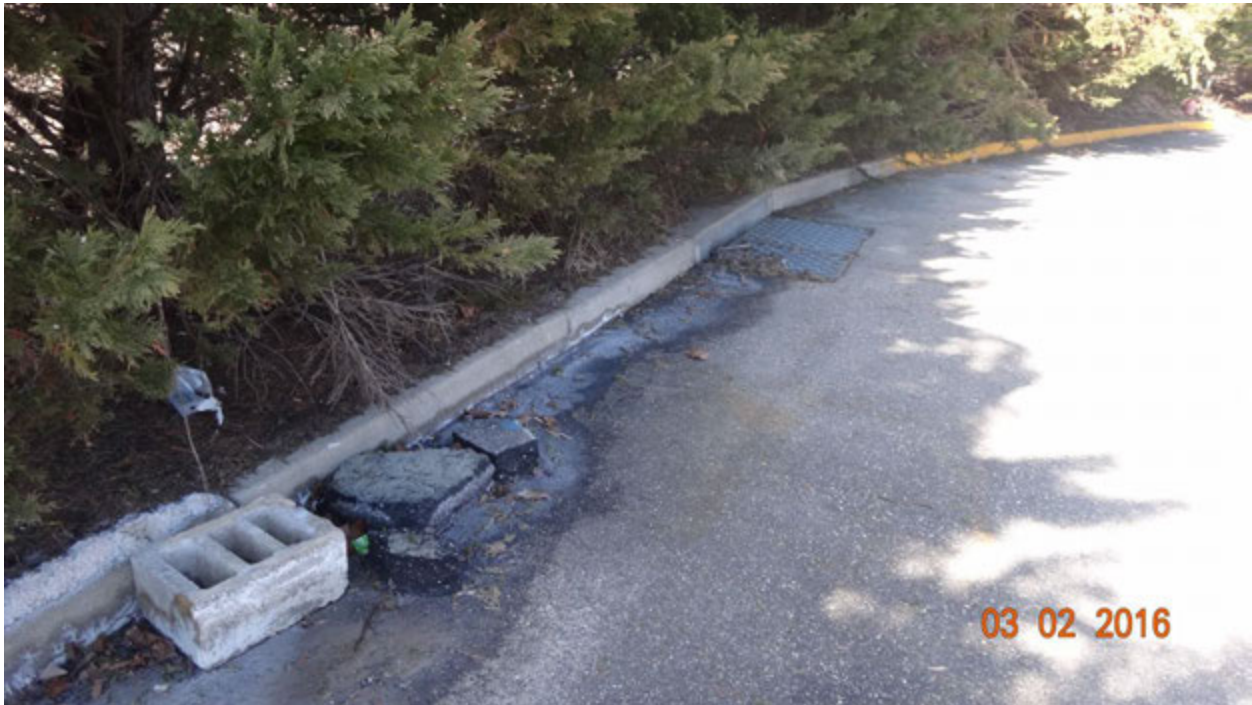
Figure 2. Evidence of the distribution of salt residue from the exposed pile of road salt along the edge of the parking lot toward the storm drain

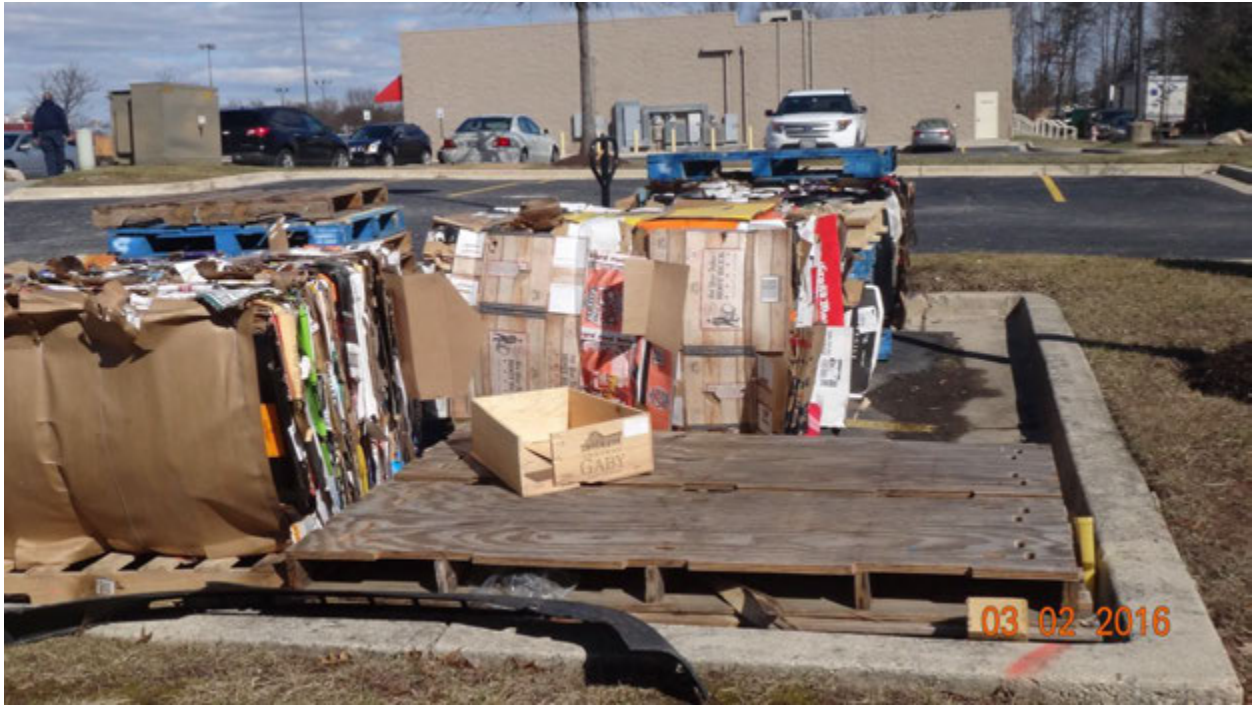
Figure 1. Accumulating cardboard material, intended for recycling

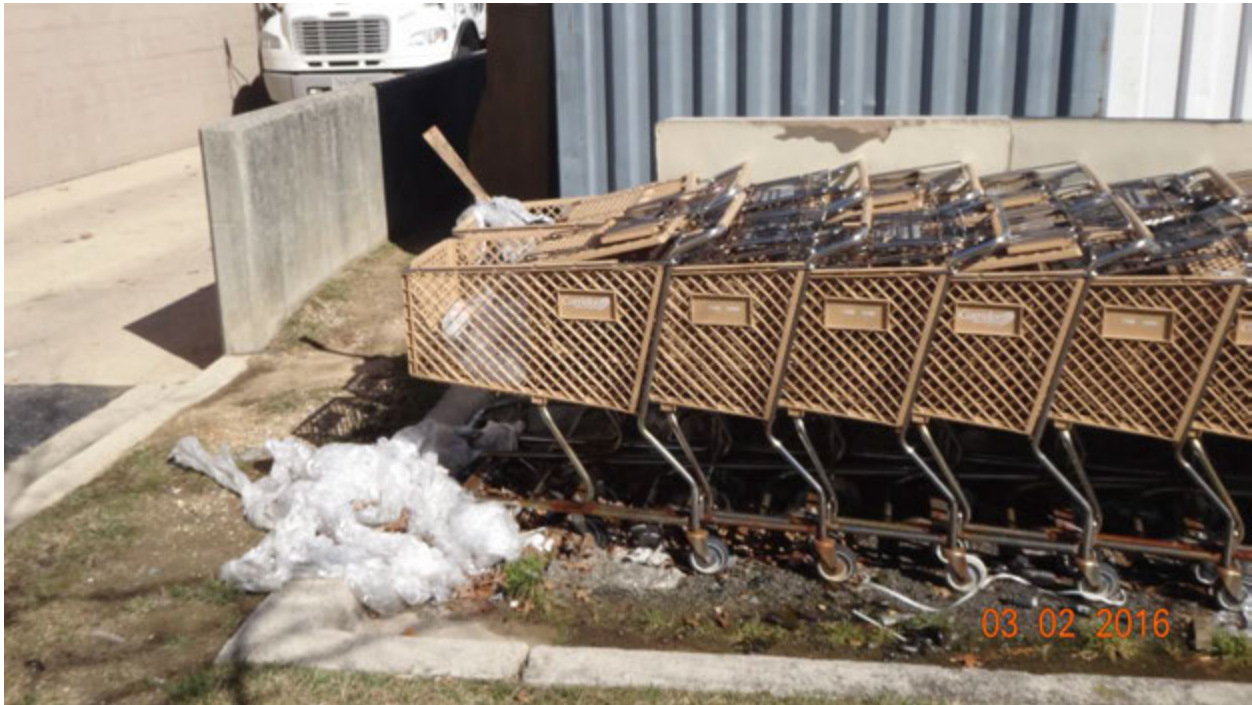
Figure 3. Loose plastic found deposited near or trapped by a storage area for shopping carts from the Total Wine store

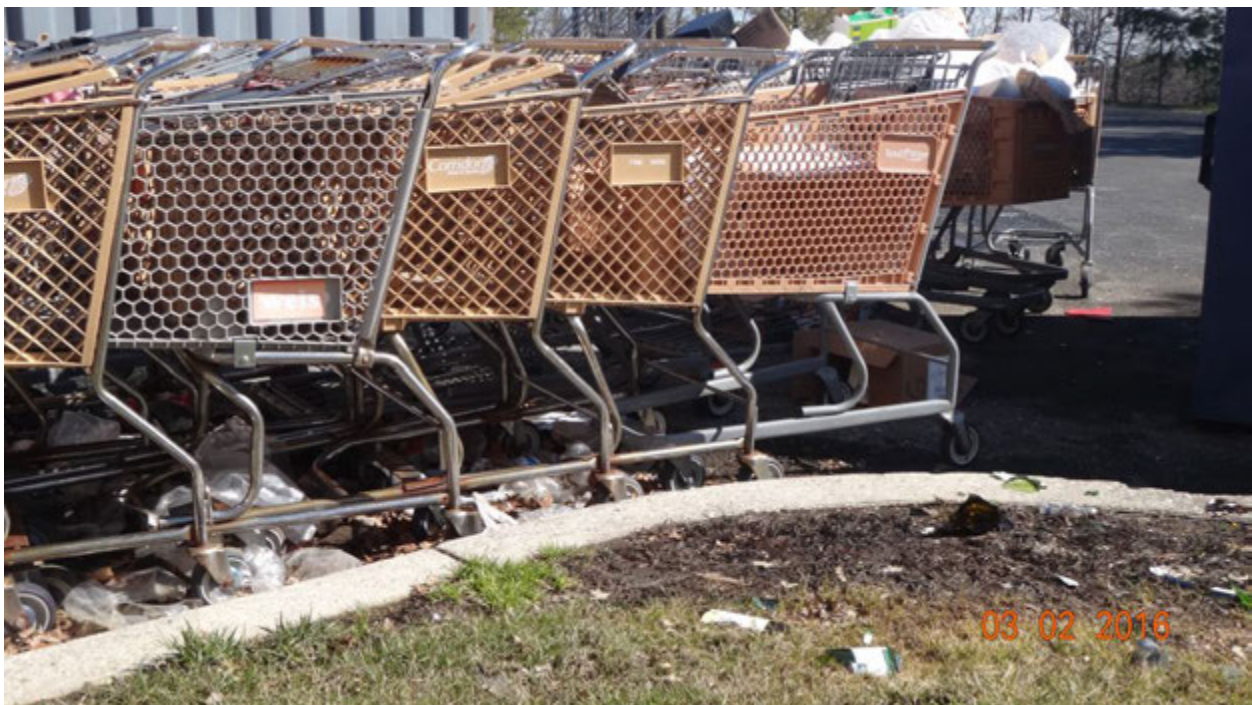
Figure 4. Loose debris found trapped under shopping carts stored alongside the Total Wine store; note the broken glass on the ground near the curb (right foreground)
