**ANNE ARUNDEL COUNTY
ILLICIT DISCHARGE DETECTION
AND ELIMINATION
2016 ANNUAL REPORT**

PERMIT NUMBER MD0068306

FINAL: January 2017

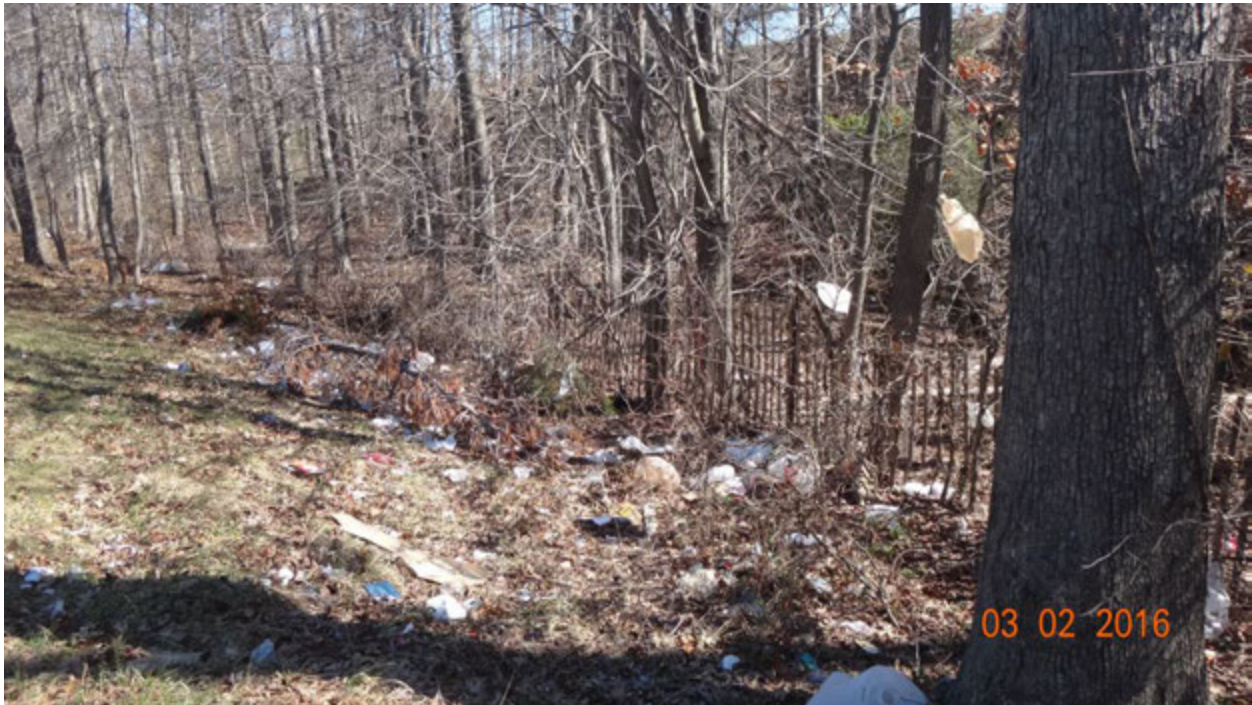
Figure 7. Loose debris found accumulating along the woods, downhill of the parking lot for the Total Wine store and other businesses at the Corridor Marketplace (facing north)
