**ILLICIT DISCHARGE DETECTION
AND ELIMINATION
2014 ANNUAL REPORT**

PERMIT NUMBER MD0068306

Versar, Inc.
9200 Rumsey Road
Columbia, MD 21045

October 2014

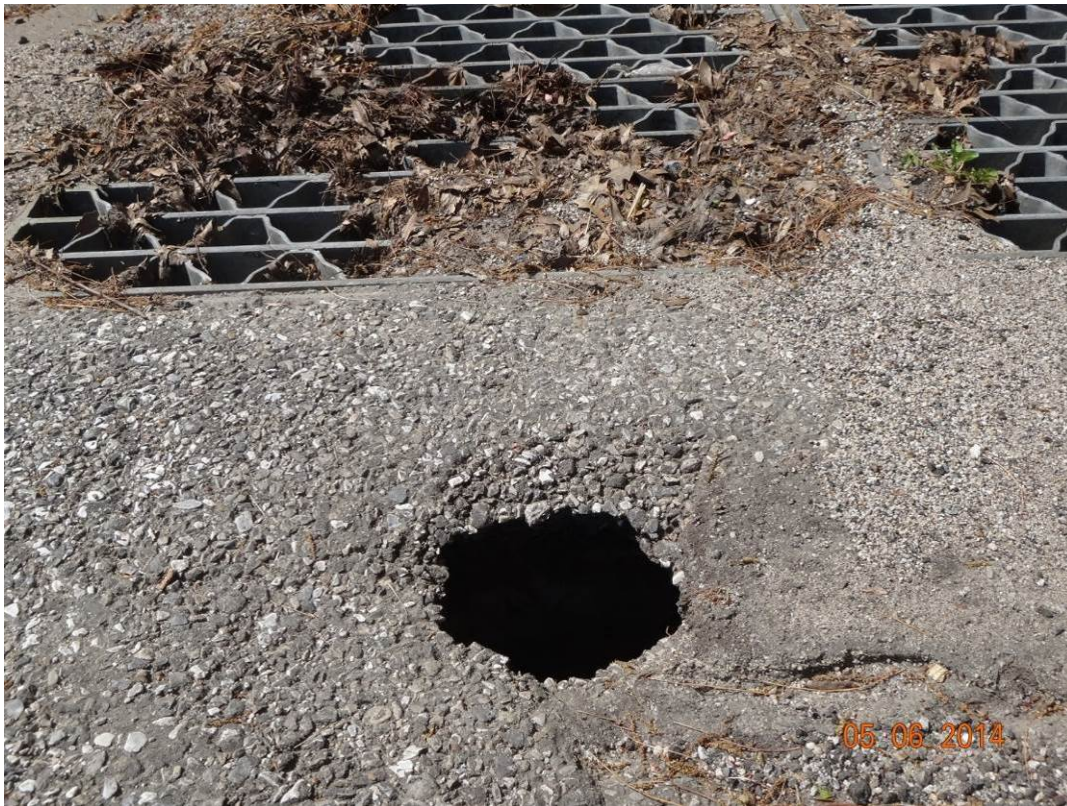
While conducting outfall screening in the target area, a Versar field team noted a hole in the asphalt near a storm drain inlet (Figure 1 and Figure 2) in the south parking area at the above address. Upon closer inspection, the interior of the catch basin could be clearly seen through the open hole (Figure 3). No vehicles were parked in this area, however the weakened asphalt could create a falling hazard for passers-by or cause damage to vehicles. If there is an erosion problem, the condition could worsen. An area map appears in Figure 4.

Figure 1. Hole in asphalt near grated inlet, 510 McCormick Drive

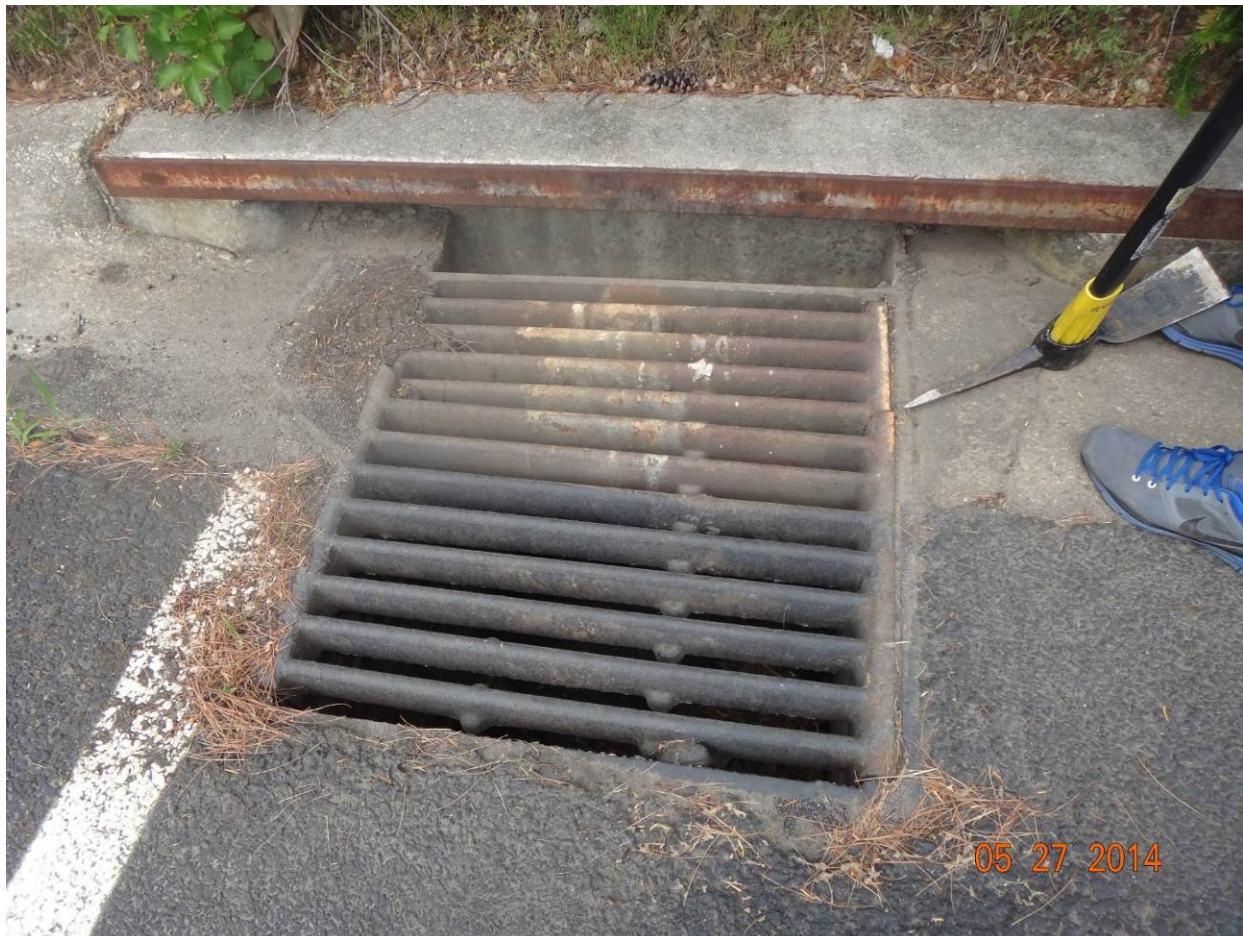
While conducting outfall screening in the target area, a Versar field team noted a cracked grate over a storm drain inlet (Figure 1) in the north parking area at the above address. There is a concern that the weight of a vehicle parked over the crack may damage the grate further. If significantly damaged, the grate may not be strong enough to support a vehicle. A partially opened inlet would pose a threat to pedestrians, cyclists, and motorists. An area map is provided in Figure 2.

Figure 1. Cracked inlet grate, indicated by pointed end of the pick axe, 1300 Concourse Drive

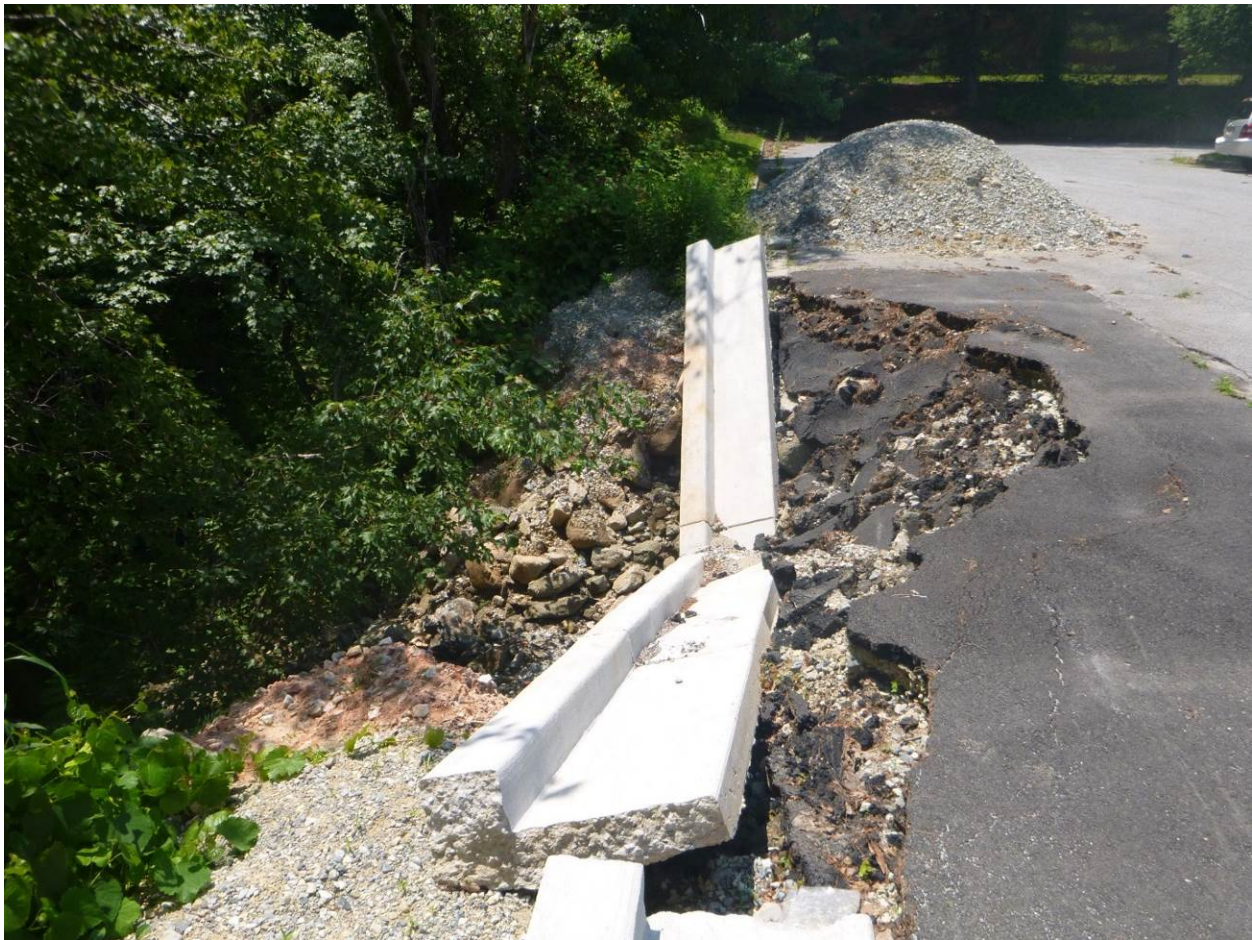
While conducting outfall screening in the target area, a Versar field team discovered a section of parking lot pavement that had collapsed along with the adjoining curb (Figure 1 and Figure 2) in the parking lot behind the building at the above location. The field team documented the condition with photographs. No vehicles were parked in this area; however, the weakened asphalt could create a falling hazard for passers-by or cause damage to vehicles. Interpretation of the photographs suggests that there may be an erosion problem, and, if that is true, the condition could worsen. The site may have been repaired previously. County GIS coverage indicates that a storm drain inlet is in the near vicinity and may be part of the problem area. An area map appears in Figure 3.

Figure 1. A section of parking lot pavement that had collapsed and the associated damaged curb

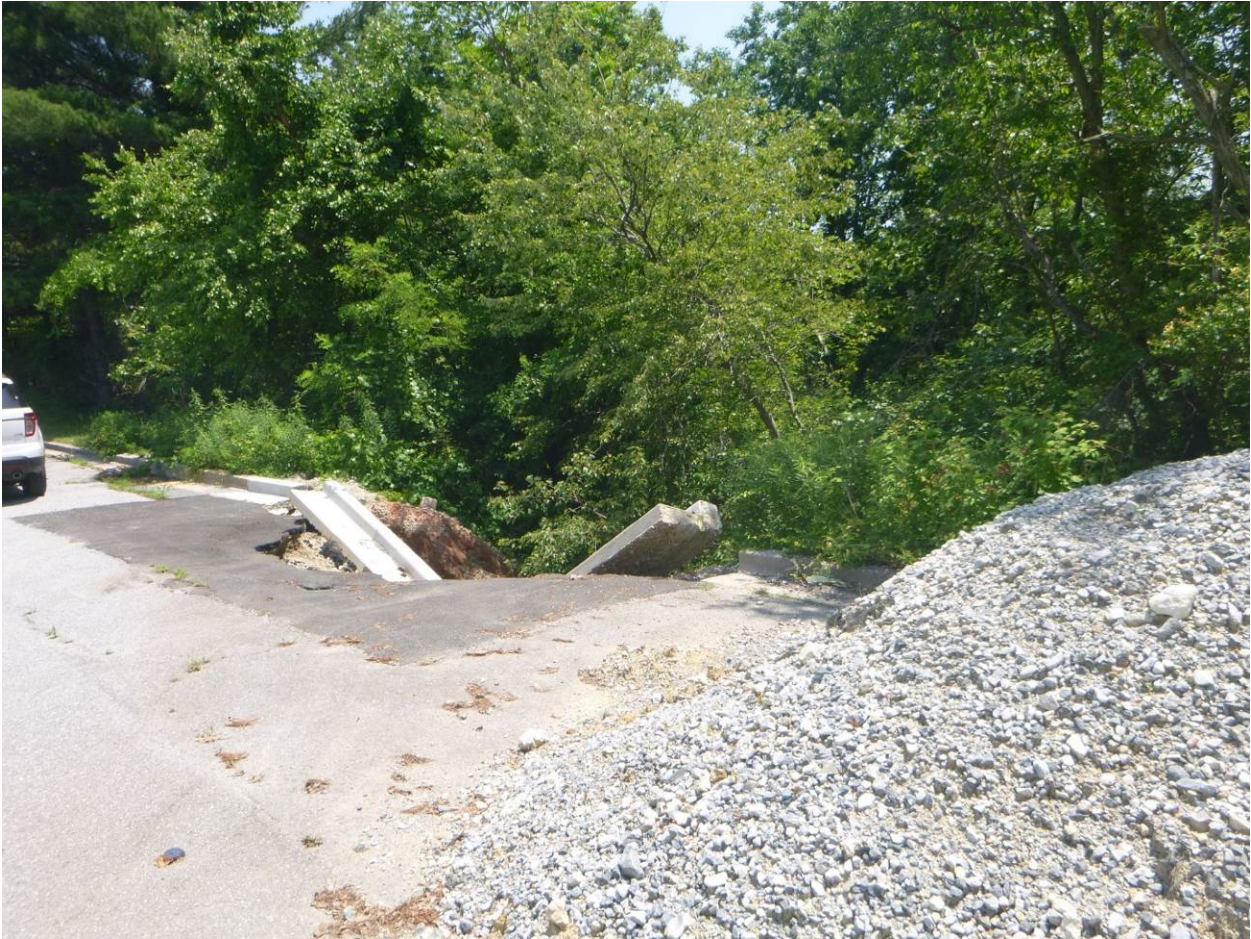
Figure 2. A view of the extent of the collapse and the jutting curb sections

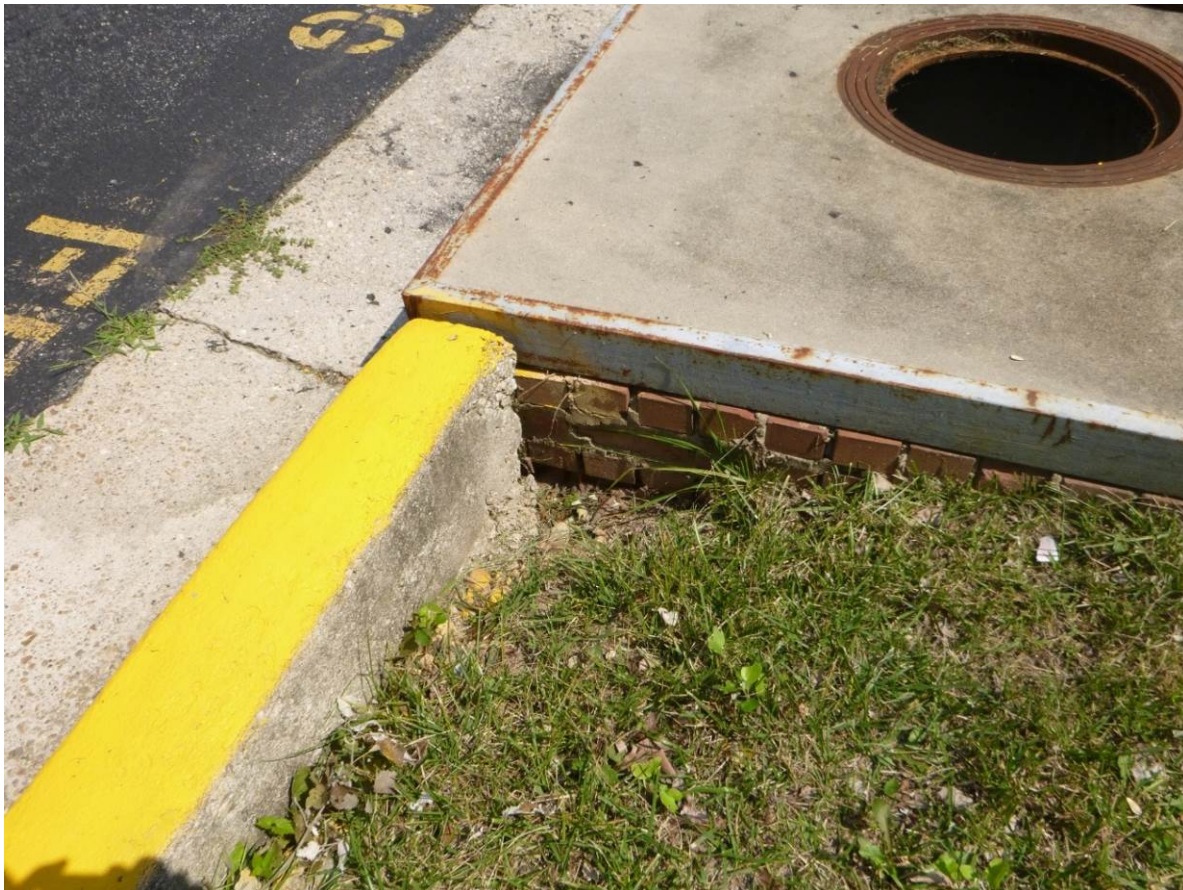
A Versar field team discovered a hole in the ground under the corner of a curb inlet (Figure 1) in the parking lot behind the Hoyt's Cinema 14 at the address given above. The loss of ground support under the bricks may contribute to a weakened state in the future and present a hazard. In another photograph taken by the field crew, there is evidence of possible structural compromises in the curb inlet support: the corner block does not show supporting mortar and there is an uneven crack through the gutter suggesting a shift in underlying support associated with the same corner (Figure 2). The field team investigated the condition but did not find evidence of an obvious cause for the missing dirt. If there is an erosion problem, the condition could worsen. An area map appears in Figure 3.

Figure 1. Evidence of ground support missing from the corner of the curb inlet

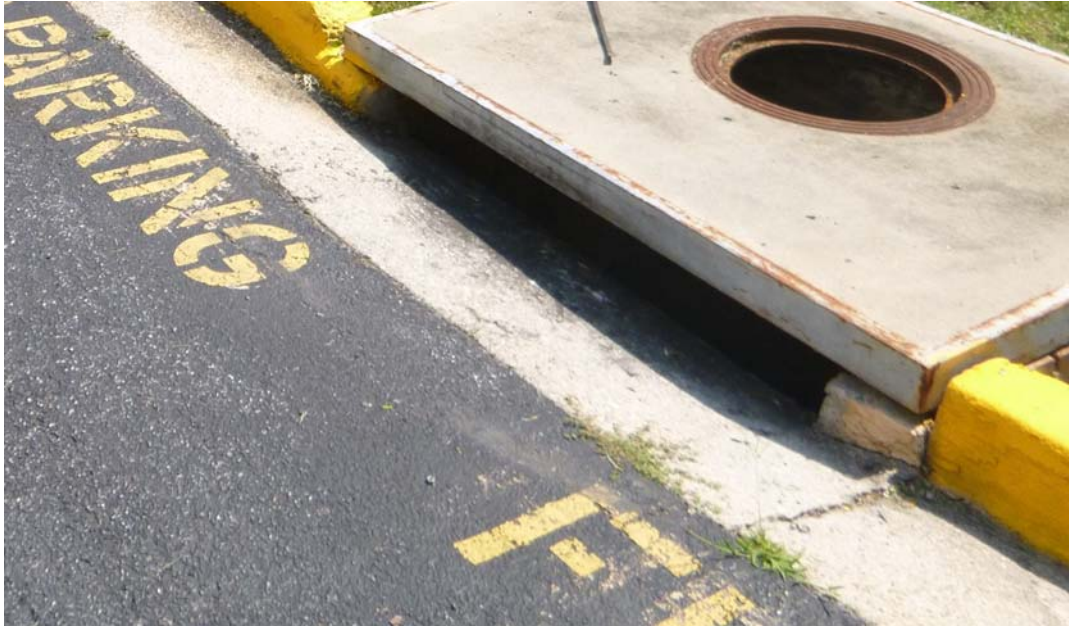
Figure 2. Evidence of a possible separation of the supporting block and a split in the gutter (lower right corner of the photograph)

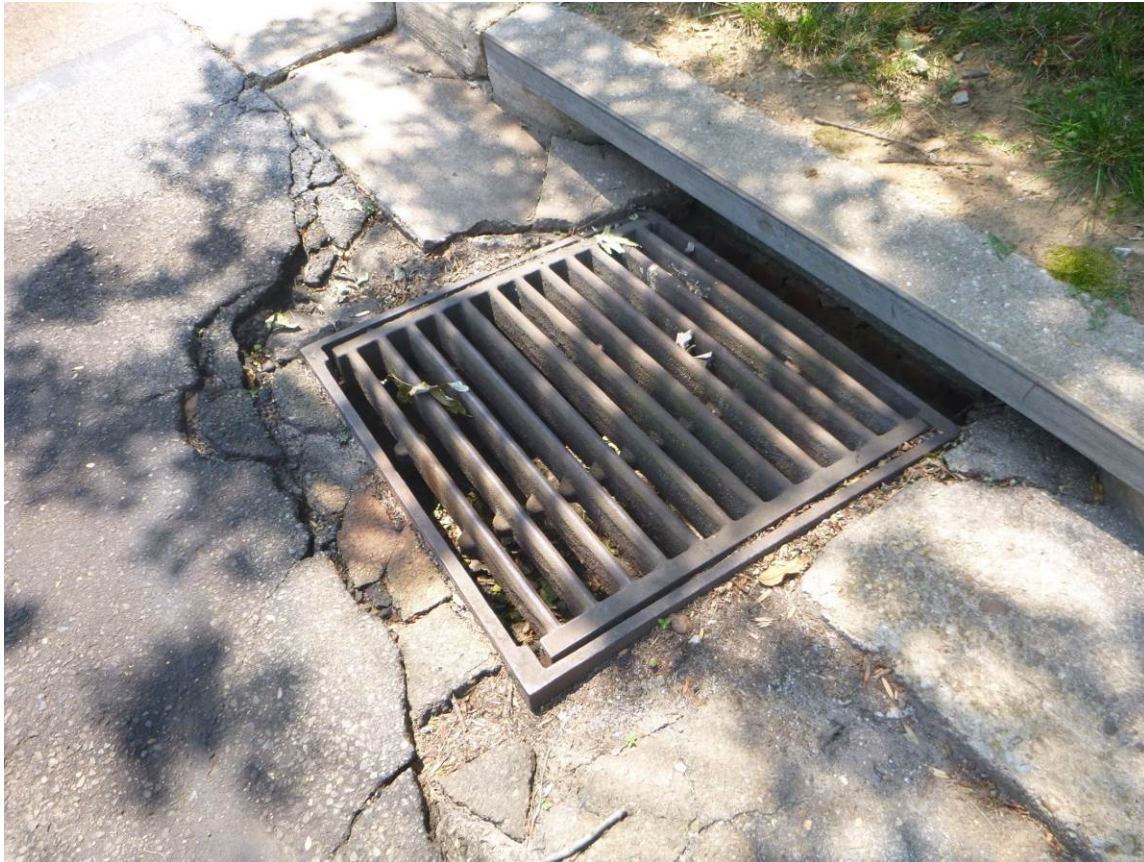
A Versar field team investigating the stormwater infrastructure along Oregon Avenue noted damage to the asphalt and gutter which has caused partial collapse of these surfaces (Figure 1 and Figure 2) bordering an inlet down the street from a warehouse at the above address (Lighting Maintenance, Inc., occupies Suite A of 832 Oregon Avenue). The field crew also observed that sediment had accumulated in the inlet box; water flow to the connected pipe did not appear to be blocked, yet. The cause of the damage could not be ascertained on the day of the site visit. The field crew did note that trucks - displaying logos that were not obviously associated with the Lighting Maintenance company - were parked alongside the curb (i.e., spanning several parking spaces) on the same side of the street as the inlet. One could surmise that the parking area and gutter damage around the inlet grate may have been caused by bearing the excessive weight of a parked truck for extended periods of time. If the inlet box structure has been compromised, or the sub-surface of the parking asphalt is being saturated due to leaks in the infrastructure, there is increased potential for damage or collapse in the future. An area map appears in Figure 3.

Figure 1. View of the asphalt and gutter damage and partial collapse as seen from the right of the inlet grate

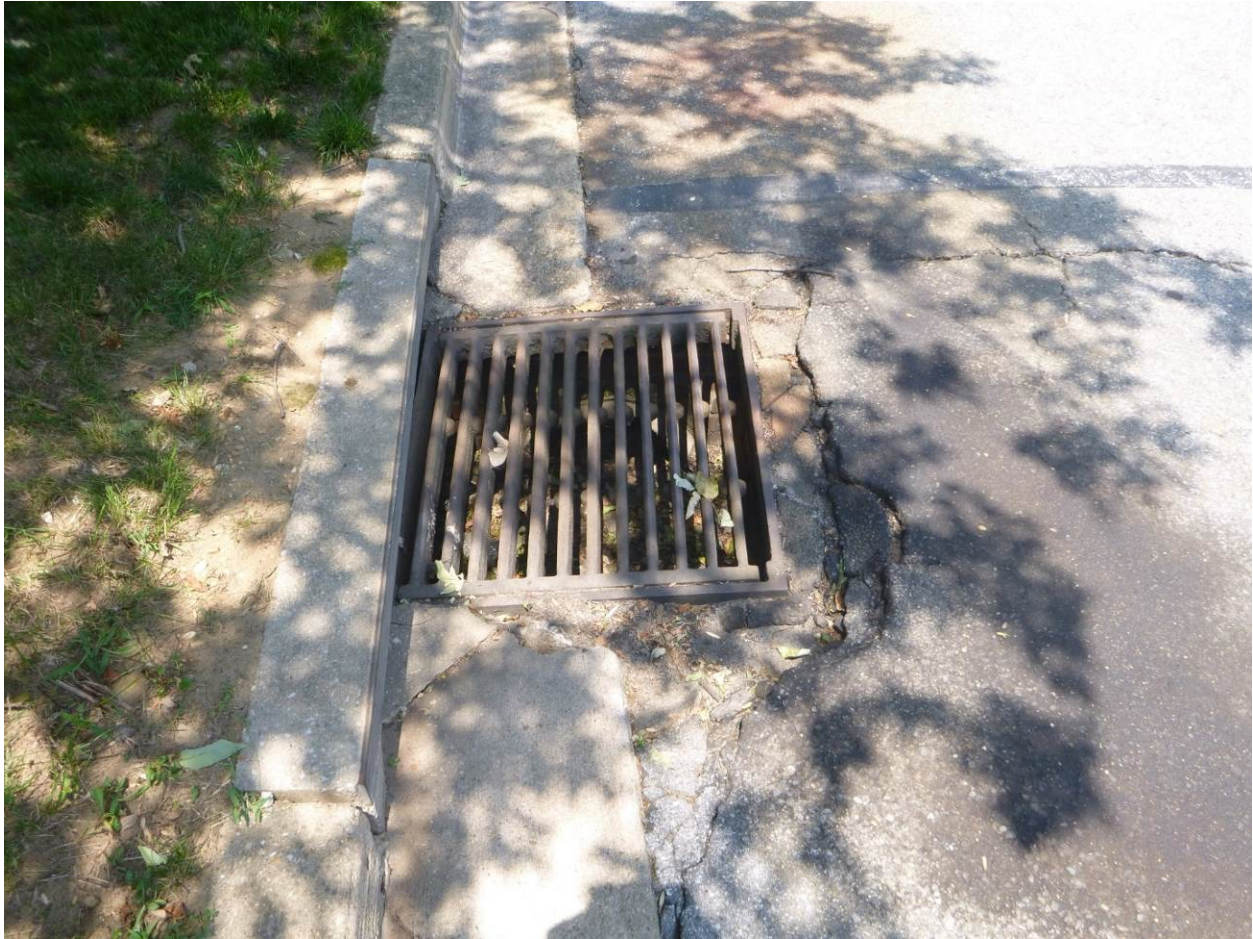
Figure 2. View of the asphalt and gutter damage and partial collapse as seen from the left of the inlet grate

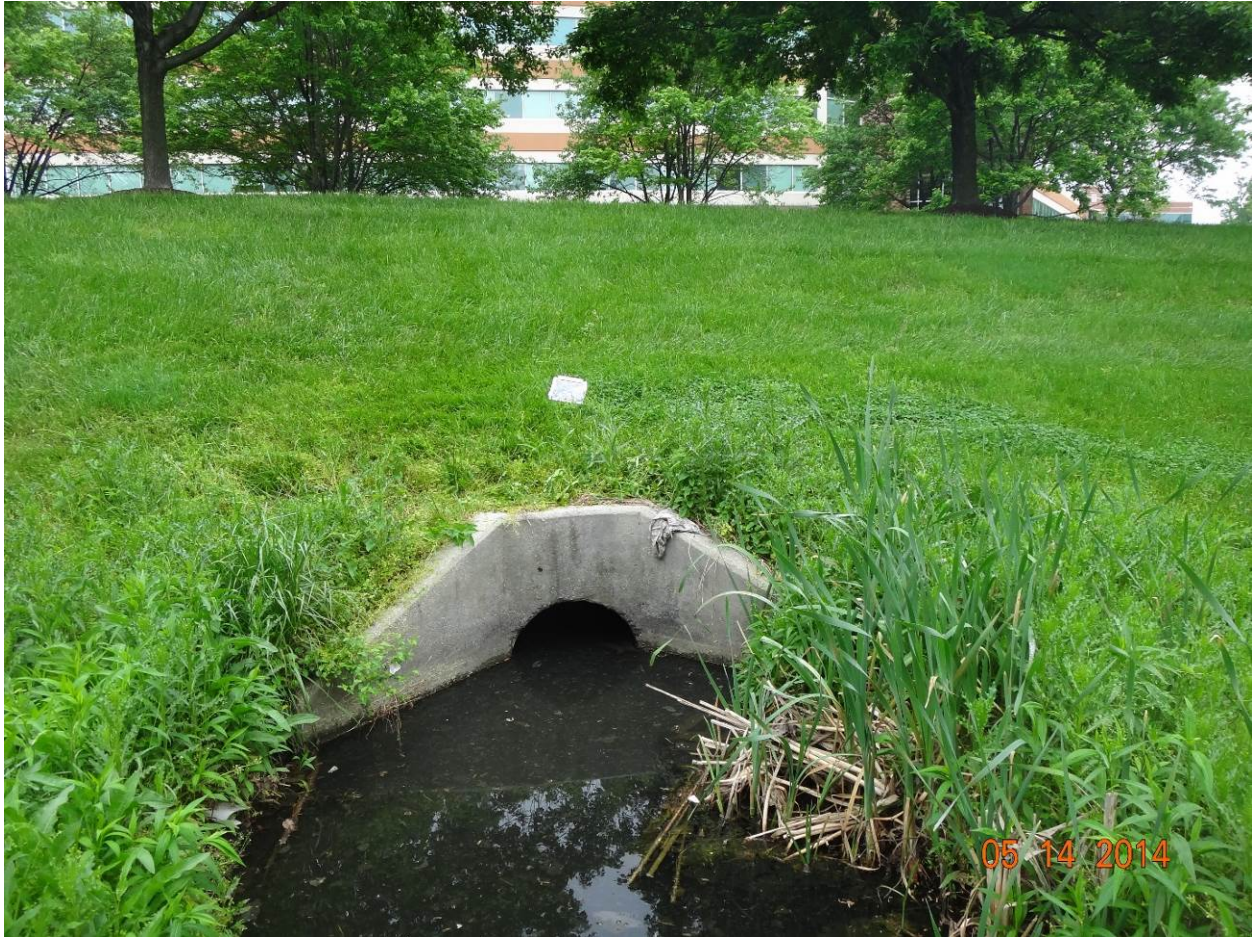
Figure 1. Outfall I03E8O015 with standing water in the orifice

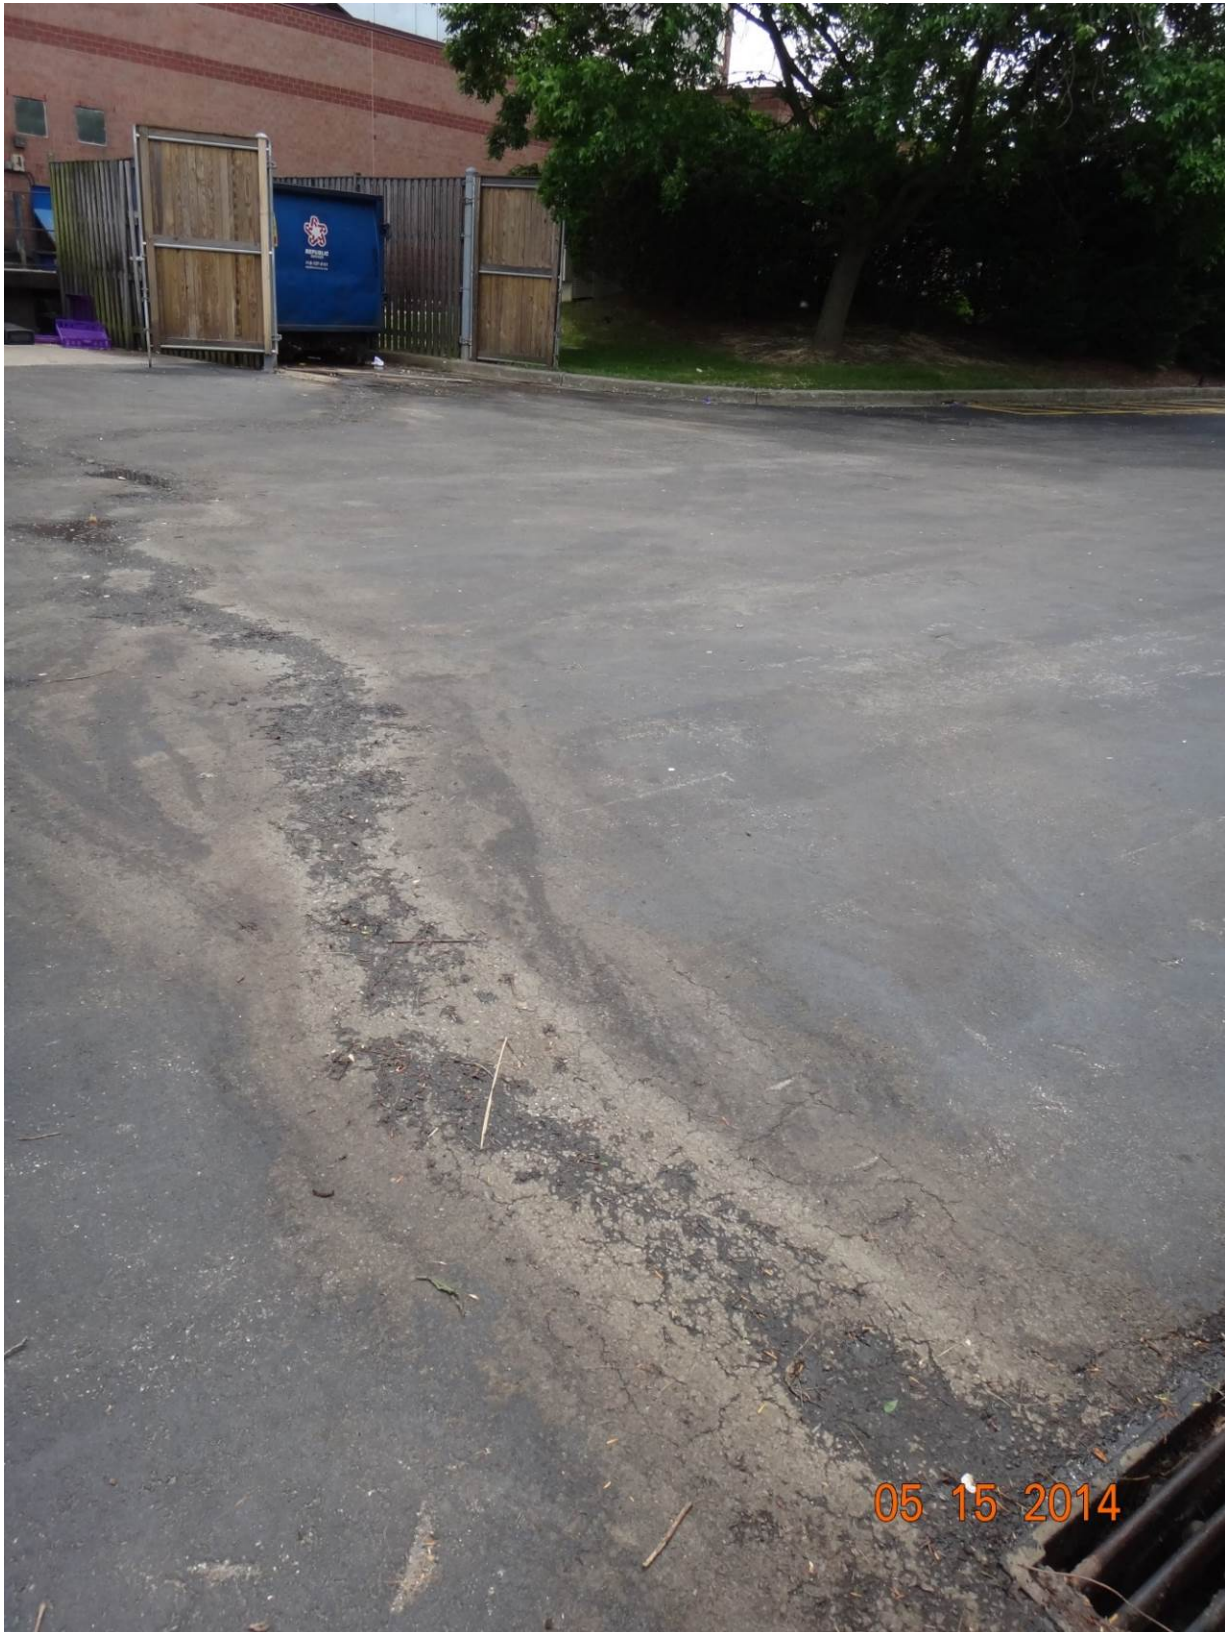
Figure 4. Stains leading from the loading dock area to the curb inlet, behind Embassy Suites, 1300 Concourse Drive

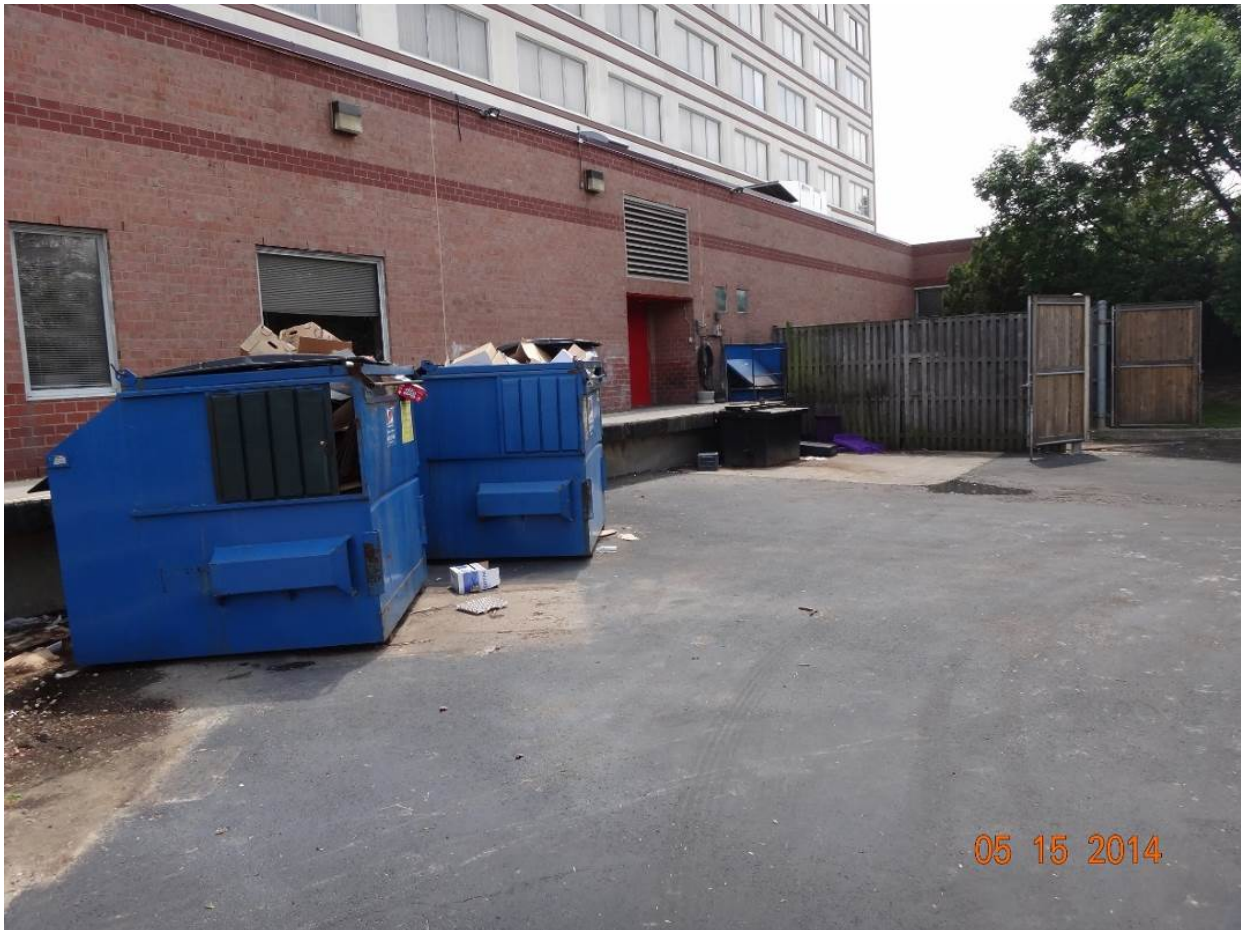
Figure 5. Overflowing dumpsters, behind 1300 Concourse Drive

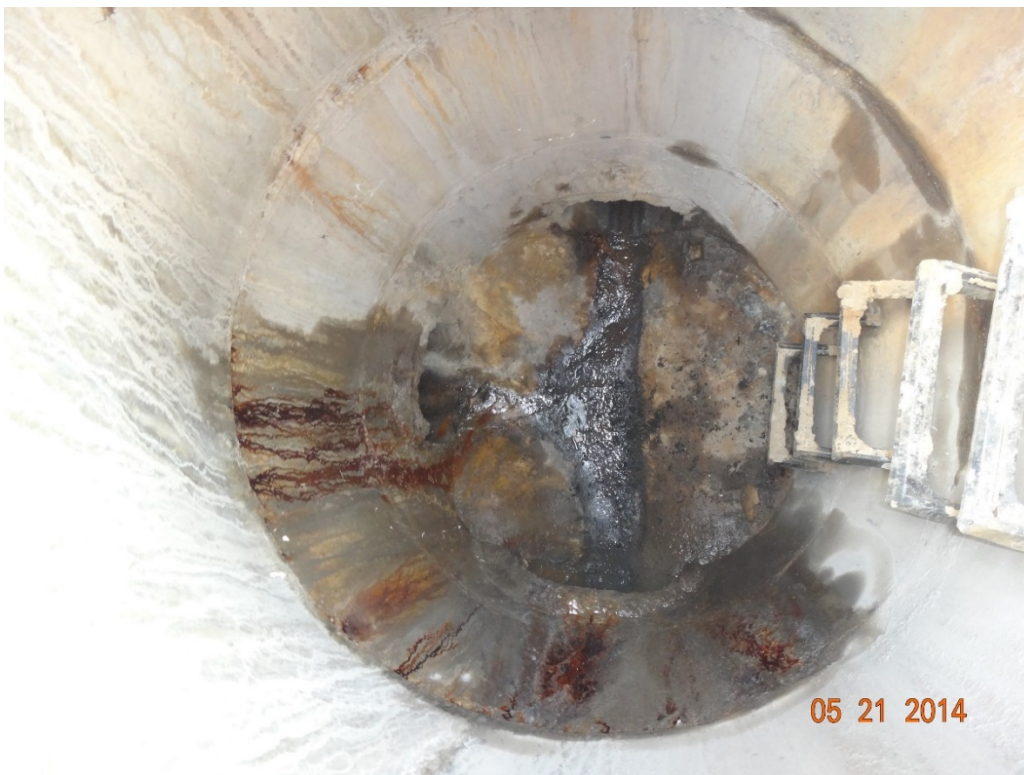
Figure 3. Interior of a junction manhole near the car wash showing moisture but no flow entering from the side pipe

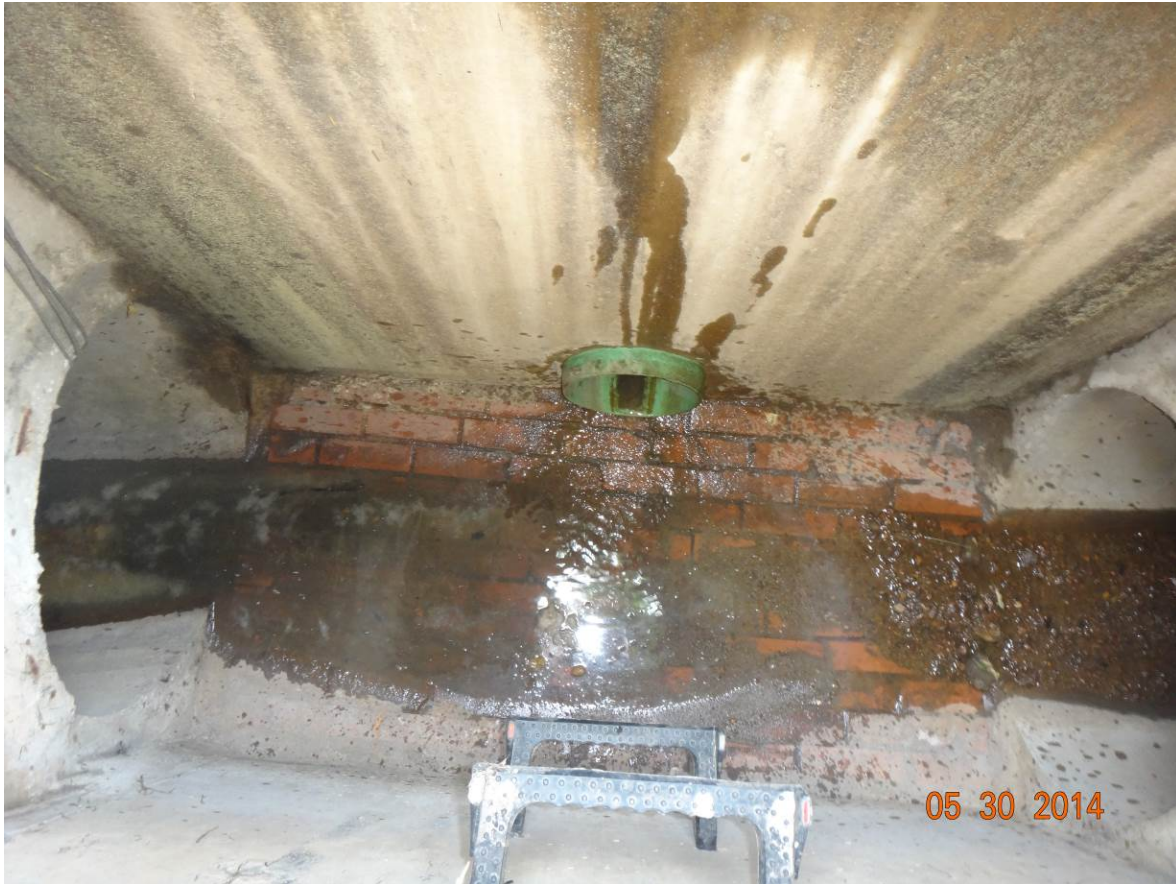
Figure 4. Sanitary sewerage discharging into catch basin (green pipe, center)

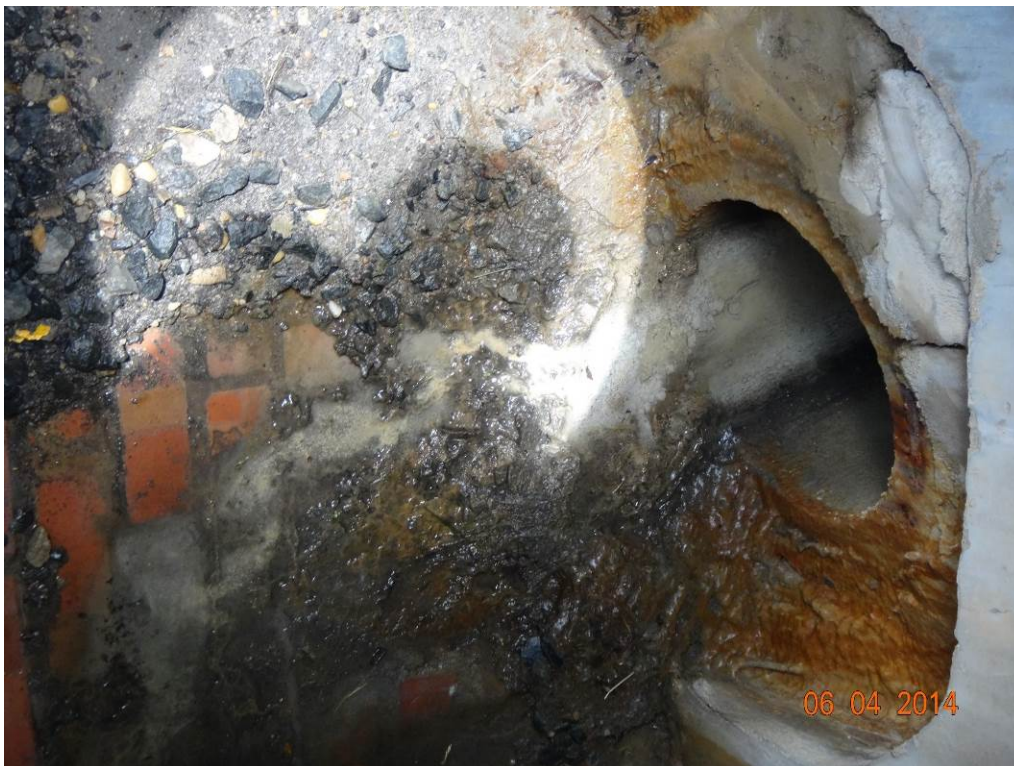
Figure 4. View of inside of first curb inlet showing mineral buildup and whitish residual staining

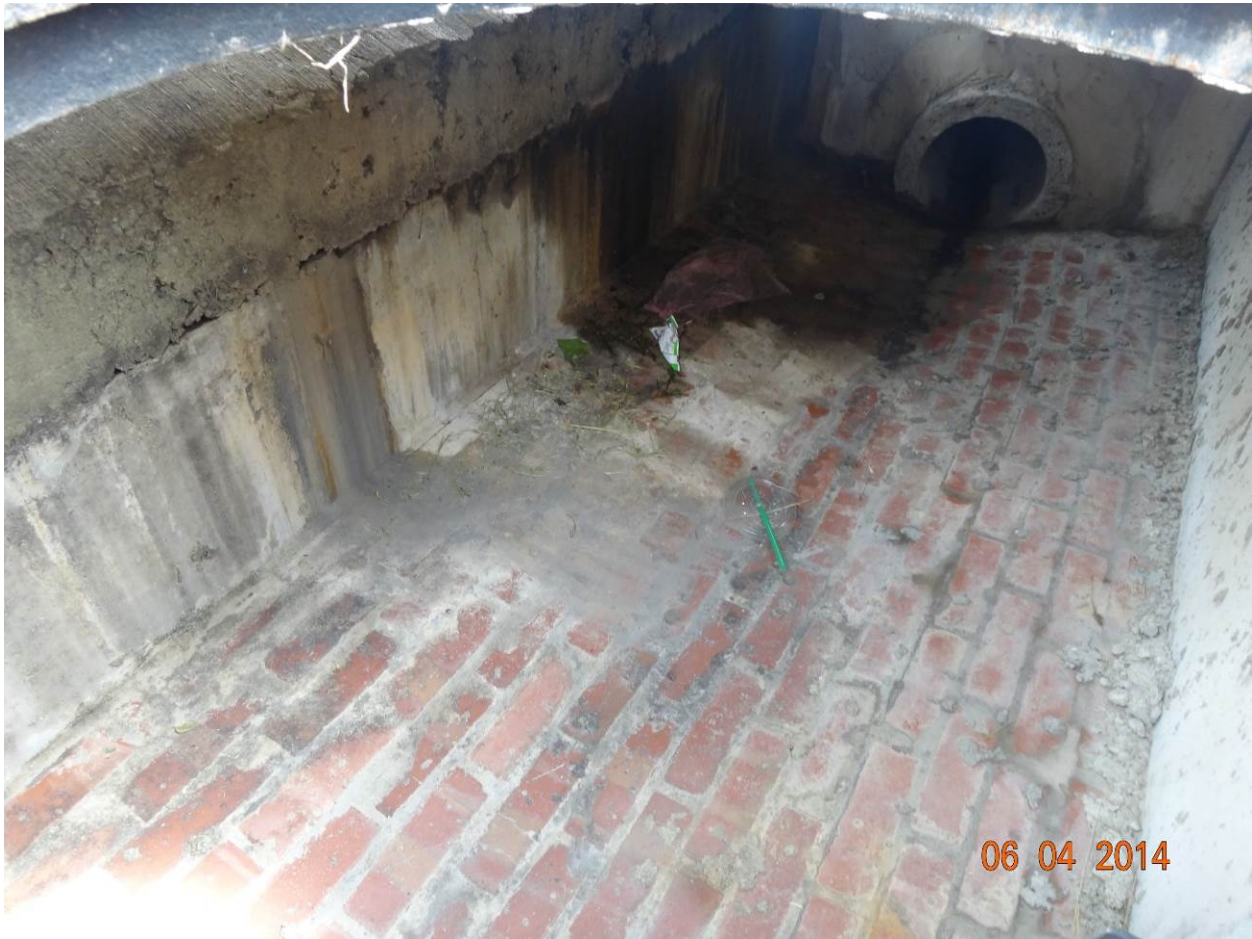
Figure 5. View inside second curb inlet; seepage and staining can be seen originating from a gap in the concrete on the left wall

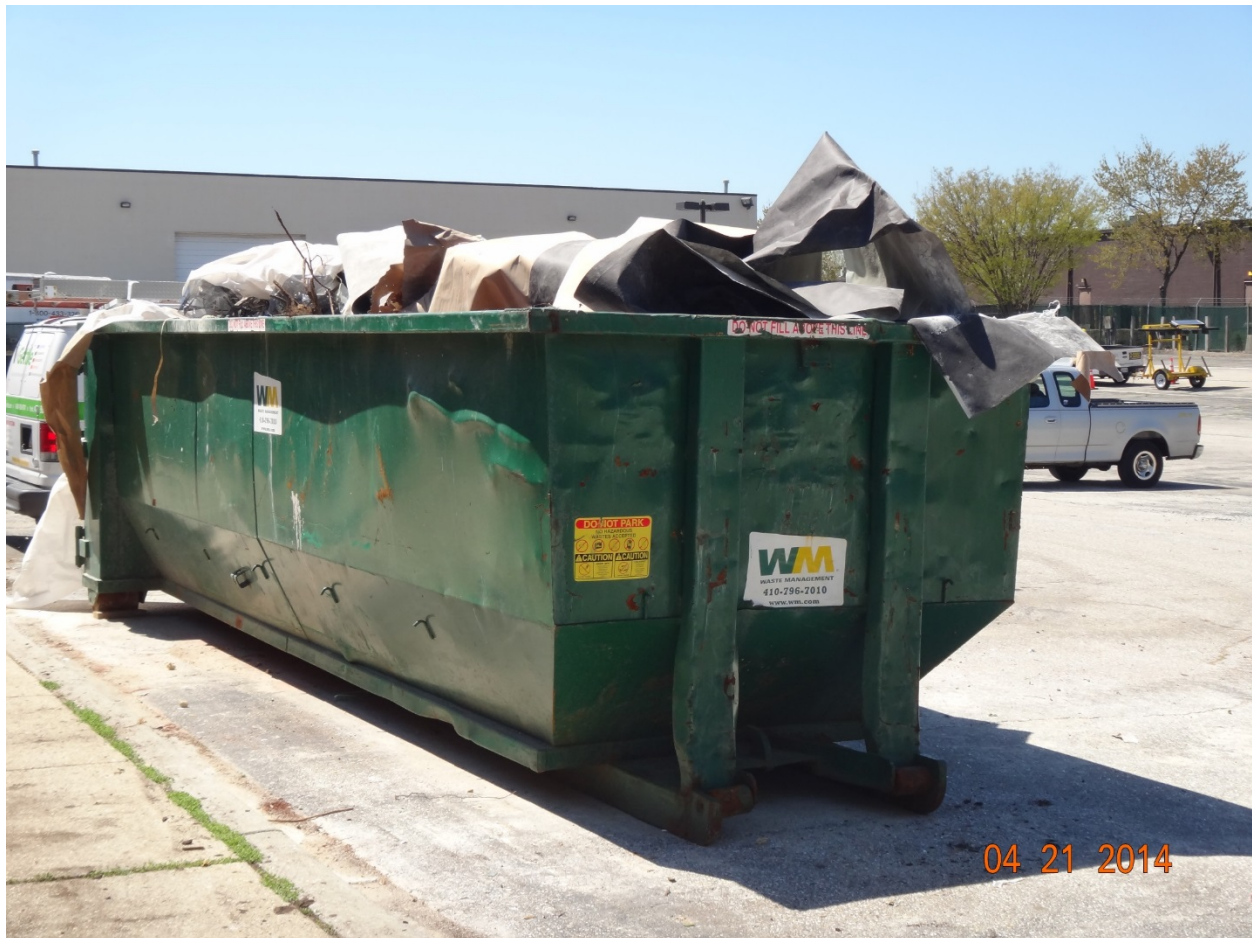
While conducting illicit discharge screening in the target area, a Versar field team noted a Waste Management roll-away dumpster, uncovered, with debris exceeding capacity (Figure 1 and Figure 2) in the parking area at the above address. The field team documented the condition with photographs. The exposure of debris above the rim of the container, and debris deposited on the ground alongside the container, may allow trash to blow off-site or leak potentially contaminating contents onto surfaces that could lead to adjacent storm drain inlets or open water. The field team also noted that the main building on the property was undergoing renovation and site conditions may be temporary. An area map is provided as Figure 3.

Figure 1. Overflowing roll-away dumpster

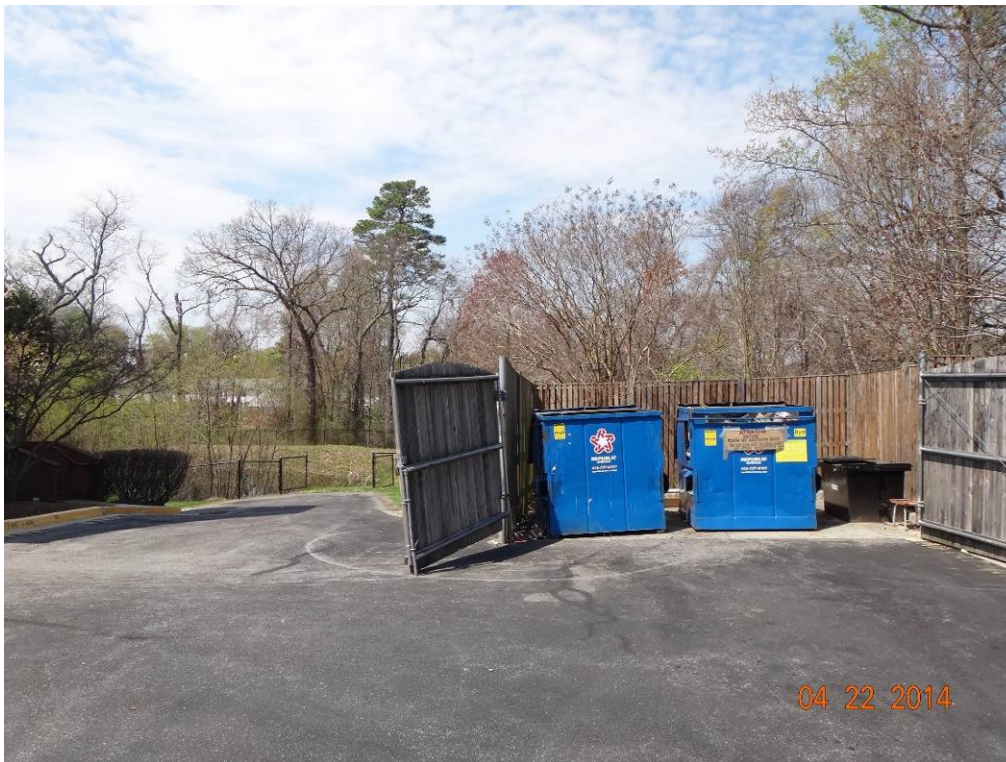
A Versar field team documented a waste management issue when traveling to a target outfall at the above property; the problems included an open dumpster, a grease spill, and a drum. The area of concern directly affects the up-gradient impervious surfaces associated with a stormwater management facility that receives their flows (Figure 1). Staff found a waste grease container with a wet stain adjacent to it (Figure 2 and Figure 3). On the day of the filed visit, the dumpsters were found to be open. The waste grease spillage and open dumpster may allow pollutants to be washed to the storm sewer network, the associated stormwater pond and surface waters. A drum of unidentified liquid material was also noted in the dumpster stall area. An area map appears in Figure 4 with the location of the problems indicated.

Figure 1. Dumpster area adjacent to a stormwater pond

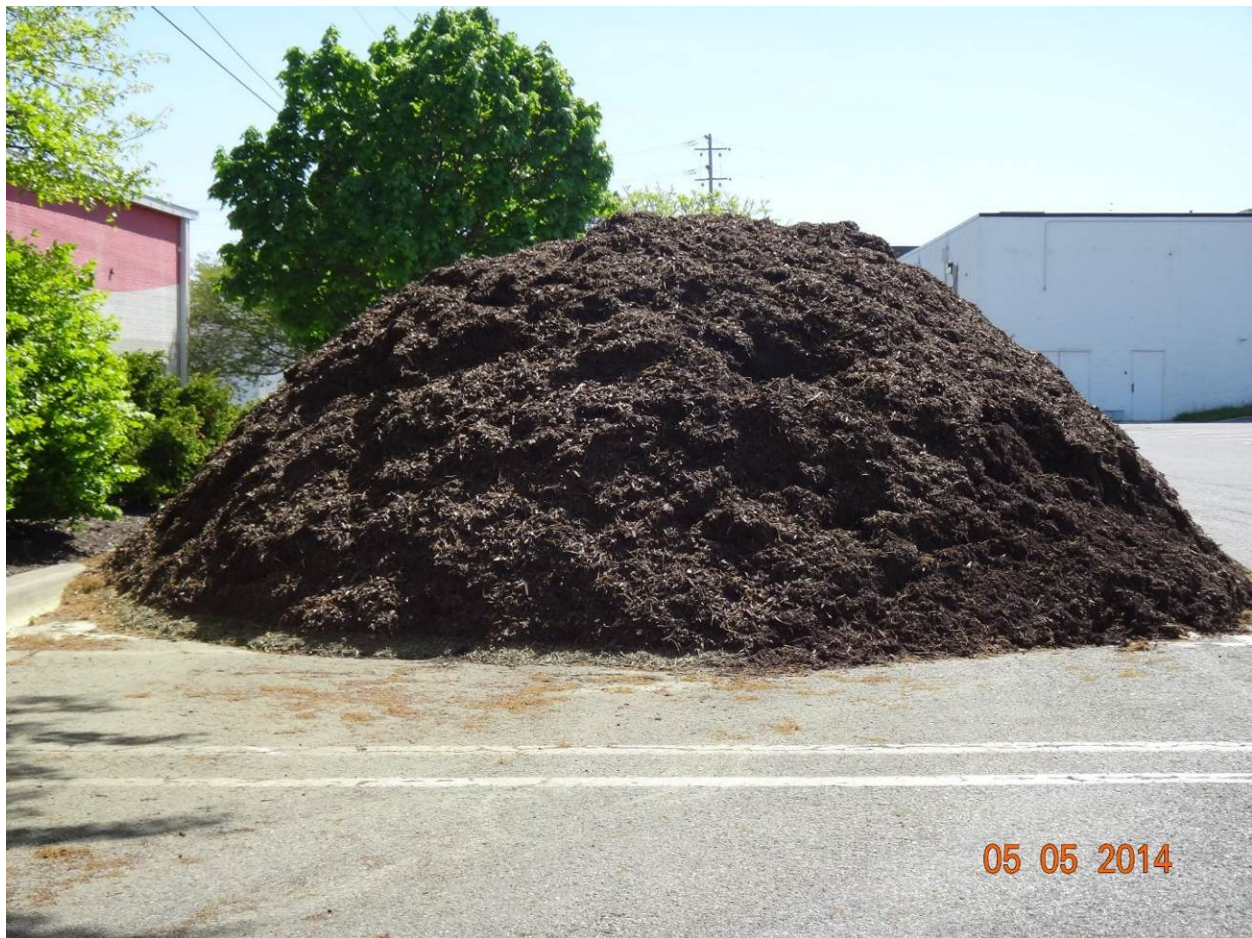
While conducting illicit discharge screening in the target area, a LimnoTech and Versar field team discovered a large, uncovered pile of mulch, extending across several parking spaces (Figure 1 and Figure 2) in the parking area behind the bowling alley at the above location: Governor Ritchie Highway, between Shelly Road and West Ordnance Road. The field team documented the condition with photographs. The placement of mulch on an impervious surface introduces the risk of distribution, by wind or rain, of mulch particles and associated nutrients which could drift into adjacent storm drain inlets or open water. An area map is provided as Figure 3.

Figure 1. Large, uncovered pile of mulch

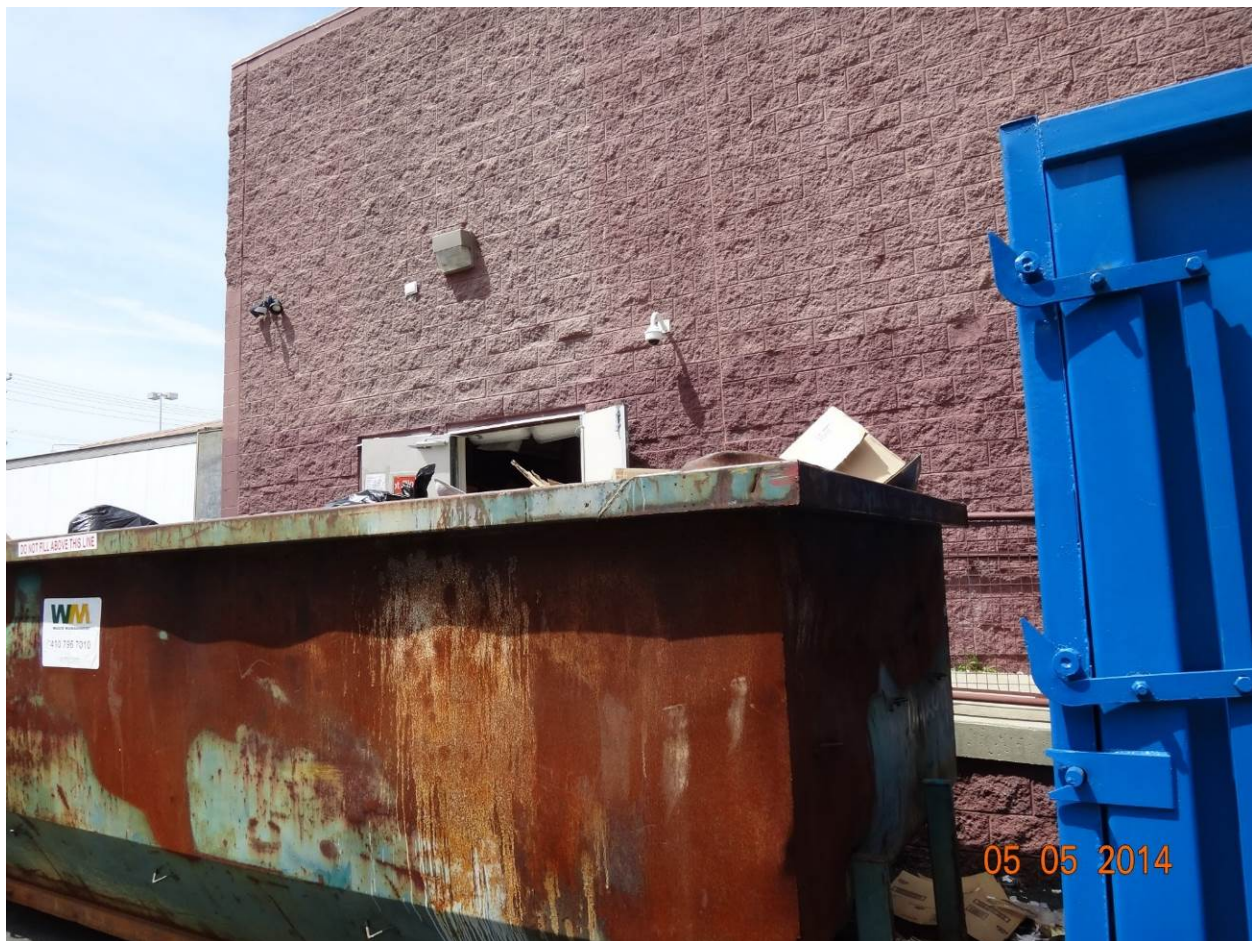
While conducting illicit discharge screening in the target area, a LimnoTech and Versar field team discovered a full, uncovered roll-off dumpster with scattered debris surrounding it (Figures 1 and 2) alongside the Target building at the above location: Ritchie Highway at Vernon Avenue. The field team documented the condition with photographs. The exposure of debris at the rim of the container, and debris deposited on the ground alongside the container, may allow trash to blow off-site or leak potentially contaminating contents onto surfaces that could lead to adjacent storm drain inlets or open water. An area map is provided as Figure 3.

Figure 1. Full roll-off dumpster alongside the Target building
