**ILLICIT DISCHARGE DETECTION
AND ELIMINATION
2014 ANNUAL REPORT**

PERMIT NUMBER MD0068306

Versar, Inc.
9200 Rumsey Road
Columbia, MD 21045

October 2014

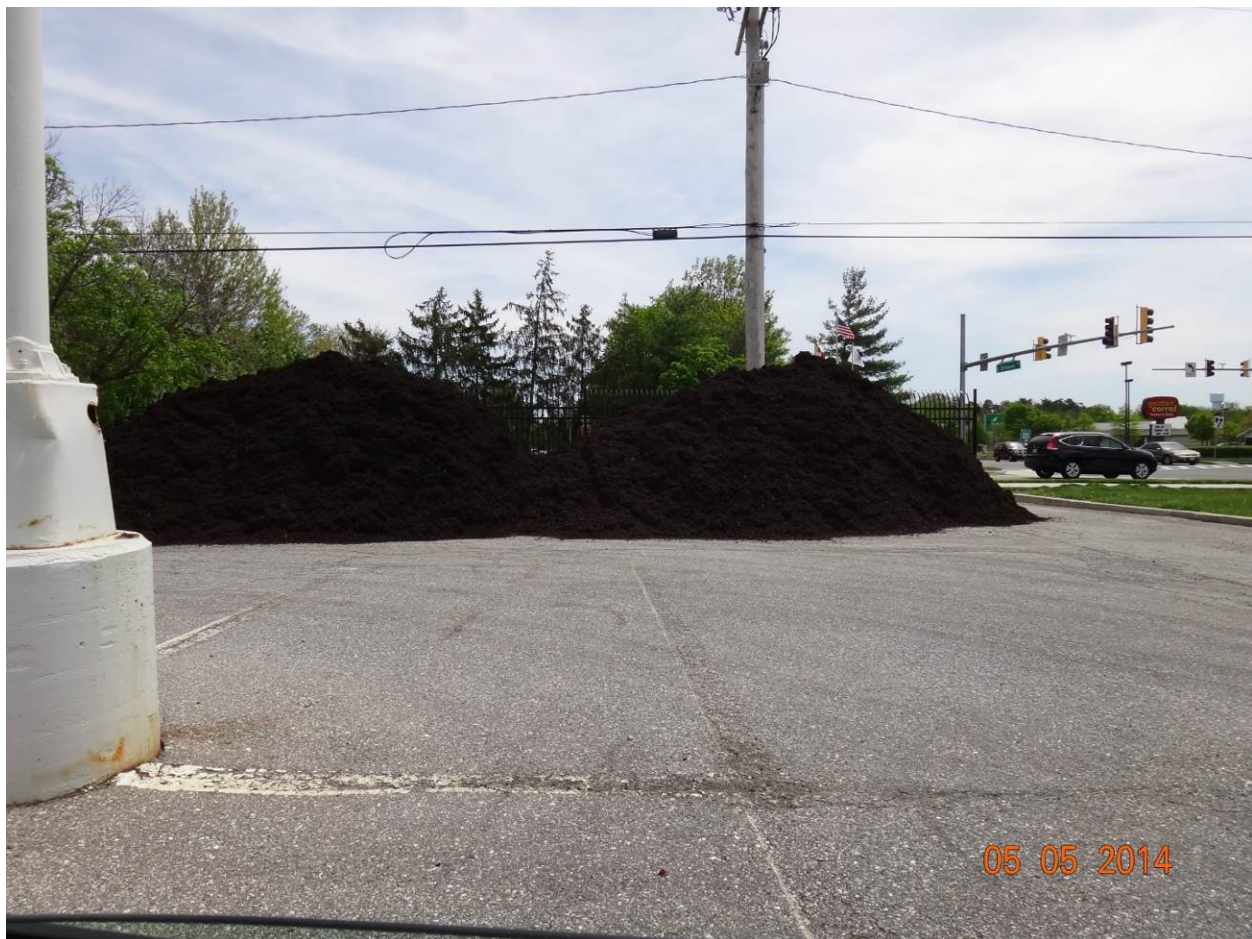
While conducting illicit discharge screening in the target area, a LimnoTech and Versar field team discovered a large, uncovered pile of mulch, extending across several parking spaces (Figure 1) in the parking area behind the Chuck E. Cheese's restaurant at the above location: Governor Ritchie Highway, at East Ordnance Road. The field team documented the condition with a photograph. The placement of mulch on an impervious surface introduces the risk of distribution, by wind or rain, of mulch particles and associated nutrients which could drift into adjacent storm drain inlets or open water. An area map is provided as Figure 2.

Figure 1. Large, uncovered pile of mulch behind Chuck E. Cheese's restaurant

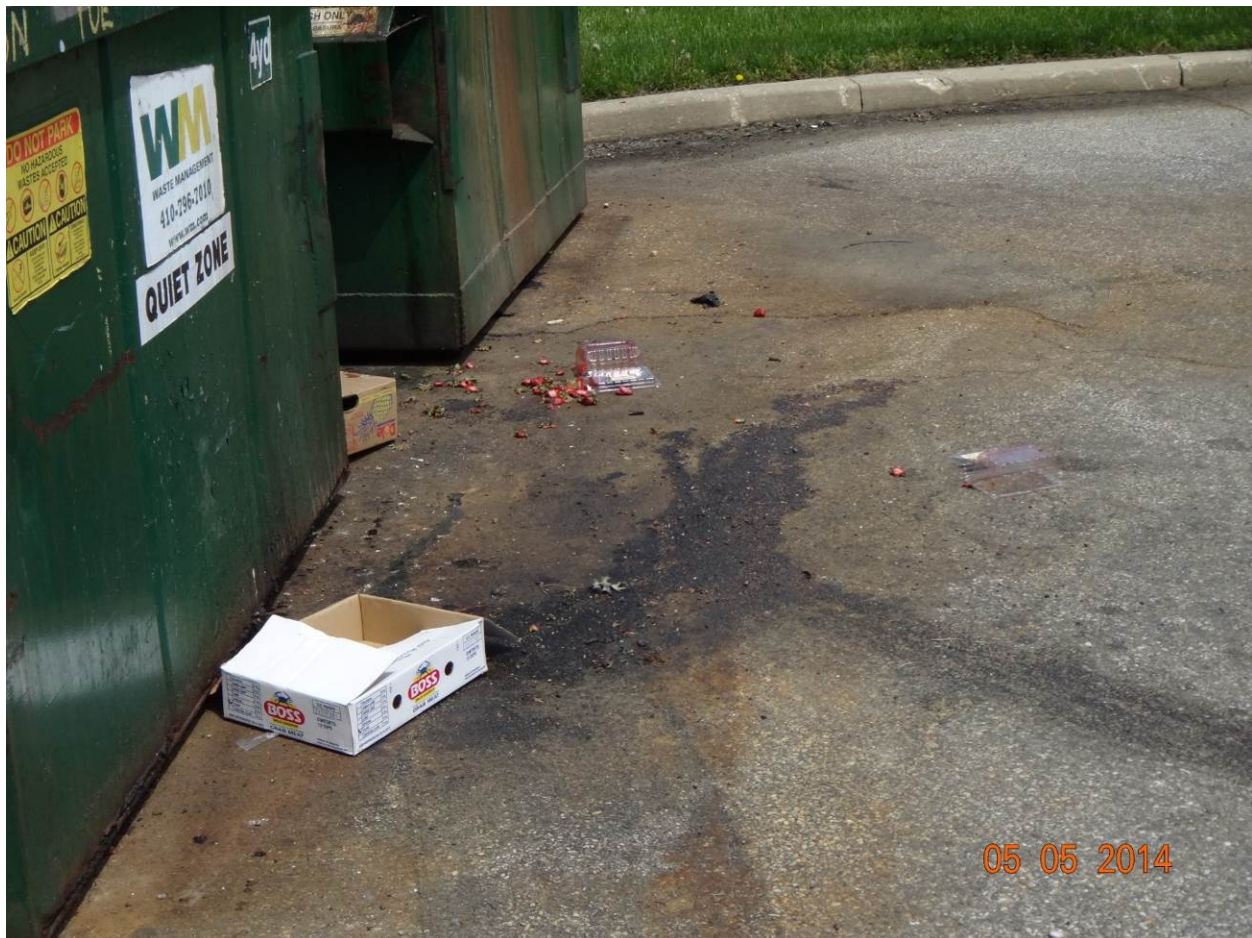
While conducting illicit discharge screening in the target area, a Versar field team noted debris and food alongside a Waste Management dumpster (Figure 1 and Figure 2) in the parking area at the above address. The field team documented the condition with photographs. Debris (cardboard and plastic) that is not properly stored in a closed container could be transported to nearby storm drain inlets and either enter or clog the inlet. If the debris includes material that can leach contaminants or concentrated substances to the impervious surface, it may also be transported to the storm drain inlet in storm runoff. Food may introduce nutrients and contaminants to the storm system through a nearby inlet. There is also a concern for attracting pests to the site. An area map is provided as Figure 3.

Figure 1. Cardboard, plastic, and food found alongside the dumpster, view 1

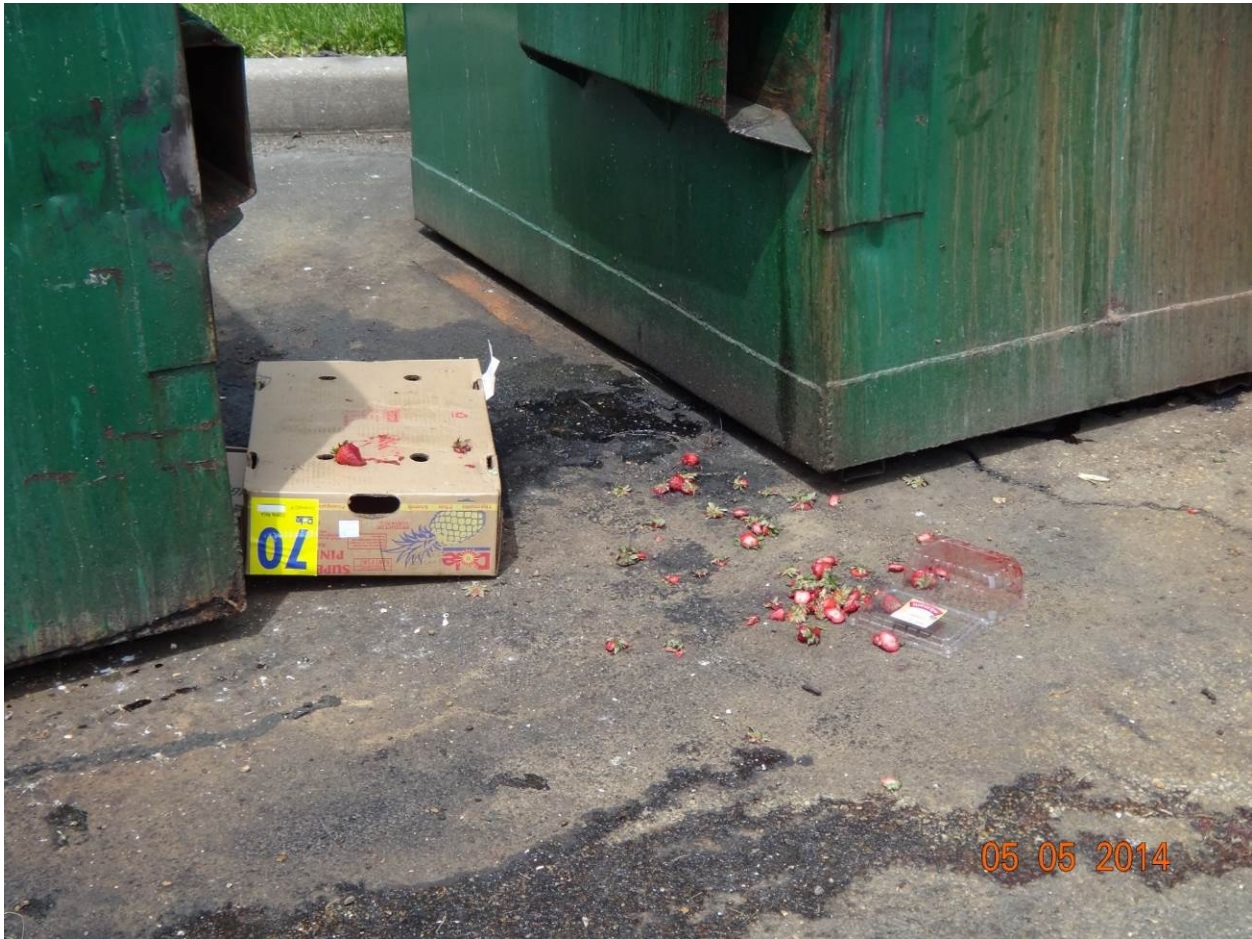
Figure 2. Cardboard, plastic, and food found alongside the dumpster, view 2

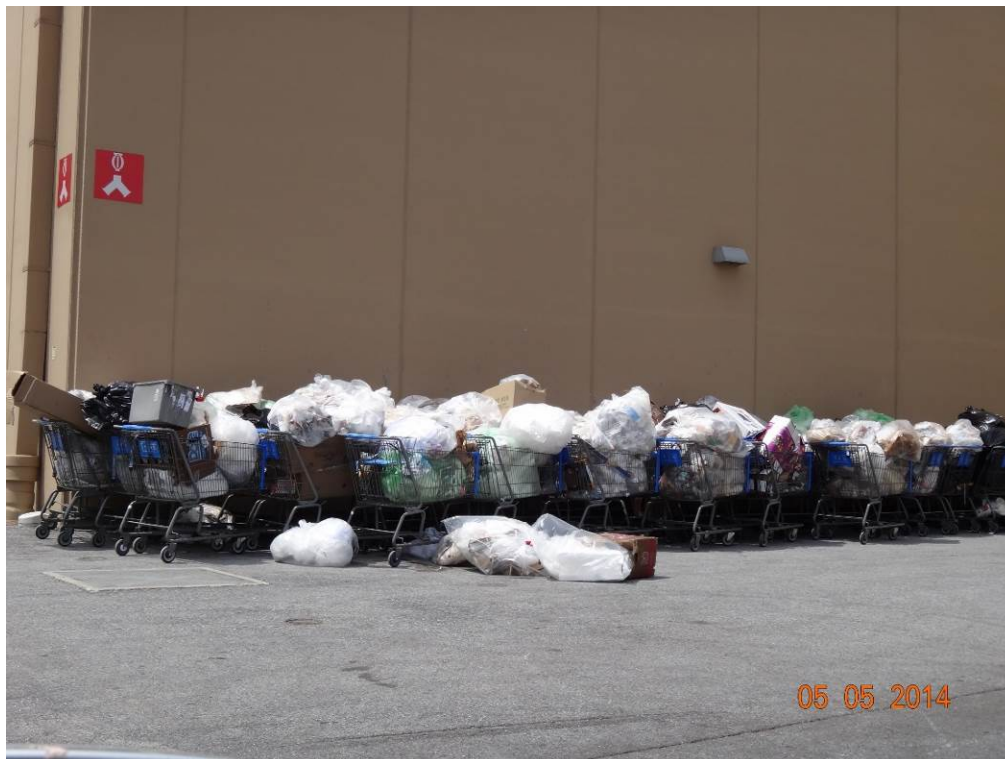
A LimnoTech and Versar team screened outfalls in the vicinity of the Walmart store at the above address. While investigating the immediate area for hotspot concerns, staff noticed a large number of shopping carts containing trash and discarded material lined up against the rear of the building (Figures 1 and 2). The field team photo-documented the condition and also the presence of bales of cardboard placed near a storm drain inlet (Figure 3). The lack of proper storage (preferably in closed containers under shelter) may allow trash to blow off-site and into the storm drain system. Additionally, discarded material should not be stored adjacent to storm drain inlets where leaching of pollutants may occur. An area map appears in Figure 4 with the location of the problem indicated.

Figure 1. Row of shopping carts containing bags of trash

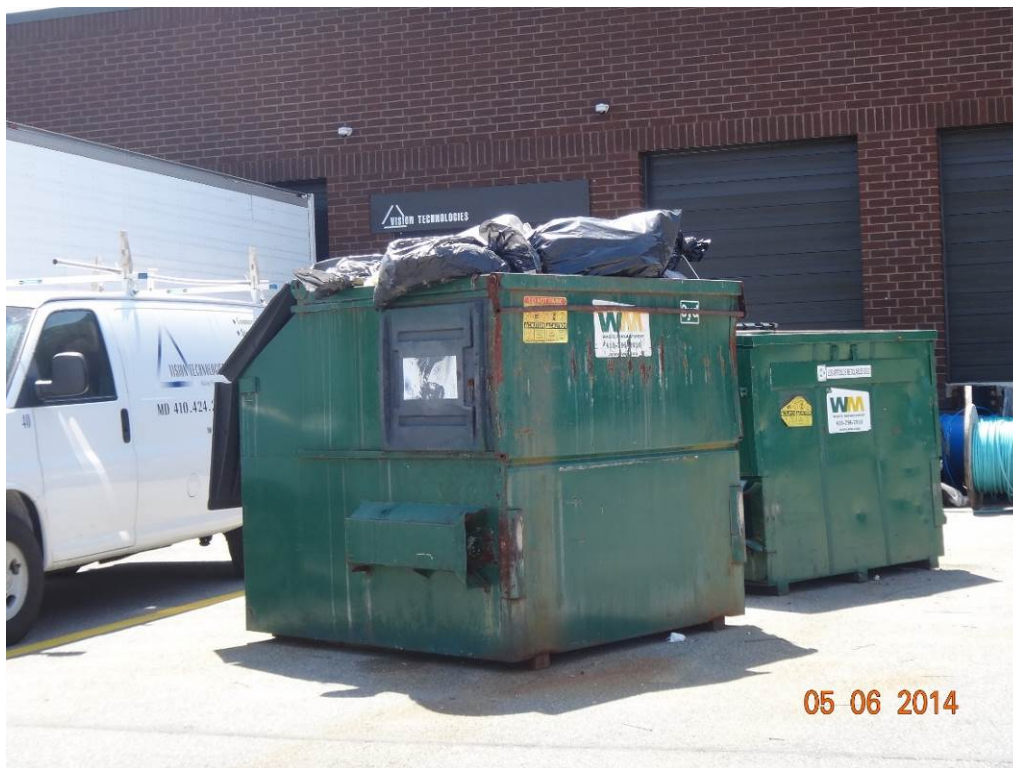
At the address above, a Versar field team identified two open dumpsters, one of which was overflowing with trash (Figure 1). Nearby, two recycling containers were overflowing with recycling material (Figure 2). Both problems were noted in the north, rear portion of the parking area of the above address. Both conditions may cause trash to blow out of containment and into the stormwater management area, storm infrastructure, or stream located on the north side of the parking lot. Two businesses nearby the problem were identified as Terminix and Vision Technologies. An area map appears in Figure 3 with the location of the problems indicated.

Figure 1. Overflowing and open dumpsters

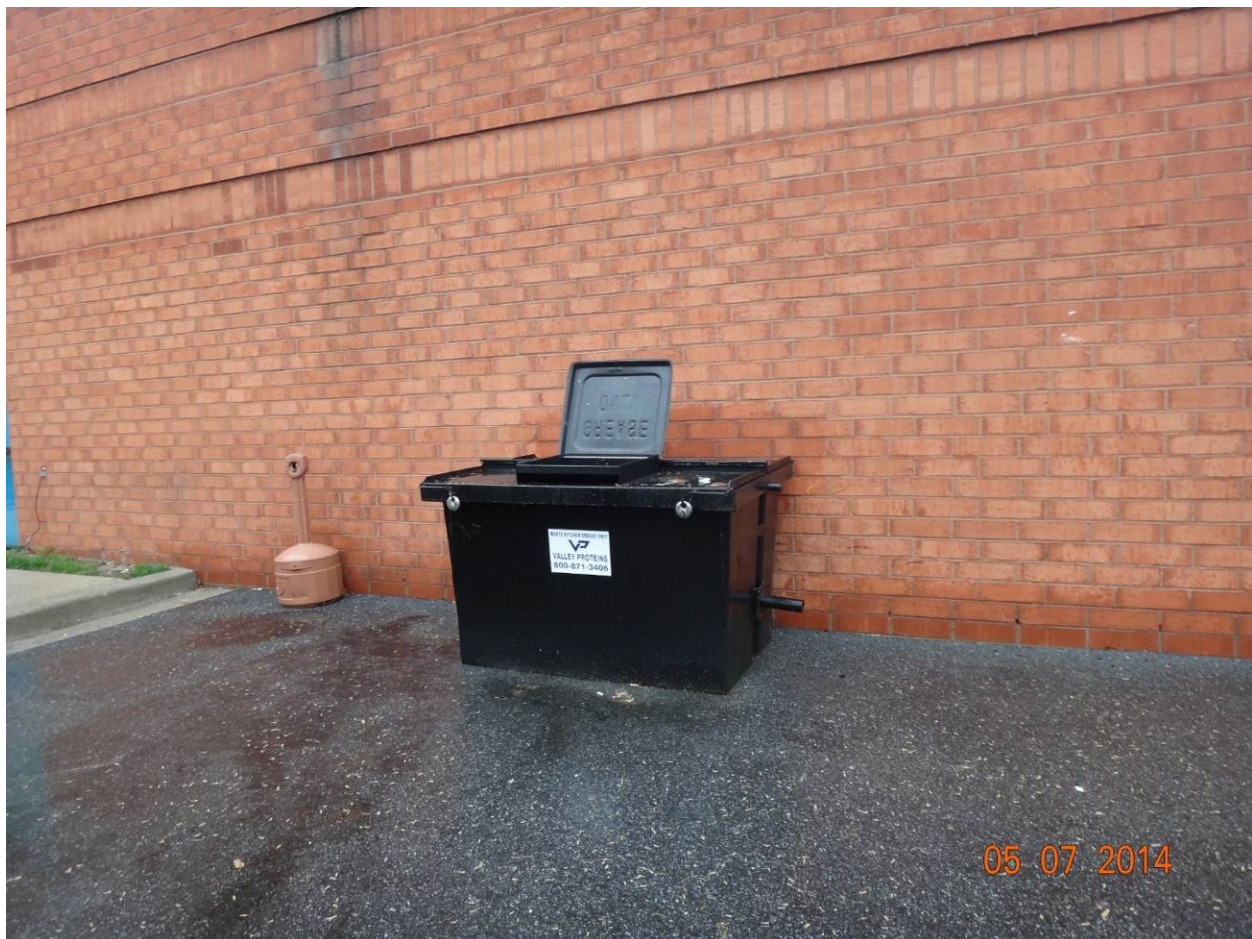
While conducting outfall screening in the target area, a Versar field team noted a Valley Proteins container, intended for the disposal of waste kitchen grease, with an open lid (Figure 1) in the parking area at the above address. The field team documented the condition with a photograph. An open container of grease poses a concern if rainwater enters the container and overflows, distributing contaminants to adjacent impervious surfaces and eventually to storm drain inlets or open water. There is also a concern for attracting pests to the site. An area map is provided as Figure 2.

Figure 1. Open waste grease disposal container

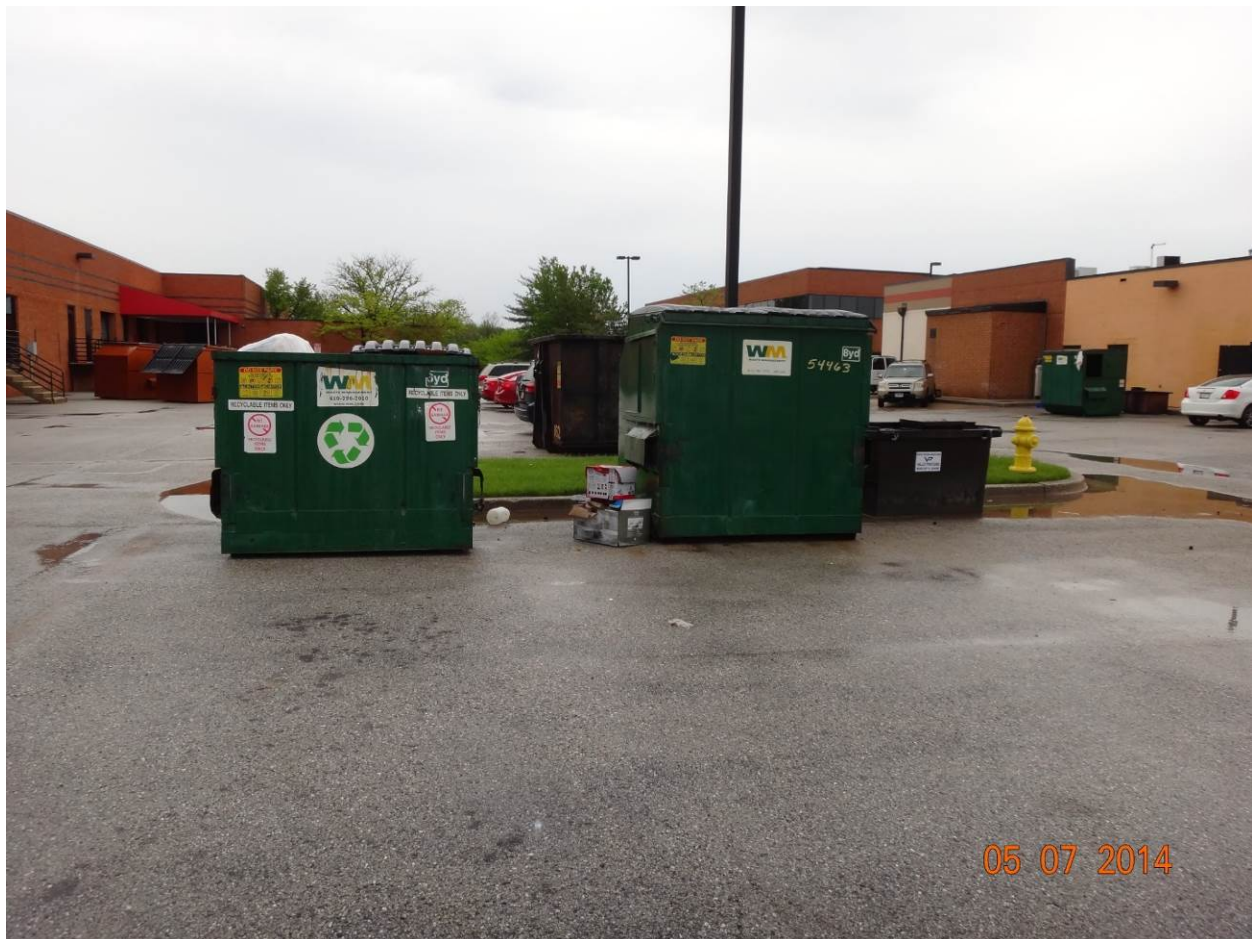
While conducting illicit discharge screening in the target area, a Versar field team noted debris alongside a Waste Management dumpster (Figure 1) in the parking area at the above address. The field team documented the condition with a photograph. Debris (cardboard and plastic) that is not properly stored in a closed container could be transported to nearby storm drain inlets and either enter or clog the inlet. If the debris includes material that can leach contaminants or concentrated substances to the impervious surface, that may also be transported to the storm drain inlet with rainwater. An area map is provided as Figure 2.

Figure 1. Cardboard and plastic containers found on the ground alongside the dumpster

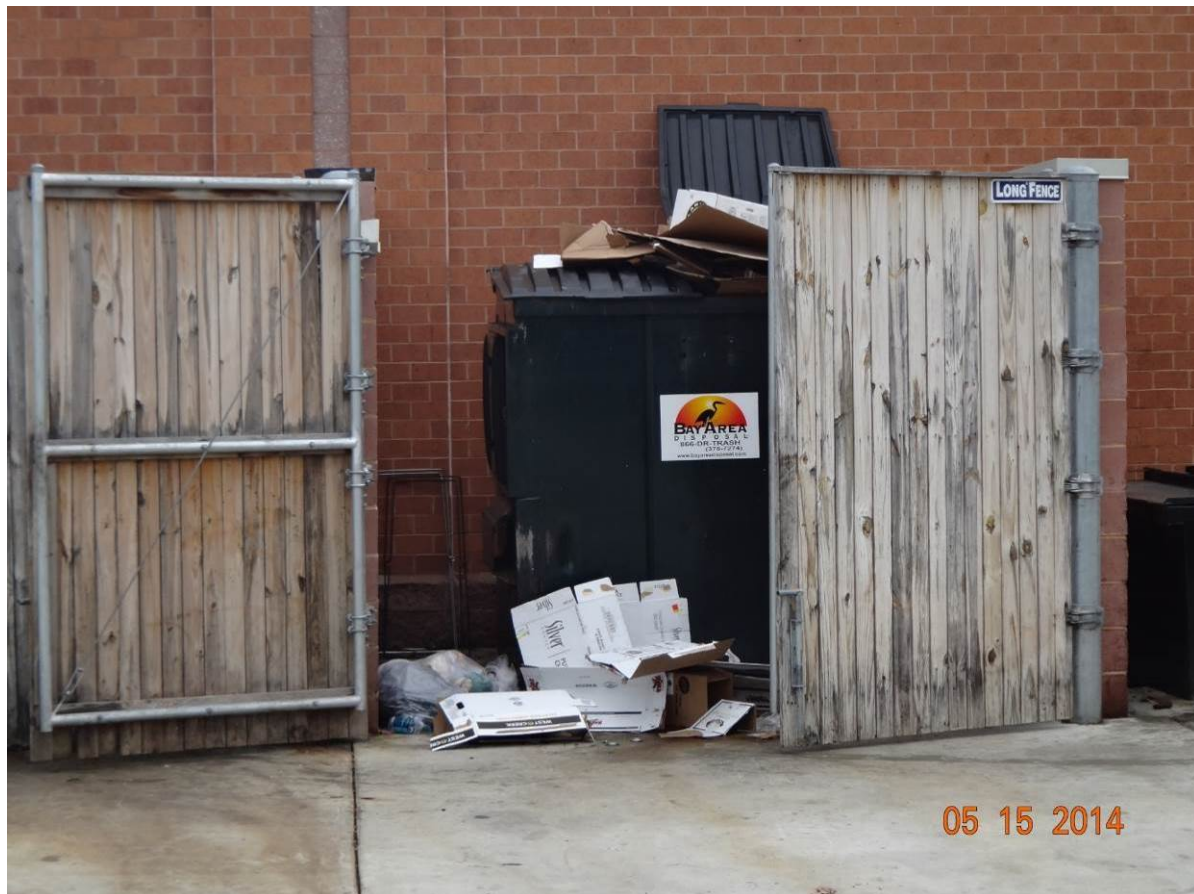
While conducting illicit discharge screening in the target area, a Versar-LimnoTech field team noted debris on the ground alongside an open, and possibly full, Bay Area Disposal dumpster (Figure 1) behind the restaurant at the above address. The field team documented the condition with a photograph. Debris (cardboard, plastic bottles, metal lids, and bagged trash) that is not properly stored in a closed container could be transported to nearby storm drain inlets and either enter or clog the inlet. If the debris includes material that can leach contaminants or concentrated substances to the impervious surface, it may also be transported to the storm drain inlet in storm runoff. Food, if present in the debris, may introduce nutrients and contaminants to the storm system through a nearby inlet. There is also a concern for attracting pests to the site. An area map is provided as Figure 2.

Figure 1. Cardboard, plastic, and bagged trash found alongside the open dumpster

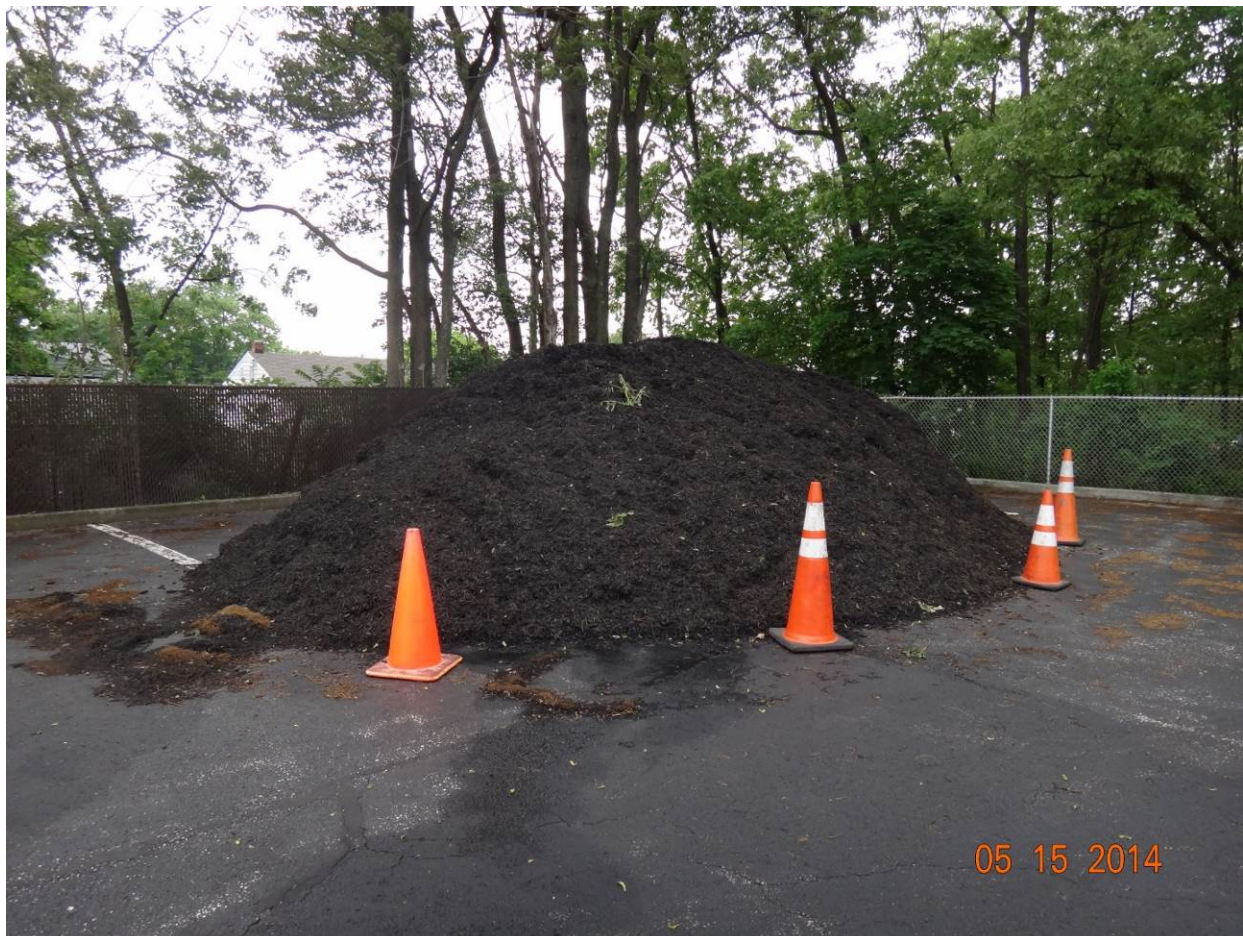
While conducting illicit discharge screening in the target area, a LimnoTech and Versar field team discovered a large, uncovered pile of mulch, extending across several parking spaces (Figure 1) in the parking alongside the Gavigan's Home Furnishings store at the above location: Governor Ritchie Highway, between 6th Avenue and Georgia Avenue, NE. The field team documented the condition with a photograph. The placement of mulch on an impervious surface introduces the risk of distribution, by wind or rain, of mulch particles and associated nutrients which could drift into adjacent storm drain inlets or open water. An area map is provided as Figure 2.

Figure 1. Large, uncovered pile of mulch

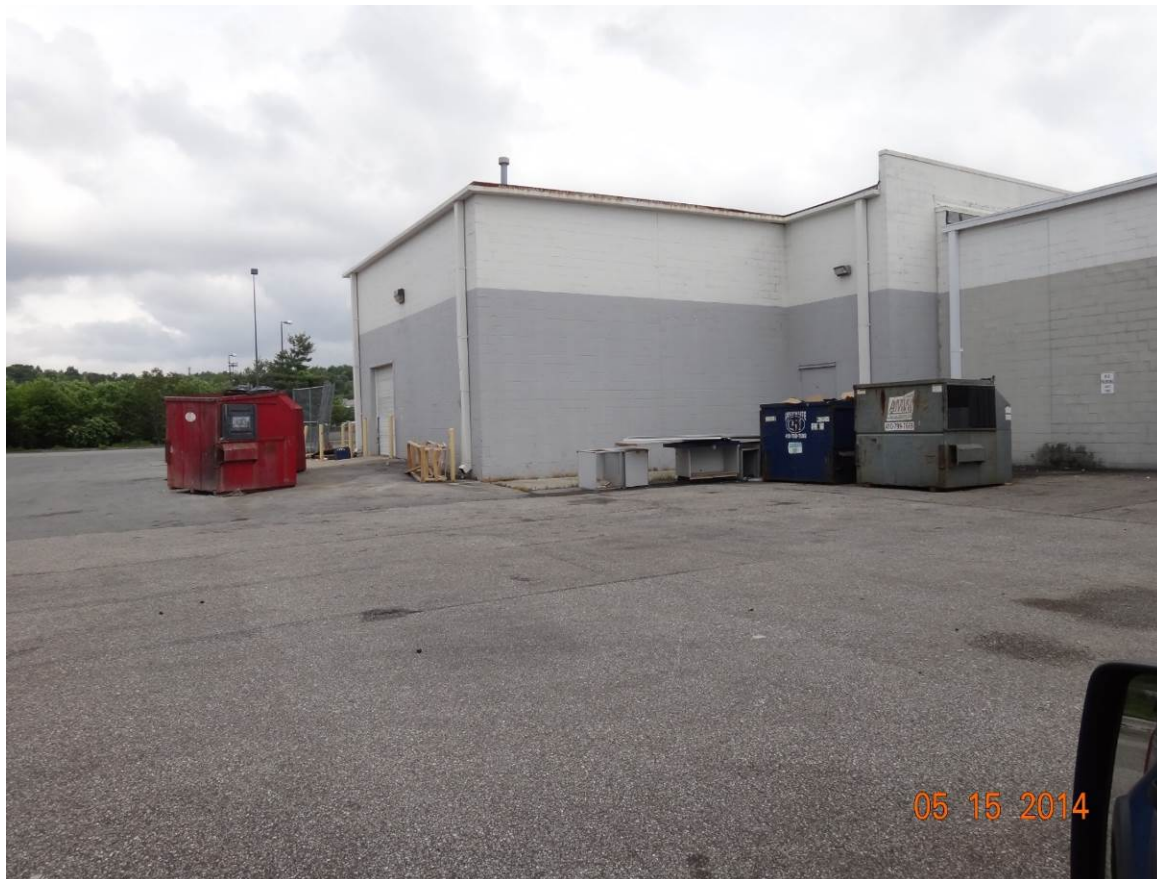
While conducting illicit discharge screening in the target area, a LimnoTech and Versar field team noted multiple large pieces of furniture and building materials on the ground alongside an open, and possibly full, AmeriWaste dumpster (Figure 1), and scattered broken pallets and loose debris behind the building portion occupied by the adjacent business (Figure 2), at the above address. The field team documented the condition with photographs. Furniture and building materials exposed to the elements may include materials that can leach contaminants to the impervious surface that could be transported to the storm drain inlet in storm runoff. Large, bulky items left in a parking lot can also trap light debris that drifts into them via wind or water. The loose boards and nails associated with the scattered and broken pallets present hazards to motorists and pedestrians. The loose cardboard from either area may float or be blown toward storm drain inlets and block flows. An area map is provided as Figure 3.

Figure 1. Discarded furniture and building materials found alongside the open dumpster

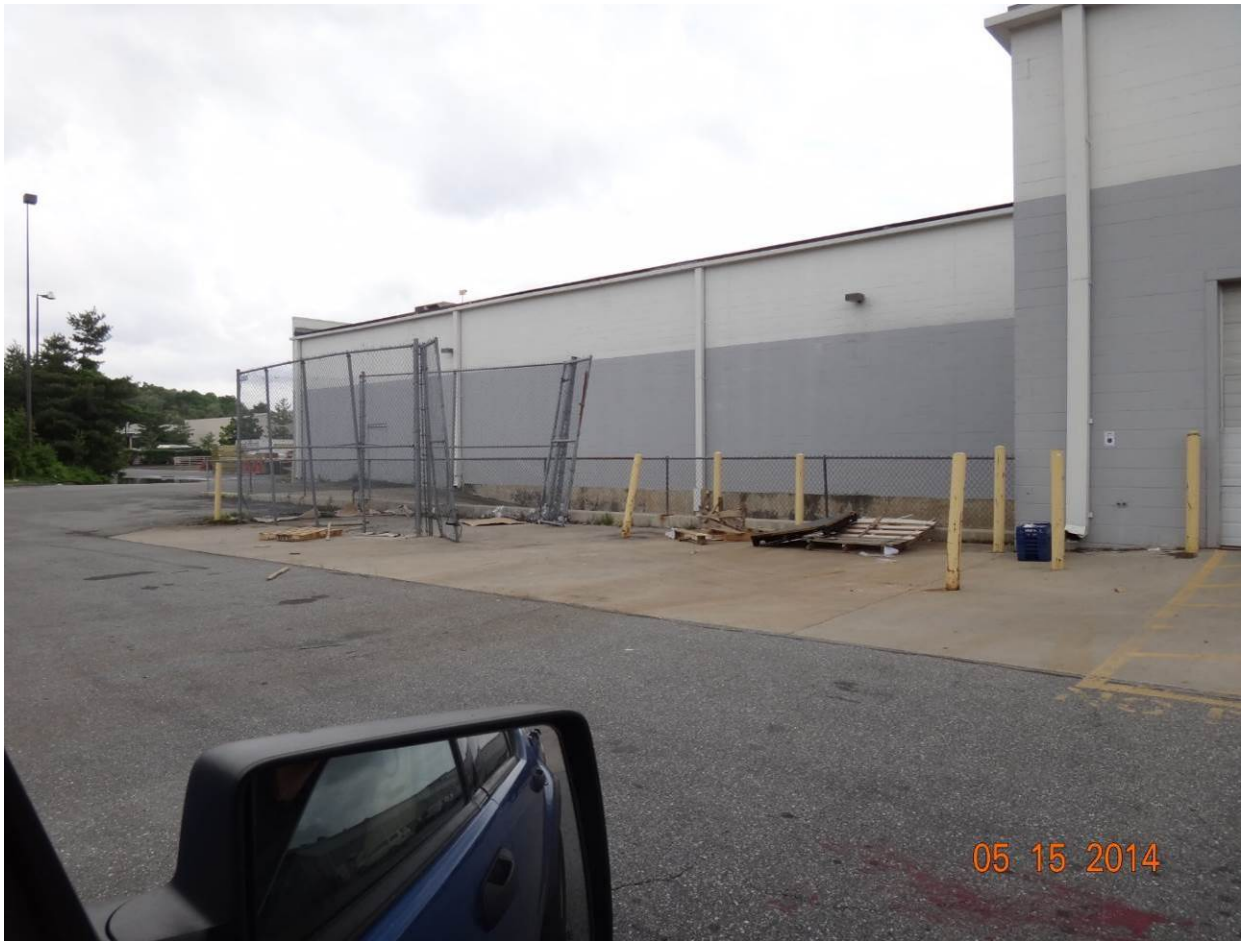
Figure 2. Scattered and broken pallets and loose cardboard found behind the building

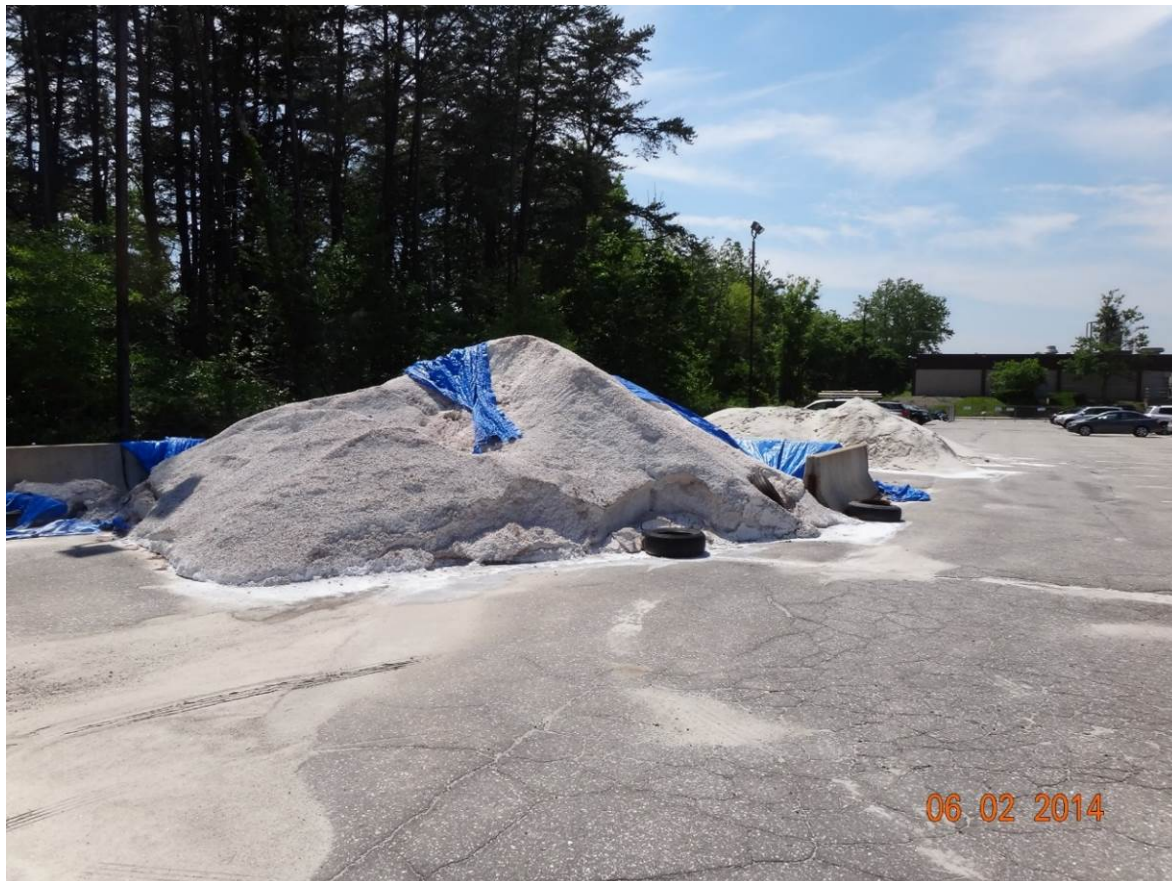
While conducting illicit discharge screening in the target area, a Versar field team discovered two large, uncovered piles - one salt and one sand (Figure 1) - at the above location, which is the parking area across the street from the Hilton BWI Airport Hotel. The field team documented the condition with photographs. The sand pile was uncontained and uncovered (Figure 2). Sand was evident in the parking area between the sand pile and the storm drain inlet at the corner of the parking lot. The field crew documented that there was sand in the storm drain, itself (Figure 3). The salt pile was partly contained with a section of concrete barrier (Jersey wall) and some tires, and partially covered (Figure 4). The placement of sand and salt on an impervious surface introduces the risk of distribution, by wind or rain, of particles and associated contaminants which could be transported into adjacent storm drain inlets or open water. An area map is provided as Figure 5.

Figure 1. Two large piles in the parking area; salt is in the foreground, sand is in the background

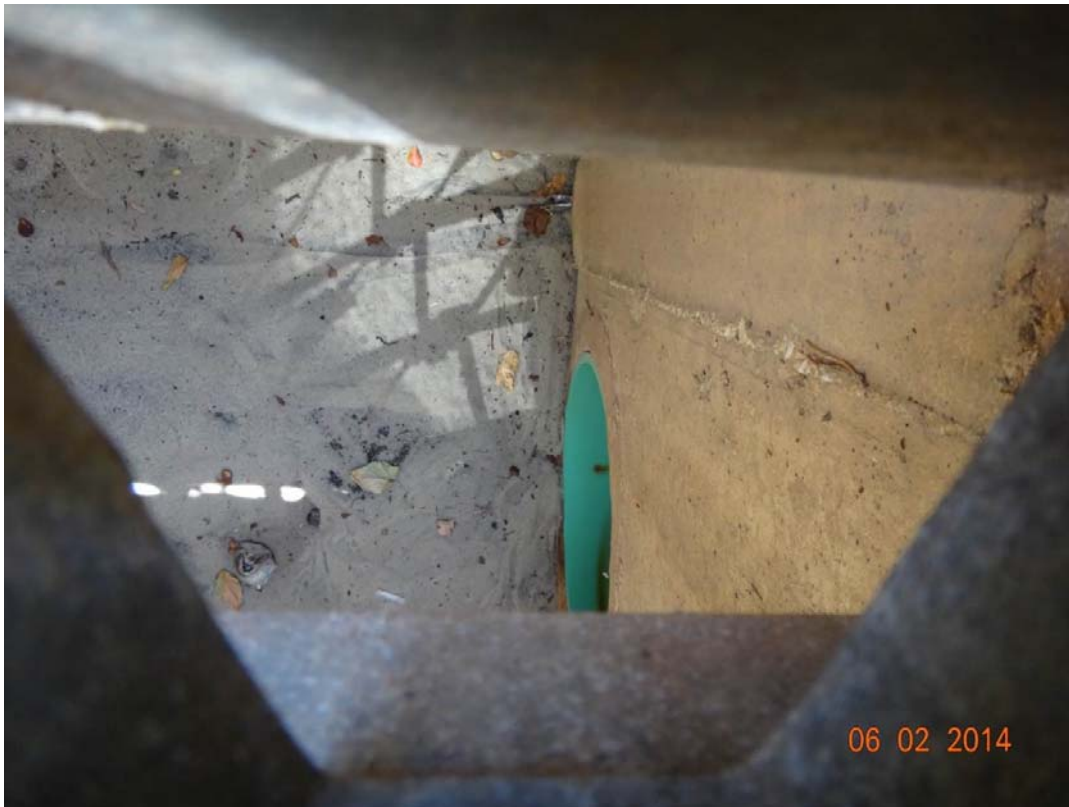
Figure 3. Sand observed in the storm drain at the corner of the parking lot

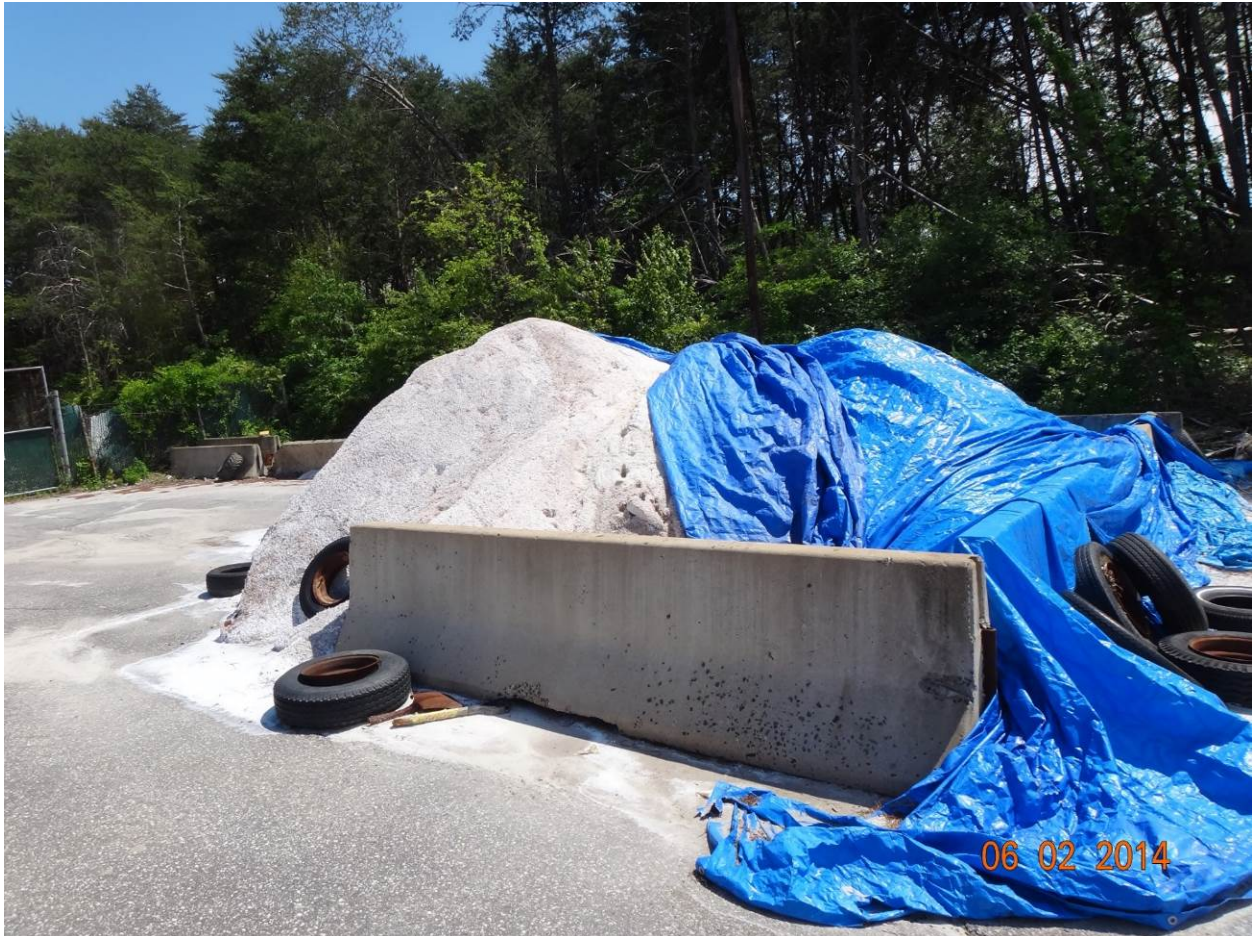
Figure 4. A salt pile found in the parking area with inadequate cover and containment

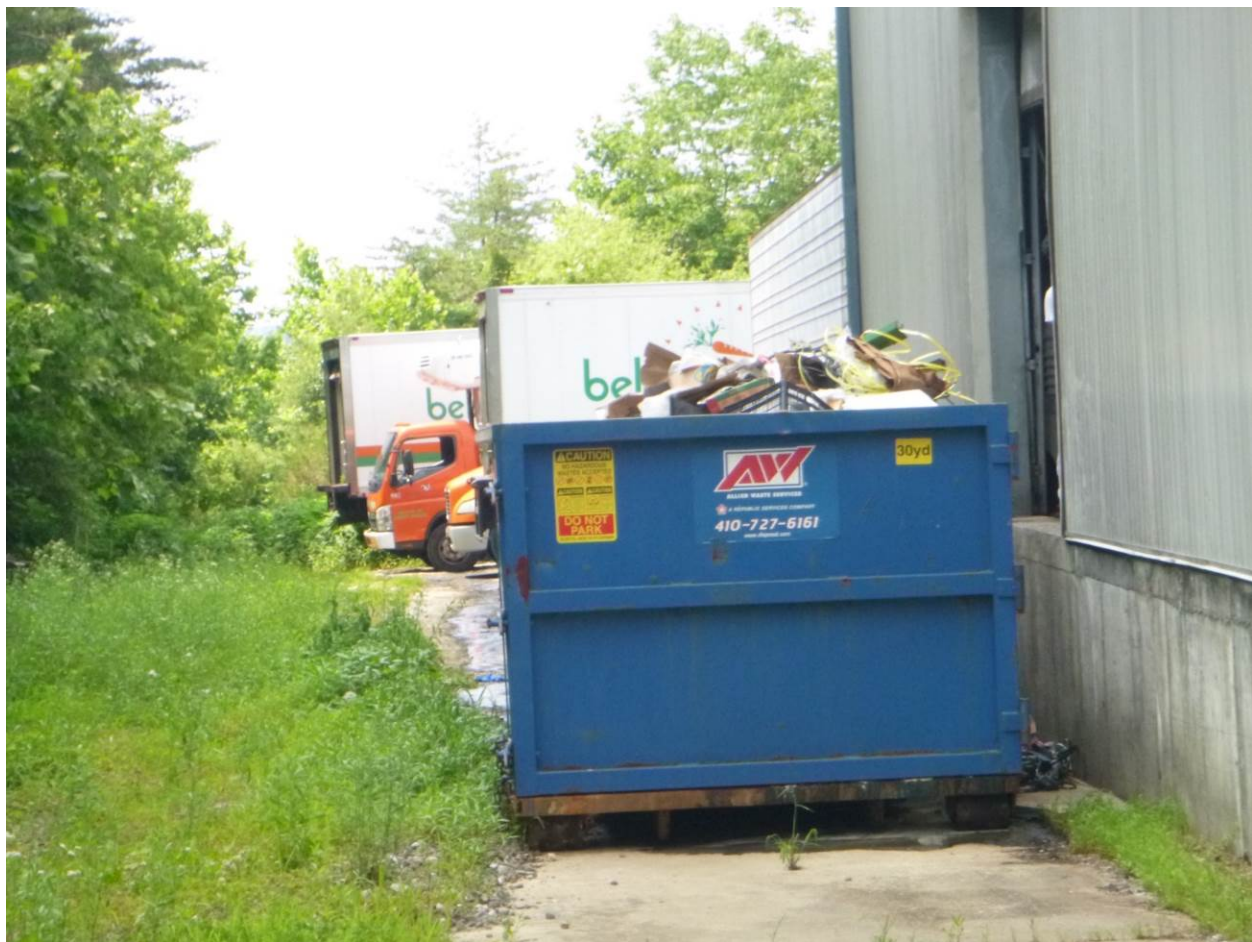
A Versar field team discovered an actively polluting condition at a roll-away dumpster found behind a Belair Produce building at the above address (Figure 1). The over-full dumpster was observed leaking a foul, sour-smelling liquid onto the parking lot (Figure 2). The area affected by the leaching material was extensive, spanning an area from the dumpster, along the edge of the parking lot, to the adjacent woods (Figures 3 and 4). The field team observed a stream in the woods, but could not ascertain whether the leachate was entering the stream (due to thick vegetation barring passage) on the day of the field visit. An area map, indicating the location of the dumpster, is provided in Figure 5.

Figure 1. Roll-away dumpster found behind the Belair Produce building actively leaking fluid

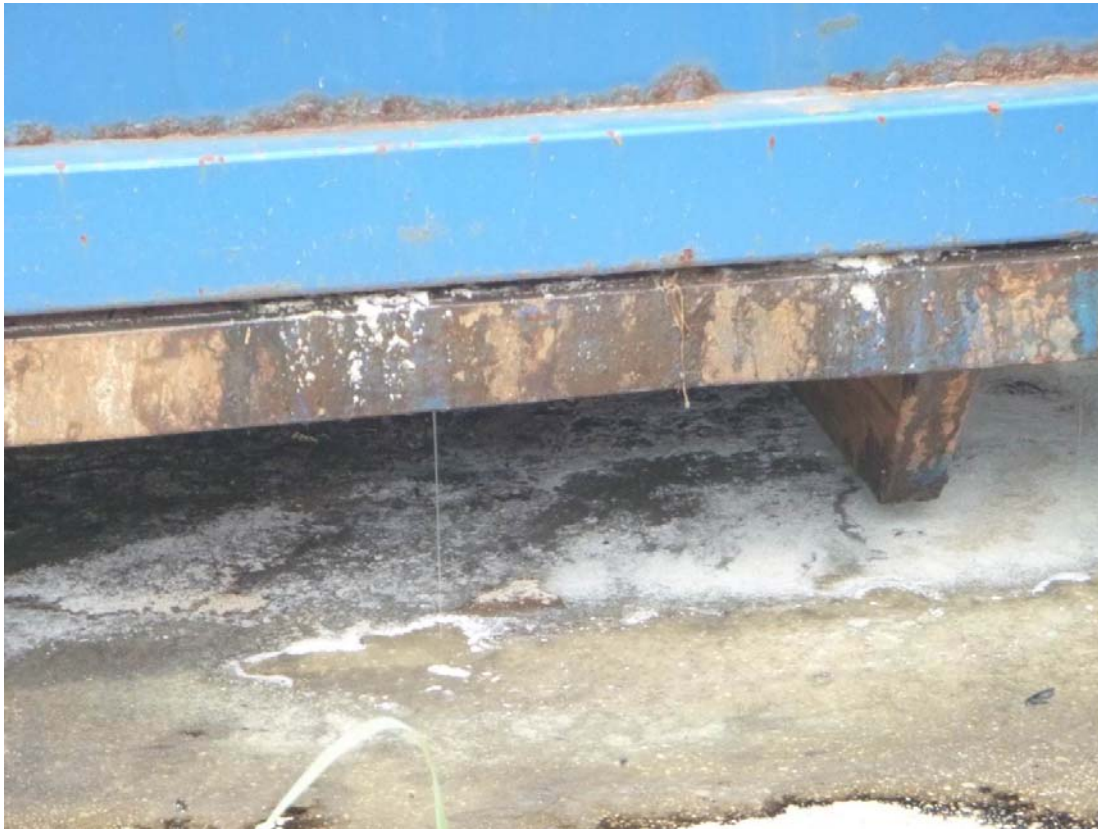
Figure 2. Fluid observed leaking from the dumpster on June 16, 2014

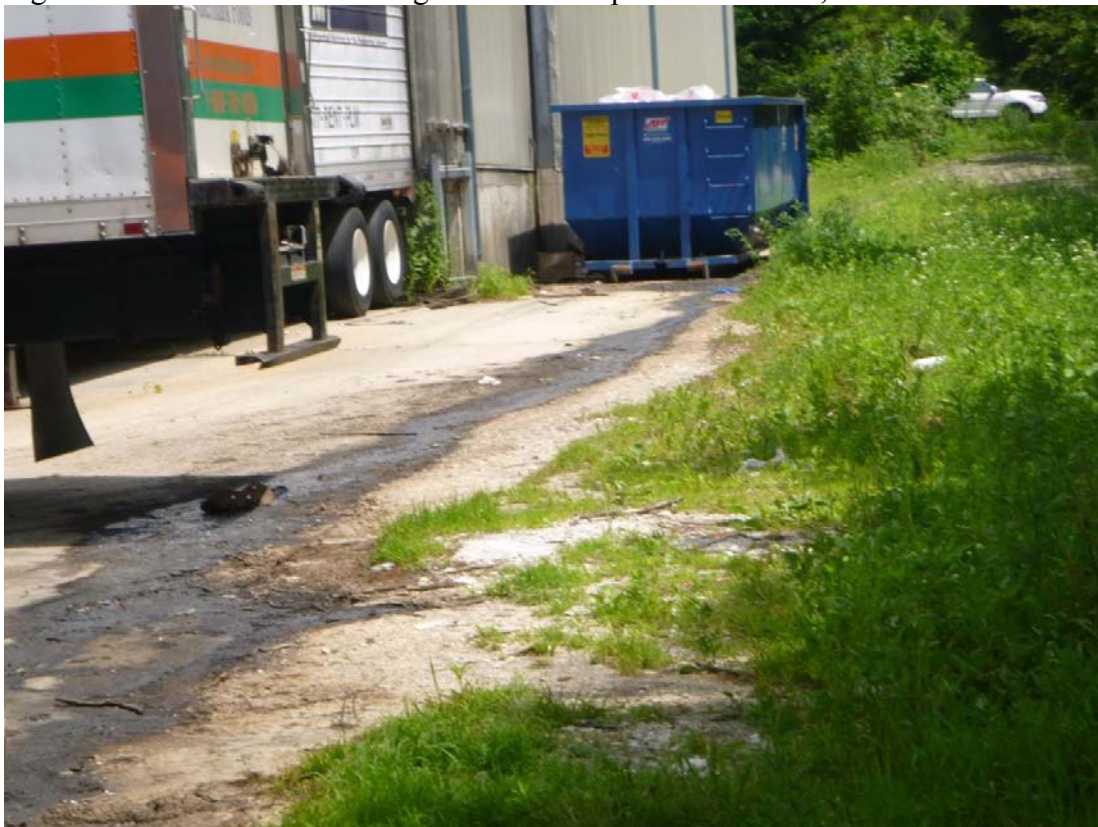
Figure 3. Fresh leachate trail as observed facing the dumpster

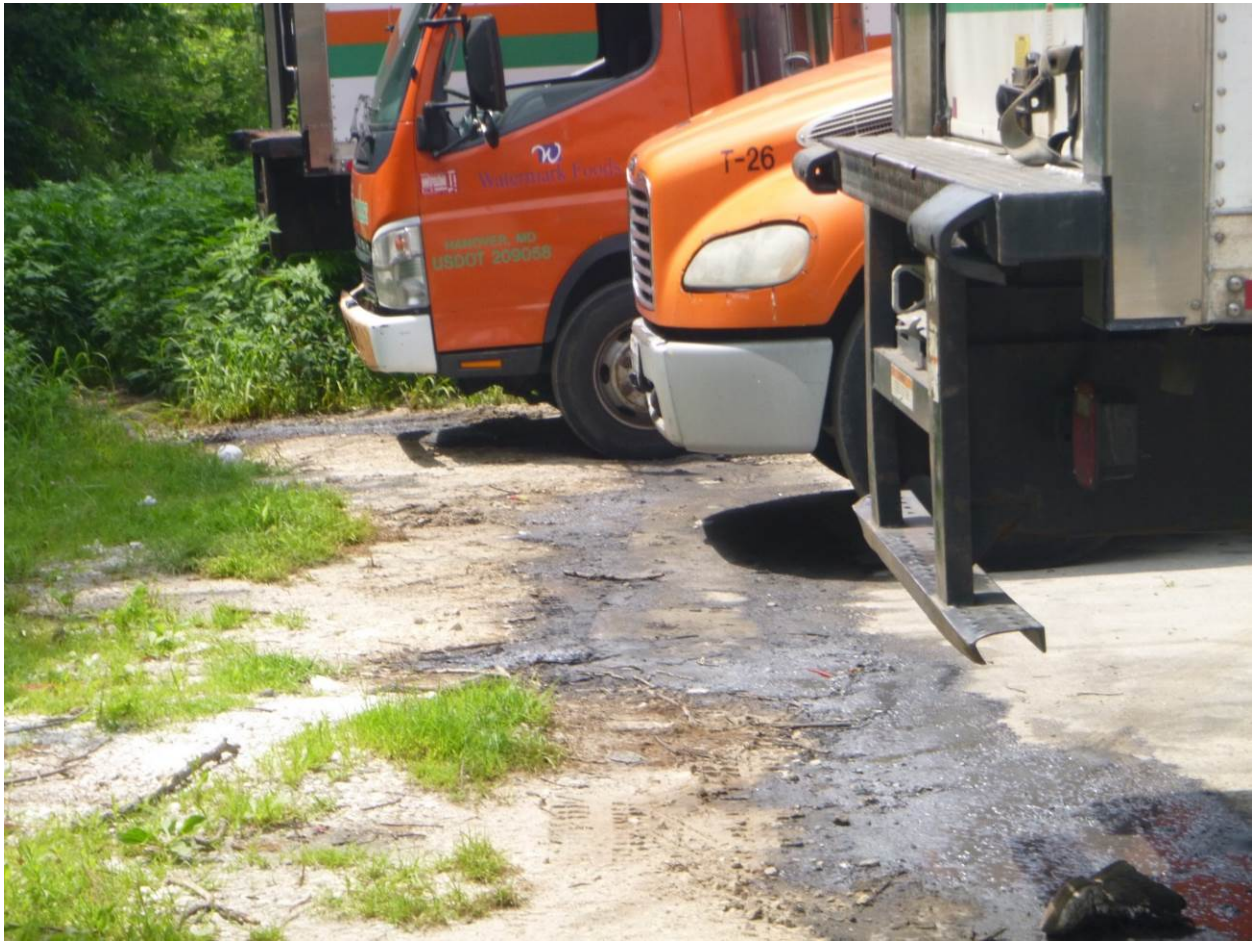
Figure 4. Fresh leachate trail as observed facing away from the dumpster

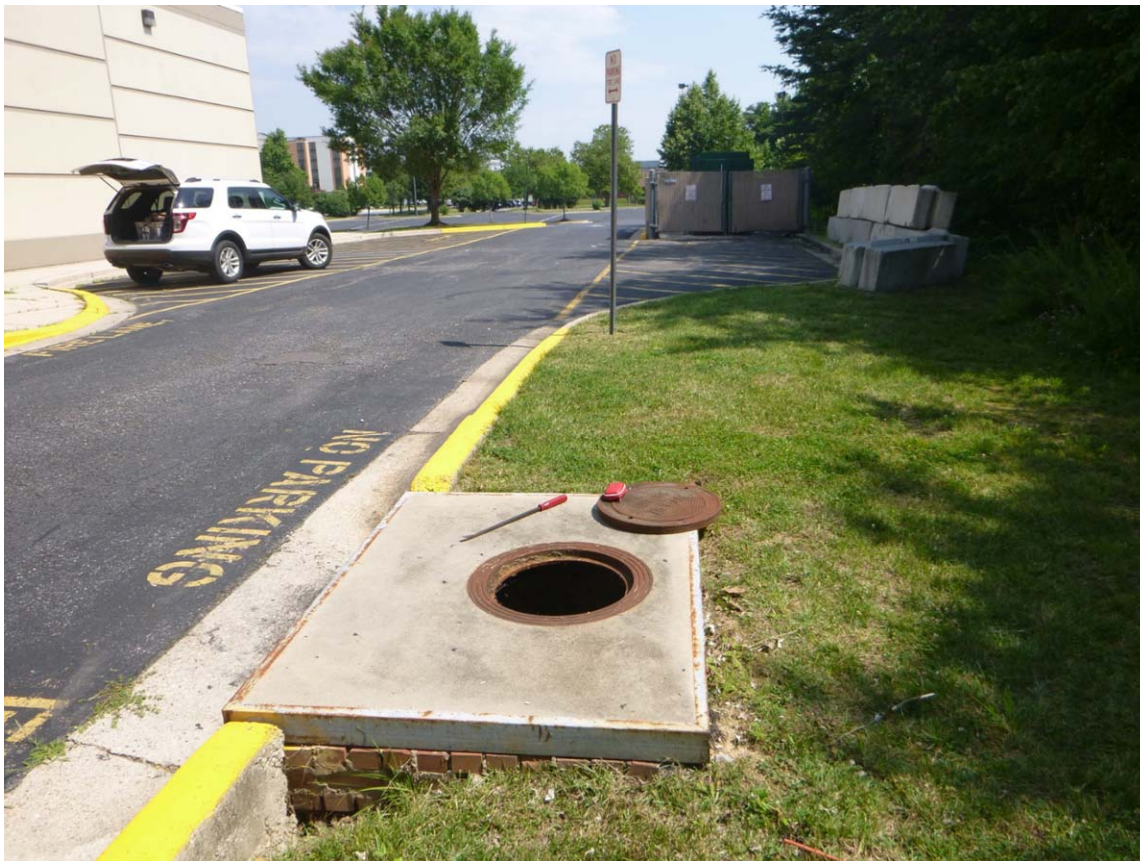
While a Versar field team was investigating a structural problem at a curb inlet in the parking lot behind the Hoyt's Cinema 14 at the address given above, team members detected a foul smell. The crew removed the manhole cover (Figure 1) and inspected the contents of the catch basin (Figure 2). The field crew noted that the debris found in the bottom of the catch basin is likely the cause of the disagreeable odor, as the trapped material is rotting in place. The field team noted that the dumpsters (seen in Figure 1) are slightly uphill from the inlet; it is possible that the debris in the storm drain system has accumulated from loose debris associated with the dumpsters (an open cover may allow loose debris to be carried out with strong winds; debris that is not properly inserted into the dumpster may become dislodged and fall to the ground). An area map appears in Figure 3.

Figure 1. Curb inlet with manhole cover removed; dumpsters in the background are slightly up-grade to the inlet
