**ILLICIT DISCHARGE DETECTION
AND ELIMINATION
2014 ANNUAL REPORT**

PERMIT NUMBER MD0068306

Versar, Inc.
9200 Rumsey Road
Columbia, MD 21045

October 2014

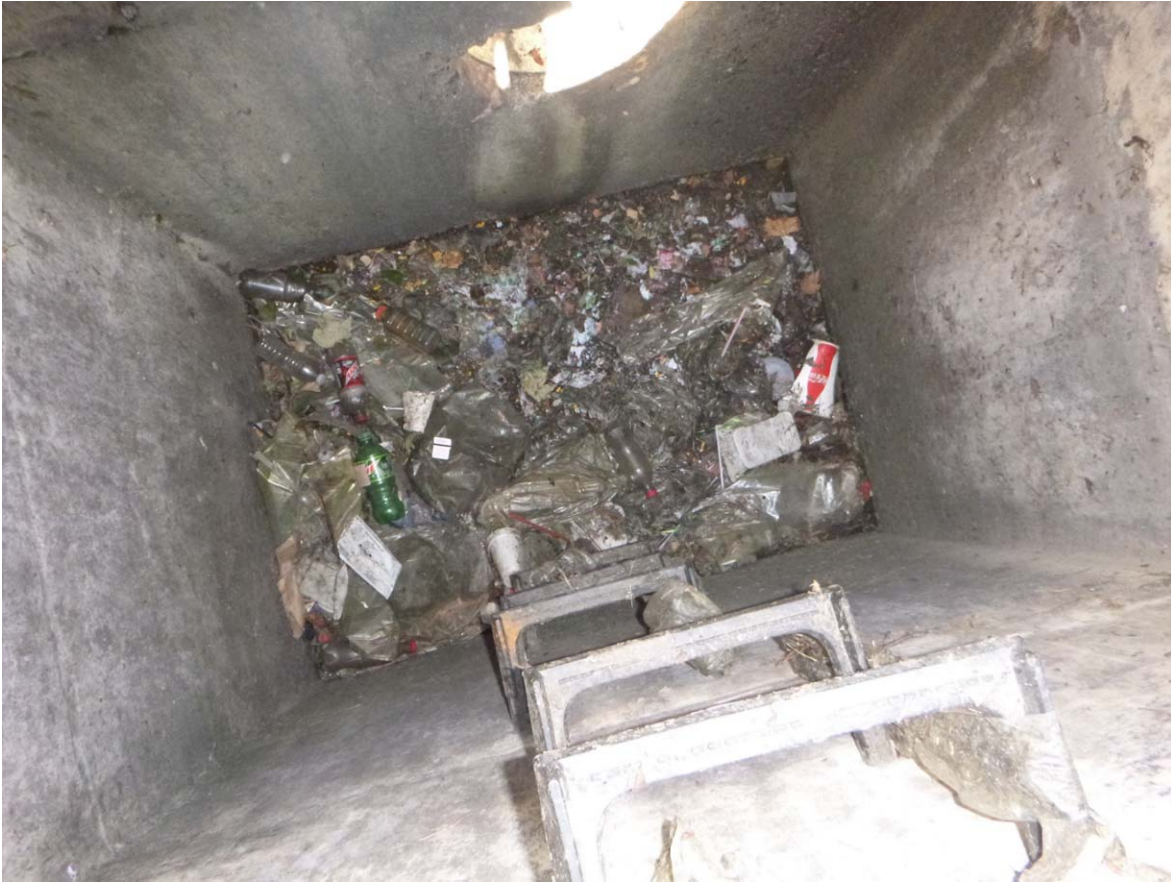
Figure 2. Foul-smelling debris observed within the curb inlet

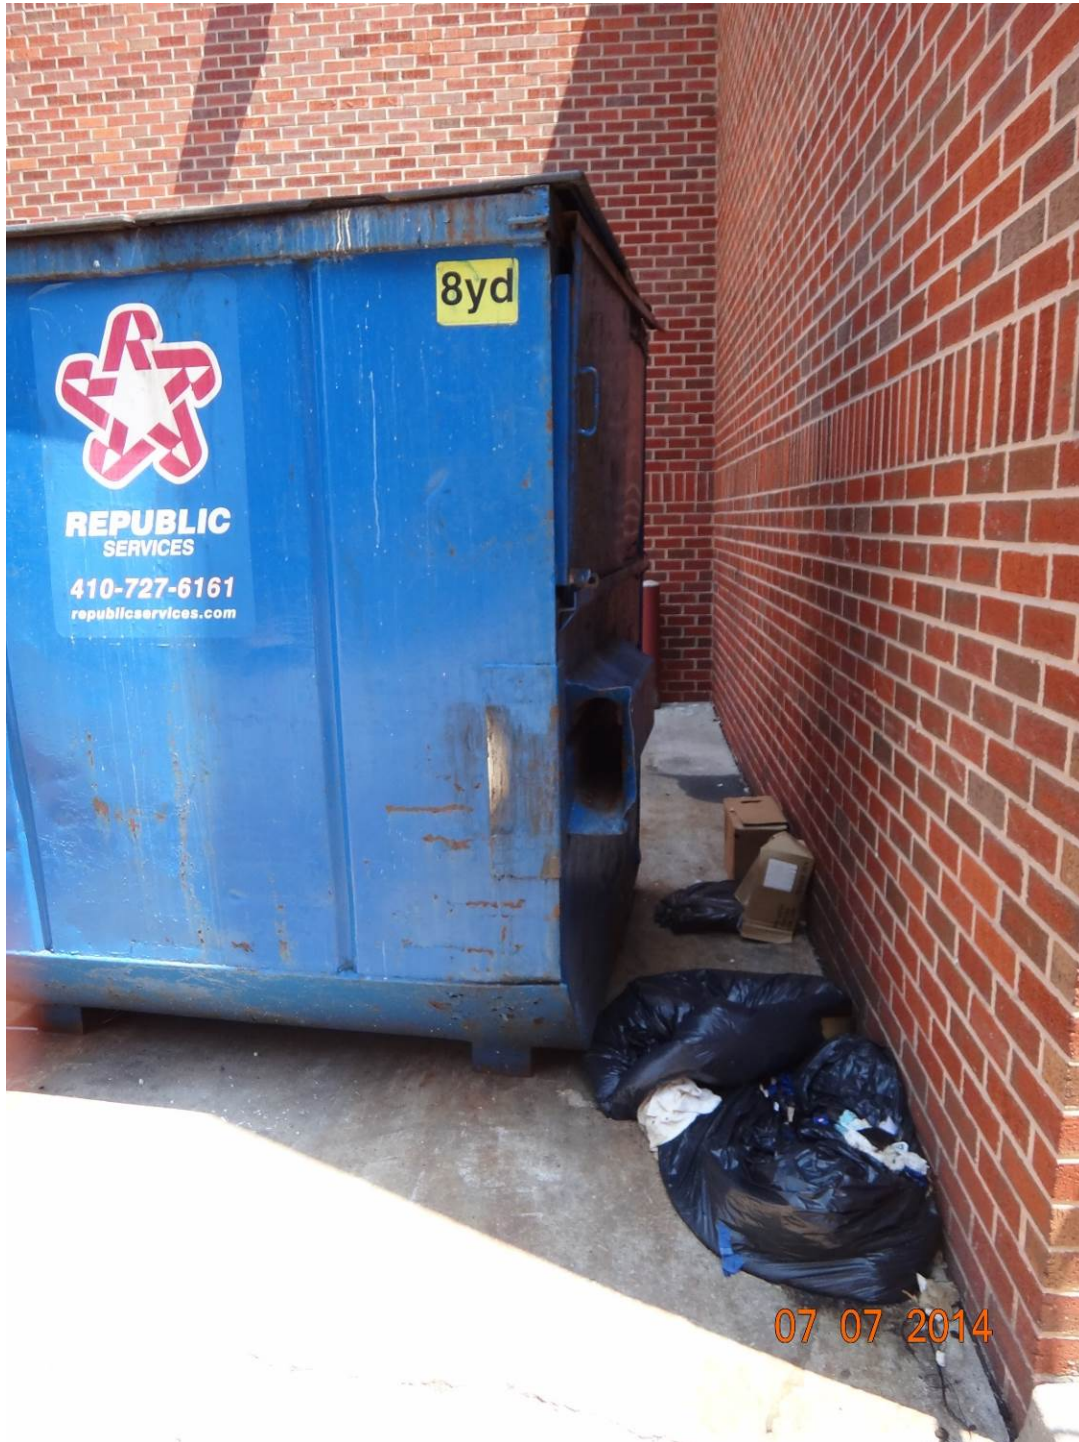
Figure 1. Filled bags and loose debris found alongside the dumpster

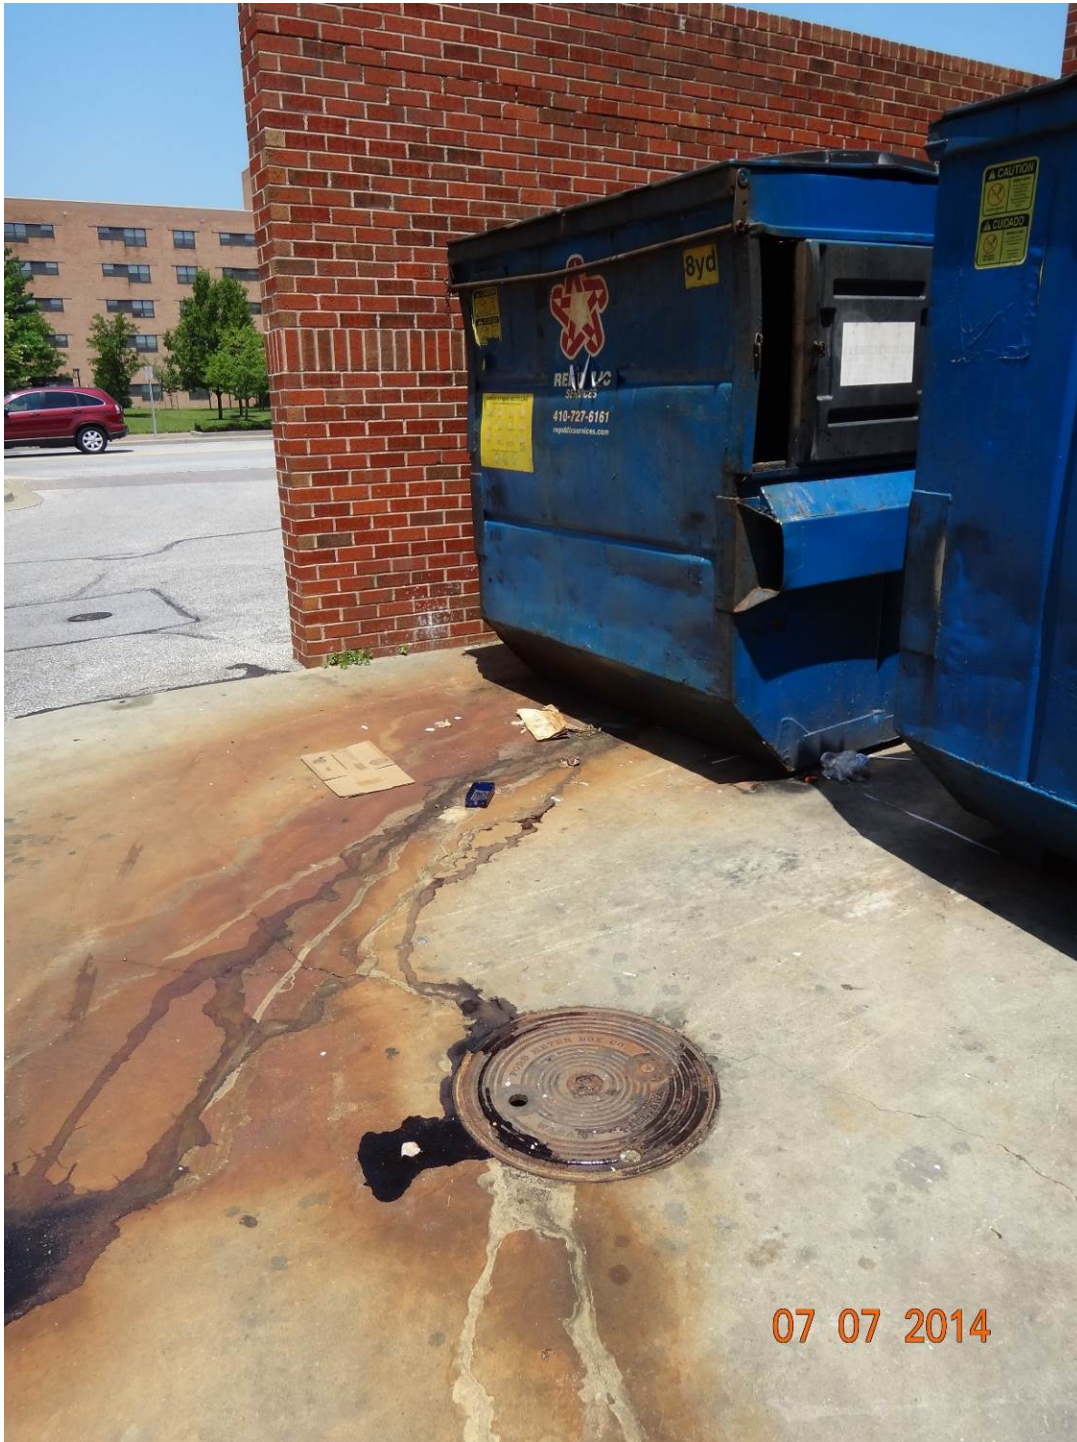
Figure 2. Evidence of liquid leaking from dumpsters

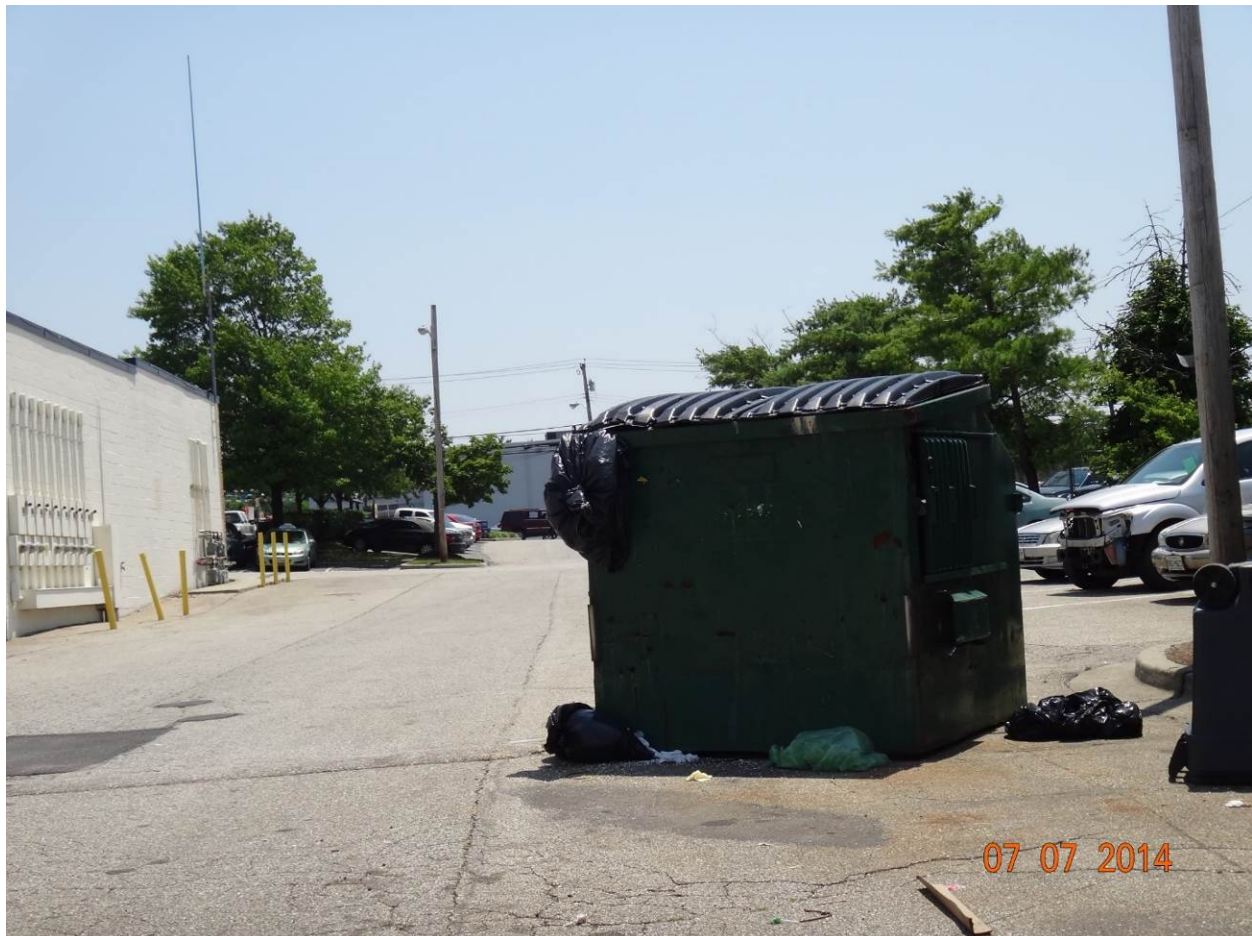
Figure 1. Filled bags and loose debris found alongside the dumpster

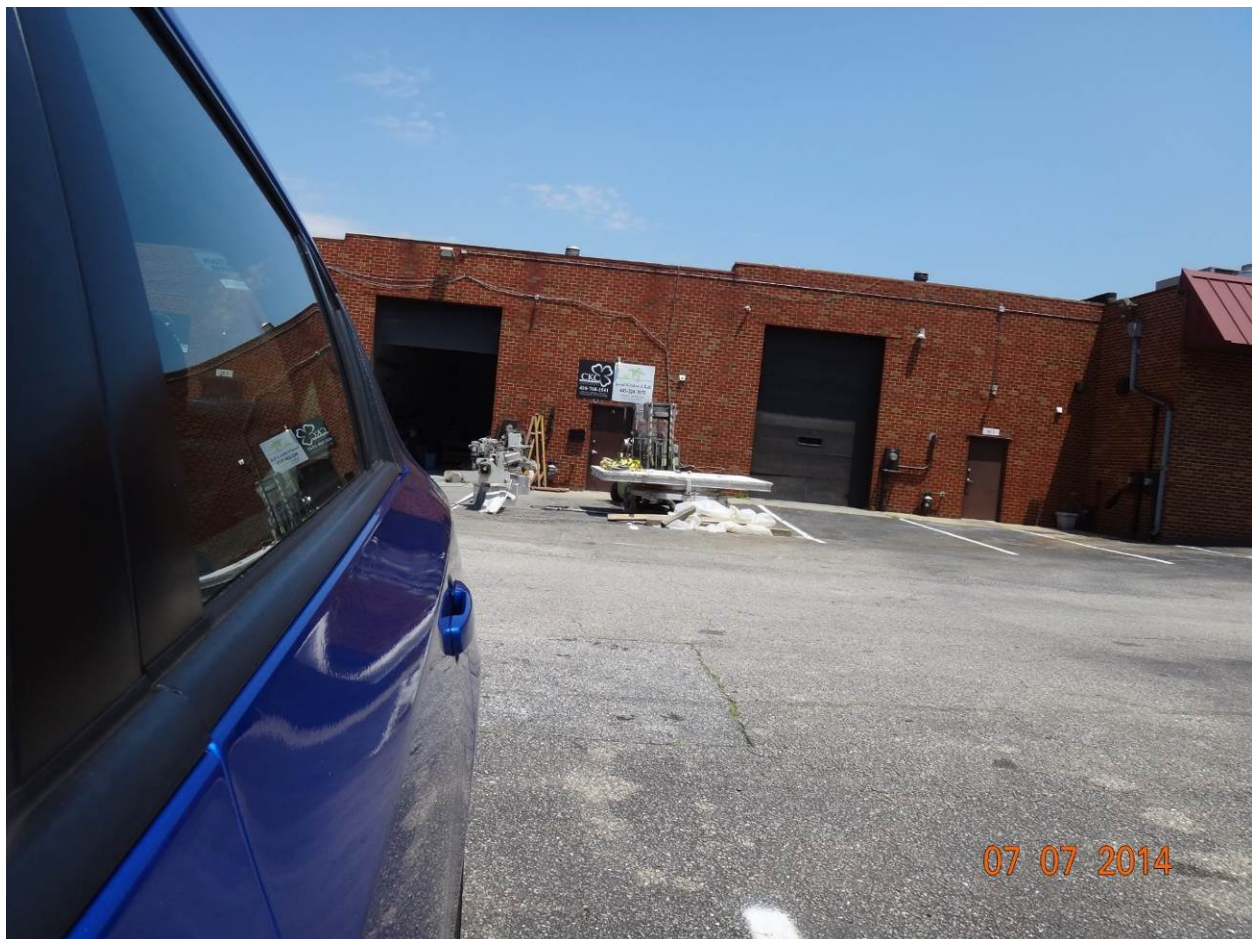
Figure 1. Tile-cutting work area established in the parking lot behind the building

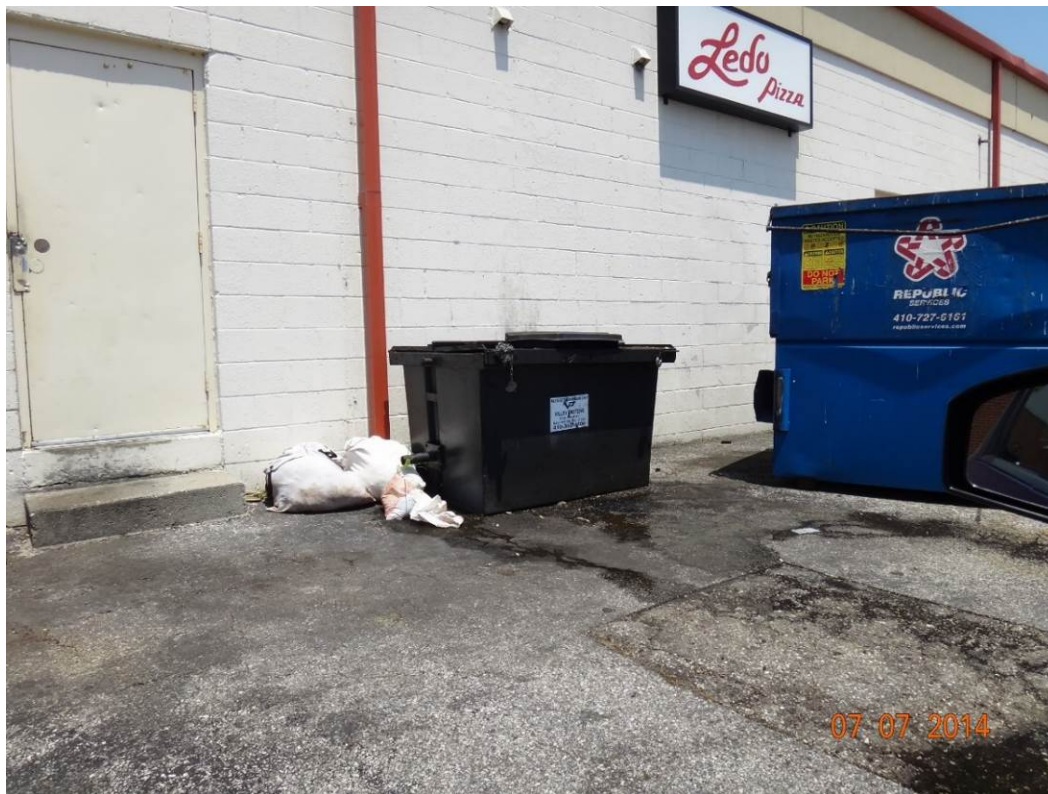
Figure 1. Waste grease disposal container with oil on nearby parking lot areas, and several bags

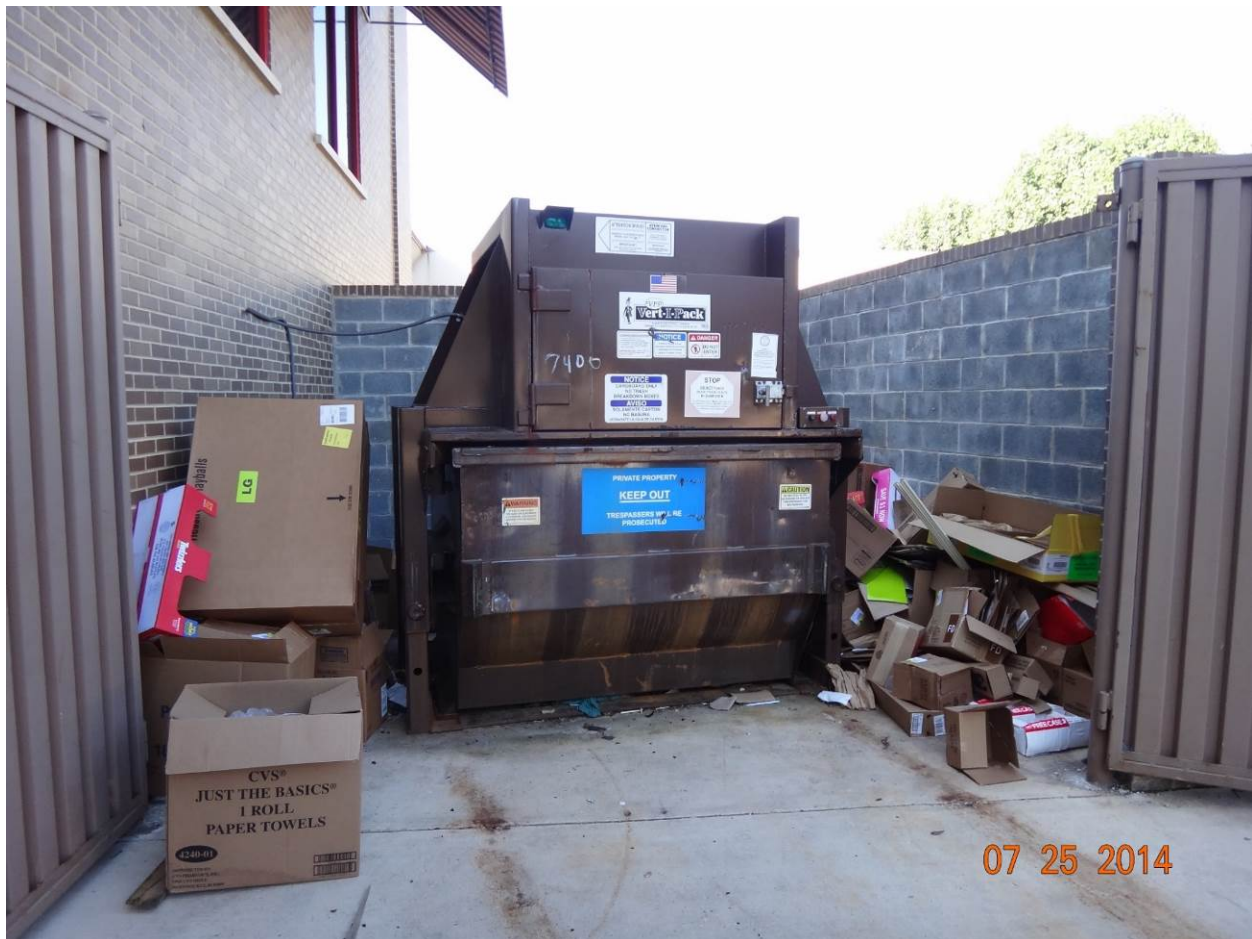
Figure 1. Debris found alongside the dumpster (compactor)

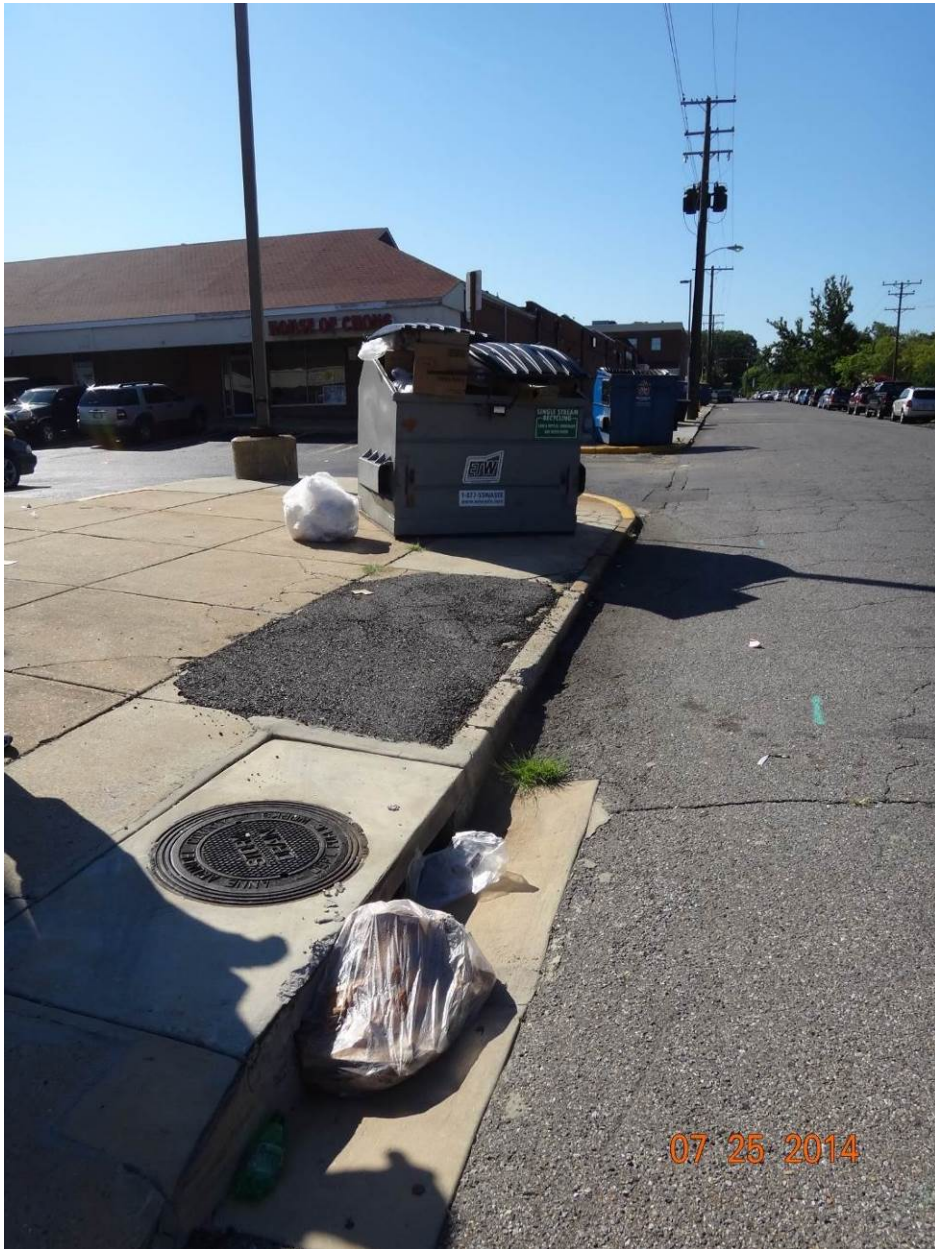
Figure 1. Debris observed alongside the dumpster and blocking the storm drain inlet

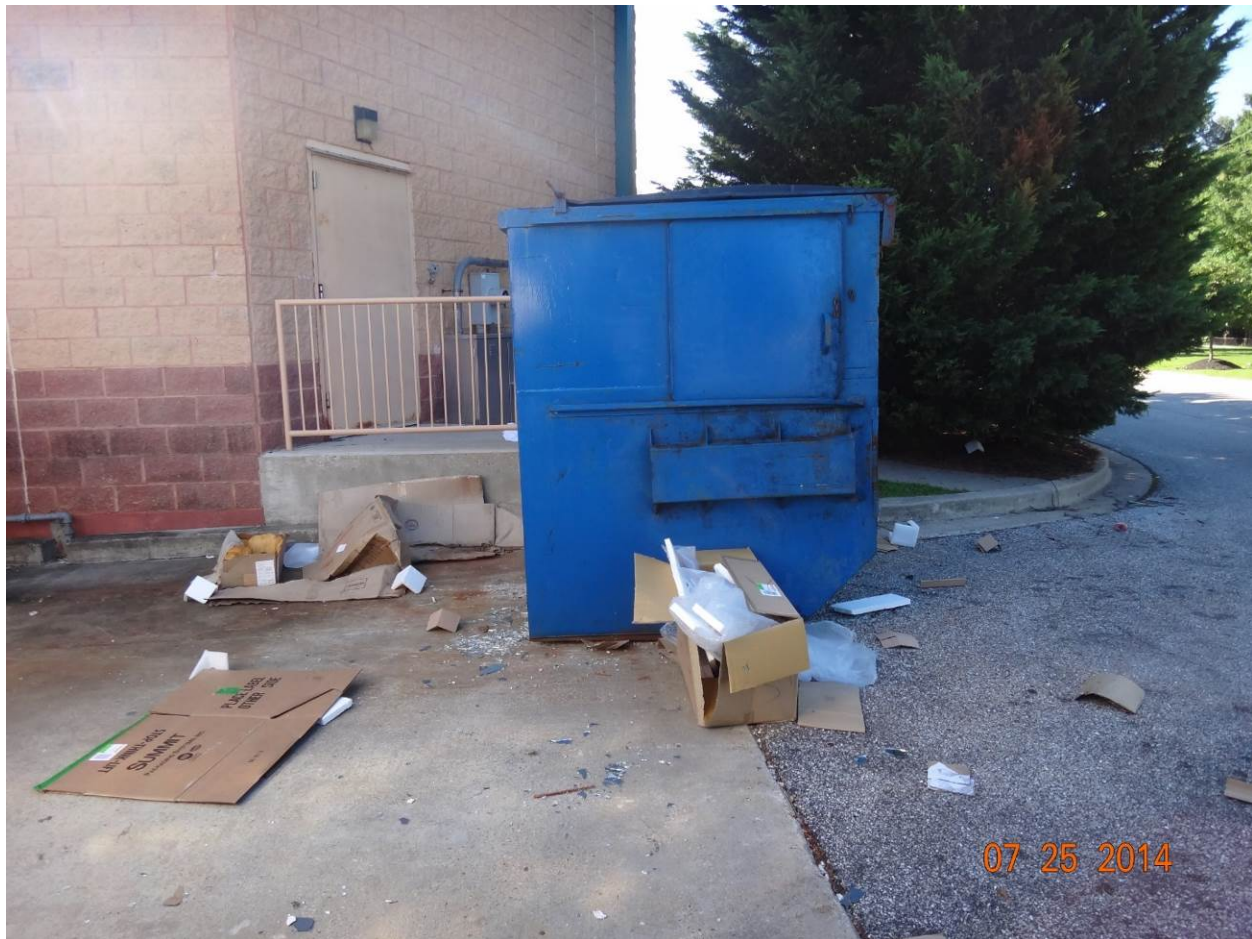
Figure 1. Debris found scattered around the dumpster
