**ANNE ARUNDEL COUNTY
ILLICIT DISCHARGE DETECTION
AND ELIMINATION**

2017 ANNUAL REPORT

PERMIT NUMBER MD0068306

FINAL: January 2018

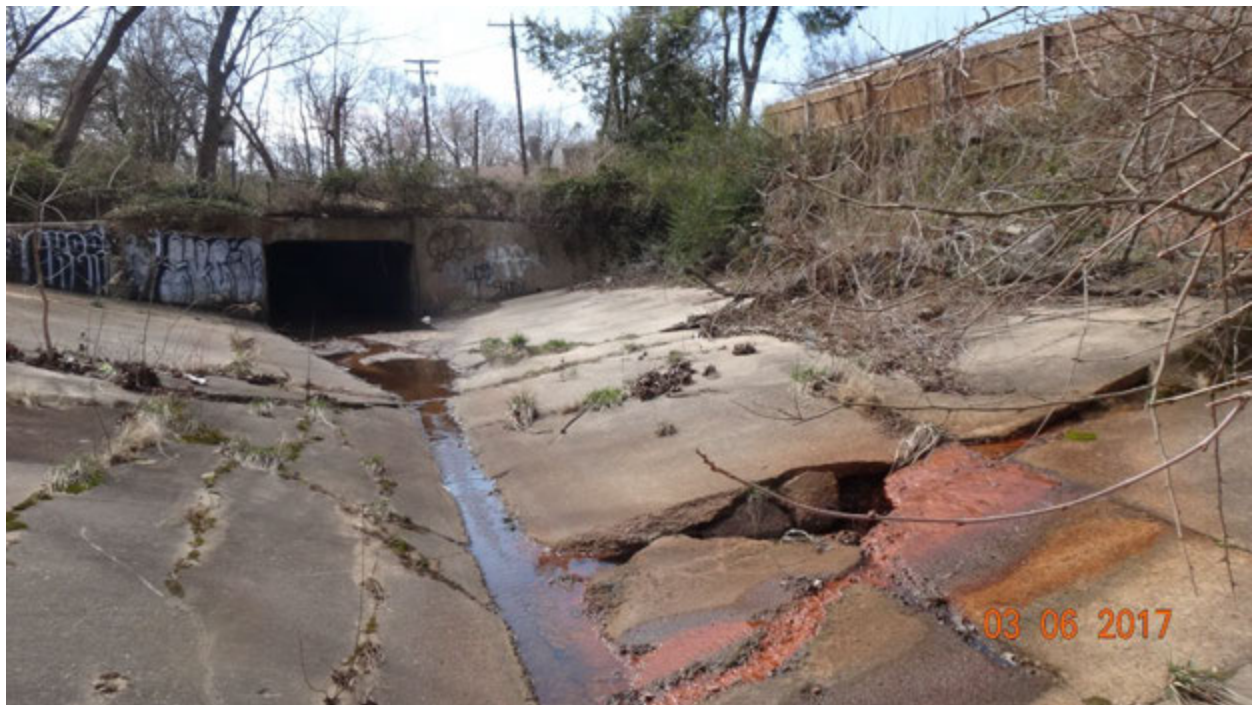
While investigating outfall M08H2O011, which is located to the east of Saunders Way, between Ingalls Road and Lorimer Road, a Versar field team member found an area of collapsed infrastructure in the receiving channel of the outfall (Figure 1). The damaged area is co-located with the discharge path of outfall M08H2O008 which is at the end of a pipe perpendicular to the main channel. The field team member noted that the damage to the concrete included a large opening in the lower part of the channel. Due to this location, discharge from either outfall may be able to flow into the hole and undercut the surrounding concrete. The team member's photographs indicated that the damage extended from the upper edge of the channel to the base (Figure 2). The extent of the damage and the presence of a significant hole may also pose a danger to pedestrians using the channel as a path from the adjacent neighborhoods. An area map, indicating the location of the infrastructure damage, is provided in Figure 3.

Figure 1. Collapsed infrastructure (foreground right) found in the receiving channel for target outfall M08H2O011

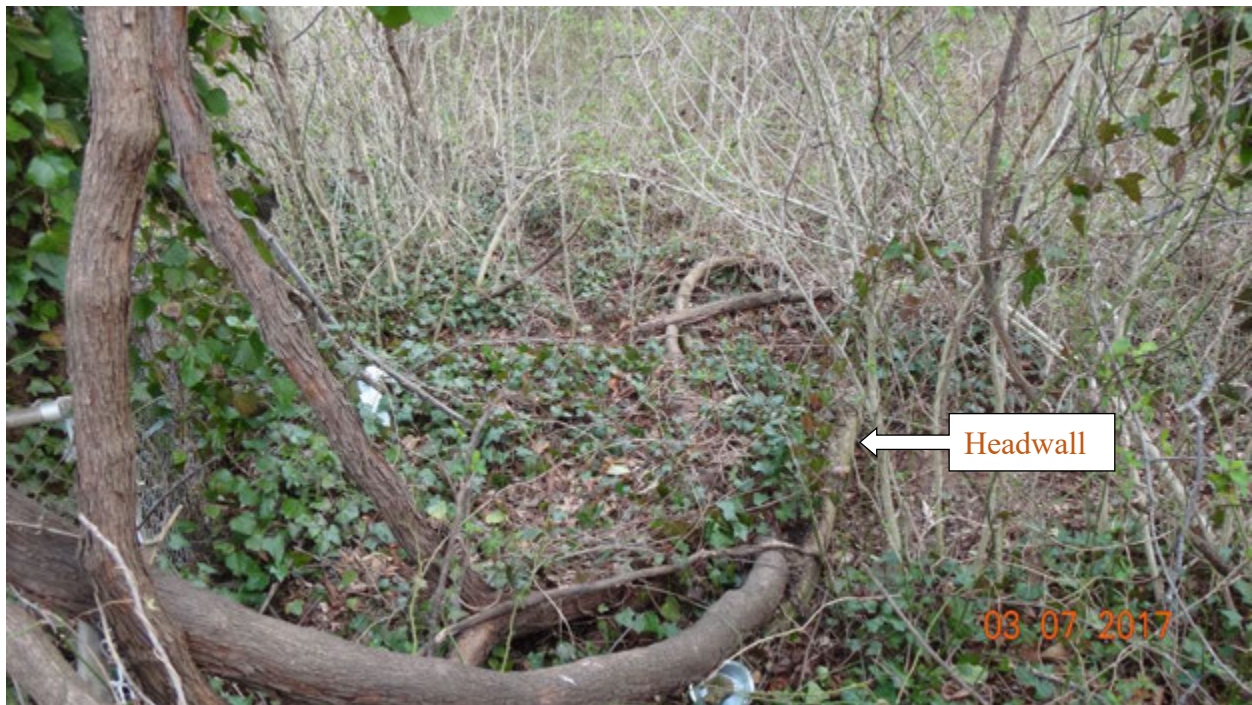
While investigating outfall M08D5O001, which is located behind the lots at the addresses listed above, a Versar field team found the outfall almost completely buried with sediment and vegetation overgrowth (Figure 1). The field team noted that the outfall exhibited a small depression in the area that would have been the plunge pool. The team surmised that the outfall would allow flow in high-water conditions. To explore possible flows into the outfall's pipe, the team investigated conditions in the nearest curb inlet, on Hutton Drive. In the inlet box, the team documented flowing conditions and pooled water (Figure 2). Tests of the flowing water did not indicate any parameter levels above program criteria. An area map, indicating the location of the buried outfall, is provided in Figure 3.

Figure 1. Outfall M08D5O001 found buried with sediment and vegetation

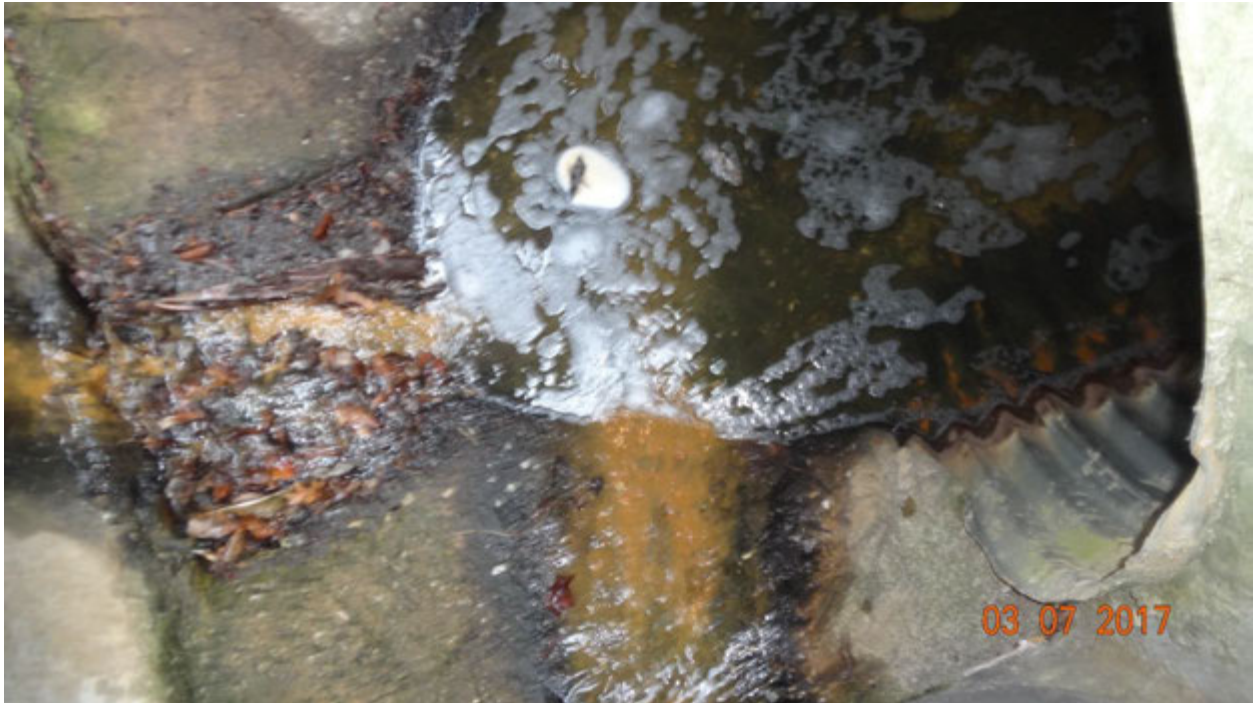
Figure 2. Evidence of pooled water in the nearest curb inlet; note flow from the two lines entering the inlet box (below and left)

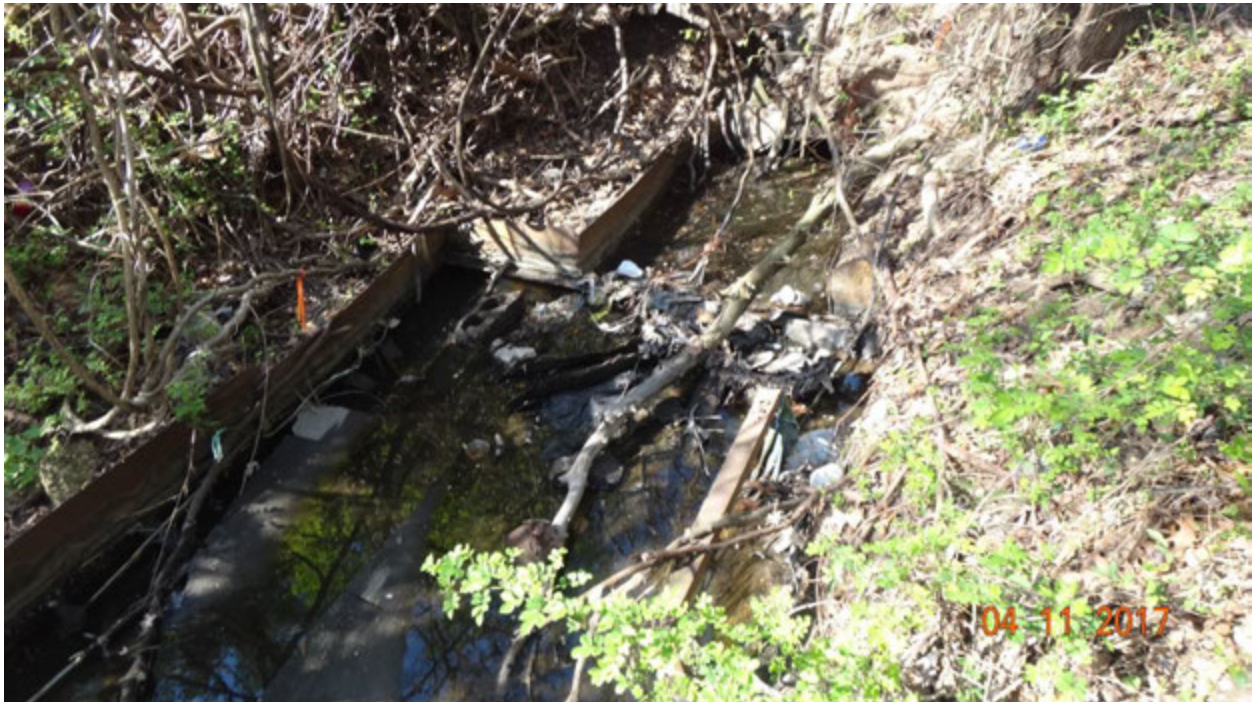
While investigating outfalls in the area, a Versar-LimnoTech field team discovered evidence and consequences of damaged infrastructure along a stream channel in the Cloverleaf Business Park in Millersville. In a short section of stream, between the emergence of the stream from the culvert under Cloverleaf Drive and a downstream piped section, the team found a combination of obstructing conditions including collapsed infrastructure and large pieces of debris in the streambed. The team noted that the open channel appeared to be partially fortified by a rudimentary structure that included plywood decking within the side frames (Figure 1). On the downstream end of the short channel, the team found a constructed frame, apparently intended to support panels above the surface of the water (Figure 2). The team presumed that the apparatus had been installed to trap debris. Photo-documentation from the site shows that some of the panels were made of expanded metal; some other panels appeared to be plywood boards (Figure 3). During the site visit, the team members discovered that a portion of the makeshift screen cover had collapsed. At least two of the sheets of expanded metal had fallen into the stream (Figure 3). The team also distinguished parts of a broken shopping cart partially covered by sticks and leaves in the streambed (Figures 2 and 3). The team observed trapped leaves, sticks, and small pieces of rubbish with these large pieces of debris (Figure 4). The stream flow appeared to be at least partially blocked by the accumulated material (Figure 4). The team did not ascertain the extent of the blockage that was in the downstream piped section. The team inspected the stream conditions on the opposite end of the piped section and found it to be a dry channel. This set of conditions suggested that the blockage would need to be cleared to allow the stream to flow effectively. An area map is provided in Figure 5. Note that the piped section and its openings are not included as features in the available versions of the County's digital data representing the stormwater infrastructure network.

Figure 1. An apparently fortified channel with plywood decking forming part of the sides (left)

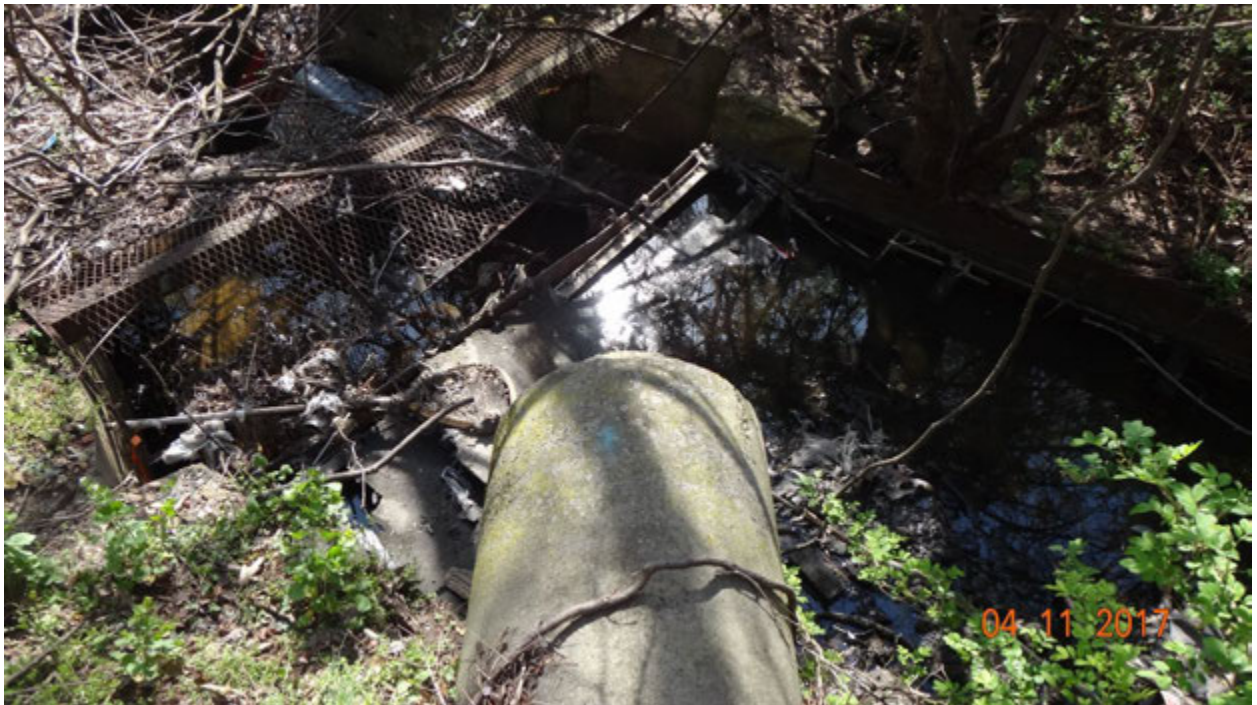
Figure 2. View of part of a super-structure constructed over the stream that supported expanded metal panels (left) and large sheets of plywood (center, under and in front of the pipe in the foreground); the grey plastic seen in the stream (upper left) is an exposed portion of a broken shopping cart

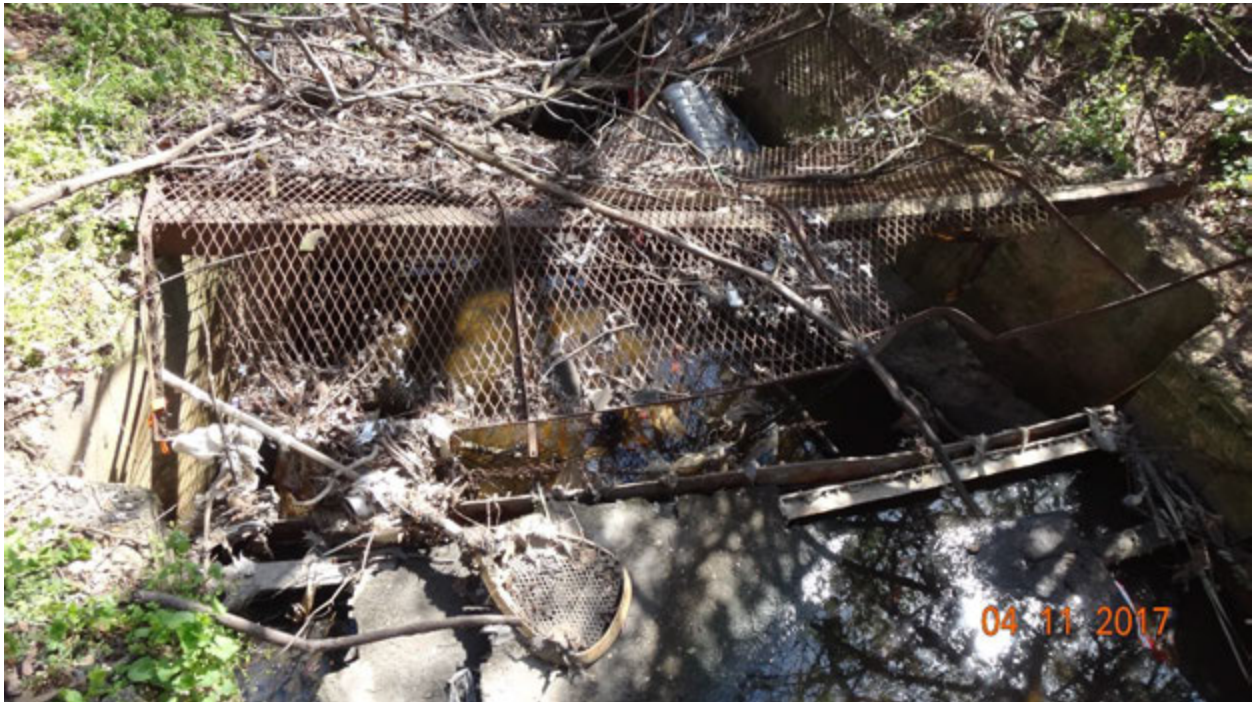
Figure 3. View of a supported expanded metal panel and at least two panels that had fallen into the stream; a portion of one is seen just above the head of the lacrosse stick in the photograph, portions of another can be seen under and around the grey plastic (top center) which was part of a broken shopping cart

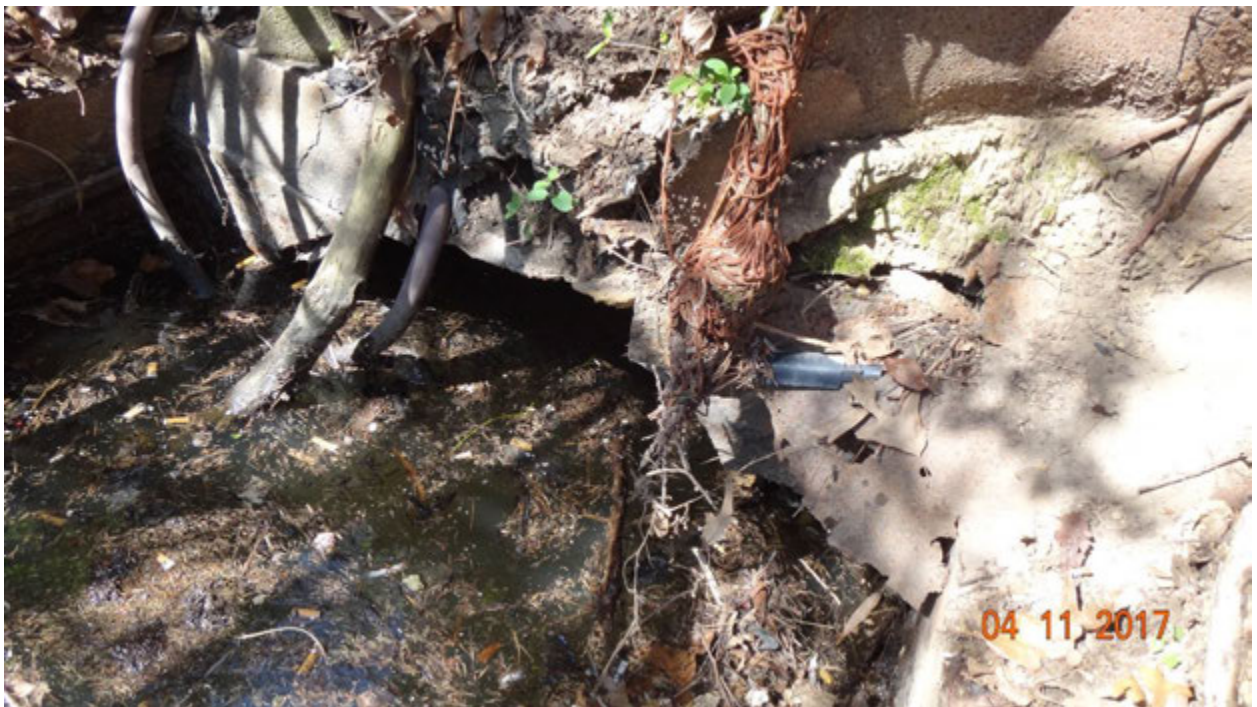
Figure 4. View of some of the impeded water that extends back into the culvert under Cloverleaf Drive

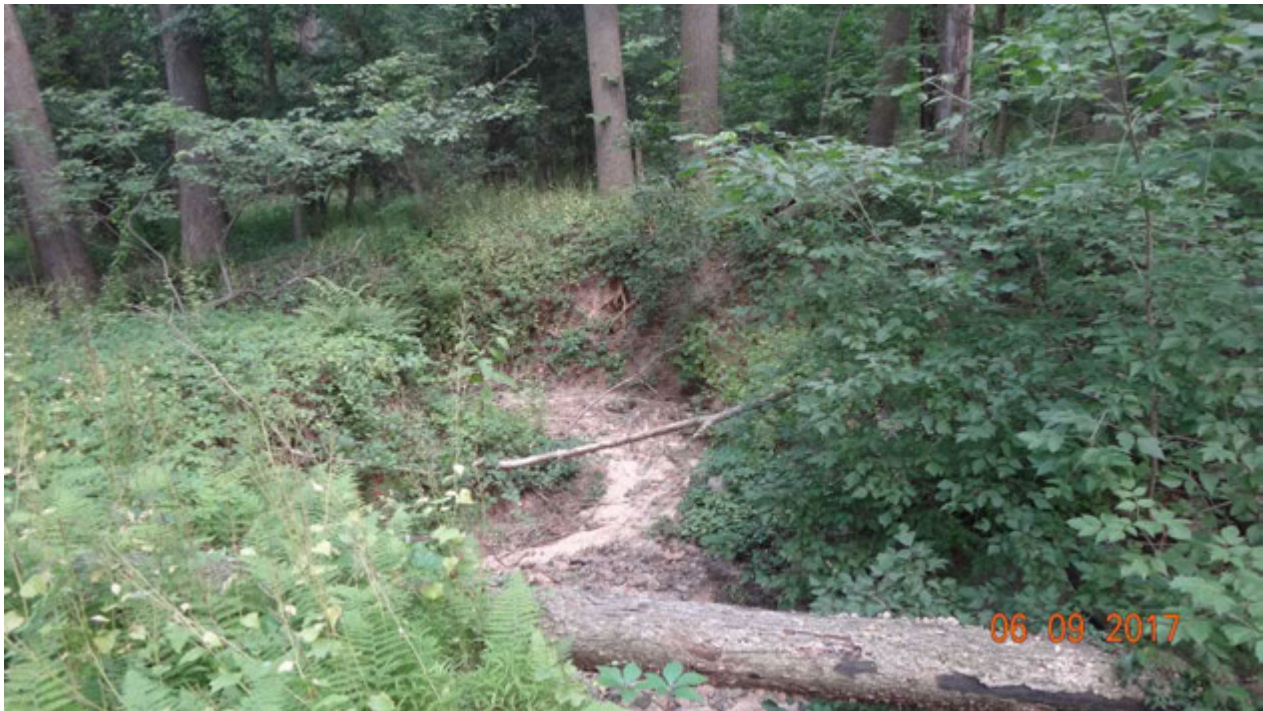
Figure 4. Further evidence of erosion observed downstream of the plunge pool of the outfall

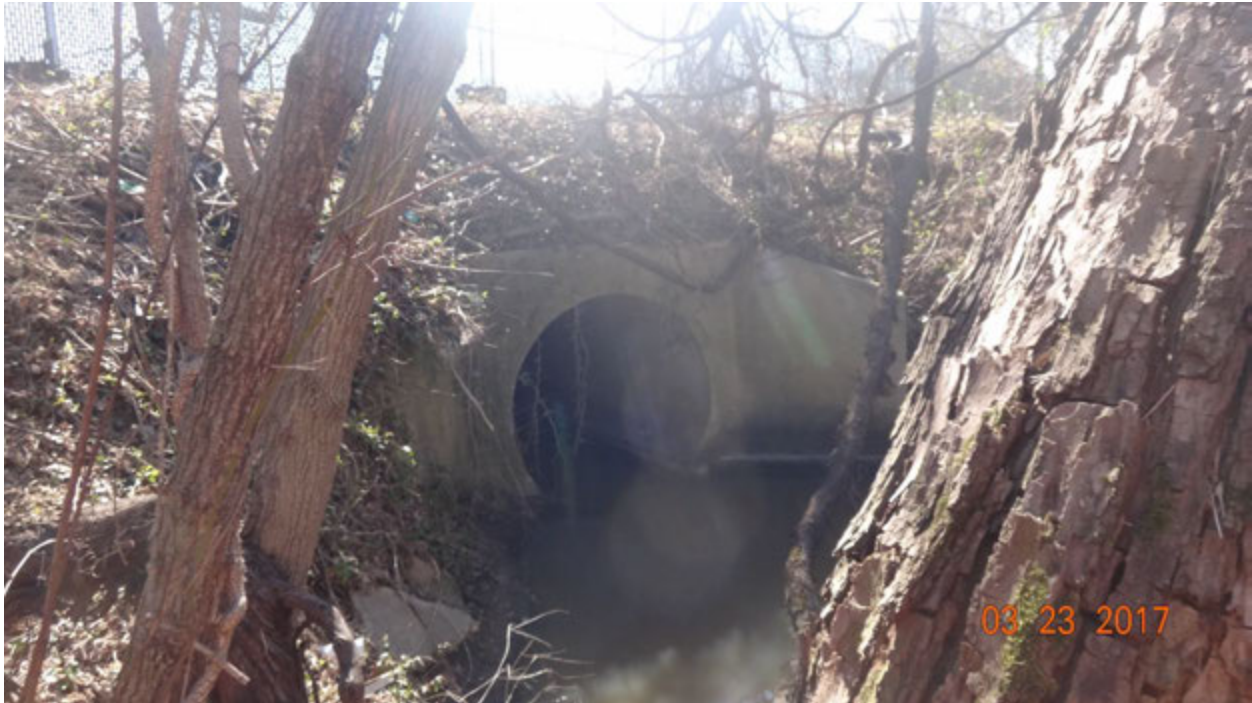
Figure 1. Conditions at outfall M06C4O008, showing pooled opaque water on March 23

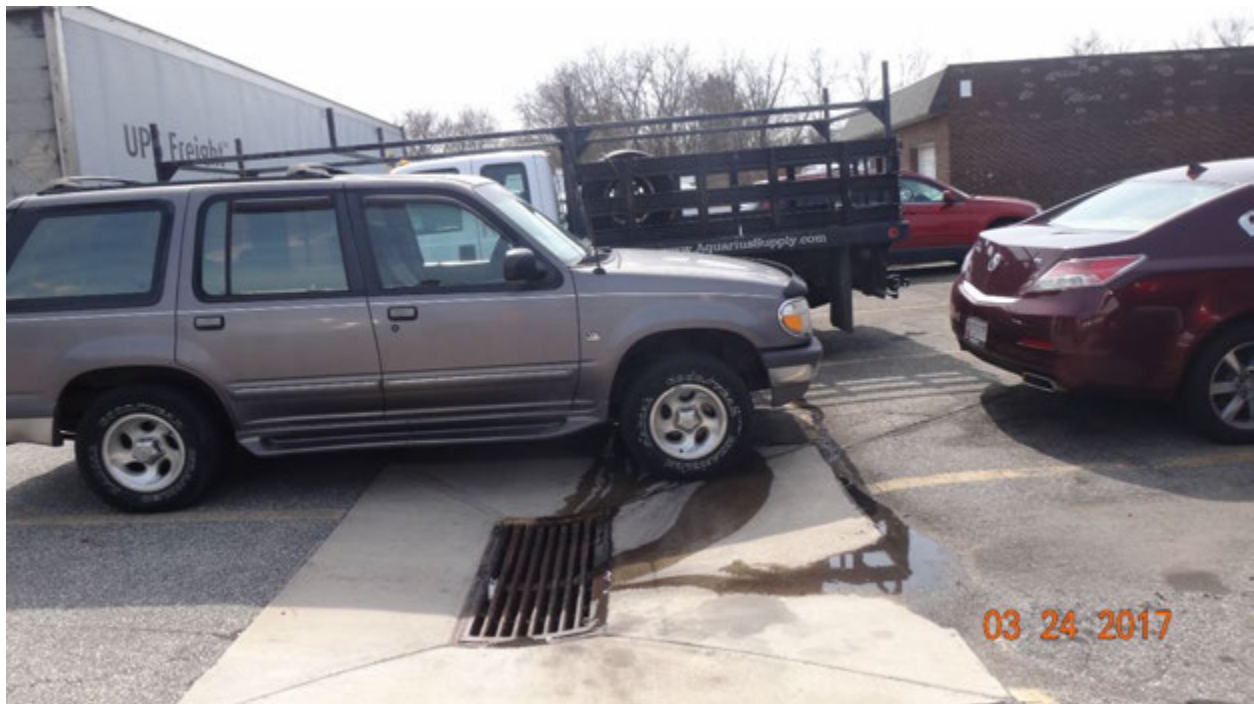
Figure 4. Evidence of the excess wash water from the vehicle washing entering the storm drain

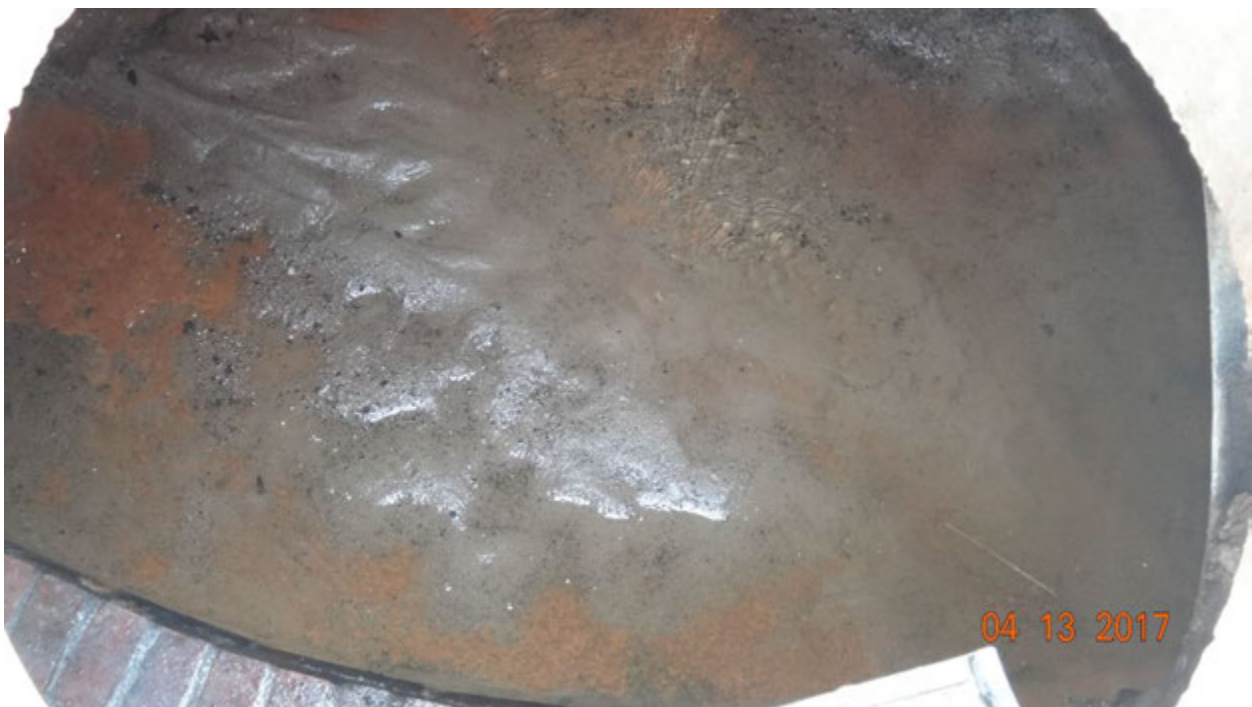
Figure 2. View inside the third manhole

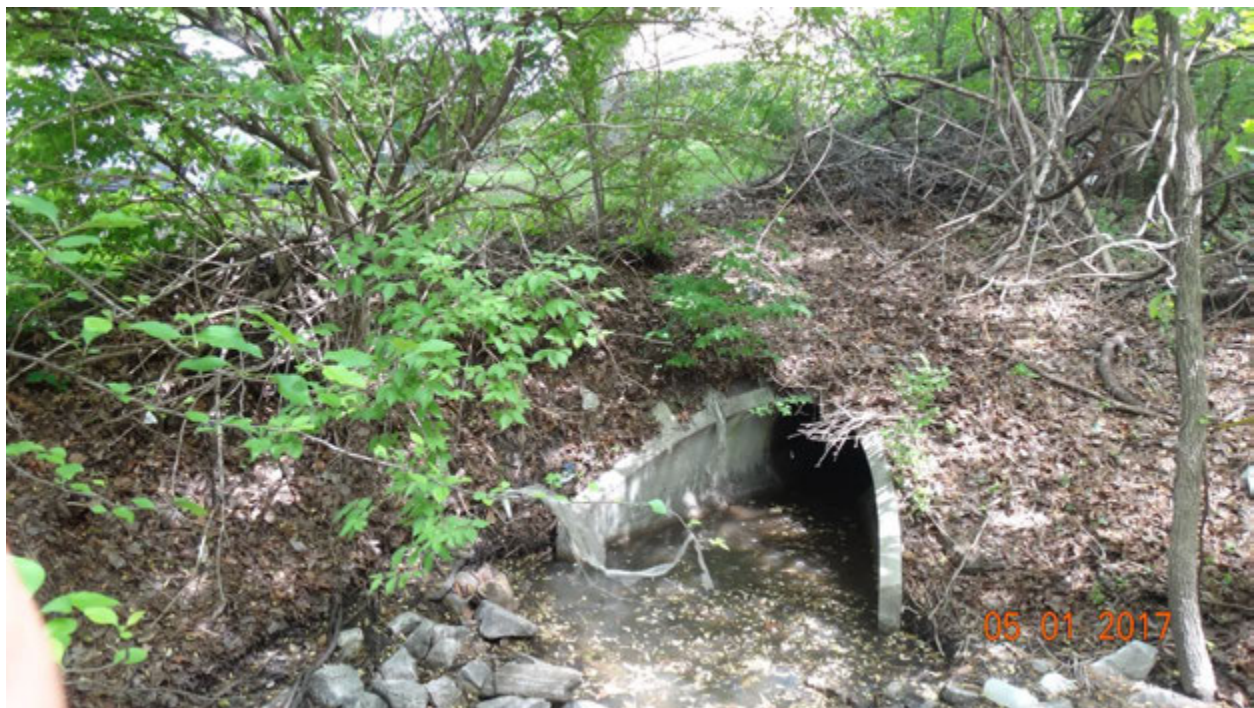
Figure 1. Conditions at outfall M08E8O006, showing opaque and brown water on May 1

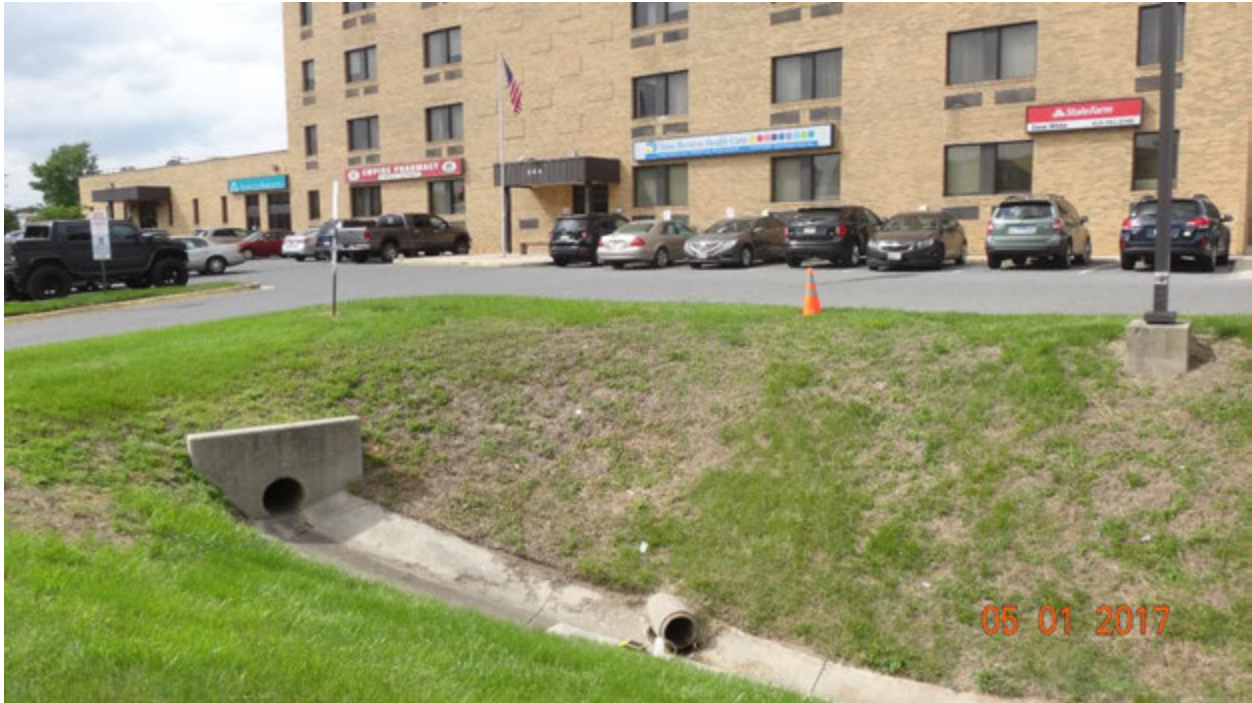
Figure 2. View of the channel in front of the building at 200 Hospital Drive; note the small pipe entering the channel at an angle from the direction of the building (outfall M08E8O003 is seen to the left)

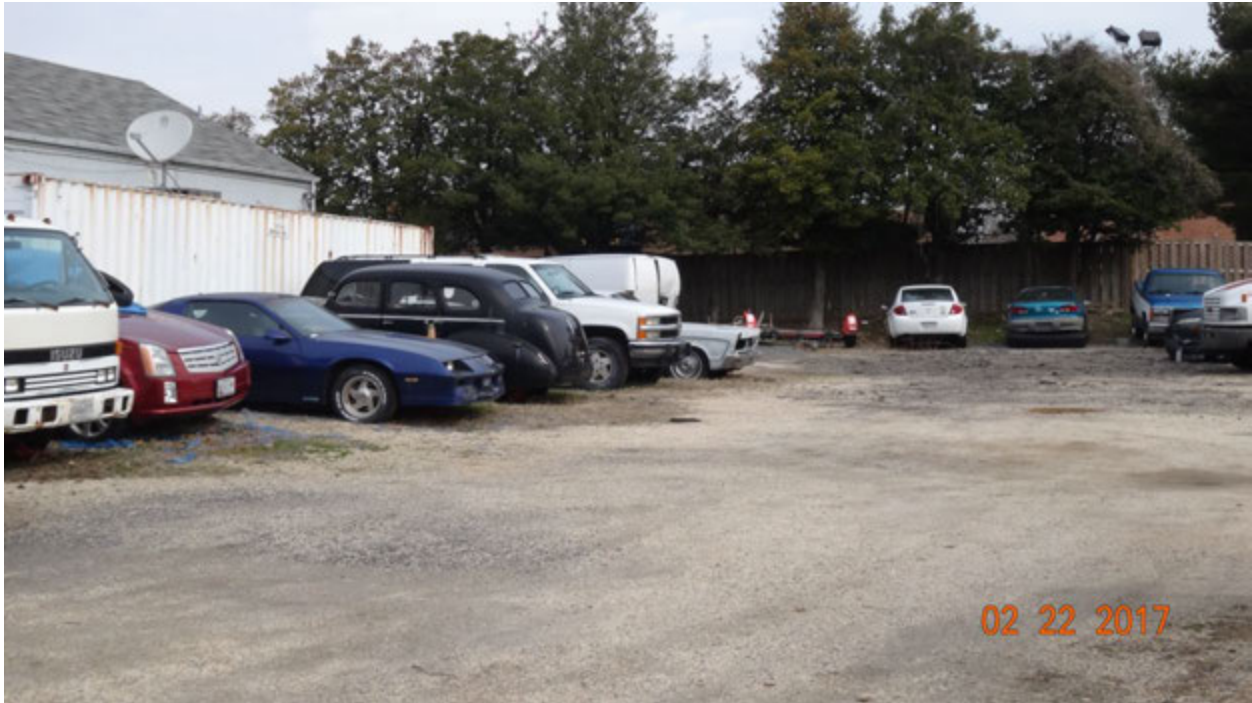
Figure 2. Some of the damaged, rusted, and unregistered vehicles found on the lot

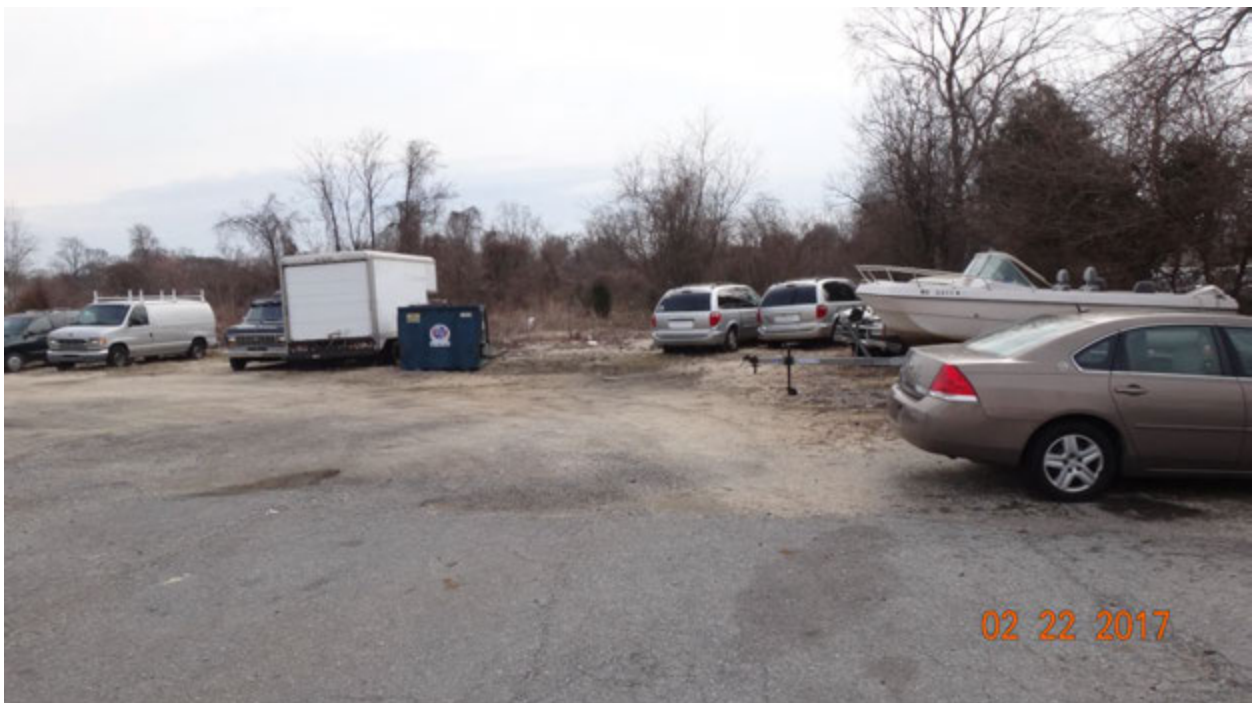
Figure 3. Many of the stored vehicles did not display current registration tags

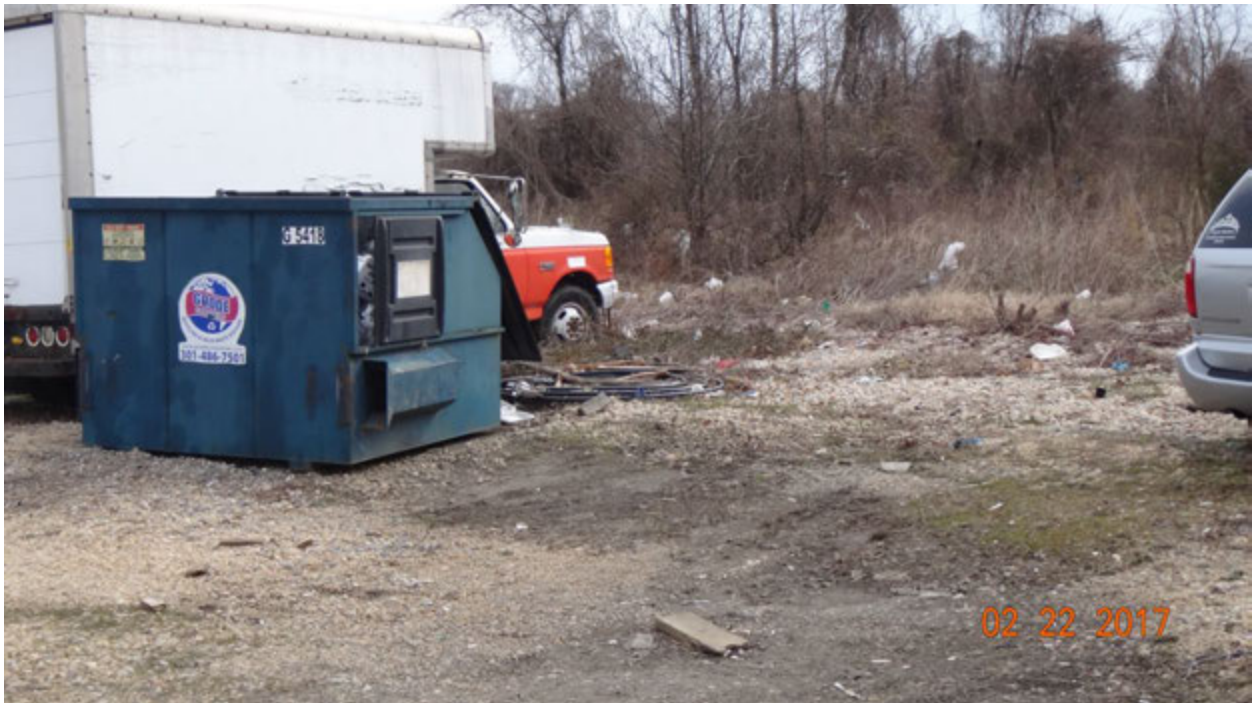
Figure 4. An open dumpster observed during the site visit, and scattered debris

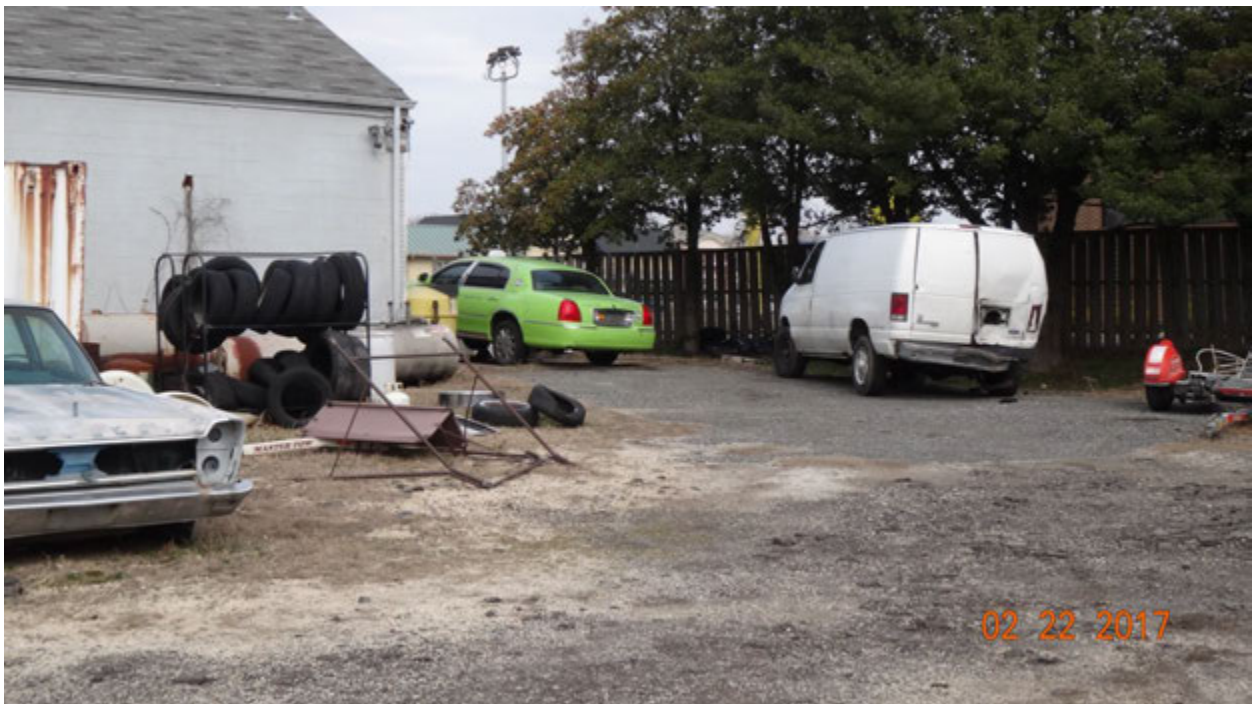
Figure 5. Debris scattered on the lot (old tires and rusting metal), rusting tanks for used oil and other fluids, and open drums

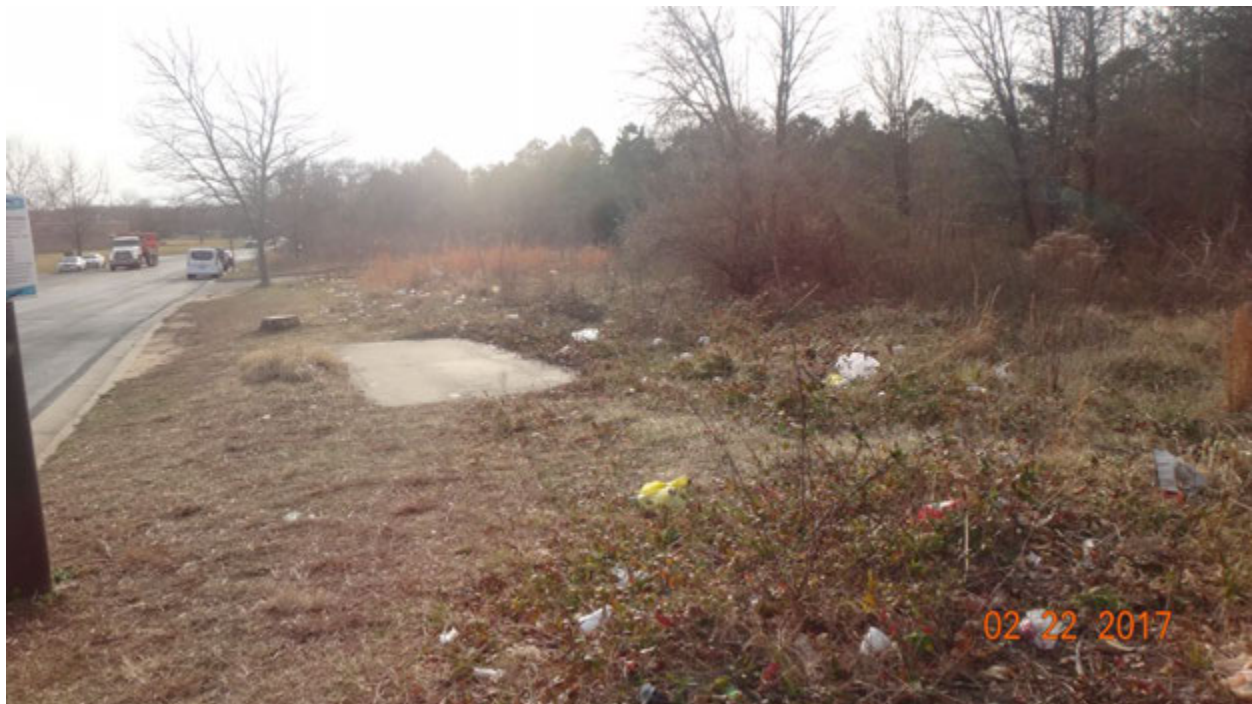
While investigating outfalls in the area, a Versar field team discovered an area exhibiting significant debris at the above address. The field team surmised that this area of Energy Parkway may be used by people using the bus service and truck drivers transporting goods, and that some of these people may be disposing of their trash along the roadside. The team observed that the debris generally included beverage and food containers, and loose wrappers (Figures 1 and 2). The larger units of debris (e.g., bags full of trash or boxes) in some locations implied that some dumping activity had also occurred (Figures 1 and 3). An area map is provided as Figure 4.

Figure 1. Debris found scattered along the roadway; the pole displaying the bus stop sign is seen on the far left

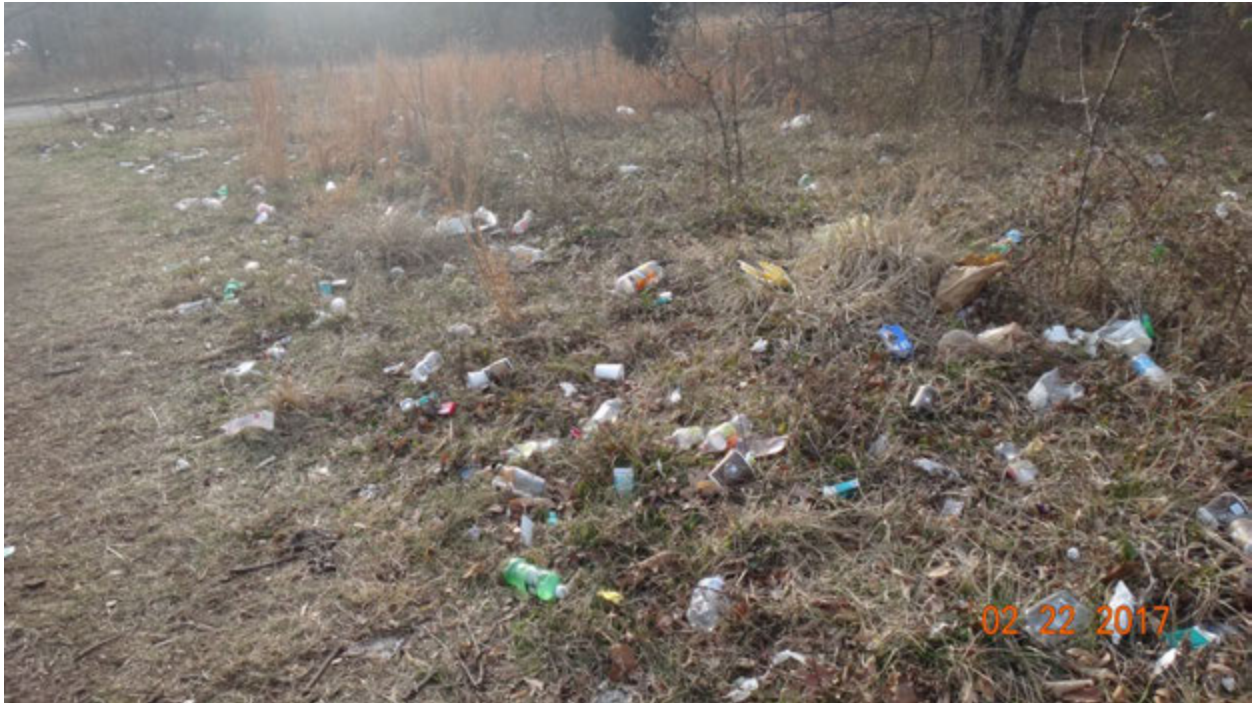
Figure 2. Another section of the long stretch of trash found along the roadway

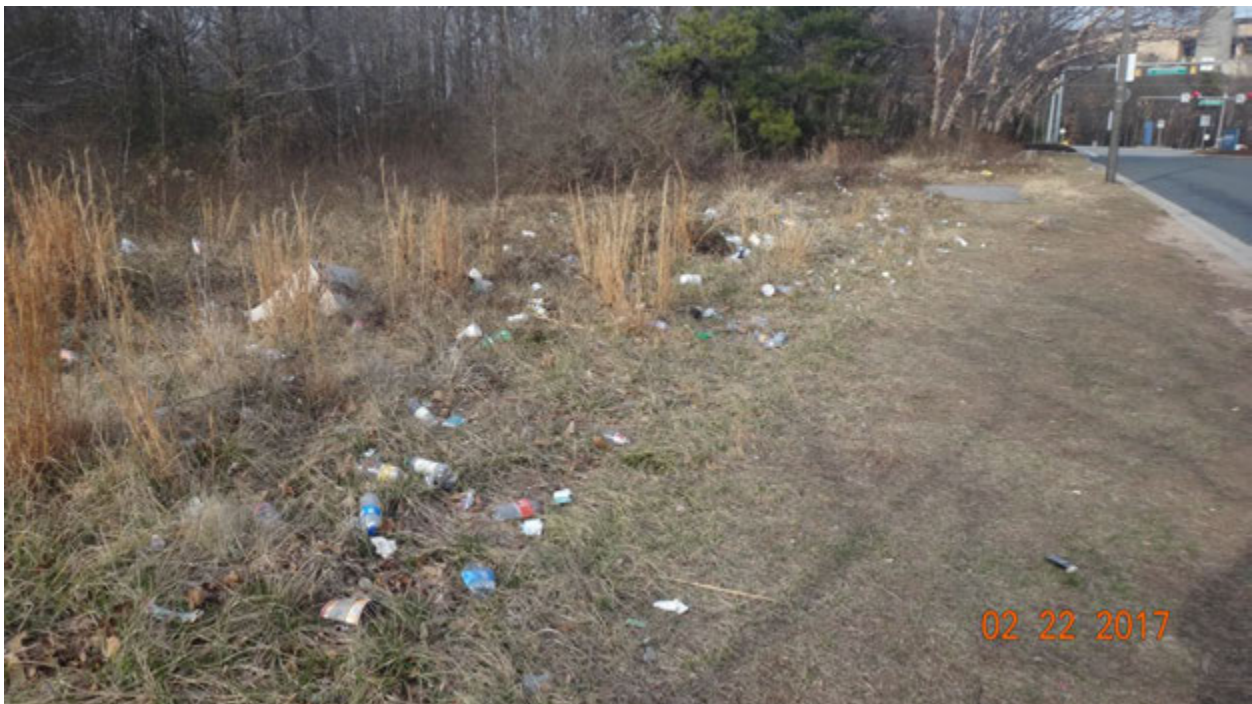
Figure 3. Some of the debris was found in larger units, such as full bags and cardboard boxes; this implies more specific, intentional dumping activity

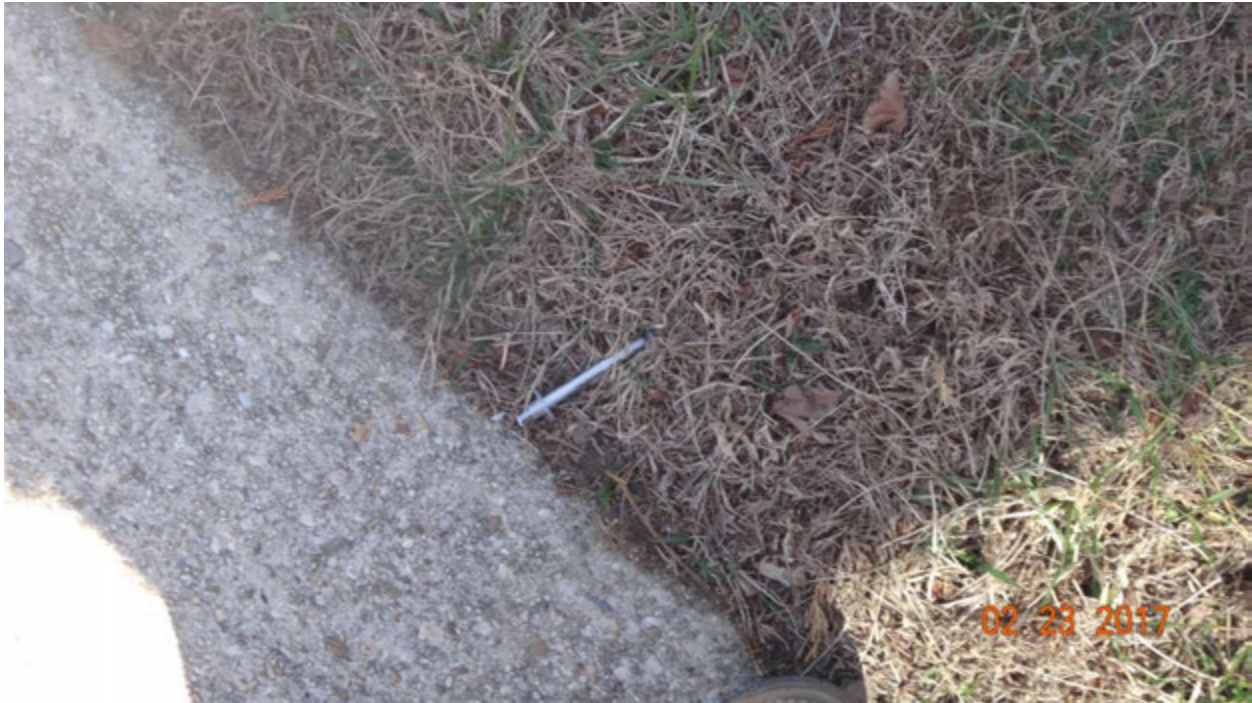
Figure 2. Another syringe-needle assembly found near a paved area

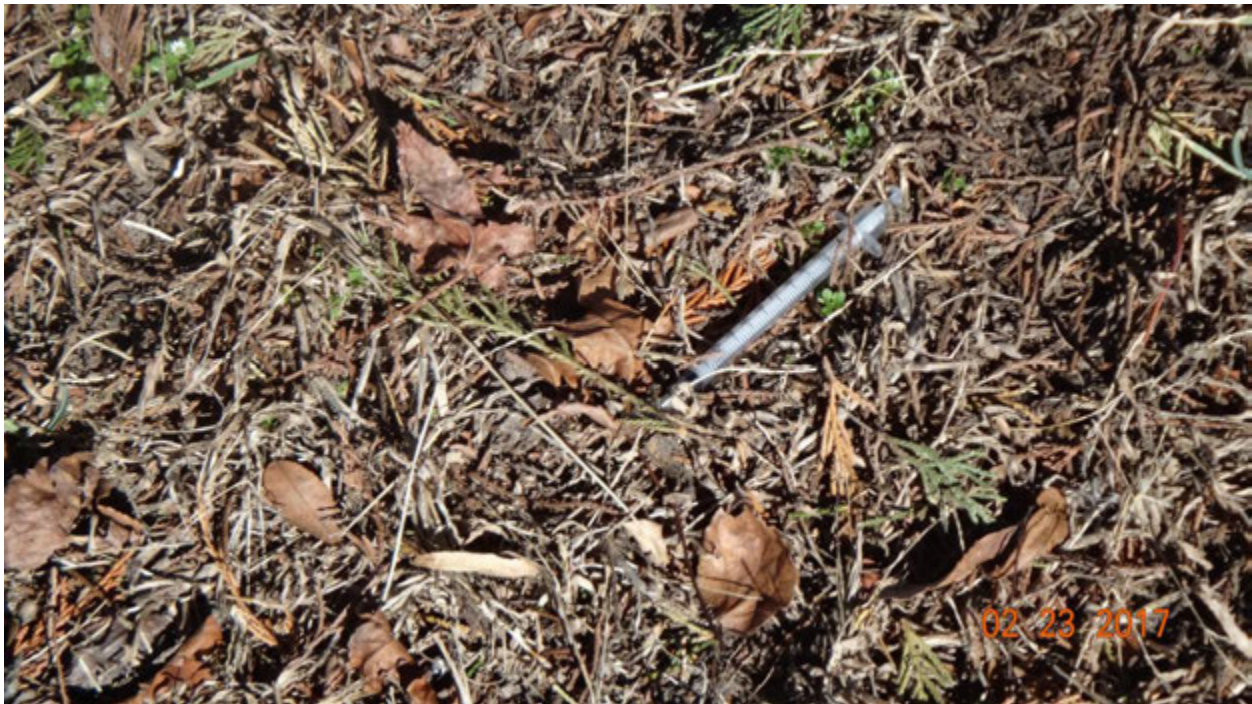
Figure 3. Another empty drug delivery device found at the site

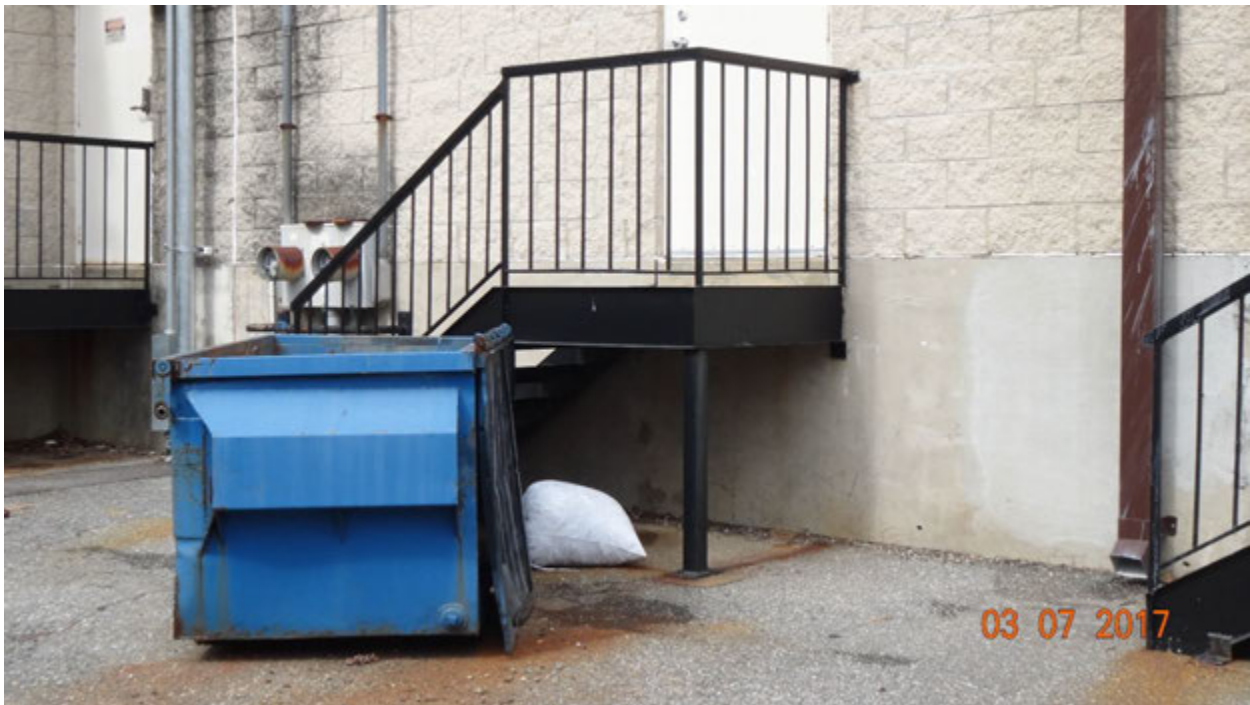
While investigating outfalls in the area, a Versar field team found signs of inadequate waste management associated with several businesses at the Southgate Marketplace shopping center. The team found a bag of trash near an open dumpster behind the door for Suite M, thought to be a Jackson Hewitt office (Figure 1). Adjacent to that, the team found another open dumpster with scattered loose trash behind the door for Suite N; the team assessed this to be a rear door for Angel Nails (Figure 2). Further down the line, the team documented a collection of bagged and loose trash near the door for Suite R, thought to be used by the Illumination business (Figure 3). An area map, indicating the general location of the businesses, is provided in Figure 4.

Figure 1. An open dumpster and a loose bag of trash behind the door for Suite M
