**ANNE ARUNDEL COUNTY
ILLICIT DISCHARGE DETECTION
AND ELIMINATION**

2017 ANNUAL REPORT

PERMIT NUMBER MD0068306

FINAL: January 2018

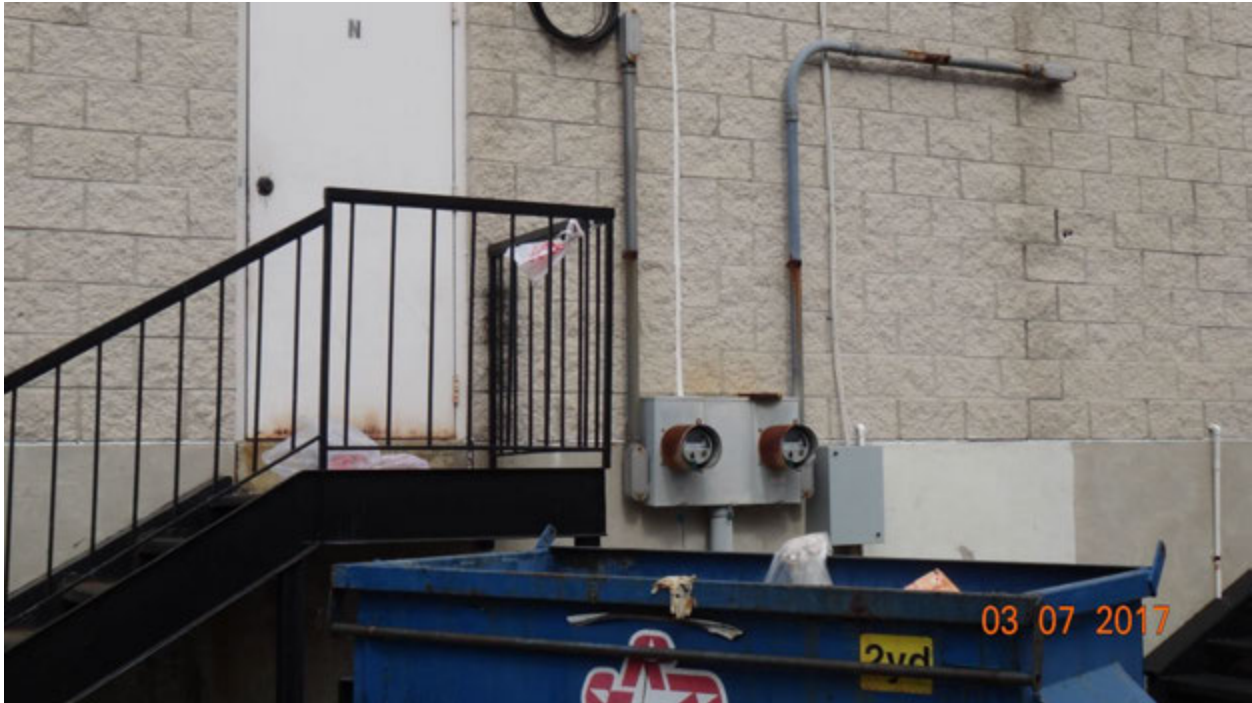
Figure 2. An open dumpster and loose trash behind the rear door for Suite N

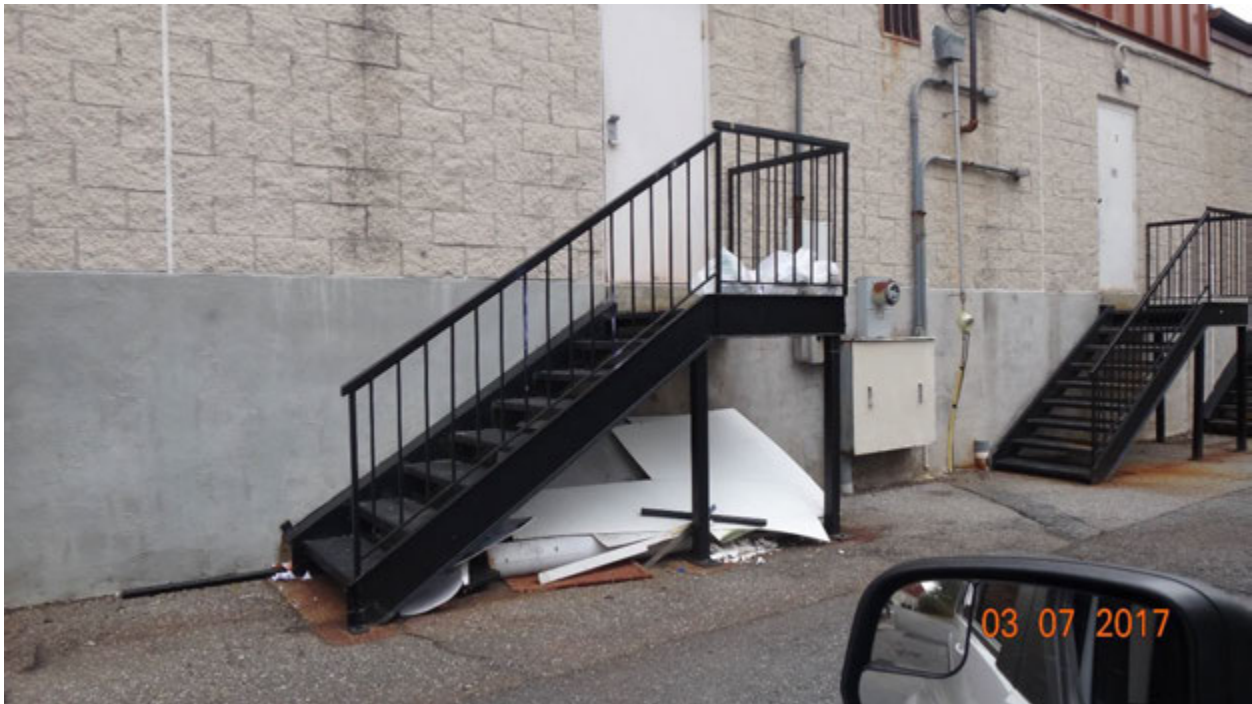
Figure 3. Bags of trash and loose debris behind and beneath the rear door for Suite R

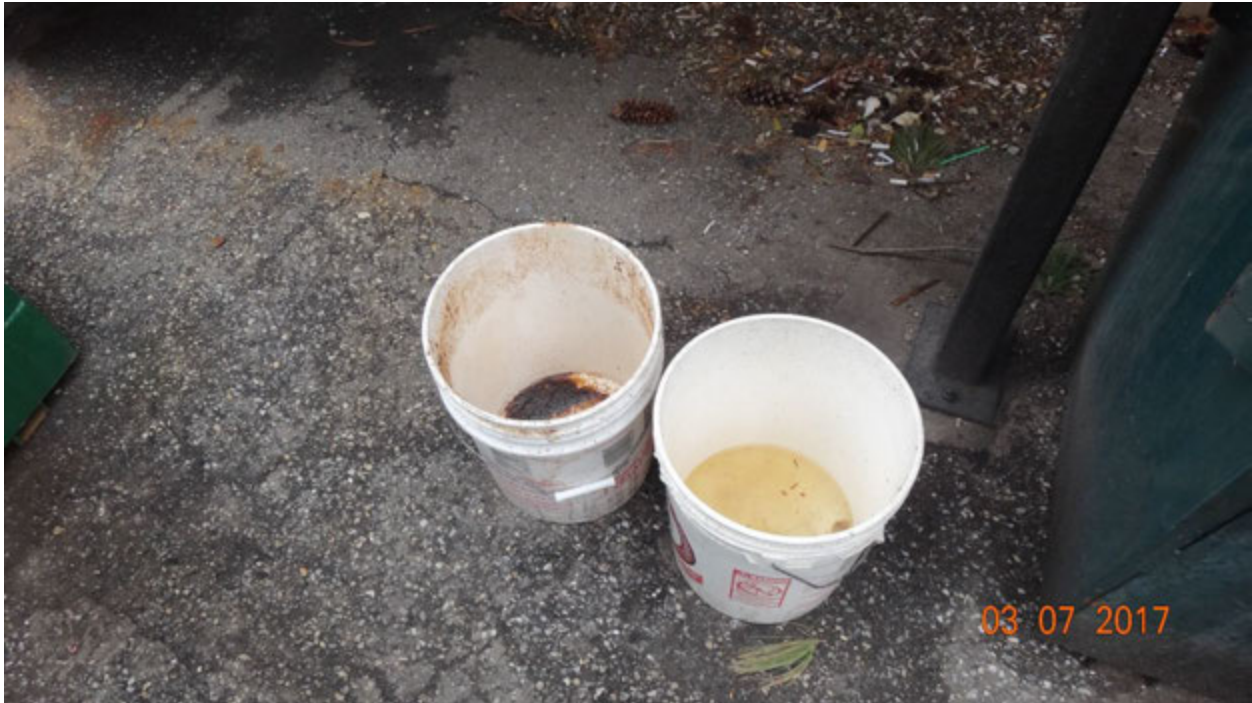
Figure 2. A view into the small buckets in Figure 1 showing residual contents

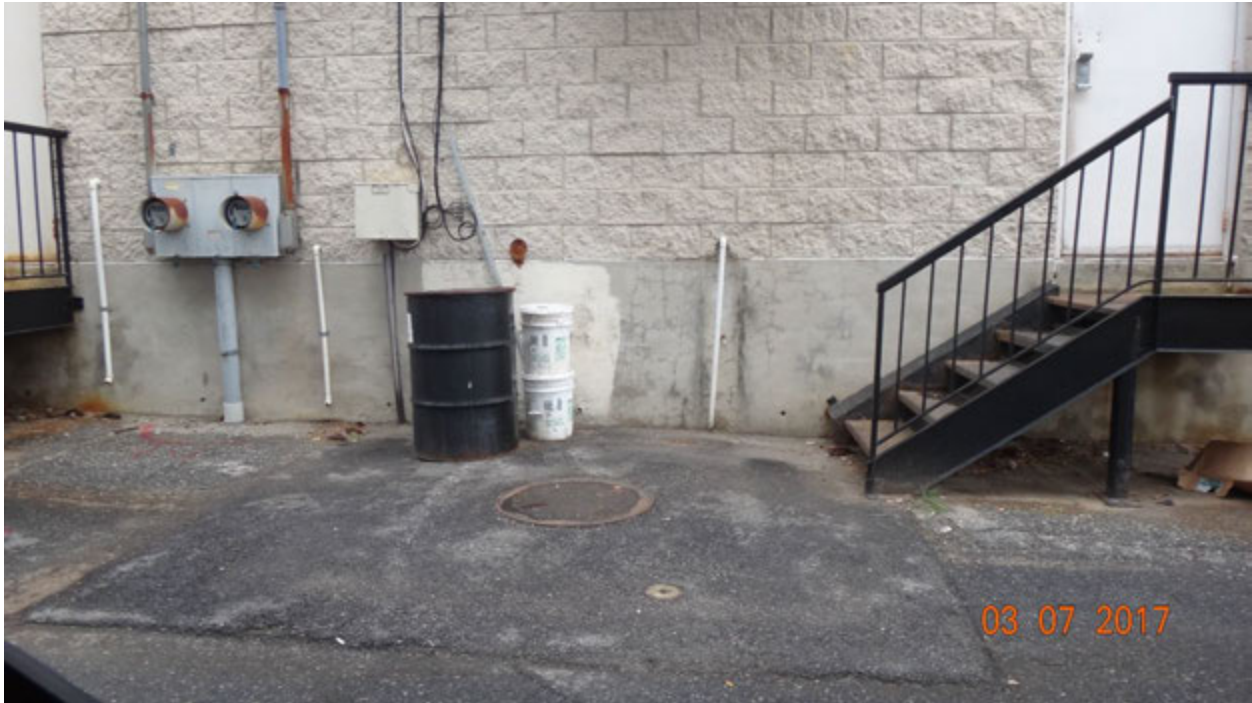
Figure 4. A 55-gallon drum and two apparently sealed buckets which may have been associated with functions at the Capri Pizza restaurant or the nearby dry cleaners business

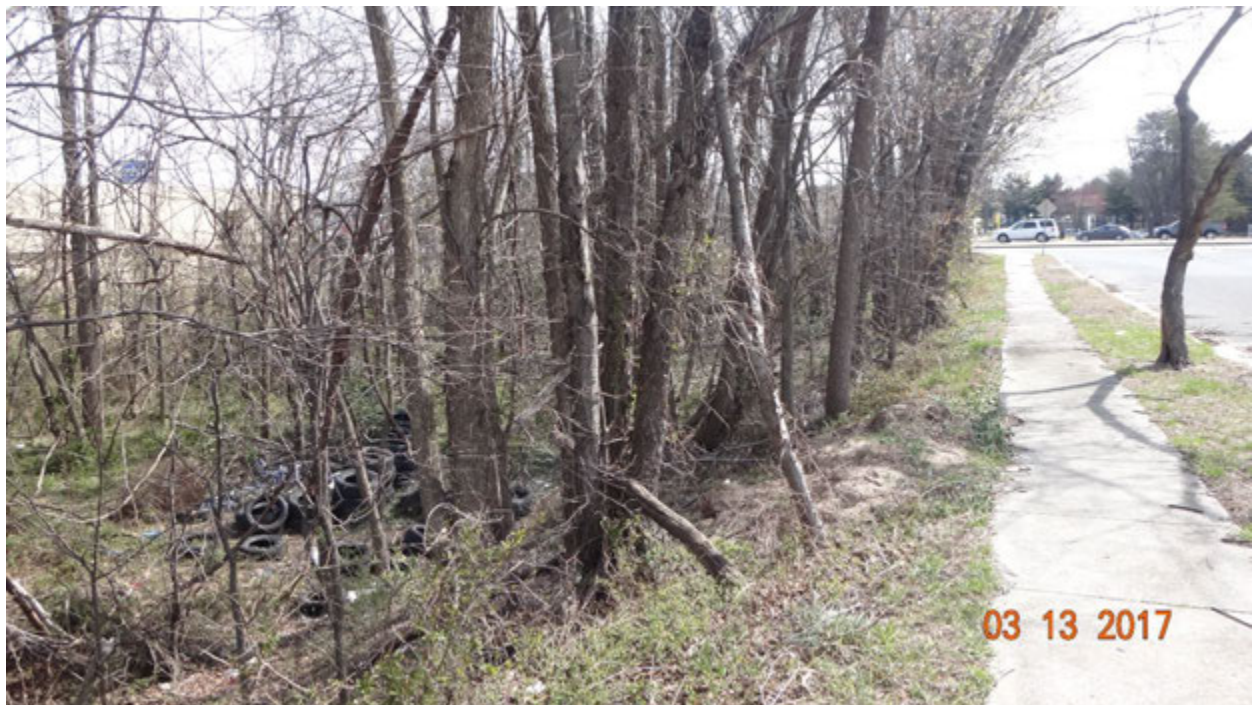
While investigating outfall L09C4O005, near East Park Drive, a Versar field team found a dump site which had amassed an extensive collection of discarded tires in a wooded area downhill of the road (Figure 1). Upon closer inspection, the team noted an adjacent area with a significant amount of debris, including beer cans, bottles, and other trash (Figure 2). The arrangement of a neatly stacked wall of tires and accumulated debris associated with food consumption suggested that this area may be frequently used as a hidden place to congregate or as a semi-permanent living arrangement by one or more people. The trash and tires were located near a stream; as such, the debris or liquid releases from the site may pose a pollution hazard to the stream. An area map, indicating the location of the dump site, is provided in Figure 3.

Figure 1. A dump site for tires (lower left) found at the bottom of a hill along the north side of East Park Drive, west of the intersection with Crain Highway

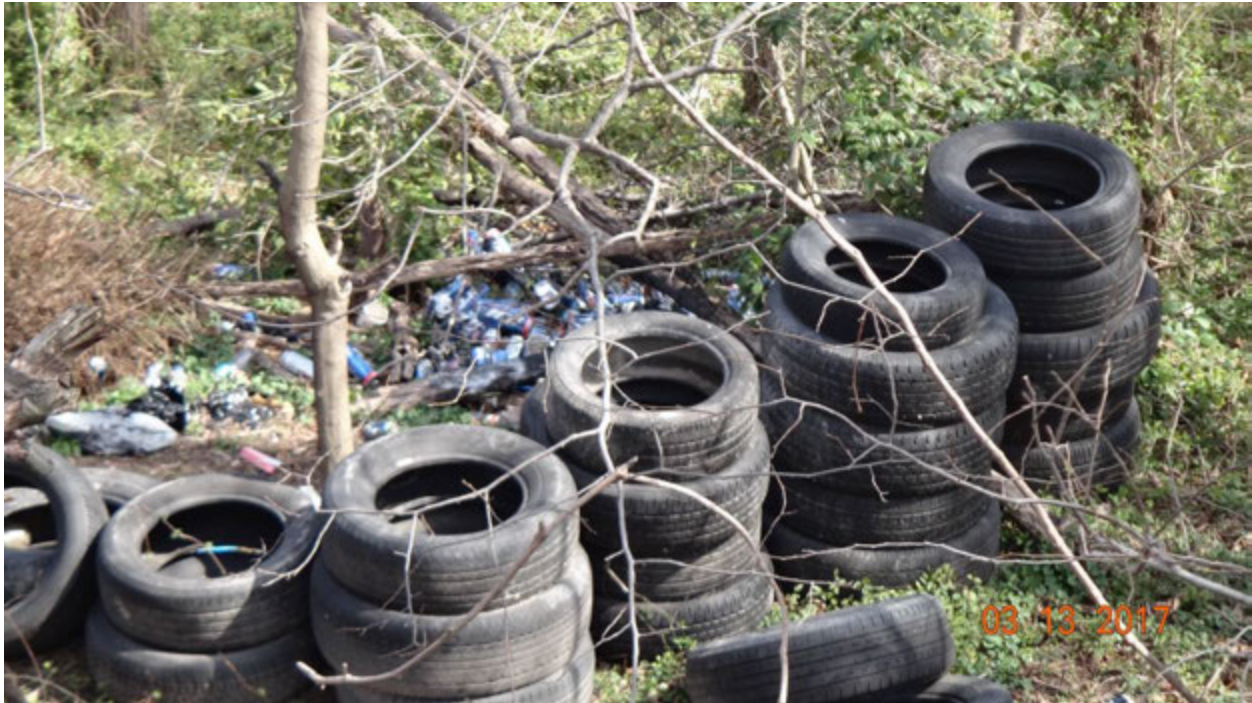
Figure 2. View showing an accumulation of beverage and food packaging waste behind a wall of stacked tires downhill from East Park Drive

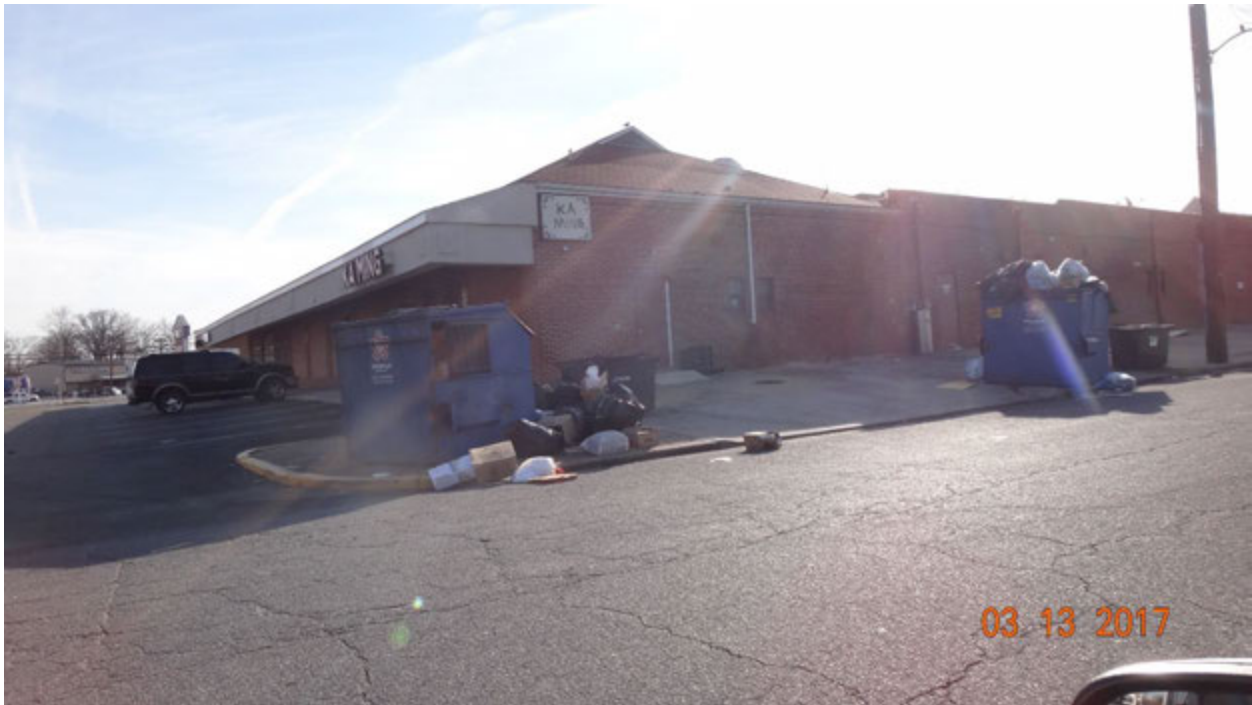
While investigating outfalls in the vicinity, a Versar field team found poor waste management conditions near some of the businesses associated with the Glen Burnie Village Shopping Center. On the sidewalk near two restaurants, Ka Ming and Mi Pueblo (at 7550 and 7556, respectively), the team found dumpsters overloaded with trash (Figure 1). The team could not ascertain that the dumpsters were exclusively receiving waste material from the two restaurants, however, the types of waste that the team observed at the site and the proximity to the restaurants did suggest predominant use by these two establishments. The team documented that excessive debris was strewn around the dumpsters and in the street; the material included full bags of trash, loose cardboard, and food-related materials (Figures 2 and 3). The team noted that trash in and around the bins emitted a foul odor. During the site visit, birds congregated around one bin and pecked at some of the bags (Figure 3). This birds' disturbance had the potential to release and disperse debris from the initial deposition site. The dumpsters were located near and upgrade of a curb inlet. The team also documented two waste grease containers in the same area that displayed dark stains on the ground around them (Figures 2 and 3). There is a concern that the combination of factors (excessive and uncovered debris and waste, spoiling food, and dispersal by animals) demonstrated a cumulative potential for debris and contaminated liquids from the dumpster area to travel to and possibly enter the storm drain system. An area map, indicating the location of the dumpsters and nearby storm drain inlet, is provided in Figure 4.

Figure 1. Two dumpsters near the restaurants Ka Ming (foreground) and Mi Pueblo (background) exhibiting overloaded conditions and excessive debris

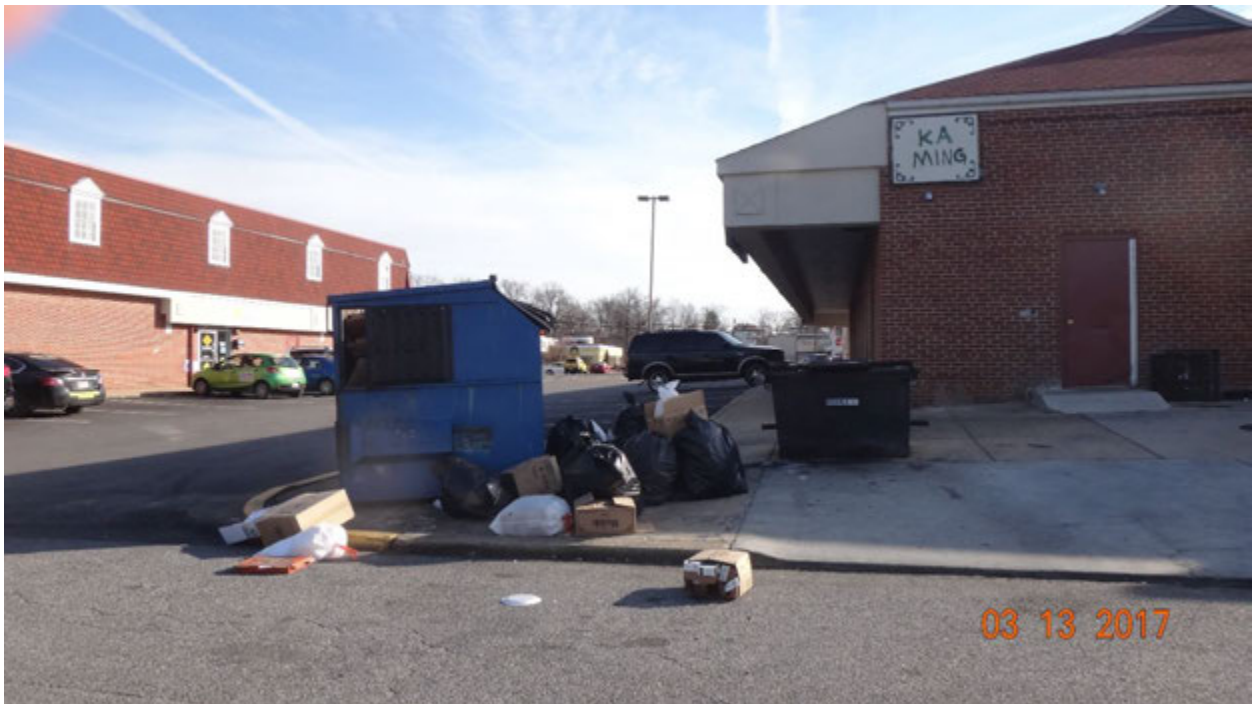
Figure 2. The dumpster and waste grease bin on the north corner of the sidewalk, near the Ka Ming entrance; note the dark stains around the grease bin on the right, also

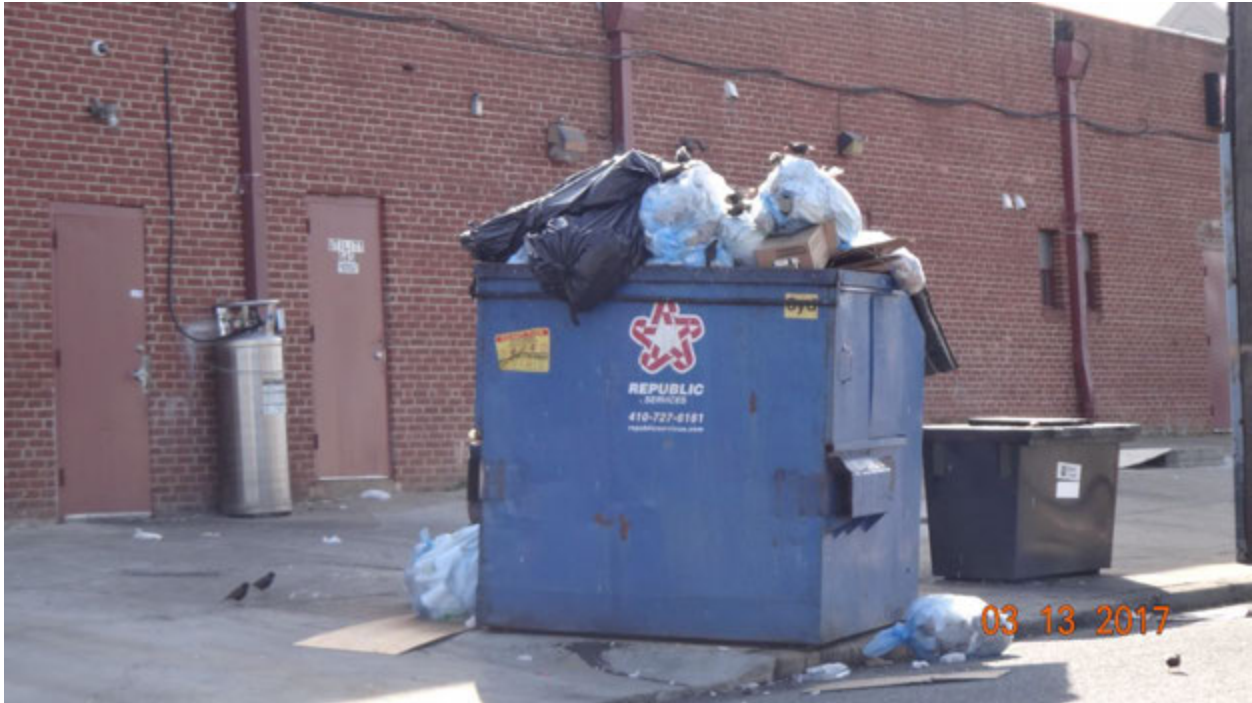
Figure 3. The second dumpster and waste grease bin at the site; note the birds congregating on and near the bags of debris

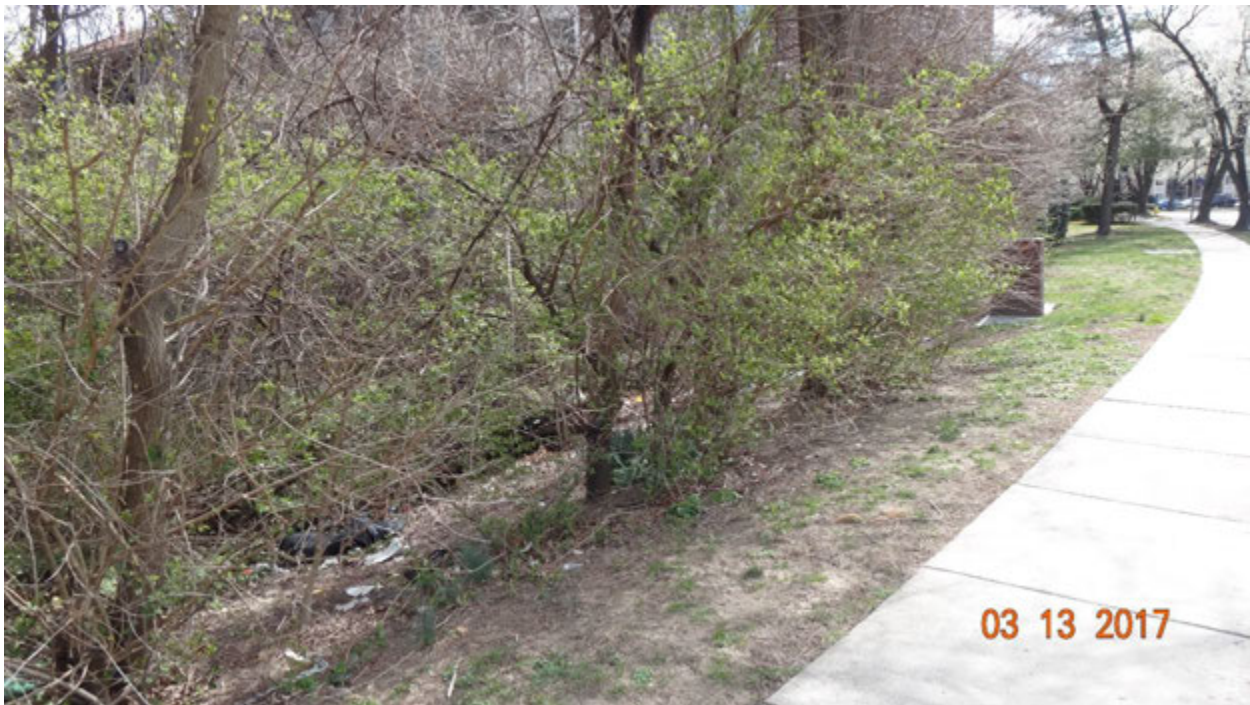
While investigating outfall L09E6O011, on the east side of Green Branch Lane, a Versar field team found a well-worn path and a widespread dump site in a wooded area downhill of the road (Figure 1). The team found trash strewn throughout the wooded area near the road (Figures 2 and 3). Further downhill, the team found debris near the edge of the stream; this material will likely enter the stream during a storm or wind event, due to its close proximity to the flowing water (Figure 4). An area map, indicating the location of the dump site, is provided in Figure 5.

Figure 1. Scattered debris found in the wooded area along the east side of Green Branch Lane; this photograph looks south

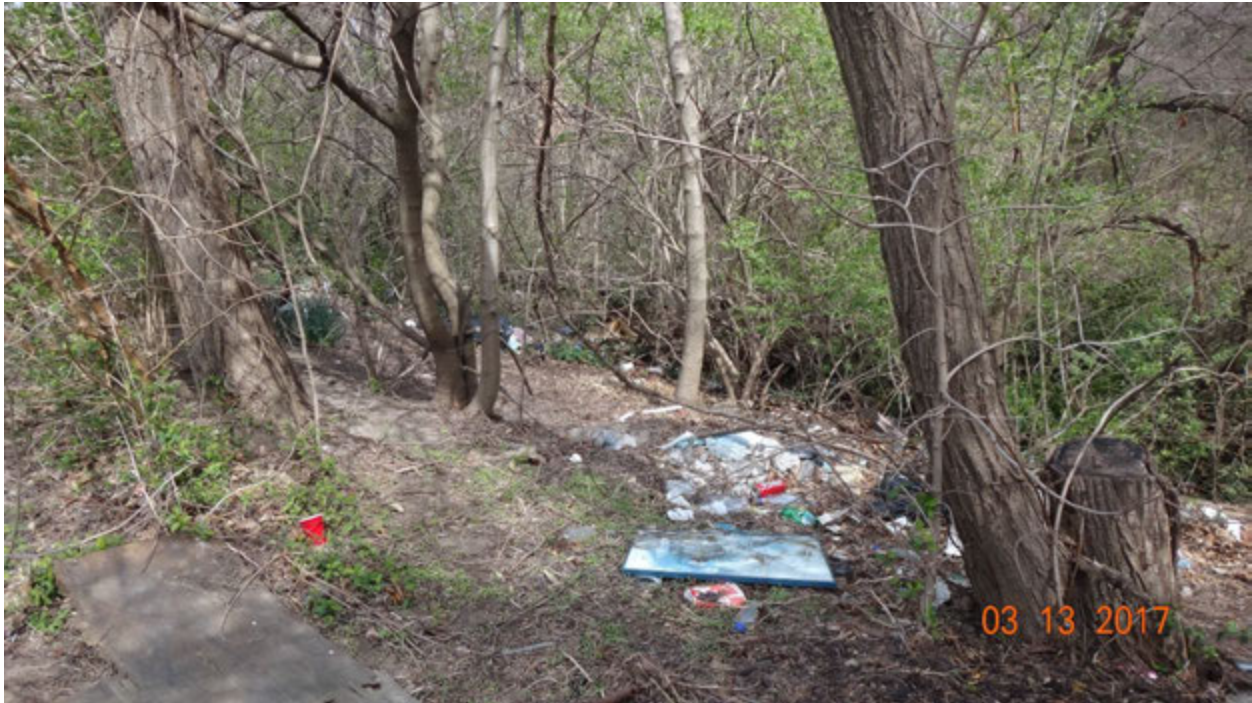
Figure 2. A widespread accumulation of debris in the woods near Green Branch Lane; this photograph looks northeast

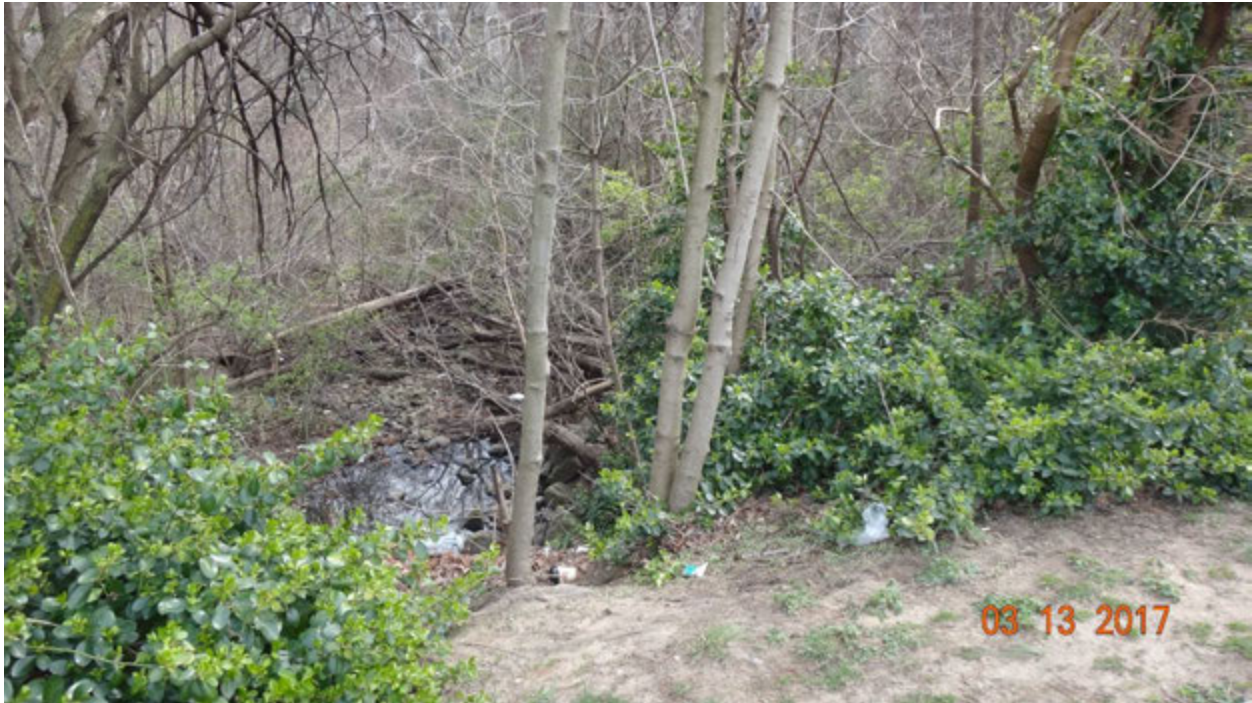
Figure 4. A view of debris found near the edge of the stream; debris close to a stream may enter the stream during a storm event

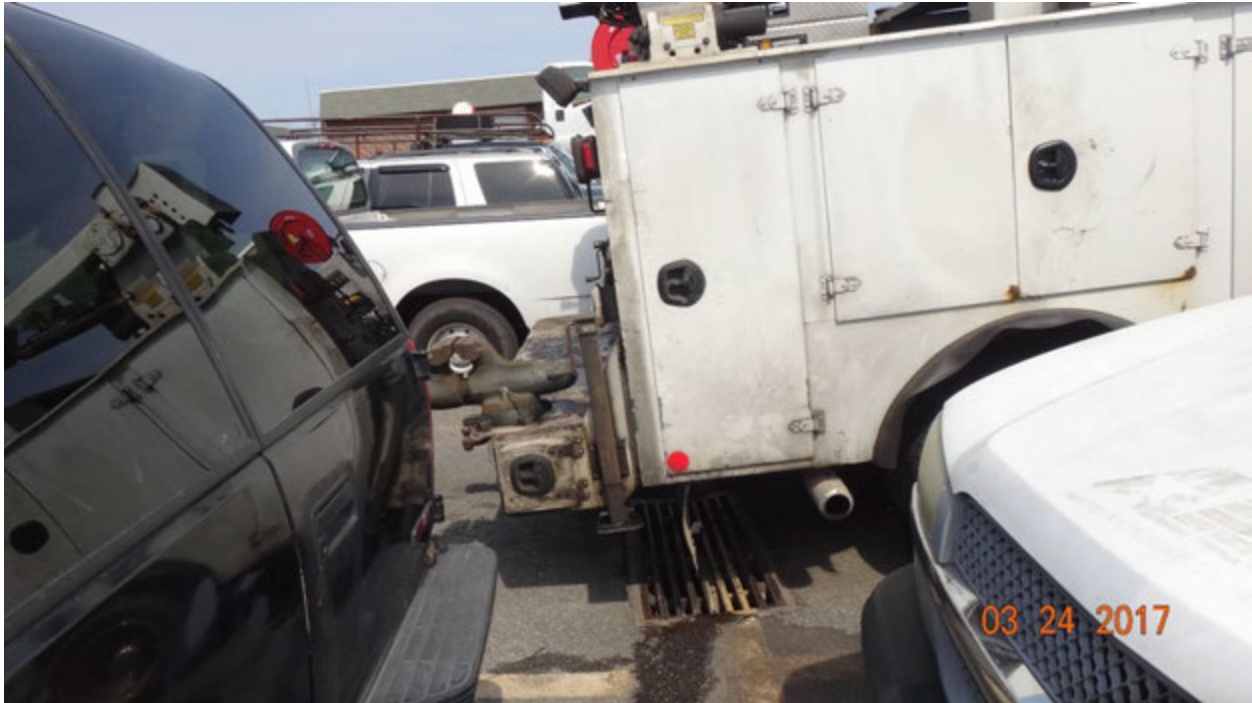
Figure 5. Evidence of fresh (wet) and previous (dried) stains indicating tainted runoff entering the grate inlet from the south (foreground); the fresh stain was associated with the runoff shown in Figure 4

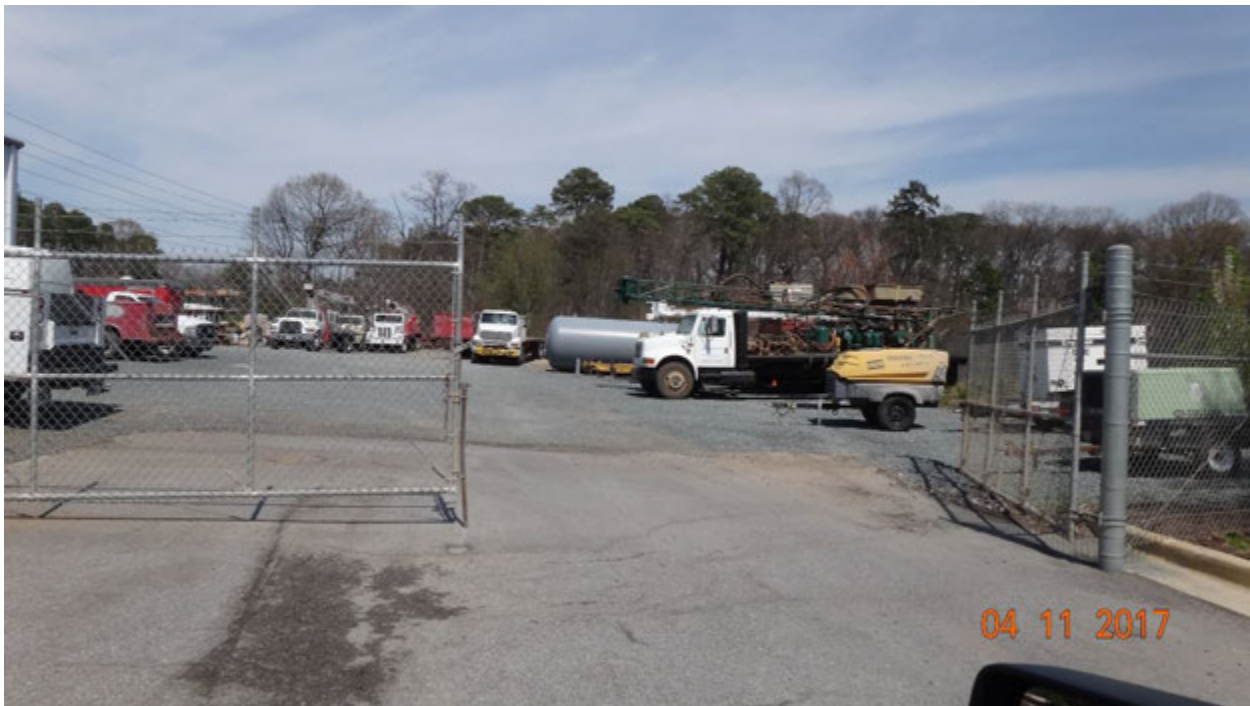
While investigating outfalls in the area, a Versar-LimnoTech field team discovered improper bulk solid storage associated with business operations at the A. C. Schultes facility, located at the above address. According to the company's Web site, <http://www.acschultes.com/>, the business provides water and wastewater services, including well construction and pump and motor repair. At the Millersville site, the field team documented that there were rusted tanks and pipes on the edge of the storage lot adjacent to a stormwater pond (Figure 1). The edge of the lot appeared to have a gravel surface and no curb. A view of the lot looking across the pond showed a steep hill immediately adjacent to the edge of the lot (Figure 2); thus, any debris, erosion or leach runoff, or leaked fluids have the potential to escape the fenced lot and enter the stormwater system directly. An area map is provided in Figure 3.

Figure 1. A view of some of the equipment stored on the lot; note the equipment stored along the perimeter, right and background (the stormwater pond is off the photograph to the right)

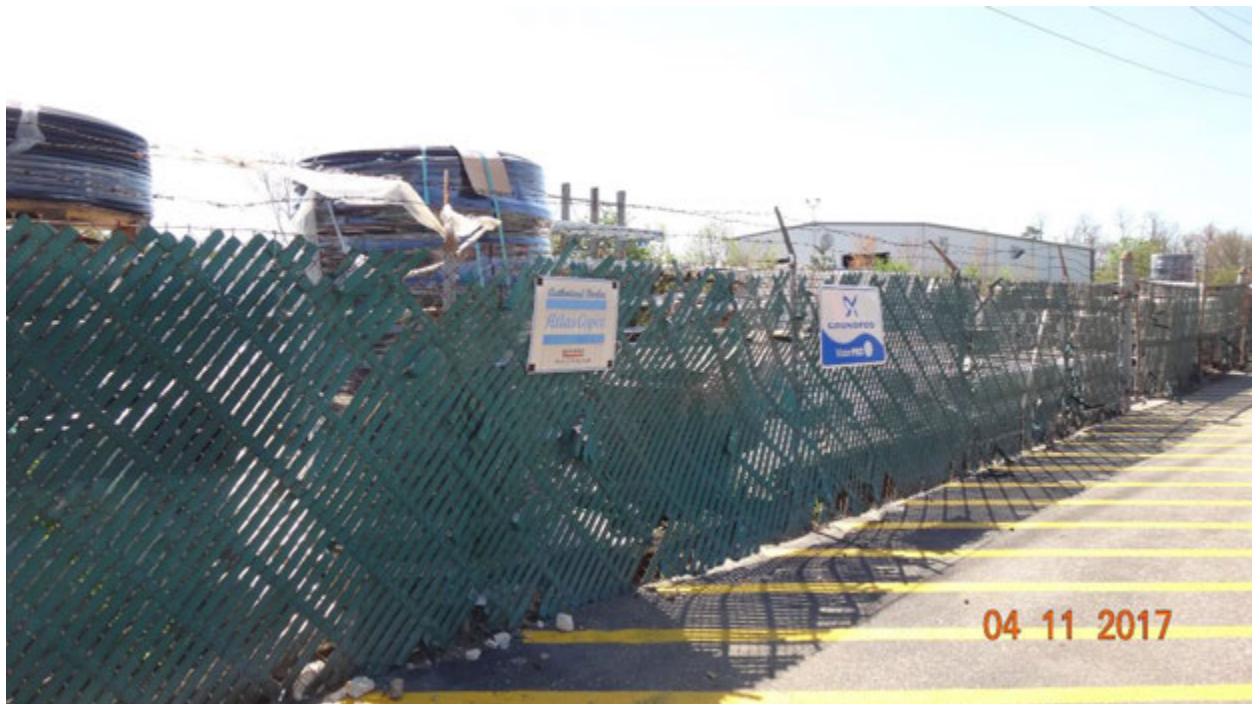
Figure 1. A fence segregating the storage area (background) from the parking lot (foreground)

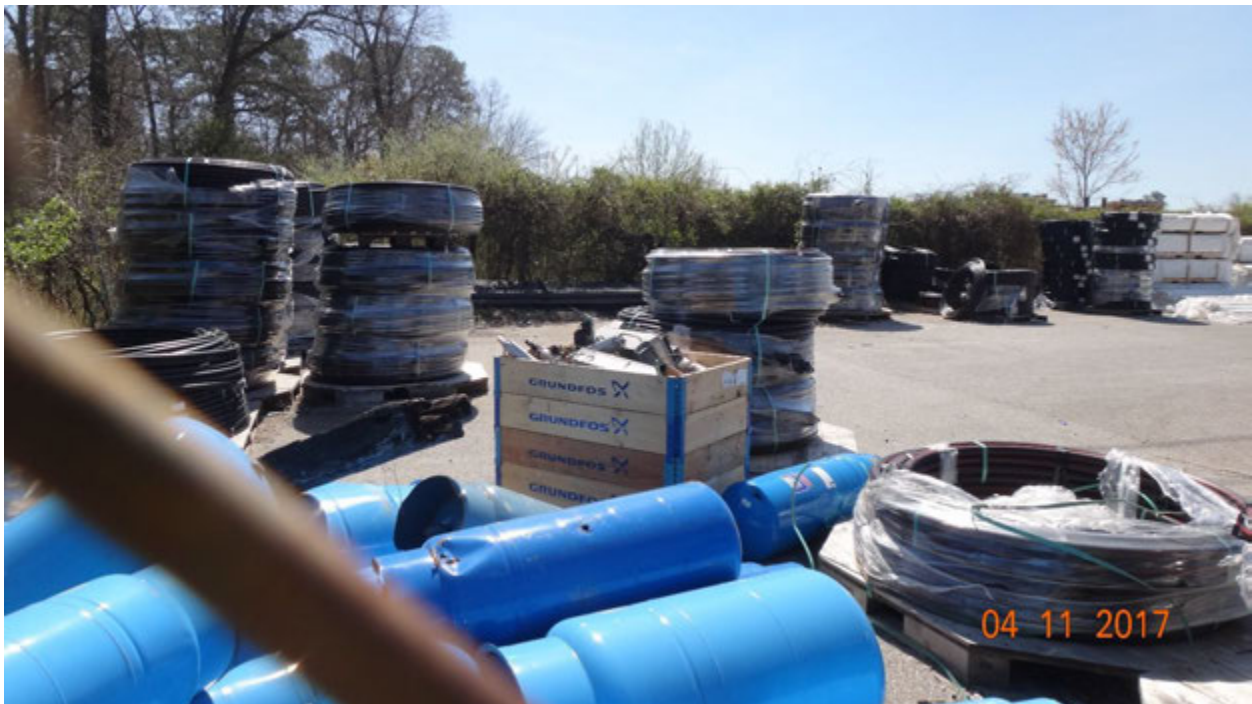
Figure 3. View inside the storage area showing an open bin for discarded materials (center), pressure tanks, bulk rolls of tubing, and stacks of pipes

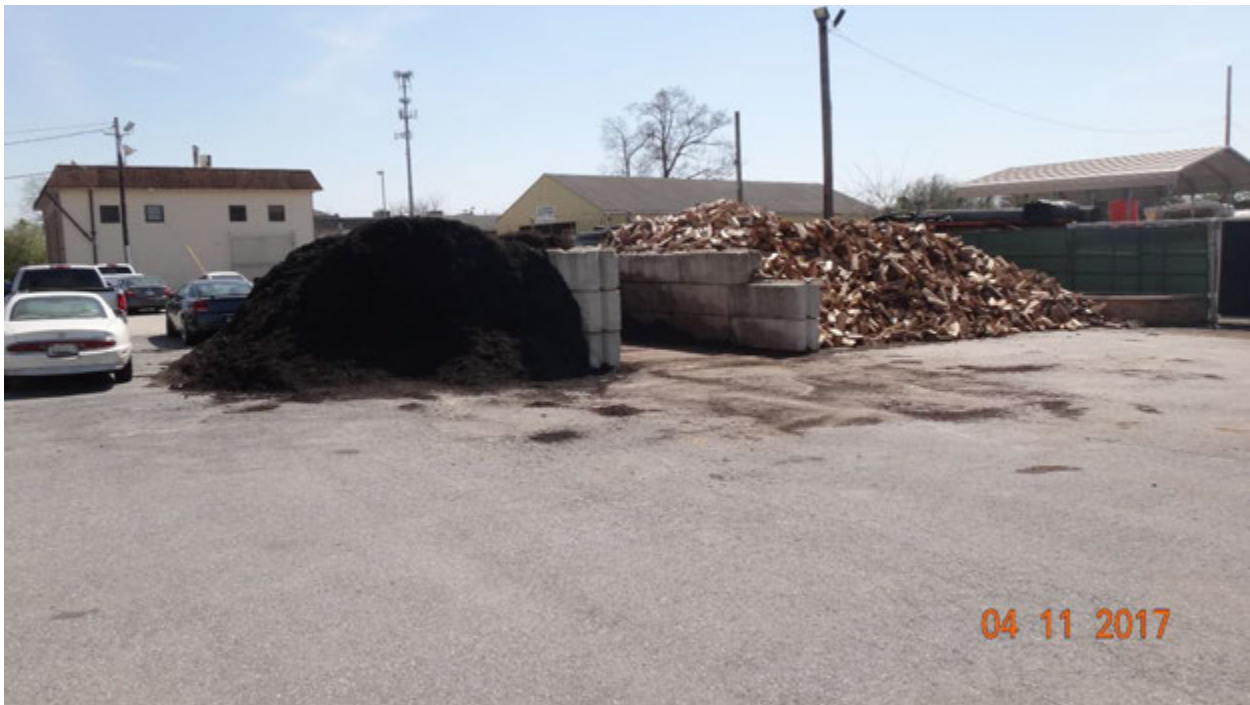
Figure 1. An uncovered pile of mulch found outside the enclosures in the front of the lot near the main road

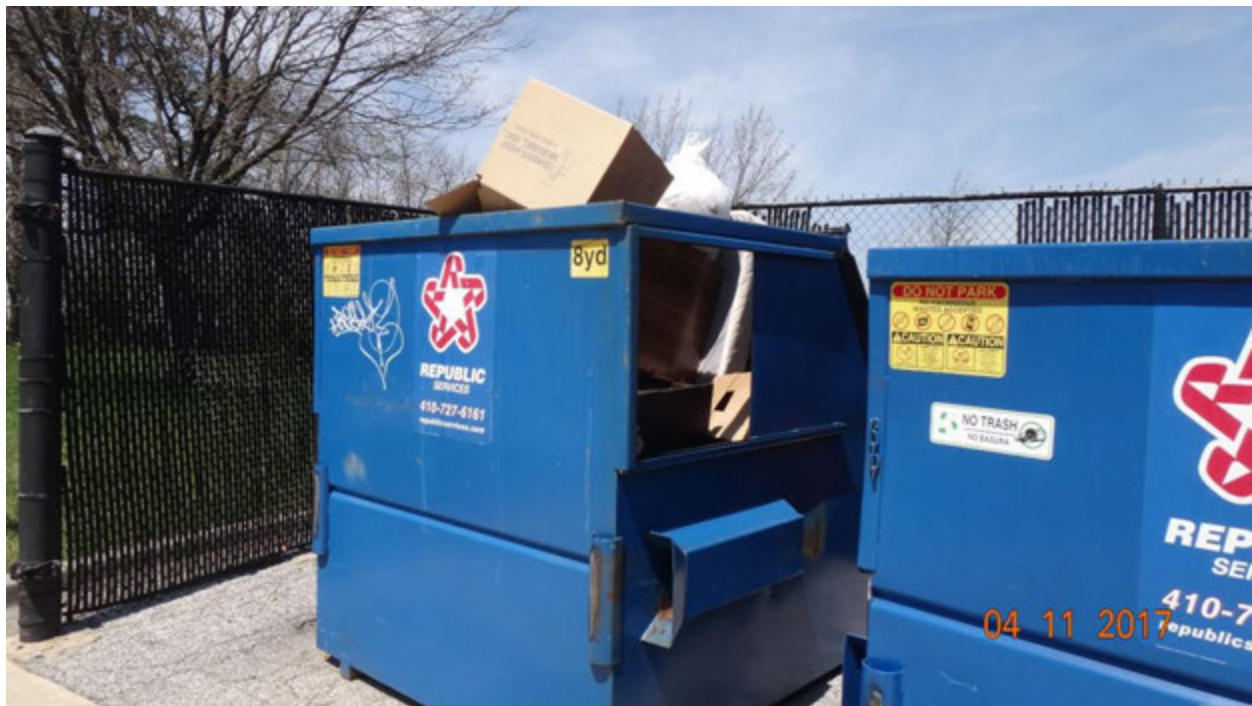
Figure 1. An overfilled dumpster found in a pen behind the Goodwill thrift store

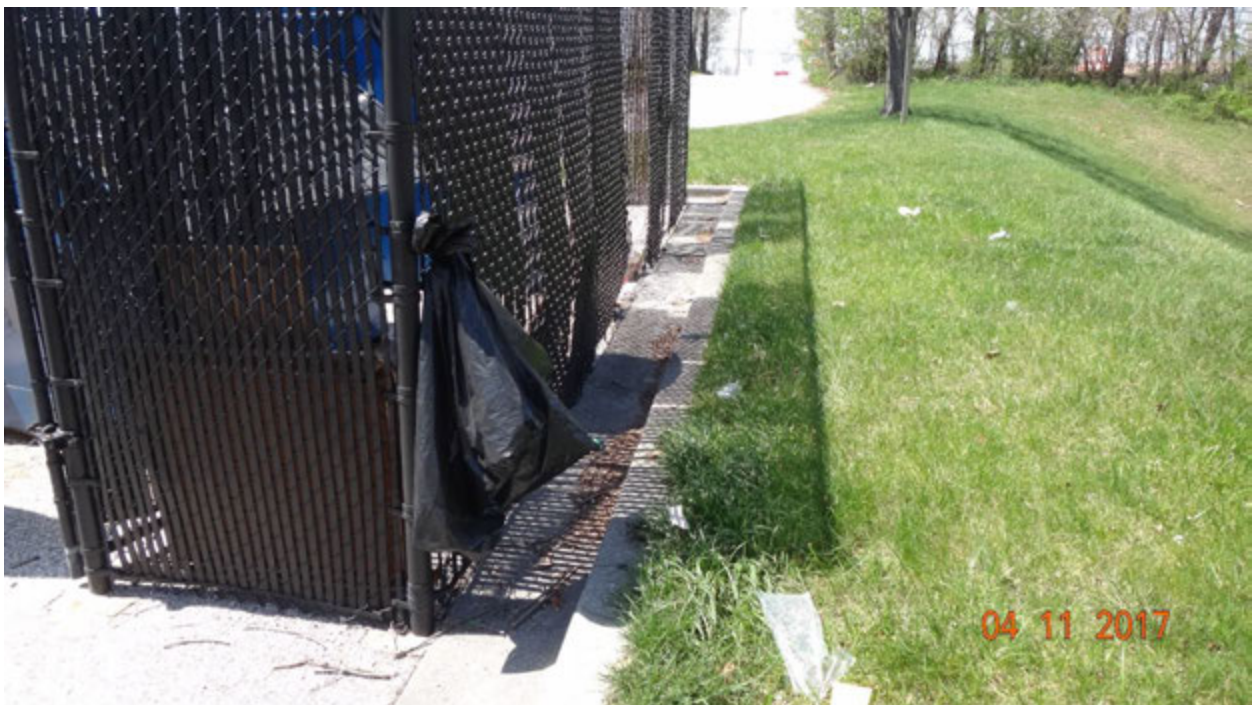
Figure 3. A trash bag tied to the rear of the pen contained loose and unsecured debris

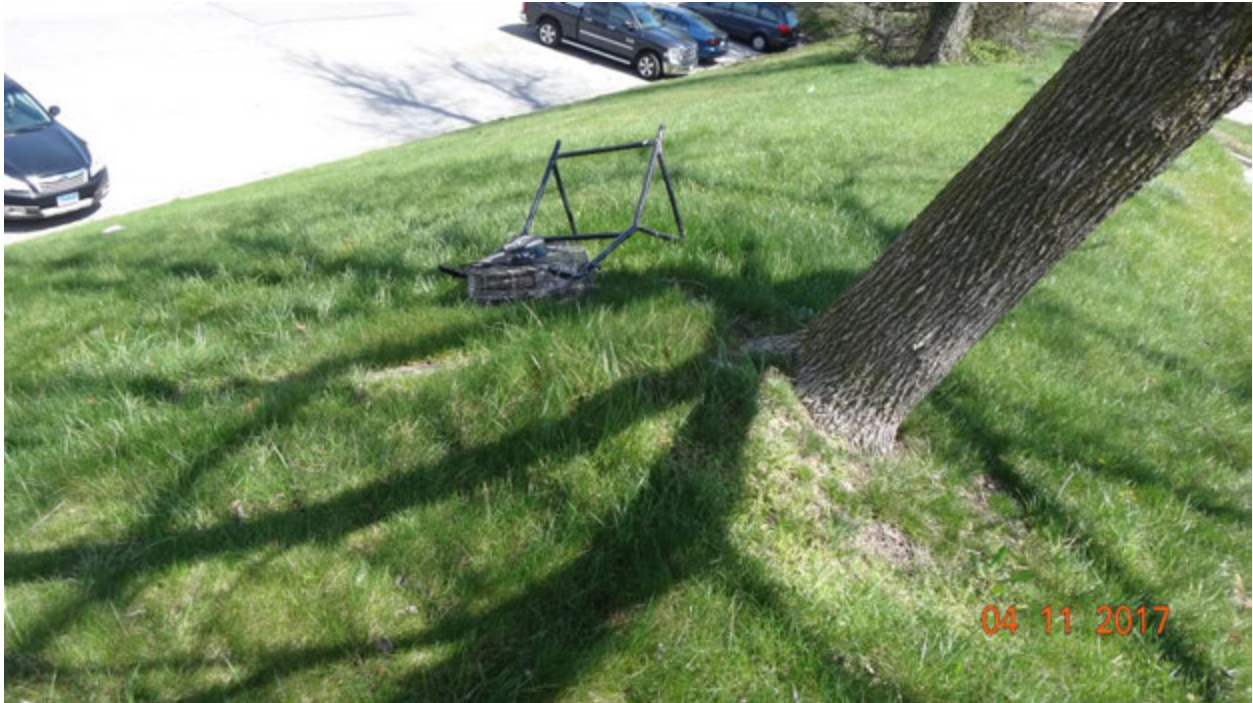
Figure 4. A discarded floor fan found on the hill behind the dumpsters

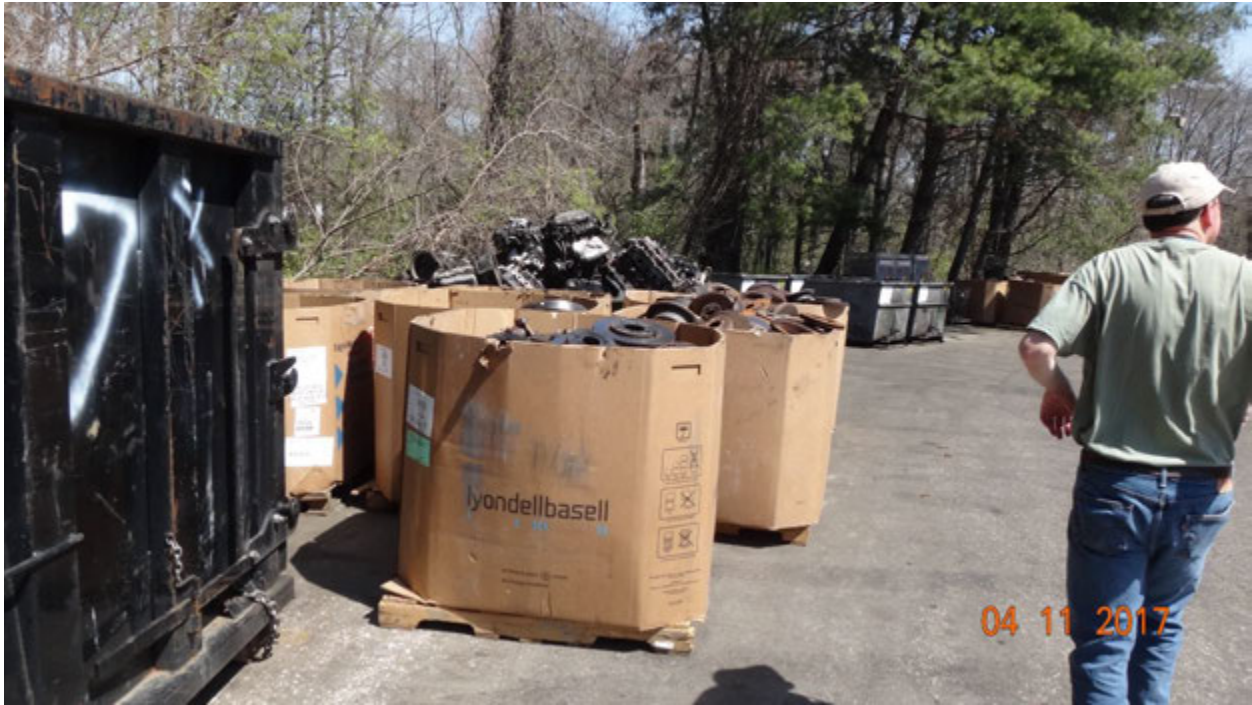
Figure 1. Open boxes and bins used to segregate and store used auto parts

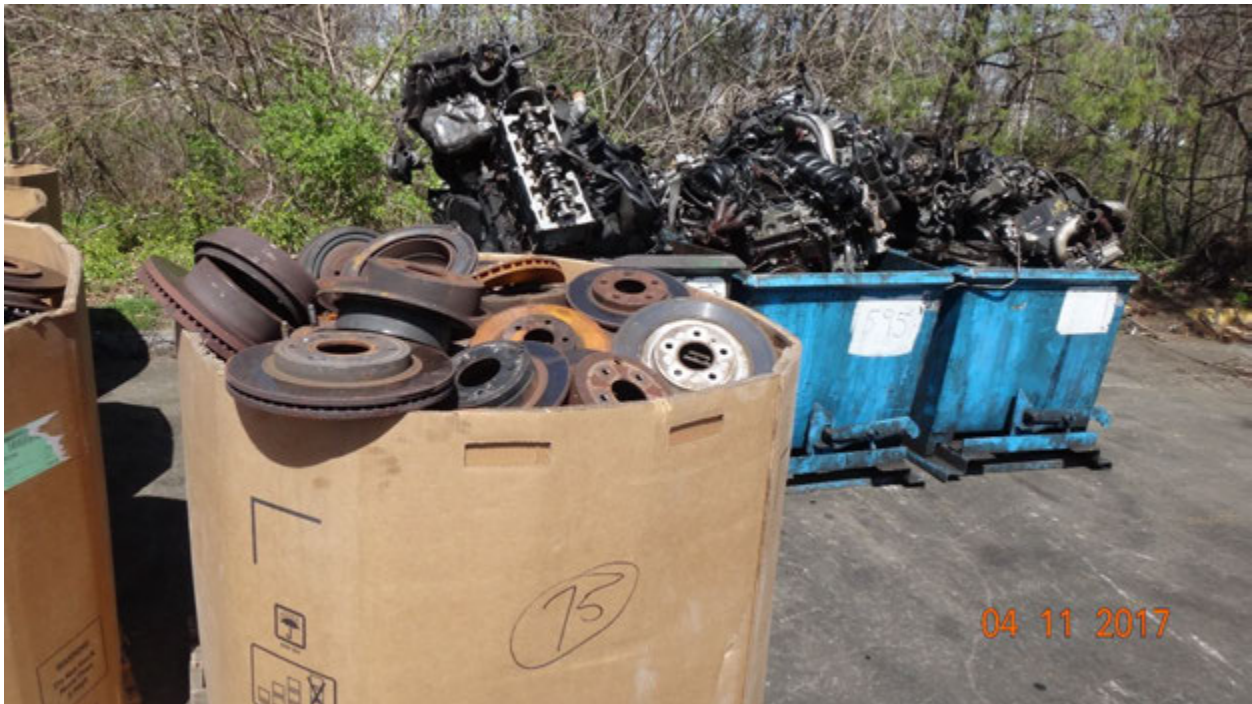
Figure 2. Boxes of rusted rotors stored in boxes (foreground) and bins with large automotive components (background) on the lot; see Figure 3 for more detail

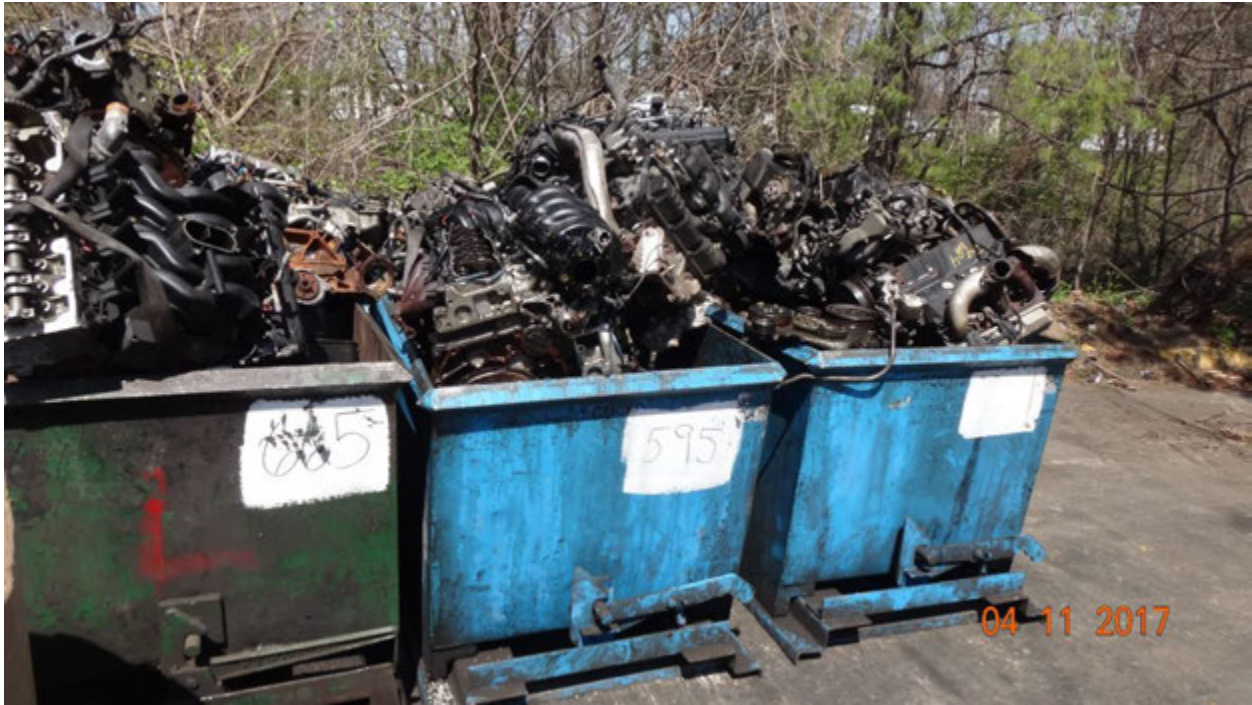
Figure 3. Overfilled bins with large automotive components stored on the pavement

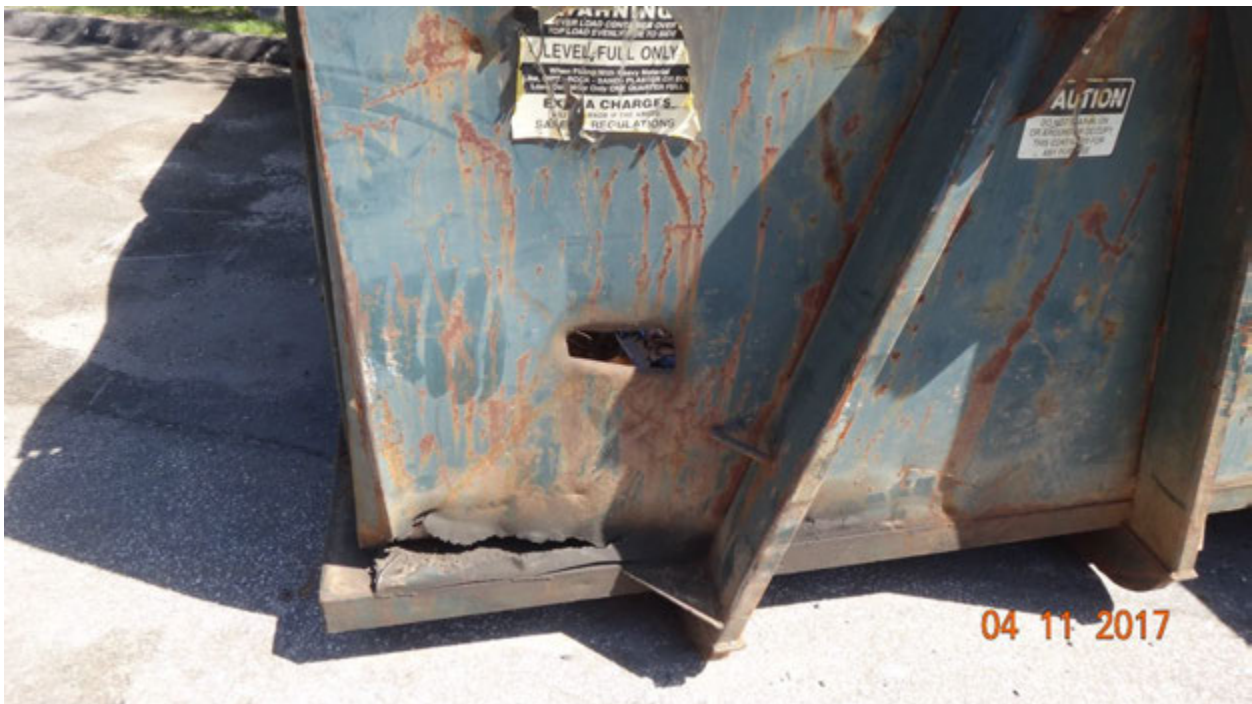
Figure 6. A rusting rollaway dumpster exhibiting a puncture hole on the side and a tear at the bottom; note stains on the pavement (left)
