**ANNE ARUNDEL COUNTY
ILLICIT DISCHARGE DETECTION
AND ELIMINATION**

2017 ANNUAL REPORT

PERMIT NUMBER MD0068306

FINAL: January 2018

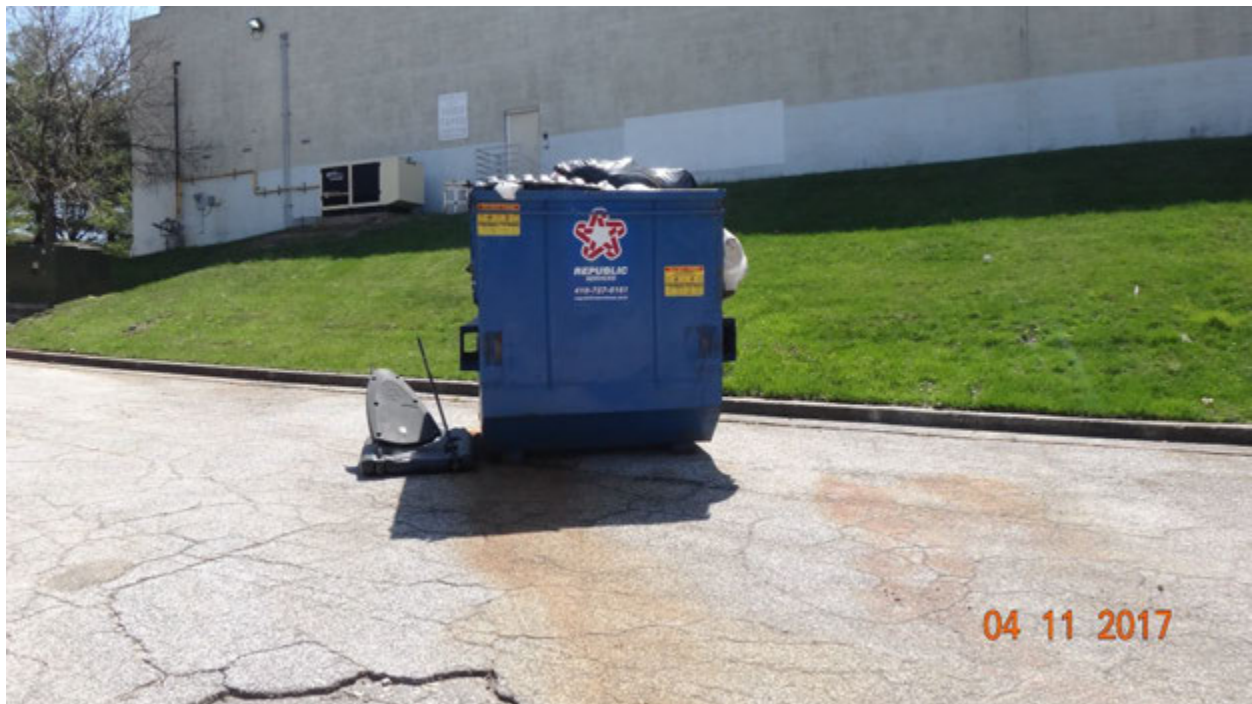
Figure 1. An overfilled dumpster found in a paved area near the Shoppers Food Warehouse grocery store; note the debris on the left that was part of a basketball hoop system

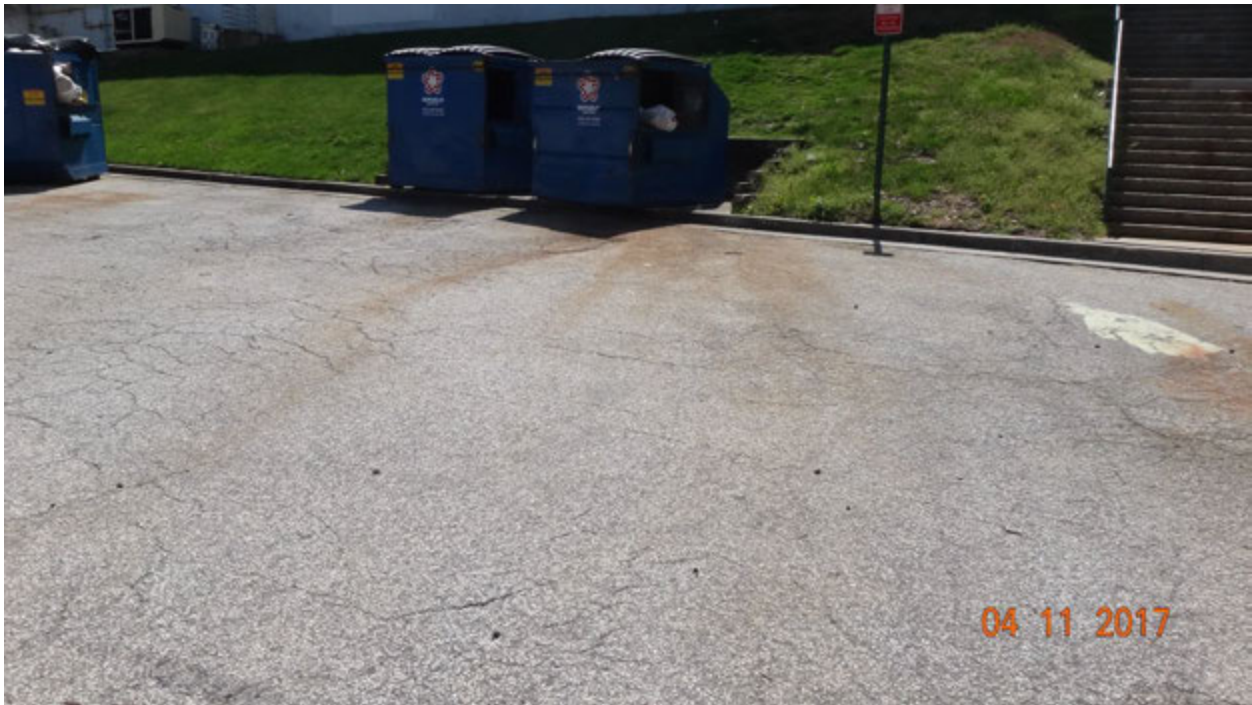
Figure 2. Orange stains evident on the pavement near three of the dumpsters that suggest prior leakage

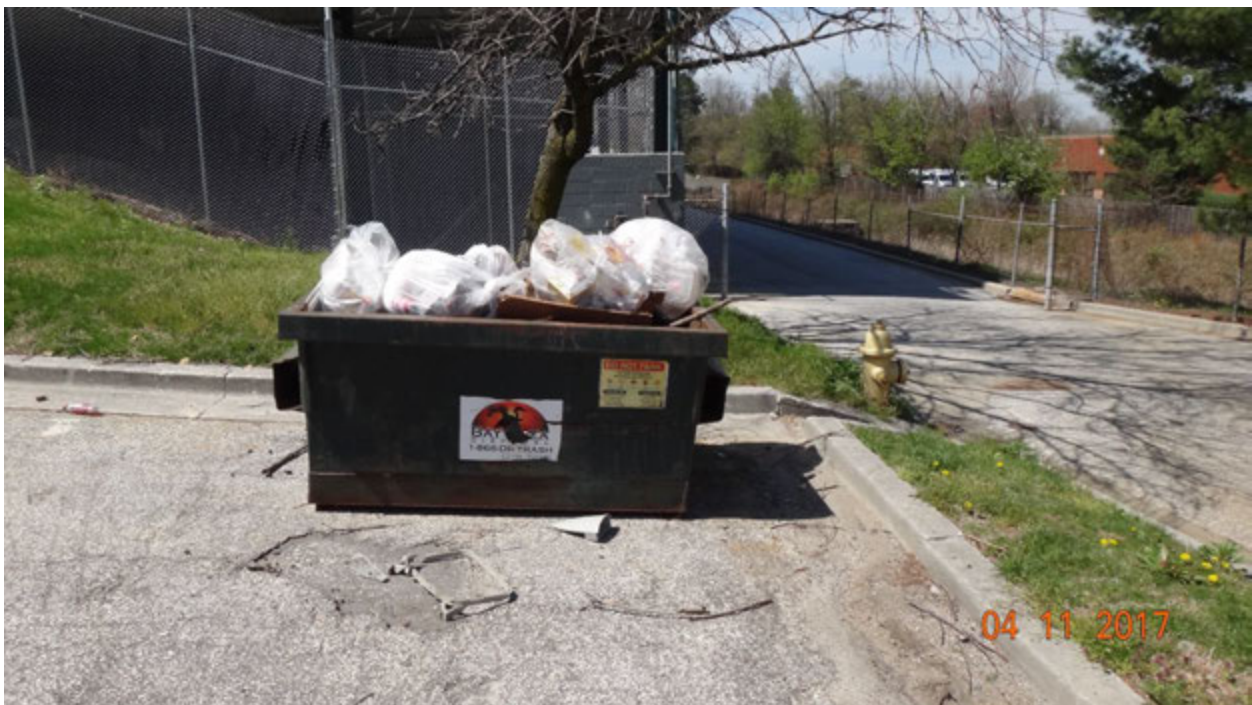
Figure 3. A second overfilled dumpster found near a curb cut-out; note the curb inlet across the side street

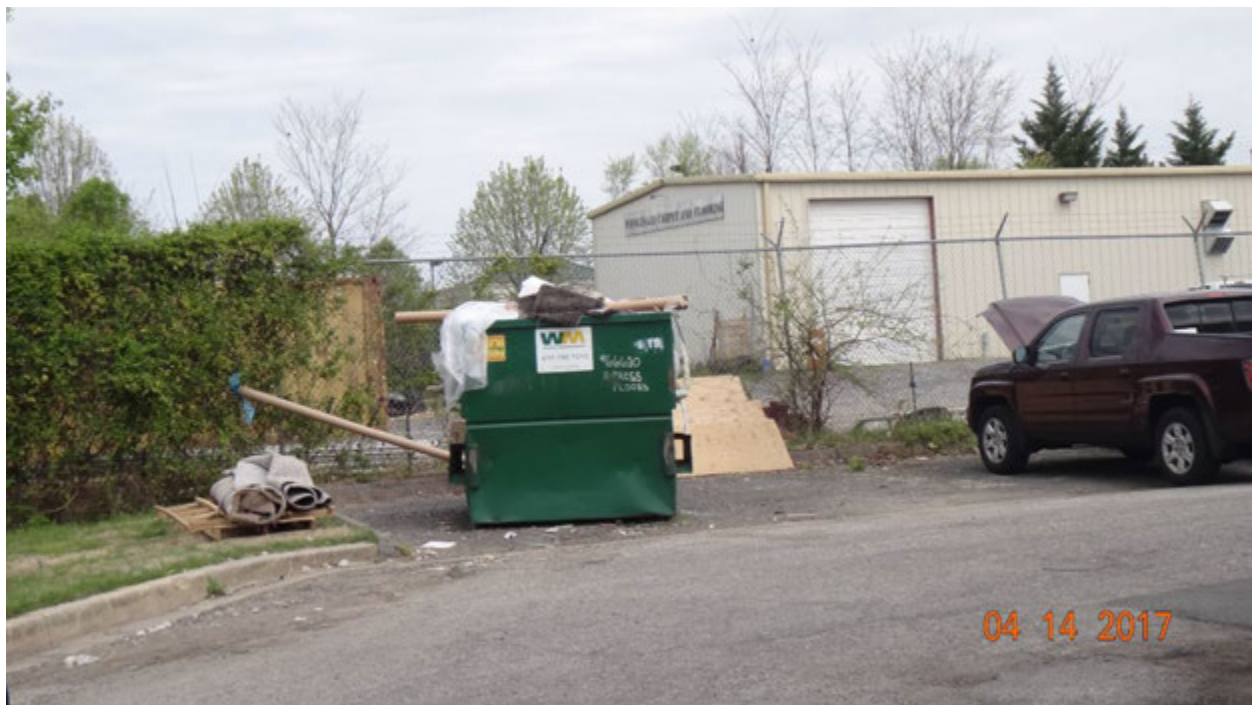
Figure 1. An overfilled dumpster with debris on and around it found on the parking lot of the Chesapeake Plaza; note the hand-written sign that reads "X-Press Floors"

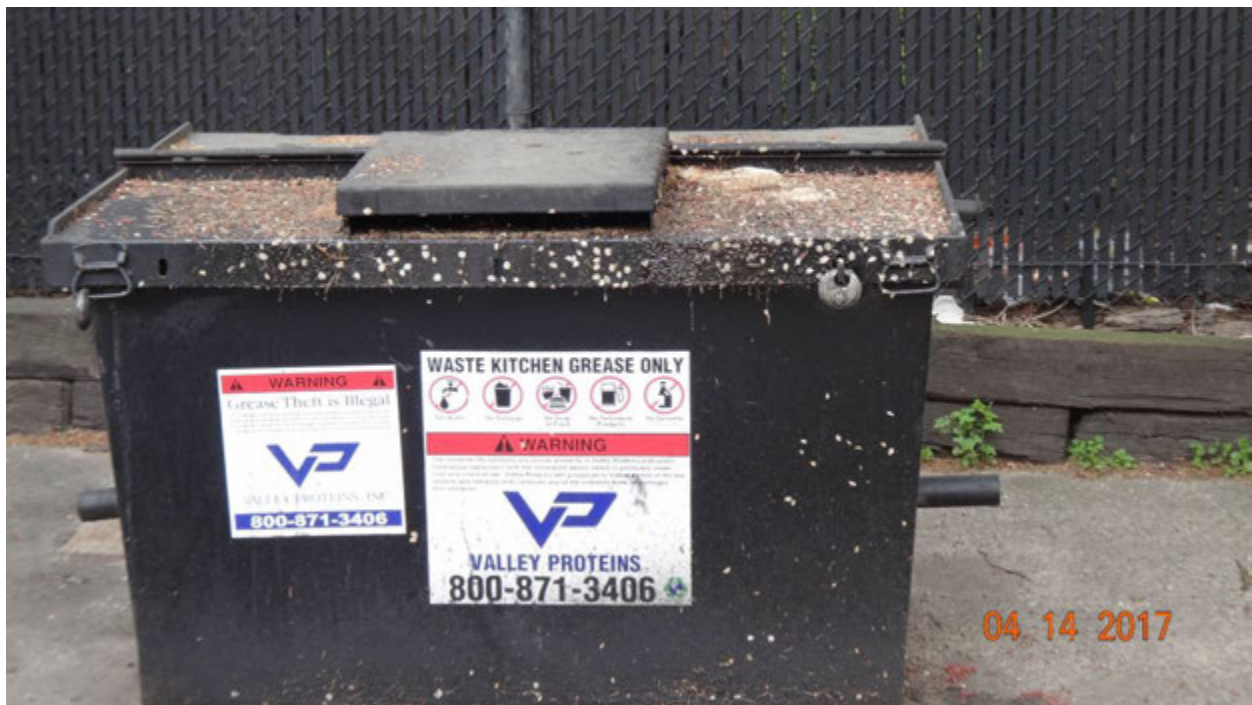
Figure 1. A waste grease container stored in a corner of the parking lot behind the Old Mill Plaza businesses

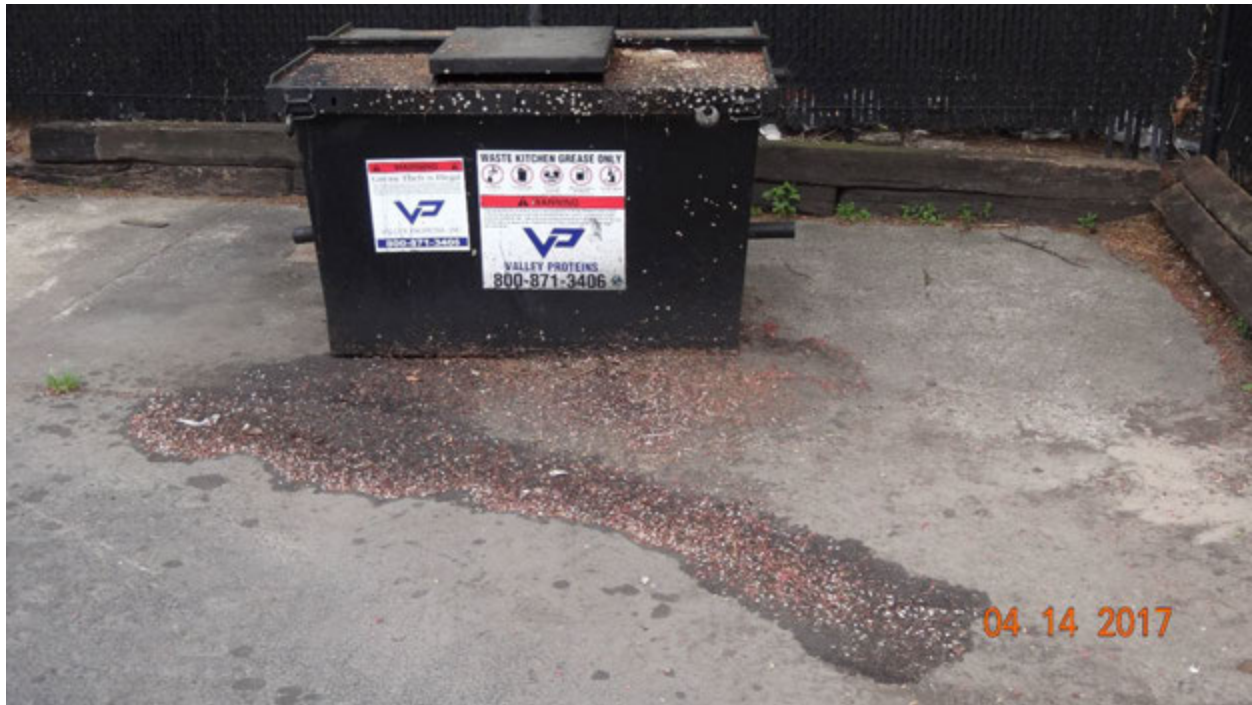
Figure 2. Evidence of a leak or a spill distributing waste grease to the pavement adjacent to the container

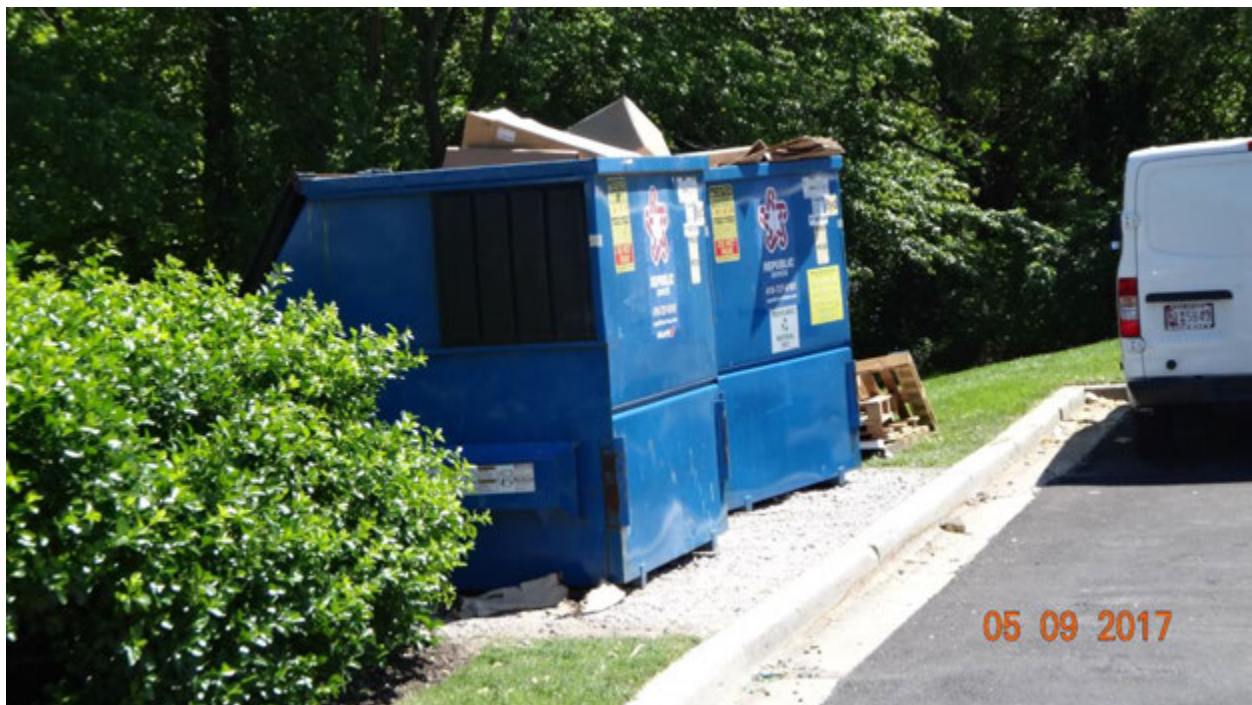
Figure 1. Two open and overfilled dumpsters found on a gravel pad adjacent to the parking lot near 413 Headquarters Drive

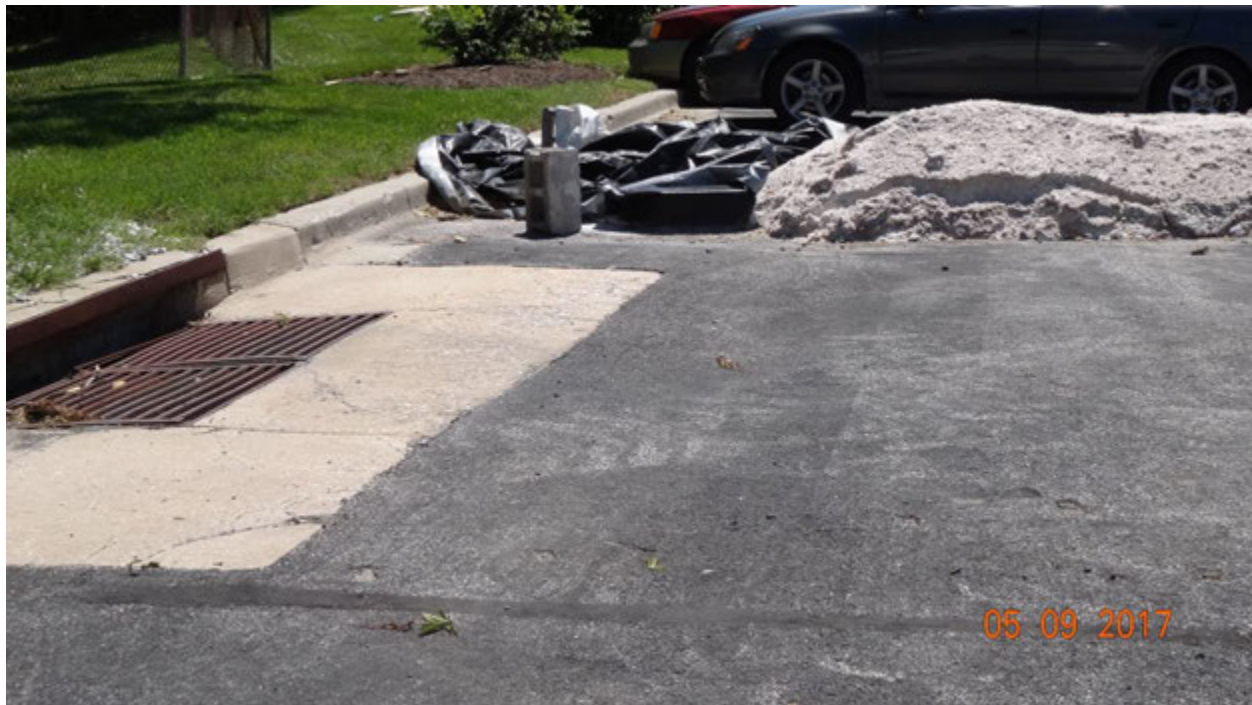
Figure 1. A pile of road salt found uncovered on the parking lot near a stormwater inlet; note the black tarp and concrete blocks to the left of the pile in the photograph
