**ANNE ARUNDEL COUNTY  
ILLCIT DISCHARGE DETECTION  
AND ELIMINATION**

**2019 ANNUAL REPORT**

**PERMIT NUMBER MD0068306**

August 2019

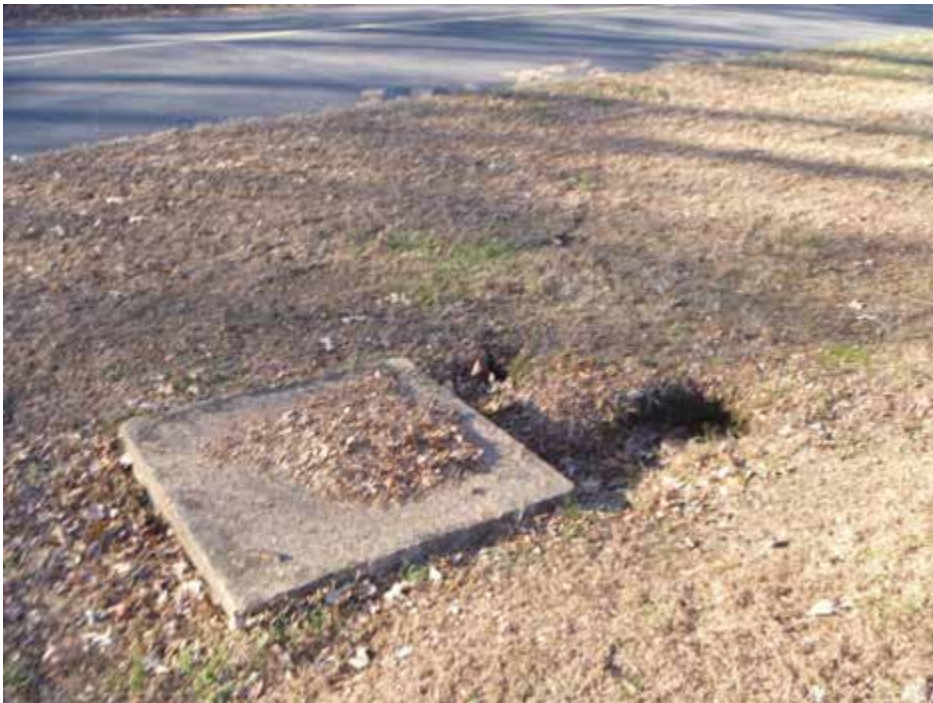
While investigating target outfalls in the vicinity, a Versar team found evidence of collapsed infrastructure in the area immediately adjacent to the inlet with Feature ID W10I023. The team observed the conditions at 2:10 p.m. on Tuesday, December 11, along Locust Cove Road, in John (Jack) Downs Memorial Park. The team observed two depressions in the swale on the north side of the structure (Figure 1). The team estimated the subsidence depth to be approximately 18 inches. An area map, indicating the location of the inlet, is provided in Figure 2.

Figure 1. Evidence of soil subsidence immediately adjacent to the inlet, Feature ID W10I023

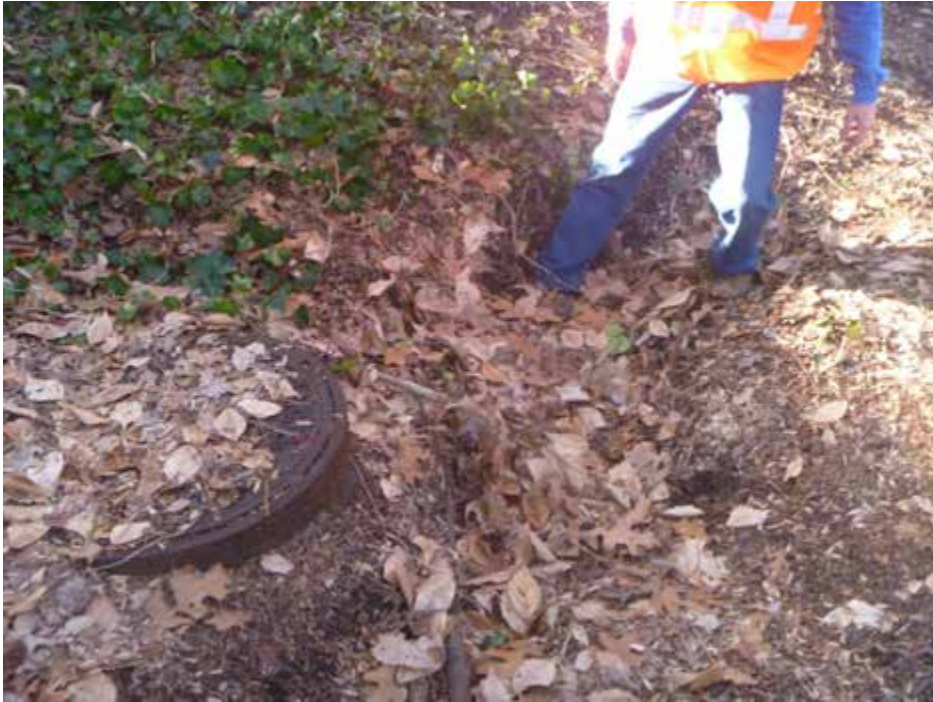
While investigating target outfalls in the vicinity, a Versar team found evidence of collapsing infrastructure at a manhole in the network associated with outfall S14O014. The team observed the conditions at 3:35 p.m. on Tuesday, February 5, along Via Amorosa. A homeowner alerted the crew to significant ground subsidence around a manhole approximately 30 feet up-network from the outfall (Figure 1). The crew observed that the outfall was also being undercut by water flowing under the end segment (Figure 2). The team estimated the undercut depth to be approximately 18 inches. An area map, indicating the location of the manhole and the outfall, is provided in Figure 3.

Figure 1. Evidence of soil subsidence immediately adjacent to the manhole

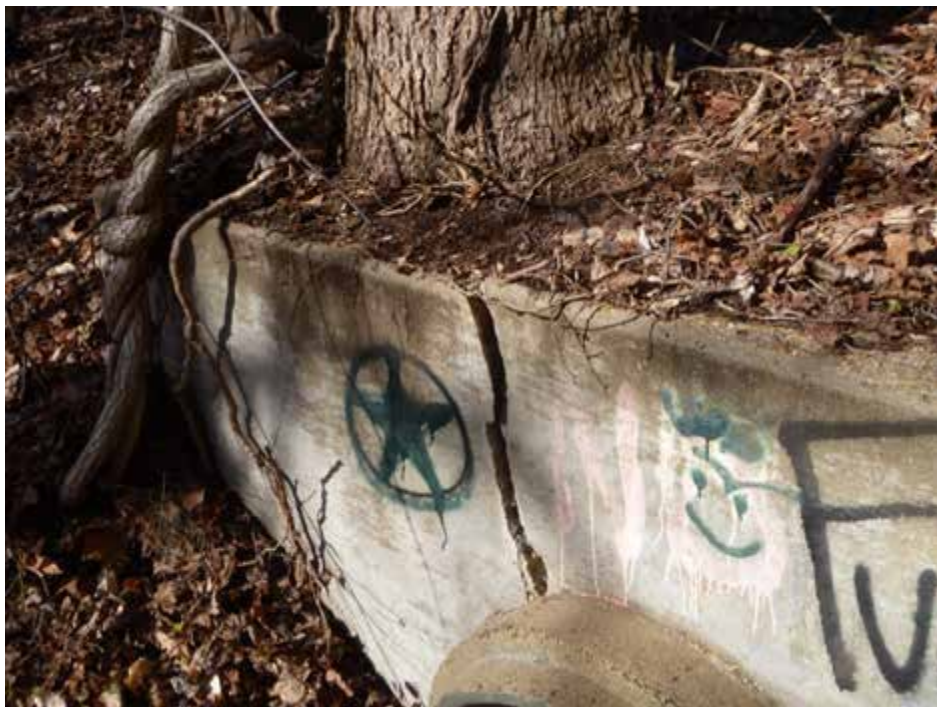
While investigating a target outfall, Facility ID S15O022, a Versar team found evidence of collapsing infrastructure at the endwall associated with the outfall. The team observed the conditions at 1:55 p.m. on Tuesday, February 5, at the northwest corner of Anne Arundel Community College campus, along Ring Road. The field crew surmised that the roots from a large tree have exerted pressure behind the endwall such that a portion of the structure is now offset by approximately 15 degrees (Figure 1). The forces on the wall are also exacerbating a crack on the face of the structure (Figure 2). These conditions compromise the structural integrity of the endwall, and further damage from water and roots is likely to continue at this site. An area map, indicating the location of the endwall, is provided in Figure 3.

Figure 1. Evidence of a displacement in part of an endwall (Facility ID: S15O022) at the base of a large tree

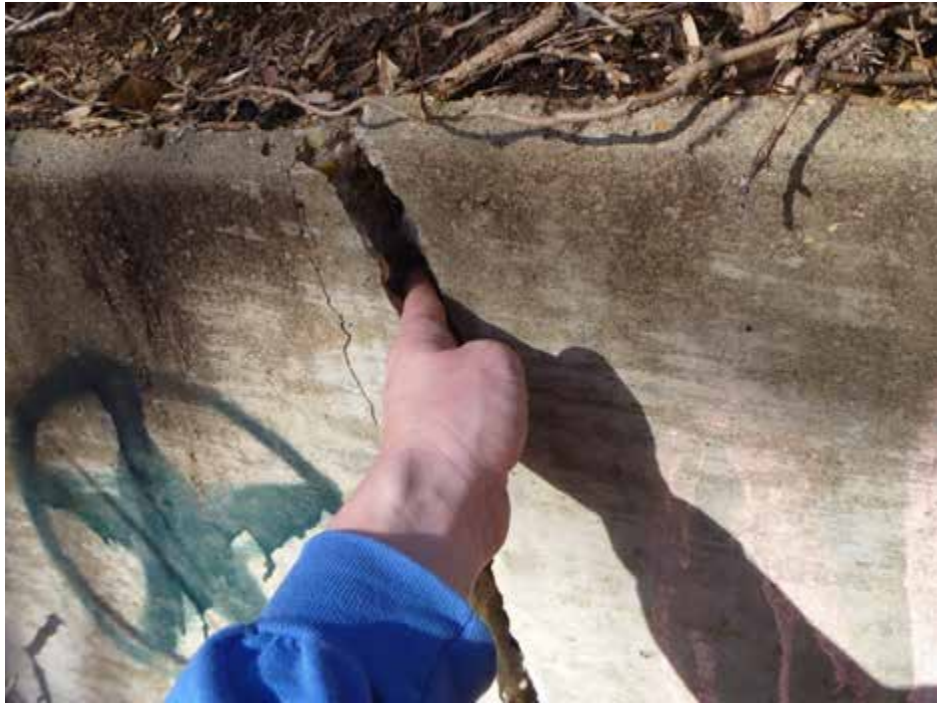
Figure 2. Detail view of the large crack (also shown in Figure 1) in the face of the endwall (Facility ID: S150022)

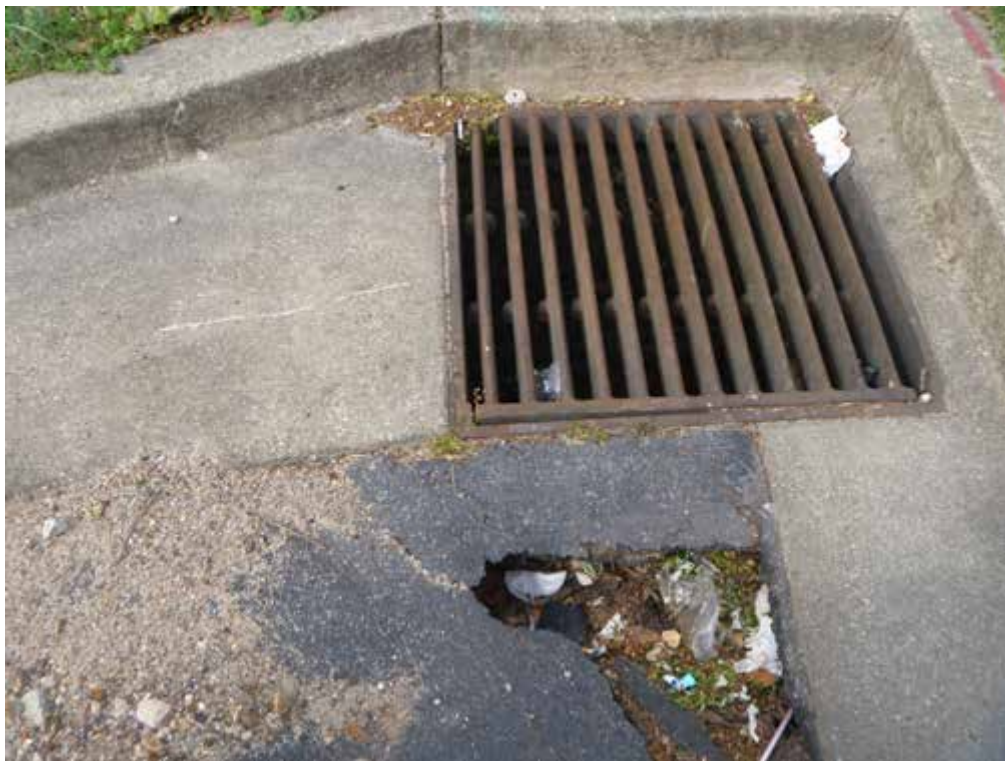
While investigating commercial establishments associated with target outfall screening areas, a Versar team found signs of collapsed infrastructure adjacent to the building for the Get Air Trampoline Park (address, 587 East Ordnance Road). The team investigated the site at 3:42 p.m. on Thursday, April 18. The team found that an area of pavement in a corner of the parking lot, adjacent to an inlet, had collapsed (Figure 1). The crew estimated that the maximum depth of the hole was approximately eight inches, at the time of the inspection. An area map, indicating the general location of the collapsed pavement, is provided in Figure 2.

Figure 1. A view of a collapsed section of the parking lot, adjacent to an inlet, found near the Get Air Trampoline Park

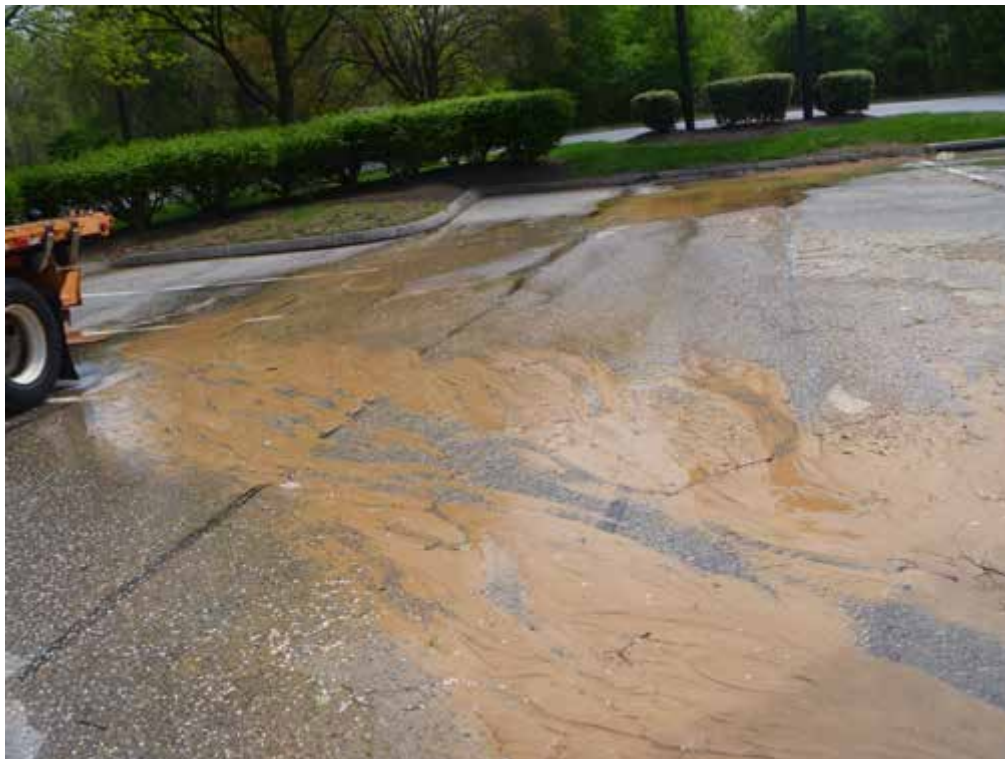
While investigating commercial establishments associated with target outfall screening areas, a Versar team found signs of damaged infrastructure in the parking lot associated with the Home Depot store at 601 East Ordnance Road). The team investigated the site at 2:40 p.m. on Thursday, April 18. The team found that an area of pavement in a corner of the parking lot, adjacent to an inlet, was being flooded with water (Figure 1). The source of the water seemed to be under a crack in the pavement (Figure 2). The field crew noted that the released water did not have a detectable odor; the crew surmised that the water was escaping from a tap water source under the pavement. The crew noted that the owners or employees with the business were aware of the condition, since cones were in place to alert the public of the unusual state. An area map, indicating the general location of the cracked pavement, is provided in Figure 3.

Figure 1. A view of flooded conditions in the parking lot at the Home Depot; note the receiving inlet in the top right corner of the photograph

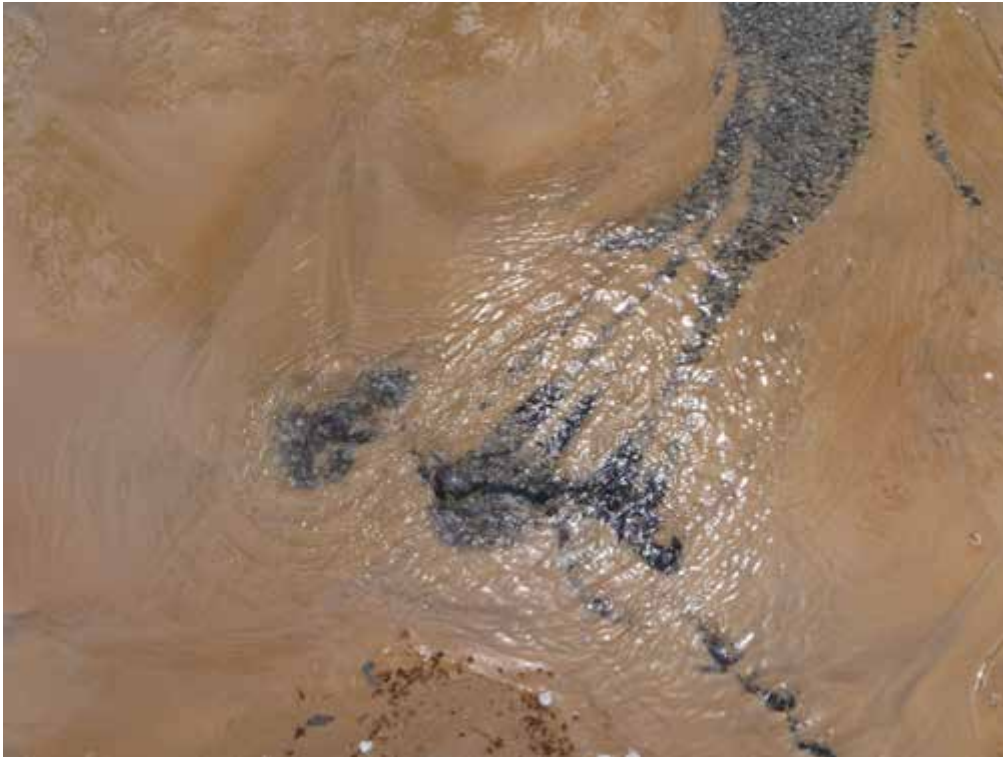
Figure 2. Evidence of water escaping from cracks in the parking lot; this appeared to be the source of the flooding

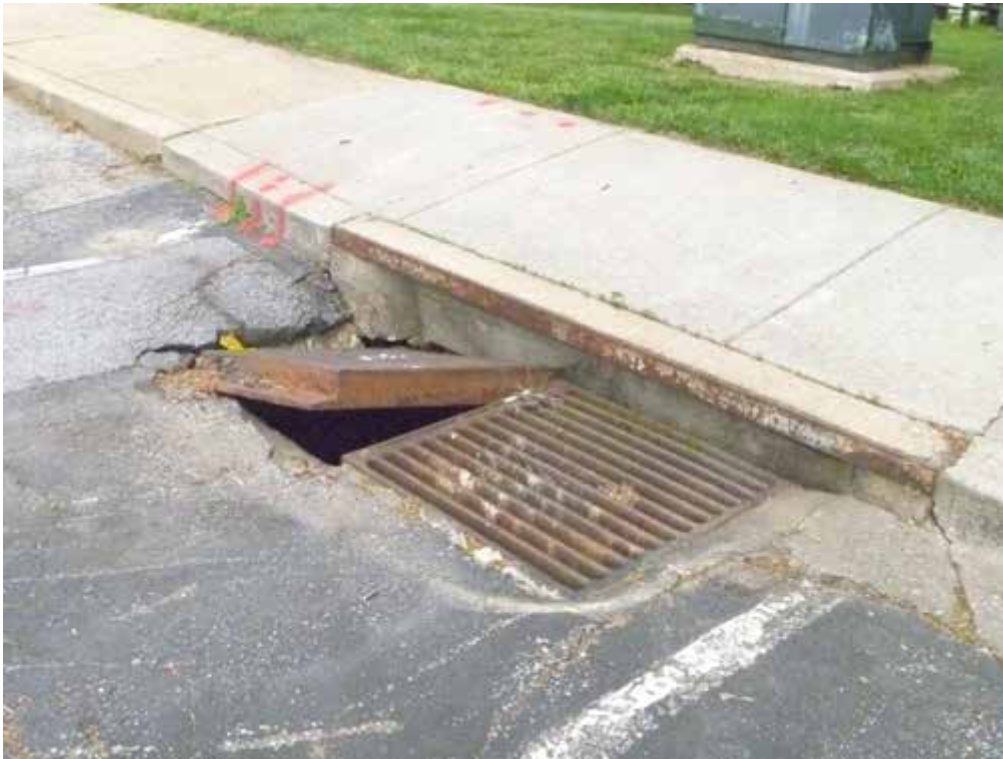
While investigating the target outfall, O06O006, a Versar team found evidence of collapsed infrastructure at a curb inlet in the parking lot immediately up-network from the outfall. The team observed the conditions at 12:50 p.m. on Wednesday, May 22, along Gatewater Court. The crew documented that one of the grates at the curb inlet was shifted in its frame, and the surrounding asphalt was crushed (Figure 1). An area map, indicating the location of the inlet, is provided in Figure 2.

Figure 1. Evidence of inlet damage on Gatewater Court

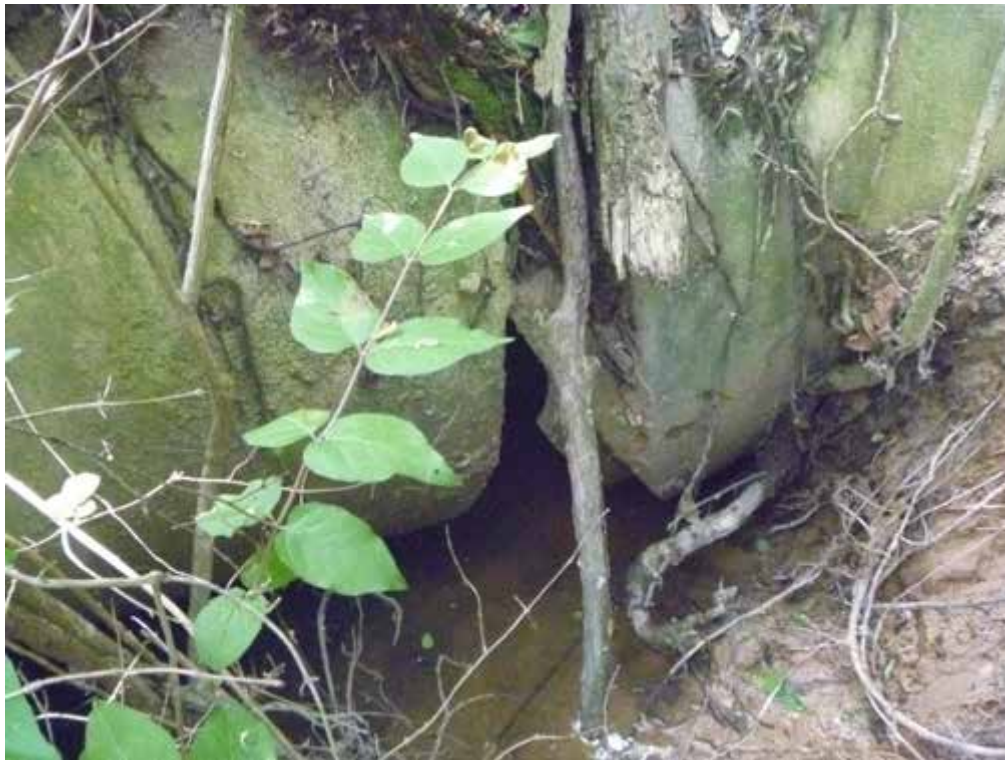
While investigating the target outfall, O04O005, a Versar team found evidence of collapsed infrastructure in the pipe network leading to the outfall. The team observed the conditions at 11:00 a.m. on Wednesday, May 22, northeast of the parking lot associated with 6704 Curtis Court. The crew surmised that erosion had removed some of the supporting ground around and under the pipe structure. Three pipe sections were disconnected from each other; this condition allowed runoff to escape the pipe and contribute to additional erosion (Figure 1 and Figure 2). The affected sections of pipe were on a sloped bank immediately behind the outfall's endwall (Figure 3). An area map, indicating the location of the affected pipe network, is provided in Figure 4.

Figure 1. Evidence of erosion and water collecting under the pipe network leading to outfall O04O005

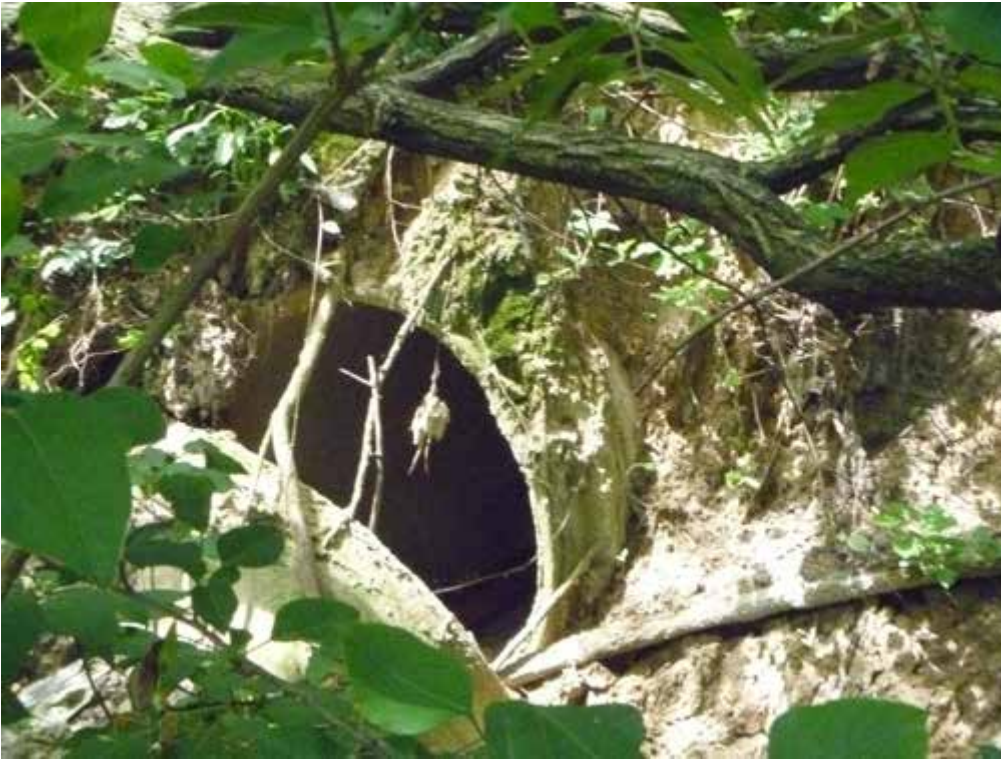
Figure 2. Evidence of erosion removing the bank surrounding the pipe network leading to outfall O04O005

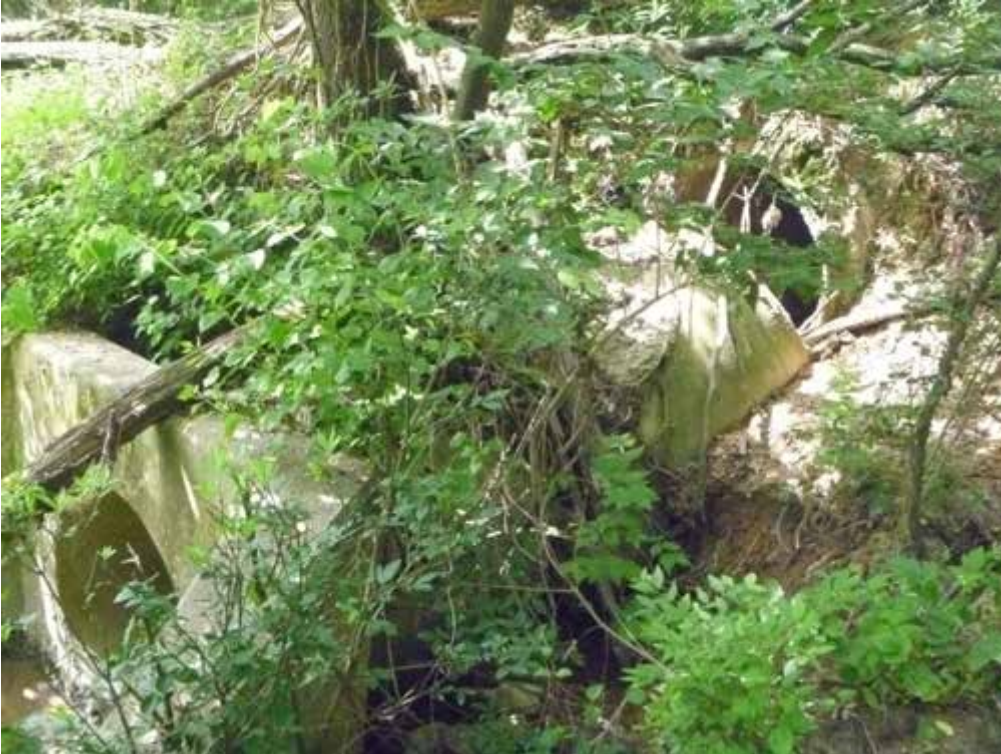
Figure 3. A view of the collapsed pipe sections (upper right and center) near outfall O04O005 (lower left)

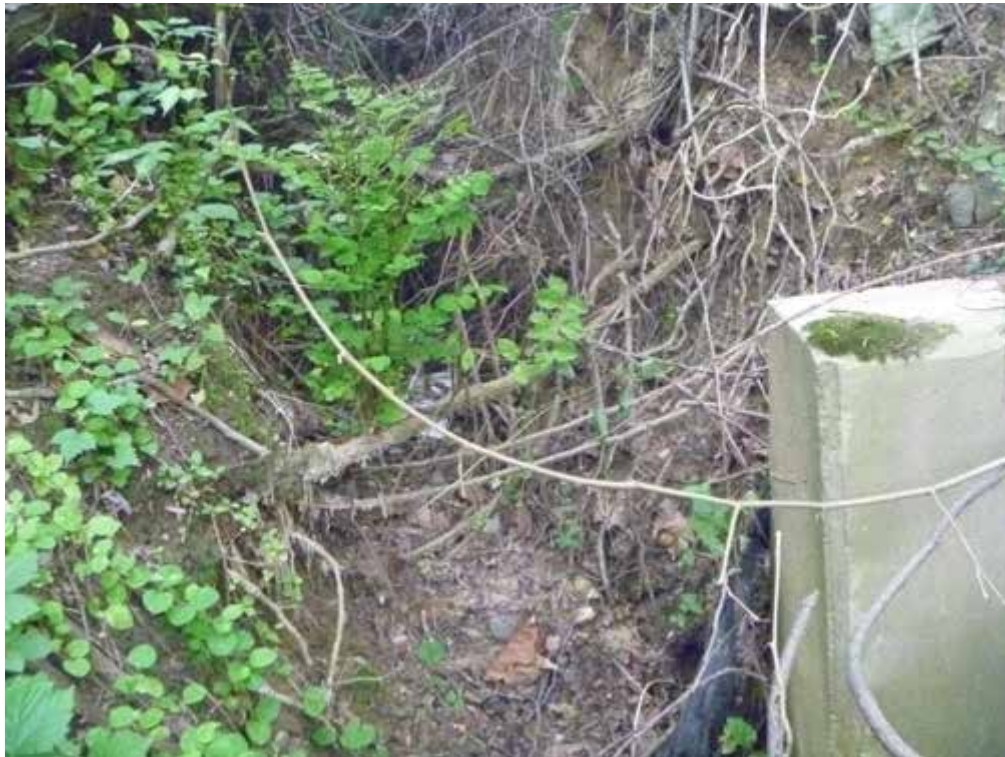
While investigating the target outfall, N04O045, a Versar team found evidence of severe erosion behind the outfall's endwall, which threatens the stability of the stormwater infrastructure at this location. The team observed the conditions at 10:50 a.m. on Wednesday, May 22, at the end of McLean Way. The crew documented that the erosion extended along the sides (Figure 1) and below the structure (Figure 2). An area map, indicating the location of the outfall, is provided in Figure 3.

Figure 1. Evidence of erosion behind the endwall of outfall N04O045

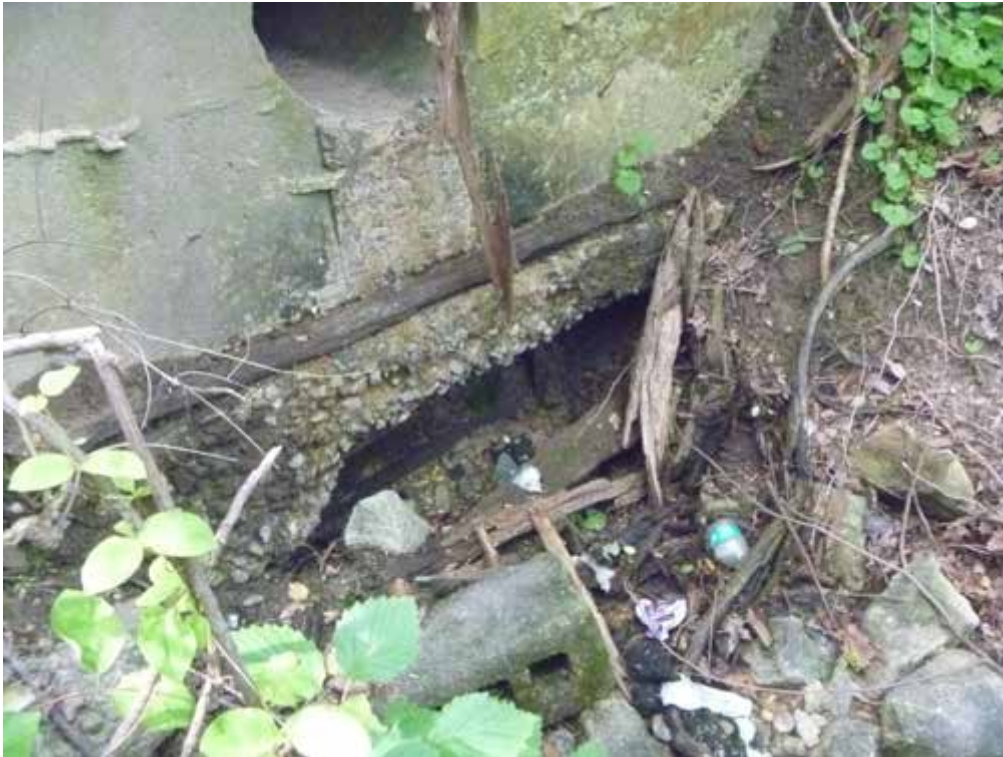
Figure 2. Evidence of erosion below the endwall of outfall N04O045

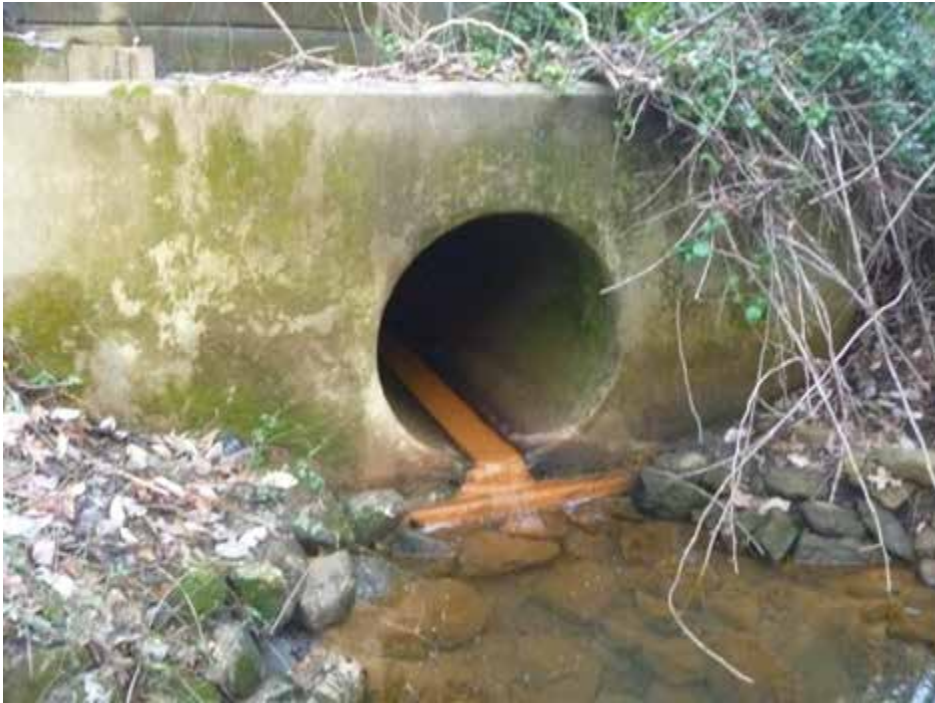
Figure 1. Conditions at outfall T15O031 on February 5

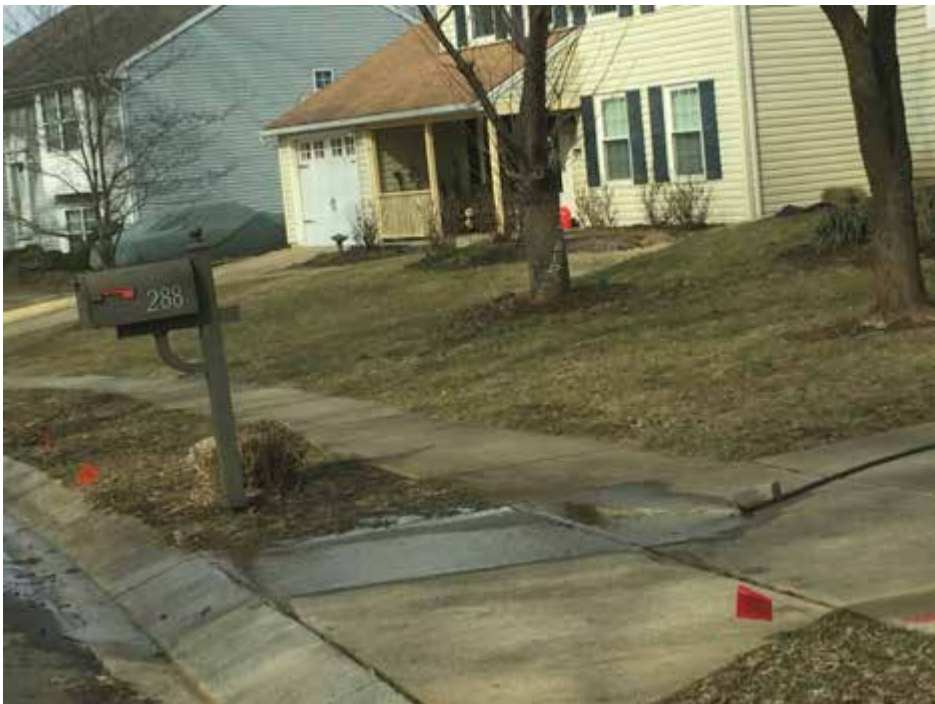
Figure 2. Evidence of a hose discharging to the street at 288 Yale Court; the source of the water was a backyard pool

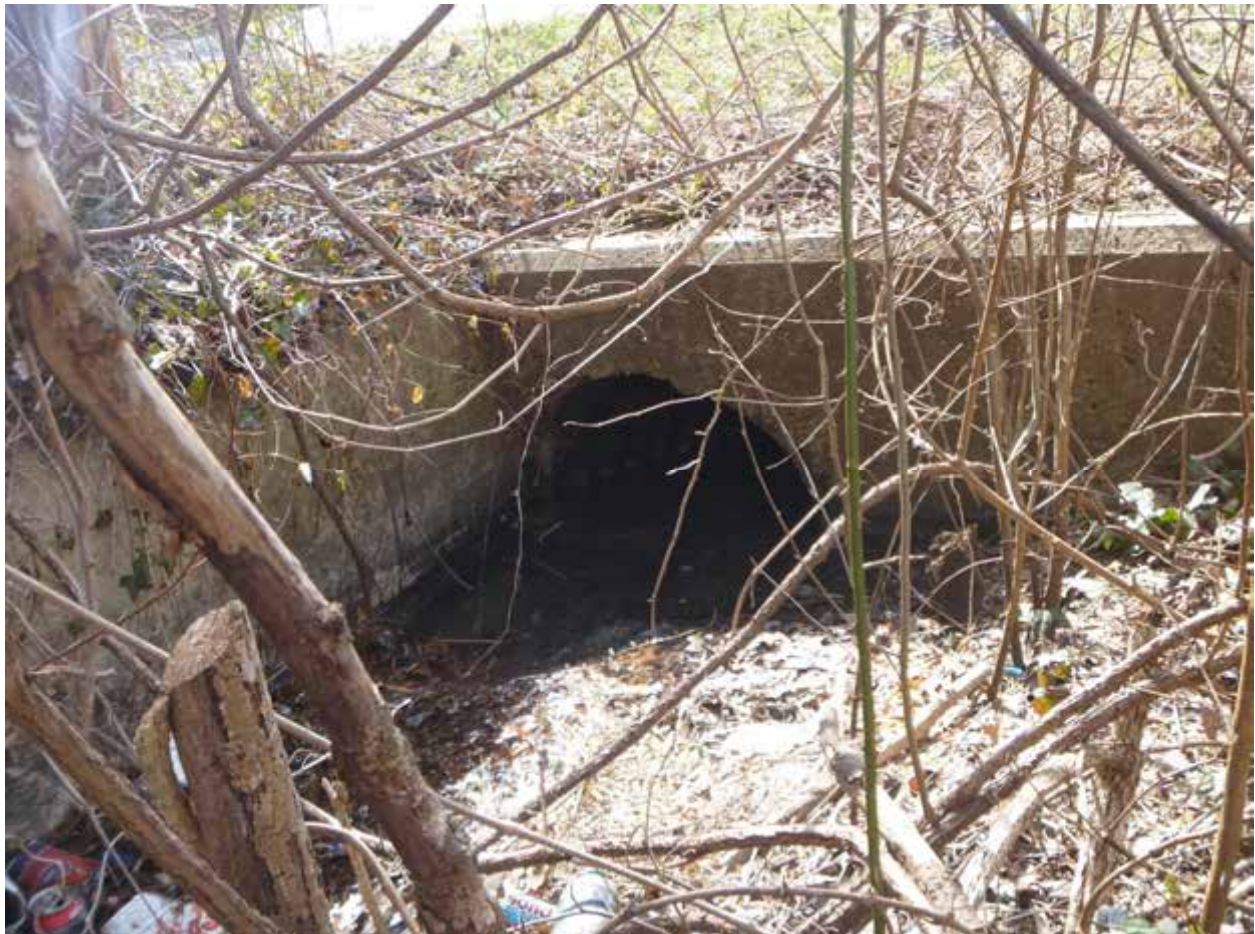
Figure 1. A view of conditions at Outfall T16O006 on March 7, 2019

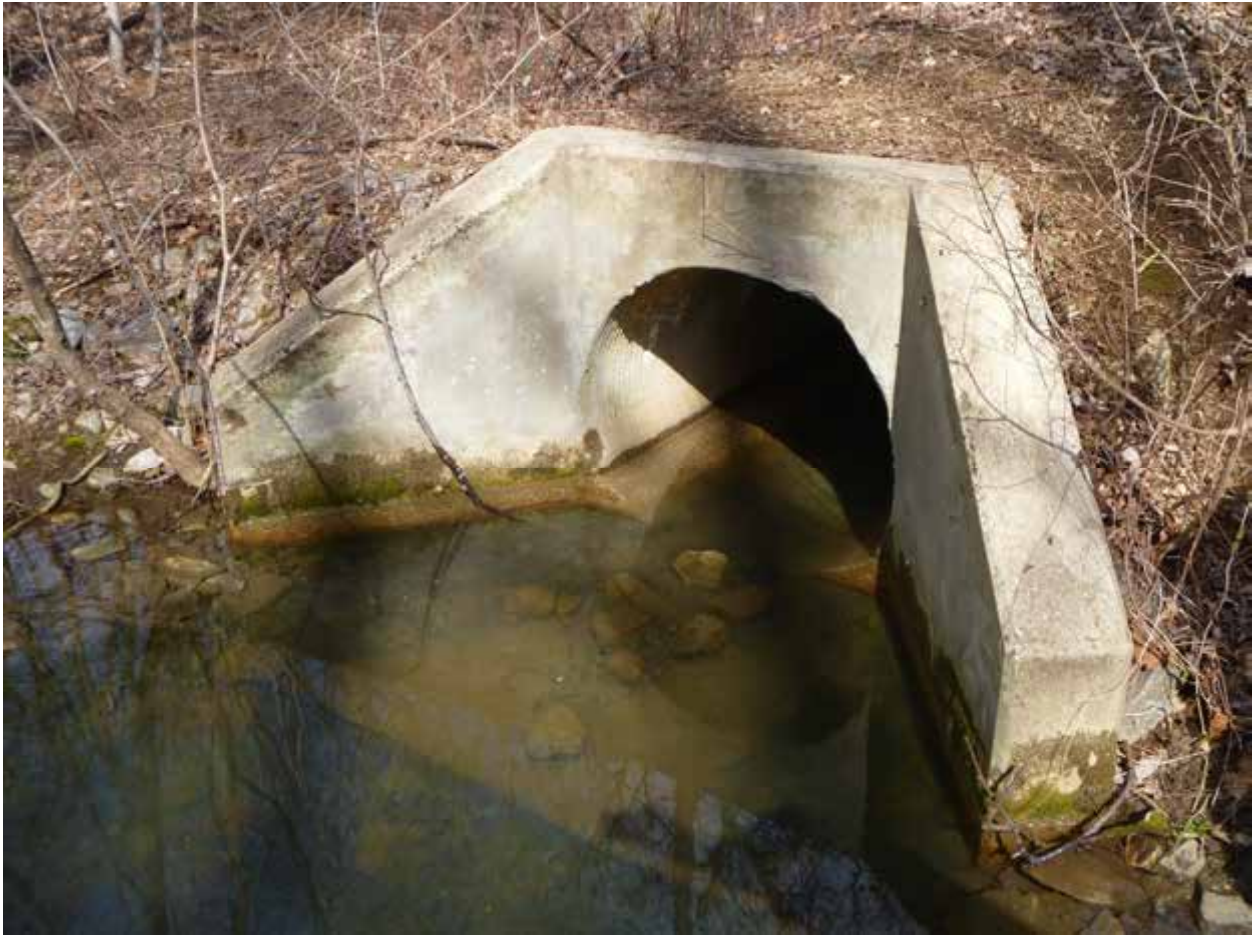
Figure 1. A view of conditions at Outfall U16O010 on March 7, 2019

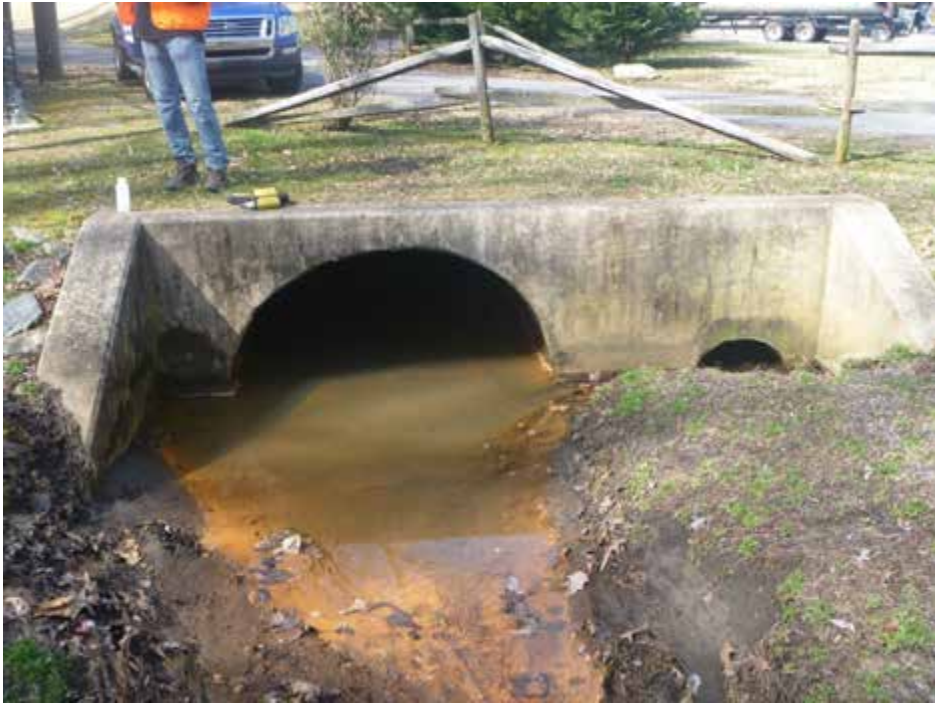
Figure 1. Conditions at outfall O22O014 on March 13

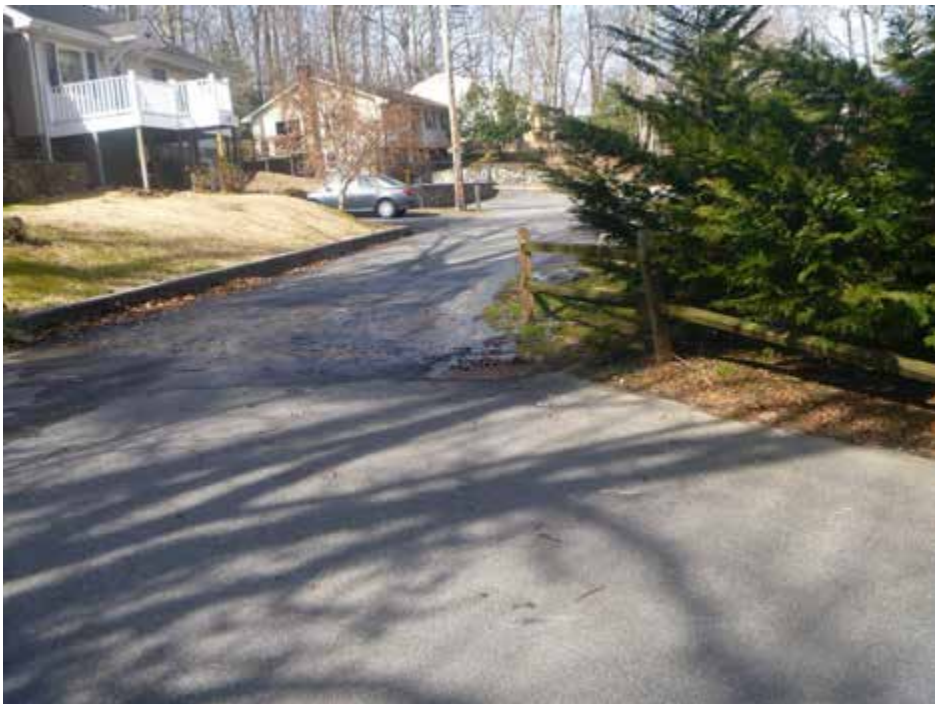
Figure 2. Evidence of a hose discharge (from the residence on the left) entering an inlet near 510 Hoot Owl Road; the source of the water was a backyard pool

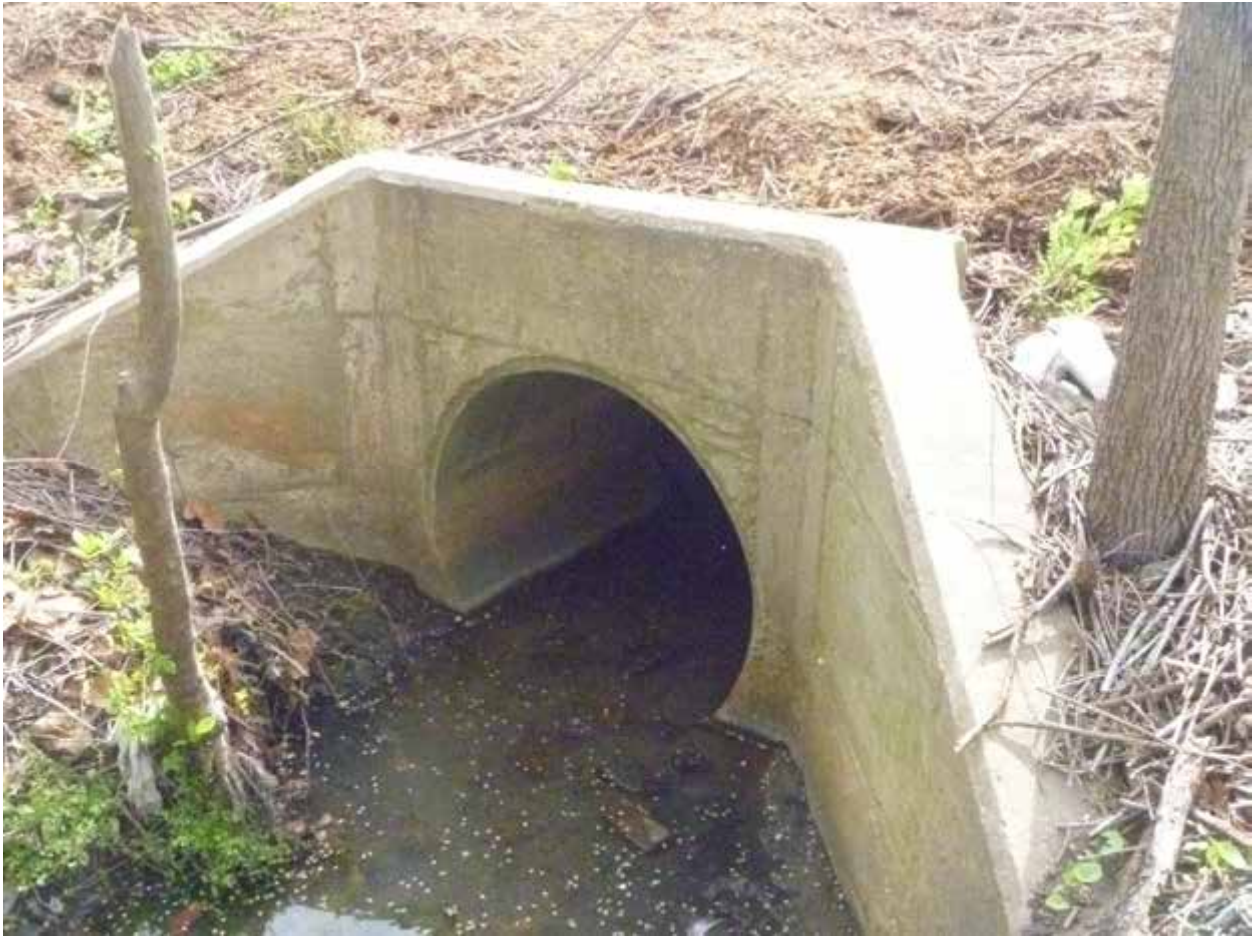
Figure 1. A view of conditions at Outfall S07O017 on April 24, 2019

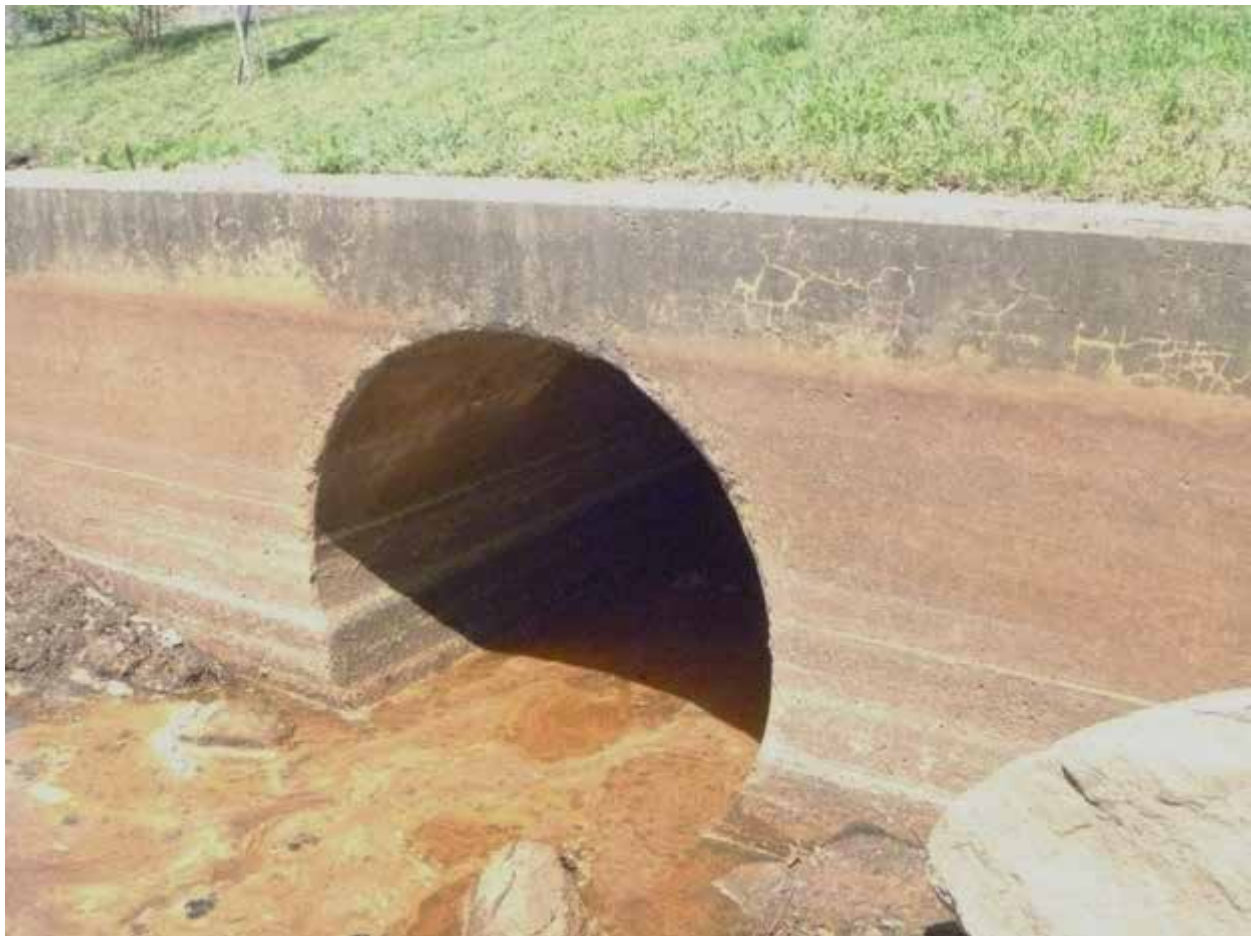
Figure 1. A view of conditions at Outfall S10O009 on April 24, 2019

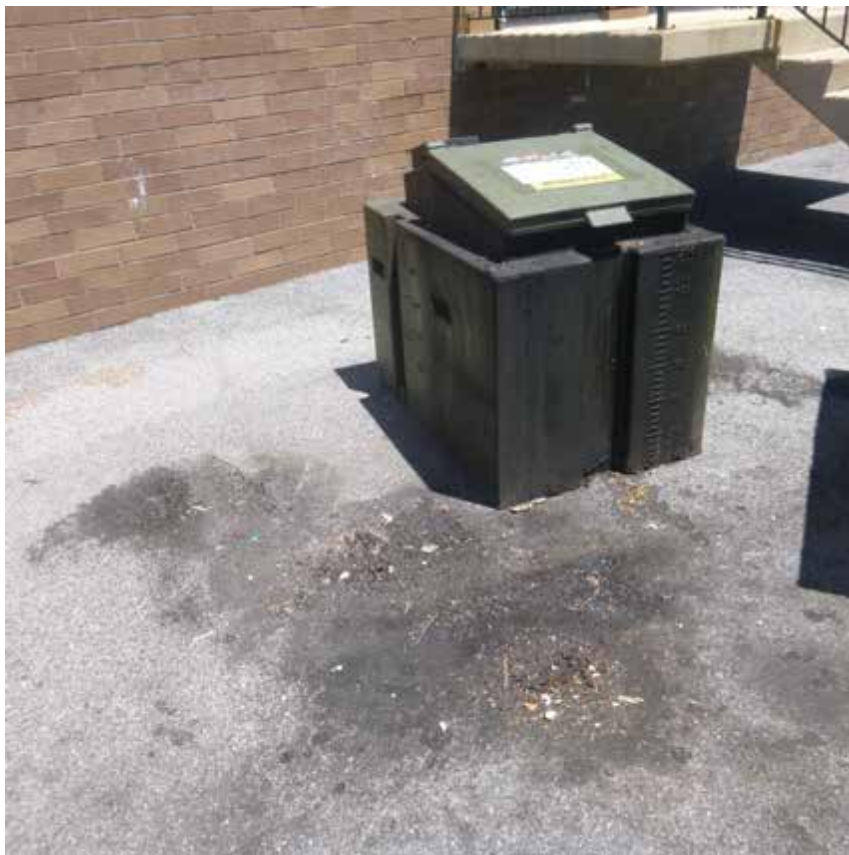
Figure 1. A kitchen waste grease bin found on July 9; note the dark grease stains on the pavement near the bin

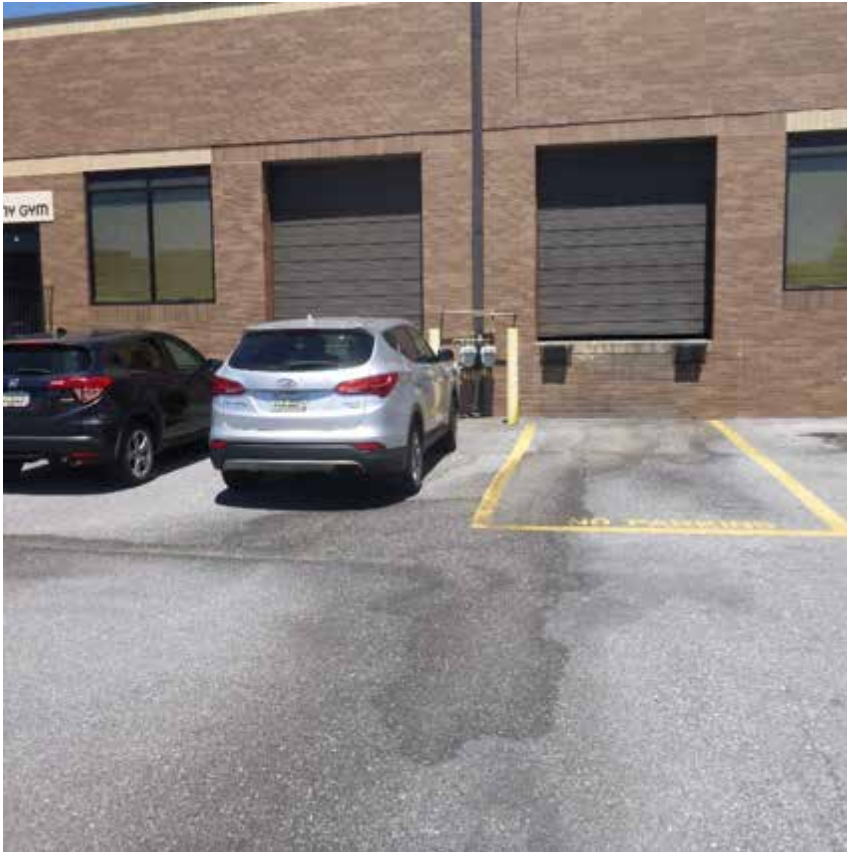
Figure 2. A view of stains on the pavement that extended from a loading dock door; this section of the parking lot was immediately adjacent to the area shown in Figure 1 (upper right edge)

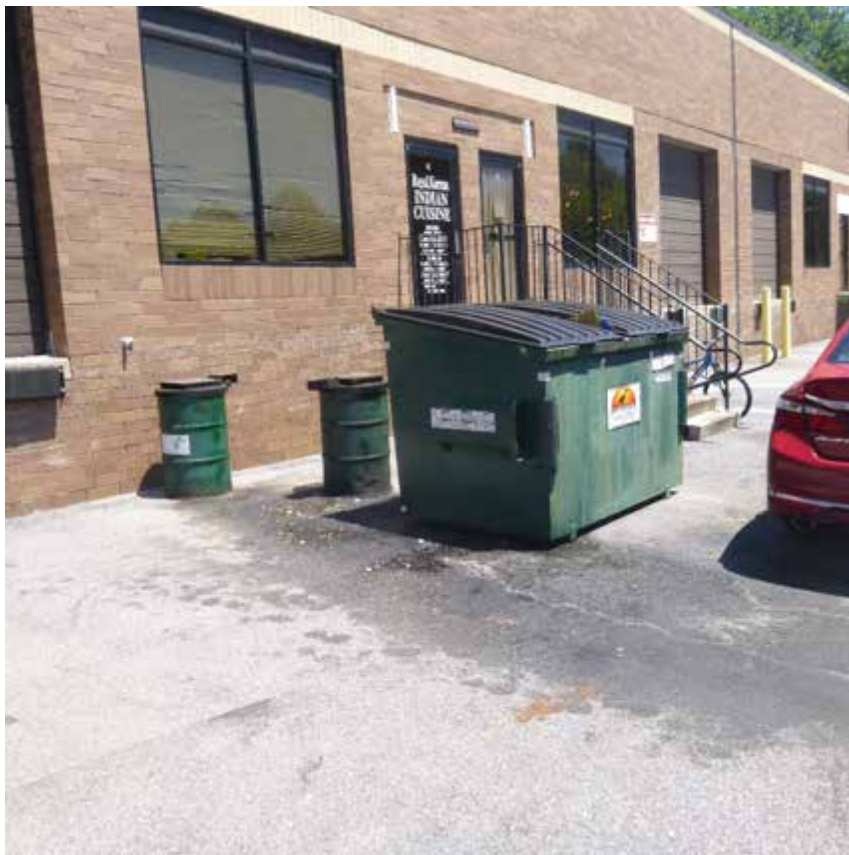
Figure 1. Stains near a kitchen waste oil bin and a dumpster found on July 9

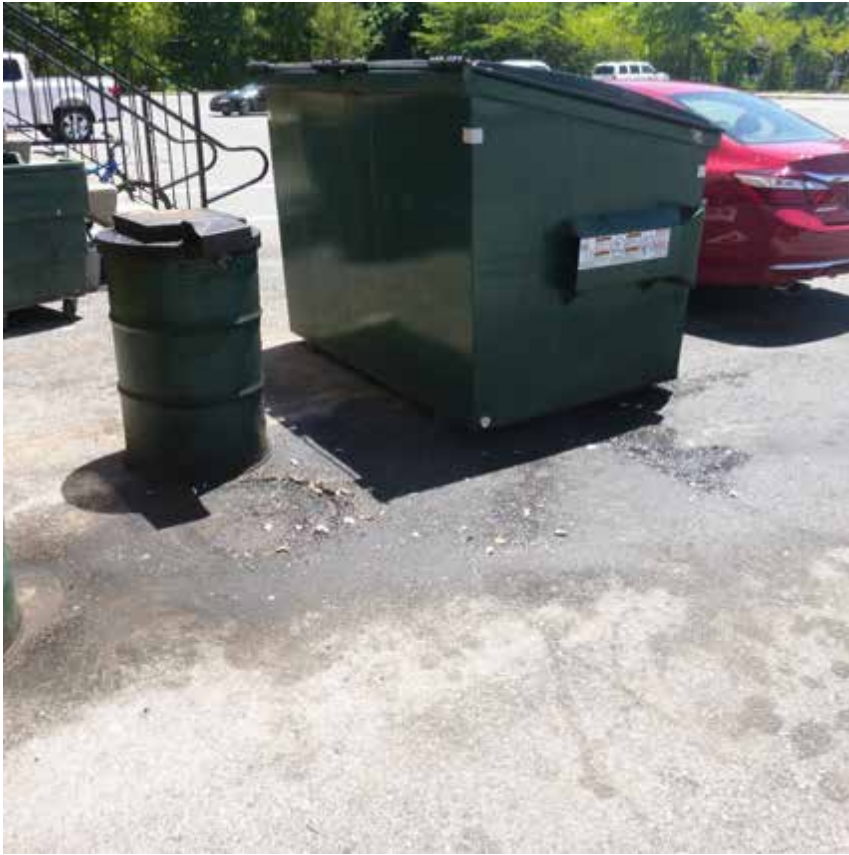
Figure 2. View of stain pattern near the dumpster; note the dark, shiny patches near the foreground edge and the right corner

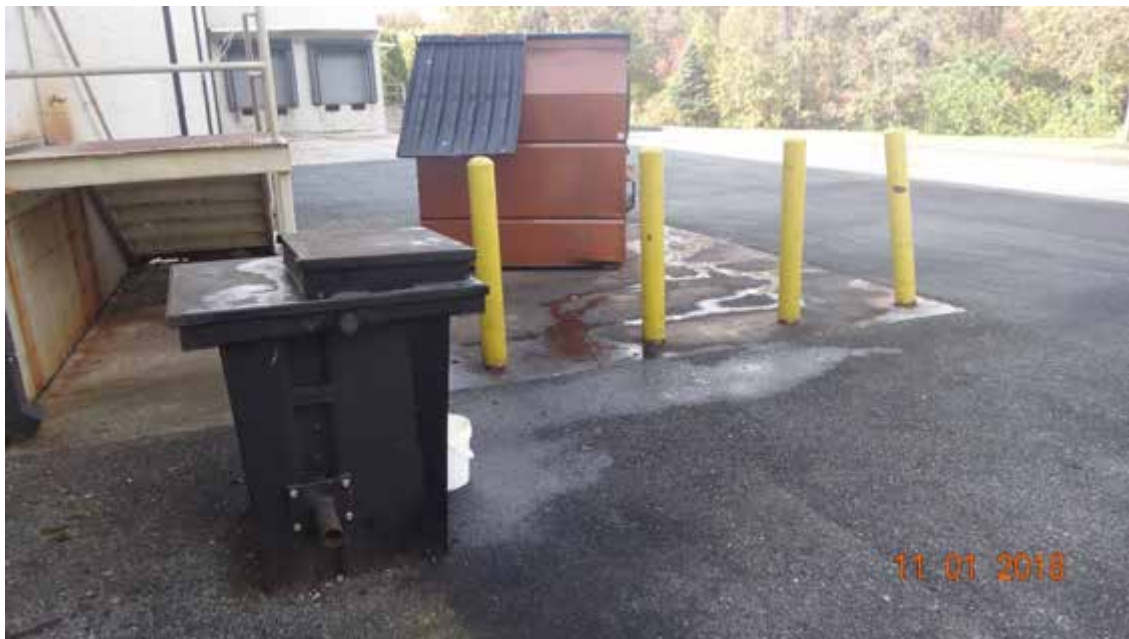
Figure 1. An open bucket containing waste kitchen oil, seen to the right of the grease bin, and evidence of recent washing activity at the parking lot associated with the Food Lion grocery store on November 1
