**ANNE ARUNDEL COUNTY  
ILLCIT DISCHARGE DETECTION  
AND ELIMINATION**

**2019 ANNUAL REPORT**

**PERMIT NUMBER MD0068306**

August 2019

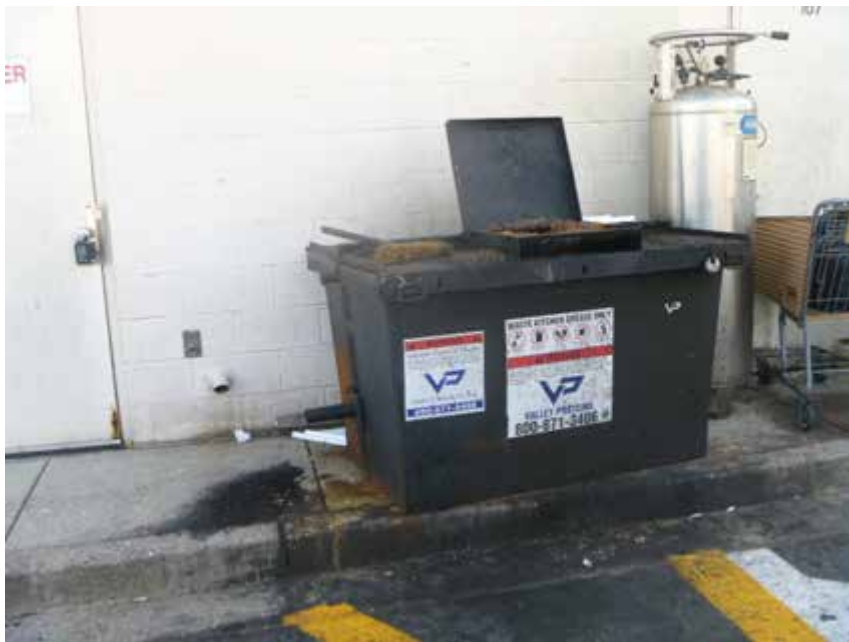
Figure 1. A kitchen waste grease bin found with an open lid, and dark grease stains on the pavement surrounding the bin, behind the Passion Asian Bistro restaurant on December 6

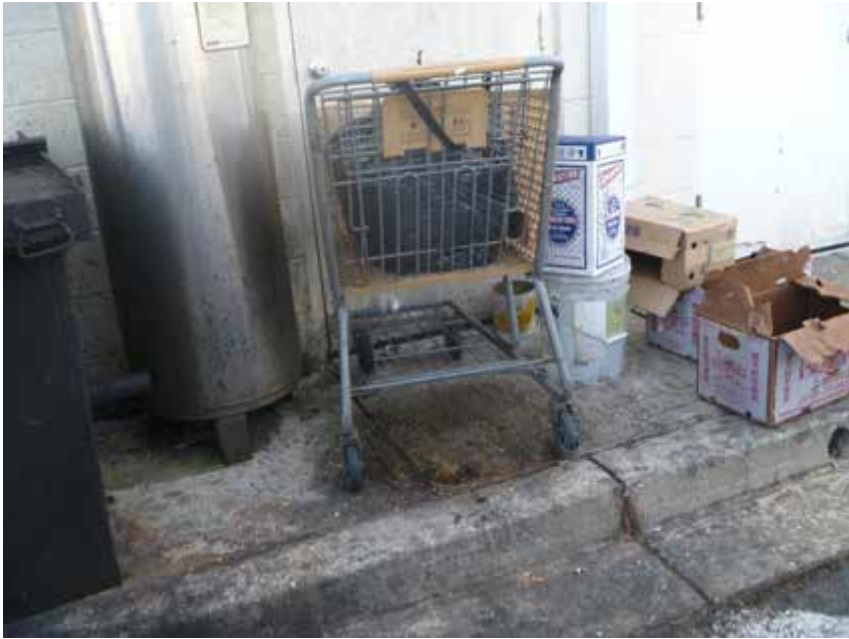
Figure 2. A shopping cart found with oily residue under the basket; the kitchen grease bin from Figure 1 is seen on the left of the photograph

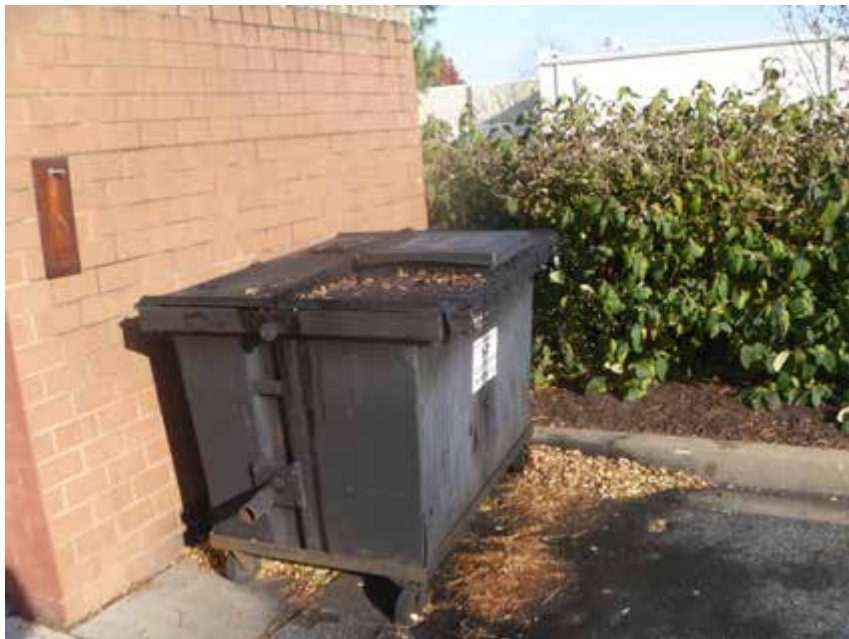
Figure 1. A kitchen waste grease bin showing dark grease stains on the pavement below the bin behind the Ledo Pizza restaurant on December 6

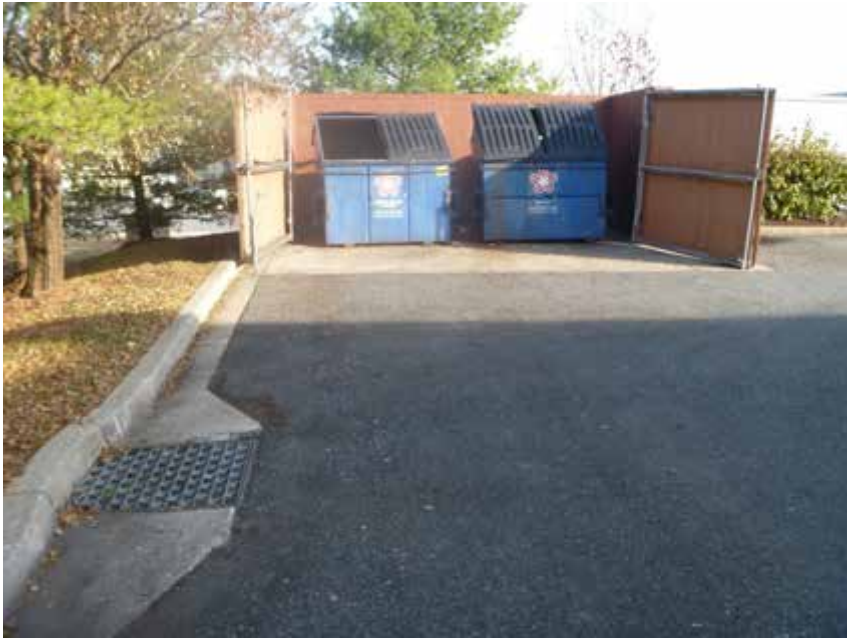
Figure 2. A view of the relative location of a storm water inlet (left foreground) to the dumpster area; the grease bin is located behind the right gate of the dumpster enclosure (right background)

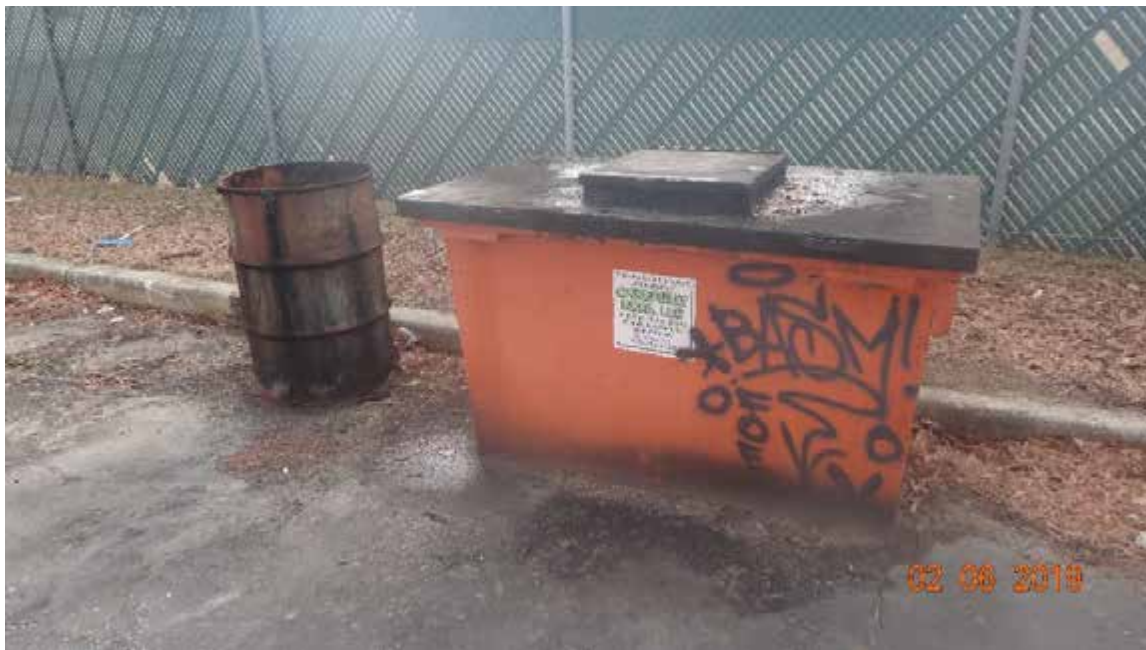
Figure 1. A kitchen waste grease bin found with dark grease stains on the pavement surrounding the bin, behind several restaurants in the Mountain Road Plaza shopping center on February 6; note the open drum to the left in the photograph

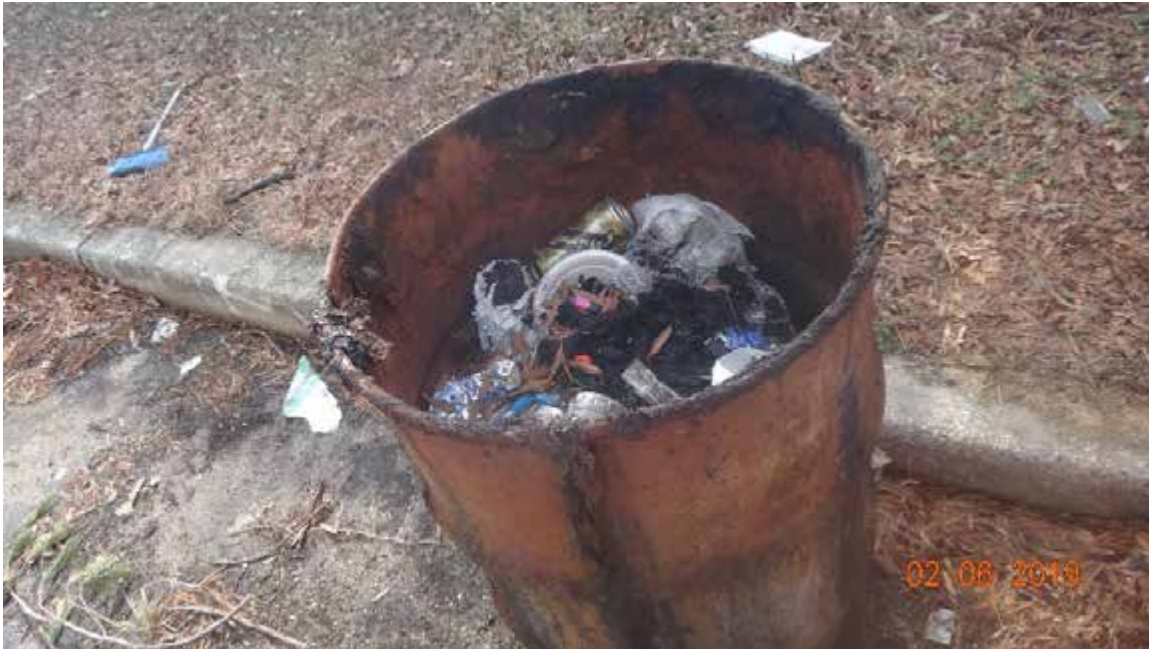
Figure 2. A view of the contents of the open drum (also seen in Figure 1) behind several restaurants operating in the shopping center

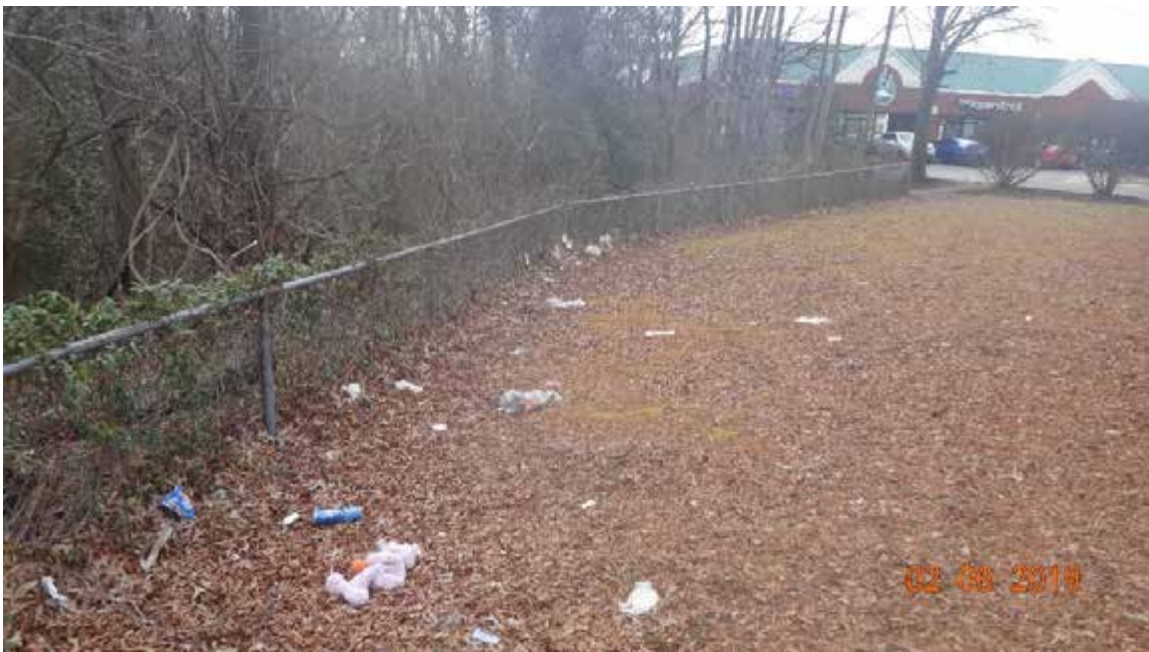
Figure 3. A view of some of the trash observed in many areas of the lot

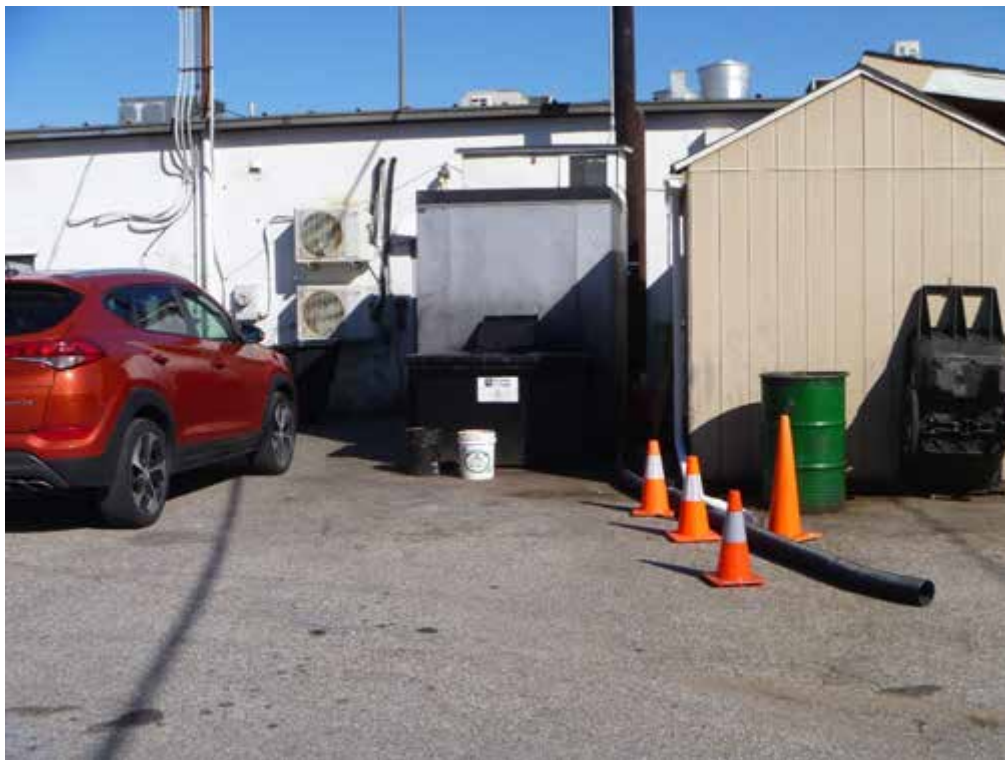
Figure 1. An open kitchen waste grease bin found on March 19 behind Vizzini's Pizza N Subs restaurant; note the dark grease stains and the buckets on the pavement near the bin

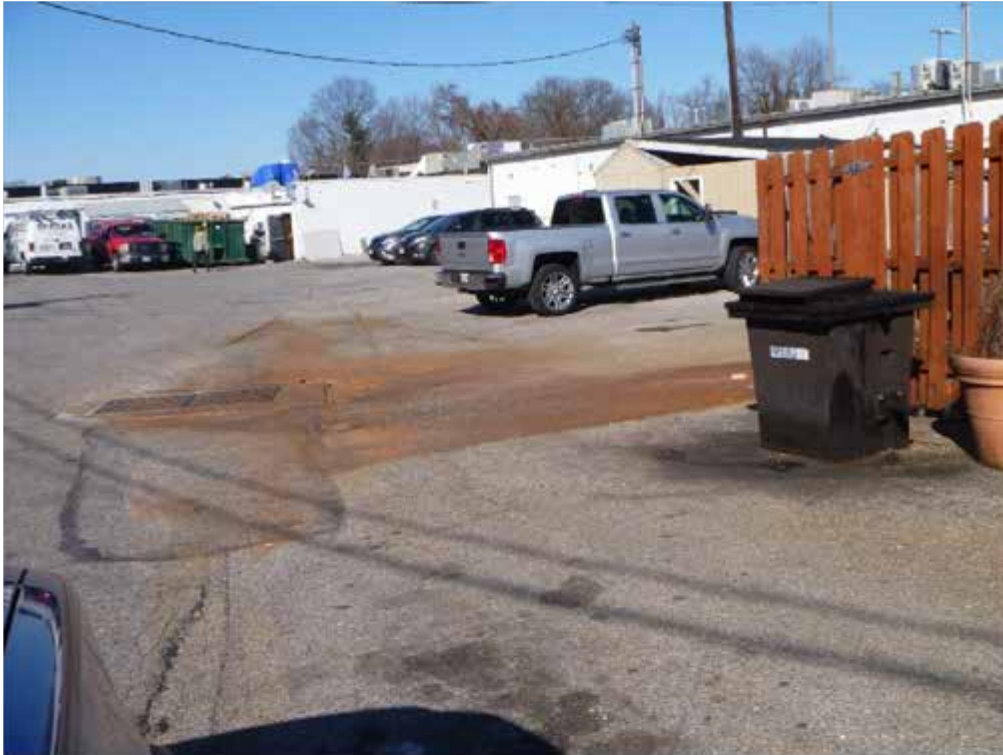
Figure 2. Signs of staining runoff and a kitchen waste grease bin near an inlet

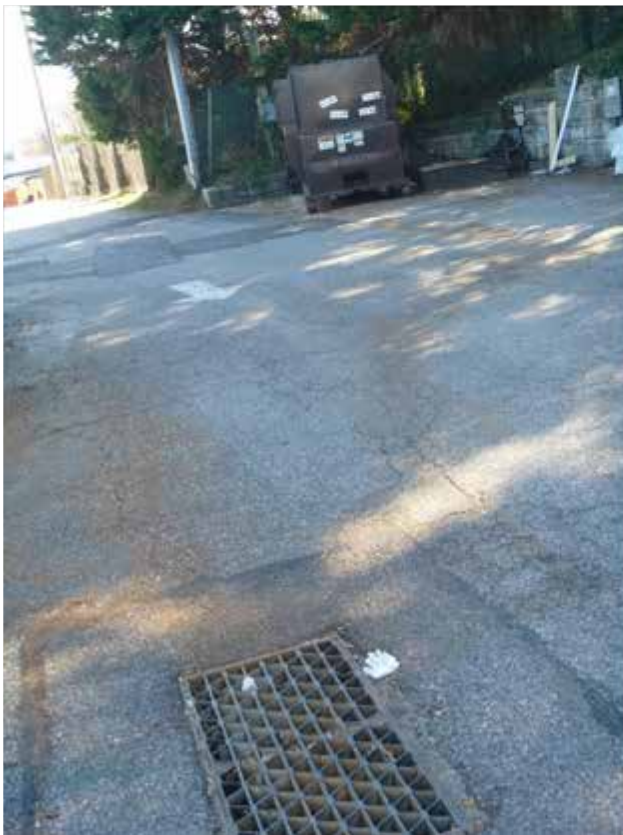
Figure 3. Evidence of residue from dumpster operations flowing to a nearby inlet

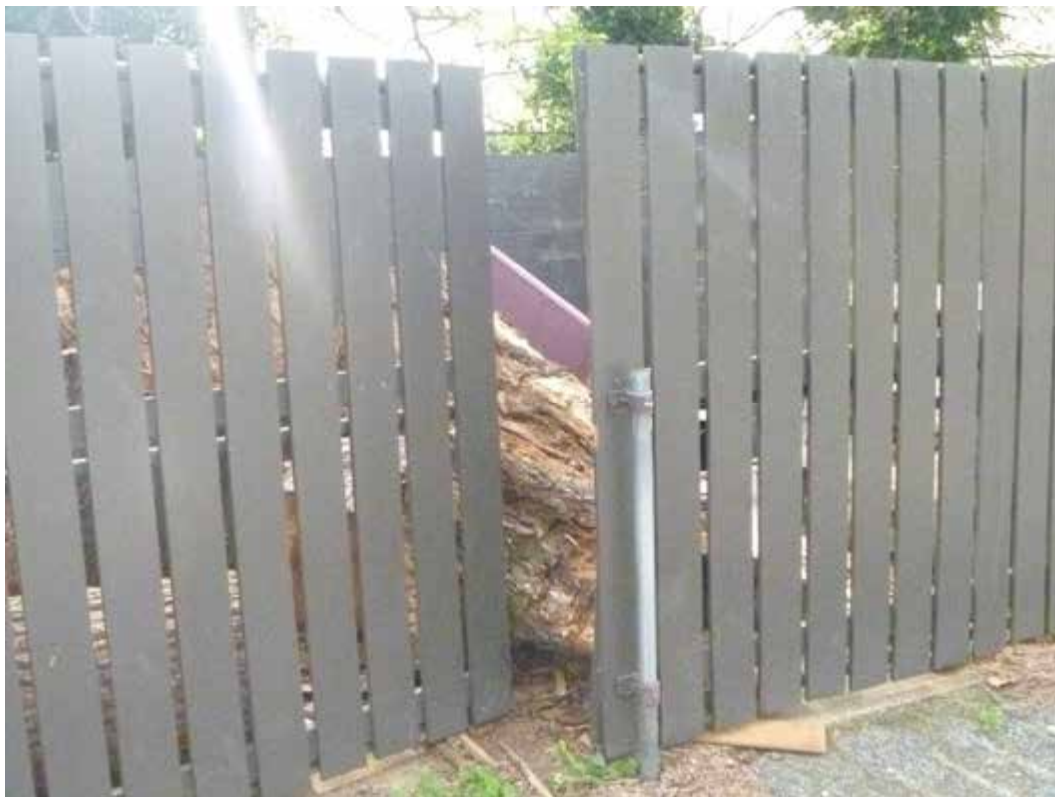
Figure 1. Evidence of large sections of a tree being stored within the dumpster enclosure on the lot investigated on April 24

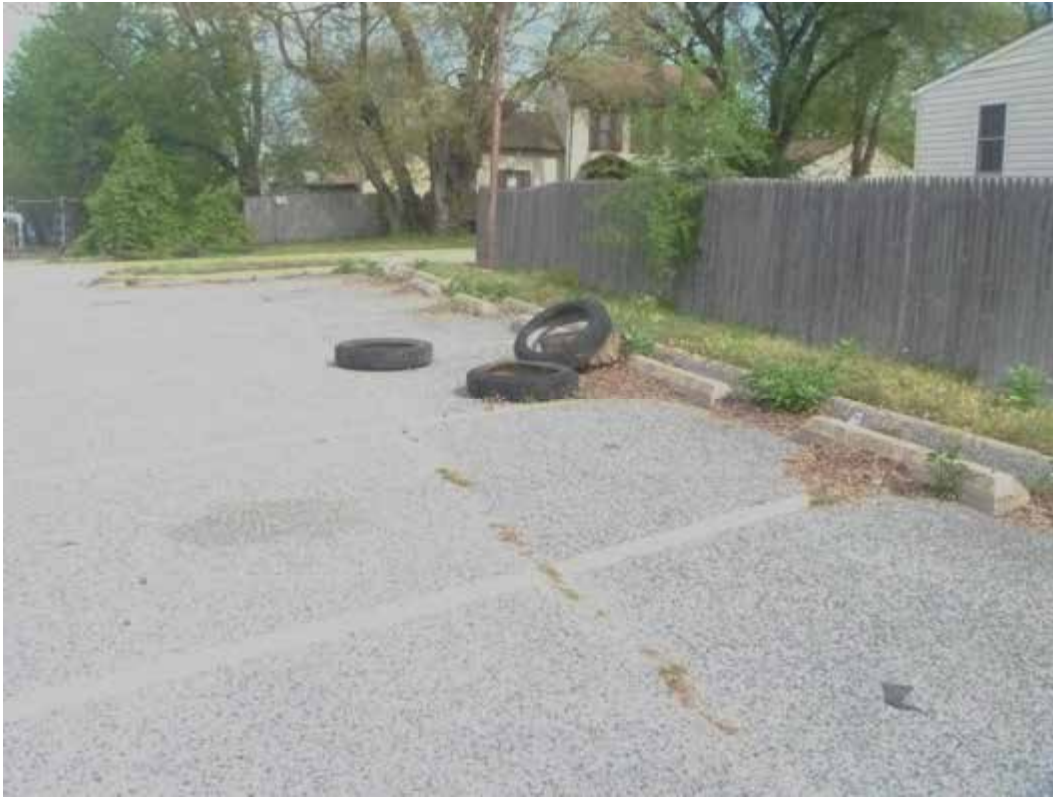
Figure 2. A view of some of the discarded tires found in the parking lot

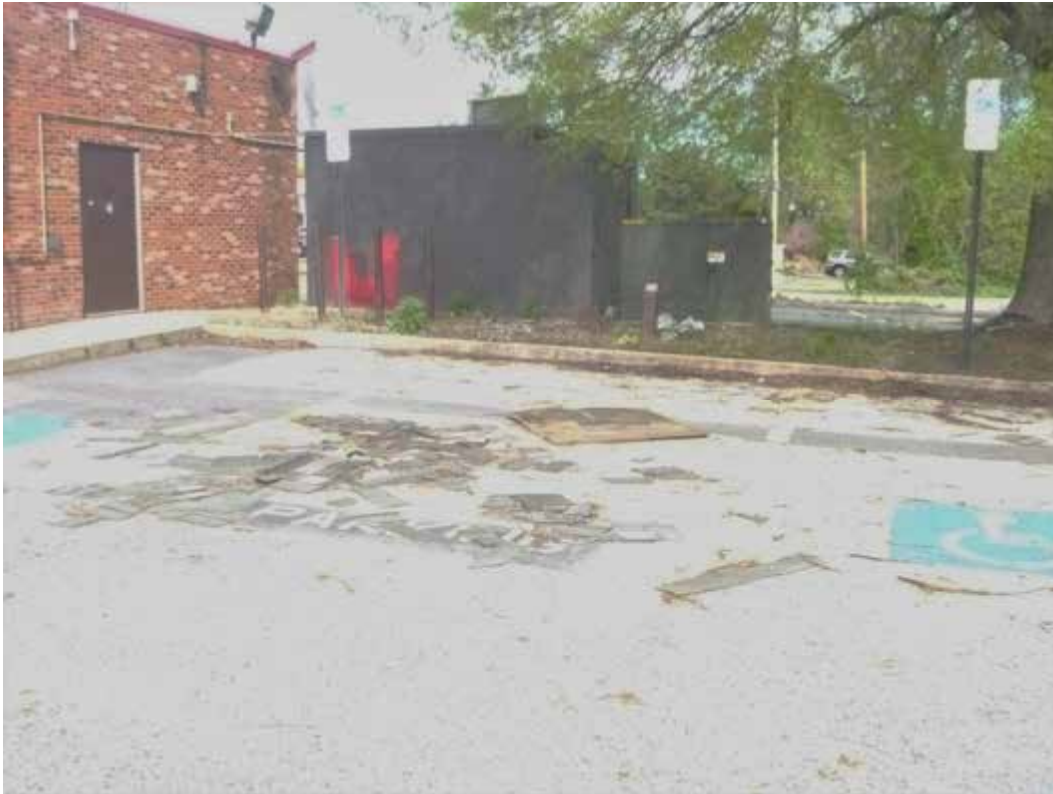
Figure 3. A view of some of the roof shingles observed in the parking lot

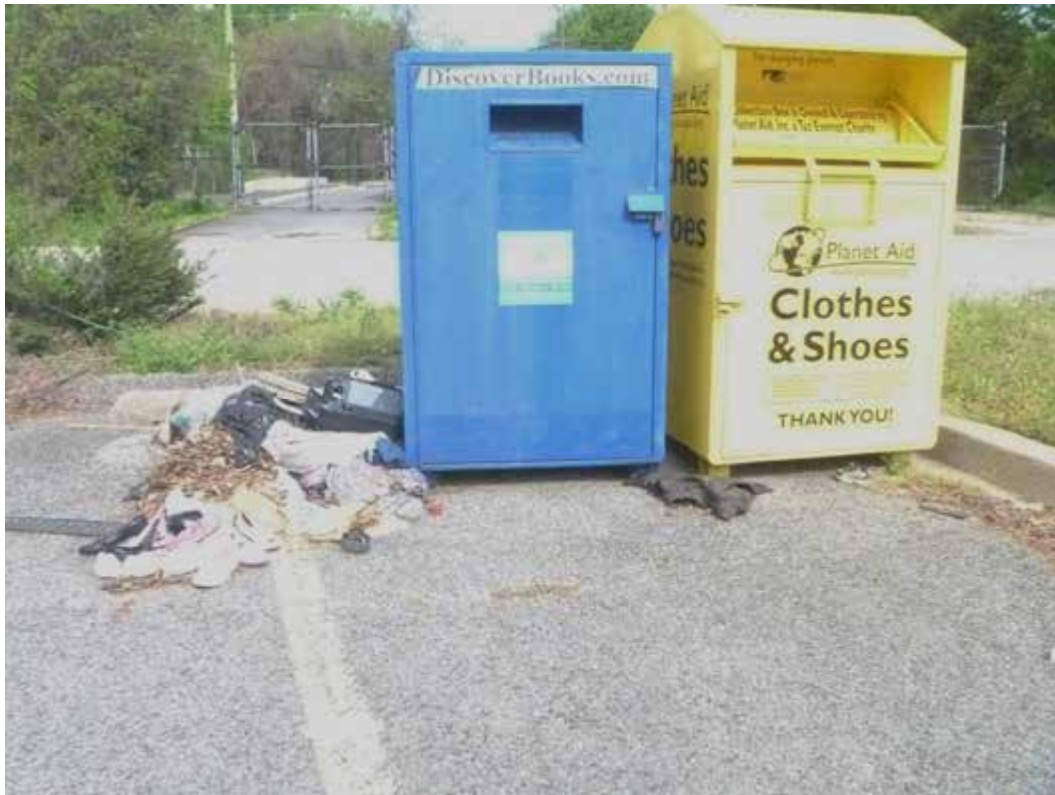
Figure 4. A view of some debris found near donation bins

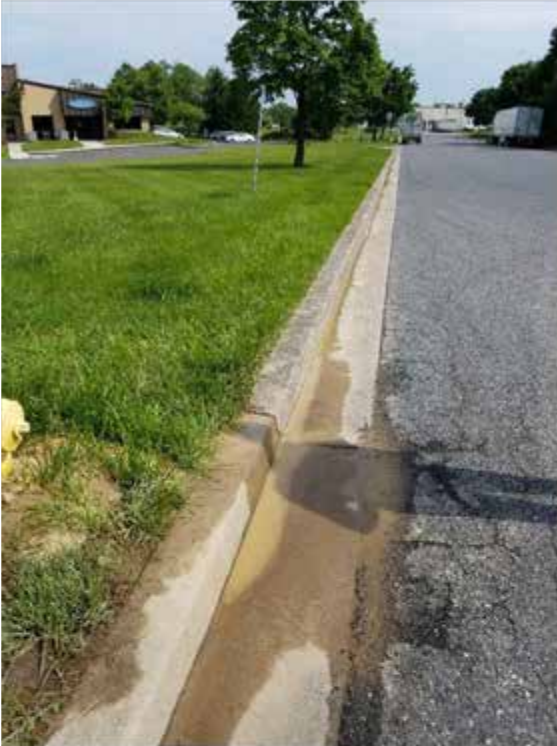
Figure 1. Flow observed from a leaking fire hydrant on the west side of Waterview Court; the yellow hydrant is visible on the left side of the photograph

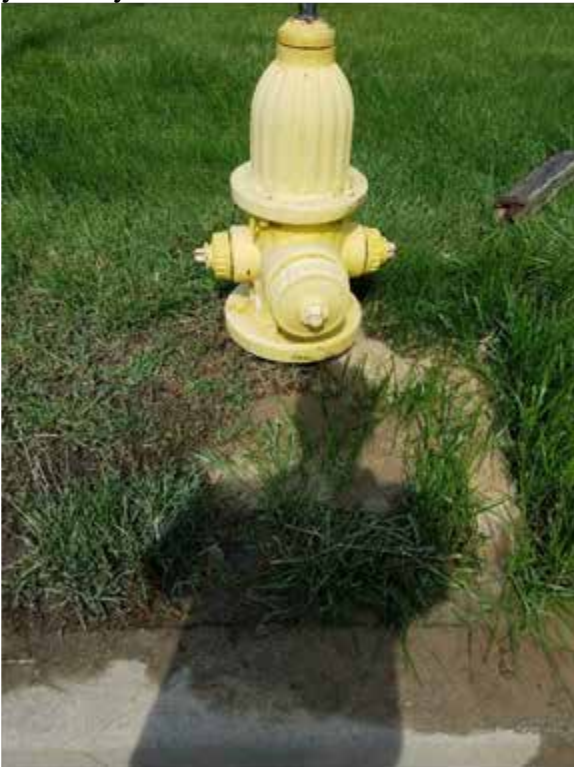
Figure 2. A view of beige foam found around the base of the fire hydrant (in front and to the right)

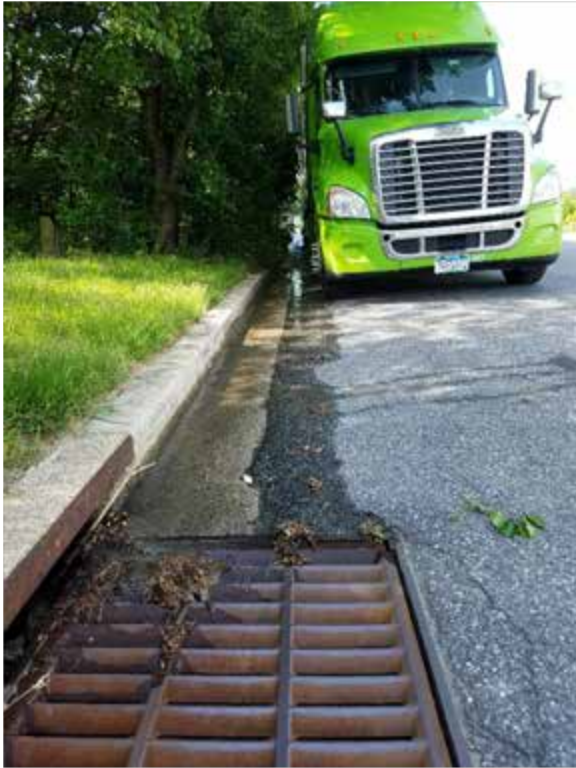
Figure 3. A view of flow entering the inlet from the east side of Waterview Court

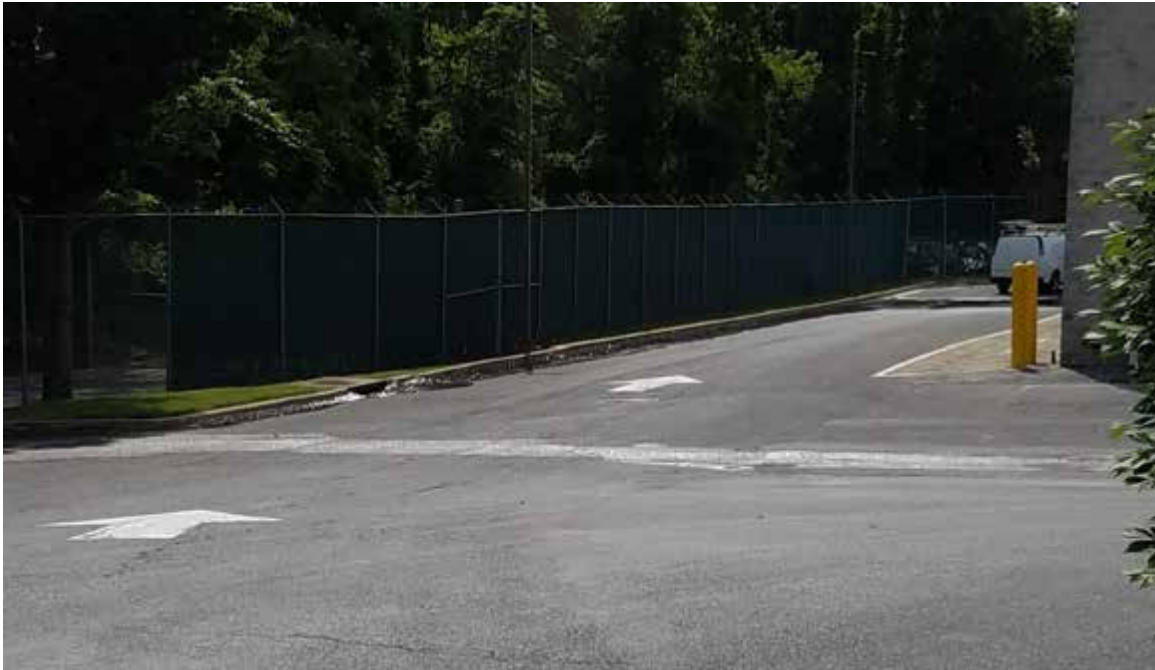
Figure 7. A view of a discharge as it was being released from the building at 6761 Waterview Court; the source of the water was to the right of the white van (upper right); the receiving inlet is in the center left of the photograph

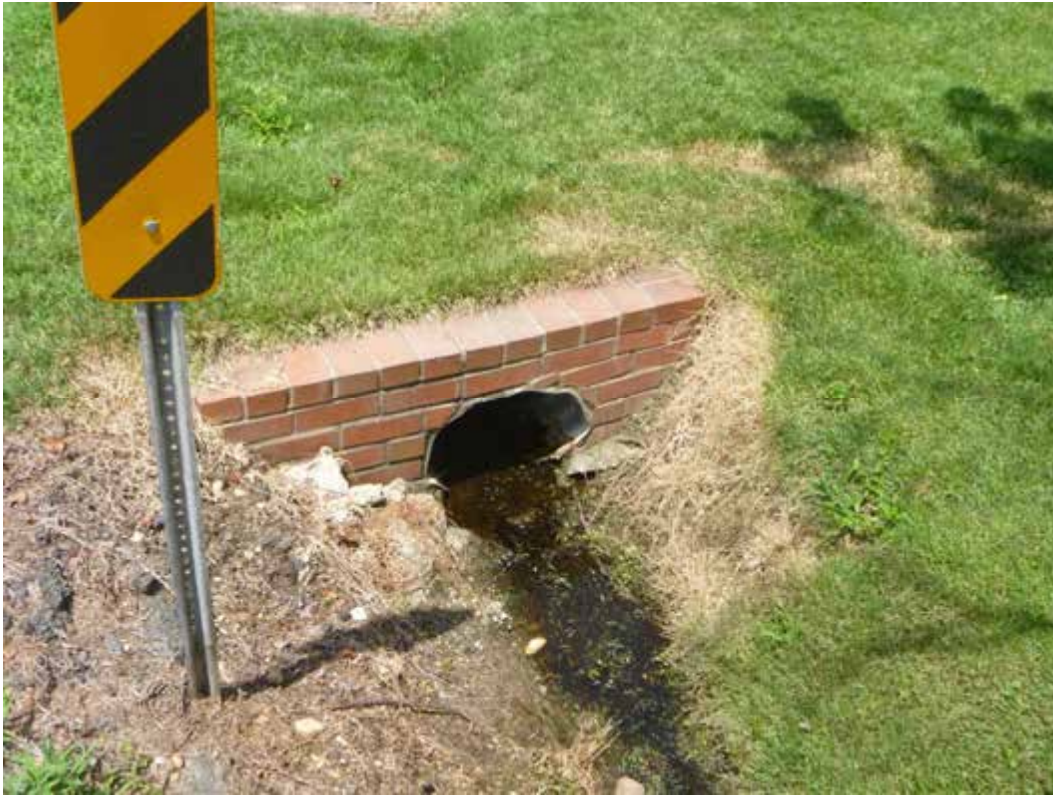
Figure 2. A view of the standing water in the pipe of inlet Q34C8I00003
