**RE: Millersville Landfill and Resource Recovery Facility
2018 Annual Comprehensive Dam Inspection for Cell 9, Pond 9-2
Dam Safety Permit No. 08-PO-0085R**

Millersville Landfill and Resource Recovery Facility
2018 Annual Comprehensive Dam Inspection for Cell 9, Pond 9-2
Dam Safety Permit No. 08-PO-0085R

**ANNUAL COMPREHENSIVE DAM INSPECTION
NOVEMBER 19, 2018**

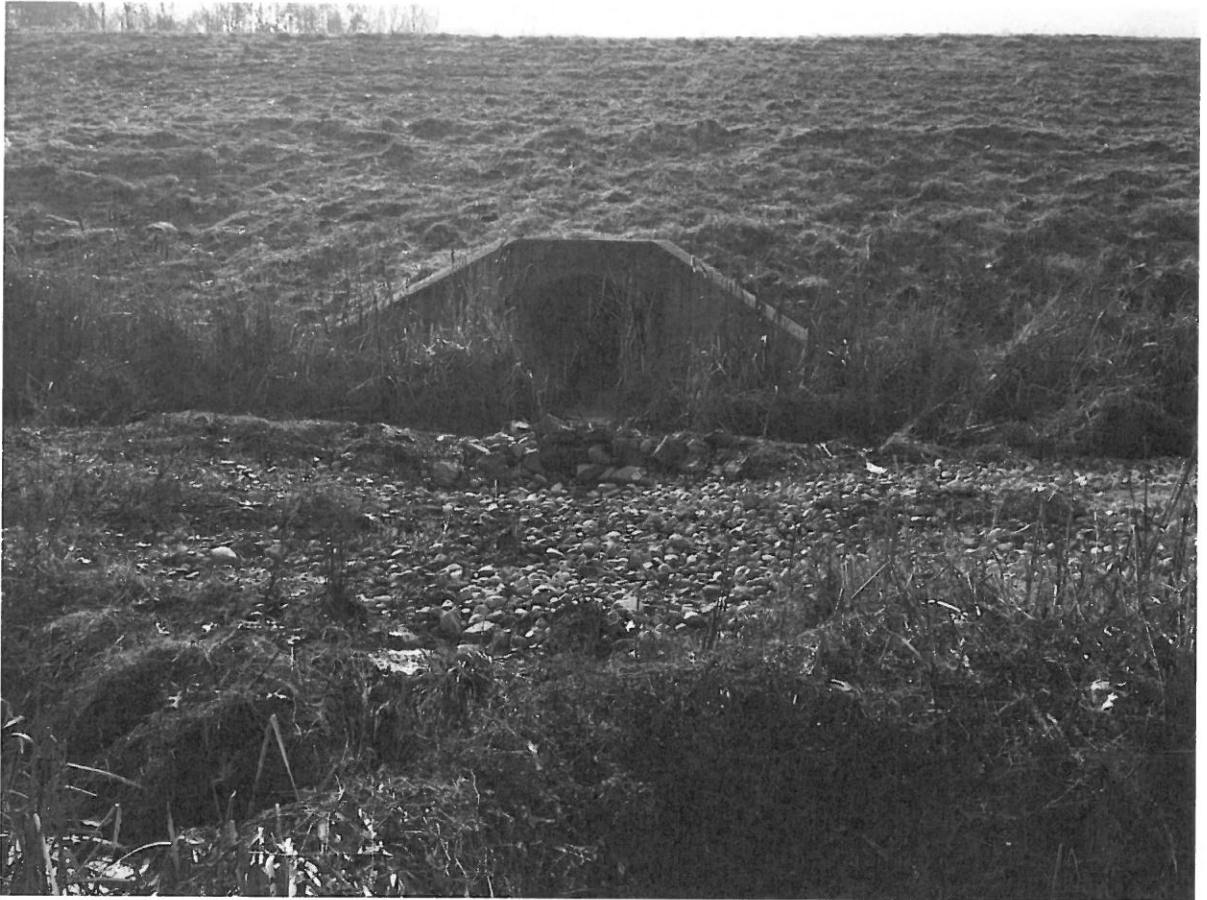
GROUND VIEW OF POND 9 OUTFALL AND STEP POOLS

2. Regenerative Stormwater Conveyance (RSC) system step pools: Good condition.
