# ANNE ARUNDEL COUNTY ILLICIT DISCHARGE DETECTION AND ELIMINATION

# 2020 ANNUAL REPORT

## PERMIT NUMBER MD0068306

FINAL: July 2020

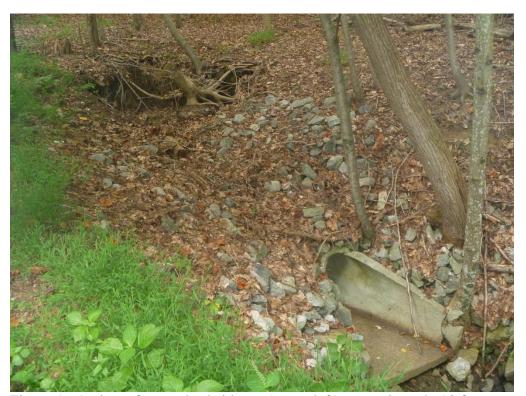
While investigating target outfalls for the County's Illicit Discharge Detection and Elimination (IDDE) program, a Versar team found signs of collapsed infrastructure at outfall O20O010. The team gained access to the outfall via a golf cart path near Golfers Ridge Road (the path was a feature with the Heritage Harbour Golf Course). The team investigated the site at 10:45 a.m. on Monday, September 16. At the site, there was evidence of ground subsidence or headcutting approximately 12 feet up-network from the outfall (Figure 1). The end section at the outfall appeared to be displaced in a lower and slightly rotated position relative to the adjacent pipe (Figure 2). The team surmised that the two conditions were related, and that the subsidence had facilitated erosion that led to undercutting and loss of support at the outfall. An area map, indicating the general location of the collapsed section, is provided in Figure 3.

Figure 1. A view of ground subsidence (upper left) approximately 12 feet up-network of outfall O20O010 (lower right)

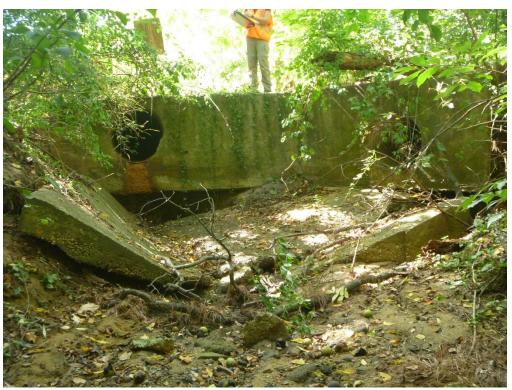
While investigating target outfalls for the County's Illicit Discharge Detection and Elimination (IDDE) program, a Versar team found signs of collapsed infrastructure at outfalls Q210003 and Q210003a. The team investigated the site at 2:50 p.m. on Friday, September 20. At the site, there was evidence of collapsed concrete decking below both outfalls (Figure 1). The team observed the effects of erosion that had undermined the pipe for outfall Q210003 behind the headwall (Figure 2). The team also documented severe erosion downstream of the outfall, which contributes to the evidence of strong forces acting on the infrastructure at the site. An area map, indicating the general location of the collapsed infrastructure, is provided in Figure 3.

Figure 1. A view of collapsed decking below outfalls Q21O003 (right) and Q21O003a (left)

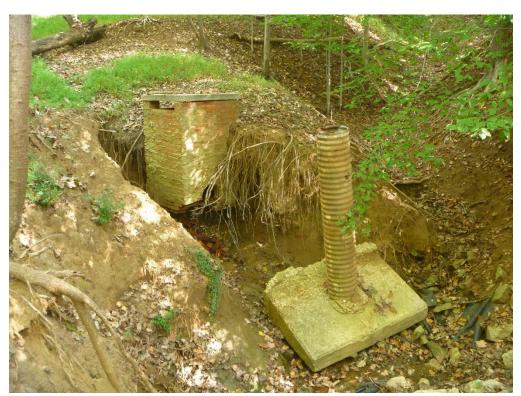
While investigating target outfalls for the County's Illicit Discharge Detection and Elimination (IDDE) program, a Versar team found signs of collapsed infrastructure at outfall N20O020. The team investigated the site at 11:00 p.m. on Thursday, September 26. At the site, there was evidence that the pipe and headwall had completely detached from the adjacent inlet, N20I004 (Figure 1). The team documented that erosion had removed supporting soil from the sides and base of the original configuration (Figure 2). The team investigated the contributing pipe network and found that a pipe entering the network from the northeast (outfall N02O009) was oriented to discharge directly on top of a concrete cap of an inlet, N20I083 (Figure 3). The team surmised that the flows from this disconnected outfall may have contributed to the erosion that had occurred approximately 140 feet down-gradient, in addition to overland flows. An area map, indicating the general location of the collapsed infrastructure and the up-network outfall, is provided in Figure 4.

Figure 1. A view of a completely detached pipe and headwall at outfall N20O020; the adjacent inlet (left) is N20O004

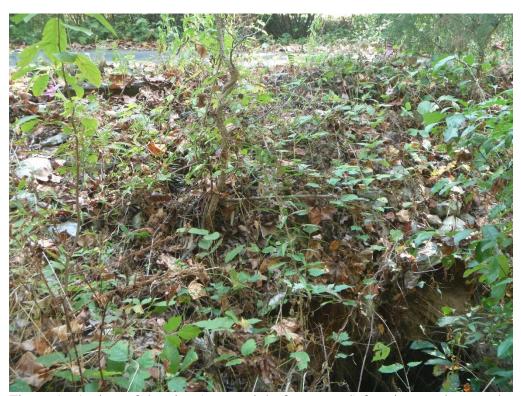
While investigating target outfalls for the County's Illicit Discharge Detection and Elimination (IDDE) program, a Versar team found signs of an undermined pipe at a driveway culvert near outfall O37O002. The team investigated the site at 2:50 p.m. on Friday, October 11. At the site, there was evidence of erosion undermining the pipe that formed the driveway culvert for the residence at 6664 Old Solomons Island Road (Figure 1). The team documented that the ground around the pipe opening appeared to be actively eroding; signs of the extent of the erosion included exposed roots and loss of soil support under the pipe (Figure 2). During the site visit, a resident informed the team that the County had been notified of the issue and the conditions at the site had not yet been resolved. An area map, indicating the general location of the undermined pipe, is provided in Figure 3.

Figure 1. A view of the pipe (center-right foreground) forming a culvert under the driveway (background) at 6664 Old Solomons Island Road; note the eroded bank (lower right)

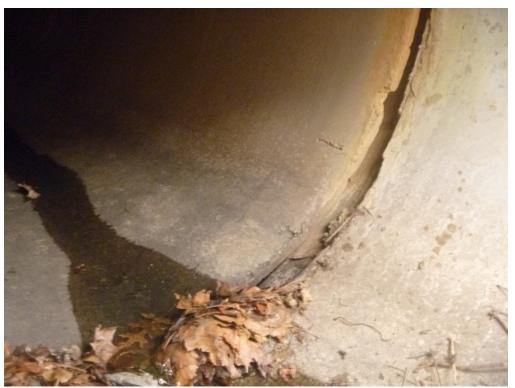
While investigating target outfalls for the County's Illicit Discharge Detection and Elimination (IDDE) program, a Versar team found signs of collapsed infrastructure at outfall J04O004. The team investigated the site at 1:00 p.m. on Thursday, January 23. At the site, the team found that the end section had partially detached from the adjacent pipe section (Figure 1). The team documented evidence of erosion associated with the separation that further undermines the end pipe at the outfall (Figure 2). An area map, indicating the general location of the collapsed infrastructure, is provided in Figure 3.

Figure 1. A view of the partially detached end pipe (lower right) at outfall J04O004, which allows water to flow under the structure and further erode the supporting soil

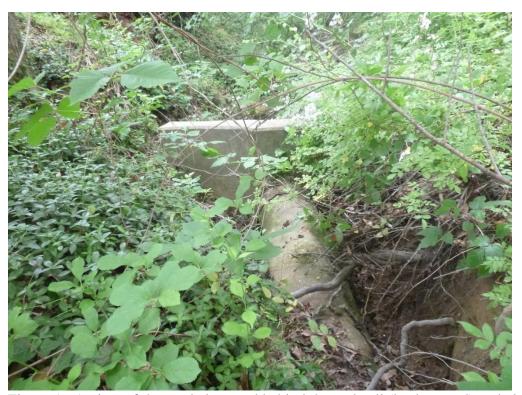
While investigating target outfalls for the County's Illicit Discharge Detection and Elimination (IDDE) program, a Versar team found signs of eroded support for stormwater infrastructure and evidence of a possibly compromised pipe network at outfall L23O001. The team investigated the site at 10:40 a.m. on Tuesday, June 2. At the site, the team found signs of significant erosion behind the endwall and along the connected pipe of the stormwater conveyance system (Figure 1). The team documented water flowing along underneath the endwall and emerging beneath the structure; the team surmised that the water was discharging from the stormwater network, and was thus evidence of a compromise in the pipe system up-network of the outfall (Figure 2). An area map, indicating the general location of the erosion, is provided in Figure 3.

Figure 1. A view of the eroded ground behind the endwall (background) and along the connected pipe (foreground) of outfall L23O001

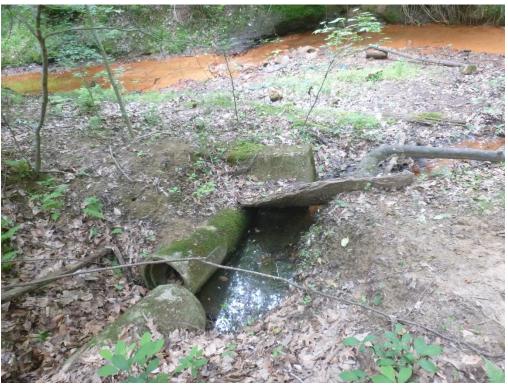
While investigating target outfalls for the County's Illicit Discharge Detection and Elimination (IDDE) program, a Versar team found signs of collapsed infrastructure at outfall M23O004. The team investigated the site at 12:45 p.m. on Tuesday, June 2. At the site, the team found that the endwall and terminal six feet of the connected pipe had dislocated from the pipe network (Figure 1). The team found evidence of significant erosion in the vicinity of the outfall and surmised that the pipe system collapsed due to the loss of structural support. The team noted the pipe system that remained intact appeared to be functioning adequately to convey stormwater. The team also found a dislocated manhole cover up-network of the outfall; the manhole number was M23M013 (Figure 2). An area map, indicating the general location of the documented conditions, is provided in Figure 3.

Figure 1. A view of the disconnected pipe system at outfall M23O004; note the severed pipe and endwall (left center) partially covered in sediment and the impromptu channel from the acting receiving pool to the stream (center right)

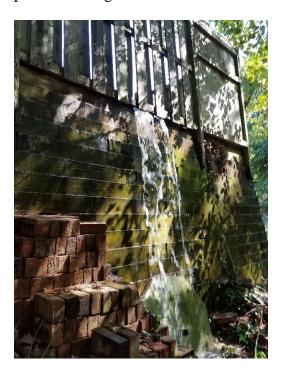
Figure 1. A view of water observed cascading down a retaining wall at the lot for 376 Berkshire Drive on September 25, 2019

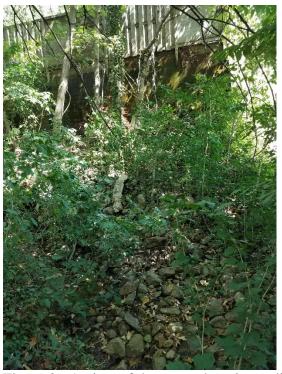
Figure 2. A view of the steep slope immediately adjacent to the retaining wall; note the flowing water passing between the bottom of the privacy fence and the top of the wall (top center)

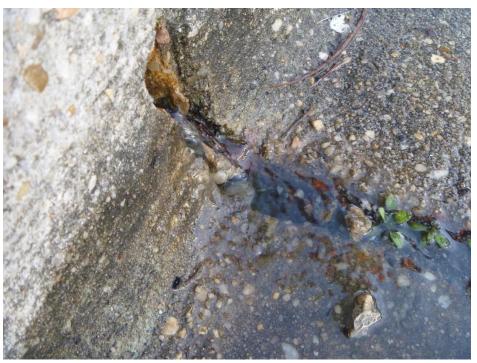
Figure 5. A view of discharge leaking through a seam in the curb along the north side of the car wash; the photograph was taken on January 24

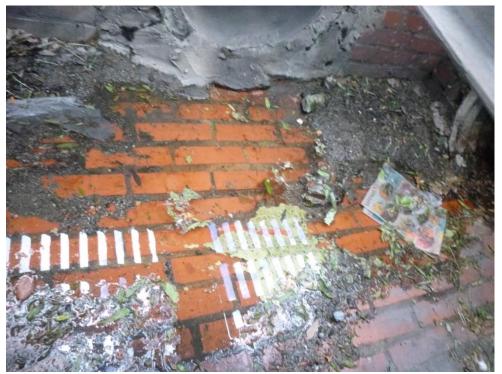
Figure 3. Flowing water observed in inlet on north side of Arnold Road

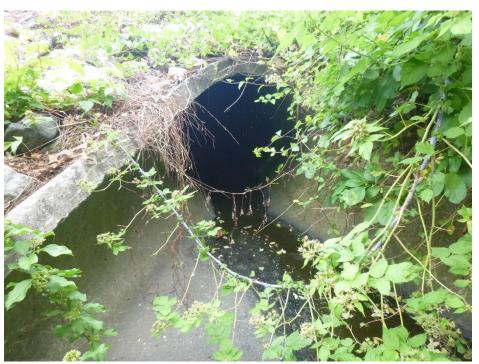
Figure 1. Flowing effluent from outfall F09F0005, as observed on May 27, 2020

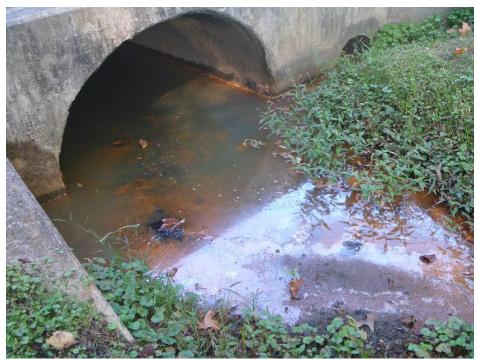
As noted, outfall O22O014 has been the subject of repeated screenings in recent reporting years. In May 2018, samples collected from this outfall had levels of copper and ammonia that exceeded the corresponding criteria; detergents were also detected. In March 2019, test results on a sample from this outfall indicated detectable levels of detergents, copper, and ammonia, at concentrations approximately half the levels needed to exceed program criteria. While investigating conditions at the site, the team found a hose discharging liquid from a residential lot (the homeowner later reported that the source was water that had accumulated on the swimming pool cover); tests of the hose discharge indicated exceeding levels of both detergents and ammonia. In both years, the County closed the cases. In 2018, County inspectors did not observe flowing conditions at the outfall. In 2019, County inspectors reported that the issues related to the resident pumping water from the lot had been adequately resolved. An area map, showing the findings from the inspections on May 13 and June 2, is provided in Figure 4.

Figure 1. Conditions at outfall O22O014 on September 27; note the sheen on the water and the clumps of orange deposits — both indicate colonies of iron-oxidizing bacteria

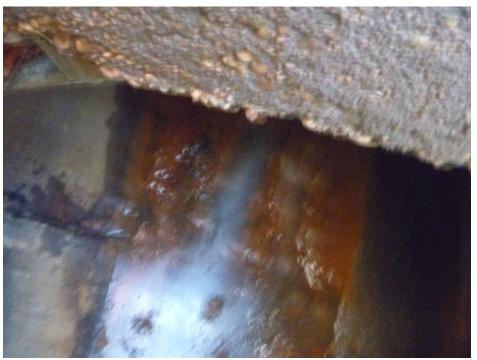
Figure 2. A view inside the inlet immediately up-network from the outfall; note evidence of bacterial colonies similar to those seen at the outfall, as shown in Figure 1

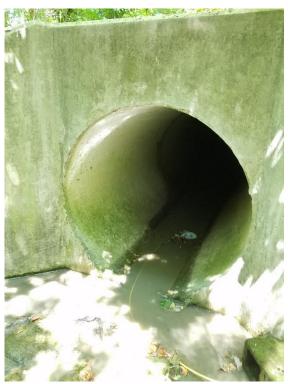
Investigators: K. McGuckin and P. Donovan Concern: Observed grey discharge

Figure 1. A view of grey, cloudy discharge in the outfall R20O017 on June 26

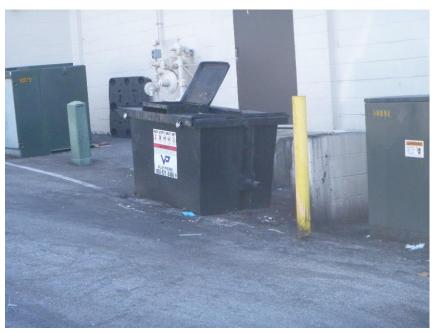
Figure 1. An open kitchen grease bin found in the parking lot behind the Restaurante Jalapeños restaurant; note the dark stains leading from the bin toward the right side of the photograph (down-gradient)

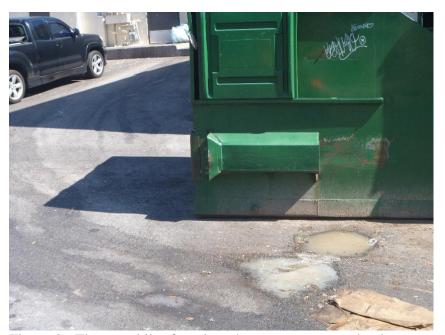
Figure 2. Three puddles found on the pavement near the dumpster closest to the kitchen grease bin seen in Figure 1; one puddle was cloudy, beige liquid with a white sheen; the other two appeared to be solidified grease; note the arc-shaped stain path on the left leading from the door (left background)

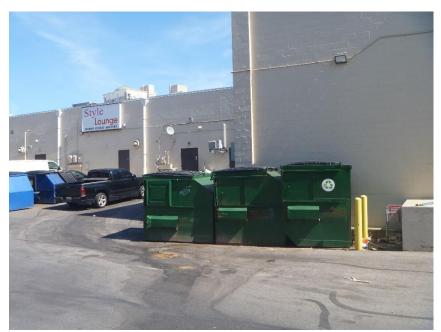
Figure 3. A view of several stain paths (left and bottom center) behind the Restaurante Jalapeños restaurant; the inlet that received the drainage from this area of the pavement was out of the photograph, below the bottom center

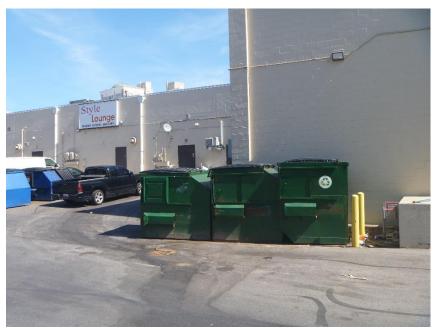
Figure 1. Stains near the dumpsters behind the northwest portion of the Forest Plaza shopping center; the inlet that received the drainage from this area of the pavement was out of the photograph, below the bottom center

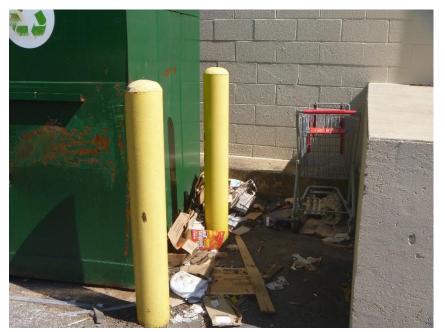
Figure 2. An example of accumulated debris on the pavement near the dumpsters generally located behind the Dollar Tree store

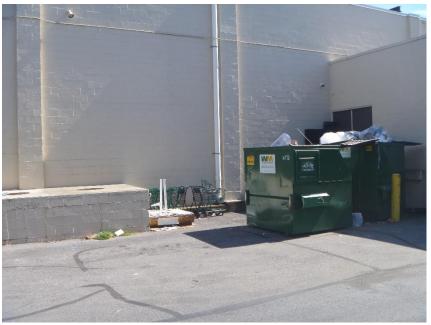
Figure 3. A view of two open and overflowing dumpsters found in an alcove along the north exterior wall of the Dollar Tree store

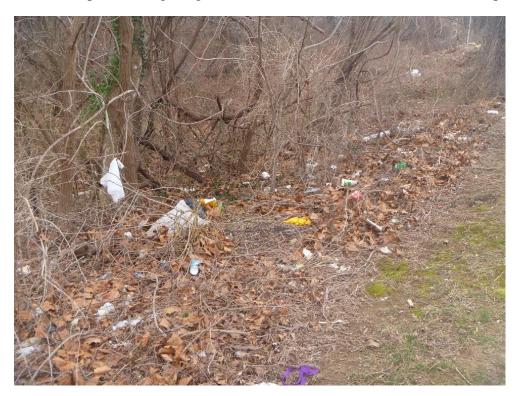
Figure 1. Debris found scattered in the woods on the lot where the Hoyt's West Nursery Cinema 14 conducts business

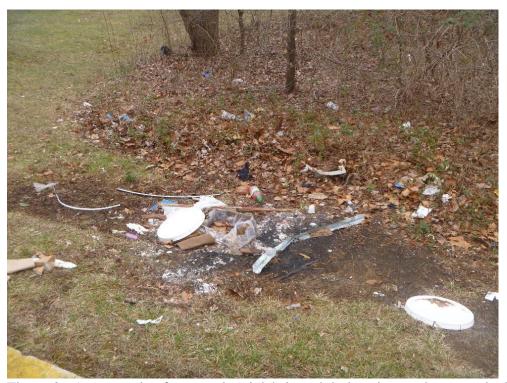
Figure 2. An example of accumulated debris and dark stains on the ground adjacent to a curb on the lot of the Hoyt's Cinema

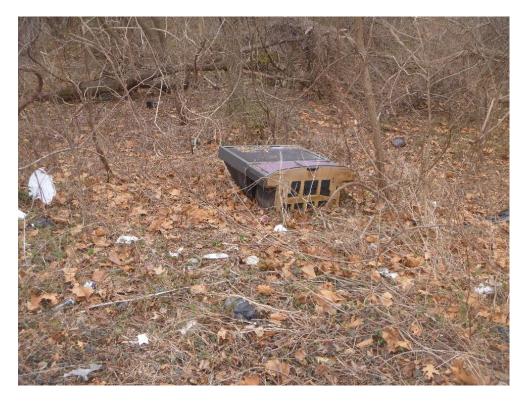
Figure 3. A discarded television set found in the woods in the midst of loose debris

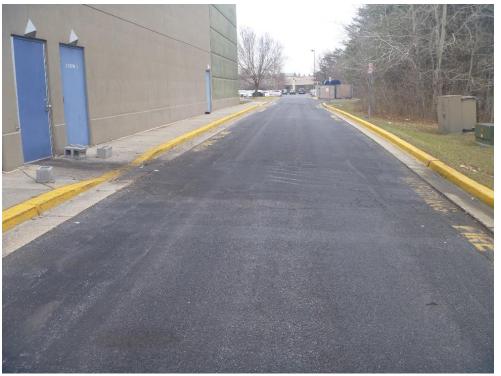
Figure 4. A view of the building side of a contiguous dark cooking oil stain between a rear door of the Hoyt's Cinema and a nearby curb inlet

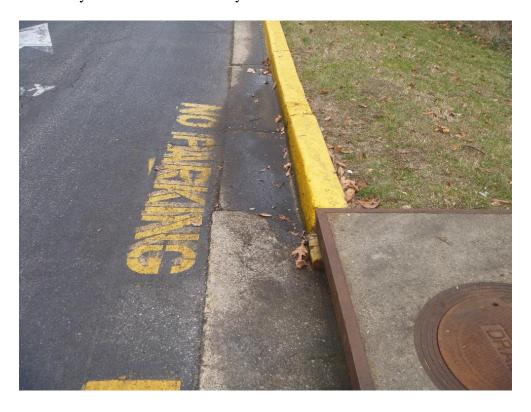
Figure 5. A view of the curb side of a contiguous dark cooking oil stain between a rear door of the Hoyt's Cinema and a nearby curb inlet; note the dark stains at the gutter and the pavement immediately in front of the inlet

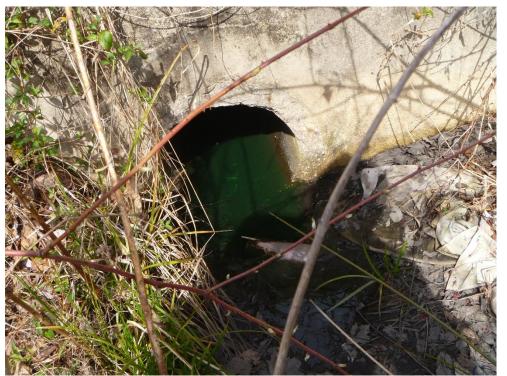
Figure 1. Green stagnant water evident in the outfall F09O003, which is immediately adjacent to the car wash of the Shell gas station

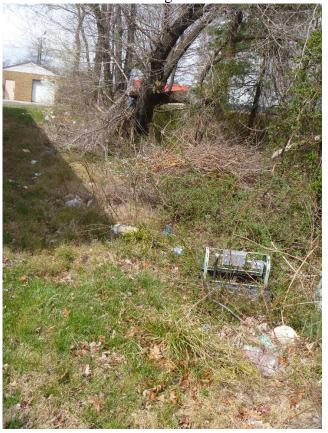
Figure 2. Debris found scattered on the hill leading from the Shell gas station toward the stream

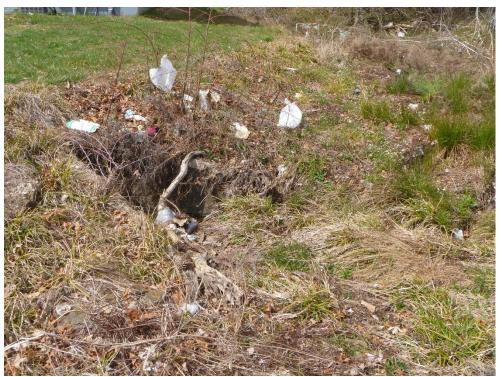
Figure 3. A view of the entrance to the culvert partially blocked by excessive vegetation; note the accumulated debris near the entrance

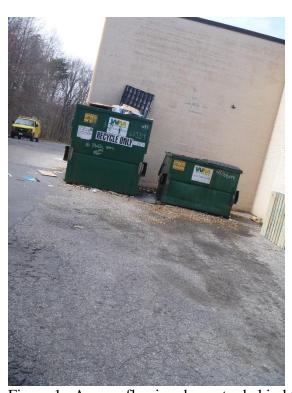
Figure 1. An overflowing dumpster behind the Dollar Store

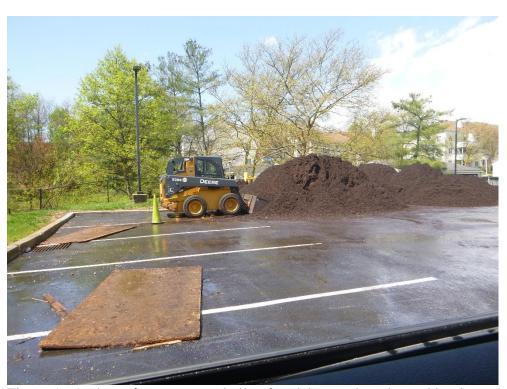
Concern: Improper bulk solid waste management

Figure 1. A view of an uncovered pile of mulch stored on the parking lot approximately 15 feet from an inlet (center left)

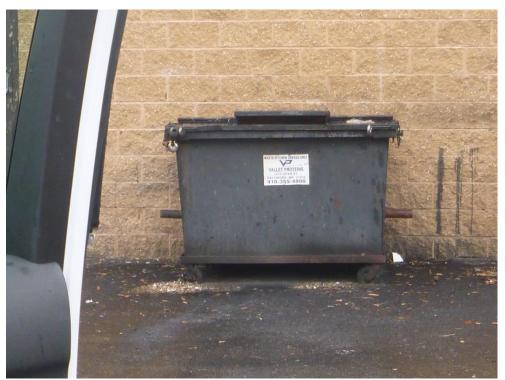
Figure 1. A view of the kitchen grease bin with accumulated grease on and around the bin; note the dark stains on the pavement

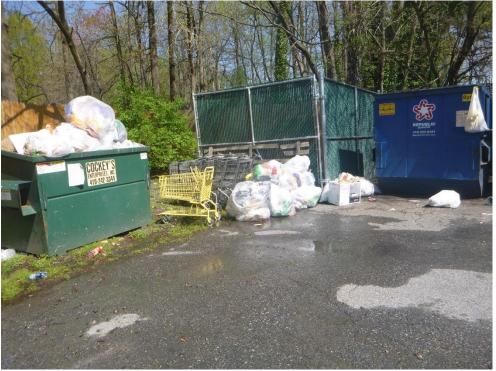
Figure 1. A view of an overflowing dumpster and numerous bags of trash accumulated on the pavement near the dumpster enclosure

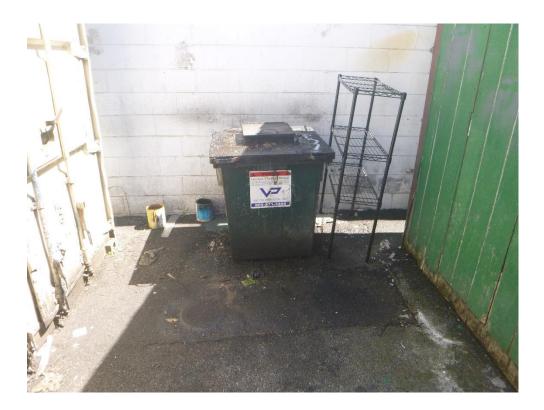
Figure 1. A view of the kitchen grease bin with obvious grease and food debris on and around the bin; note the dark stains on the pavement

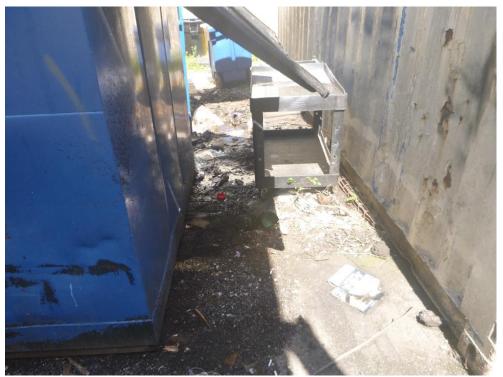
Figure 2. A view of an open dumpster with debris scattered around the base; note the dark stains on and around the base of the bin

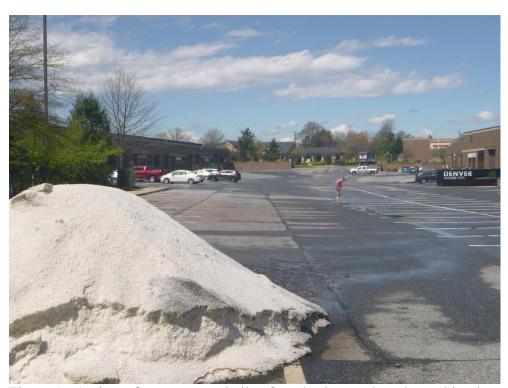
Figure 1. A view of an uncovered pile of road salt stored on the parking lot approximately 100 feet from an inlet (indicated by the team member's position in the photograph)

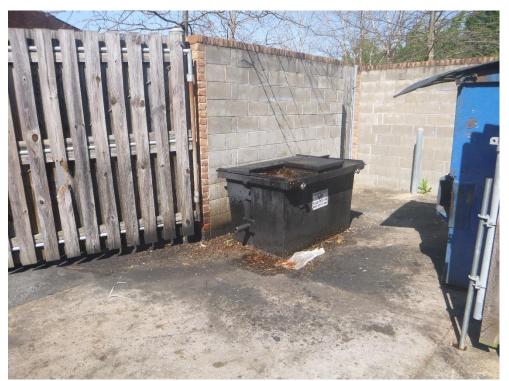
Figure 1. A view of the kitchen grease bin with evidence of numerous grease spills on the pavement near the bin, seen as dark stains in the photograph

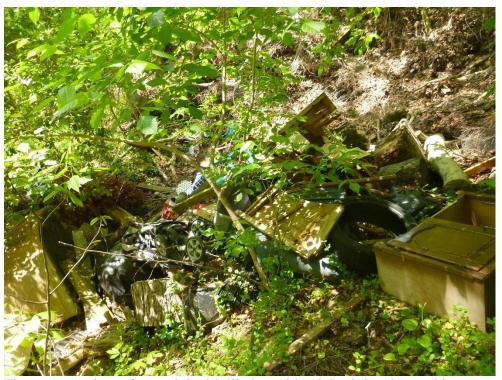
Figure 1. A view of material with likely residential origins dumped into a wooded area to the west of North Zona Street in Parkway Village

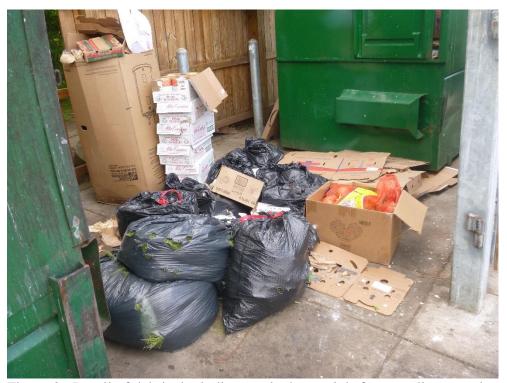
Figure 2. Detail of debris, including stacked materials for recycling, torn bags of trash and grass clippings, and food, found in the dumpster enclosure

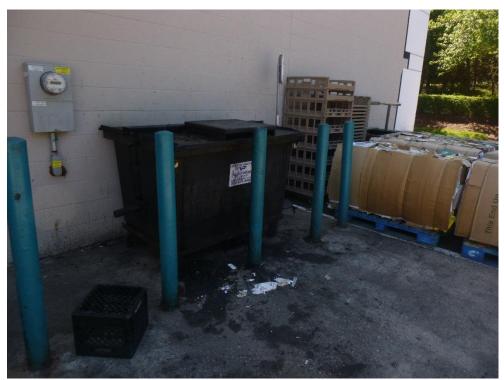
Figure 1. Evidence of cooking oil spills on the pavement near a disposal bin for used kitchen grease near a rear door for the grocery store The Fresh Market

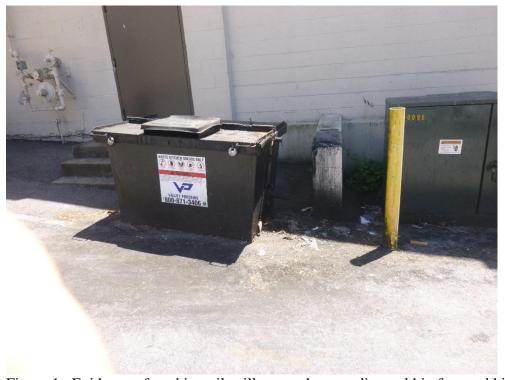
Figure 1. Evidence of cooking oil spills on and near a disposal bin for used kitchen grease in a rear alcove near the Jalapeños Restaurant

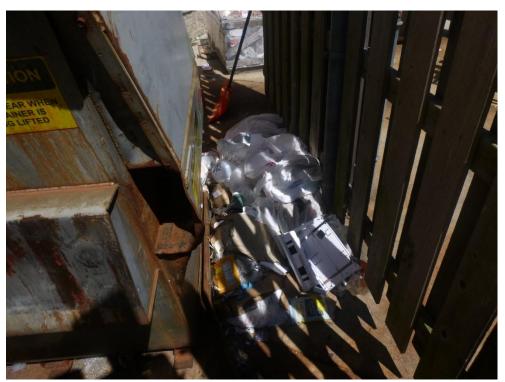
Figure 1. Debris found on the pavement alongside the trash compactor near the Walgreens store
