# Fiscal Year 2021 Annual Report

Illicit Discharge Detection and Elimination

Permit Number: MD0068306

Prepared for  
Anne Arundel County

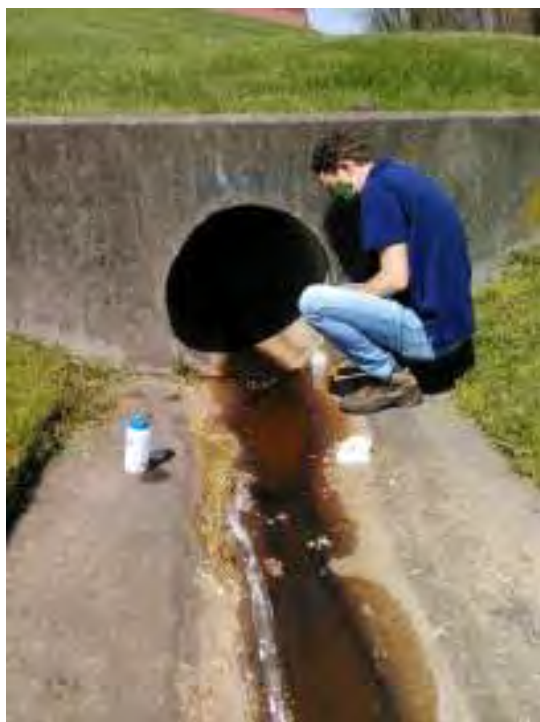
**Figure 1:** Outfall Ko2O016 flowing on 4/20/21

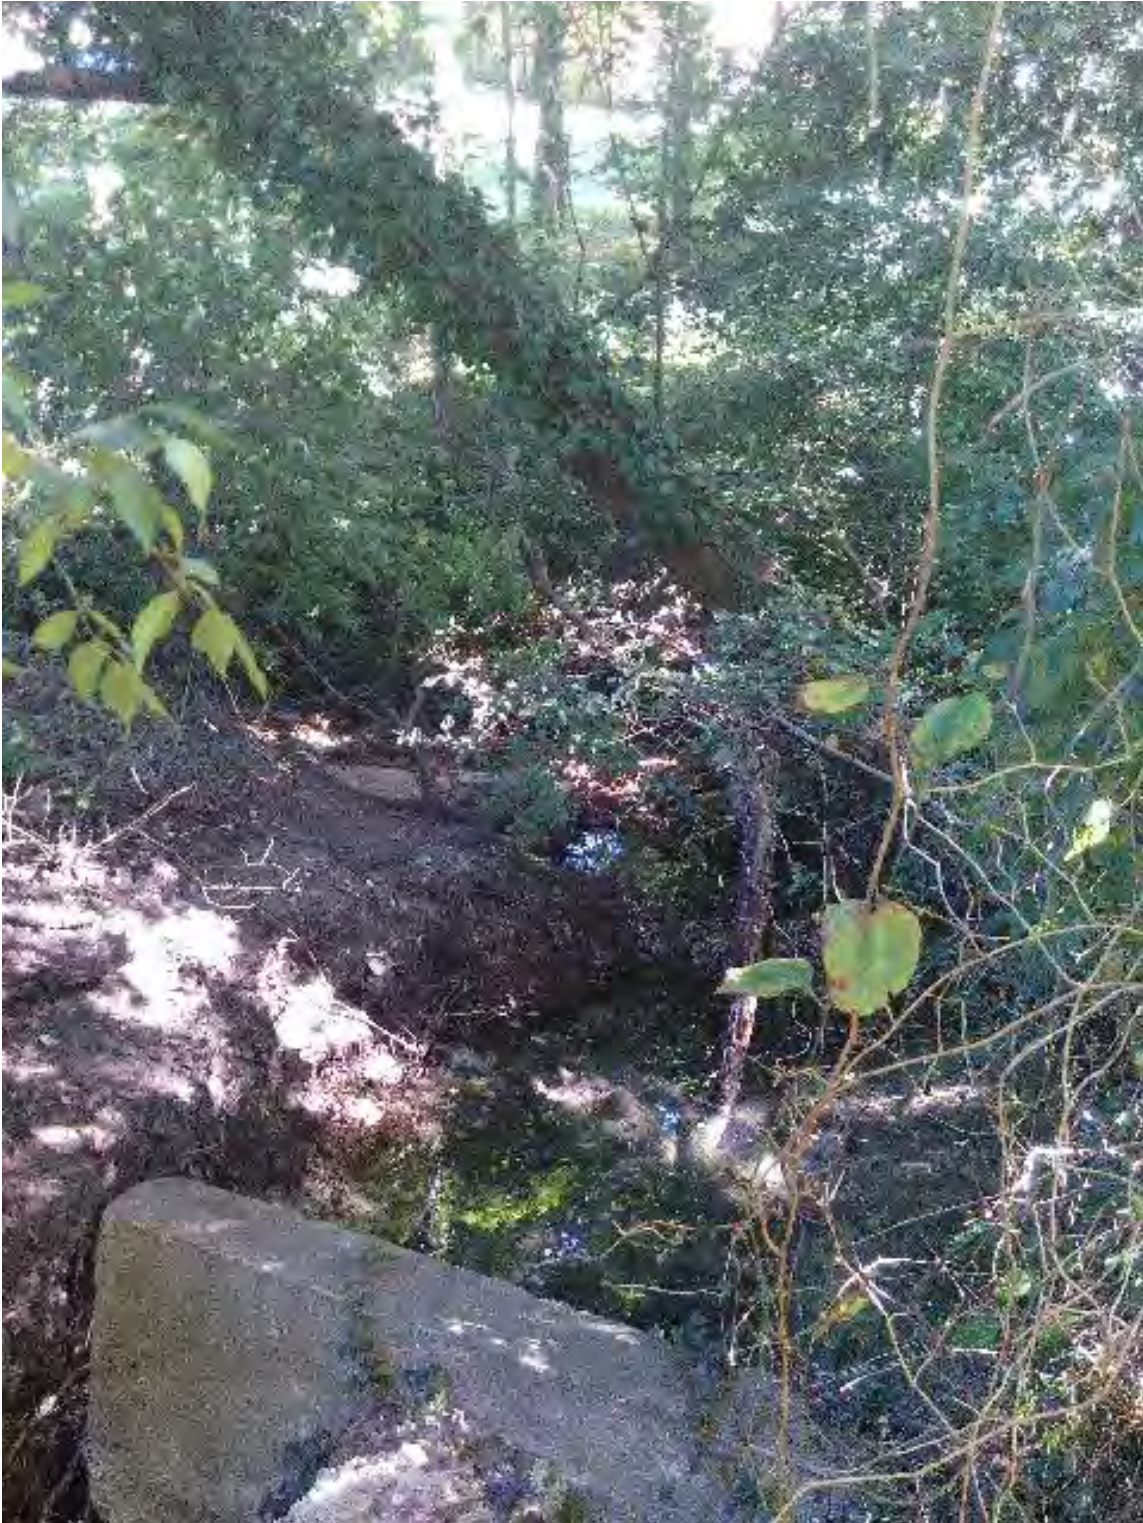
**Figure 3:** Broken and collapsed end section of Outfall L090021.

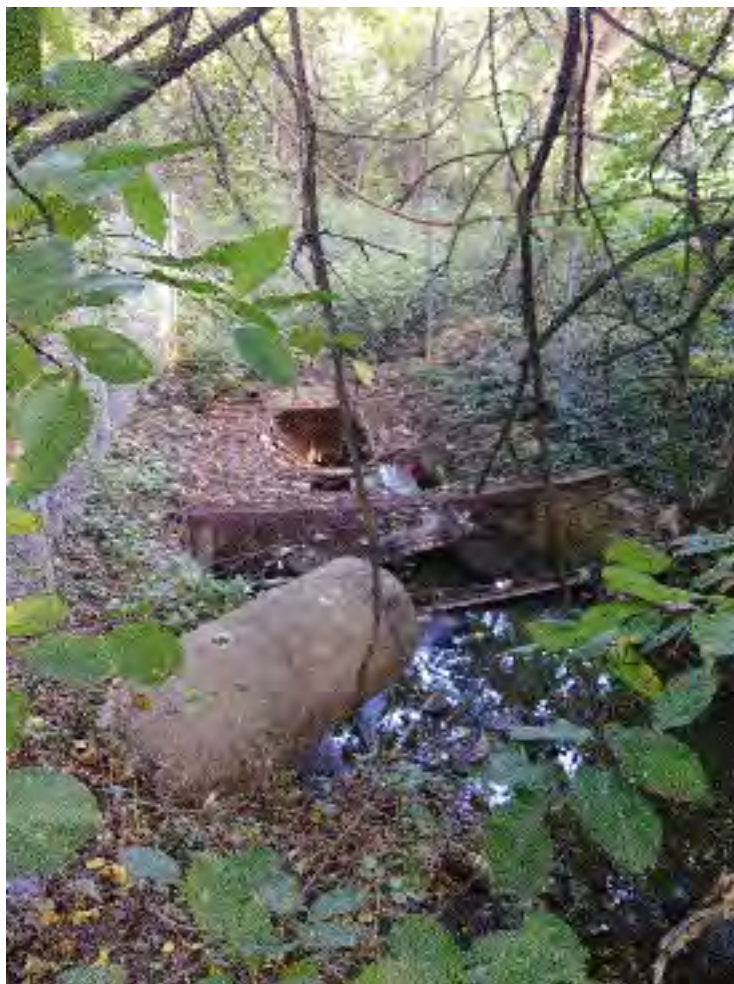
**Figure 2:** Outfall L10O007 pictured in poor condition behind damaged stabilizing structure/trash trap. Outfall L10O010 pictured in foreground.

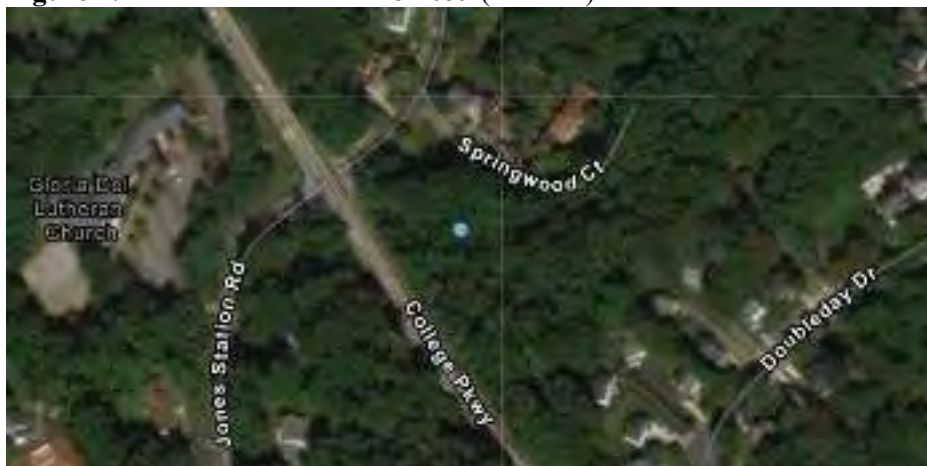
Figure 2: Outfall T15O059

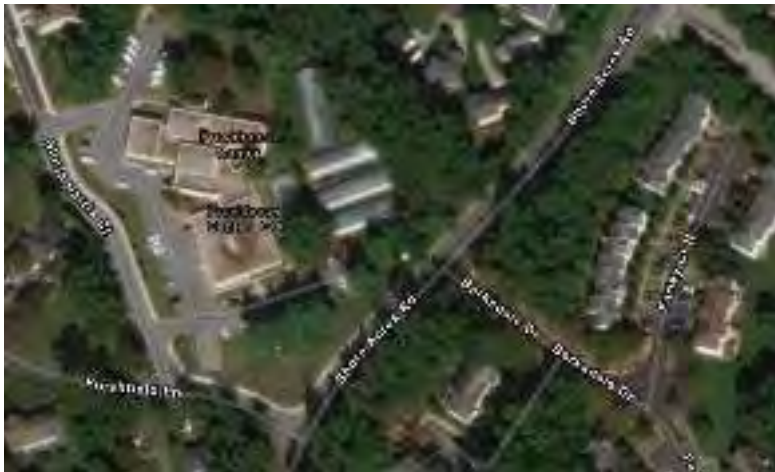
**Figure 2:** Outfall U16O014

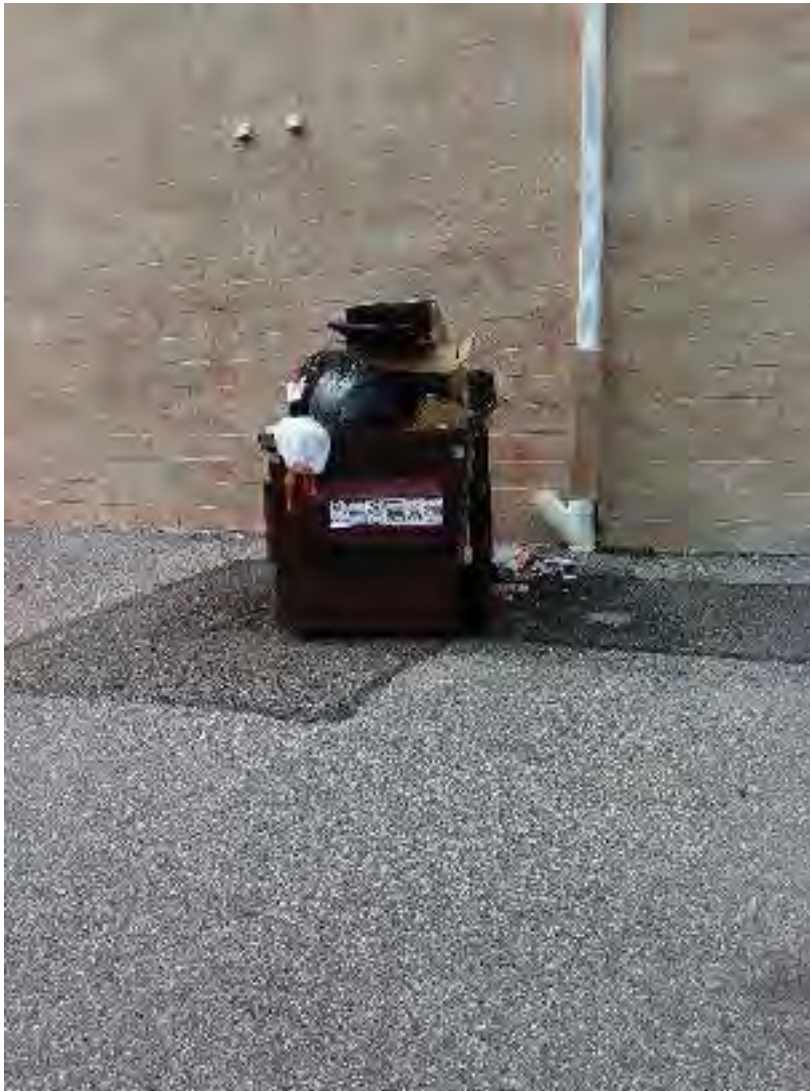
**Figure 2:** An overflowing dumpster with visible trash spilled on the ground, behind DollarGeneral.

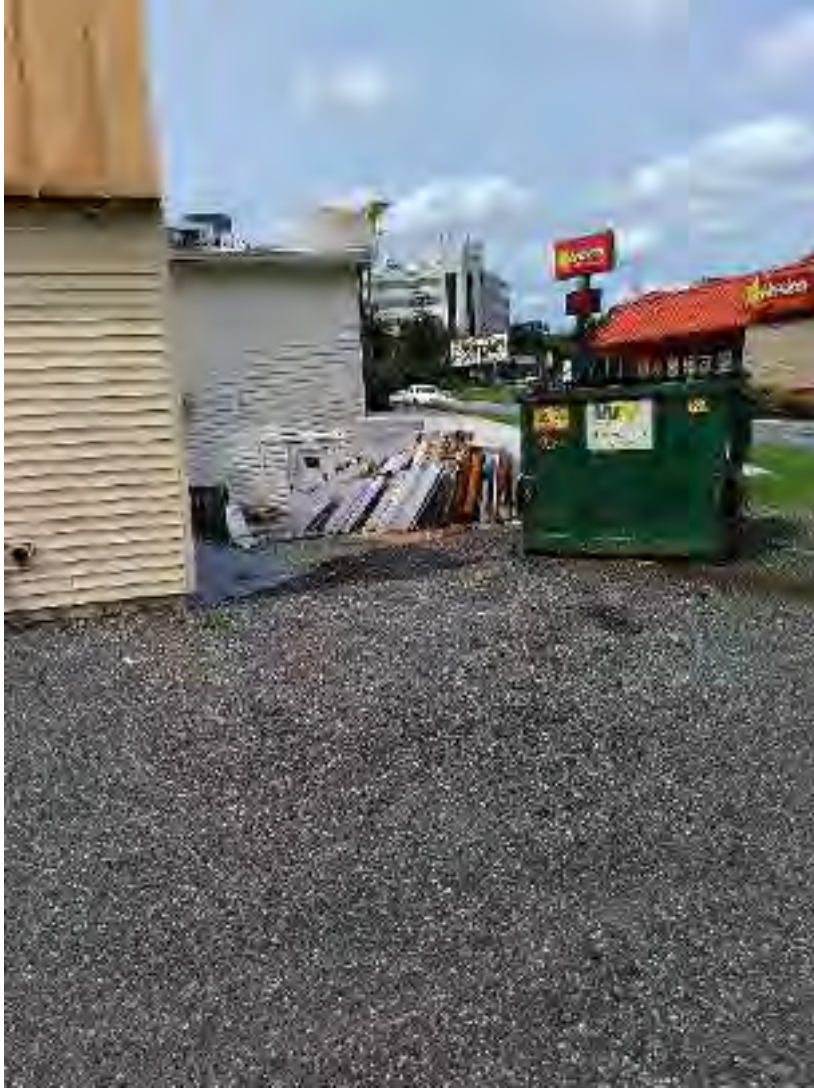
**Figure 2:** Bulk solids consisting of sheet metal and foam stored uncovered behind LindyRedding Heating and Air Conditioning.

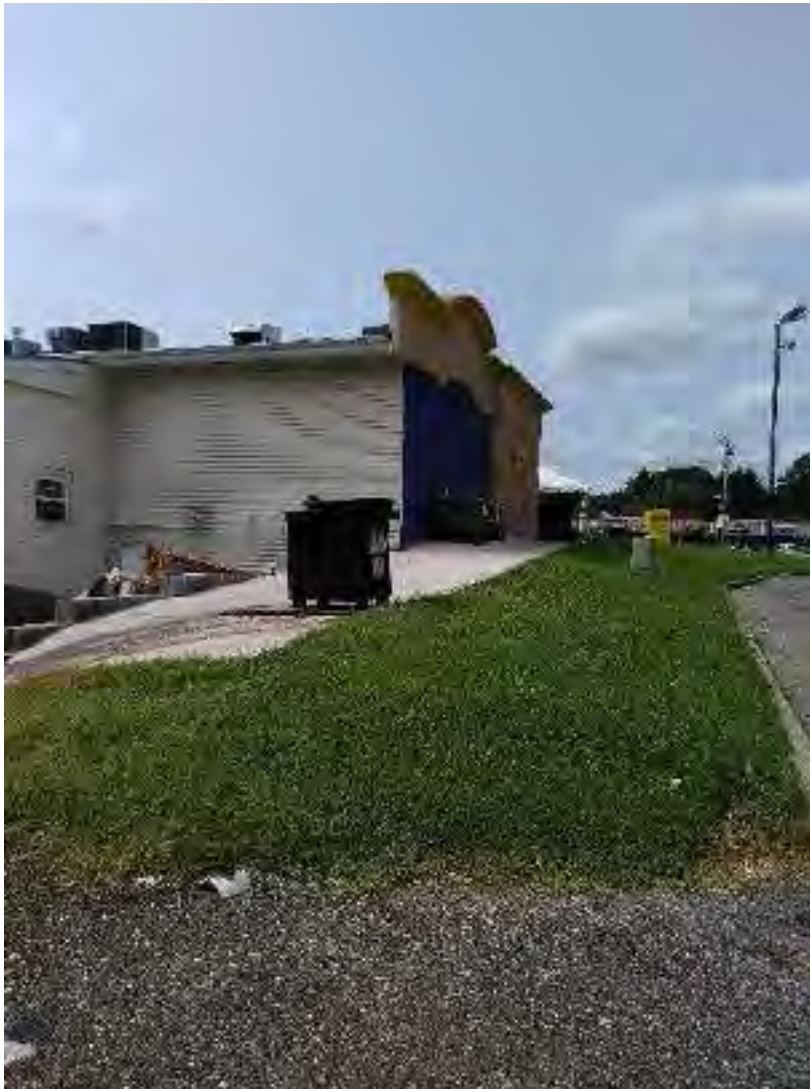
**Figure 2:** La Trampita Restaurant's grease storage container with visual evidence of leaking grease on the ground to the left of the container.

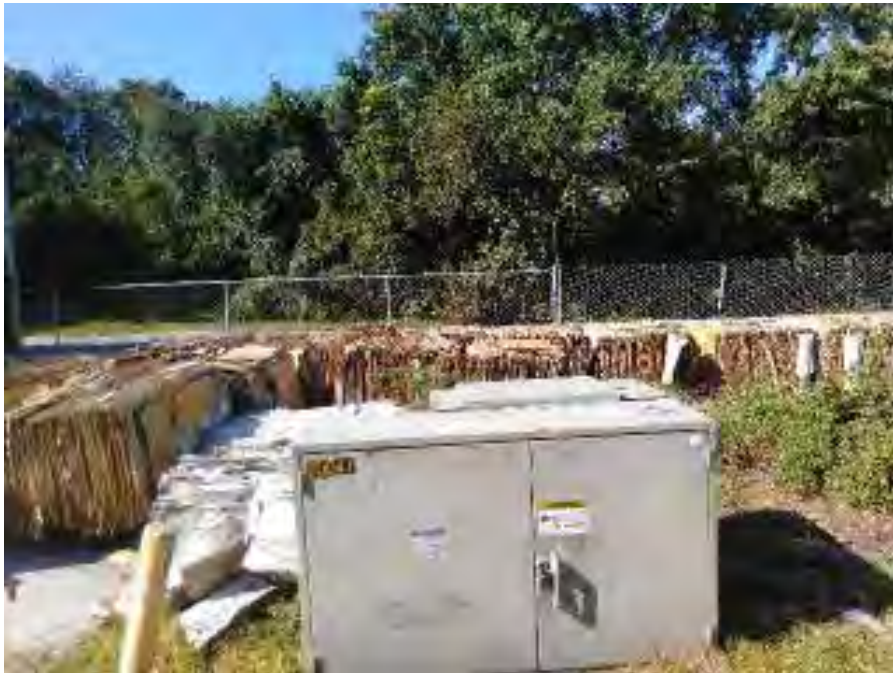
**Figure 2:** Bulk cardboard storage.

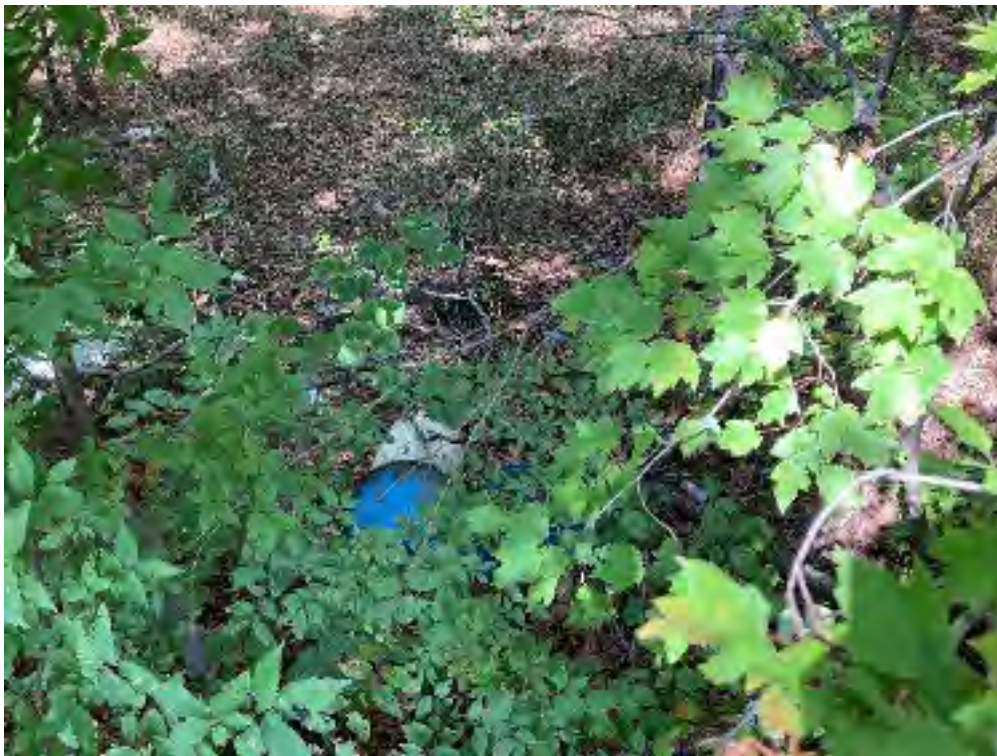
**Figure 2:** Drum front top of embankment on Cloverleaf Dr.

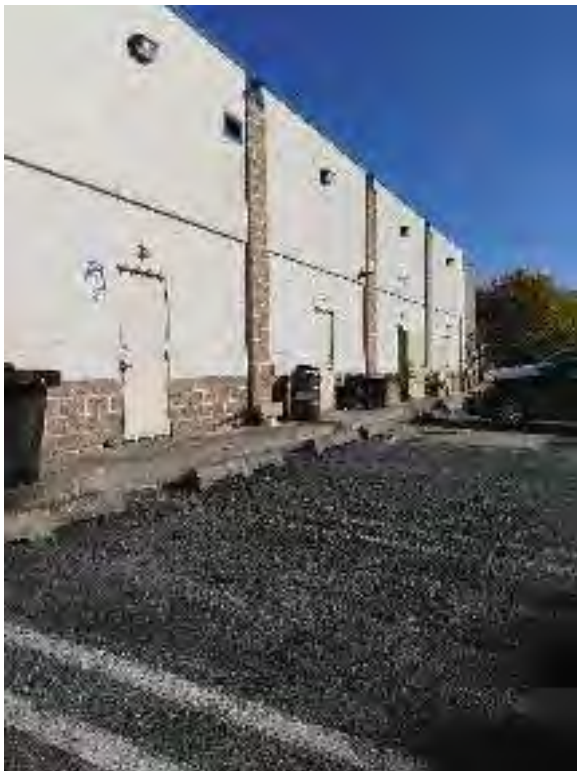
**Figure 2:** Drum with oil/grease leaks present and visible on sidewalk.

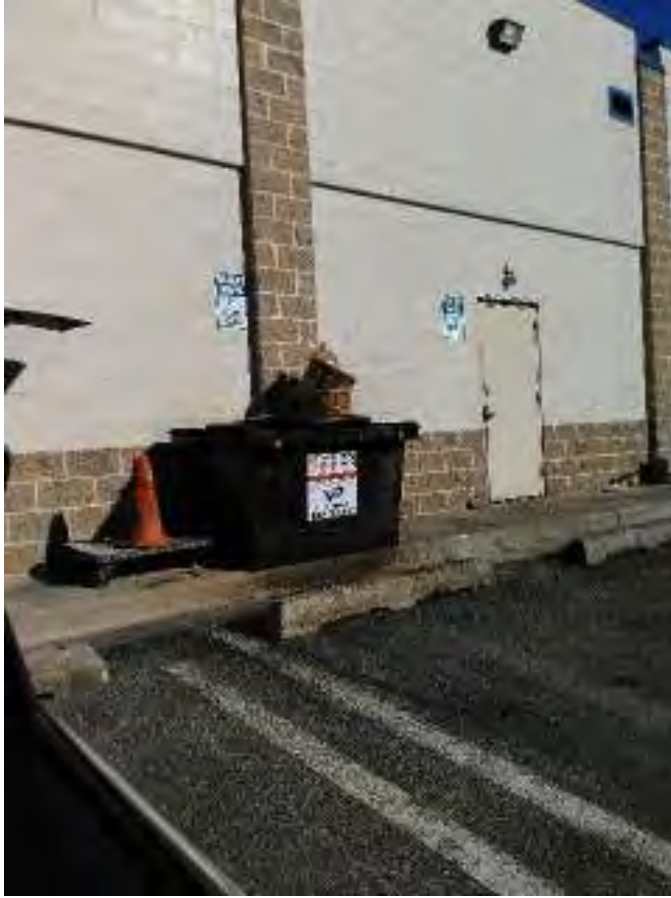
**Figure 3:** Grease trap with oil/grease leaks present and visible on sidewalk.

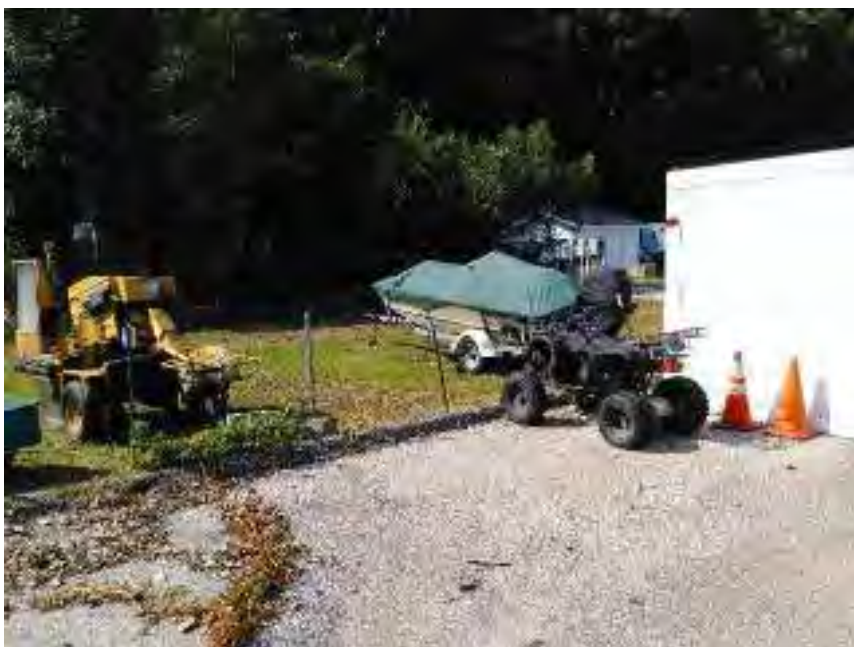
**Figure 3:** Improper storage of vehicles and equipment.

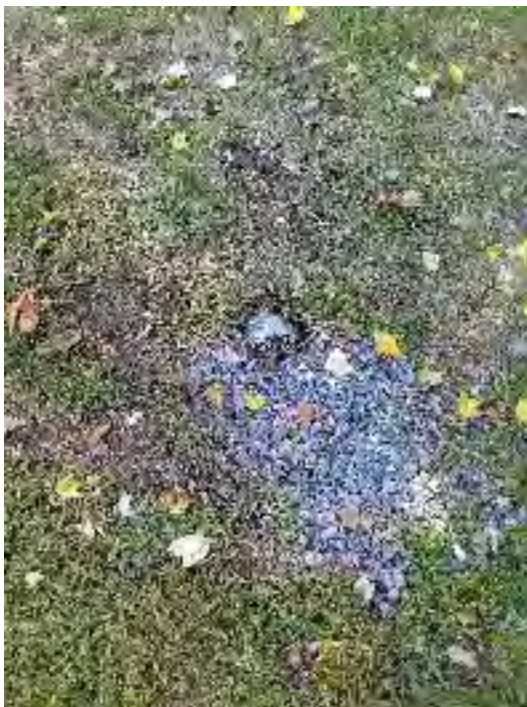
**Figure 7:** Undocumented outfall.

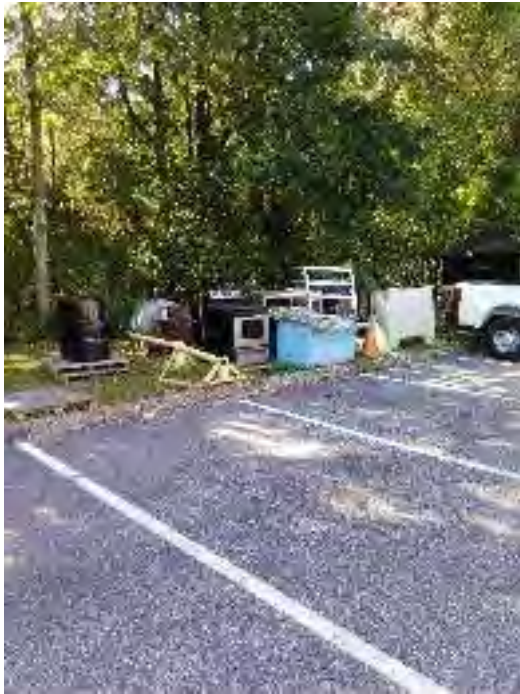
Figure 6: Improper bulk solid and liquid storage located on south edge of property.

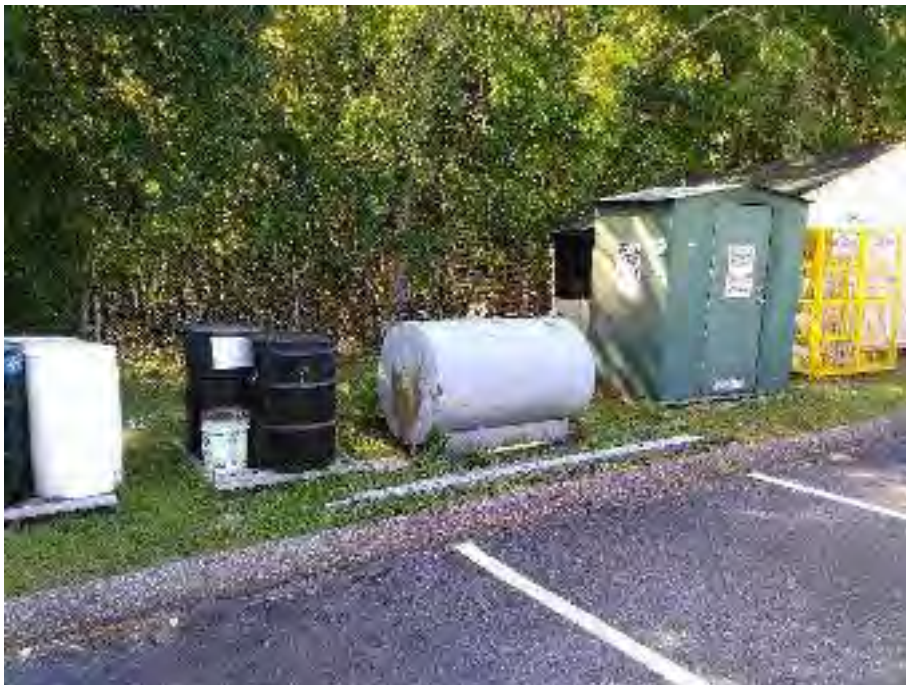
Figure 7: Improper liquid storage.

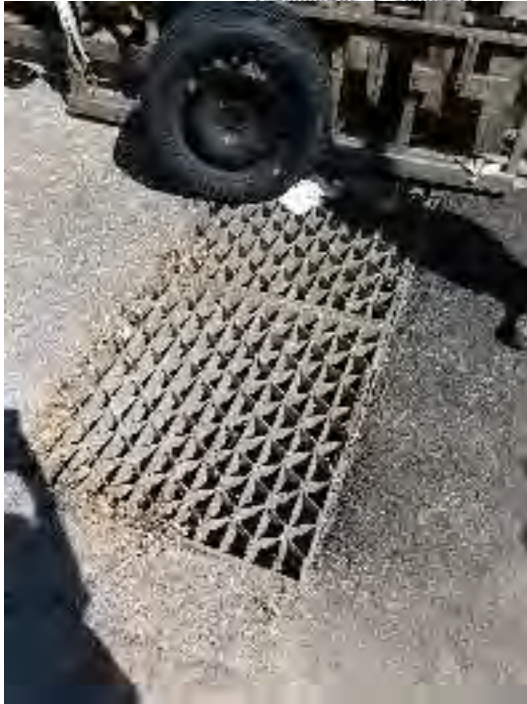
Figure 4: High water elevation in catch basin at SW end of property

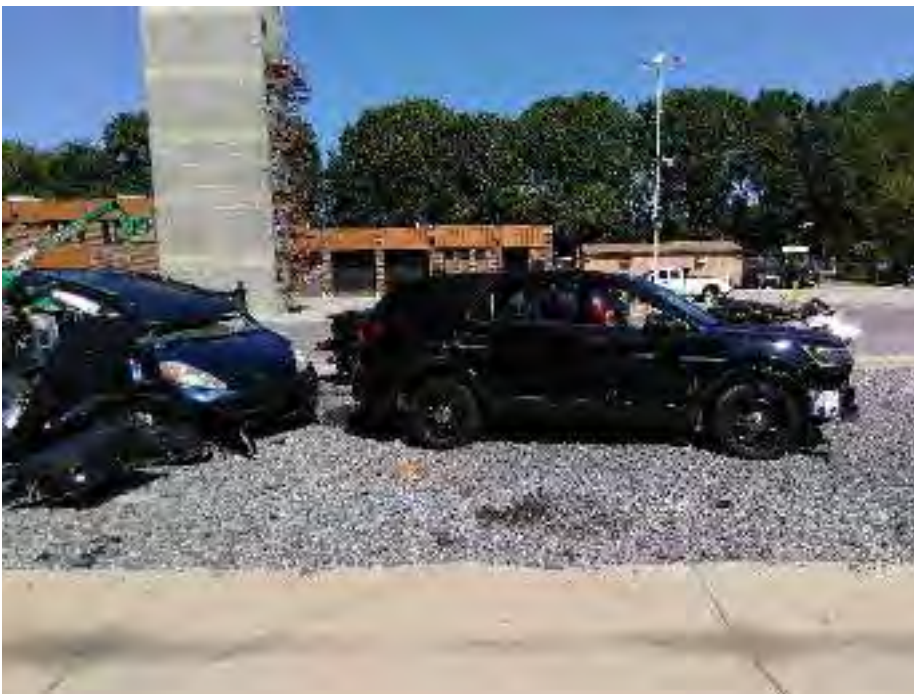
Figure 7: Damaged cars.

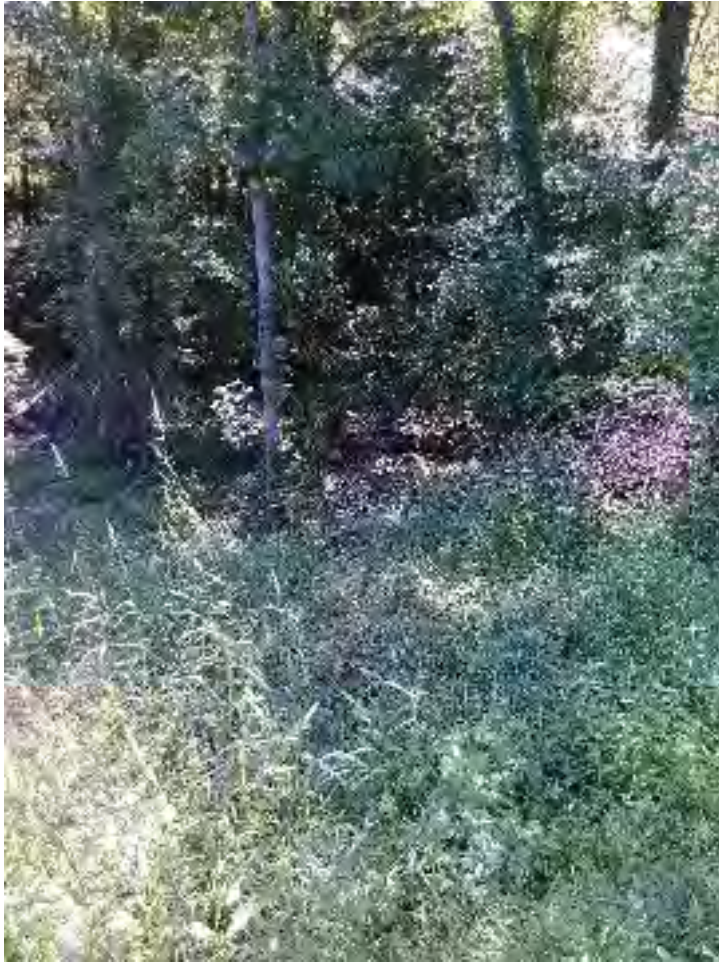
Figure 14: Outfall location. Outfall was not accessible due to a locked fence.

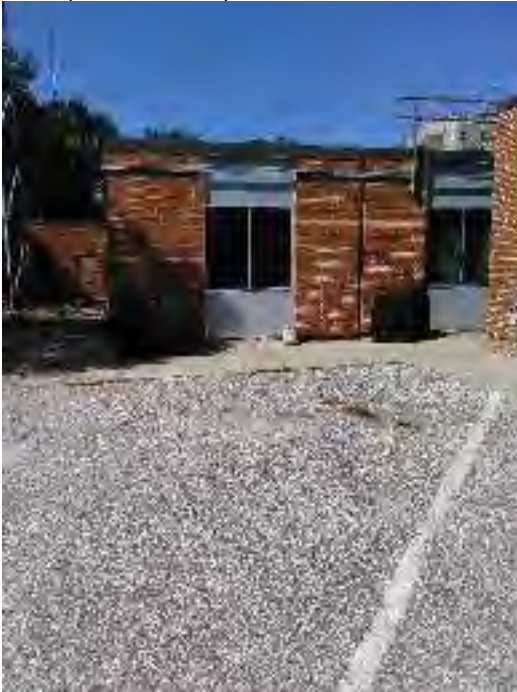
Figure 2: Improper liquid storage

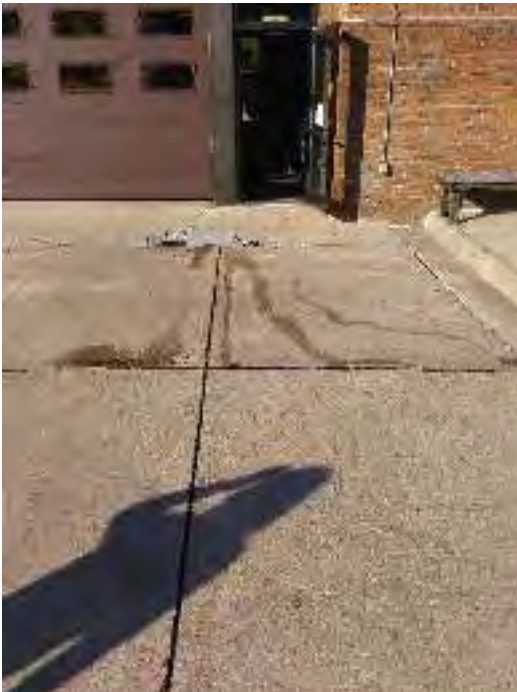
Figure 5: Potential washdown activity.

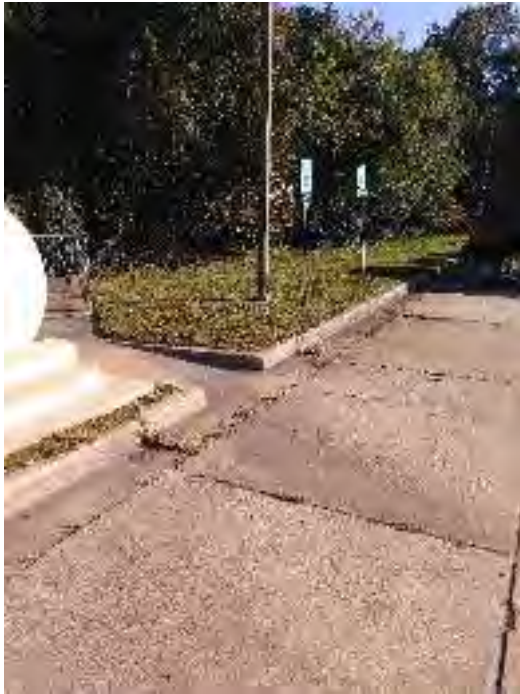
Figure 6: pavement staining of potential washing activity.

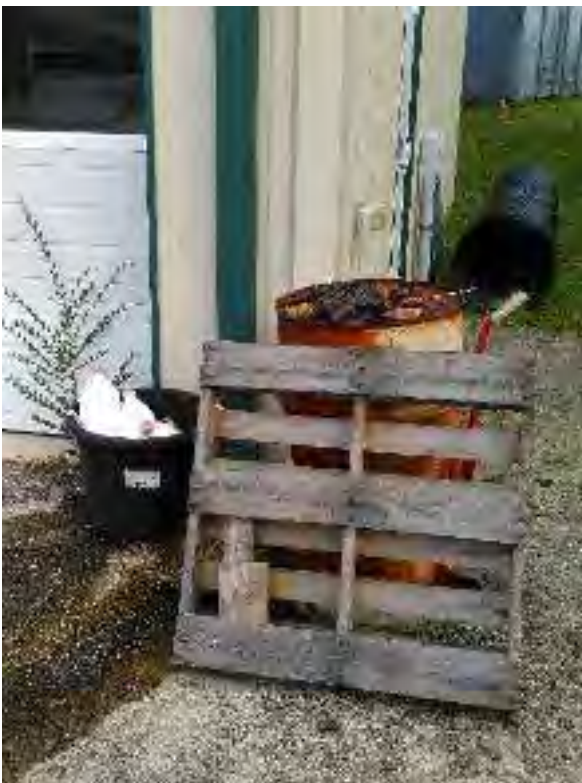
This site also has improper liquid storage located near the shed in the rear of the property. It consists of several small plastic containers, and a large 55-gal drum. These liquids are not labeled, are not in secondary containment (not covered), and appear to be leaking fluid onto the pavement and the 55-gal drum is rusting. This liquid is running onto the pavement and will be washed to a nearby storm drain inlet if not resolved.

Figure 3: Improper liquid storage.

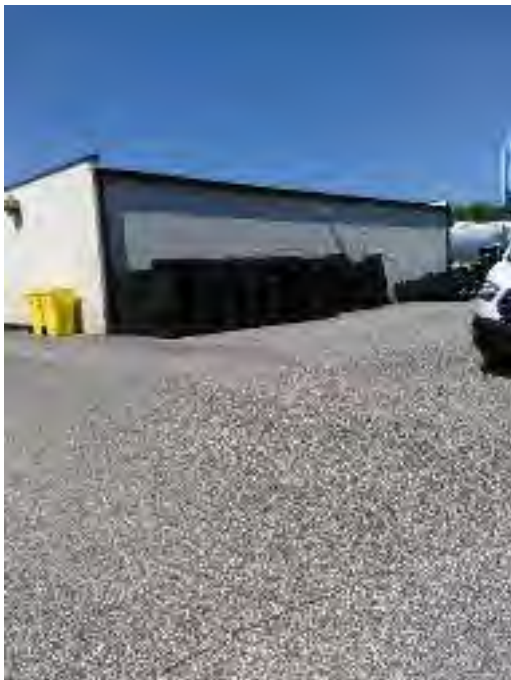
Figure 3: Improper bulk solid storage of tires.

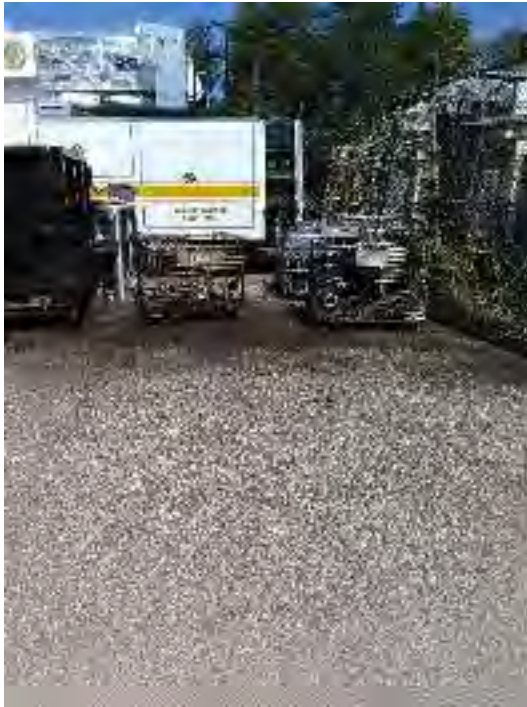
Figure 4: Improper bulk solid storage of parts.

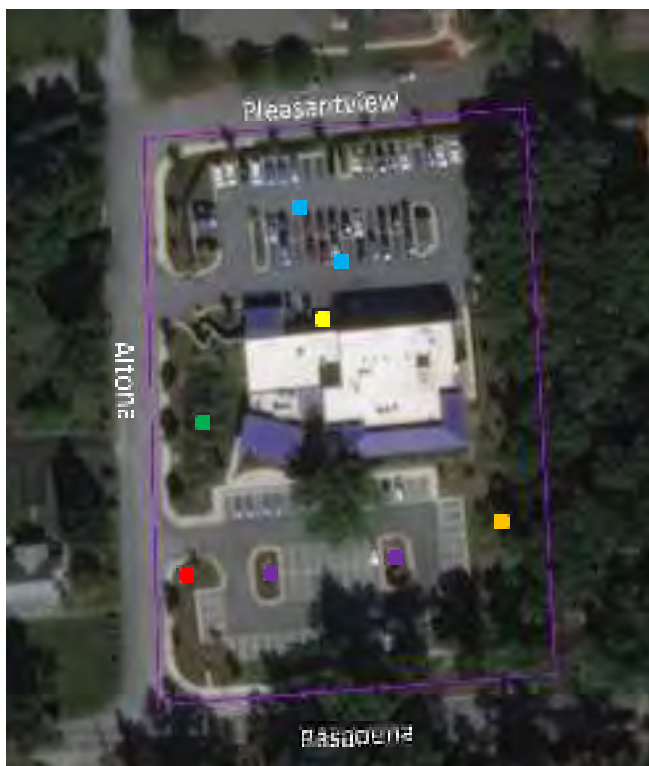
During the site visit the field team found a single blocked inlet (Figure 1 – red circle) in a conveyance channel near the entrance to the front parking lot. The inlet was mulched over completely blocking flow. Additionally the field team observed a work crew temporarily storing mulch and trimmings on the permeable pavement. The work crew did blow off the pavement after completing work and there was no notable sign of clogging observed, but it's possible that finer sediment remained which could decrease the effectiveness of permeable pavement. The County should consider if there is a need to revise landscaping practices to avoid landscaping on permeable pavement if possible.

Figure 1: Aerial map of the Eastern District Police Station. Red Circle = Blocked inlet which has been mulched over. Yellow Circle = Vehicle washing area  
 Green Circle = Micro bioretention Orange Circle = Raingarden  
 Purple Circles = Landscape infiltration practices  
 Blue Circle = Manhole cleanouts associated with infiltration trench

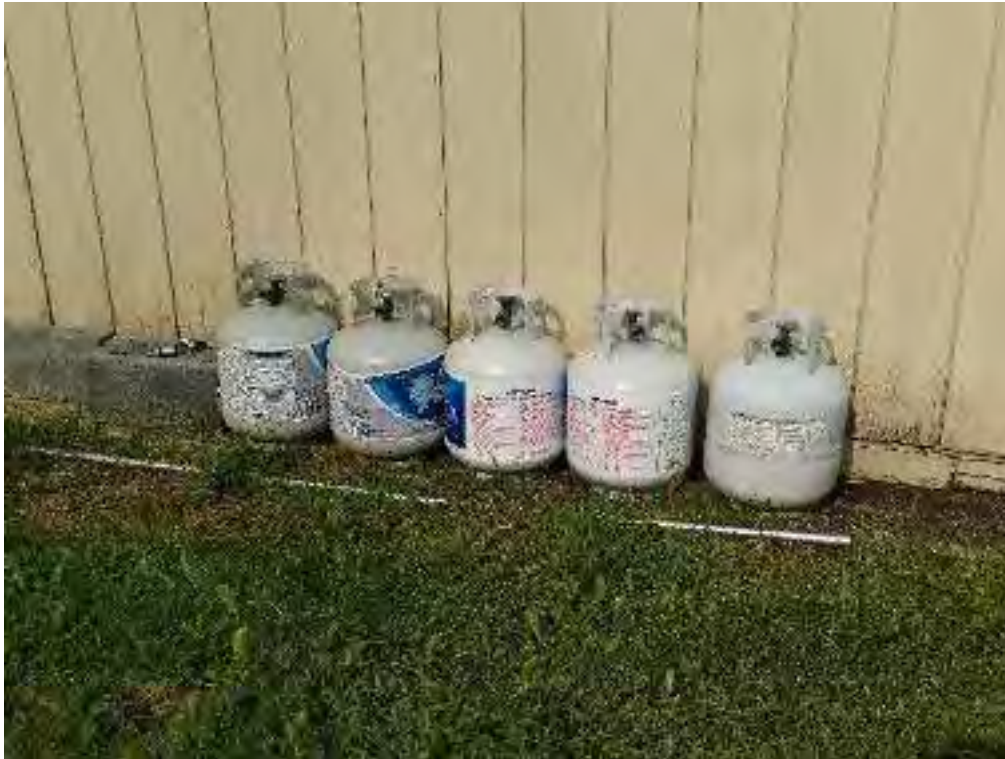
Figure 4: Illicit liquid storage.

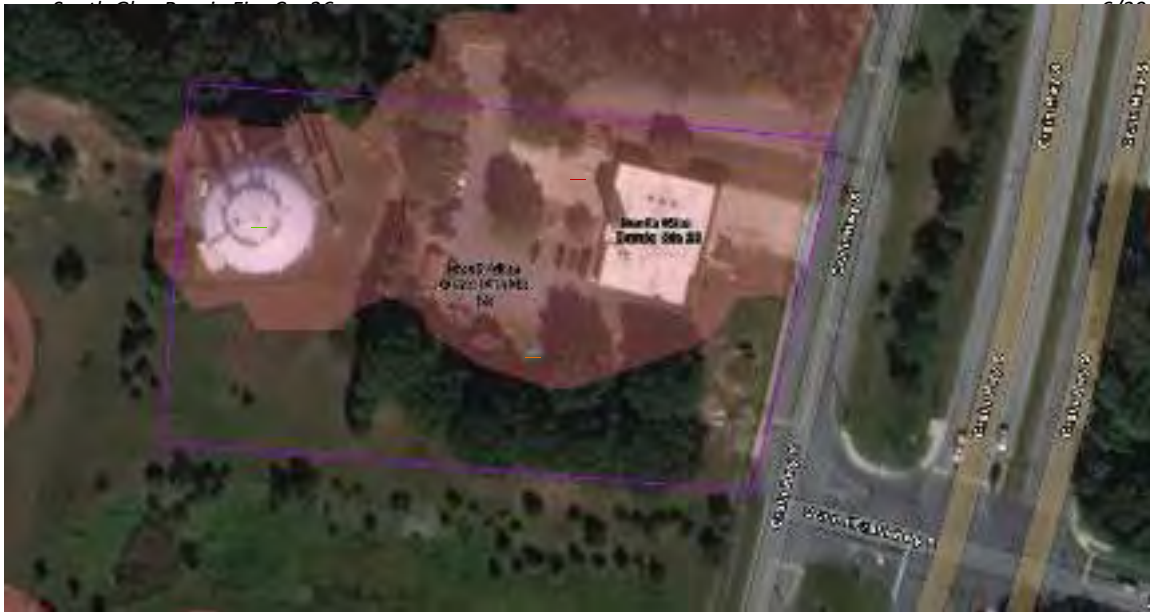
During the first visit (9:00am) to this site staff were actively washing a fire engine on the rear garage pad (red point in Figure 1). Washwater flowed south to a storm drain inlet that captured flow and conveyed it to a nearby outfall. This outfall was actively flowing and showed obvious foam/bubbles from the washing activity. This discharge was tested and was exceeding the detergents limit (See Figure 2 through Figure 6). The team reinvestigated the site 4 hours later and the washing activity had stopped and the outfall was no longer flowing. Because the outfall did not exceed thresholds twice it was not marked as illicit and was not reported.

Figure 1: Aerial map of the South Glen Burnie Fire Co. 26  
Purple Outline = Parcel Boundary  
Orange Point = Washwater affected outfall  
Red Point = Washwater affected outfall

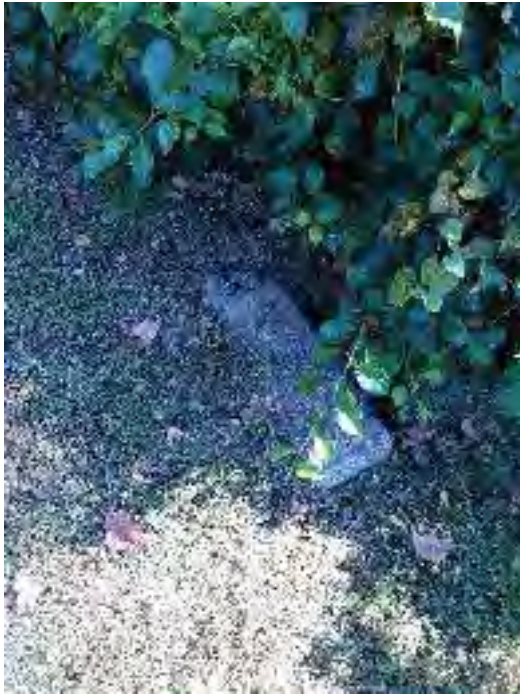
Figure 4: Dry outfall.
