**GEOMORPHOLOGICAL CONDITION  
IN THE PICTURE SPRING BRANCH  
SUBWATERSHED, SEVERN RIVER  
WATERSHED, ANNE ARUNDEL COUNTY,  
MARYLAND: FY2021**

FINAL: June 2021

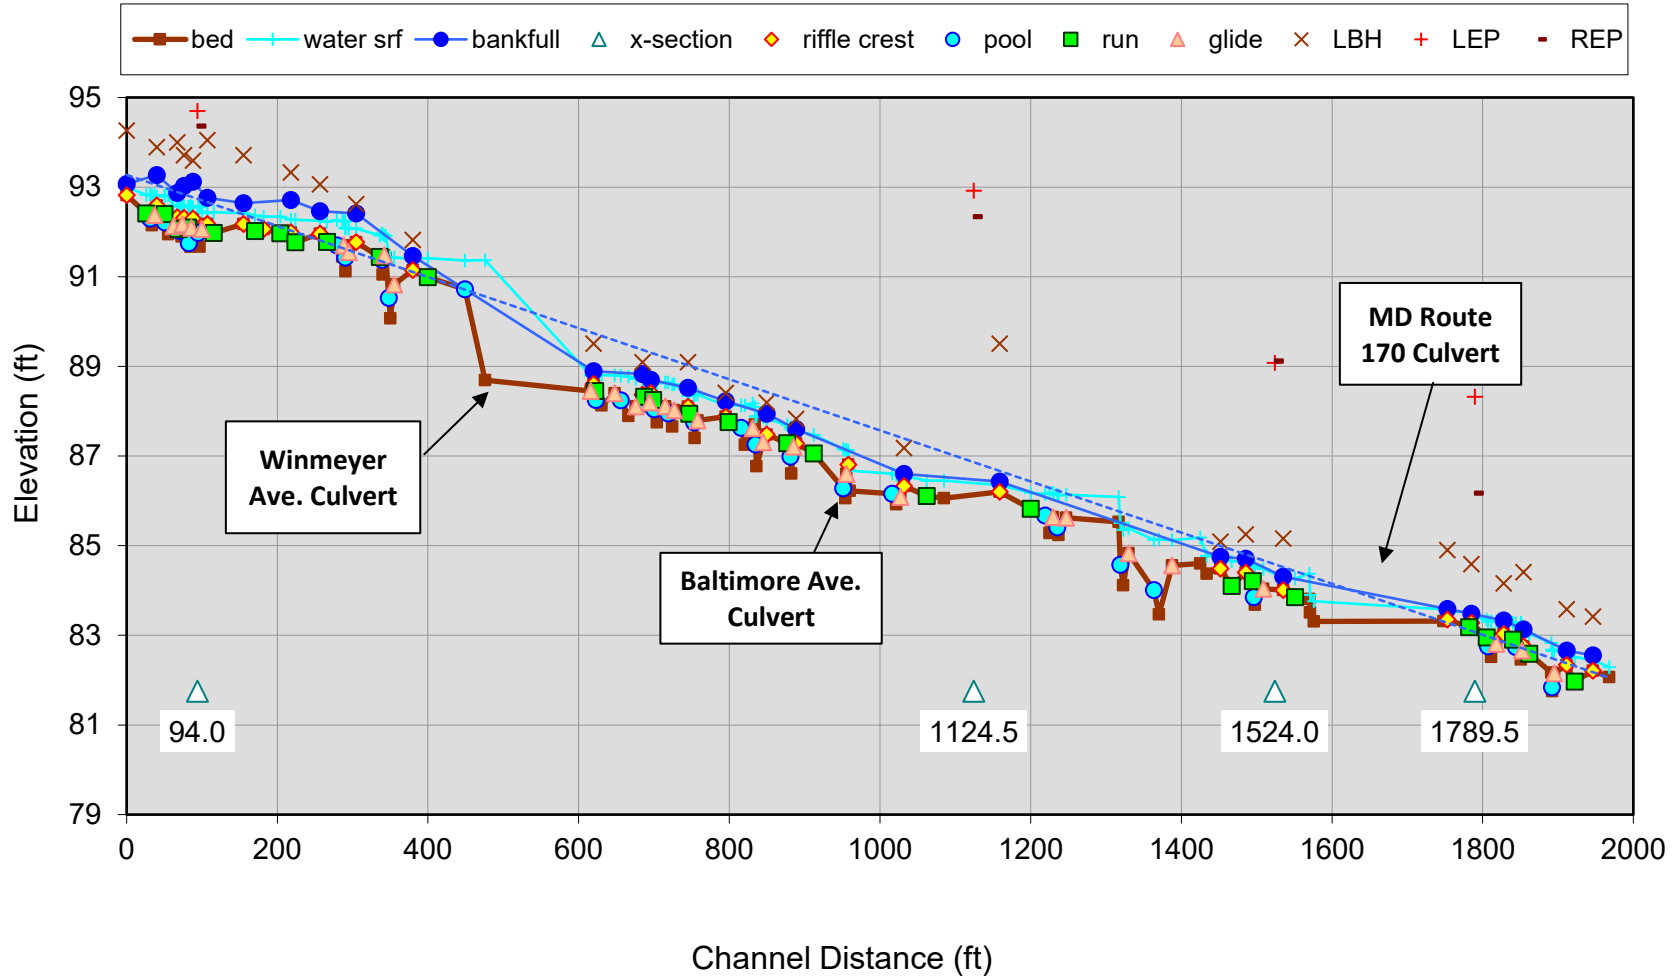
**Picture Spring Branch  
 North Tributary Longitudinal Profile Fall 2020**

An overlay of North Tributary longitudinal profiles shows little change occurring to this reach from 2007 through Spring 2020; significant aggradation was seen throughout this reach during the Fall 2020 survey (Appendix B). Numerous man-made structures (i.e., culverts, concrete-lined channel) throughout this reach appear to be providing adequate grade control, preventing substantial channel degradation. In one portion of the reach between cross-sections 1 and 2 (profile stations 383 – 454), notable aggradation has occurred particularly between 2016 and 2020. This is the area just above the Winmeyer Avenue culvert. Aggradation also appears to be occurring between stations 1,000 and 1,300, between stations 1,400 and 1,500, as well as between stations 1,800 and 1,950; continued monitoring of these areas is recommended to further determine if they continue to aggrade or return to conditions seen in prior surveys.

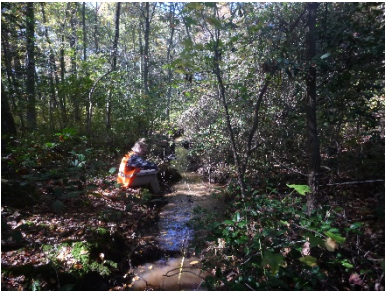
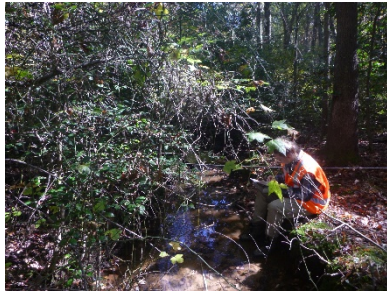
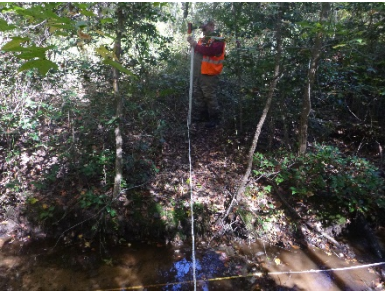
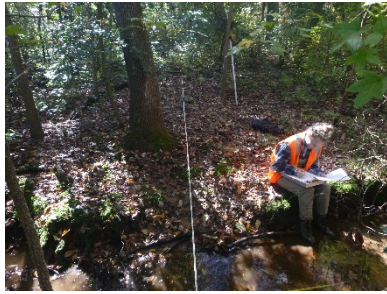
Cross-section 1, located in the well-forested upper portion of the North Tributary continues to exhibit characteristics typical of both C and E type channels, as well as some characteristics that fit neither. For example, E channels are typically very sinuous; however, this reach had very little sinuosity. Likewise, C channels often have numerous point bars, which were not common along

this reach. Based on these characteristics, in 2017 best professional judgment was applied and the classification was changed from a C5 to an E5 given the decreased entrenchment and width/depth ratio. The same conditions were still present in 2018, 2019, and 2020 and the channel remains classified as an E5.

<b>Fall 2020 Geomorphic Assessment Results</b>	
Upstream View	Downstream View	Bankfull Width ( $W_{bkf}$ ) (feet)	5.0
		Mean Depth ( $d_{bkf}$ ) (feet)	0.6
		Bankfull Cross-sectional Area ( $A_{bkf}$ ) (feet <sup>2</sup> )	2.9
		Width/Depth Ratio ( $W_{bkf}/d_{bkf}$ )	8.7
		Width of Flood-prone Area ( $W_{fpa}$ ) (feet)(feet)	13.4
		Entrenchment Ratio (ER) = $W_{fpa}/W_{bkf}$	2.7
		Channel Materials $D_{50}$ (millimeters)	0.093
		Water Surface Slope (S)	0.0048
		Sinuosity (K) = stream length/valley length	<1.2
		Adjustments?	Sin ↑

<b>STREAM TYPE</b>	<b>E5</b>
Left Bank View	Right Bank View

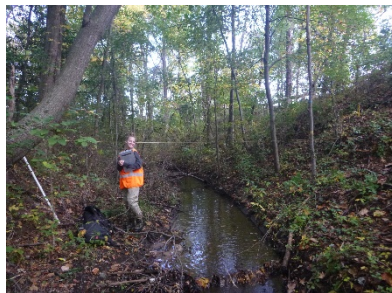
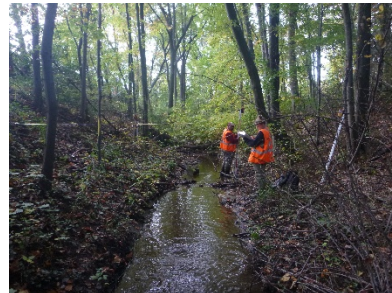
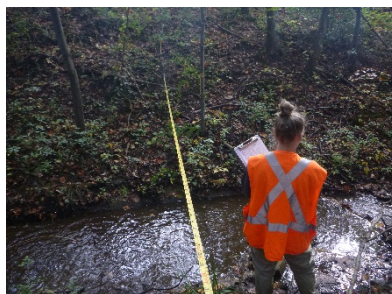
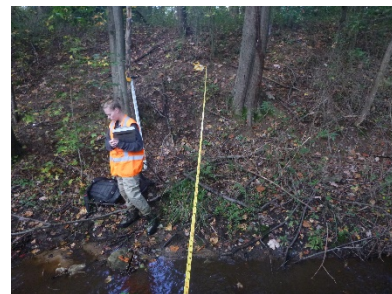
F5 channels were identified at cross-sections 2 and 3 which are located on the North Tributary upstream of Maryland State Highway 170. The stream segment along this portion of the North Tributary was over-widened as a result of past alteration with the installation of a concrete trapezoidal channel. However, it continues to adjust by filling with sediment and woody debris, thus establishing a more “natural” stream channel within the man-made, engineered channel.

Bankfull Width ( $W_{bkf}$ ) (feet)	7.1
Mean Depth ( $d_{bkf}$ ) (feet)	0.5
Bankfull Cross-sectional Area ( $A_{bkf}$ ) (feet <sup>2</sup> )	3.5
Width/Depth Ratio ( $W_{bkf}/d_{bkf}$ )	14.4
Width of Flood-prone Area ( $W_{fpa}$ ) (feet)	13.2
Entrenchment Ratio (ER) = $W_{fpa}/W_{bkf}$	1.5
Channel Materials $D_{50}$ (millimeters)	0.091
Water Surface Slope (S)	0.0054
Sinuosity (K) = stream length/valley length	<1.2
Adjustments?	Sin ↑, ER ↓
<b>STREAM TYPE</b>	<b>F5</b>

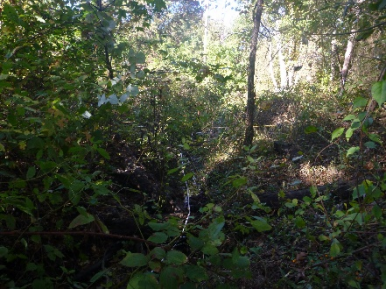
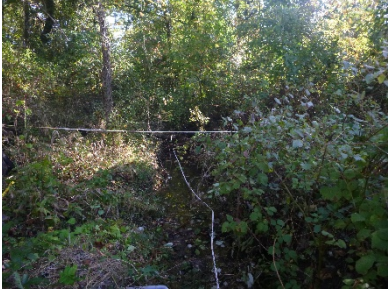
A G5 channel was maintained at cross-section 4 on the South Tributary, a change from an E5b channel in 2019 to G4 channel in Spring 2020. While it is possible that this reach may exhibit both G and E characteristics along different portions of the reach, it was assigned an E5b classification in 2019, primarily based on the entrenchment and width/depth ratios measured at the cross-section location, as well as the channel slope within the vicinity of the cross-section. However, a reduced entrenchment ratio and increased width/depth ratio observed in 2020 more aligned this site as a G channel. In comparison to the North Tributary, the South Tributary is not over-widened and has a steeper longitudinal gradient than the North Tributary. Indicators were observed that show some limited floodplain connectivity along the upstream portion of the tributary where the cross-section is located. However, just downstream of the cross-section location, the channel is noticeably entrenched and shows signs of active downcutting. Significant changes in the shape of this cross-section were observed during the 2013 survey, as the channel had noticeably deepened and widened since the 2012 survey (Appendix B). Over the next year, aggradation occurred affecting the bed level by raising it approximately 0.5 feet. From 2014 to 2015, the channel shifted slightly but remained stable in terms of aggradation or deepening. Noticeable aggradation occurred again in 2016 with an approximate 0.5-foot rise in bed elevation, but the bed was stable between the 2016 and 2018 surveys. Between 2018 and 2019, the stream experienced downcutting (approximately 0.3 ft) and erosion (slightly less than one foot at the most affected area) at/near the right bank; between 2019 and 2020 the downcutting continued at this location, deepening by approximately 0.5 ft and impacting the left bank, such that the channel edges are now similar and the stream bed is flat across the width of the channel.

<b>Fall 2020 Geomorphic Assessment Results</b>	
Upstream View	Downstream View	Bankfull Width ( $W_{bkf}$ ) (feet)	3.4
		Mean Depth ( $d_{bkf}$ ) (feet)	0.6
Left Bank View	Right Bank View	Bankfull Cross-sectional Area ( $A_{bkf}$ ) (feet <sup>2</sup> )	2.1
		Width/Depth Ratio ( $W_{bkf}/d_{bkf}$ )	5.6
		Width of Flood-prone Area ( $W_{fpa}$ ) (feet)	5.0
		Entrenchment Ratio (ER) = $W_{fpa}/W_{bkf}$	1.5
		Channel Materials $D_{50}$ (millimeters)	0.12
		Water Surface Slope (S)	0.037
		Sinuosity (K) = stream length/valley length	<1.2
		Adjustments?	Sin ↑, ER ↓
		<b>STREAM TYPE</b>	<b>G5</b>

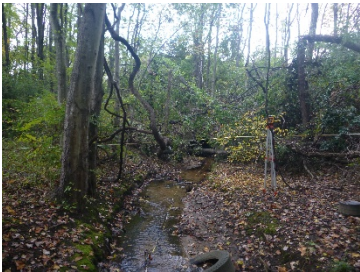
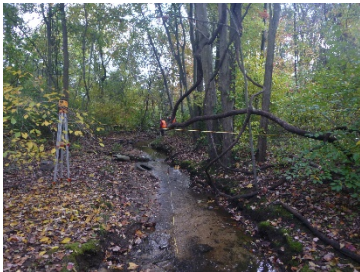
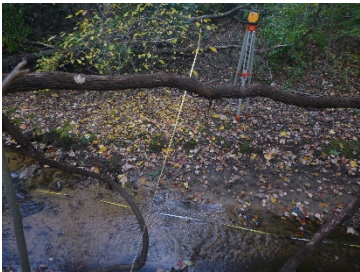
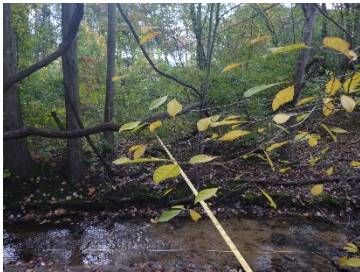
Cross-section 5, located downstream of Maryland State Highway 170, was reclassified from a C5 channel to an F5 channel in Spring 2020 due a decrease in entrenchment ratio. The Rosgen classification at this cross-section previously changed from an F5 in 2014 to a C5 in 2015 and remained classified as a C5 channel with similar entrenchment and width/depth ratios from 2016 through 2019. This location was reclassified again in Fall 2020 back to a C5 channel due to an increase in entrenchment ratio.

<p>Downstream View</p>	Fall 2020 Geomorphic Assessment Results	
		Bankfull Width ( $W_{bkf}$ ) (feet)	8.2
		Mean Depth ( $d_{bkf}$ ) (feet)	0.7
		Bankfull Cross-sectional Area ( $A_{bkt}$ ) (feet <sup>2</sup> )	5.7
		Width/Depth Ratio ( $W_{bkt}/d_{bkt}$ )	11.8
		Width of Flood-prone Area ( $W_{fpa}$ ) (feet)	20.6
		Entrenchment Ratio (ER) = $W_{fpa}/W_{bkt}$	2.5
		Channel Materials $D_{50}$ (millimeters)	0.092
		Water Surface Slope (S)	0.0042
		Sinuosity (K) = stream length/valley length	<1.2
		Adjustments?	Sin ↑, W/D ↑

<p>Right Bank View</p>	STREAM TYPE	C5
