**BIOLOGICAL AND
GEOMORPHOLOGICAL CONDITION
IN THE PICTURE SPRING BRANCH
SUBWATERSHED, SEVERN RIVER
WATERSHED, ANNE ARUNDEL COUNTY,
MARYLAND: 2015**

Anne Arundel County, Maryland
Department of Public Works
Watershed Protection and Restoration Program
2662 Riva Road
Annapolis, MD 21401

Versar, Inc.
9200 Rumsey Road
Columbia, MD 21045

February 2016

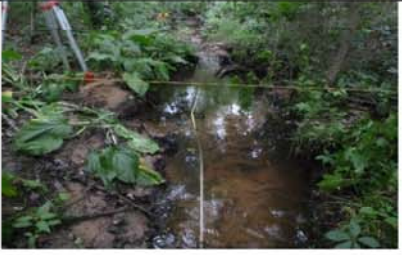
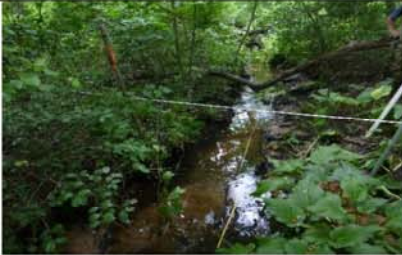
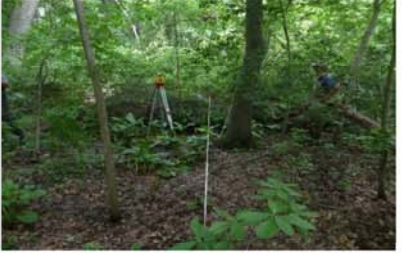
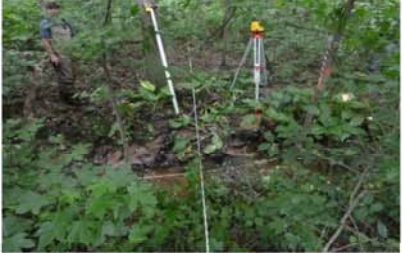
Channel Materials D_{50} (millimeters)	0.18
		Water Surface Slope (S)	0.0092
		Sinuosity (K) = stream length/valley length	<1.2
		Adjustments?	Sin ↑, WD ↑
		STREAM TYPE	C5

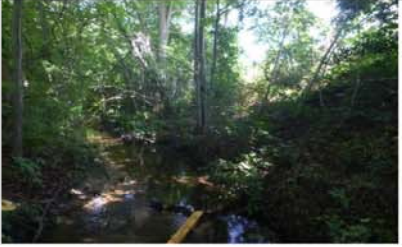
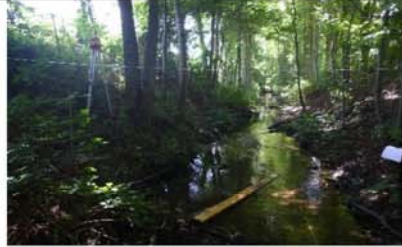
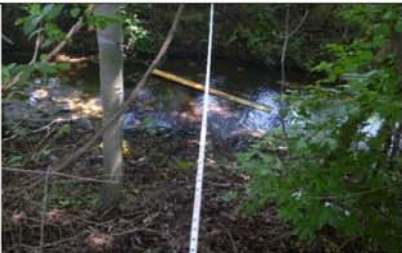
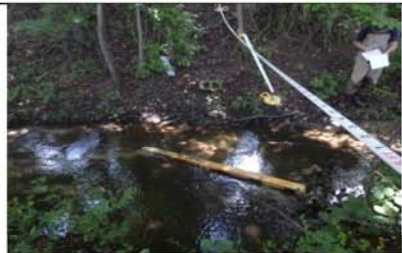
Mean Depth (d_{bkt}) (feet)	0.7
				Bankfull Cross-sectional Area (A_{bkt}) (feet ²)	7.8
Left Bank View		Right Bank View		Width/Depth Ratio (W_{bkt}/d_{bkt})	14.6
				Width of Flood-prone Area (W_{fpa}) (feet)	14.2
Left Bank View		Right Bank View		Entrenchment Ratio (ER) = W_{fpa}/W_{bkt}	1.3
				Channel Materials D_{50} (millimeters)	0.23
Left Bank View		Right Bank View		Water Surface Slope (S)	0.0021
				Sinuosity (K) = stream length/valley length	<1.2
Left Bank View		Right Bank View		Adjustments?	Sin ↑
				STREAM TYPE	F5

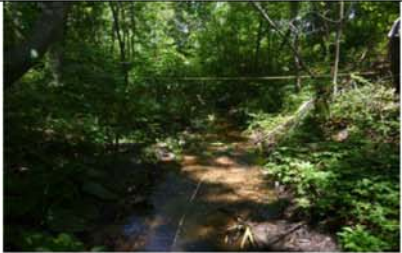
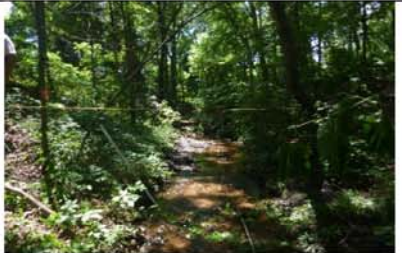
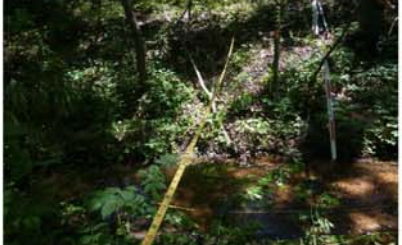
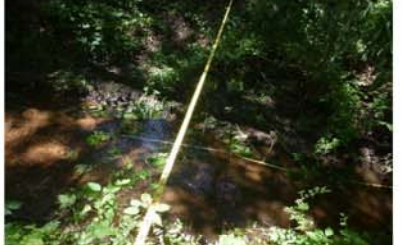
Mean Depth (d_{bkt}) (feet) 0.4	
				Bankfull Cross-sectional Area (A_{bkt}) (feet ²) 3.9	
<p style="text-align: center;">Upstream View</p>		<p style="text-align: center;">Downstream View</p>		Width/Depth Ratio (W_{bkt}/d_{bkt}) 25.0	
				Width of Flood-prone Area (W_{fpa}) (feet) 13.1	
<p style="text-align: center;">Left Bank View</p>		<p style="text-align: center;">Right Bank View</p>		Entrenchment Ratio (ER) = W_{fpa}/W_{bkt} 1.3	
				Channel Materials D_{50} (millimeters) 1.3	
<p style="text-align: center;">Upstream View</p>		<p style="text-align: center;">Downstream View</p>		Water Surface Slope (S) 0.011	
				Sinuosity (K) = stream length/valley length <1.2	
<p style="text-align: center;">Left Bank View</p>		<p style="text-align: center;">Right Bank View</p>		Adjustments? Sin ↑	
				STREAM TYPE F5

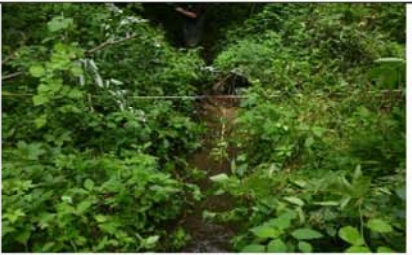
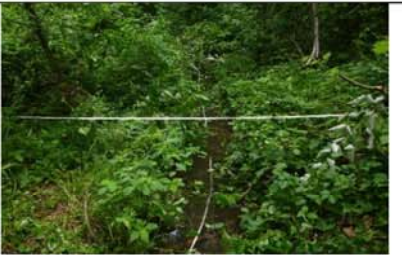
An E channel was identified at cross section 4 on the South Tributary, which appeared to have been channelized in the past and is piped underground for a significant distance upstream, further modifying its hydrology. However, the South Tributary is not overwidened and is significantly steeper than the North Tributary. Indicators were observed that show some limited floodplain connectivity along the upstream portion of the tributary where the cross section is located. However, just downstream of the cross section location, the channel became noticeably entrenched and showed signs of active downcutting. While it is possible that this reach may exhibit both B and E characteristics along different portions of the reach, it was assigned an E5 classification primarily based on the entrenchment and width/depth ratios measured at the cross section location. Evidence of recent downcutting (e.g., nick points) suggests that the reach is unstable and is likely shifting from an E channel to a B channel. Significant changes in the shape of this cross section were observed during the 2013 survey, as the channel had noticeably deepened and widened since the 2012 survey (Appendix B). Over the next year, as seen in the 2014 survey, aggradation occurred affecting the bed level by raising it approximately 0.5 feet. From 2014 to 2015, the channel has shifted slightly, but has remained stable in terms of aggradation or deepening. Analysis of the longitudinal profile overlay from 2007 through 2015 shows considerable downcutting between stations 1+00 and 2+20 (Appendix B). However, during 2014 the pool near station 2+00 has mostly filled in. This trend has continued in 2015, with the pool working its way up the reach to station 1+80. The headcut and large scour pool between stations 2+68 and 2+90 just downstream from this eroded section have not worsened. It is recommended that this area continue to be monitored, since further erosion could eventually lead to undermining of the concrete-lined channel just downstream.

2015 Geomorphic Assessment Results	
Upstream View		Downstream View		Bankfull Width (W_{bkt}) (feet)	3.1
				Mean Depth (d_{bkt}) (feet)	0.8
Left Bank View		Right Bank View		Bankfull Cross-sectional Area (A_{bkt}) (feet ²)	2.3
				Width/Depth Ratio (W_{bkt}/d_{bkt})	4.1
				Width of Flood-prone Area (W_{fpa}) (feet)	8.4
				Entrenchment Ratio (ER) = W_{fpa}/W_{bkt}	2.7
				Channel Materials D_{50} (millimeters)	0.23
				Water Surface Slope (S)	0.016
				Sinuosity (K) = stream length/valley length	<1.2
				Adjustments?	Sin ↑
				STREAM TYPE	E5

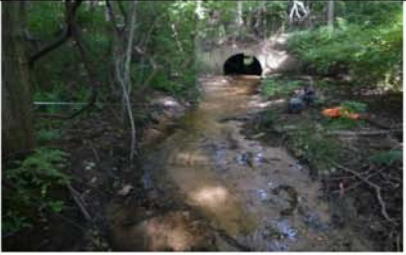
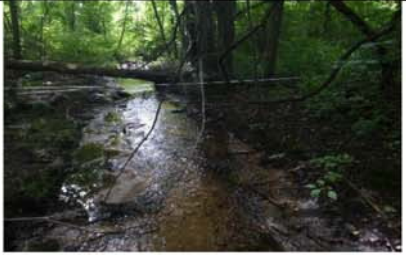
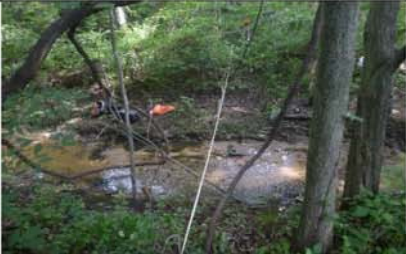
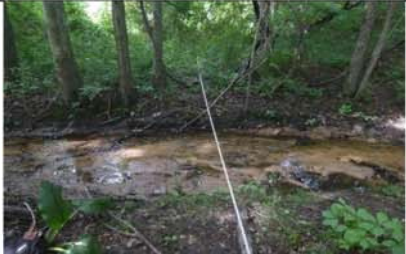
Entrenchment Ratio (ER) = W_{fpa}/W_{bkt}	2.4
		Channel Materials D_{50} (millimeters)	0.55
<p style="text-align: center;">Left Bank View</p>		Water Surface Slope (S)	0.0023
		Sinuosity (K) = stream length/valley length	<1.2
<p style="text-align: center;">Right Bank View</p>		Adjustments?	Sin ↑
		STREAM TYPE

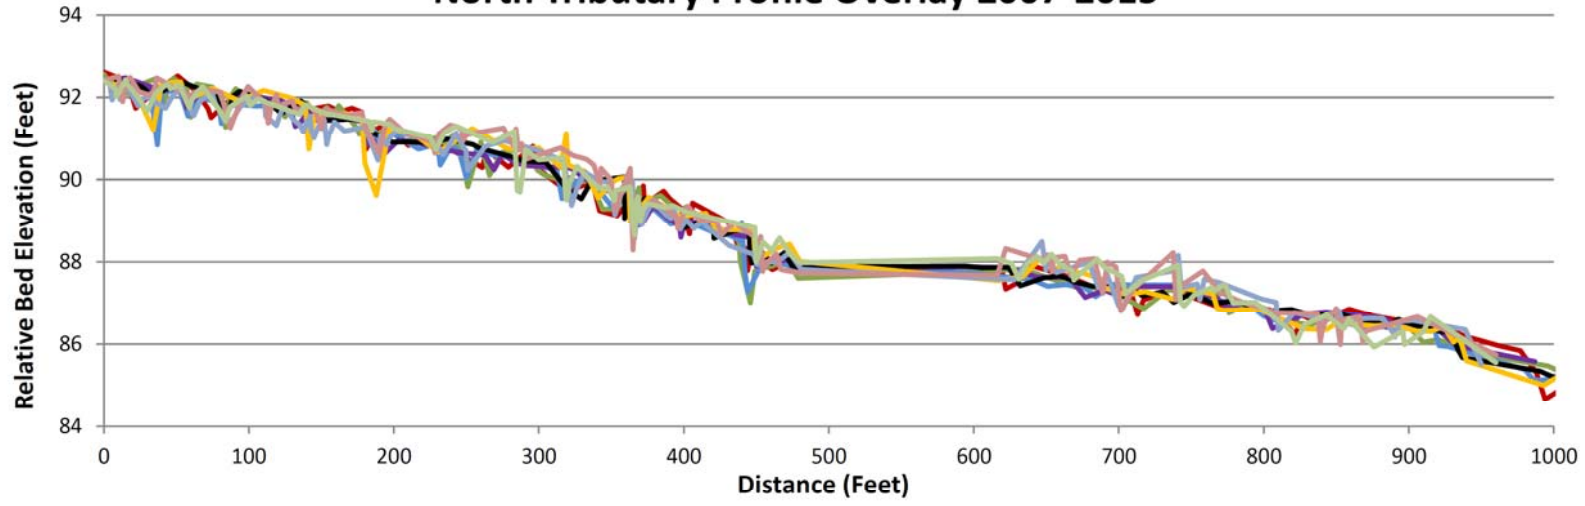
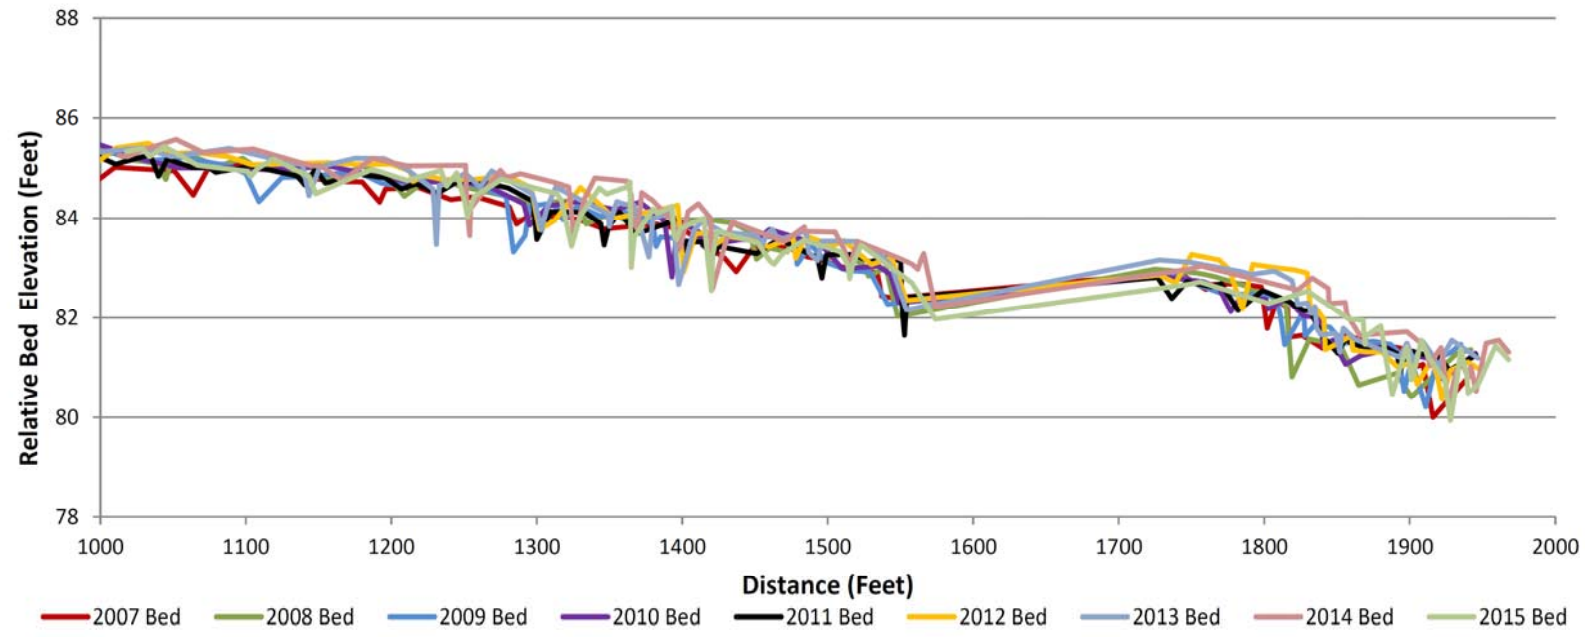
North Tributary Profile Overlay 2007-2015

An overlay of North Tributary longitudinal profiles shows little change occurring to this reach from 2007 through 2015 (Appendix B). Numerous man-made structures (i.e., culverts, concrete-lined channel) throughout this reach appear to be providing adequate grade control, preventing substantial channel degradation.
