Description of terms

Manual: Anne Arundel County Practices and Procedures Manual

Example with step-by-step instructions

Heritage Complex Project
Project Number 123-4567
Field Investigation Date: February 3rd, 2023 and March 1st, 2023
Scale: 1" = 400'

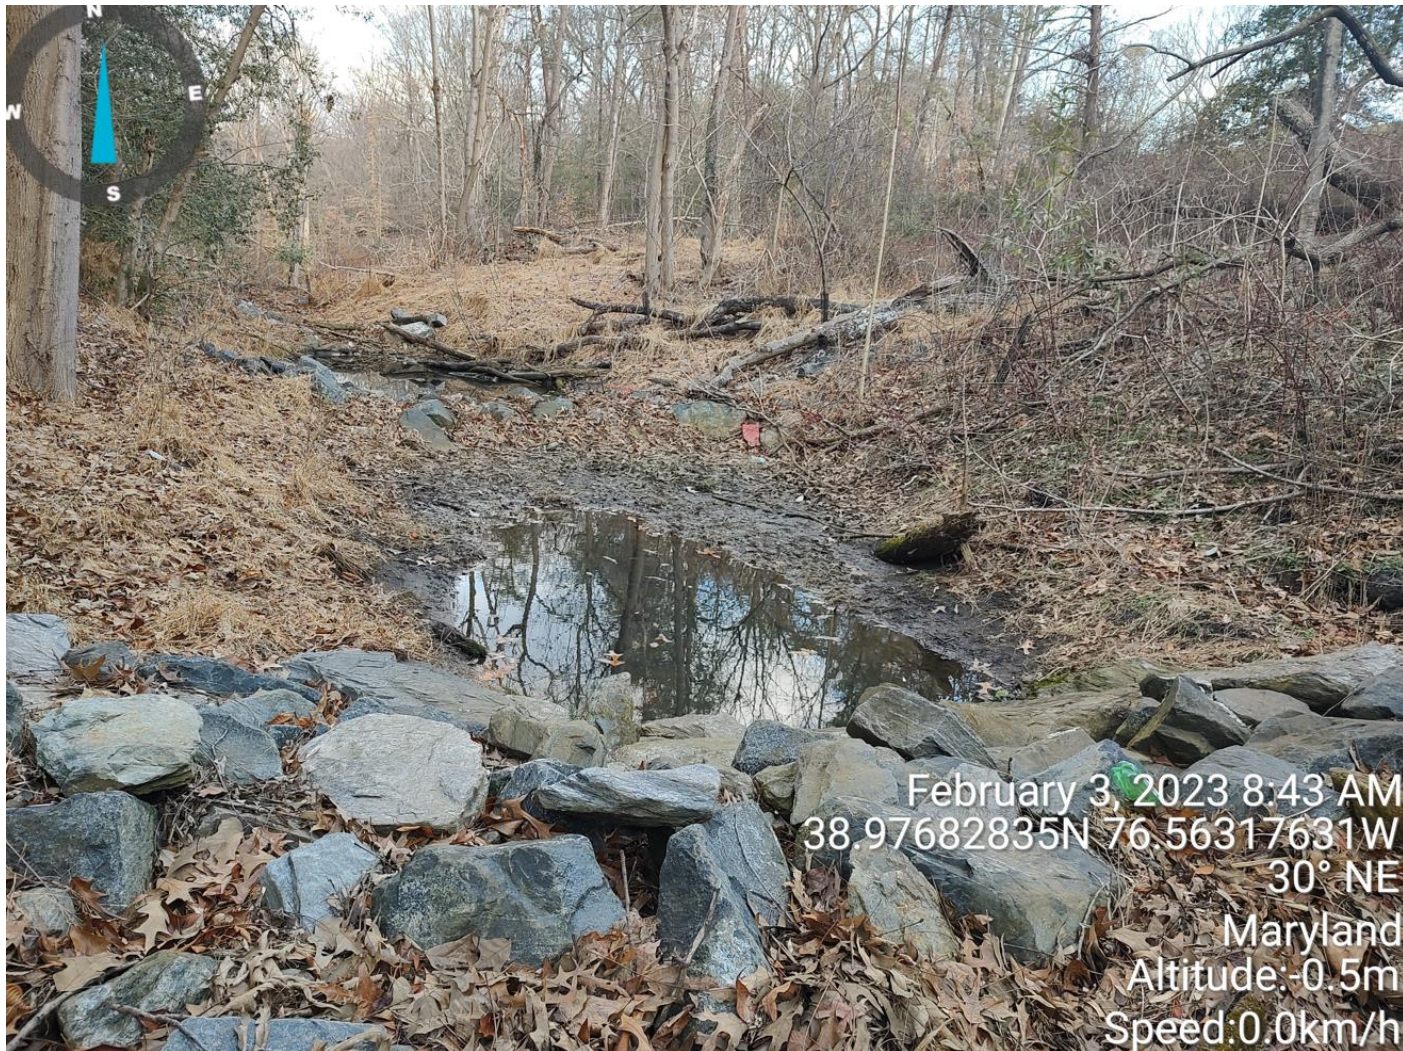
Photo 7

Downstream View of Broad Creek; Check dam and step pool can be seen in picture

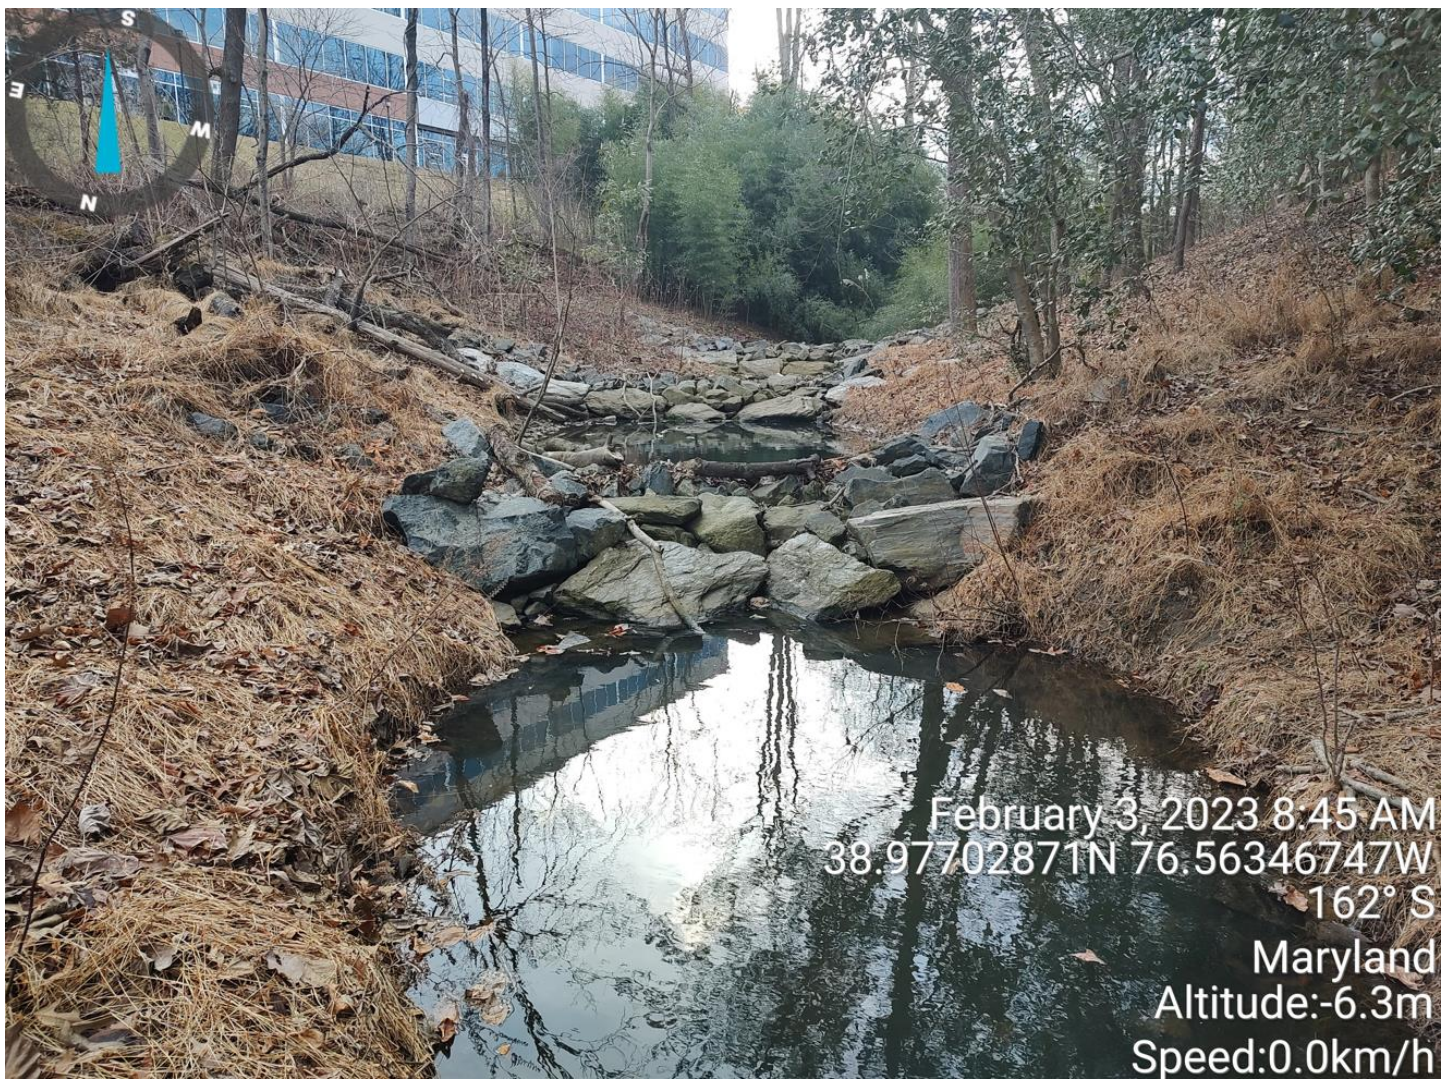
Photo 9

Upstream view of Broad Creek with step pools and check dams shown. This is located near the hypothetical POI

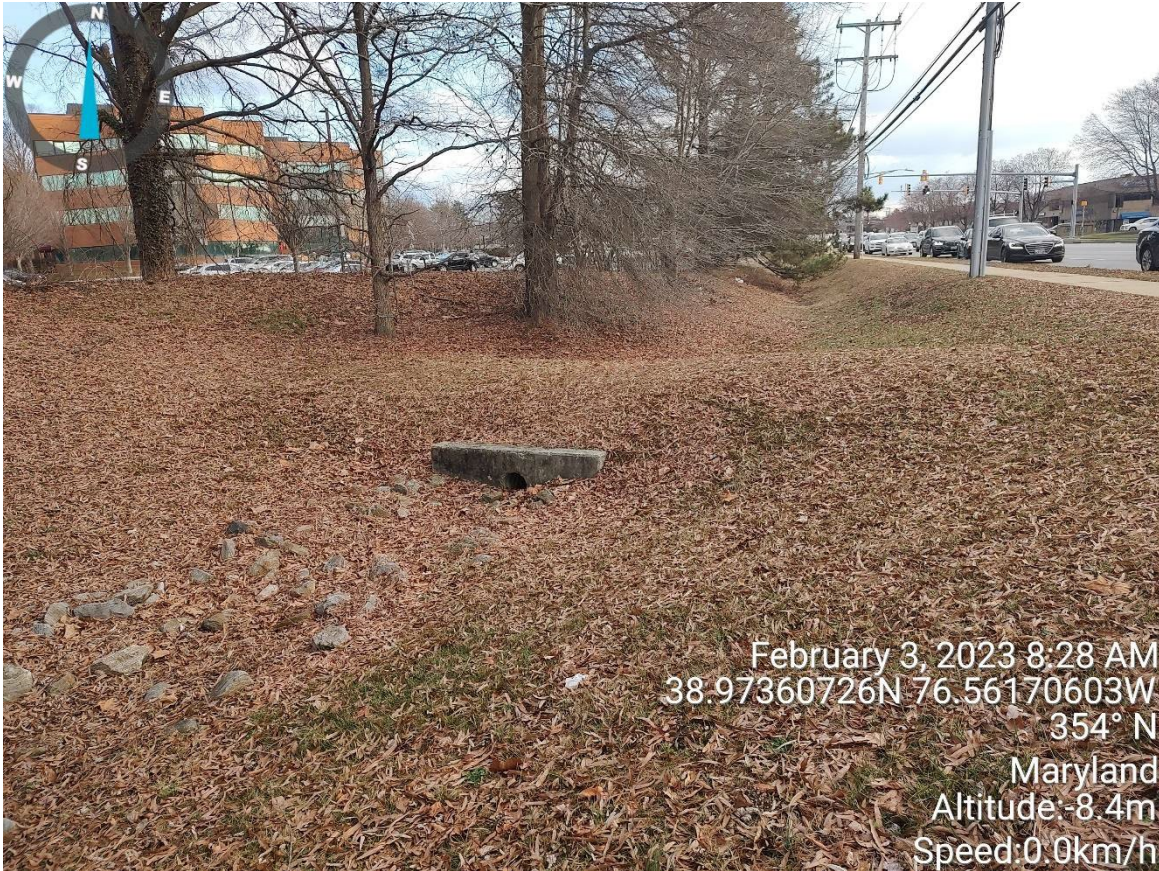
Photo 10

View of the roadside swell with a culvert along Riva Road, adjacent to the Project property. The area appears stable. No erosion is present.

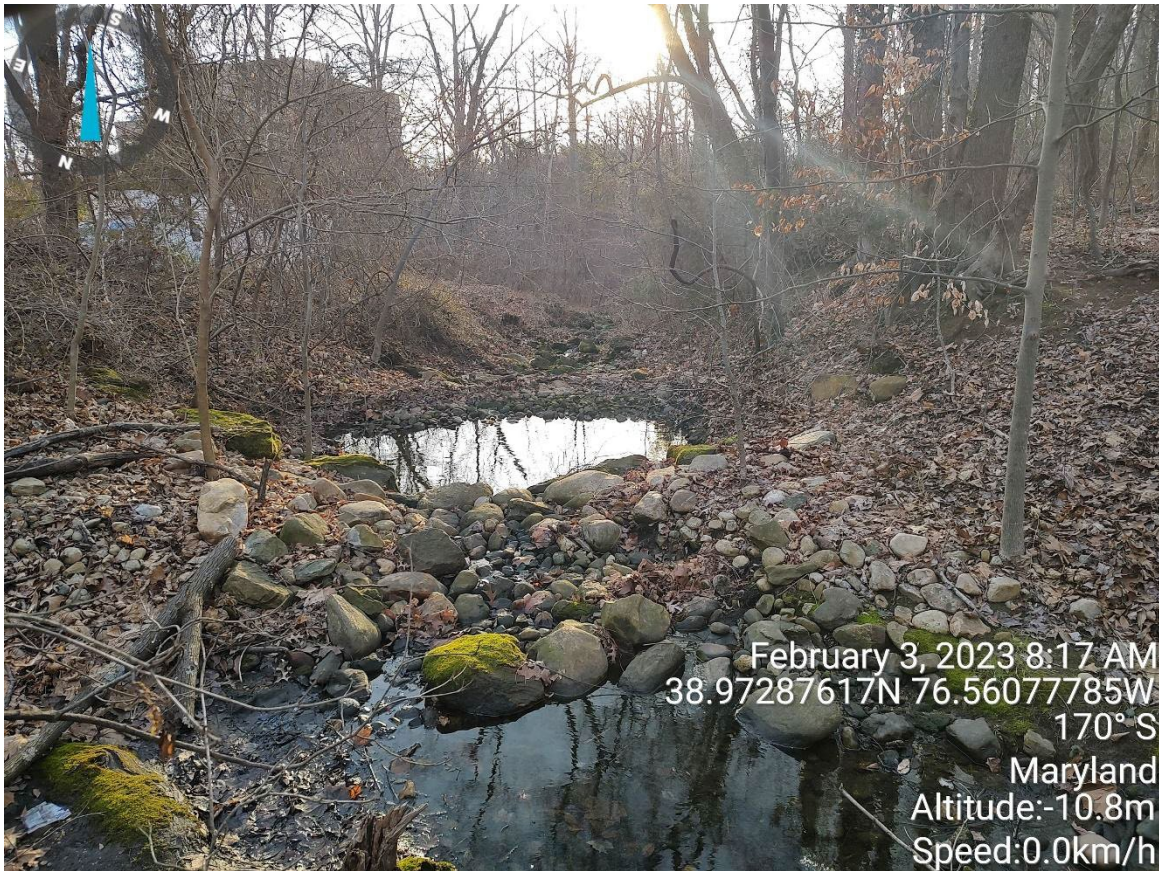
Photo 15

Step pool conveyance facing south along the channel. Area appears stable with no signs of erosion.

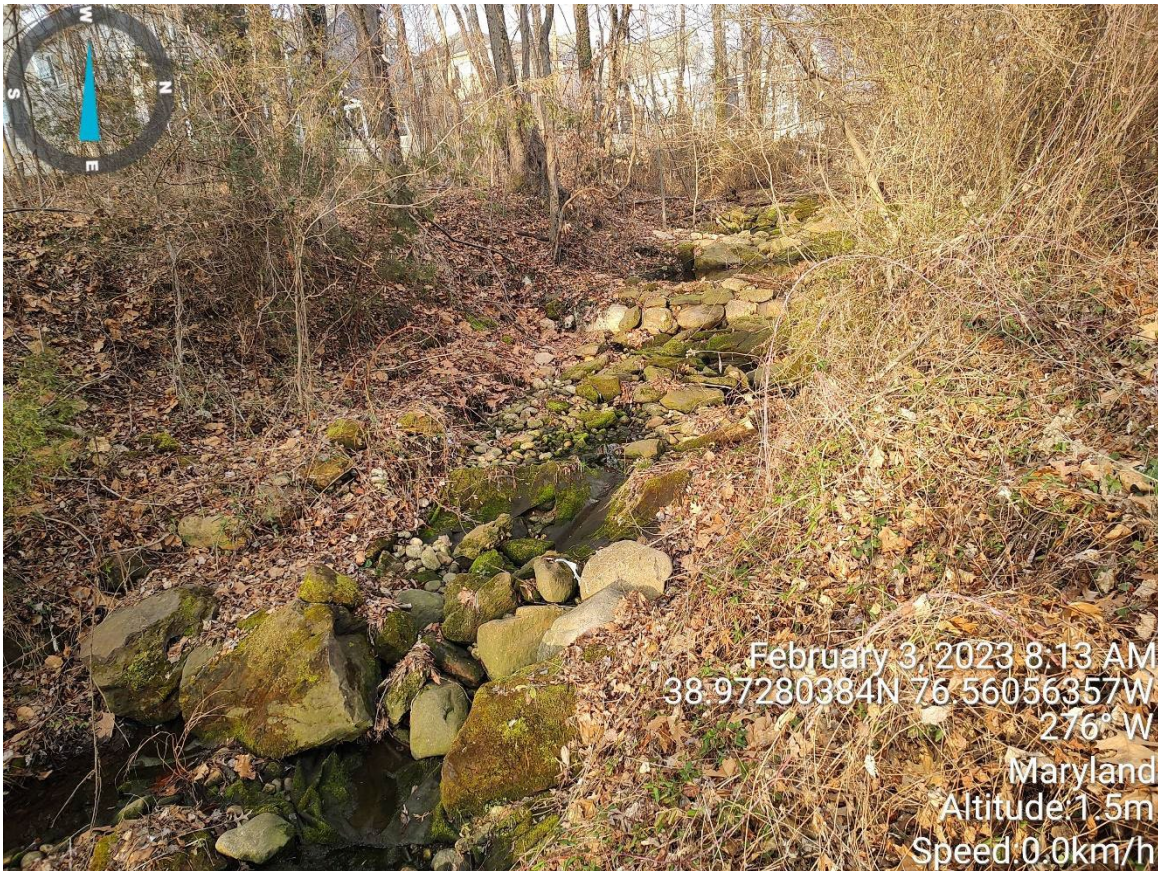
Photo 16

View of the stable channel facing west. Area appears stable with no signs of erosion.
