**BIOLOGICAL AND
GEOMORPHOLOGICAL CONDITION
IN THE PICTURE SPRING BRANCH
SUBWATERSHED, SEVERN RIVER
WATERSHED, ANNE ARUNDEL COUNTY,
MARYLAND: 2013 - 2014**

Versar, Inc.
9200 Rumsey Road
Columbia, MD 21045

September 2014

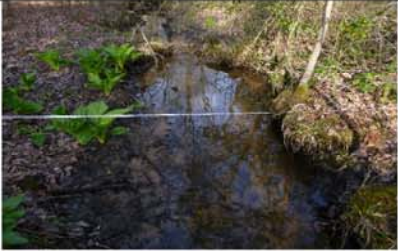
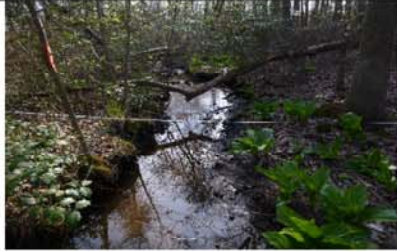
2014 Geomorphic Assessment Results	
Upstream View		Downstream View		Bankfull Width (W_{bkt}) (feet)	7.5
				Mean Depth (d_{bkt}) (feet)	0.6
Left Bank View		Right Bank View		Bankfull Cross-sectional Area (A_{bkt}) (feet ²)	4.8
				Width/Depth Ratio (W_{bkt}/d_{bkt})	11.7
Left Bank View		Right Bank View		Width of Flood-prone Area (W_{fpa}) (feet)	53.8
				Entrenchment Ratio (ER) = W_{fpa}/W_{bkt}	7.1
Left Bank View		Right Bank View		Channel Materials D_{50} (millimeters)	0.19
				Water Surface Slope (S)	0.007
Left Bank View		Right Bank View		Sinuosity (K) = stream length/valley length	<1.2
				Adjustments?	Sin ↑, WD↑
Left Bank View		Right Bank View		STREAM TYPE	C5

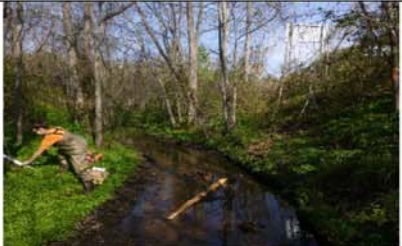
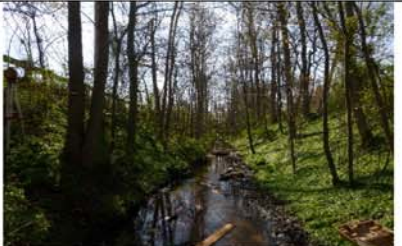
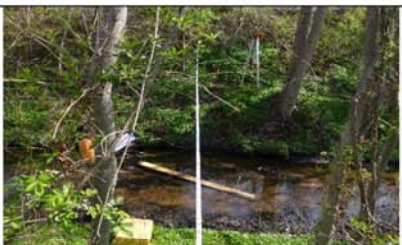
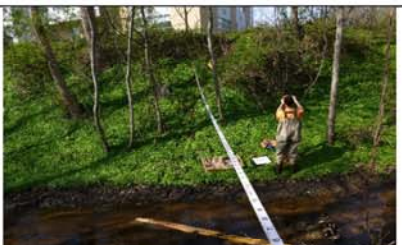
Mean Depth (d_{bkf}) (feet)	0.8
				Bankfull Cross-sectional Area (A_{bkf}) (feet ²)	7.3
<p>Upstream View</p>		<p>Downstream View</p>		Width/Depth Ratio (W_{bkf}/d_{bkf})	11.7
				Width of Flood-prone Area (W_{fpa}) (feet)	15.2
<p>Left Bank View</p>		<p>Right Bank View</p>		Entrenchment Ratio (ER) = W_{fpa}/W_{bkf}	1.6
				Channel Materials D_{50} (millimeters)	0.18
<p>Left Bank View</p>		<p>Right Bank View</p>		Water Surface Slope (S)	0.003
				Sinuosity (K) = stream length/valley length	<1.2
<p>Left Bank View</p>		<p>Right Bank View</p>		Adjustments?	Sin ↑, ER ↓, WD ↑
				STREAM TYPE	F5

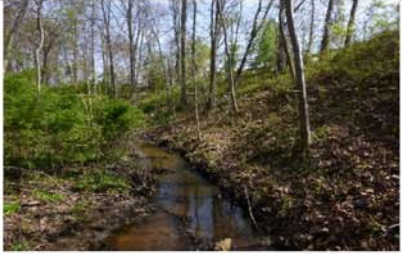
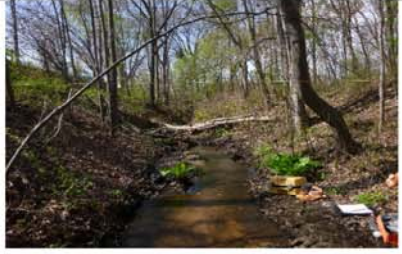
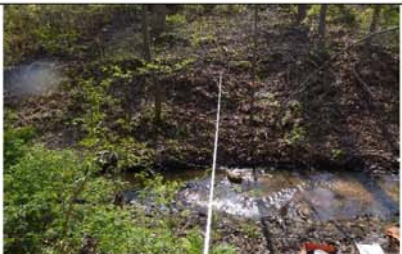
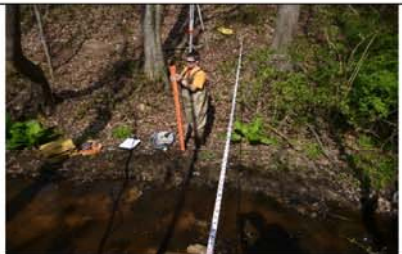
Mean Depth (d_{bkt}) (feet)	0.6
Left Bank View		Right Bank View		Bankfull Cross-sectional Area (A_{bkt}) (feet ²)	7.0
				Width/Depth Ratio (W_{bkt}/d_{bkt})	19.1
				Width of Flood-prone Area (W_{fpa}) (feet)	14.0
				Entrenchment Ratio (ER) = W_{fpa}/W_{bkt}	1.2
				Channel Materials D_{50} (millimeters)	0.23
				Water Surface Slope (S)	0.005
				Sinuosity (K) = stream length/valley length	<1.2
				Adjustments?	Sin ↑
				STREAM TYPE	F5

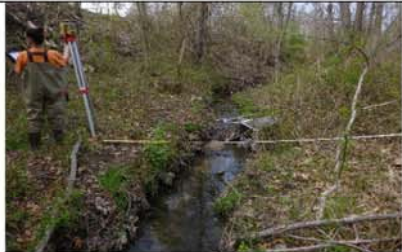
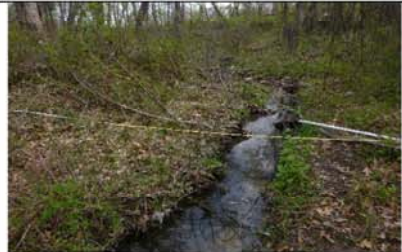
2014 Geomorphic Assessment Results	
Upstream View		Downstream View		Bankfull Width (W_{bkt}) (feet)	3.5
				Mean Depth (d_{bkt}) (feet)	1.0
Left Bank View		Right Bank View		Bankfull Cross-sectional Area (A_{bkt}) (feet ²)	3.5
				Width/Depth Ratio (W_{bkt}/d_{bkt})	3.5
Left Bank View		Right Bank View		Width of Flood-prone Area (W_{fpa}) (feet)	24.2
				Entrenchment Ratio (ER) = W_{fpa}/W_{bkt}	6.9
Left Bank View		Right Bank View		Channel Materials D_{50} (millimeters)	0.56
				Water Surface Slope (S)	0.02
Left Bank View		Right Bank View		Sinuosity (K) = stream length/valley length	<1.2
				Adjustments?	Sin ↑
STREAM TYPE		STREAM TYPE		E5

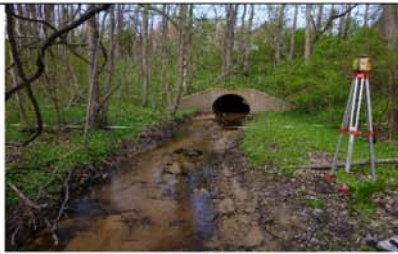
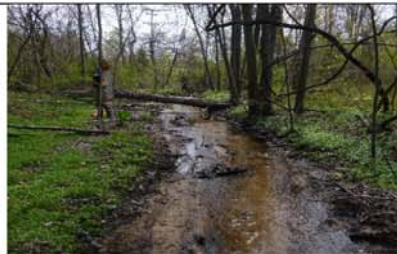
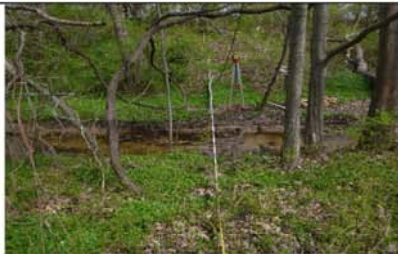
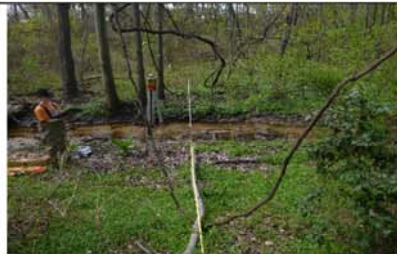
Bankfull Width (W_{bkt}) (feet)	19.2
Mean Depth (d_{bkt}) (feet)	0.6
Bankfull Cross-sectional Area (A_{bkt}) (feetz)	12.4
Width/Depth Ratio (W_{bkt}/d_{bkt})	29.7
Width of Flood-prone Area (W_{fpa}) (feet)	30.6
Entrenchment Ratio (ER) = W_{fpa}/W_{bkt}	1.6
Channel Materials D_{50} (millimeters)	0.52
Water Surface Slope (S)	0.003
Sinuosity (K) = stream length/valley length	<1.2
Adjustments?	Sin ↑, ER ↓
STREAM TYPE	F5
