Anne Arundel County Department of Inspections and Permits Provides Guidance on Downstream Analyses

Subject: **Downstream Investigation Guidance**

Heritage Complex Project
 Project Number 123-4567
 Field Investigation Date: February 3rd, 2023 and March 1st, 2023
 Scale: 1" = 400'

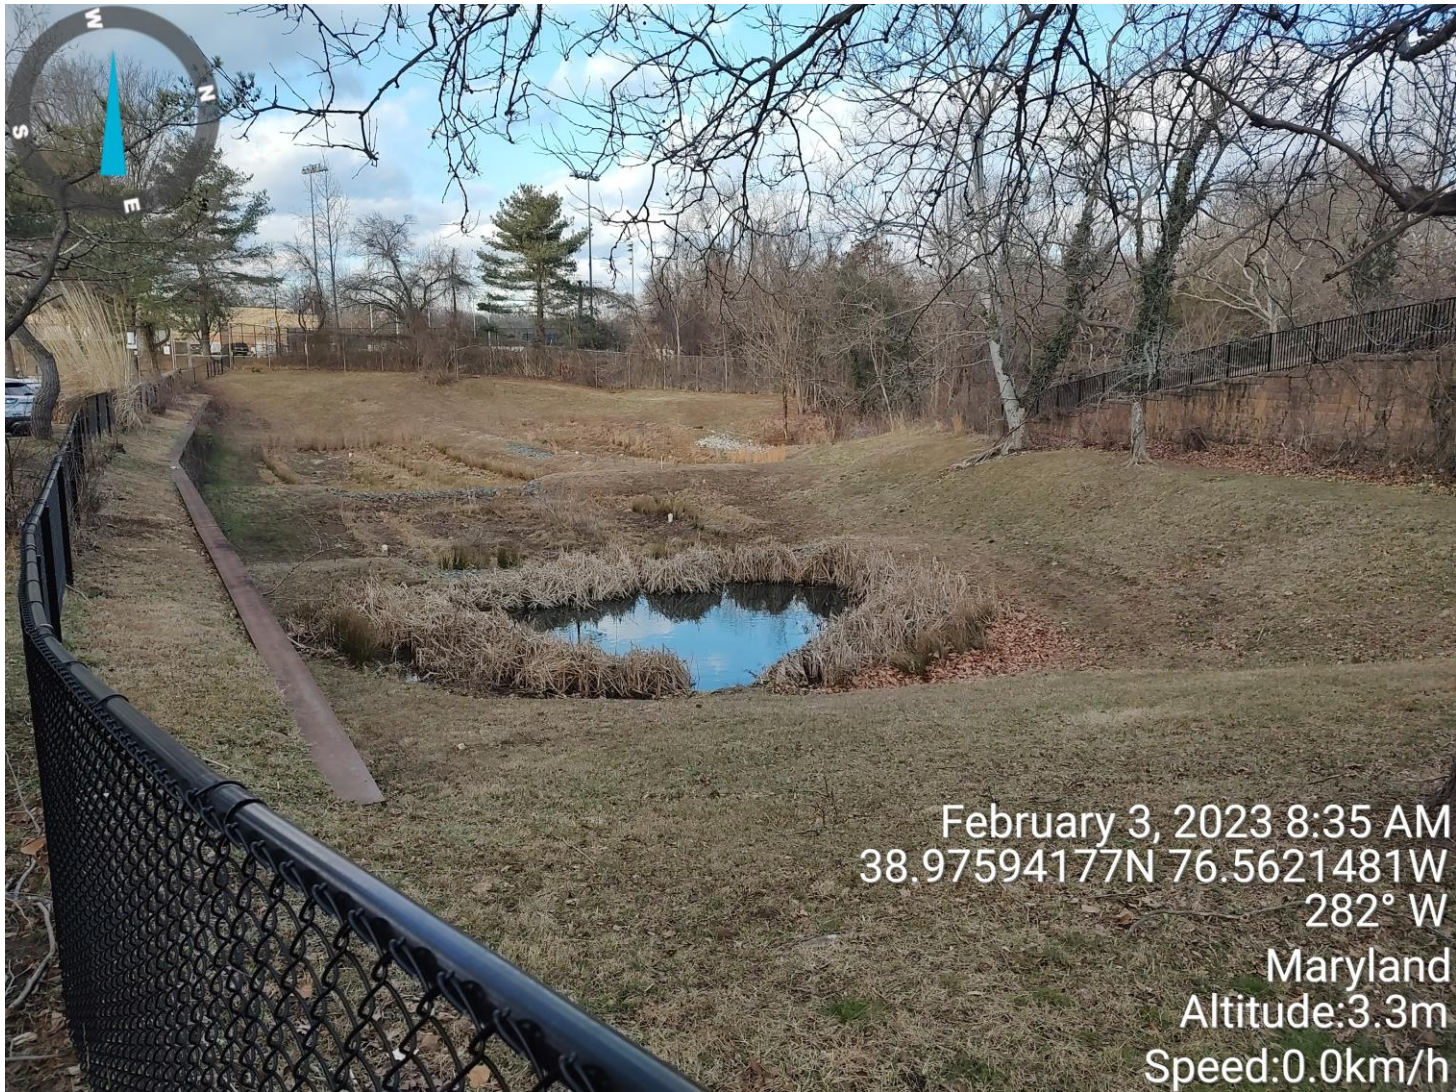
Photo 1

Stormwater Basin located at Site Outfall (West View)

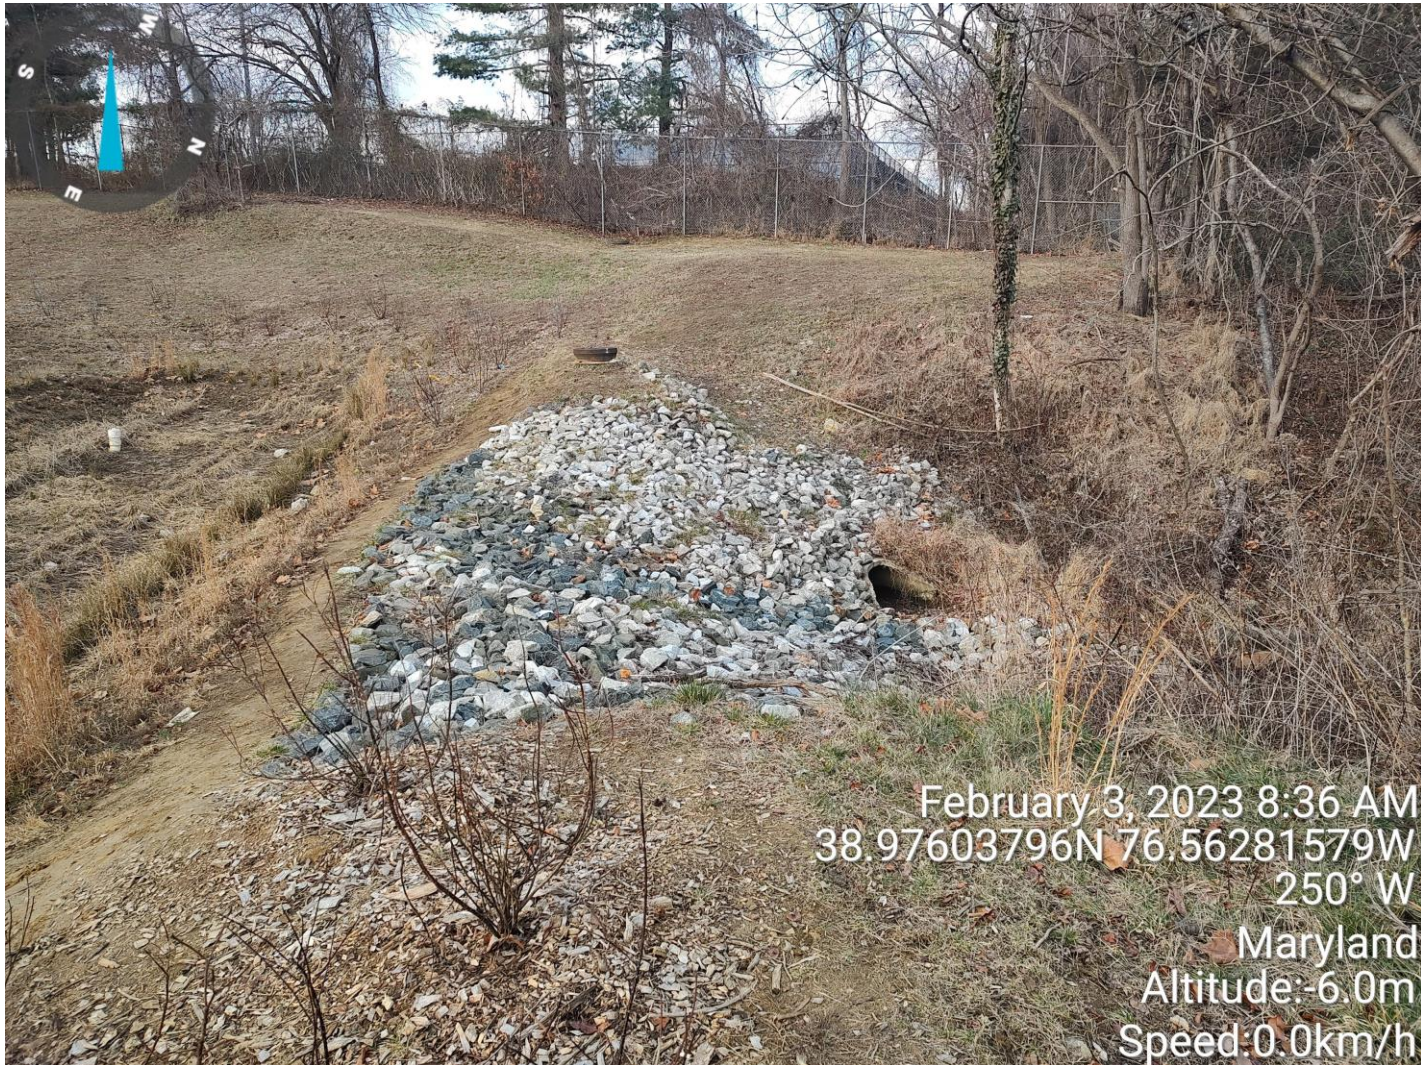
Photo 3

Stones located in stormwater basin

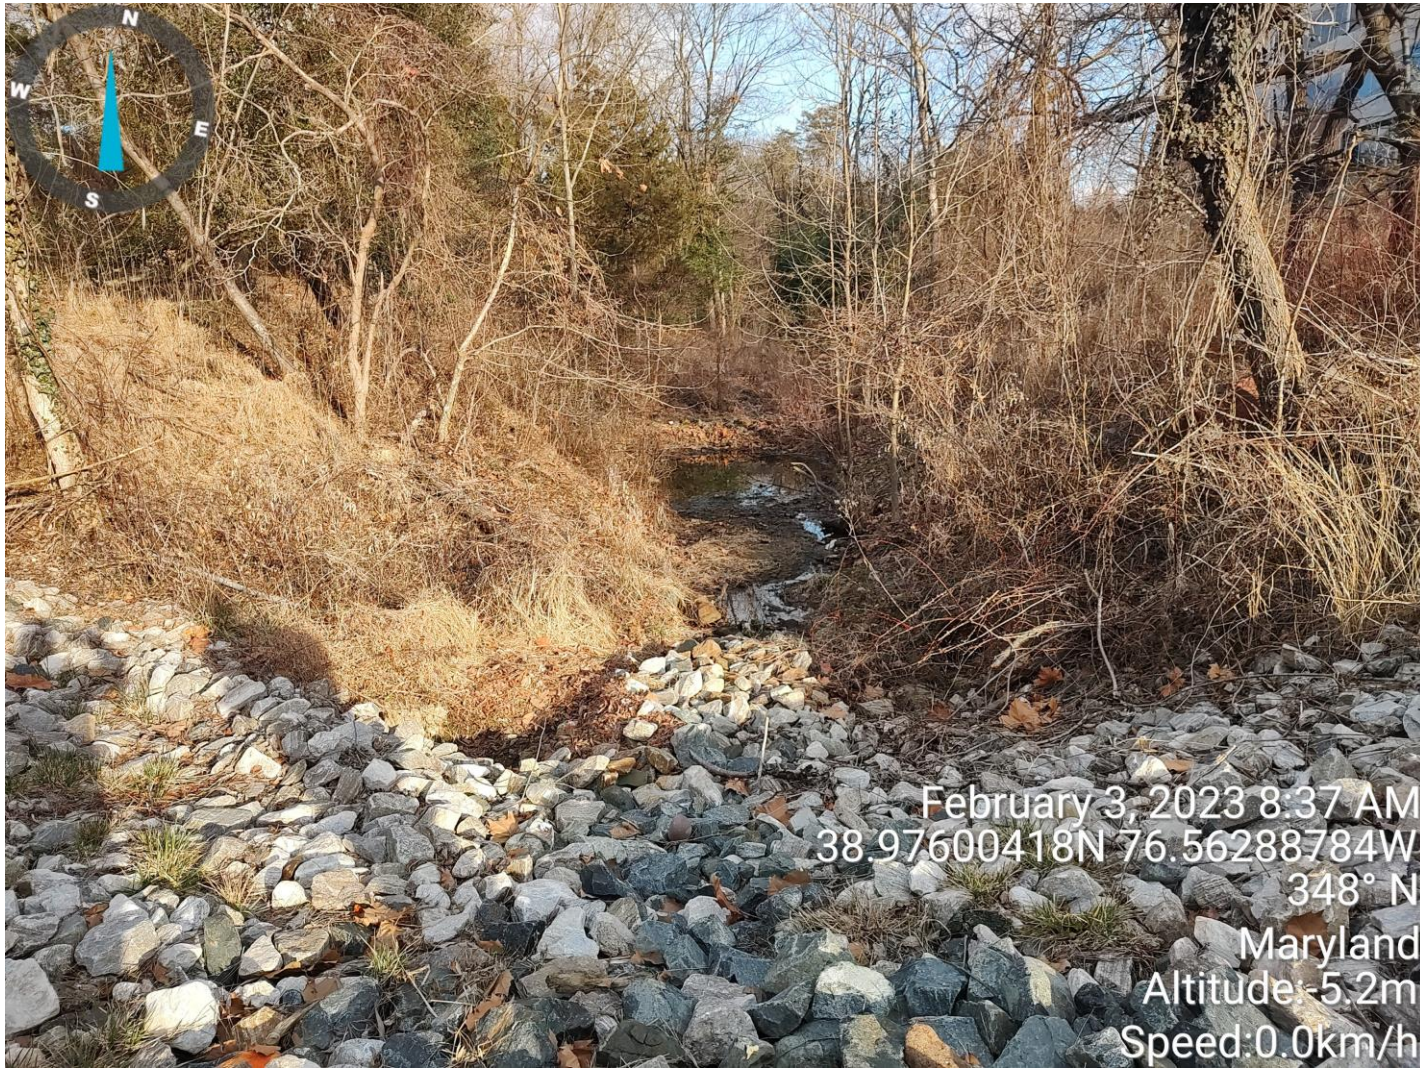
Photo 4

Site outfall (see map 2 and overall site map) discharging from the stormwater basin into Broad Creek

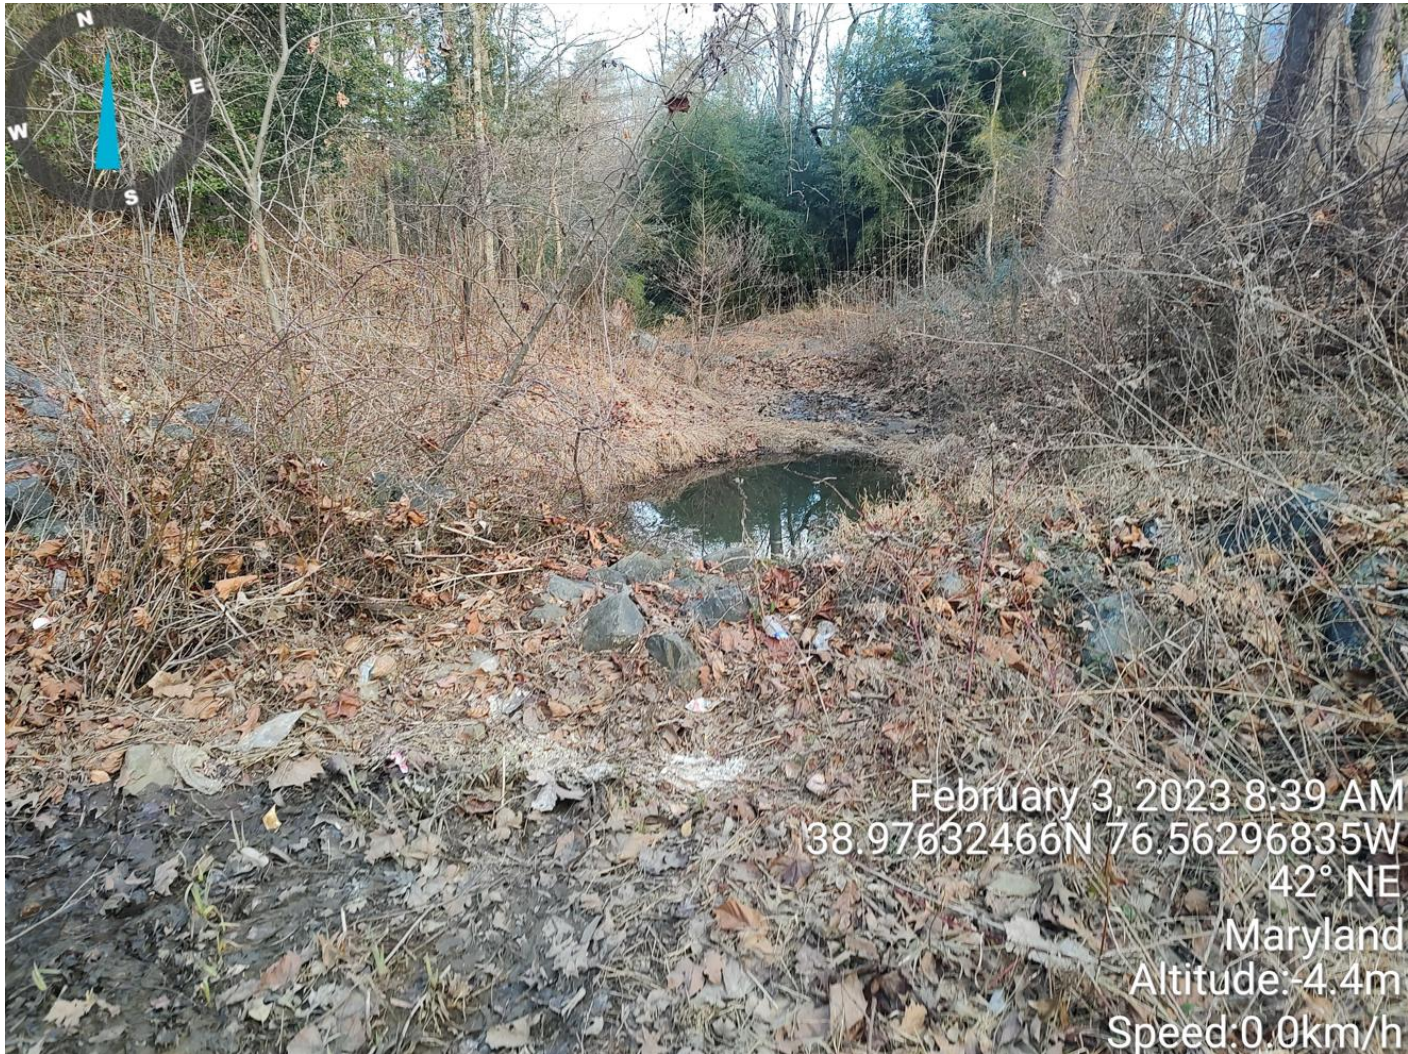
Photo 5

Downstream view of the beginning of Broad Creek

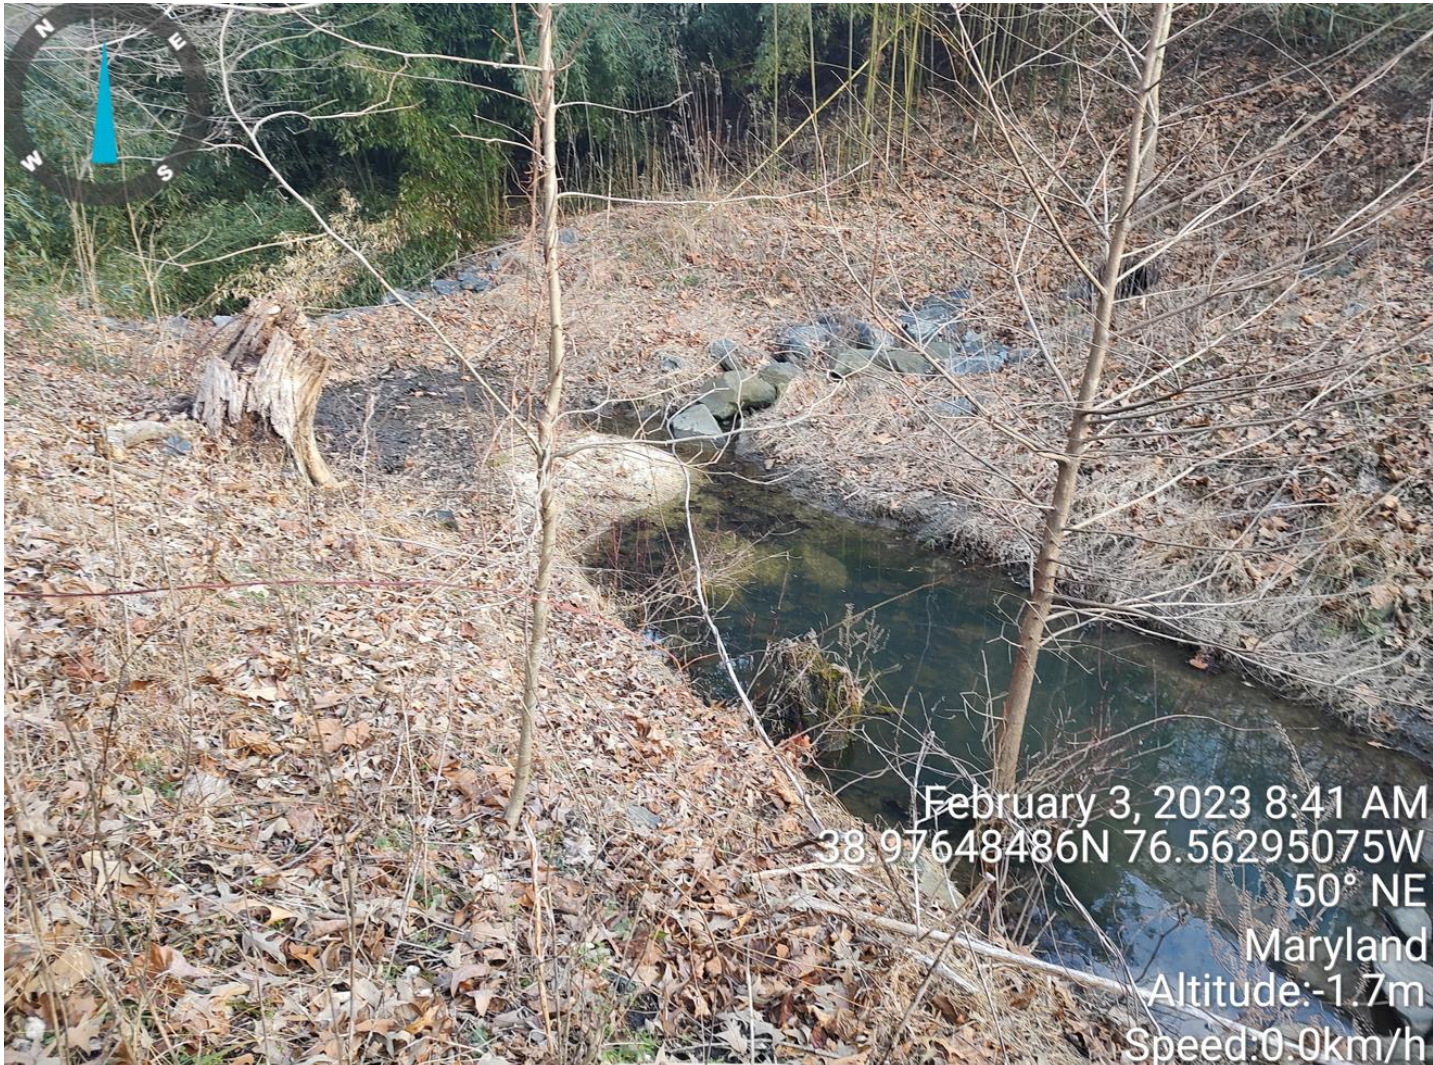
Photo 6

Downstream View of Broad Creek. Check dams can be seen in the distance

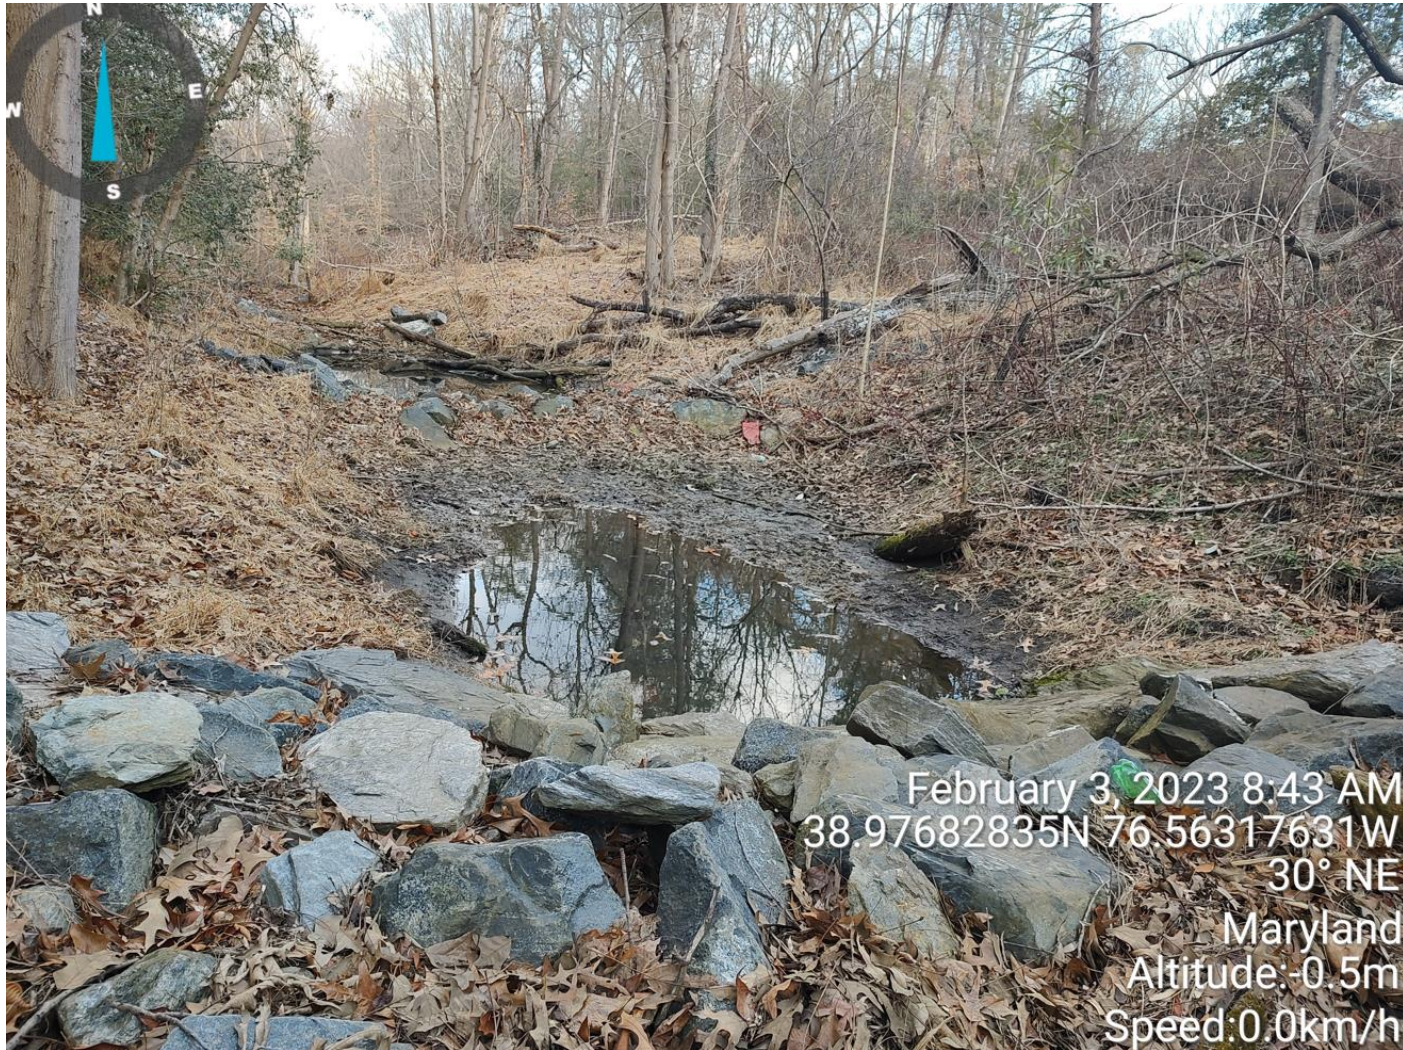
Photo 7

Downstream View of Broad Creek; Check dam and step pool can be seen in picture

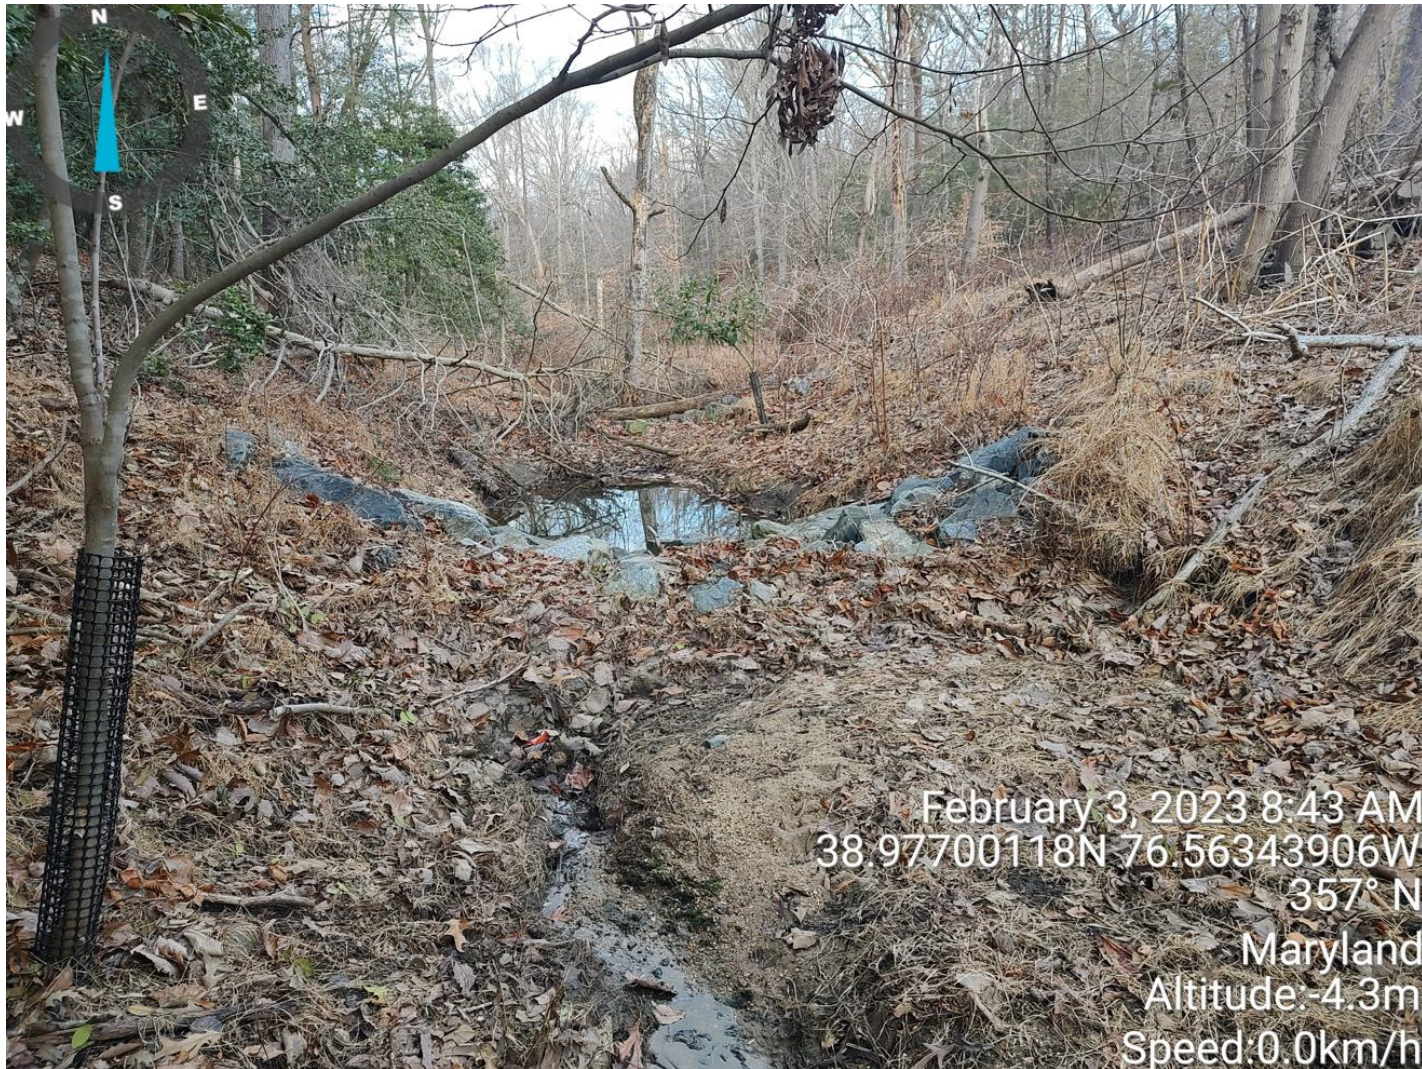
Photo 8

Downstream view of Broad Creek with check dam and step pool show. POI location can be seen in the distance (see map 1)

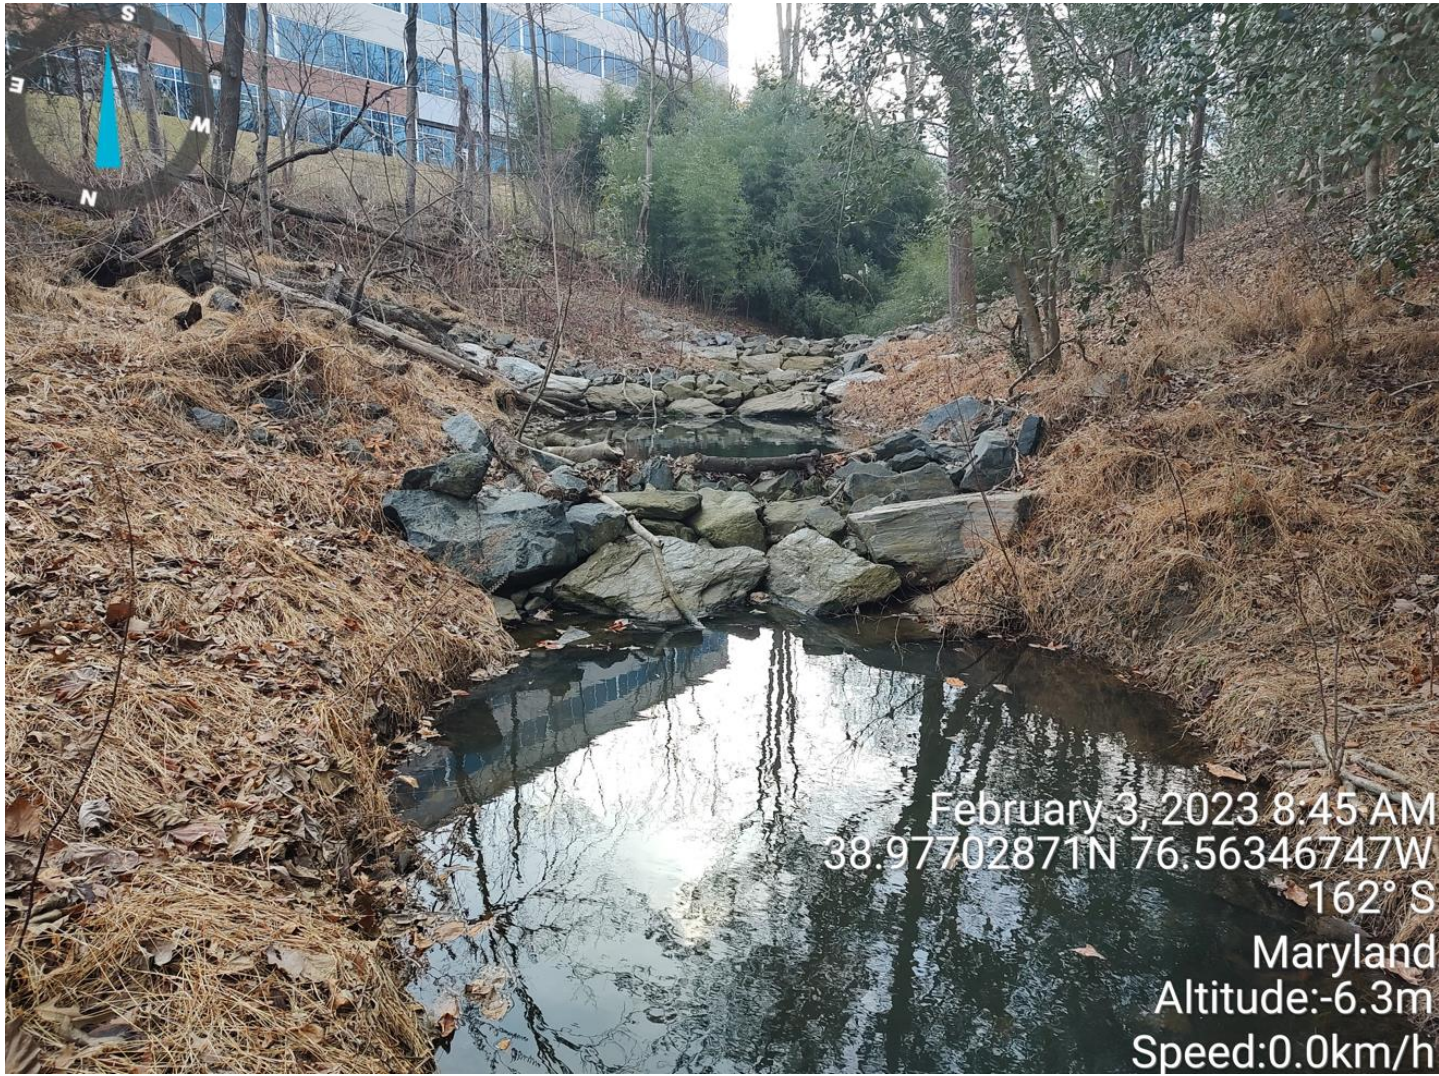
Photo 9

Upstream view of Broad Creek with step pools and check dams shown. This is located near the hypothetical POI

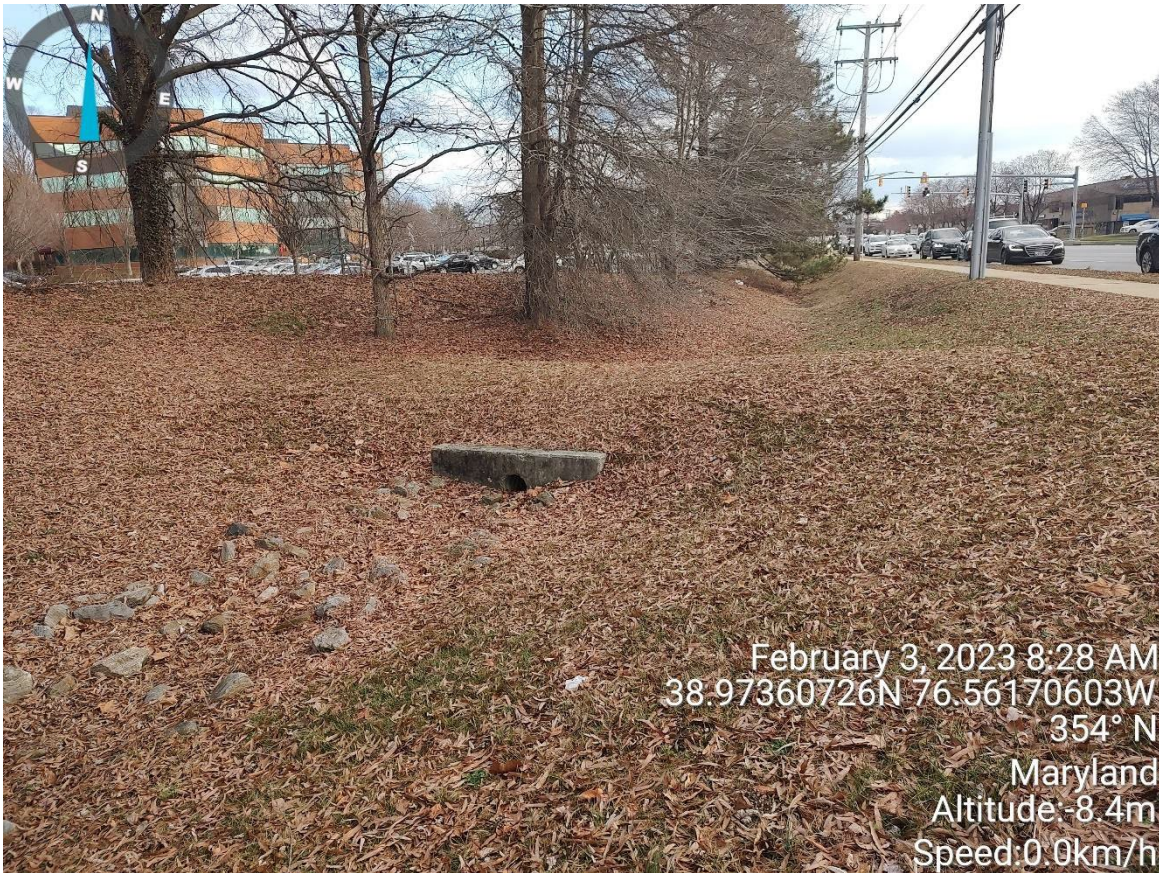
Photo 10

View of the roadside swell with a culvert along Riva Road, adjacent to the Project property. The area appears stable. No erosion is present.

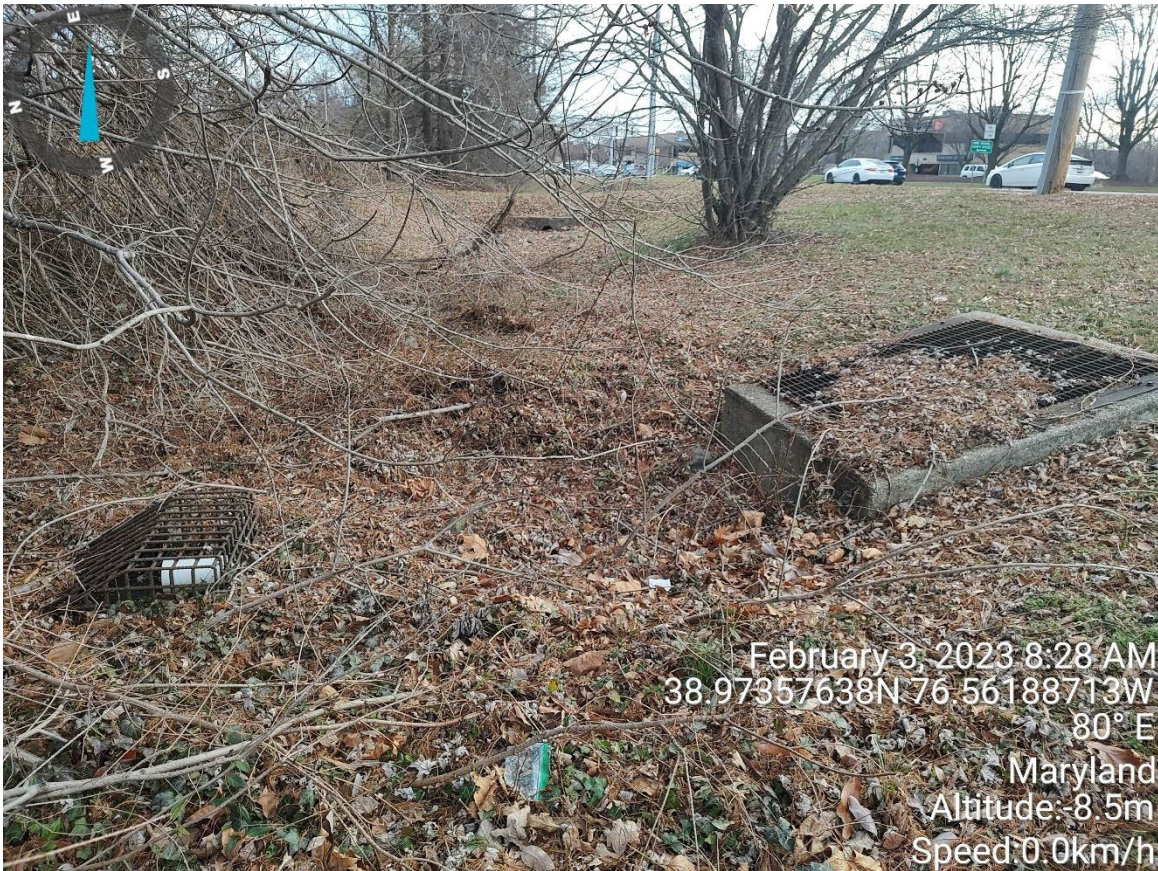
Photo 11

View of the roadside ditch and an inlet, north of Riva Road. The inlet appears to be partially clogged with debris. This area appears stable with no erosion present.

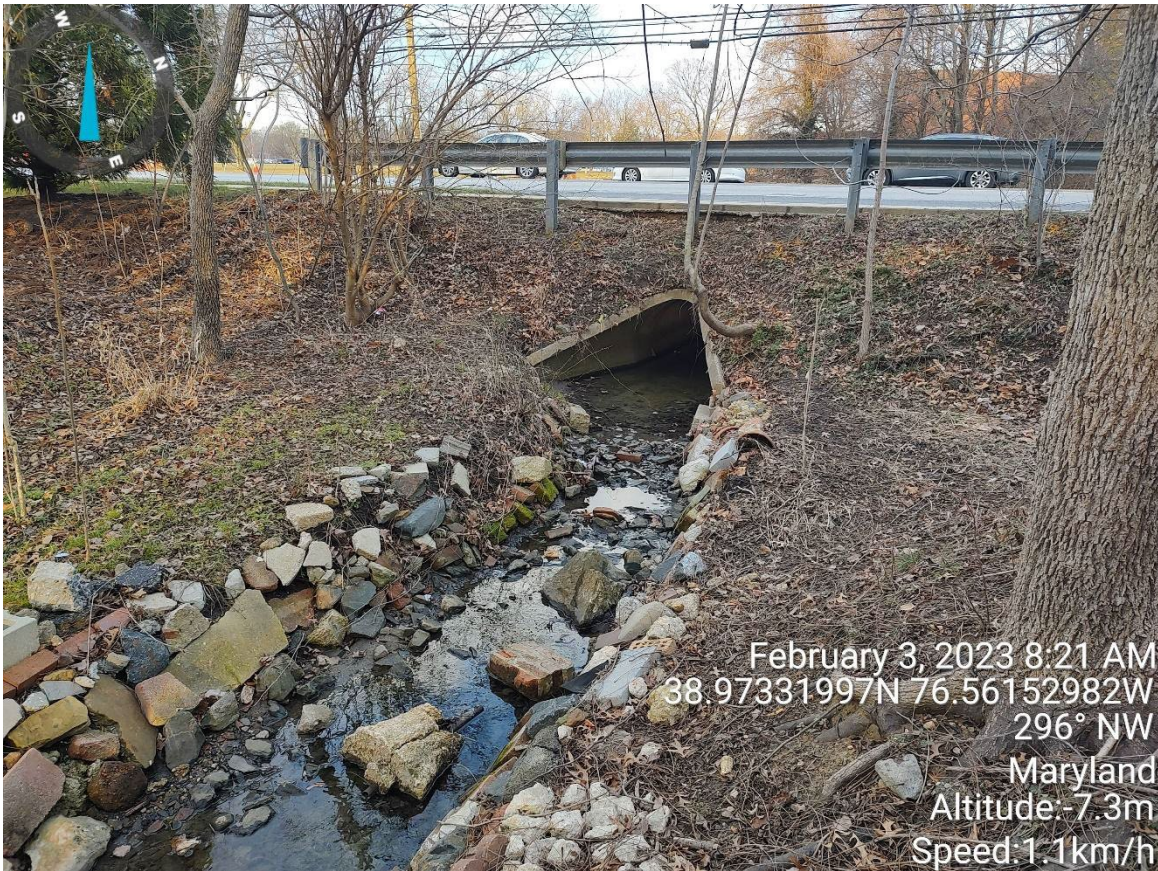
Photo 12

View of the Discharge Point 1, a 48" storm drain, an outlet, and rip rap to the south of Riva Road. Displaced rip rap is present. The area appears to be stable with no erosion present.

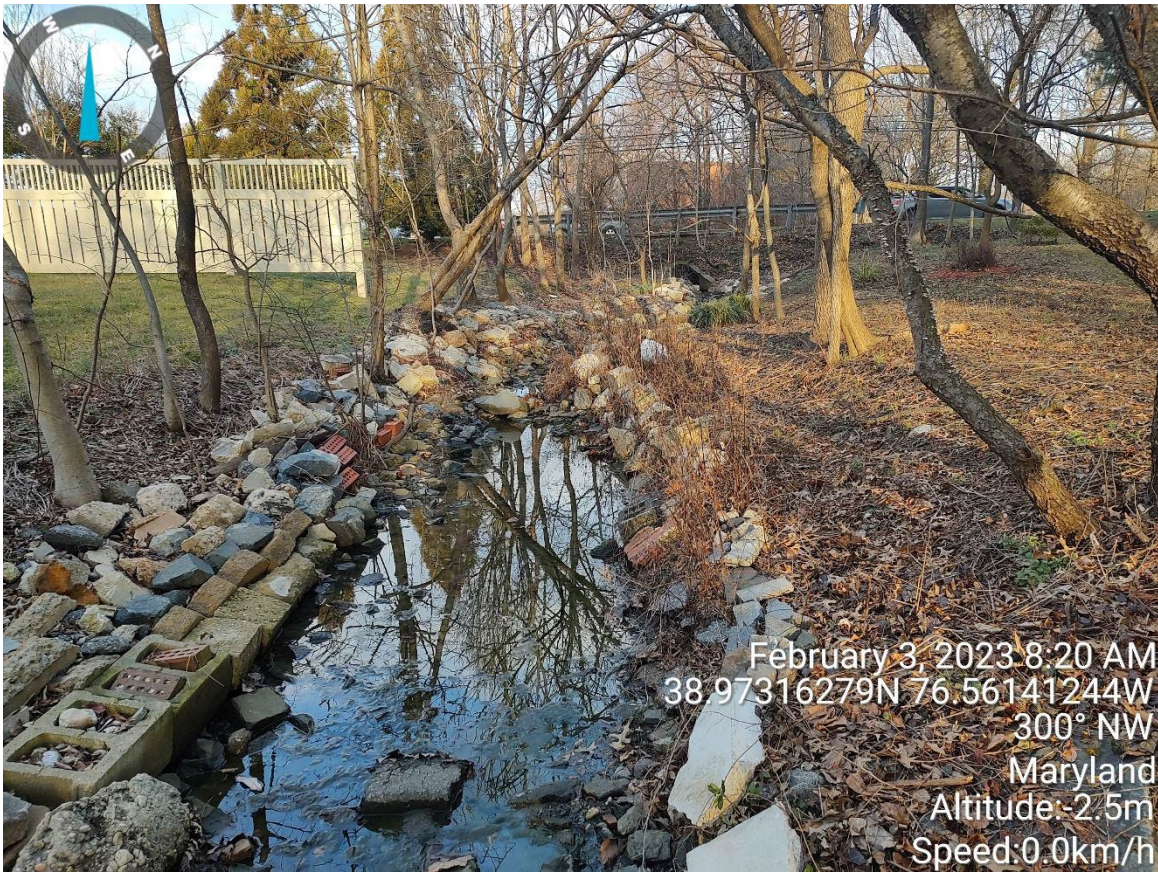
Photo 13

View of the reinforced channel facing the outlet. Area appears stable with no erosion present.

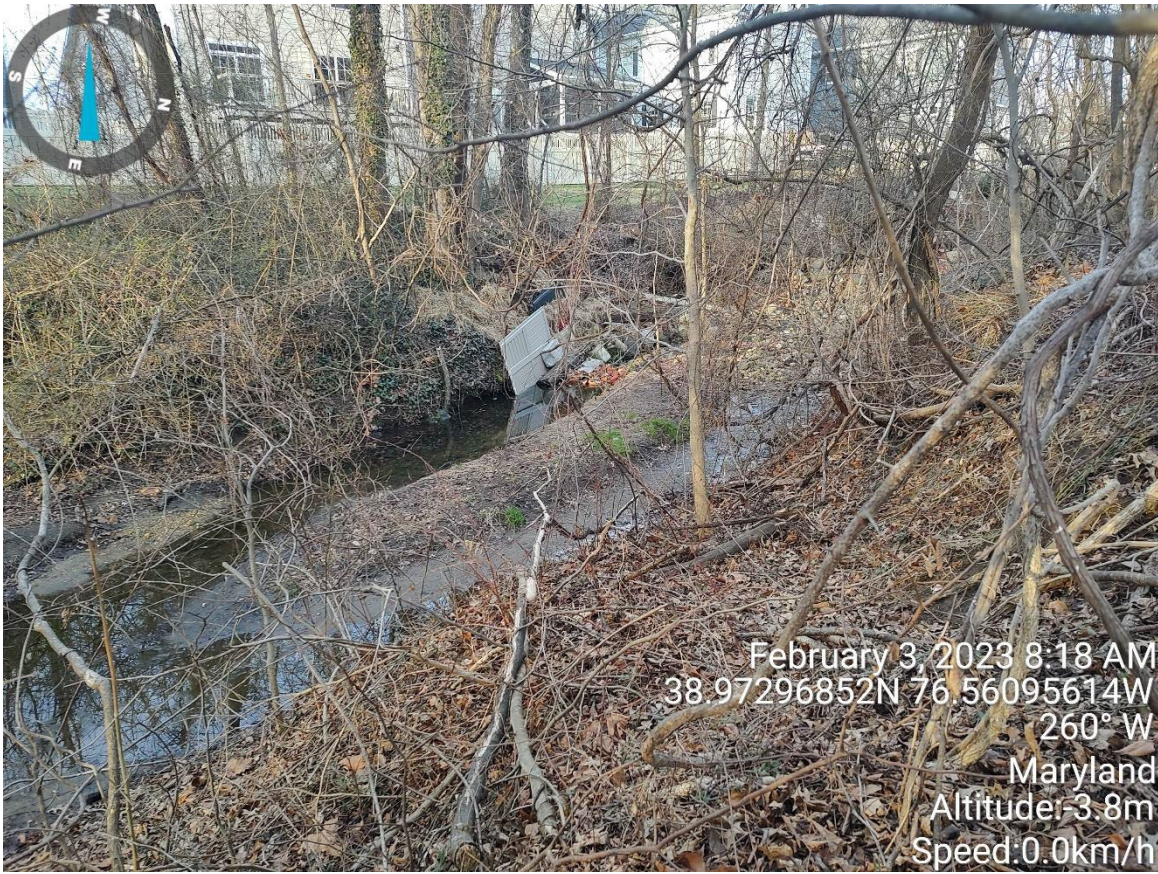
Photo 14

View of the channel facing west. Trash and siltation are present in this portion of the channel. Area appears stable.

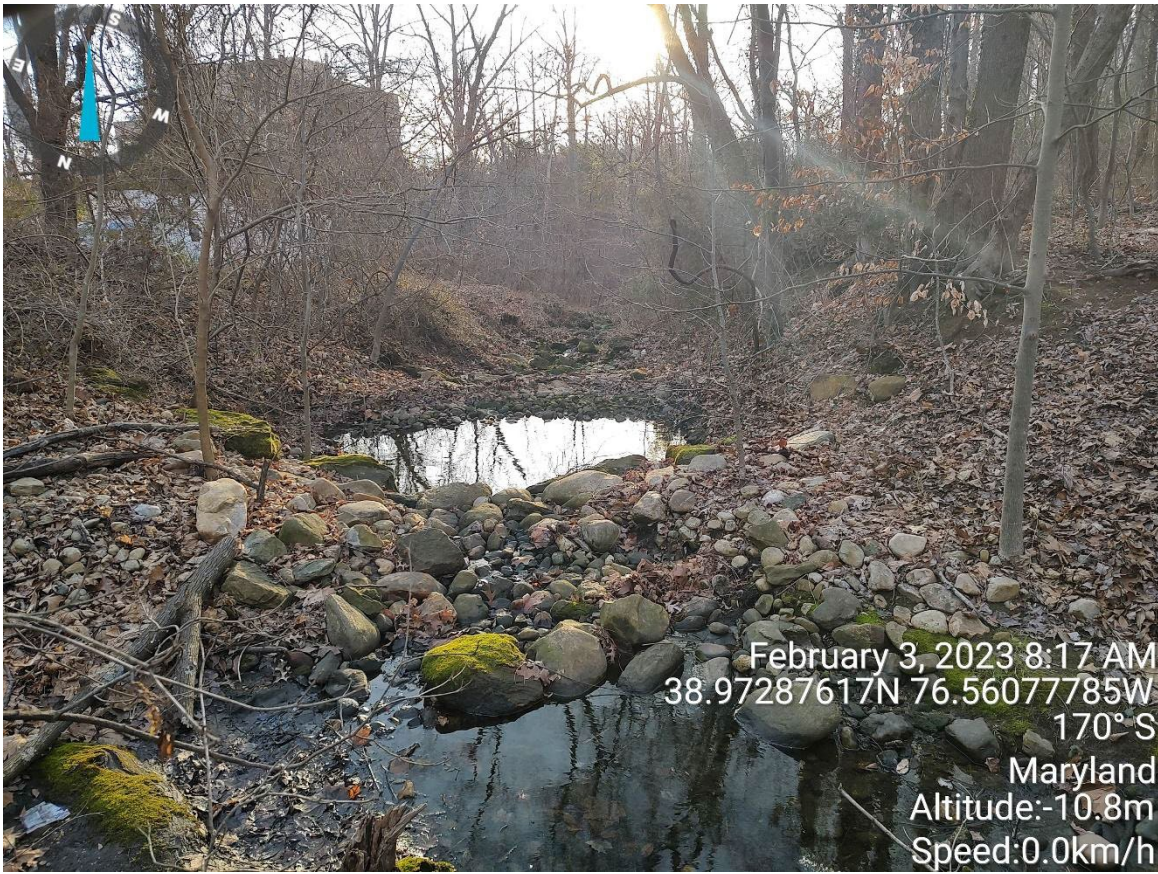
Photo 15

Step pool conveyance facing south along the channel. Area appears stable with no signs of erosion.

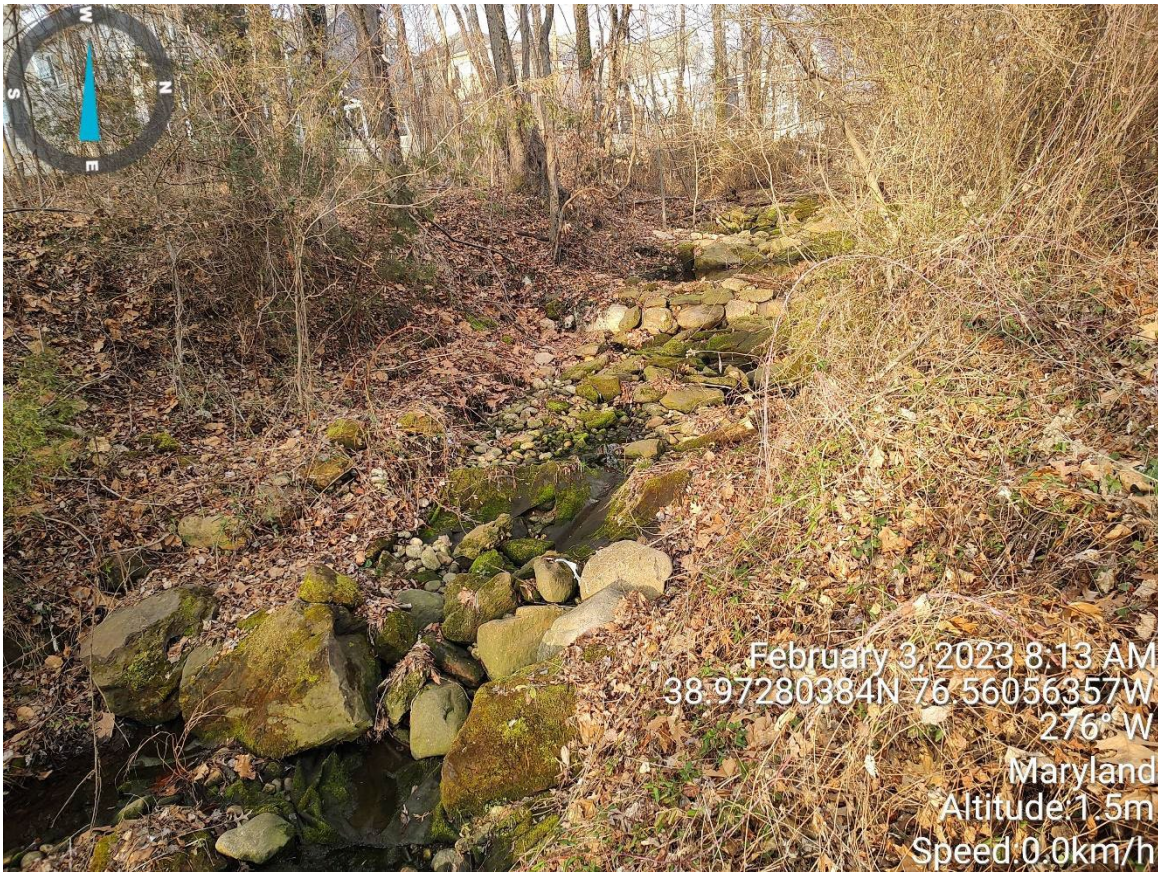
Photo 16

View of the stable channel facing west. Area appears stable with no signs of erosion.

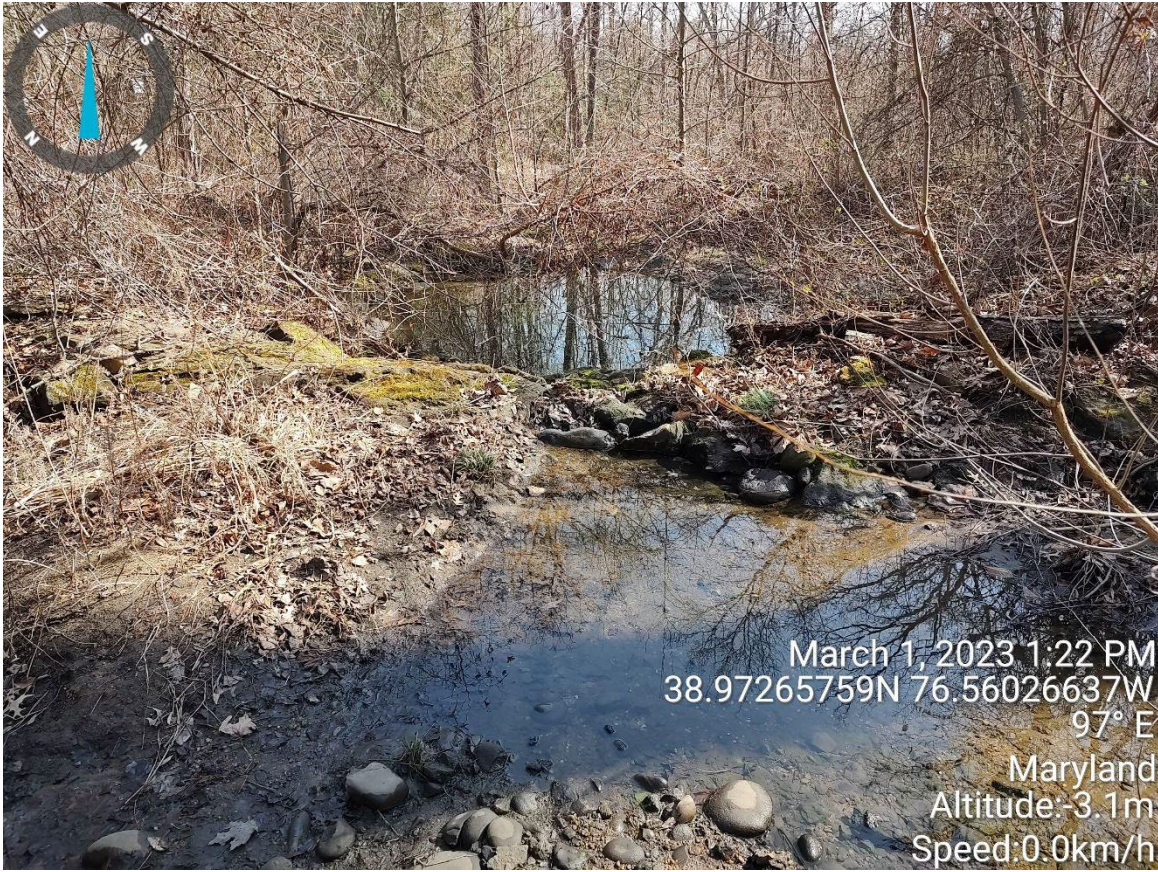
Photo 17

Step pool conveyance facing southwest along the channel. Area appears stable with no signs of erosion.

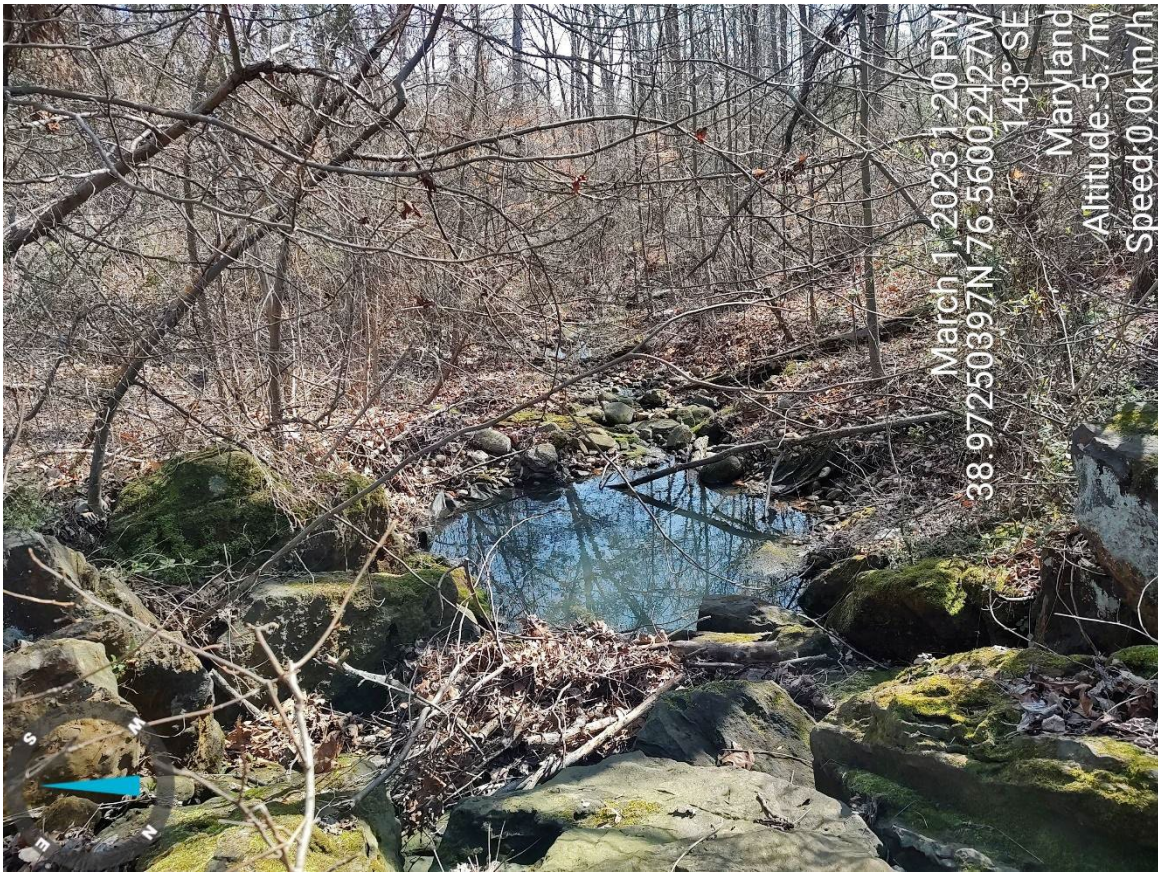
Photo 18

Step pool conveyance facing southwest along the channel. Area appears stable with no signs of erosion.

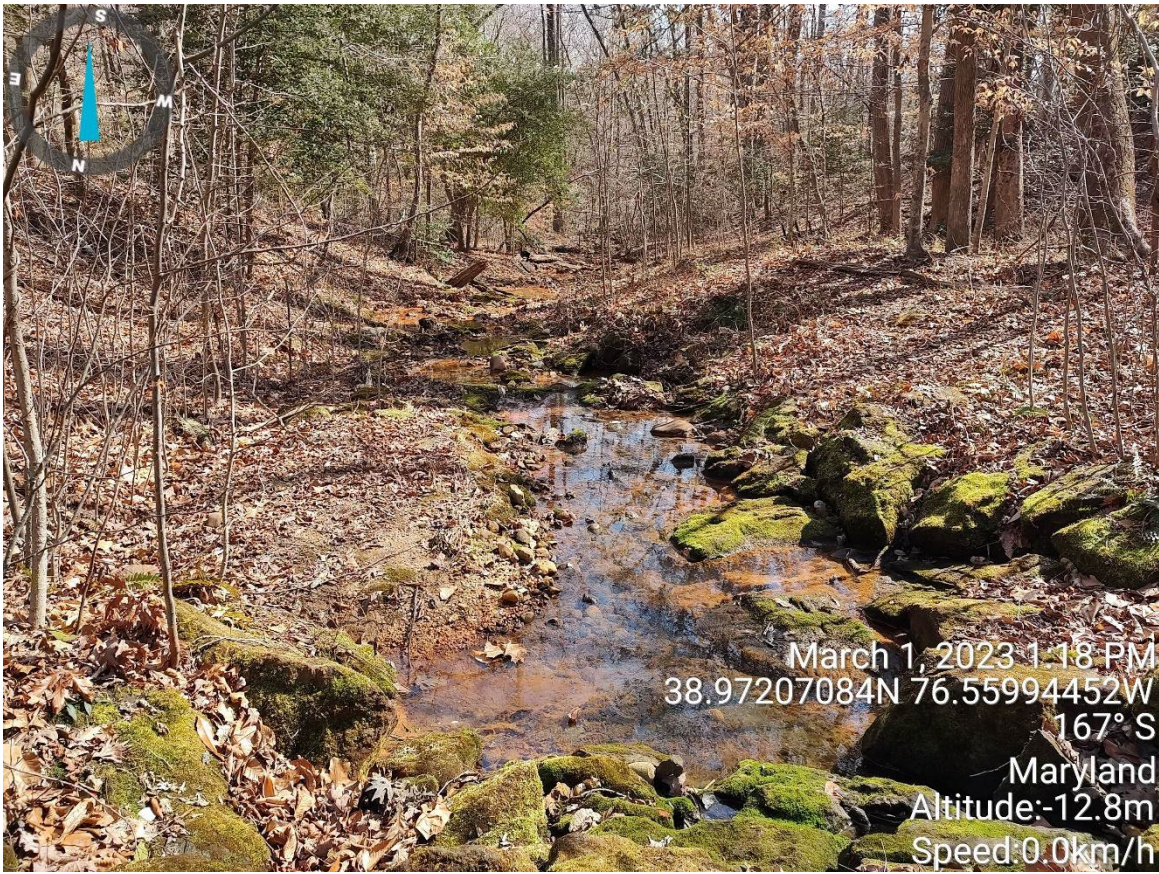
Photo 19

View of the channel facing south.
