Anne Arundel County Department of Inspections and Permits Provides Guidance on Downstream Analyses

Subject: **Downstream Investigation Guidance**

Heritage Complex Project
 Project Number 123-4567
 Field Investigation Date: February 3rd, 2023 and March 1st, 2023
 Scale: 1" = 400'

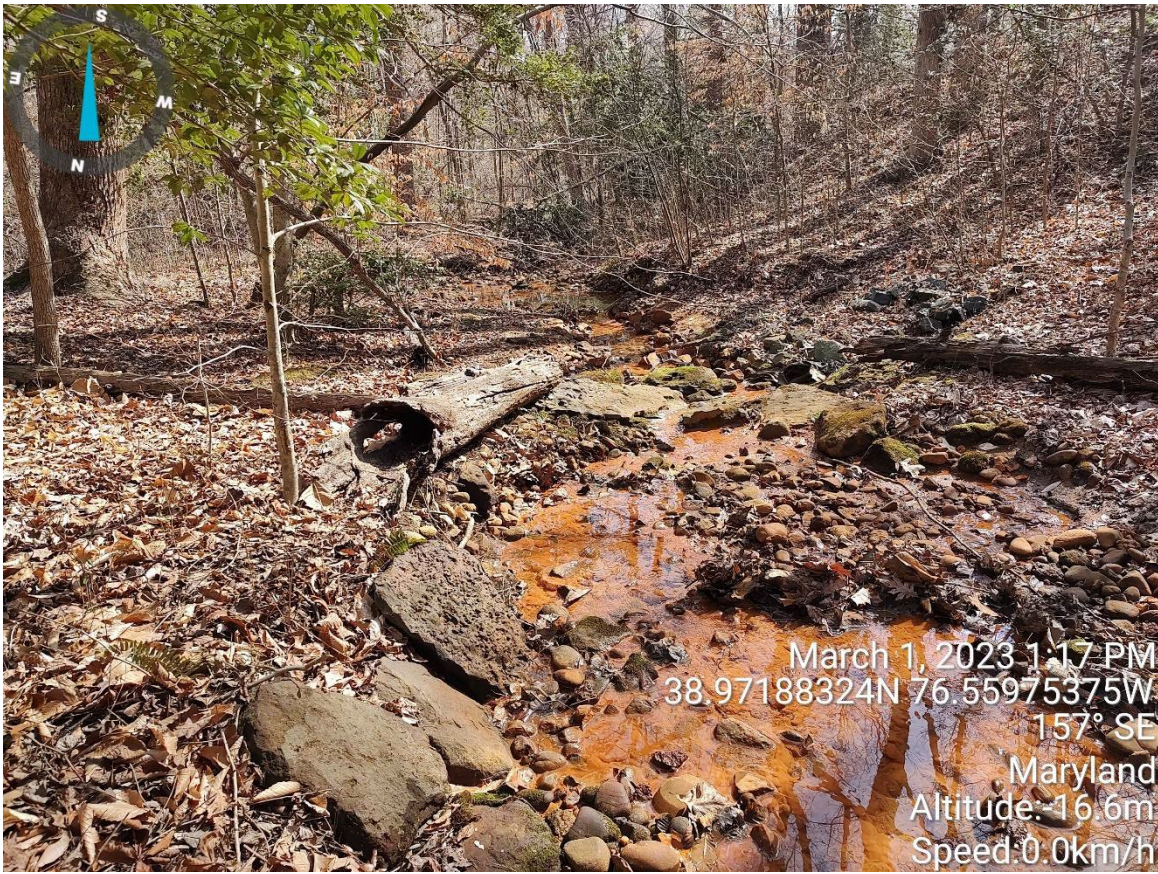
Photo 20

View of the channel facing south.
