**BIOLOGICAL AND
GEOMORPHOLOGICAL CONDITION
IN THE PICTURE SPRING BRANCH
SUBWATERSHED, SEVERN RIVER
WATERSHED, ANNE ARUNDEL COUNTY,
MARYLAND: 2016 - 2017**

FINAL REPORT

Versar, Inc.
9200 Rumsey Road
Columbia, MD 21045

February 8, 2018

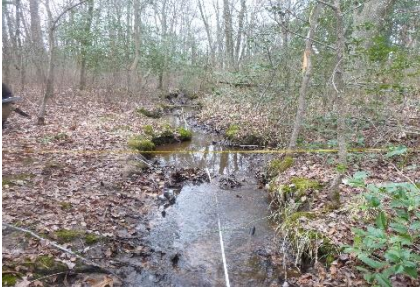
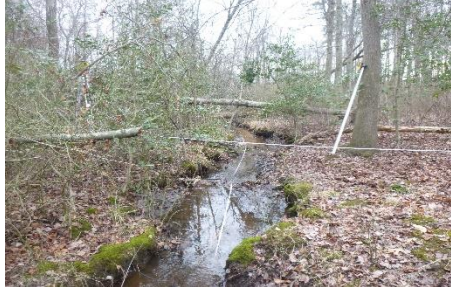
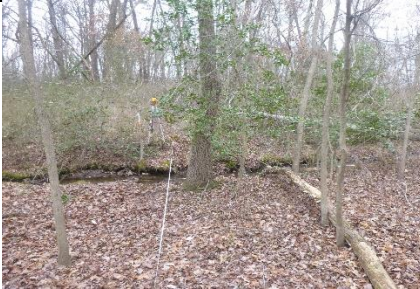
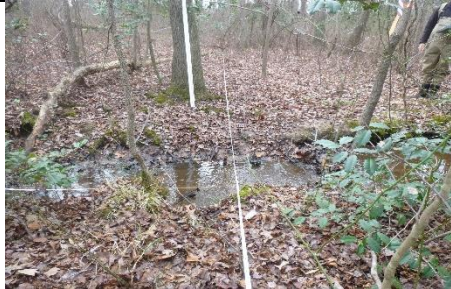
Entrenchment Ratio (ER) = W_{fpa}/W_{bkt}	5.5
		Channel Materials D_{50} (millimeters)	0.11
		Water Surface Slope (S)	0.012
		Sinuosity (K) = stream length/valley length	<1.2
		Adjustments?	Sin ↑
Left Bank View	Right Bank View	STREAM TYPE	E5

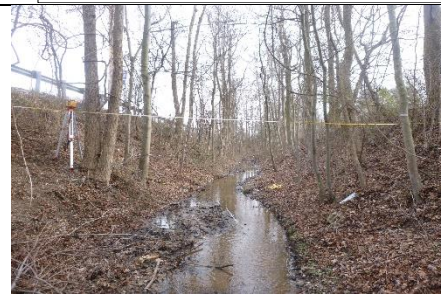
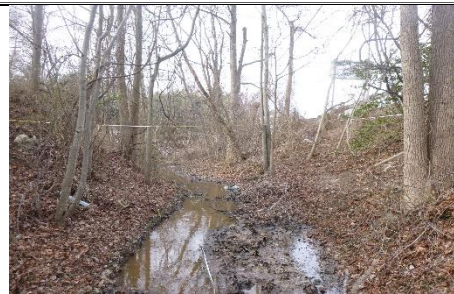
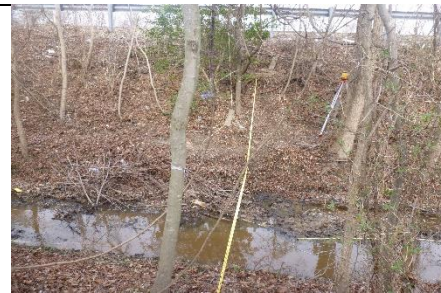
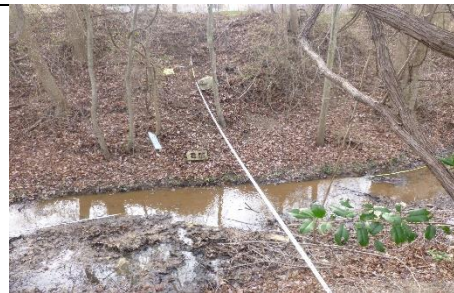
Bankfull Width (W_{bkt}) (feet)	11.1
Mean Depth (d_{bkt}) (feet)	0.6
Bankfull Cross-sectional Area (A_{bkt}) (feet ²)	6.9
Width/Depth Ratio (W_{bkt}/d_{bkt})	18.0
Width of Flood-prone Area (W_{fpa}) (feet)	13.5
Entrenchment Ratio (ER) = W_{fpa}/W_{bkt}	1.2
Channel Materials D_{50} (millimeters)	0.30
Water Surface Slope (S)	0.0027
Sinuosity (K) = stream length/valley length	<1.2
Adjustments?	Sin ↑

F5

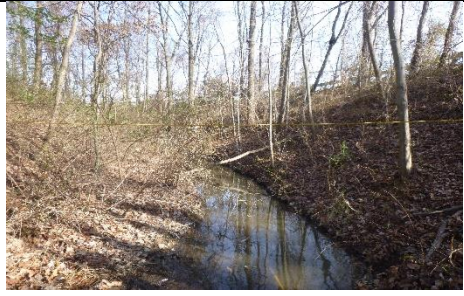
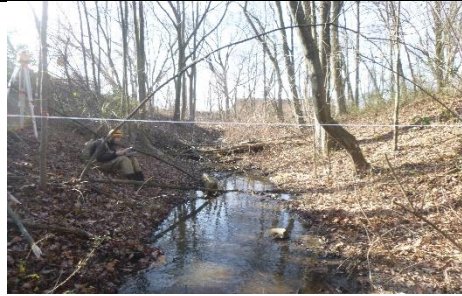
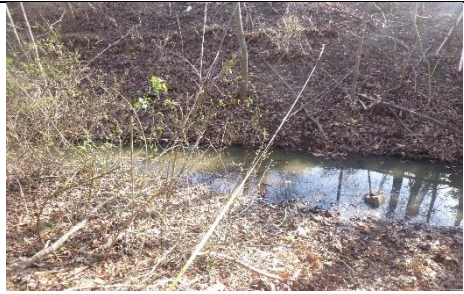
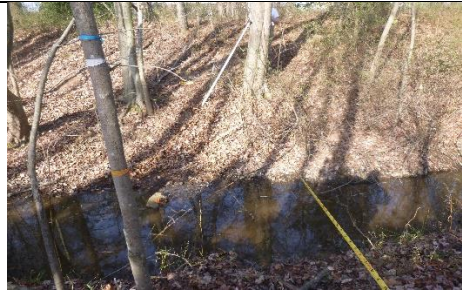
2017 Geomorphic Assessment Results	
Bankfull Width (W_{bkt}) (feet)	11.4
Mean Depth (d_{bkt}) (feet)	0.5
Bankfull Cross-sectional Area (A_{bkt}) (feet ²)	5.9
Width/Depth Ratio (W_{bkt}/d_{bkt})	21.9
Width of Flood-prone Area (W_{fpa}) (feet)	14.2
Entrenchment Ratio (ER) = W_{fpa}/W_{bkt}	1.2
Channel Materials D_{50} (millimeters)	0.35
Water Surface Slope (S)	0.0039
Sinuosity (K) = stream length/valley length	<1.2
Adjustments?	Sin ↑
STREAM TYPE	F5

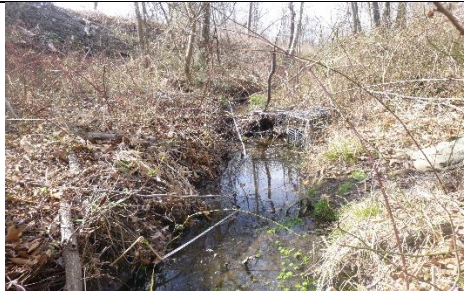
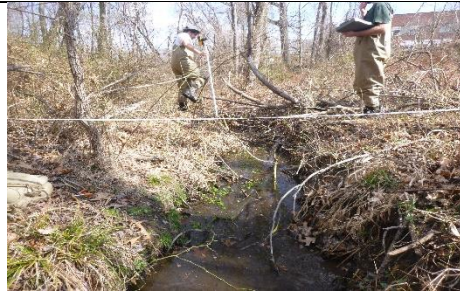
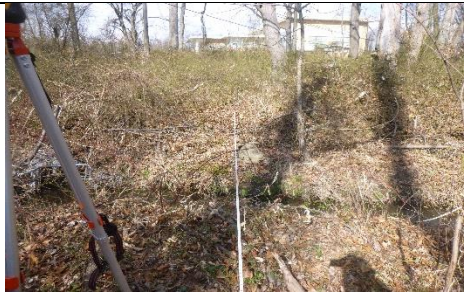
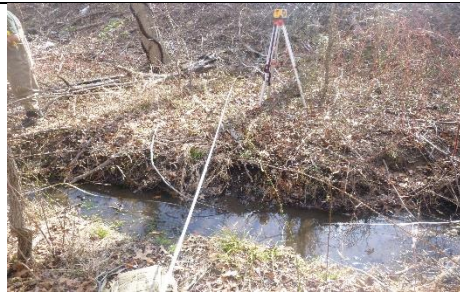
An E channel was identified at cross-section 4 on the South Tributary, which appeared to have been channelized in the past and is piped underground for a significant distance upstream, further modifying its hydrology. However, the South Tributary is not overwidened and is significantly steeper than the North Tributary. Indicators were observed that show some limited floodplain connectivity along the upstream portion of the tributary where the cross-section is located. However, just downstream of the cross-section location, the channel became noticeably entrenched and showed signs of active downcutting. While it is possible that this reach may exhibit both B and E characteristics along different portions of the reach, it was assigned an E5 classification primarily based on the entrenchment and width/depth ratios measured at the cross-section location. Evidence of recent downcutting (e.g., nick points) suggests that the reach is unstable and is likely shifting from an E channel to a B channel. Significant changes in the shape of this cross-section were observed during the 2013 survey, as the channel had noticeably deepened and widened since the 2012 survey (Appendix B). Over the next year, as seen in the 2014 survey, aggradation occurred affecting the bed level by raising it approximately 0.5 feet. From 2014 to 2015, the channel has shifted slightly, but has remained stable in terms of aggradation or deepening. Noticeable aggradation occurred again in 2016 by an approximate 0.5-foot rise in bed elevation but the bed was stable between the 2016 and 2017 surveys. Analysis of the longitudinal profile overlay from 2007 through 2017 shows considerable downcutting between stations 1+00 and 2+20 (Appendix B). However, during 2014 the pool near station 2+00 has mostly filled in. This trend continued in 2015, with the pool working its way up the reach to station 1+80. In 2016, the pool remained at station 1+80 but deepened by almost a foot with no additional changes occurring in 2017. The headcut and large scour pool between stations 2+68 and 2+90 just downstream from this eroded section have not worsened. However, in 2016 this scour pool shifted downstream by a few feet. It is recommended that this area continue to be monitored, since further erosion could eventually lead to undermining of the concrete-lined channel just downstream.

Bankfull Width (W_{bkf}) (feet)	3.9
Mean Depth (d_{bkf}) (feet)	0.7
Bankfull Cross-sectional Area (A_{bkf}) (feet ²)	2.8
Width/Depth Ratio (W_{bkf}/d_{bkf})	5.3
Width of Flood-prone Area (W_{fpa}) (feet)	22.9
Entrenchment Ratio (ER) = W_{fpa}/W_{bkf}	5.9
Channel Materials D_{50} (millimeters)	0.31
Water Surface Slope (S)	0.015
Sinuosity (K) = stream length/valley length	<1.2
Adjustments?	Sin ↑
STREAM TYPE	E5

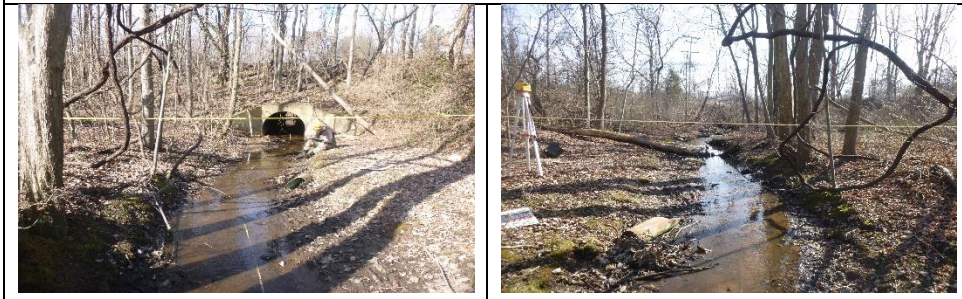
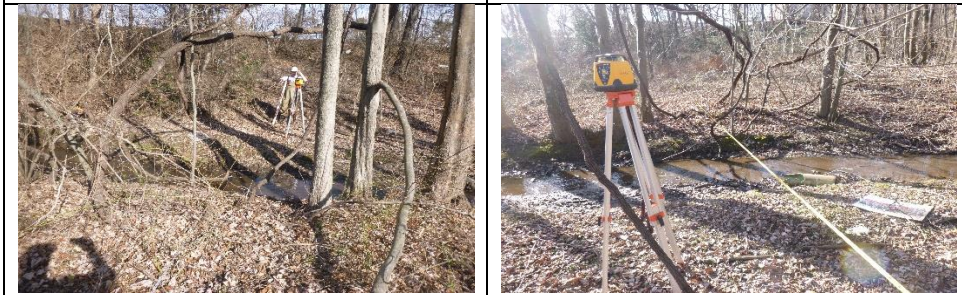
2017 Geomorphic Assessment Results	
Bankfull Width (W_{bkt}) (feet)	9.3
Mean Depth (d_{bkt}) (feet)	0.7
Bankfull Cross-sectional Area (A_{bkt}) (feetz)	6.6
Width/Depth Ratio (W_{bkt}/d_{bkt})	13.1
Width of Flood-prone Area (W_{fpa}) (feet)	22.3
Entrenchment Ratio (ER) = W_{fpa}/W_{bkt}	2.4
Channel Materials D_{50} (millimeters)	1.1
Water Surface Slope (S)	0.0046
Sinuosity (K) = stream length/valley length	<1.2
Adjustments?	Sin ↑
STREAM TYPE	C5
