**BIOLOGICAL AND
GEOMORPHOLOGICAL CONDITION
IN THE PICTURE SPRING BRANCH
SUBWATERSHED, SEVERN RIVER
WATERSHED, ANNE ARUNDEL COUNTY,
MARYLAND: 2017 - 2018**

Anne Arundel County, Maryland
Department of Public Works
Watershed Protection and Restoration Program
2662 Riva Road
Annapolis, MD 21401

Versar, Inc.
9200 Rumsey Road
Columbia, MD 21045

October 30, 2018

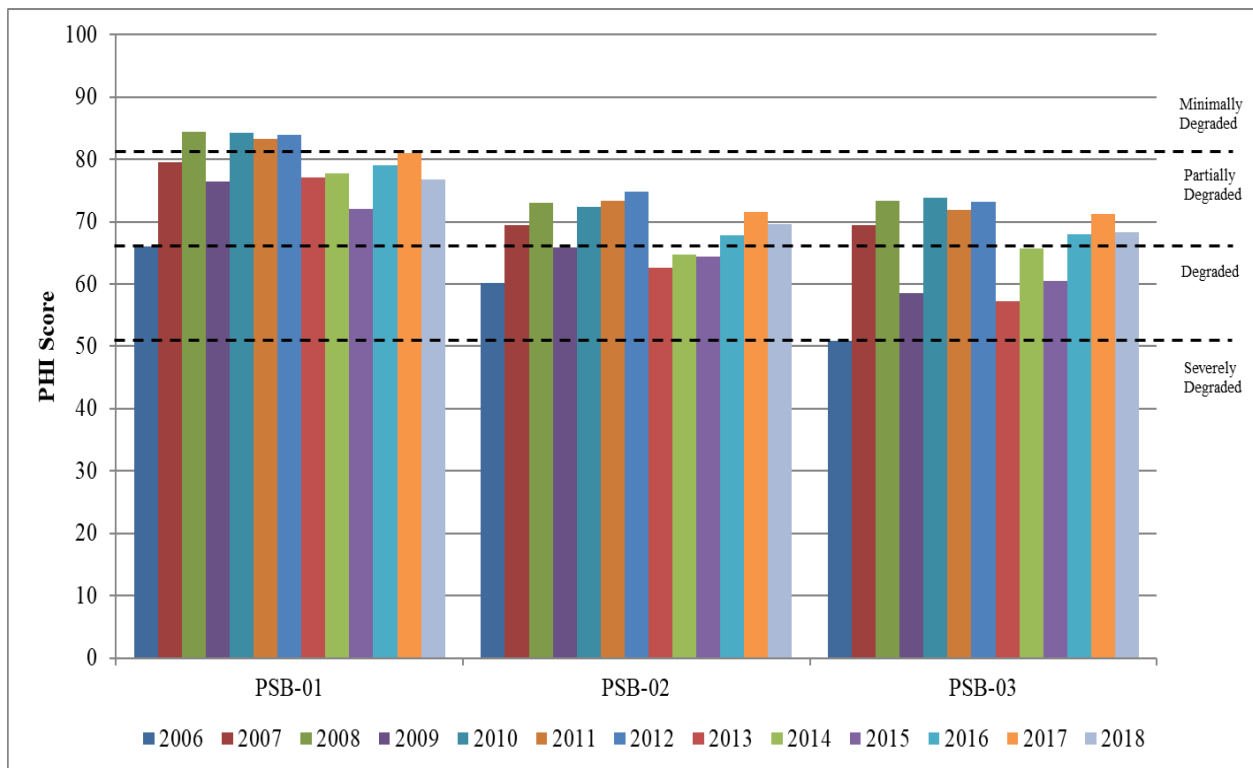
Figure 4-1. Comparison of PHI Habitat Scores from 2006 through 2018

Physical habitat was rated “Partially Degraded” at all three Picture Spring Branch sites. Although the narrative rating declined only at PSB-01, the PHI scores at all three sites showed a decrease from 2017 scores (Table 4-1). The overall decrease in scores is primarily a result of declines in epifaunal substrate. PSB-02 had a minor change in physical habitat score from 2017 that was entirely driven by a reduction in epifaunal substrate score. The modest reduction in physical habitat score at PSB-03 is largely driven by reductions in bank stability and instream habitat. The bank stability score decreased because of the increased extent of erosion along both banks.

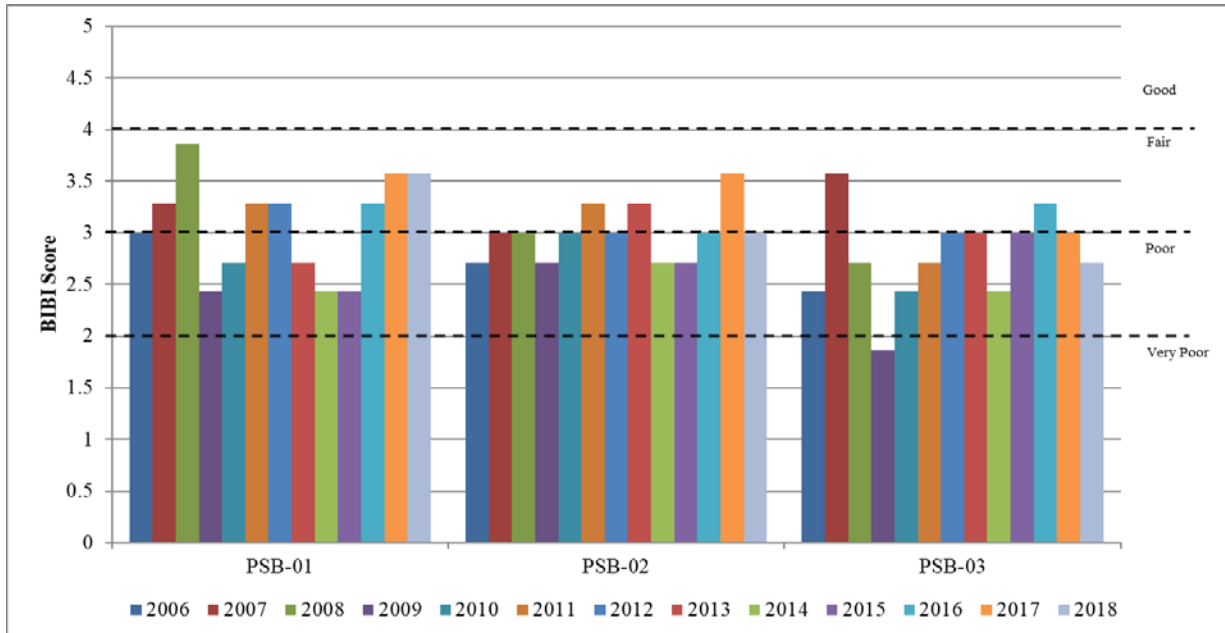
Figure 4-2. Comparison of BIBI Scores from 2006 through 2018

BIBI scores decreased at PSB-02 and PSB-03 but were unchanged at PSB-01 (Table 4-2). The scores at PSB-02 and PSB-03 decreased due to fewer EPT taxa and a smaller percentage of taxa intolerant to urbanization. Figure 4-2 provides a visual comparison of BIBI scores over time and shows scores fluctuating from year to year.

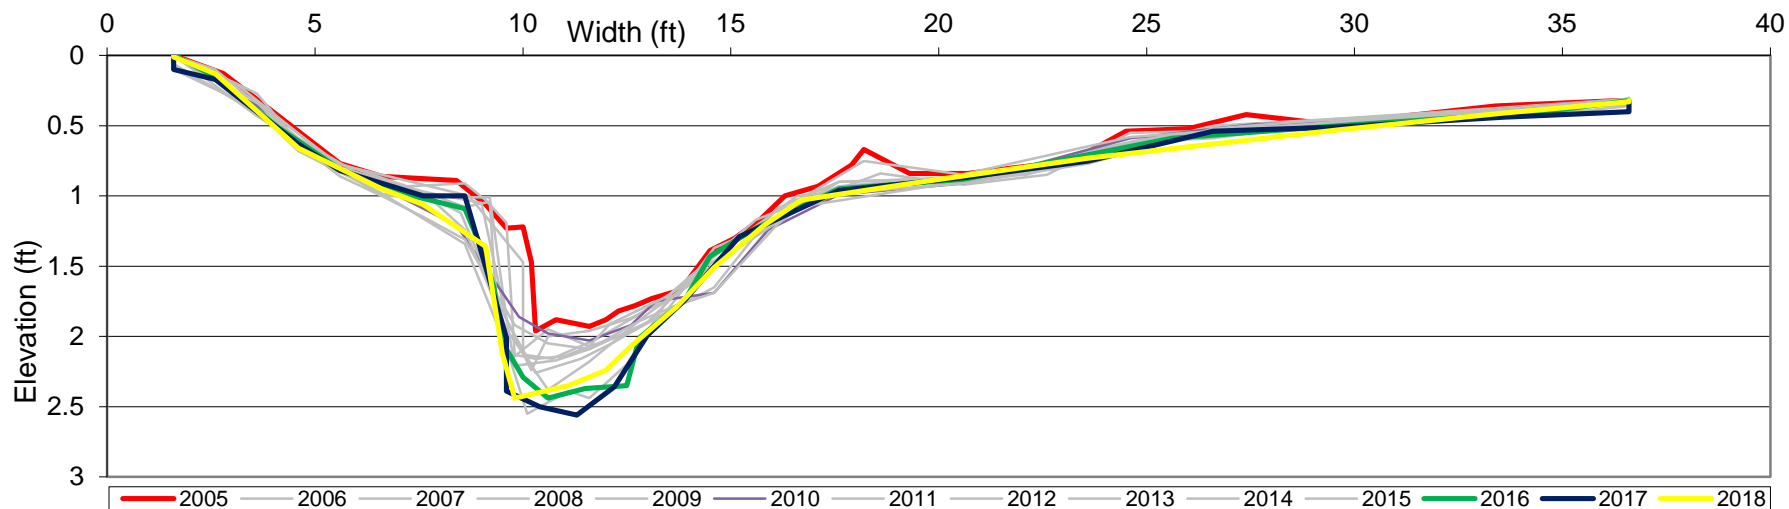
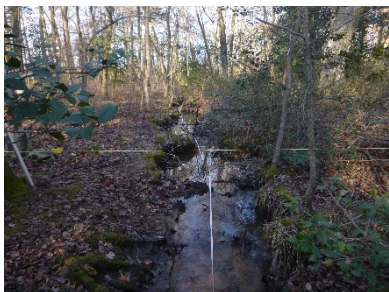
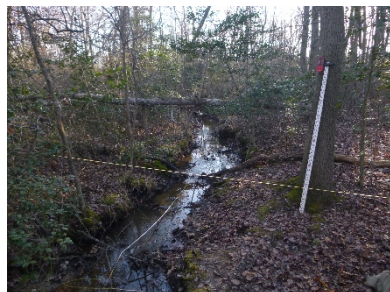
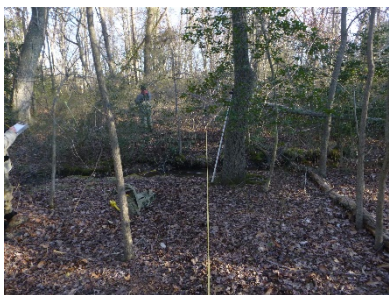
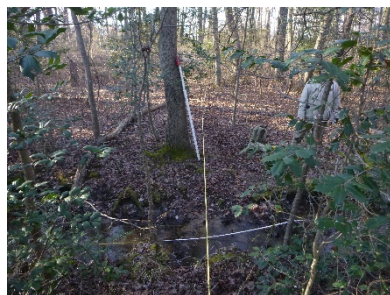
CROSS SECTION 1

Bankfull Width (W_{bkt}) (feet)	4.4
Mean Depth (d_{bkt}) (feet)	0.4
Bankfull Cross-sectional Area (A_{bkt}) (feet ²)	1.8
Width/Depth Ratio (W_{bkt}/d_{bkt})	10.7
Width of Flood-prone Area (W_{fpa}) (feet)(feet)	8.2
Entrenchment Ratio (ER) = W_{fpa}/W_{bkt}	1.9
Channel Materials D_{50} (millimeters)	0.10
Water Surface Slope (S)	0.0067
Sinuosity (K) = stream length/valley length	<1.2
Adjustments?	Sin ↑
STREAM TYPE	E5

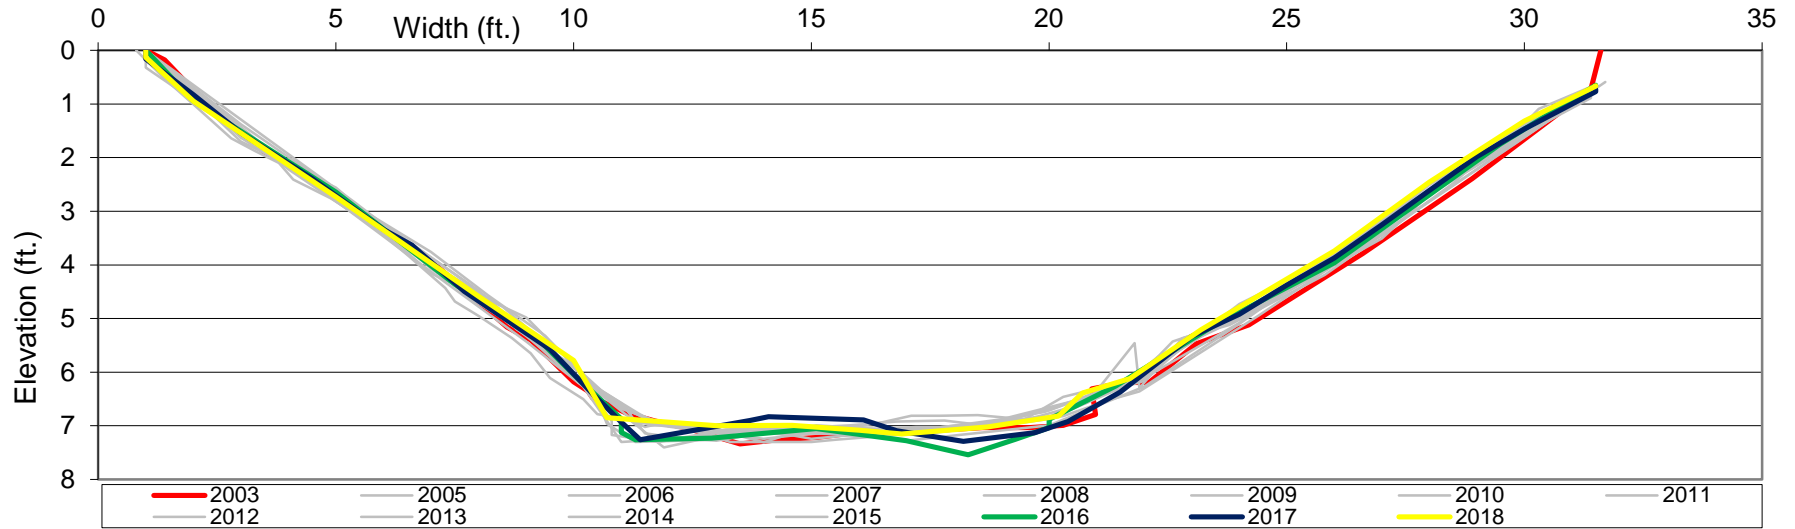
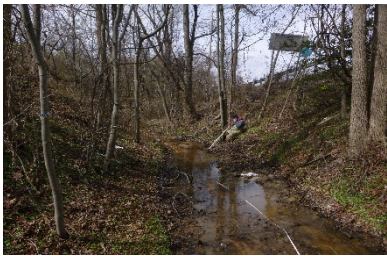
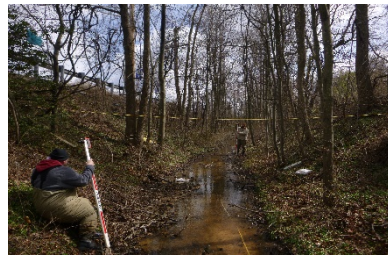
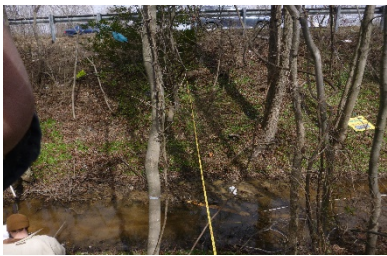
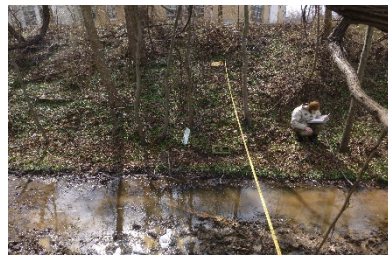
CROSS SECTION 2

Bankfull Width (W_{bkt}) (feet)	10.3
Mean Depth (d_{bkt}) (feet)	0.6
Bankfull Cross-sectional Area (A_{bkt}) (feet ²)	6.0
Width/Depth Ratio (W_{bkt}/d_{bkt})	17.8
Width of Flood-prone Area (W_{fpa}) (feet)	12.8
Entrenchment Ratio (ER) = W_{fpa}/W_{bkt}	1.2
Channel Materials D_{50} (millimeters)	0.09
Water Surface Slope (S)	0.0041
Sinuosity (K) = stream length/valley length	<1.2
Adjustments?	Sin ↑
STREAM TYPE	F5

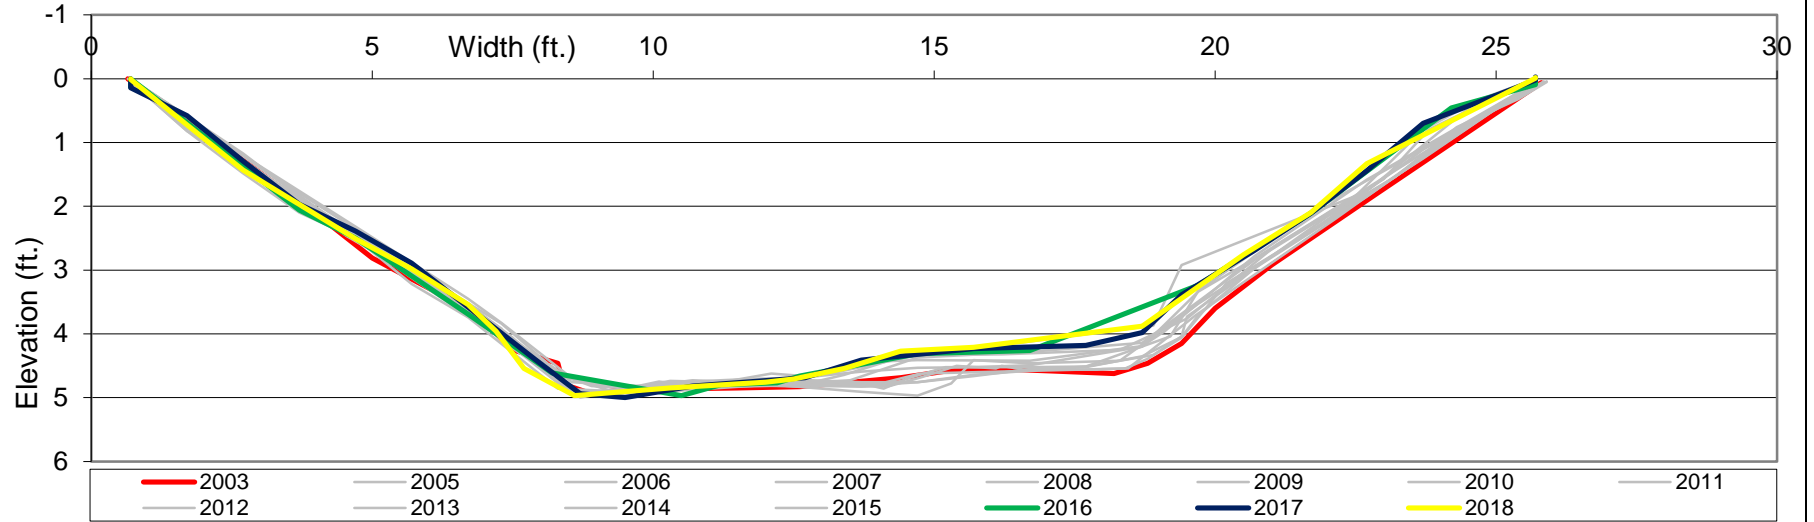
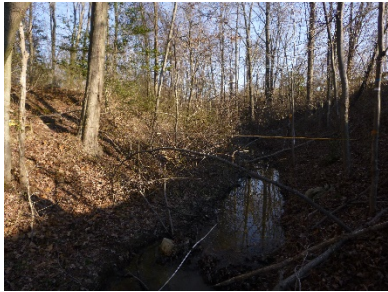
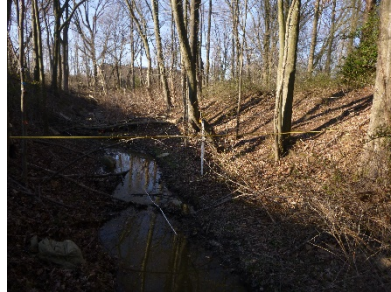
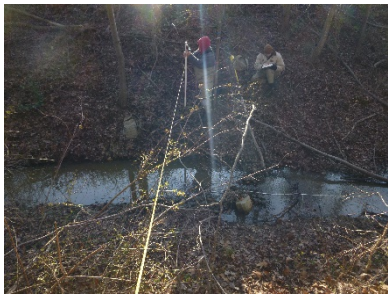
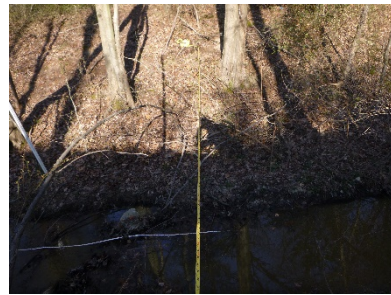
CROSS SECTION 3

Bankfull Width (W_{bkf}) (feet)	10.6
Mean Depth (d_{bkf}) (feet)	0.5
Bankfull Cross-sectional Area (A_{bkf}) (feet ²)	5.8
Width/Depth Ratio (W_{bkf}/d_{bkf})	19.4
Width of Flood-prone Area (W_{fpa}) (feet)	13.8
Entrenchment Ratio (ER) = W_{fpa}/W_{bkf}	1.3
Channel Materials D_{50} (millimeters)	0.35
Water Surface Slope (S)	0.0049
Sinuosity (K) = stream length/valley length	<1.2
Adjustments?	Sin ↑
STREAM TYPE	F5

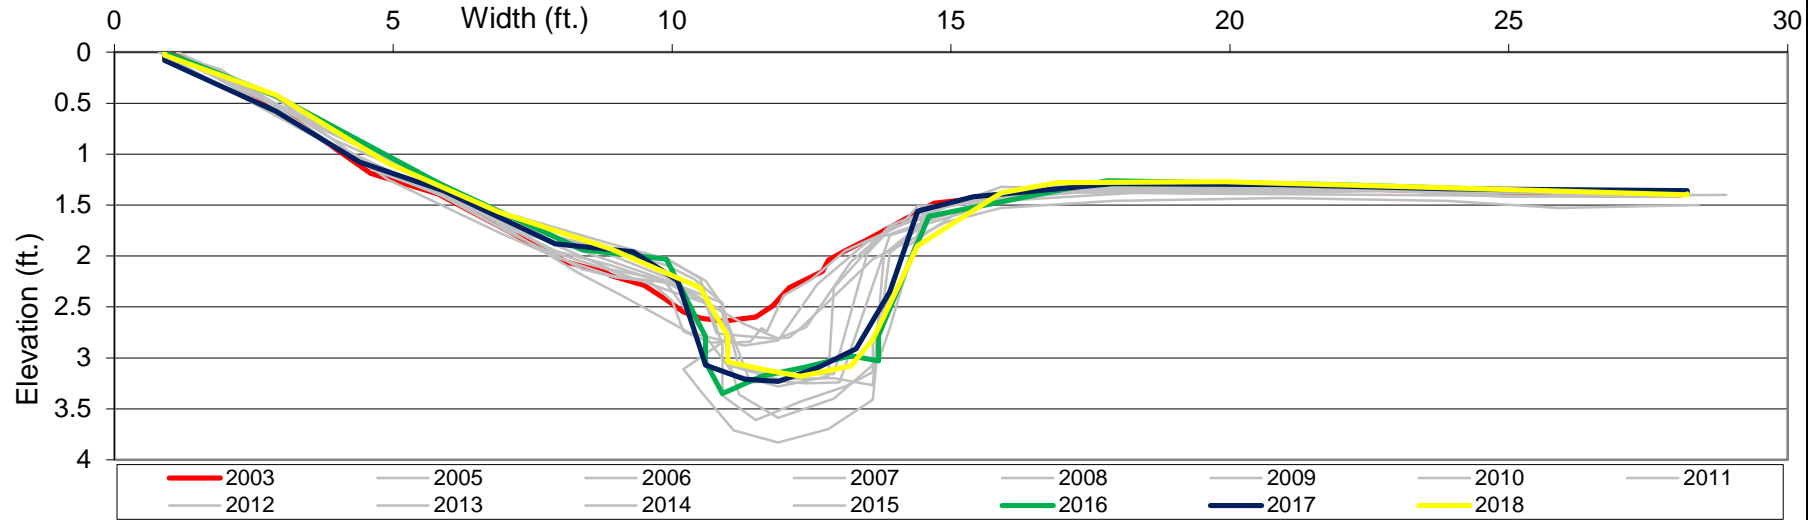
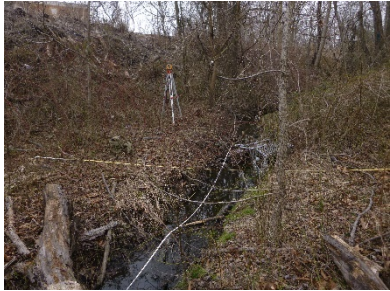
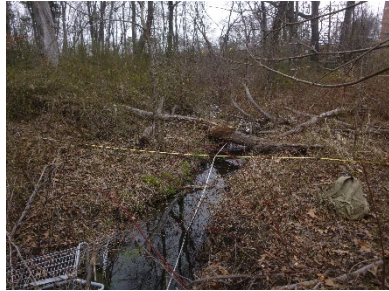
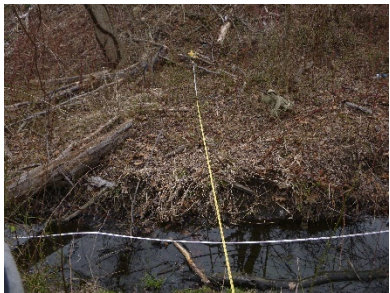
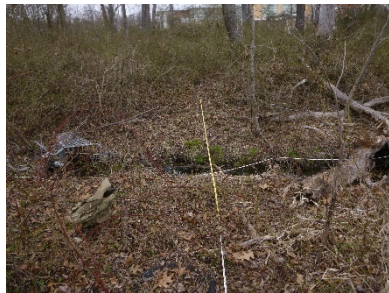
CROSS SECTION 4

An E5 channel was identified at cross-section 4 on the South Tributary. This reach appears to have been channelized in the past and is piped underground for a significant distance upstream, further modifying its hydrology. In comparison to the North Tributary the South Tributary is not over-widened and has a steeper longitudinal gradient than the North Tributary. Indicators were observed that show some limited floodplain connectivity along the upstream portion of the tributary where the cross-section is located. However, just downstream of the cross-section location, the channel is noticeably entrenched and shows signs of active downcutting. While it is possible that this reach may exhibit both B and E characteristics along different portions of the reach, it was assigned an E5 classification primarily based on the entrenchment and width/depth ratios measured at the cross-section location. Evidence of recent downcutting (e.g., nick points) suggests that the reach is unstable and is likely shifting from an E channel to a B channel. Significant changes in the shape of this cross-section were observed during the 2013 survey, as the channel had noticeably deepened and widened since the 2012 survey (Appendix B). Over the next year, as seen in the 2014 survey, aggradation occurred affecting the bed level by raising it approximately 0.5 feet. From 2014 to 2015, the channel shifted slightly but remained stable in terms of aggradation or deepening. Noticeable aggradation occurred again in 2016 by an approximate 0.5-foot rise in bed elevation, but the bed was stable between the 2016 and 2018 surveys. Analysis of the longitudinal profile overlay from 2007 through 2018 shows considerable downcutting between stations 1+00 and 2+20 (Appendix B). However, during 2014, the pool near station 2+00 has mostly filled in. This trend continued in 2015, with the pool working its way up the reach to station 1+80. In 2016, the pool remained at station 1+80 but deepened by almost a foot with no additional changes occurring in 2017. In 2018, the pool shifted slightly downstream and deepened by about half a foot. The headcut and large scour pool between stations 2+68 and 2+90 just downstream from this eroded section have not worsened. However, in 2016 this scour pool shifted downstream by a several feet and aggradation has raised the channel bed by almost a foot between 2017 and 2018. It is recommended that this area continue to be monitored, as further erosion could eventually lead to undermining of the concrete-lined channel just downstream.

Bankfull Width (W_{bkf}) (feet)	3.5
Mean Depth (d_{bkf}) (feet)	0.6
Bankfull Cross-sectional Area (A_{bkf}) (feet ²)	2.3
Width/Depth Ratio (W_{bkf}/d_{bkf})	5.5
Width of Flood-prone Area (W_{fpa}) (feet)	9.4
Entrenchment Ratio (ER) = W_{fpa}/W_{bkf}	2.6
Channel Materials D_{50} (millimeters)	0.1
Water Surface Slope (S)	0.032
Sinuosity (K) = stream length/valley length	<1.2
Adjustments?	Sin ↑
STREAM TYPE	E5

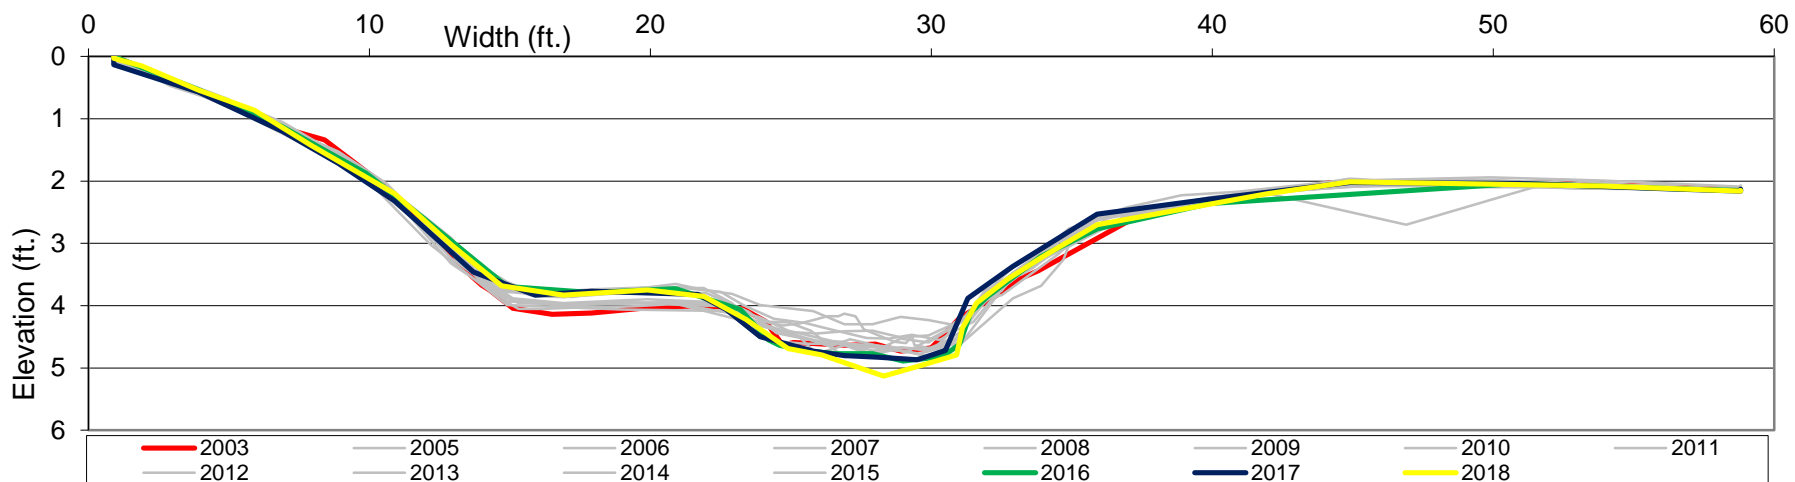
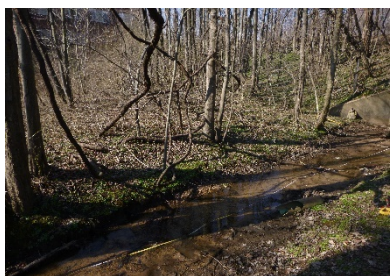
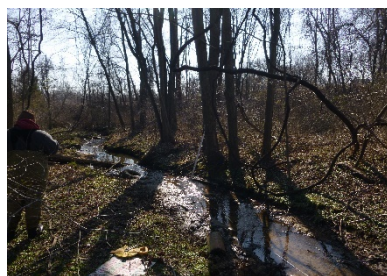
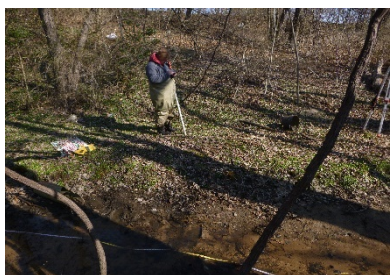
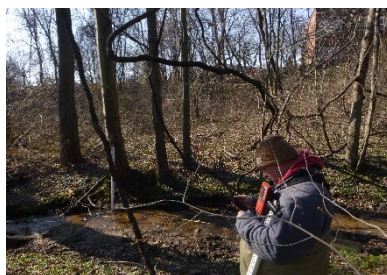
CROSS SECTION 5

Bankfull Width (W_{bkf}) (feet)	7.9
Mean Depth (d_{bkf}) (feet)	0.6
Bankfull Cross-sectional Area (A_{bkf}) (feet ²)	4.6
Width/Depth Ratio (W_{bkf}/d_{bkf})	13.48
Width of Flood-prone Area (W_{fpa}) (feet)	19.9
Entrenchment Ratio (ER) = W_{fpa}/W_{bkf}	2.5
Channel Materials D_{50} (millimeters)	0.11
Water Surface Slope (S)	0.0037
Sinuosity (K) = stream length/valley length	<1.2
Adjustments?	Sin ↑
STREAM TYPE	C5

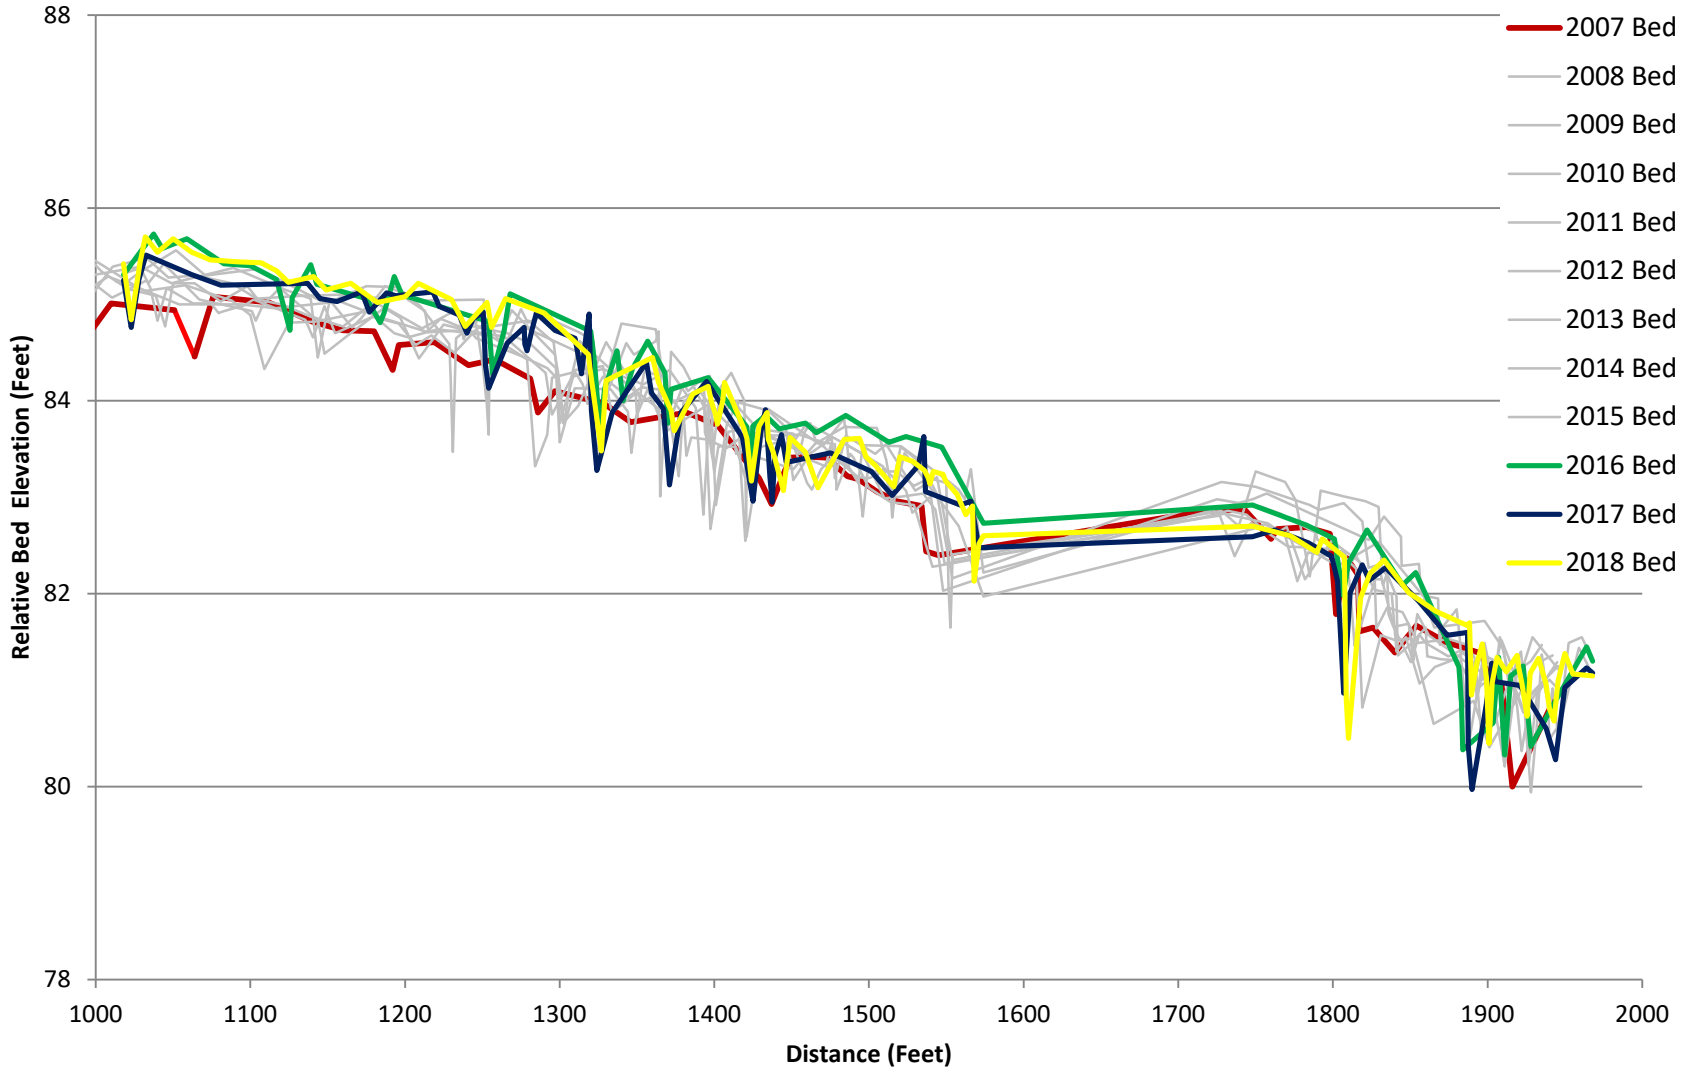
North Tributary Profile Overlay 2007-2018 (Continued)

An overlay of North Tributary longitudinal profiles shows little change occurring to this reach from 2007 through 2018 (Appendix B). Numerous man-made structures (i.e., culverts, concrete-lined channel) throughout this reach appear to be providing adequate grade control, preventing substantial channel degradation.
