**BIOLOGICAL AND  
GEOMORPHOLOGICAL CONDITION  
IN THE PICTURE SPRING BRANCH  
SUBWATERSHED, SEVERN RIVER  
WATERSHED, ANNE ARUNDEL COUNTY,  
MARYLAND: 2018 - 2019**

Anne Arundel County, Maryland  
Department of Public Works  
Watershed Protection and Restoration Program  
2662 Riva Road  
Annapolis, MD 21401

Versar, Inc.  
9200 Rumsey Road  
Columbia, MD 21045

October 2019 FINAL

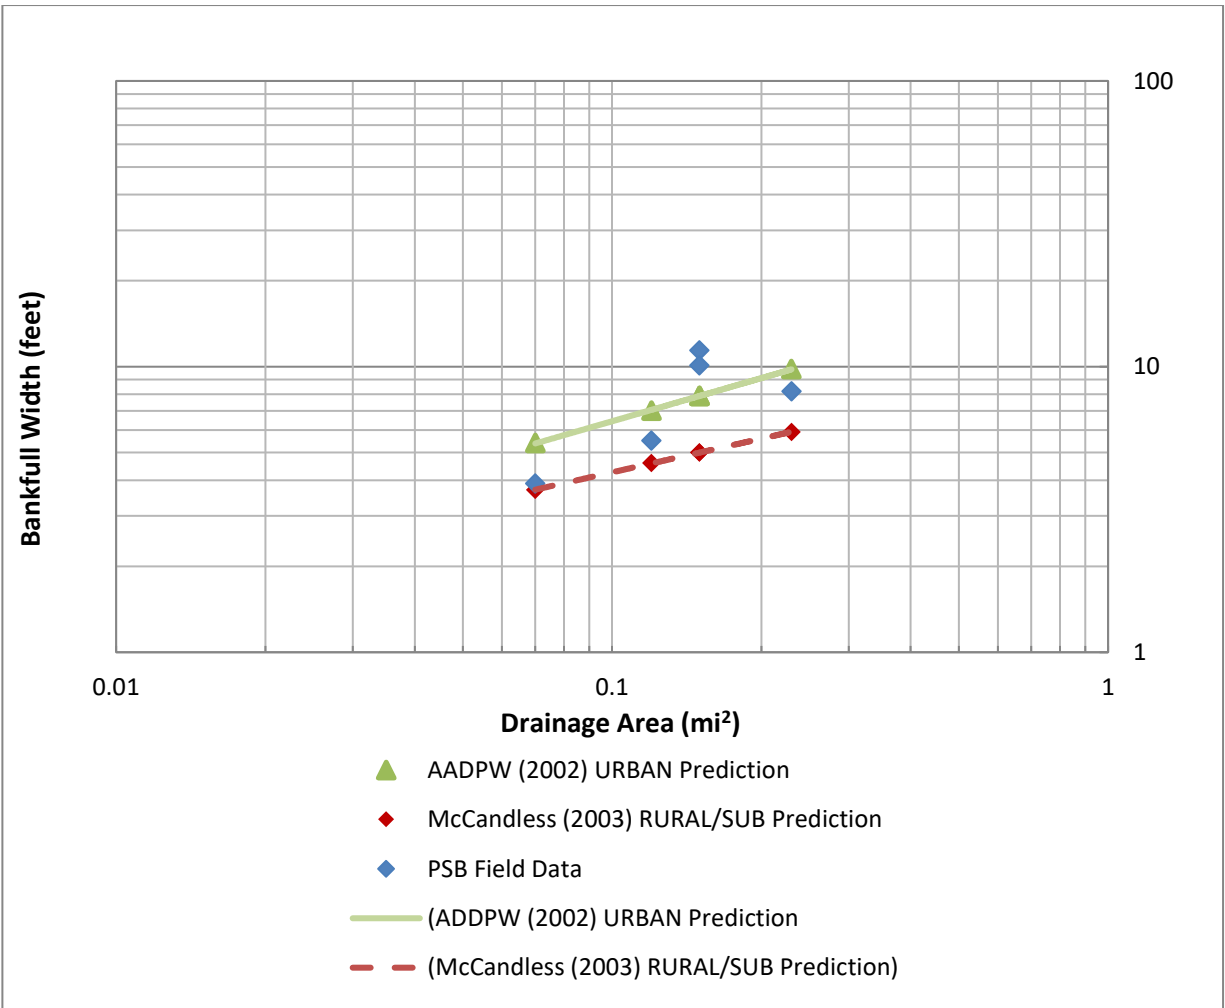
Figure 3-1. Comparison of the bankfull width drainage area relationship between Picture Spring Branch (PSB) 2019 field data and regional relationship curve data

The geomorphic assessment field data were compared to both the Maryland Coastal Plain (MCP) regional relationships of bankfull channel geometry (McCandless 2003) and relationships for gauged urban Coastal Plain streams developed specifically for Anne Arundel County (AADPW 2002) to determine how bankfull characteristics observed in the field compared to those predicted by the MCP and urban relationships. Comparisons of bankfull width, bankfull cross-sectional area, and mean bankfull depth are shown in Figures 3-1, 3-2, and 3-3, respectively. In 2019, bankfull width values fell between the MCP and urban curve values at three sites, with two points wider than predicted by either curve. All bankfull cross-sectional area field data values fell between the MCP curve and urban curve predictions. Field data for mean bankfull depth mainly fell between the MCP curve and urban curve predictions, with one site more shallow than predicted by either curve. Overall, most of the field data fell somewhere between the MCP and urban relationships. However, the regional curves were developed using streams with drainage areas ranging from 0.3 to 89.7 square miles, with the majority of data collected in watersheds greater than one square-mile with low (zero to three percent) imperviousness. Thus, it is possible that stream channels with smaller drainage areas and more imperviousness, such as those studied in this assessment (ranging from 0.07 to 0.23 square miles), exhibit greater variability in channel dimensions when compared to the MCP relationships. Additionally, the Rosgen method is best used on streams that are free to adjust their lateral boundaries under the current discharge regime experienced by the system (Rosgen 1996), conditions which do not necessarily exist in the study area. For example, cross-sections 2, 3, and 5 are underlain by concrete trapezoidal channels, possibly making the accurate determination of the bankfull indicators in the field at these locations problematic. Regardless, given the high imperviousness of the study drainage area and the modified nature of the channel, it is not surprising that the field data deviated in many cases from the MCP curve and were more closely matched to urban curve predictions for bankfull width.

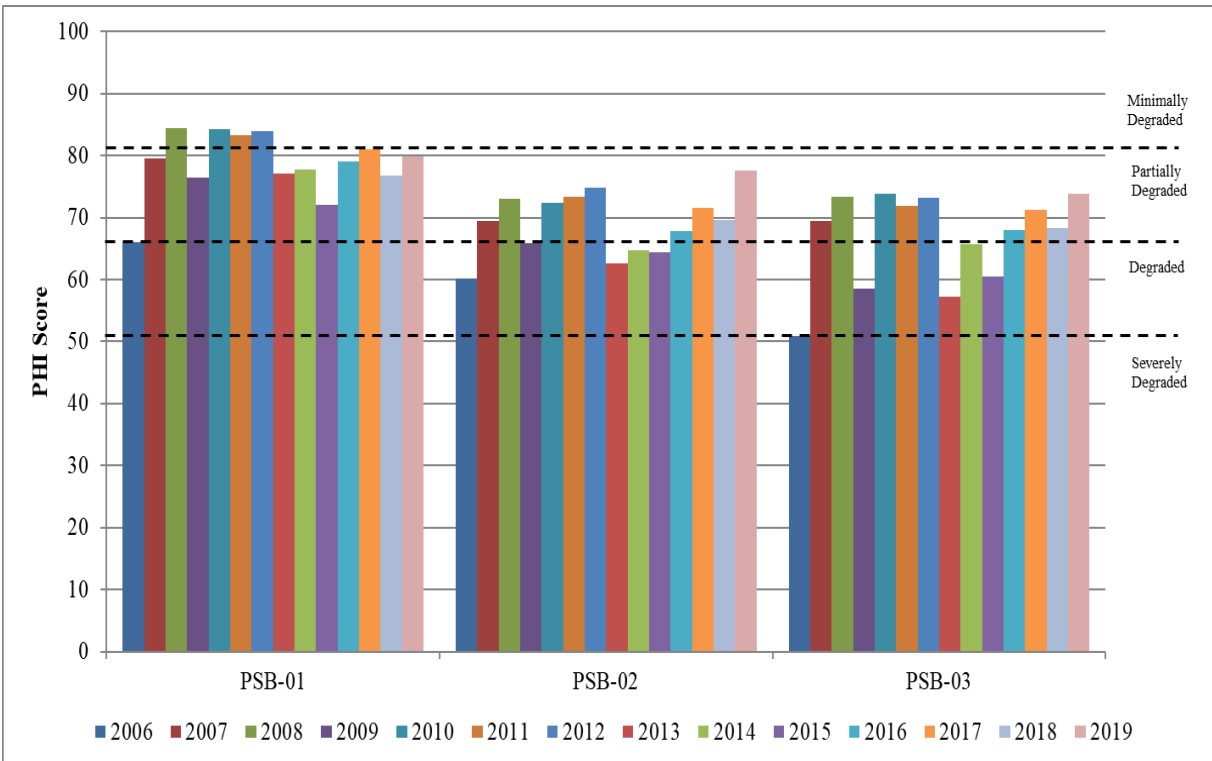
Figure 4-1. Comparison of PHI Habitat Scores from 2006 through 2019

Physical habitat PHI ratings were “Partially Degraded” at all three Picture Spring Branch sites. Although the narrative rating remained the same at these three stations, the PHI scores at all three sites showed an increase from 2018 scores (Table 4-1). The slight increase in scores is primarily a result of improvements in the quality of epifaunal substrate and instream habitat. While the epifaunal substrate score remained the same and instream habitat score slightly decreased at PSB-01, the minor change in physical habitat score from 2018 could be attributed to a large increase in the amount of woody debris present for colonization. During the past five years of monitoring, PHI scores have fluctuated slightly from year to year (Figure 4-1). Fluctuations in annual physical habitat scores may be attributed to two primary factors: 1) changes in habitat suitable for colonization (i.e., changes in substrate/embeddedness and changes in the quantity of woody debris) affects direct scoring of this parameter, and also indirectly influences scoring for epifaunal substrate and instream habitat; and 2) variability in qualitative visual assessment scoring between field crews. In 2013, the updated MBSS PHI methods (Paul et al. 2003) were used to calculate PHI instead of the original MBSS methods (Hall et al. 2002) which had been used in the Picture Spring Branch watershed reports from prior years. Scores for 2006-2012 shown in Table 4-1 and Figure 4-1 were calculated using the original method, while the scores for 2013-2018 were calculated using the updated method.

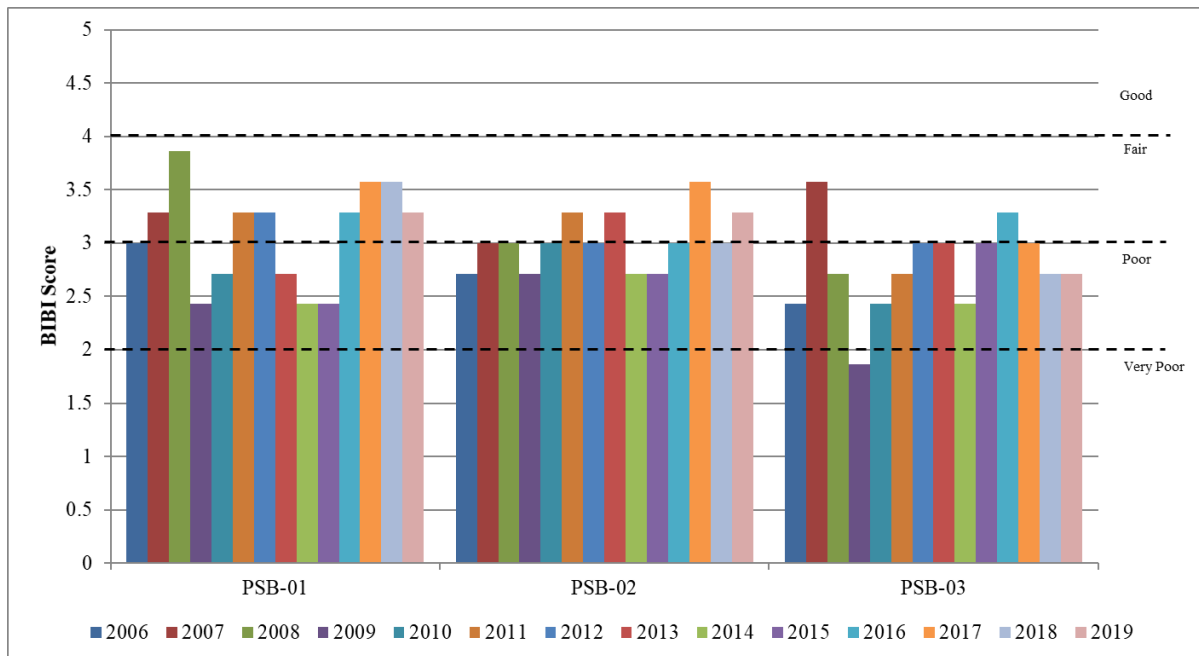
Figure 4-3. Comparison of BIBI Scores from 2006 through 2019

In 2019, the benthic macroinvertebrate community at one site within the Picture Spring Branch study area was rated as “Poor”, while the other two sites received a “Fair” rating. These ratings remained the same from 2018 but represent a slight decrease in BIBI scores since 2017, when all three sites received a “Fair” rating. Taxa diversity remained the same or slightly increased across all sites in 2019, and no Ephemeroptera taxa were found at any site during the 2019 sampling period.

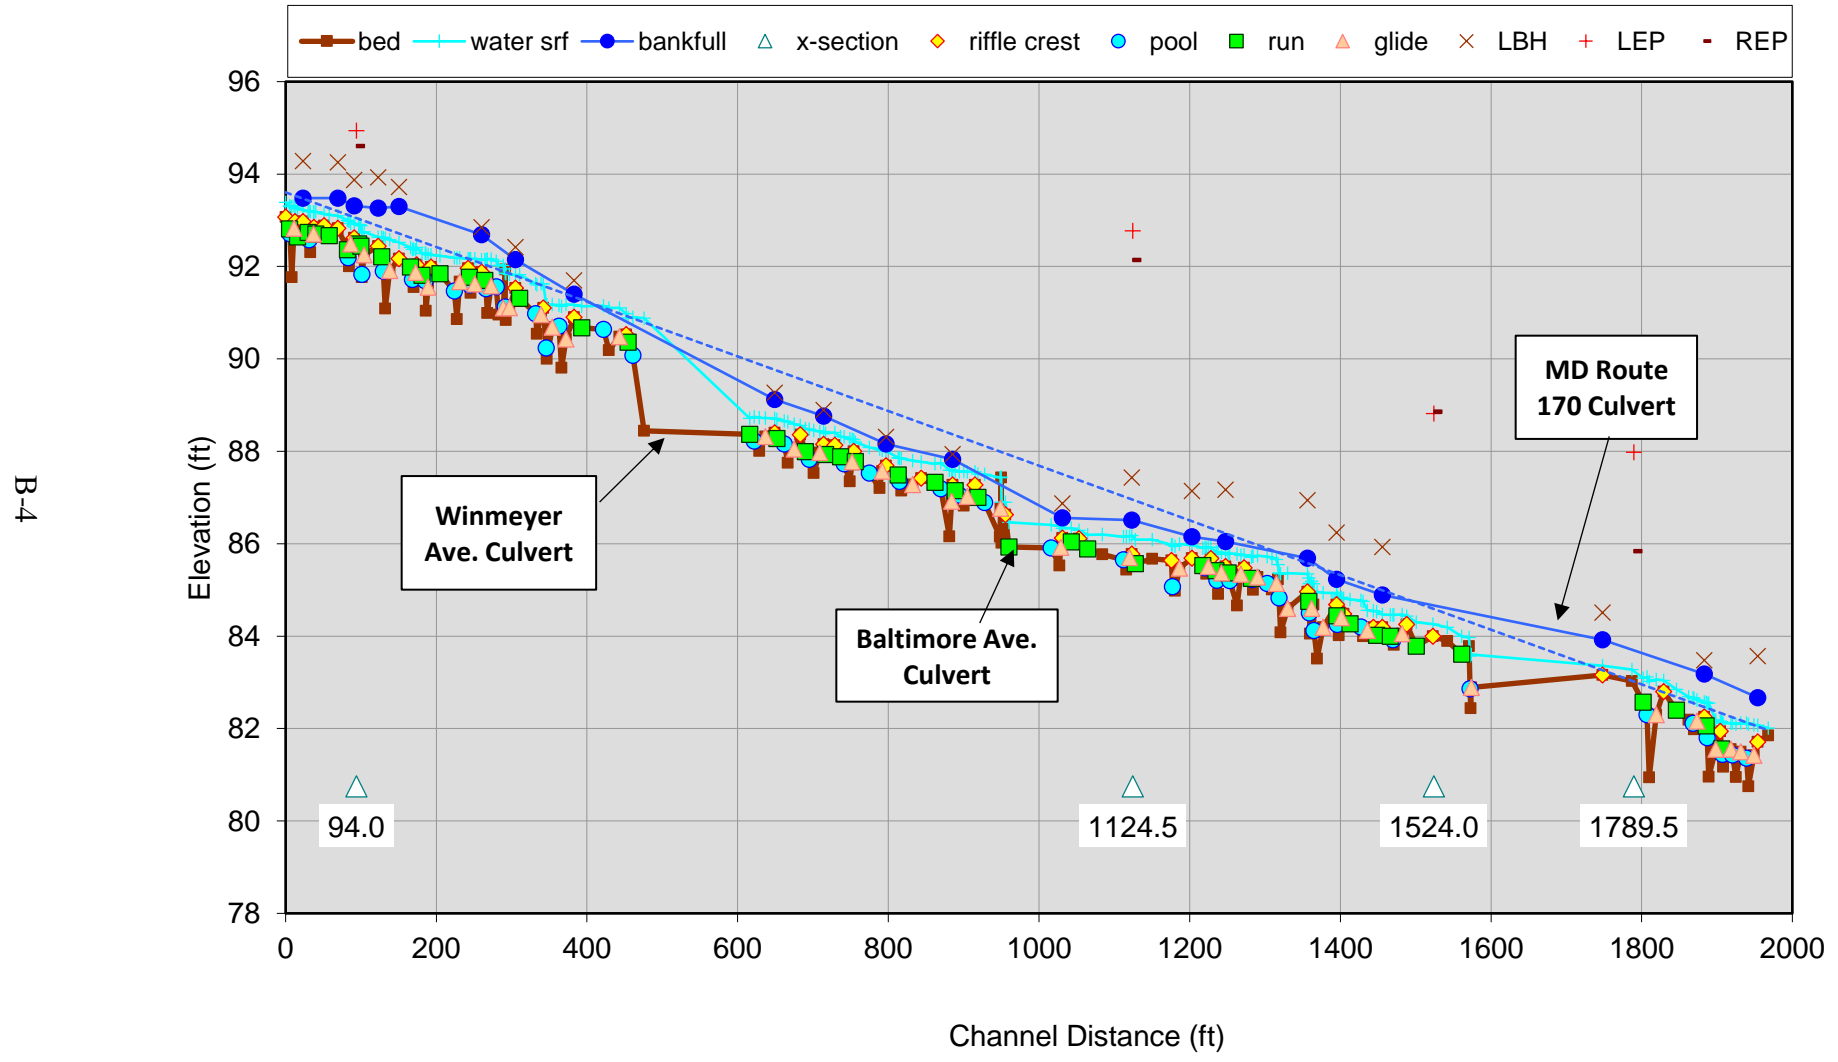
### Picture Spring Branch North Tributary Longitudinal Profile 2019

An overlay of North Tributary longitudinal profiles shows little change occurring to this reach from 2007 through 2019 (Appendix B). Numerous man-made structures (i.e., culverts, concrete-lined channel) throughout this reach appear to be providing adequate grade control, preventing substantial channel degradation. In one portion of the reach between cross-sections 1 and 2 (profile stations 383 – 454), notable aggradation has occurred particularly between 2016 and 2019. This is the area just above the Winmeyer Avenue culvert.

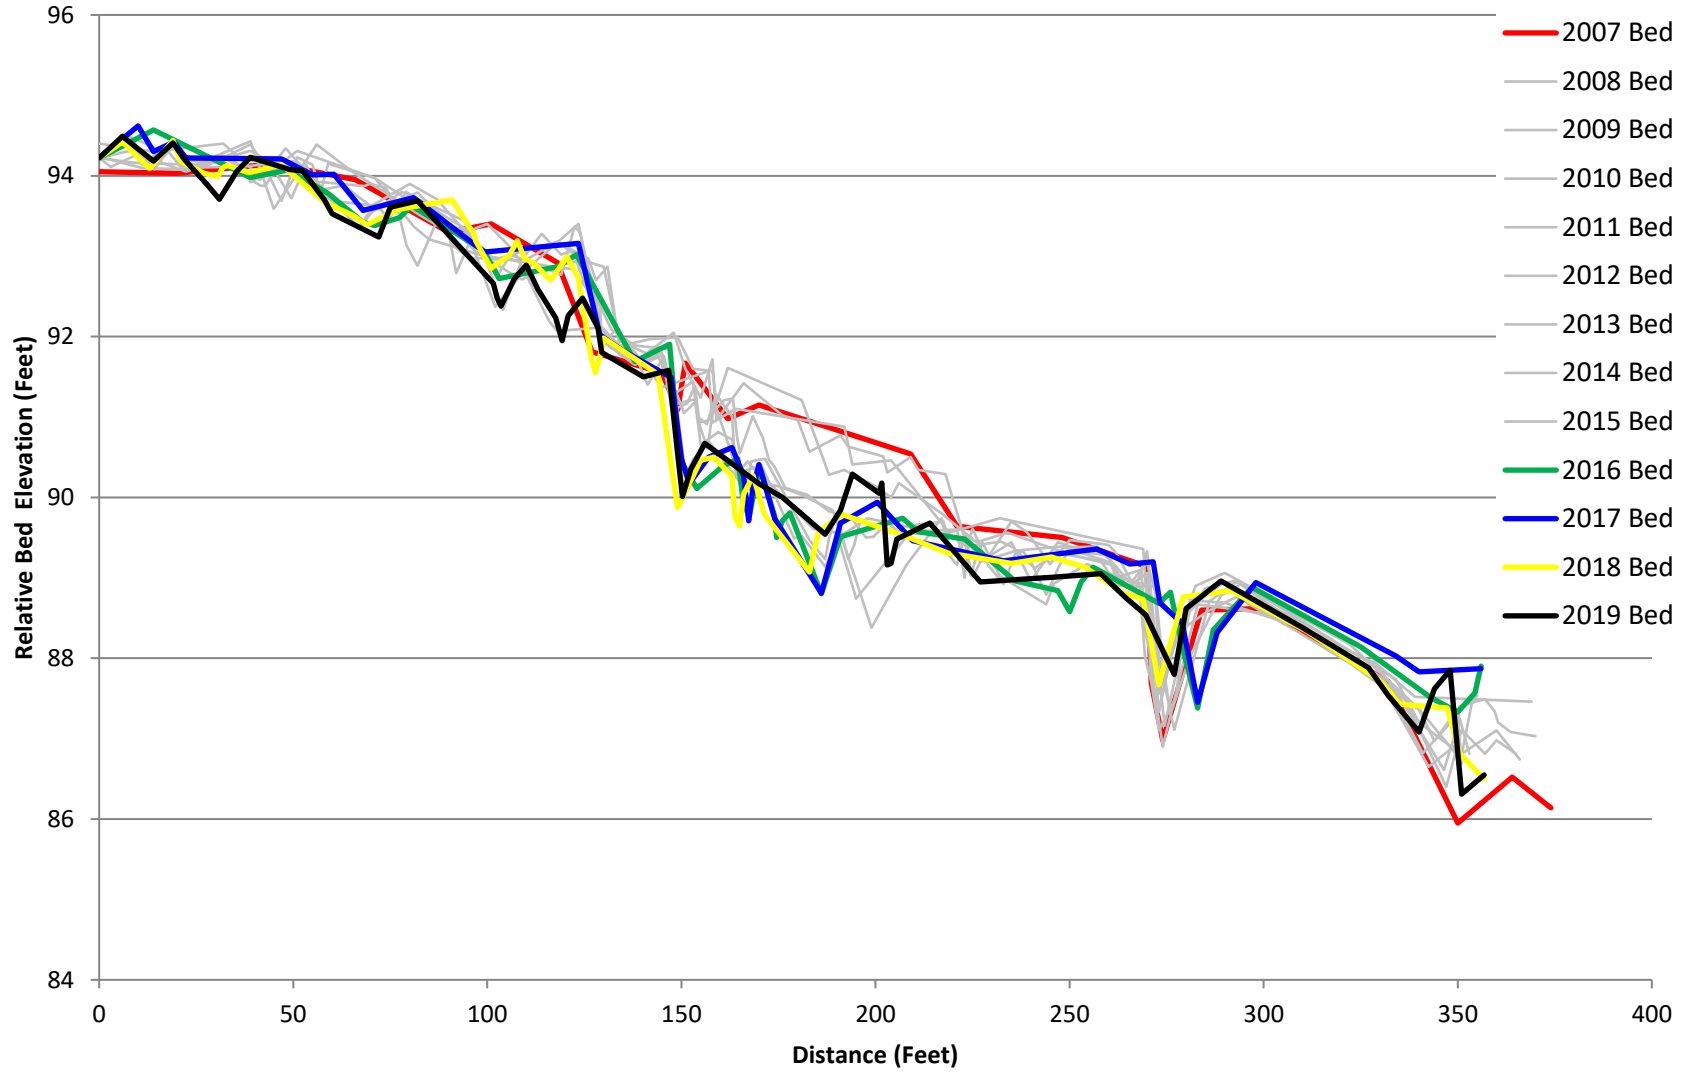
# South Tributary Profile Overlay 2007-2019

An E5b channel was identified at cross-section 4 on the South Tributary. This reach appears to have been channelized in the past and is piped underground for a significant distance upstream, further modifying its hydrology. In comparison to the North Tributary, the South Tributary is not over-widened and has a steeper longitudinal gradient than the North Tributary. Indicators were observed that show some limited floodplain connectivity along the upstream portion of the tributary where the cross-section is located. However, just downstream of the cross-section location, the channel is noticeably entrenched and shows signs of active downcutting. While it is possible that this reach may exhibit both B and E characteristics along different portions of the reach, it was assigned an E5b classification in 2019, primarily based on the entrenchment and width/depth ratios measured at the cross-section location, as well as the channel slope within the vicinity of the cross-section. In addition, evidence of recent downcutting (e.g., nick points) suggests that the reach is unstable and is likely shifting from an E channel to a B channel. Significant changes in the shape of this cross-section were observed during the 2013 survey, as the channel had noticeably deepened and widened since the 2012 survey (Appendix B). Over the next year, aggradation occurred affecting the bed level by raising it approximately 0.5 feet. From 2014 to 2015, the channel shifted slightly but remained stable in terms of aggradation or deepening. Noticeable aggradation occurred again in 2016 with an approximate 0.5-foot rise in bed elevation, but the bed was stable between the 2016 and 2018 surveys. Between 2018 and 2019, the stream experienced downcutting (approximately 0.3 ft) and erosion (slightly less than one foot at the most affected area) at/near the right bank.

0.3 feet in depth. The headcut and large scour pool between stations 2+68 and 2+90 just downstream from this eroded section have not increased in height nor depth. However, in 2016 this scour pool shifted downstream by several feet. Furthermore, aggradation raised the channel bed by almost a foot between 2017 and 2018. Little change was observed in this area between 2018 and 2019. It is recommended that this area continue to be monitored, as further erosion could eventually lead to undermining of the concrete-lined channel just downstream.
