**BIOLOGICAL AND  
GEOMORPHOLOGICAL CONDITION  
IN THE PICTURE SPRING BRANCH  
SUBWATERSHED, SEVERN RIVER  
WATERSHED, ANNE ARUNDEL COUNTY,  
MARYLAND: 2019 - 2020**

Anne Arundel County, Maryland  
Department of Public Works  
Bureau of Watershed Protection and Restoration  
2662 Riva Road  
Annapolis, MD 21401

Versar, Inc.  
9200 Rumsey Road, Suite 1  
Columbia, MD 21045

FINAL: October 2020

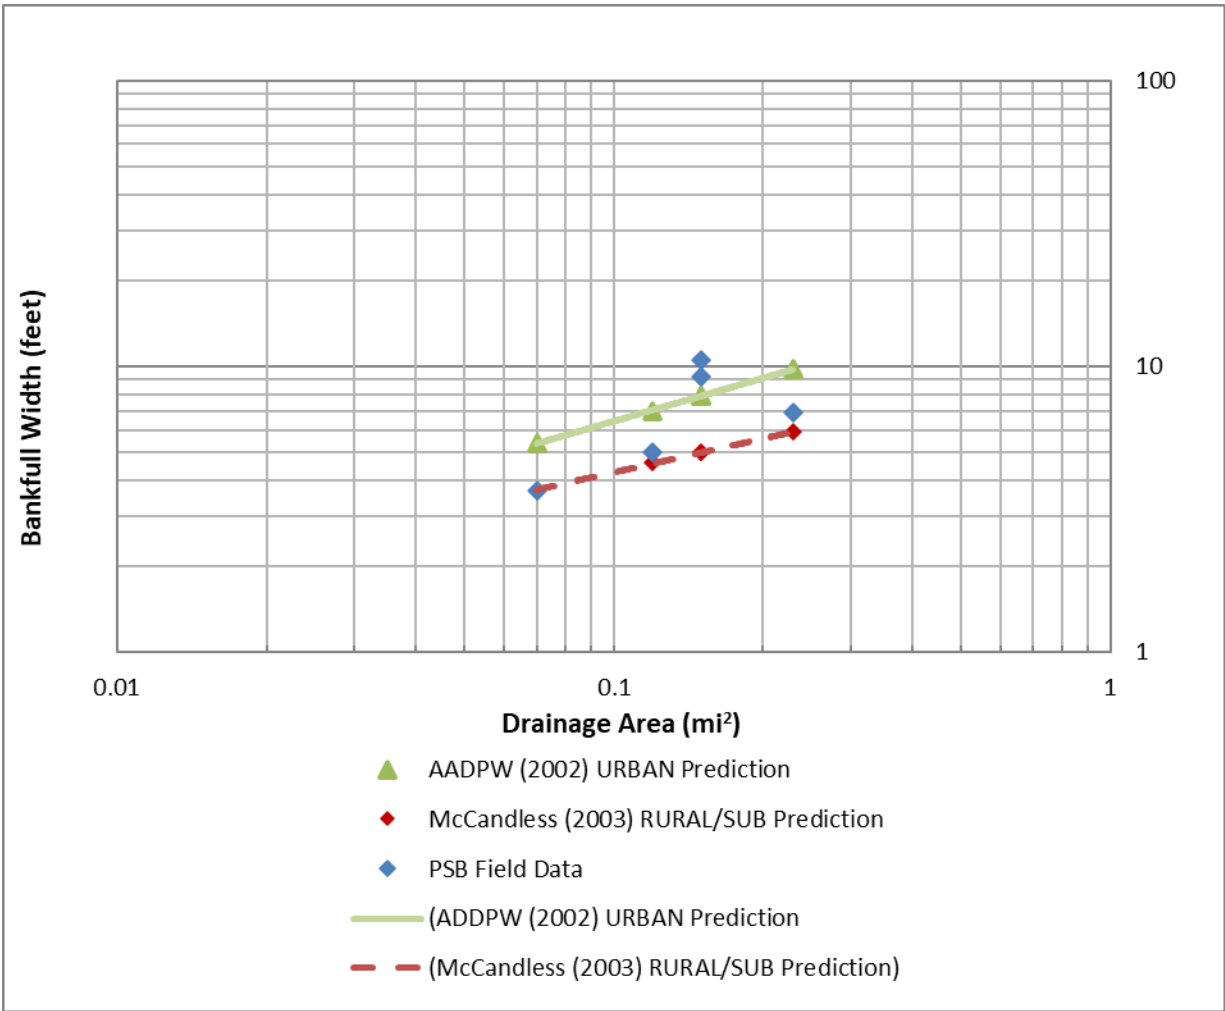
Figure 3-1. Comparison of the bankfull width drainage area relationship between Picture Spring Branch (PSB) 2020 field data and regional relationship curve data

The geomorphic assessment field data were compared to both the Maryland Coastal Plain (MCP) regional relationships of bankfull channel geometry (McCandless 2003) and relationships for gauged urban Coastal Plain streams developed specifically for Anne Arundel County (AADPW 2002) to determine how bankfull characteristics observed in the field compared to those predicted by the MCP and urban relationships. Comparisons of bankfull width, bankfull cross-sectional area, and mean bankfull depth are shown in Figures 3-1, 3-2, and 3-3, respectively. In 2020, bankfull width values fell between the MCP and urban curve values at three sites, with two points wider than predicted by either curve. Similarly, four bankfull cross-sectional area field data values fell between the MCP curve and urban curve predictions, with one point smaller than predicted by either curve. Field data for mean bankfull depth mainly fell between the MCP curve and urban curve predictions, with one site more shallow than predicted by either curve. Overall, most of the field data fell somewhere between the MCP and urban relationships. However, the regional curves were developed using streams with drainage areas ranging from 0.3 to 89.7 square miles, with the majority of data collected in watersheds greater than one square-mile with low (zero to three percent) imperviousness. Thus, it is possible that stream channels with smaller drainage areas and more imperviousness, such as those studied in this assessment (ranging from 0.07 to 0.23 square miles), exhibit greater variability in channel dimensions when compared to the MCP relationships. Additionally, the Rosgen method is best used on streams that are free to adjust their lateral boundaries under the current discharge regime experienced by the system (Rosgen 1996), conditions which do not necessarily exist in the study area. For example, cross-sections 2, 3, and 5 are underlain by concrete trapezoidal channels, possibly making the accurate determination of the bankfull indicators in the field at these locations problematic. Regardless, given the high imperviousness of the study drainage area and the modified nature of the channel, it is not surprising that the field data deviated in some cases from the MCP curve and were more closely matched to urban curve predictions for bankfull width.

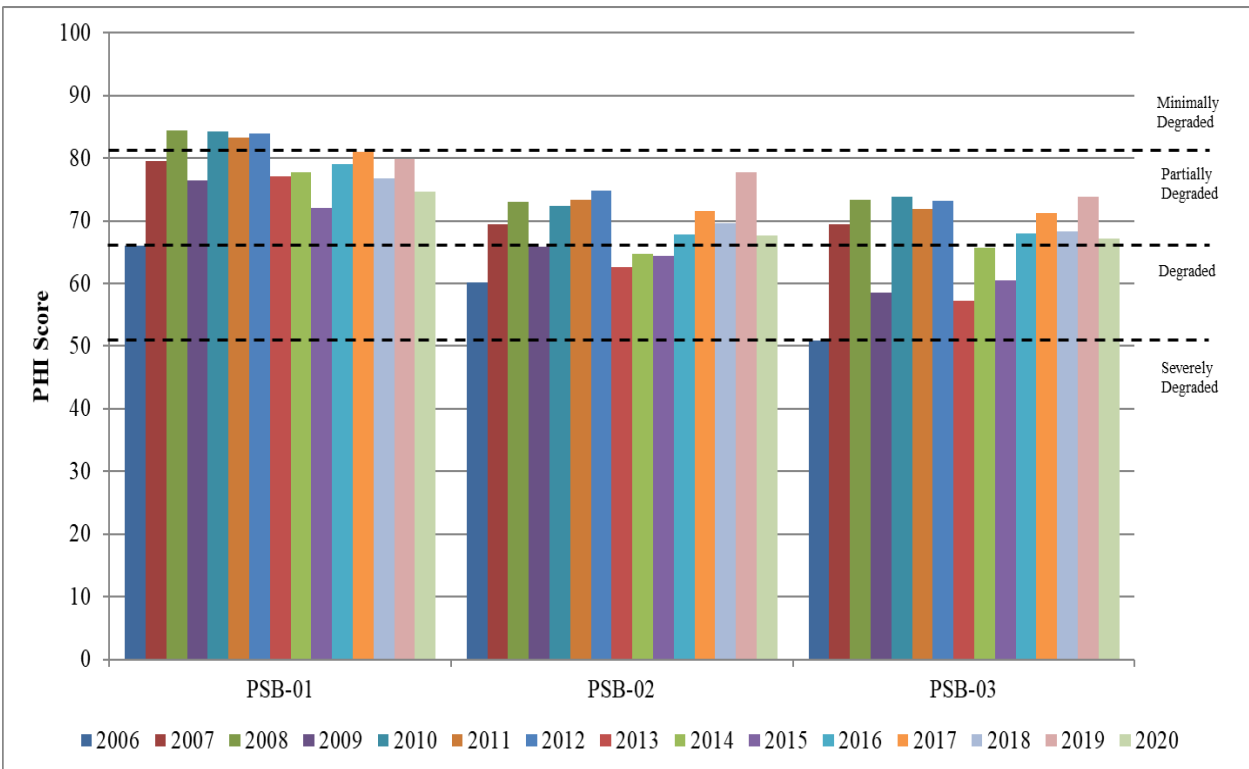
Figure 4-1. Comparison of PHI Habitat Scores from 2006 through 2020

Physical habitat PHI ratings were “Partially Degraded” at all three Picture Spring Branch sites. Although the narrative rating remained the same at these three stations, the PHI scores at all three sites showed a decrease from 2019 scores (Table 4-1). The slight decrease in scores is primarily a result of declines in the quality of epifaunal substrate and instream habitat. During the past five years of monitoring, PHI scores have fluctuated slightly from year to year (Figure 4-1). Fluctuations in annual physical habitat scores may be attributed to two primary factors: 1) changes in habitat suitable for colonization (i.e., changes in substrate/embeddedness and changes in the quantity of woody debris) affects direct scoring of this parameter, and also indirectly influences scoring for epifaunal substrate and instream habitat; and 2) variability in qualitative visual assessment scoring between field crews. In 2013, the updated MBSS PHI methods (Paul et al. 2003) were used to calculate PHI instead of the original MBSS methods (Hall et al. 2002) which had been used in the Picture Spring Branch watershed reports from prior years. Scores for 2006-2012 shown in Table 4-1 and Figure 4-1 were calculated using the original method, while the scores for 2013-2020 were calculated using the updated method.

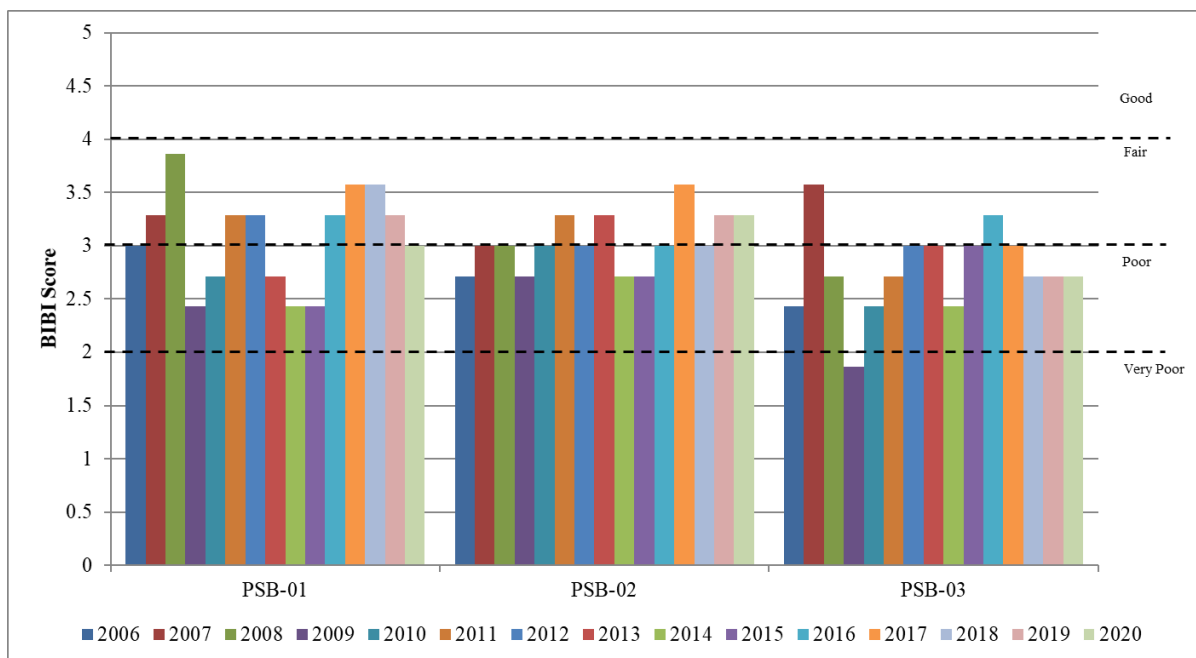
Figure 4-3. Comparison of BIBI Scores from 2006 through 2020

In 2020, the benthic macroinvertebrate community at one site within the Picture Spring Branch study area was rated as “Poor”, while the other two sites received a “Fair” rating. These ratings remained the same from 2019 but represent a slight decrease in BIBI scores since 2017, when all three sites received a “Fair” rating. Taxa diversity slightly increased across all sites in 2020, and no Ephemeroptera taxa were found at any site during the 2020 sampling period.

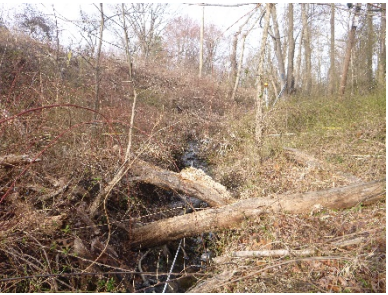
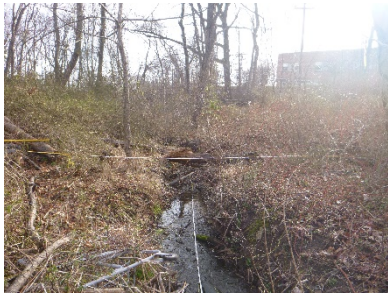
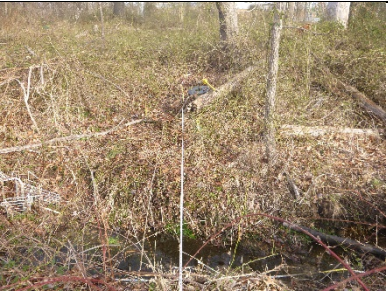
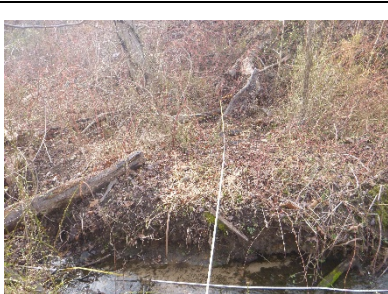
A G4 channel was identified at cross-section 4 on the South Tributary, a change from an E5b channel in 2019. While it is possible that this reach may exhibit both G and E characteristics along different portions of the reach, it was assigned an E5b classification in 2019, primarily based on the entrenchment and width/depth ratios measured at the cross-section location, as well as the channel slope within the vicinity of the cross-section. However, a reduced entrenchment ratio and increased width/depth ratio observed in 2020 more aligned this site as a G channel. In comparison to the North Tributary, the South Tributary is not over-widened and has a steeper longitudinal gradient than the North Tributary. Indicators were observed that show some limited floodplain connectivity along the upstream portion of the tributary where the cross-section is located. However, just downstream of the cross-section location, the channel is noticeably entrenched and shows signs of active downcutting. Significant changes in the shape of this cross-section were observed during the 2013 survey, as the channel had noticeably deepened and widened since the 2012 survey (Appendix B). Over the next year, aggradation occurred affecting the bed level by raising it approximately 0.5 feet. From 2014 to 2015, the channel shifted slightly but remained stable in terms of aggradation or deepening. Noticeable aggradation occurred again in 2016 with an approximate 0.5-foot rise in bed elevation, but the bed was stable between the 2016 and 2018 surveys. Between 2018 and 2019, the stream experienced downcutting (approximately 0.3 ft) and erosion (slightly less than one foot at the most affected area) at/near the right bank; between 2019 and 2020 the downcutting continued at this location, deepening by approximately 0.5 ft and impacting the left bank, such that the channel edges are now similar and the stream bed is flat across the width of the channel.
