**CHEMICAL, BIOLOGICAL, AND  
PHYSICAL CHARACTERIZATION  
OF THE CHURCH CREEK AND  
PAROLE PLAZA NPDES MONITORING  
STATIONS: 2014 - 2015**

Anne Arundel County  
Department of Public Works  
Watershed Protection and Restoration Program  
2662 Riva Road  
Annapolis, MD 21401

Versar, Inc.  
9200 Rumsey Road  
Columbia, MD 21045

February 2016

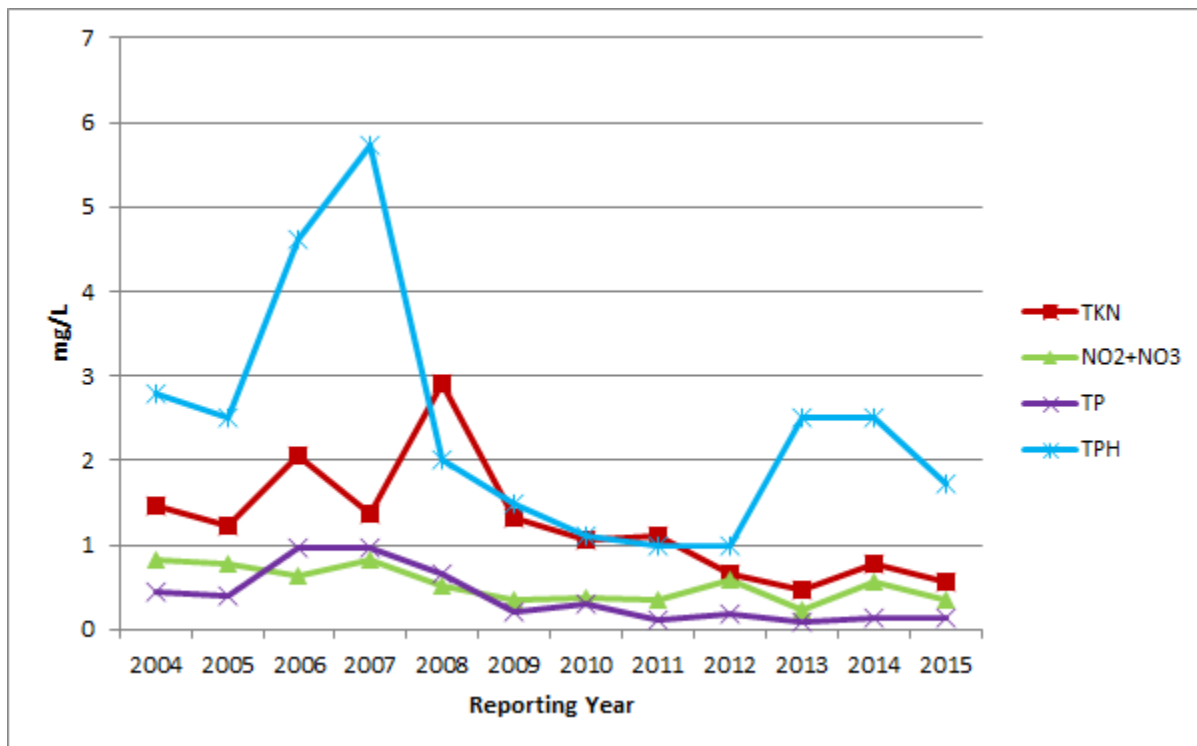
Figure 4-1. Parole station long-term monitoring: annual EMCs (TKN, NO<sub>2</sub>+NO<sub>3</sub>, TP, TPH; mg/L)

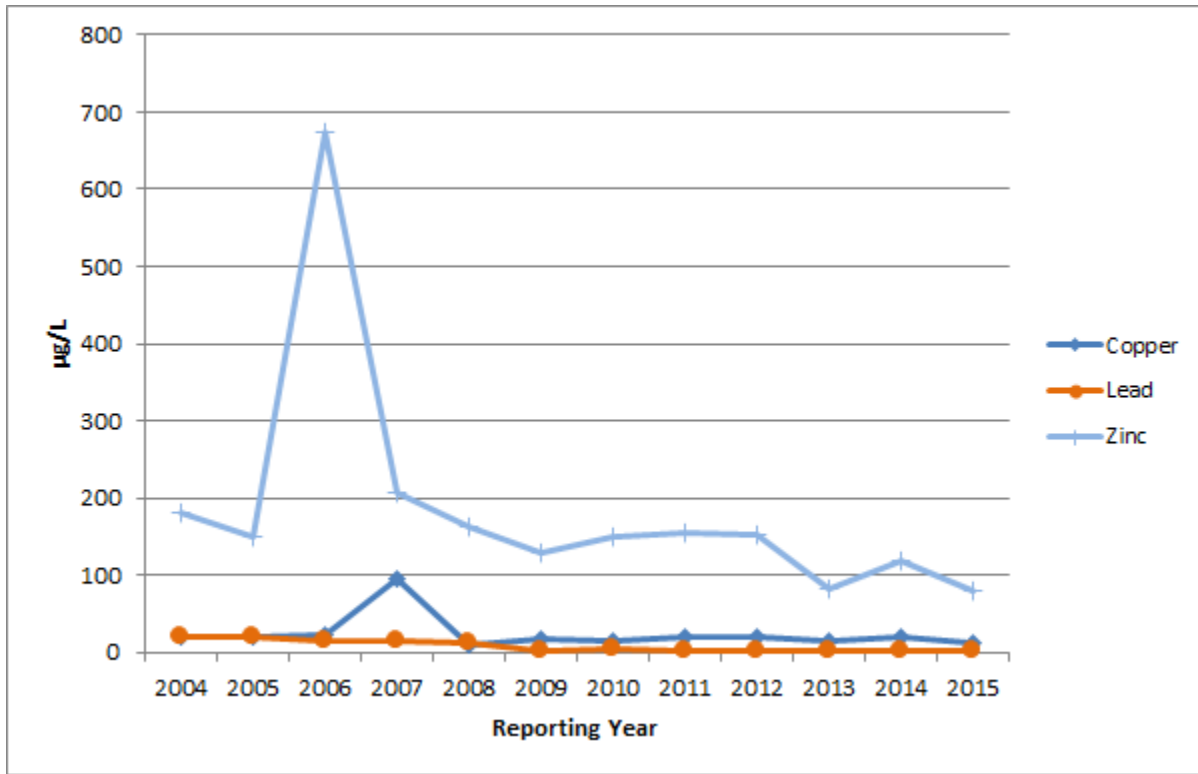
Figure 4-2. Parole station long-term monitoring: annual EMCs (Cu, Pb, Zn; mg/L)

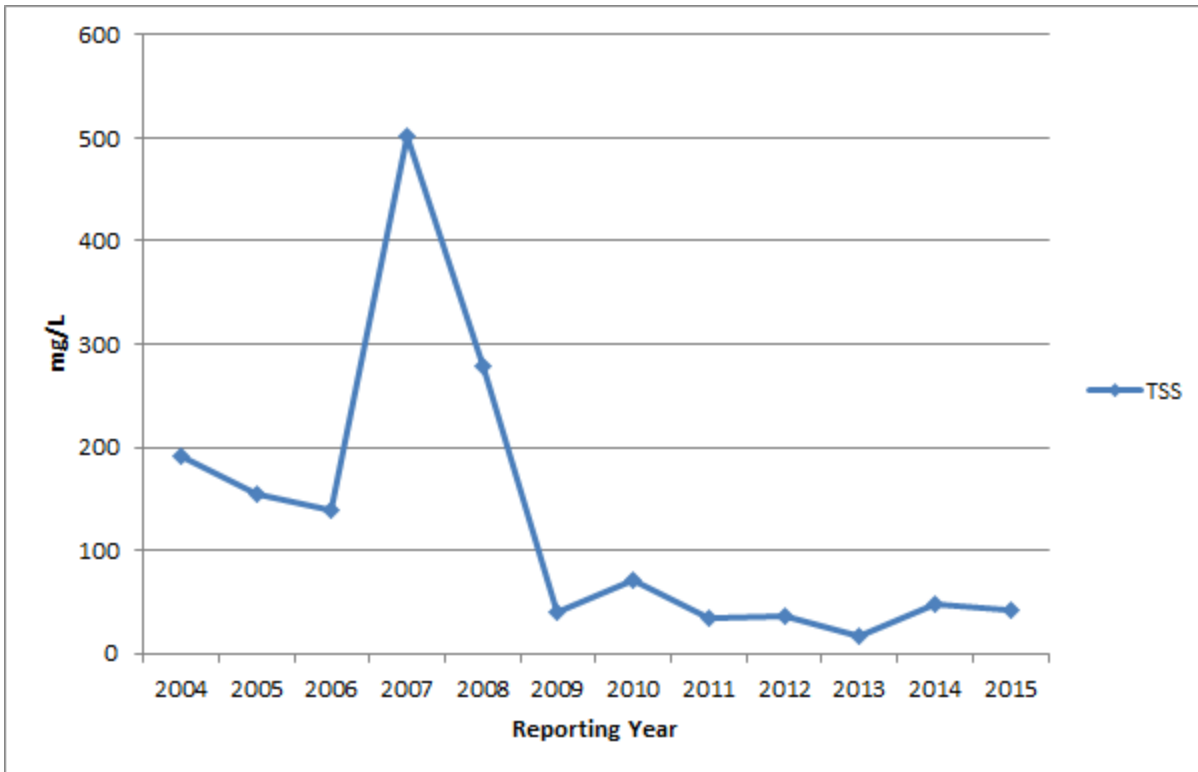
Figure 4-3. Parole station long-term monitoring: annual EMCs (TSS; mg/L)

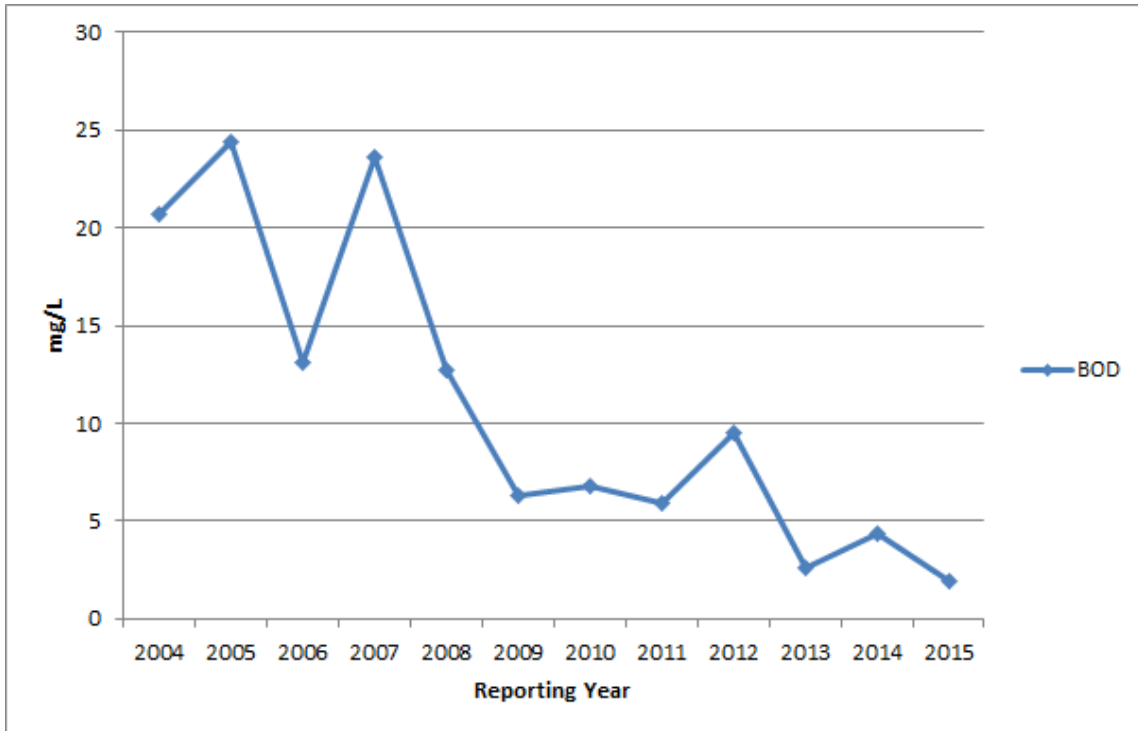
Figure 4-4. Parole station long-term monitoring: annual EMCs (BOD<sub>5</sub>; mg/L)

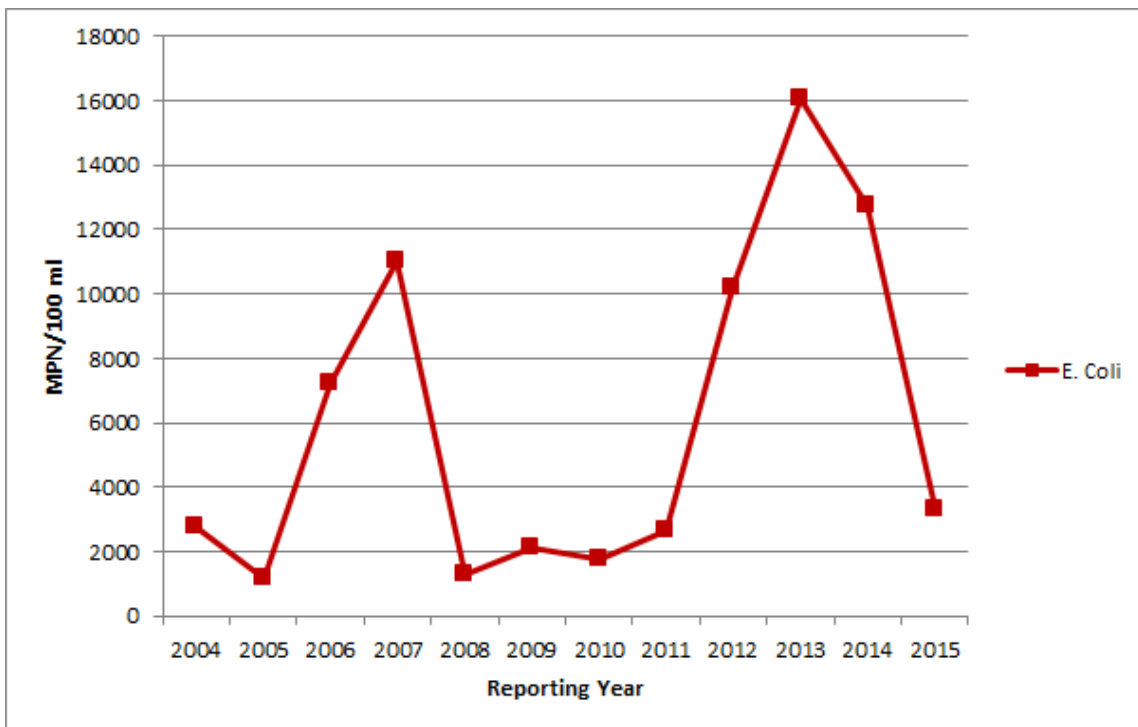
Figure 4-5. Parole station long-term monitoring: annual EMCs (*E. coli*; MPN/100 mL)

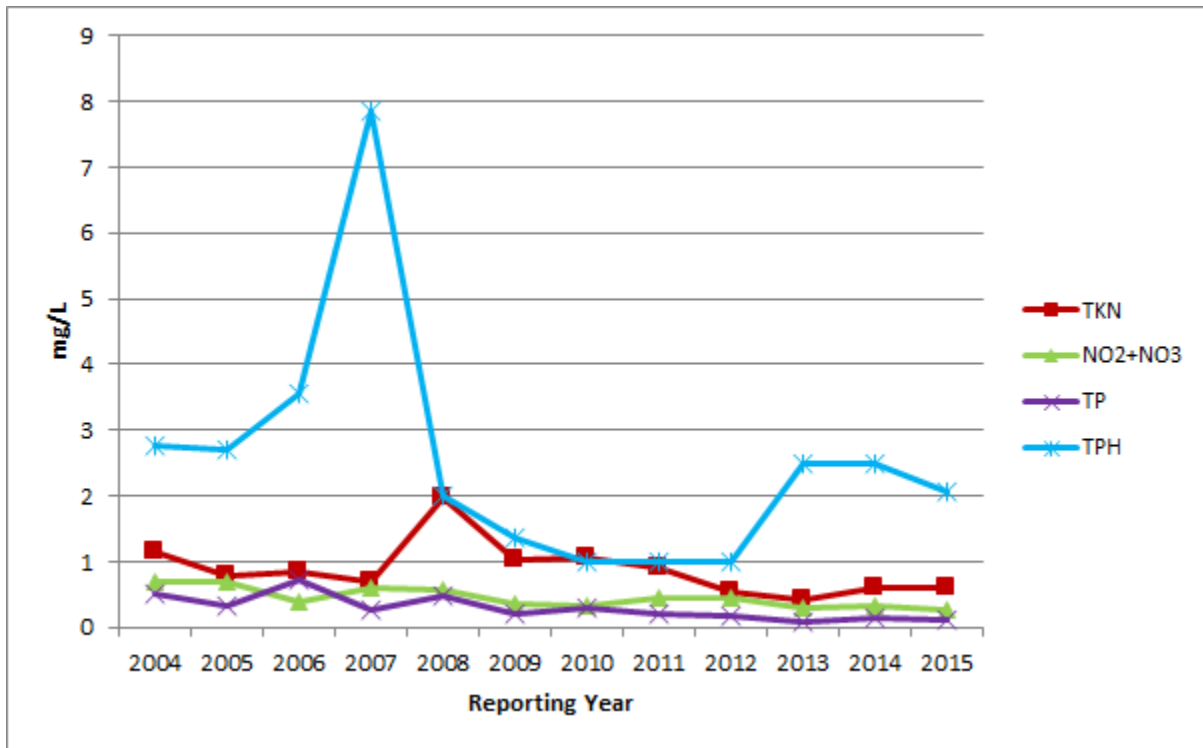
Figure 4-6. Church Creek station long-term monitoring: annual EMCs (TKN, NO<sub>2</sub>+NO<sub>3</sub>, TP, TPH; mg/L)

Figures 4-6 through 4-10 show a slightly different trend in EMCs for the Church Creek Monitoring Station. A slight rise in pollutant concentrations at Church Creek was observed in 2015 for TKN, nitrate-nitrite, TSS, zinc, and lead when compared to 2014 EMCs. Note that the apparent rise in TPH at Church Creek in 2013, like Parole Plaza, was due to an increase in the detection limit. Also like Parole Plaza, summer season concentrations were not included with the 2013 EMC data.

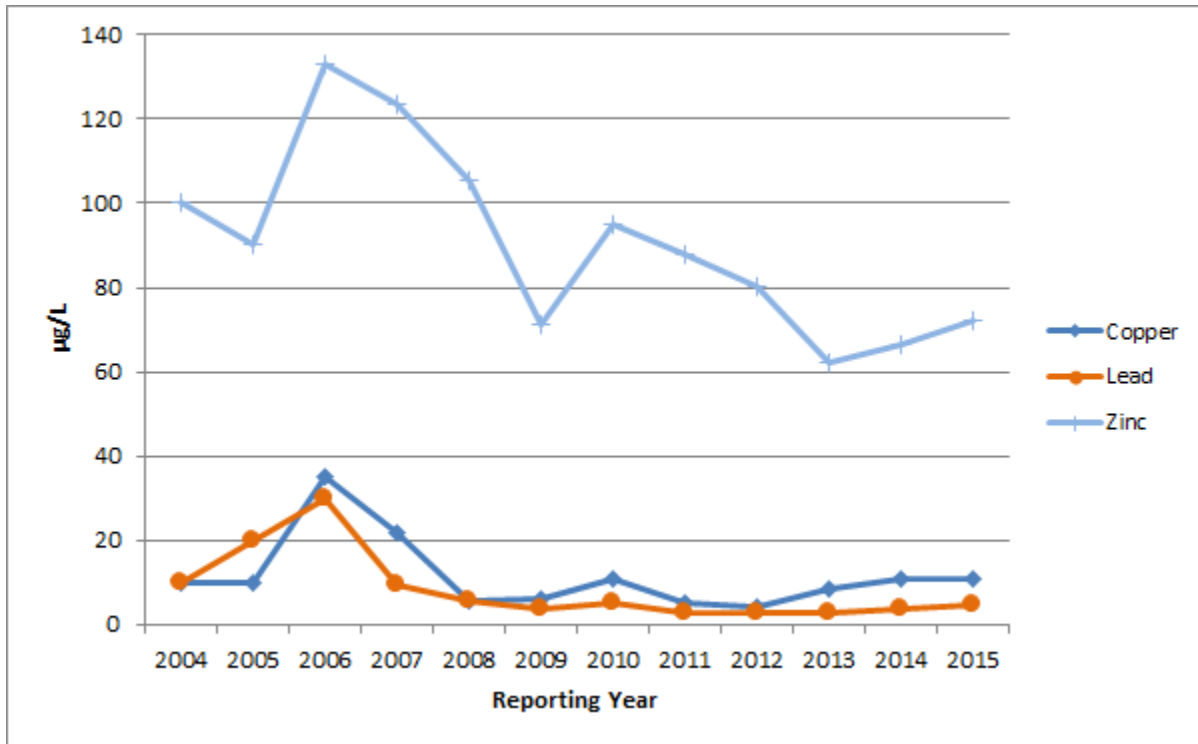
Figure 4-7. Church Creek station long-term monitoring: annual EMCs (Cu, Pb, Zn; mg/L)

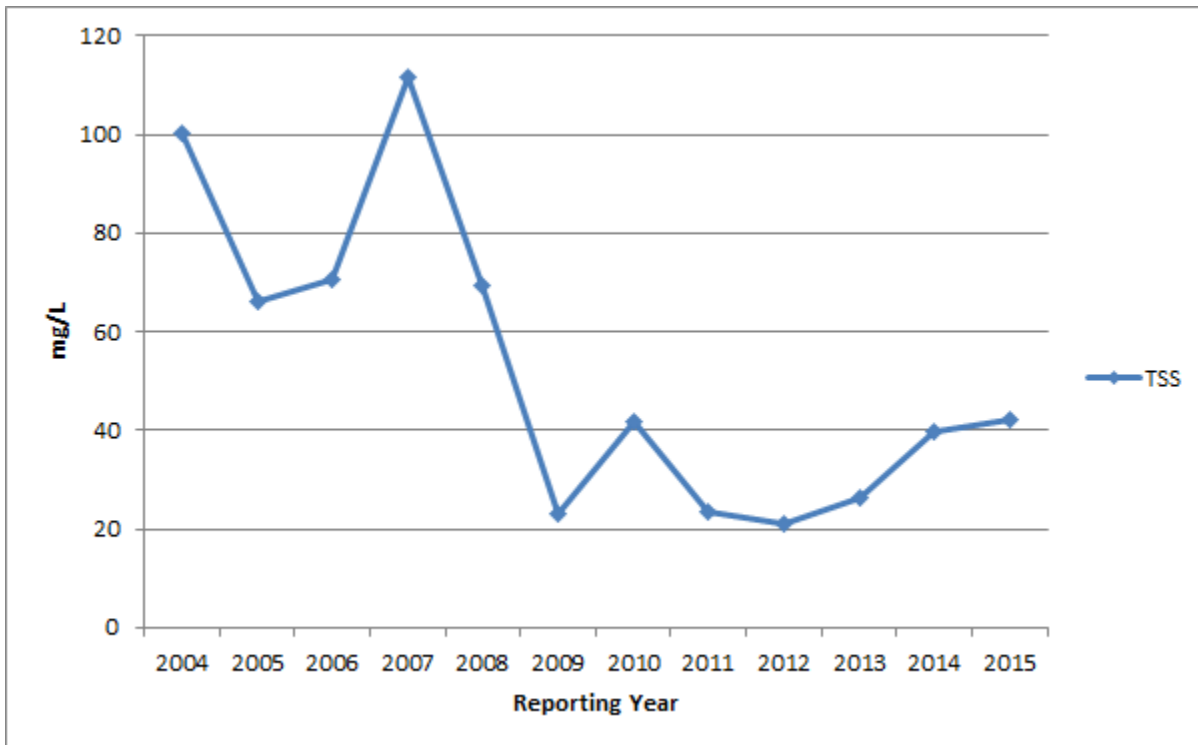
Figure 4-8. Church Creek station long-term monitoring: annual EMCs (TSS; mg/L)

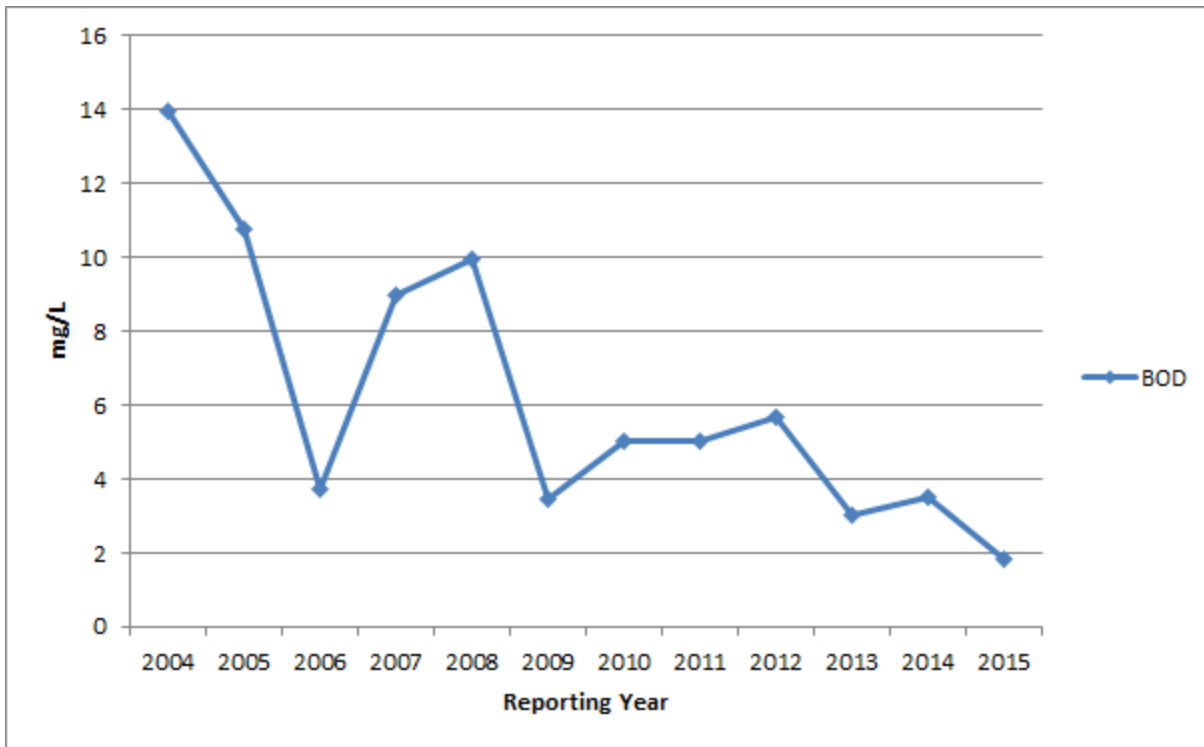
Figure 4-9. Church Creek station long-term monitoring: annual EMCs (BOD<sub>5</sub>; mg/L)

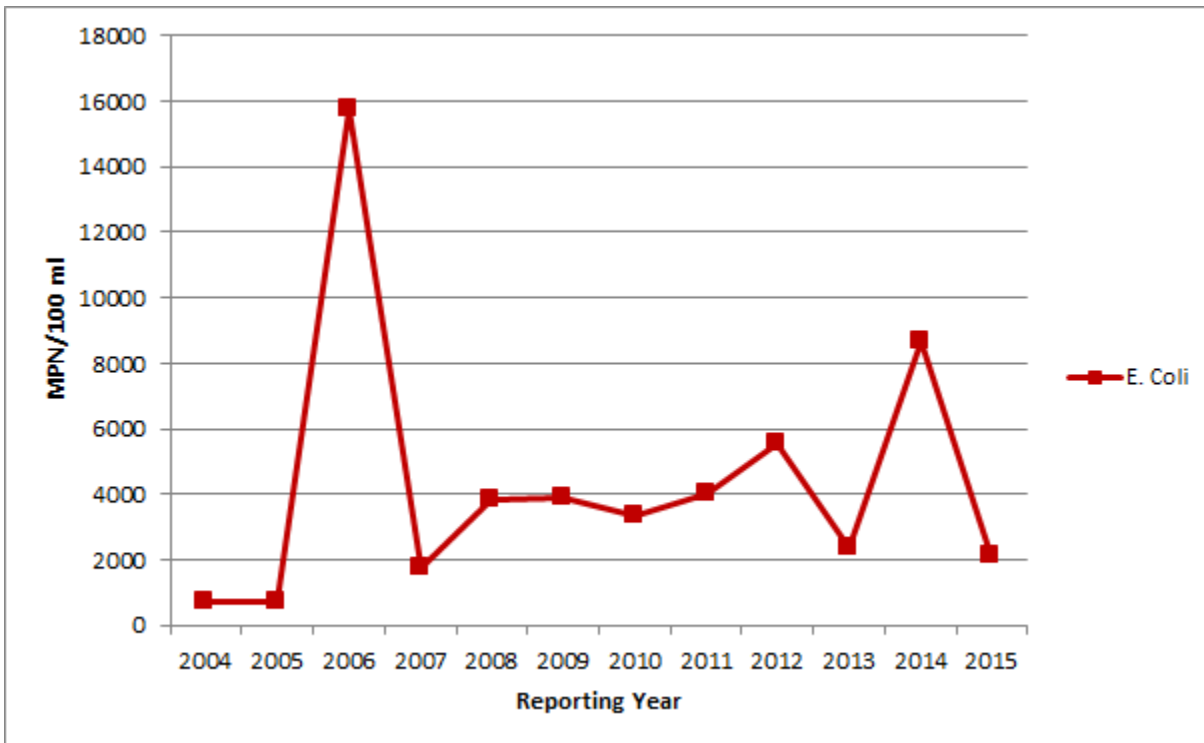
Figure 4-10. Church Creek station long-term monitoring: annual EMCs (*E. coli*; MPN/100 mL)

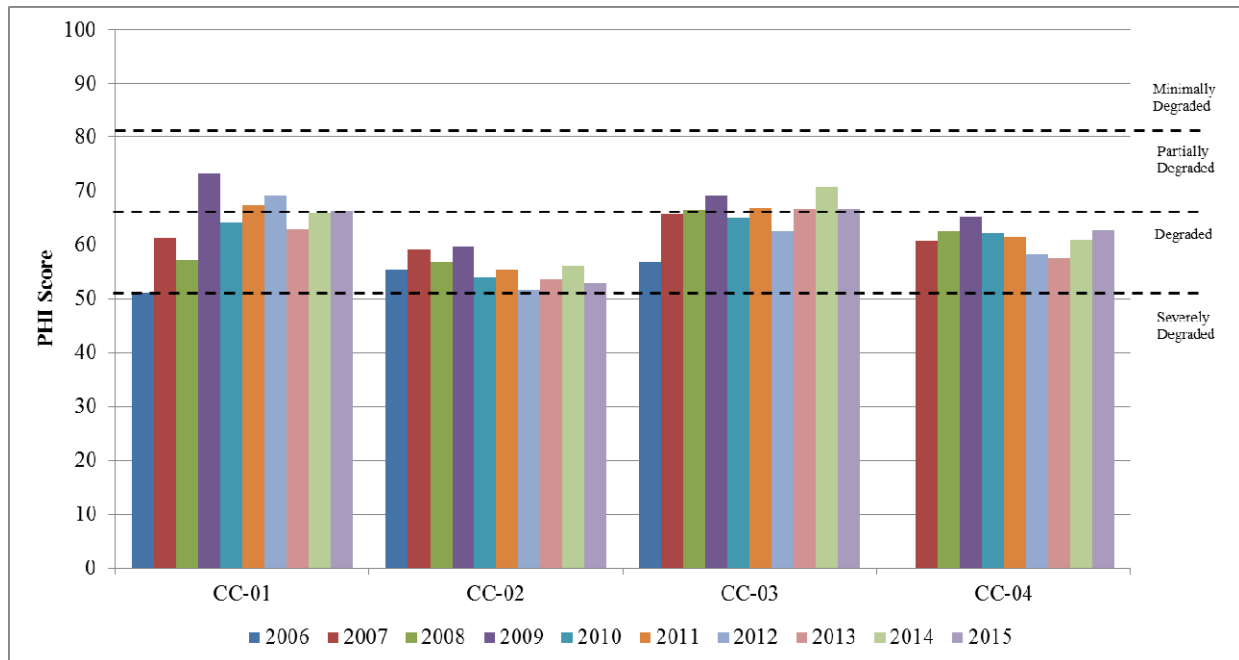
calculate PHI instead of the original MBSS methods (Hall et al. 2002) which had been used in the Church Creek watershed reports from prior years. Scores for 2006-2012 shown in Table 4-9 and Figure 4-11 were calculated using the original method, while scores for 2013, 2014, and 2015 were calculated using the updated method.

Physical habitat and biological conditions within the Church Creek study area continue to be impaired by urbanization within the surrounding watershed. Stream physical habitat remains degraded throughout the entire study reach and appears to have changed very little from the previous year (Table 4-9, Figure 4-11). Three of the four sites were rated the same in 2015 as in 2014 indicating no change in habitat condition. One site (CC-01) was slightly upgraded from a rating of Degraded in 2014 to a rating of Partially Degraded in 2015. Urban stressors such as hydrologic alteration (i.e., increased runoff, increased frequency of peak flows, reduced infiltration) within the watershed have resulted in a reduction of stable instream habitat as well as increased channel erosion and sedimentation. A general lack of a stable epifaunal substrate further limits the capacity of the stream to support a diverse and healthy macroinvertebrate community. In addition, elevated conductivity levels reflect high levels of dissolved solids during baseflow conditions, which typically indicate the presence of water quality stressors.

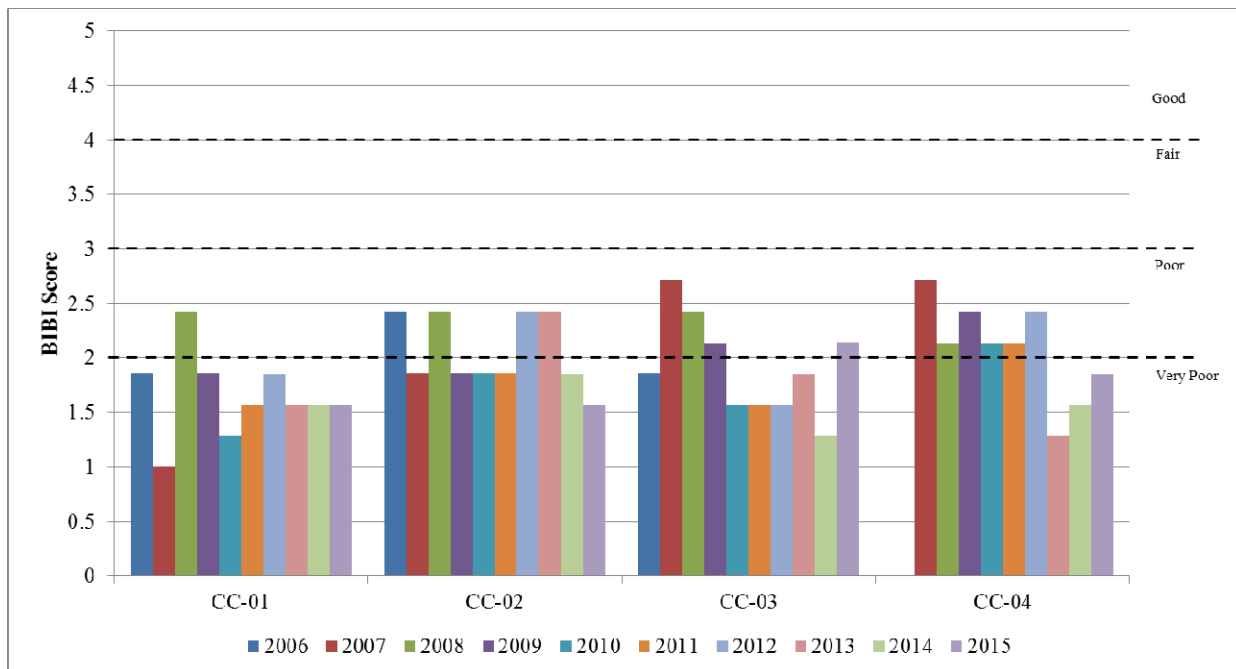
Figure 4-12. Comparison of BIBI scores from 2006 to 2015

Biological impairment is evident within this watershed as reflected by the macroinvertebrate communities found throughout the study reach. A comparison of BIBI scores from 2006 through 2015 (Table 4-10) shows no substantial change in biological conditions throughout the study reach. While BIBI scores tend to fluctuate from year to year, overall classifications have changed very little with sites consistently rating either “Poor” or “Very Poor”, no clear trends have been established (Figure 4-12). It appears that the biological community continues to be limited by the presence of urban stressors and the degraded physical condition of the stream, and annual shifts in BIBI scores are likely related to random and systematic variability inherent in the assessment process.

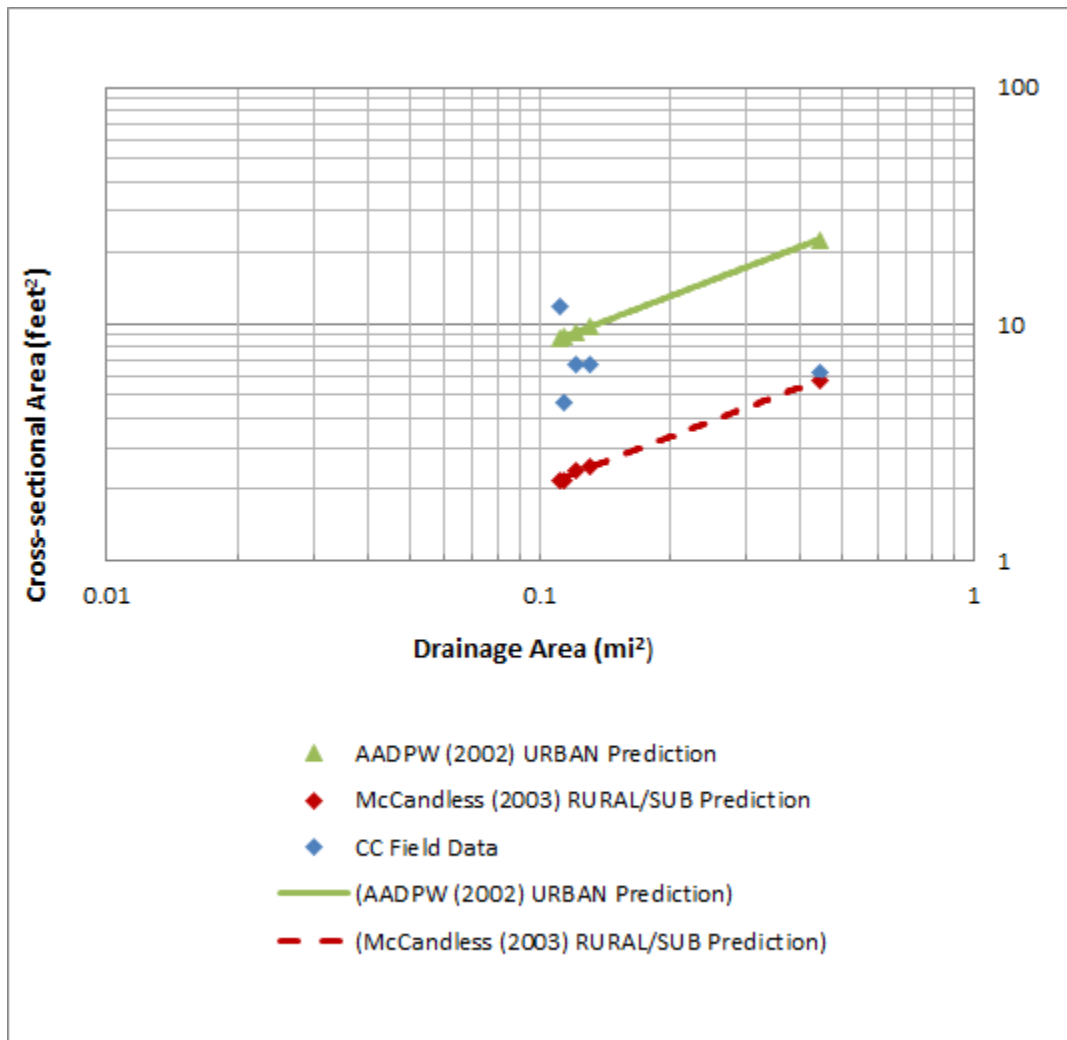
Figure 4-13. Comparison of bankfull channel cross sectional area to drainage area (CC = Church Creek, 2015 data)

Bankfull channel dimensions (cross sectional area, width, depth) in the Church Creek study area showed significant departure from expected values, as derived from Maryland Coastal Plain regional relationships of bankfull channel geometry (McCandless, 2003). Almost all dimensions were generally larger in the Church Creek study area (see Figures 4-13, 4-14, and 4-15), and were often more similar to relationships of bankfull channel geometry derived from gaged urban watersheds located in the Coastal Plain. These relationships were developed for an urban stream restoration project in Anne Arundel County (AADPW 2002). Values measured in 2015 were roughly consistent with prior assessment results. This reflects the higher level of imperviousness in the study area, as compared to the lower impervious levels in the drainage areas used to develop the regional relationship data. The results suggest that this stream has become enlarged as a result of the high imperviousness, and is both wider and deeper than stable C and E type channels located in rural/suburban watersheds of the coastal plain. It should be noted, however, that locating bankfull elevations in the field on actively eroding, previously stabilized, or incising channels is difficult and not recommended due to unreliable and/or

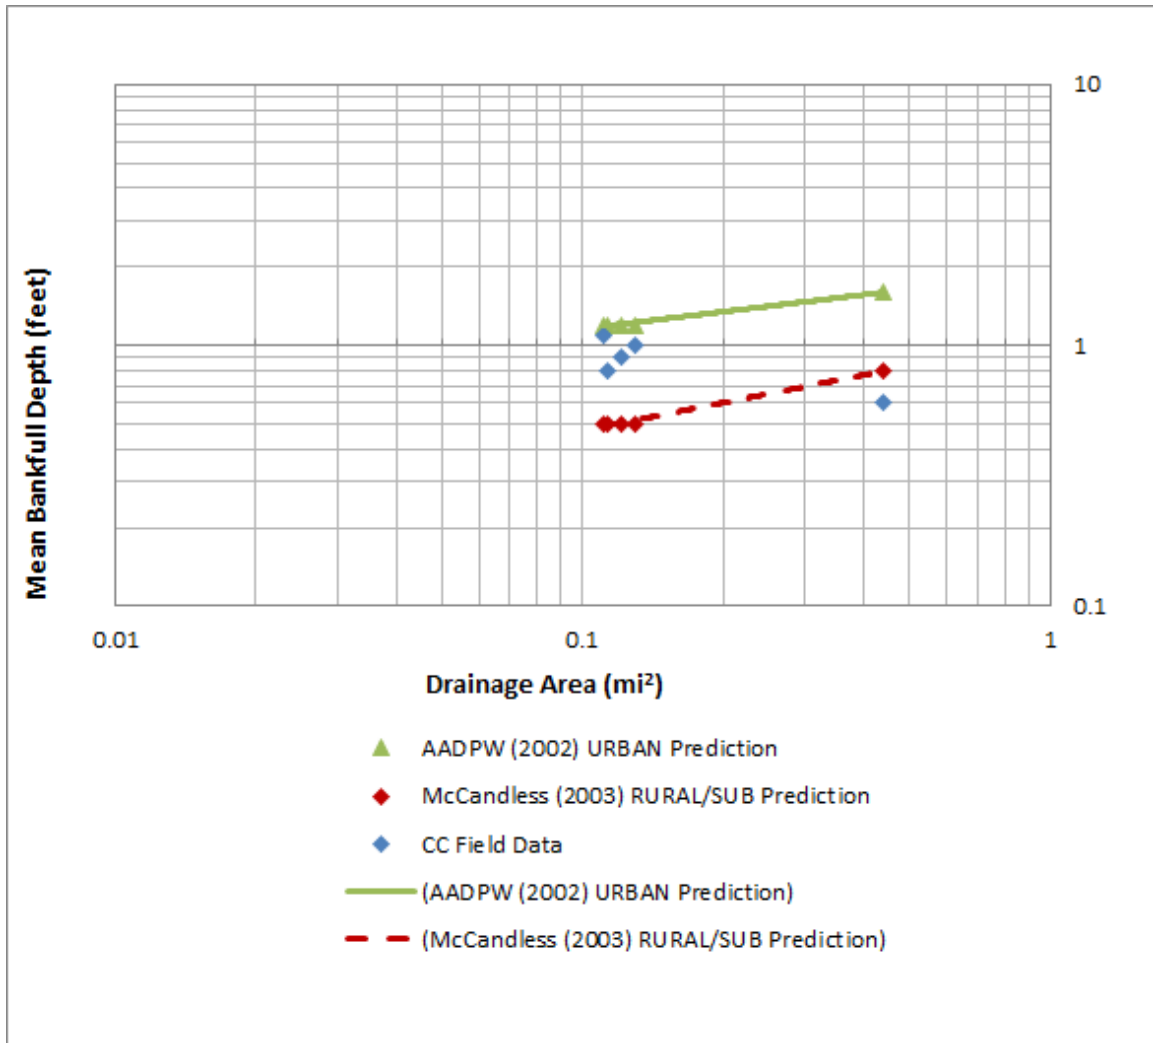
Figure 4-14. Comparison of mean bankfull depth to drainage area (CC = Church Creek, 2015 data)

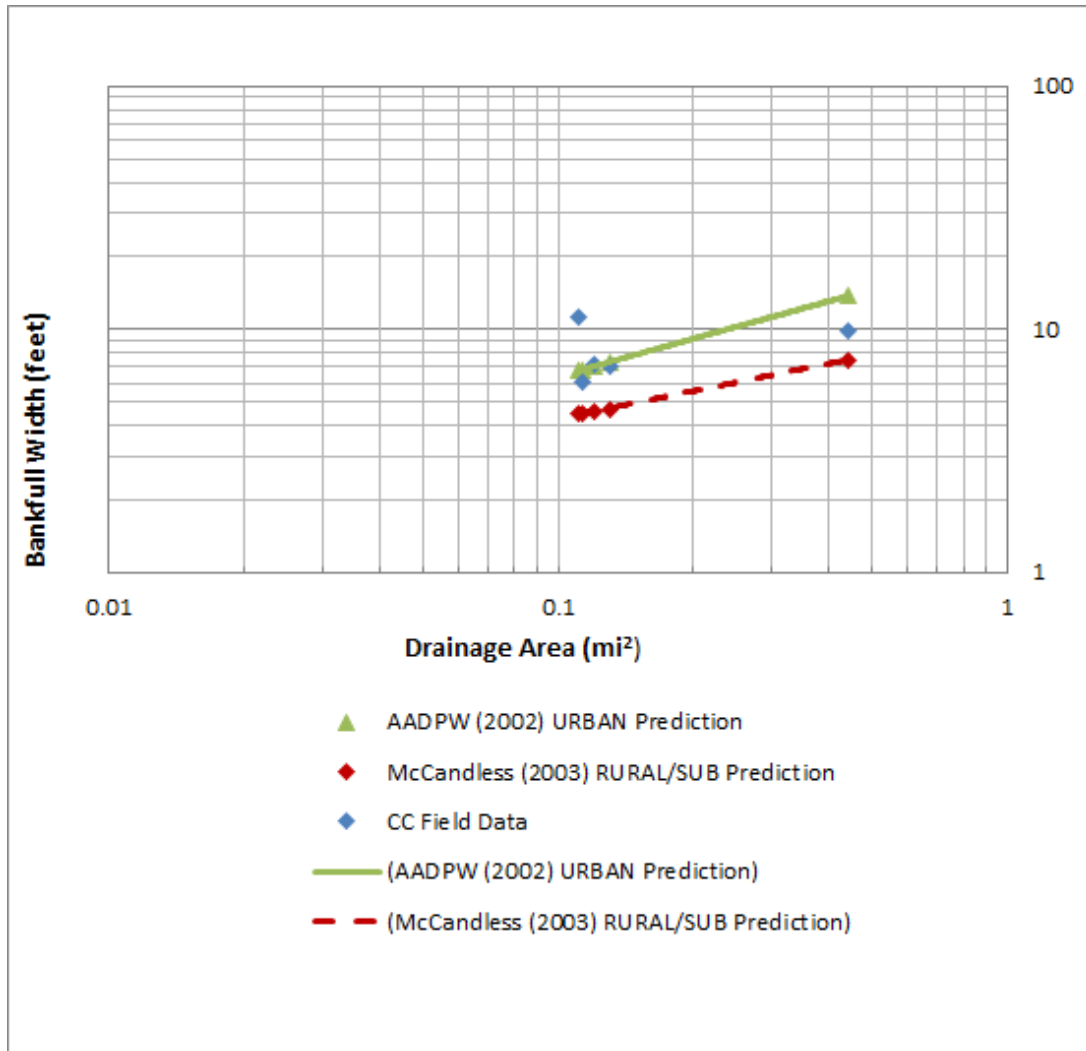
Figure 4-15. Comparison of bankfull width to drainage area (CC = Church Creek, 2015 data)

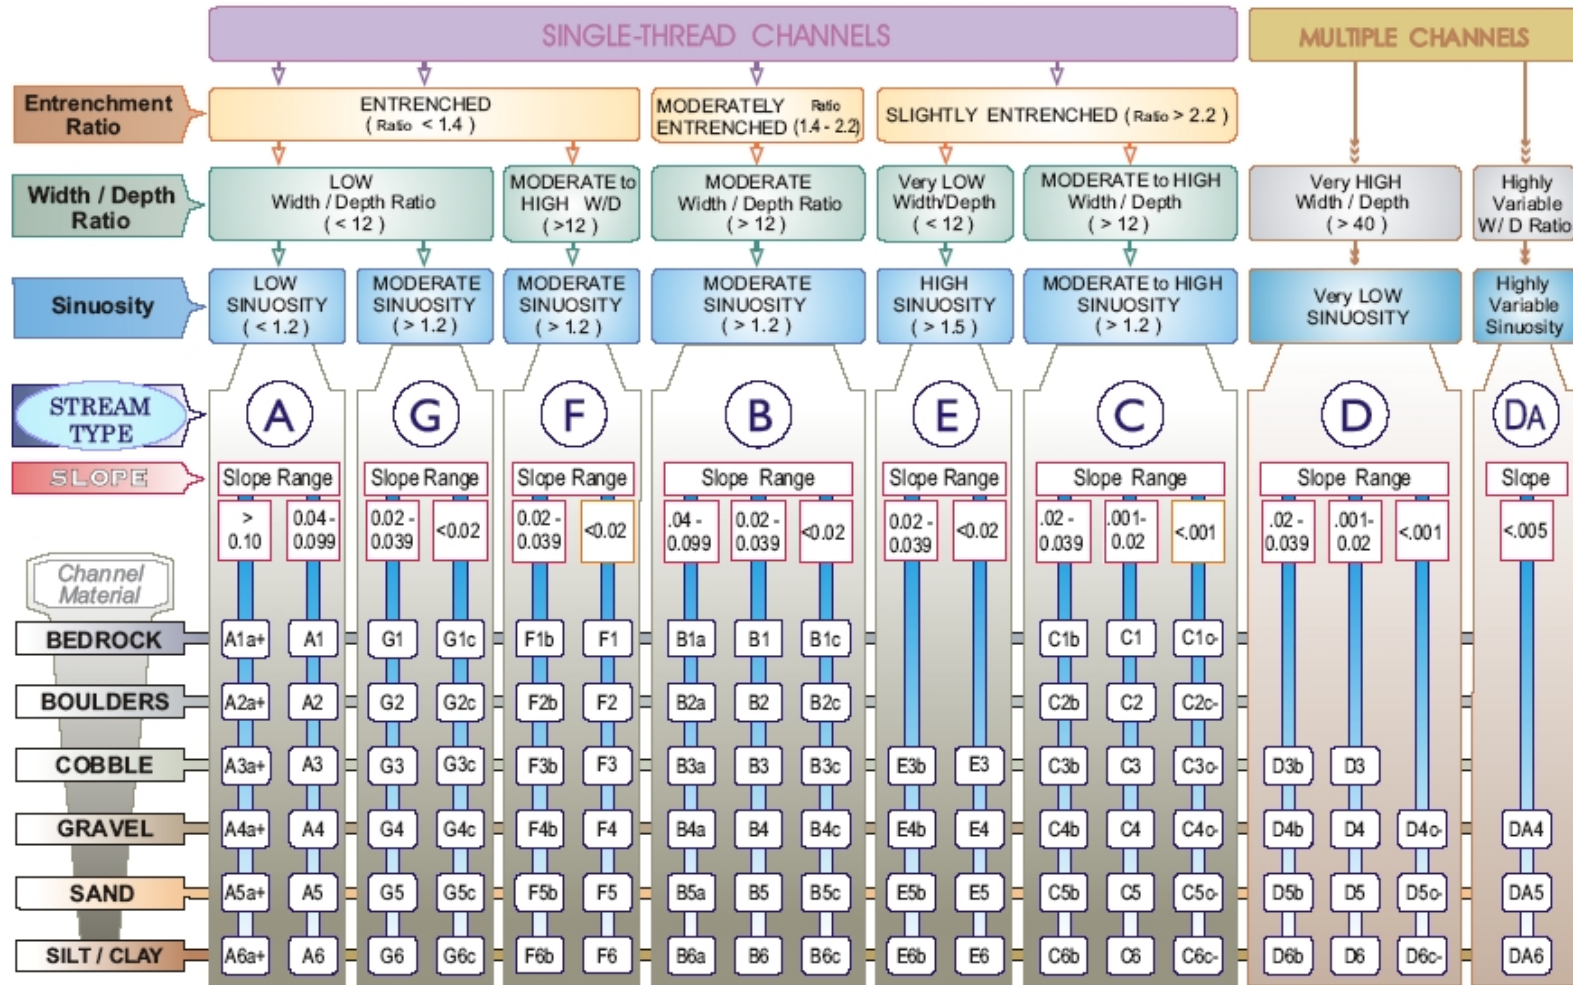
# The Key to the Rosgen Classification of Natural Rivers

KEY to the **ROSGEN** CLASSIFICATION of NATURAL RIVERS. As a function of the "continuum of physical variables" within stream reaches, values of **Entrenchment** and **Sinuosity** ratios can vary by +/- 0.2 units; while values for **Width / Depth** ratios can vary by +/- 2.0 units.

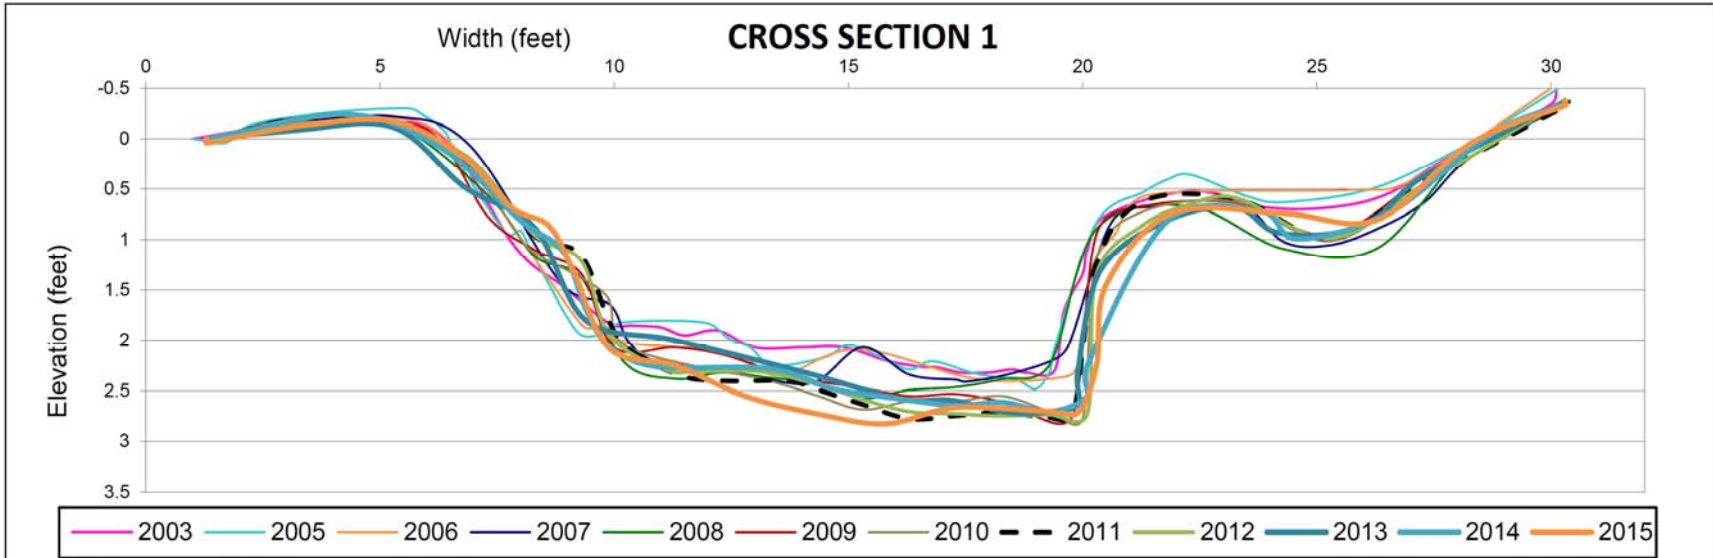
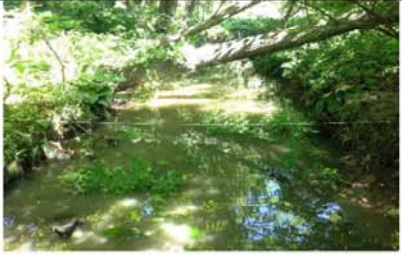
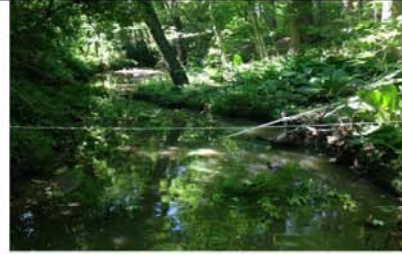
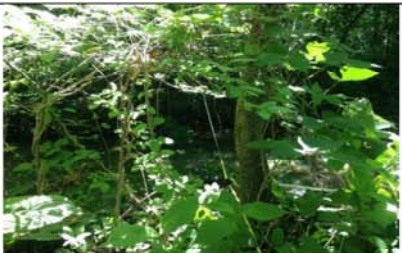
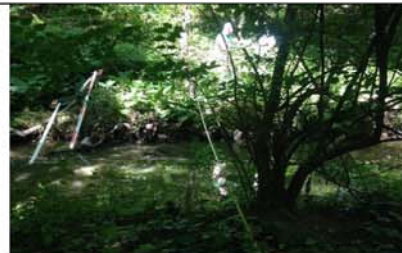
<b>2015 Geomorphic Assessment Results</b>	
Upstream View		Downstream View		Bankfull Width ( $W_{bkt}$ ) (feet)	11.2
				Mean Depth ( $d_{bkt}$ ) (feet)	1.1

Bankfull Cross-sectional Area ( $A_{bkt}$ ) (feet <sup>2</sup> )	12.0
				Width/Depth Ratio ( $W_{bkt}/d_{bkt}$ )	10.5
Left Bank View		Right Bank View		Width of Flood-prone Area ( $W_{fpa}$ ) (feet)	21.9
				Entrenchment Ratio (ER) = $W_{fpa}/W_{bkt}$	1.9
				Channel Materials $D_{50}$ (millimeters)	15
				Water Surface Slope (S)	0.003
				Sinuosity (K) = stream length/valley length	<1.2
				Adjustments?	Sin ↑, ER ↓, W/D ↑
				<b>STREAM TYPE</b>	<b>F4</b>

The most upstream reach on the Parole Plaza Tributary, XS-1, has been undergoing a transition from a Rosgen C4/5 channel to a F4 channel, as evidenced by changes in the width/depth and entrenchment ratios. Previous monitoring in 2010 suggested that this reach was shifting from an E to a C channel as evidenced by channel degradation along the right bank and a notable increase in sediment deposition and point bar formation along the right bank just downstream. Additional degradation between 2010 and 2012 suggest that the channel had lost connectivity to the floodplain and had likely shifted to an F stream type. Mid-channel degradation continued between 2014 and 2015 showing approximately a 0.3 feet difference. In 2015, geomorphic assessment parameters continue to support the classification of this reach as an F channel. The channel evolution is supported by a 36.3% increase in channel cross-sectional area since 2003 and considerable widening and mid-channel bar formation immediately downstream, which is indicative of a channel that is not stable and is undergoing a widening and degradation phase. Left bank widening was also apparent between 2013 and 2014 monitoring years and remained consistent during 2015. However, it is also important to acknowledge that this cross section is no longer located in a riffle feature and is now in a pool feature, which affects the channel dimensions and complicates classification using the Rosgen system.

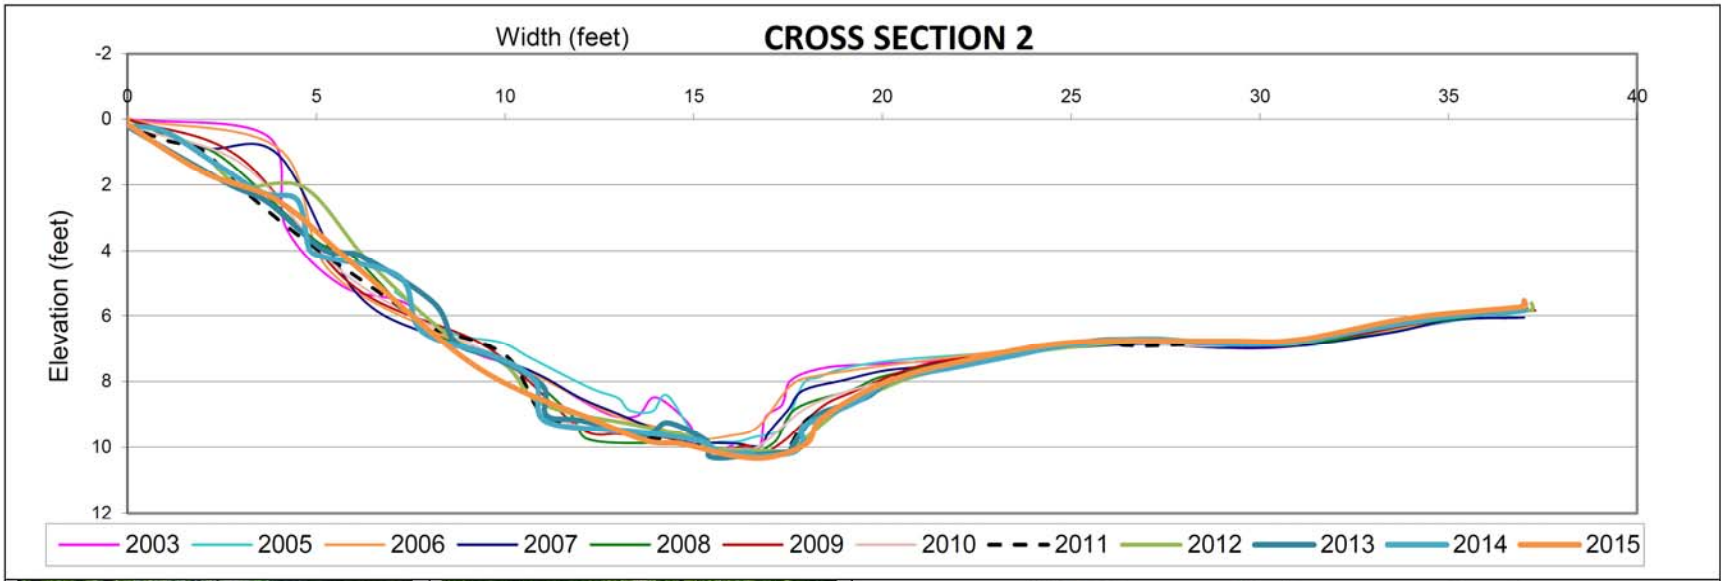
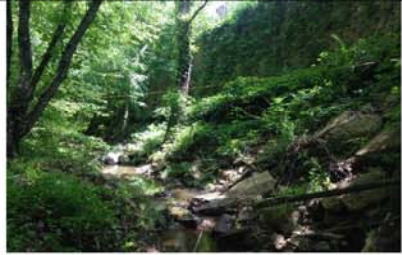
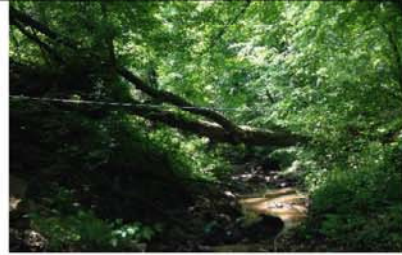
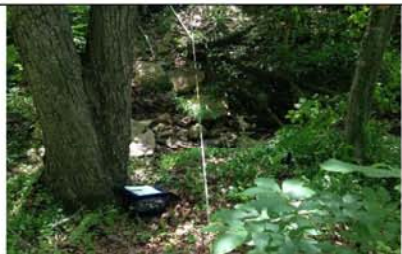
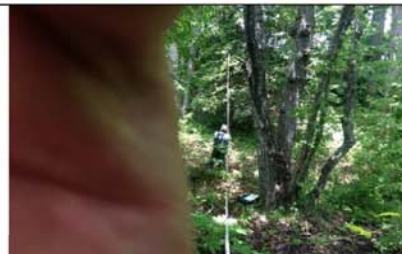
Bankfull Width ( $W_{bkt}$ ) (feet)	6.1
Upstream View	Downstream View	Mean Depth ( $d_{bkt}$ ) (feet)	0.8

Bankfull Cross-sectional Area ( $A_{bkt}$ ) (feet <sup>2</sup> )	4.7
Left Bank View	Right Bank View	Width/Depth Ratio ( $W_{bkt}/d_{bkt}$ )	7.9
		Width of Flood-prone Area ( $W_{fpa}$ ) (feet)	10.5
		Entrenchment Ratio (ER) = $W_{fpa}/W_{bkt}$	1.7
		Channel Materials $D_{50}$ (millimeters)	10
		Water Surface Slope (S)	0.022
		Sinuosity (K) = stream length/valley length	<1.2
		Adjustments?	Sin ↑ ER ↓
		<b>STREAM TYPE</b>	<b>G4</b>

The next site downstream on the Parole Plaza Tributary, XS-2, was classified as a Rosgen G4 channel based on its low width/depth ratio, relatively low slope, and sandy substrate. Between 2014 and 2015 monitoring the substrate became slightly less coarse. Since 2012 its entrenchment ratio was slightly higher than those typical of G streams, but to retain consistency with the 2011 classification, the G rating was retained. This reach was previously classified as an E type channel; however, it was noted that the reach was actively degrading and widening. While E streams are typically more sinuous, this segment has been noticeably straightened and stabilized by a retaining wall and rubble/fill along the left bank (facing downstream). The lack of sinuosity in the channel has likely resulted in instability, and consequently resulted in a shift to a less-stable form.

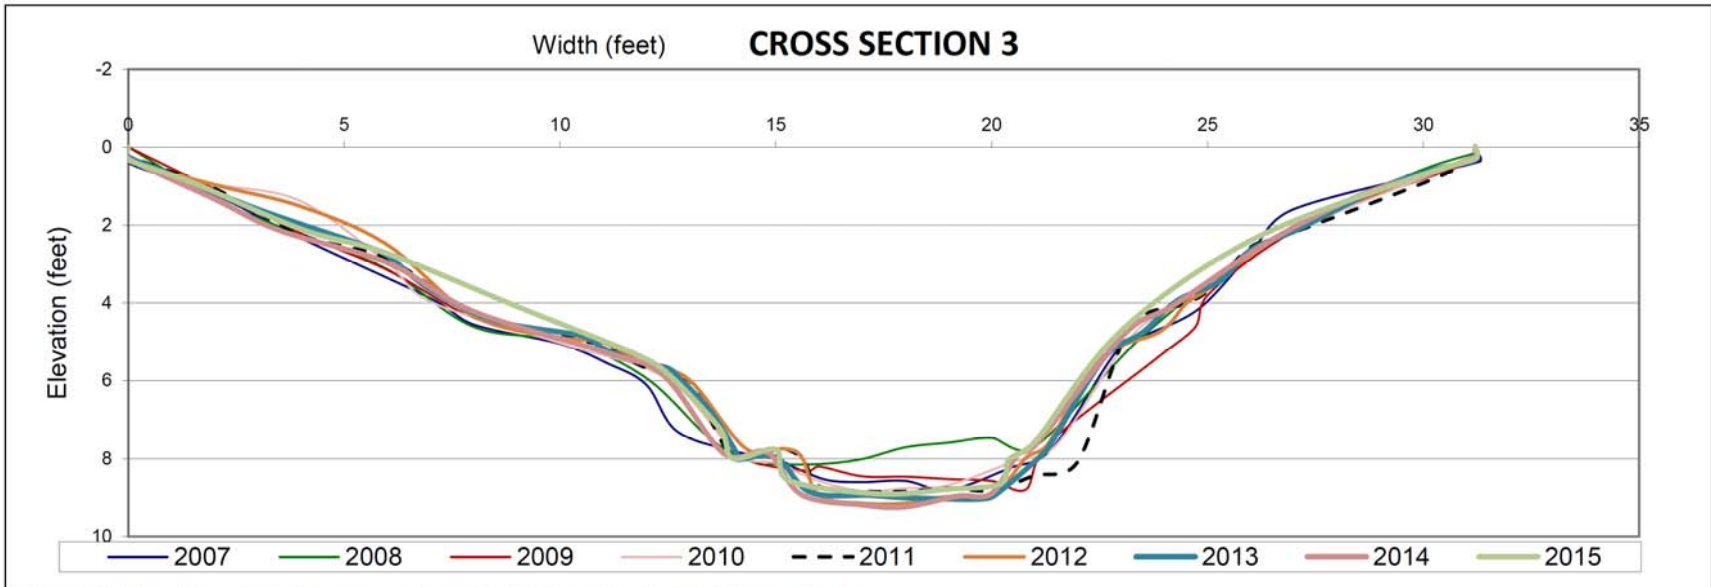
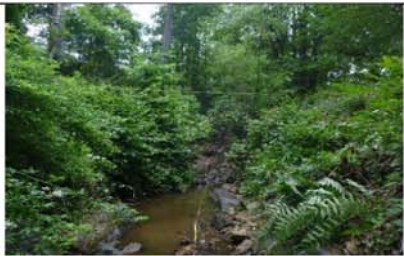
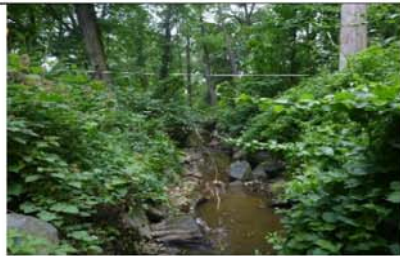
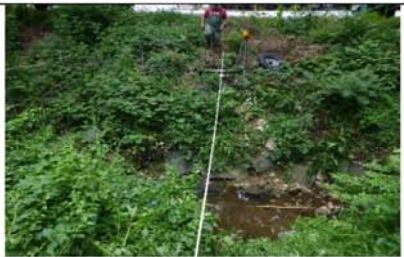
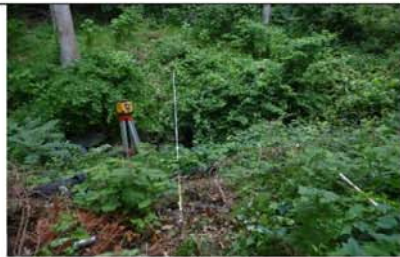
Bankfull Width ( $W_{bkt}$ ) (feet)	7.2
Mean Depth ( $d_{bkt}$ ) (feet)	0.9
Bankfull Cross-sectional Area ( $A_{bkt}$ ) (feet <sup>2</sup> )	6.7
Width/Depth Ratio ( $W_{bkt}/d_{bkt}$ )	7.7
Width of Flood-prone Area ( $W_{fpa}$ ) (feet)	9.1
Entrenchment Ratio (ER) = $W_{fpa}/W_{bkt}$	1.3
Channel Materials $D_{50}$ (millimeters)	16
Water Surface Slope (S)	0.005
Sinuosity (K) = stream length/valley length	<1.2
Adjustments?	Sin ↑
<b>STREAM TYPE</b>	<b>G4/3c</b>
