**CHEMICAL, BIOLOGICAL, AND  
PHYSICAL CHARACTERIZATION  
OF THE CHURCH CREEK AND  
PAROLE PLAZA NPDES MONITORING  
STATIONS: 2014 - 2015**

Anne Arundel County  
Department of Public Works  
Watershed Protection and Restoration Program  
2662 Riva Road  
Annapolis, MD 21401

Versar, Inc.  
9200 Rumsey Road  
Columbia, MD 21045

February 2016

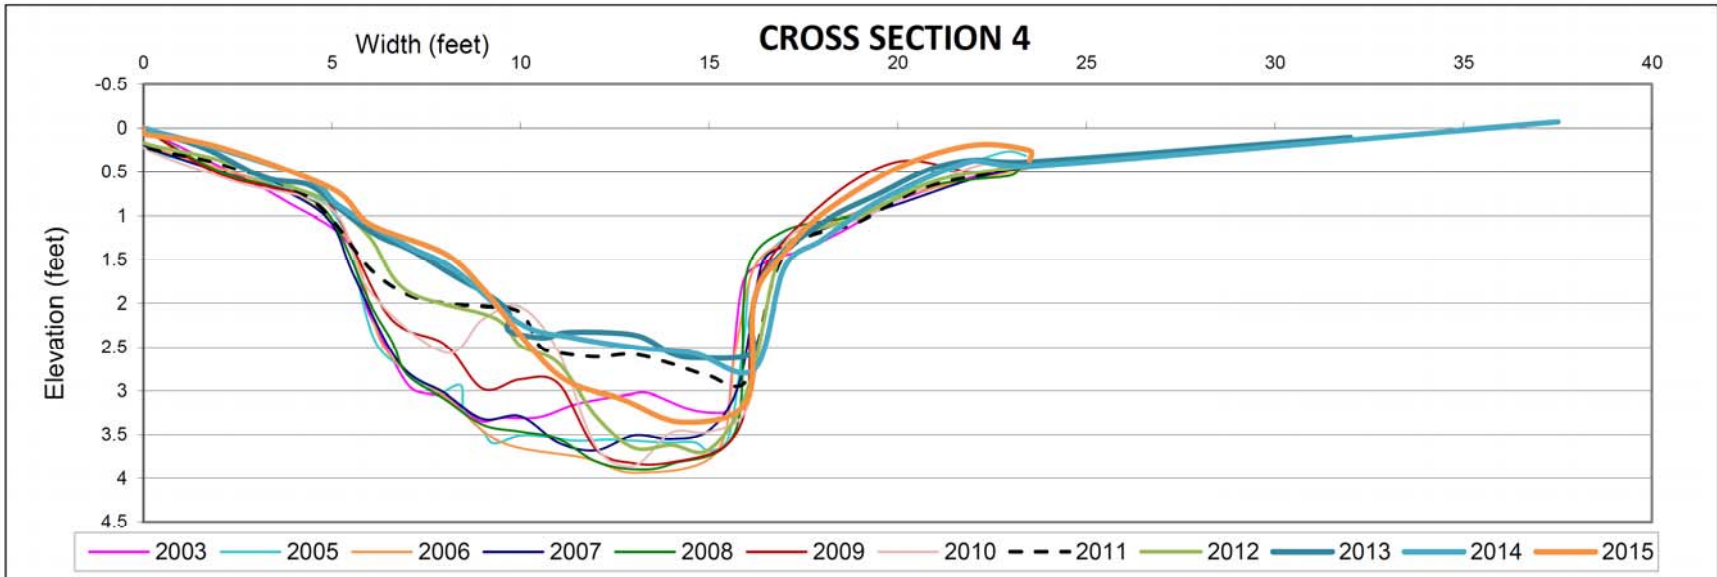
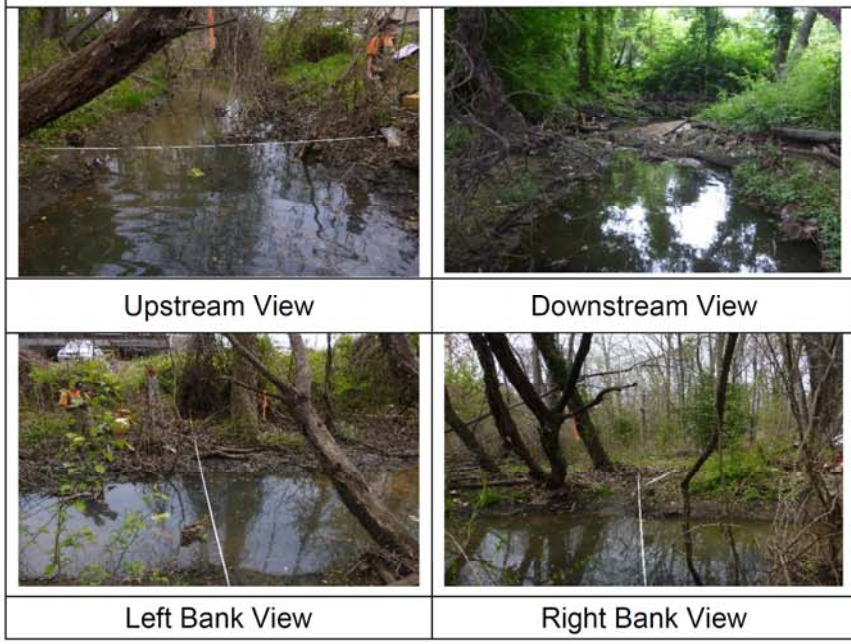
2015 Geomorphic Assessment Results	
Bankfull Width ( $W_{bkt}$ ) (feet)	7.0
Mean Depth ( $d_{bkt}$ ) (feet)	1.0
Bankfull Cross-sectional Area ( $A_{bkt}$ ) (feet <sup>2</sup> )	6.8
Width/Depth Ratio ( $W_{bkt}/d_{bkt}$ )	7.1
Width of Flood-prone Area ( $W_{fpa}$ ) (feet)	15.6
Entrenchment Ratio (ER) = $W_{fpa}/W_{bkt}$	2.2
Channel Materials $D_{50}$ (millimeters)	1.3
Water Surface Slope (S)	0.002
Sinuosity (K) = stream length/valley length	<1.2
Adjustments?	Sin ↑, W/D ↑
<b>STREAM TYPE</b>	<b>C5</b>

The most downstream site on the Parole Plaza Tributary, XS-4, has transitioned from a Rosgen E5 channel to a C5 channel due to an increase in width/depth ratio. It should also be noted that a large woody debris jam located just downstream of the cross section location has resulted in a considerable accumulation of fine sediment and debris across the channel and, consequently, is leading to aggradation and a reduction in the cross sectional area. Since 2003 cross-sectional area has decreased by 35.7%.

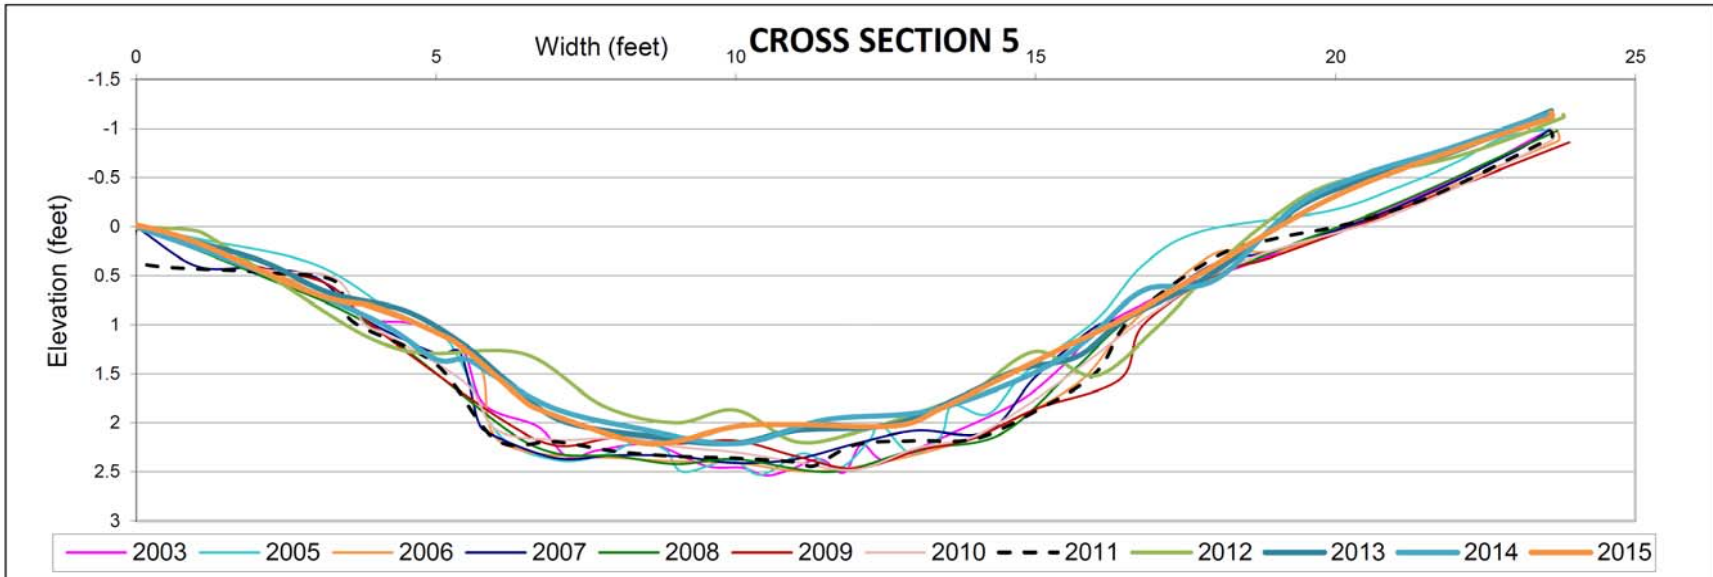
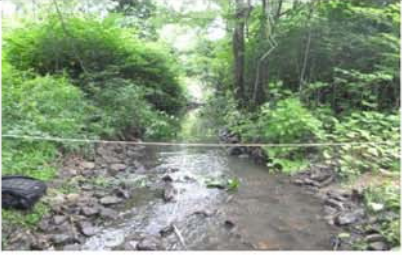
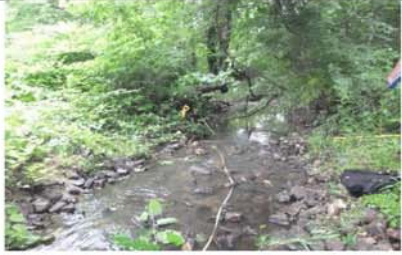
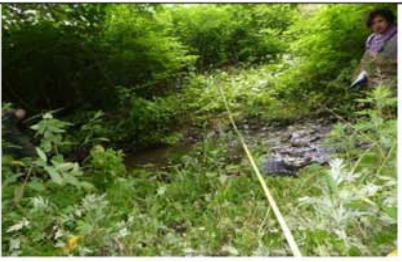
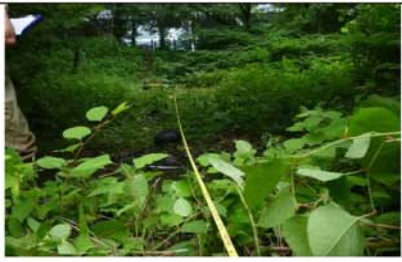
Bankfull Width ( $W_{bkt}$ ) (feet)	9.9

Mean Depth ( $d_{bkt}$ ) (feet)	0.6
Upstream View		Bankfull Cross-sectional Area ( $A_{bkt}$ ) (feet <sup>2</sup> )	6.2
Downstream View		Width/Depth Ratio ( $W_{bkt}/d_{bkt}$ )	15.6

Width of Flood-prone Area ( $W_{fpa}$ ) (feet)	16.7

Entrenchment Ratio (ER) = $W_{fpa}/W_{bkt}$	1.7
Left Bank View		Channel Materials $D_{50}$ (millimeters)	61
Right Bank View		Water Surface Slope (S)	0.003
		Sinuosity (K) = stream length/valley length	<1.2
		Adjustments?	Sin ↑, ER ↓
		<b>STREAM TYPE</b>	<b>F4/3</b>
