**CHEMICAL, BIOLOGICAL, AND
PHYSICAL CHARACTERIZATION
OF THE CHURCH CREEK AND
PAROLE PLAZA NPDES MONITORING
STATIONS: 2013 - 2014**

Anne Arundel County
Department of Public Works
Watershed Protection and Restoration Program
2662 Riva Road
Annapolis, MD 21401

Versar, Inc.
9200 Rumsey Road
Columbia, MD 21045

September 2014

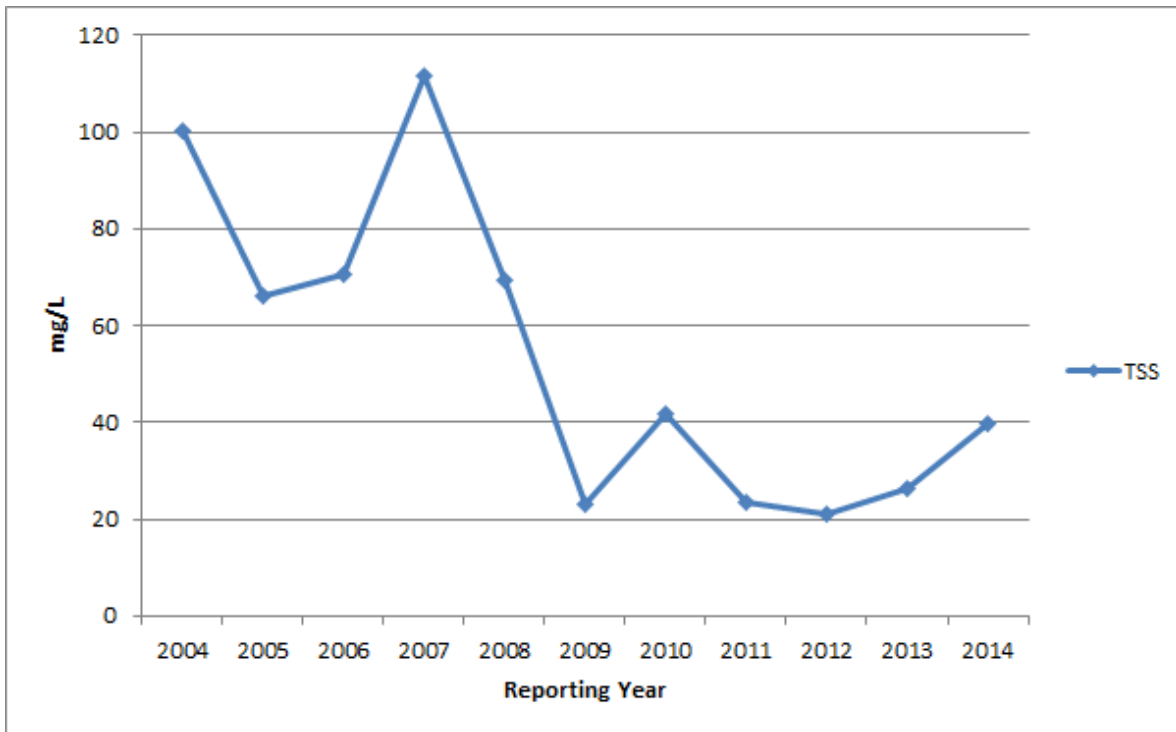
Figure 4-8. Church Creek station long-term monitoring: annual EMCs (TSS; mg/L)

Figures 4-6 through 4-10 show similar trends in EMCs for the Church Creek Monitoring Station. Pollutant concentrations at Church Creek increased in 2014 for all monitored parameters, with the exception of TPH, which showed no change from 2013. Note that the apparent rise in TPH at Church Creek in 2013, like Parole Plaza, was due to an increase in the detection limit. Also like Parole Plaza, summer season concentrations were not included with the 2013 EMC data.

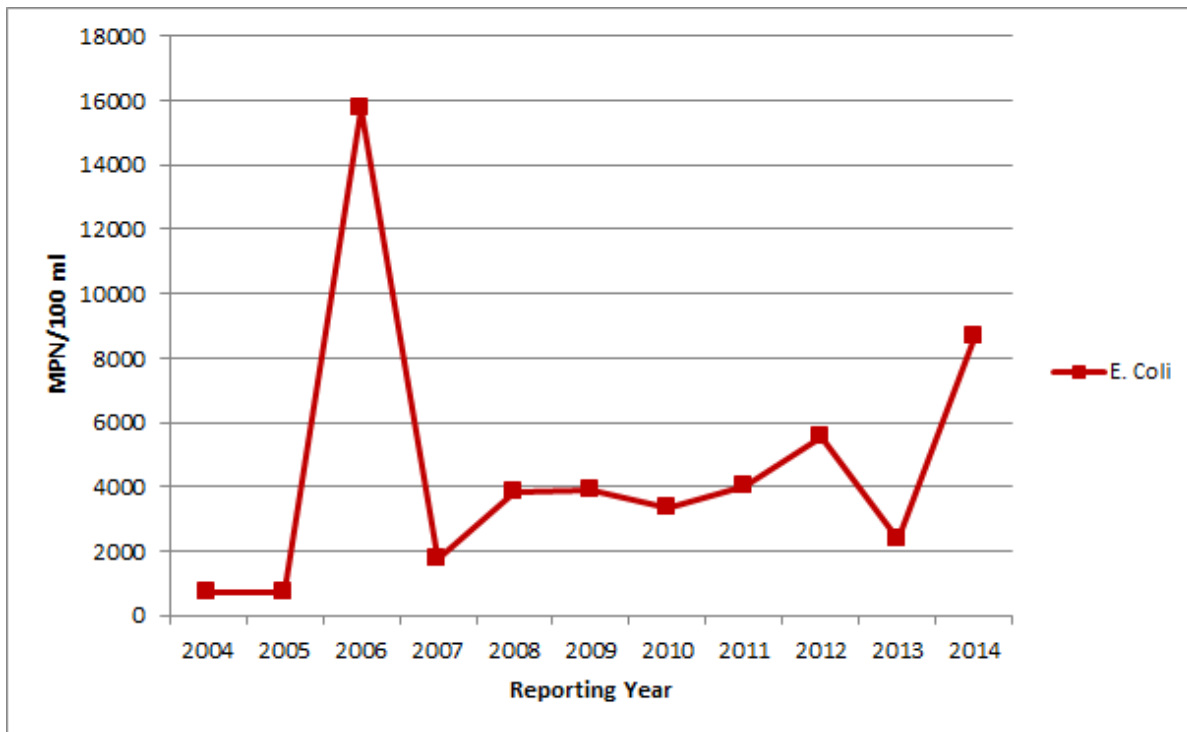
Figure 4-10. Church Creek station long-term monitoring: annual EMCs (*E. coli*; MPN/100 mL)

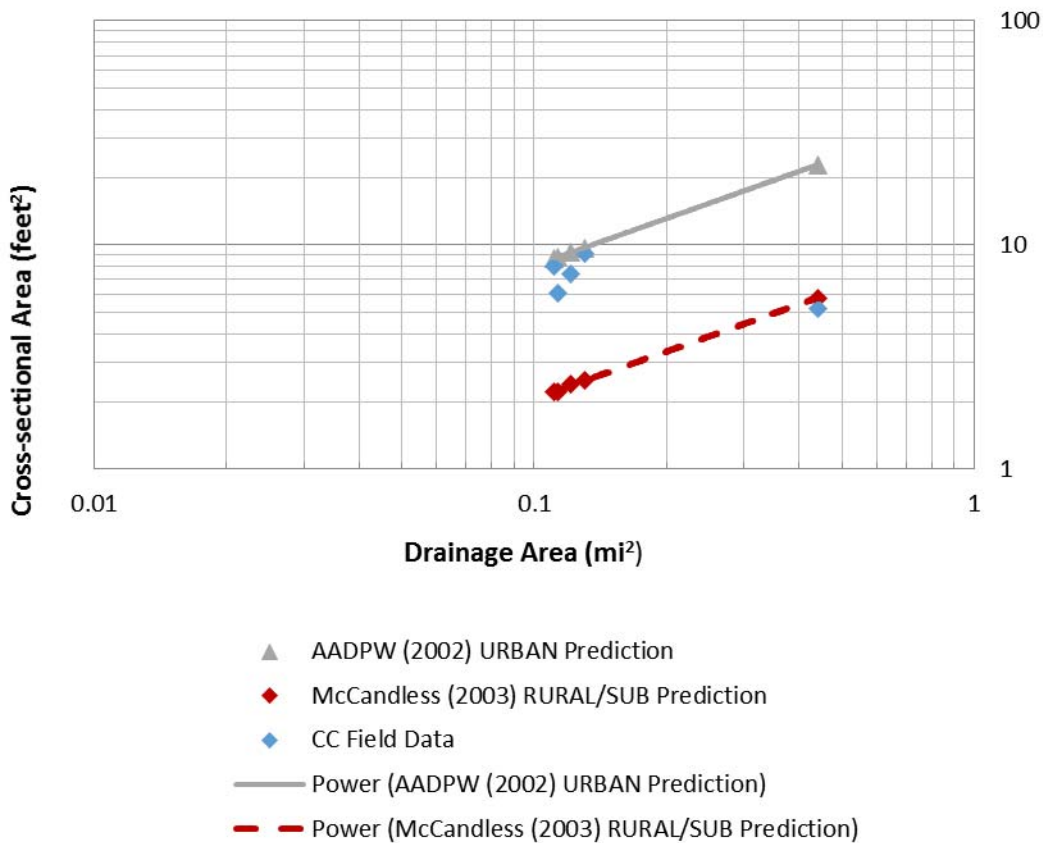
Figure 4-13. Comparison of bankfull channel cross sectional area to drainage area (CC = Church Creek, 2014 data)

Bankfull channel dimensions (cross sectional area, width, depth) in the Church Creek study area showed significant departure from expected values, as derived from Maryland Coastal Plain regional relationships of bankfull channel geometry (McCandless, 2003). Almost all dimensions were generally larger in the Church Creek study area (see Figures 4-13, 4-14, and 4-15), and were often more similar to relationships of bankfull channel geometry derived from gaged urban watersheds located in the Coastal Plain. These relationships were developed for an urban stream restoration project in Anne Arundel County (AADPW 2002). Values measured in 2014 were roughly consistent with prior assessment results. This reflects the higher level of imperviousness in the study area, as compared to the lower impervious levels in the drainage areas used to develop the regional relationship data. The results suggest that this stream has become enlarged as a result of the high imperviousness, and is both wider and deeper than stable C and E type channels located in rural/suburban watersheds of the coastal plain. It should be noted, however, that locating bankfull elevations in the field on actively eroding, previously stabilized, or incising channels is difficult and not recommended due to unreliable and/or misleading indicators, and instead bankfull elevations should be estimated using the

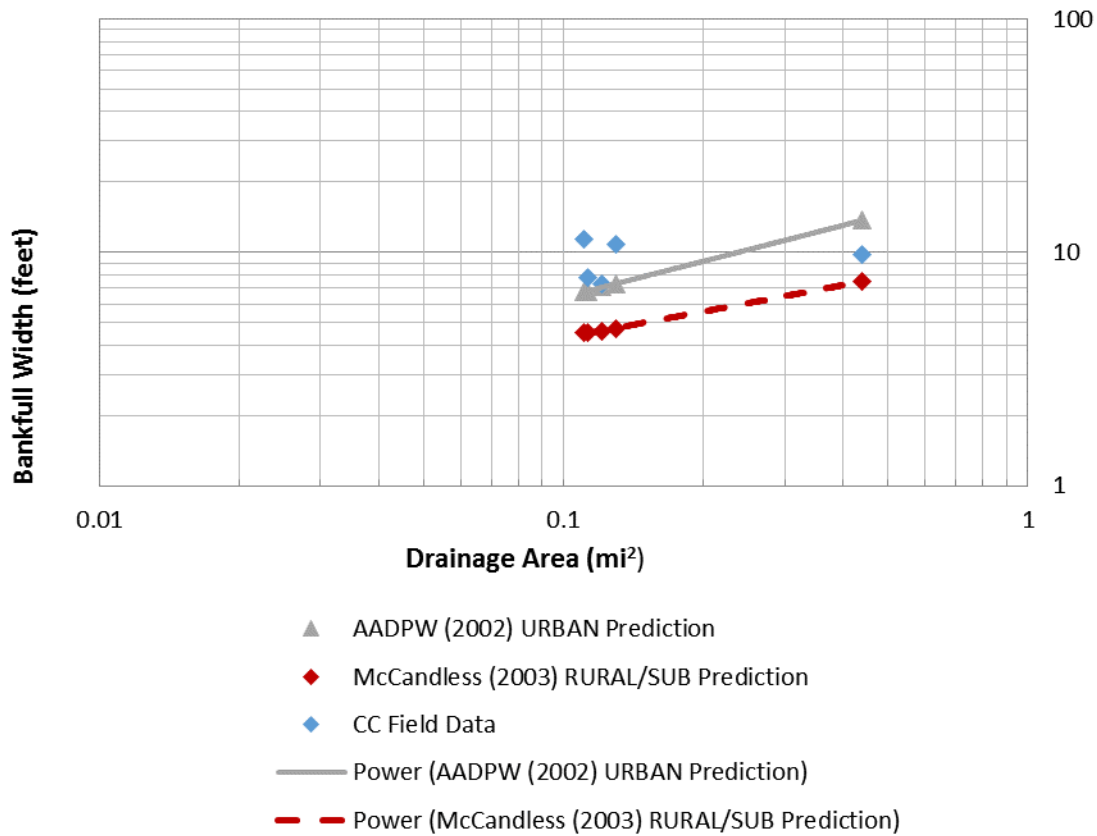
Figure 4-15. Comparison of bankfull width to drainage area (CC = Church Creek, 2014 data)

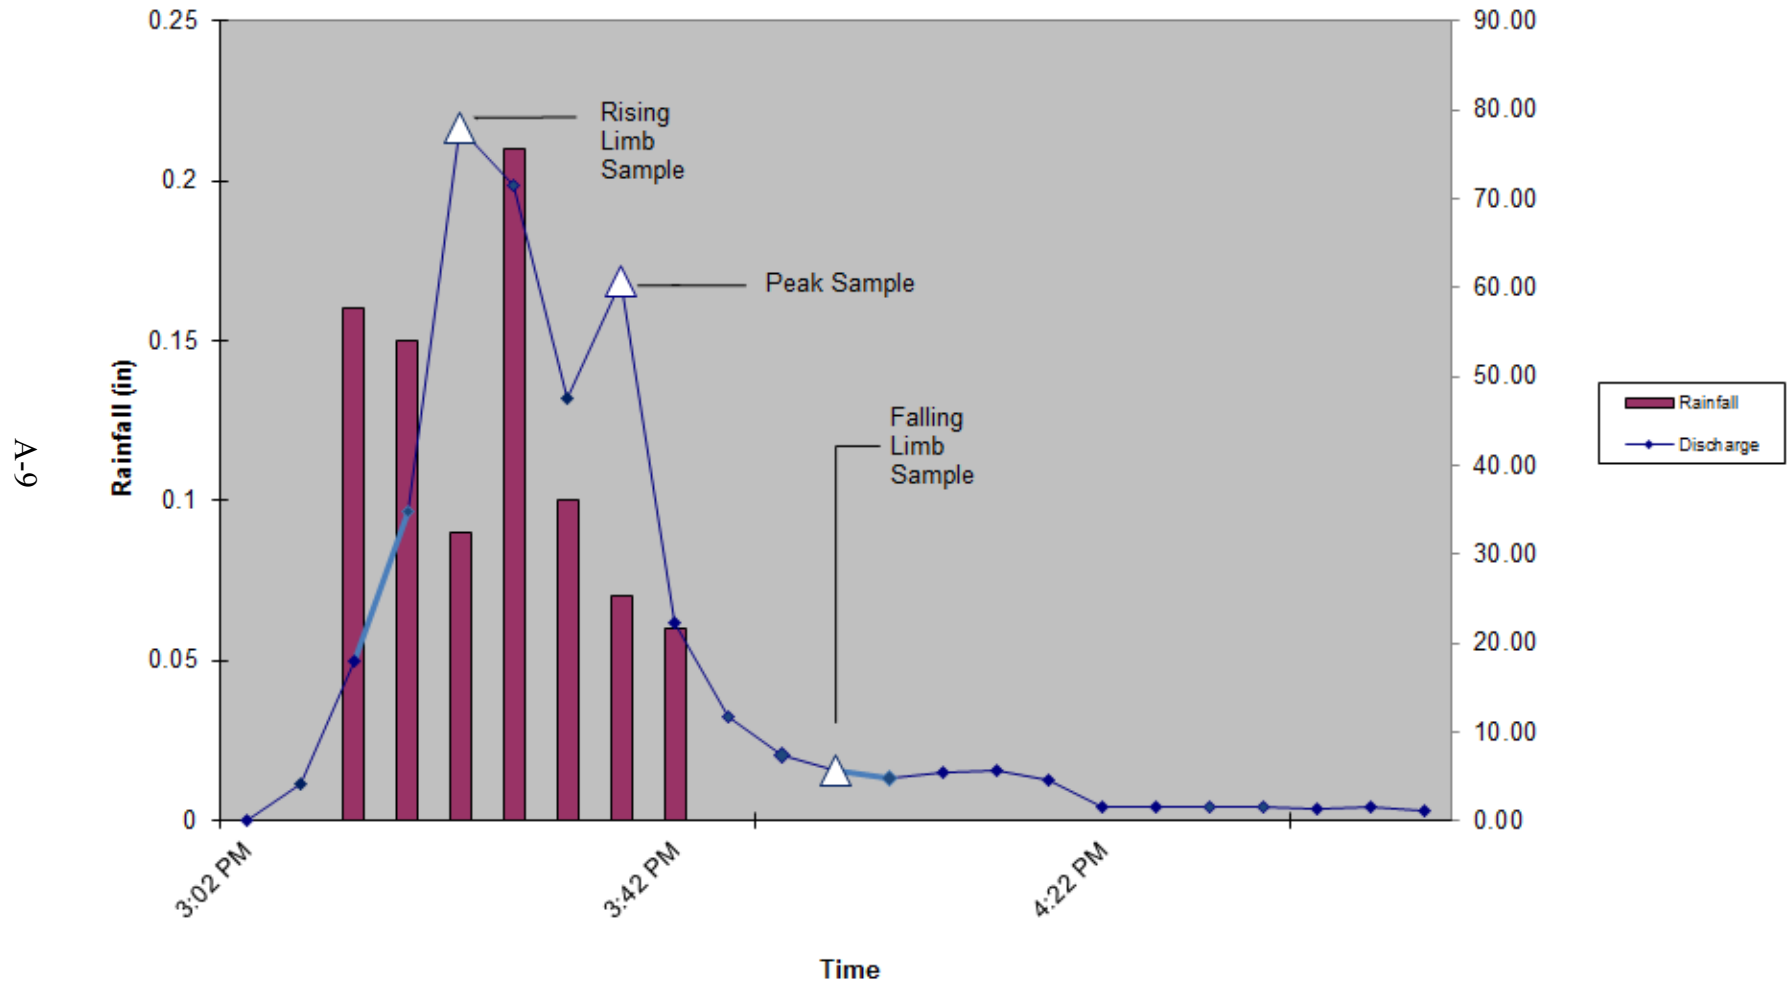
Hydrograph for September 12, 2013 Storm Parole Plaza

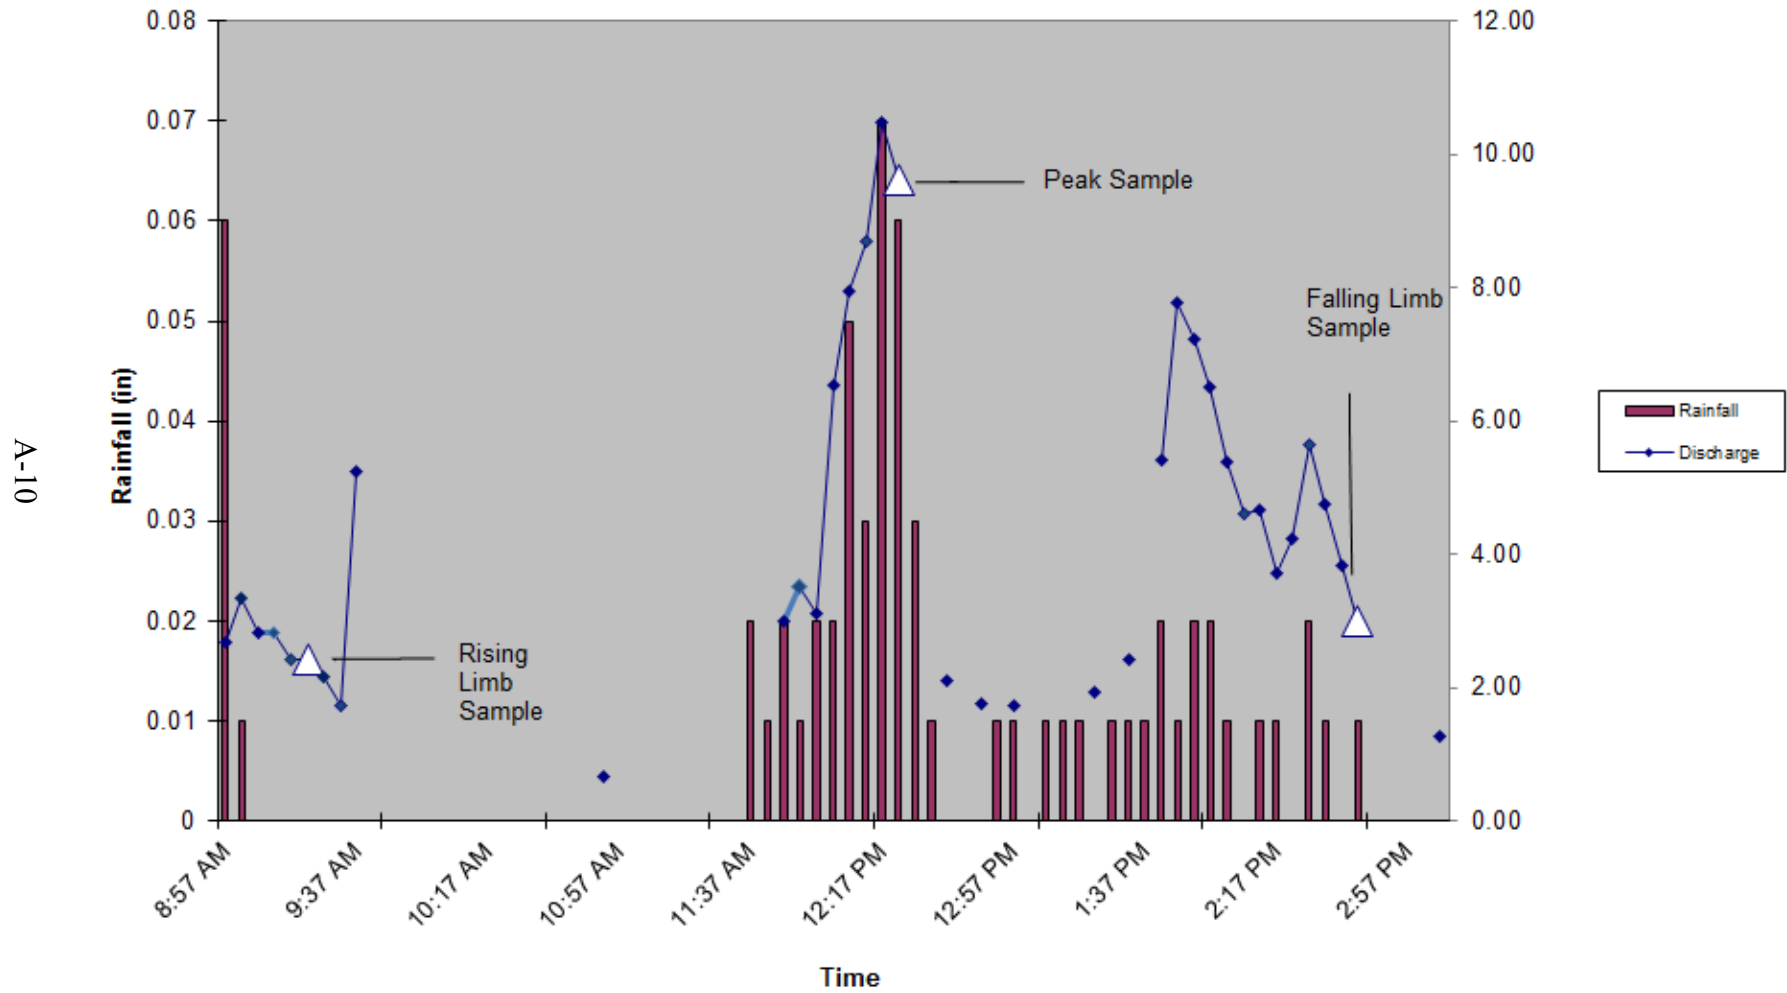
Hydrograph for October 7, 2013 Storm Parole Plaza

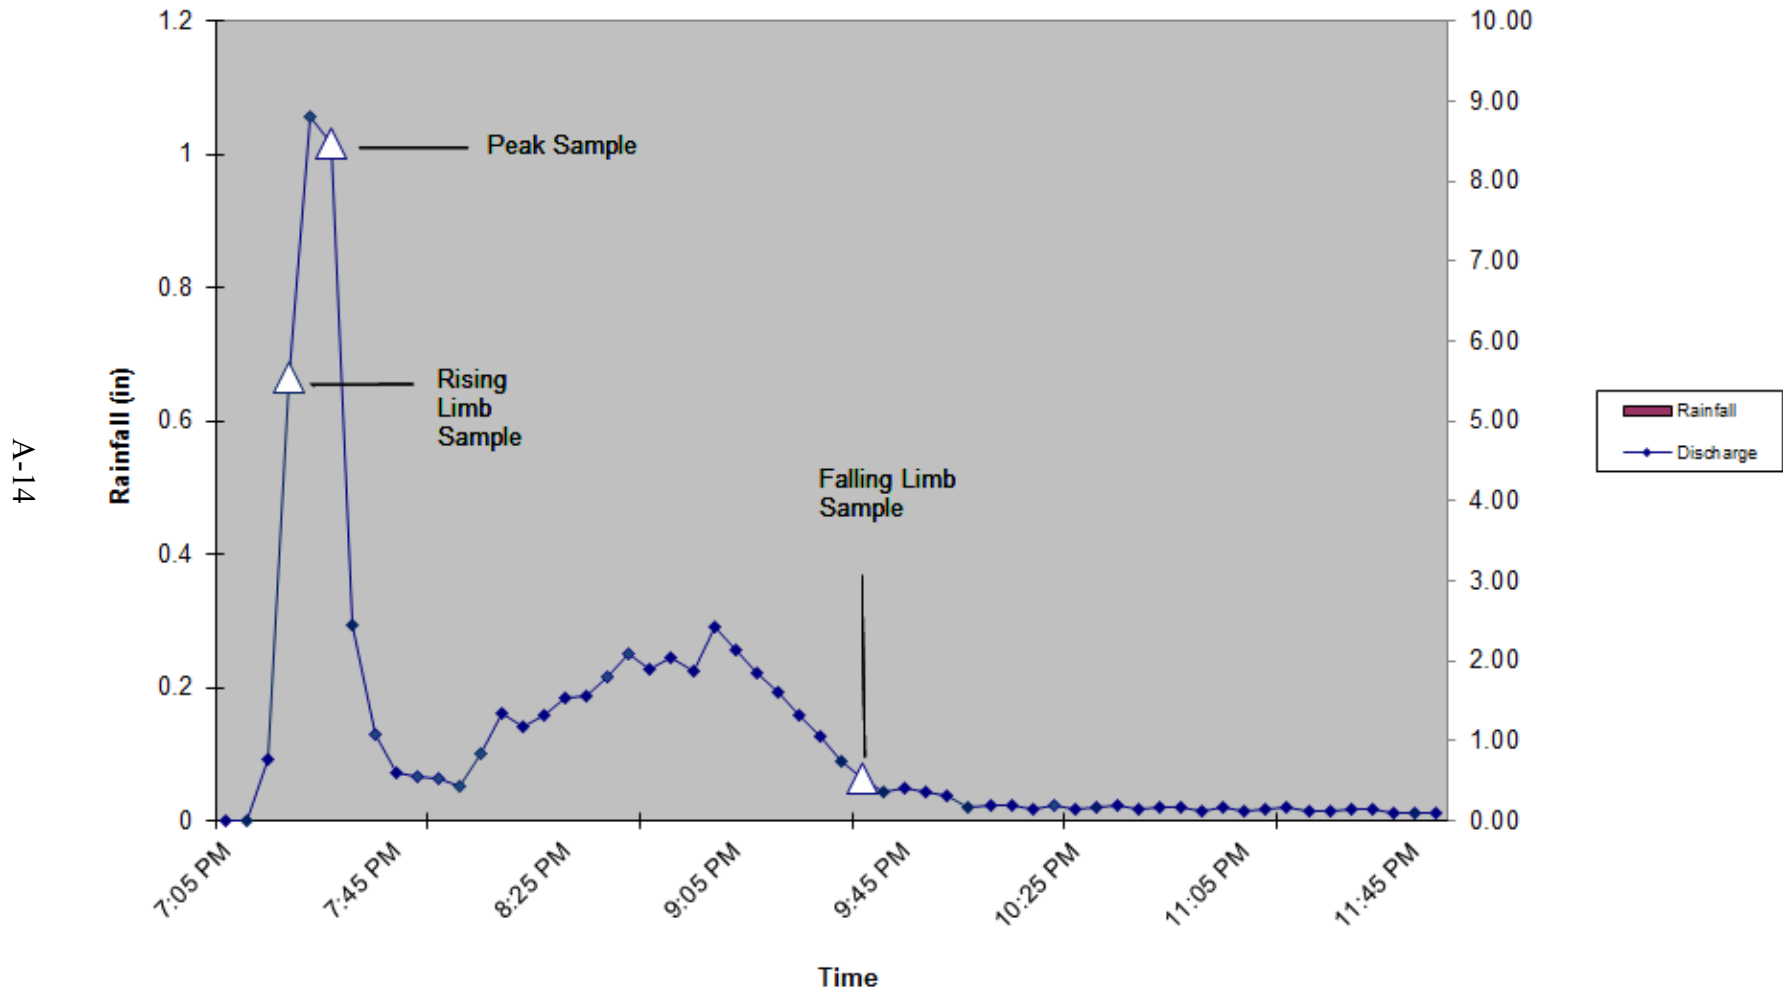
Hydrograph for May 27, 2014 Storm Parole Plaza

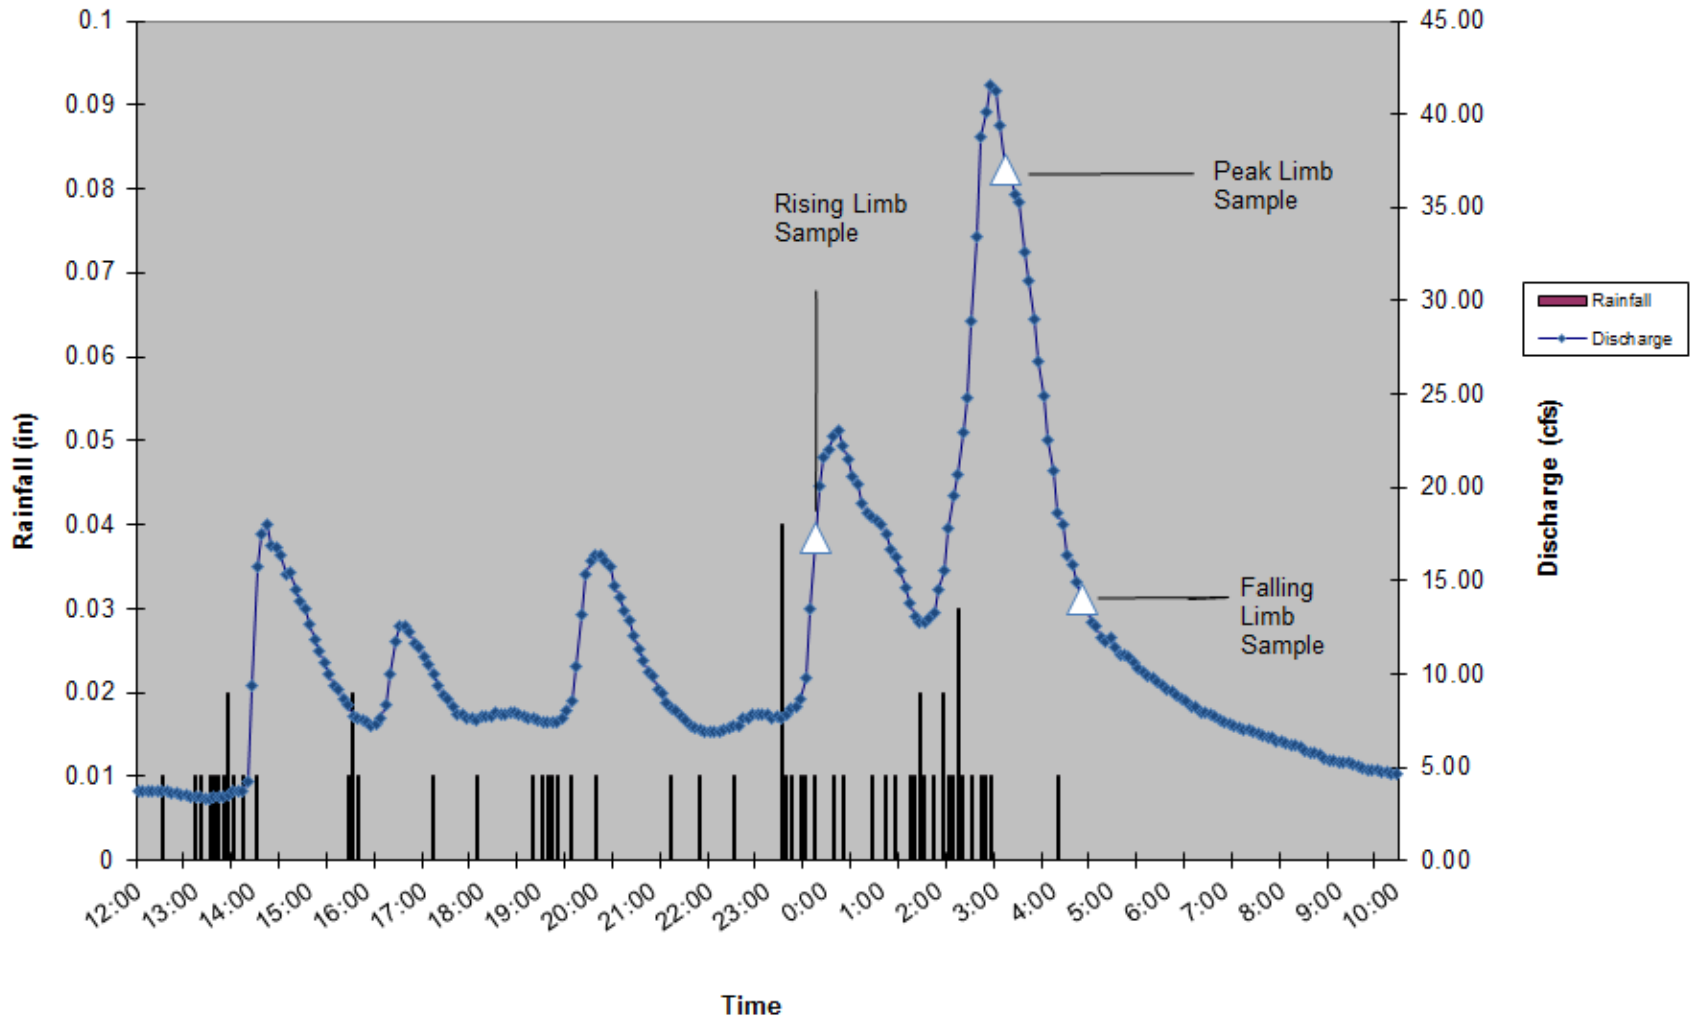
Hydrograph for December 6, 2013 Storm Church Creek

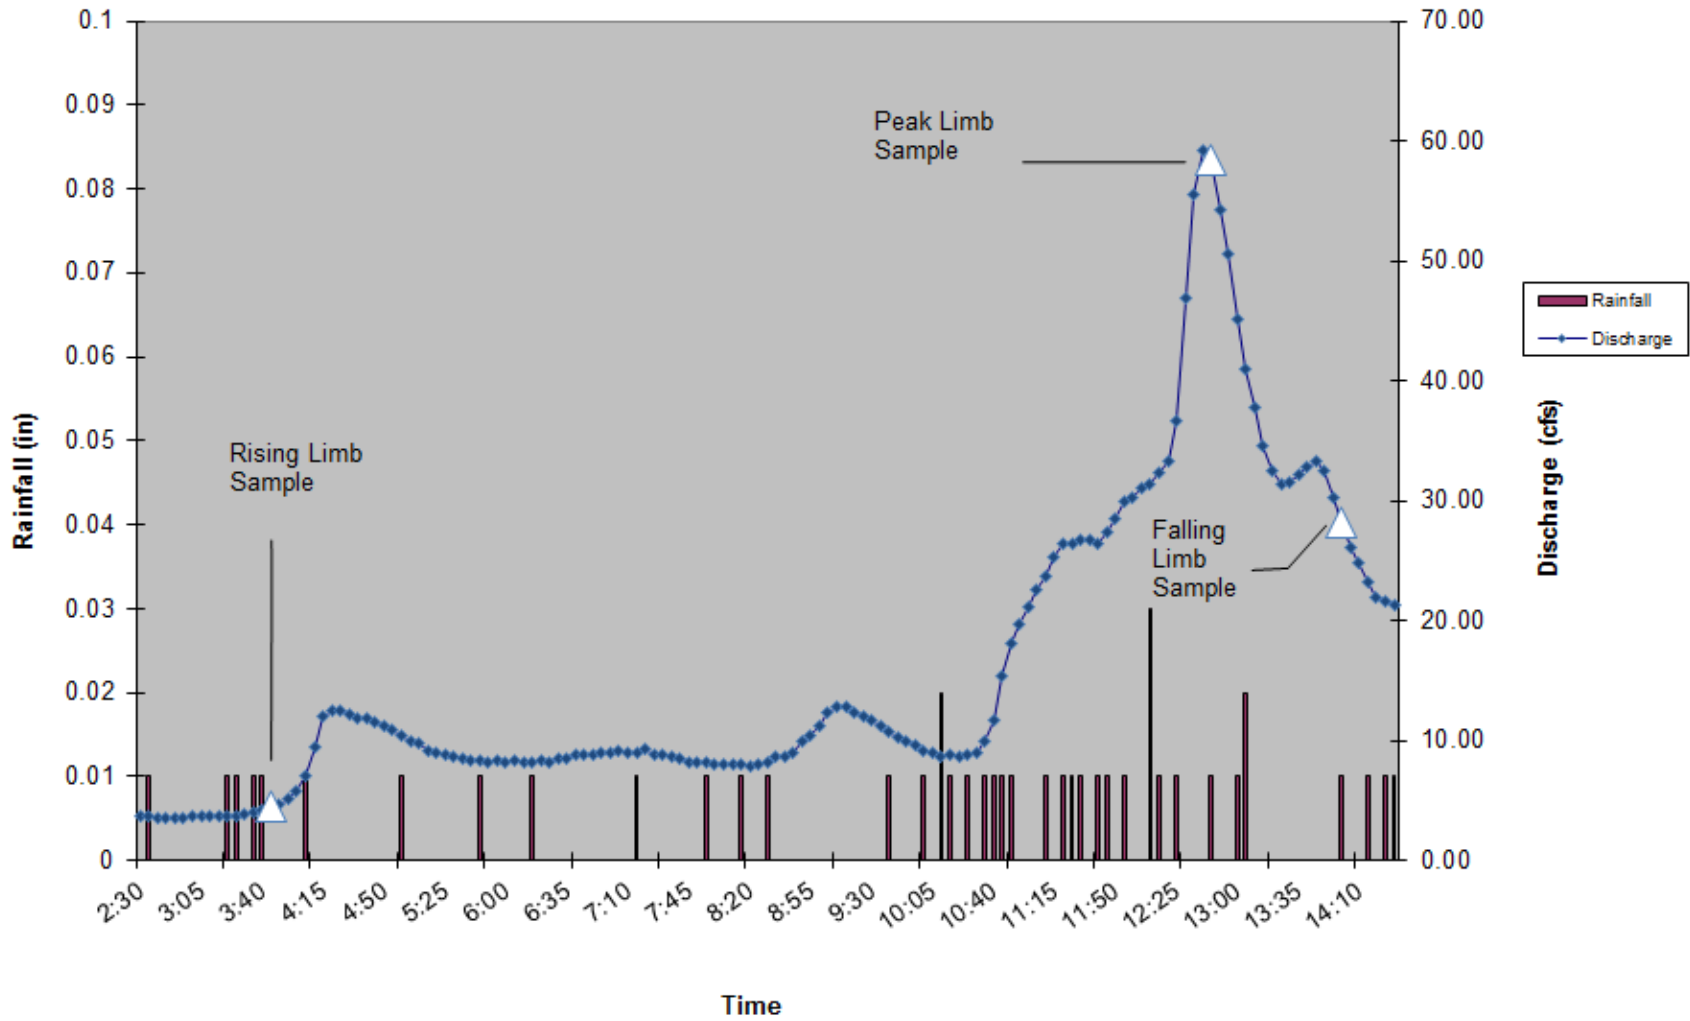
Hydrograph for December 23, 2013 Storm Church Creek

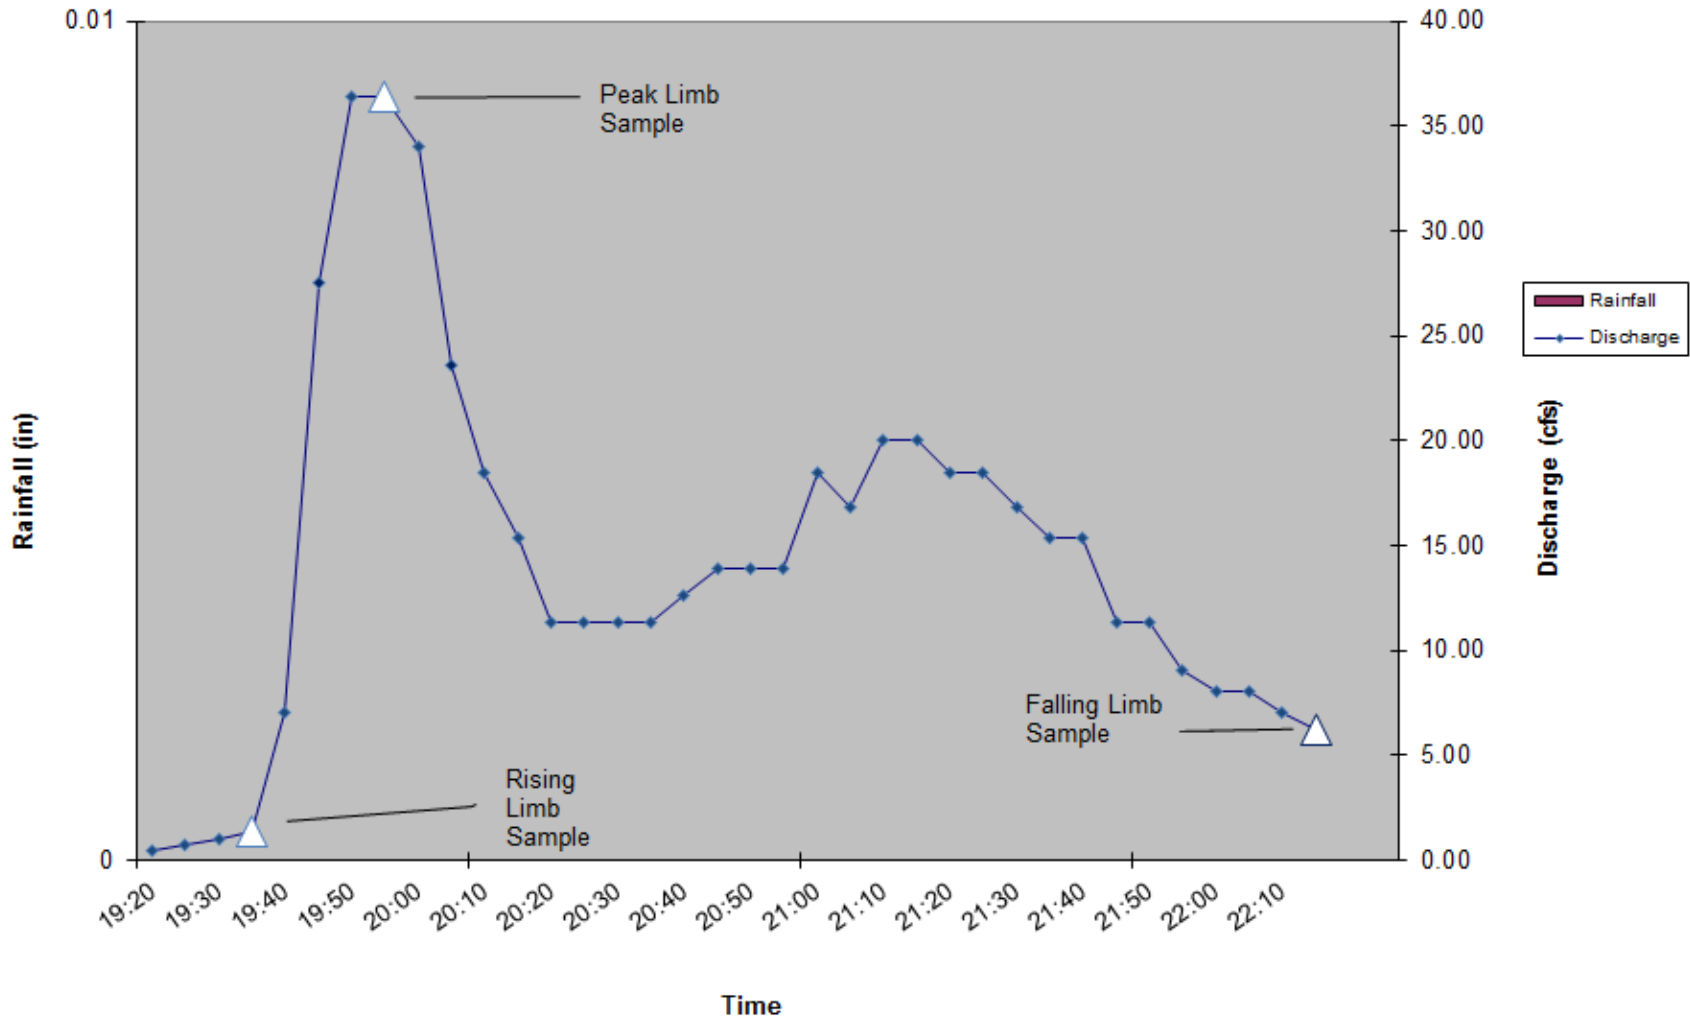
Hydrograph for May 27, 2014 Storm Church Creek

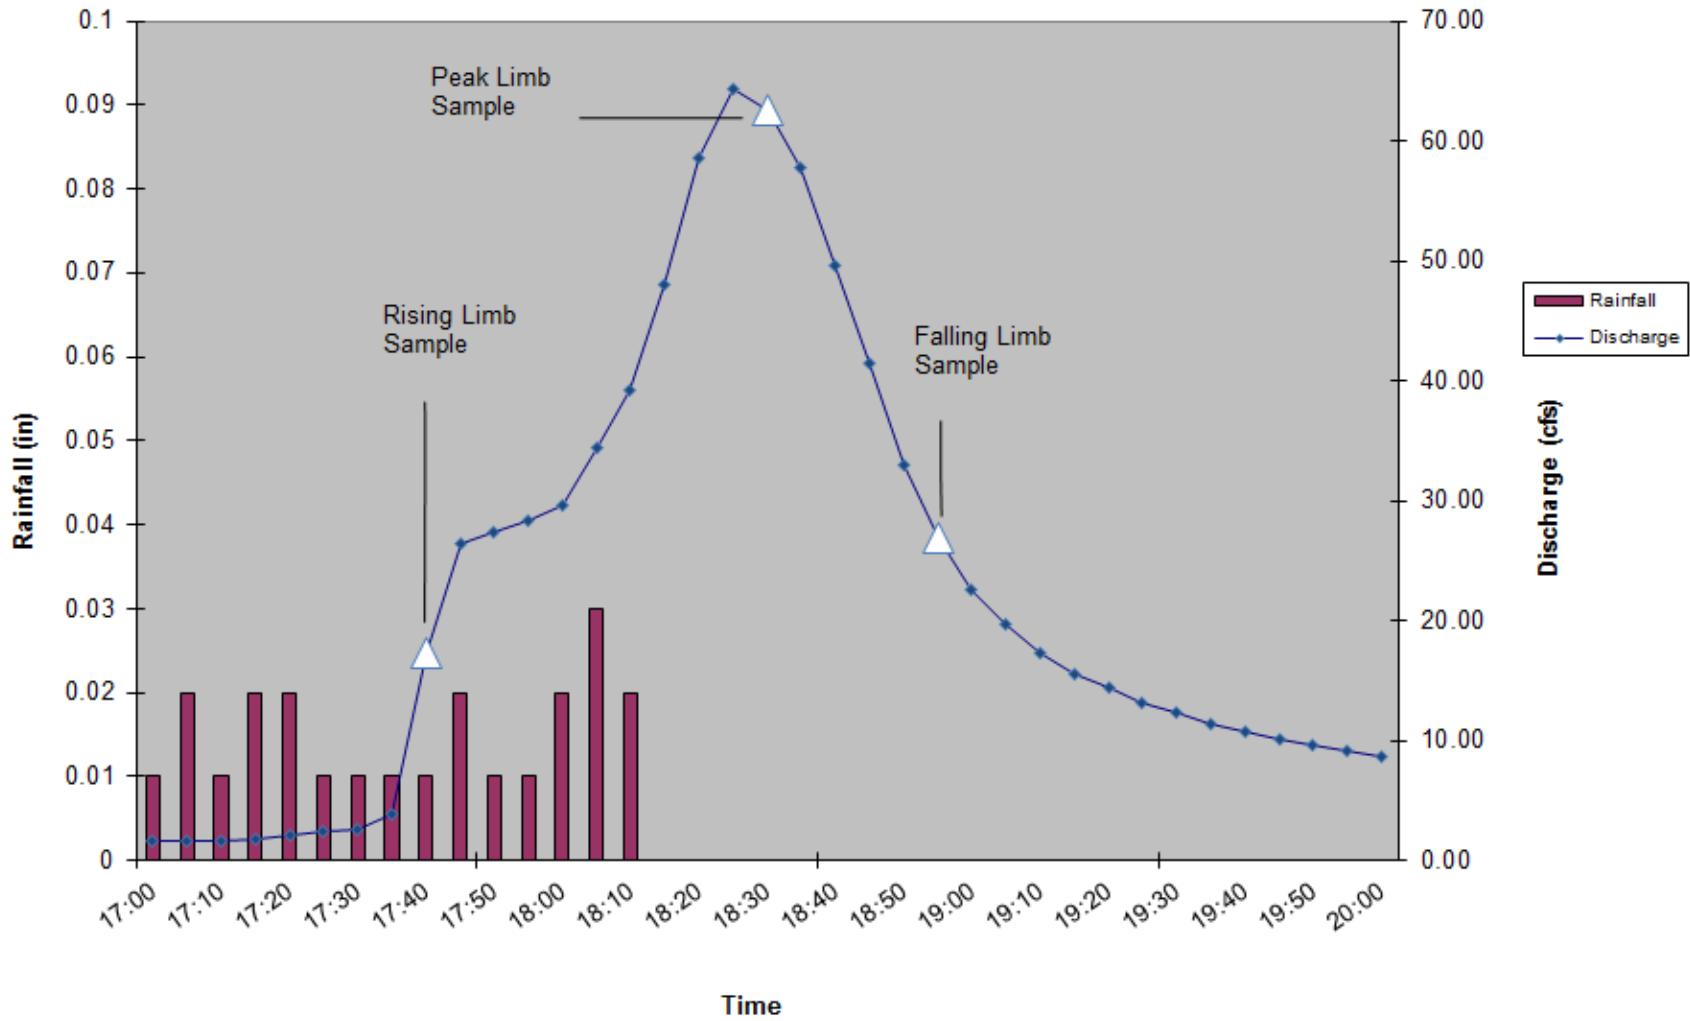
Hydrograph for June 19, 2014 Storm Church Creek

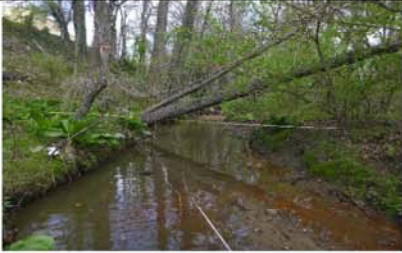
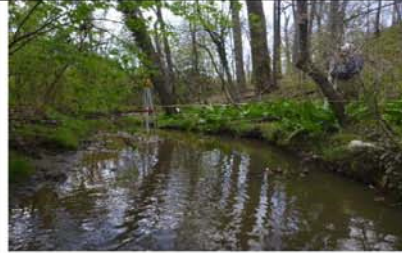
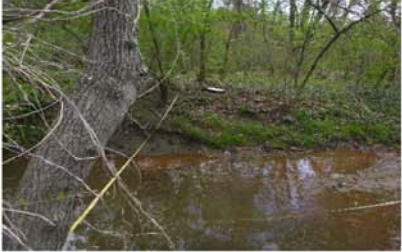
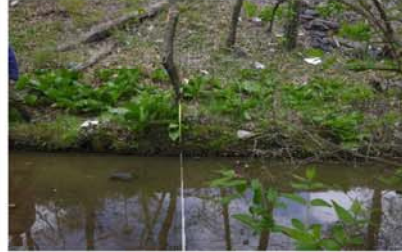
2014 Geomorphic Assessment Results	
				Bankfull Width (W_{bkt}) (feet)	11.4

Mean Depth (d_{bkt}) (feet)	0.7
				Bankfull Cross-sectional Area (A_{bkt}) (feetz)	8.0
Upstream View		Downstream View		Width/Depth Ratio (W_{bkt}/d_{bkt})	16.1
				Width of Flood-prone Area (W_{fpa}) (feet)	19.0
Left Bank View		Right Bank View		Entrenchment Ratio (ER) = W_{fpa}/W_{bkt}	1.7
				Channel Materials D_{50} (millimeters)	0.89
Left Bank View		Right Bank View		Water Surface Slope (S)	0.003
				Sinuosity (K) = stream length/valley length	<1.2
Left Bank View		Right Bank View		Adjustments?	Sin ↑ ER ↓
				STREAM TYPE	F5/4

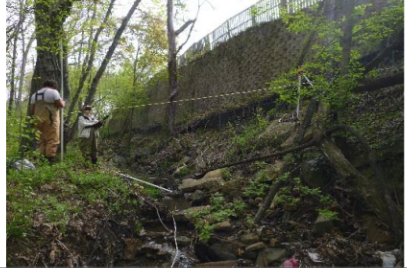
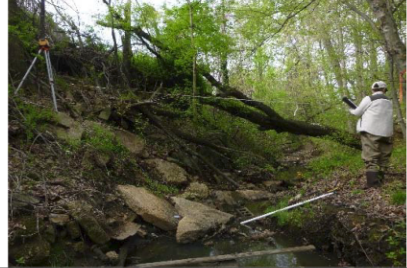
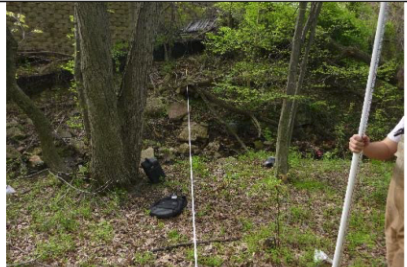
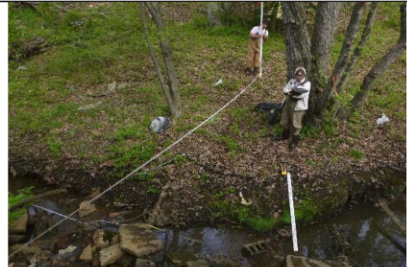
2014 Geomorphic Assessment Results	
Upstream View		Downstream View		Bankfull Width (W_{bkt}) (feet)	7.8

Mean Depth (d_{bkt}) (feet)	0.8
				Bankfull Cross-sectional Area (A_{bkt}) (feet ²)	6.1
Left Bank View		Right Bank View		Width/Depth Ratio (W_{bkt}/d_{bkt})	9.9
				Width of Flood-prone Area (W_{fpa}) (feet)	12.1
Left Bank View		Right Bank View		Entrenchment Ratio (ER) = W_{fpa}/W_{bkt}	1.6
				Channel Materials D_{50} (millimeters)	11
Left Bank View		Right Bank View		Water Surface Slope (S)	0.014
				Sinuosity (K) = stream length/valley length	<1.2
Left Bank View		Right Bank View		Adjustments?	Sin ↑ ER ↓
				STREAM TYPE	G4c

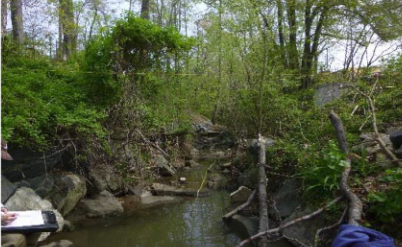
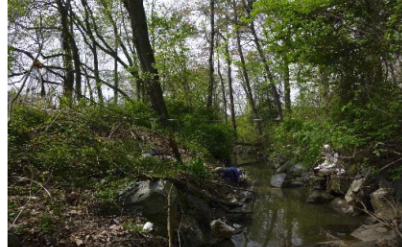
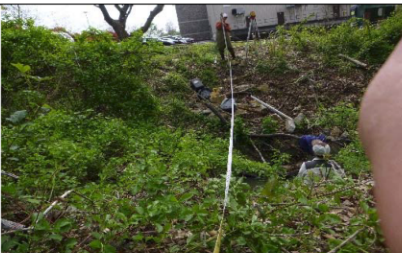
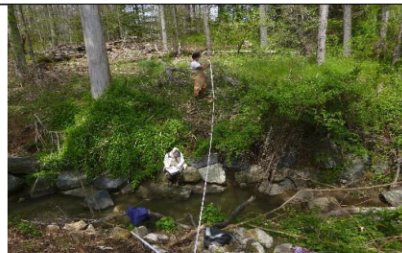
2014 Geomorphic Assessment Results	
<p style="text-align: center;">Upstream View</p>		<p style="text-align: center;">Downstream View</p>		Bankfull Width (W_{bkf}) (feet)	7.3
				Mean Depth (d_{bkf}) (feet)	1.0

Bankfull Cross-sectional Area (A_{bkf}) (feet ²)	7.4
				Width/Depth Ratio (W_{bkf}/d_{bkf})	7.3
<p style="text-align: center;">Left Bank View</p>		<p style="text-align: center;">Right Bank View</p>		Width of Flood-prone Area (W_{fpa}) (feet)	9.6
				Entrenchment Ratio (ER) = W_{fpa}/W_{bkf}	1.3
<p style="text-align: center;">Left Bank View</p>		<p style="text-align: center;">Right Bank View</p>		Channel Materials D_{50} (millimeters)	9
				Water Surface Slope (S)	0.003
<p style="text-align: center;">Left Bank View</p>		<p style="text-align: center;">Right Bank View</p>		Sinuosity (K) = stream length/valley length	<1.2
				Adjustments?	Sin ↑
				STREAM TYPE	G4c

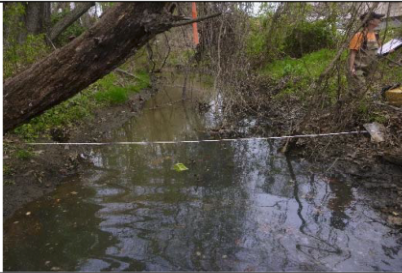
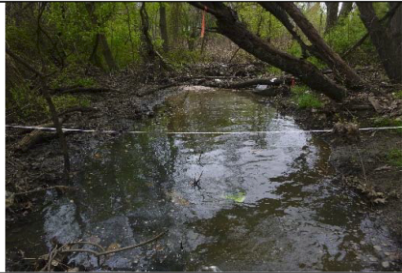
2014 Geomorphic Assessment Results	
Upstream View		Downstream View		Bankfull Width (W_{bkf}) (feet)	10.8
				Mean Depth (d_{bkf}) (feet)	1.4
Left Bank View		Right Bank View		Bankfull Cross-sectional Area (A_{bkf}) (feet ²)	9.1
				Width/Depth Ratio (W_{bkf}/d_{bkf})	12.8
				Width of Flood-prone Area (W_{fpa}) (feet)	38.0
				Entrenchment Ratio (ER) = W_{fpa}/W_{bkf}	3.5
				Channel Materials D_{50} (millimeters)	0.74
				Water Surface Slope (S)	0.001
				Sinuosity (K) = stream length/valley length	<1.2
				Adjustments?	Sin ↑
				STREAM TYPE	C5

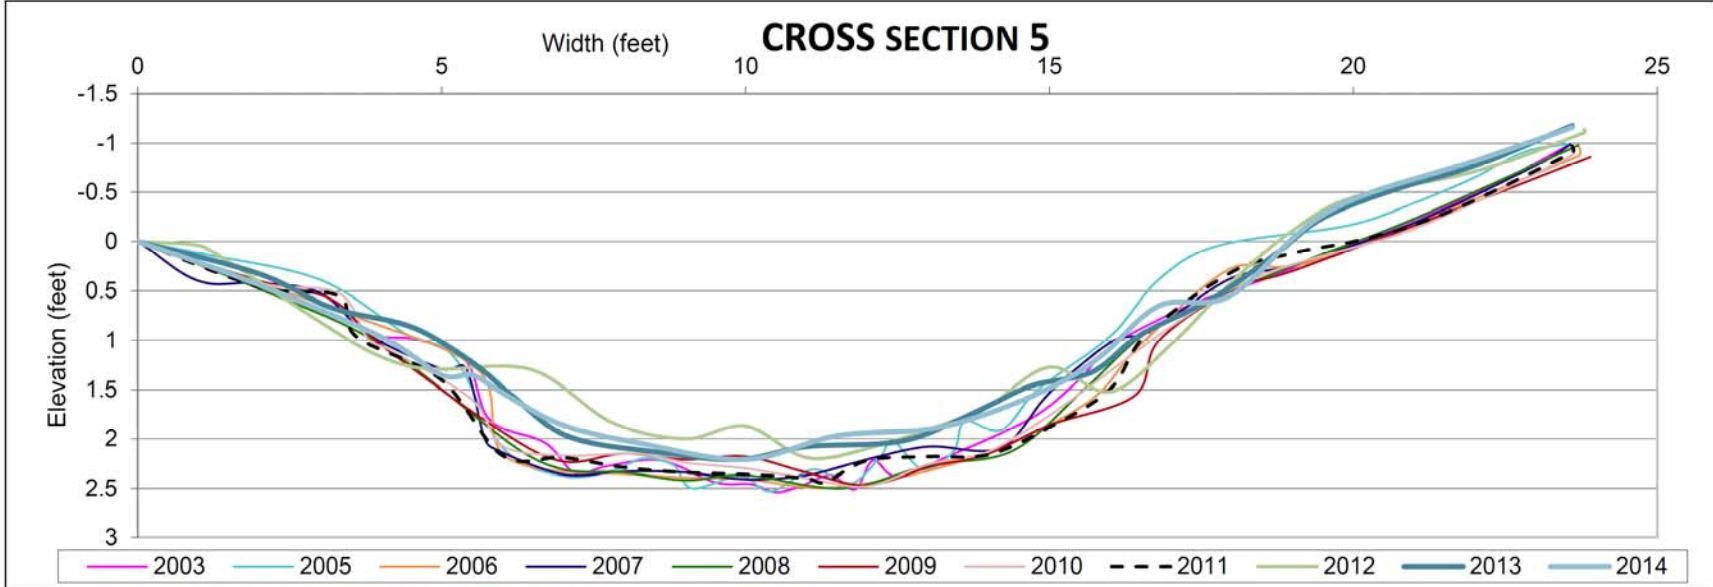
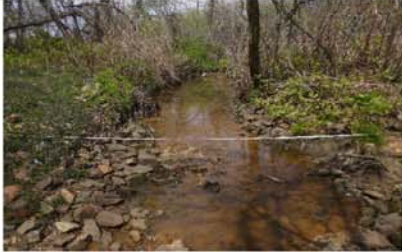
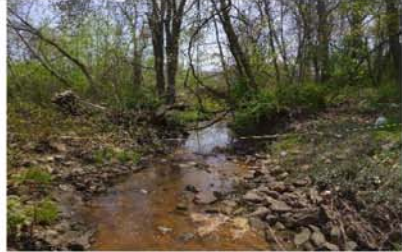
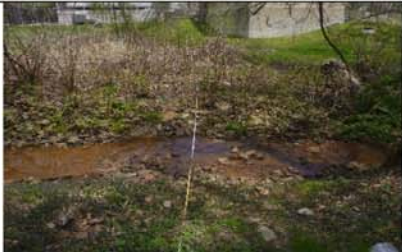
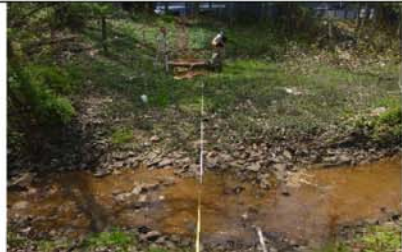
2014 Geomorphic Assessment Results	
<p>Upstream View</p>		<p>Downstream View</p>		Bankfull Width (W_{bkt}) (feet)	9.8

Mean Depth (d_{bkt}) (feet)	0.5
<p>Left Bank View</p>		<p>Right Bank View</p>		Bankfull Cross-sectional Area (A_{bkt}) (feet ²)	5.2
				Width/Depth Ratio (W_{bkt}/d_{bkt})	18.5
				Width of Flood-prone Area (W_{fpa}) (feet)	15.9
				Entrenchment Ratio (ER) = W_{fpa}/W_{bkt}	1.6
				Channel Materials D_{50} (millimeters)	75
				Water Surface Slope (S)	0.013
				Sinuosity (K) = stream length/valley length	<1.2
				Adjustments?	Sin ↑ ER ↓
				STREAM TYPE	F3

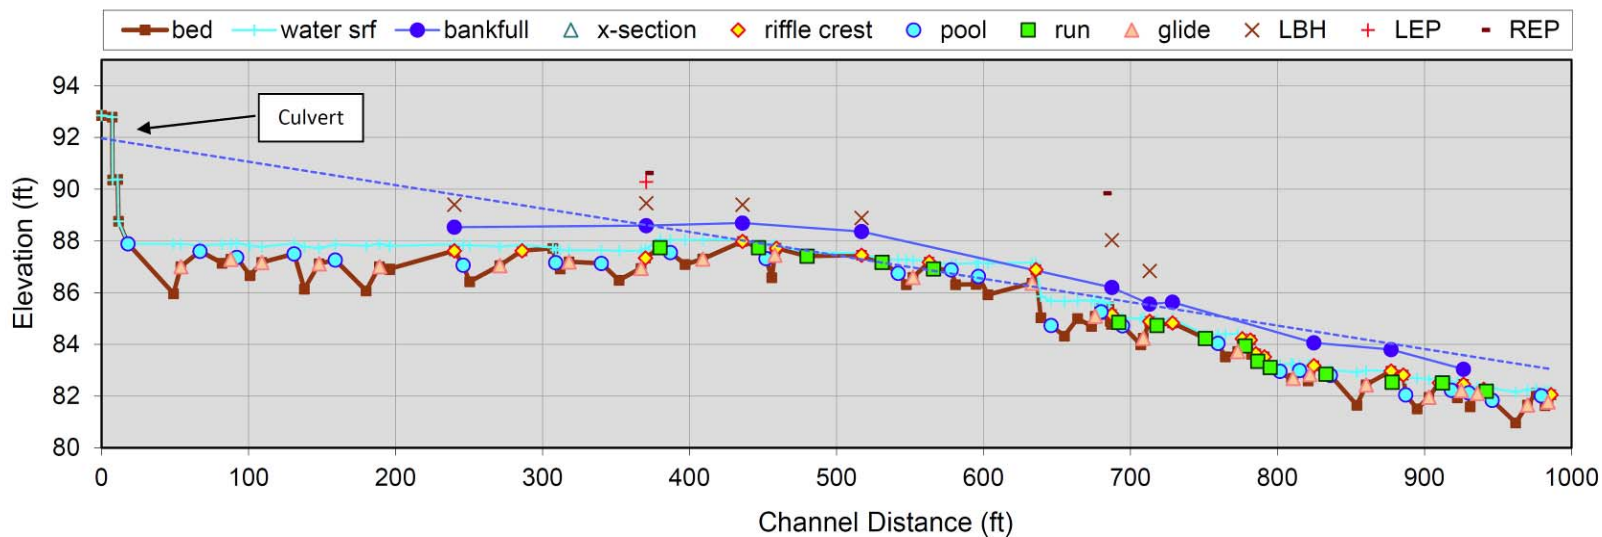
Church Creek Longitudinal Profile

Church Creek 2008 - 2014

— 2008 Bed — 2009 Bed — 2010 Bed — 2011 Bed — 2012 Bed — 2013 Bed — 2014 Bed
