**CHEMICAL, BIOLOGICAL, AND PHYSICAL
CHARACTERIZATION
OF THE CHURCH CREEK AND
PAROLE PLAZA NPDES MONITORING STATIONS: 2016 -
2017**

FINAL REPORT

Anne Arundel County
Department of Public Works
Watershed Protection and Restoration Program
2662 Riva Road
Annapolis, MD 21401

February 8, 2018

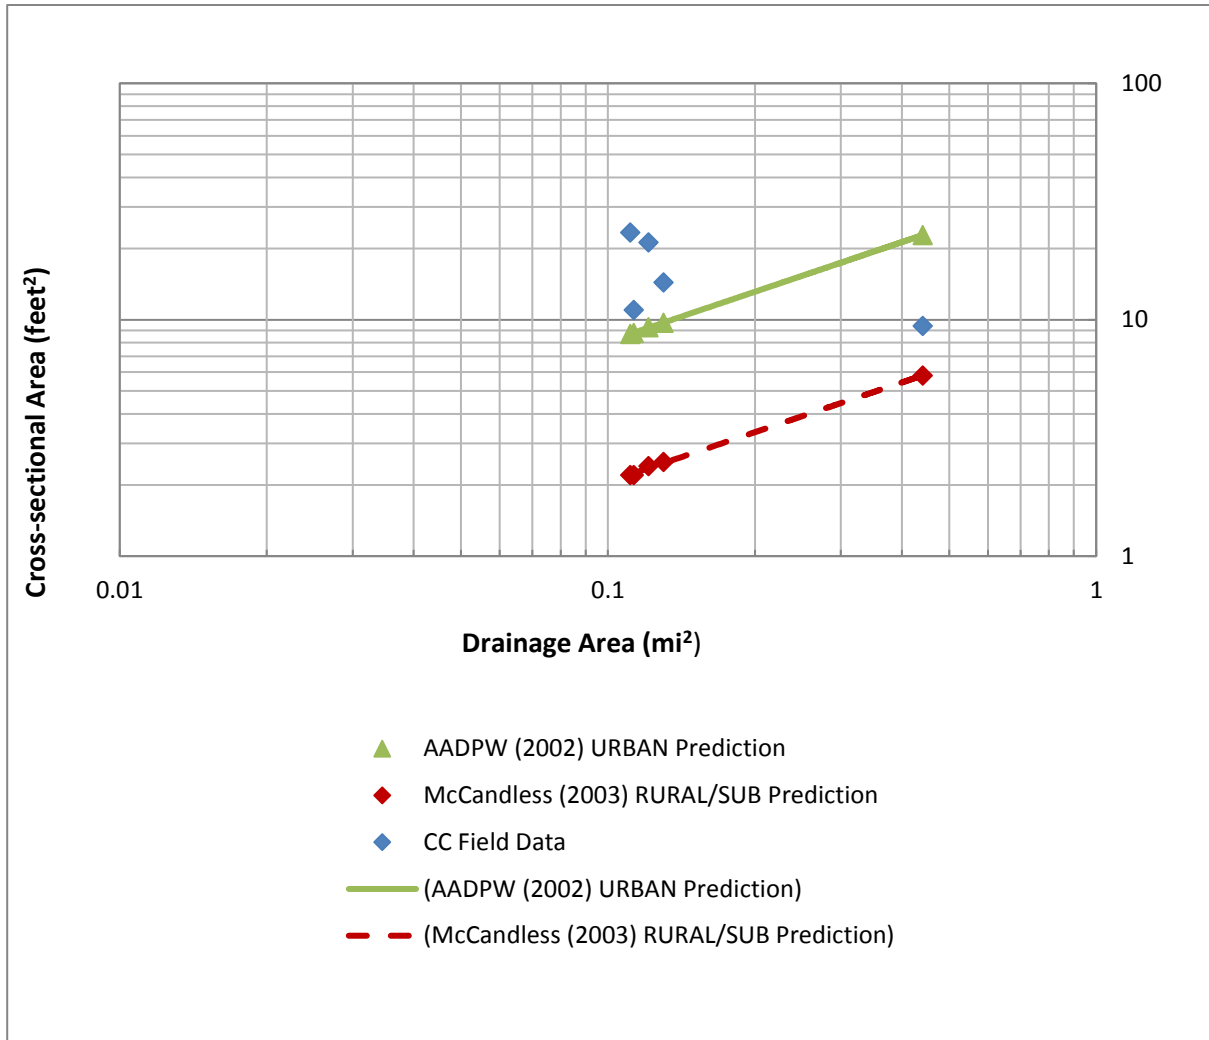
Figure 4-13. Comparison of bankfull channel cross-sectional area to drainage area (CC = Church Creek, 2017 data)

Bankfull channel dimensions (cross-sectional area, width, depth) in the Church Creek study area showed significant departure from expected values, as derived from Maryland Coastal Plain regional relationships of bankfull channel geometry (McCandless 2003). Almost all dimensions were generally larger in the Church Creek study area (see Figures 4-13, 4-14, and 4-15), and were often more similar to relationships of bankfull channel geometry derived from gaged urban watersheds located in the Coastal Plain. These relationships were developed for an urban stream restoration project in Anne Arundel County (AADPW 2002). Values measured in 2017 were slightly higher than prior assessment results. This reflects the higher level of imperviousness in the study area, as compared to the lower impervious levels in the drainage areas used to develop the regional relationship data. The results suggest that this stream has become enlarged as a result of the high imperviousness, and is both wider and deeper than stable C and E type channels located in rural/suburban watersheds of the coastal plain. It should be noted, however, that locating bankfull elevations in the field on actively eroding, previously stabilized, or incising channels is difficult and not recommended due to unreliable and/or misleading indicators, and instead bankfull elevations should be estimated using the aforementioned regional curves (Rosgen, personal communication, May 2011). Where bankfull indicators were suspect or questionable, the indicator approximating the rural/suburban regional curve for bankfull area was used to estimate bankfull elevations. Additionally, the Rosgen method is best used on streams that are free to adjust their lateral boundaries under the current discharge regime experienced by the system (Rosgen 1996). Given the high levels of rip rap and/or concrete rubble armoring found in the reaches containing cross-sections 2, 3 and 5, the accurate determination of the bankfull indicators in the field at these locations is problematic.
