**CHEMICAL, BIOLOGICAL, AND PHYSICAL
CHARACTERIZATION
OF THE CHURCH CREEK AND
PAROLE PLAZA NPDES MONITORING
STATIONS: 2017 - 2018**

Anne Arundel County
Department of Public Works
Watershed Protection and Restoration Program
2662 Riva Road
Annapolis, MD 21401

Versar, Inc.
9200 Rumsey Road
Columbia, MD 21045

October 30, 2018

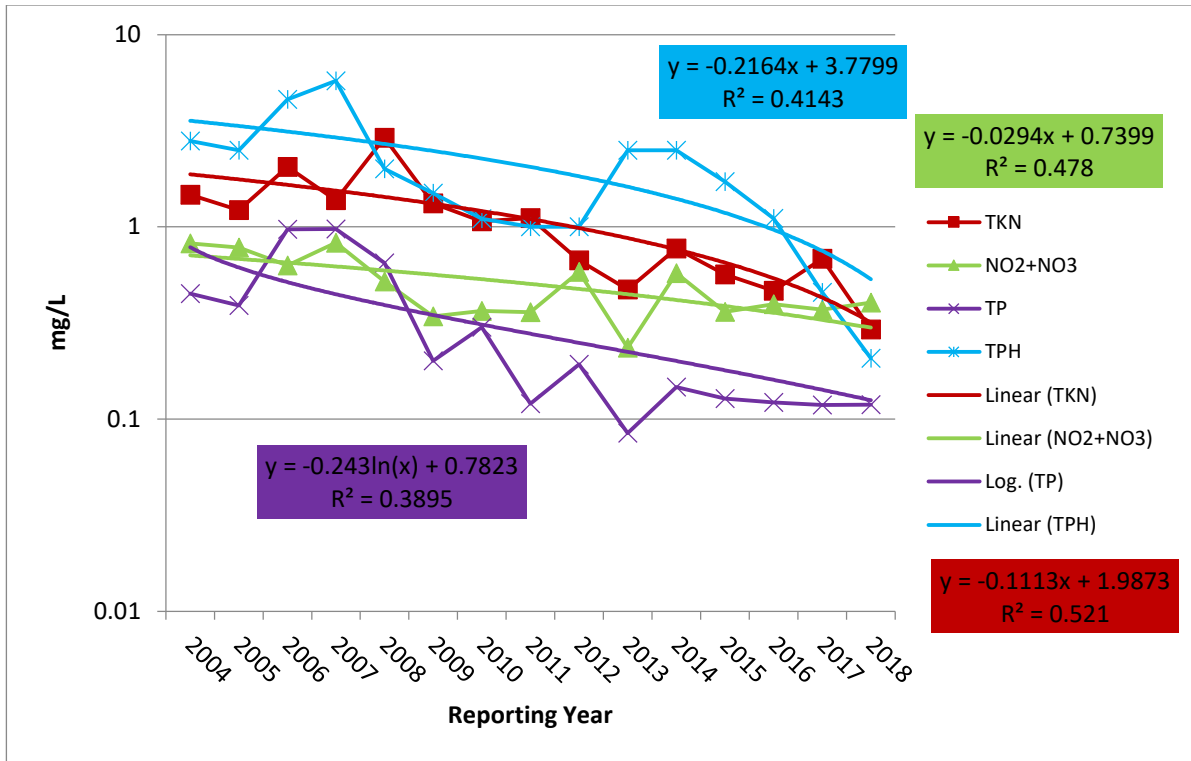
Figure 4-1. Parole Plaza station long-term monitoring: annual EMCs (TKN, NO₂+NO₃, TP, TPH; mg/L)

Annual average EMCs were plotted for each monitoring year. Plots were constructed to illustrate the impact that construction activity and redevelopment of the Annapolis Towne Centre site has had on water quality within the study reach. Figures 4-1 through 4-5 show how EMCs have changed from 2004 to 2018 at the Parole Monitoring Station. Nearly every concentration rose substantially between 2006 and 2007 when the majority of the site work took place at the Towne Centre. These concentrations fell notably in 2008, as the site stabilized. This downward trend continued in 2009. The reduction in pollutant concentrations stabilized in 2010 and 2011 possibly indicating that the stream has reached a post-construction baseline. The 2013 rise in TPH was due to an increase in the detection limit, and may not be associated with an actual increase in concentration, as greater than 95% of TPH concentrations fell below the detection limit. It is important to note that the 2013 data included in these plots do not include summer season data (Versar 2013), which is often the season that produces the highest EMCs for many of the parameters. At Parole Plaza, annual pollutant concentrations in 2018 slightly decreased for most parameters, except for BOD and nitrate-nitrite which slightly increased. Overall, with the exception of copper and *E. coli*, there is evidence of a weak to moderate downward trend in EMC values at Parole Plaza since approximately 2006. For copper, the concentration trend is downward, but weaker. For *E. coli*, the trend is sharply upward and is the only parameter at the Parole Plaza station showing such a trend.

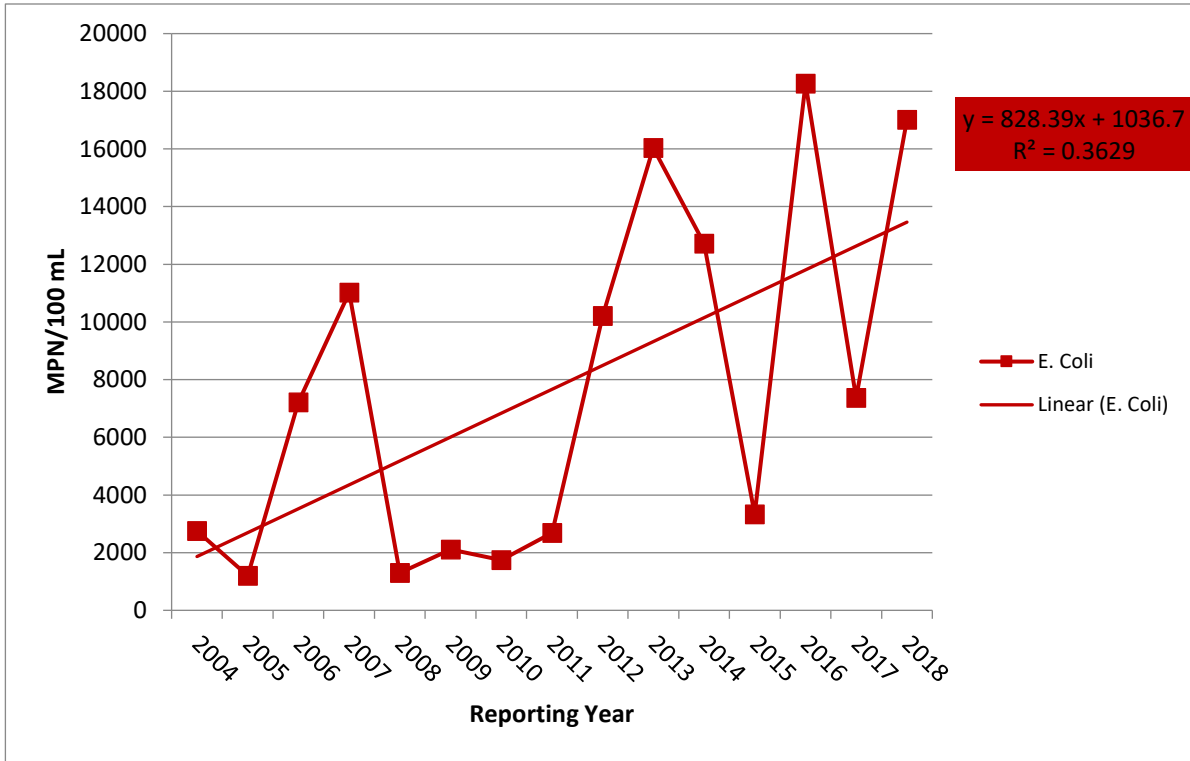
Figure 4-5. Parole Plaza station long-term monitoring: annual EMCs (*E. coli*; MPN/100 mL)

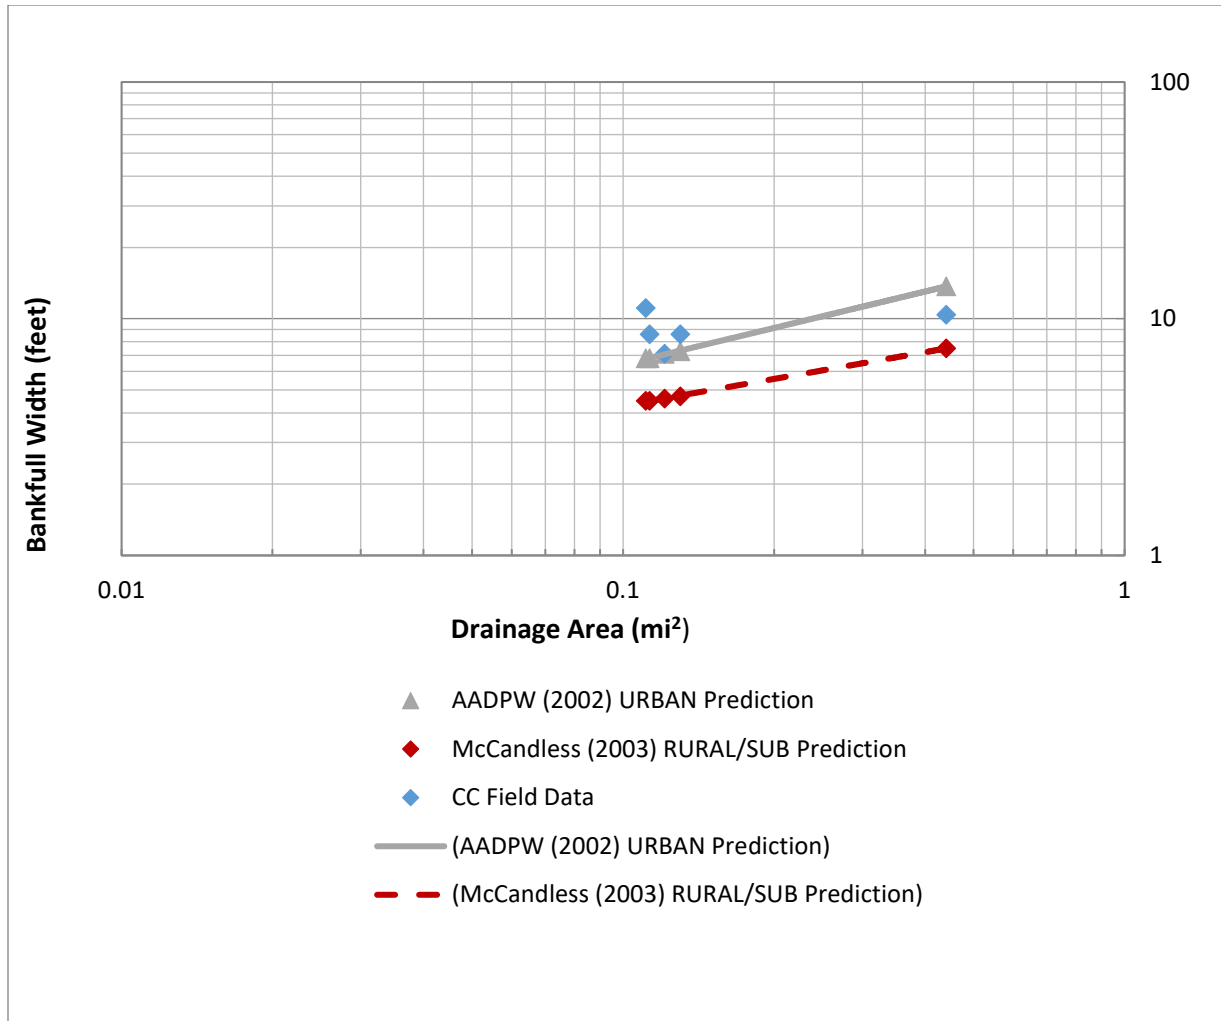
Figure 4-15. Comparison of bankfull width to drainage area (CC = Church Creek, 2018 data)

Bankfull channel dimensions (cross-sectional area, width, depth) in the Church Creek study area showed significant departure from expected values, as derived from Maryland Coastal Plain regional relationships of bankfull channel geometry (McCandless 2003). Almost all dimensions were generally larger in the Church Creek study area (see Figures 4-13, 4-14, and 4-15), and were often more similar to relationships of bankfull channel geometry derived from gaged urban watersheds located in the Coastal Plain. These relationships were developed for an urban stream restoration project in Anne Arundel County (AADPW 2002). Values measured in 2018 were slightly higher than prior assessment results. This reflects the higher level of imperviousness in the study area, as compared to the lower impervious levels in the drainage areas used to develop the regional relationship data. The results suggest that this stream has become enlarged as a result of the high imperviousness, and is both wider and deeper than stable C and E type channels located in rural/suburban watersheds of the coastal plain. It should be noted, however, that locating bankfull elevations in the field on actively eroding, previously stabilized, or incising channels is difficult and not recommended due to unreliable and/or misleading indicators, and instead bankfull elevations should be estimated using the aforementioned regional curves (Rosgen, personal communication, May 2011). Where bankfull indicators were suspect or questionable, the indicator approximating the rural/suburban regional curve for bankfull area was used to estimate bankfull elevations. Additionally, the Rosgen method is best used on streams that are free to adjust their lateral boundaries under the current discharge regime experienced by the system (Rosgen 1996). Given the high levels of rip rap and/or concrete rubble armoring found in the reaches containing cross-sections 2, 3 and 5, the accurate determination of the bankfull indicators in the field at these locations is problematic.

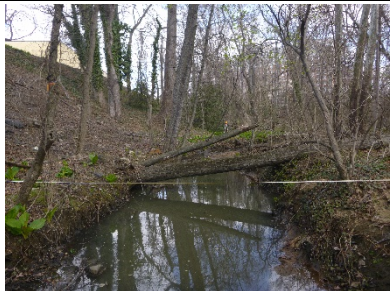
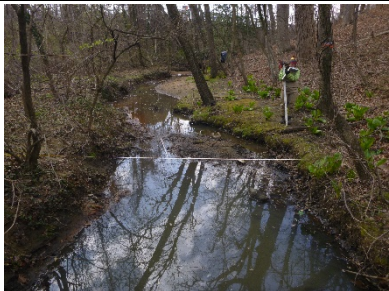
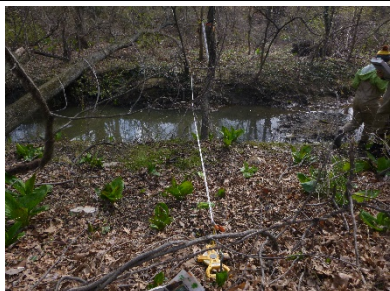
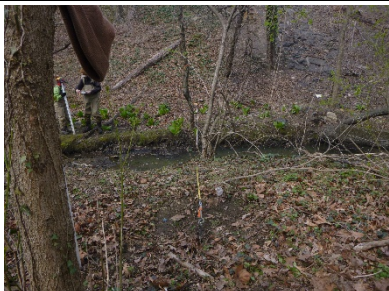
2018 Geomorphic Assessment Results	
		Bankfull Width (W_{bkf}) (feet)	11.1
		Mean Depth (d_{bkf}) (feet)	1.0
		Bankfull Cross-sectional Area (A_{bkf}) (feet ²)	11.3
		Width/Depth Ratio (W_{bkf}/d_{bkf})	10.9
Upstream View	Downstream View	Width of Flood-prone Area (W_{fpa}) (feet)	19.2

Entrenchment Ratio (ER) = W_{fpa}/W_{bkf}	1.7
		Channel Materials D_{50} (millimeters)	1.4
		Water Surface Slope (S)	0.0015
		Sinuosity (K) = stream length/valley length	<1.2
		Adjustments?	Sin ↑, ER ↓, W/D ↑
Left Bank View	Right Bank View	STREAM TYPE	F4

The most upstream reach on the Parole Plaza Tributary, XS-1, has been undergoing a transition from a Rosgen C4/5 channel to a F4 channel, as evidenced by changes in the width/depth and entrenchment ratios. Previous monitoring in 2010 suggested that this reach was shifting from an E to a C channel because of channel degradation, a notable increase in sediment deposition, and point bar formation along the right bank just downstream. Additional degradation

between 2010 and 2012 suggest that the channel had lost connectivity to the floodplain and had likely shifted to an F stream type. Mid-channel degradation continued between 2014 and 2018 showing approximately a 0.85 feet difference. In 2018, geomorphic assessment parameters continue to support the classification of this reach as an F4 channel. The channel evolution is supported by a 69.0% increase in channel cross-sectional area since 2003 and considerable widening and mid-channel bar formation immediately downstream, which is indicative of a channel that is not stable and is undergoing a widening and degradation phase. Cross-sectional area at this location has been increasing every year since 2009. Left bank widening was also apparent between 2013 and 2014 monitoring years and remained consistent during 2015 and through 2018. However, it is also important to acknowledge that this cross-section is no longer located in a riffle feature and is now in a glide feature, which affects the channel dimensions and complicates classification using the Rosgen system.

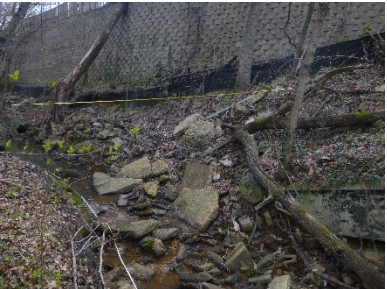
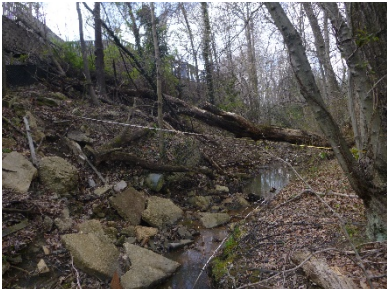
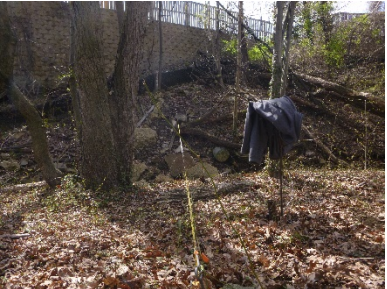
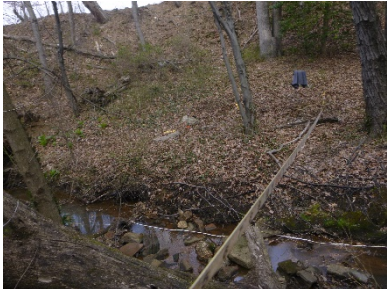
2018 Geomorphic Assessment Results	
Upstream View	Downstream View	Bankfull Width (W_{bkf}) (feet)	8.6
		Mean Depth (d_{bkf}) (feet)	1.0
		Bankfull Cross-sectional Area (A_{bkf}) (feet ²)	9.0
		Width/Depth Ratio (W_{bkf}/d_{bkf})	8.3
		Width of Flood-prone Area (W_{fpa}) (feet)	12.7
		Entrenchment Ratio (ER) = W_{fpa}/W_{bkf}	1.5
		Channel Materials D_{50} (millimeters)	10.0
		Water Surface Slope (S)	0.014
		Sinuosity (K) = stream length/valley length	<1.2
		Adjustments?	Sin ↑, ER ↓

STREAM TYPE	G4c
Left Bank View	Right Bank View

The next site downstream on the Parole Plaza Tributary, XS-2, was classified as a Rosgen G4c channel based on its continued low width/depth ratio, low slope, and gravel substrate. Since 2012 its entrenchment ratio was slightly higher than those typical of G streams, but in 2017 and 2018 the ratio of entrenchment decreased. This reach was previously classified as an E type channel; however, it was noted that the reach was actively degrading and widening. While E streams are typically more sinuous, this segment has been noticeably straightened and stabilized by a retaining wall and rubble/fill along the left bank (facing downstream). The lack of sinuosity in the channel has likely resulted in instability, and consequently resulted in a shift to a less-stable form.

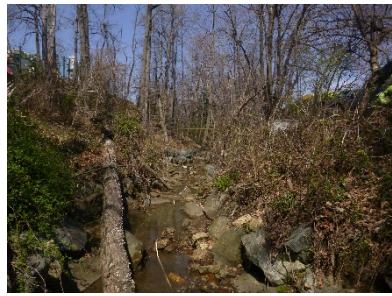
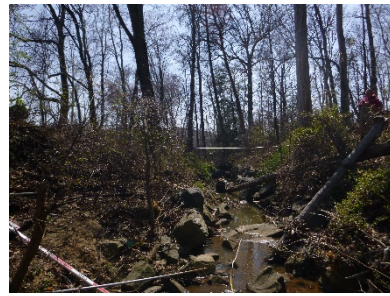
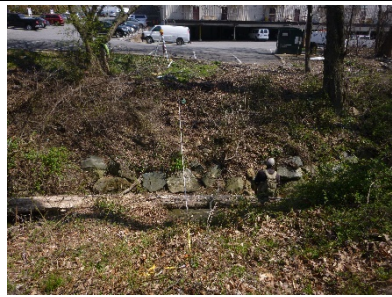
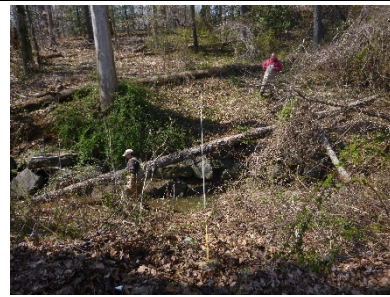
CROSS SECTION 3

Bankfull Width (W_{bkt}) (feet)	7.1
Mean Depth (d_{bkt}) (feet)	0.9
Bankfull Cross-sectional Area (A_{bkt}) (feet ²)	6.1
Width/Depth Ratio (W_{bkt}/d_{bkt})	8.2
Width of Flood-prone Area (W_{fpa}) (feet)	9.3
Entrenchment Ratio (ER) = W_{fpa}/W_{bkt}	1.3
Channel Materials D_{50} (millimeters)	18
Water Surface Slope (S)	0.0175
Sinuosity (K) = stream length/valley length	<1.2
Adjustments?	Sin ↑
STREAM TYPE	G4c

Site XS-3, located along the restored segment of Parole Plaza Tributary, was not classified until 2013, allowing 3 years after restoration for the area to settle and stabilize. In 2013 and 2014 it was classified as a Rosgen G4c channel based on its low entrenchment ratio, low width/depth ratio, and low slope. In 2015 XS-3 remained a G type channel; however, the substrate had become coarser resulting in a G4/3c classification. Variable coarseness caused XS-3 to return to a G4c during the 2016 survey and it has maintained that classification since. Before restoration, this cross-section was classified as a Rosgen G5c channel; however, since the Rosgen scheme was developed to classify natural channels, or those that are shaped naturally by fluvial processes, it was deemed inappropriate to classify immediately after construction. This section is still heavily armored and reliable bankfull indicators are not easily identified. Little change has been documented at XS-3 but the erosion behind the armored bank documented in the 2017 survey has aggraded.

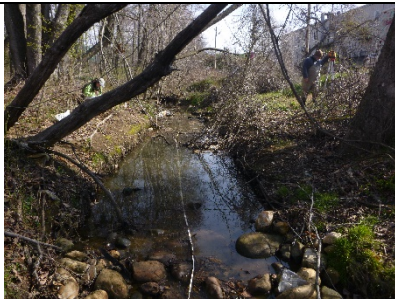
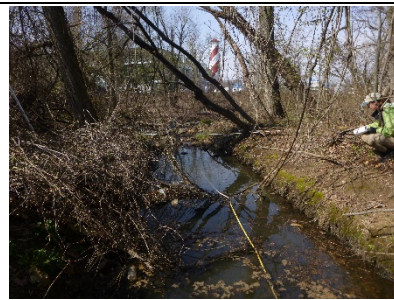
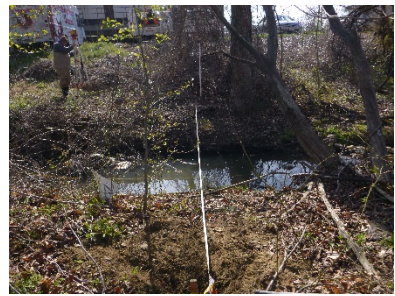
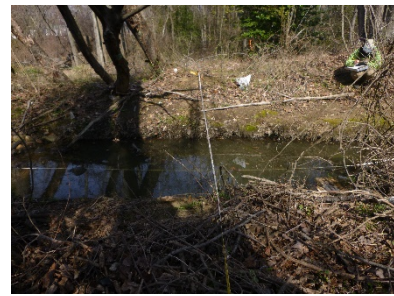
CROSS SECTION 4

Bankfull Width (W_{bkt}) (feet)	8.6
Mean Depth (d_{bkt}) (feet)	1.6
Bankfull Cross-sectional Area (A_{bkt}) (feet ²)	13.9
Width/Depth Ratio (W_{bkt}/d_{bkt})	5.3
Width of Flood-prone Area (W_{fpa}) (feet)	24
Entrenchment Ratio (ER) = W_{fpa}/W_{bkt}	2.8
Channel Materials D_{50} (millimeters)	8.8
Water Surface Slope (S)	0.01
Sinuosity (K) = stream length/valley length	<1.2
Adjustments?	Sin ↑
STREAM TYPE	E4/5
