**CHEMICAL, BIOLOGICAL, AND PHYSICAL
CHARACTERIZATION
OF THE CHURCH CREEK AND
PAROLE PLAZA NPDES MONITORING
STATIONS: 2018 - 2019**

Anne Arundel County
Department of Public Works
Watershed Protection and Restoration Program
2662 Riva Road
Annapolis, MD 21401

Versar, Inc.
9200 Rumsey Road
Columbia, MD 21045

November 2019 FINAL

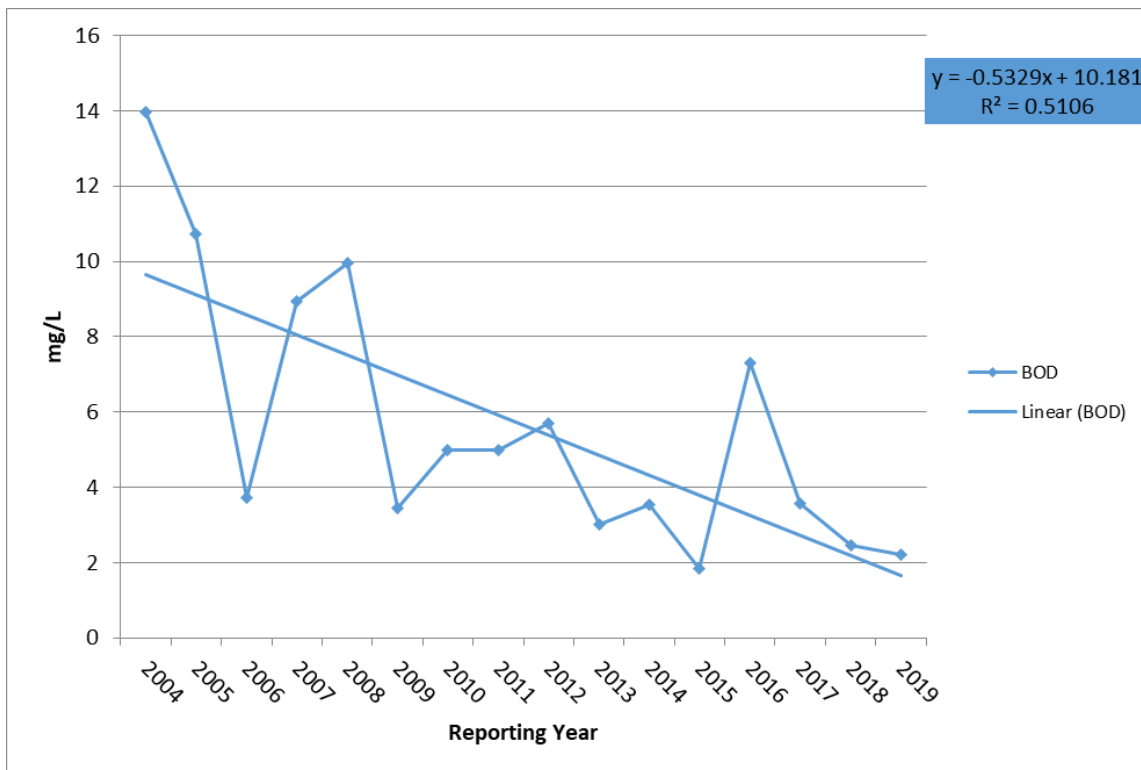
Figure 4-9. Church Creek station long-term monitoring: annual EMCs (BOD₅; mg/L)

Figures 4-6 through 4-10 show trends in average annual EMCs for the Church Creek monitoring station. Most pollutant concentrations decreased at Church Creek in 2019 compared to 2018 EMCs except for combined nitrate and nitrite. Note that the apparent rise in TPH at Church Creek in 2013 was due to an increase in the detection limit. Also, summer season concentrations were not included with the 2013 EMC data (Versar 2013).

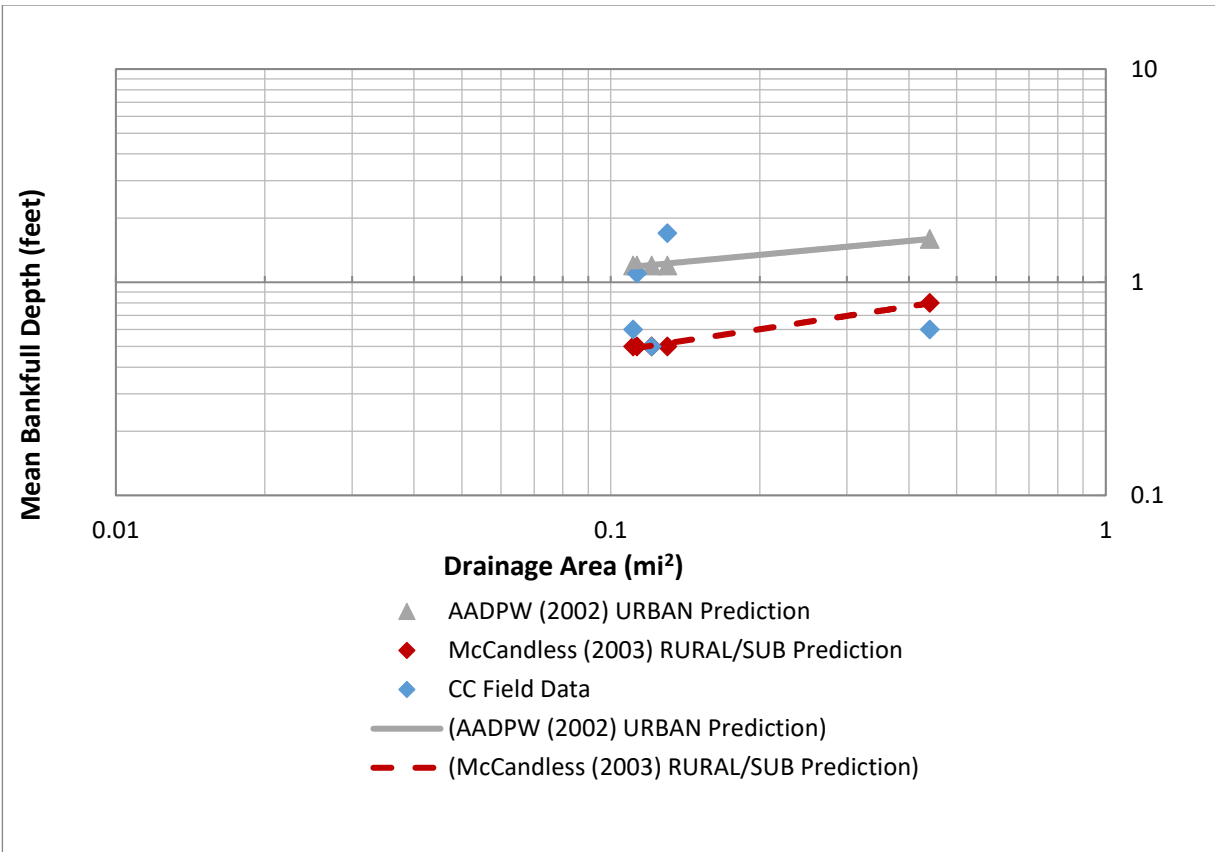
Figure 4-15. Comparison of mean bankfull depth to drainage area (CC = Church Creek, 2019 data)

Bankfull channel dimensions (cross-sectional area, width, depth) in the Church Creek study area showed departure from expected values, as derived from Maryland Coastal Plain regional relationships of bankfull channel geometry (McCandless 2003). Almost all dimensions were generally larger in the Church Creek study area (see Figures 4-14, 4-15, and 4-16), and were often more similar to relationships of bankfull channel geometry derived from gaged urban watersheds located in the Coastal Plain. These relationships were previously developed for an urban stream restoration project in Anne Arundel County (AADPW 2002). Recent dimensions have been slightly higher than previous assessment values. This reflects the higher level of imperviousness in the study area, as compared to the lower impervious levels in the drainage areas used to develop the regional relationship data. The results suggest that this stream has become enlarged as a result of the high imperviousness, and is both wider and deeper than stable C and E type channels located in rural/suburban watersheds of the coastal plain. It should be noted, however, that locating bankfull elevations in the field on actively eroding, previously stabilized, or incising channels is difficult and not recommended due to unreliable and/or misleading indicators, and instead bankfull elevations should be estimated using the aforementioned regional curves (Rosgen, personal communication, May 2011). Where bankfull indicators were suspect or questionable, the indicator approximating the rural/suburban regional curve for bankfull area was used to estimate bankfull elevations. Additionally, the Rosgen method is best used on streams that are free to adjust their lateral boundaries under the current discharge regime experienced by the system (Rosgen 1996). Given the high levels of rip rap and/or concrete rubble armoring found in the reaches containing cross-sections 2, 3 and 5, the accurate determination of the bankfull indicators in the field at these locations is problematic.

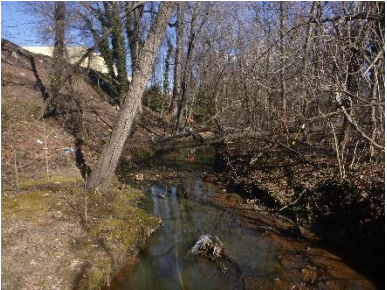
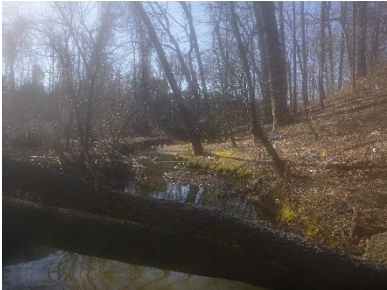
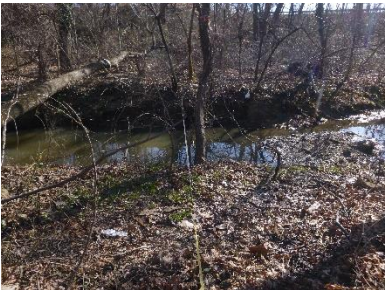
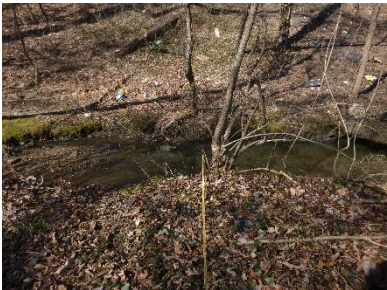
2019 Geomorphic Assessment Results	
		Bankfull Width (W_{bkt}) (feet)	11.8
		Mean Depth (d_{bkt}) (feet)	0.6
		Bankfull Cross-sectional Area (A_{bkt}) (feet ²)	7.2
		Width/Depth Ratio (W_{bkt}/d_{bkt})	19.2
Upstream View	Downstream View	Width of Flood-prone Area (W_{fpa}) (feet)	12.6

Entrenchment Ratio (ER) = W_{fpa}/W_{bkt}	1.1
		Channel Materials D_{50} (millimeters)	1.2
		Water Surface Slope (S)	0.0003
		Sinuosity (K) = stream length/valley length	<1.2
		Adjustments?	Sin ↑
Left Bank View	Right Bank View	STREAM TYPE	F5

The most upstream reach on the Parole Plaza Tributary, XS-1, has been undergoing a transition from a Rosgen C4/5 channel to a F4 channel, as evidenced by changes in the width/depth and entrenchment ratios. Previous monitoring in 2010 suggested that this reach was shifting from an E to a C channel because of channel degradation, a notable increase in sediment deposition, and point bar formation along the right bank just downstream. Additional degradation between 2010 and 2012 suggest that the channel had lost connectivity to the floodplain and had likely shifted to an F stream type. Mid-channel degradation continued between 2014 and 2019 showing approximately a 0.85-foot difference. In 2019, geomorphic assessment parameters continue to support the classification of this reach as an F4 channel. The channel evolution is supported by an 82.1% increase in channel cross-sectional area since 2003 and considerable widening and mid-channel bar formation immediately downstream, which is indicative of a channel that is not stable and is undergoing a widening and degradation phase. Cross-sectional area at this location has been increasing every year since 2009. Left bank widening was also apparent between 2013 and 2014 monitoring years, remained consistent during 2015 through 2018, and continued to widen in 2019. However, it is important to acknowledge that this cross-section is no longer located in a riffle feature and is now in a pool feature, which affects the channel dimensions and complicates classification using the Rosgen system.

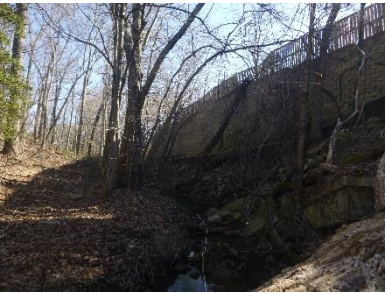
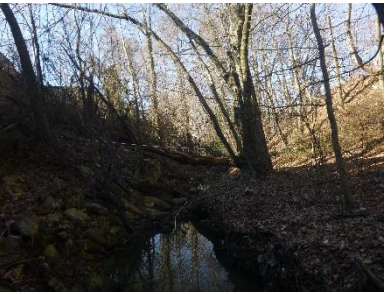
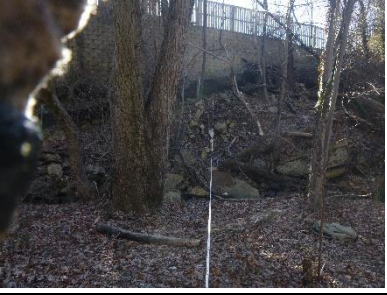
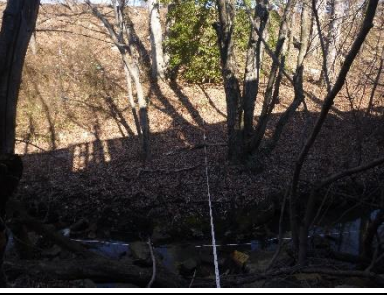
2019 Geomorphic Assessment Results	
Upstream View		Downstream View		Bankfull Width (W_{bkf}) (feet)	8.1

Mean Depth (d_{bkf}) (feet)	1.1
				Bankfull Cross-sectional Area (A_{bkf}) (feet ²)	8.5
Left Bank View		Right Bank View		Width/Depth Ratio (W_{bkf}/d_{bkf})	7.6
				Width of Flood-prone Area (W_{fpa}) (feet)	12.6
Left Bank View		Right Bank View		Entrenchment Ratio (ER) = W_{fpa}/W_{bkf}	1.6
				Channel Materials D_{50} (millimeters)	11.0
Left Bank View		Right Bank View		Water Surface Slope (S)	0.014
				Sinuosity (K) = stream length/valley length	<1.2
Left Bank View		Right Bank View		Adjustments?	Sin ↑, ER ↓
				STREAM TYPE	G4c

The next site downstream on the Parole Plaza Tributary, XS-2, was classified as a Rosgen G4c channel based on its continued low width/depth ratio, low slope, and gravel substrate. Since 2012 its entrenchment ratio was slightly higher than those typical of G streams, but in 2017-2019 the ratio of entrenchment decreased. This reach was previously classified as an E type channel; however, it was noted that the reach was actively degrading and widening. While E streams are typically more sinuous, this segment has been noticeably straightened and stabilized by a retaining wall and rubble/fill along the left bank (facing downstream). The lack of sinuosity in the channel has likely resulted in instability, and consequently resulted in a shift to a less-stable form.

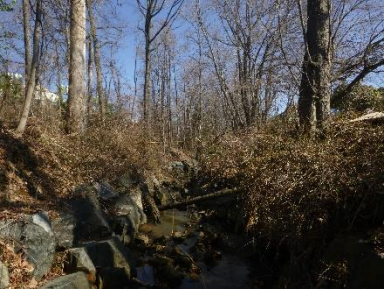
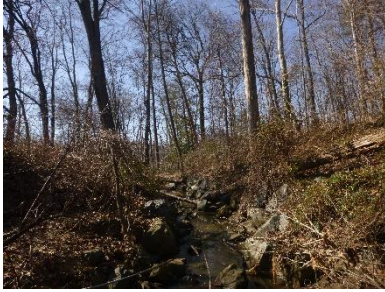
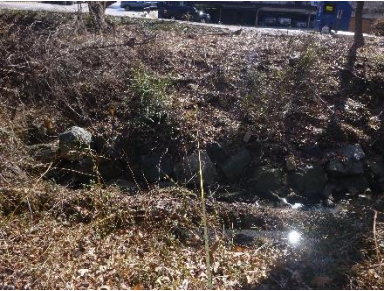
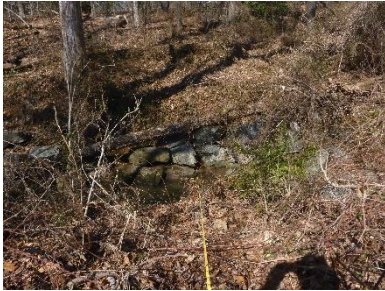
2019 Geomorphic Assessment Results	
				Bankfull Width (W_{bkt}) (feet)	6.6

Mean Depth (d_{bkt}) (feet)	0.5
				Bankfull Cross-sectional Area (A_{bkt}) (feet ²)	3.6
<p style="text-align: center;">Upstream View</p>		<p style="text-align: center;">Downstream View</p>		Width/Depth Ratio (W_{bkt}/d_{bkt})	12.2
				Width of Flood-prone Area (W_{fpa}) (feet)	8.3
<p style="text-align: center;">Left Bank View</p>		<p style="text-align: center;">Right Bank View</p>		Entrenchment Ratio (ER) = W_{fpa}/W_{bkt}	1.3
				Channel Materials D_{50} (millimeters)	13
<p style="text-align: center;">Right Bank View</p>		<p style="text-align: center;">Left Bank View</p>		Water Surface Slope (S)	0.009
				Sinuosity (K) = stream length/valley length	<1.2
<p style="text-align: center;">Left Bank View</p>		<p style="text-align: center;">Right Bank View</p>		Adjustments?	Sin ↑, W/D ↓
				STREAM TYPE

Site XS-3, located along the restored segment of Parole Plaza Tributary, was not classified until 2013, allowing 3 years after restoration for the area to settle and stabilize. In 2013 and 2014 it was classified as a Rosgen G4c channel based on its low entrenchment ratio, low width/depth ratio, and low slope. In 2015 XS-3 remained a G type channel; however, the substrate had become coarser resulting in a G4/3c classification. Variable coarseness caused XS-3 to return to a G4c during the 2016 survey and it has maintained that classification since. Before restoration, this cross-section was classified as a Rosgen G5c channel; however, since the Rosgen scheme was developed to classify natural channels, or those that are shaped naturally by fluvial processes, it
