**CHEMICAL, BIOLOGICAL, AND  
PHYSICAL CHARACTERIZATION  
OF THE CHURCH CREEK AND  
PAROLE PLAZA NPDES MONITORING STATIONS: 2019 - 2020**

Anne Arundel County  
Department of Public Works  
Bureau of Watershed Protection and Restoration  
2662 Riva Road  
Annapolis, MD 21401

Versar, Inc.  
9200 Rumsey Road, Suite 1  
Columbia, MD 21045

FINAL: October 2020

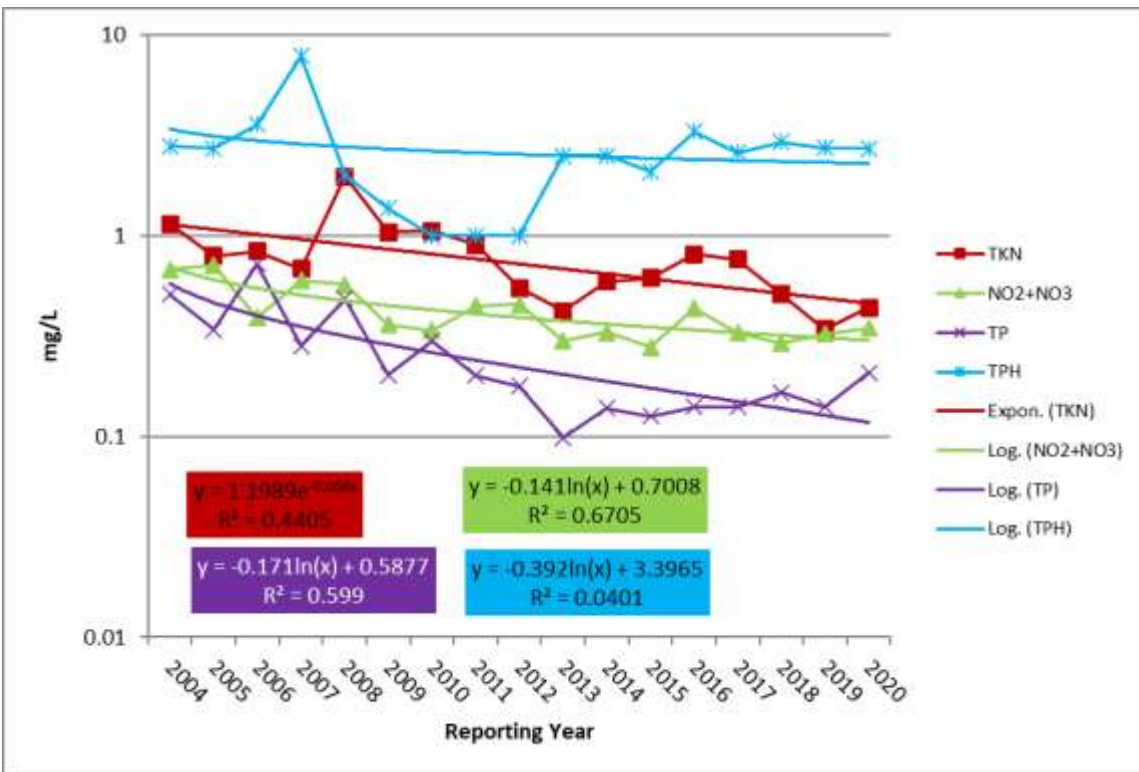
Figure 4-6. Church Creek station long-term monitoring: annual EMCs (TKN, NO<sub>3</sub>+NO<sub>2</sub>, TP, TPH; mg/L)

Figures 4-6 through 4-10 show trends in average annual EMCs for the Church Creek monitoring station. Most pollutant concentrations increased at Church Creek in 2020 compared to 2019 EMCs except for TPH and *E. coli*. Note that the apparent rise in TPH at Church Creek in 2013 was due to an increase in the detection limit. Also, summer season concentrations were not included with the EMC data for 2013 (Versar 2013).

Annual EMCs of most parameters during the current monitoring period, though higher than in 2019, fell within the normal variability of historical (2004 to present) values. Notably, annual EMCs for total phosphorus, lead, and TSS in 2020 were the highest since 2010 or earlier. Similar to Parole Plaza, annual average concentrations of most parameters achieved local maxima during the 2006-2007 periods, probably due to redevelopment construction effects carrying downstream. Local maxima for most parameter EMCs reappeared during 2016-2017 time frame, possibly as a result of effects of construction of the additional stream restoration and retrofit projects. Overall, similar to Parole Plaza, EMCs are generally trending downward, except for *E. coli*. The upward trend in *E. coli* at this station appears to be weaker than the trend observed at Parole Plaza.

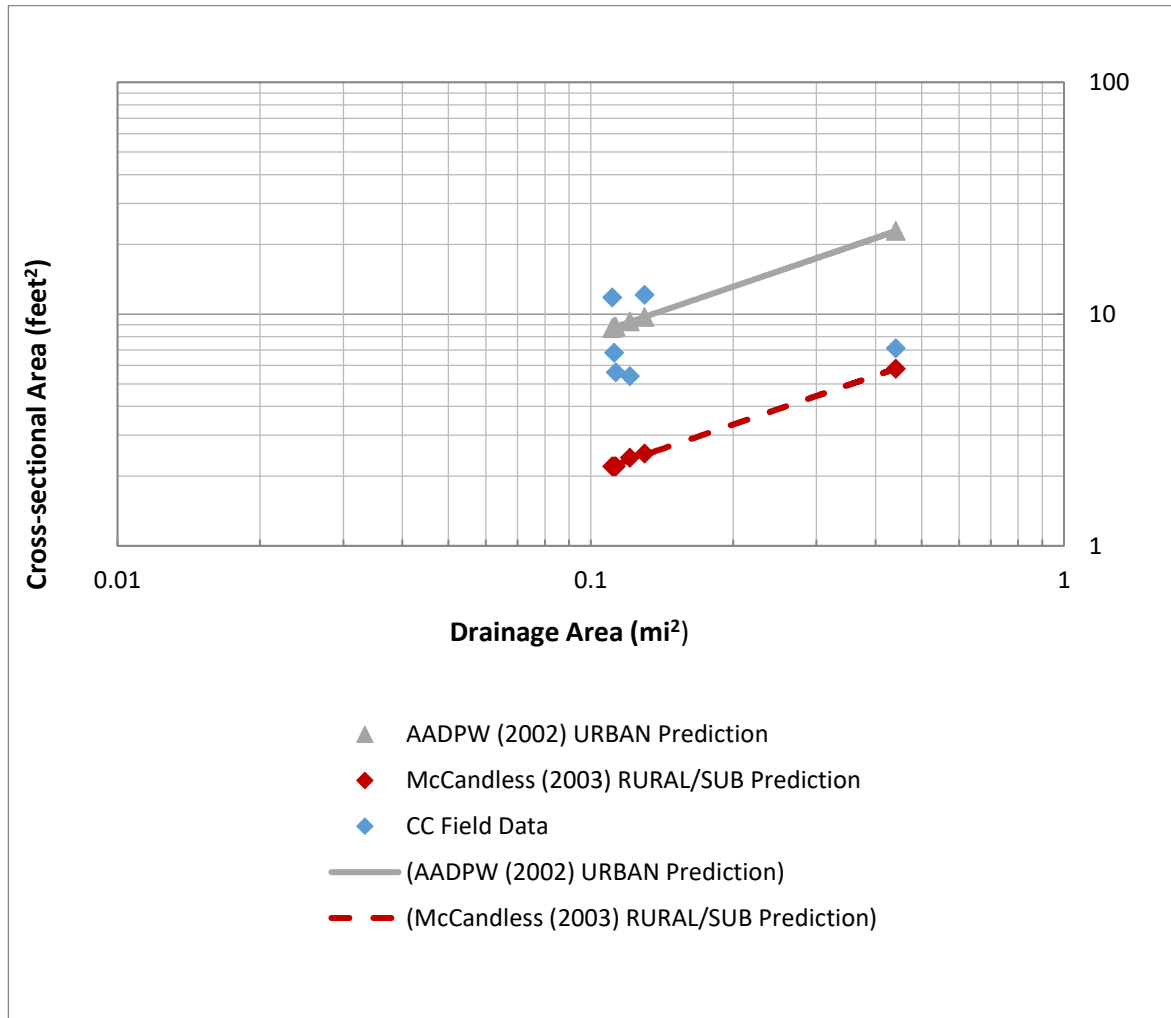
Figure 4-14. Comparison of bankfull channel cross-sectional area to drainage area (CC = Church Creek, 2020 data)

Bankfull channel dimensions (cross-sectional area, width, depth) in the Church Creek study area showed departure from expected values, as derived from Maryland Coastal Plain regional relationships of bankfull channel geometry (McCandless 2003). Almost all dimensions were generally larger in the Church Creek study area (see Figures 4-14, 4-15, and 4-16), and were often more similar to relationships of bankfull channel geometry derived from gaged urban watersheds located in the Coastal Plain. These relationships were previously developed for an urban stream restoration project in Anne Arundel County (AADPW 2002). Recent dimensions have been slightly higher than previous assessment values. This reflects the higher level of imperviousness in the study area, as compared to the lower impervious levels in the drainage areas used to develop the regional relationship data. The results suggest that this stream has become enlarged as a result of the high imperviousness, and is both wider and deeper than stable C and E type channels located in rural/suburban watersheds of the coastal plain. It should be noted, however, that locating bankfull elevations in the field on actively eroding, previously stabilized, or incising channels is difficult and not recommended due to unreliable and/or misleading indicators, and instead bankfull elevations should be estimated using the aforementioned regional curves (Rosgen, personal communication, May 2011). Where bankfull indicators were suspect or questionable, the indicator approximating the rural/suburban regional curve for bankfull area was used to estimate bankfull elevations. Additionally, the Rosgen method is best used on streams that are free to adjust their lateral boundaries under the current discharge regime experienced by the system (Rosgen 1996). Given the high levels of rip rap and/or concrete rubble armoring found in the reaches containing

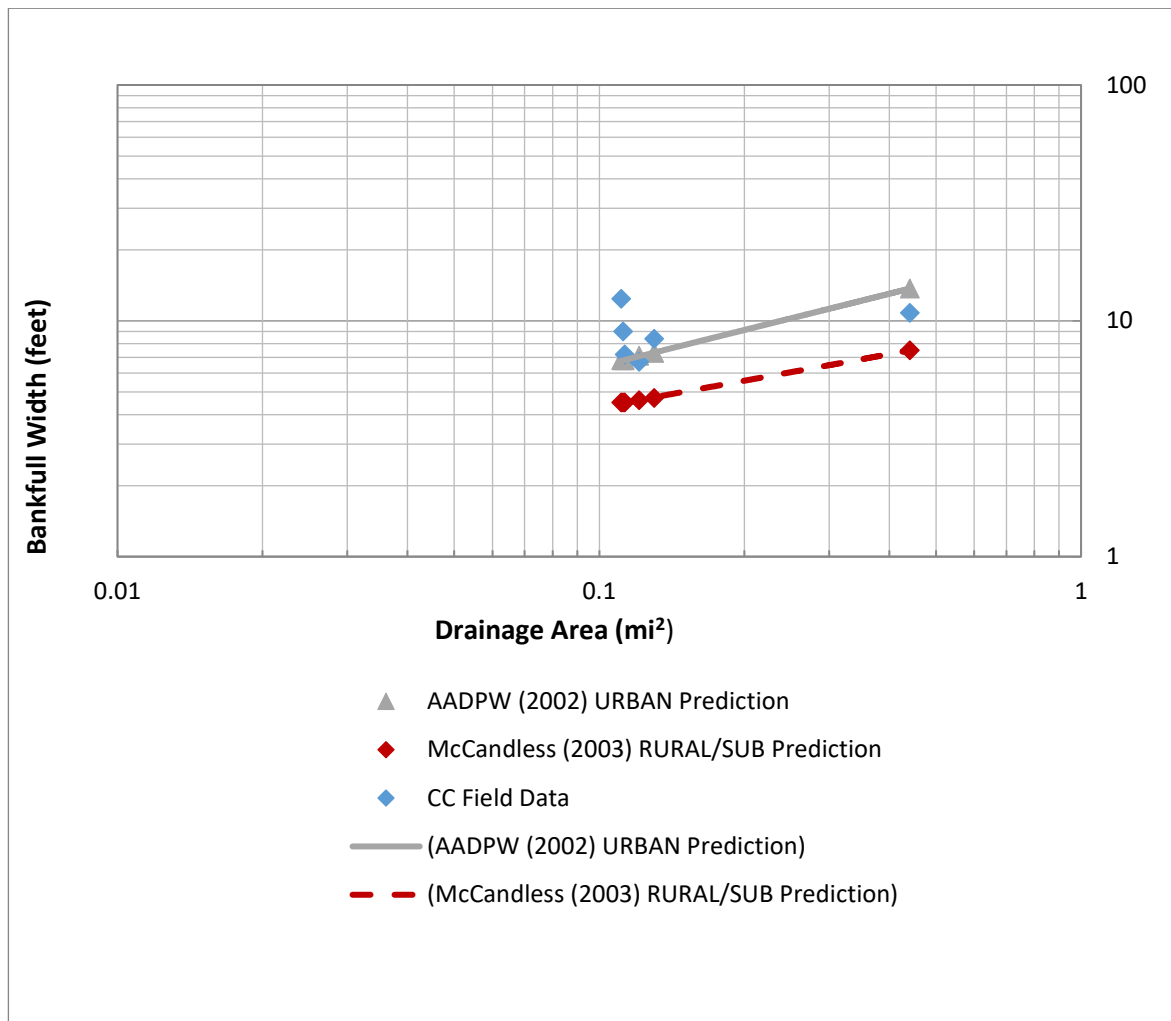
Figure 4-16. Comparison of bankfull width to drainage area (CC = Church Creek, 2020 data)

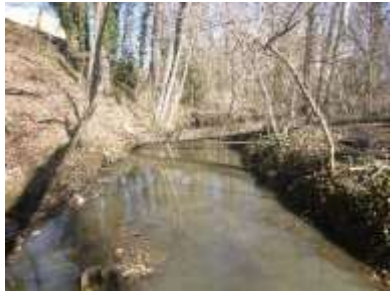
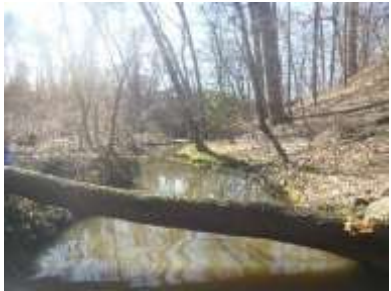
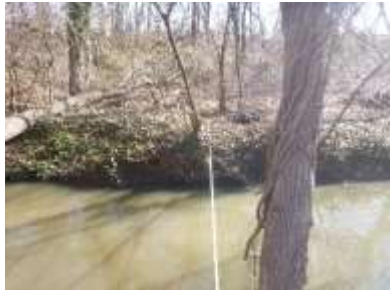
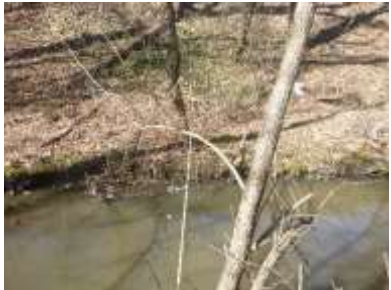
<b>2020 Geomorphic Assessment Results</b>	
		Bankfull Width ( $W_{bkt}$ ) (feet)	12.4

Mean Depth ( $d_{bkt}$ ) (feet)	1.0
		Bankfull Cross-sectional Area ( $A_{bkt}$ ) (feet <sup>2</sup> )	11.8
Upstream View		Width/Depth Ratio ( $W_{bkt}/d_{bkt}$ )	12.9
Downstream View		Width of Flood-prone Area ( $W_{fpa}$ ) (feet)	13.5
Left Bank View		Entrenchment Ratio (ER) = $W_{fpa}/W_{bkt}$	1.1
		Channel Materials $D_{50}$ (millimeters)	1.1
Right Bank View		Water Surface Slope (S)	0.0002
		Sinuosity (K) = stream length/valley length	<1.2
Left Bank View		Adjustments?	Sin ↑
Right Bank View		<b>STREAM TYPE</b>	<b>F5</b>

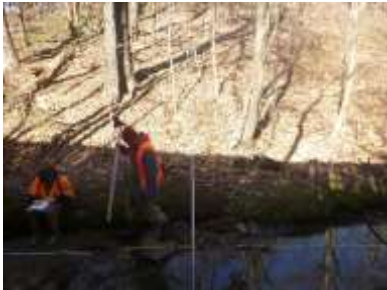
<b>2020 Geomorphic Assessment Results</b>	
		Bankfull Width ( $W_{bkf}$ ) (feet)	9.0

Mean Depth ( $d_{bkf}$ ) (feet)	0.7
		Bankfull Cross-sectional Area ( $A_{bkf}$ ) (feet <sup>2</sup> )	6.8
Upstream View	Downstream View	Width/Depth Ratio ( $W_{bkf}/d_{bkf}$ )	12.0
		Width of Flood-prone Area ( $W_{fpa}$ ) (feet)	17.8
		Entrenchment Ratio (ER) = $W_{fpa}/W_{bkf}$	2.0
		Channel Materials $D_{50}$ (millimeters)	N/A
		Water Surface Slope (S)	0.0059
		Sinuosity (K) = stream length/valley length	<1.2
		Adjustments?	Sin ↑, ER ↓
Left Bank View	Right Bank View	<b>STREAM TYPE</b>	<b>C4</b>

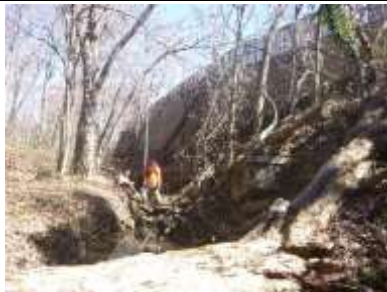
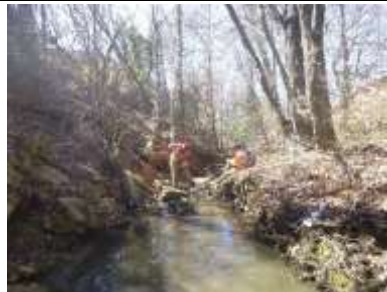
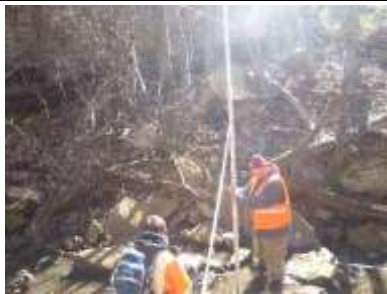
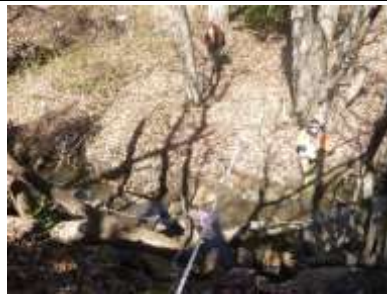
Bankfull Width ( $W_{bkt}$ ) (feet)	7.2
Mean Depth ( $d_{bkt}$ ) (feet)	0.8
Bankfull Cross-sectional Area ( $A_{bkt}$ ) (feet <sup>2</sup> )	5.7
Width/Depth Ratio ( $W_{bkt}/d_{bkt}$ )	9.1
Width of Flood-prone Area ( $W_{fpa}$ ) (feet)	9.7
Entrenchment Ratio (ER) = $W_{fpa}/W_{bkt}$	1.3
Channel Materials $D_{50}$ (millimeters)	19.0
Water Surface Slope (S)	0.013
Sinuosity (K) = stream length/valley length	<1.2
Adjustments?	Sin ↑, ER ↓
<b>STREAM TYPE</b>	<b>G4c</b>

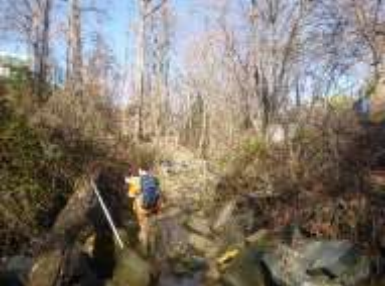
<p style="text-align: center;">Upstream View</p>	  <p style="text-align: center;">Downstream View</p>	<b>2020 Geomorphic Assessment Results</b>	
		Bankfull Width ( $W_{bkf}$ ) (feet)	6.7
		Mean Depth ( $d_{bkf}$ ) (feet)	0.8
		Bankfull Cross-sectional Area ( $A_{bkf}$ ) (feet <sup>2</sup> )	5.4
		Width/Depth Ratio ( $W_{bkf}/d_{bkf}$ )	8.3
		Width of Flood-prone Area ( $W_{fpa}$ ) (feet)	8.2
		Entrenchment Ratio (ER) = $W_{fpa}/W_{bkf}$	1.2
		Channel Materials $D_{50}$ (millimeters)	15.0
		Water Surface Slope (S)	0.011
		Sinuosity (K) = stream length/valley length	<1.2
		Adjustments?	Sin ↑, W/D ↓
  <p style="text-align: center;">Left Bank View</p>	  <p style="text-align: center;">Right Bank View</p>	<b>STREAM TYPE</b>	<b>G4c</b>

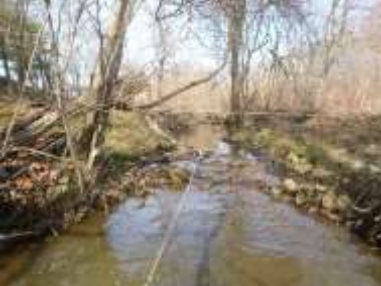
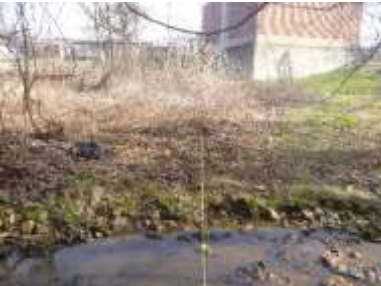
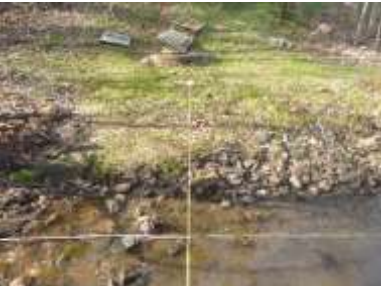
<b>2020 Geomorphic Assessment Results</b>	
Upstream View		Downstream View		Bankfull Width ( $W_{bkf}$ ) (feet)	10.8

Mean Depth ( $d_{bkf}$ ) (feet)	0.7
				Bankfull Cross-sectional Area ( $A_{bkf}$ ) (feet <sup>2</sup> )	7.1
Left Bank View		Right Bank View		Width/Depth Ratio ( $W_{bkf}/d_{bkf}$ )	16.3
				Width of Flood-prone Area ( $W_{fpa}$ ) (feet)	15.8
Left Bank View		Right Bank View		Entrenchment Ratio (ER) = $W_{fpa}/W_{bkf}$	1.5
				Channel Materials $D_{50}$ (millimeters)	56.0
Left Bank View		Right Bank View		Water Surface Slope (S)	0.013
				Sinuosity (K) = stream length/valley length	<1.2
Left Bank View		Right Bank View		Adjustments?	Sin ↑, ER ↓
				<b>STREAM TYPE</b>	<b>F4</b>
