Total Maximum Daily Load Restoration Plan for Bacteria

2020 Annual Bacteria TMDL Assessment

**Anne Arundel County
Department of Public Works
Bureau of Watershed Protection and Restoration
2662 Riva Road
Annapolis, Maryland 21401**

January 2021

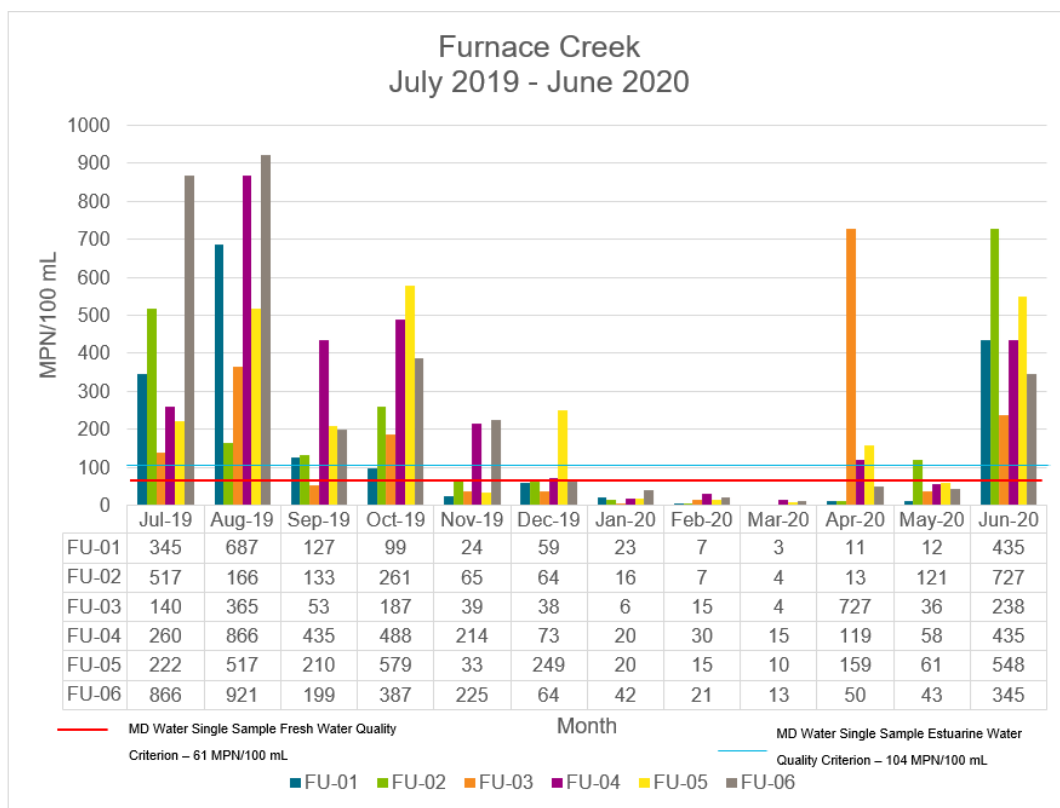
Figure 4-1: Furnace Creek Enterococci Data from July 2019 to June 2020

The data collected for Furnace Creek show bacteria trends to be higher during the summer months and lower during the winter months. The highest values were seen at FU-06 (the tidal site), FU-04, FU-03, and FU-02. From January 2020 through March 2020 all sites met the Beach Action Value (104 MPN/100 mL). FU-01 met the single sample water quality criterion for fresh water of 61 MPN/100 mL for November through May; FU-02 met the criterion for January through April; FU-03 met the criterion for September and November through March; FU-04 met the criterion for January through March and in May; FU-05 met the criterion in November, January through March, and May. FU-06 met the single sample water quality criterion for estuarine waters of 104 MPN/100 mL December through May. **Figure 4-1** shows the data for all sites. The sections below discuss results for each sampling site.

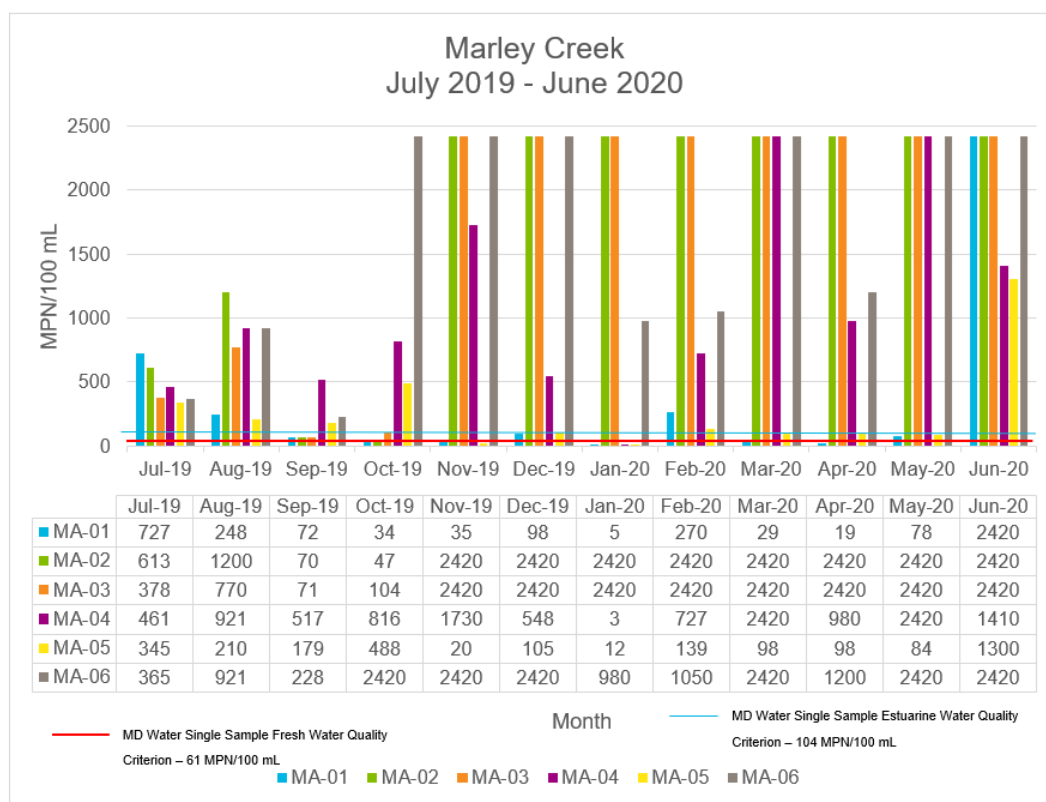
Figure 4-8: Marley Creek Bacteria Data from July 2019 to June 2020

Marley Creek results show bacteria trends for all sites to be highest on average during June. However, stations MA-02, MA-03, and MA-06 tended to experience extremely elevated concentrations continuously from November through June. MA-06 exceeded Beach Action Value (104 MPN/mL) during every month of the sampling period. Additionally, at least two-thirds of all sites (MA-02, MA-03, MA-04 and MA-06) did not meet the Beach Action Value nine months out of the 12-month sampling period. No sites met the Beach Action Value during the months of July, August, February, or June. Two sites met the single sample water fresh quality criterion for fresh water of 61 MPN/100 mL during the months of October (MA-01 and MA-02) and November (MA-01 and MA-05); three sites met the fresh water criterion in January (MA-01, MA-04, and MA-05); and MA-01 met this criterion in April. No sites met the water quality criterion from July through September, or in December, February, May, or June. Monitoring station MA-03 never met the water quality criterion during the entire sampling period. MA-06 exceeded the single sample water quality criterion for estuarine waters of 104 MPN/mL every month. **Figure 4-8** shows the data for all sites. The sections below discuss results for each sampling site.

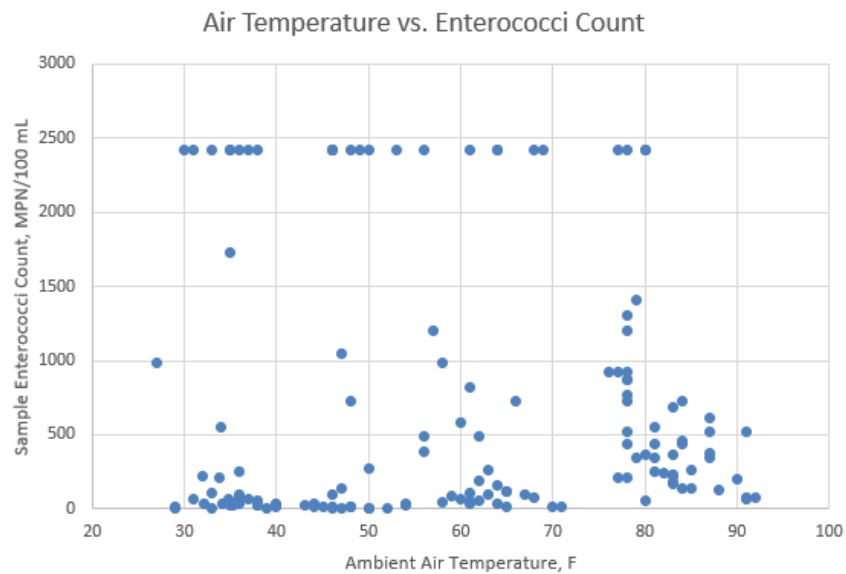
Figure 5-7: Plot of Air Temperature vs. Bacteria Count

The air temperature at the time of sample collection ranged from 27°F to 92°F. Samples with high enterococci counts were found year-round, indicating that this parameter is not strongly correlated with bacteria count. An exponential function best fit this dataset with an R^2 value of 0.06. **Figure 5-7** shows a plot of this dataset.

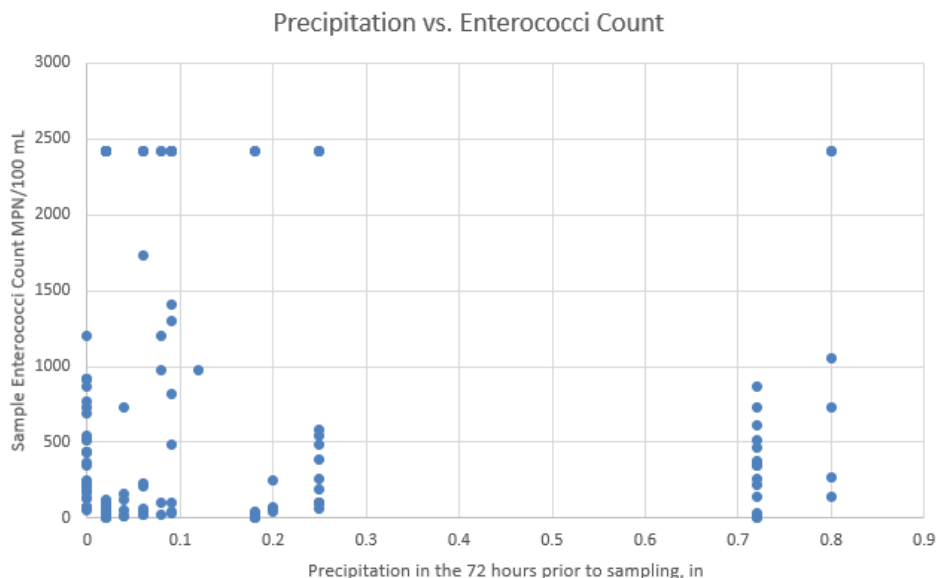
Precipitation within 72 hours prior to sampling ranged from 0 inch – 0.8 inches, with most events producing less than 0.3 inch of precipitation. For sampling days with precipitation in the prior 72 hours, the precipitation type was rainfall on all but one day. The sampling event in January 2020 experienced mixed snowfall, which was converted to equivalent snowmelt. Fitting these data to a polynomial function yielded the highest R^2 value of 0.004, which indicates a weak correlation between precipitation and enterococci count. **Figure 5-10** shows a plot of these data.

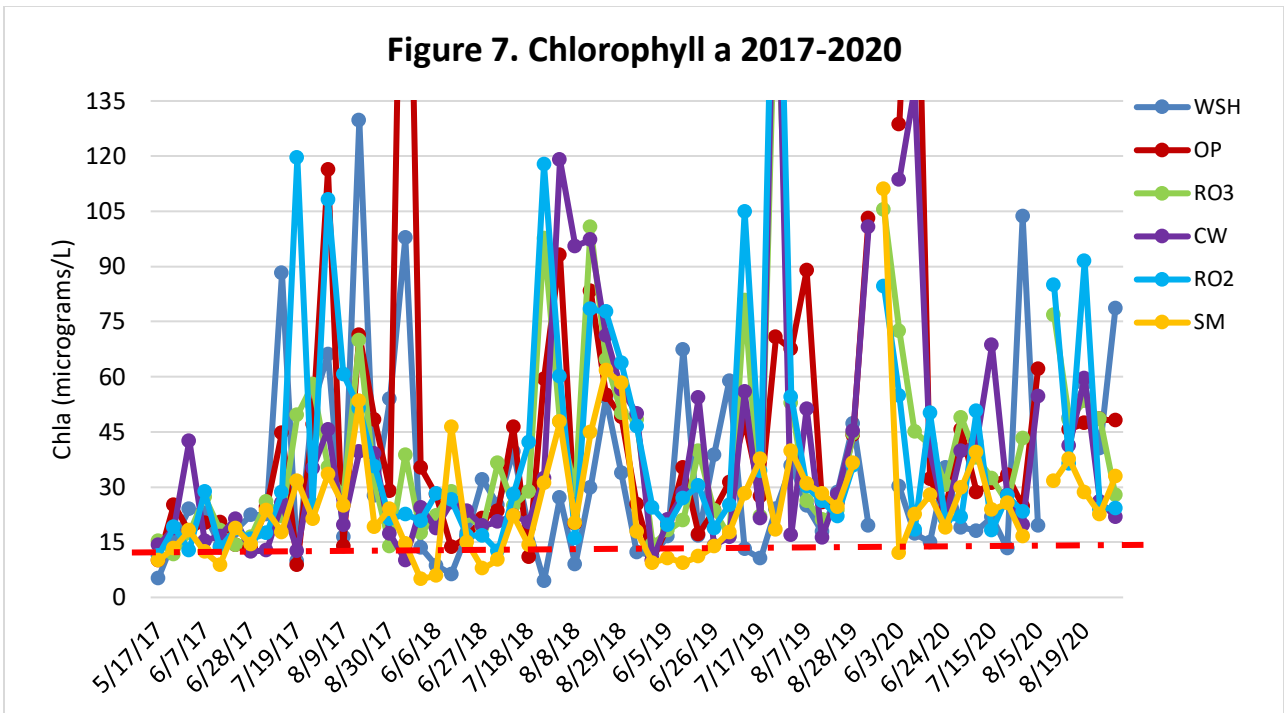
Figure 8. Secchi Depth and Total Chlorophyll 2017-2020

Chlorophyll concentrations are typically lower early in the season and increase as the water warms and nutrient concentrations increase. That pattern was observed from 2017 through 2019. However, from early May through early June 2020 an algal bloom (*Prorocentrum minimum*) was observed along the mid-Chesapeake Bay including the West and Rhode Rivers. The bloom caused the appearance of the characteristic mahogany color, decreased clarity, increased TSS, and very high chlorophyll concentrations (figures 5-8). The inverse relationship between clarity and total chlorophyll concentration is illustrated in figure 8, and the unusual pattern with high chlorophyll (green) and low clarity (blue) early in the 2020 season is evident when compared with the previous three seasons.
