**CHEMICAL AND GEOMORPHIC CHARACTERIZATION  
OF THE CHURCH CREEK AND PAROLE PLAZA NPDES  
MONITORING STATIONS: 2020 - 2021**

Anne Arundel County  
Department of Public Works  
Bureau of Watershed Protection and Restoration  
2662 Riva Road  
Annapolis, MD 21401

Versar, Inc.  
9200 Rumsey Road, Suite 1  
Columbia, MD 21045

FINAL: August 2021

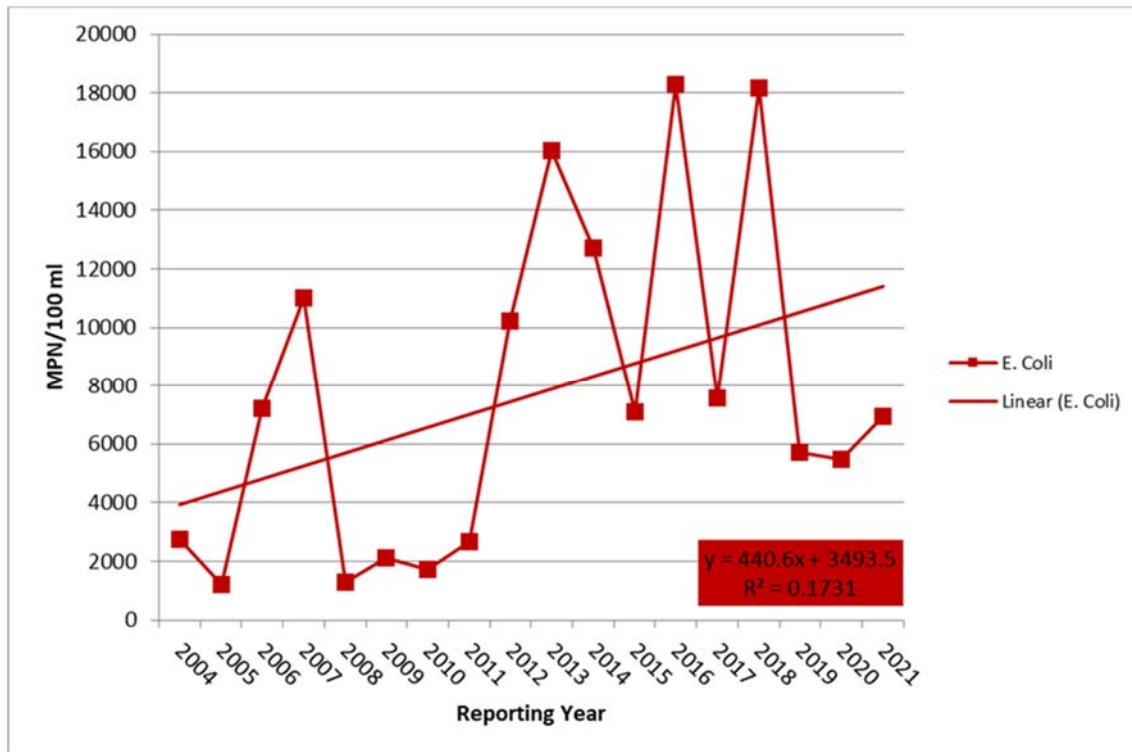
Figure 4-5. Parole Plaza station long-term monitoring: annual EMCs (fecal coliform 2004-2006 and *E. coli* 2007-2021; MPN/100 mL)

Annual average EMCs were plotted for each monitoring year. Plots were constructed to illustrate the impact that construction activity and redevelopment of the Annapolis Towne Centre site (2004-2008), subsequent stream restoration (2015-2016), and stormwater retrofit (2017) has had on water quality within the study reach. Figures 4-1 through 4-5 show the change in EMCs from 2004 to 2021 at the Parole Plaza Monitoring Station. Nearly every EMC rose substantially between 2006 and 2007, coinciding with the majority of the site work at the Towne Centre. These EMCs fell notably in 2008 as the site stabilized and this stability has been reflected in time series plots ever since. At Parole Plaza, annual pollutant EMCs of TKN, combined nitrate and nitrite, copper, lead, zinc, and TSS in 2021 resumed their recent, downward trending track that initiated approximately 2006. EMCs of BOD<sub>5</sub> and total phosphorus slightly increased in 2021, but overall maintained their downward trend. EMCs of *E. coli* increased slightly in 2021, continuing their overall upward, though variable, trend. EMCs of TPH have been nearly flat since an increase in the analytical detection limit in 2013 resulted in only higher concentration results to be incorporated into EMCs and plotted. Note that the 2013 data included in these plots do not include the summer season (Versar 2013), which is often the season that produces the highest EMCs for many of the parameters.

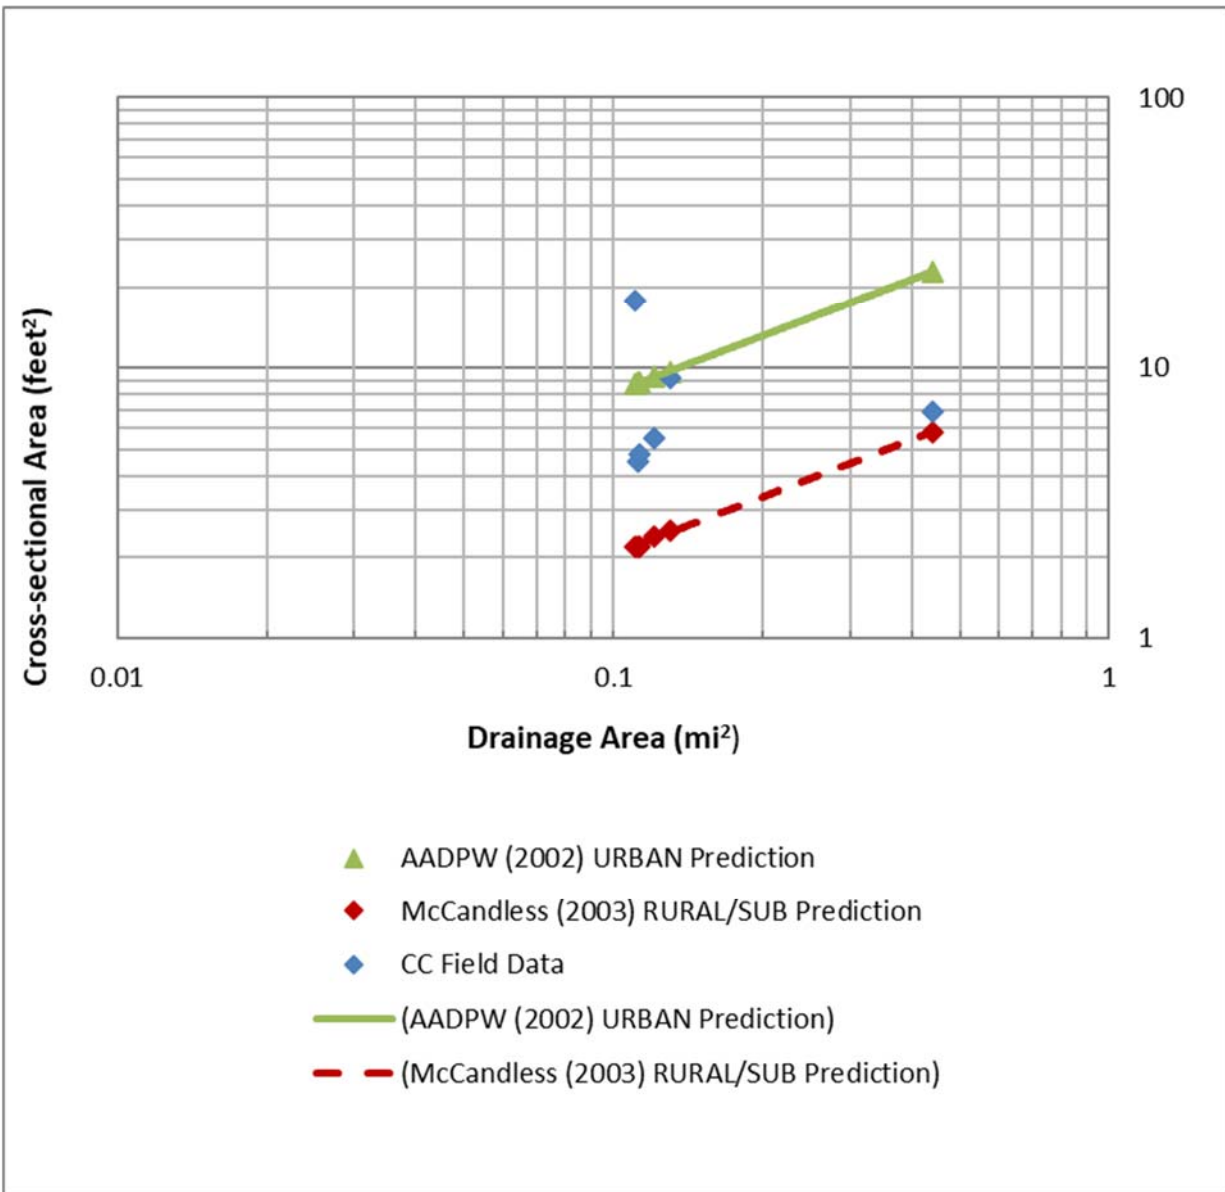
Figure 4-11. Comparison of bankfull channel cross-sectional area to drainage area (CC = Church Creek, Fall 2020 data)

Bankfull channel dimensions (cross-sectional area, width, depth) in the Church Creek study area showed departure from expected values, as derived from Maryland Coastal Plain regional relationships of bankfull channel geometry (McCandless 2003). Almost all dimensions were generally larger in the Church Creek study area (see Figures 4-11, 4-12, and 4-13), and were often more similar to relationships of bankfull channel geometry derived from gaged urban watersheds located in the Coastal Plain. These relationships were previously developed for an urban stream restoration project in Anne Arundel County (AADPW 2002). Recent dimensions have been slightly higher than previous assessment values. This reflects the higher level of imperviousness in the study area, as compared to the lower impervious levels in the drainage areas used to develop the regional relationship data. The results suggest that this stream has become enlarged as a result of the high imperviousness, and is both wider and deeper than stable C and E type channels located in rural/suburban watersheds of the coastal plain. It should be noted, however, that locating

bankfull elevations in the field on actively eroding, previously stabilized, or incising channels is difficult and not recommended due to unreliable and/or misleading indicators, and instead bankfull elevations should be estimated using the aforementioned regional curves (Rosgen, personal communication, May 2011). Where bankfull indicators were suspect or questionable, the indicator approximating the rural/suburban regional curve for bankfull area was used to estimate bankfull elevations. Additionally, the Rosgen method is best used on streams that are free to adjust their lateral boundaries under the current discharge regime experienced by the system (Rosgen 1996). Given the high levels of rip rap and/or concrete rubble armoring found in the reaches containing cross-sections 2, 3 and 5, the accurate determination of the bankfull indicators in the field at these locations is problematic.

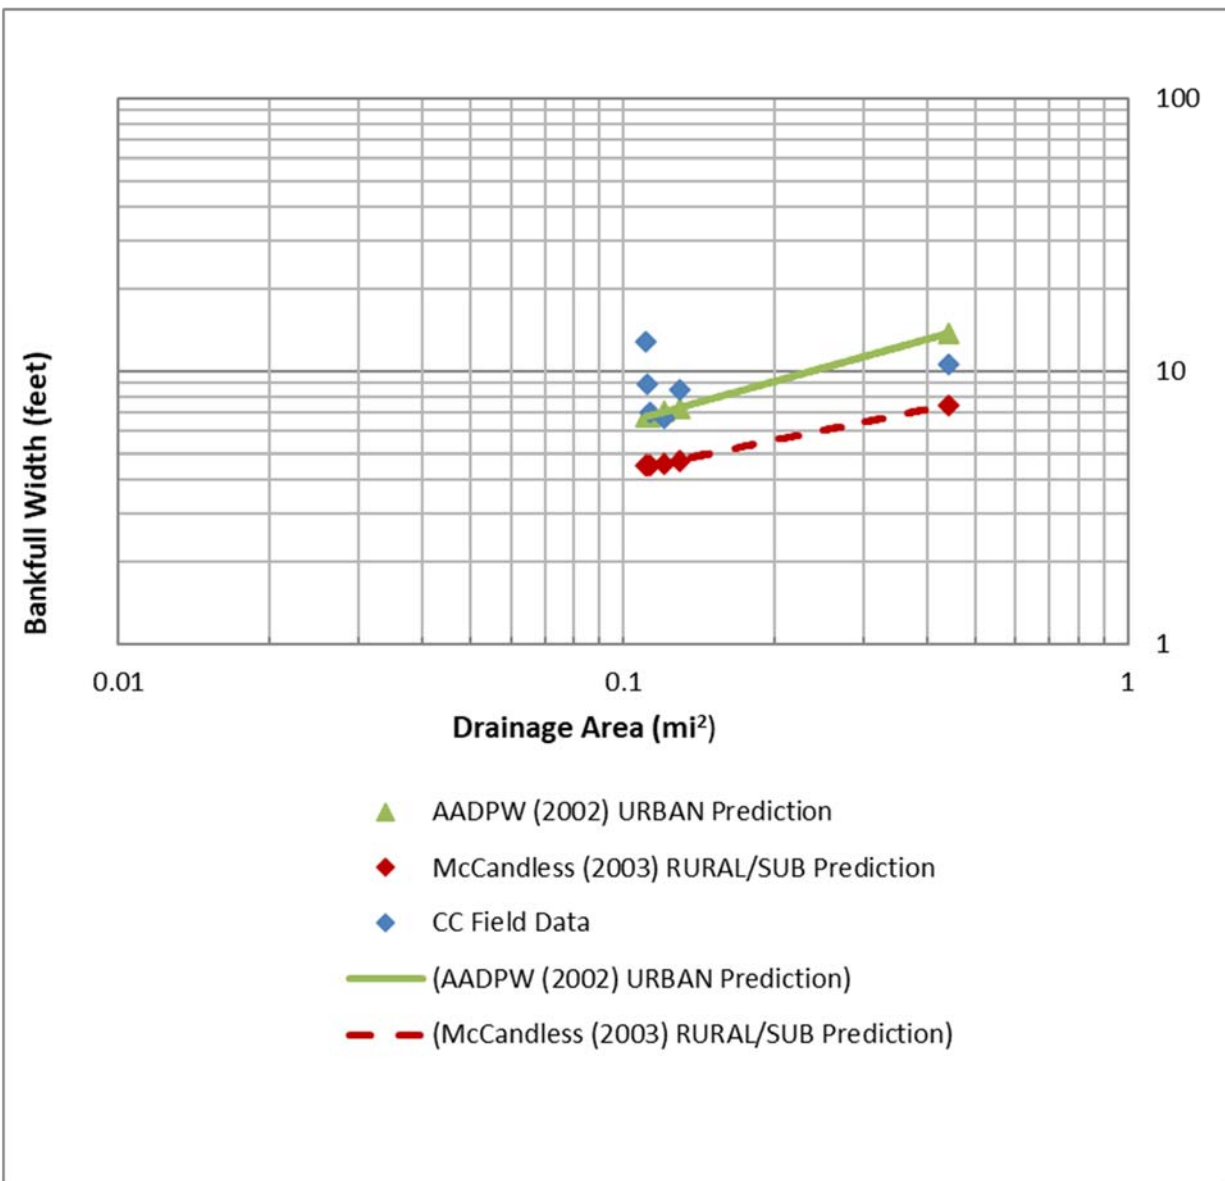
Figure 4-13. Comparison of bankfull width to drainage area (CC = Church Creek, Fall 2020 data)

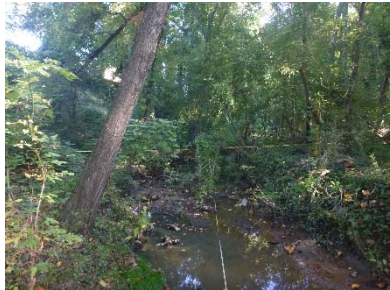
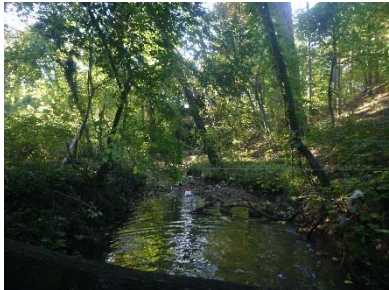
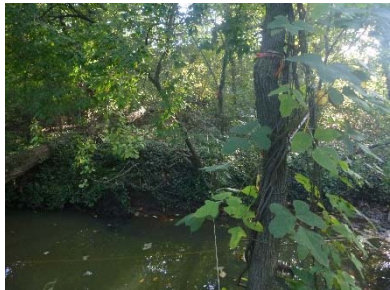
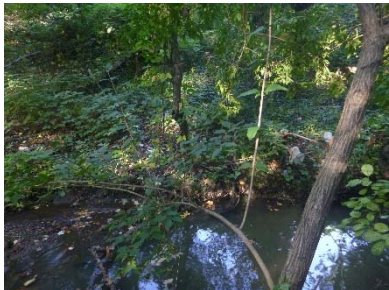
<b>Fall 2020 Geomorphic Assessment Results</b>	
Upstream View	Downstream View	Bankfull Width ( $W_{bkt}$ ) (feet)	12.7
		Mean Depth ( $d_{bkt}$ ) (feet)	1.4
		Bankfull Cross-sectional Area ( $A_{bkt}$ ) (feet <sup>2</sup> )	17.8
		Width/Depth Ratio ( $W_{bkt}/d_{bkt}$ )	9.1
		Width of Flood-prone Area ( $W_{fpa}$ ) (feet)	13.9
		Entrenchment Ratio (ER) = $W_{fpa}/W_{bkt}$	1.1
		Channel Materials $D_{50}$ (millimeters)	1.2
		Water Surface Slope (S)	0.0025
		Sinuosity (K) = stream length/valley length	<1.2
		Adjustments?	Sin ↑, W/D ↑, ER ↑

<b>STREAM TYPE</b>	<b>F5</b>
Left Bank View	Right Bank View

The most upstream reach on the Parole Plaza Tributary, XS-1, has been undergoing a transition from a Rosgen C4/5 channel to a F4 channel, as evidenced by changes in the width/depth and entrenchment ratios. Previous monitoring in 2010 suggested that this reach was shifting from an E to a C channel because of channel degradation, a notable increase in sediment deposition, and point bar formation along the right bank just downstream. Additional degradation between 2010 and 2012 suggest that the channel had lost connectivity to the floodplain and had likely shifted to an F stream type. Mid-channel degradation continued between 2014 and 2020 showing approximately a 0.9-foot difference. In 2020, geomorphic assessment parameters continued to support the classification of this reach as an F channel, but due to continued small median particle size this site remained classified as a F5 in 2020. The channel evolution is supported by an 97.0% increase in channel cross-sectional area since 2003 and considerable widening and mid-channel bar formation immediately downstream, which is indicative of a channel that is not stable and is undergoing a widening and degradation phase. Cross-sectional area at this location has been increasing every year since 2009. Left bank widening was also apparent between 2013 and 2014 monitoring years, remained consistent during 2015 through 2018, and continued to widen in 2019 and 2020. However, it is important to acknowledge that this cross-section is no longer located in a riffle feature and is now in a pool feature, which affects the channel dimensions and complicates classification using the Rosgen system.

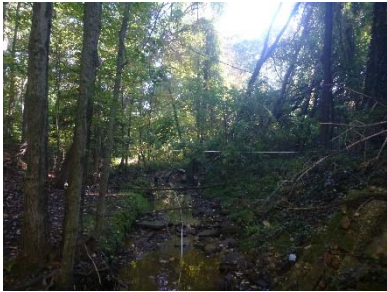
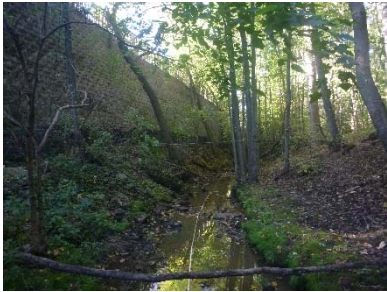
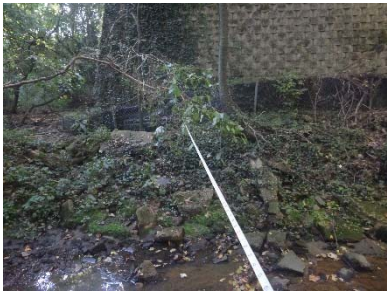
### CROSS-SECTION 1D

— Spring 2020
 — Fall 2020

**F5**

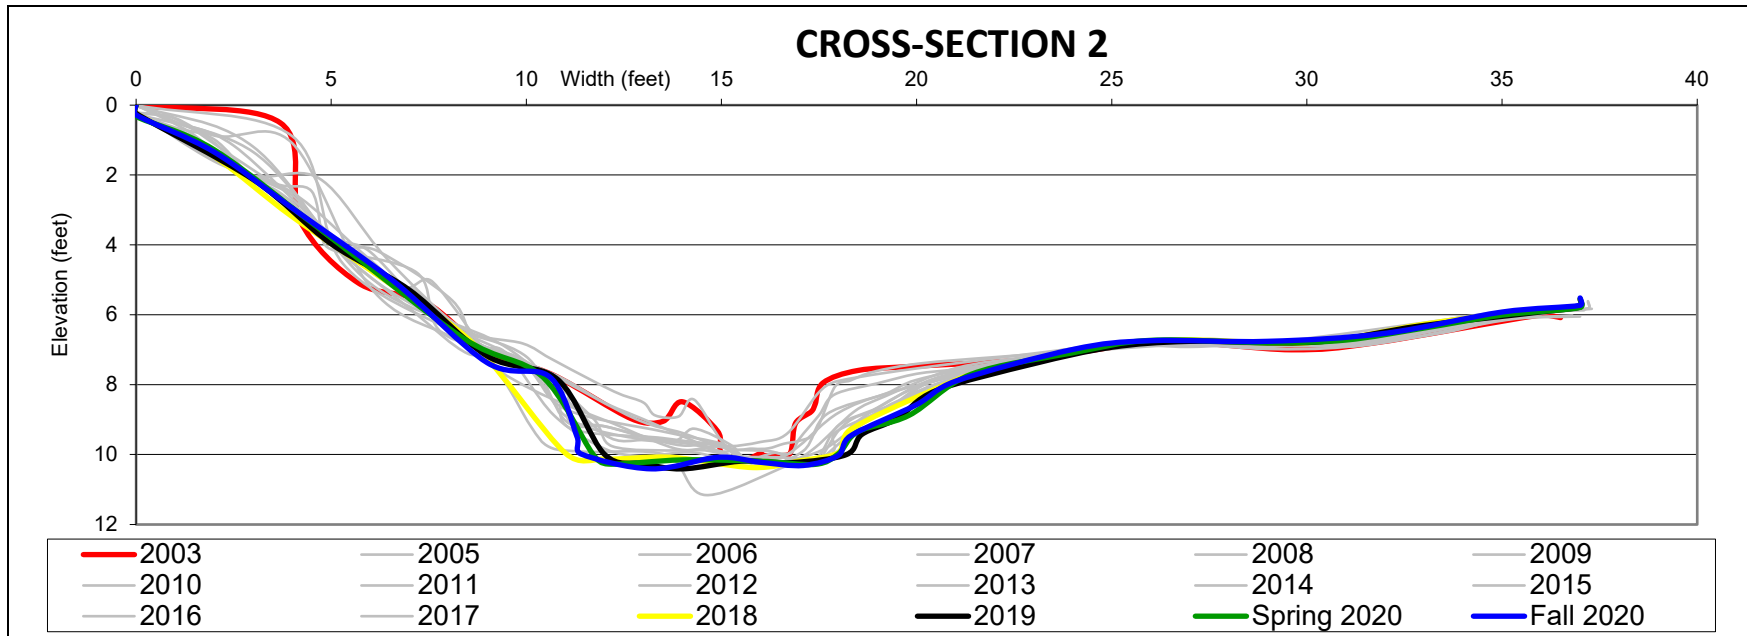
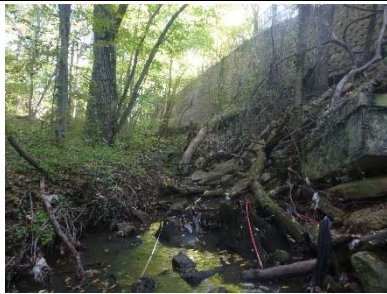
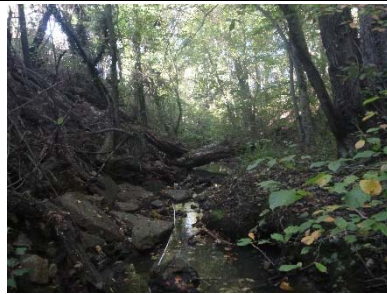
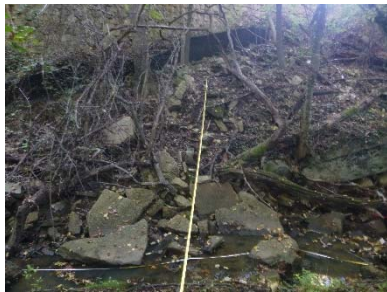
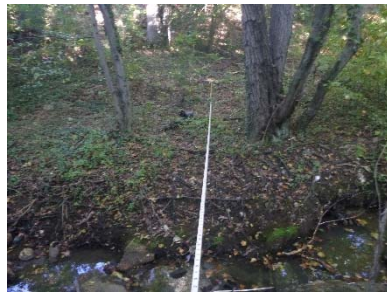
<b>Fall 2020 Geomorphic Assessment Results</b>	
Bankfull Width ( $W_{bkf}$ ) (feet)	7.0
Mean Depth ( $d_{bkf}$ ) (feet)	0.7
Bankfull Cross-sectional Area ( $A_{bkf}$ ) (feet <sup>2</sup> )	4.8
Width/Depth Ratio ( $W_{bkf}/d_{bkf}$ )	10.1
Width of Flood-prone Area ( $W_{fpa}$ ) (feet)	9.1
Entrenchment Ratio (ER) = $W_{fpa}/W_{bkf}$	1.3
Channel Materials $D_{50}$ (millimeters)	7.7
Water Surface Slope (S)	0.0093
Sinuosity (K) = stream length/valley length	<1.2
Adjustments?	Sin ↑
<b>STREAM TYPE</b>	<b>G4c</b>

The next site downstream on the Parole Plaza Tributary, XS-2, was classified as a Rosgen G4c channel based on its continued low width/depth ratio, low slope, and gravel substrate. Since 2012 its entrenchment ratio has been slightly higher than those typical of G streams, but in 2017-2020 the ratio of entrenchment decreased. This reach was previously classified as an E type channel; however, it was noted that the reach was actively degrading and widening. While E streams are typically more sinuous, this segment has been noticeably straightened and stabilized

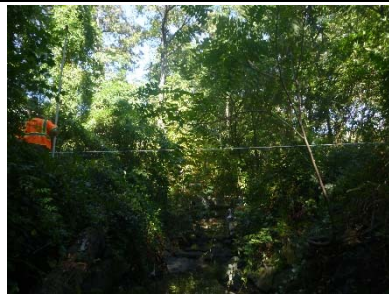
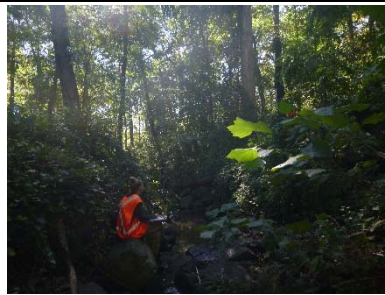
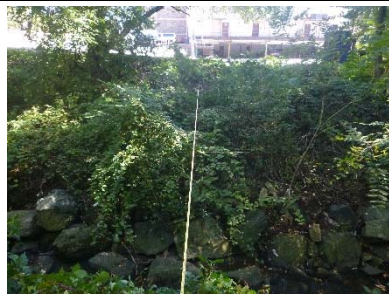
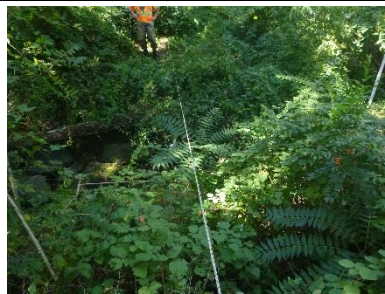
<b>STREAM TYPE</b>	<b>G5c</b>
--------------------	------------

Site XS-3, located along the restored segment of Parole Plaza Tributary, was not classified until 2013, allowing 3 years after restoration for the area to settle and stabilize. In 2013 and 2014 it was classified as a Rosgen G4c channel based on its low entrenchment ratio, low width/depth ratio, and low slope. In 2015, XS-3 remained a G type channel; however, the substrate had become coarser resulting in a G4/3c classification. Variable coarseness caused XS-3 to return to a G4c during the 2016 survey and it has maintained that classification since. Before restoration, this cross-section was classified as a Rosgen G5c channel; however, since the Rosgen scheme was developed to classify natural channels, or those that are shaped naturally by fluvial processes, it was deemed inappropriate to classify immediately after construction. This section is still heavily armored and reliable bankfull indicators are not easily identified. Little overall change has been documented at XS-3 but the cycle of erosion and aggradation that has been observed on the right bank continued in 2020, with the most recent survey showing a retreat of approximately 2.2 feet in the seven months between the 2020 surveys. The reach at XS-3 was classified as a G5c channel in the Fall 2020 survey.

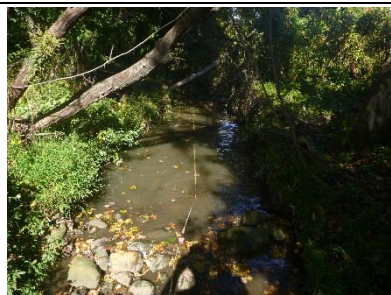
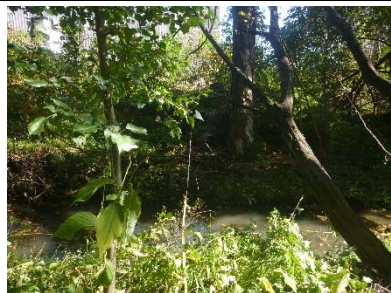
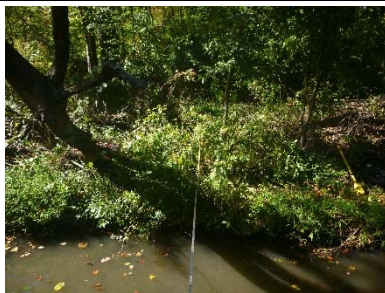
### CROSS-SECTION 4

Bankfull Width ( $W_{bkf}$ ) (feet)	8.5
Mean Depth ( $d_{bkf}$ ) (feet)	1.1
Bankfull Cross-sectional Area ( $A_{bkf}$ ) (feet <sup>2</sup> )	9.2
Width/Depth Ratio ( $W_{bkf}/d_{bkf}$ )	7.8
Width of Flood-prone Area ( $W_{fpa}$ ) (feet)	9.6
Entrenchment Ratio (ER) = $W_{fpa}/W_{bkf}$	1.1
Channel Materials $D_{50}$ (millimeters)	1.1
Water Surface Slope (S)	0.0002
Sinuosity (K) = stream length/valley length	<1.2
Adjustments?	Sin ↑, ER ↑
<b>STREAM TYPE</b>	<b>E5</b>

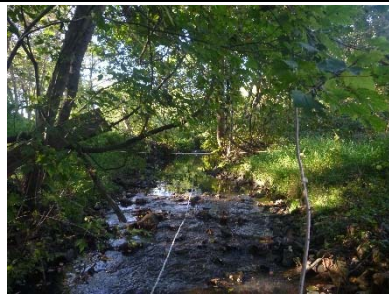
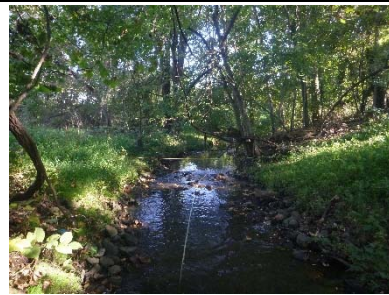
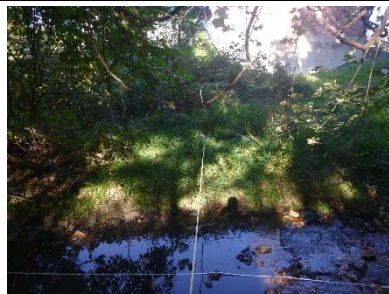
**F4**
