**ANNE ARUNDEL COUNTY
ILLICIT DISCHARGE DETECTION
AND ELIMINATION
2015 ANNUAL REPORT**

PERMIT NUMBER MD0068306

January 12, 2016

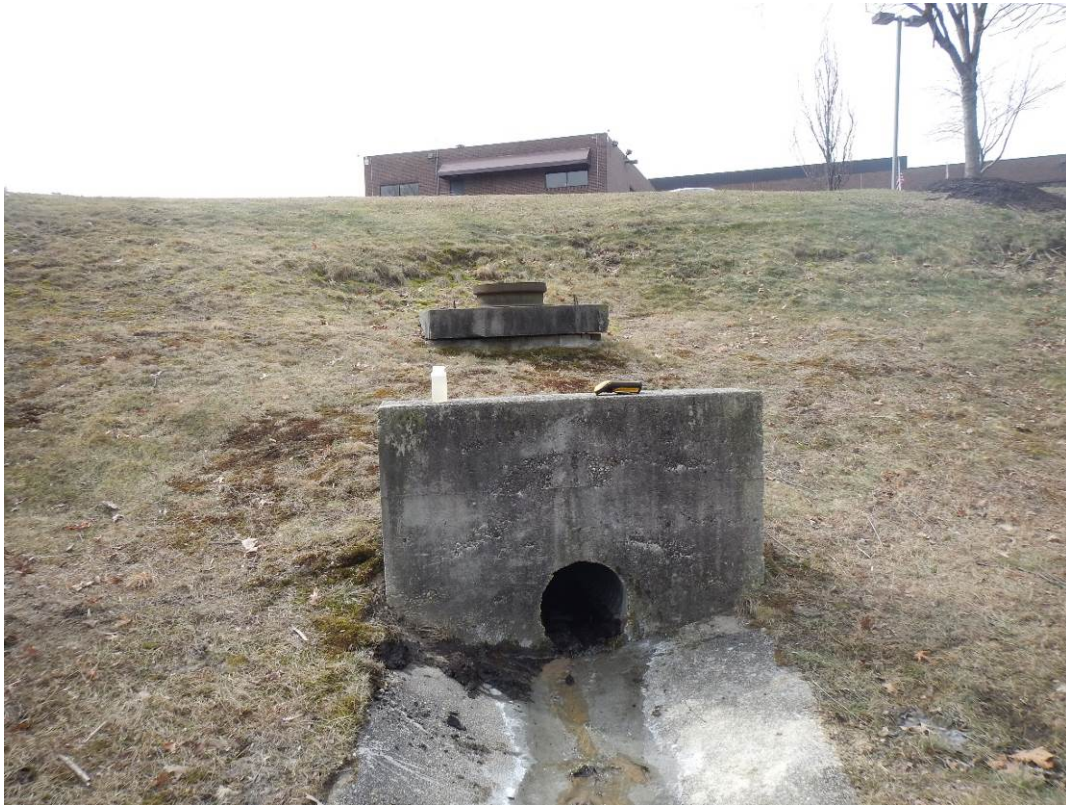
At 11:30 a.m. on March 19, a LimnoTech field team inspected the outfall (Figure 1) designated as L07A1O004, located at 1000 Stewart Ave., which is the address of a SunTrust Bank branch. The discharge was noted to be sporadic and began shortly after the arrival of the field team. A gasoline odor was also apparent. The flowing water tested above action levels for copper, chlorine, and detergents. Fluoride was also elevated but was below the action level.

At 4:05 p.m., the team returned to the site and performed a 2nd test of the flowing water. At this time, only chlorine was above the corresponding action level. Fluoride was again elevated at this time, but below the action level. The flow rate was lower during the return visit and was continuous. The discharge was also not as cloudy and had a less significant gas odor than our first visit. The team documented a noticeable white powdery residue in the concrete channel that received the discharge. Results are summarized in Table 1 below. After the retest, the field team tracked flow from three directions in the network. Two of the branches originated in parking lot catch basins. The center branch originated from the south, from the direction of the building. The field crew was not able to open the manhole near the building which would confirm that the illicit discharge was originating from the building. An area map is provided in Figure 3.

Figure 1. Outfall L07A1O004 at 1000 Stewart Ave.

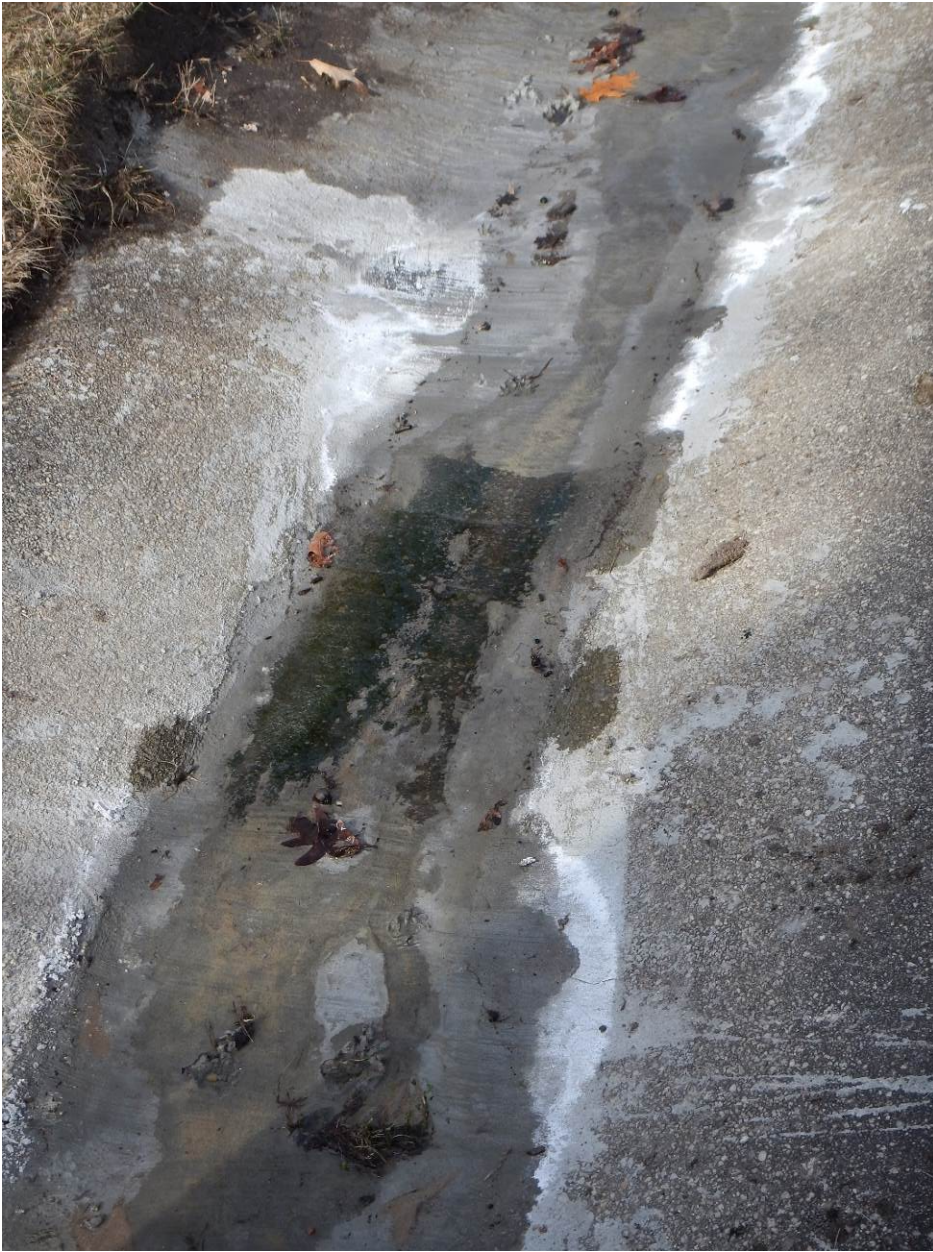
Figure 2. Whitish residue on concrete channel downstream of outfall.

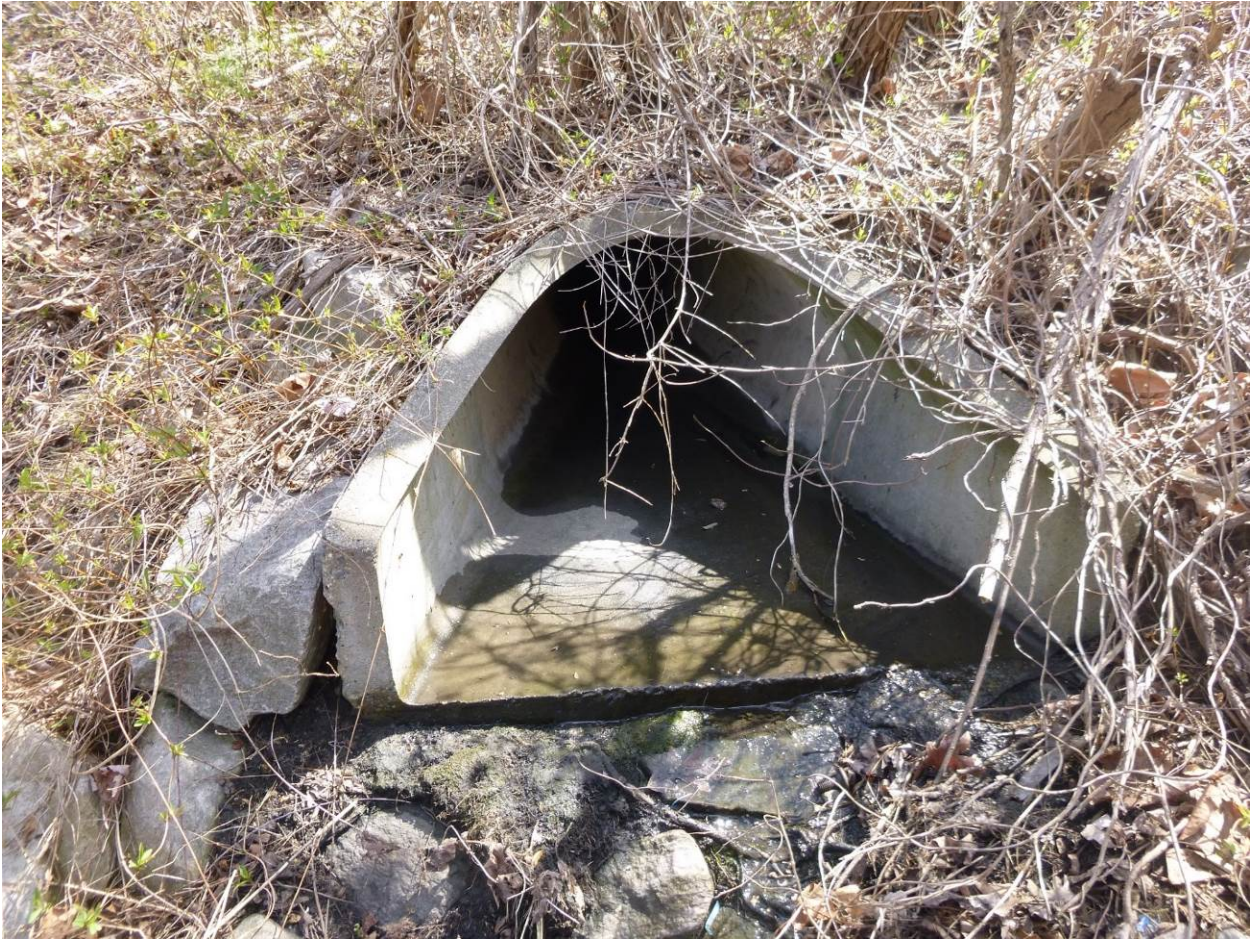
Versar field staff conducted site visits to two outfalls (one, a target) associated with a stormwater pond along Parkway Drive South, near the Raspberry Deli at the above address, on April 13. On the first visit to the outfall F06H4O016, at 11:32 a.m., the field crew documented flow from the 18-inch pipe discharging to the pond (Figure 1). The field team tracked the pipe back to the inlet on the southwest edge of Parkway Drive South (the only source of water for the outfall) and found the inlet dry. The screening results at the outfall on the first visit were above action levels for chlorine (1.0 mg/l) and detergents (0.5 mg/l); these results are tabulated in the Test 1 Result column of Table 1.

Figure 1. Outfall F06H4O016 showing a small amount of flowing water on April 13

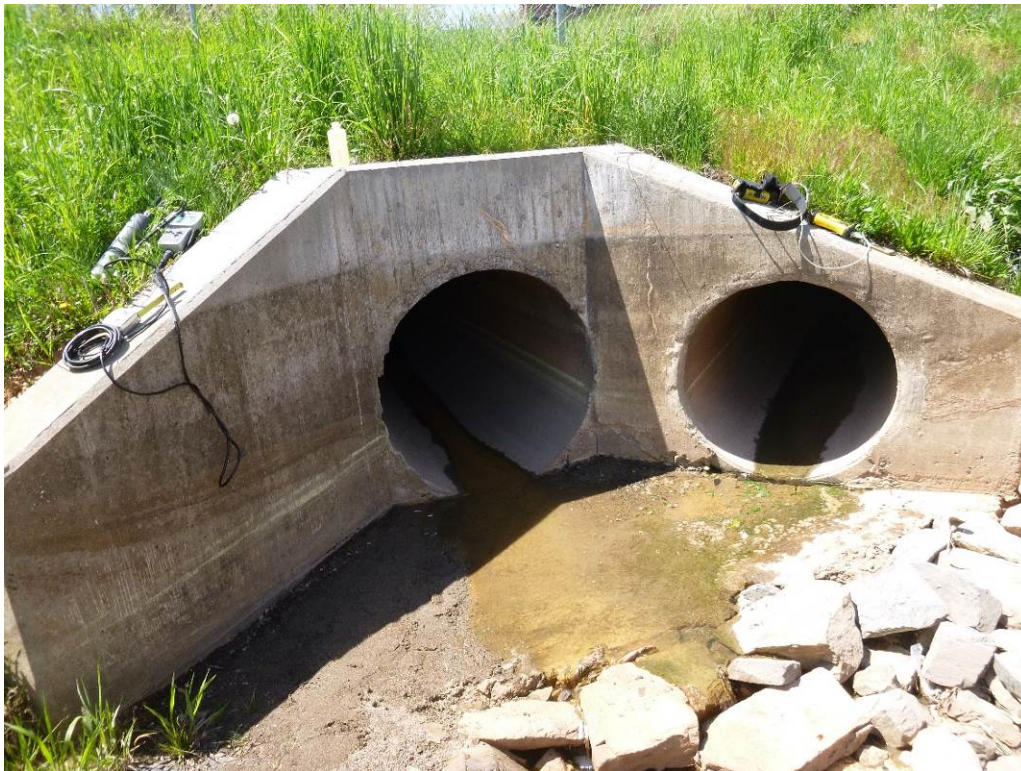
Outfall F07F8O003 (42”, on the left) had sewage smell, was slightly brownish in color, and had a faint sheen on the water surface. The sound of water entering upstream suddenly increased during inspection. The discharge failed chemical tests for detergents (0.9 mg/l) and ammonia (10 mg/l). Outfall F07F8O003NEW (36”, on the right) had no color or sheen, but had noticeable toilet paper residue at the outfall opening (Figure 2). It, too, had a sewage smell and the ammonia concentration was above the action level at 2.5 mg/l (Table 1 and Table 2).

Figure 1. Outfalls F07F8O003 and F07F8O003NEW near Arbor Grove Drive

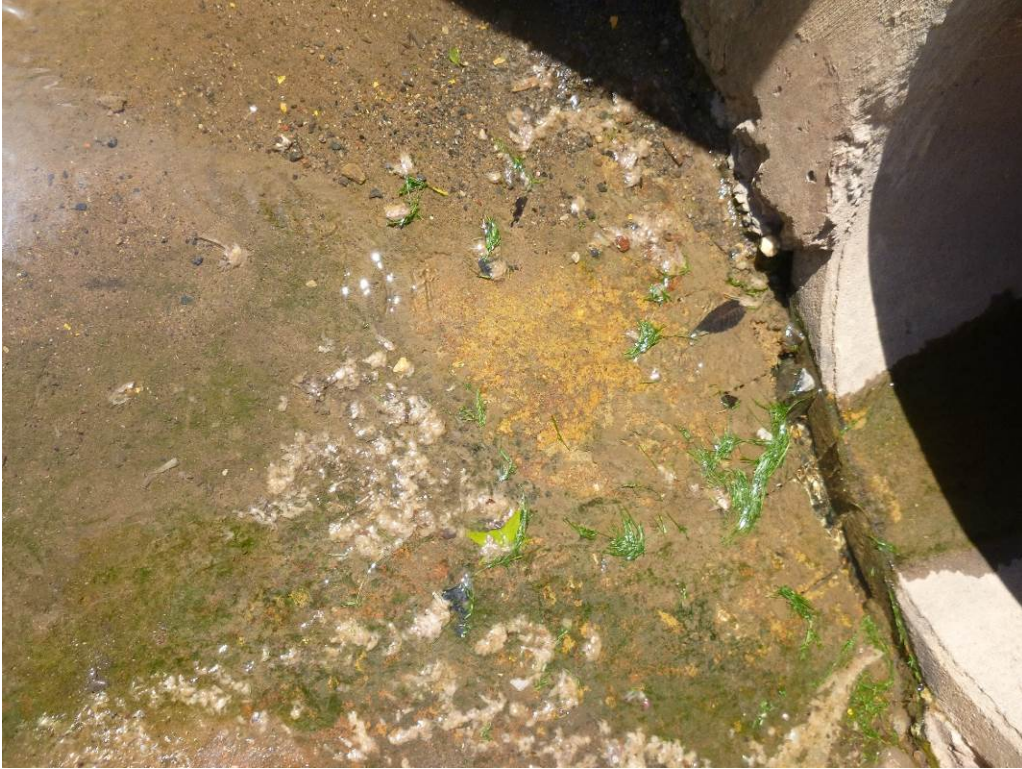
Figure 2. Noticeable toilet paper at the opening of outfall F07F8O003NEW

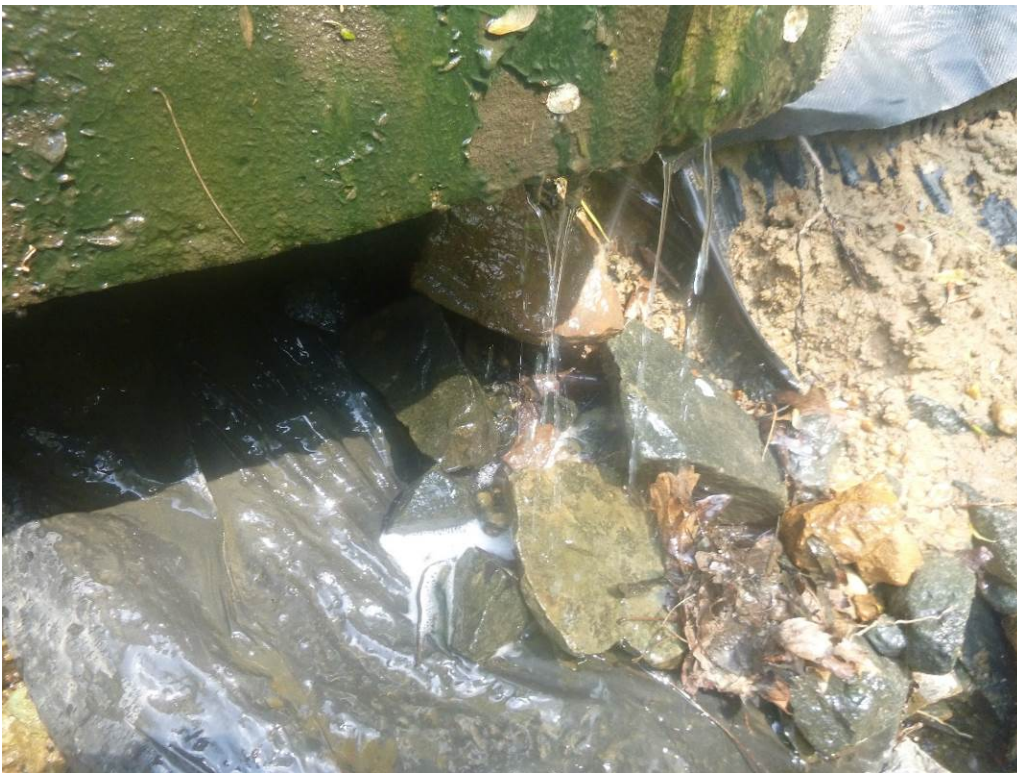
A Versar field team inspected the above outfall (actually the downstream end of a crossing) at 3:05 p.m. on May 5, 2015. The field team immediately noted that the water below the outfall had a greenish color, and there were suds where the dripping water was pooling (Figure 1 and Figure 2). The field team collected a water sample (Figure 3), which had an oily odor and contained above action concentration of detergents (0.9 mg/l; Table 1). The area around the outfall was severely eroded (Figure 4).

Figure 2. Discharge and suds below oufall F09F5O001

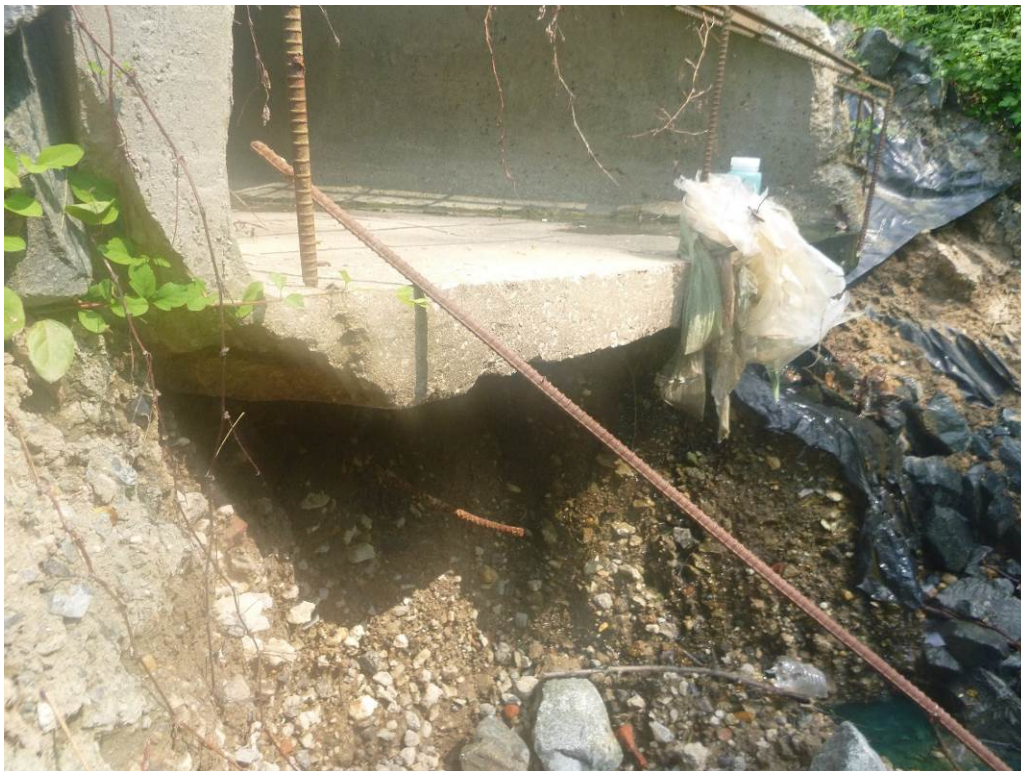
Figure 4. Erosion at outfall F09F50001

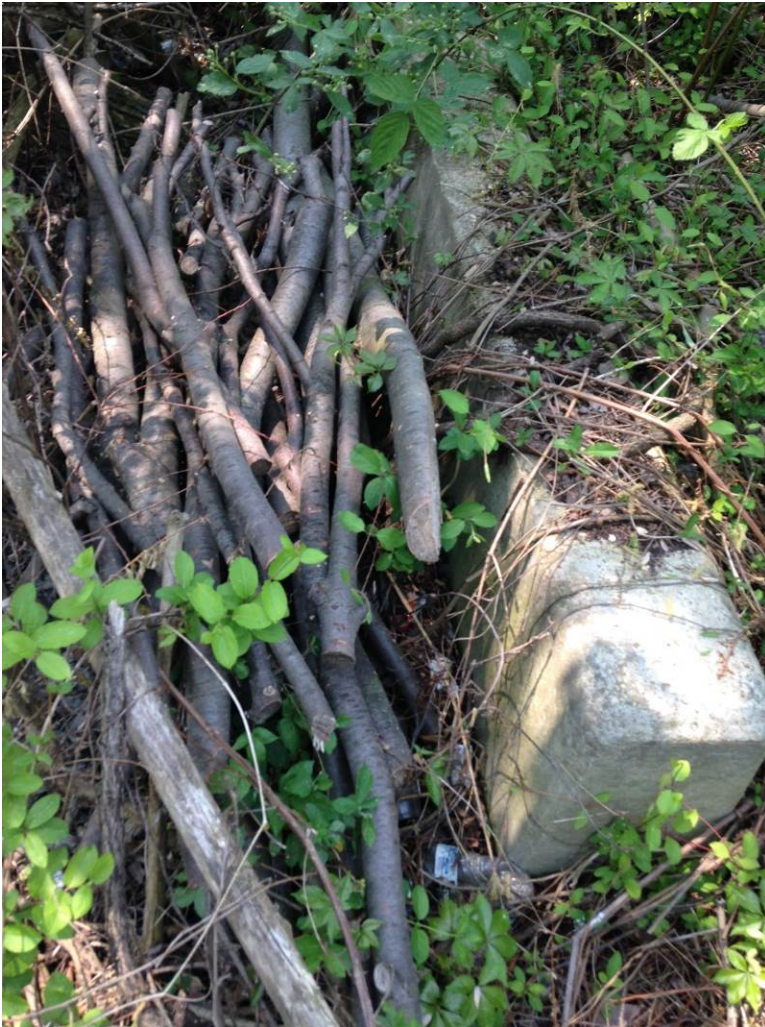
At 1:12 p.m. on May 6, 2015, the team retested the outfall and obtained a result of 3 mg/l for detergents. Versar tracked the flow through the crossing and overland to another outfall (F09G5O001). The orifice of the outfall was found to be blocked by tree branches that appeared to have been deliberately placed (Figure 5). The team tested the flowing water from this outfall and obtained a detergents result that was off-scale. Source tracking of the discharge led the team to a car wash at a Shell fueling station. Two trench drains (at the entrance and exit; Figure 6) appeared to be connected to the storm drain system. Considering the persistence of flow through the network and through a downstream crossing, it is probable that much excess wash water is entering the system via the trench drains or possibly the main car wash effluent drainage is directly connected to the stormwater network. On May 7, Versar contacted I&P via the pollution hotline to report the matter. An area map is provided in Figure 7.

Figure 5. Outfall F09G5O001 with branches placed in front of orifice.

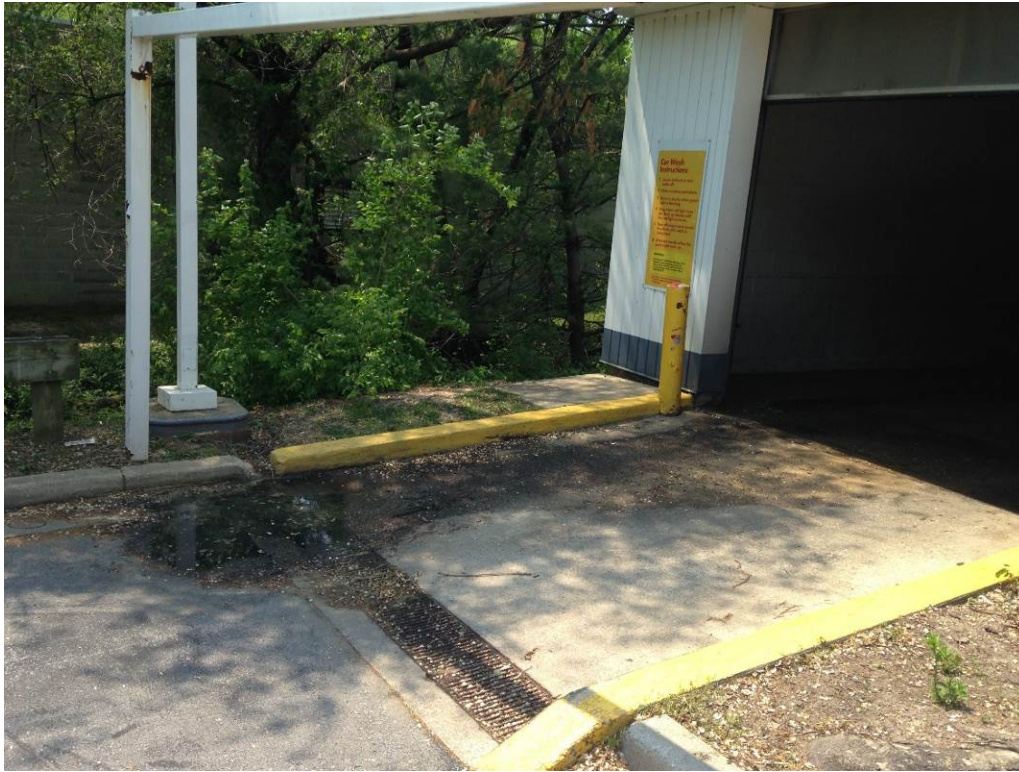
Figure 6. Trench drain at entry to Shell car wash

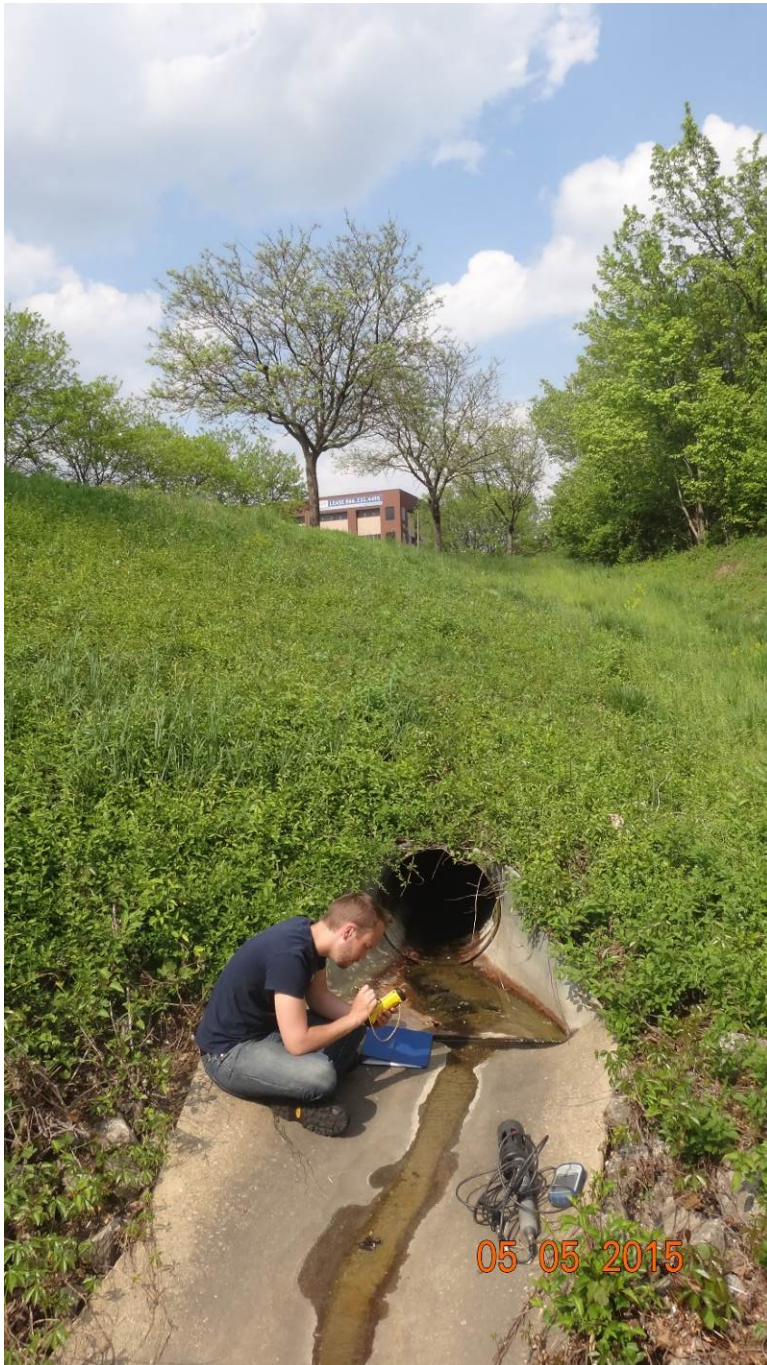
Figure 2. Outfall I04F3O014 discharging to dry pond

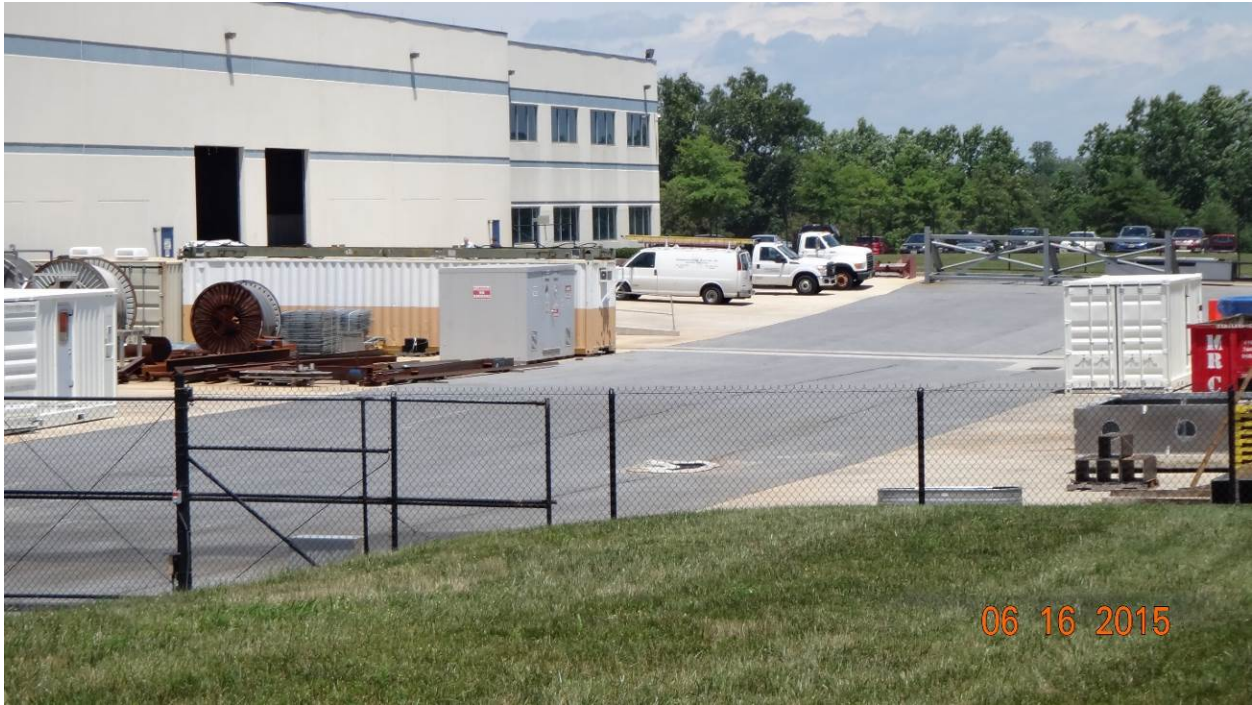
Figure 2. Enclosed area behind 7001 Dorsey Rd. with absorbent berms around yard inlet

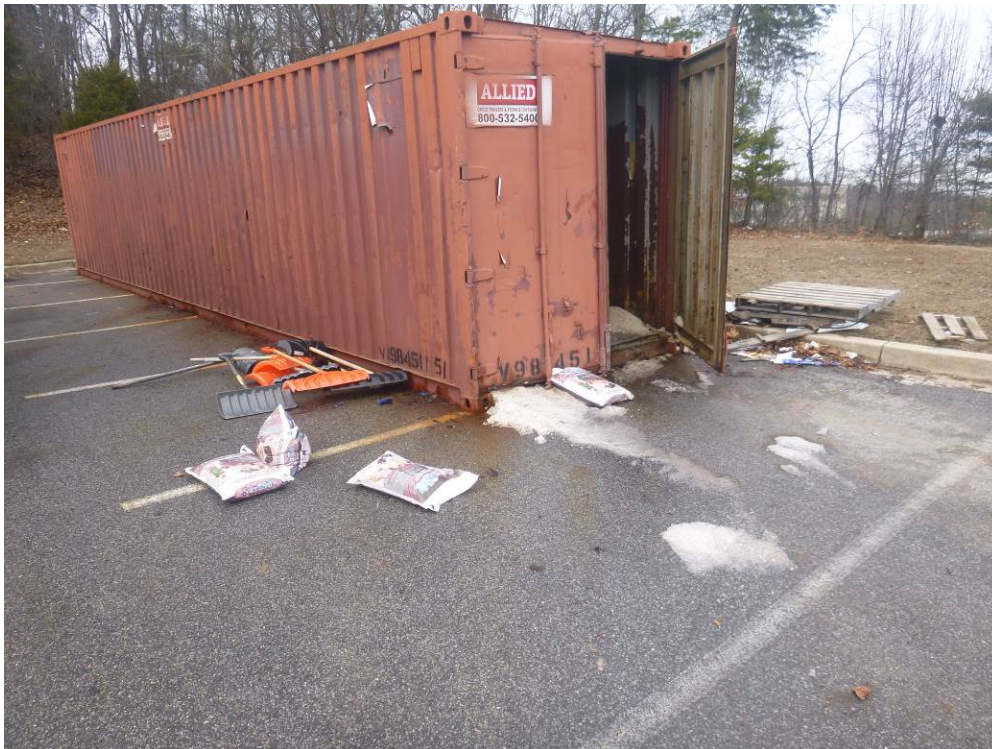
A Versar field team discovered a condition of improper bulk solid storage, in the form of snow removal and road de-icing supplies and tools, in the parking lot adjacent to (immediately to the west of) the building located at 1334 Ashton Road, in Hanover, MD. The field crew documented bags of salt, loose salt, and an open storage trailer at this location (Figure 1). The field crew found a skid steer loader in the same area with residual de-icing salt in its bucket (Figure 2). The truck parked between the storage trailer and the skid loader, with a snow plow attachment, displayed a company logo for Beneficial Landscaping, LLC (Figure 3). This small company is located in Sykesville, MD, so the Hanover storage site may be established under an agreement with the landowner of the Ashton Road building, or the building at 7467 Ridge Road, Hanover, which lies adjacent to the parking lot on the southwest side. The placement of salt on an impervious surface introduces the risk of distribution, by wind or rain, of salt particles and associated nutrients which could drift into adjacent storm drain inlets or open water. An area map, indicating the location of the loose salt, is provided in Figure 4.

Figure 1. An open storage trailer and several small piles of de-icing salt found in the parking lot

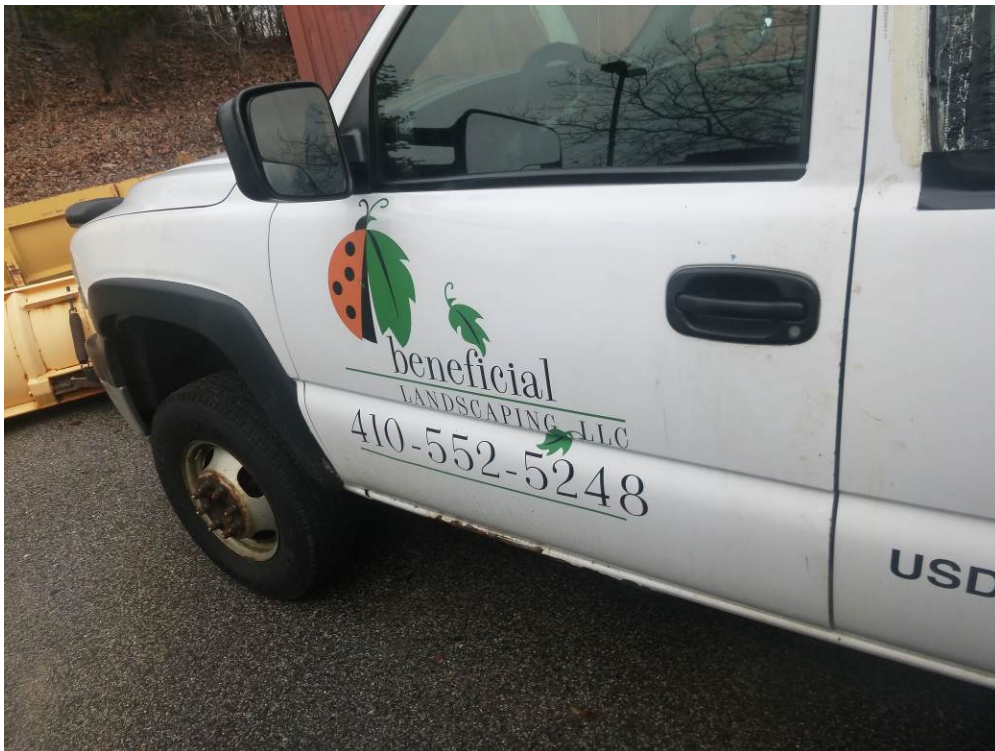
Figure 3. Truck found alongside the storage trailer, with company logo on the door

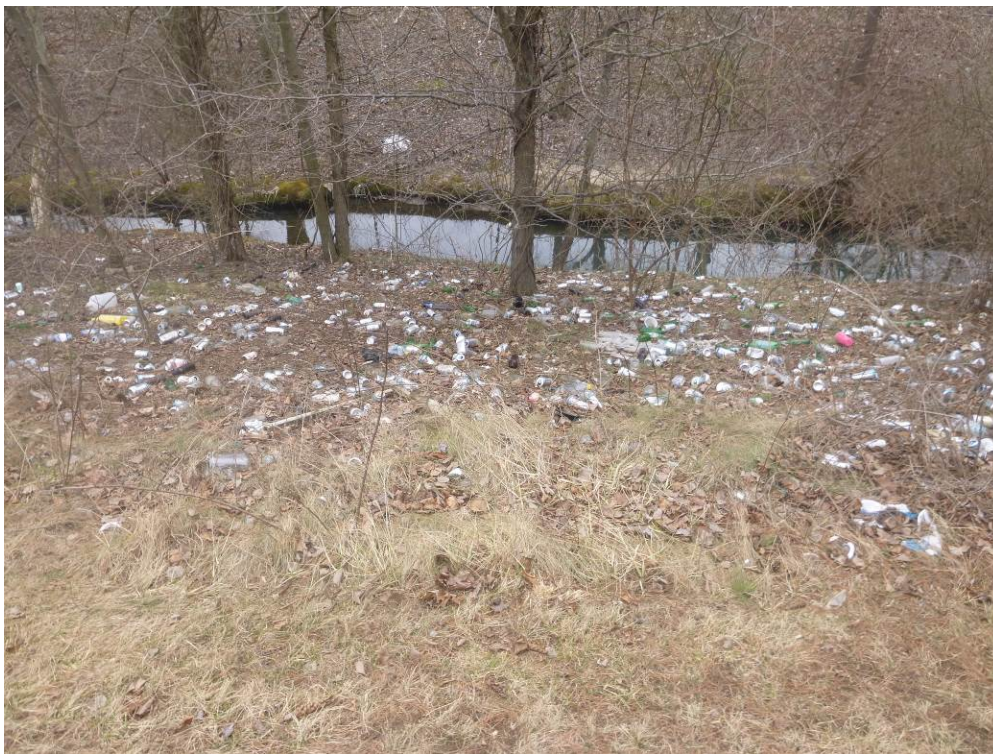
A Versar field team discovered a large amount of debris on a slope leading to a stream alongside a parking lot associated with United Stationers at the above address (Figure 1). The material deposited on the slope included bottles, cans, and plastic containers. In one area, there were also larger pieces: plastic bags, a box, and strips of foam (Figure 2). The trash was found strewn along a wide stretch of the woods along the stream. The sloped land would contribute to a significant pollution source from this site, as materials could enter the stream easily, carried by wind or rain. Debris deposited on the ground may also leak potentially contaminating contents onto surfaces that could lead to the open water. Some debris may also attract pests to the site. An area map, indicating the location of the debris, is provided in Figure 3.

Figure 1. Abundant loose debris found on a slope alongside a stream

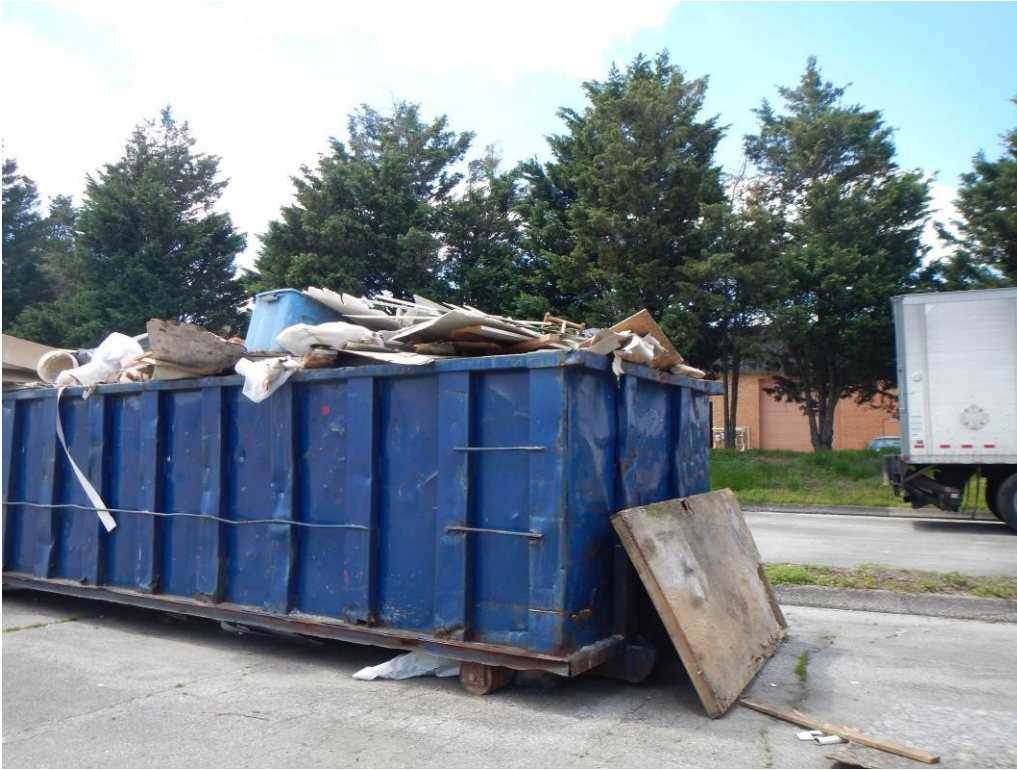
A LimnoTech field team discovered an overfilled roll-off dumpster in the parking lot behind the West Marine store at the above address (Figure 1). Debris evident at the top of the pile included several open, used containers; the field crew was unable to determine the contents of these visible containers. The field crew also found large pieces of debris scattered around the dumpster (Figure 2). The lack of proper storage (preferably in closed containers under shelter) may allow trash to blow off-site or into the nearby storm drain system. Large pieces of debris, already on the ground or blown to the ground with a strong wind, may create hazards for drivers in the parking lot. Debris that falls onto the ground may also leak potentially contaminating contents onto surfaces that could lead to nearby storm drain inlets or open water; open containers in the dumpster may also release contaminants into the dumpster during rain events. Some debris may also attract pests to the site. An area map, indicating the location of the dumpster, is provided in Figure 3.

Figure 1. An overfilled dumpster investigated on April 24 and 29; several open containers are evident in the debris (photography date: April 29, 2015)

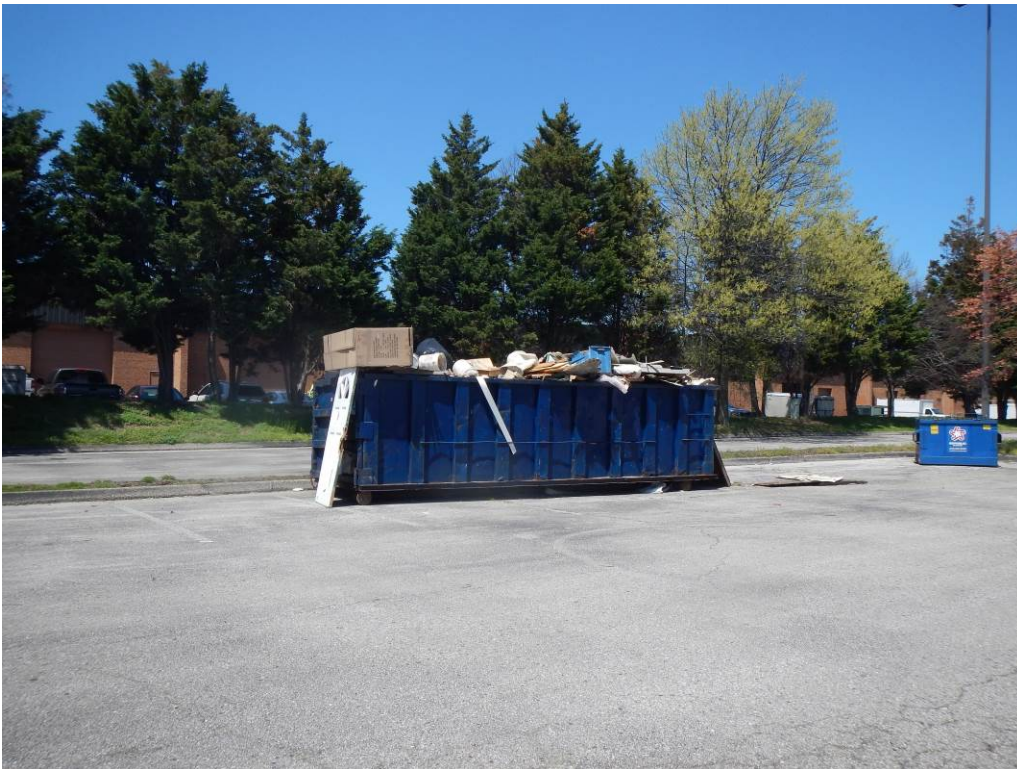
Figure 2. Large pieces of debris scattered around the overfilled dumpster (photography date: April 24, 2015)

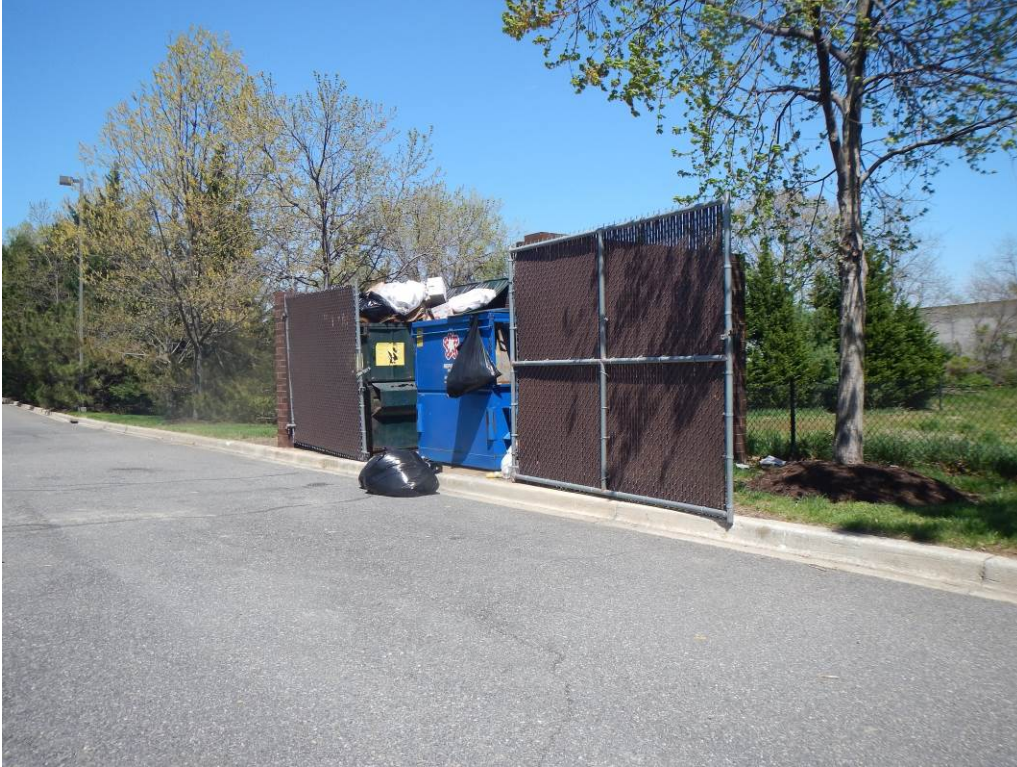
A LimnoTech field team discovered a pair of open dumpsters in an enclosure alongside the parking lot behind the Cromwell Business Park building (multiple businesses) at the above address. One dumpster, intended for the disposal of recyclable material, was overfilled (Figure 1). The other dumpster, intended for trash, had many bags of garbage strewn around it and some loose debris; food containers were apparent in some of the bags (Figure 2). The dumpsters were situated on a concrete pad above the curb. There were curb inlets near the dumpsters, one approximately 65 feet north and the other approximately 117 feet south of the enclosure. The lack of proper storage (preferably in closed containers under shelter) may allow trash to blow off-site or into the nearby storm drain system. Debris on the ground may leak potentially contaminating contents onto surfaces that could lead to nearby storm drain inlets or open water. Some debris may also attract pests to the site. An area map, indicating the location of the dumpsters, is provided in Figure 3.

Figure 1. An overfilled dumpster (left), intended for materials to be recycled; the nearby curb inlet to the north is evident on the left side of the photograph

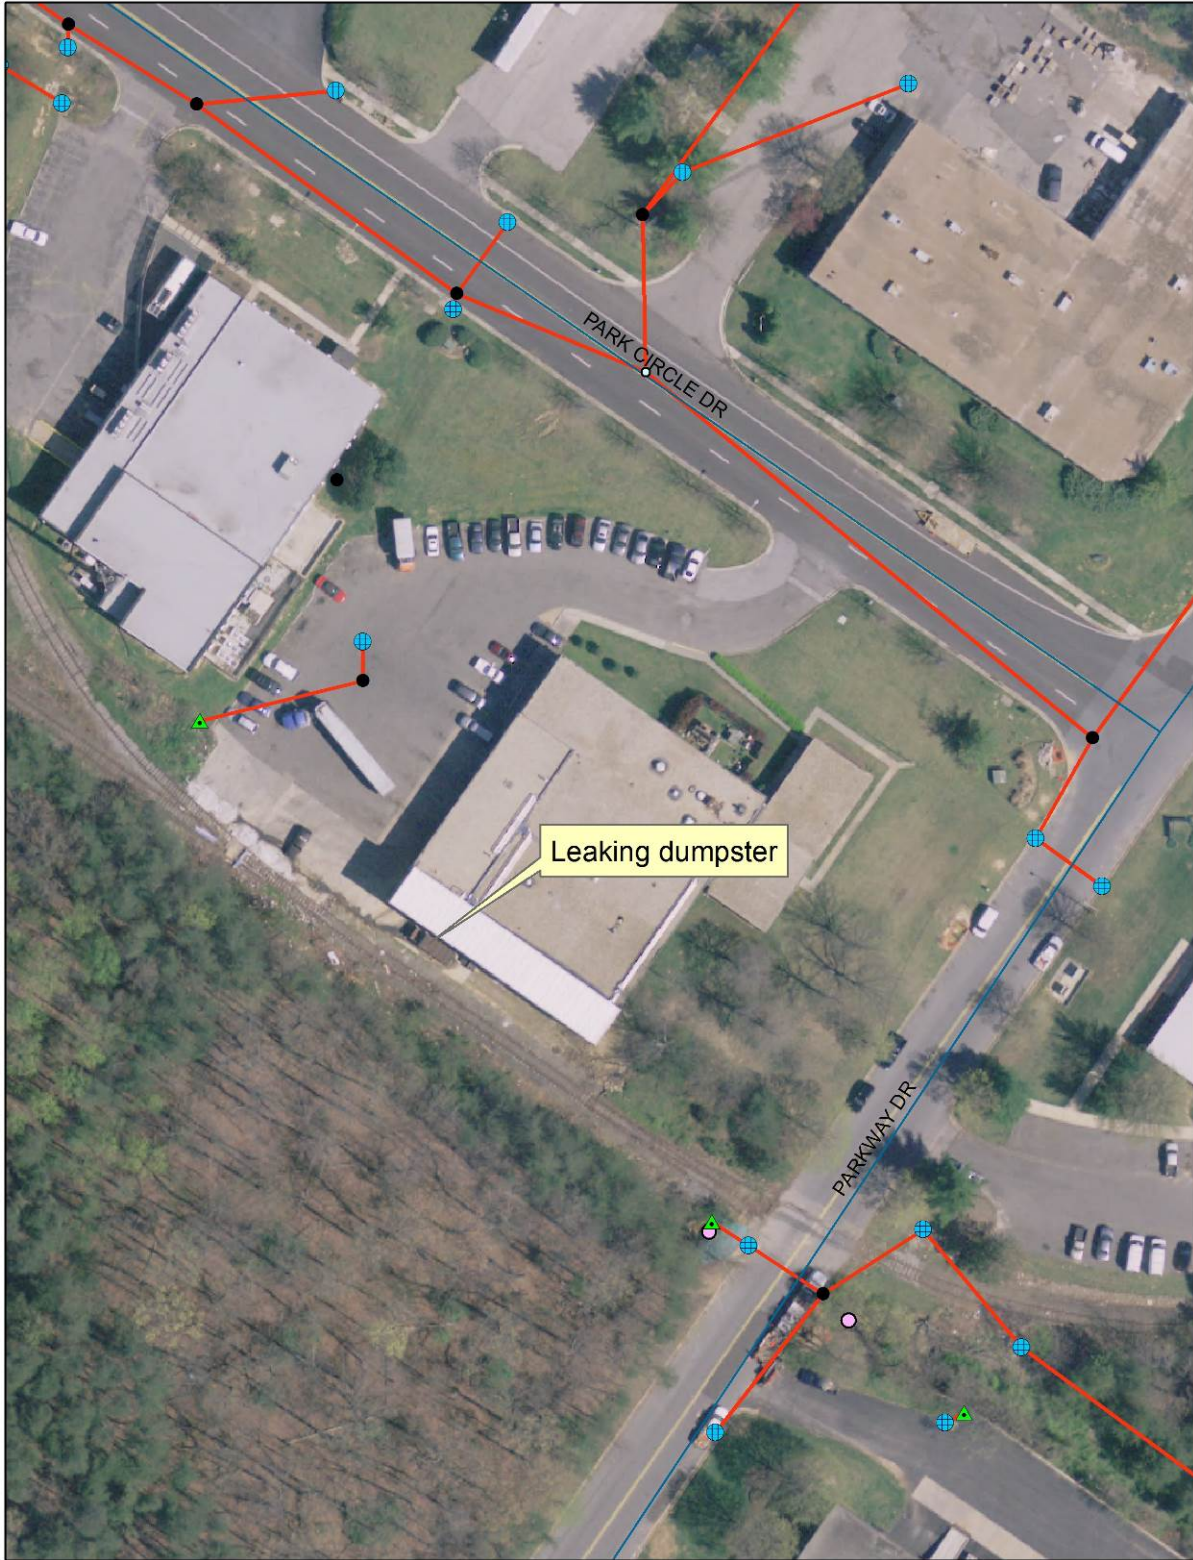
Figure 5. Area map (note that the leachate trail is evident in this aerial photograph from 2007)
