**BIOLOGICAL AND
GEOMORPHOLOGICAL CONDITION
IN THE PICTURE SPRING BRANCH
SUBWATERSHED, SEVERN RIVER
WATERSHED, ANNE ARUNDEL COUNTY,
MARYLAND: 2015**

Anne Arundel County, Maryland
Department of Public Works
Watershed Protection and Restoration Program
2662 Riva Road
Annapolis, MD 21401

Versar, Inc.
9200 Rumsey Road
Columbia, MD 21045

February 2016

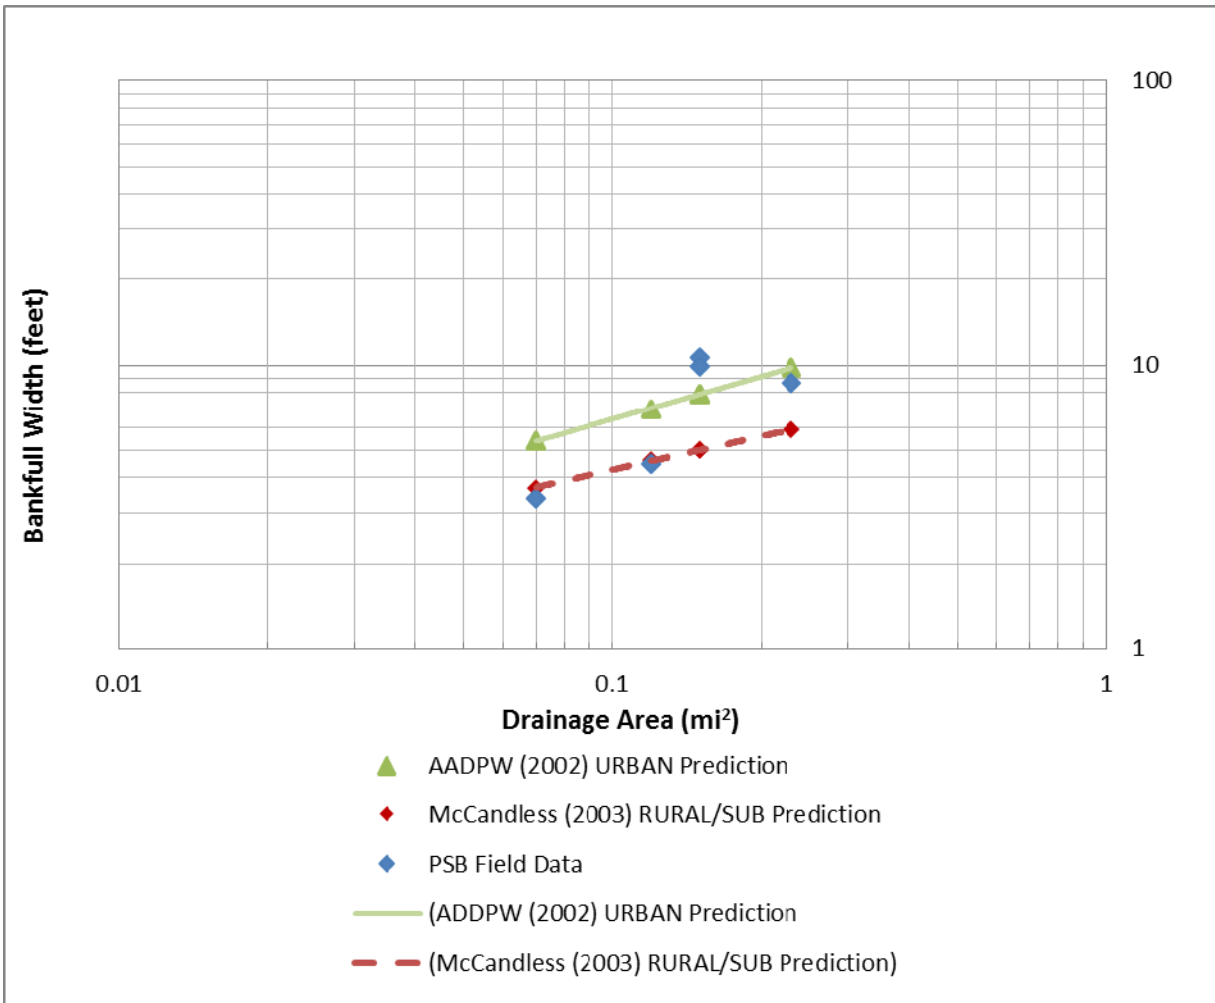
Figure 3-1. Comparison of the bankfull width drainage area relationship between Picture Spring Branch (PSB) 2015 field data and regional relationship curve data

The geomorphic assessment field data were compared to both the Maryland Coastal Plain (MCP) regional relationships of bankfull channel geometry (McCandless 2003) and relationships for gaged urban Coastal Plain streams developed specifically for Anne Arundel County (AADPW 2002) to determine how bankfull characteristics observed in the field compared to those predicted by the MCP and urban relationships. Comparisons of bankfull width, bankfull cross-sectional area, and mean bankfull depth are shown in Figures 3-1, 3-2, and 3-3, respectively. Bankfull width values tended to loosely fit the predictions of the urban curve, with some points wider than predicted due to the engineered channel design. All bankfull cross-section area field data values fell between the MCP curve and urban curve predictions. Field data for mean bankfull depth mainly fell between the MCP curve and urban curve predictions, with one site falling just below the MCP curve. Overall, it appears that some of the field data were not consistent with the MCP relationships; however, it should be noted that the regional curves were developed using streams with drainage areas ranging from 0.3 to 89.7 square miles, with the majority of the data collected in watersheds greater than one square-mile with low (zero to three percent) imperviousness. Thus, it is possible that stream channels with smaller drainage areas, such as those studied in this assessment (ranging from 0.07 to 0.23 square miles), exhibit greater variability in channel dimensions when compared to the MCP relationships. Additionally, the Rosgen method is best used on streams that are free to adjust their lateral boundaries under the current discharge regime experienced by the system (Rosgen 1996), conditions which do not necessarily exist in the study area. For example, cross sections 2, 3, and 5 are underlain by concrete trapezoidal channels, possibly making the accurate determination of the bankfull indicators in the field at these locations problematic. Regardless, given the high imperviousness of the study drainage area and the modified nature of the channel, it is not surprising that the field data deviated in many cases from the MCP curve and were more closely matched to urban curve predictions for bankfull width.

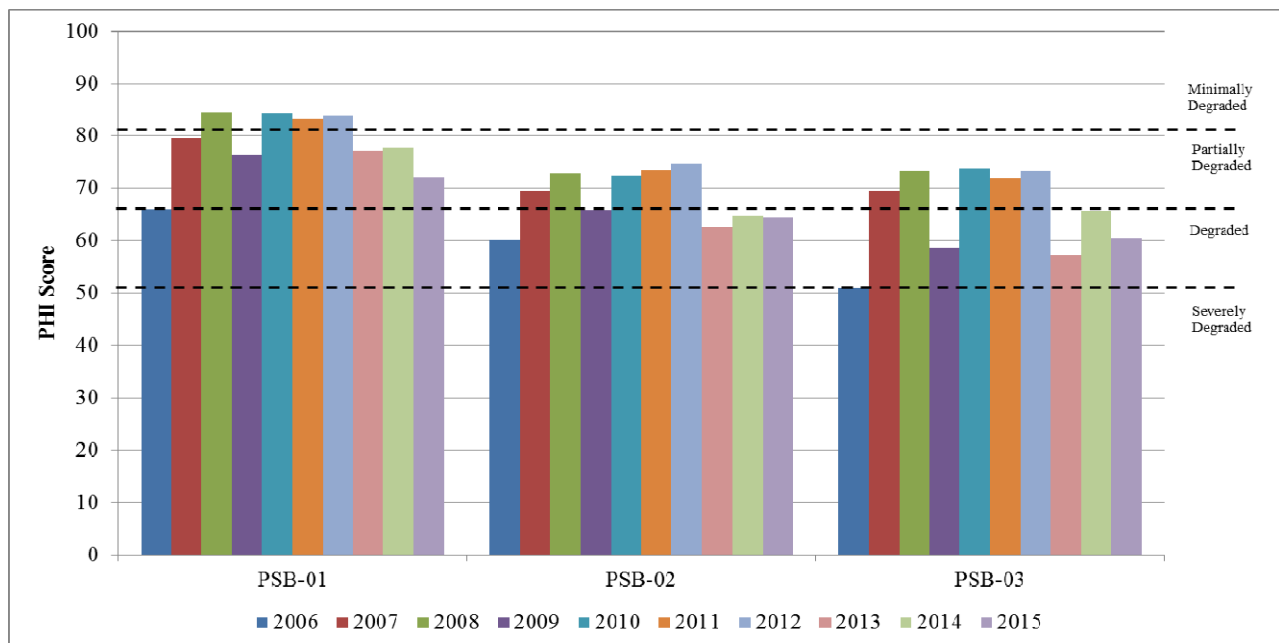
Figure 4-1. Comparison of PHI Habitat Scores from 2006 through 2015

During the past five years of monitoring, PHI scores have fluctuated slightly from year to year (Figure 4-1). Fluctuations in annual physical habitat scores may be attributed to two primary factors: 1) changes in habitat suitable for colonization (i.e., changes in substrate/embeddedness and changes in the quantity of woody debris) affects direct scoring of this parameter, and also indirectly influences scoring for epifaunal substrate and instream habitat; and 2) variability in qualitative visual assessment scoring between field crews.

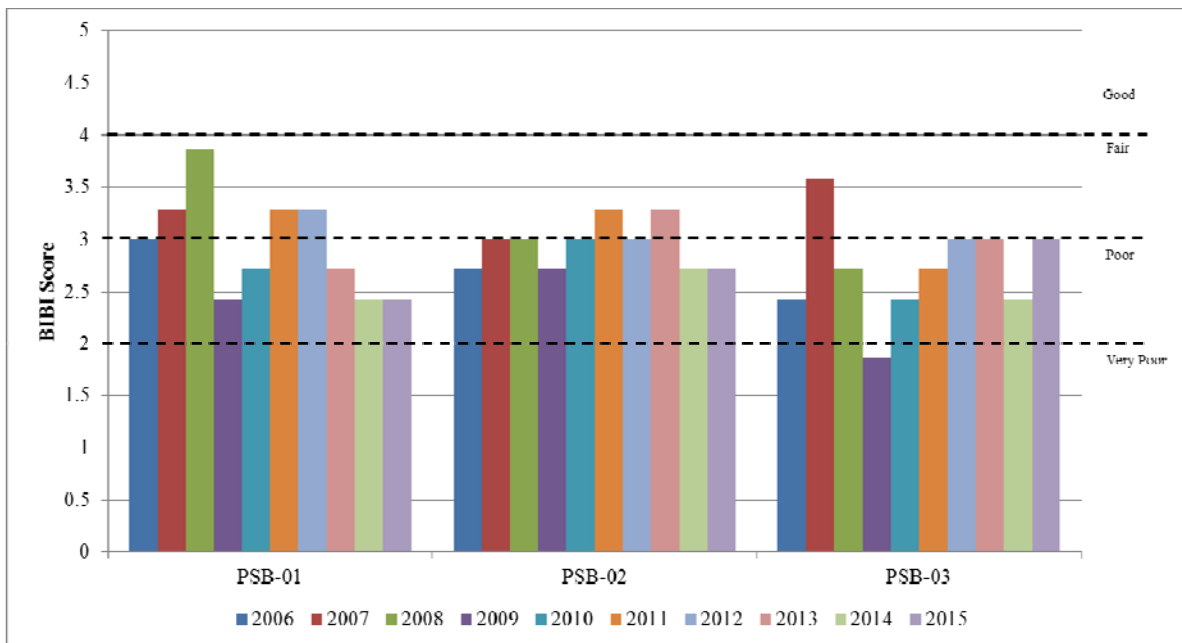
Figure 4-2. Comparison of BIBI Scores from 2006 through 2015

BIBI scores increased at PSB-03, and stayed constant at the other two sites from 2014 to 2015 (Table 4-2). The narrative ratings, like the BIBI scores, stayed the same at two sites, while improving from “Poor” to “Fair” at PSB-03. Figure 4-2 provides a visual comparison of BIBI scores over time and shows scores fluctuating from year to year.

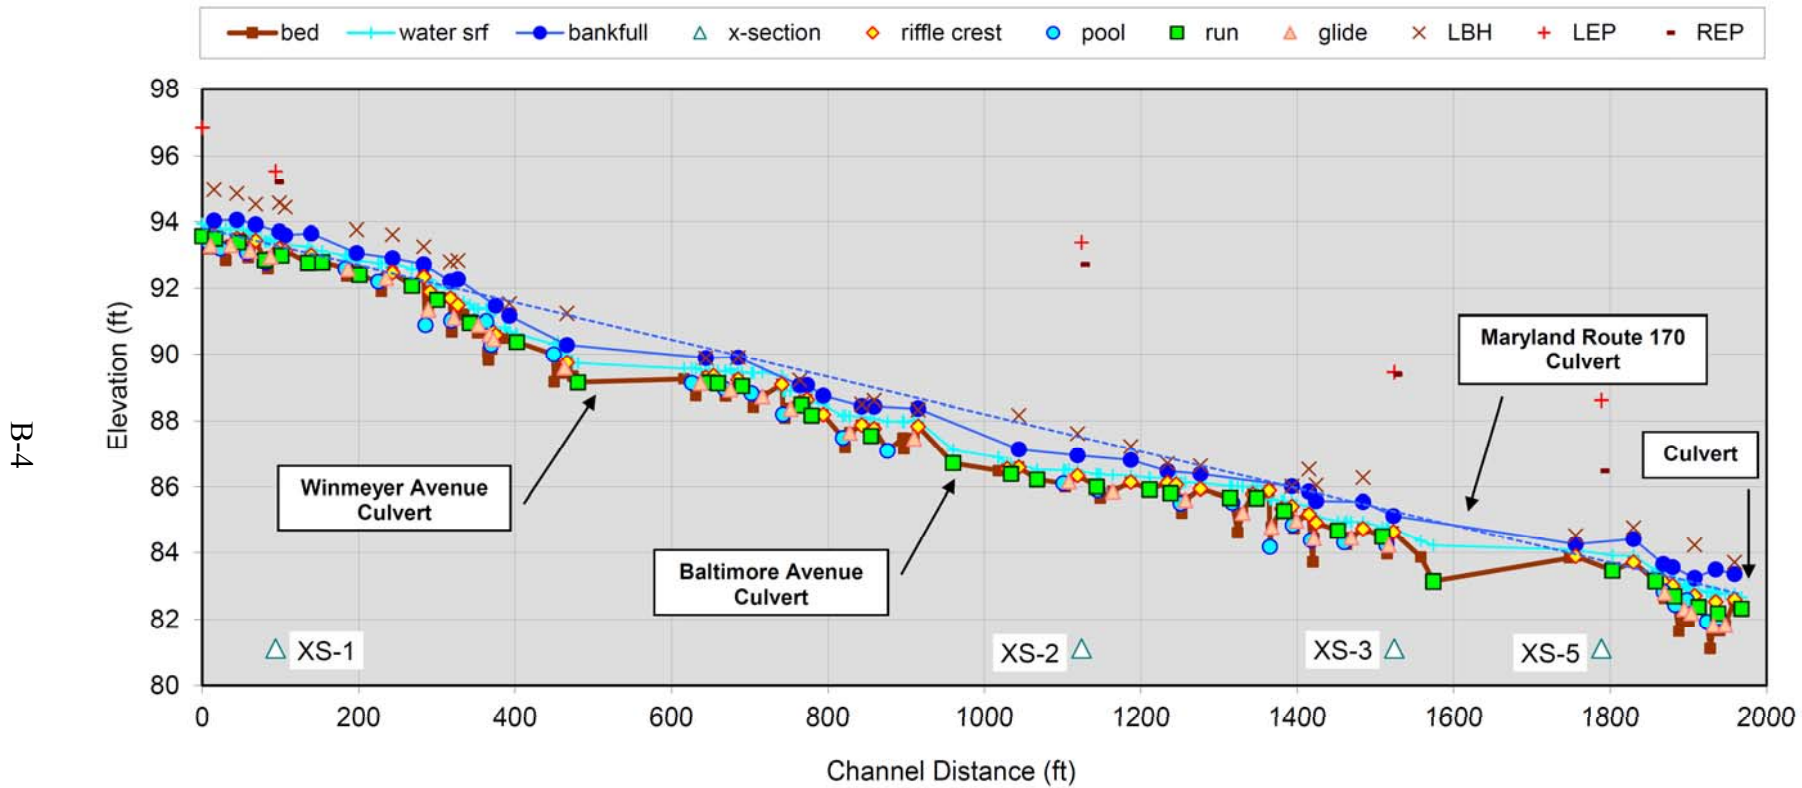
Picture Spring Branch North Tributary Longitudinal Profile

An overlay of North Tributary longitudinal profiles shows little change occurring to this reach from 2007 through 2015 (Appendix B). Numerous man-made structures (i.e., culverts, concrete-lined channel) throughout this reach appear to be providing adequate grade control, preventing substantial channel degradation.

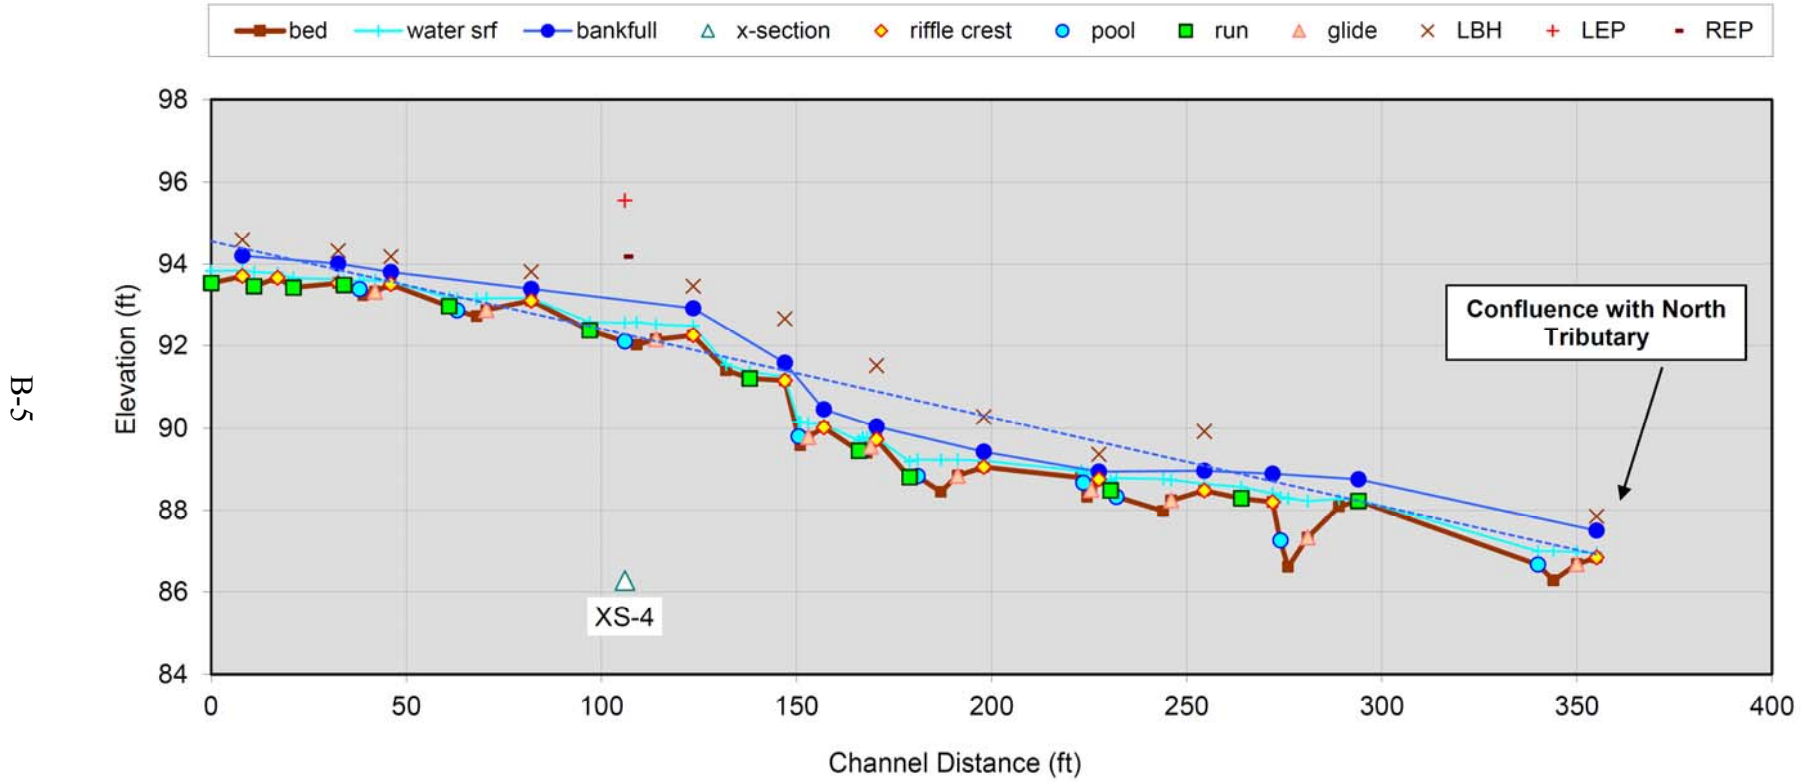
Picture Spring Branch South Tributary Longitudinal Profile

An E channel was identified at cross section 4 on the South Tributary, which appeared to have been channelized in the past and is piped underground for a significant distance upstream, further modifying its hydrology. However, the South Tributary is not overwidened and is significantly steeper than the North Tributary. Indicators were observed that show some limited floodplain connectivity along the upstream portion of the tributary where the cross section is located. However, just downstream of the cross section location, the channel became noticeably entrenched and showed signs of active downcutting. While it is possible that this reach may exhibit both B and E characteristics along different portions of the reach, it was assigned an E5 classification primarily based on the entrenchment and width/depth ratios measured at the cross section location. Evidence of recent downcutting (e.g., nick points) suggests that the reach is unstable and is likely shifting from an E channel to a B channel. Significant changes in the shape of this cross section were observed during the 2013 survey, as the channel had noticeably deepened and widened since the 2012 survey (Appendix B). Over the next year, as seen in the 2014 survey, aggradation occurred affecting the bed level by raising it approximately 0.5 feet. From 2014 to 2015, the channel has shifted slightly, but has remained stable in terms of aggradation or deepening. Analysis of the longitudinal profile overlay from 2007 through 2015 shows considerable downcutting between stations 1+00 and 2+20 (Appendix B). However, during 2014 the pool near station 2+00 has mostly filled in. This trend has continued in 2015, with the pool working its way up the reach to station 1+80. The headcut and large scour pool between stations 2+68 and 2+90 just downstream from this eroded section have not worsened. It is recommended that this area continue to be monitored, since further erosion could eventually lead to undermining of the concrete-lined channel just downstream.
