**BIOLOGICAL AND
GEOMORPHOLOGICAL CONDITION
IN THE PICTURE SPRING BRANCH
SUBWATERSHED, SEVERN RIVER
WATERSHED, ANNE ARUNDEL COUNTY,
MARYLAND: 2015 - 2016**

FINAL REPORT

Versar, Inc.
9200 Rumsey Road
Columbia, MD 21045

February 1, 2017

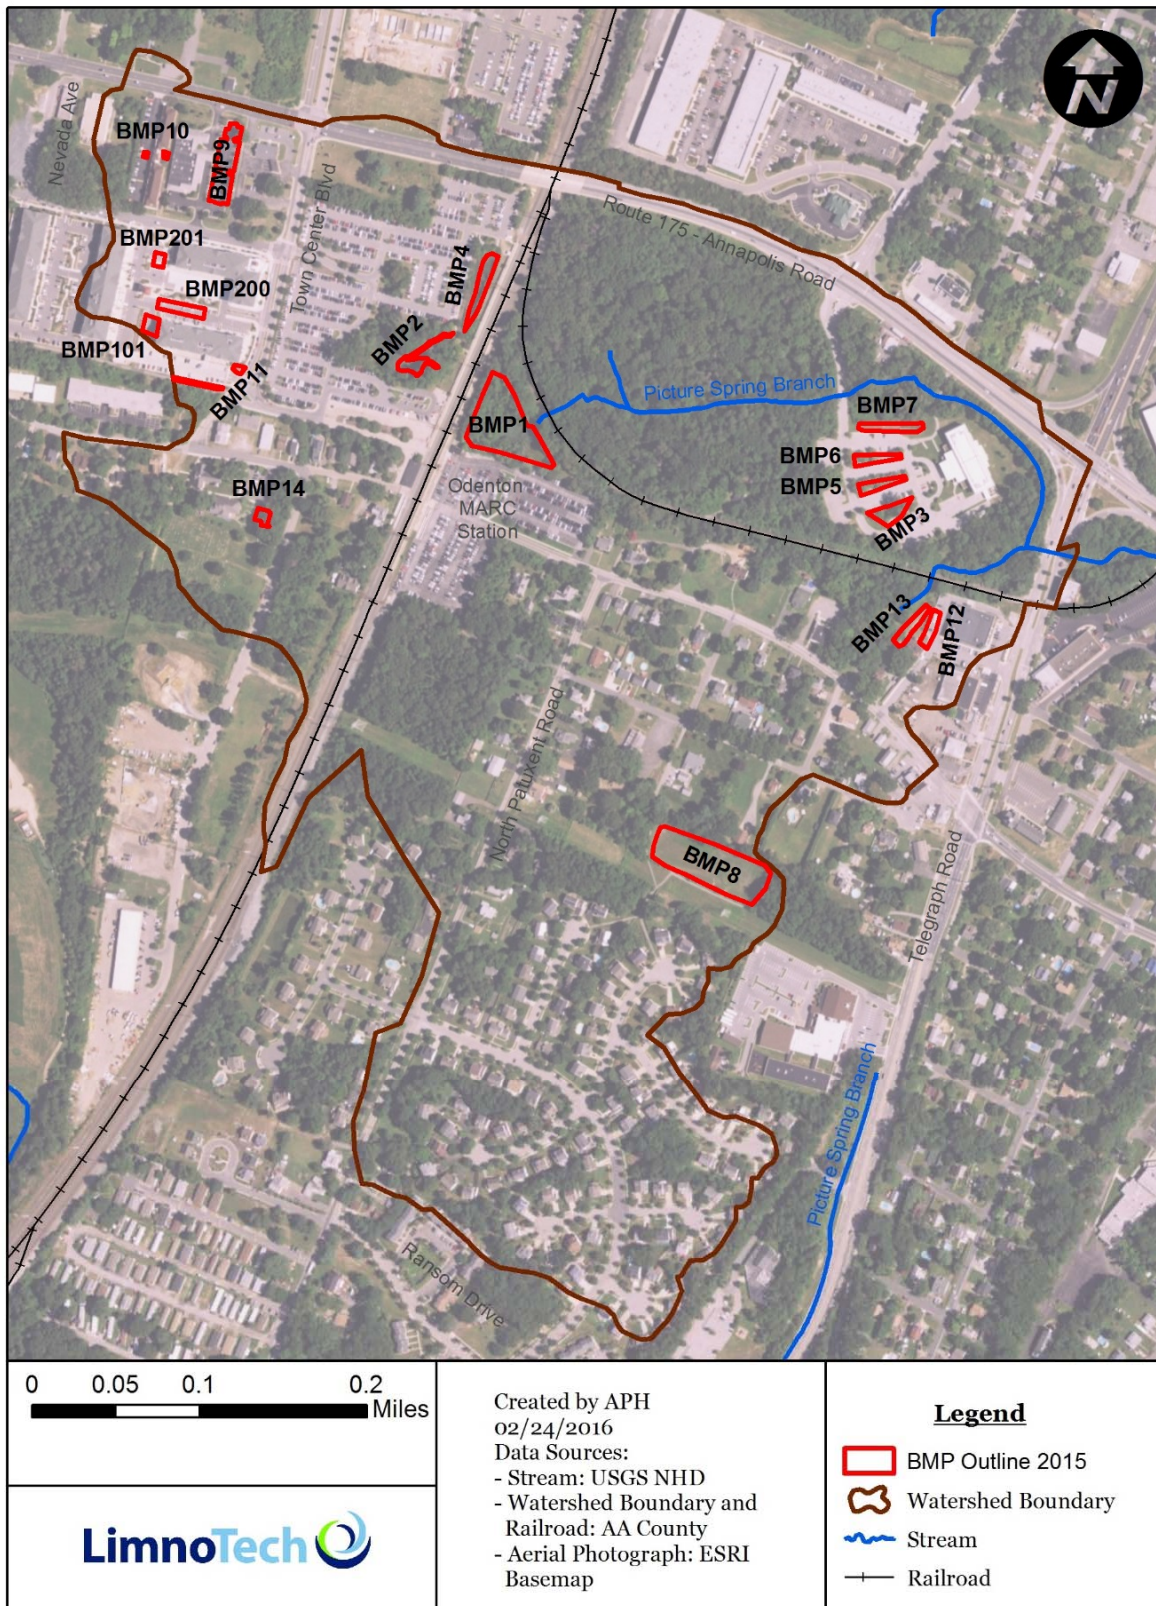
Figure 2-2. Picture Spring Branch BMPs

The Picture Spring Branch watershed contains 17 BMPs, as shown in Figure 2-2 and Table 2-8. Inspections were conducted on November 16, 2015 and January 13, 2016 (hereafter termed the “2015/2016 inspections”). Inspections at BMPs under the County’s jurisdiction are carried out regularly and the records are maintained at the County offices. Each BMP was inspected during dry weather conditions (defined as a minimum 48 hours of dry weather since the last rain event). A brief overview of actions recommended to address maintenance/performance issues at specific BMPs are in the following section. Further details, including the detailed inspection findings for each of the BMPs, inspection forms, and photographs, are included in Appendix G.

- The stormwater ponds located along the parking lot and tracks of the Odenton MARC train station (BMPs 1, 2, and 4) have a significant amount of invasive vegetation that should be cleared as soon as possible to prevent failure. BMPs 1 and 2 also have trash and debris build up which should be cleared. Note that these BMPs are owned by MTA and the County may want to coordinate with MTA regarding these BMPs.

- BMPs 3, 5, 6, 8, 9, 10, 11, 12, 13, are all in good condition.
- BMPs 14, 101, 200, and 201 appear to be in good condition, but it should be noted that the condition of these Infiltration Trenches could not be fully assessed because of the limited access to the underground facilities. Flow-in points appear to be clear.

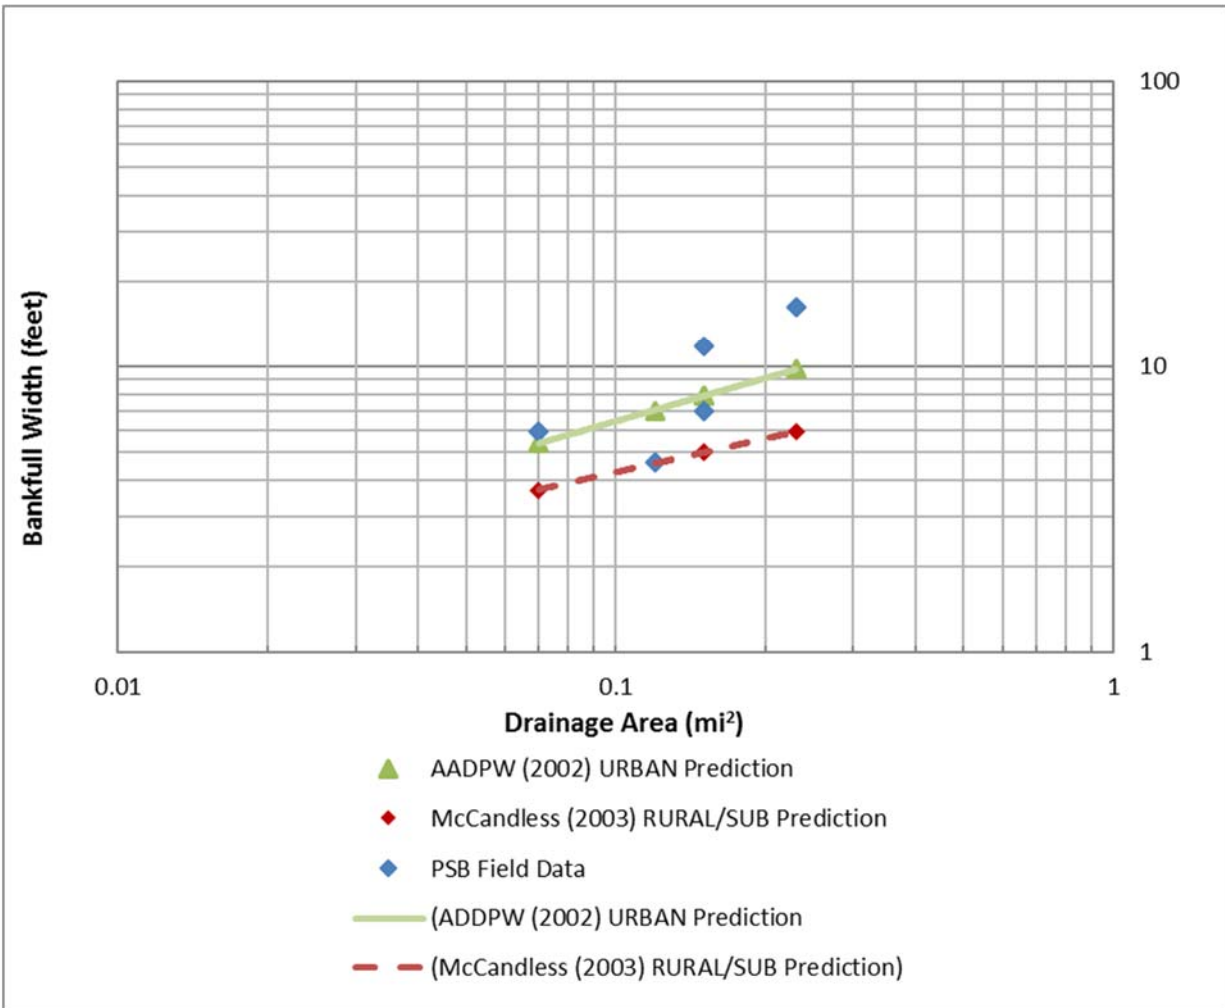
Figure 3-1. Comparison of the bankfull width drainage area relationship between Picture Spring Branch (PSB) 2016 field data and regional relationship curve data

The geomorphic assessment field data were compared to both the Maryland Coastal Plain (MCP) regional relationships of bankfull channel geometry (McCandless 2003) and relationships for gaged urban Coastal Plain streams developed specifically for Anne Arundel County (AADPW 2002) to determine how bankfull characteristics observed in the field compared to those predicted by the MCP and urban relationships. Comparisons of bankfull width, bankfull cross-sectional area, and mean bankfull depth are shown in Figures 3-1, 3-2, and 3-3, respectively. Bankfull width values tended to loosely fit the predictions of the urban curve, with some points wider than predicted due to the engineered channel design. All bankfull cross-section area field data values fell between the MCP curve and urban curve predictions. Field data for mean bankfull depth mainly fell between the MCP curve and urban curve predictions, with one site falling just below the MCP curve. Overall, it appears that some of the field data were not consistent with the MCP relationships; however, it should be noted that the regional curves were developed using streams with drainage areas ranging from 0.3 to 89.7 square miles, with the majority of the data collected in watersheds greater than one square-mile with low (zero to three percent) imperviousness. Thus, it is possible that stream channels with smaller drainage areas, such as those studied in this assessment (ranging from 0.07 to 0.23 square miles), exhibit greater variability in channel dimensions when compared to the MCP relationships. Additionally, the Rosgen method is best used on streams that are free to adjust their lateral boundaries under the current discharge regime experienced by the system (Rosgen 1996), conditions which do not necessarily exist in the study area. For example, cross sections 2, 3, and 5 are underlain by concrete trapezoidal channels, possibly making the accurate determination of the bankfull indicators in the field at these locations problematic. Regardless, given the high imperviousness of the study drainage area and the modified nature of the channel, it is not surprising that the field data deviated in many cases from the MCP curve and were more closely matched to urban curve predictions for bankfull width.

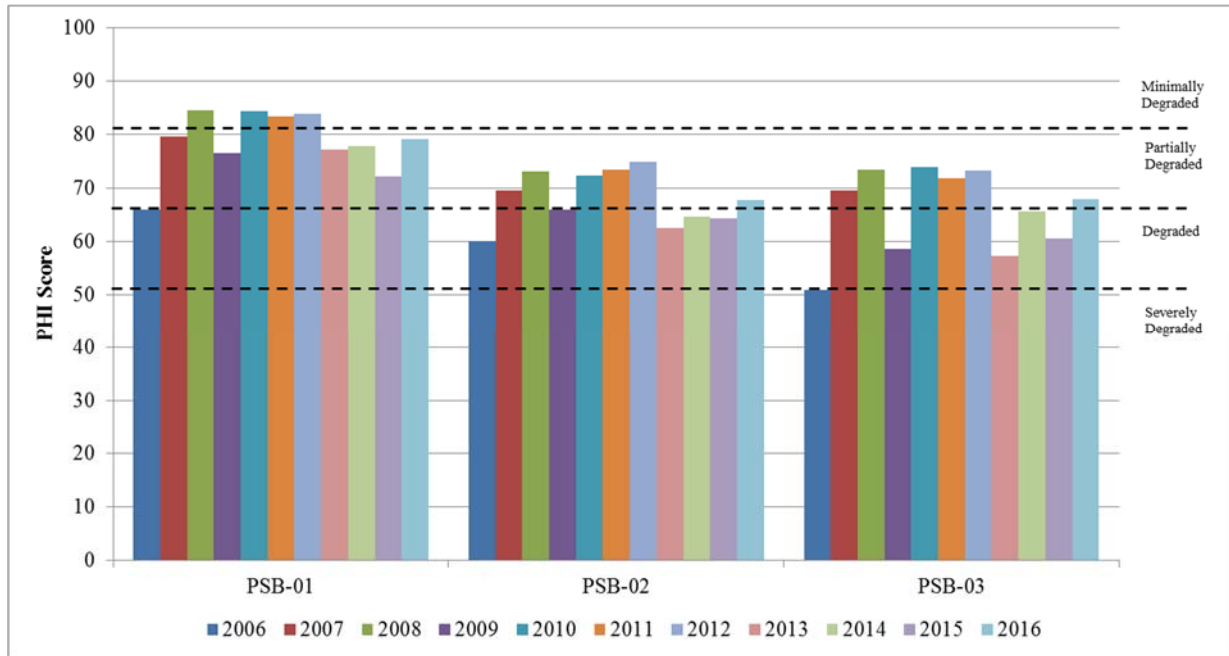
Figure 4-1. Comparison of PHI Habitat Scores from 2006 through 2016

During the past five years of monitoring, PHI scores have fluctuated slightly from year to year (Figure 4-1). Fluctuations in annual physical habitat scores may be attributed to two primary factors: 1) changes in habitat suitable for colonization (i.e., changes in substrate/embeddedness and changes in the quantity of woody debris) affects direct scoring of this parameter, and also indirectly influences scoring for epifaunal substrate and instream habitat; and 2) variability in qualitative visual assessment scoring between field crews.

In 2013, the updated MBSS PHI methods (Paul et al. 2003) were used to calculate PHI instead of the original MBSS methods (Hall et al. 2002) which had been used in the Picture Spring Branch watershed reports from prior years. Scores for 2006-2012 shown in Table 4-1 and Figure 4-1 were calculated using the original method, while the scores for 2013-2015 were calculated using the updated method.

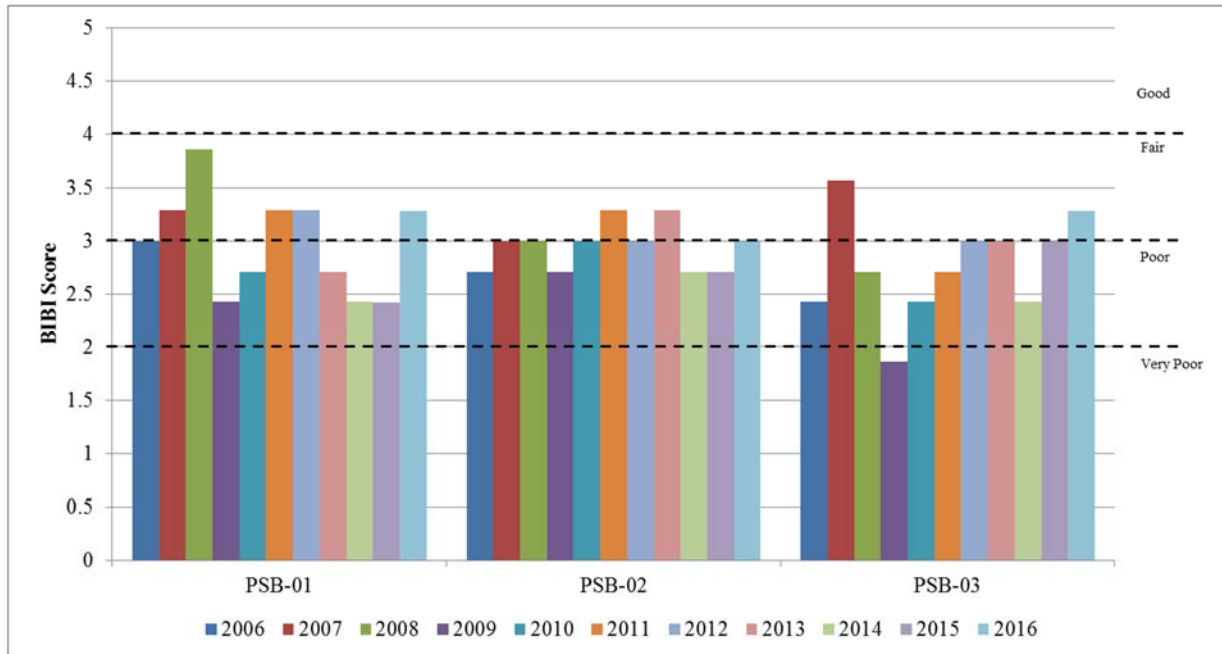
Figure 4-2. Comparison of BIBI Scores from 2006 through 2016

BIBI scores increased at PSB-01, PSB-02, and PSB-03 (Table 4-2). The narrative rating stayed the same at PSB-03, while improving from “Poor” to “Fair” at both PSB-01 and PSB-02. Figure 4-2 provides a visual comparison of BIBI scores over time and shows scores fluctuating from year to year.
