**ANNE ARUNDEL COUNTY
ILLICIT DISCHARGE DETECTION
AND ELIMINATION
2016 ANNUAL REPORT**

PERMIT NUMBER MD0068306

FINAL: January 2017

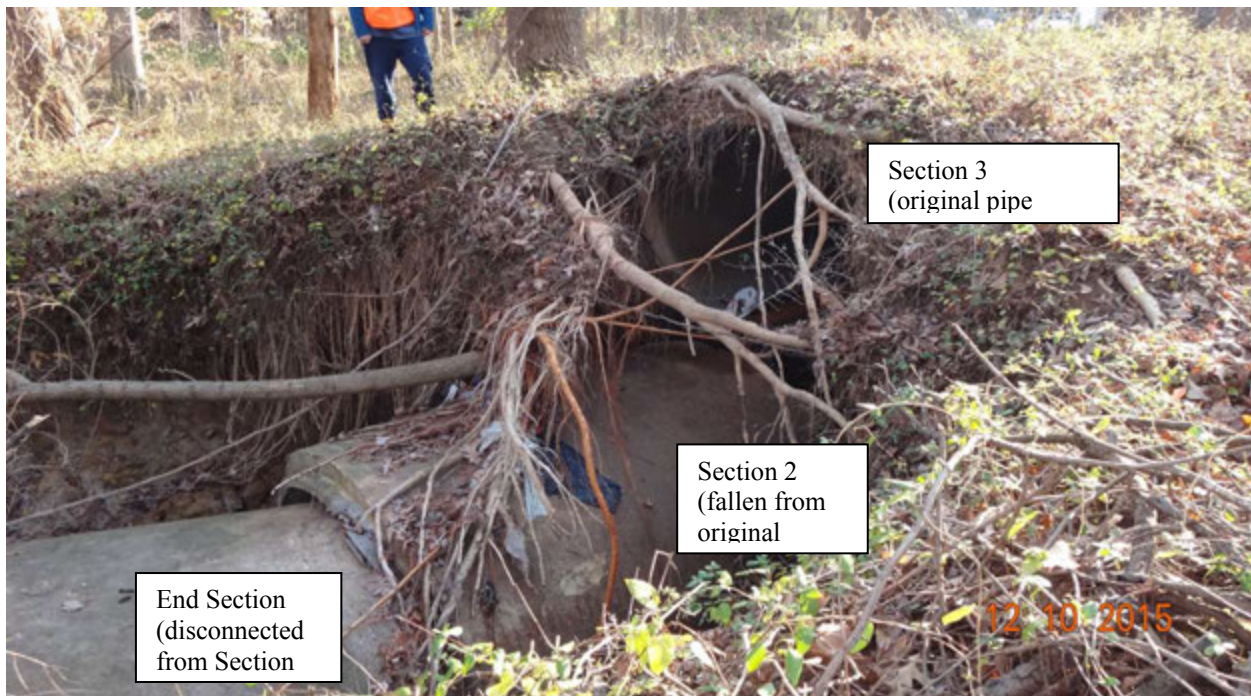
While investigating outfall B11F5O001 for the County dry weather screening effort, a Versar field team discovered collapsed infrastructure at the outfall, located to the east of Woodland Manor Drive behind the above address. Three evident sections of the large (73 by 48 inches) reinforced concrete pipe were found separated from each other; the End Section and Section 2 were completely disconnected from Section 3 which was still embedded in the ground (Figure 1). The wingwall-style End Section was lying in the lower receiving bed, misaligned with Section 2 (Figures 3 and 4). The field team documented erosion around Section 3 (Figures 1 and 2); significant erosion at the site likely created the pit that now holds the disconnected sections. The field crew also documented an eroded bank opposite the End Section (Figure 5). An area map is included as Figure 6.

Figure 1. Three disconnected sections of pipe infrastructure associated with outfall B11F5O001; note original height of outfall pipes and ground level at Section 3, and erosion along all sections

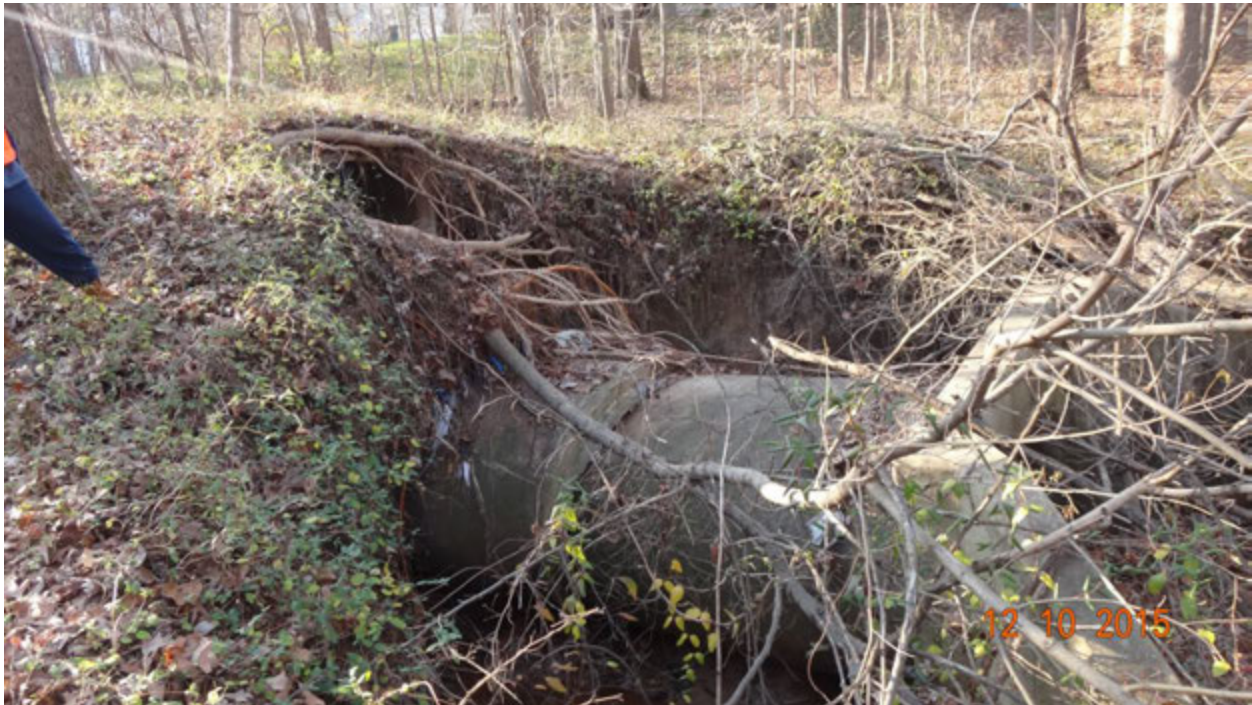
Figure 2. Collapsed outfall pipe showing extent of erosion along disconnected pipe sections (photograph taken facing approximately northwest)

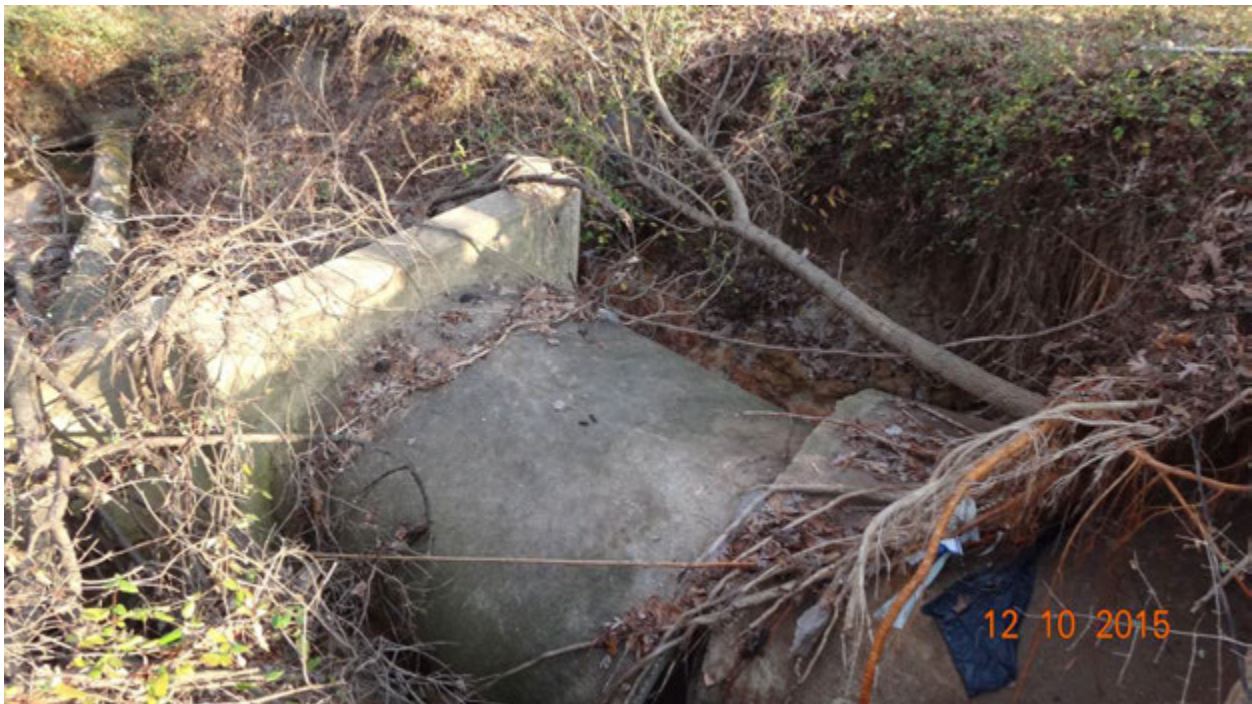
Figure 3. Detail of collapsed outfall pipe infrastructure showing misaligned junction between the End Section (left) and Section 2 (right)

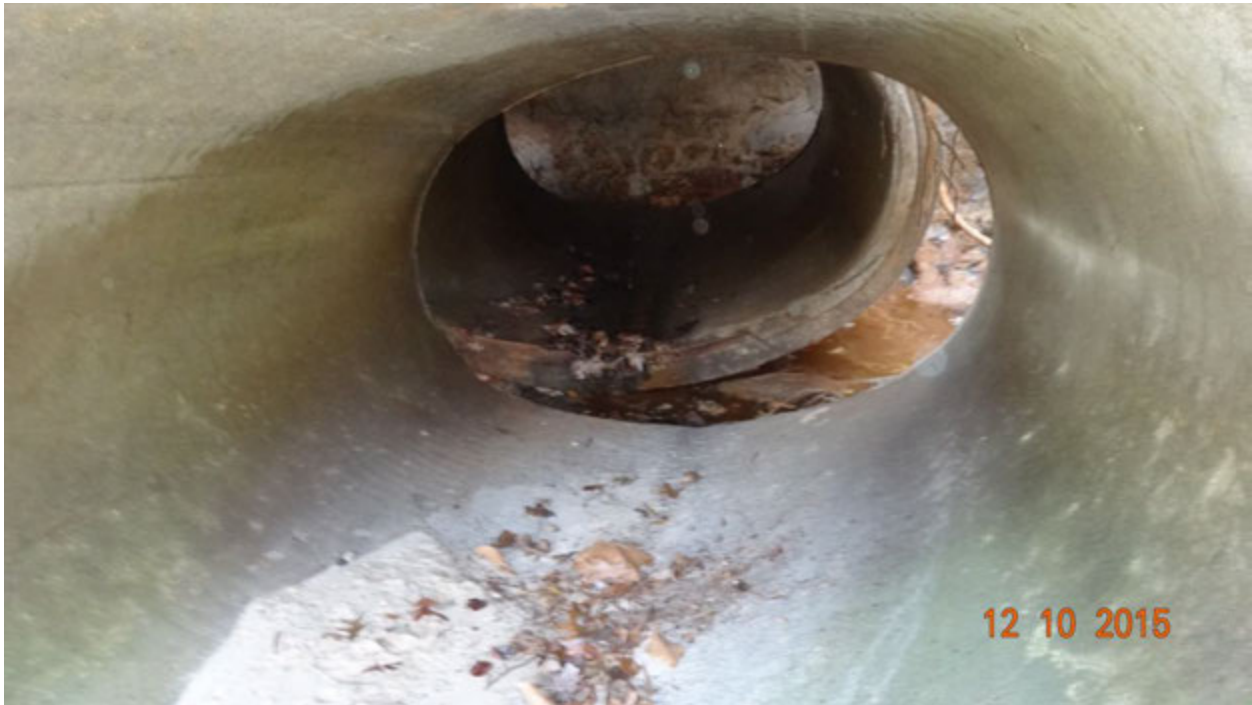
Figure 4. Photograph taken inside the End Section, showing the extent of disconnection with Section 2

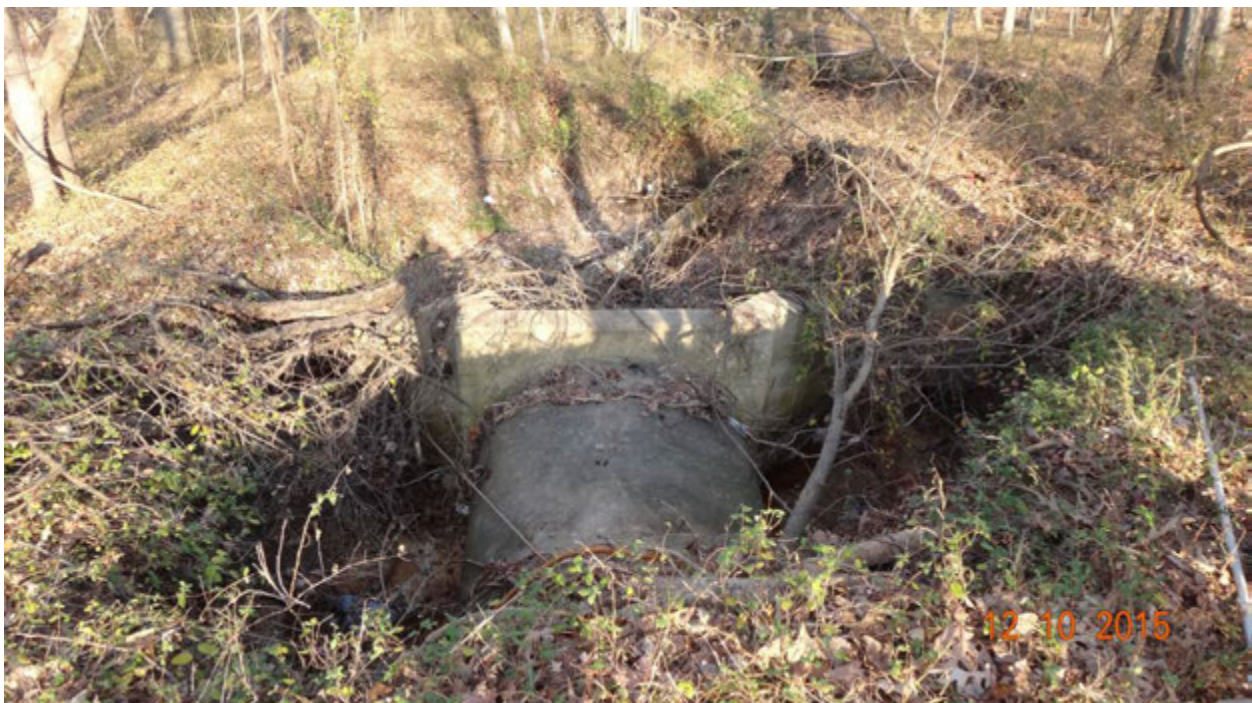
Figure 5. Photograph taken facing approximately northeast (standing over Section 3); note erosion on the bank opposite the End Section

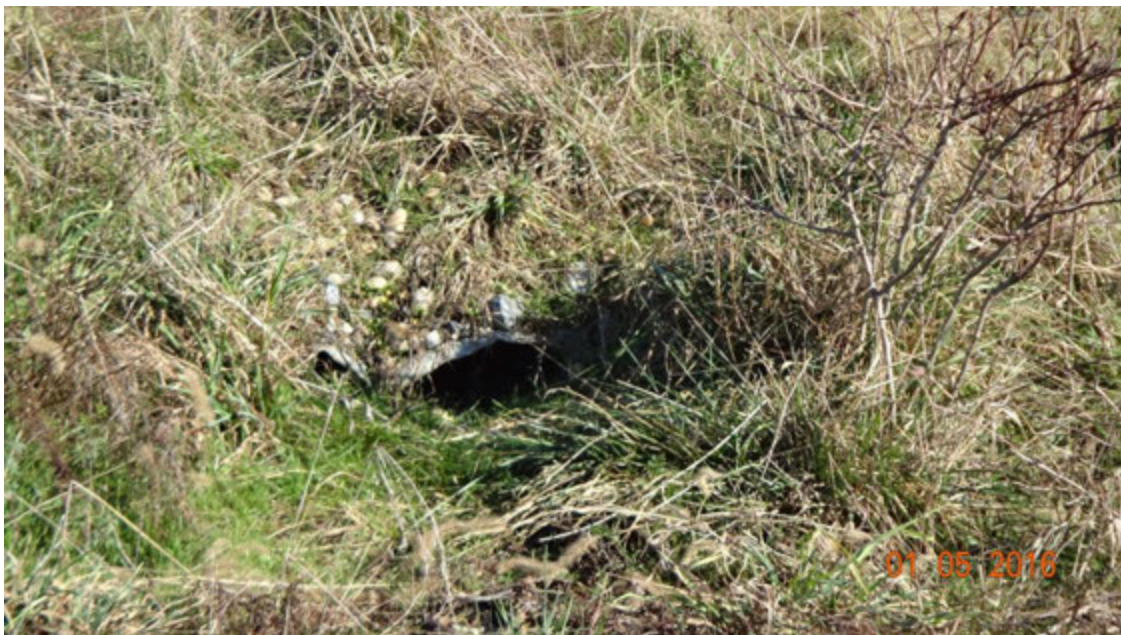
While investigating outfall C10E4O001, a Versar field team discovered the outfall crushed and buried in sediment (Figure 1). The team determined that the opening of the corrugated metal pipe had been so reduced in size that it may no longer effectively function; the outfall opening was surrounded by possible remnants of fill dirt (small rocks) and well-established vegetation (Figures 1 and 2). The outfall appeared to have been installed to drain an area that was very recently developed (Figure 3). The new building on the lot, which is now 8201 Dorsey Run Road, is part of the Annapolis Junction Business Park. There is evidence in Google maps (<https://www.google.com/maps>) that a road, Deer Creek Court, used to pass through the lot that has now been developed as 8201; it is possible that outfall C10E4O001 provided drainage for that road in previous years, and that the outfall may no longer be in service. The field team surmised that a new infrastructure network likely has been installed to control runoff from the new building and parking lot; thus, it is also possible that pipes to the outfall C10E4O001 had been connected to the revised network during construction, and that it now functions in a limited capacity for some of the runoff. An area map, indicating the location of the outfall, is provided in Figure 4.

Figure 1. Photograph showing detail of the outfall C10E4O001 and the narrowed opening of the crushed pipe; note the small rocks on the top of the pipe, possibly associated with fill dirt, and the extensive vegetation partially blocking the opening

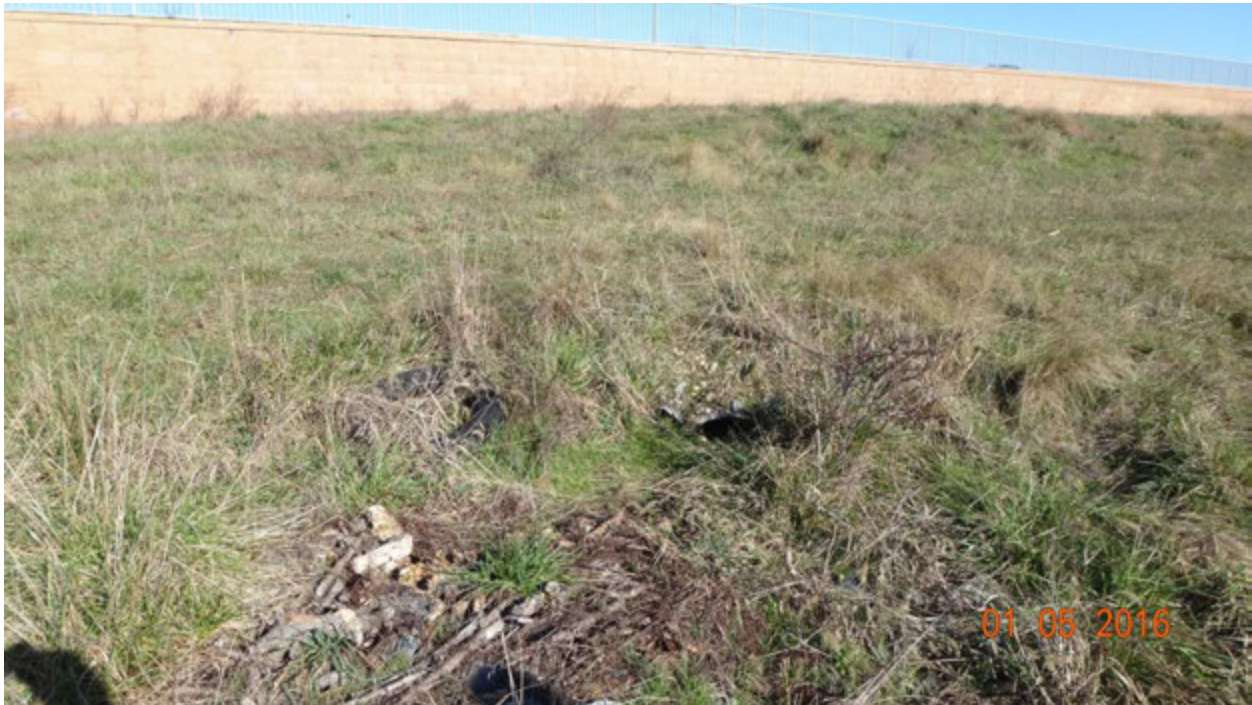
Figure 2. Photograph showing the opening for outfall C10E4O001 (seen as a dark oval in the center right) in context with the retaining wall for the parking lot for 8201 Dorsey Run Road

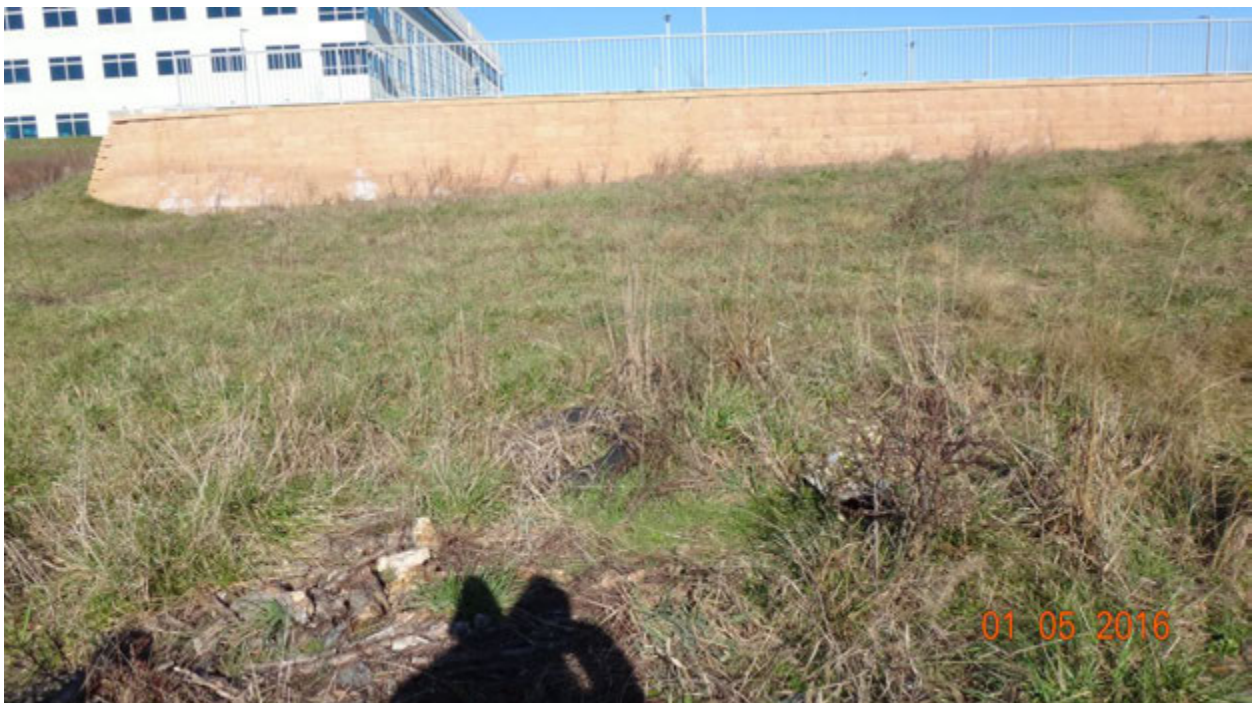
Figure 3. Photograph showing the crushed outfall C10E4O001 (seen as a silver object under vegetation in the lower center right) in context with the new building at 8201 Dorsey Run Road; note the brown vegetation on the upper left of the photograph which indicates the east end of the long drainage ditch behind the three adjacent parking lots

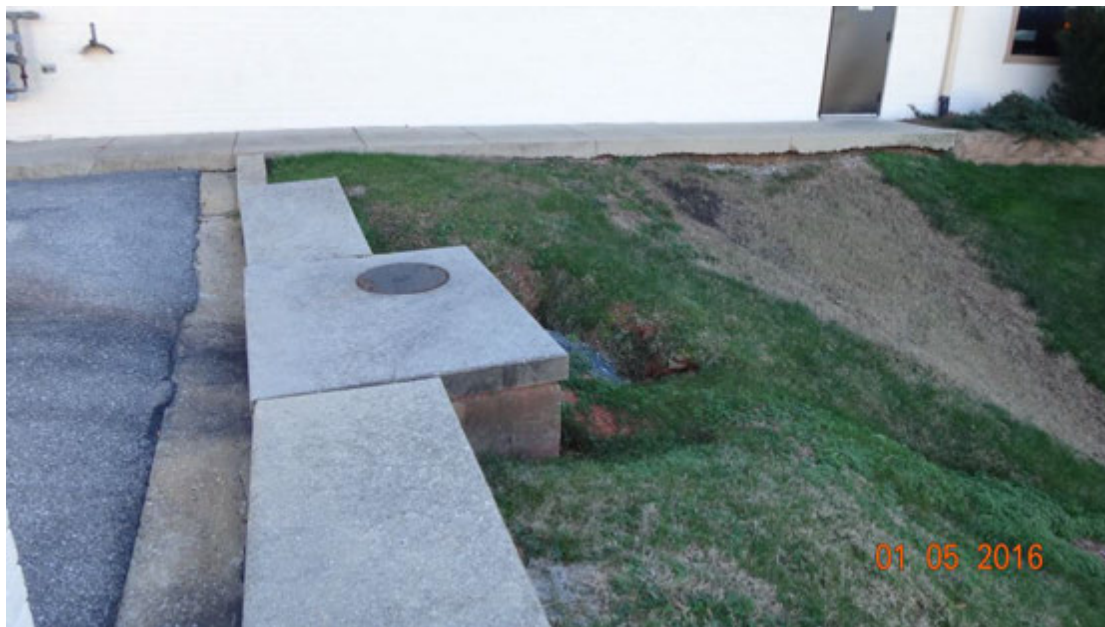
While investigating outfall F09H5O001, behind the Pizza Hut restaurant at the above address, a Versar field team discovered collapsing infrastructure associated with the curb-opening inlet and the outfall pipe. At the curb behind the restaurant, field crews documented that the curb inlet and outfall pipe were subsiding, yet still connected (Figure 1). The topsoil behind the catch basin had eroded, exposing the fill. The team documented that the catch basin is separating from the top slab as it sinks (Figure 2). The field team observed that a nearby portion of the sidewalk was also resting on eroding soil; the vegetation downhill of this second erosion area shows a distinct growth pattern, implying that there are multiple effects of the runoff in this section (Figures 1 and 3). The depression that has developed behind and alongside the catch basin exacerbates the potential for damage from flowing runoff and trapped water (Figure 3). Although the collapsed infrastructure was the primary concern during the site visit, the photographs taken during the inspection also show stains in the parking lot leading from the corner of the Pizza Hut walkway to the curb inlet; suggesting that there may have been leakage from a container on the premises at some point. An area map, indicating the location of the curb inlet, is provided in Figure 4.

Figure 1. Photograph showing the curb-opening inlet with significant erosion behind it (center), and a nearby sidewalk area with erosion apparent underneath it and a distinct runoff pattern evident in the downslope vegetation (top right); note, also, stains in the parking lot leading from the Pizza Hut restaurant to the curb inlet (left)

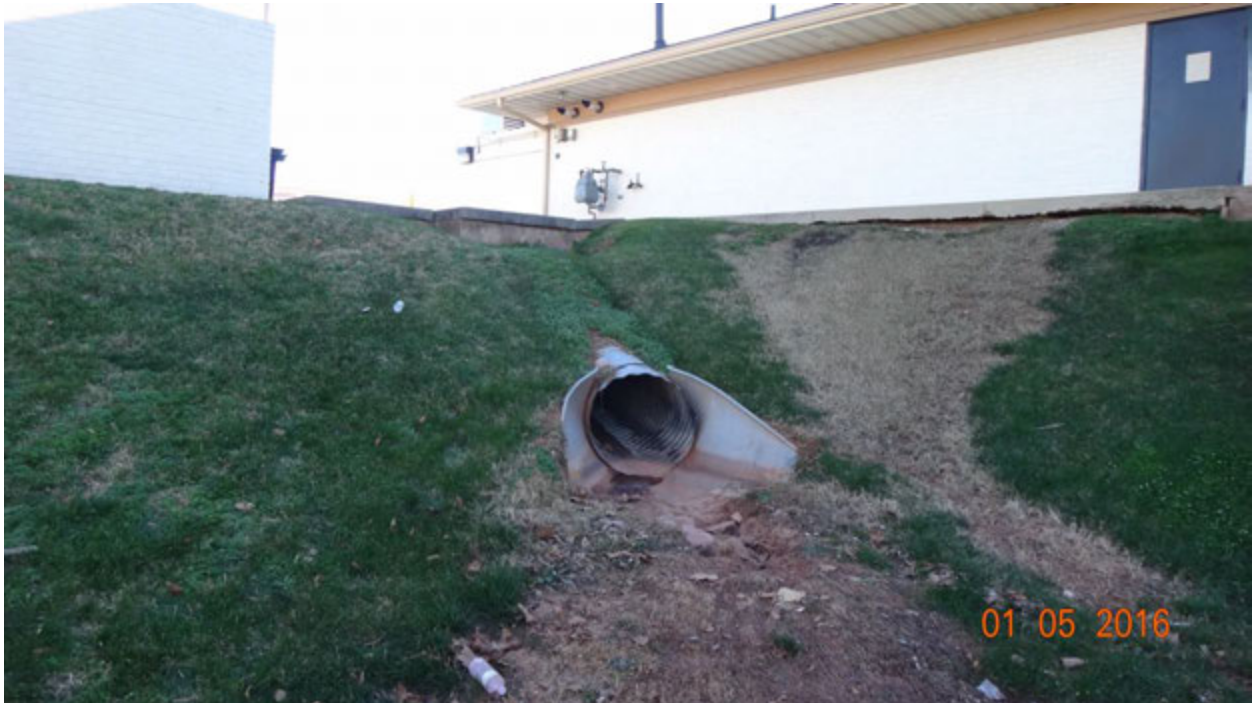
Figure 2. View looking uphill from the stormwater management facility; note the separation of the catch basin from the top slab (upper center left), the sunken ground around the outfall pipe (center), and the erosion under the sidewalk (upper right)

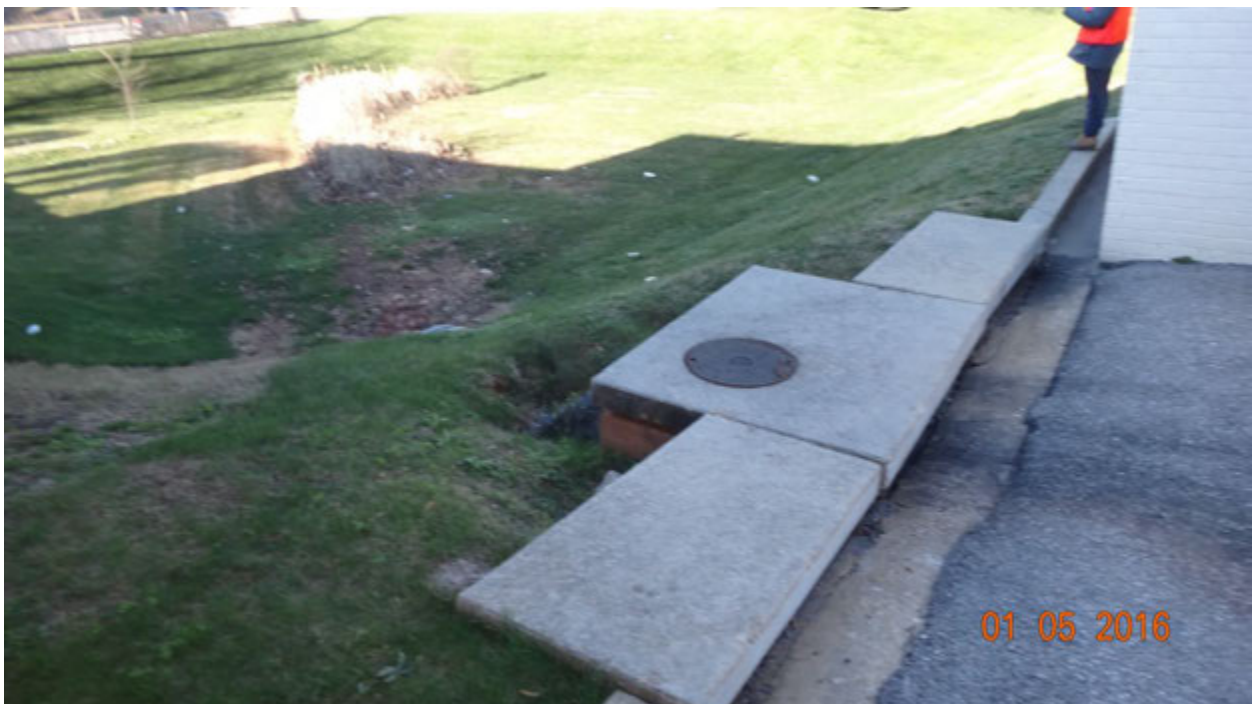
Figure 3. View from the curb inlet toward the stormwater management facility showing the depression behind the catch basin and side structures; also note stains leading into the curb inlet

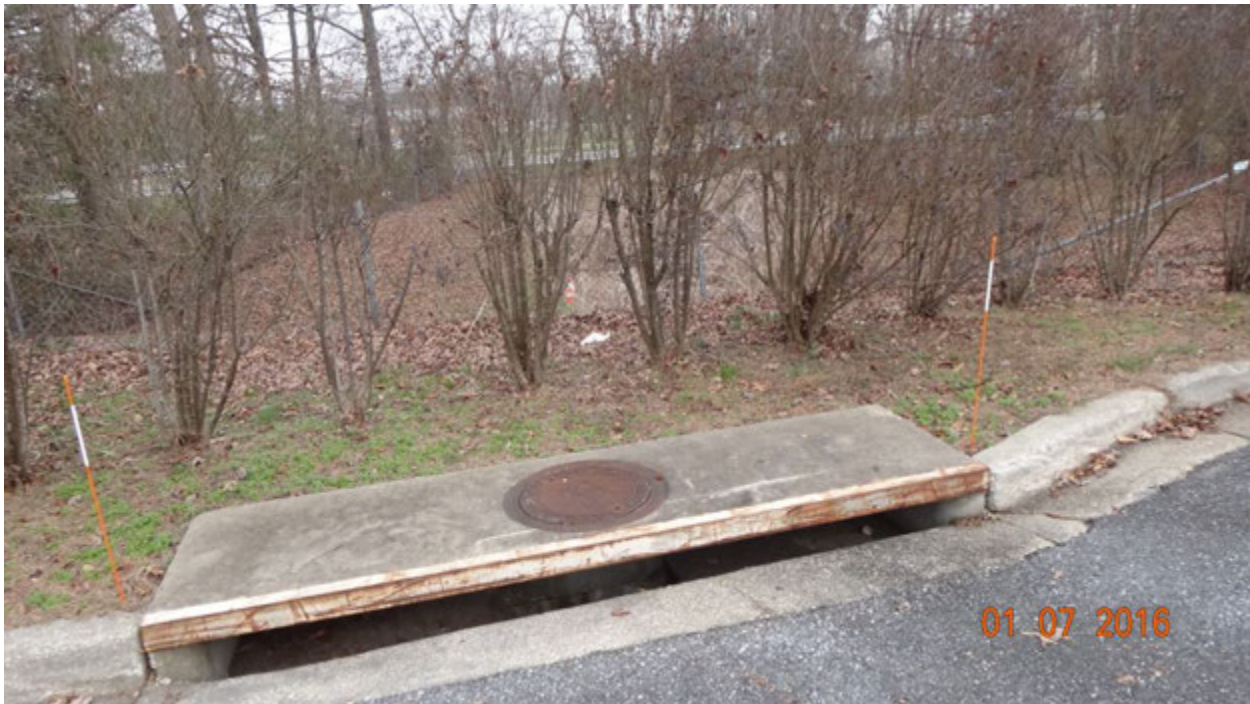
Figure 1. View from the curb inlet at the parking lot toward outfall I13B1O009; note the position of the orange cone (center) which serves as a reference in Figure 2

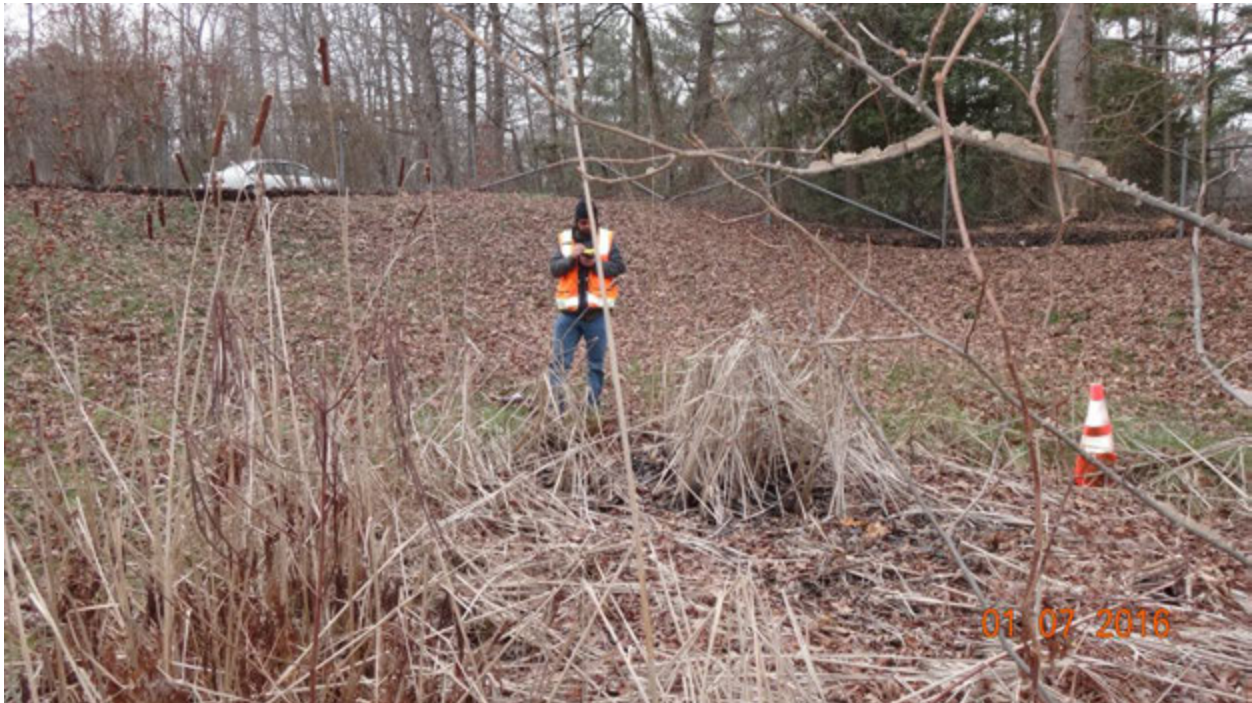
Figure 2. A member of the field team documenting conditions at the outfall which is located directly in front of him; the orange cone is the same marker as is seen in Figure 1

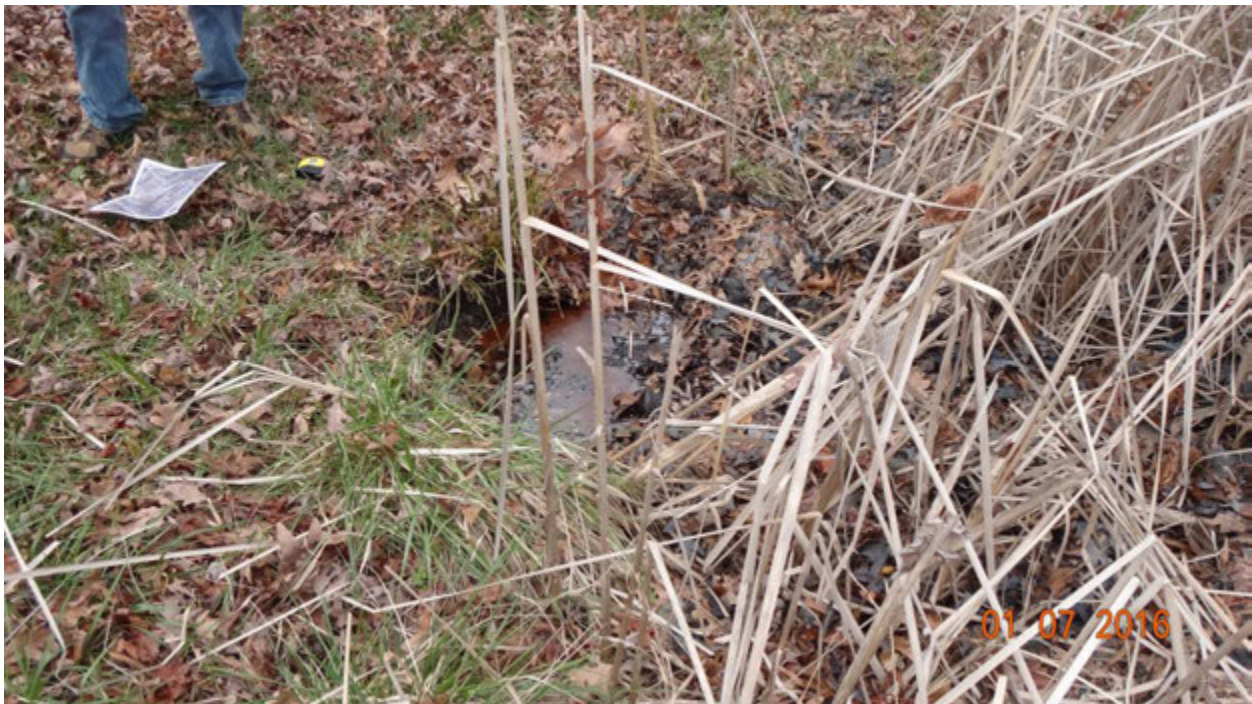
While investigating outfall I13B1O009, which is located north of the parking lot for the Catherine L. O'Malley Senior Center, a Versar field team found the outfall almost completely buried in mud and sediment (Figures 1, 2, and 3, collectively). The field team noted that the outfall was in a small depression that contained liquid - possibly effluent - with an oily sheen (Figure 4). The team could not determine the effectiveness of the outfall under these conditions; hence, the team could not clarify the source of the oil sheen during the site visit. An area map, indicating the location of the buried outfall, is provided in Figure 5.

Figure 3. Photograph showing the conditions at outfall I13B1O009; the pipe was found almost completely buried in sediment at the time of the site visit

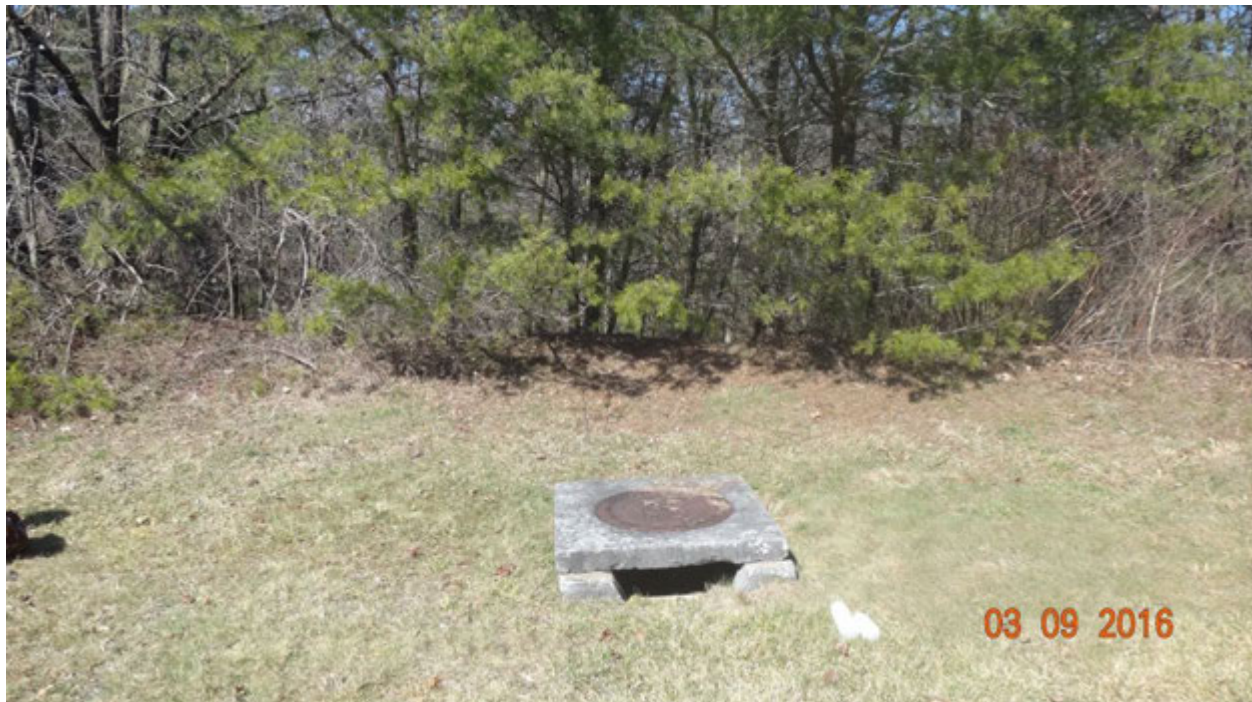
While on-site to investigate a possible illicit discharge condition, a field team consisting of Versar and LimnoTech staff discovered a damaged yard inlet associated with outfall G13G7O006, behind the BGE maintenance lot located at 730 New Waugh Chapel Road in Odenton. At the slab top yard drain nearest to the outfall (Figure 1), the field crew noted that the soil had collapsed on the side facing the wooded area (Figures 2 and 3). Staff also documented that the concrete lid had shifted and was loose at the time of the inspection. These conditions pose hazards to passersby; the concrete lid should also be secured to protect the integrity of the stormwater conduit system. An area map is provided as Figure 4.

Figure 1. Slab top yard inlet found in damaged condition during the field visit

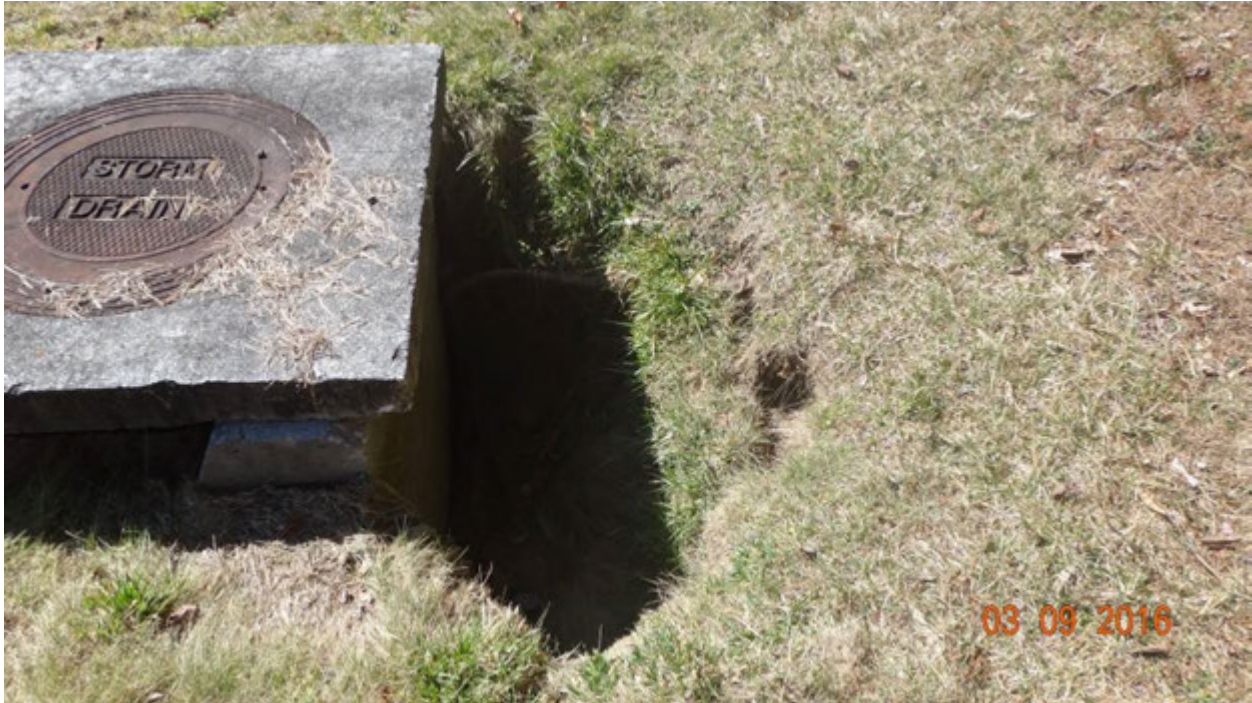
Figure 2. Evidence of collapsed soil on the northwest side of the inlet frame, seen facing southwest

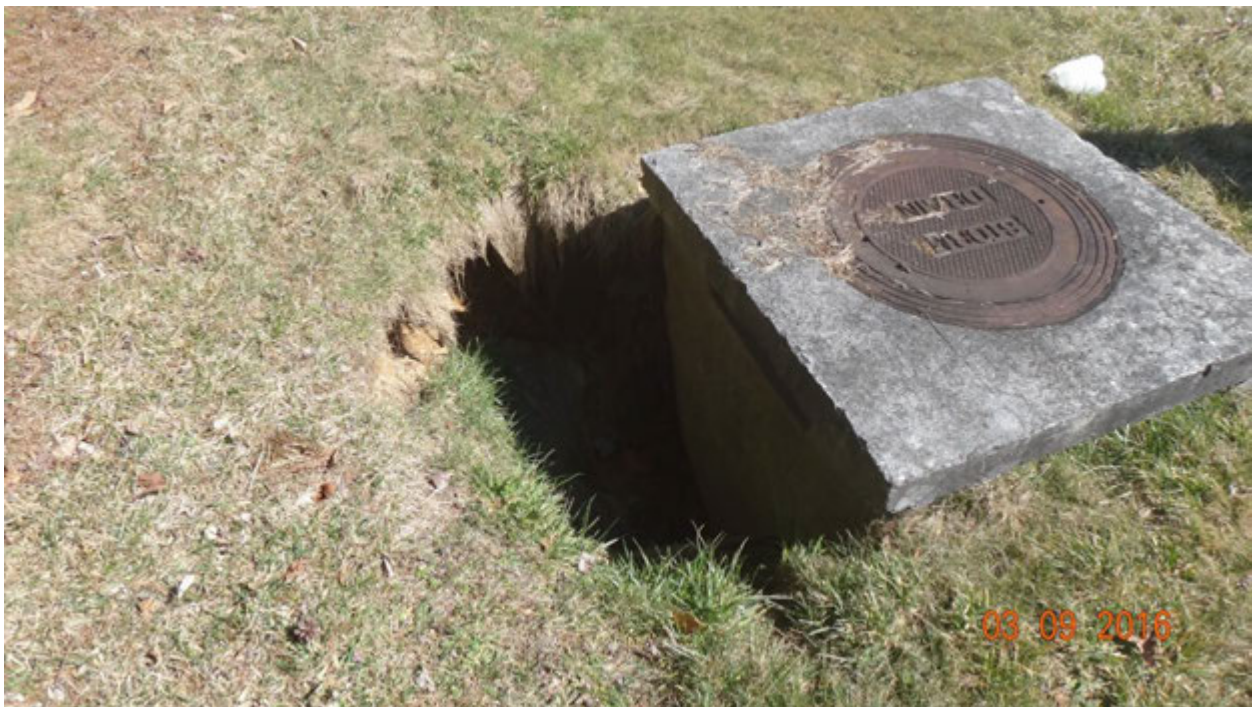
Figure 3. Evidence of collapsed soil on the northwest side of the inlet frame, seen facing northeast

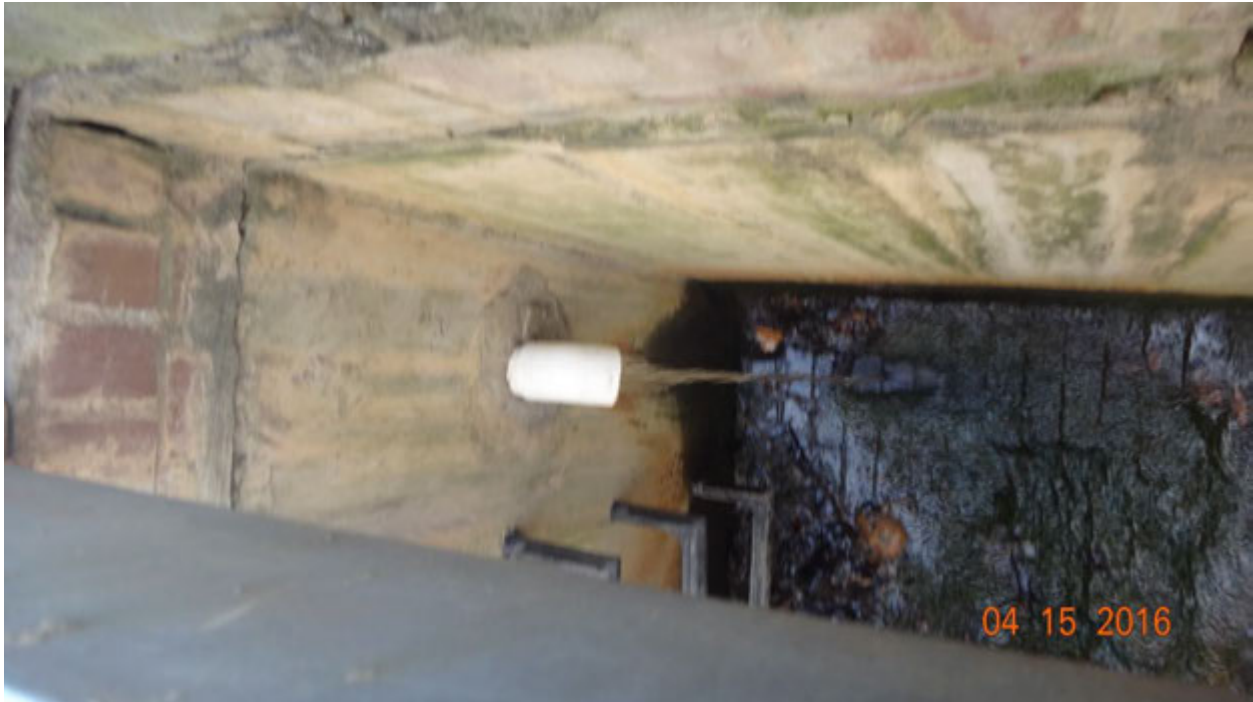
Figure 2. Evidence of strongly flowing effluent from a PVC pipe in the curb inlet box on April 15

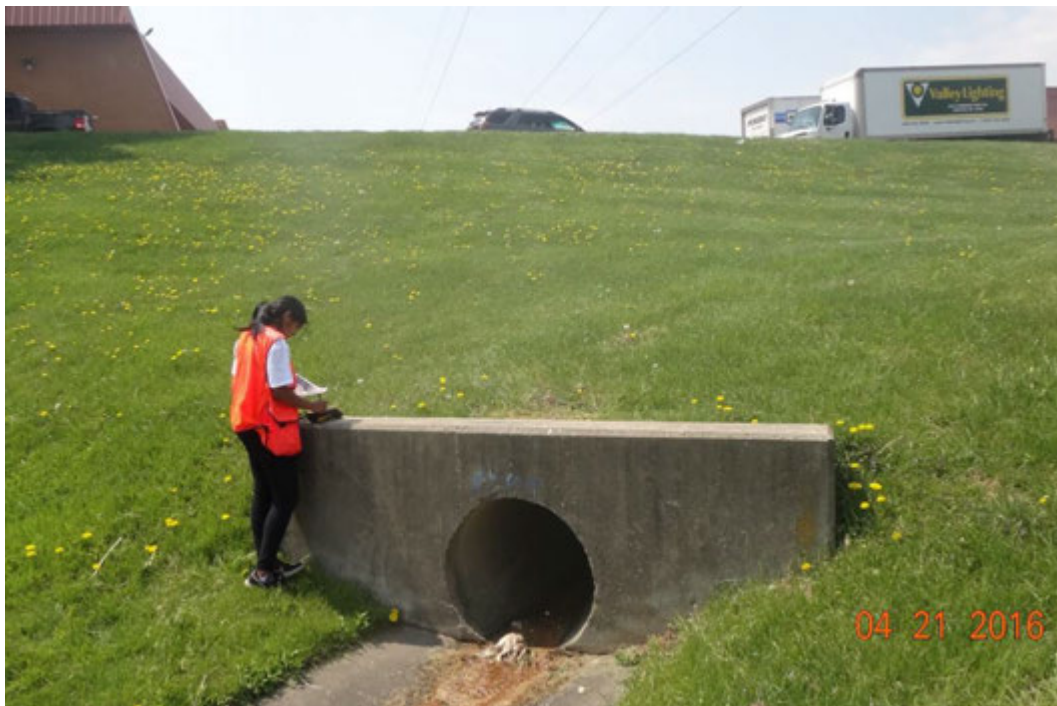
On April 21, the Versar field team inspected the target outfall, K02B8O002, which is located in a stormwater retention pond east of the parking lots for 601 and 611 Hammonds Ferry Road. At the outfall's 27-inch round concrete pipe, the team observed a small amount of shallow flowing water (Figure 1). The flow from the outfall was slightly impeded by leaves and debris in the outfall channel. The team also noted persistent iron flocculent along the water line. The team extracted a sample of the discharge with a syringe and tested the water for contaminants. Test results are presented in Table 1, as Test 1; the test results showed an above-action-level concentration of detergents (0.5 mg/L). The field crew investigated the associated parking lots for active washing or dumping activity; the team did not observe any such evidence on the day of the first visit.

Figure 1. The target outfall, K02B8O002, located in a stormwater retention pond east of 601 and 611 Hammonds Ferry Road, as observed on April 21, 2016

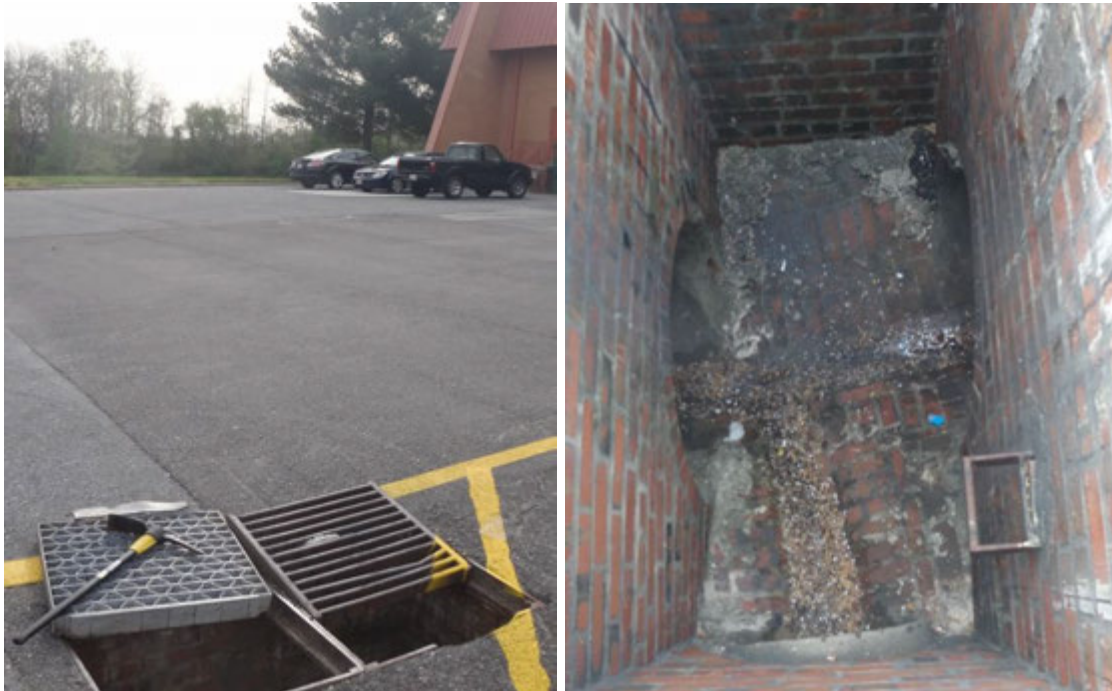
Figure 2. Yard grate (left) in the parking lot between the buildings at 601 and 611 Hammonds Ferry Road where the northwest and southwest drainage lines intersect (right) before draining into the pipe leading to the target outfall

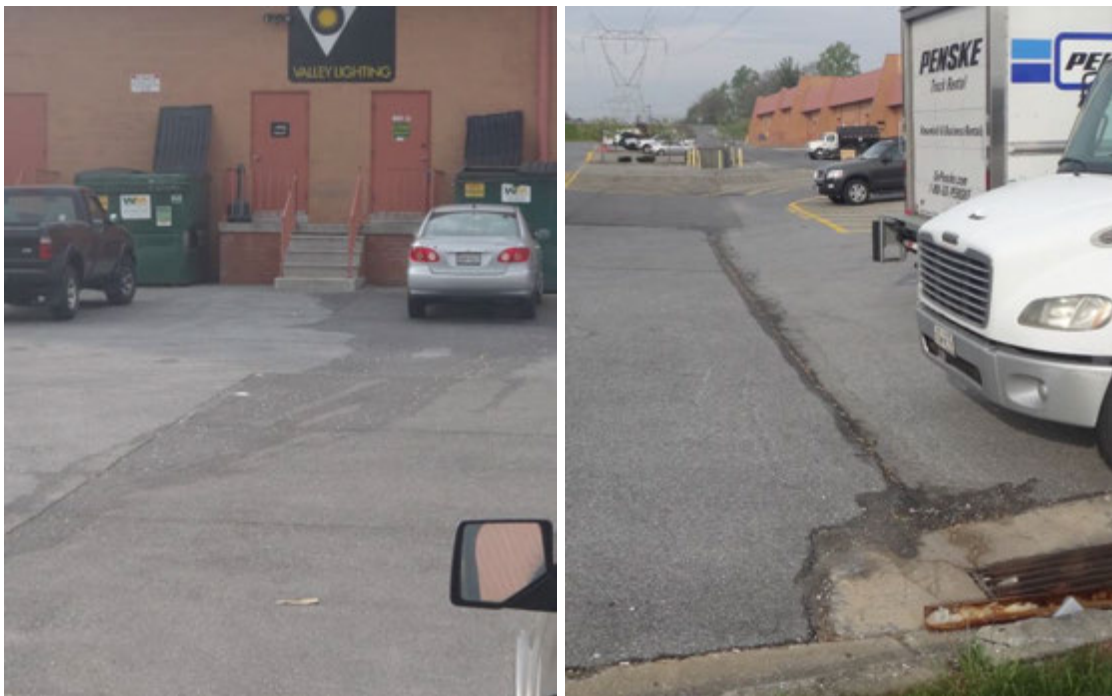
Figure 3. Damp pavement evident around a personal vehicle behind Valley Lighting (left) and evidence of runoff to the curb inlet at the east end of the parking lot (right)

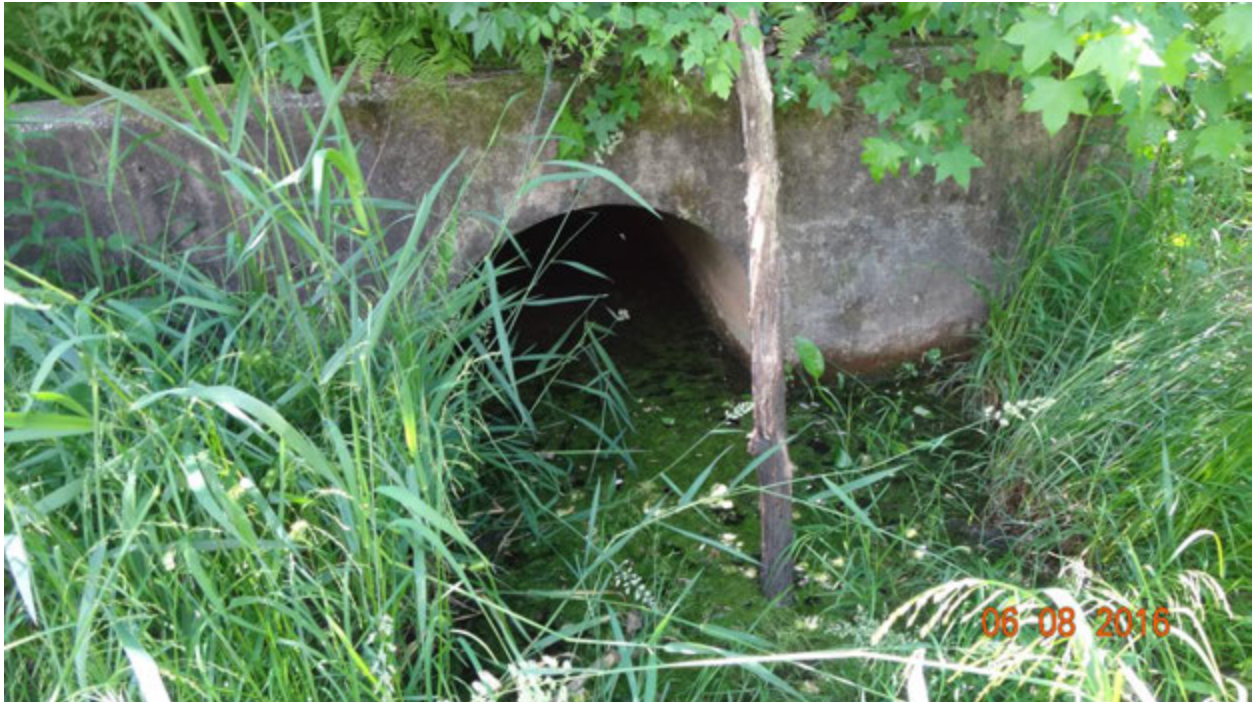
On June 8, 2016, a Versar field team inspected outfall I12E1O001 behind the warehouses at 1710 Crossroads Drive, in Odenton, MD. On this first field visit, Versar staff found the 42-inch reinforced concrete pipe outfall partially submerged (Figure 1). The discharge in the plunge pool exhibited a thick patch of algae. A short distance from the pipe, the field crew observed that the discharge was flowing into a downstream channel. The crew obtained a sample from the flowing water to test for illicit discharge indicators. The results of the tests are provided in Table 1, as Test 1. The result for pH indicated a reading below the acceptable range (5.45).

Figure 1. Outfall I12E1O001 as observed on June 8, 2016; note the extensive algae growing in the plunge pool

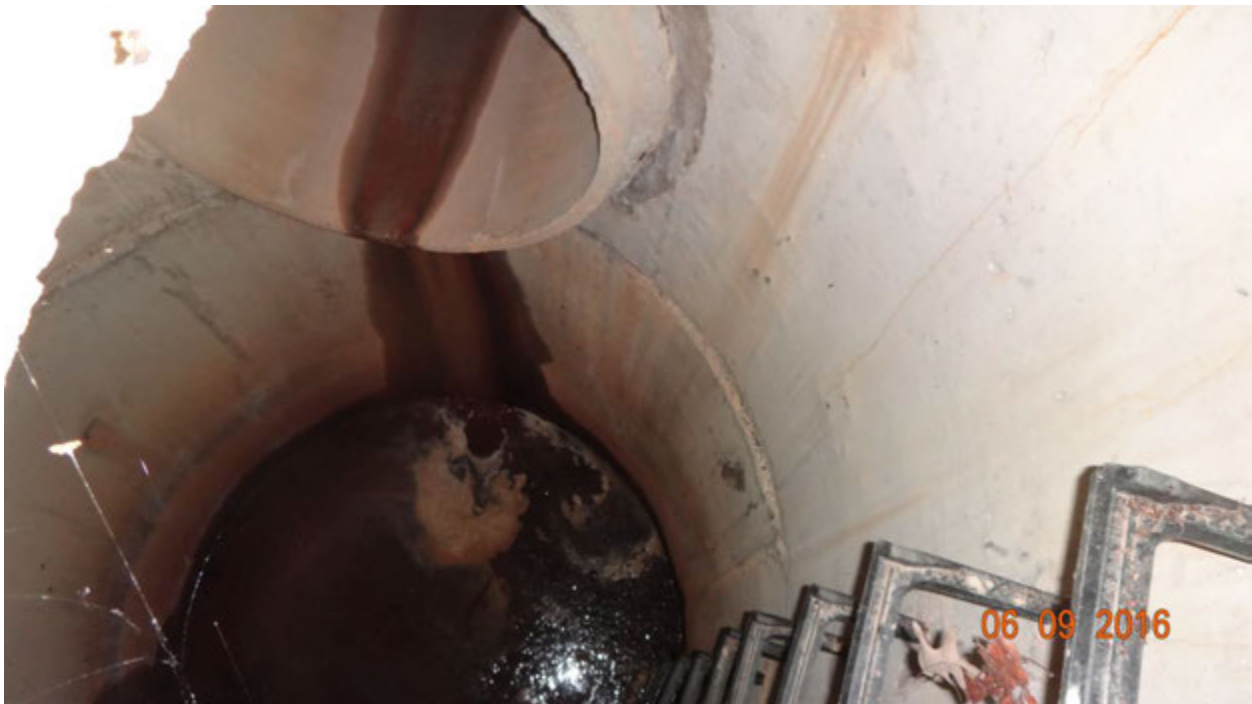
Figure 2. View inside the first manhole; note the slight trickle of water from the main pipe (top)
