**ANNE ARUNDEL COUNTY
ILLICIT DISCHARGE DETECTION
AND ELIMINATION
2016 ANNUAL REPORT**

PERMIT NUMBER MD0068306

FINAL: January 2017

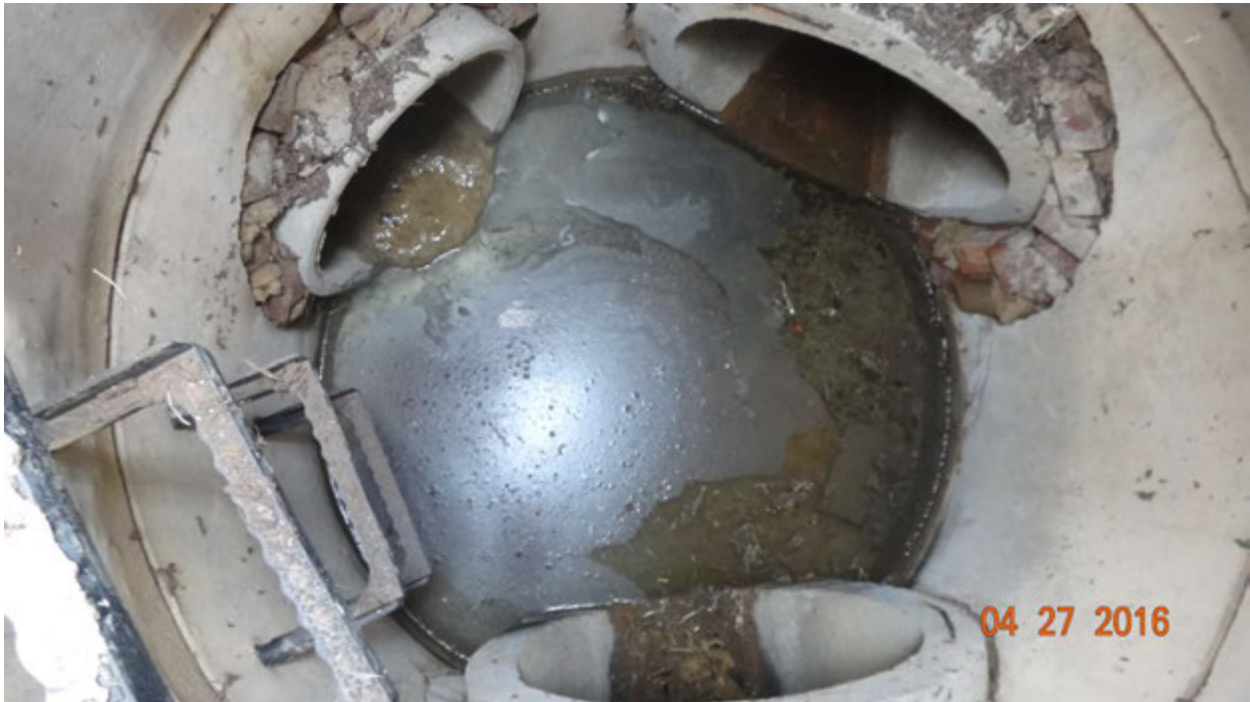
Figure 2. Three pipes connecting at the first manhole (MH1); note the thick slurry of minerals in the flowing water from the north pipe (upper left)

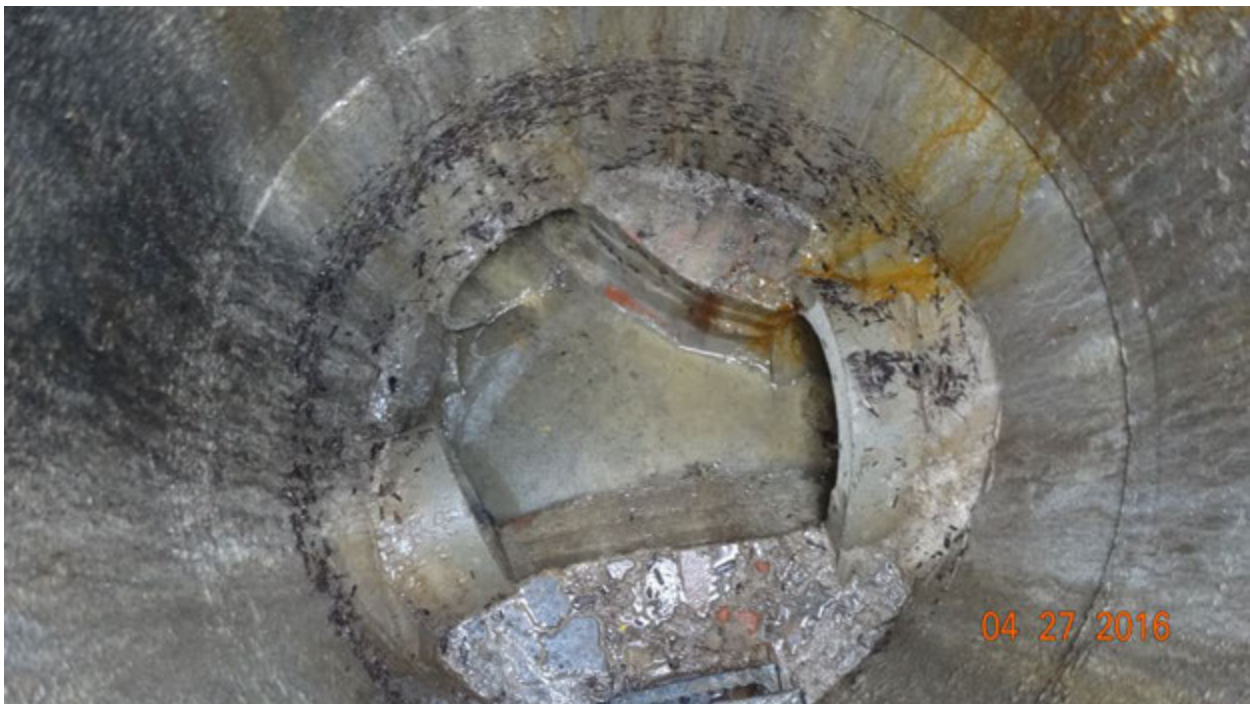
Figure 3. View inside third manhole (MH3) showing mineral deposits in the flowing water and signs of seepage along the walls

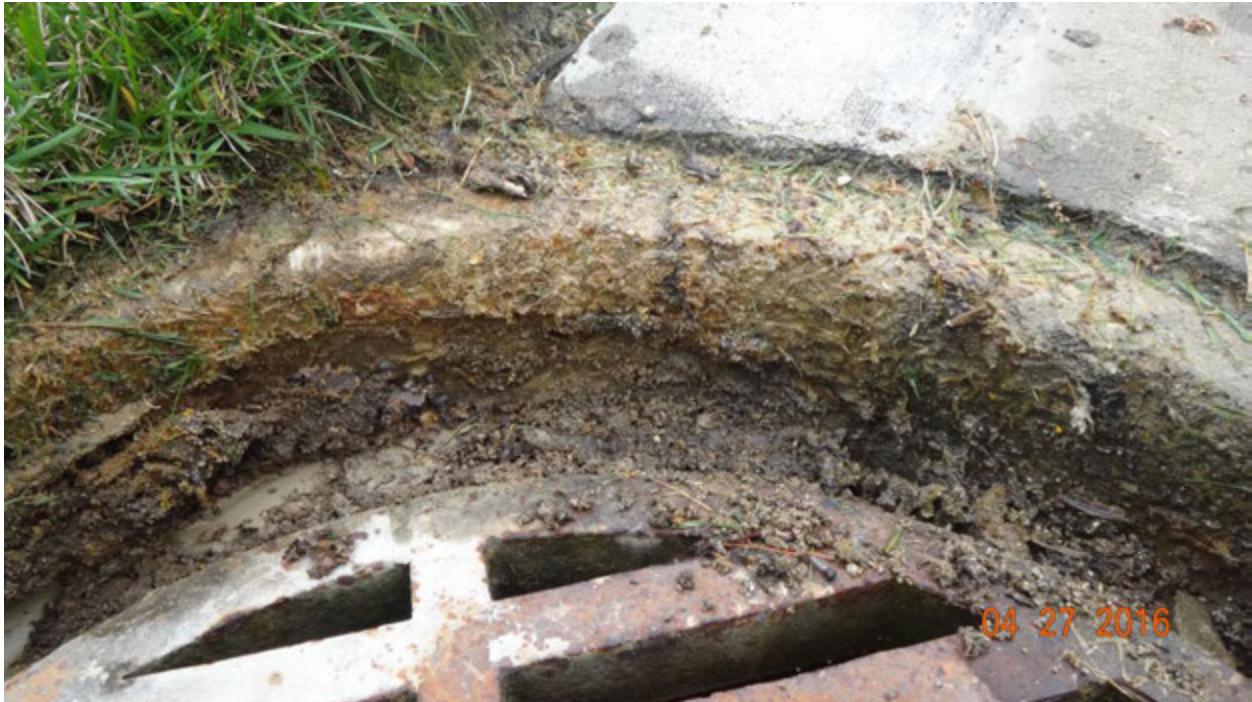
The team tracked the more likely main drainage line to a manhole in the northwest corner of the parking lot; there, the team found flowing water with a slurry of mineral deposits. The team also noted that the walls in this manhole were seeping (Figure 3). The team tested the flowing water and found a pH reading of 11.84; the similarity of this pH reading and flow condition confirmed an in-line connection with the pipe in the manhole at the south end of the parking lot, so the team continued to search this line and collect samples for pH levels. At the next upstream manhole in the system, the team observed a similar slurry of mineral deposits in the shallow water, and continued to the next access point – a yard grate near the northeast corner of the parking lot. There, the team discovered excessive seepage in the walls of the catch basin and more evidence of accumulating mineral deposits in the draining water; the crew noted that the concrete frame supporting the grate was soft and crumbling (Figure 4). Within the catch

Figure 4. Signs of crumbling concrete at the opening for the yard grate, YG1

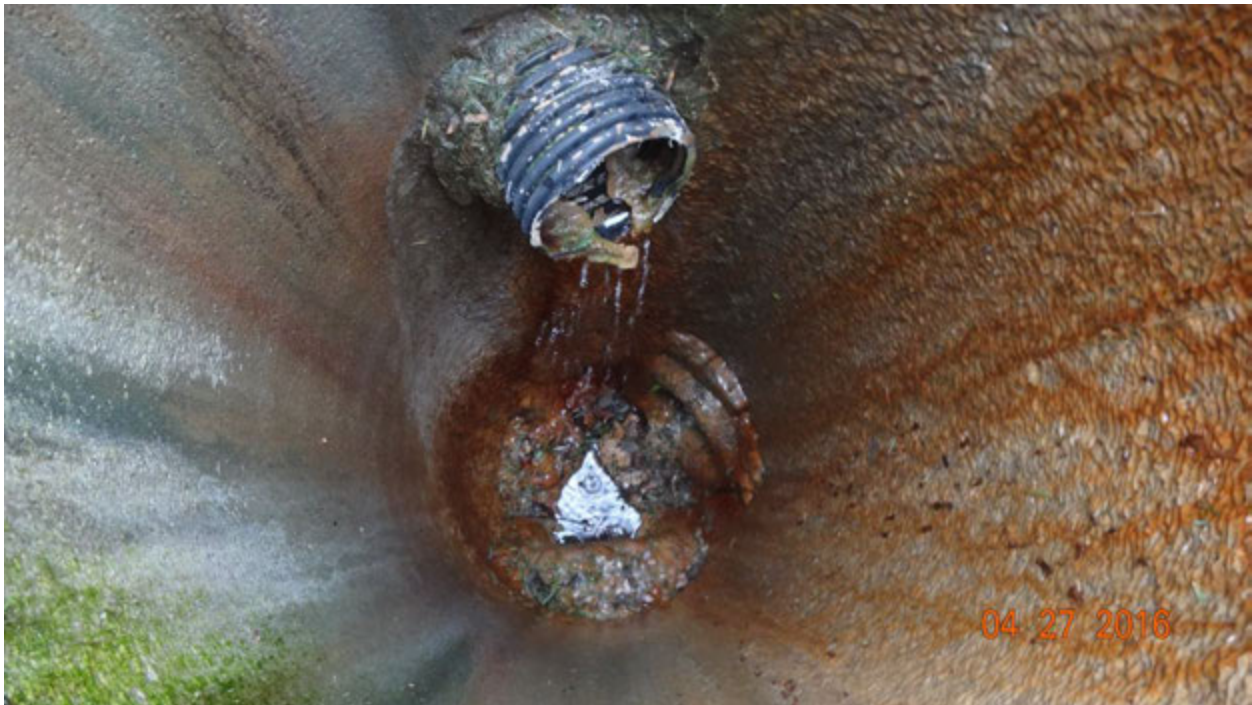
basin, the team observed a 4-inch black PVC pipe leading from the eastern edge of the parking lot that delivered flowing water to the network (Figure 5). As team members attempted to determine the origin of the small pipe, they entered the woods and discovered a pipe end in a wet, muddy, grass area. The team surmised that this area may constitute a French drain installed to remove excess water from the ground. The pH of a water sample collected at the entrance to this pipe was 11.95 in the field test.

Figure 5. View inside the yard grate, YG1, showing the flow of water from a black PVC pipe drawing flow from the east side of the lot

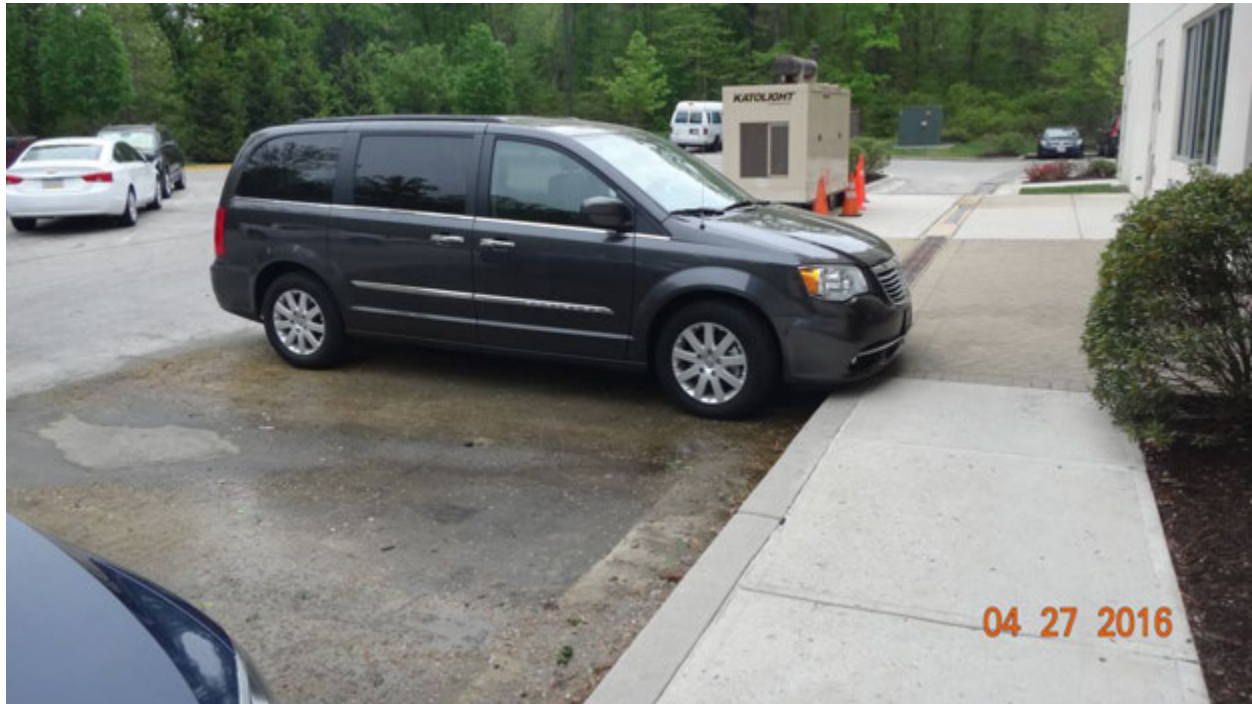
The team found correlated evidence from several sources and four field visits that the hotel stands on a very porous, possibly high pH, soil, and that the lot receives ground water flow from a spring of very high pH water at the eastern (rear) side of the property. On both main storm drain lines, the team members traced pH values increasing as they approached the back side of the hotel property. An area map, depicting the estimated drain line infrastructure and the pH test results at various locations across the lot, is provided as Figure 7.

Figure 6. Signs of groundwater seeping through the parking lot on the east side of the hotel; note the trench drains in the parking lot (upper right)

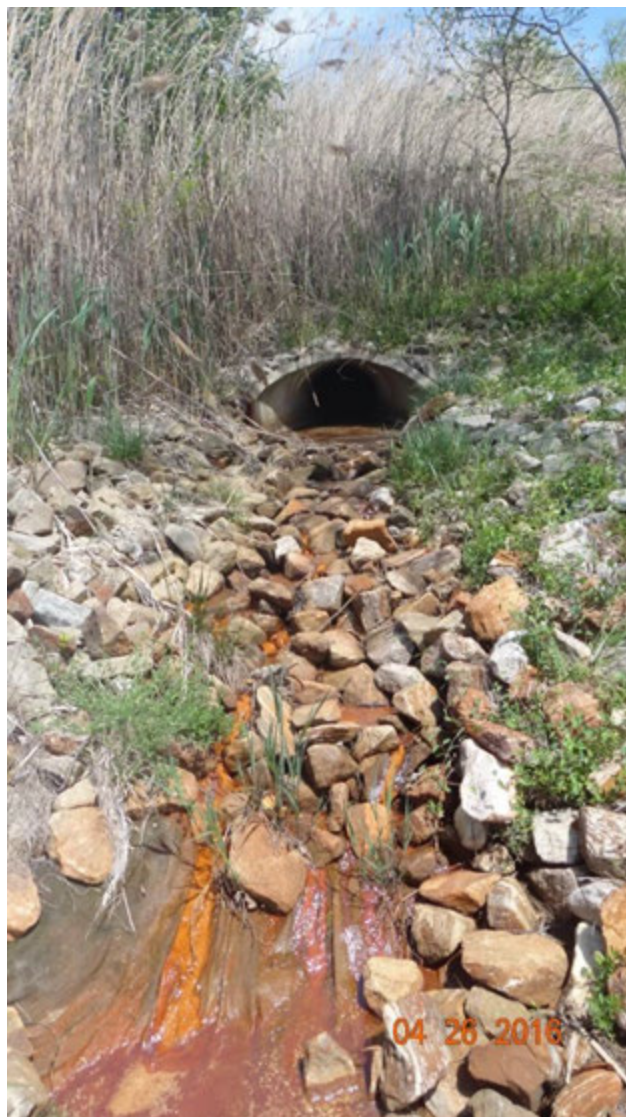
A Versar field team inspected the outfall, Q06H3Onew, located east of the warehouse at 7621 Energy Parkway, on April 26. A field crew had previously visited this outfall in 2013 (the site has been previously identified as Q06H3F002new2). The 33-inch, reinforced concrete pipe outfall discharged to a large wet pond. The team found flowing water in the outfall; the effluent showed evidence of iron flocculent, bacterial growth, and a surface sheen (Figures 1 and 2). The effluent also emitted a sulfur odor. The field staff carefully collected a sample of clear discharge at the outfall to test for possible illicit discharge constituents. The results of the tests are provided in Table 1, as Test 1. Phenol levels tested above the acceptable range for the sample taken on the first site visit (4 mg/l).

Figure 1. Outfall Q06H3Onew as observed on April 26, 2016; note the orange iron flocculent

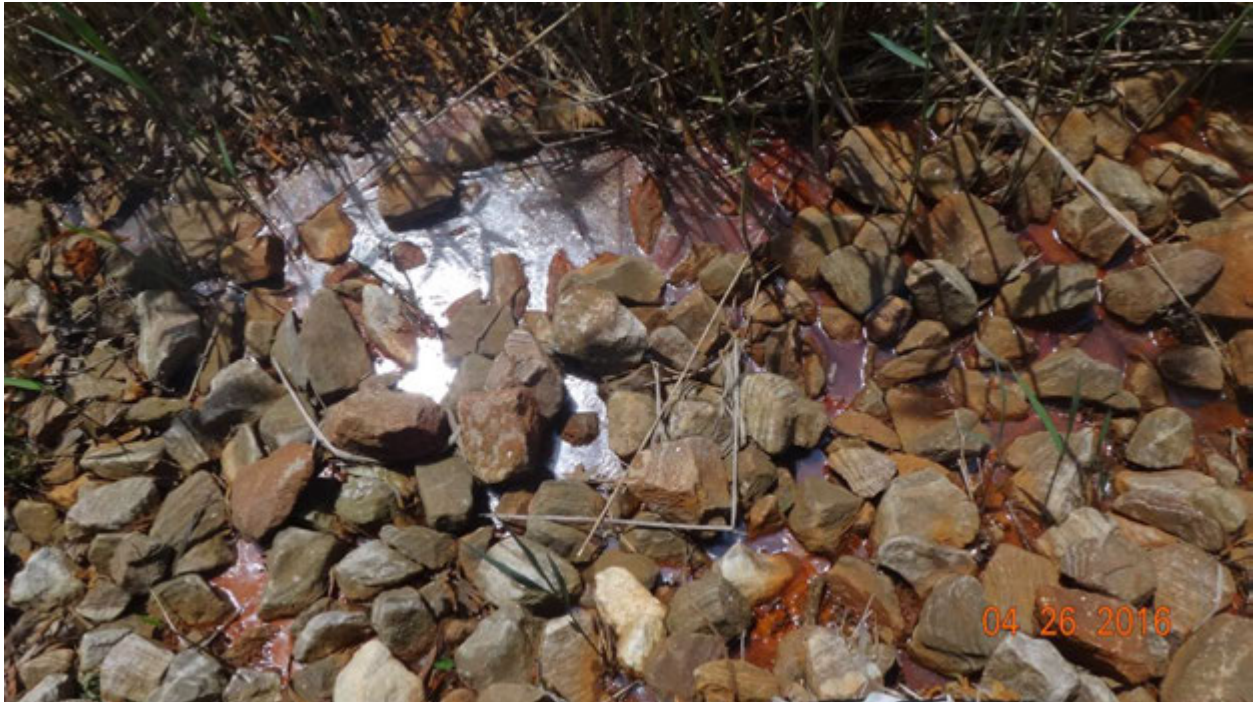
Staff members returned to the site the following day, April 27. They found conditions at the outfall similar to the observations made the previous day. They again observed and tested flowing water at the outfall; the results are provided in Table 1, as Test 2. Phenol levels were again above the acceptable range. Due to the presence of elevated contaminant levels combined with characteristics of concern (odor and excessive iron), the field crew initiated a trackdown on the site to attempt to isolate the source of the phenols. The team tested flowing water in the parking lot grate closest to the outfall, in the southeast corner of the parking lot; the test results did not detect phenols. The team searched the lot for evidence of additional pipes entering the system that may be contributing to the flows, but did not discover any such infrastructure. As the flow at the nearest grate was significantly lower than the flows observed at the outfall, the team considered that there may be infiltration of groundwater into the pipe as it passes under the adjacent field, before discharging to the pond. The team searched for an indication of the pipe's route between the parking lot grate and the outfall; without such evidence, the assumption is that the pipe directly connects the two access points in a straight line without a deviation in the path.

Figure 2. Evidence of a sheen on the effluent from outfall Q06H3Onew, as observed on April 26, 2016

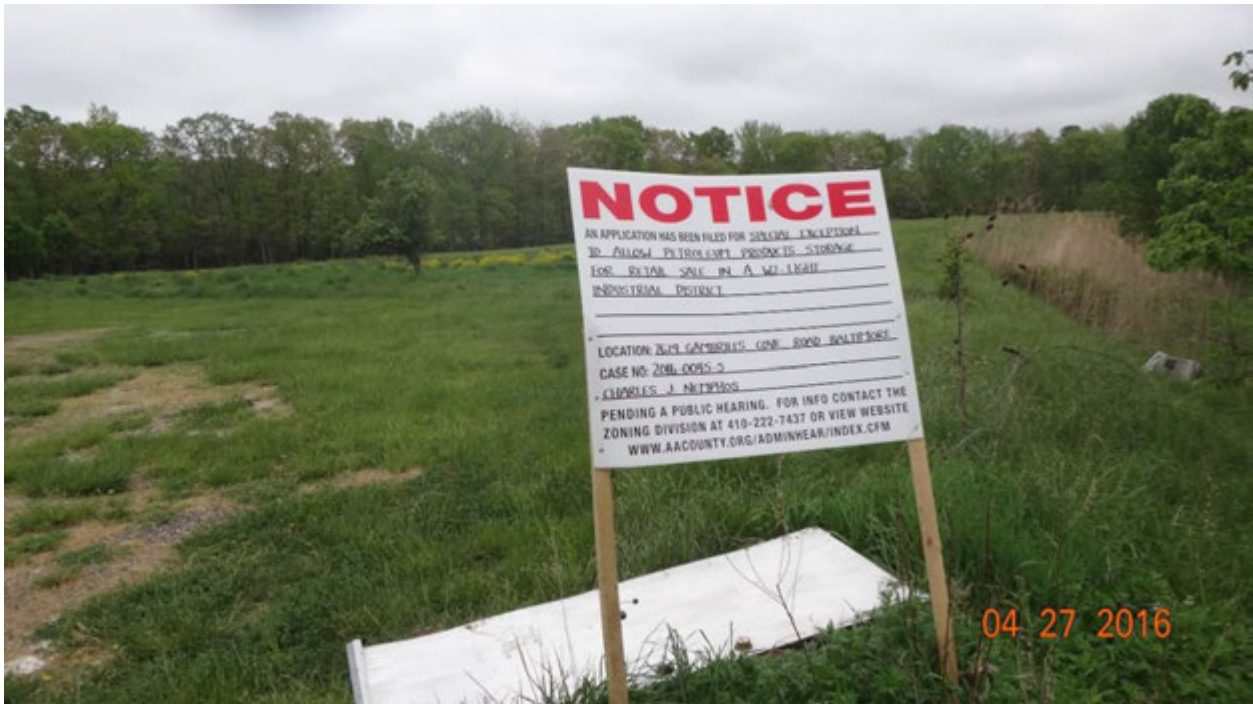
As part of the site evaluation, the team documented the presence of a sign announcing a potential future use of the property as a fuel storage site (Figure 3). The team noted that the field contained PVC pipe markers for wells (Figure 4). Research conducted for this report revealed that the lot at 7621 Energy Parkway had been used as a fly ash disposal site by Baltimore Gas and Electric Company between 1982 and 1992 (Energy Parkway.pdf [sic] available from www.mde.state.md.us/programs/Land/MarylandBrownfieldVCP/mapping/Documents/7621_Energy_Parkway.pdf). In 1997, property modifications added an impervious cap for the majority of the disposal area, in the form of a large warehouse and associated parking area. The extent to which the presence of a capped fly ash disposal site may influence the phenol levels recorded in the outfall screening tests is unknown. An area map is provided in Figure 5.

Figure 3. A notice posted on the lot announcing plans to use the lot for petroleum product storage

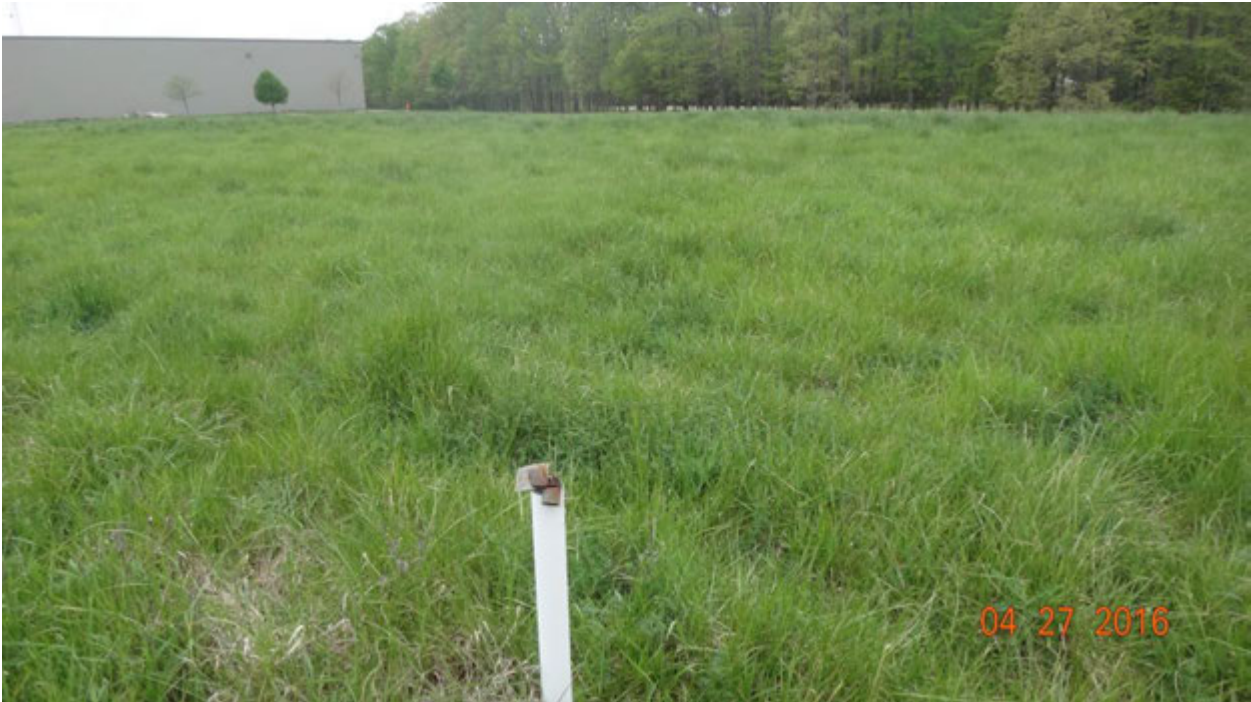
Figure 4. A PVC pipe well marker found in the field between the paved areas and the outfall at 7621 Energy Parkway

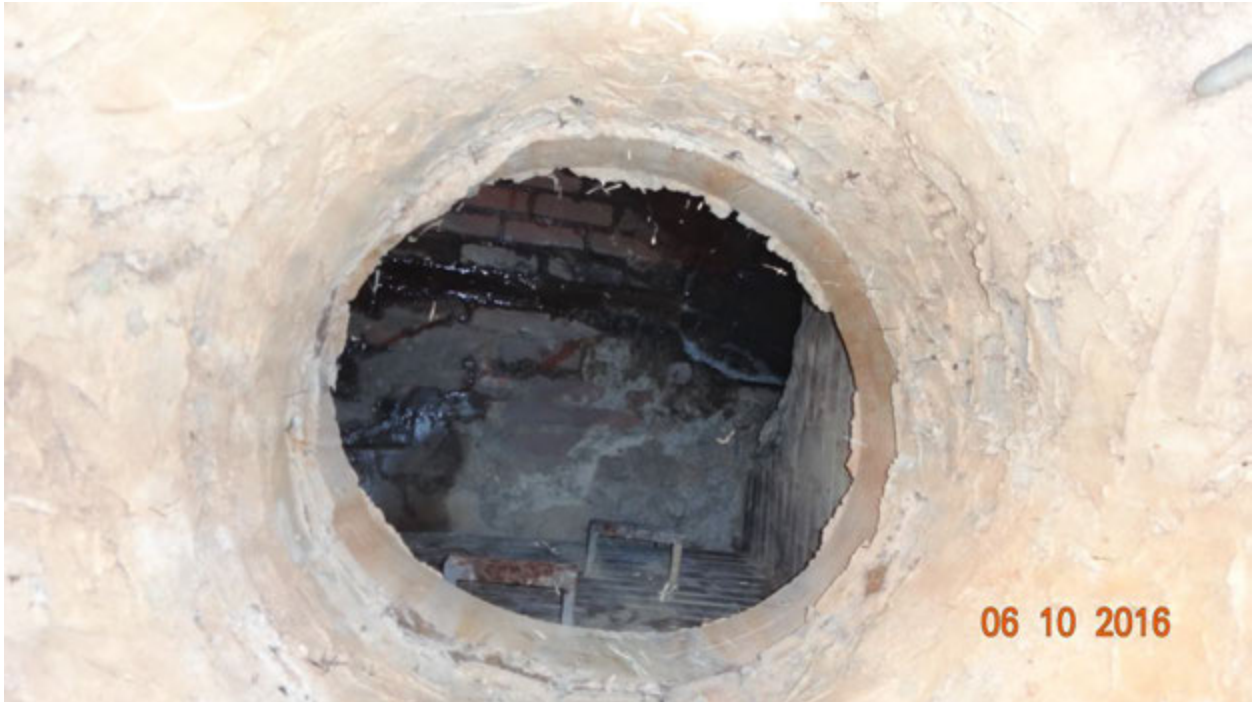
Figure 2. View inside the fourth manhole; note the trail of water from the west (right)

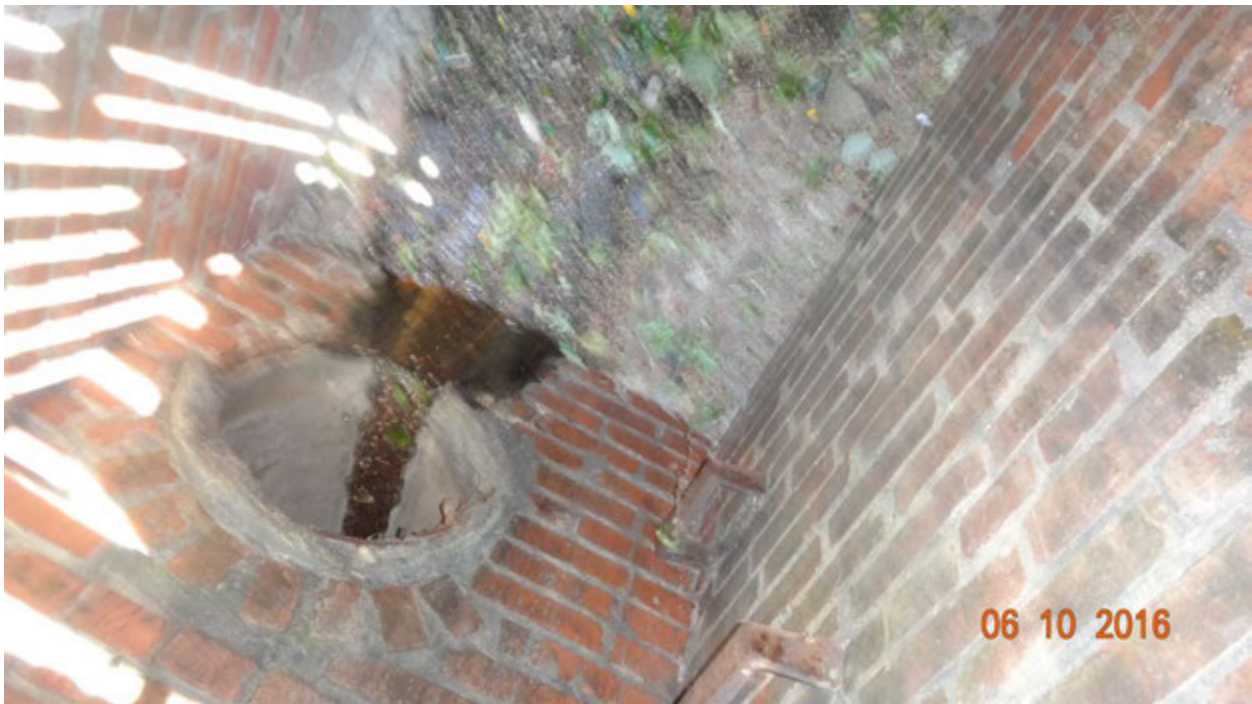
The Versar team returned the next day and collected a sample of the flowing effluent. The results of the tests are provided in Table 1, as Test 2. The result for pH on the revisit indicated a reading below the acceptable range (6.2). In response to the pH results out of the acceptable range, the team initiated a trackdown of the network to attempt to locate a possible source. The team used a map of the County's GIS data sets illustrating the stormwater infrastructure in the area, but found that some of the features in the data sets did not correlate with network components and connections observed in the field. The field team sought but did not find the first three manholes up-network from the outfall, as indicated in the GIS data; the team succeeded in locating the fourth manhole in the system (note that there is also an input to this manhole from the west that is not indicated in the County's GIS-based network). This fourth manhole had standing water near the opening for the input pipe from the west (Figure 2). The team obtained a sample of this water; the pH reading was within the acceptable range (6.9). The team noted a weak flow from the main pipe coming from the south, but the water level was too low to provide an adequate sample. An inspection of the curb inlet to the south also revealed a faint flow of water but without sufficient volume to obtain a sample (Figure 3).

Figure 3. View inside the curb inlet south of the fourth manhole, showing a faint flow of water

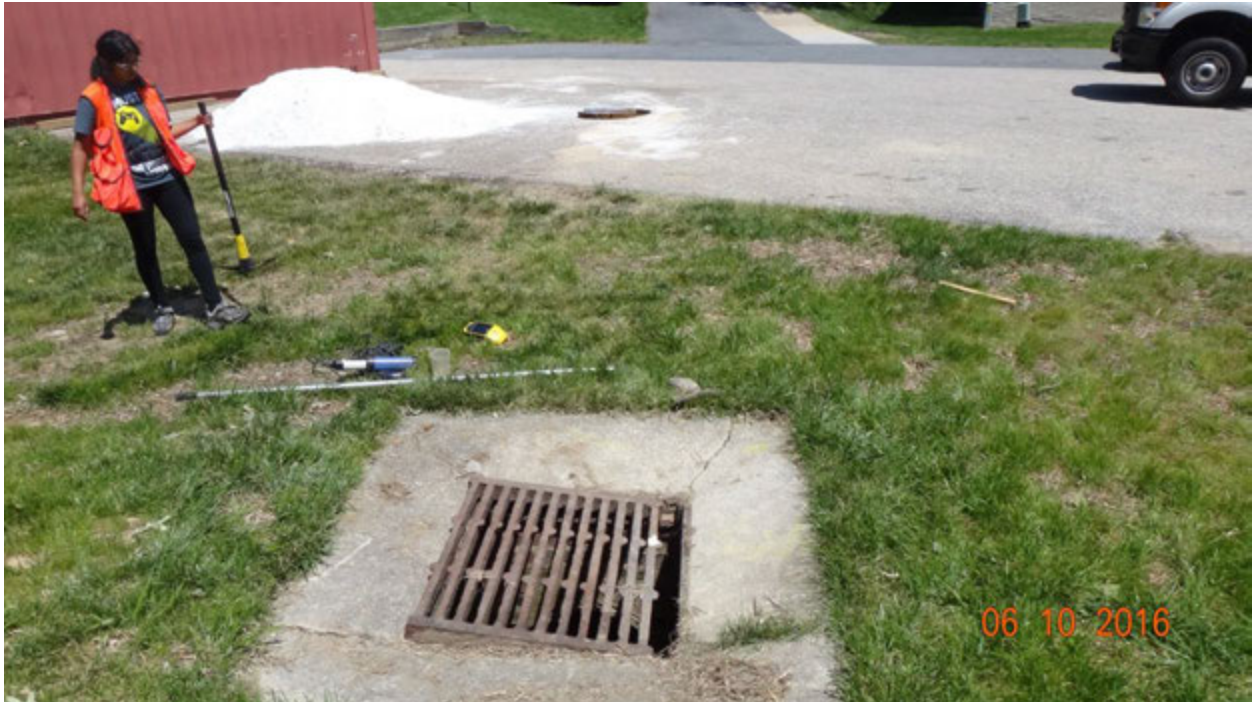
The team attempted to track a source of flow from a portion of the network to the west, which may have contributed to the water in the fourth manhole. The fifth manhole (to the west of the fourth), located in a parking lot between the apartment clusters for Andrew Court and Red Clay Road, displayed four tie-ins upon inspection (the County's GIS layer for stormwater pipes shows three). The team observed flowing water in the pipe entering the manhole from the west; a sample of this water had a pH of 7.6. A pipe entering from the south (the one pipe missing in the data set) also contained flowing water. Due to its close proximity, the team considered that this pipe may have been associated with a yard grate in the grassy area adjacent to the parking lot (Figure 4). In the yard inlet, the team documented that a small white drain pipe had flowing effluent (Figure 5). A sample of the flowing water from the white pipe had a pH of 7.03.

Figure 4. A yard grate (foreground) that appeared to be connected to and contributing water to the manhole in the parking lot (background)

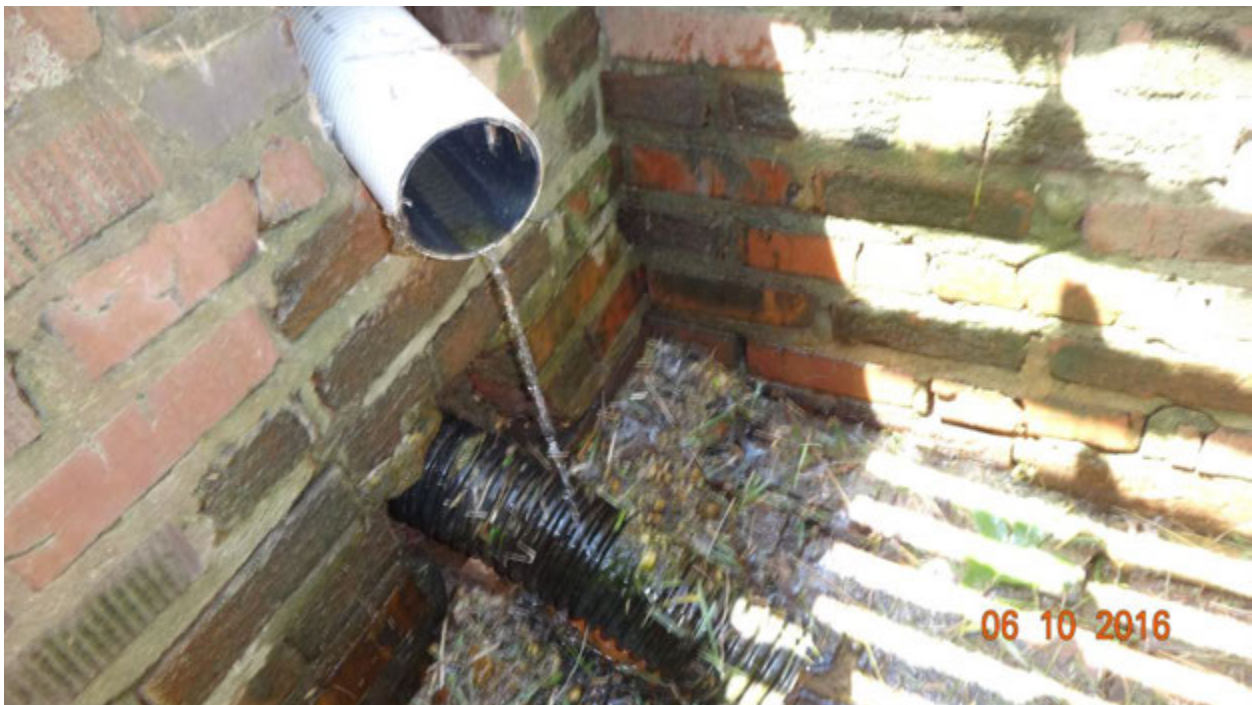
Figure 5. View inside the yard inlet showing flowing water from a small white pipe

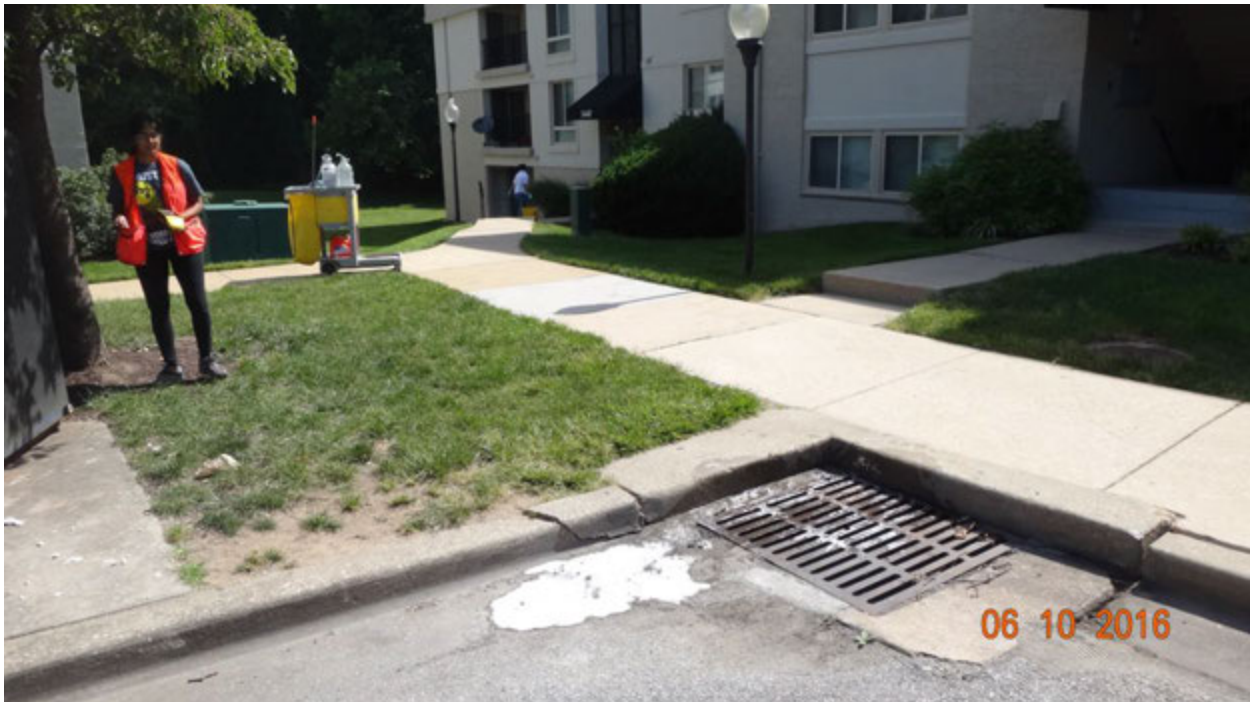
On June 10, 2016, while conducting outfalls inspections near the Ashley Apartments complex, a Versar field team discovered soap suds at a curb inlet and along the adjacent curb along Andrew Court. The team noticed a janitor's cart, and a janitor walking with a mop bucket nearby (Figure 1). The team opened a nearby manhole to investigate conditions in the stormwater system (Figure 2). Note that the connection between the manhole, located across the sidewalk from the curb inlet, and the curb inlet is not depicted correctly in the GIS data layers provided by the County. In the manhole, the water from the input from the curb inlet was stagnant (Figure 3). The team obtained a sample of the pooled water to test for illicit discharge indicators. The results of the tests are provided in Table 1. Several indicators had results above acceptable limits. Since the investigation was initiated by a chance encounter, and not as a result of a systematic outfall screen, no second visit was made to the site of the mop dumping. An area map is provided in Figure 4; note that features have been added to the map which represent the correct manhole location and the connection between the curb inlet and the manhole.

Figure 1. Soapy waste water observed at a curb inlet in the Ashley Apartments complex; note the yellow janitor's cart (left) and the janitor (top center-left) carrying a mop bucket toward the entrance to 3440 Andrew Court

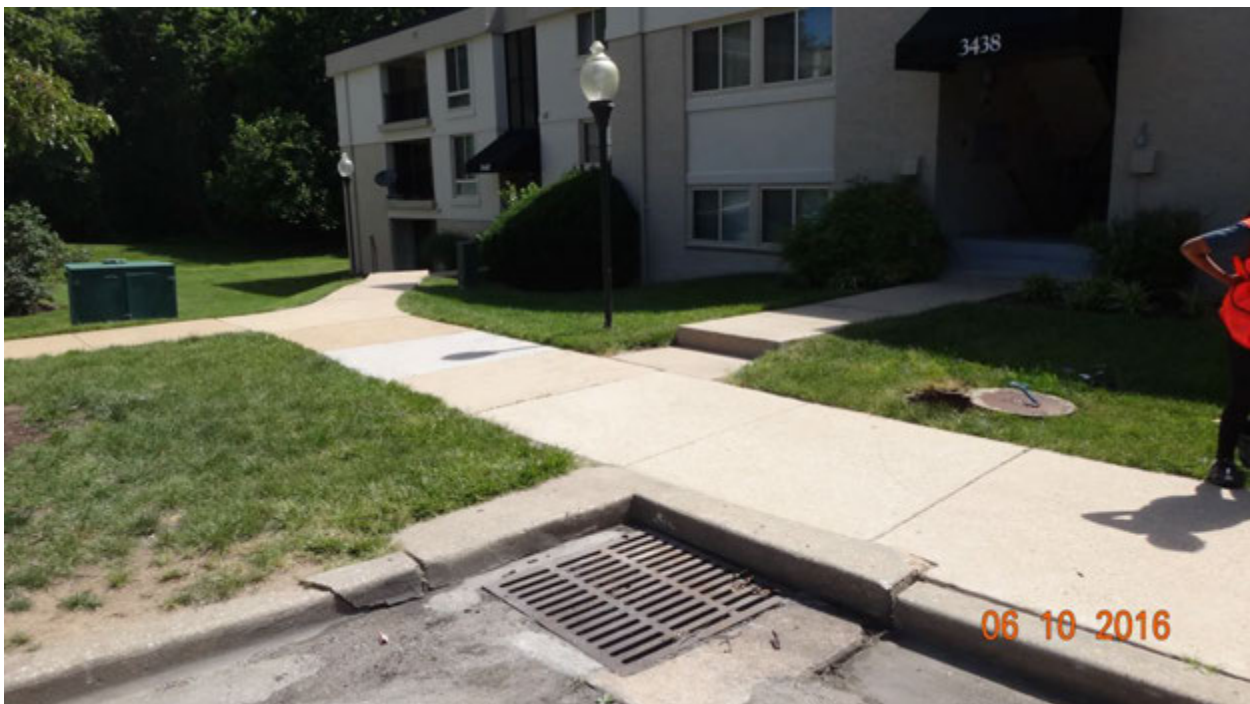
Figure 2. View showing the relative location of the manhole (center-right) to the curb inlet; the team obtained a sample of water for testing from the opened manhole

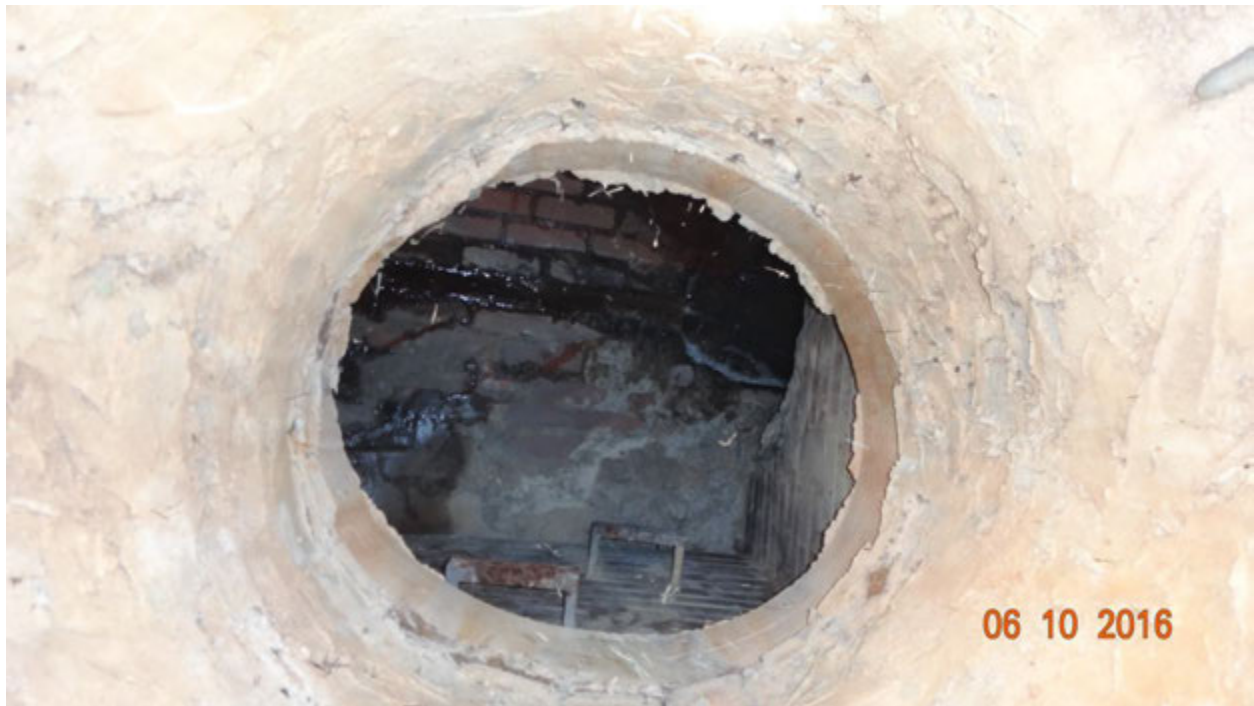
Figure 3. View inside the manhole; note the soapy waste water pooled on the right

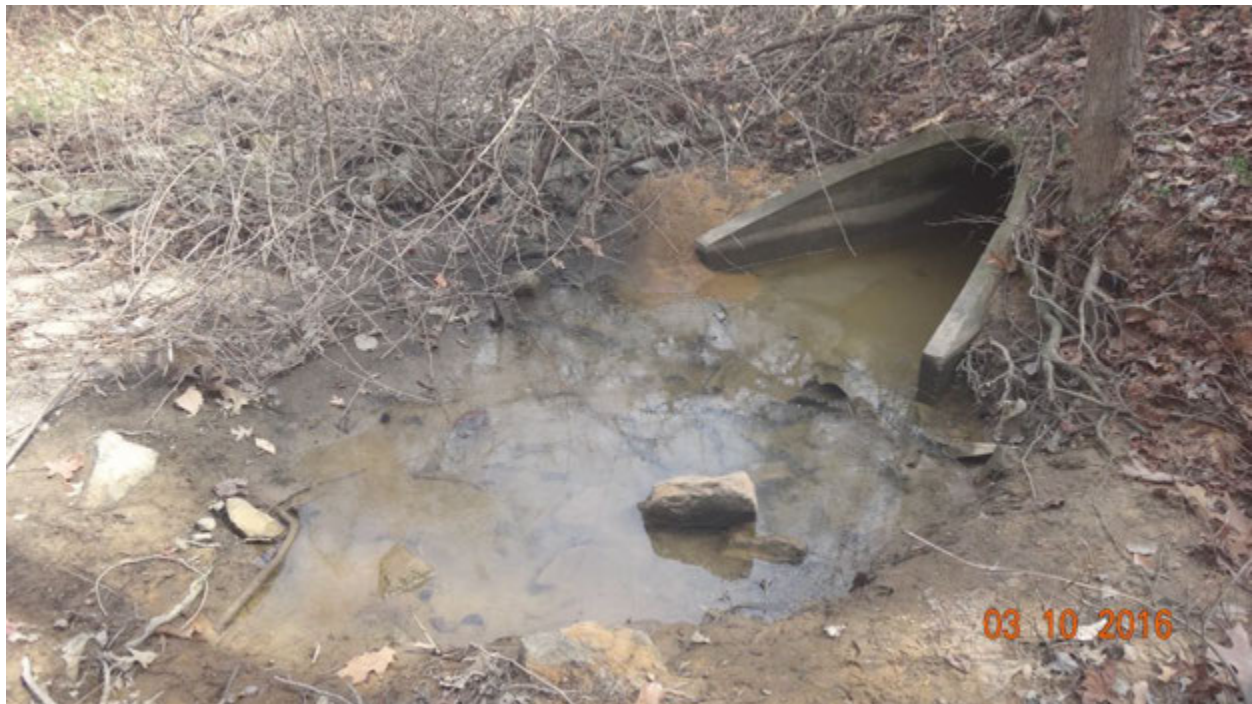
Figure 1. Stagnant water found at outfall G13G7O006 on March 9

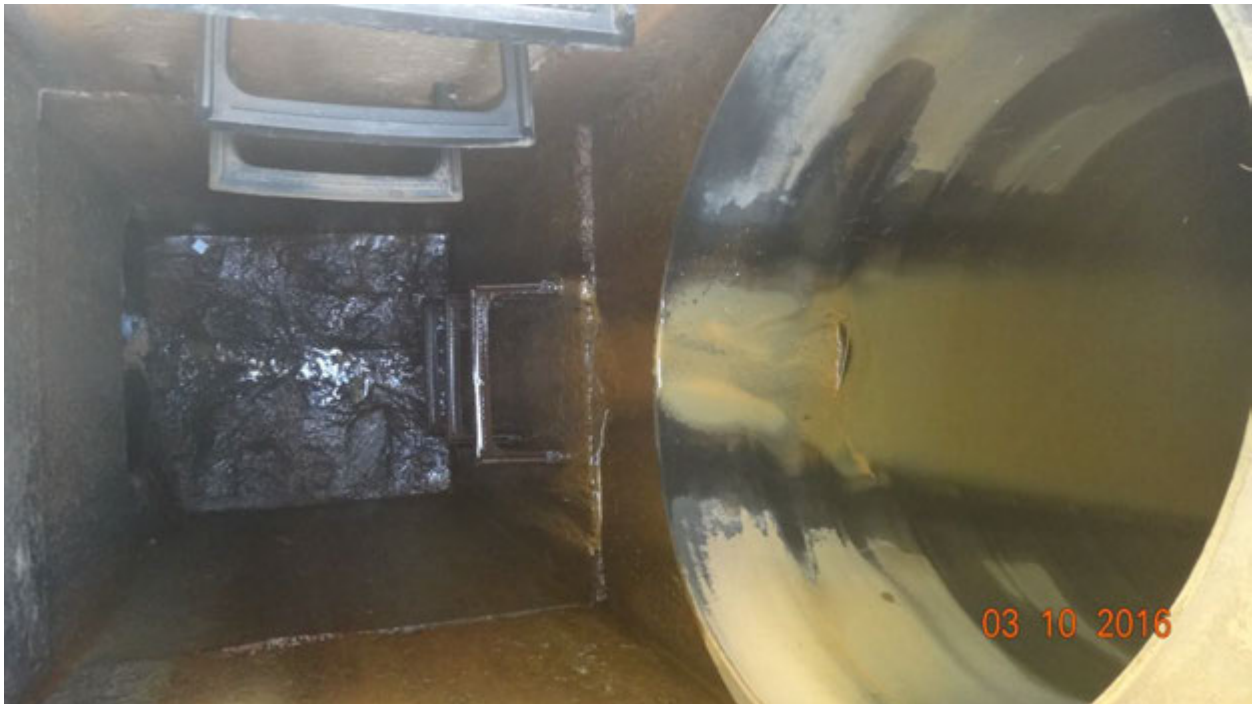
Figure 2. Evidence of flowing effluent in the yard grate, the nearest access point on the network from the outfall; note that this photograph was taken on March 10

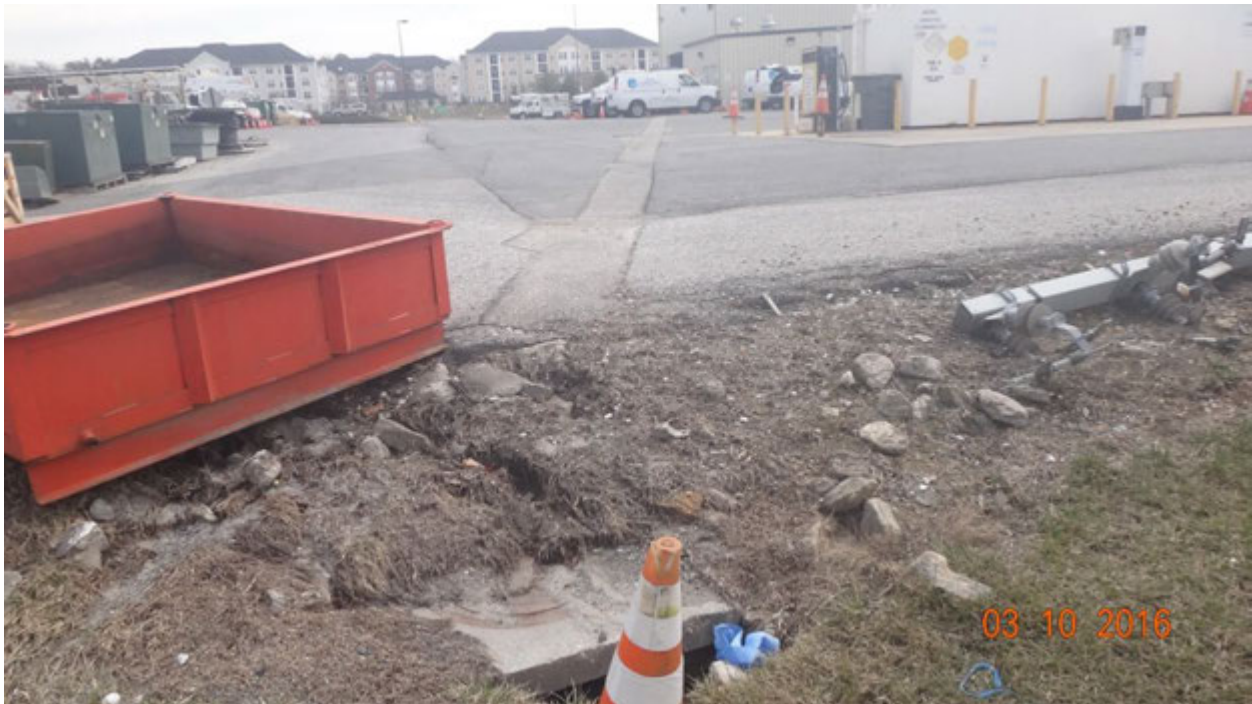
Figure 3. Photograph showing part of the repaved portion of the parking lot that correlates with the stormwater network; note that staff did not open the curb inlet in the foreground

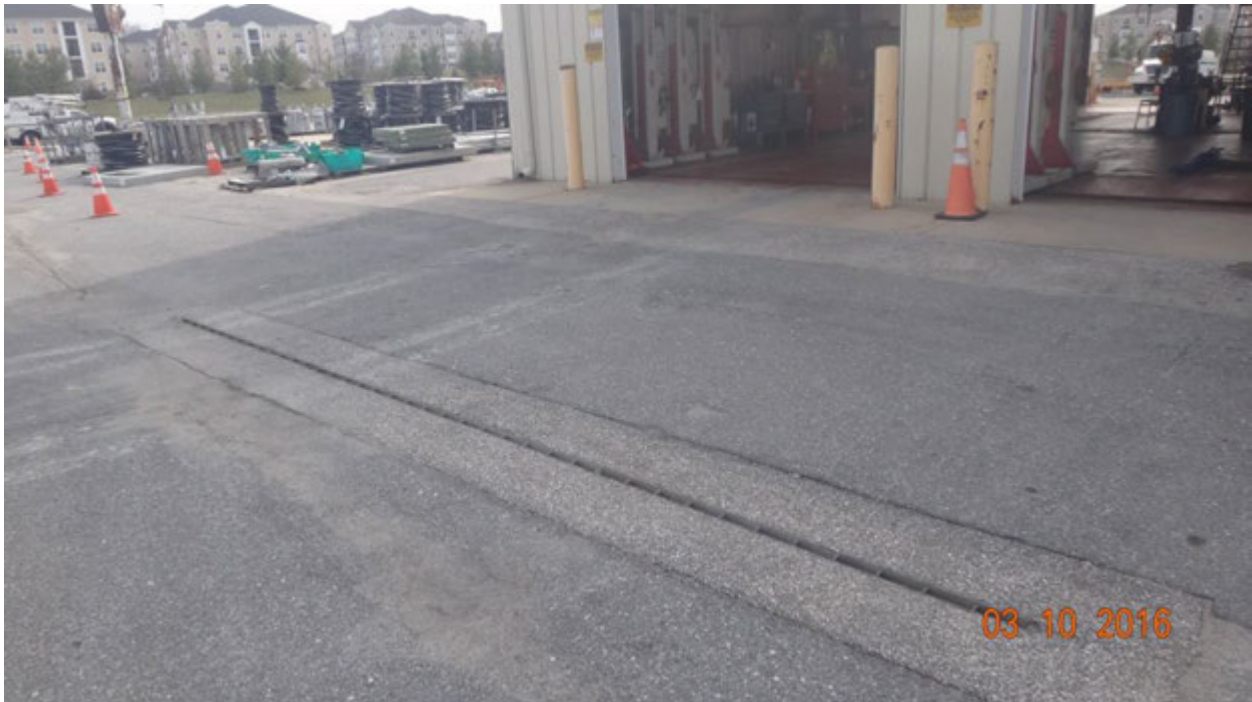
Figure 4. Photograph showing the end of the repaved portion of the parking lot that extends to the trench inlets by the bay doors; note that staff documented the presence of water in these inlets on March 10 but did not obtain samples for testing

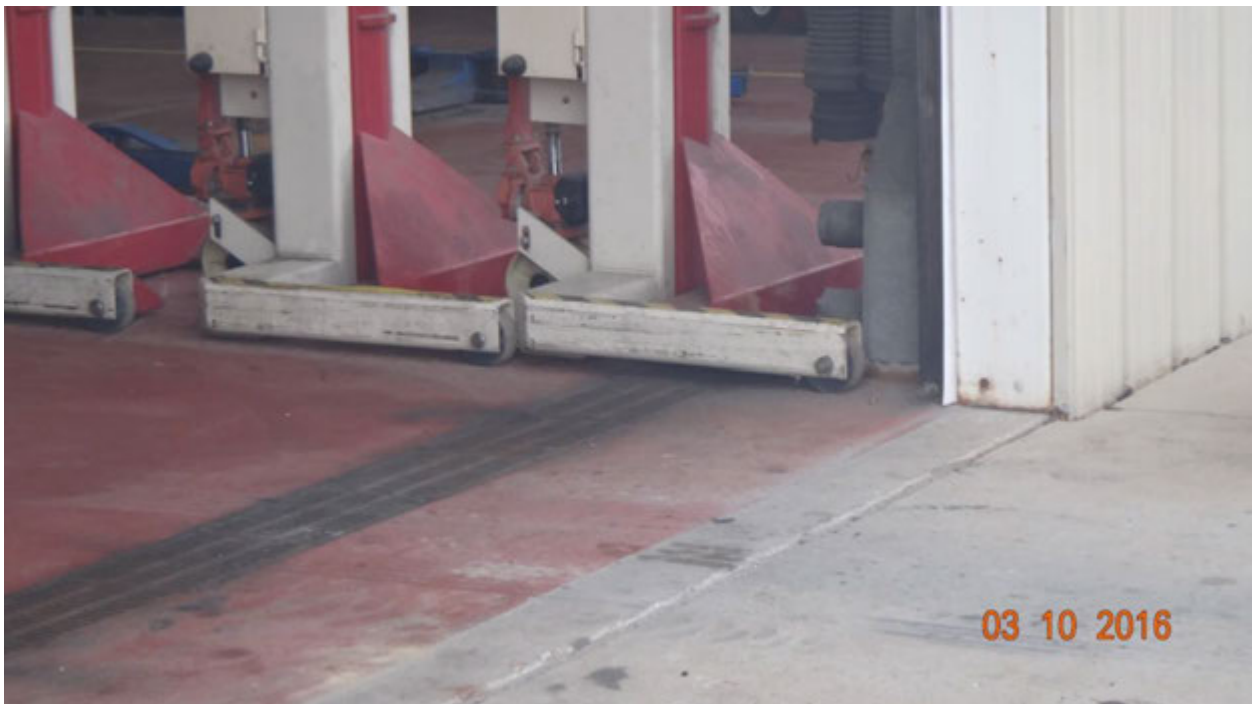
Figure 5. Photograph showing trench inlets in the bays; staff presumed that these were also connected to the stormwater network via new pipes

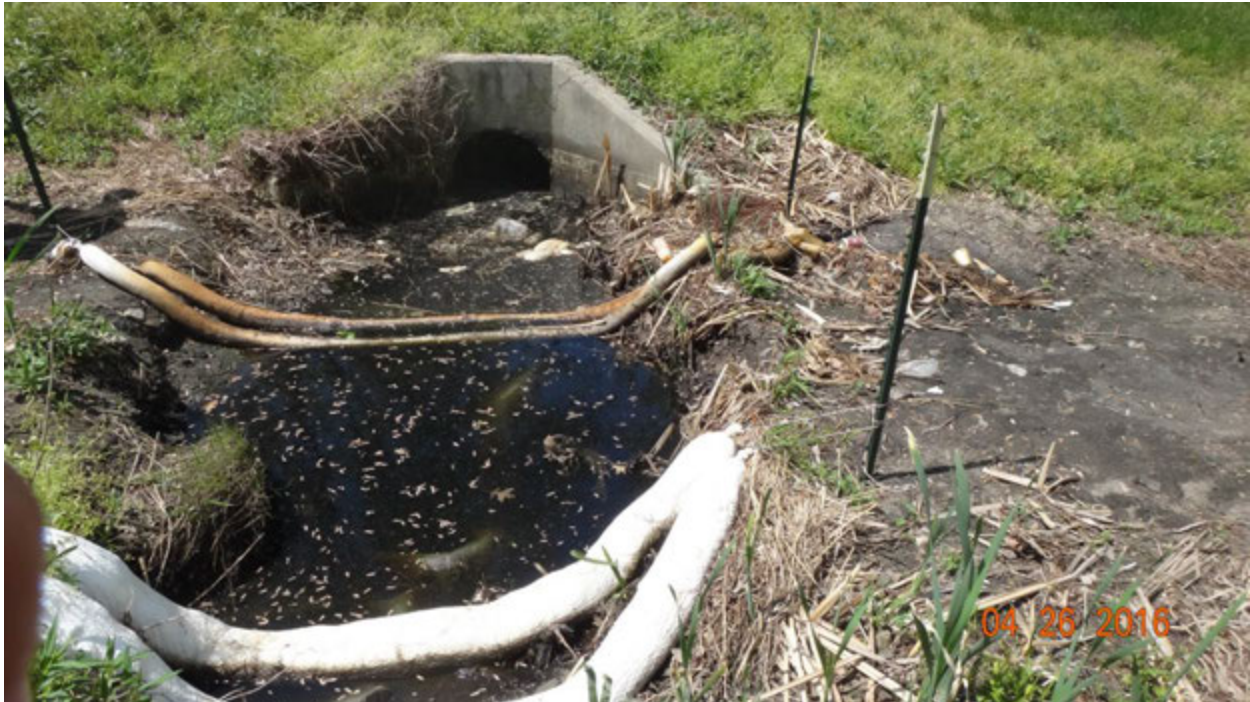
On April 26, 2016, a Versar field team was inspecting outfalls in the area and discovered what appeared to be evidence of a petroleum spill at outfall I03E8O003, near Concourse Drive in Linthicum Heights, MD. As team members approached the outfall, they observed several absorbent socks draped across the plunge pool; the stagnant water was dark grey and cloudy (Figure 1). The team noted a strong odor of oil at the site. The team briefly attempted to locate a viable source for the discharge, and began to search the nearby network access points for clues. At the nearest manhole, the team found flowing water and detected an odor of gasoline. Staff did not find other sources or evidence on the first visit. The crew collected a sample of the effluent in the manhole to test for illicit discharge indicators. The results of the tests are provided in Table 1; no tested parameters exceeded County action levels.

Figure 1. Outfall I03E8O003 as observed on April 26, 2016, with the absorbent socks installed to constrain the fuel in the water
