**ANNE ARUNDEL COUNTY
ILLICIT DISCHARGE DETECTION
AND ELIMINATION
2016 ANNUAL REPORT**

PERMIT NUMBER MD0068306

FINAL: January 2017

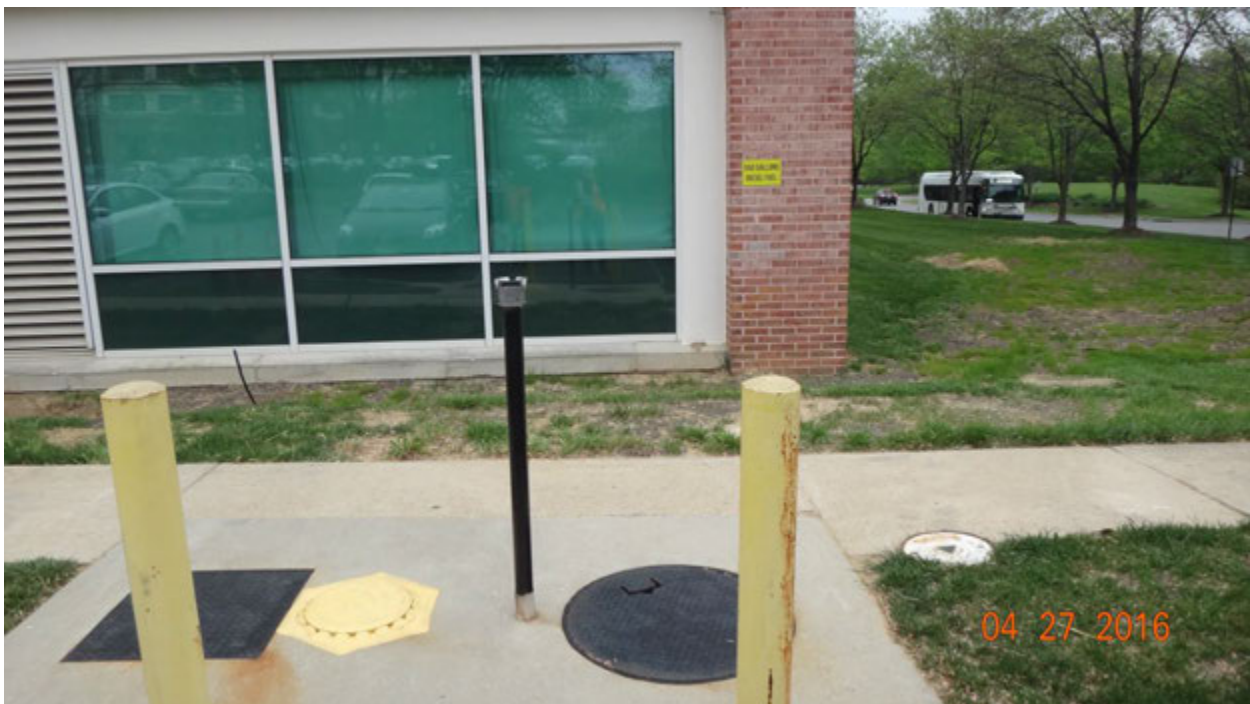
Figure 2. A yellow sign (upper center-right) indicating fuel storage mounted on the building at 1302 Concourse Drive; the sign reads, "550 gallons diesel fuel." Evidence of new grass and loose straw can be seen on the right side of the photograph.

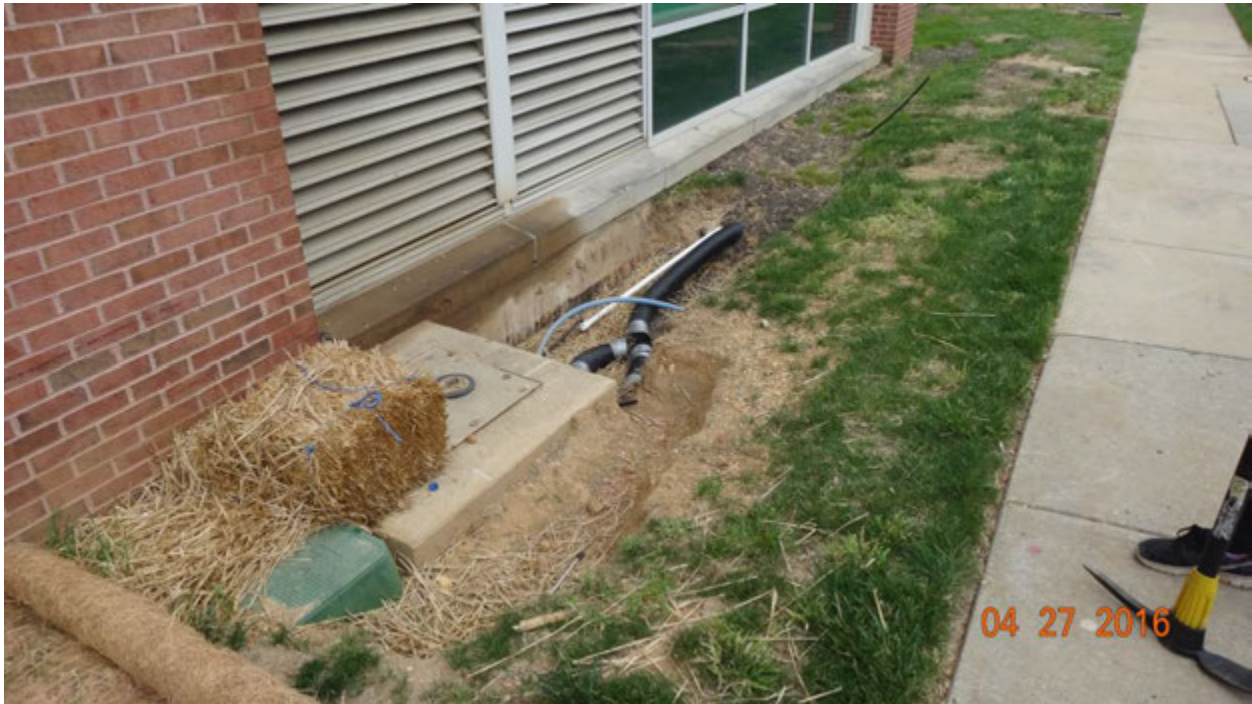
Figure 3. Signs of a hole opened alongside the building and exposed lines; note the dark stain on the sill

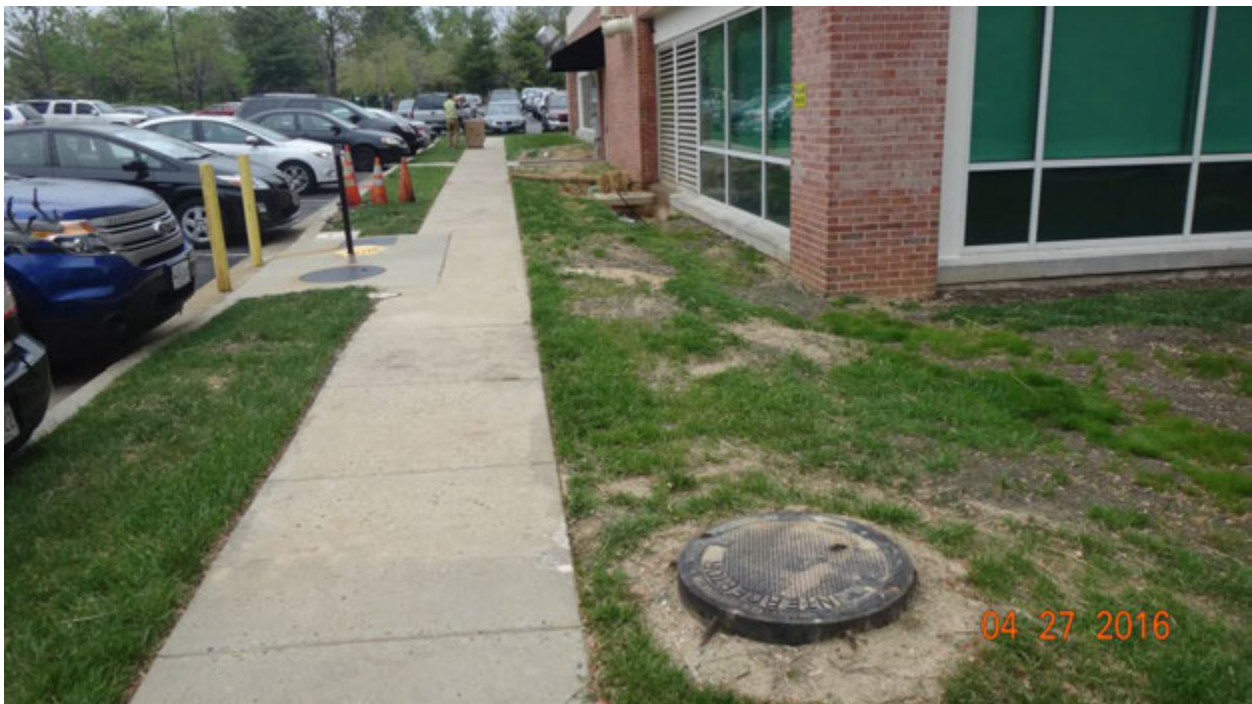
Figure 4. View showing the relative location of the yellow sign, on the near corner of the building, and the hole with the exposed lines (upper center, under the windows)

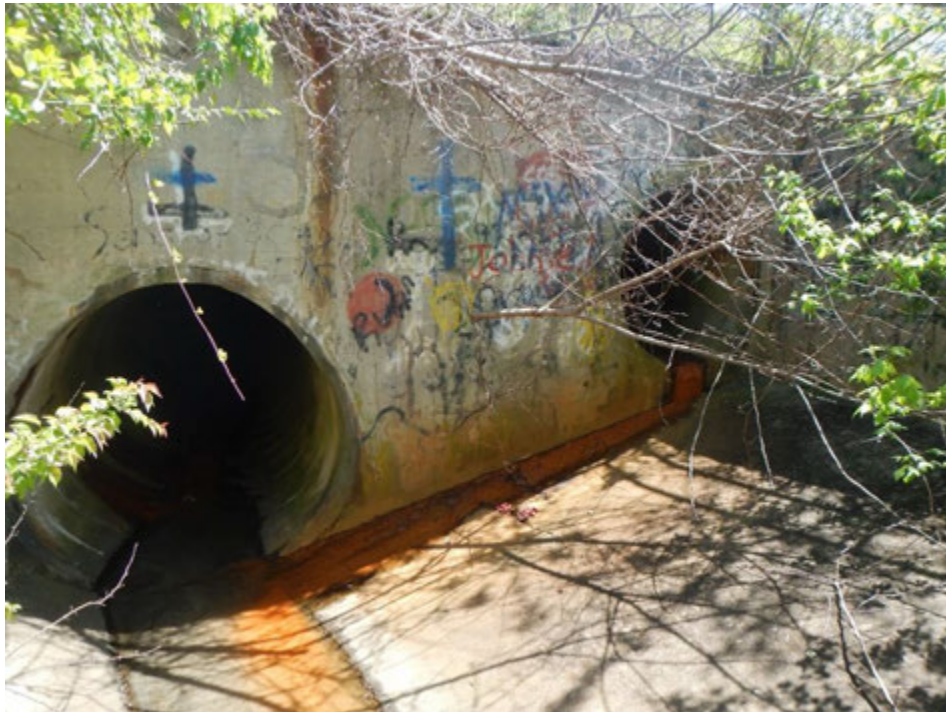
On April 18, the LimnoTech field team inspected the target outfall, I17B6O007, which is located on the west side of Crain Highway, opposite the Crofton Centre shopping center in Crofton, MD. At the 72-inch outfall, the field team observed a rust-colored discharge (Figure 1); the team obtained a sample to test for illicit discharge indicators. The results of the tests are provided in Table 1, for Test 1. The result for pH indicated a reading below the acceptable range (4.80).

Figure 1. Outfall I17B6O007 exhibiting a rust-colored discharge, as observed by the LimnoTech field crew on April 18, 2016

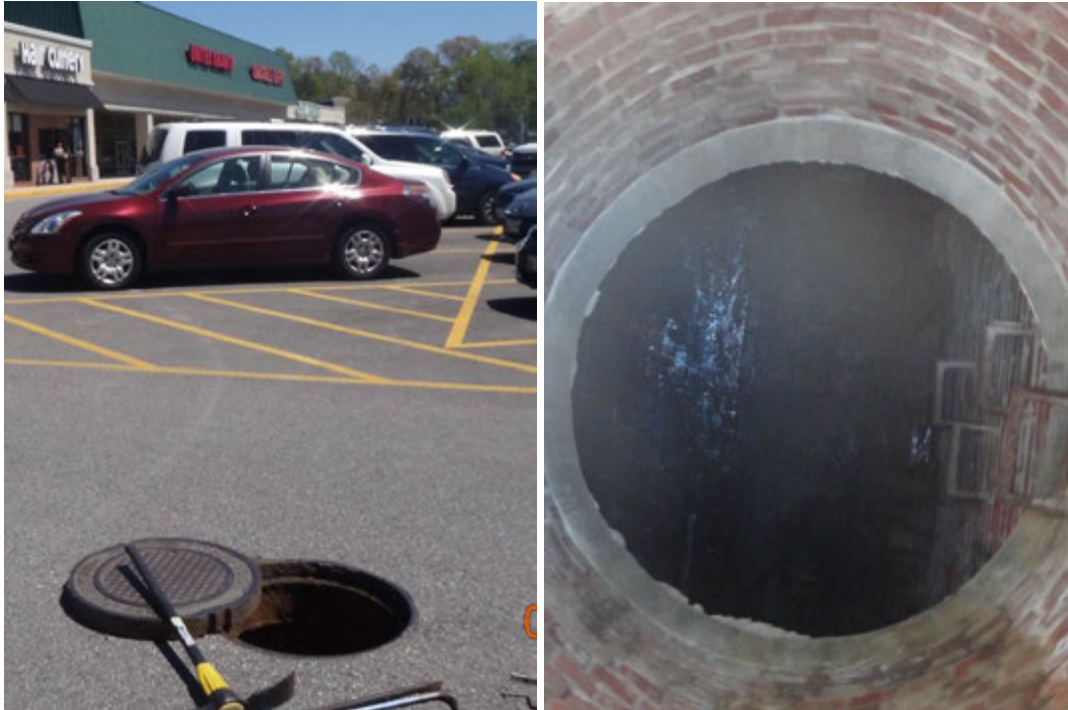
The LimnoTech field crew conducted a partial trackdown on the second site visit. The crew determined that the flow was coming from the drainage line leading east under the parking lot of Crofton Centre. A Versar team visited the site on April 20 to continue the investigation of the source of the discharge; the team documented a low pH reading at the outfall of 5.50 on April 20. The Versar team followed the main drainage line that extends eastward under Crain Highway, in front of the Wells Fargo branch and the Osaka Grill restaurant, and toward the Sears Auto Center. At the manhole in the parking lot just southeast of the Wells Fargo branch, the team observed flow; a test result indicated a pH of 5.66 (Figure 2). There was insufficient sample volume to test other parameters. The team determined that other pipes in the vicinity (i.e., near the Checker's restaurant drive-through and in the parking lot behind the Sears Auto Center) did not contribute to the discharge. The Versar team did not find additional evidence that would further clarify the source of the illicit discharge on April 20. An area map, showing the results of the trackdown efforts, is provided as Figure 3.

Figure 2. Flow observed (right photograph) from a manhole in the eastern drain line under Crofton Centre, in front of the Wells Fargo branch (left photograph) on April 20, 2016

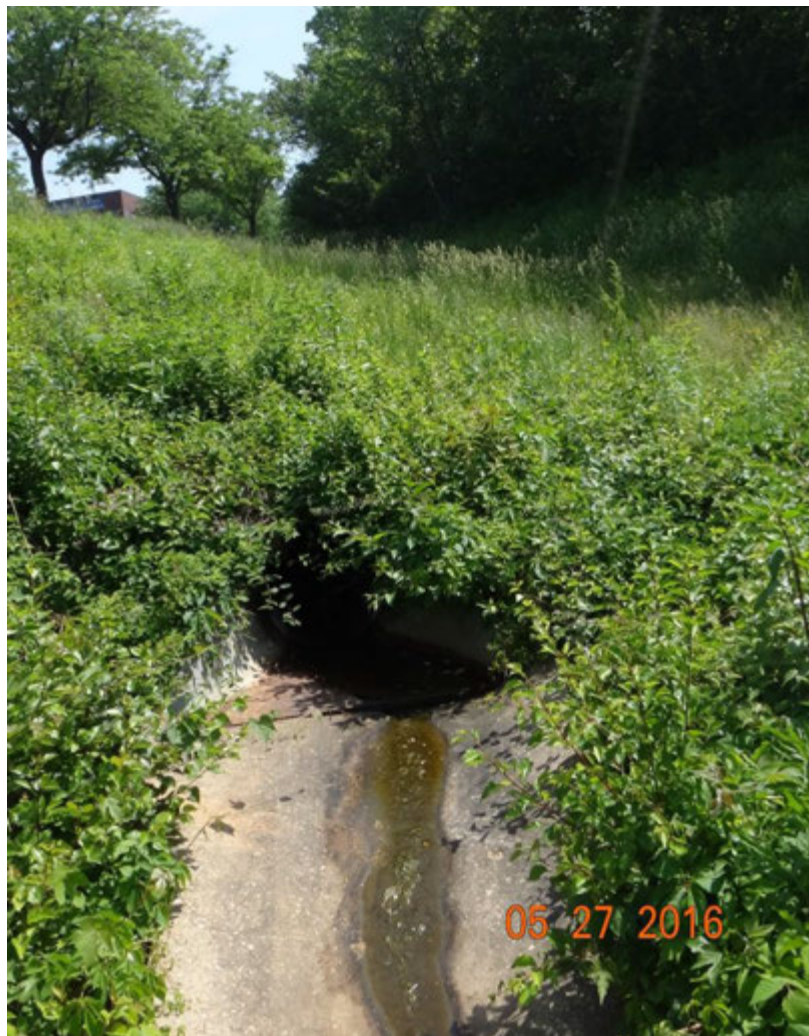
Staff members returned to the site at the next opportunity (that is, a sampling period with a preceding 72 hours of dry weather) – May 27, 2016. They again observed flowing water at the outfall (Figure 1). The tests on the discharge showed above-action-level concentrations of detergents (0.6 mg/l); the results are provided in Table 1, as Test 2. The team initiated a trackdown of the system to identify the source of the flow. The digital infrastructure data provided by County staff includes one manhole and two curb inlets in the stormwater conveyance system leading to the outfall. Field staff found evidence that there are more elements to the network than the digital data indicate. The field crew inspected the manhole and found two inlet pipes; one was a large concrete trunk line pipe which was dry, and one was a smaller black pipe which had flowing effluent from the direction of the first curb inlet (Figure 2). The crew proceeded to the next access point, the first curb inlet. This inlet also displayed two input pipes; one pipe leading from the second curb inlet (northeast) had flowing effluent, and one pipe conveying flow from the southeast was damp (Figure 3). The field crew inspected the second curb inlet, which is the easternmost extent of the stormwater infrastructure network according to the County's data set. The crew found a small PVC pipe contributing flowing effluent to this inlet from a source to the east (Figure 4). The crew tested this effluent for detergents; results showed concentrations above action levels (0.8 mg/l). Due to security constraints at the guarded National Security Agency facility, the field crew did not attempt to track the source of this small PVC pipe; consequently, the team did not identify the source of the flowing discharge. An area map is provided in Figure 5.

Figure 1. Outfall I04F3O014 with flowing discharge as observed on May 27, 2016

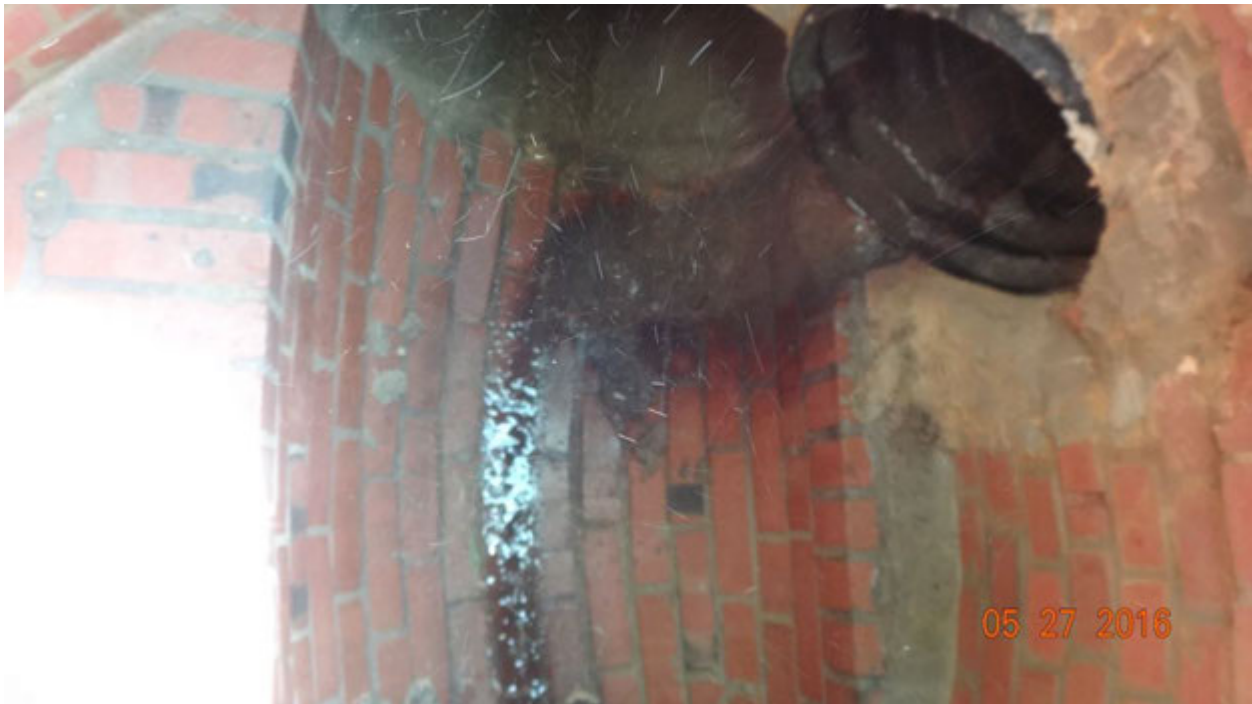
Figure 2. Two input pipes for the manhole up-system from the outfall; the large concrete pipe (top) was dry and the black pipe (top right) had flowing effluent from a source in line with the curb inlet to the east

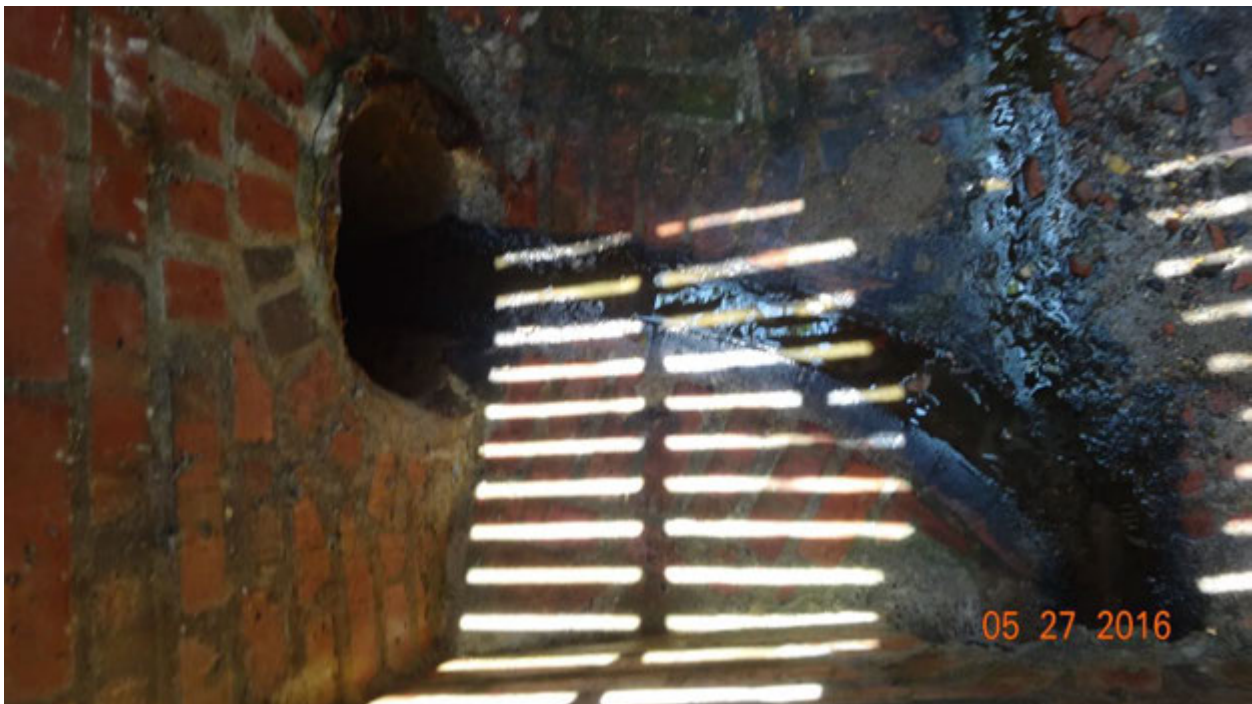
Figure 3. View inside the first curb inlet, showing the discharge flowing from the direction of the second curb inlet (left); note the line of moisture in the upper right which indicates a second pipe input to this inlet (from the southeast)

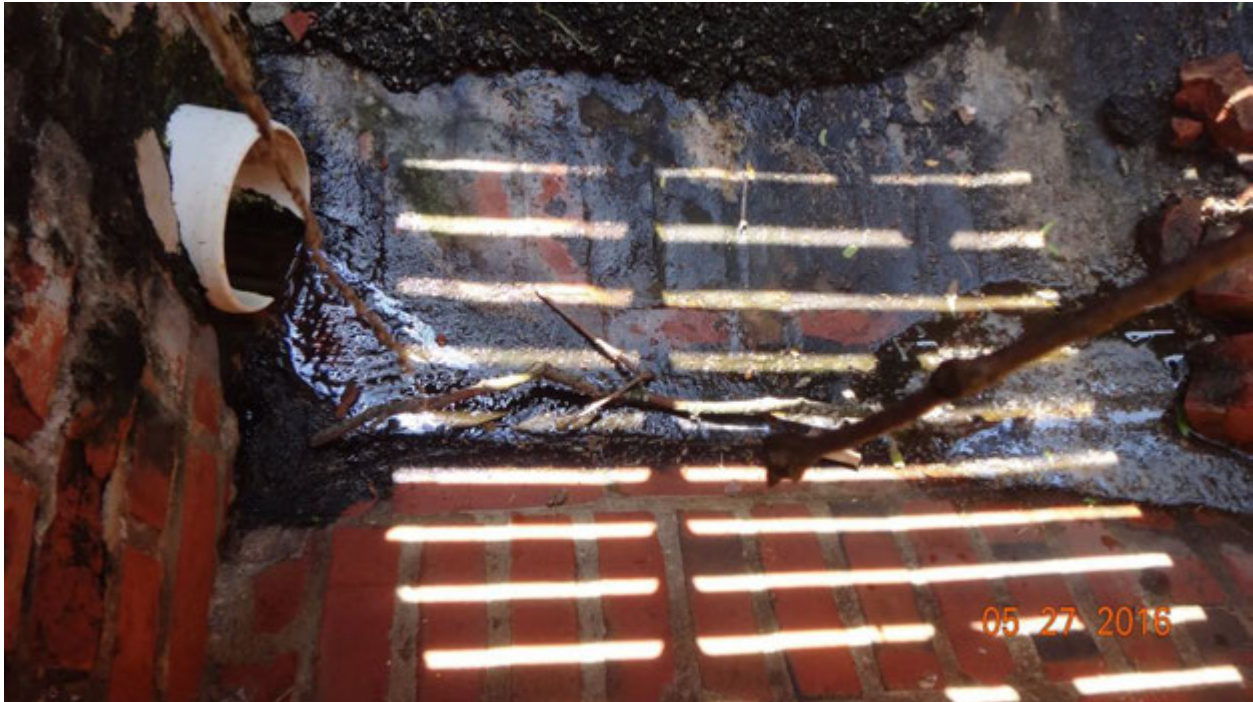
Figure 4. A white PVC pipe (left) contributing flow to the stormwater system from a source to the east of the second curb inlet up-network from the outfall

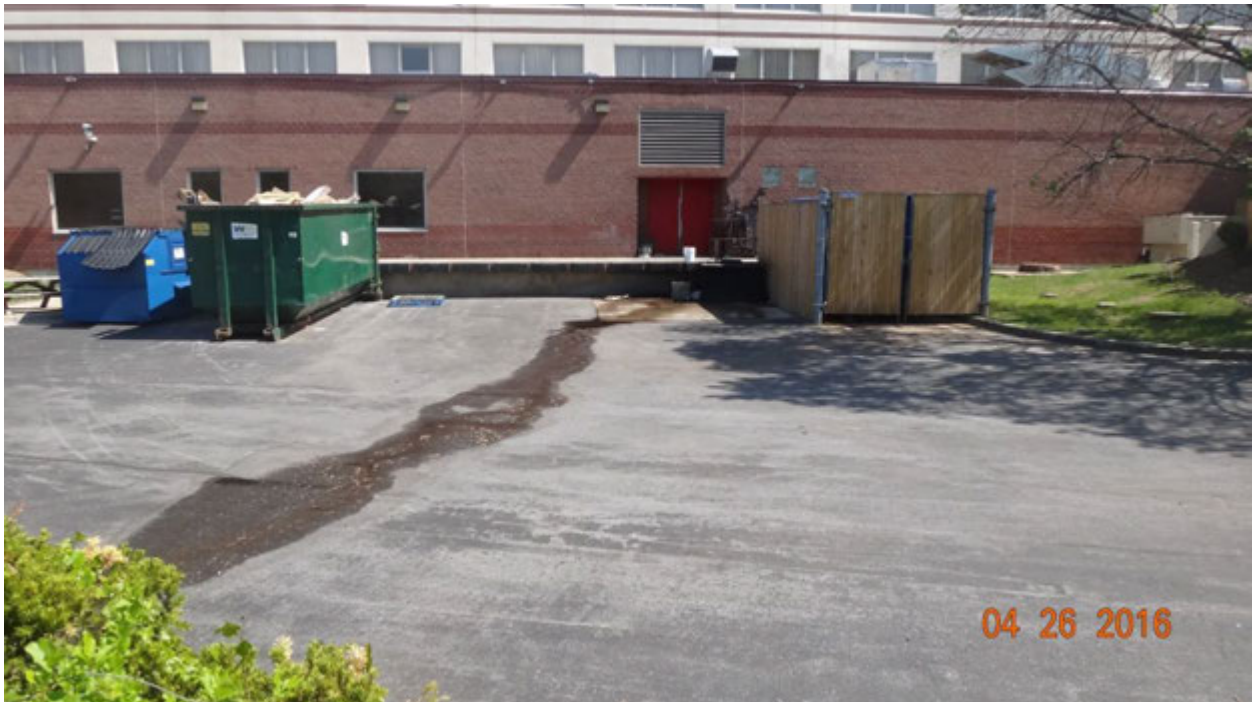
In lieu of a trackdown, since that was not warranted, the team inspected the loading dock area of the Embassy Suites hotel. As team members approached the rear of the establishment, they observed evidence of a significant amount of wash water in the parking lot, starting from a point immediately behind a loading dock, and leading across the rear parking lot (Figure 1). The field team documented the presence of a hose stored on a hanger on the outside wall and an uncovered bucket which appeared to contain liquid at the edge of the dock (Figure 2). The path of the water continued to the curb inlet on the opposite side of the parking lot, where it then could enter the storm sewer system (Figure 3). Although the field team did not observe washing activity, the fresh evidence of discharge suggested that hotel staff may be inappropriately releasing wash water to the stormwater system through outdoor washing activities. In 2014, field staff documented that the pavement from the loading dock toward the curb inlet in the same location showed stains from repeated flows of wash water that had left deposits on the pavement. An area map is provided in Figure 4.

Figure 1. Wash water observed in a path from the loading dock (rear center) to the curb inlet (lower left corner, out of sight) behind the Embassy Suites Hotel on April 26, 2016

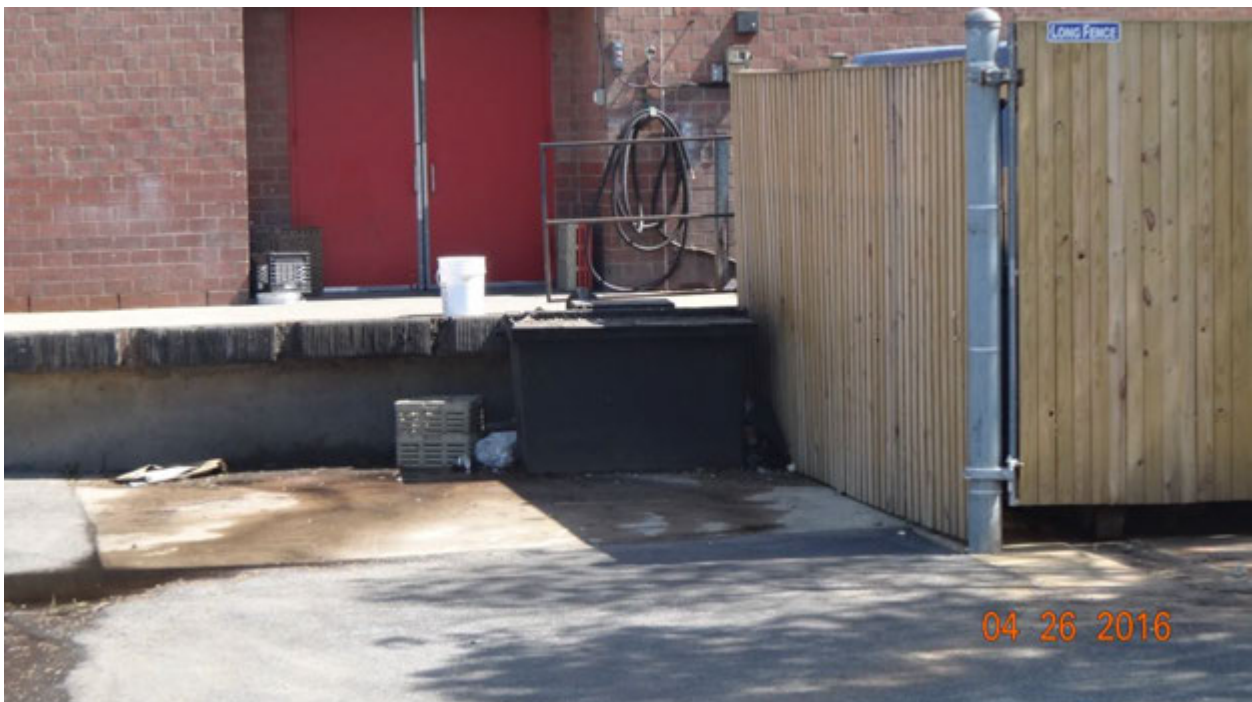
Figure 2. Evidence of an outside-mounted hose and an uncovered bucket that appeared to contain liquid at the loading dock for the Embassy Suites Hotel on April 26, 2016

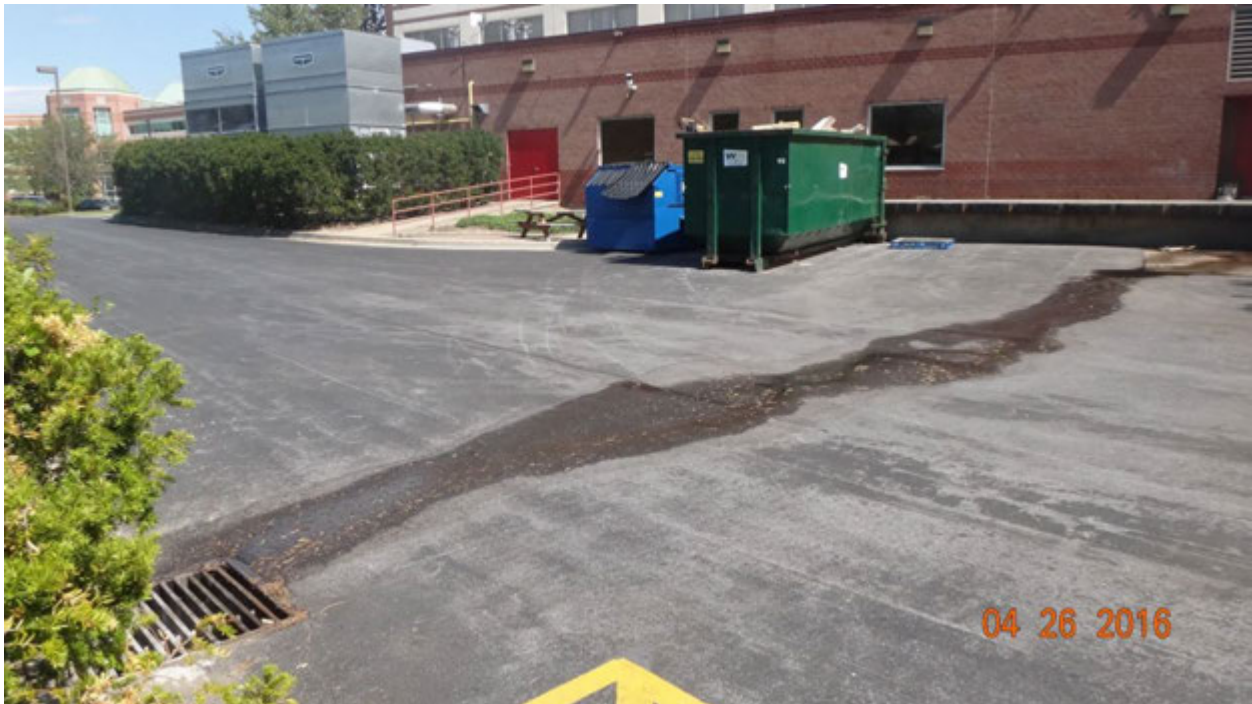
Figure 3. Evidence that the wash water from activities at the loading dock (upper right corner, off the edge of the photograph) was of significant volume to cross the parking lot and enter the curb inlet (lower left corner)

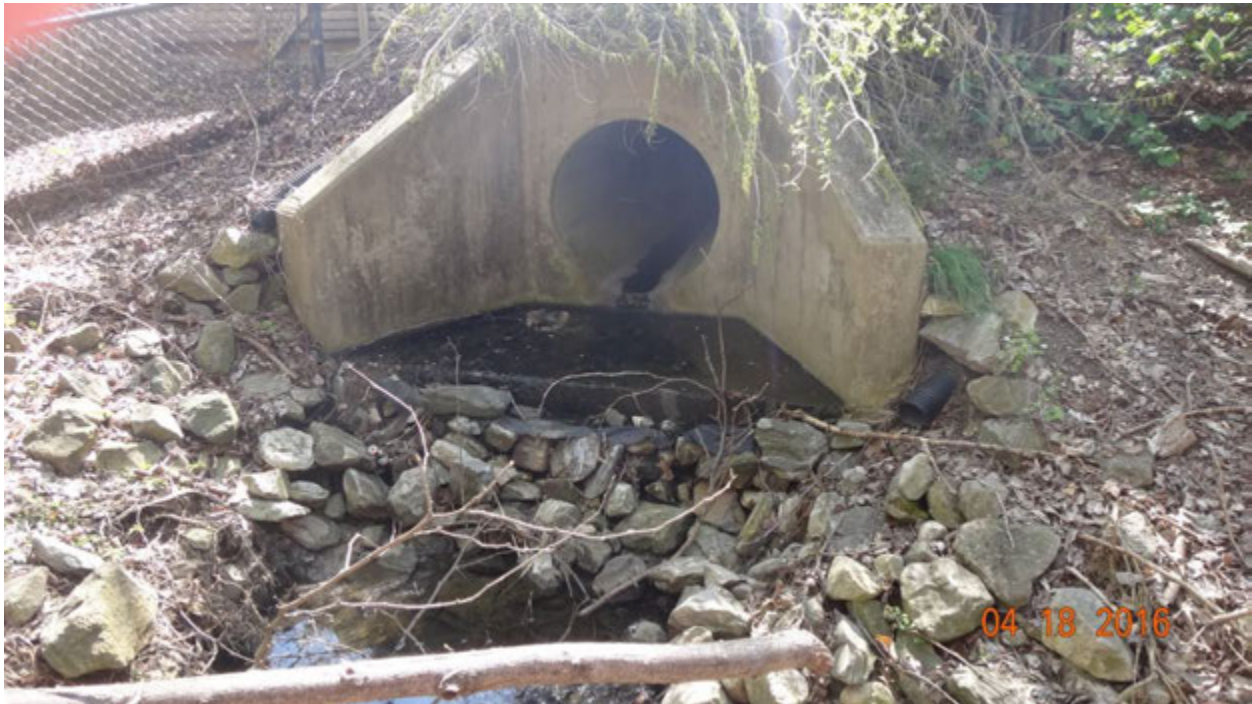
A Versar field team inspected the outfall, Q09C3O001, located east of Escalon Avenue, on April 18, as per County request to investigate a possible illicit discharge. On the first field visit, staff observed that the water in the outfall was flowing (Figure 1); staff noted that the water was clear, and the receiving deck had an excessive amount of algae growth. The field team also detected a sour, rancid smell in the vicinity of the outfall. The field staff collected a sample of the discharge at the outfall to test for possible illicit constituents. The results of the tests are provided in Table 1, for Test 1. Detergent levels tested above the acceptable range for the sample taken on the first site visit (2 mg/l).

Figure 1. Outfall Q09C3O001 as observed on April 18

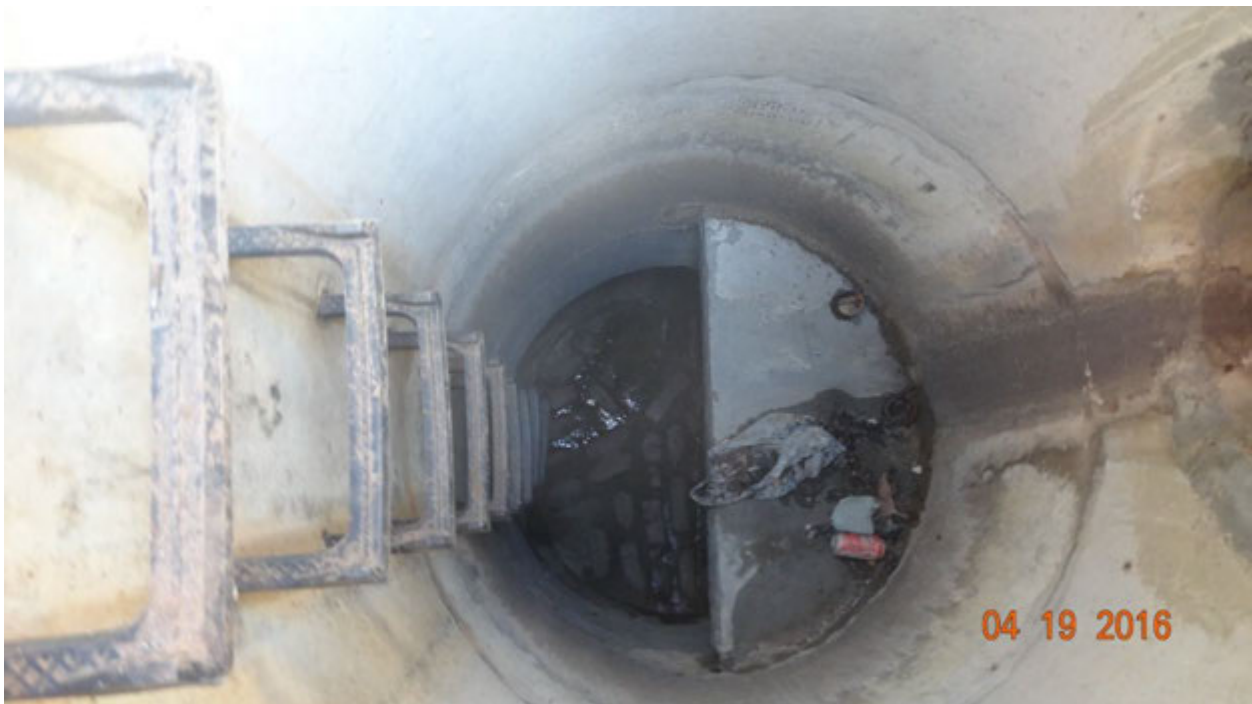
Figure 2. Flowing water observed in a manhole on the eastern side of the Escalon Avenue neighborhood on April 19; the water flowed from the west

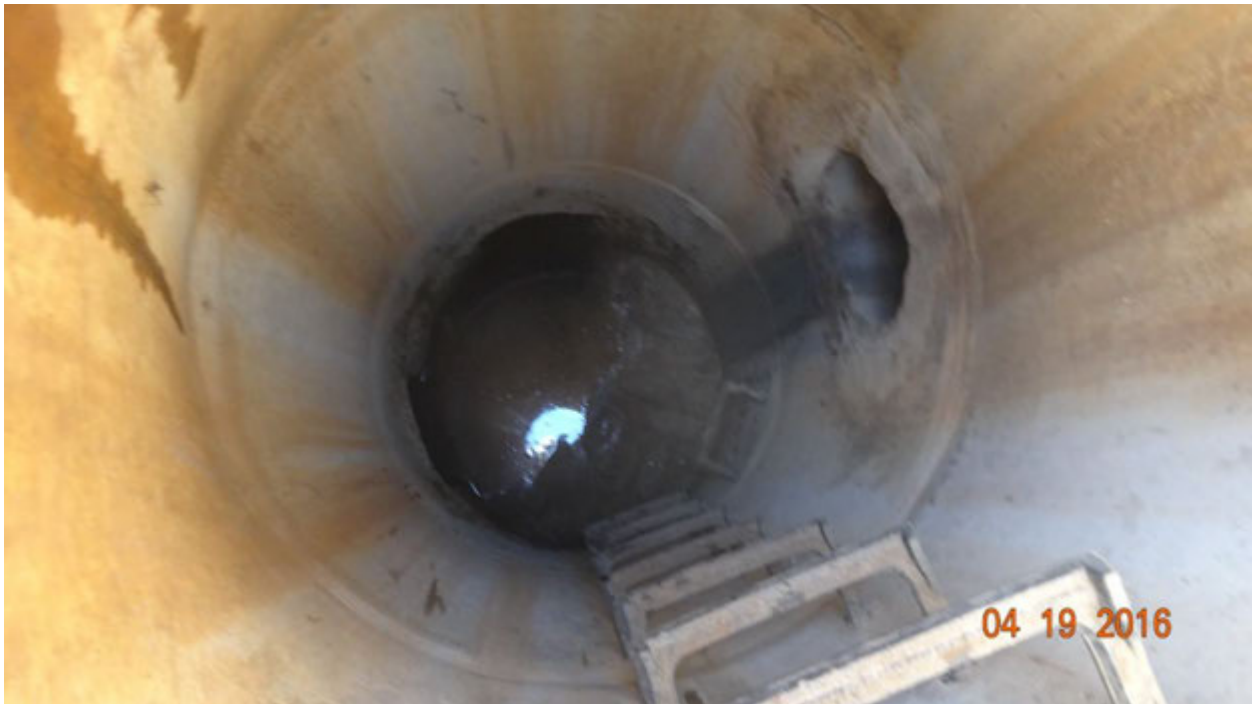
Figure 3. Evidence of standing water in the stormwater system on the western side of Escalon Avenue on April 19

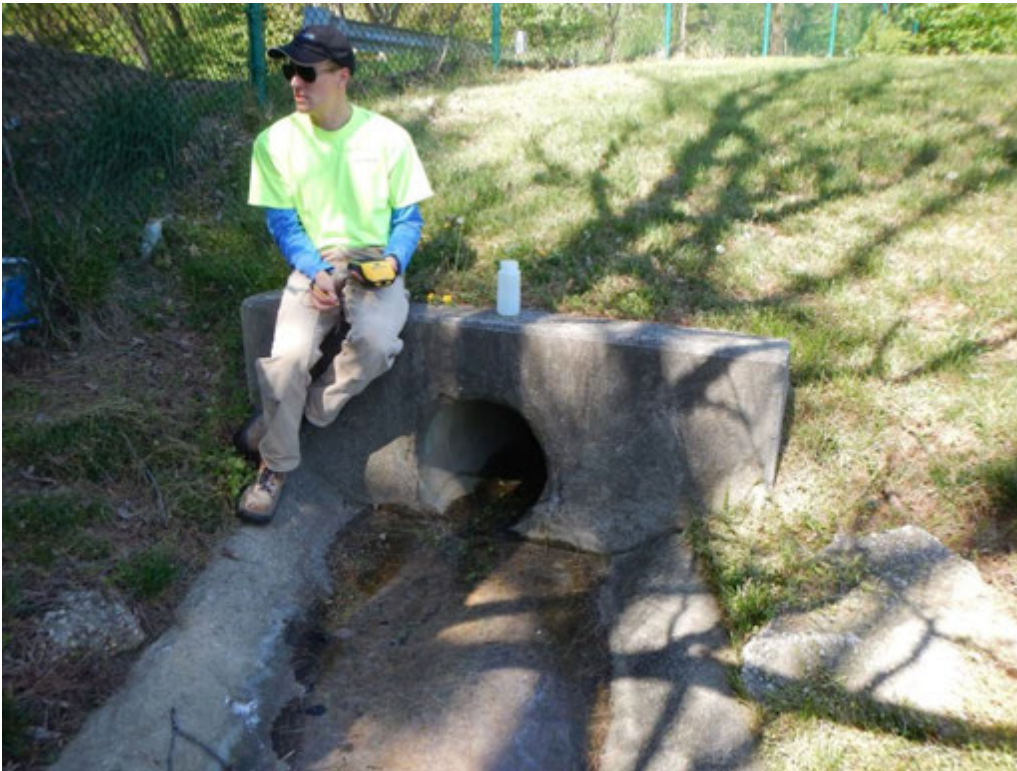
On April 18, 2016, a LimnoTech field team inspected target outfall I17D5O001 near Martha Greenleaf Drive in Crofton, MD. This outfall drains the southeast end of Crofton Station Court, and a parking lot associated with the Anne Arundel Carver Center, into a stormwater pond. The team observed a discharge flowing from the pipe (Figure 1); the team obtained a sample to test for illicit discharge indicators. The results of the tests are provided in Table 1, as Test 1. The result for pH indicated a reading below the acceptable range (6.35).

Figure 1. Outfall I17D5O001 as observed on April 18, 2016

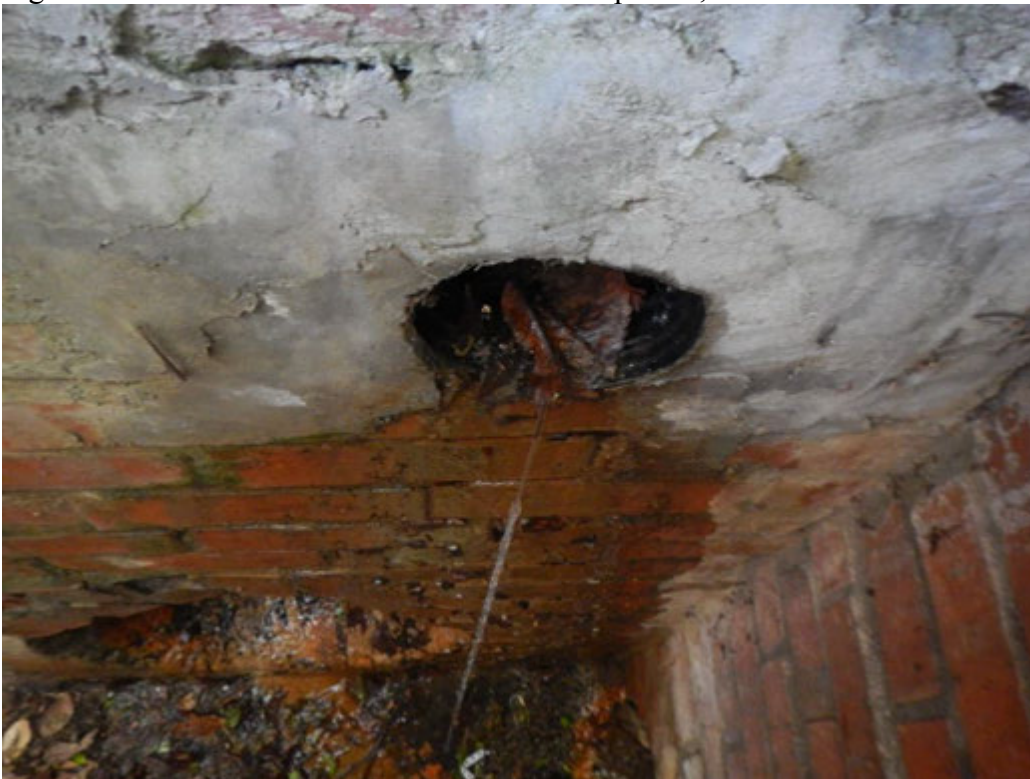
The LimnoTech team did not identify any other flowing contributions to the target outfall on April 19. The team was also unable to determine the origin of the 4-inch pipe at the catch basin or to find additional evidence to identify the source of the illicit discharge. An area map is provided as Figure 3.

Figure 2. Flow observed from a 4-inch pipe entering a network curb inlet (third catch basin up the network from the outfall) on April 19

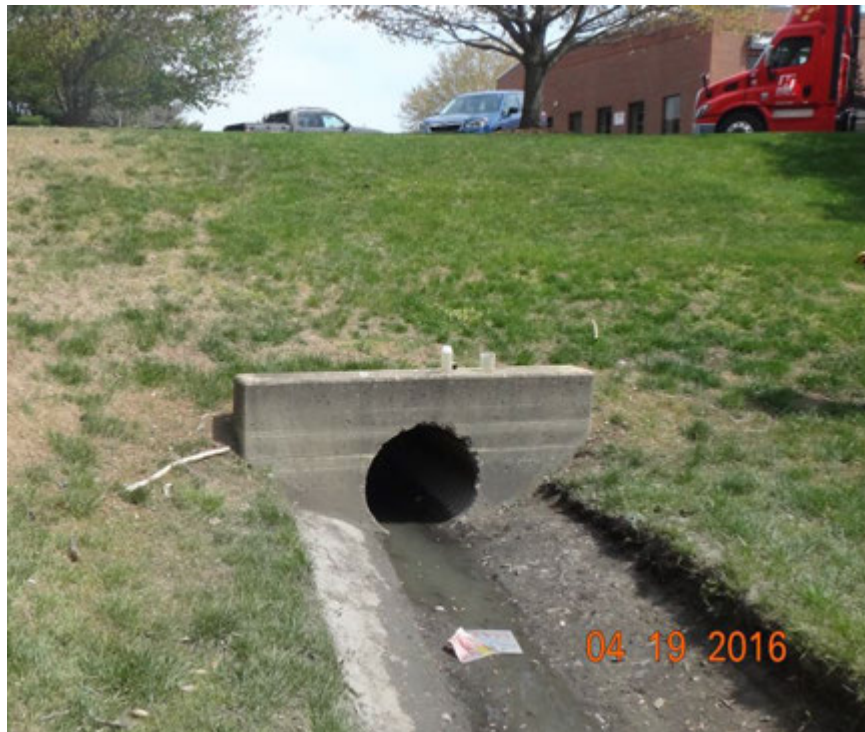
Figure 1. Outfall I19B6Onew2, showing cloudy discharge on April 19

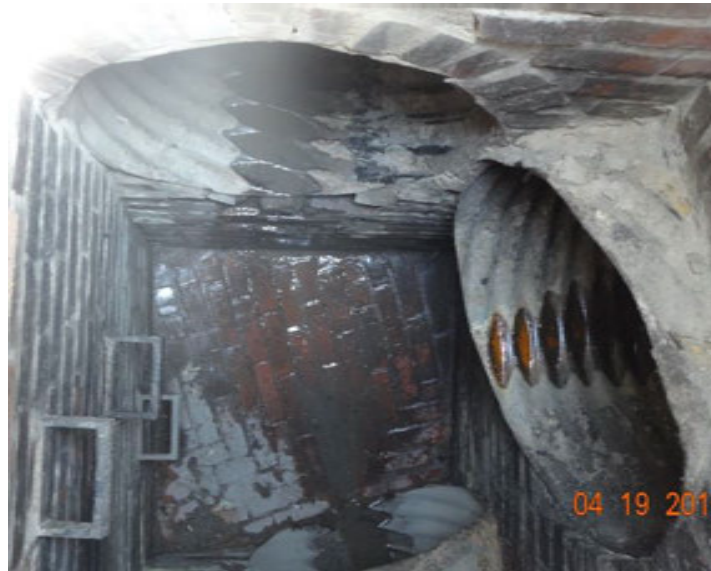
Figure 2. Flowing water observed from one of the pipes (from the east) contributing to the network, as documented from within a manhole to the east of the outfall

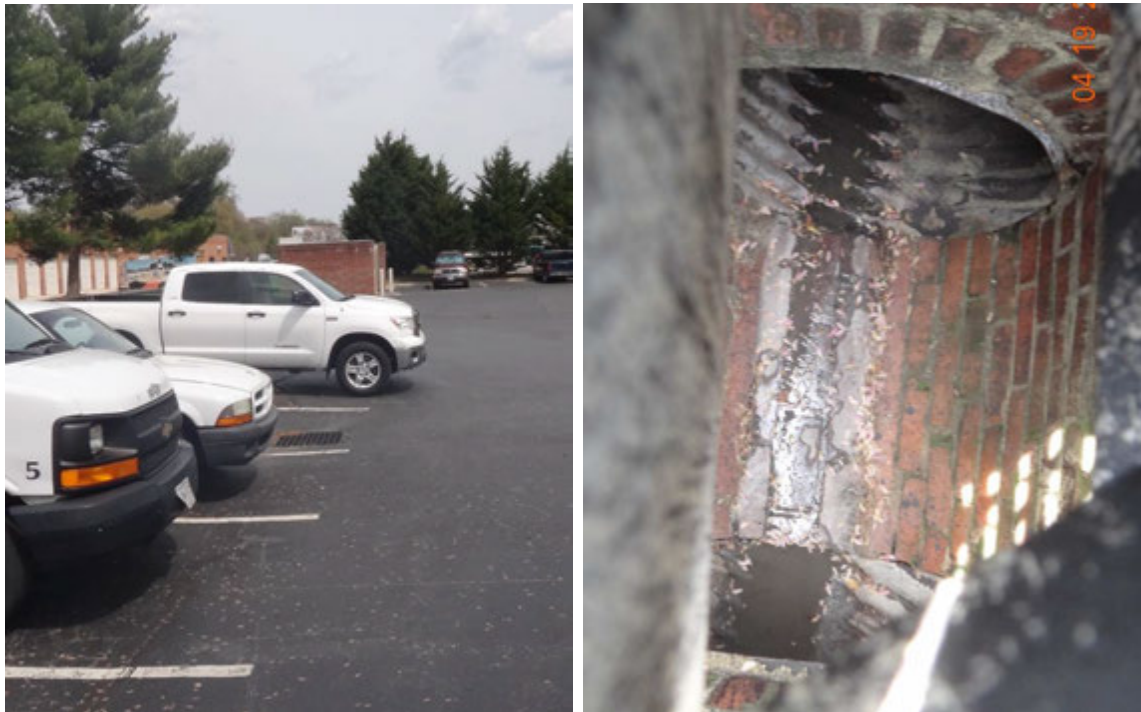
On April 19, the Versar field team inspected an outfall, I19B6Onew2, which drains the parking lot of Patuxent Materials, Inc. (Versar field crews previously visited this outfall in August 2015; this site has been previously identified as I19B6O008new1). At the 24-inch corrugated metal pipe opening of the outfall, the team observed a small amount of cloudy discharge (Figure 1). A manhole adjacent to the outfall revealed an intersection of two corrugated metal drainage pipes; the pipe on the east side exhibited slowly flowing water (Figure 2). The team collected a sample of the flowing water from the pipe to test water quality. Test results are presented in Table 1, as Test 1; the test results showed above-action-level concentrations of ammonia (10 mg/L), detergents (0.5 mg/L), and fluoride (5.0 mg/L). The team conducted a partial trackdown of a source within the drainage system on April 19. At the next access point to the east of the intersection, the team documented flowing water in the yard inlet in the parking lot, near the pass-through (Figure 3).

Figure 3. Yard grate located at the north end of the parking lot at 2124 Priest Bridge Drive showing slowly flowing discharge from the east on April 19

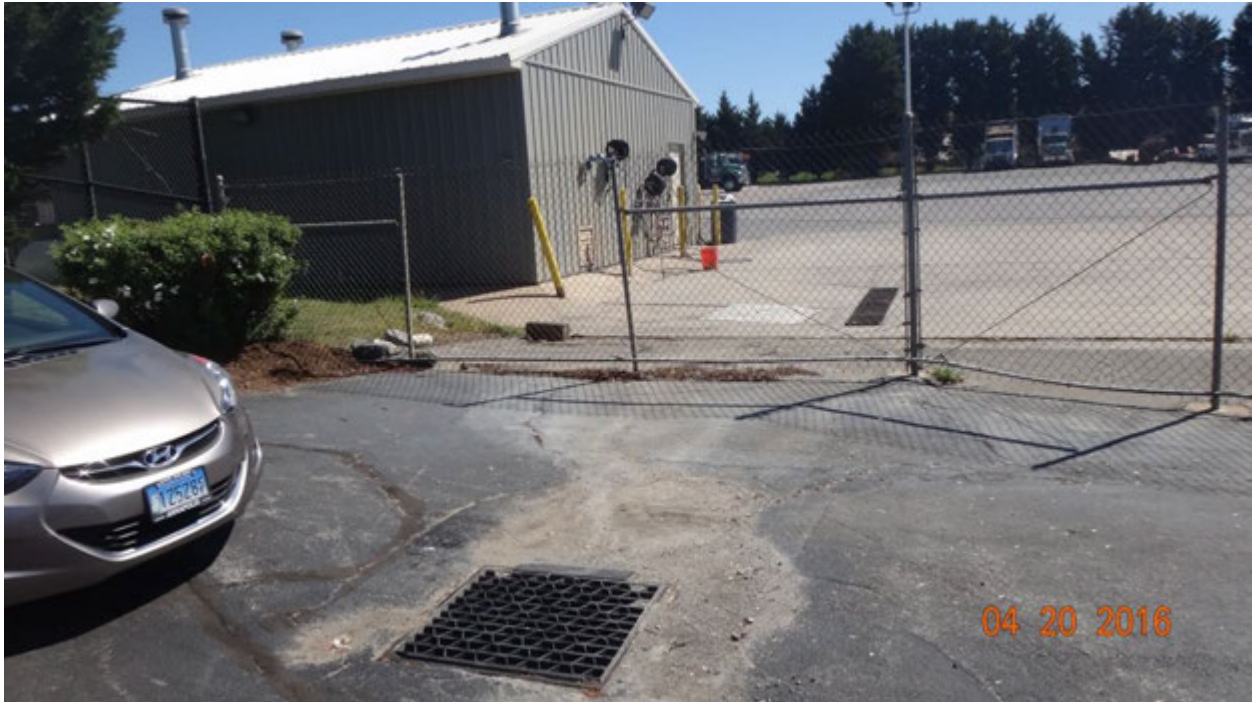
The field team did not obtain additional information which might confirm the source of the illicit discharge. The team surmised that the origin may be near the top of the drainage system leading from the area adjacent to the Patuxent Materials washdown area; the yard grates in this area were bolted or welded shut, making them difficult to sample. Evidence collected thus far suggests that the potential source may be effluent from the Patuxent Materials washdown area or associated water conveyance facilities.

Figure 4. Yard grate adjacent to the maintenance lot and washdown area associated with Patuxent Materials, Inc.; although there is evidence of flow into the grate, as suggested by the accumulated sediment, the field team did not find flowing discharge at this location on April 20

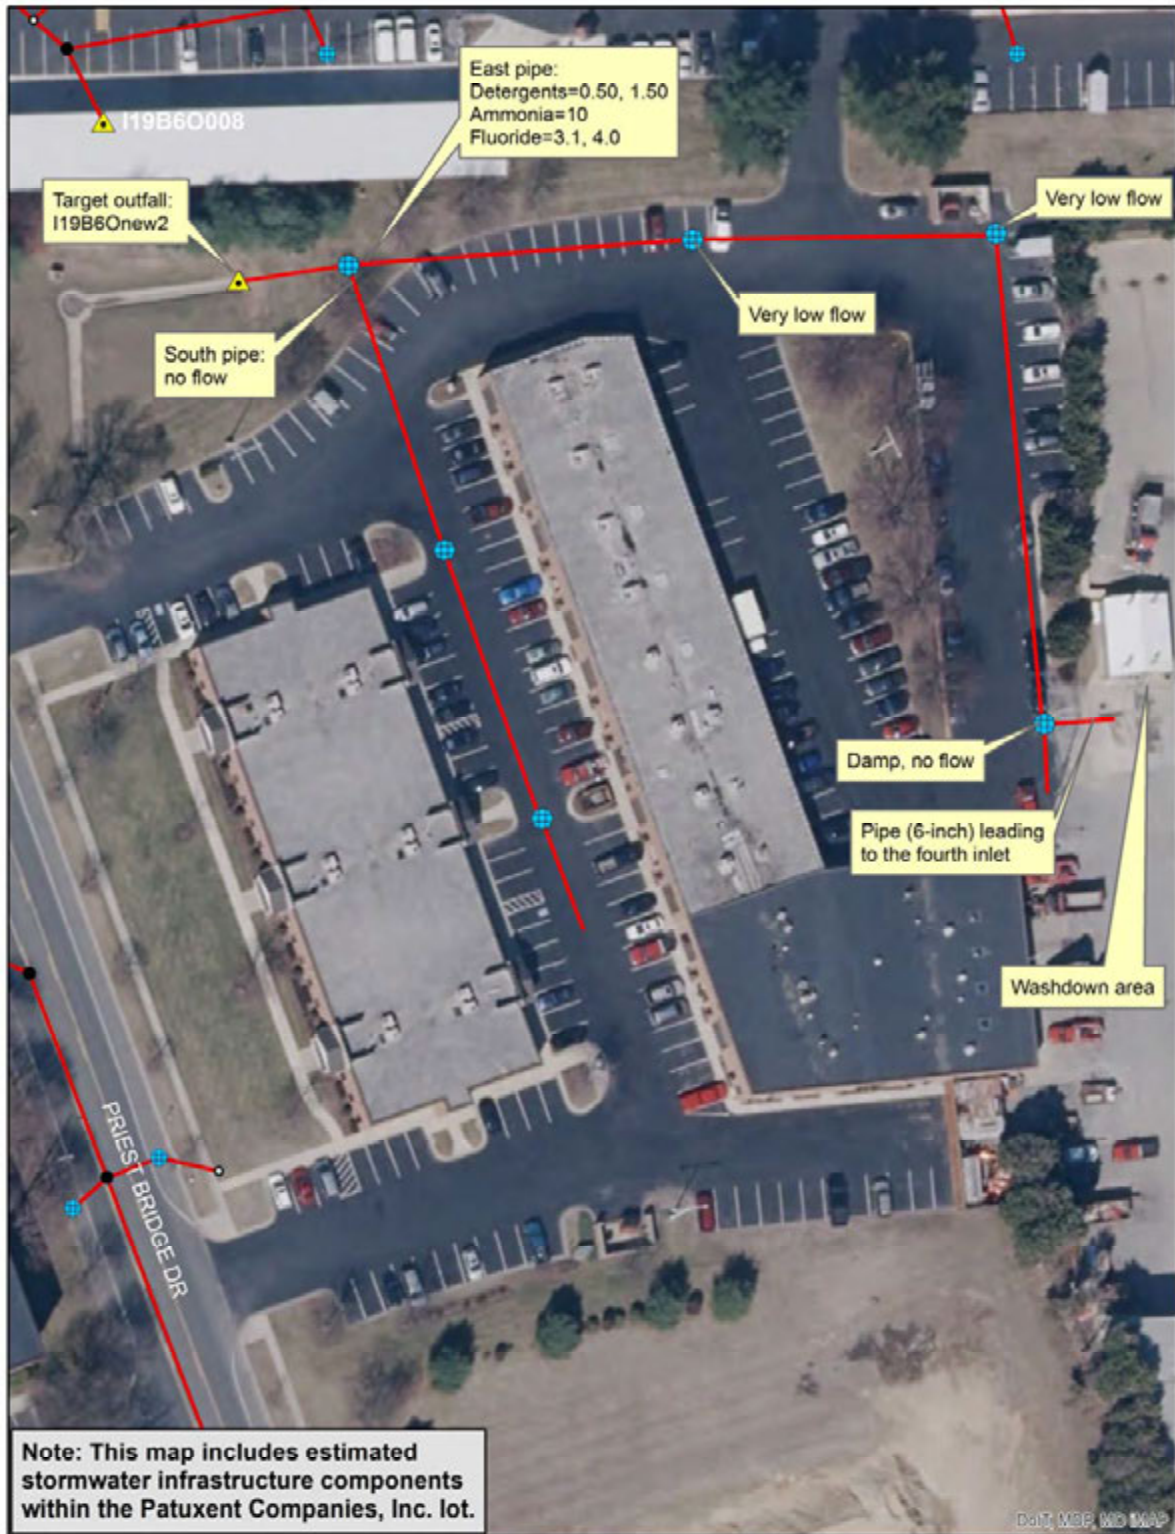
Figure 5. Area map, showing flow observations, and listing above-action-level readings for the water in the pipe from the east at the intersection

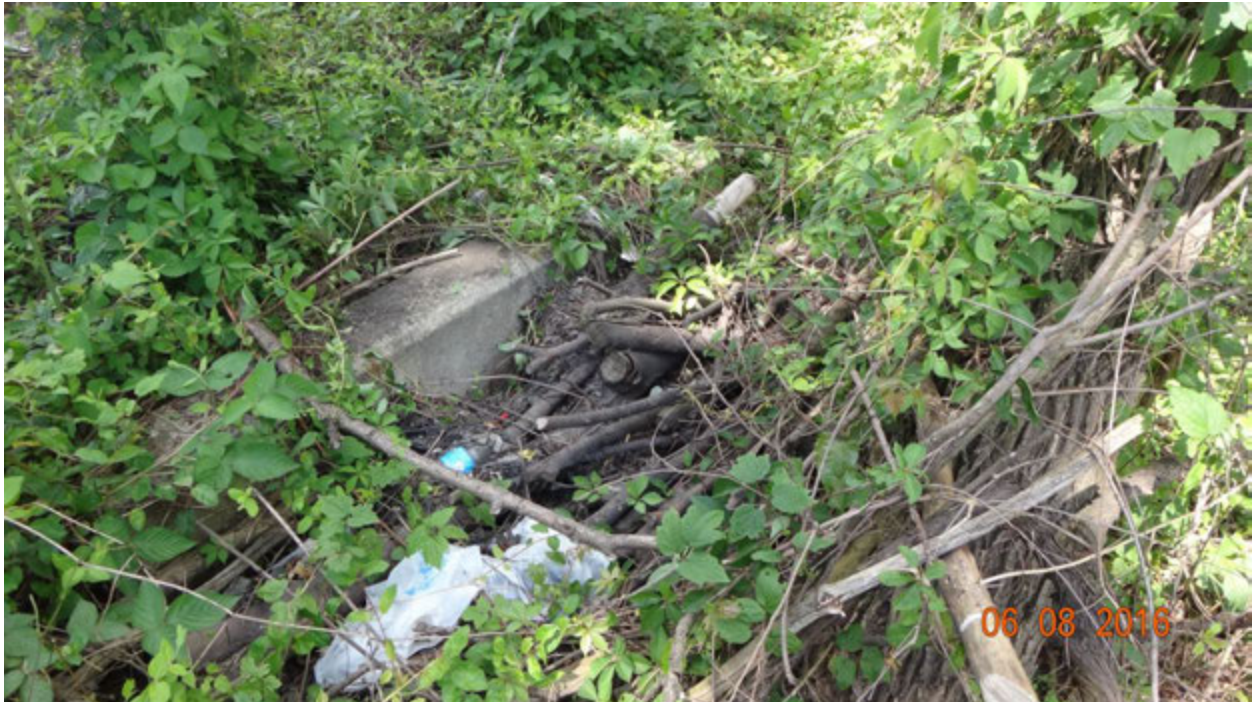
Figure 1. Outfall F09G5O001 as observed on June 8, 2016; note that cut limbs had been placed across the opening to the extent that the outfall appeared to be almost totally blocked during the field inspection
