**ANNE ARUNDEL COUNTY
ILLICIT DISCHARGE DETECTION
AND ELIMINATION
2016 ANNUAL REPORT**

PERMIT NUMBER MD0068306

FINAL: January 2017

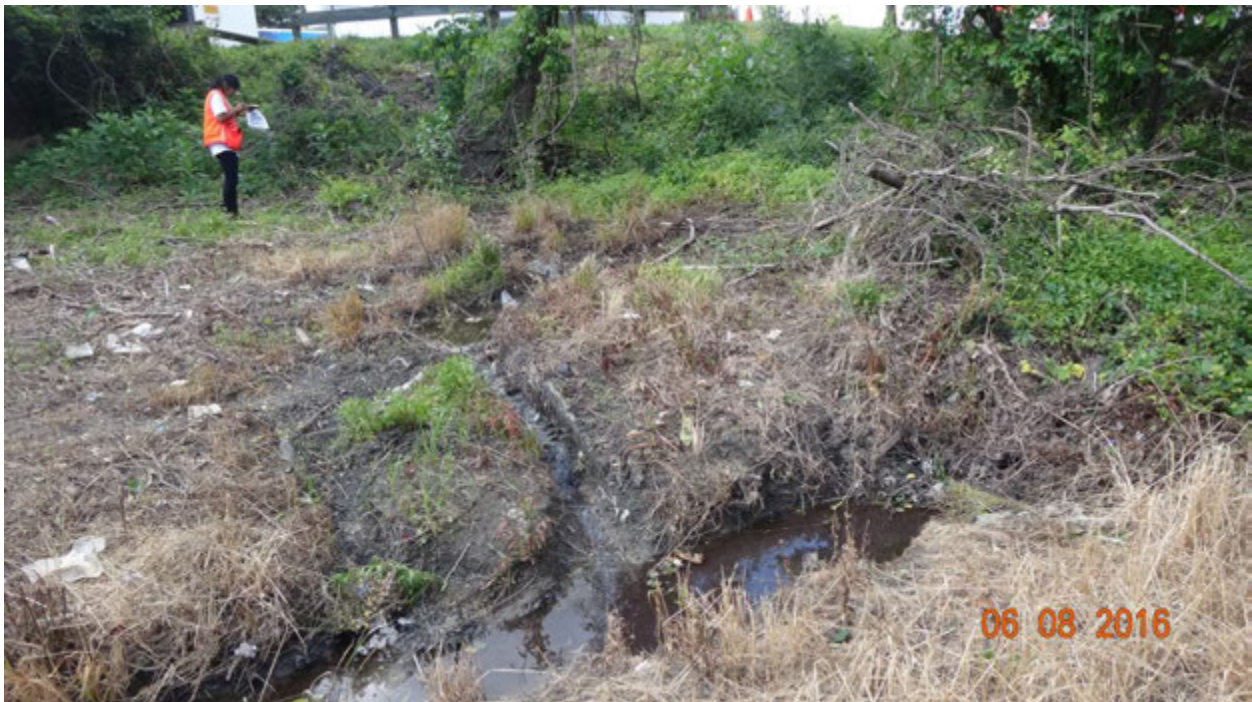
Figure 2. View showing the small stream (center) that receives and conveys flowing water from the outfall (top center, hidden from view) and the hillside adjacent to the entrance to the car wash (top left)

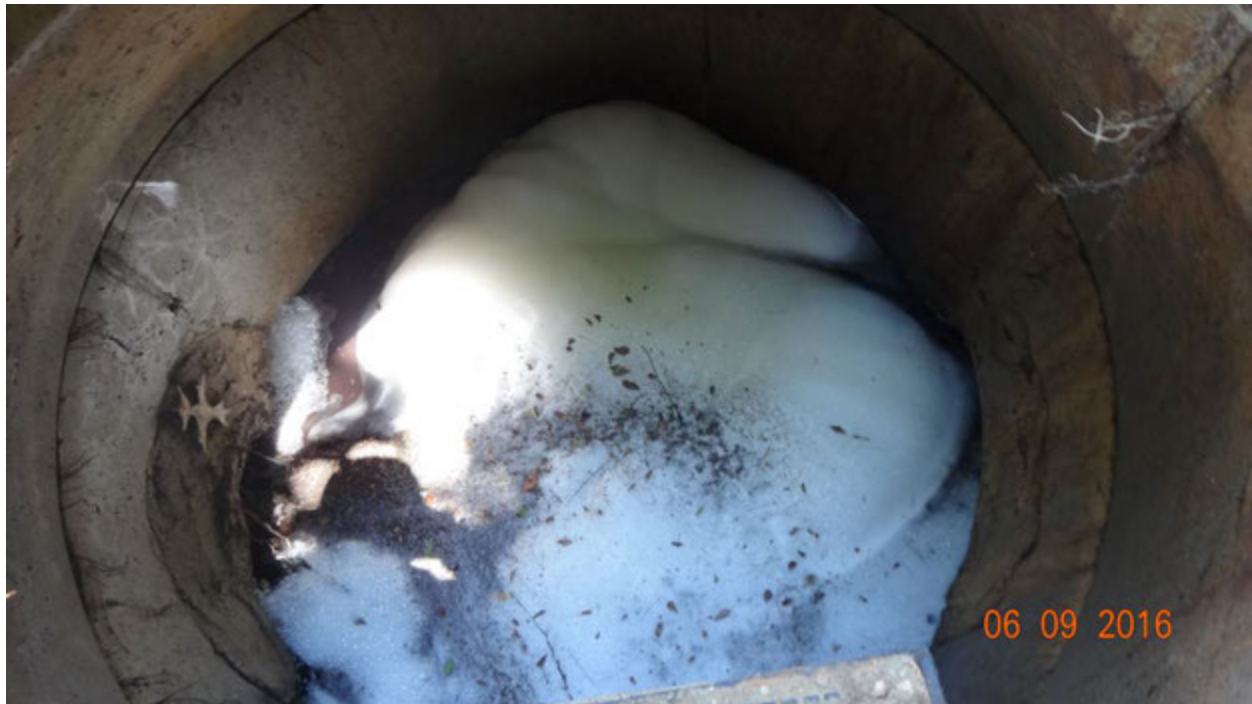
Figure 7. View of excessive suds inside the third manhole as observed on June 9

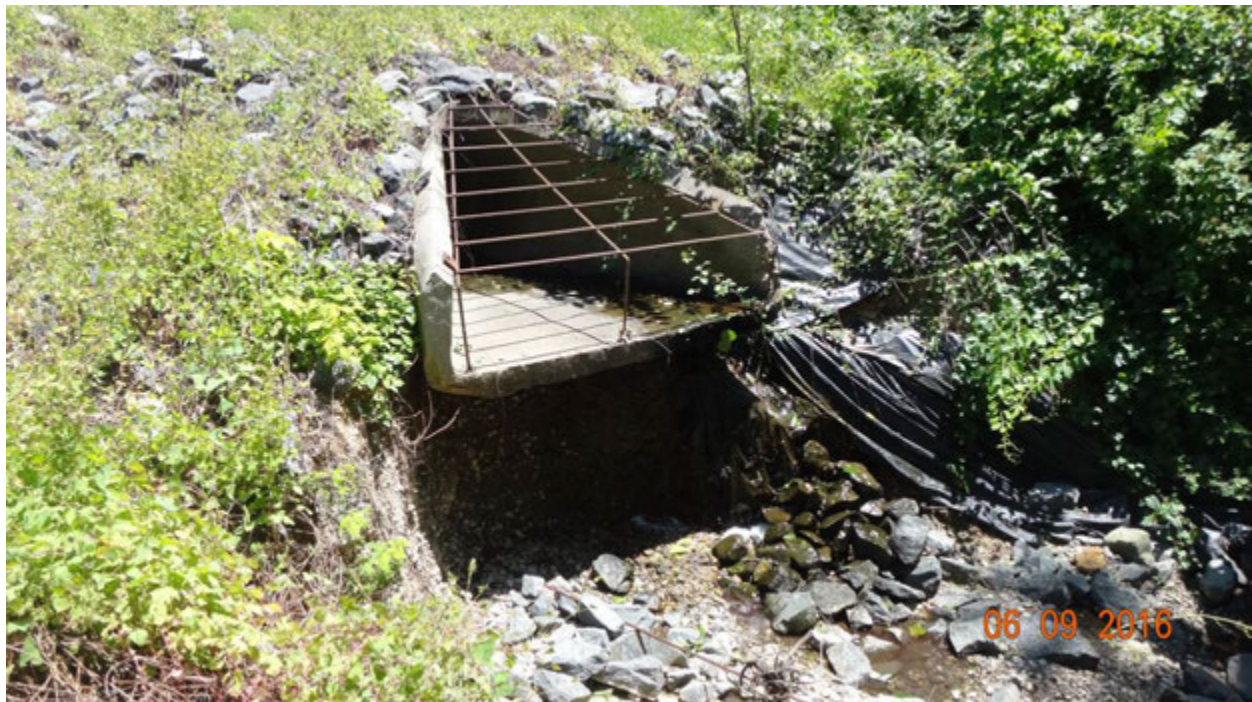
Figure 8. Flowing effluent from outfall F09F5O001, as observed on June 9, 2016; note white suds among the rocks in the plunge pool

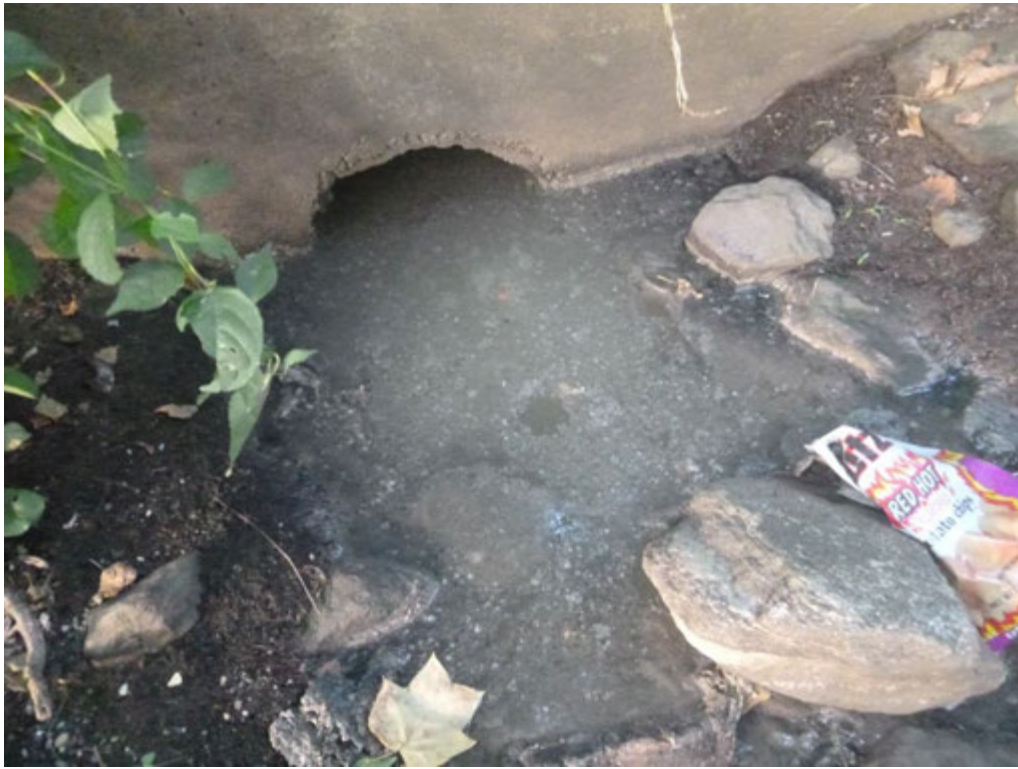
The team returned to the site on August 17 to reinspect the outfall because of a suspicion of illicit discharge due to the noxious nature of the effluent present in the outfall. The field team was able to obtain a clearer sample of water and performed chemical tests, which resulted in failure of the outfall due to unacceptable levels of detergents, ammonia, and pH (Table 1). The team could not perform a trackdown of the source of the flow because the material placed on top of the inlet access prevented inspection of the inlet and catch basin for straight pipe connections and tracking of the flow leading to the outfall. An area map is provided in Figure 3.

Figure 1. Outfall with turbid flow, August 17, 2015

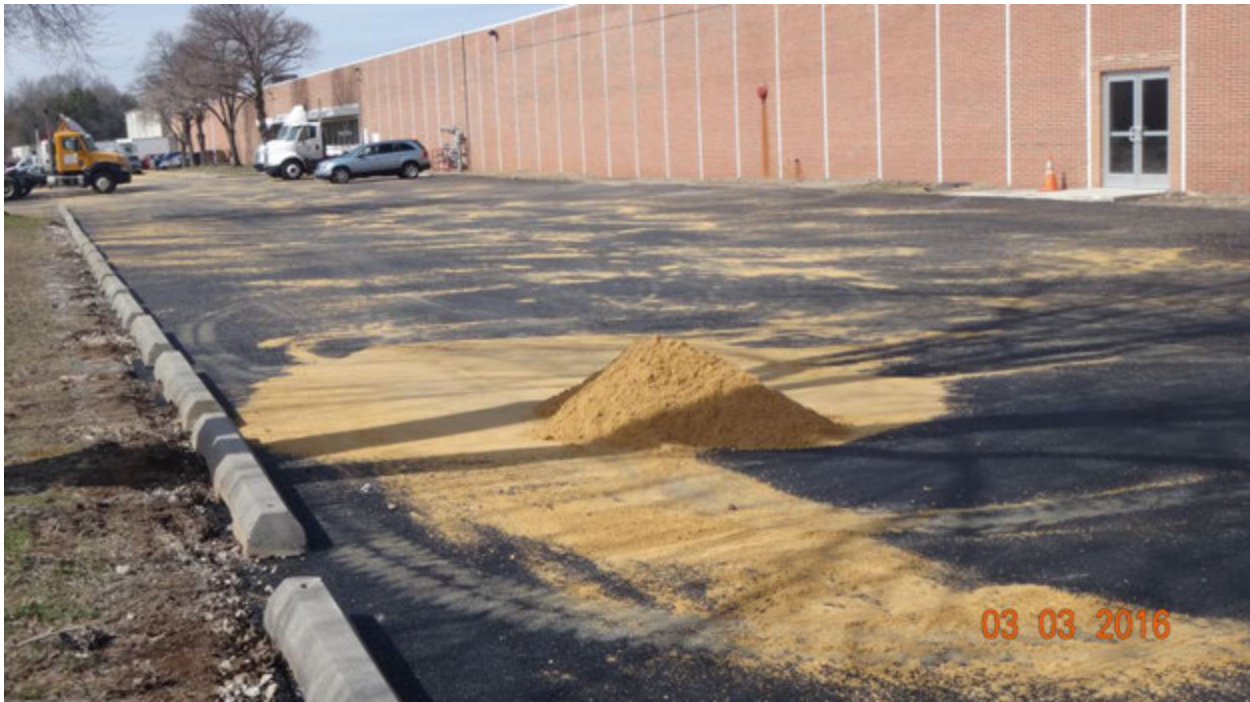
A Versar field team investigated the site of a paving operation along the front of the long warehouse on the right side of Midway Road (1710) and found two piles of material deposited on impervious surfaces near the paving area. The team found a pile of sand in the southeast corner of the parking lot (Figure 1). There was evidence that vehicles had dispersed some of the sand throughout the parking lot. The team also found a pile of crushed concrete along the edge of the cul-de-sac of Midway Road (Figure 2). The location of this material presents more of a concern than the sand because there is a grated storm drain inlet downgrade of the cement (Figure 3). The team noted that tire tracks on the ground above the inlet imply that trucks may be using this area for turning or backing into the warehouse docks, and thus routinely disturbing the soil immediately adjacent to the storm inlet (Figure 4). Team members photo-documented the relative location of the concrete to the inlet (Figure 5). The Versar team surmised that if paving crews were still active in the area (Figure 6), these materials may yet be removed, in due course of company business on the site; however, the proximity of the concrete to the storm inlet, and the potential of uninhibited concrete particles entering the storm drain after disturbance from routine heavy truck maneuvers at the site, denote a significant concern. Lighter particles of concrete, and the component materials (including the possibility of lead), may also enter the storm drain with rain and wind events. An area map, indicating the locations of the two piles of material and the storm drain inlet, is provided in Figure 7.

Figure 1. A pile of sand found in the warehouse parking lot on March 3 (foreground); note that the sand had also been distributed throughout the parking lot (background)

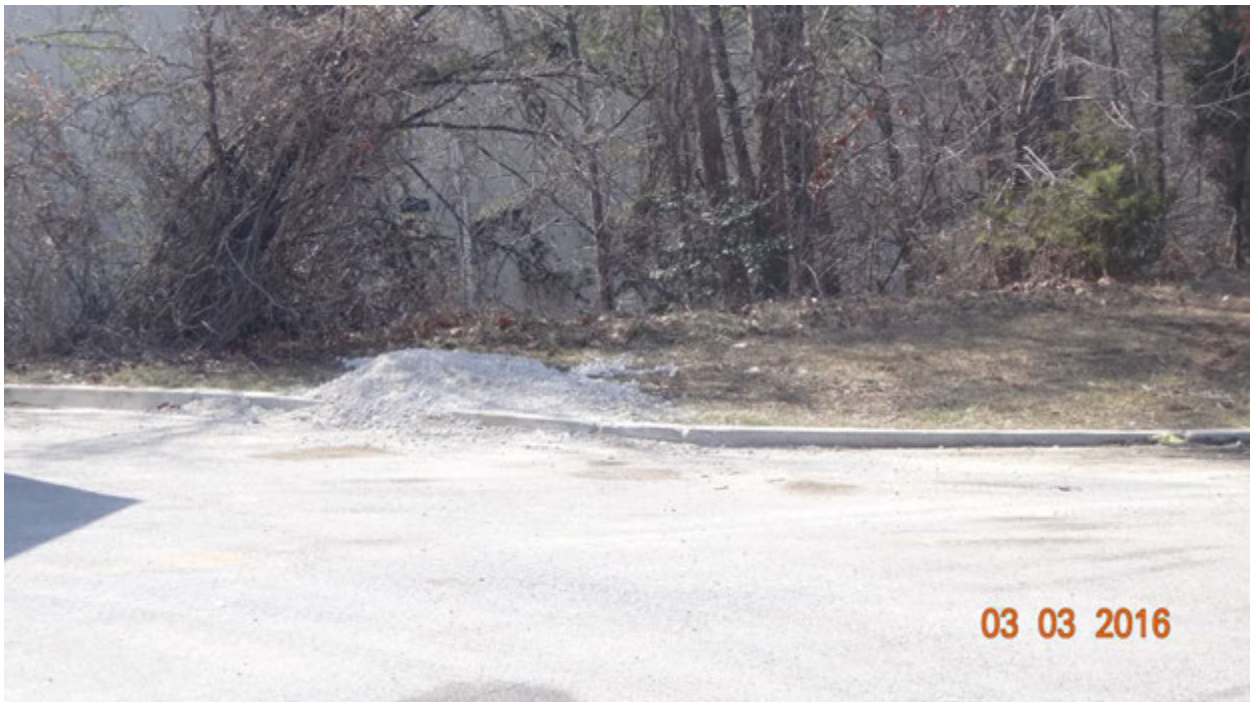
Figure 2. A pile of crushed concrete found along the cul-de-sac of Midway Road on March 3

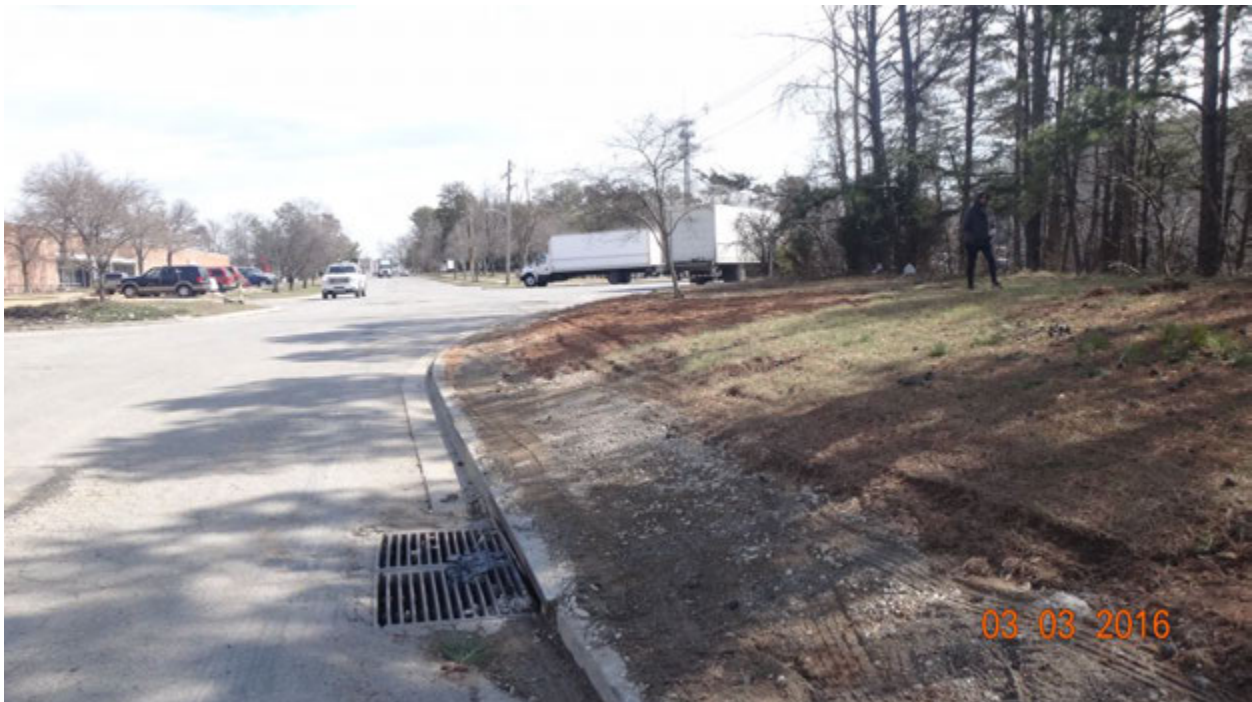
Figure 4. A photograph of the storm drain inlet to the west of the cul-de-sac of Midway Road, as seen facing east-southeast; note the tire tracks on the ground above the inlet and toward the cul-de-sac

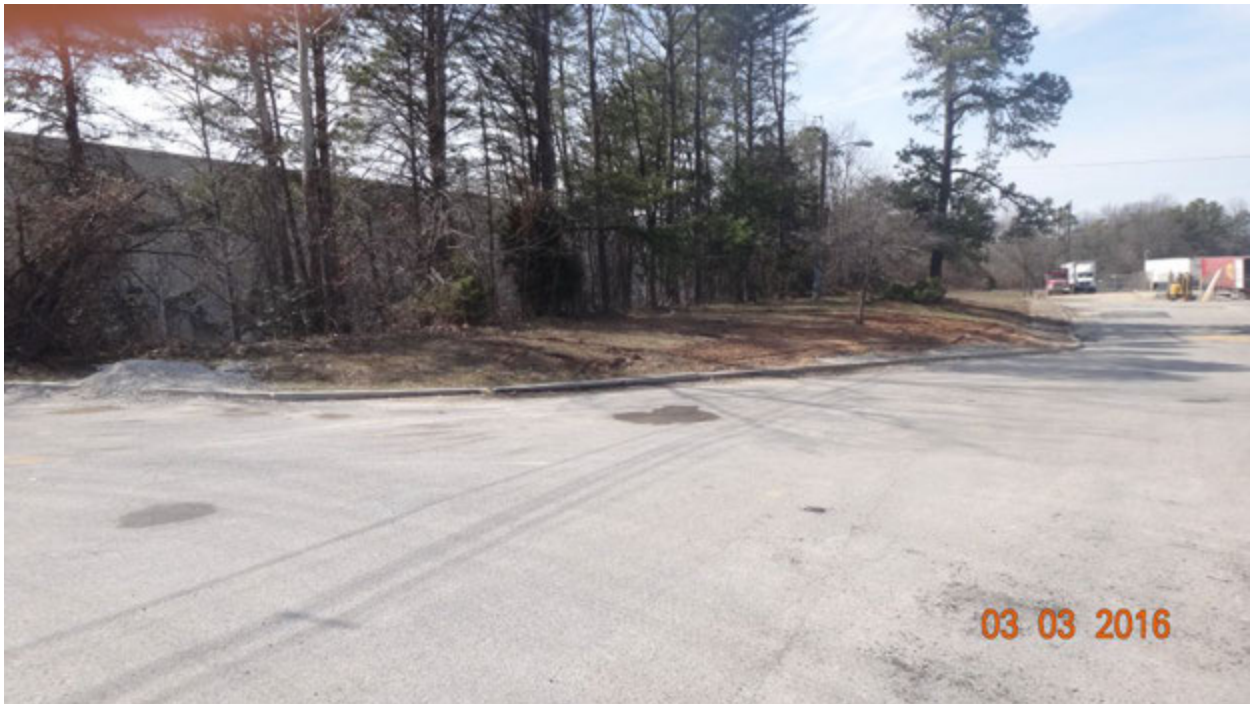
Figure 5. A photograph showing the relative locations of the crushed cement (left) and the storm drain inlet (right); also refer to Figures 3 and 4 for a more detailed depiction of the inlet's location

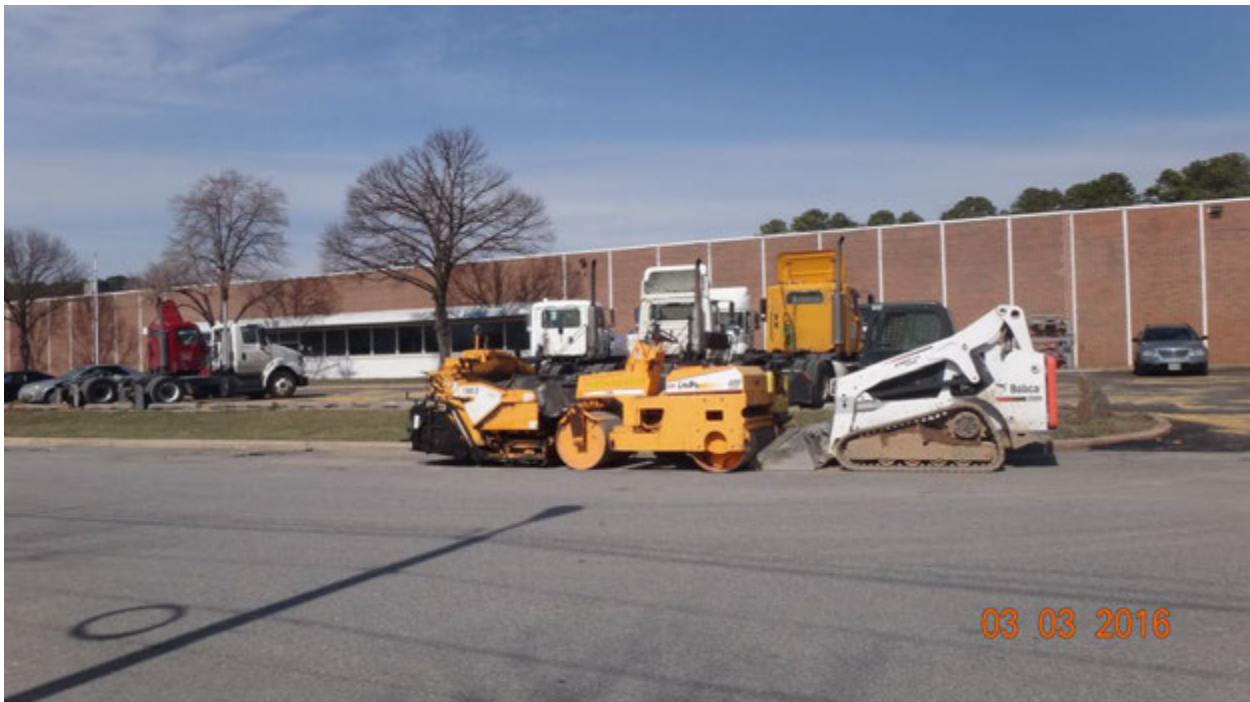
Figure 6. A photograph showing some of the evidence that paving crews may still be active in the vicinity

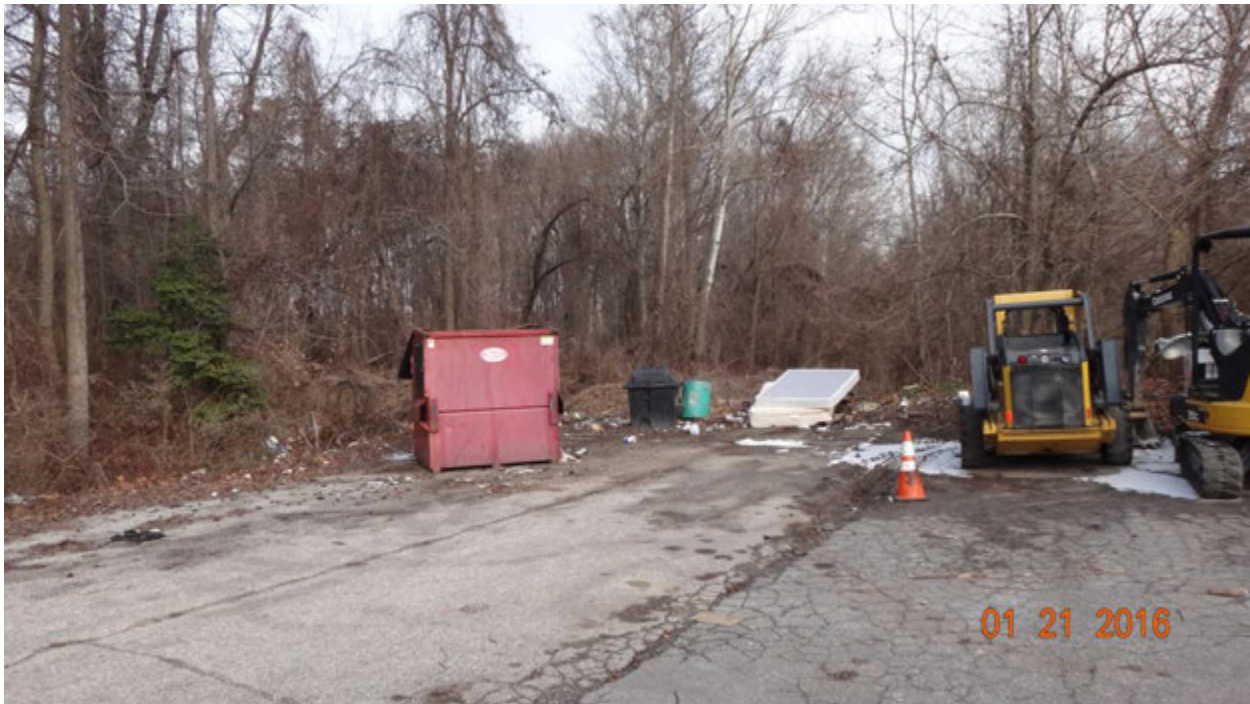
While investigating outfalls in the Odenton, MD, area, a Versar field team found evidence of inadequate waste management in a shared parking lot behind businesses at 1584 and 1586 Annapolis Road, in Odenton. Several businesses occupy the building at 1584, so the field team could not determine which organization(s) may have been responsible for the debris. In the northeast corner of the parking lot, generally behind the building at 1586, the field team found an open dumpster and large debris, including a mattress and box spring, a kitchen grease receptacle, and a weather-worn plastic barrel (Figures 1 and 2). The field team found the area around the open dumpster littered with debris (Figure 3). An area map, indicating the general location of the dumpster and debris, is provided in Figure 4.

Figure 1. Photograph of the open dumpster and large debris discarded in the northeast corner of the parking lot

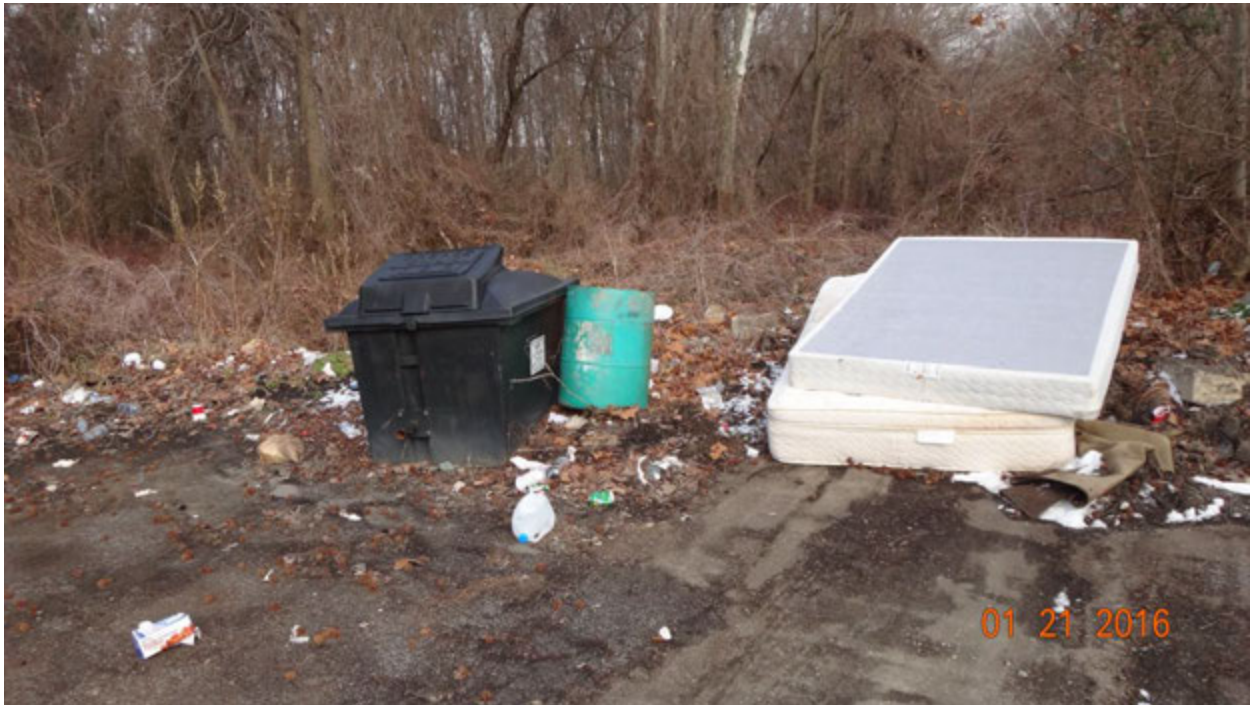
Figure 2. Large debris, including a mattress set, a kitchen grease waste receptacle, and an unmarked plastic barrel, along with an excessive amount of loose debris at the edge of the woods in the corner of the parking lot

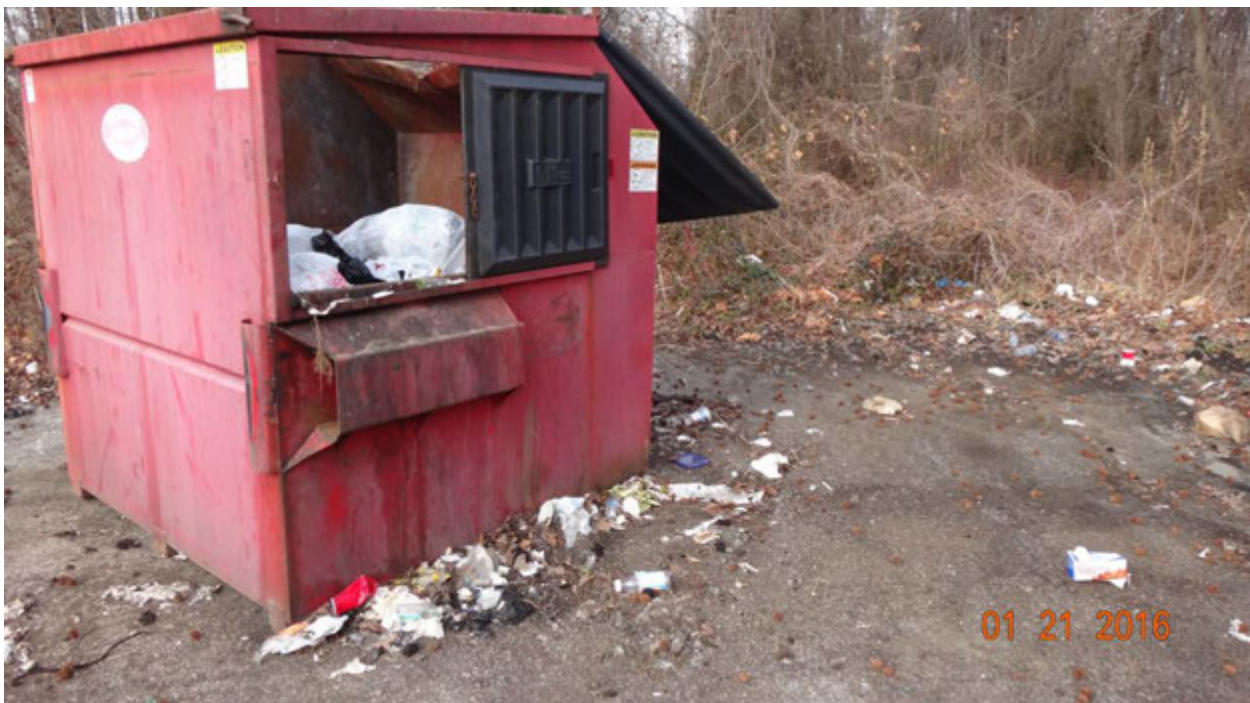
Figure 3. Detail of the littered conditions on and around the open dumpster

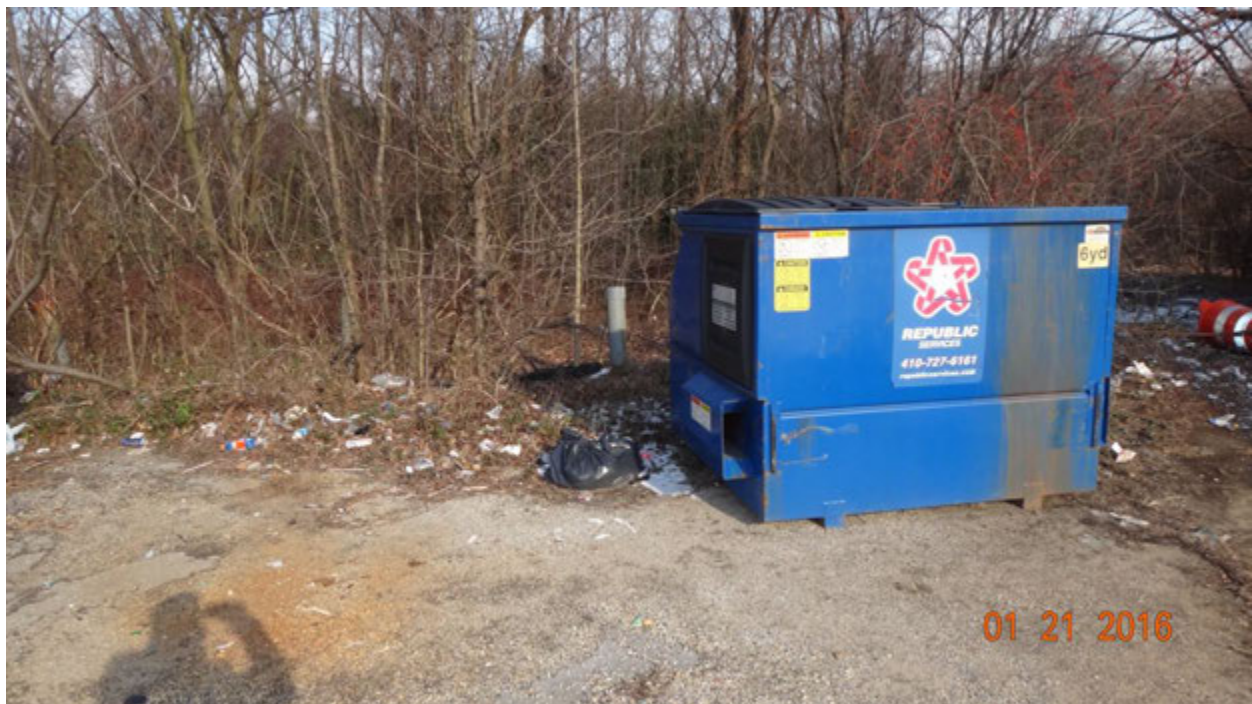
While investigating outfalls in the Odenton, MD, area, a Versar field team found evidence of inadequate waste management in an apparently vacant lot adjacent to 1604 Annapolis Road, in Odenton. The lot at 1604 is occupied by a BP gas station; at the time of the site visit, the field team could not determine if the activities on the vacant lot were associated with the BP station facility. The field team noted that the U-Haul truck parked on the vacant lot appeared to be for rent. In the vacant lot, the field team found an open dumpster and excessive debris (Figure 1), including a tire (Figure 2), and traffic cones (Figures 1 and 3). An area map, indicating the general location of the dumpster, is provided in Figure 4.

Figure 1. Photograph of the open dumpster and excess debris discarded along the edge of the woods; note the orange traffic cone on the right

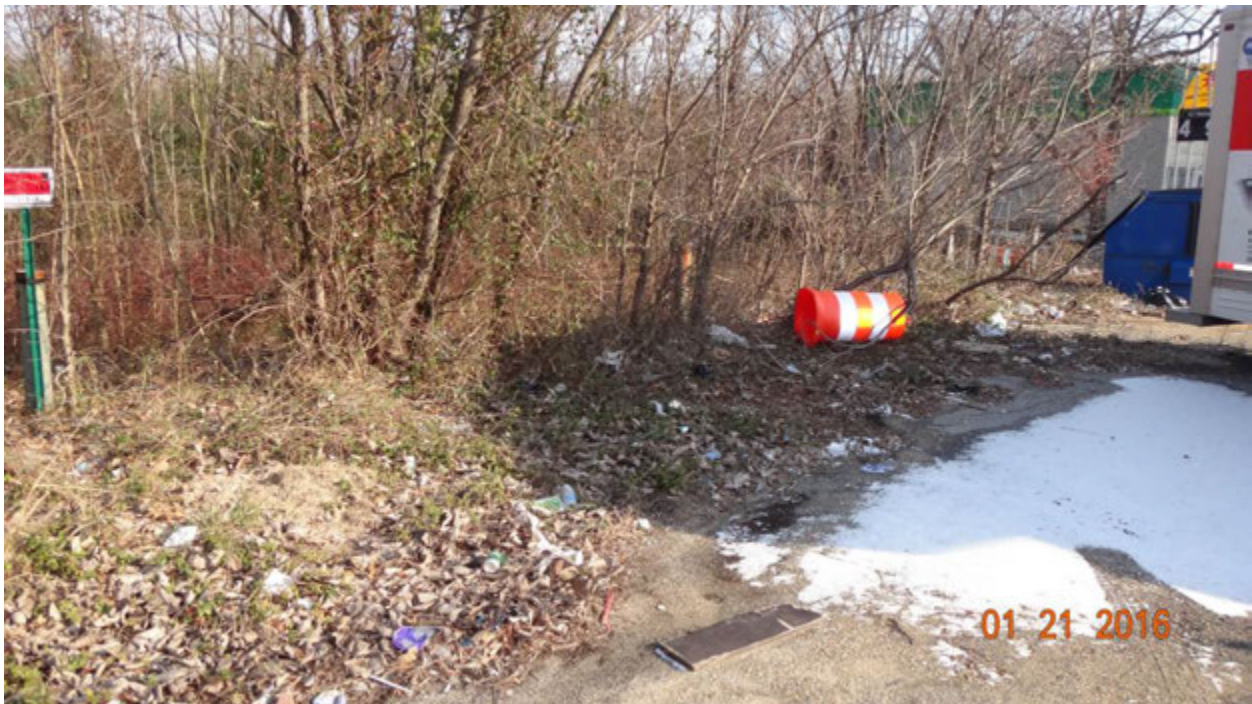
Figure 3. Debris found scattered along the edge of the woods near the open dumpster; note the second orange traffic cone and the rear corner of a U-Haul truck parked on the vacant lot (right)

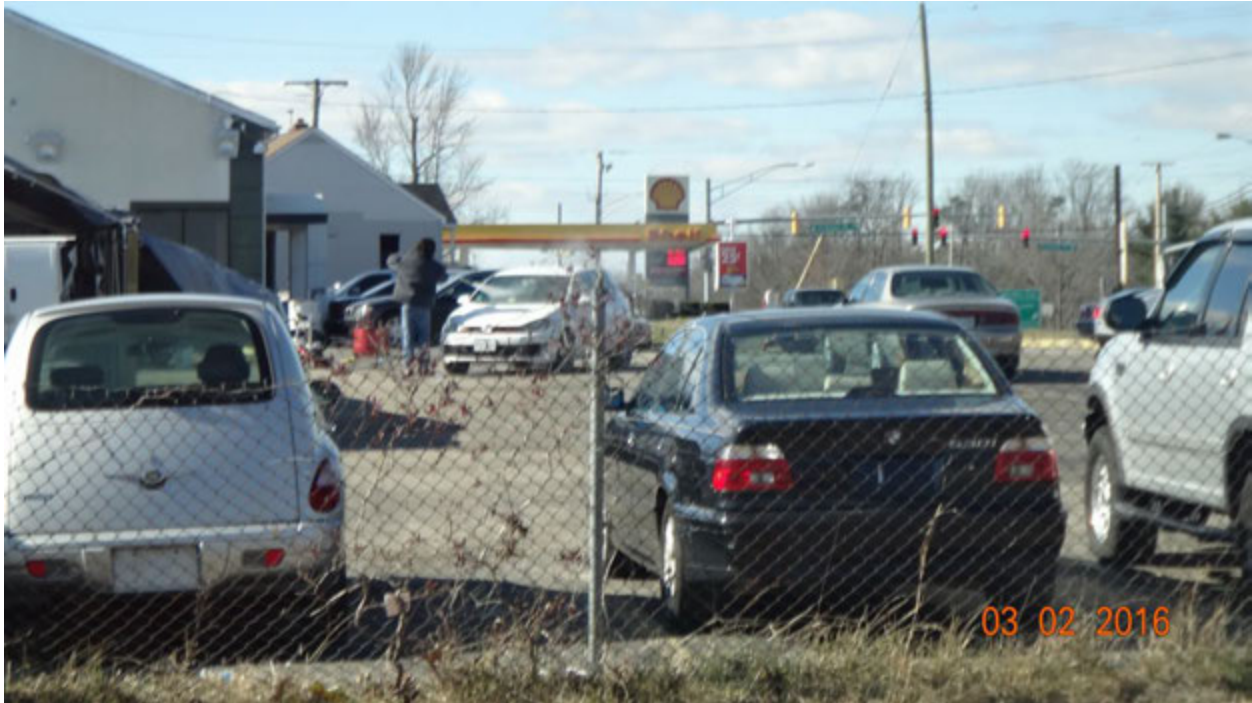
In the middle of the afternoon of Wednesday, March 2, a Versar field team observed possibly improper vehicle washing activity in the parking lot of the Baltimore Washington Auto Outlet business at the above address. The business activities include used car sales and auto detailing services; a sign advertises hand washing and detailing services for vehicles. When the field crew approached the lot, crew members witnessed an employee from the business power-washing a white hatchback vehicle in the parking lot (Figure 1). Field team noted that there was a tarp covering an open structure on the southeast side of the building; the crew surmised that this may have been intended as a temporary cover for vehicle-washing activities, as would be appropriate. While the field crew members photo-documented the activities, the business employee proceeded to use a sponge from a bucket of liquid to scrub the vehicle (Figure 2). Later, as the first employee began to work inside the white vehicle, a second employee began to power-wash another vehicle – a beige SUV (Figure 3).

Figure 1. Business employee observed power-washing a vehicle (white hatchback) in the parking lot; note the tarp covering an open structure on the far left of the photograph

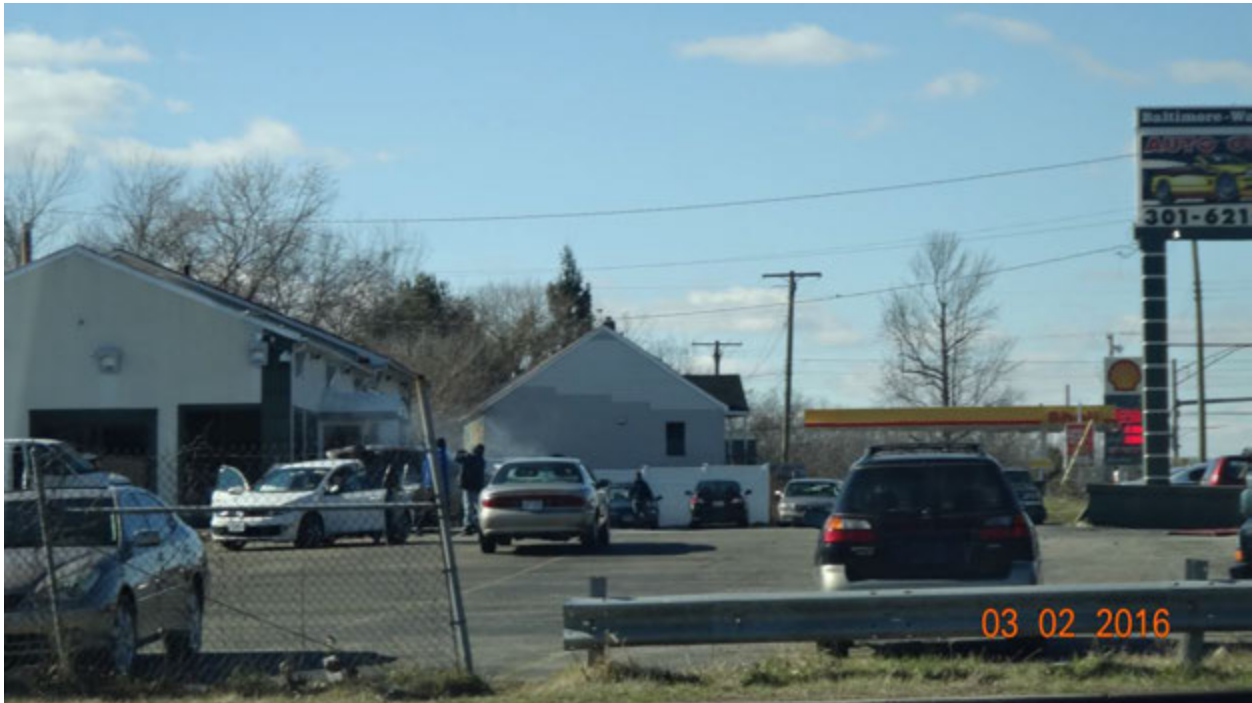
Figure 3. Photograph showing one business employee attending to the first washed vehicle (white) while a second employee starts to power-wash another vehicle (beige) in the parking lot

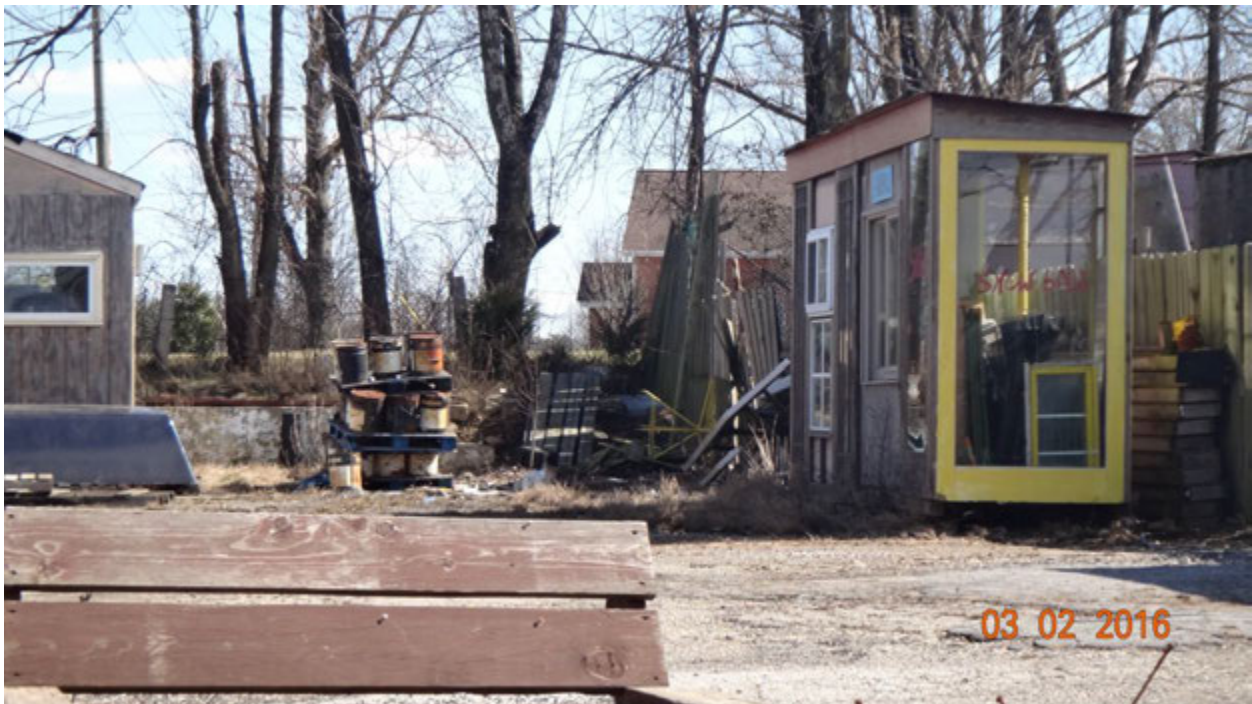
Figure 3. Photograph of the collection of buckets, possibly containing roofing compounds, stored on one of the lots (three tiers high, center left)

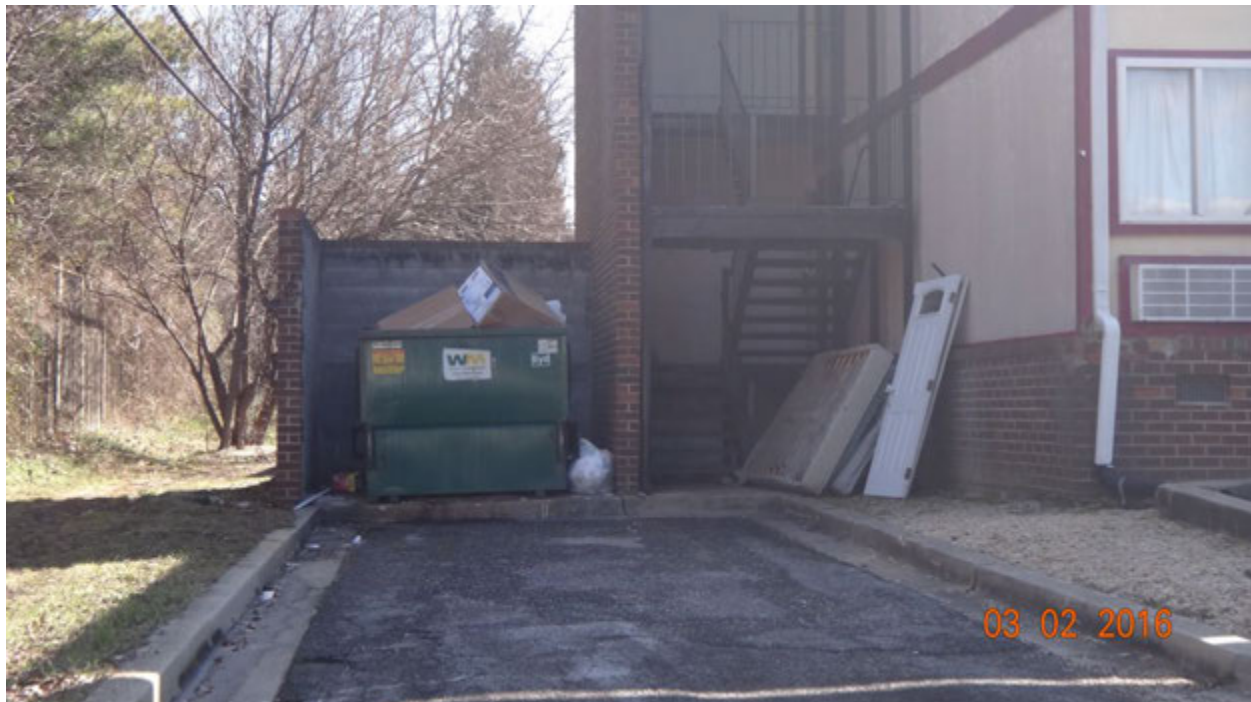
A Versar field team found an open, overfilled dumpster with debris scattered around it on the north side of the Red Crown Inn at the above address (Figure 1). Near the dumpster, the crew noted several large pieces of debris (including a mattress, a box spring, and a door) stored alongside the building. These items were stored immediately adjacent to the stairwell, and thus may pose a danger to hotel guests or emergency response crews in the event of an emergency. Discarded items and surplus material of this type should be temporarily stored in secure, closed containers, preferably under shelter. Without these safeguards, some of the loose debris in the dumpster may blow off-site and into the storm drain system. Debris on the ground may be carried by wind or water to nearby storm drain inlets; it may also leak potentially contaminating contents onto surfaces that could also lead to nearby storm drain inlets or open water. Some debris may also attract pests to the site. An area map, indicating the location of the dumpster, is provided in Figure 3. The aerial photo indicates that trash may be blowing offsite to the north.

Figure 1. An open, overfilled dumpster with debris scattered around it found near the Red Crown Inn on March 2; note the large debris stored alongside the building, near the stairwell

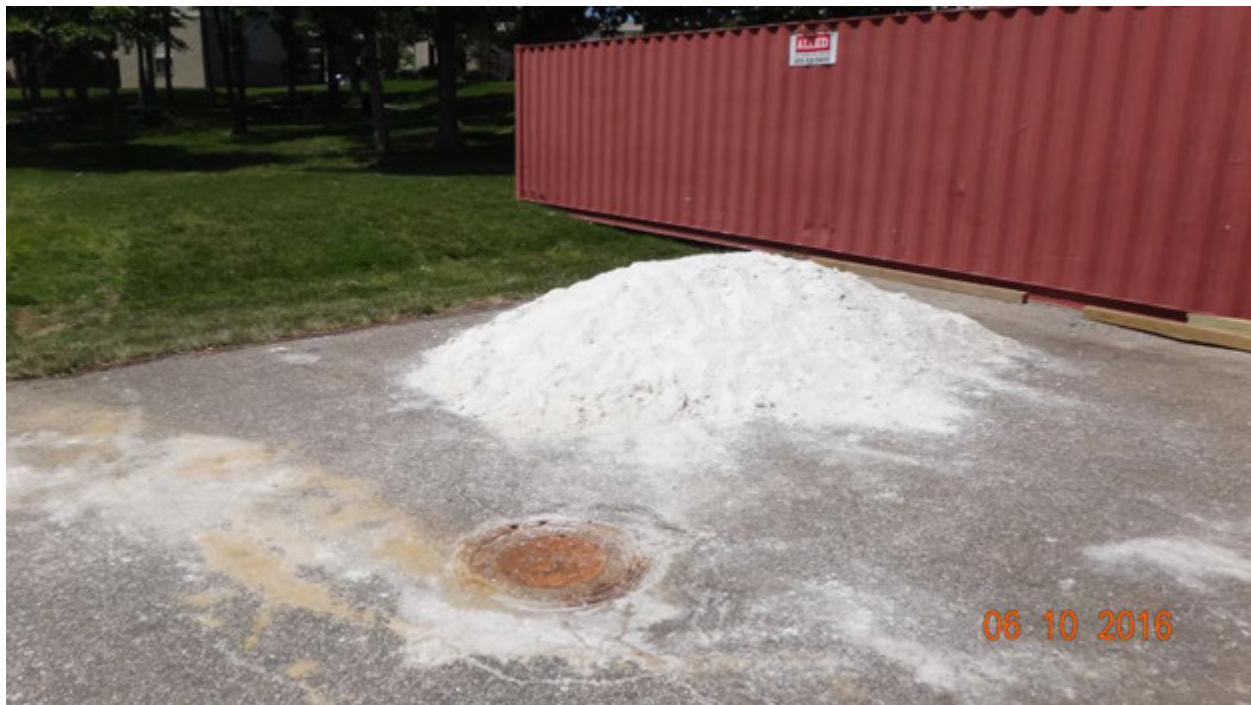
A Versar field team discovered what appeared to be a large pile of road de-icing salt in a parking lot in the Ashley Apartments complex between Andrew Court and Red Clay Road, to the northwest of the lot at 3452 Andrew Court. At the time of the site visit, the pile was uncovered, and located immediately adjacent to a manhole (Figure 1). The field crew documented a line of residue leading from the area of the pile toward the manhole and extending to the edge of the parking lot leading to a yard drain (Figure 2). As the yard drain is not depicted in the County's GIS data sets of stormwater infrastructure, the fate of material entering this device could not be ascertained. The placement of salt on an impervious surface introduces the risk of distribution of salt particles and associated nutrients – by wind, rain, or physical disturbance – which could then be carried via stormwater runoff into adjacent storm drain inlets or open water. An area map is provided in Figure 3.

Figure 1. A large, uncovered pile of road de-icing salt found on June 10; note the line of residue leading to the manhole cover and extending to the edge of the parking lot (left)

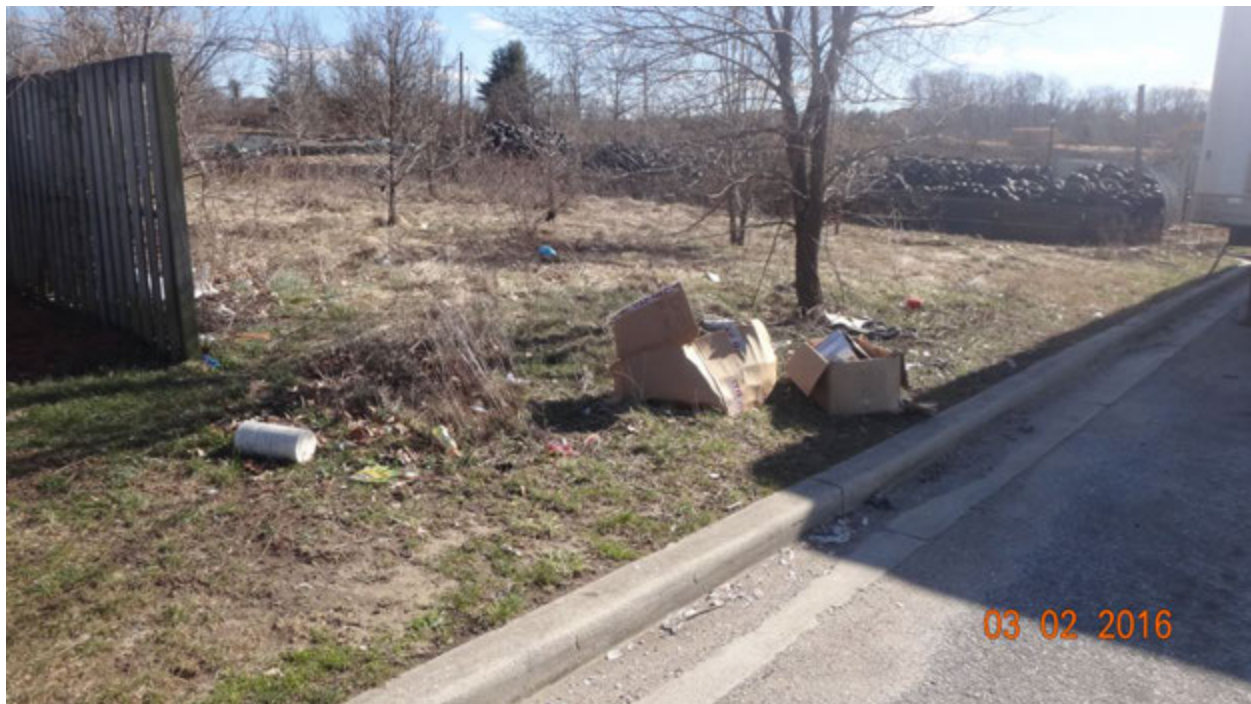
Figure 1. Dirt in gutter pan and discarded cardboard boxes on vacant lot, east side of access road

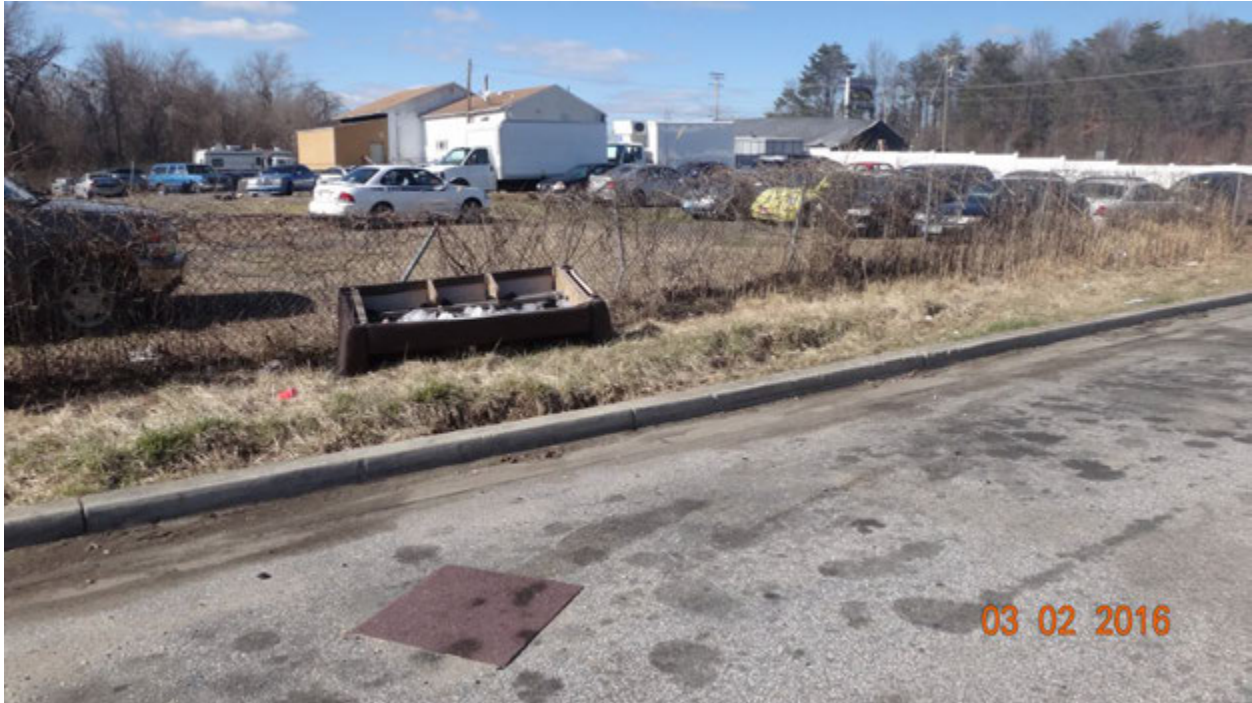
Figure 2. Discarded bulk item, and stains and material in roadway, west side of access road

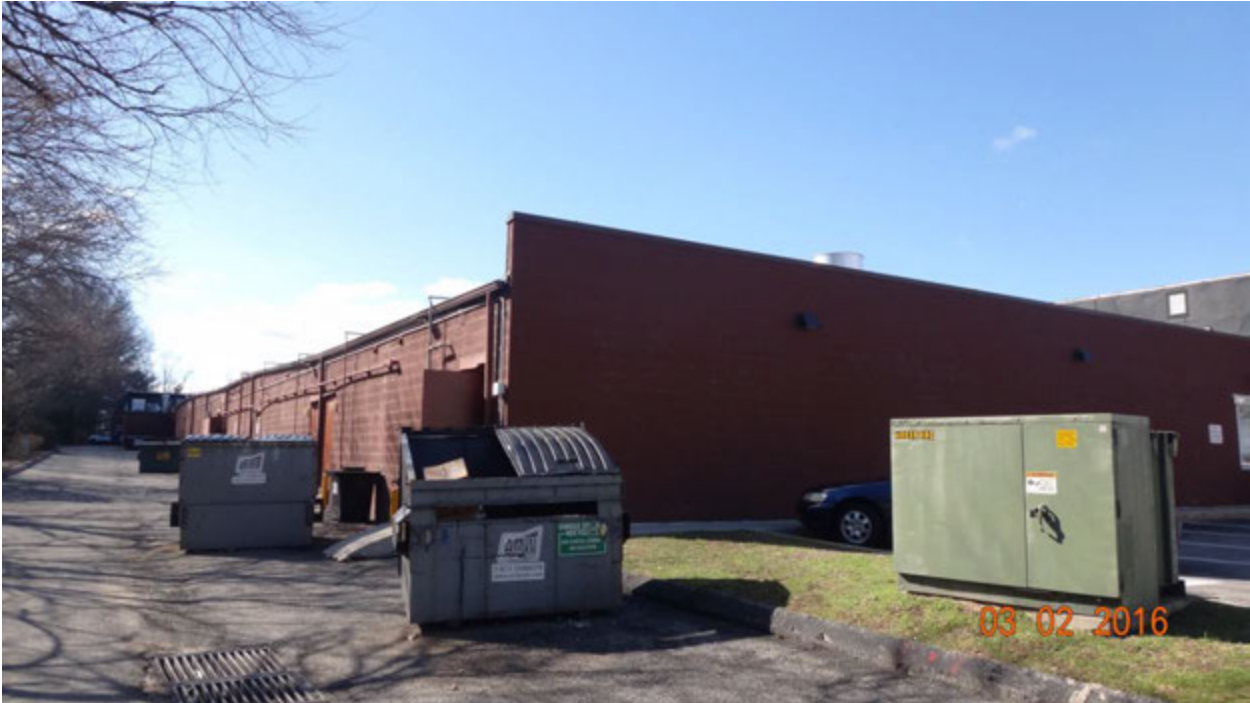
Figure 2. Open dumpster found near storm drain

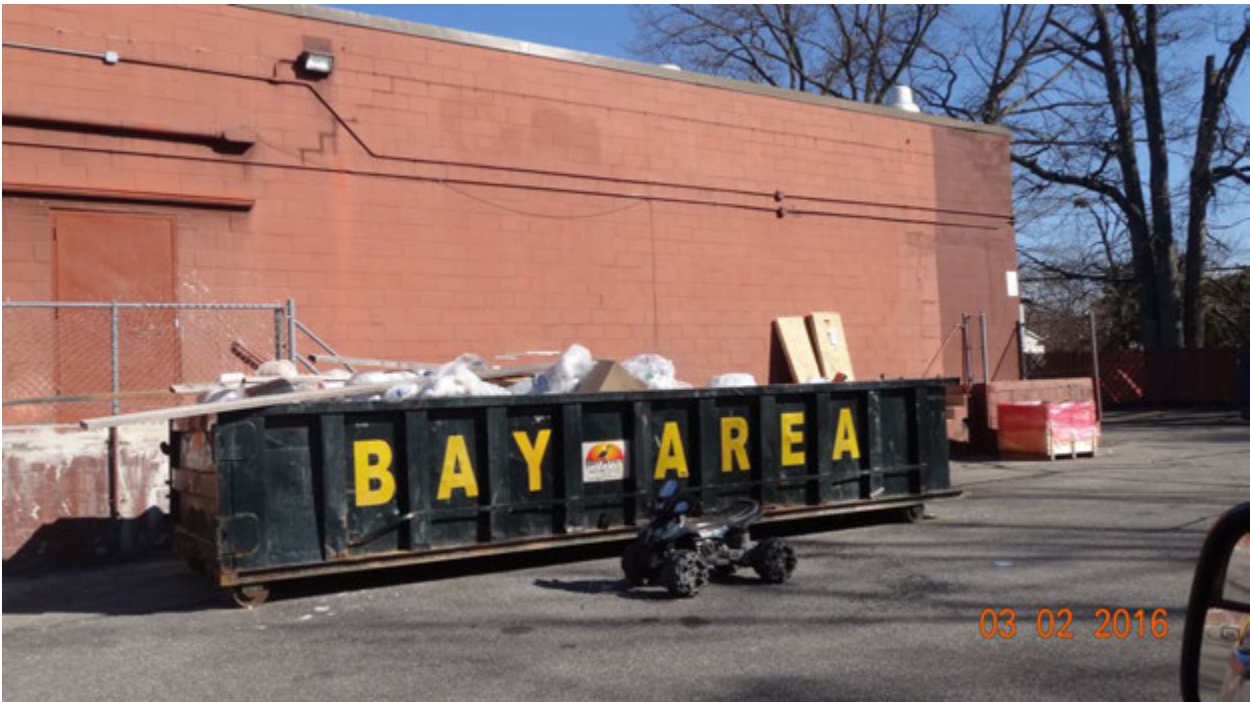
Figure 3. A nearly full roll-off dumpster found behind businesses adjacent to Aaron's Rentals
