**ANNE ARUNDEL COUNTY
ILLICIT DISCHARGE DETECTION
AND ELIMINATION
2016 ANNUAL REPORT**

PERMIT NUMBER MD0068306

FINAL: January 2017

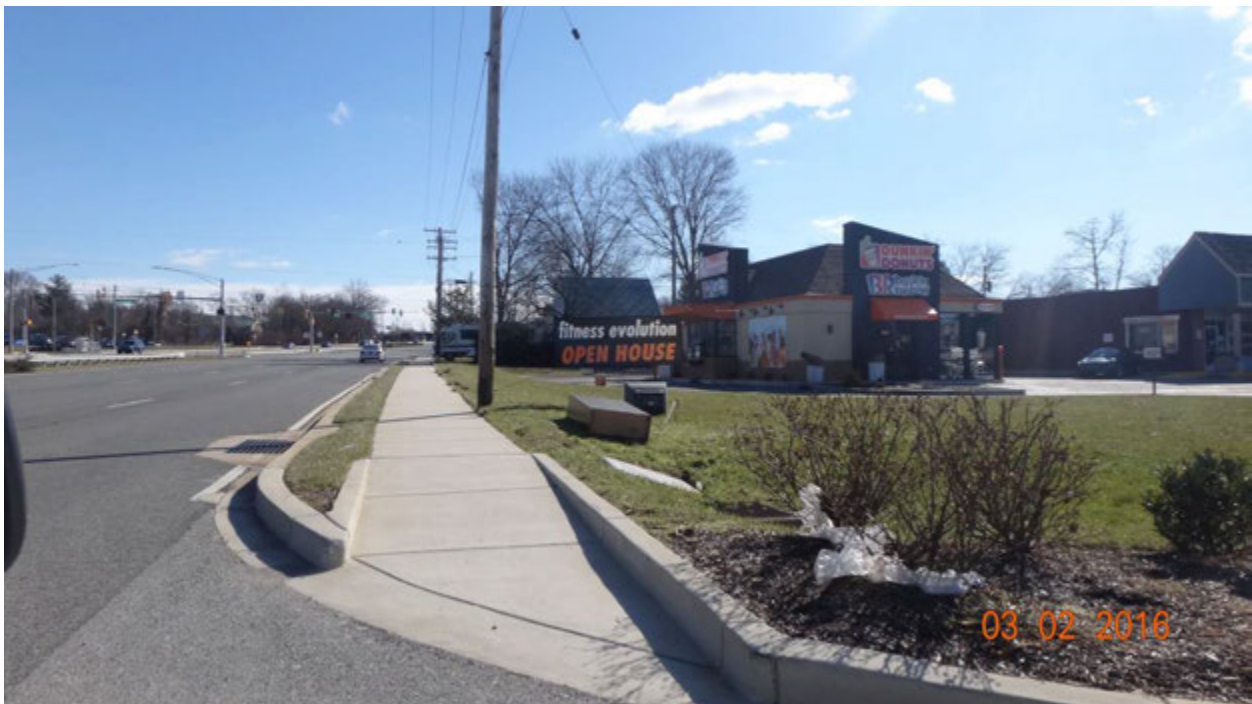
Figure 5. Cabinet and television found deposited near the entrance to the Brockbridge Shopping Center

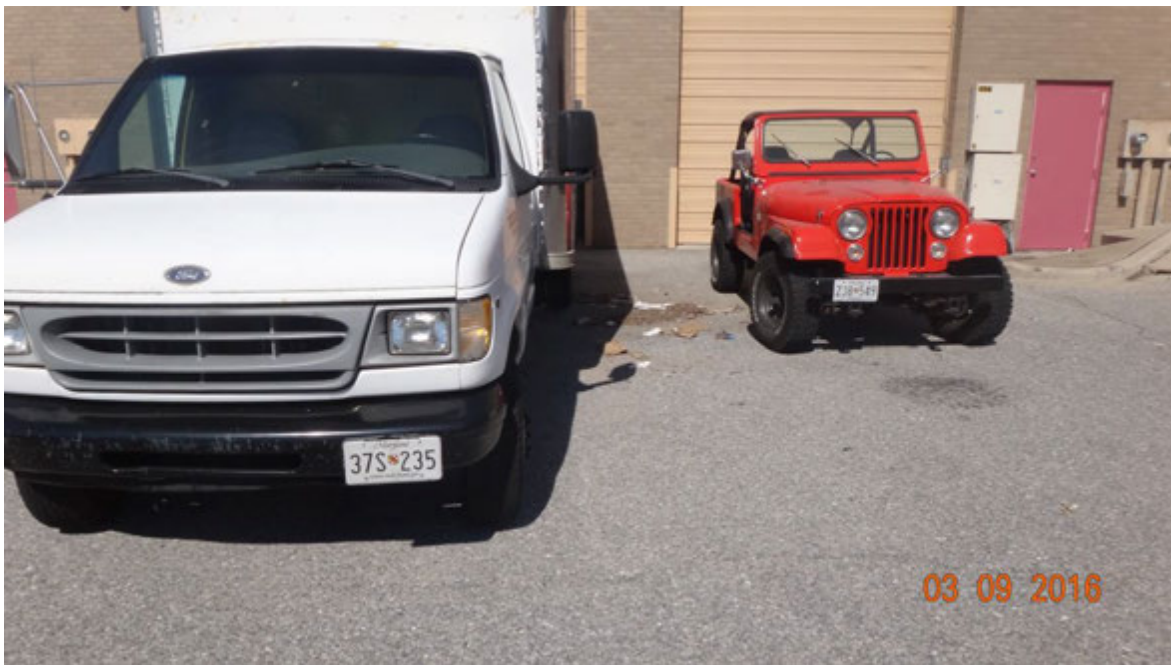
Figure 3. Loose debris found among vehicles in the parking lot on March 9, including paper and aluminum

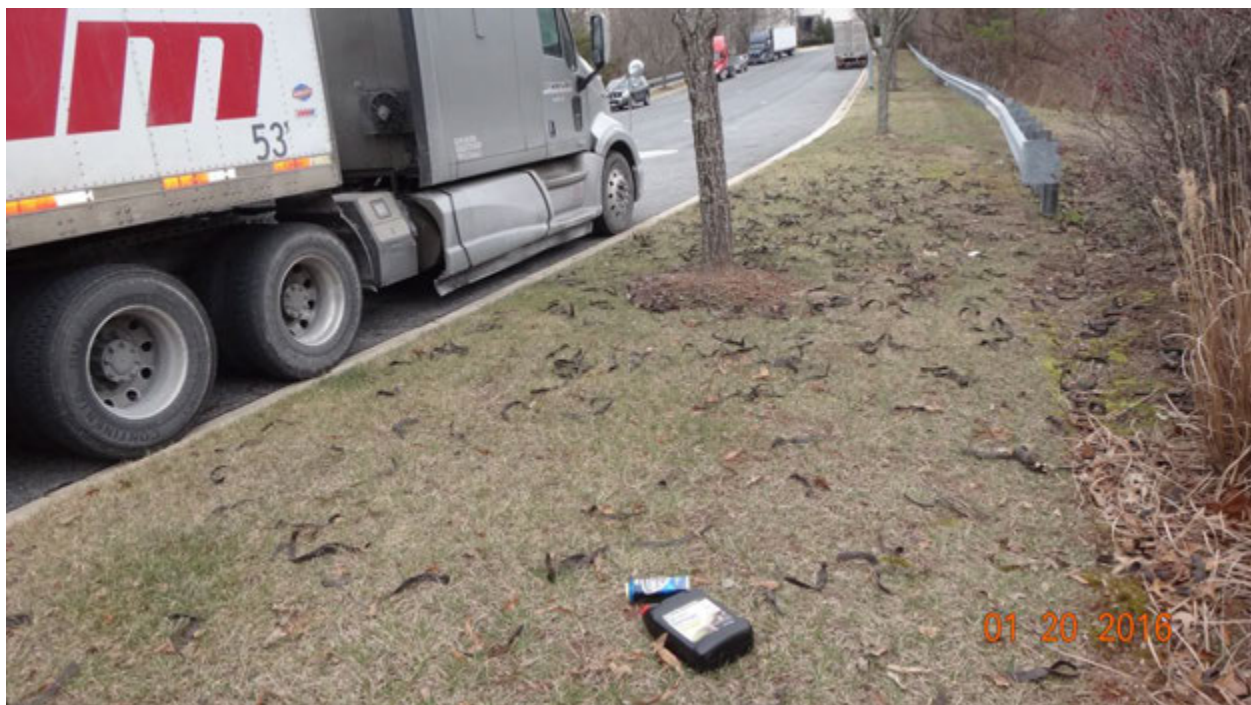
Figure 1. Photograph of an antifreeze container (and a beer can) found along the south side of Crossroads Drive during the site visit

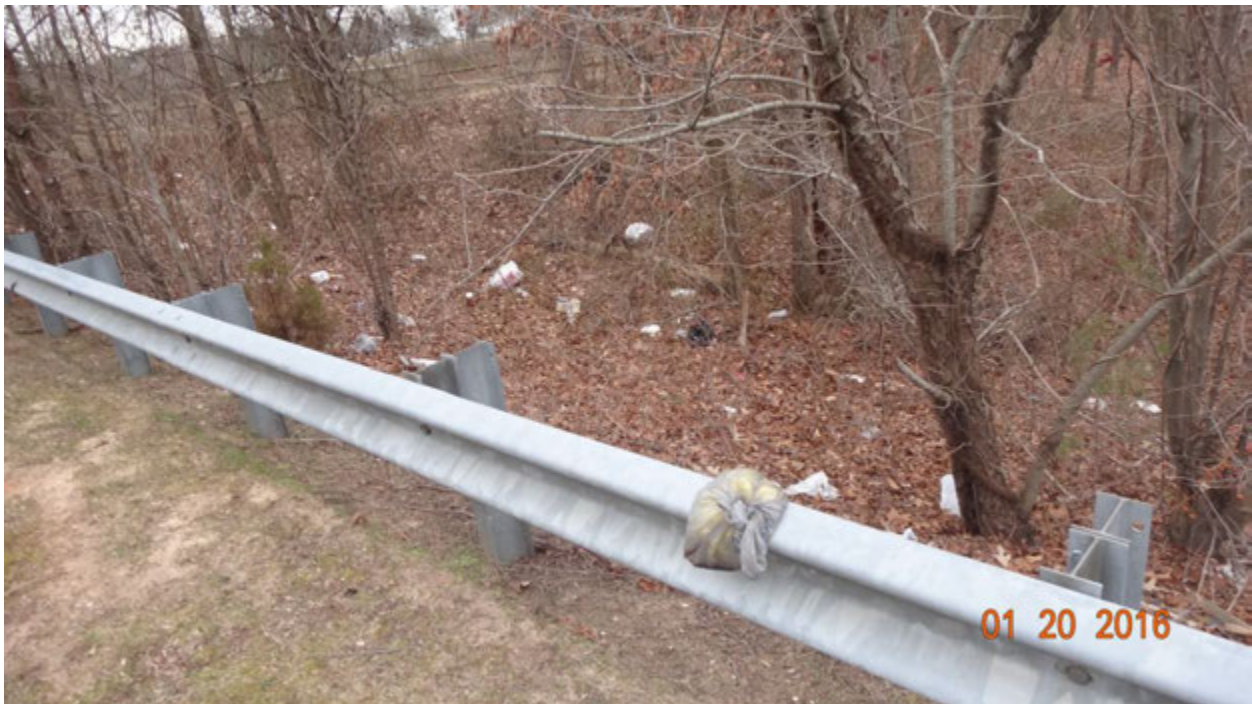
Figure 3. Photograph of a bag of oil-soaked rags discarded onto the guardrail and extensive debris in the wooded area beyond the guardrail found along the south side of Crossroads Drive

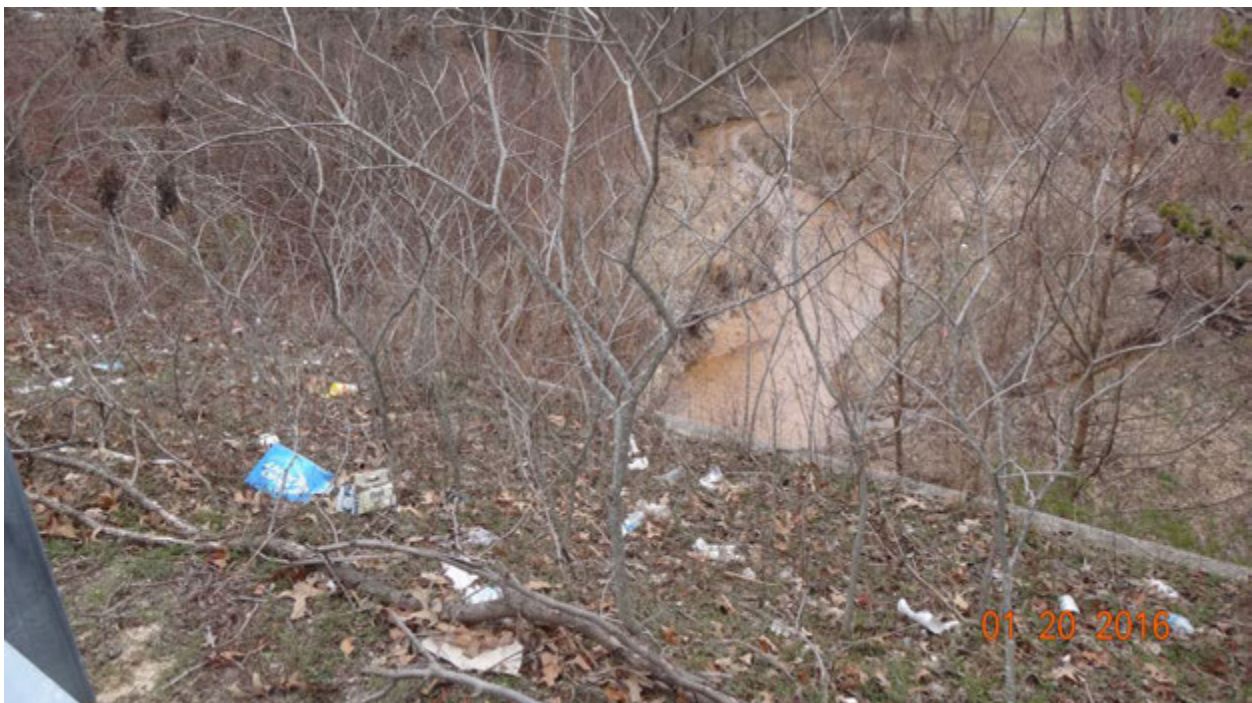
Figure 5. Photograph documenting a section of the roadside (south side) littered with debris; note the stream in the ravine in the background

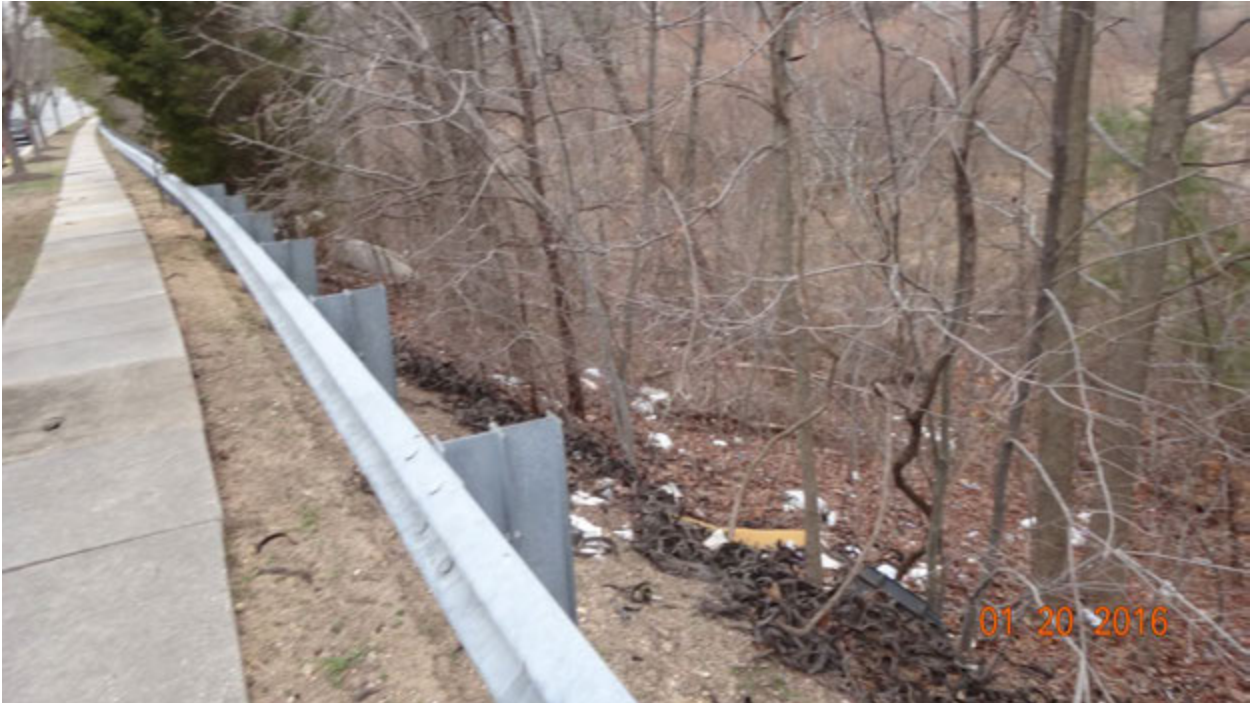
Figure 6. Photograph of some of the extensive debris deposited on the hillsides along the north side of Crossroads Drive; the stream is in the ravine to the right of the view

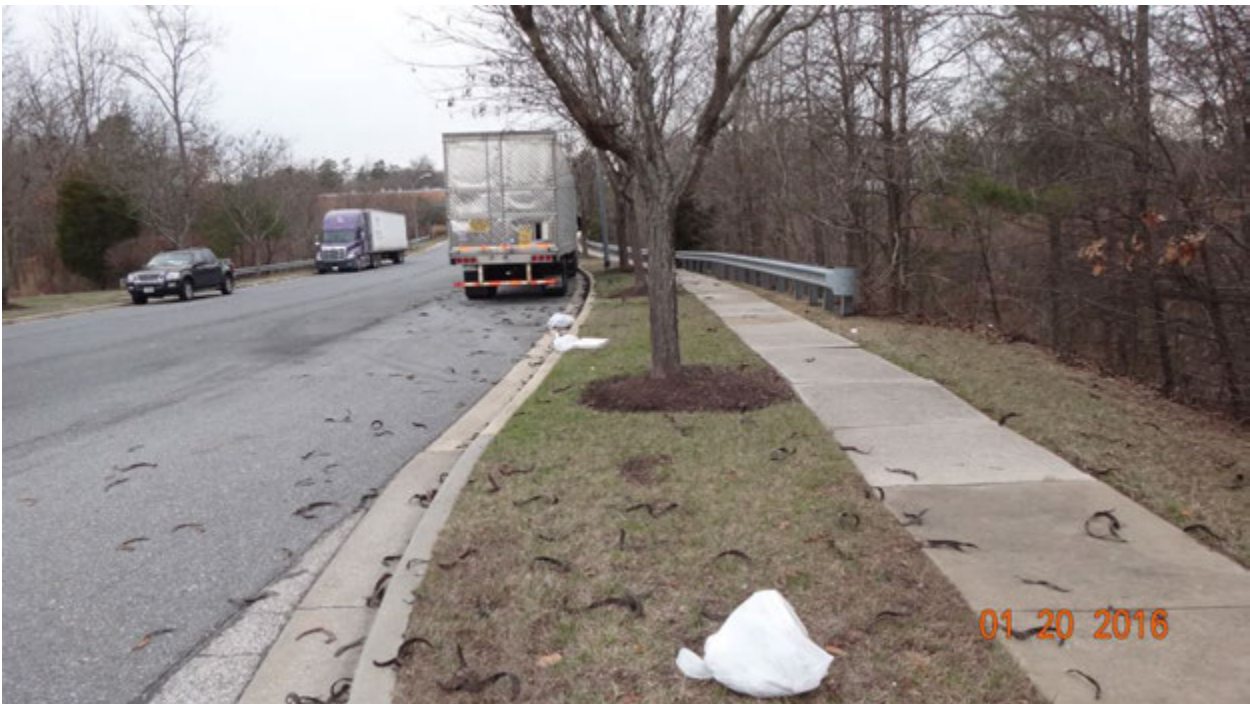
Figure 7. Photograph of discarded filled trash bags and a pizza box found on the north side of Crossroads Drive

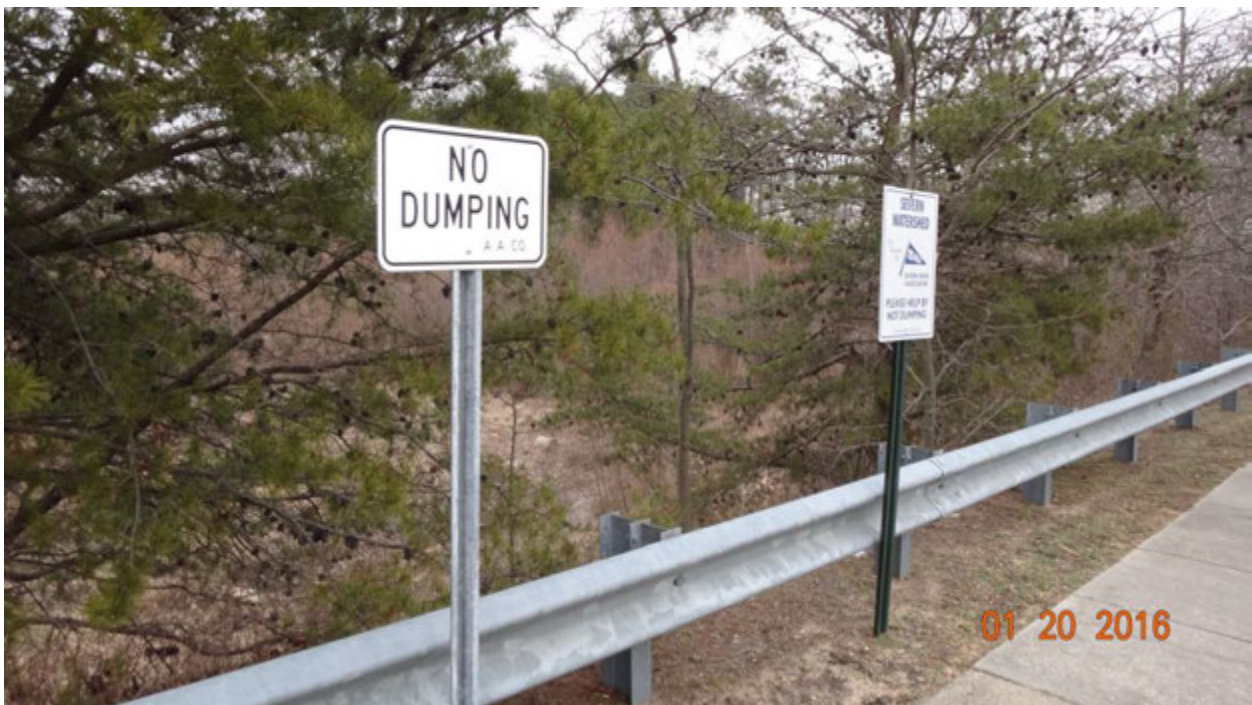
Figure 9. Signs posted on the north side of the roadway prohibiting dumping; signs were posted by Anne Arundel County and the Severn River Association

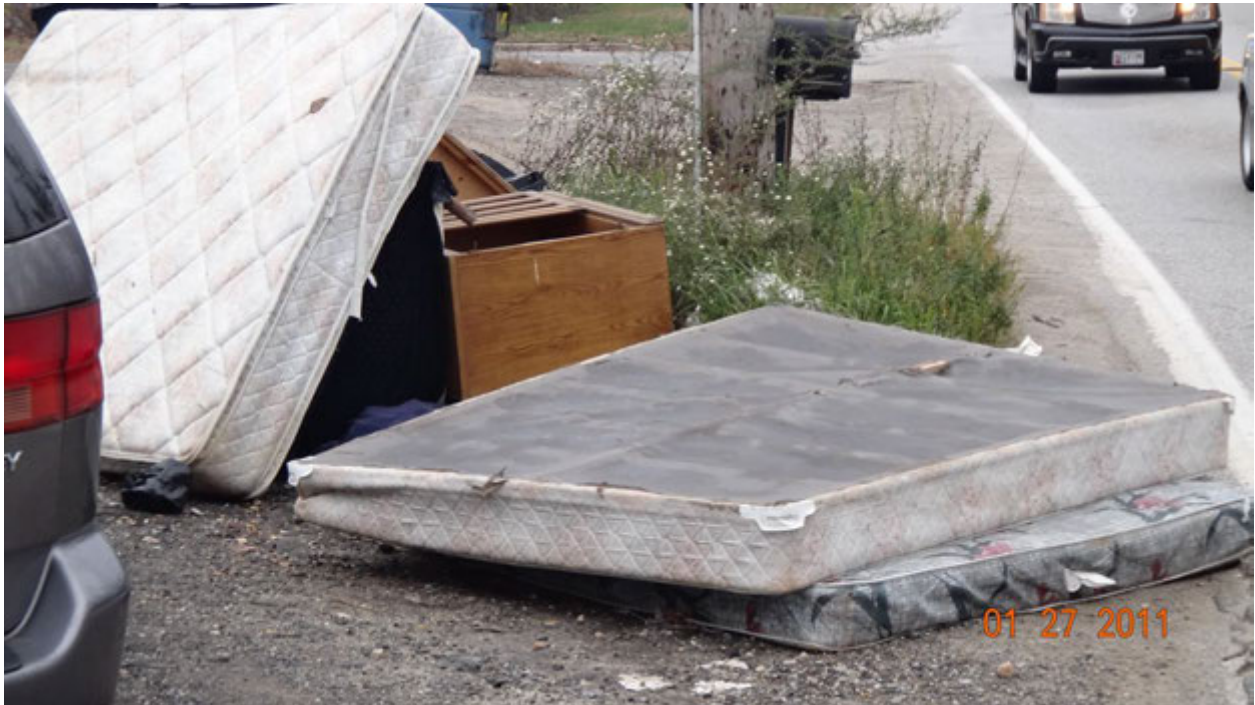
Figure 2. A collection of large pieces of furniture deposited near the roadway, facing south on Brock Bridge Road (photography date: December 9, 2015)

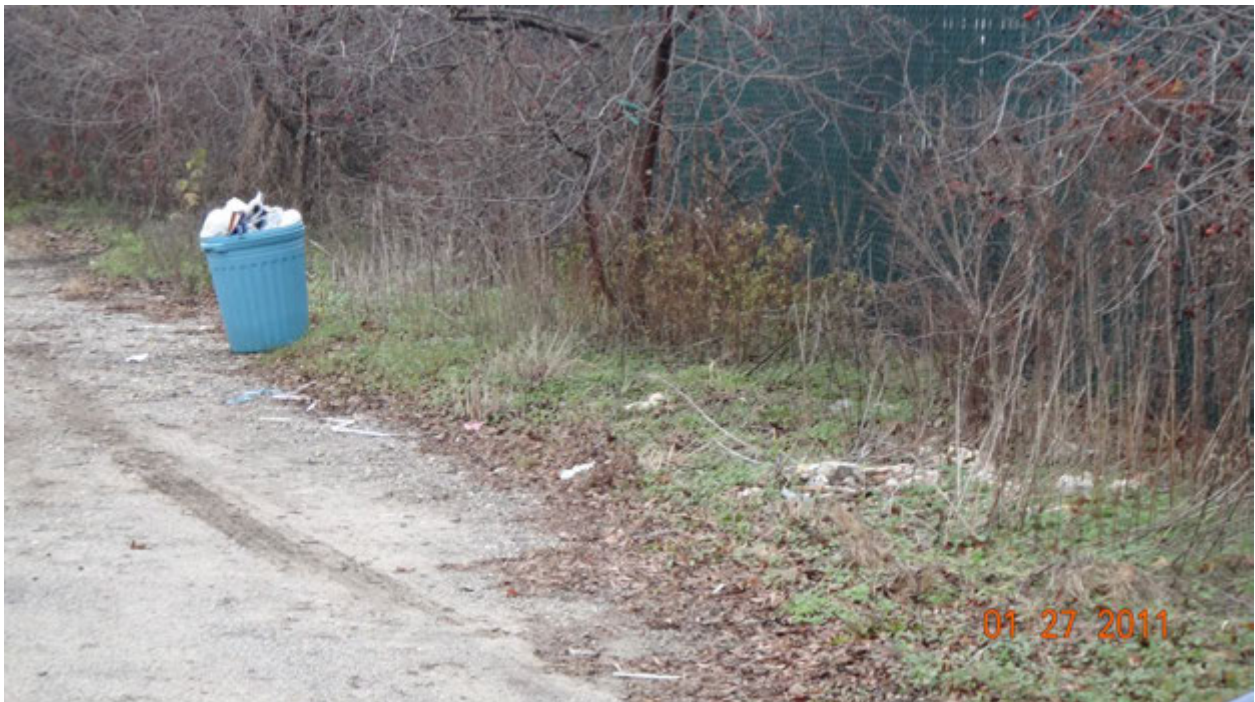
Figure 5. An overfilled open bin and loose debris observed on-site (photography date: December 9, 2015)

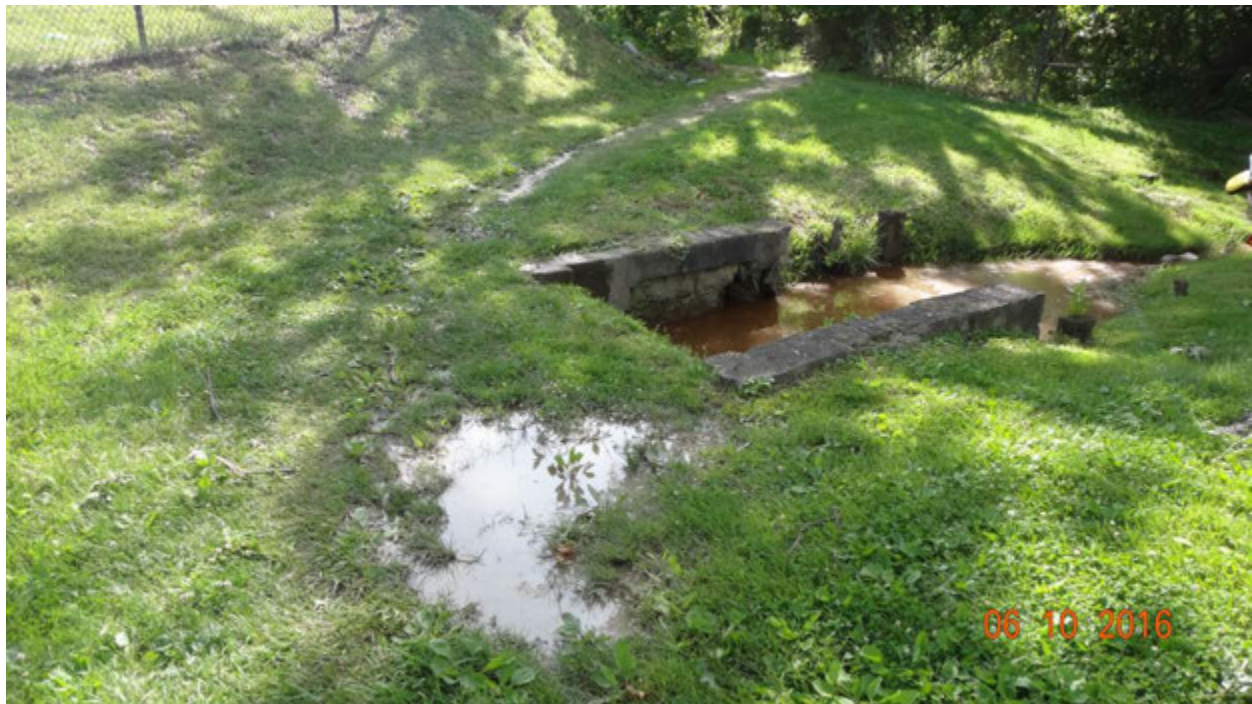
While investigating outfalls in the area on June 10, 2016, a Versar field team observed a trail of pooled and flowing cloudy water originating from a source at the south corner of the Laurel Race Track property. The team noticed a pool of cloudy water on the hill adjacent to outfall A11C7O001 (Figure 1). The team observed that the water in the outfall was stagnant and orange, with an oily sheen (Figure 2). The team members headed northeast to investigate the trail of water leading to the outfall. They found an area along the fence line where water coursed through some rocks and pooled along a footpath behind a maintenance area for the race track (Figure 3). Further to the northeast, along the fence, the team observed a larger volume of water exiting the fenced area at a gate (Figure 4). Alongside the opening, the team noted that a post hydrant was leaking, spraying water into the air (Figure 5). The team surmised that this and related pumps are available and used to fill water tanker trucks employed to wet down the race track as part of routine maintenance (Figure 6); wash down activities may also be routine in the maintenance area. An area map is provided in Figure 7.

Figure 1. A pool of water (foreground) observed adjacent to outfall A11C7O001 on June 10

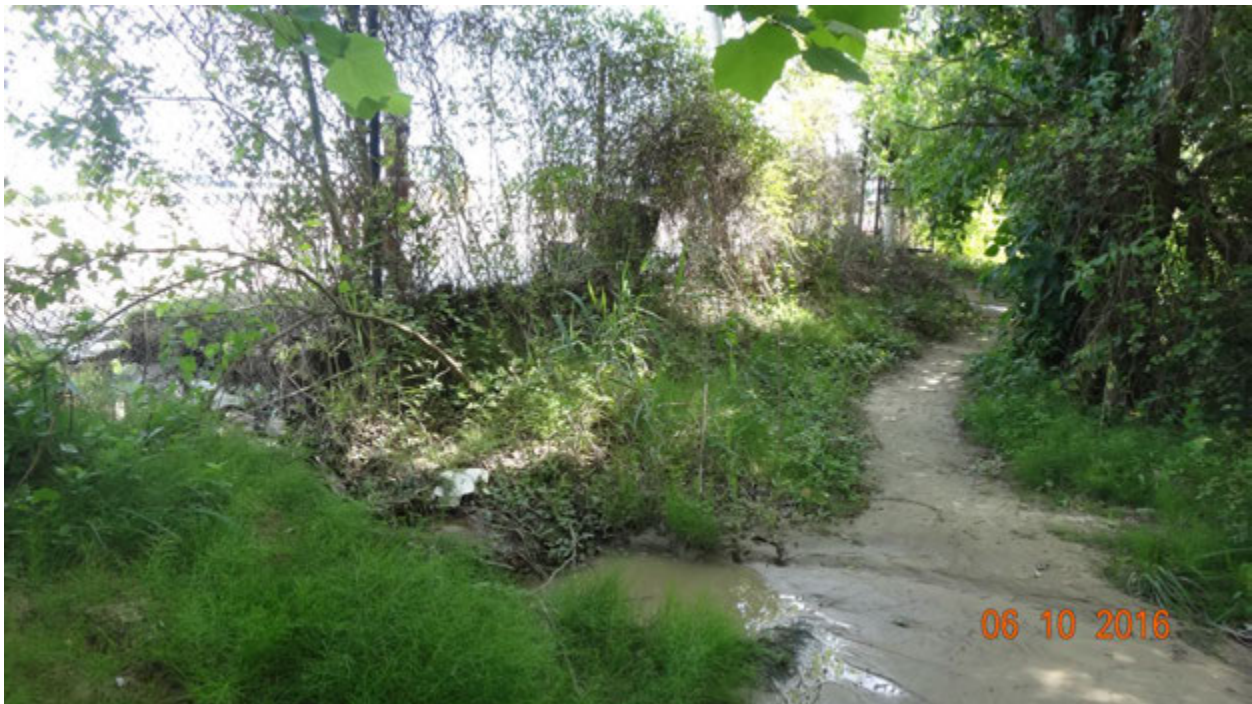
Figure 3. A view of a discharge path for excess wash water from the race track maintenance area; note the bed of rocks along the embankment leading from the fence line (center-left) and the pool of water alongside the footpath

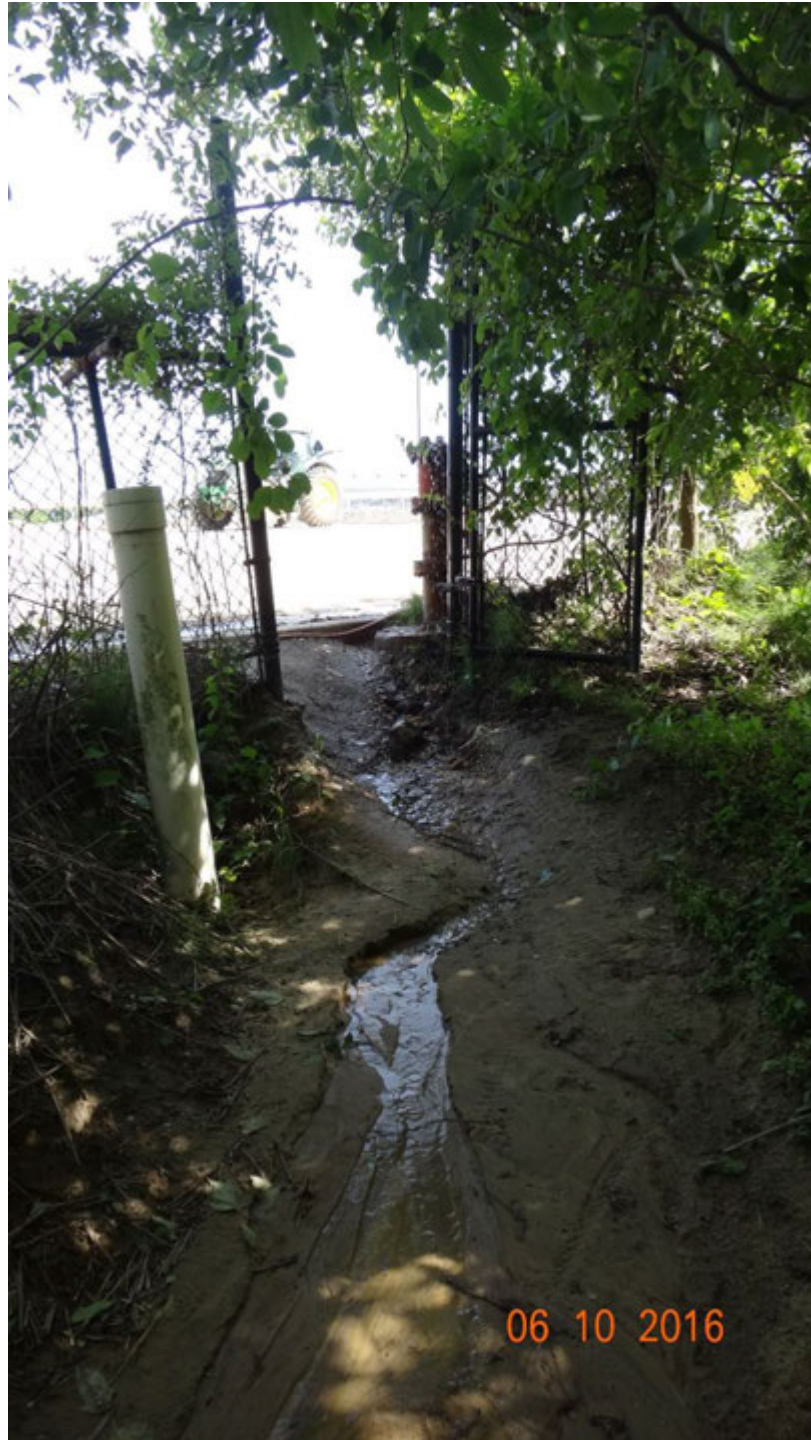
Figure 4. Excess wash water flowing out of a small gate in the fence bordering the race track maintenance area; note the red post hydrant to the right just inside the entrance

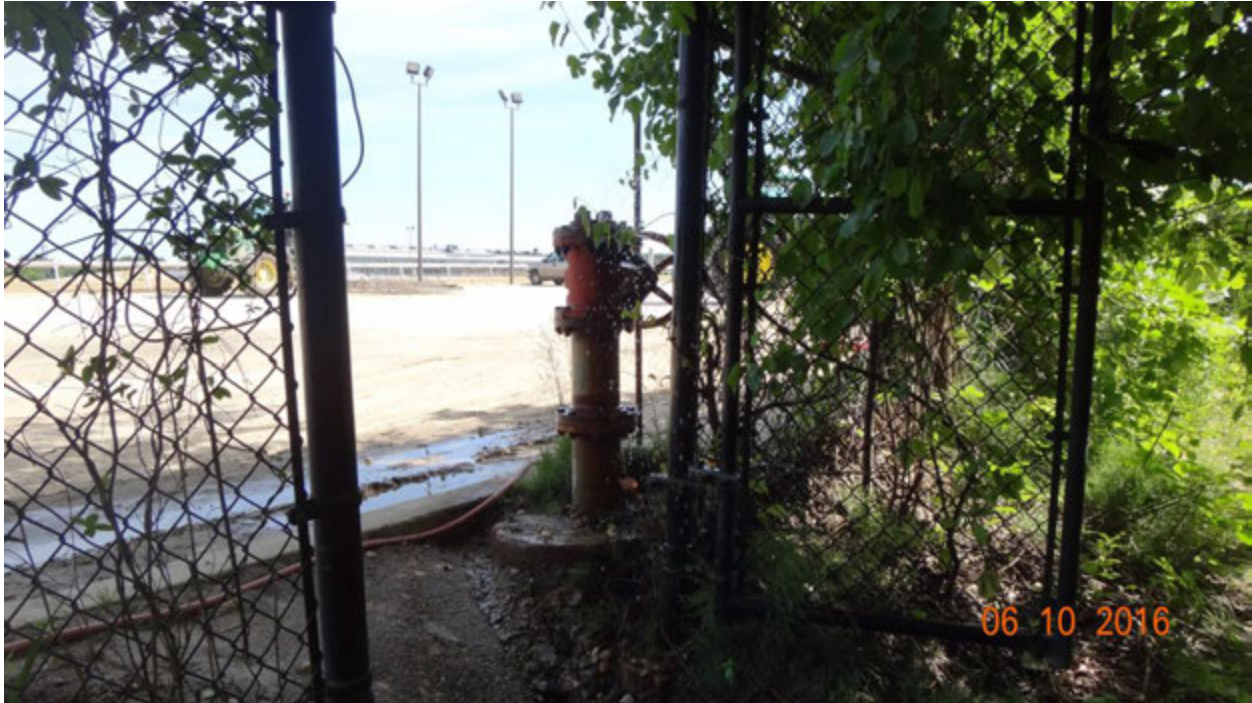
Figure 5. A red post hydrant with a valve inside the fenced maintenance area; at the time of the field visit in June 10, this hydrant was leaking water (spraying it into the air)

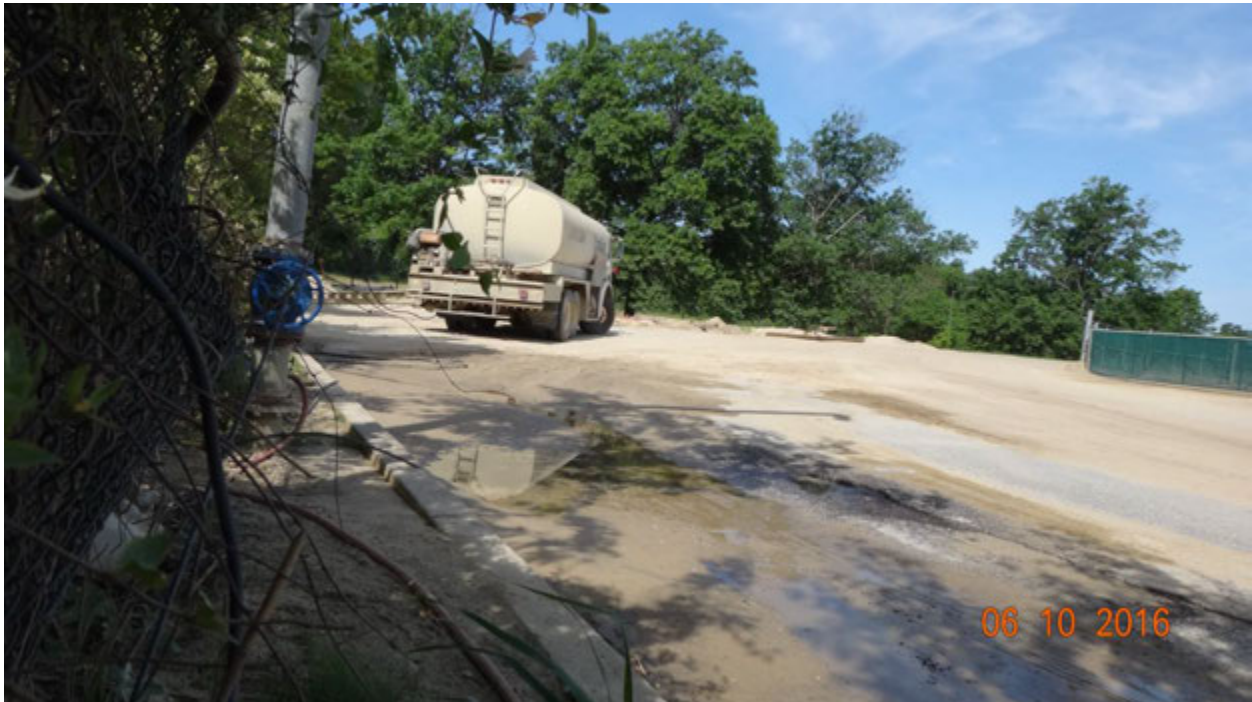
Figure 6. View inside the fenced maintenance area showing pooled and flowing water, numerous hoses, and a tanker truck on-site at the race track

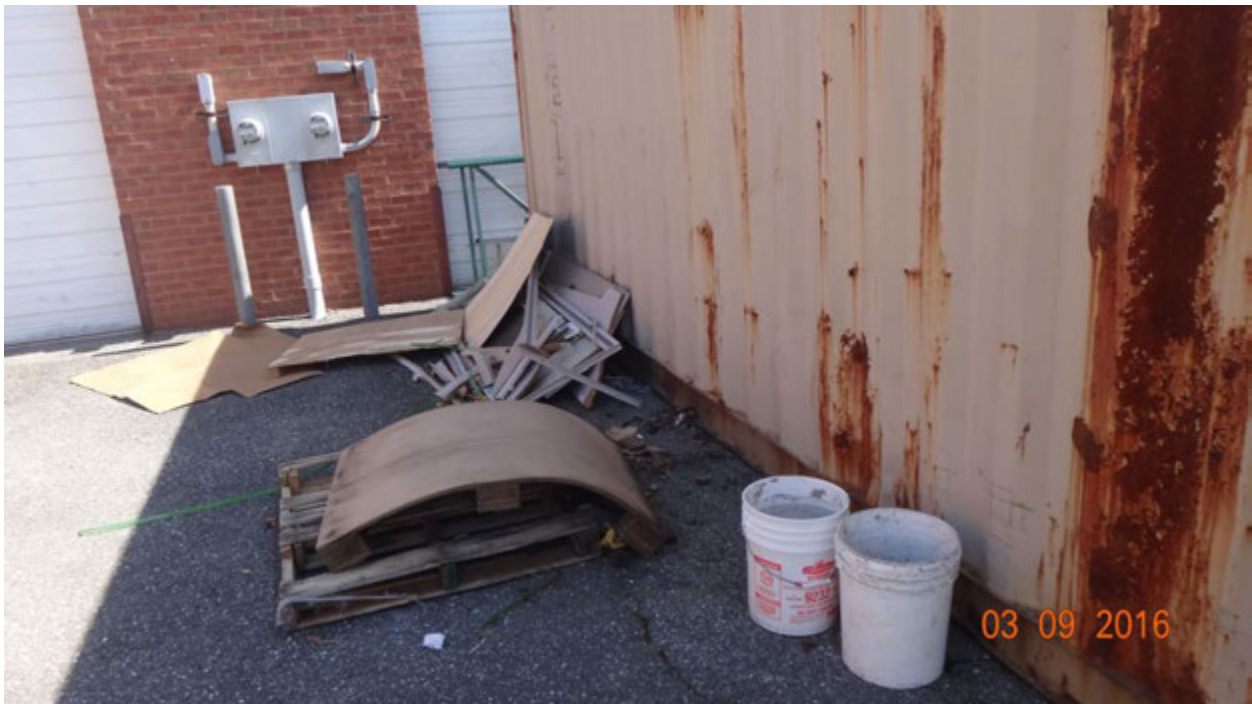
Figure 4. Loose debris found in the alcove behind National Carpet, including wood pallets, cardboard, metal framing, and two reused plastic buckets found on March 9

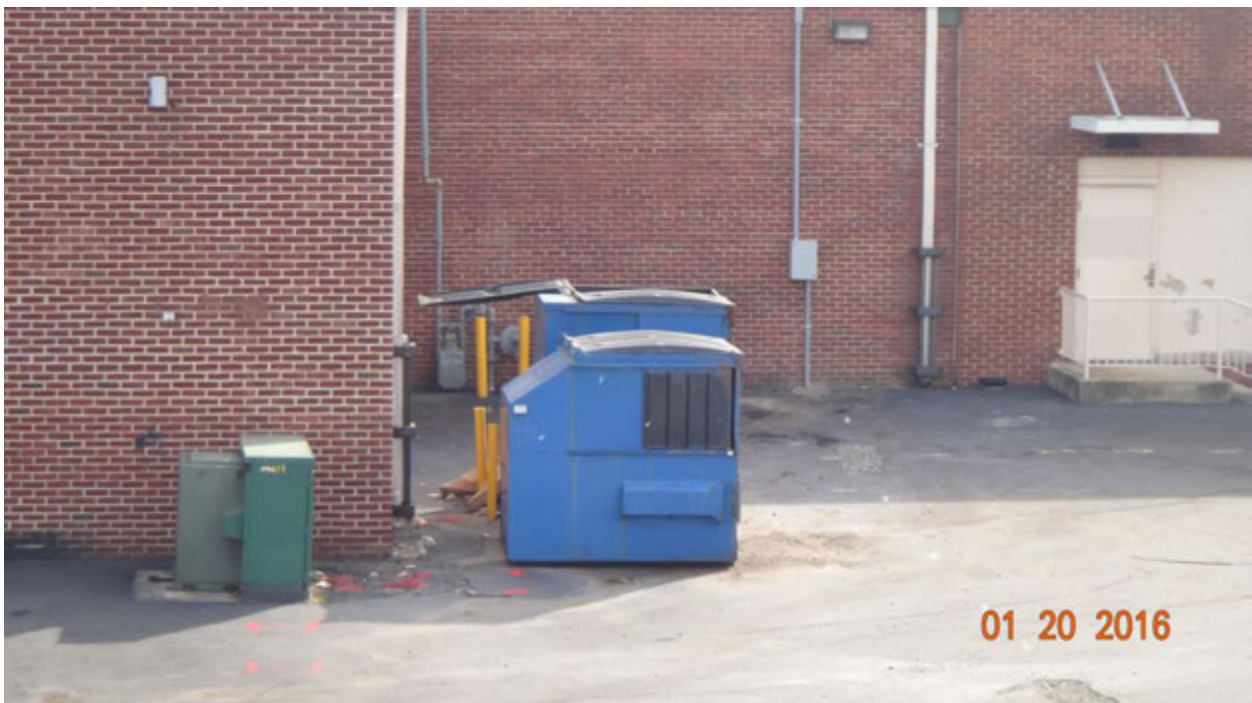
Figure 2. Photograph of a second open dumpster (the one in the background) found near a side door of the Five Guys Burgers and Fries restaurant

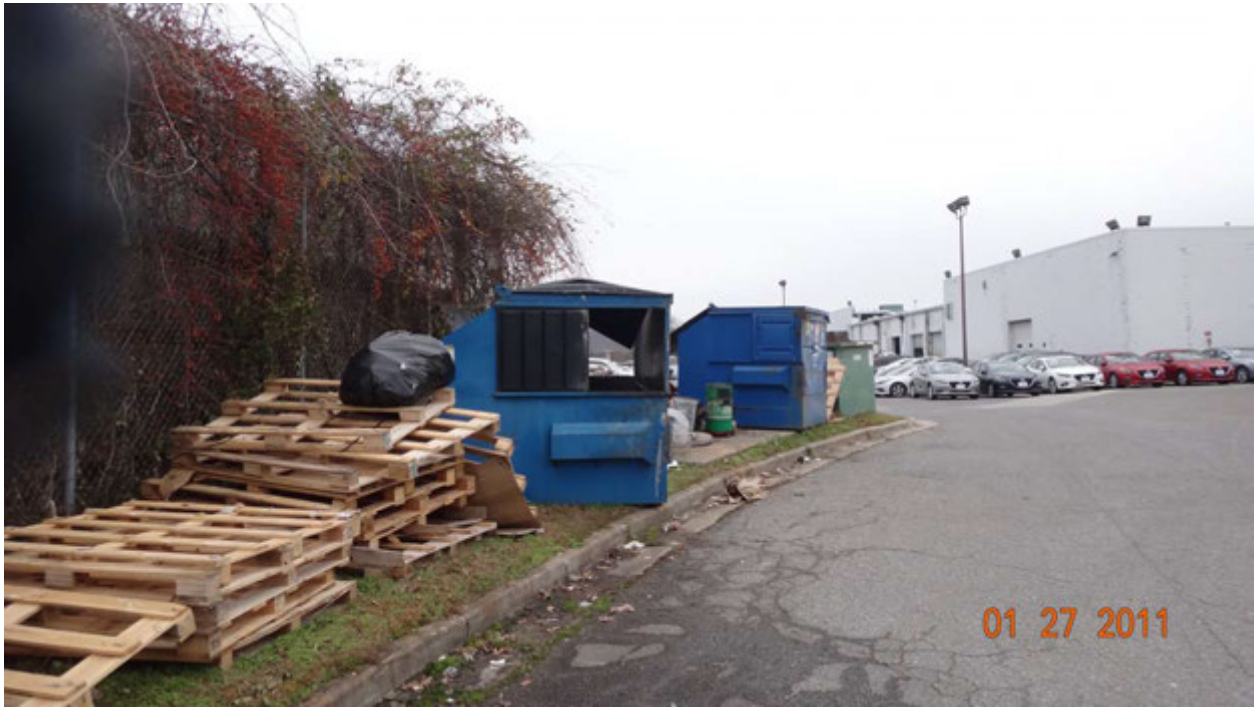
Figure 2. A collection of wooden pallets and bagged debris deposited near a partially open dumpster (photography date: December 9, 2015)

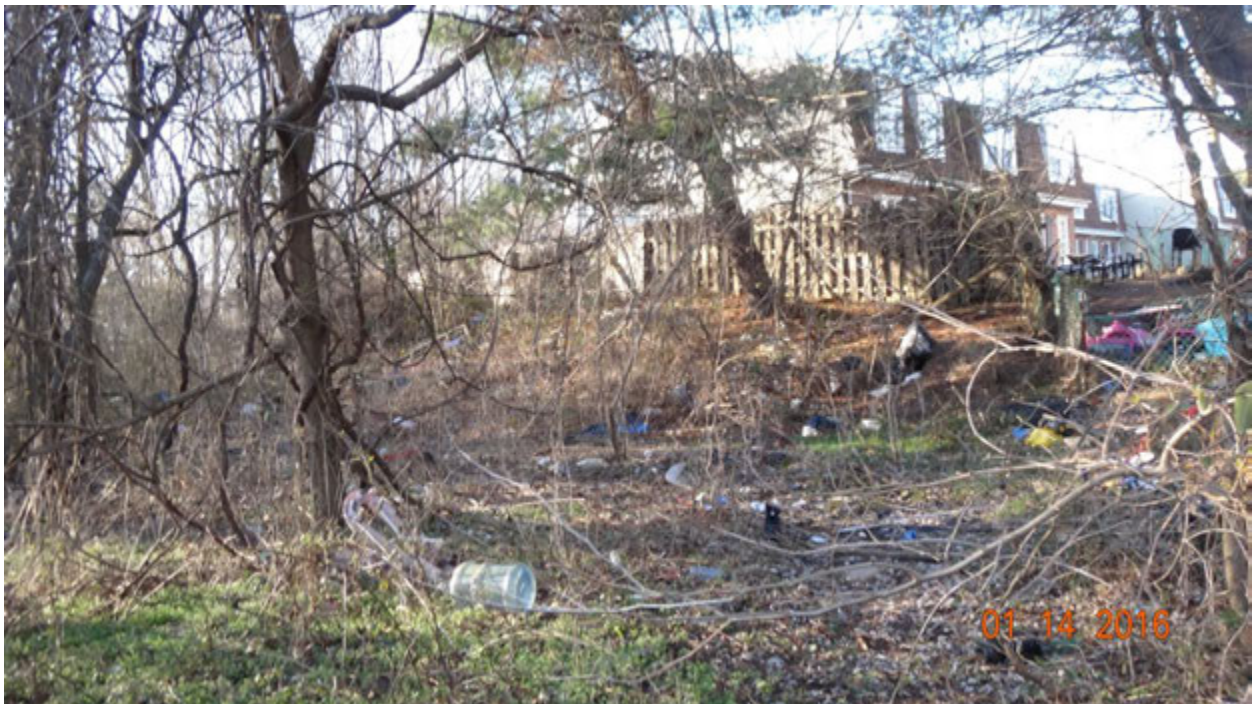
Figure 3. A large area of scattered debris, including newer items, found near 8385 Pioneer Drive on the bank leading to Severn Run

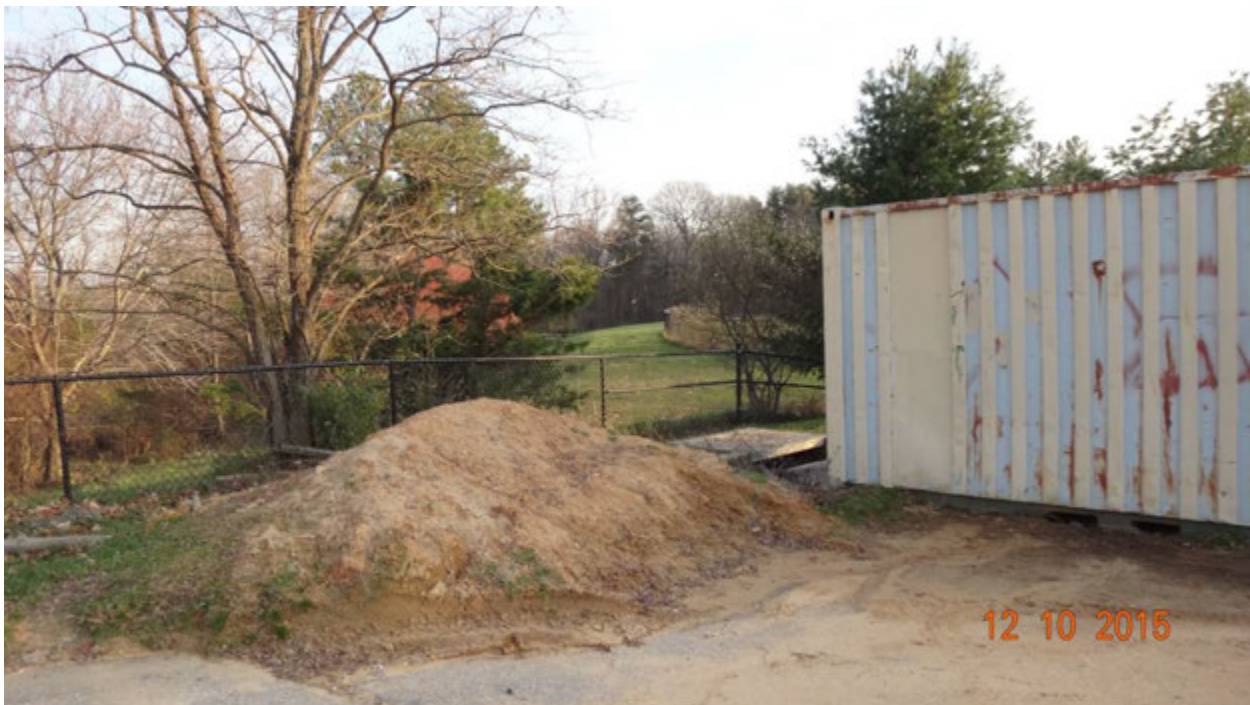
While investigating outfalls in the area, a Versar field team discovered an uncovered pile of sand and sediment that had been deposited on a corner of a parking lot in Provinces Park (also known as Jessup-Provinces Park), which is an Anne Arundel County Parks and Recreation facility, located at the above address (Figure 1). The field team documented that the pile of sand and sediment was located immediately adjacent to a storm drain inlet (Figure 2). The figures illustrate that the location of the pile partially blocks intended flows to the inlet; flows are also partially blocked by storage trailers in the same section of the parking area. Material from the pile may be dislodged by disturbances from humans, animals, or rain; this material may then enter the storm drain system and transport associated metals and nutrients to the system and contribute occluding bulk material to the pipes and downstream areas (Figure 3). An area map is provided as Figure 4.

Figure 1. An uncovered pile of sand and sediment found on the parking lot adjacent to a storage trailer; note the curb inlet which can be seen between the two

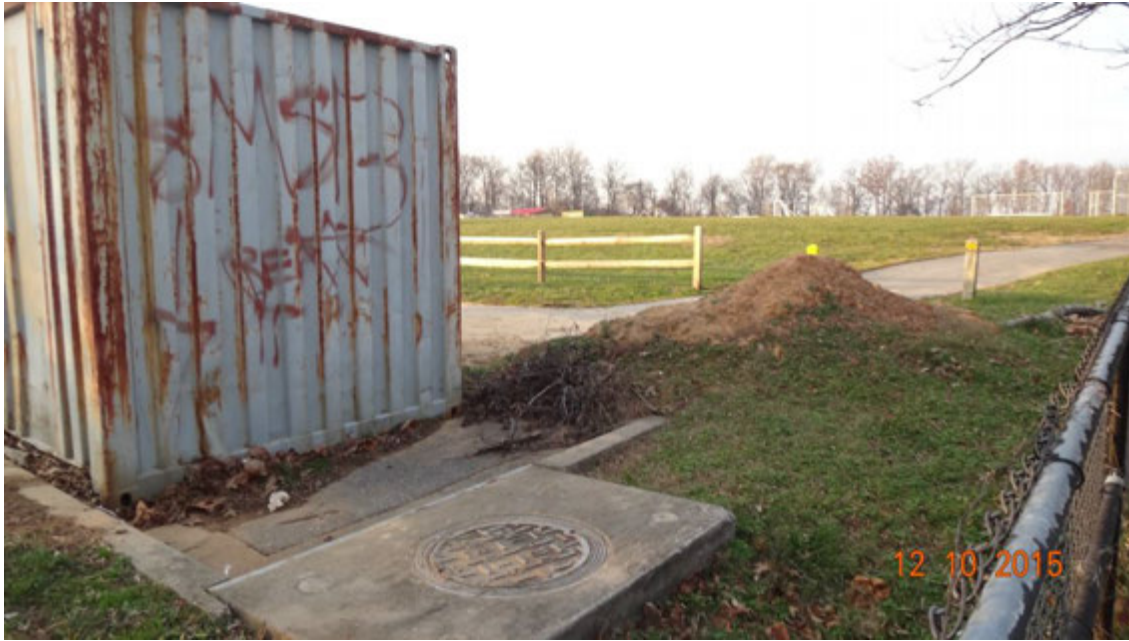
Figure 2. A view of the impervious surface leading to the storm drain inlet; the flows to the inlet are almost completely blocked by the storage trailer and the large pile of sand and sediment

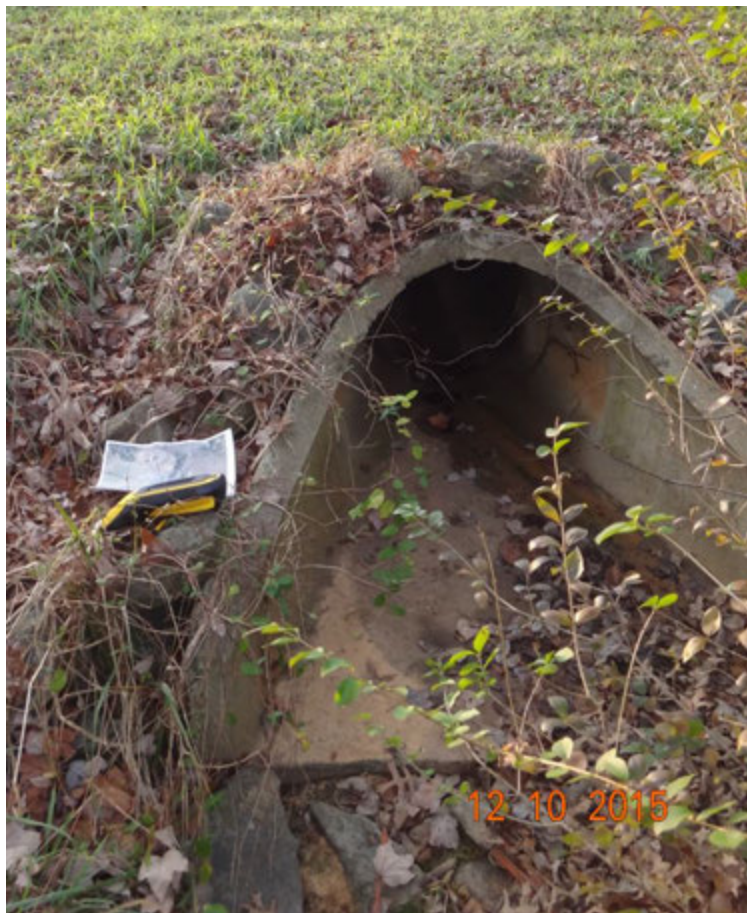
Figure 3. Sand deposit on outfall apron (left side when facing outfall)

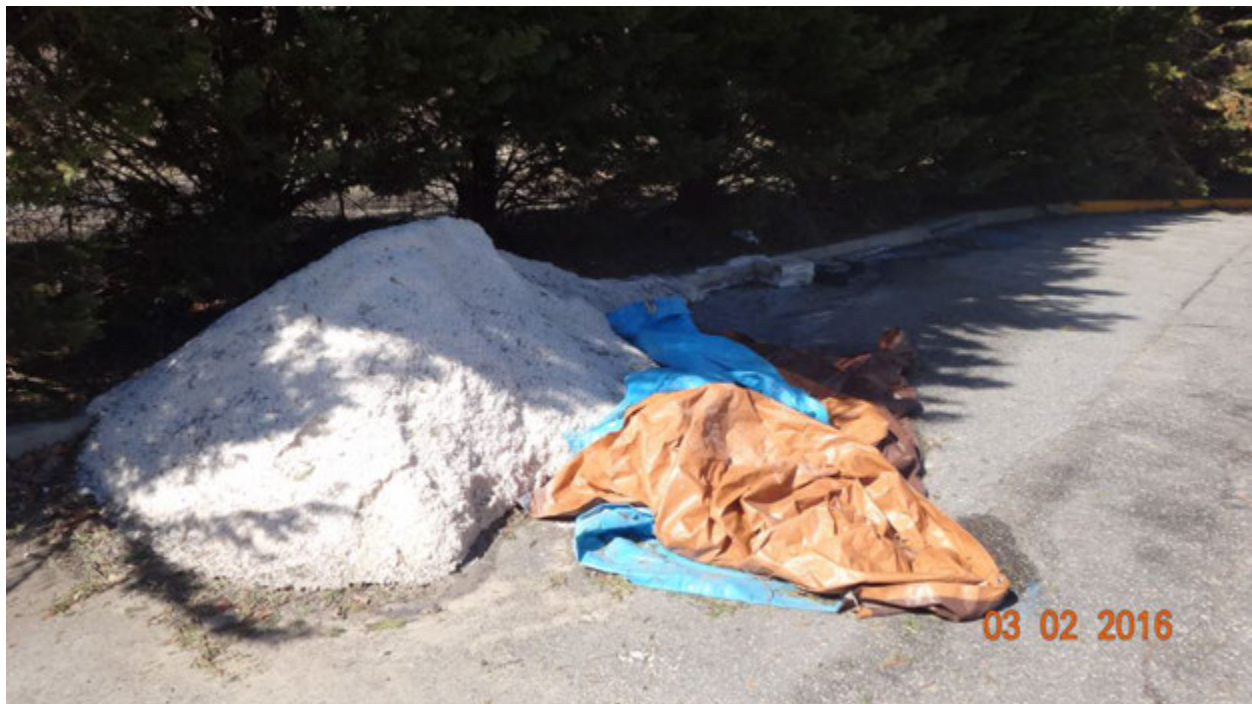
A Versar field team discovered what appeared to be a large pile of road de-icing salt in the parking lot on the west side of the rear parking lot of the Seven Oaks Shopping Center on Blue Water Blvd. At the time of the site visit, the pile was uncovered, two tarps with weight stones were placed on the pavement immediately adjacent to the pile (Figure 1). The field crew noted that a line of residue leading from the area of the pile along the side of the parking lot to the storm drain (Figure 2). The placement of salt on an impervious surface introduces the risk of distribution of salt particles and associated nutrients – by wind, rain, or physical disturbance – which could then be carried via stormwater runoff into adjacent storm drain inlets or open water. An area map, indicating the location of the large salt pile, is provided in Figure 3.

Figure 1. A large, uncovered pile of road de-icing salt found on March 2; the tarps did have weight stones available at the time of the site visit

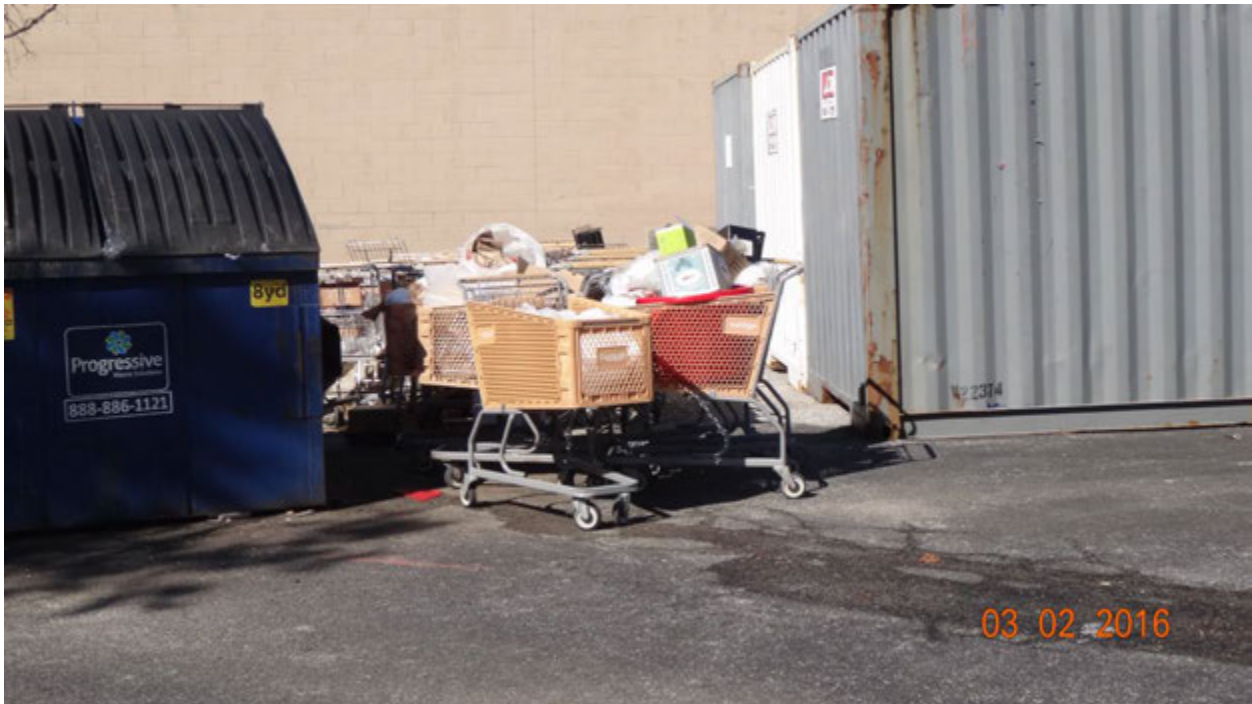
Figure 2. Shopping carts found overloaded with cardboard boxes and loose debris alongside the Total Wine store
