**ANNE ARUNDEL COUNTY
ILLICIT DISCHARGE DETECTION
AND ELIMINATION
2016 ANNUAL REPORT**

PERMIT NUMBER MD0068306

FINAL: January 2017

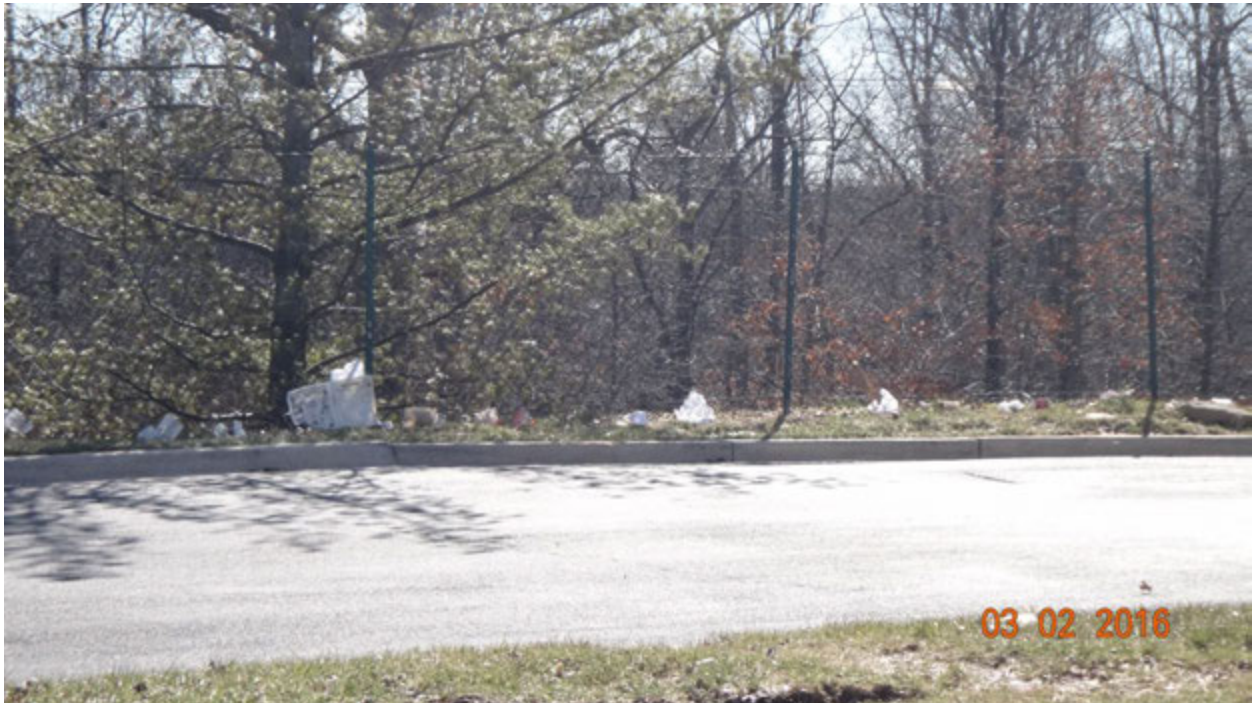
On the southeast edge of the parking lot, nearest the Total Wine store, the field crew discovered a long line of loose debris along a chain link fence (Figure 5). Where there was a break in the fence line, the field crew observed more loose debris further down the hill (toward Interstate 295); debris in this area included cardboard (with labels for alcoholic beverages), plastic bags (including those with labels advertising the Total Wine business), food wrappers, plastic bottles, Styrofoam food containers, and an old shopping cart (Figures 6 and 7). An area map, indicating the locations of the debris, is provided in Figure 8.

Figure 5. A long line of loose debris found trapped against a chain link fence to the southeast of the Total Wine store

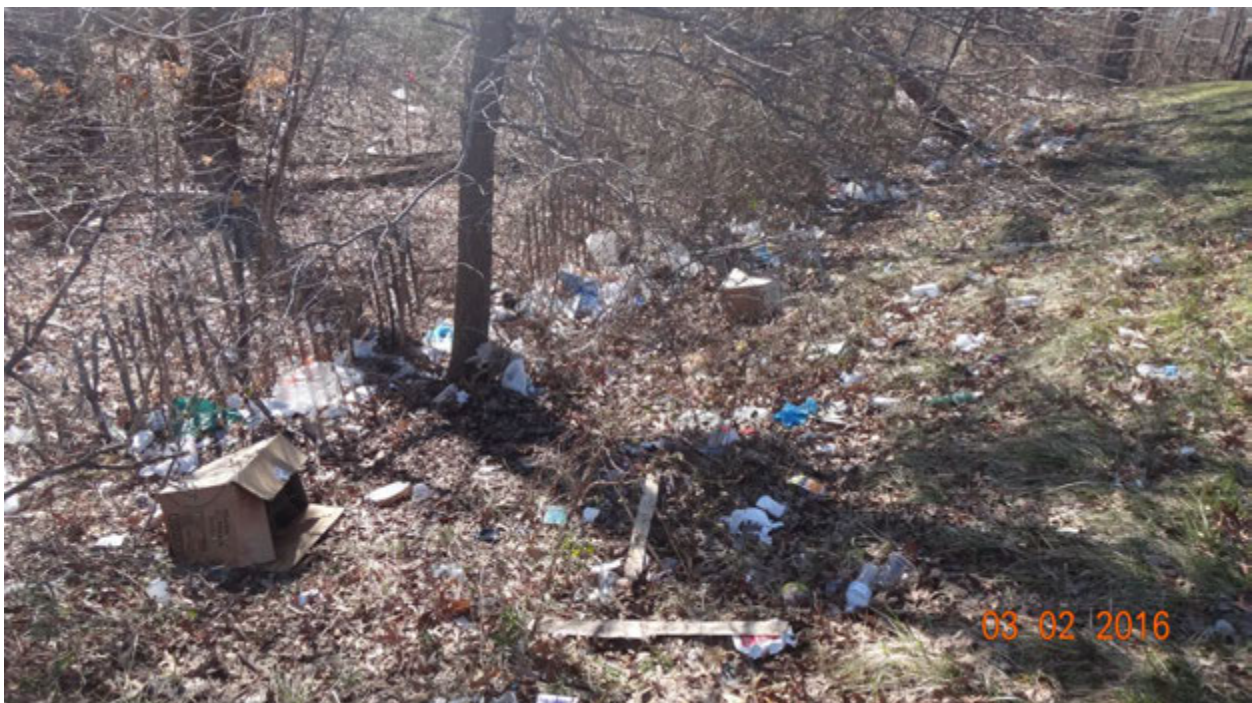
Figure 6. Loose debris found accumulating along the woods, downhill of the parking lot for the Total Wine store and other businesses at the Corridor Marketplace (facing south)
