**ILLICIT DISCHARGE DETECTION
AND ELIMINATION
2014 ANNUAL REPORT**

PERMIT NUMBER MD0068306

Versar, Inc.
9200 Rumsey Road
Columbia, MD 21045

October 2014

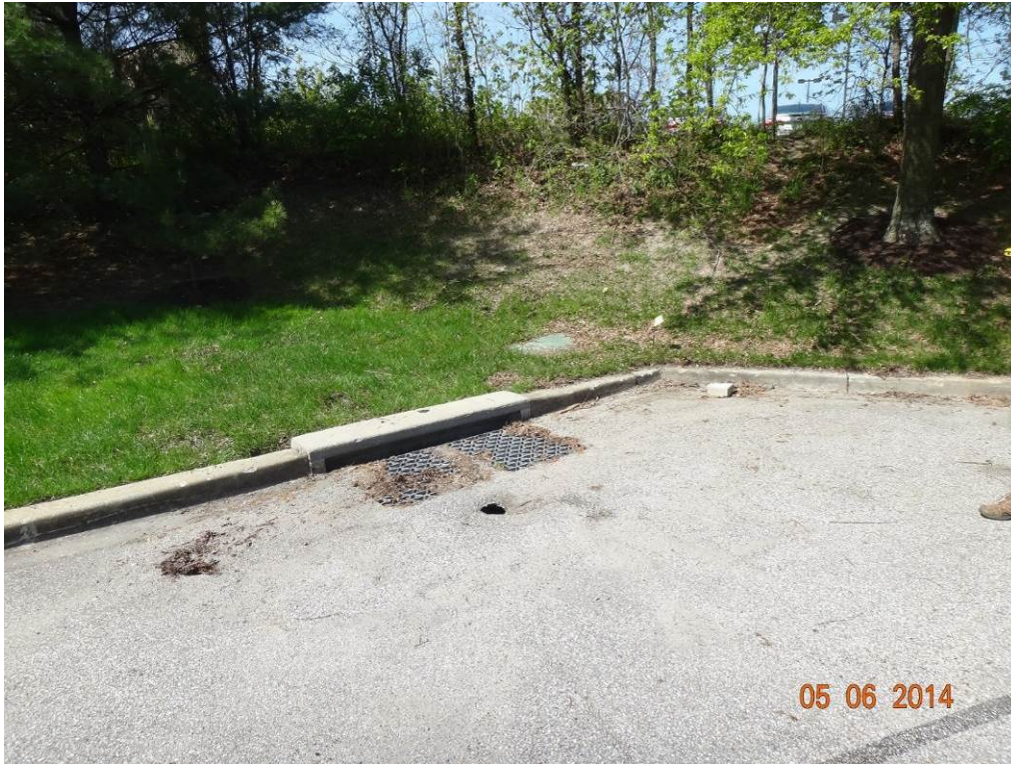
Figure 2. Inlet with nearby hole in asphalt

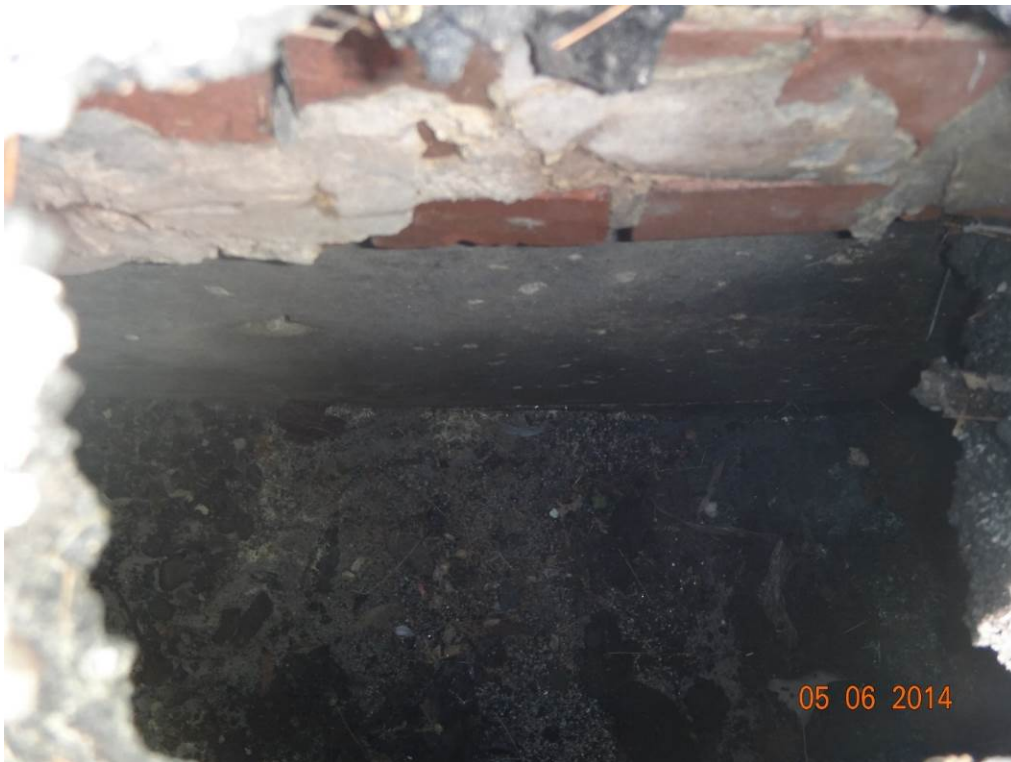
Figure 3. Interior of catch basin as viewed through the hole

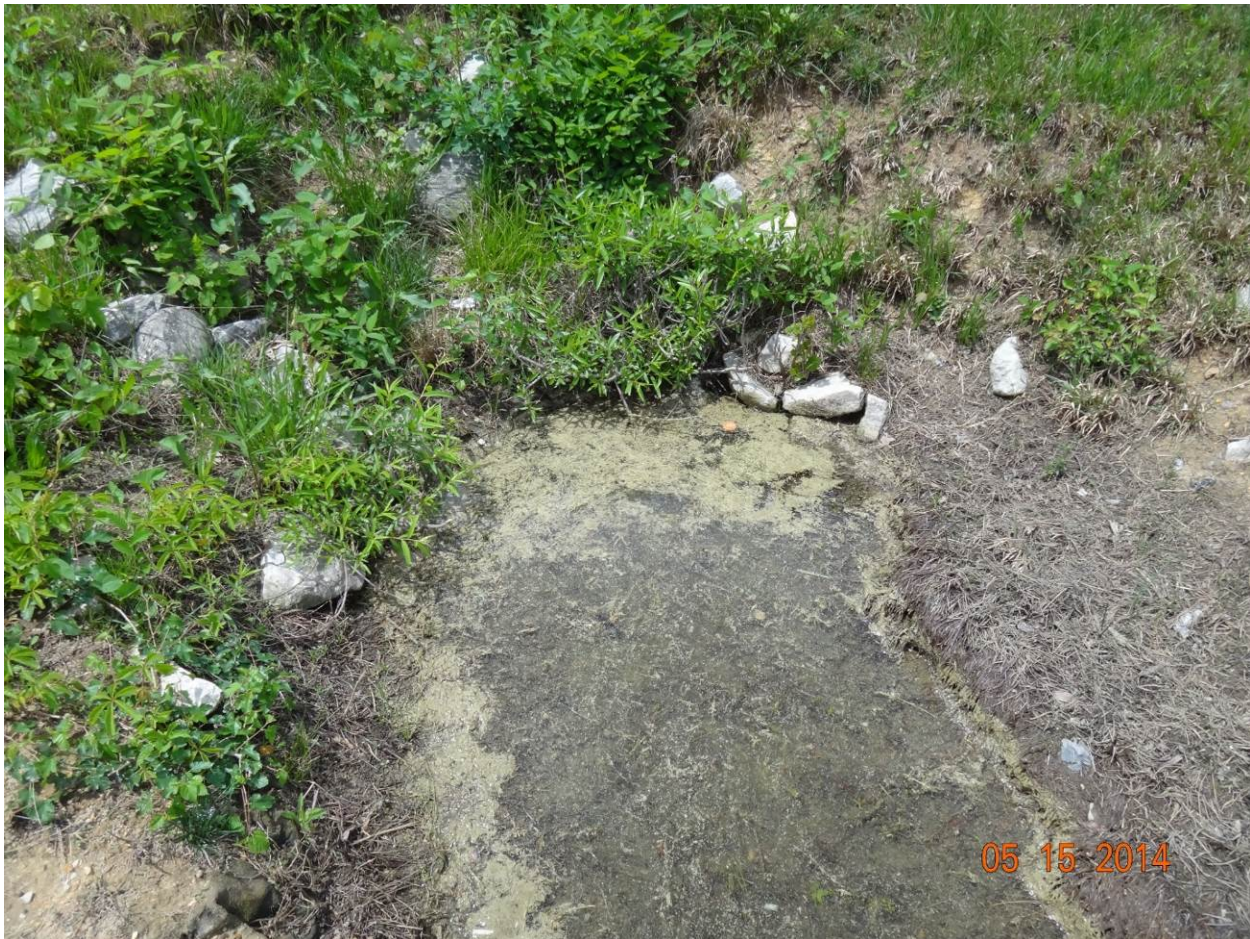
While conducting outfall screening in the target area, a LimnoTech and Versar field team discovered an outfall (N04H2O015) almost completely blocked by hard sediment (Figure 1). The outfall drains a parking lot to a stormwater pond behind the building at the above location. The photograph, taken by the field crew on May 15, shows some standing water near the outlet. A thin, top layer of algae downstream of the pipe opening suggests that water may continue to trickle through the pipe; the field crew reported that the outlet was not draining on the day of the field visit. Sluggish drainage of the parking lot in this corner may pose a hazard for motorists and pedestrians with accumulating debris, leaves, standing water, and ice. An area map appears in Figure 2.

Figure 1. Evidence of a storm infrastructure outfall blocked by sediment

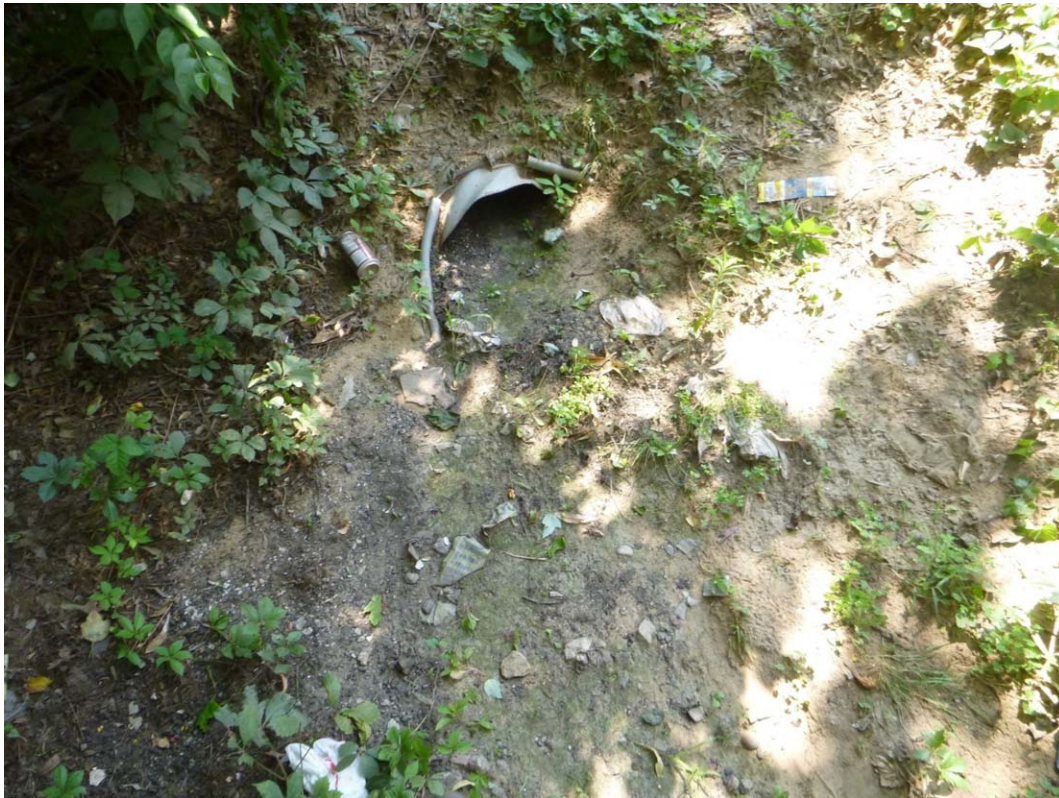
A Versar field team investigating the stormwater infrastructure between the Motel 6 and the McDonald's restaurant at the above location discovered a partially clogged outlet for a pipe that drains the Motel 6 parking lot (Figure 1 and Figure 2). The outlet is occluded with hard sediment. One crew member inspected the interior of the pipe and reported that he was not able to see an opening for water passage. The presence of similar sedimentation around the opening suggests that the discharged fine silt has been accumulating over time, and a thin top layer of algae on the sediment suggests that water may be still trickling through the pipe, although the drainage is no longer fully effective. Sluggish drainage of the parking lot in this corner may pose a hazard for motorists and pedestrians with accumulating debris, leaves, standing water, and ice. An area map appears in Figure 3.

Figure 1. Evidence of sediment accumulation in and around the pipe outlet draining the Motel 6 parking lot; there is algae growth extending downstream of the pipe opening

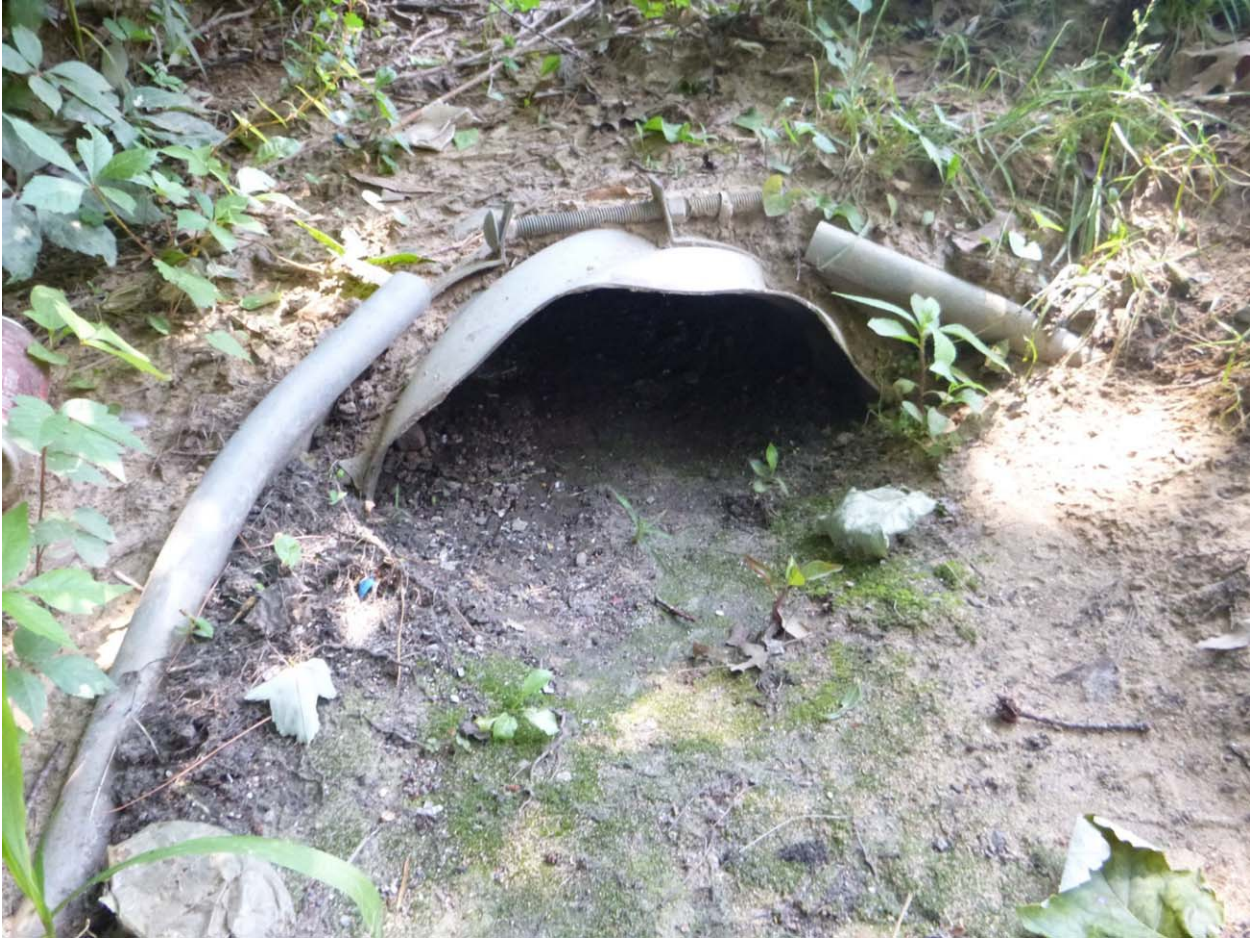
Figure 2. Close-up view of the pipe opening showing the level of accumulated sediment; the interior of the pipe is also occluded with sediment

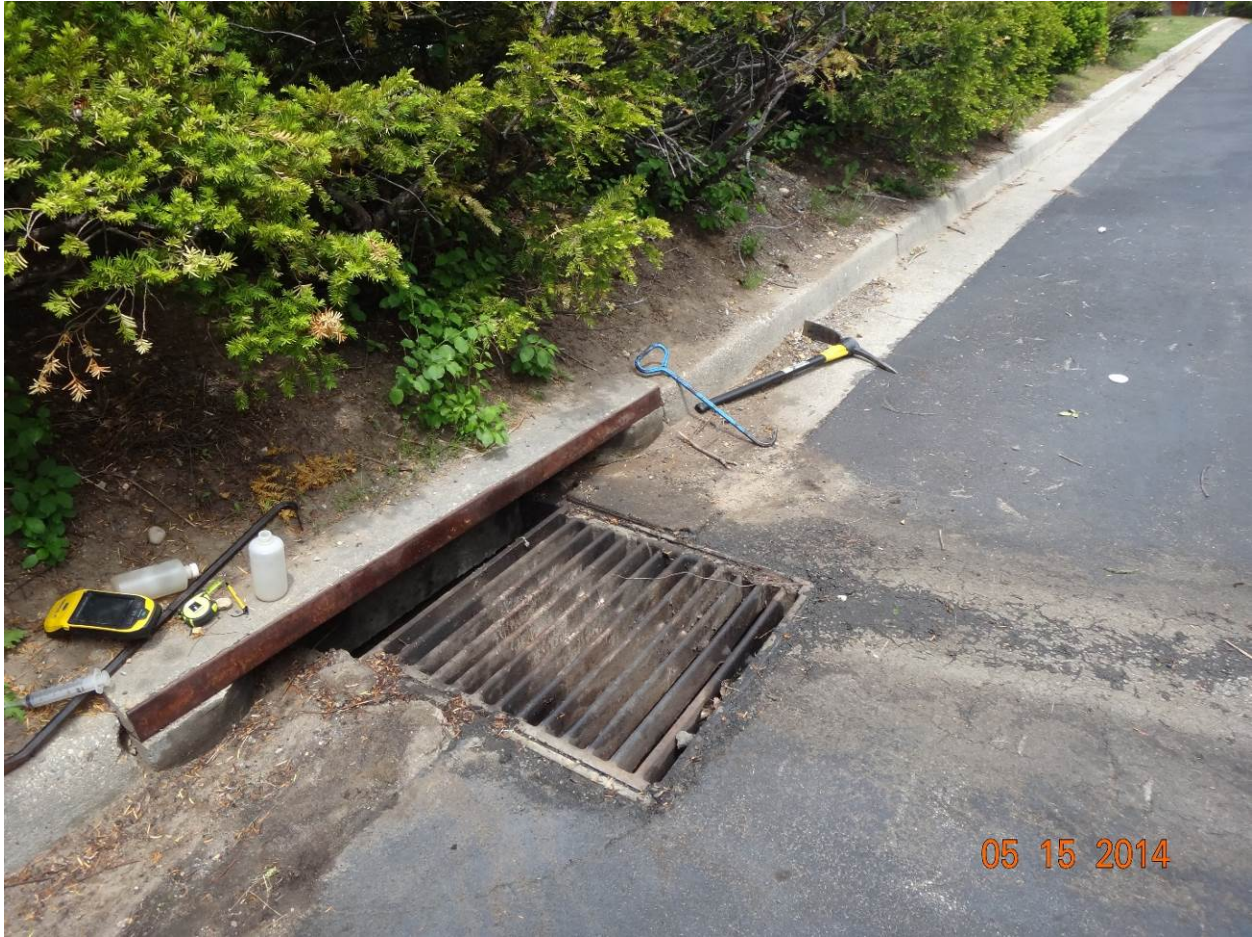
Figure 2. Curb inlet in the loading dock area of Embassy Suites, 1300 Concourse Drive

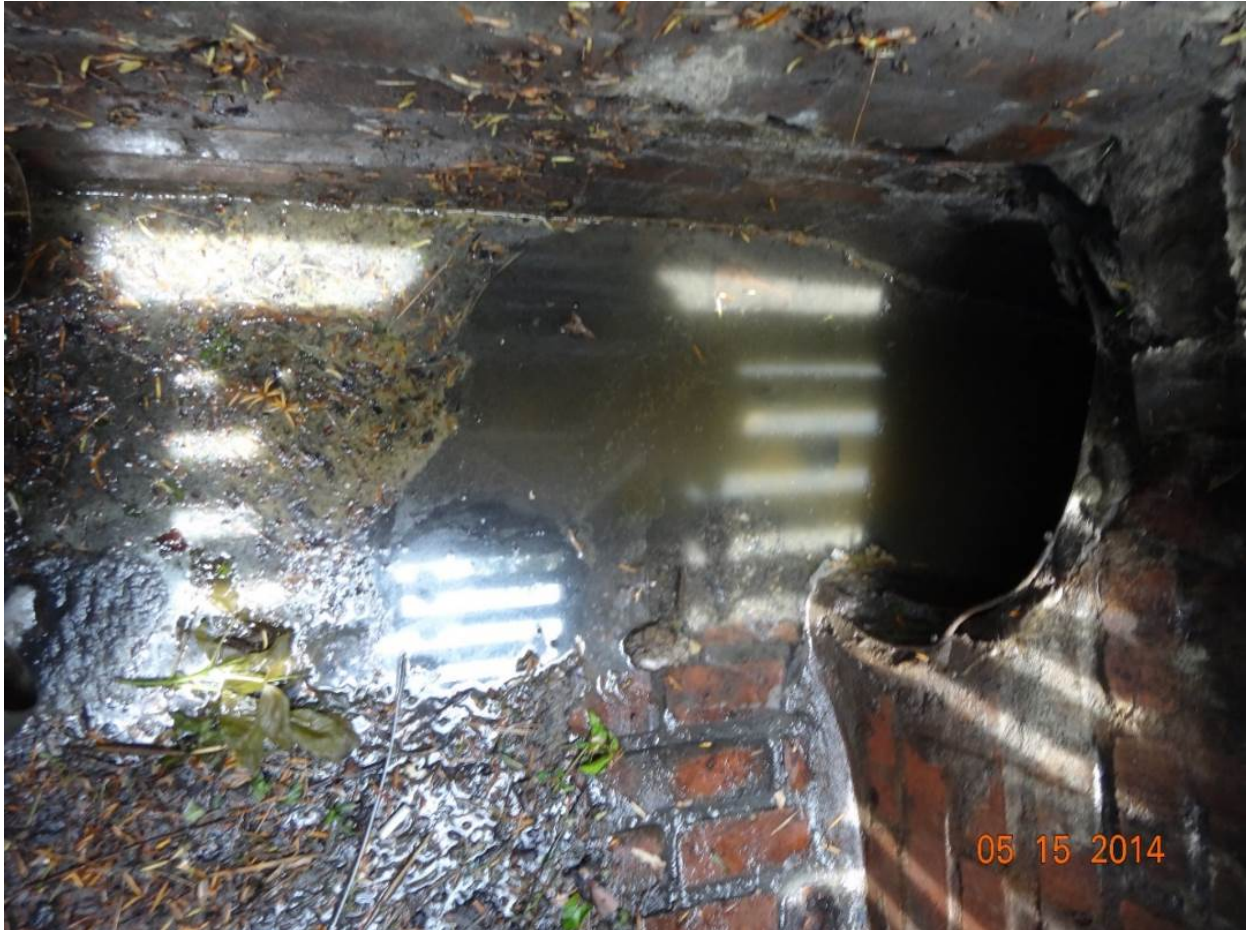
Within this curb inlet, the field team found some standing gray water with a strong foul odor (Figure 3). Testing of the water again yielded elevated detergents (0.75 mg/l) and elevated ammonia (0.2 mg/l). A general inspection of the area around the curb inlet and of the loading dock area showed no signs of active illicit discharge activities. The field crew noted and photo-documented conditions of the dock area as the curb inlet grate was generally grungy and some staining of the pavement from the direction of the loading dock toward the curb inlet was readily apparent (Figure 4). Some residual puddled grey water was found in the area as well but staff couldn't discern the source. Field crew noted the condition of the loading dock to be messy. One large rollaway dumpster had some residual fluid on the ground adjacent to the dumpster and

Figure 3. Interior of curb inlet in the loading dock area of Embassy Suites, 1300 Concourse Drive, showing off-color water; detergent concentration was 0.75 mg/l

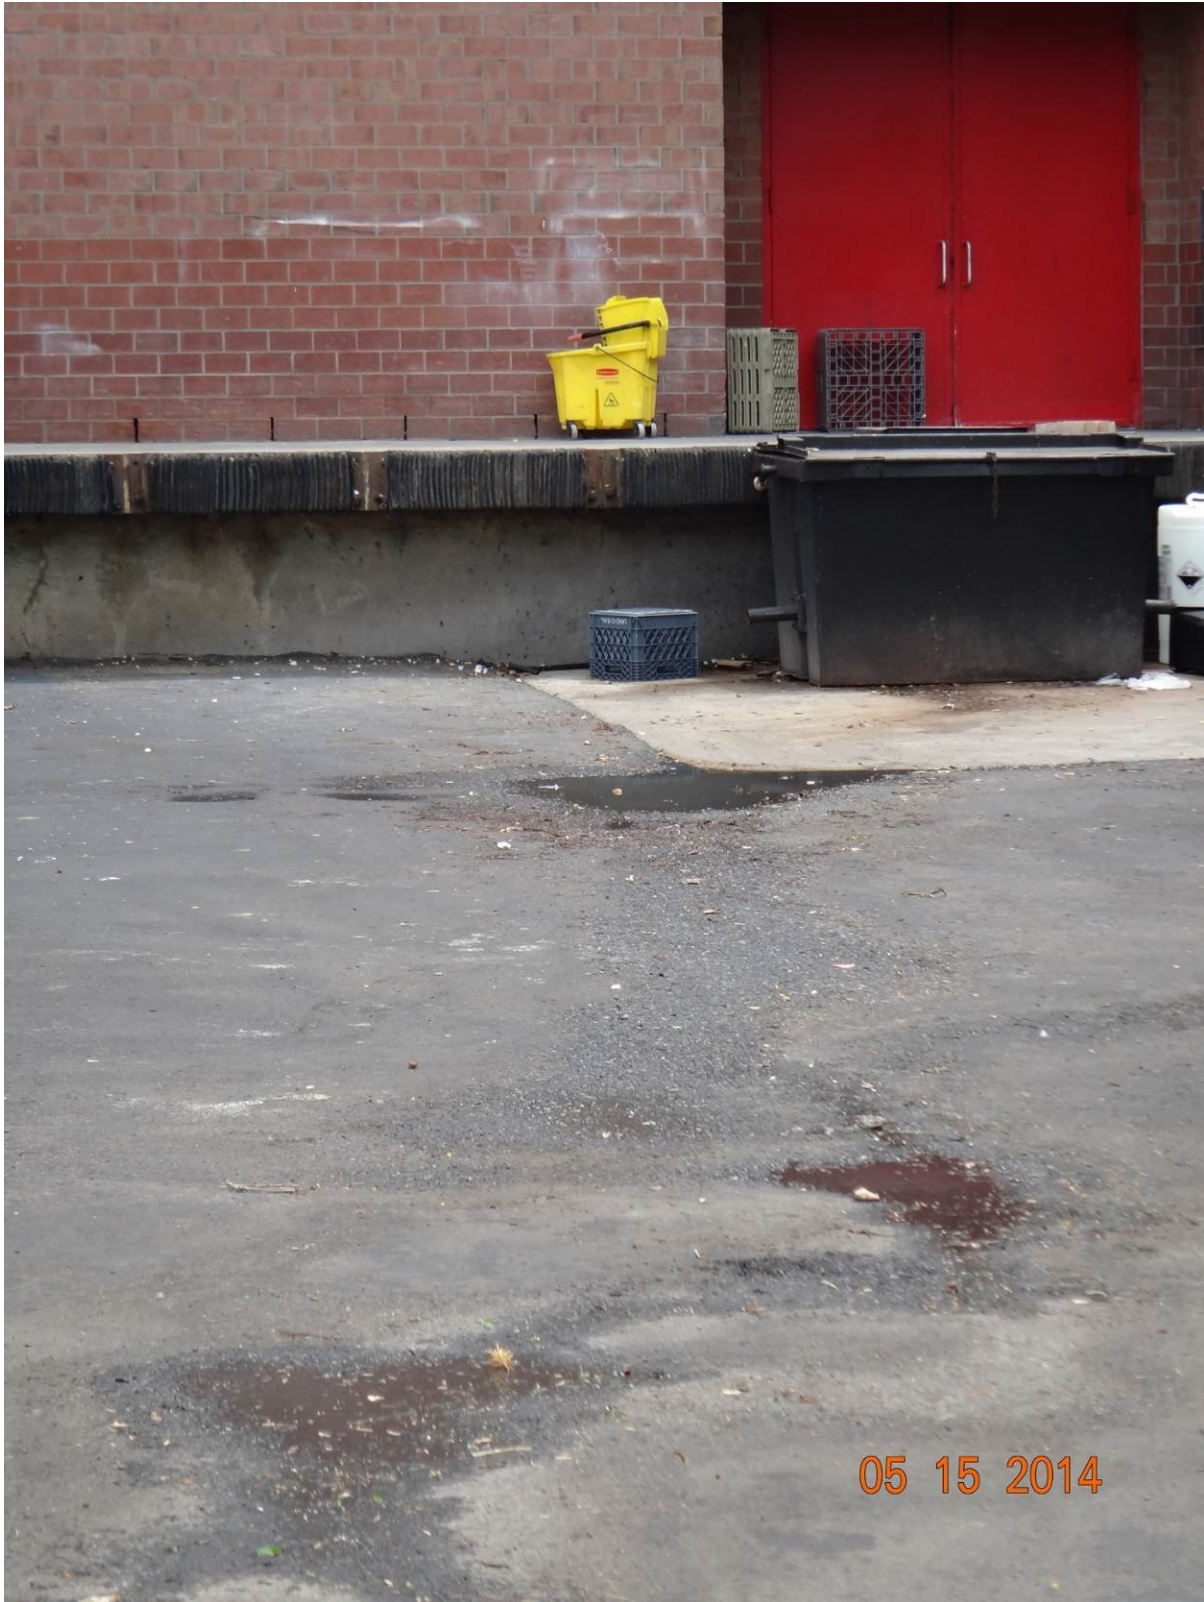
Figure 6. Loading dock area showing mop pail and puddles of water

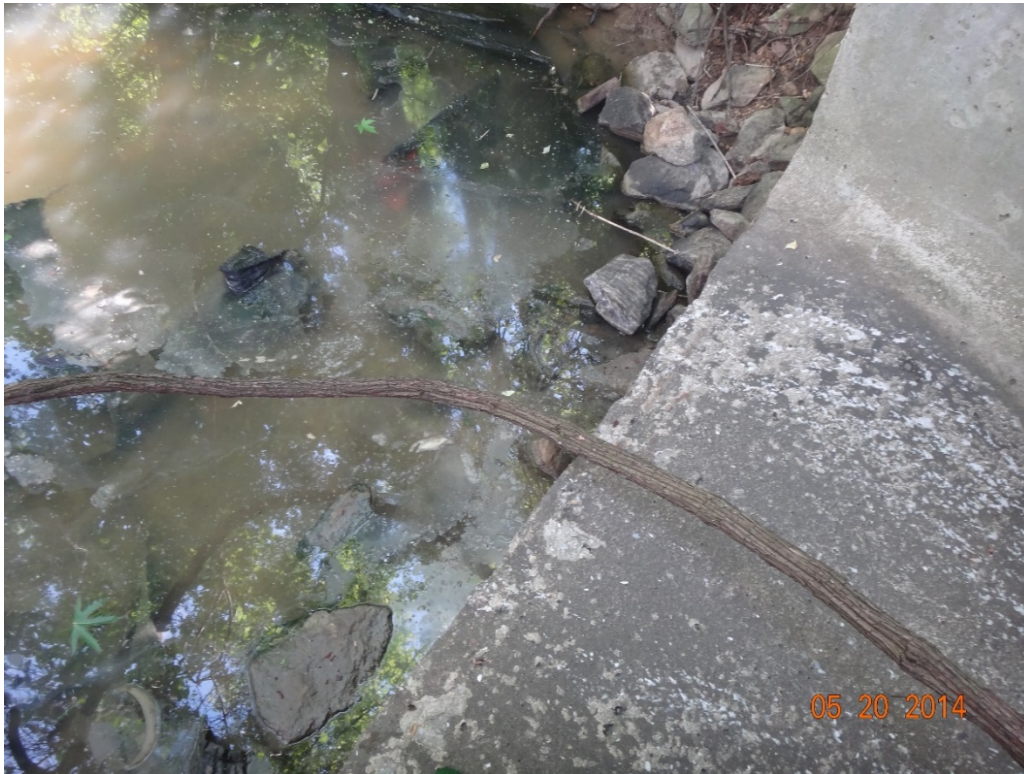
Figure 2. Close-up of Outfall J04C1O018 showing the paper-like material on the apron

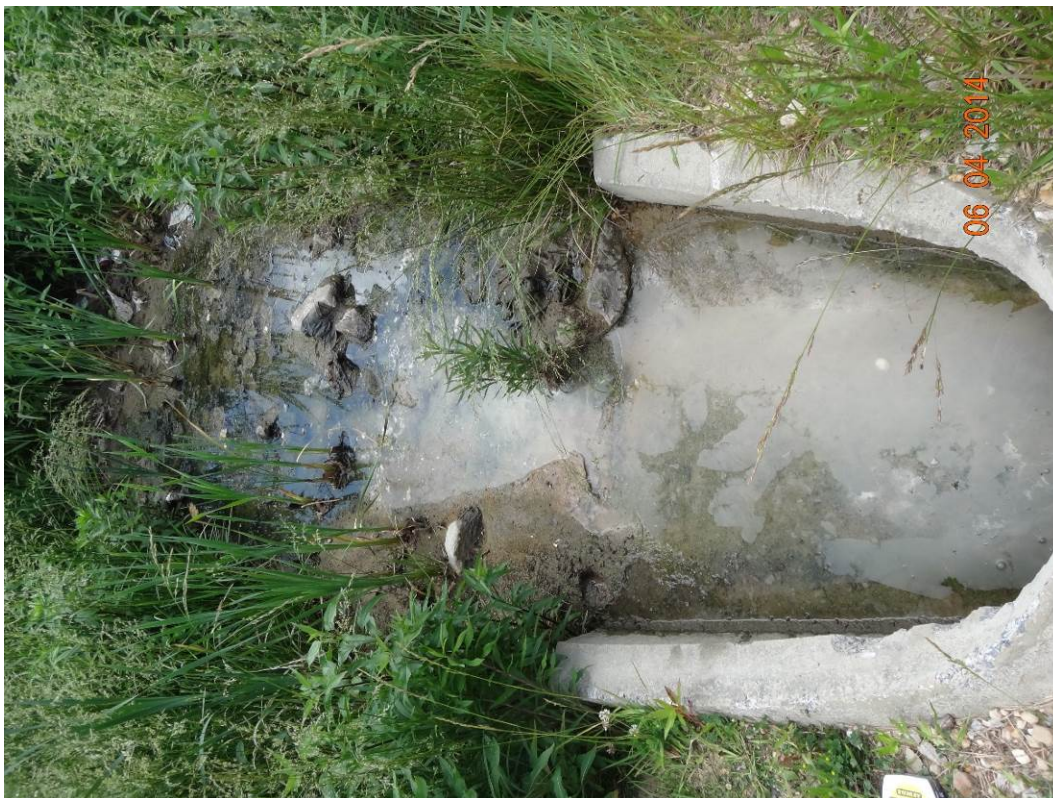
The following afternoon, the field crew returned at approximately 2:30 p.m. The pH of the flowing water at the outfall was 10.60 (Table 1, Test 2) and the whitish film on the water surface at the outfall was again noted (Figure 2). Field staff then initiated trackdown procedures to determine the source of the flow. The hotel (Aloft Hotels) at 1741 W. Nursery Road is newly built and therefore the building and stormwater infrastructure are not on the County orthophotography or in GIS data sets. The team investigated the stormwater infrastructure using line-of-sight to determine connections. The field crew opened the first manhole upstream of the outfall and found it to be a junction of two pipes that were both partially submerged (Figure 3). The pipe coming in from the left side (when facing up-network) was flowing slightly and the field crew obtained a pH of 10.90. This pipe also showed signs of a mineral deposit at its end. The field crew proceeded to the first inlet up the network from the first manhole. Within the first curb inlet, the field team found minimal water, which was insufficient to test; yet, the field crew noted whitish residue and deposition in the pipe (Figure 4). Up-network of the first curb inlet was a second curb inlet located on the other side of the hotel entrance. The second curb inlet was dry but seeping stains could be seen running down the inside wall, from a gap in the concrete, and into the pipe (Figure 5).

Figure 2. Whitish film on water surface at outfall

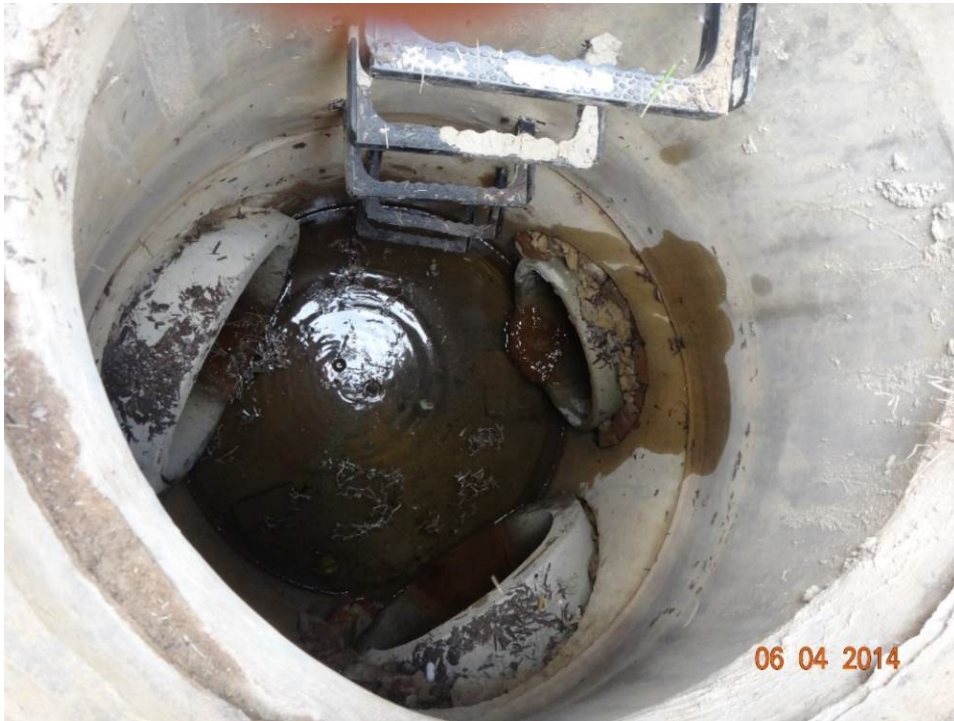
Figure 3. Inside of manhole upstream of outfall; the pipe on the left flows toward the outfall; the smaller pipe on the top right seen flowing and with depositional buildup is the probable source of the high pH levels

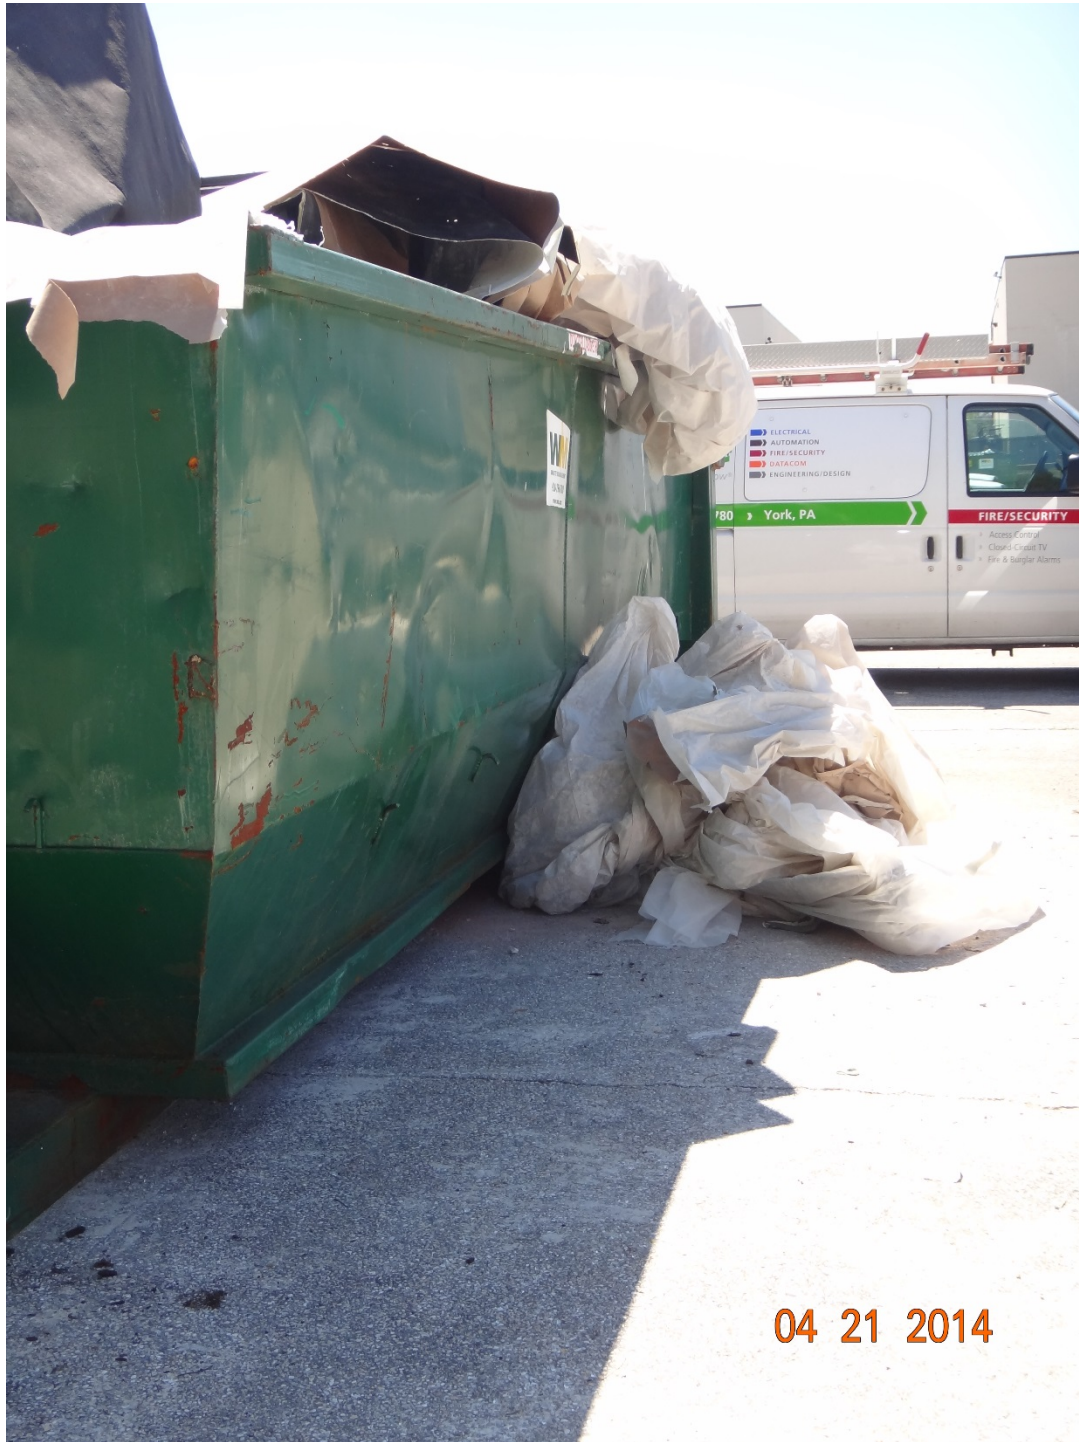
Figure 2. Debris deposited alongside dumpster

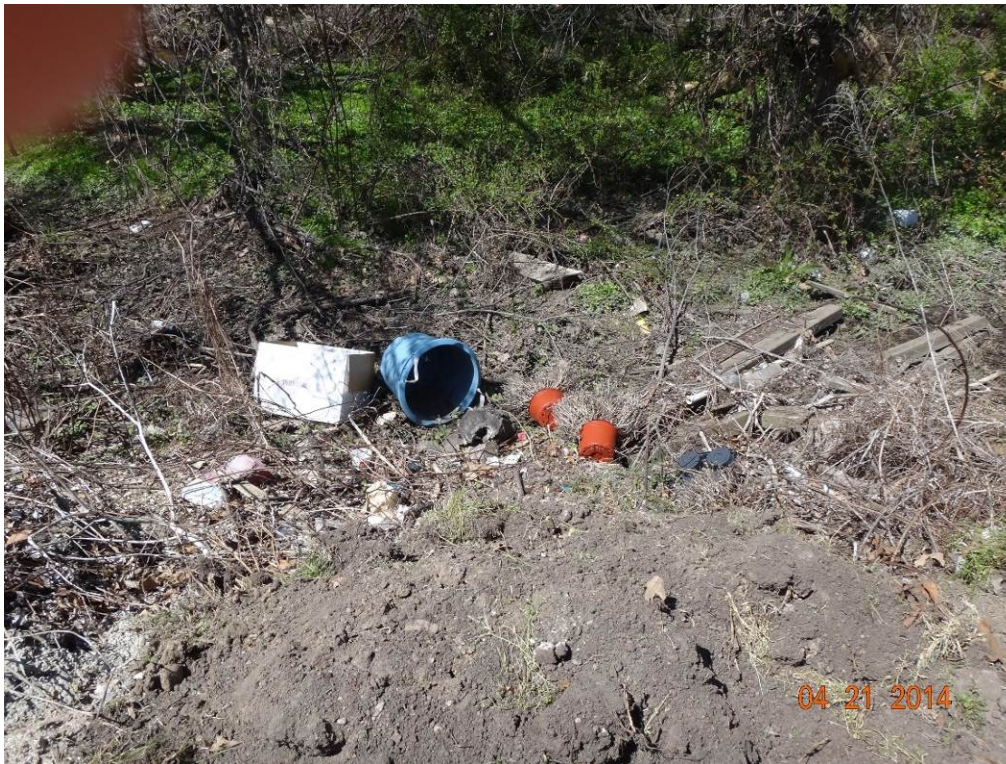
A Versar and LimnoTech field team identified a dumpsite in the floodplain of Sawmill Branch during the joint field calibration day. The team was attempting to locate an outfall at the rear of the property and discovered freshly dumped soil and material on the northern periphery of the parking area (Figure 1 and Figure 2). The name and address of the property could not be immediately ascertained; however, it appeared that the building in the rear holds an operating snowball stand and the building adjacent to the road had been used for a bait and tackle shop. Additionally, at the rear of the premises were two areas of stored and discarded material; however, the material was on pervious surfaces located approximately 20 meters from the stream (Figure 3). The material consisted of five-gallon buckets and other articles of plastic. An area map appears in Figure 4 with the location of the problems indicated.

Figure 1. Dumping area in floodplain of Sawmill Branch

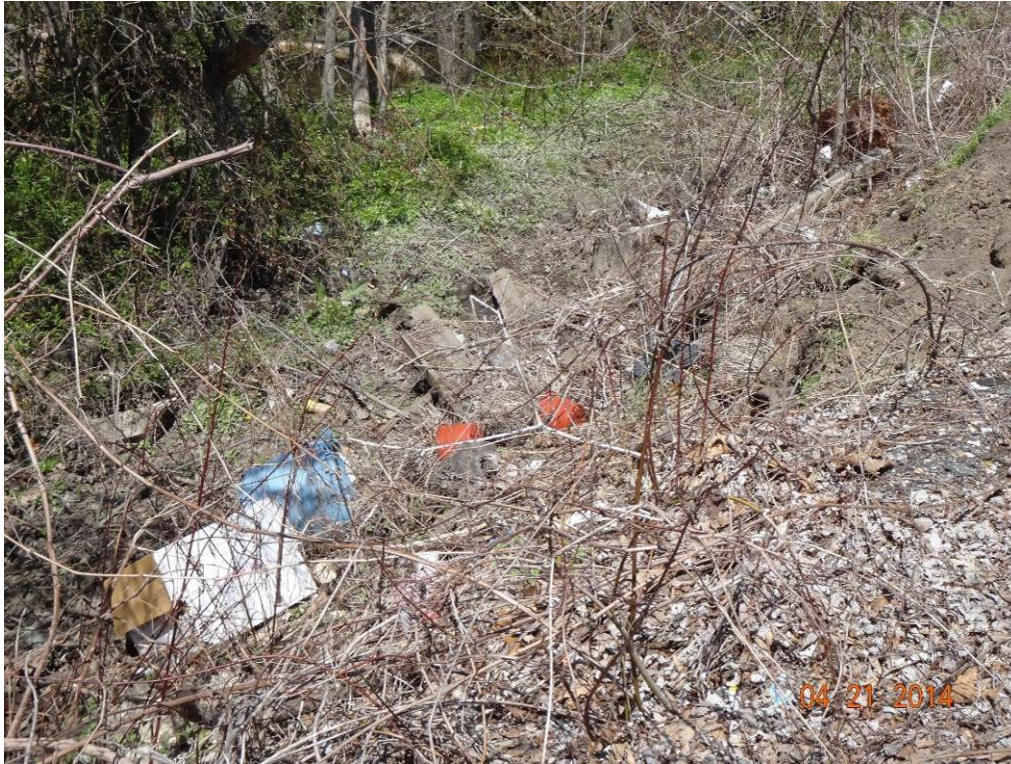
Figure 2. Dumpsite adjacent to parking area (foreground) and Sawmill Branch (background)

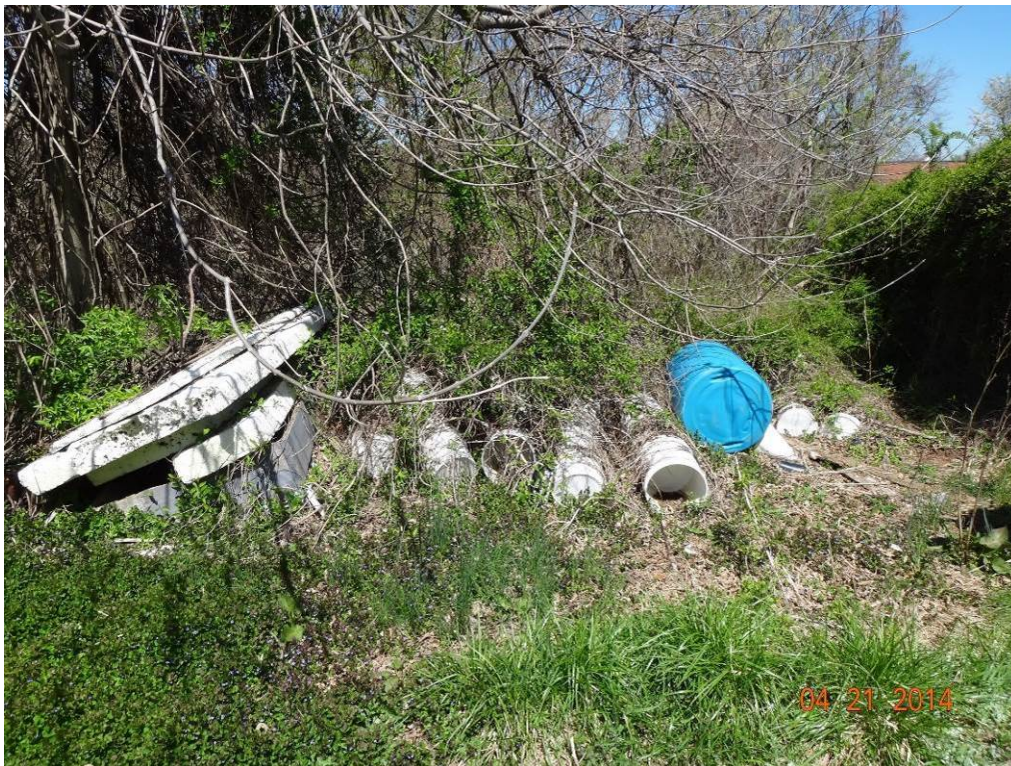
Figure 3. Discarded material in rear of property

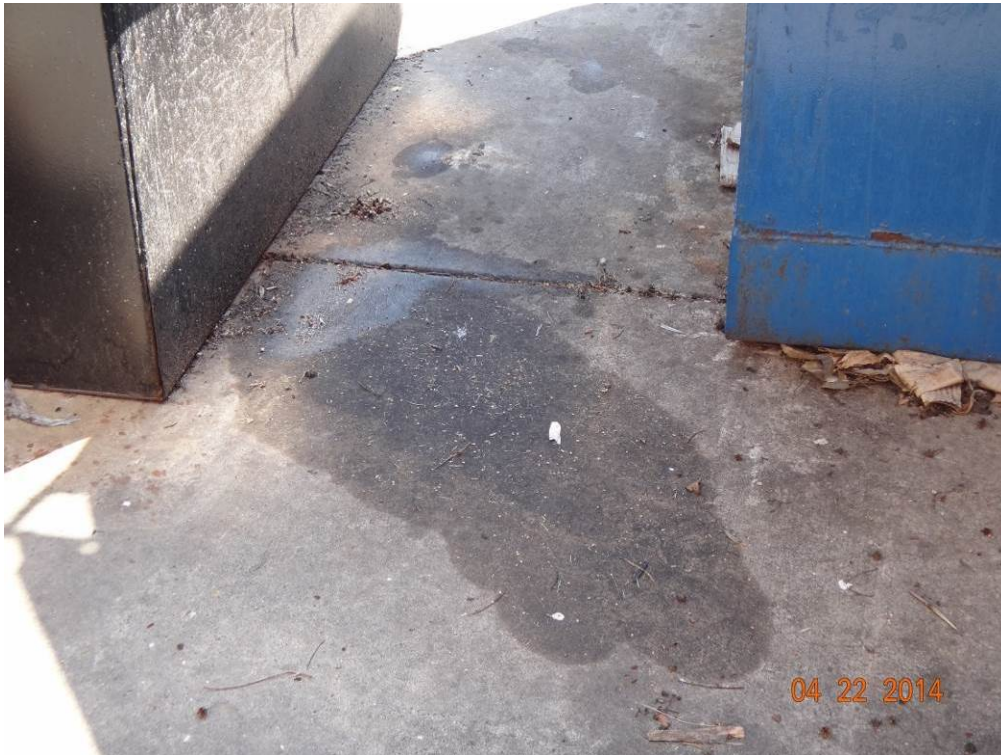
Figure 2. Detail of a grease spill near the waste grease container

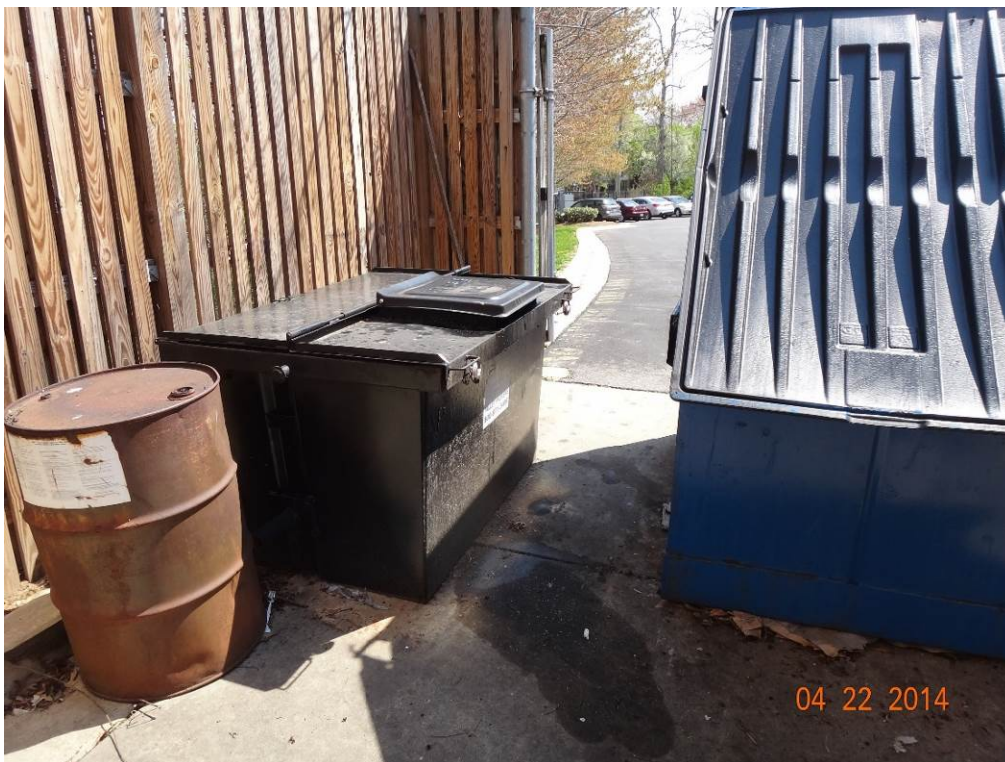
Figure 3. The waste grease container, open dumpster, and unidentified drum in the dumpster stall area

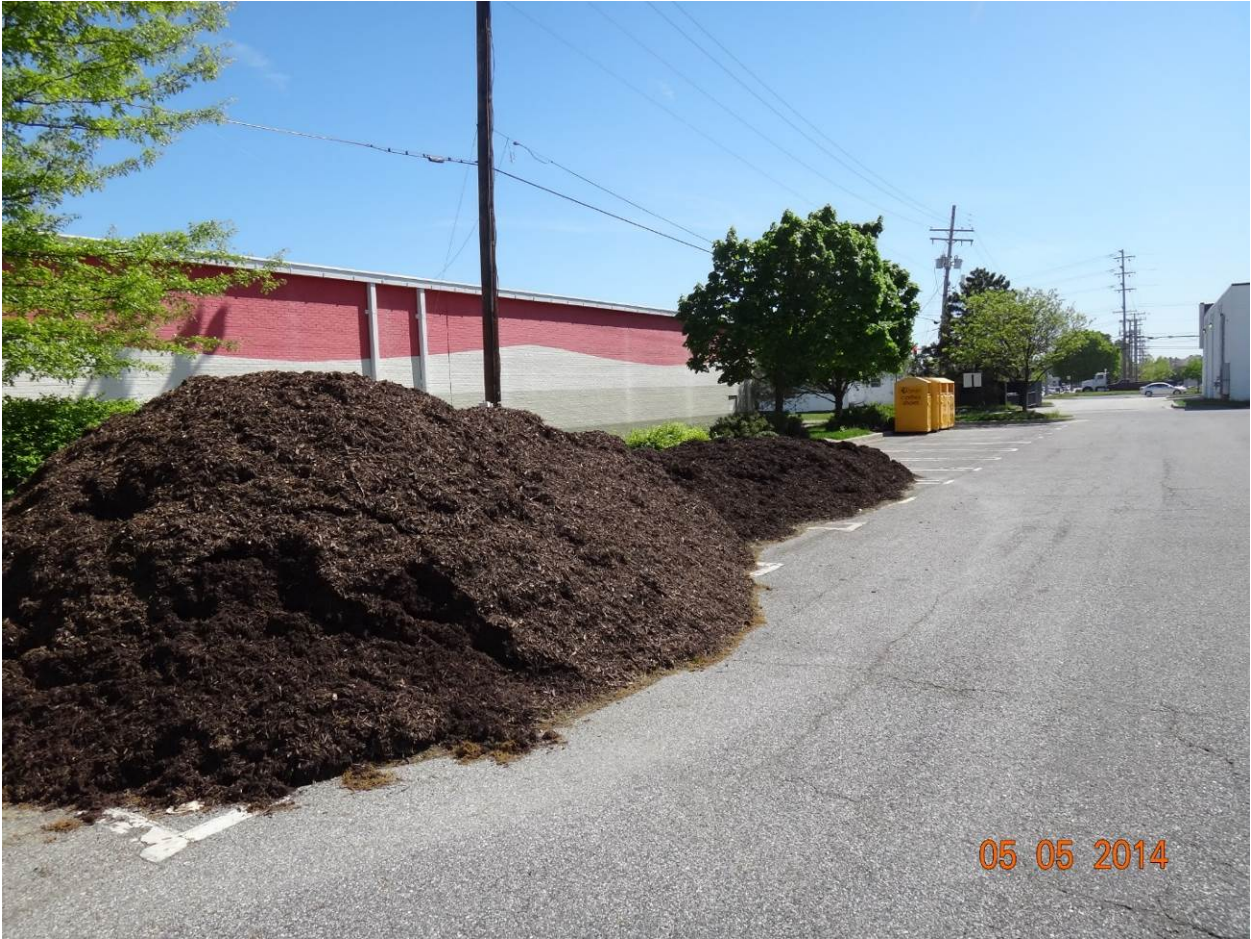
Figure 2. Extent of mulch pile across several parking spaces

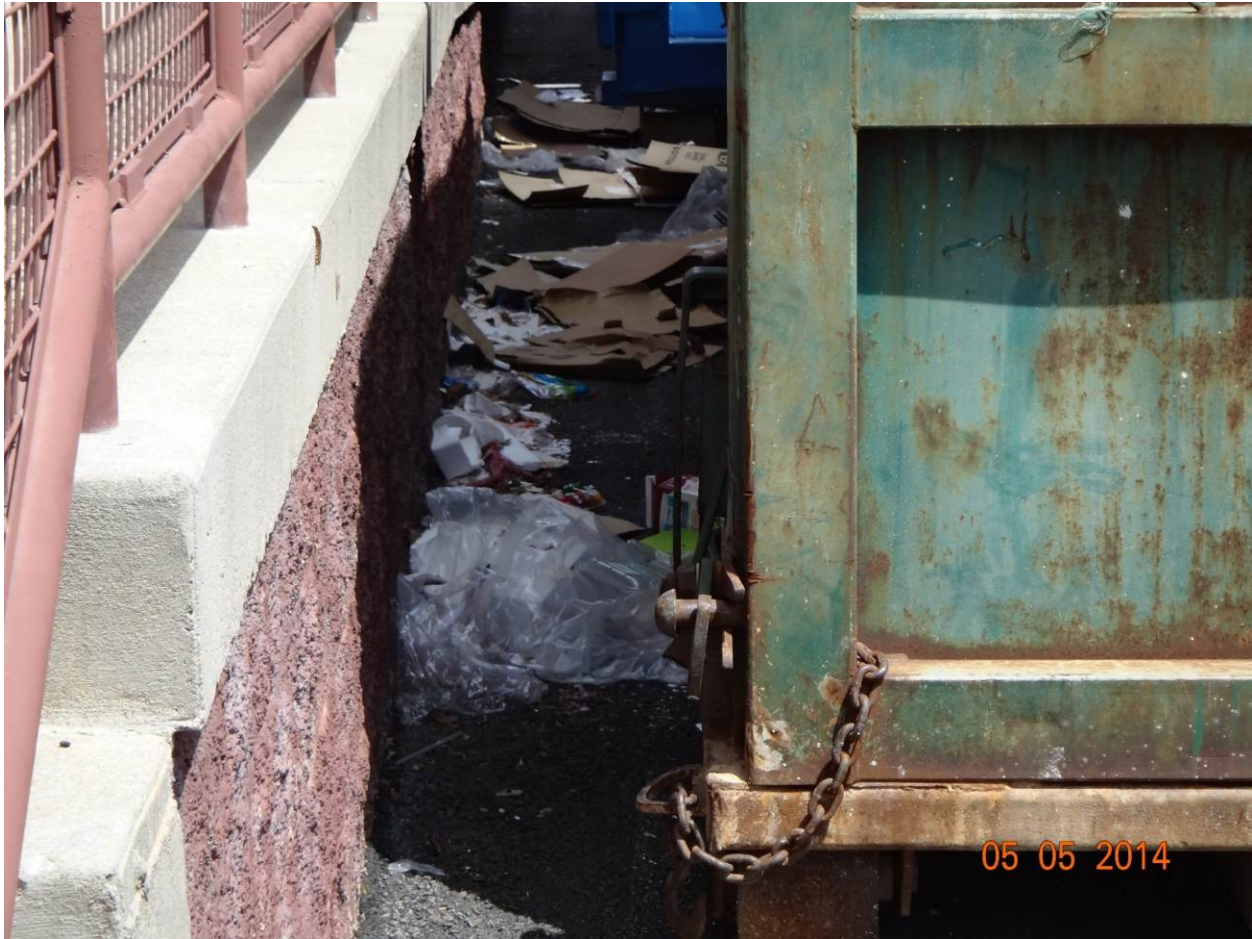
Figure 2. Debris between the roll-off dumpster and the Target building

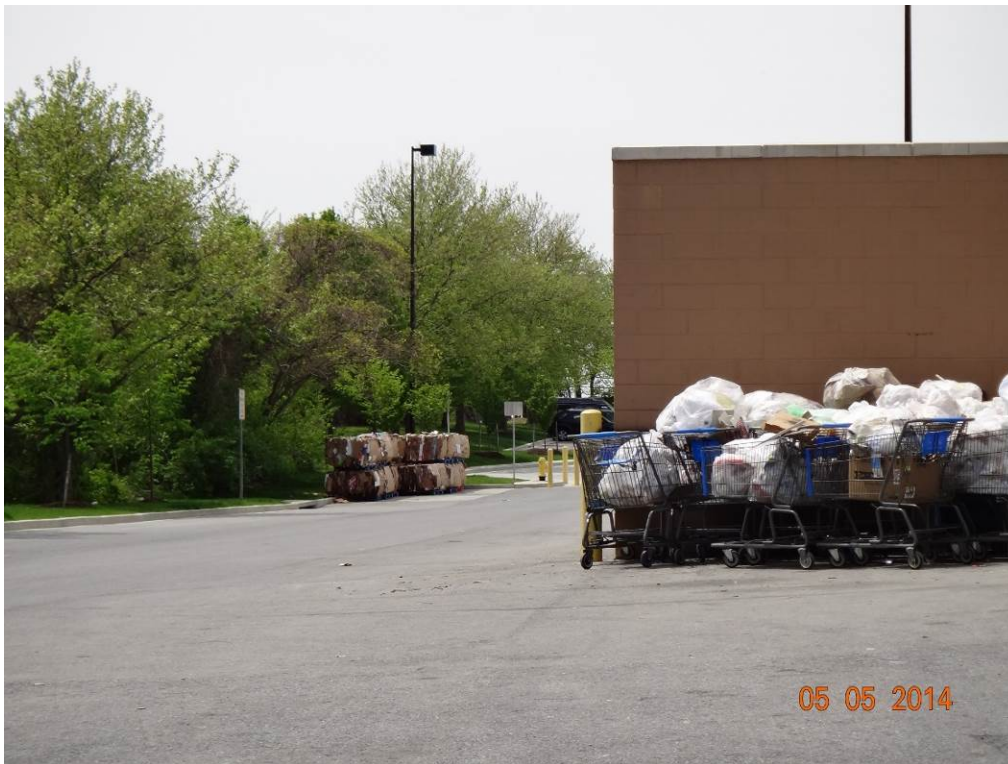
Figure 3. Trash stored in shopping carts (foreground) and bales of cardboard near storm drain inlet (background)

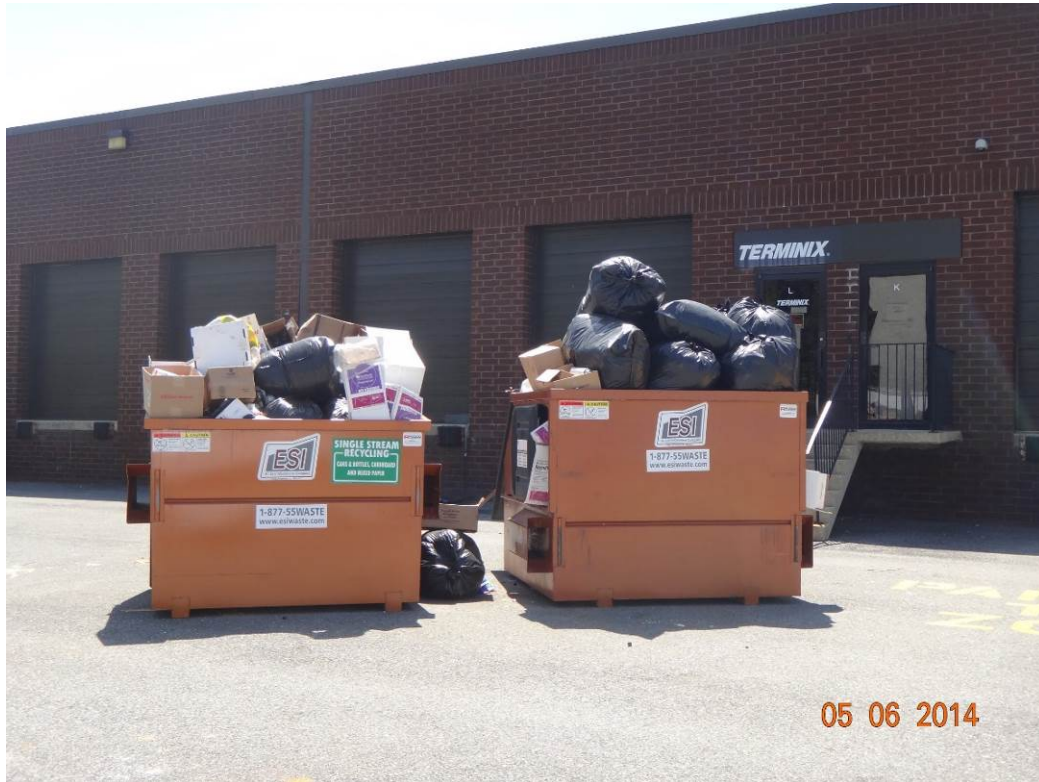
Figure 2. Overflowing recycling bins
