**ILLICIT DISCHARGE DETECTION
AND ELIMINATION
2014 ANNUAL REPORT**

PERMIT NUMBER MD0068306

Versar, Inc.
9200 Rumsey Road
Columbia, MD 21045

October 2014

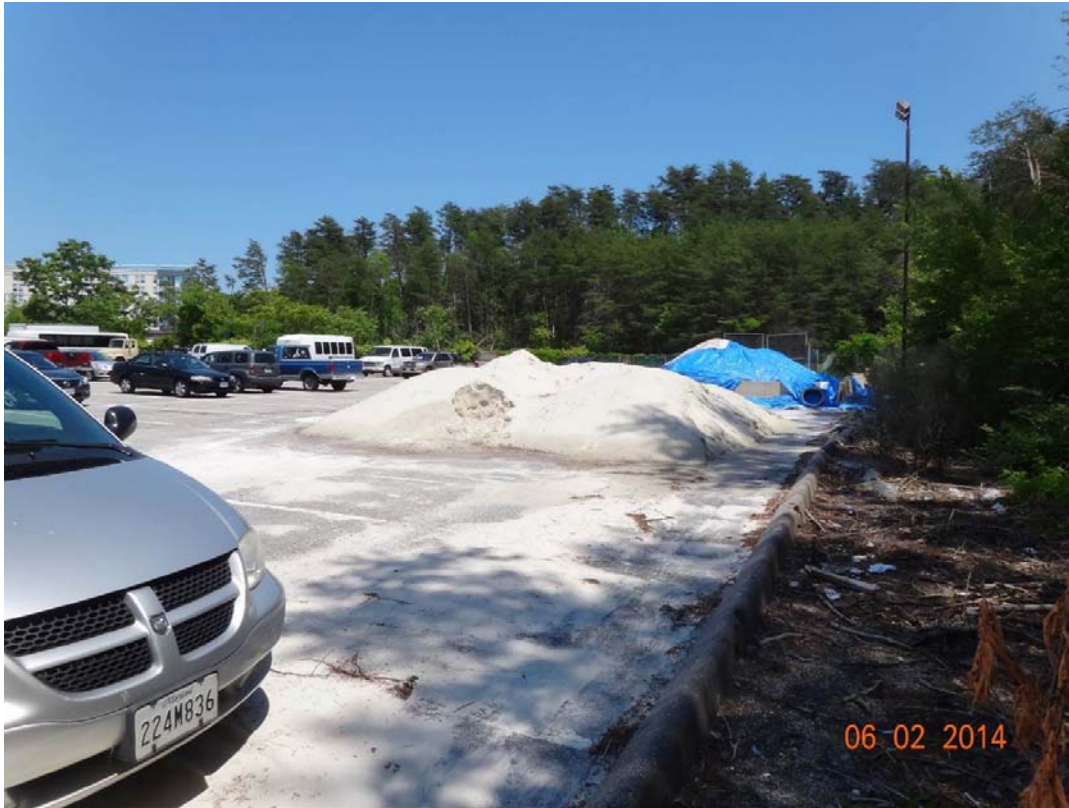
Figure 2. Sand pile and some of the associated runoff in the parking area
