**BIOLOGICAL AND
GEOMORPHOLOGICAL CONDITION
IN THE PICTURE SPRING BRANCH
SUBWATERSHED, SEVERN RIVER
WATERSHED, ANNE ARUNDEL COUNTY,
MARYLAND: 2016 - 2017**

FINAL REPORT

Versar, Inc.
9200 Rumsey Road
Columbia, MD 21045

February 8, 2018

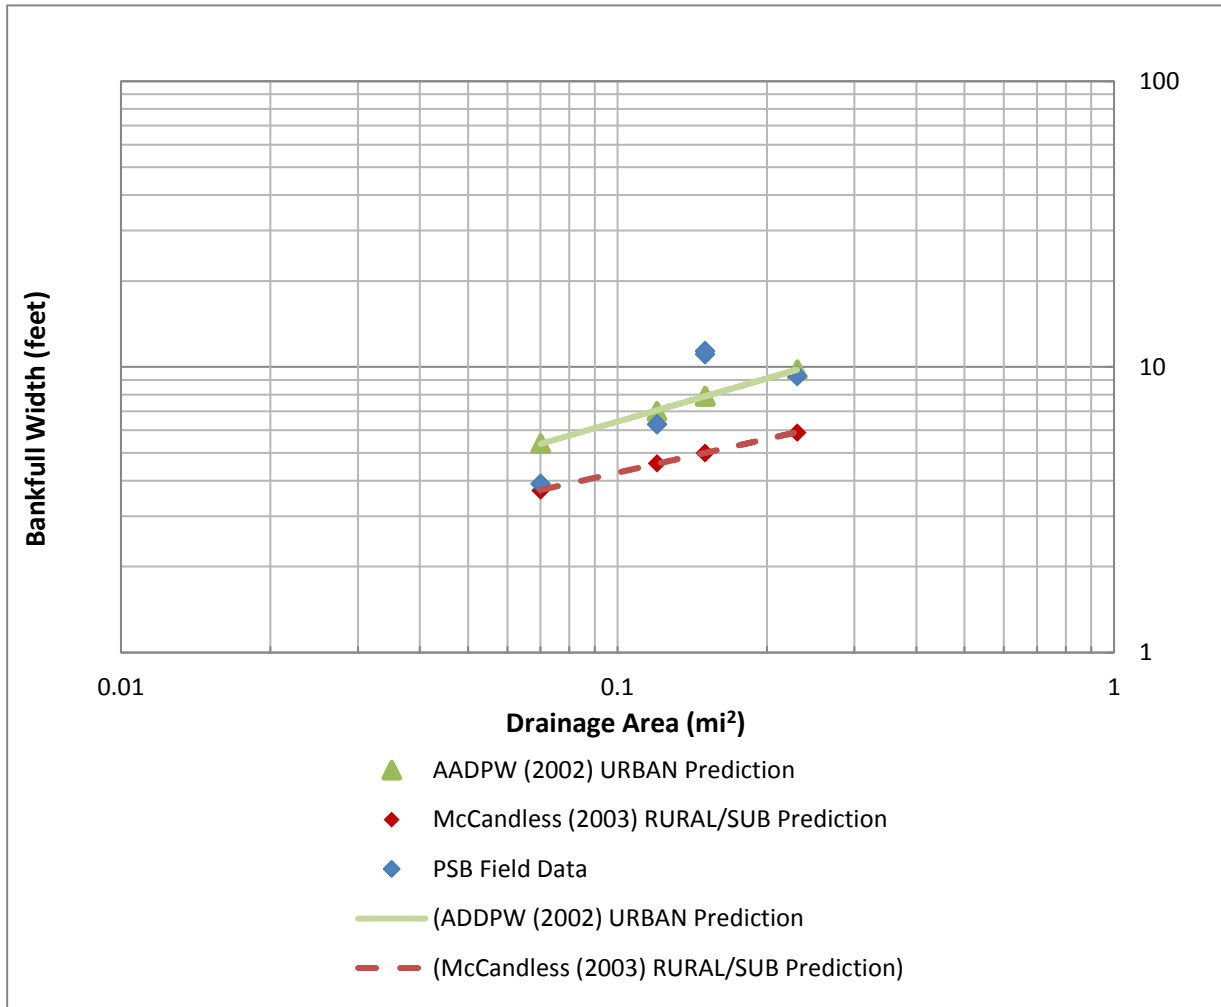
Figure 3-1. Comparison of the bankfull width drainage area relationship between Picture Spring Branch (PSB) 2017 field data and regional relationship curve data

The geomorphic assessment field data were compared to both the Maryland Coastal Plain (MCP) regional relationships of bankfull channel geometry (McCandless 2003) and relationships for gaged urban Coastal Plain streams developed specifically for Anne Arundel County (AADPW 2002) to determine how bankfull characteristics observed in the field compared to those predicted by the MCP and urban relationships. Comparisons of bankfull width, bankfull cross-sectional area, and mean bankfull depth are shown in Figures 3-1, 3-2, and 3-3, respectively. Bankfull width values tended to loosely fit the predictions of the urban curve, with some points wider than predicted due to the engineered channel design. All bankfull cross-section area field data values fell between the MCP curve and urban curve predictions. Field data for mean bankfull depth mainly fell between the MCP curve and urban curve predictions, with one site falling just below the MCP curve. Overall, it appears that some of the field data were not consistent with the MCP relationships; however, it should be noted that the regional curves were developed using streams with drainage areas ranging from 0.3 to 89.7 square miles, with the majority of the data collected in watersheds greater than one square-mile with low (zero to three percent) imperviousness. Thus, it is possible that stream channels with smaller drainage areas, such as those studied in this assessment (ranging from 0.07 to 0.23 square miles), exhibit greater variability in channel dimensions when compared to the MCP relationships. Additionally, the Rosgen method is best used on streams that are free to adjust their lateral boundaries under the current discharge regime experienced by the system (Rosgen 1996), conditions which do not necessarily exist in the study area. For example, cross-sections 2, 3, and 5 are underlain by concrete trapezoidal channels, possibly making the accurate determination of the bankfull indicators in the field at these locations problematic. Regardless, given the high imperviousness of the study drainage area and the modified nature of the channel, it is not surprising that the field data deviated in many cases from the MCP curve and were more closely matched to urban curve predictions for bankfull width.

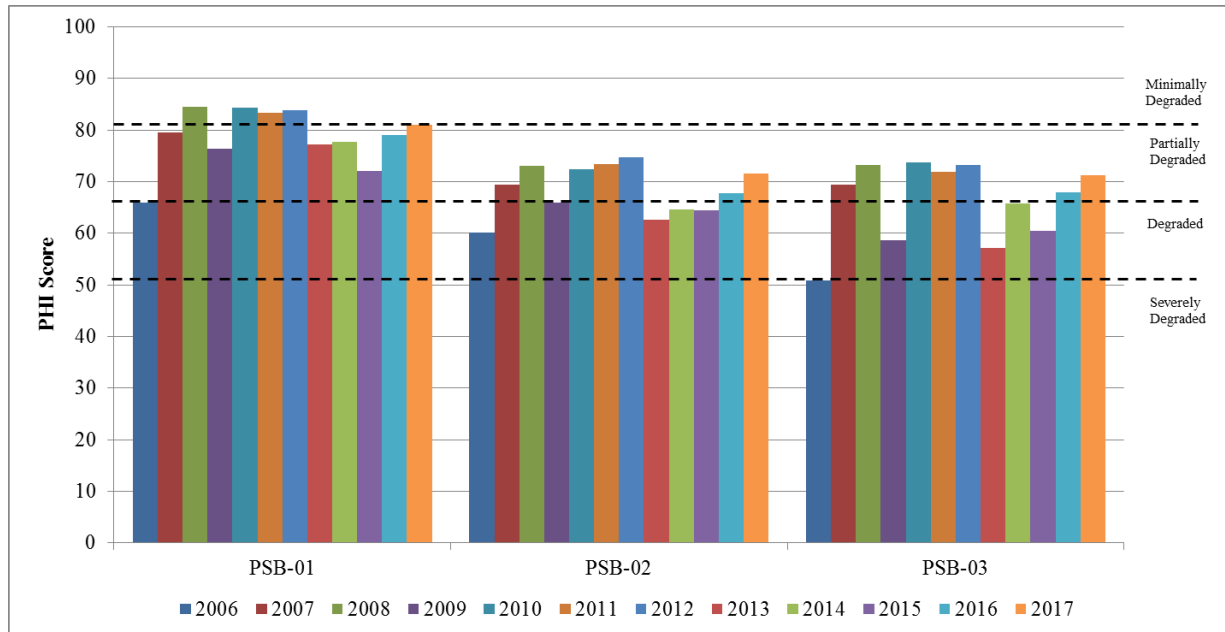
Figure 4-1. Comparison of PHI Habitat Scores from 2006 through 2017

During the past five years of monitoring, PHI scores have fluctuated slightly from year to year (Figure 4-1). Fluctuations in annual physical habitat scores may be attributed to two primary factors: 1) changes in habitat suitable for colonization (i.e., changes in substrate/embeddedness and changes in the quantity of woody debris) affects direct scoring of this parameter, and also indirectly influences scoring for epifaunal substrate and instream habitat; and 2) variability in qualitative visual assessment scoring between field crews.

Rating	Partially Degraded	Partially Degraded	Partially Degraded
2017	PHI Score	81.1	71.5	71.2
	Rating	Minimally Degraded	Partially Degraded	Partially Degraded

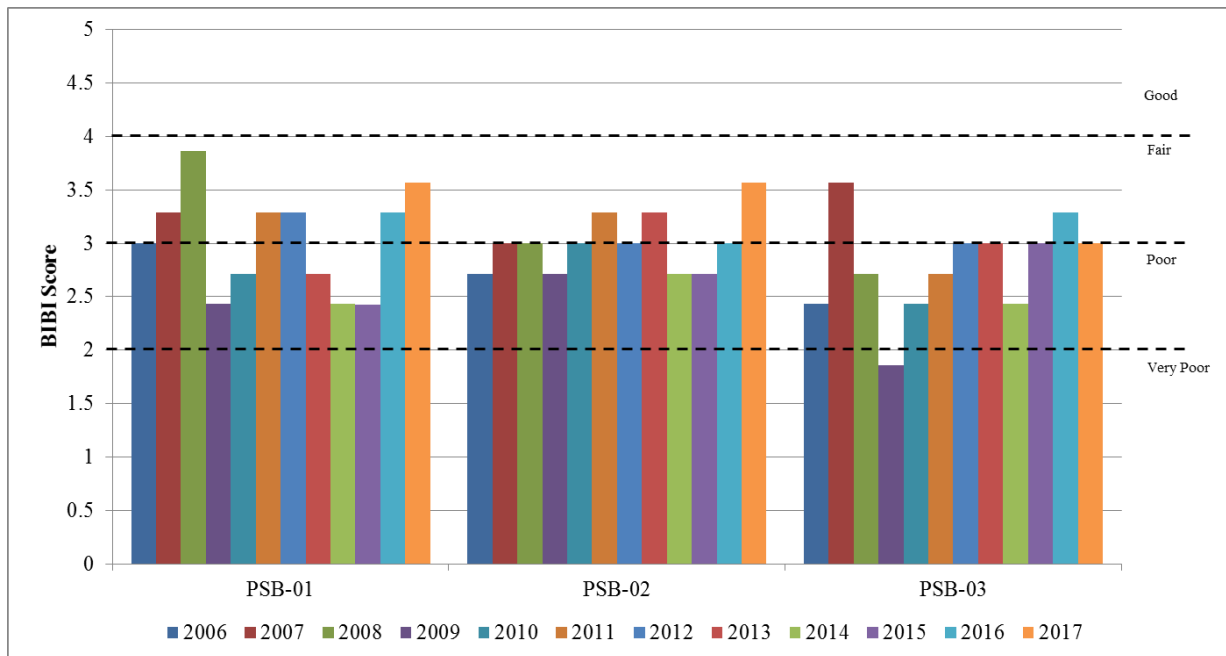
Figure 4-2. Comparison of BIBI Scores from 2006 through 2017

In 2016 and 2017, the benthic macroinvertebrate community at all three sites within the Picture Spring Branch study area were rated as “Fair”. These BIBI scores are higher than in 2014 and 2015, and rank in the “Fair” category for the first time since 2012. A variety of the individual BIBI metrics have shown steady increases over this time period. For example, taxa diversity as measured by total taxa has increased at all three sites every year since 2014. Percentage of sample intolerant to urban stressors at sites showed improvement as well and increased in percentage of sub-sample for the last three years. In 2017, these individuals ranged from 3.4% (PSB-03) to 26.1% (PSB-01) of the total specimens. Percentages of climbers also increased at all three sites. No Ephemeroptera taxa were found at any site during this sampling period. Figure 4-2 provides a visual comparison of BIBI scores over time.
